Lake Superior South Watershed Stressor Identification Report

Evaluating potential causes of degraded fish and aquatic macroinvertebrate communities in the
Lake Superior South Watershed

Document number: wq-ws5-04010102a

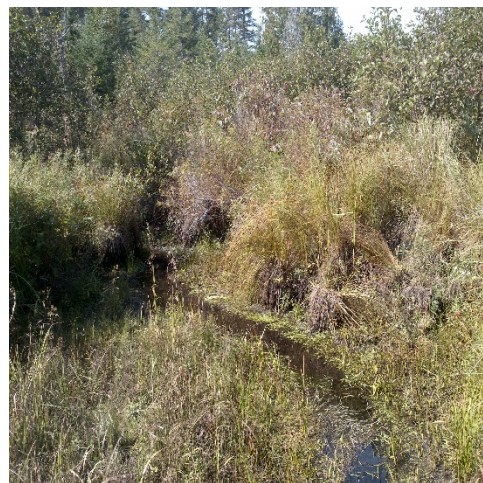
Figure 3. Cold water from a tributary spring to Brophy Creek in the Sucker River watershed near Duluth

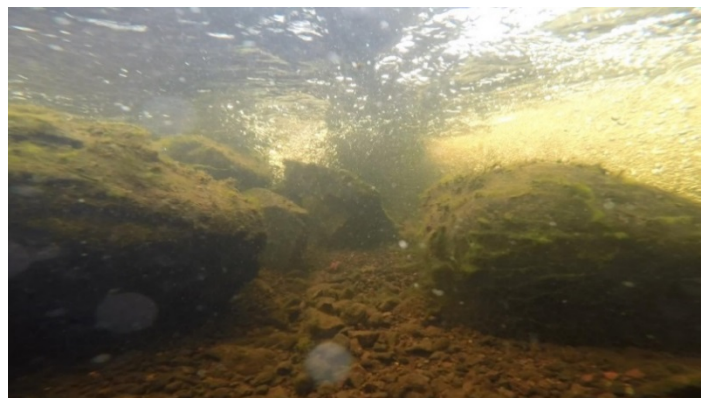
Figure 4. Oxygen diffusion within the water column

its capability to hold oxygen decreases. Low DO can be an issue in streams with slow currents, excessive temperatures, high biological oxygen demand, and/or high groundwater seepage (Hansen, 1975). In most streams and rivers, the critical seasonal conditions for stream DO usually occur during late summer when water temperatures are at or near the annual high while stream flow volumes and rates are near base flow. The critical daily period for DO is early morning, when the daily DO flux is at its minimum.

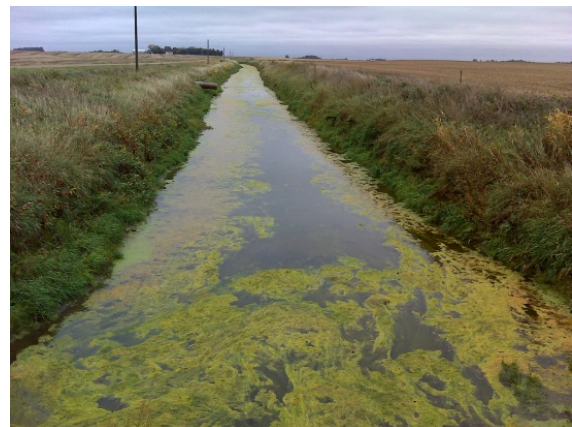
Figure 5. Excessive production of algae in a stream

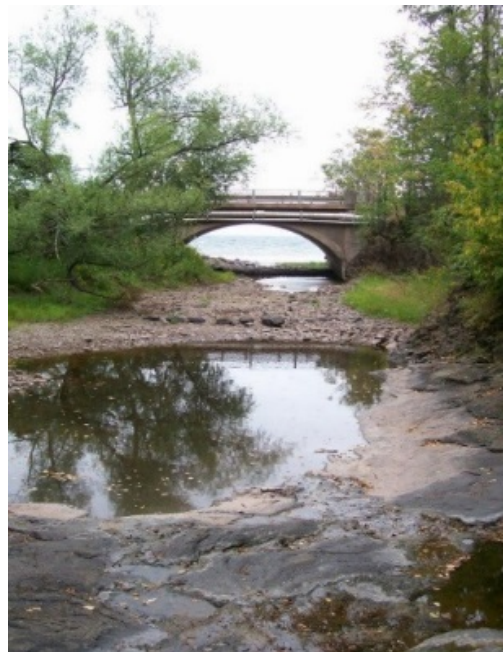
Figure 6. Stream with lack of adequate flow.
Photo: Talmadge River near Duluth, MN
Credit: Jesse Schomburg (MN Sea Grant)

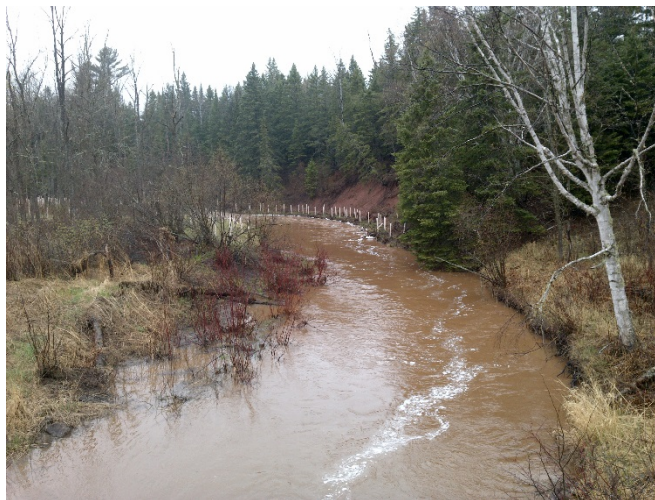
Figure 7. Elevated TSS concentrations on North Shore Lake Superior tributary during spring snowmelt. Flute Reed River near Hovland, Minnesota.

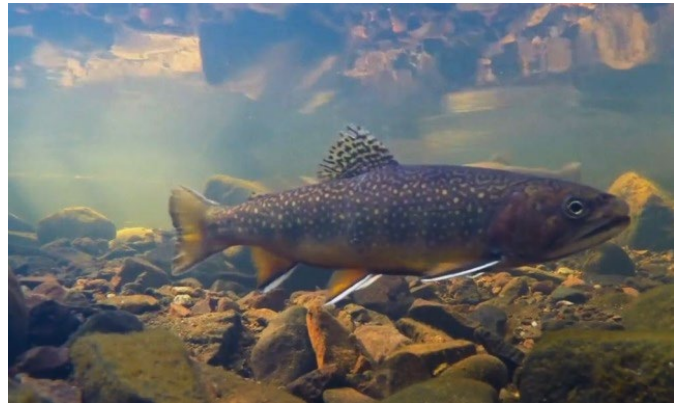
Figure 8. Brook trout require clean, coarse substrate for spawning. Photo: Knife River near Knife River, MN

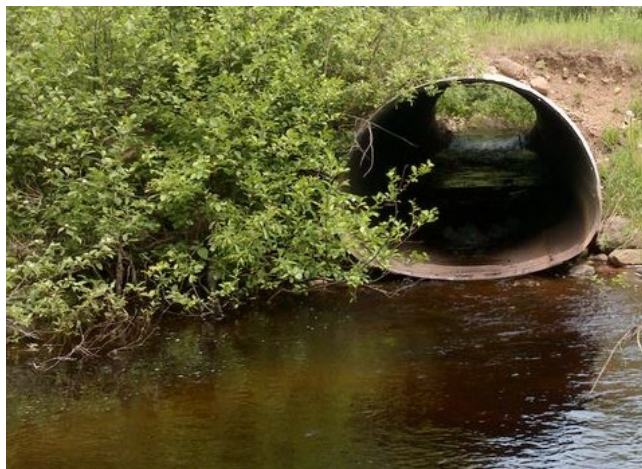
Figure 9. A perched culvert disrupting flow and fish passage on a North Shore Lake Superior tributary. Photo: Fredenberg Creek near Schroeder, MN

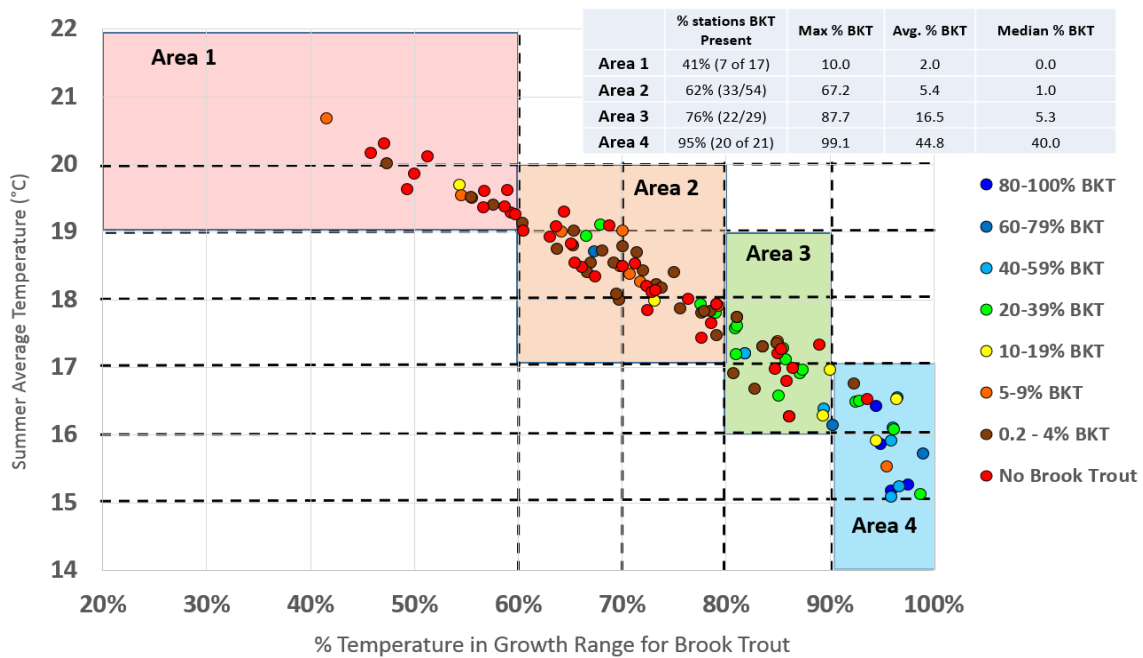
Figure 11. Scatter-plot of summer average temperature vs % of time temperature within Brook Trout growth range. Marker colors correspond to relative densities of Brook Trout sampled. Data include all Lake Superior South/Lake Superior North 8HUC stations with biological and temperature data from same season.

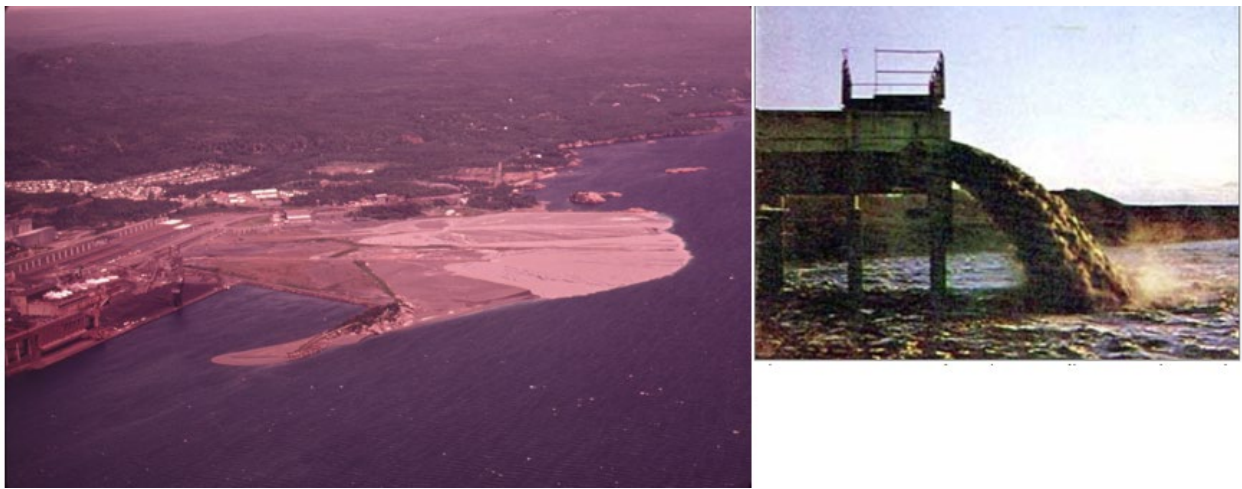
Figure 17. Reserve Mining Company discharged directly into Lake Superior at Silver Bay

In 1980, another prominent chapter in the history of this watershed occurred as Reserve Mining Company was ordered to stop discharging taconite tailings directly into Lake Superior. Reserve Mining began operations in Silver Bay in 1955 as a taconite pellet processing facility for iron ore mined in Minnesota's Iron Range. For every ton taconite pellets produced by the facility, two tons of waste rock (called "tailings") was left over. Over a 25-year period, as much as 67,000 tons per day of untreated tailings were discharged directly into Lake Superior under a permit issued to the facility from the State of Minnesota, forming a large delta of waste rock extending nearly a half mile into the lake (Figure 17). Other environmental concerns surfaced, including several related to the public health of area residents, and Reserve Mining was ultimately forced to cease this discharge in 1980 as part of an order issued by a federal judge.

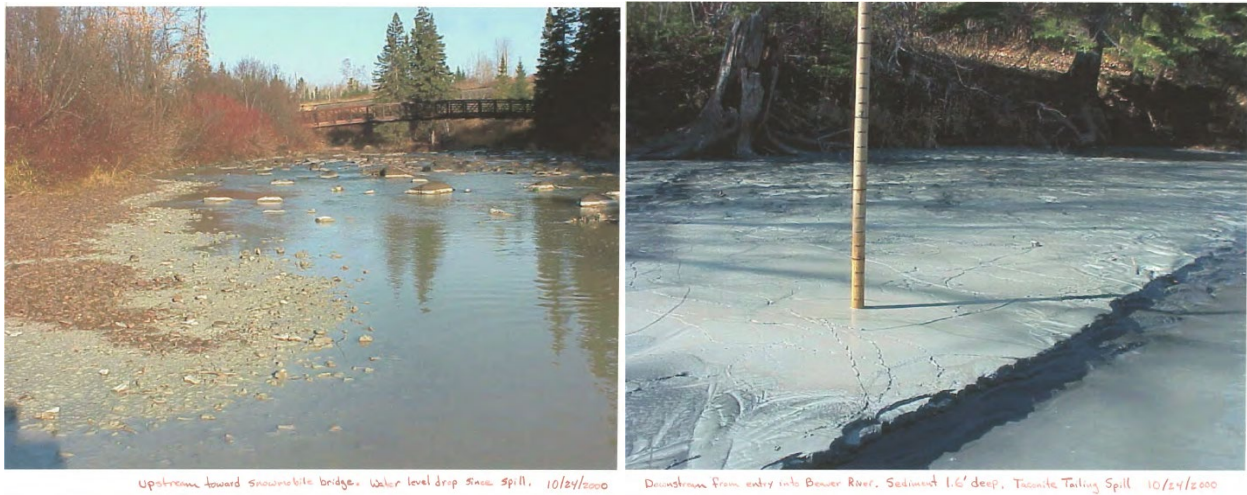
Figure 18. Effects of October 2000 pipeline break that spilled 10 million gallons of taconite tailings slurry into the Beaver River watershed

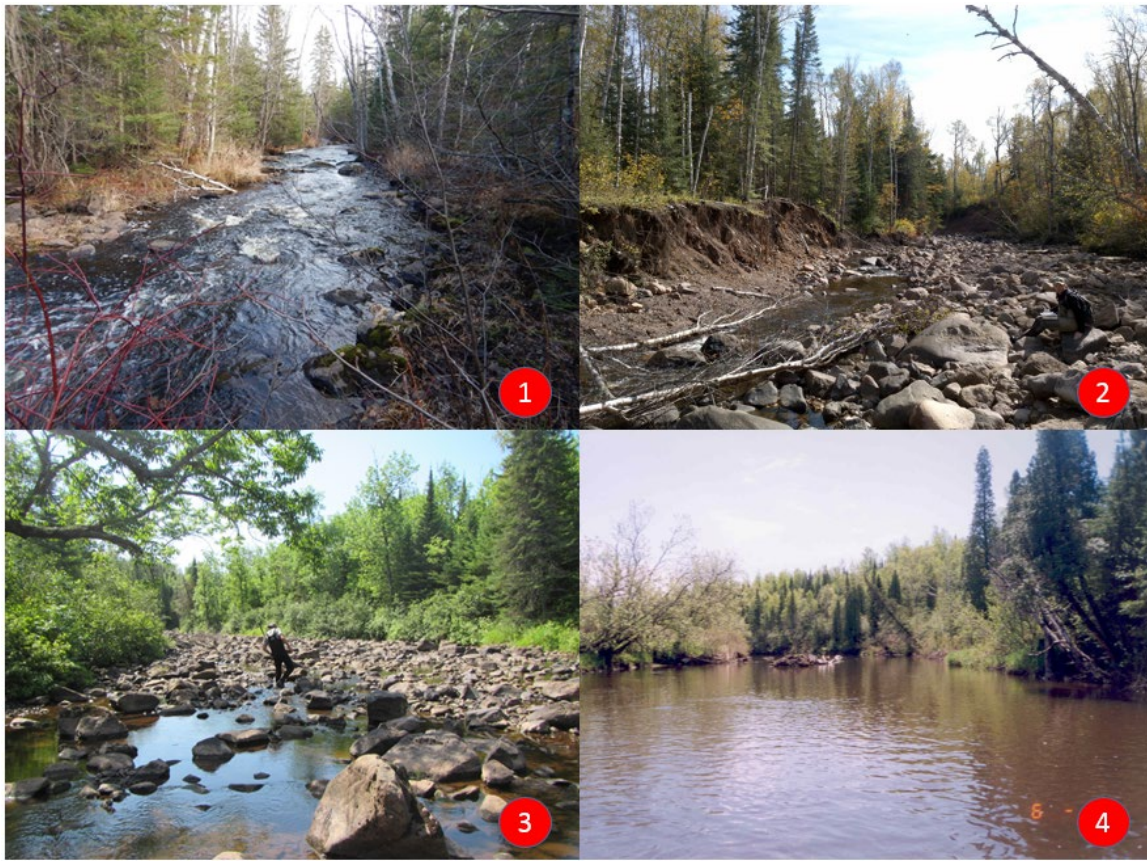
Figure 23. Examples of stream channel condition along the Beaver River. Conditions in photos 2-4 lead to warmer water temperatures.

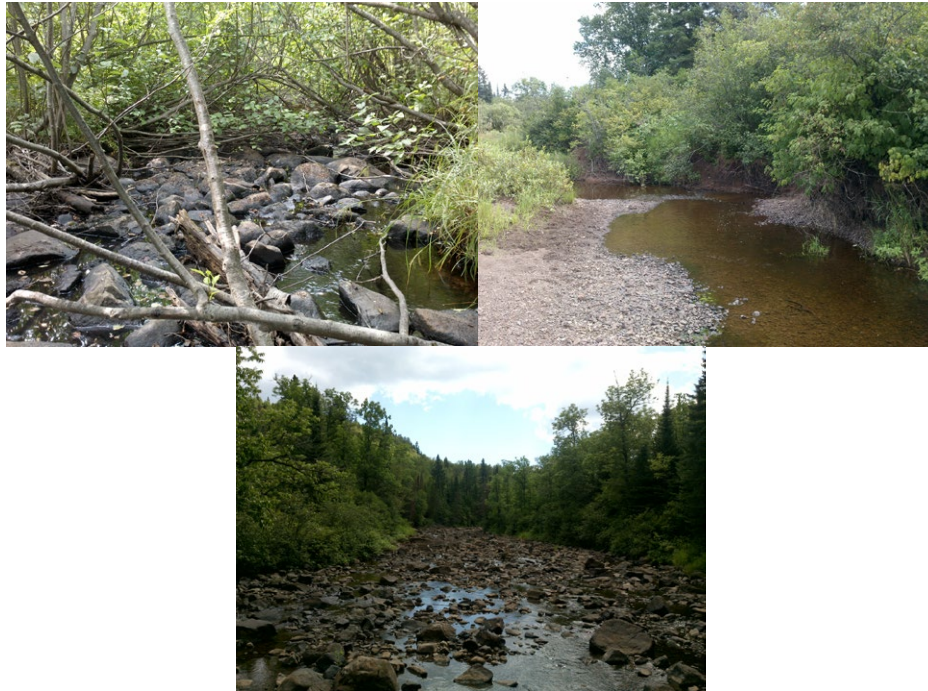
Figure 26. Lower DO concentrations were observed in the headwaters of the Beaver River (left photo), and briefly fell below the 7 mg/L standard at several other stations in the middle reaches of the Beaver River. Several of these stations are prone to low streamflow conditions in the summer months, which are exacerbated by stream channels that are extremely wide and shallow (high width/depth ratio) and lack shading from direct sunlight (middle and right photo)

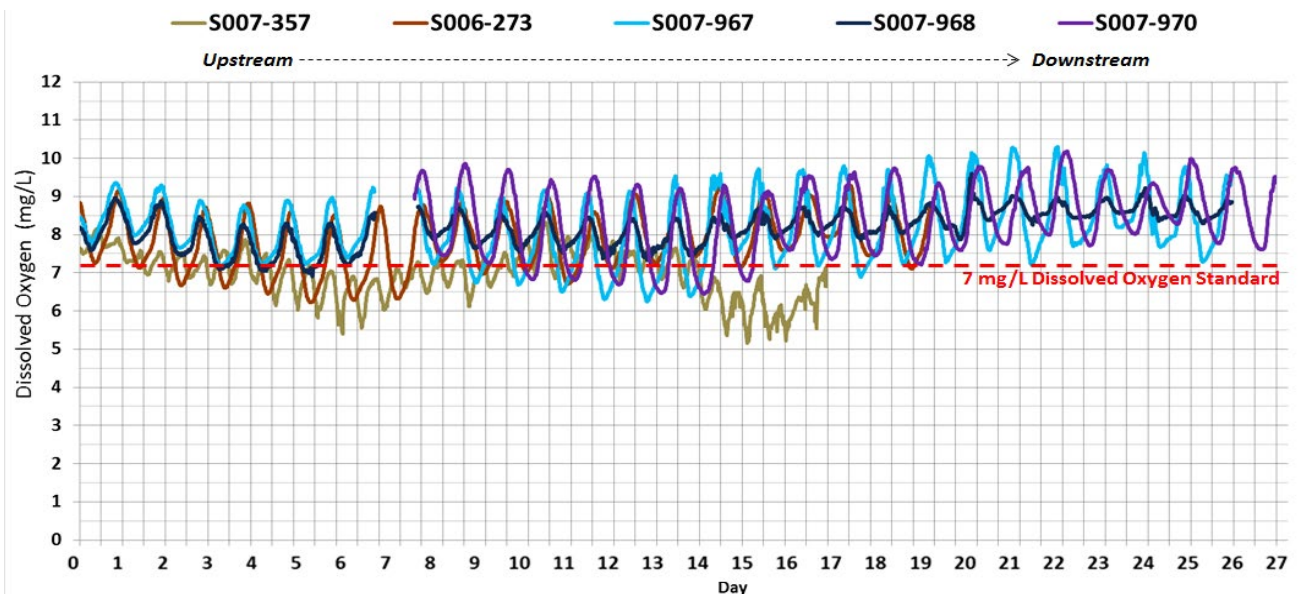
Figure 27. Continuous DO profiles from Beaver River monitoring stations; 7/14/15 – 8/11/15

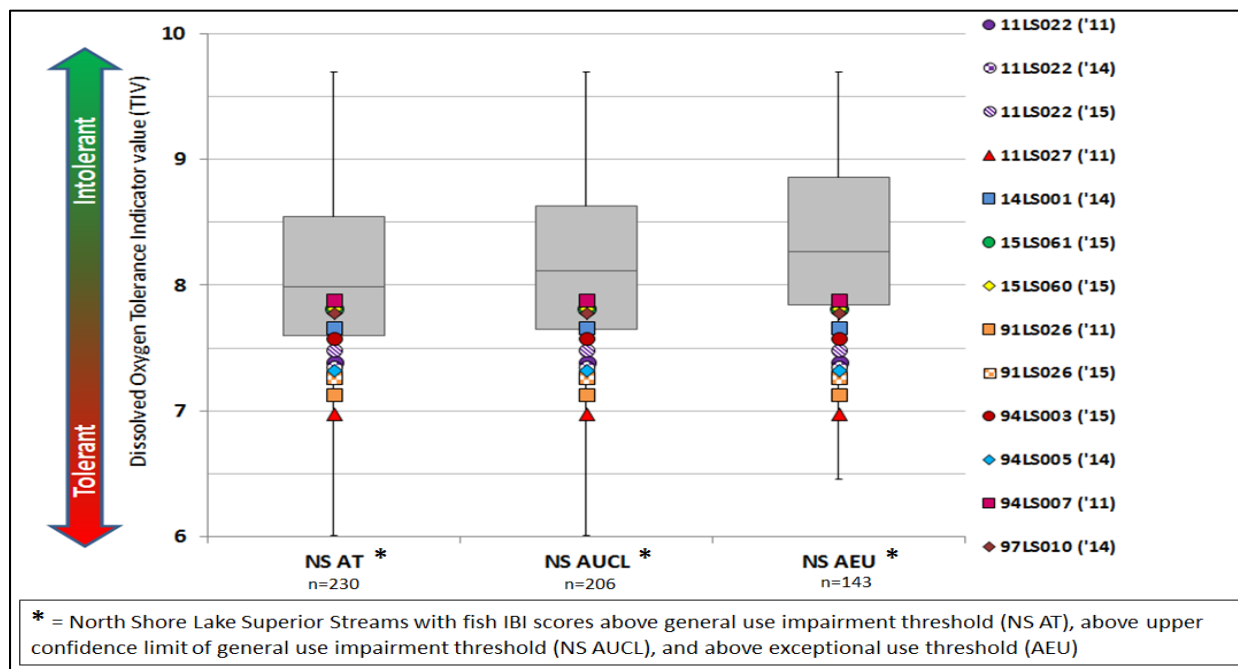
Figure 29. DO TIV for Talmadge River biological monitoring stations compared to results from comparable high quality reference stations. See Section 4.5 for TIV development.

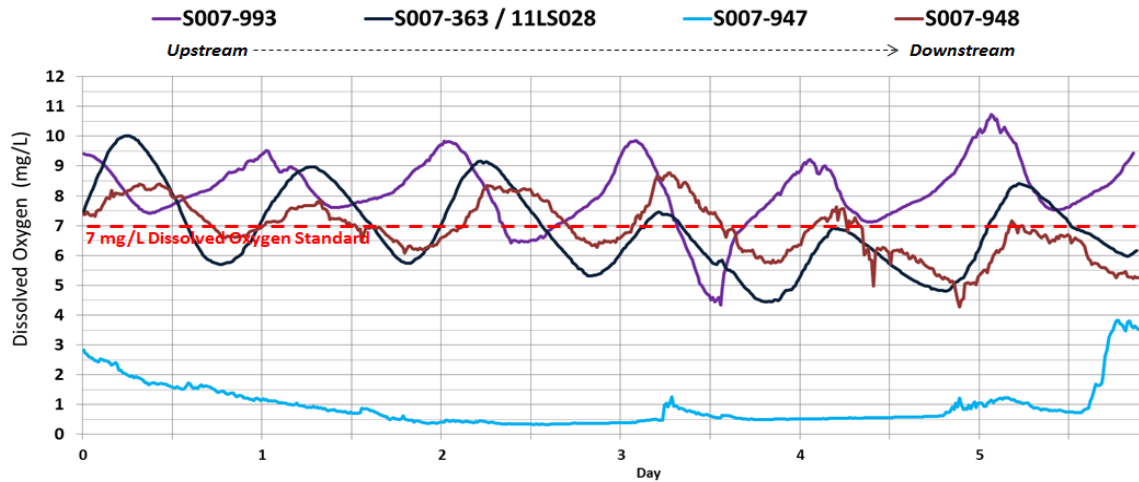
Figure 30. Dissolved oxygen profile collected in the West Branch Beaver River 7/18/14 – 7/24/14

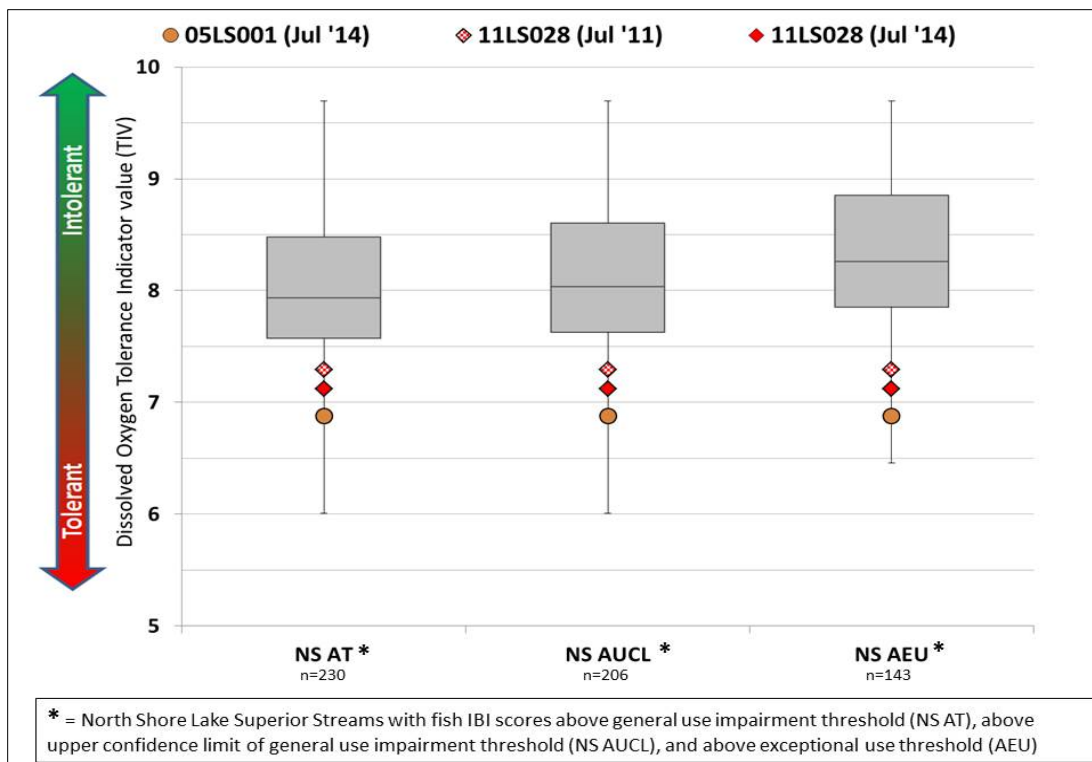
Figure 33. Fish tolerance indicator values (TIV) for DO at Talmadge River biological monitoring stations compared to results from comparable high quality reference stations. See Section 4.5 for TIV development

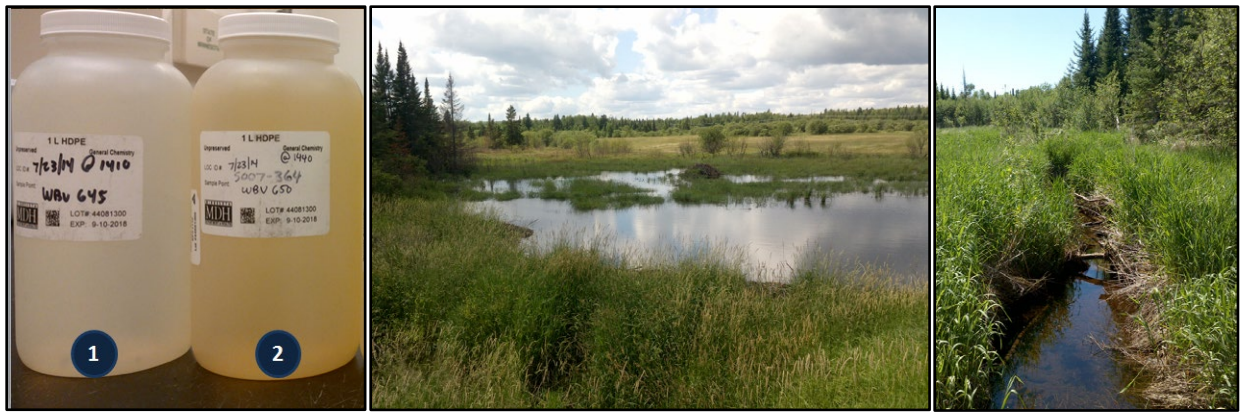
Figure 35. Samples collected upstream of large beaver dam at biological monitoring station 05LS001 (bottle 1 and far right photo) vs. immediately downstream of beaver dam (bottle 2). Note showing increase in staining due to organics.

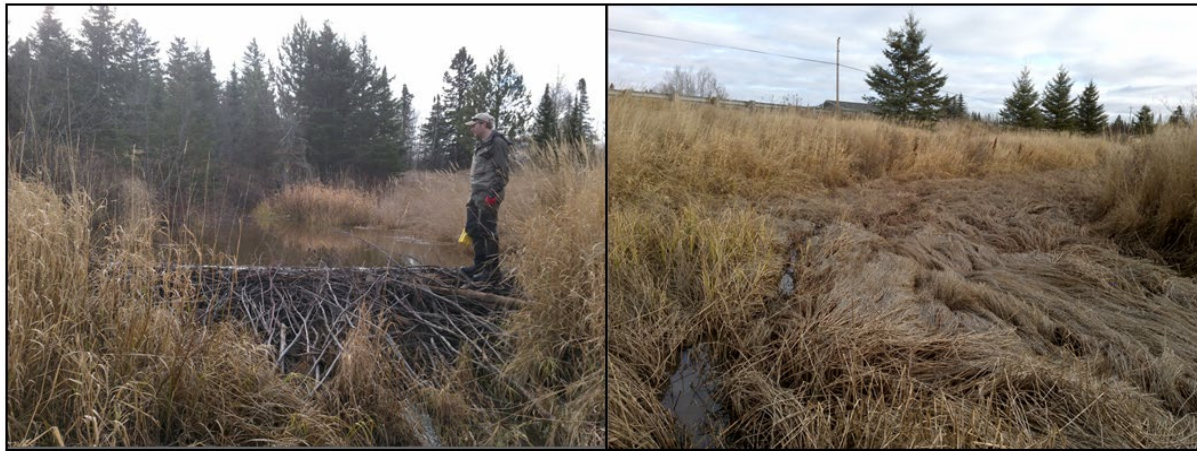
Figure 36. A beaver dam upstream of station S007-947 reduces streamflow and influences the DO regime in this reach. These photos were taken from the same location November 14, 2015 looking upstream (left) and downstream (right) near the beaver dam.

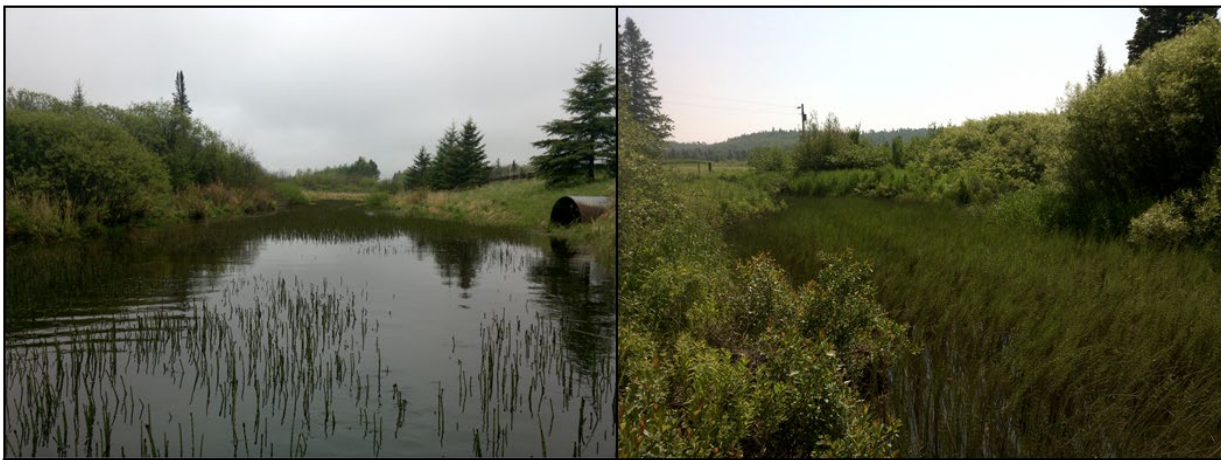
Figure 37. Channelized reach of the WBBR adjacent to Highway 3. This reach is downstream of a beaver dam and water levels are frequently very low. Marsh horsetail (*Equisetum palustre*) covers much of the stream channel in the summer and fall

- One site (S007-947 – see Figure 37) has wetland characteristics within the channel. These characteristics likely extend both up and downstream from the site.
- The vegetation within the reach at S007-947 is dominated by a native species (*Equisetum palustre*) that only occasionally forms such dense stands, and the community is considered to be in good condition.
- The stream (WBBR) is providing the predominant water source to the wetlands, as opposed to the wetlands continuously supplying the stream with water.
- Adjacent riparian wetlands are in fair condition, though are very close to being in good condition.

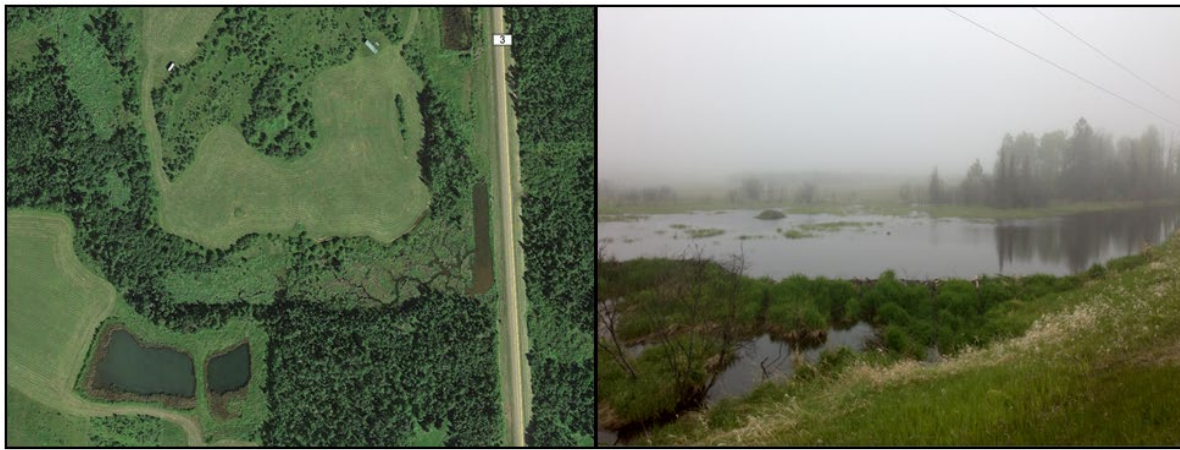
Figure 38. Aerial photo (left) and photo from Highway 3 (right) showing large beaver pond. DO concentrations were significantly lower downstream of the pond compared to free-flowing reaches upstream and 1+ miles downstream.

Road crossings, beaver dams, and stream channelization are all factors that affect the hydrology and physical pattern and profile of the WBBR. Several large beaver dams were observed on the WBBR over the course of this study. Historical aerial photos of the area taken in 1940 reveal that some of these dams were present in nearly the same location over seventy-five years ago. The most recent aerial photos (2016) show a higher number of dams in the middle to lower portions of the WBBR in comparison to 1940, although the increase in dams is rather minimal. The potential for beaver dams to impact water quality and habitat conditions in the WBBR is not due to the number of dams, but rather their size, location, and the small size of the WBBR itself. Two large beaver dams were observed within the reaches of the WBBR evaluated for this study. Streamflow was typically stagnant downstream of these dams during site inspections (Figure 36). DO concentrations were significantly lower below beaver impoundments, particularly during lower flow conditions.

Total phosphorus concentrations in the WBBR were below the applicable TP standard of 0.055 mg/L at most sampling locations. The exception was station S007-364, which exceeded the TP standard in two of the four samples collected. This particular station is located just downstream from a very large beaver dam impoundment (see Figure 38). TP is one of several WQ parameters negatively impacted from the impoundment of the stream at this location (temperature and DO being others). Very low DO concentrations (0.5 – 2.0 mg/L) were regularly observed downstream of this impoundment, which likely results in releases of TP into the stream from bottom sediments.

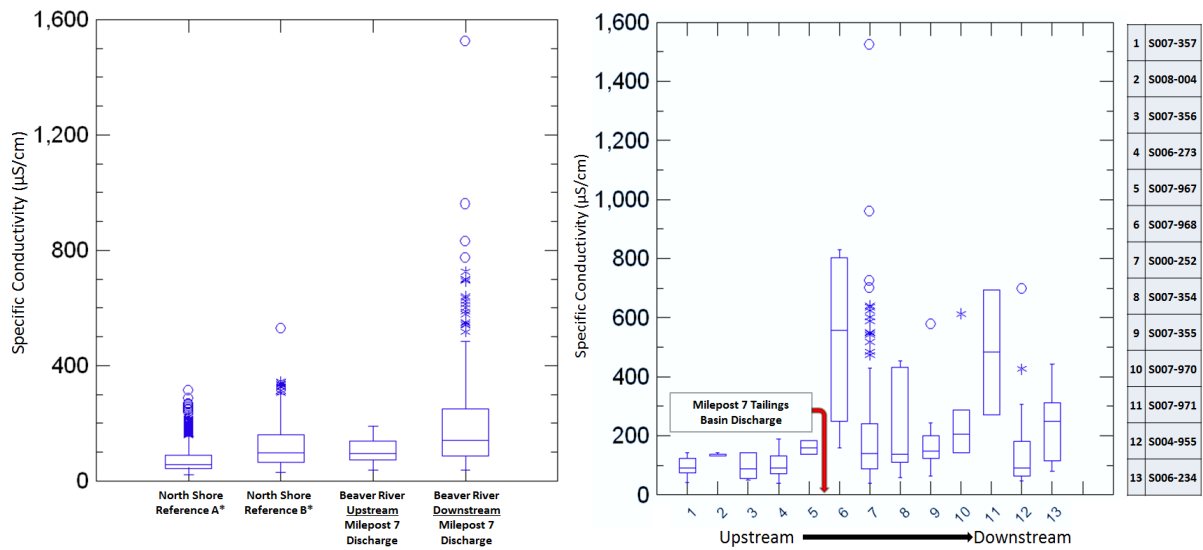
Figure 39. Summary of specific conductivity results in the Beaver River compared to other North Shore streams

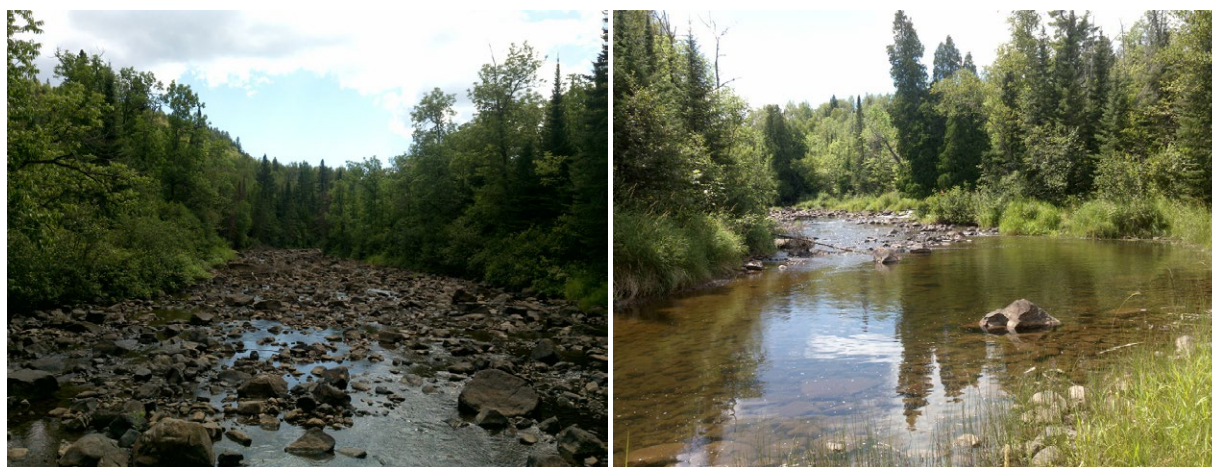
Figure 42. Beaver River upstream (left photo) and downstream (right photo) of Milepost 7 basin discharge point

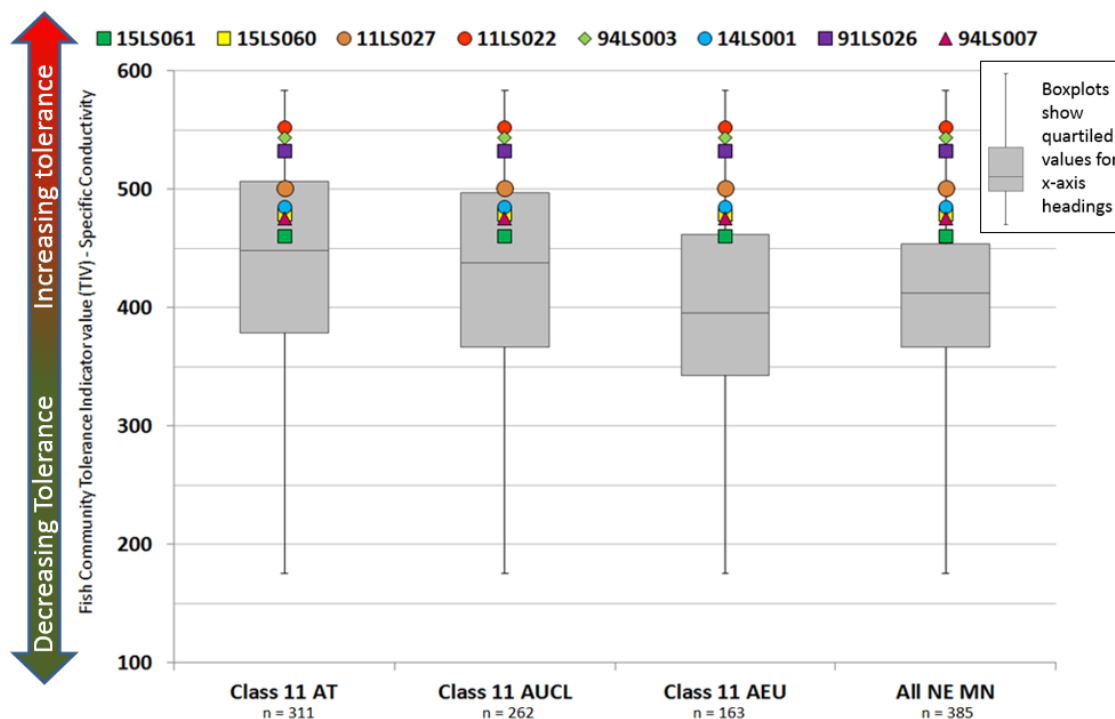
Figure 43. Collection of box-plot distribution graphs comparing biological response data from Beaver River to results from other Class 11 (Northern Coldwater) biological monitoring stations * See Section 4.5 for explanation of TIVs. AUCL = Stations scoring above upper confidence limit of FIBI threshold; AT = Stations scoring above FIBI threshold; AEU = Stations scoring above exceptional use criteria; ALL NE MN = All Northeast Minnesota biological monitoring.

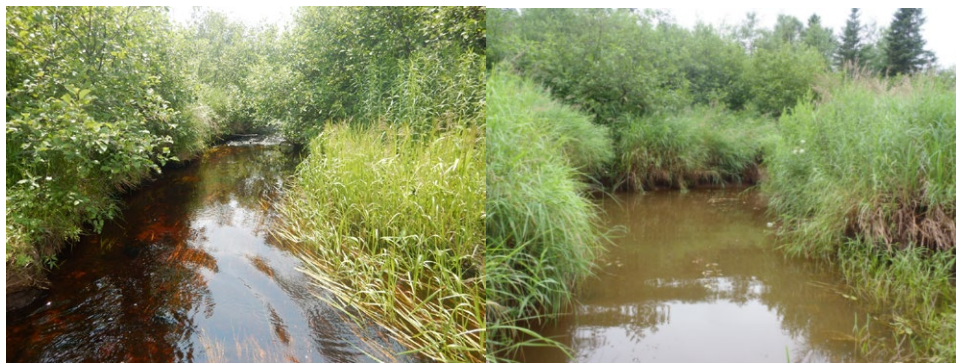
Figure 51. The reference E5 channel at Little Gooseberry River station 11LS004 (left photo) has a lower width to depth ratio at low flow and more fish cover compared to the impaired reach of the West Branch Beaver River (right photo, station 11LS028).

A lack of large woody debris (LWD) cover, or fish cover in general, was another limiting factor identified in the impaired reach of the West Branch Beaver River (WBBR). Most of the riparian corridor along the WBBR consists of alder, dogwood, small willows, and grasses. Few inputs exist for large woody debris as a habitat feature. Fine woody debris (often called fine particulate organic matter or FPOM) was also a limiting factor that emerged from comparing station 11LS028 to the reference reach (Figure 50). MSHA results for cover corroborated the BTSa findings, giving the impaired reach a grade of "C" for fish cover. Some cover is present within this reach due to some undercut banks and aquatic vegetation. Streams of the E channel type in broad, lacustrine valleys often have less LWD as cover due the wetland/wet meadow riparian vegetation (forbs/shrub). However, the reference channel has retained some LWD features due to fewer disturbances in the riparian corridor and superior channel stability (Figure 51).

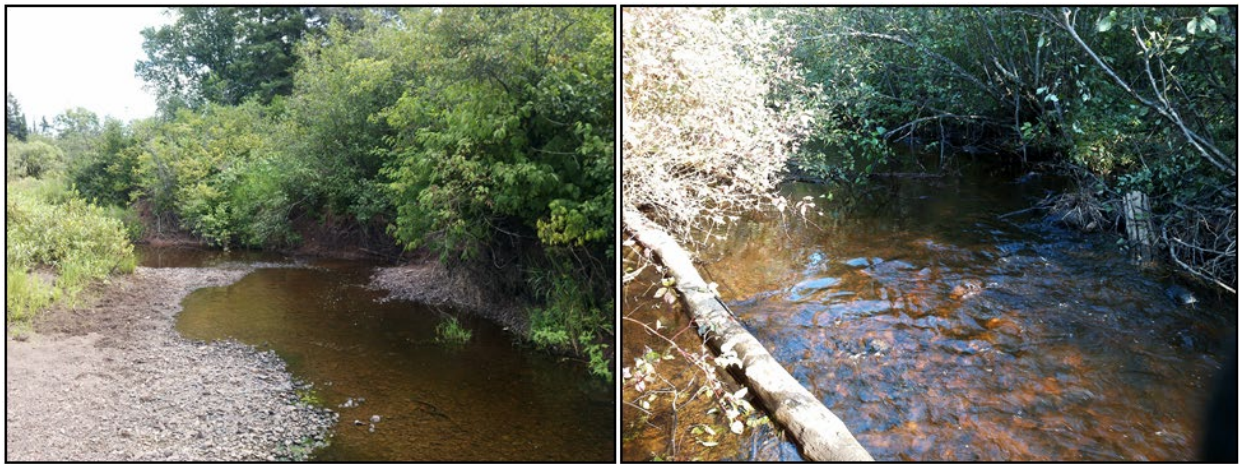
Figure 58. Impaired reach of Beaver River (left photo; station 94LS005) showing lack of fish cover at low compared to reference reach (right photo; Two Island River station 98LS028).

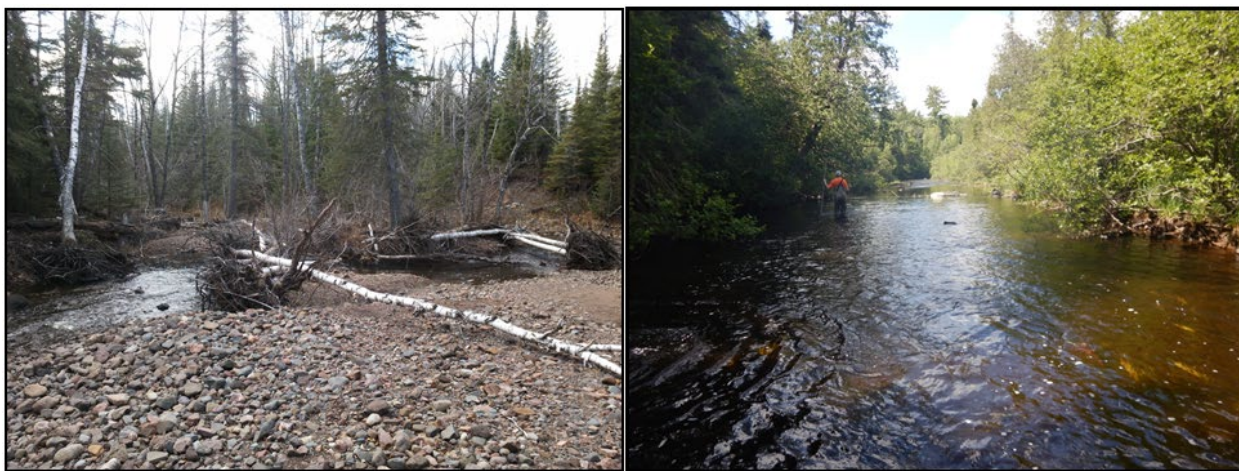
Figure 60. (Left photo) Streambed aggradation (excess deposits of gravel, sand, cobble) has caused channel widening in some areas of the Beaver River. Large woody cover congregates in logjams. (Right) Stable stream channels route sediment more effectively, and maintain suitable width/depth ratios and retain in-stream cover.

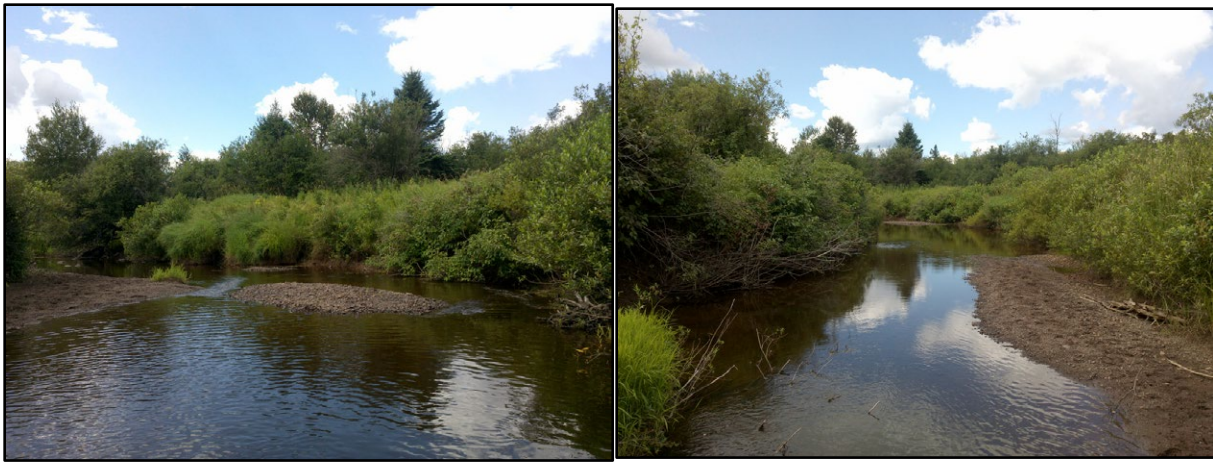
Figure 61. Mid-channel bar (left) and side bars (right) showing accelerated sediment deposition at Beaver River station 94LS005. These are indicators of channel aggradation as sediment inputs exceed transport capacity of the channel.

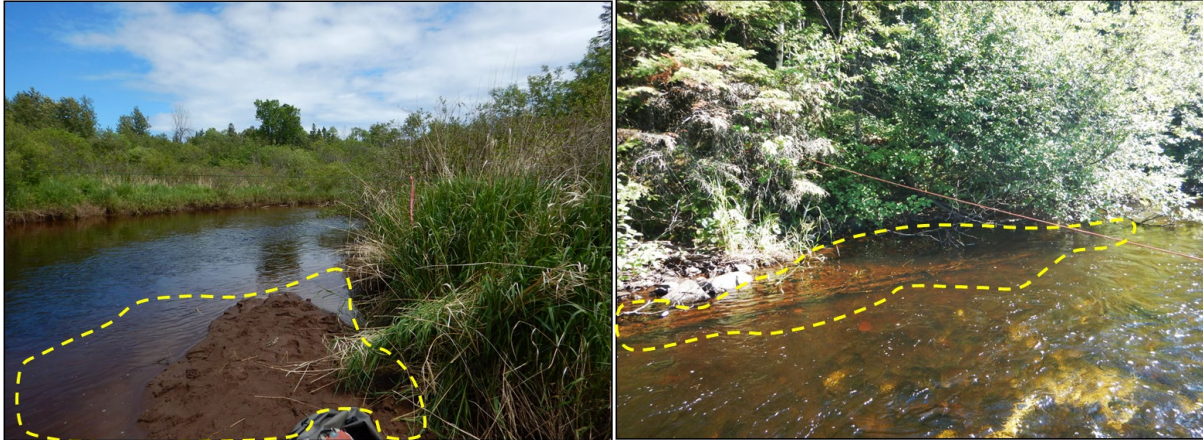
Figure 62. (Left) Minimal side channel habitats were available within impacted areas of the Beaver River. Where present, they were generally filled in with fine sediment, lacked cover, and were exposed to direct sunlight. (Right) An example of quality side channel habitat from Cascade River station 13LS043.

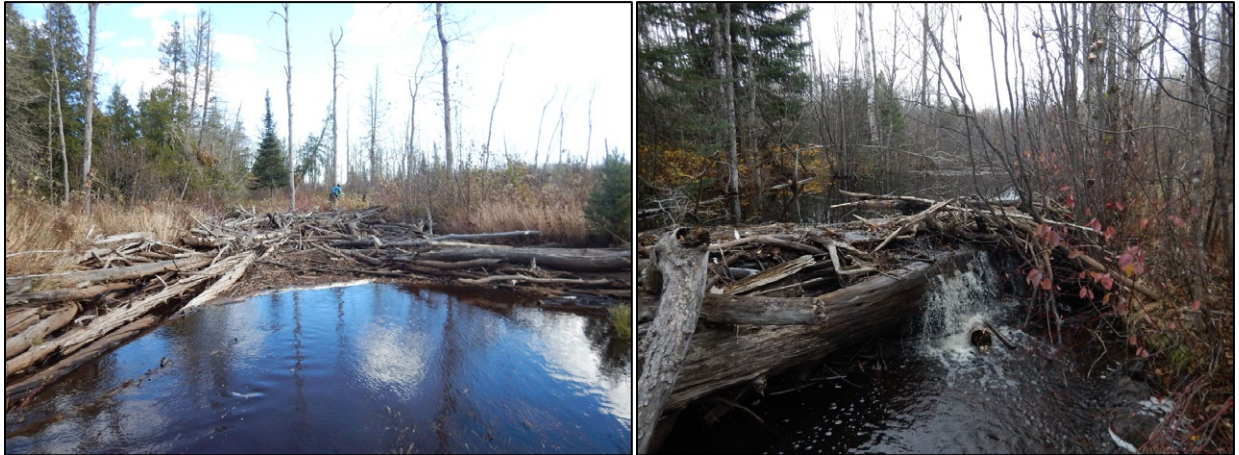
Figure 65. Major log-jams are fairly common in the upper and middle reaches of the Beaver River

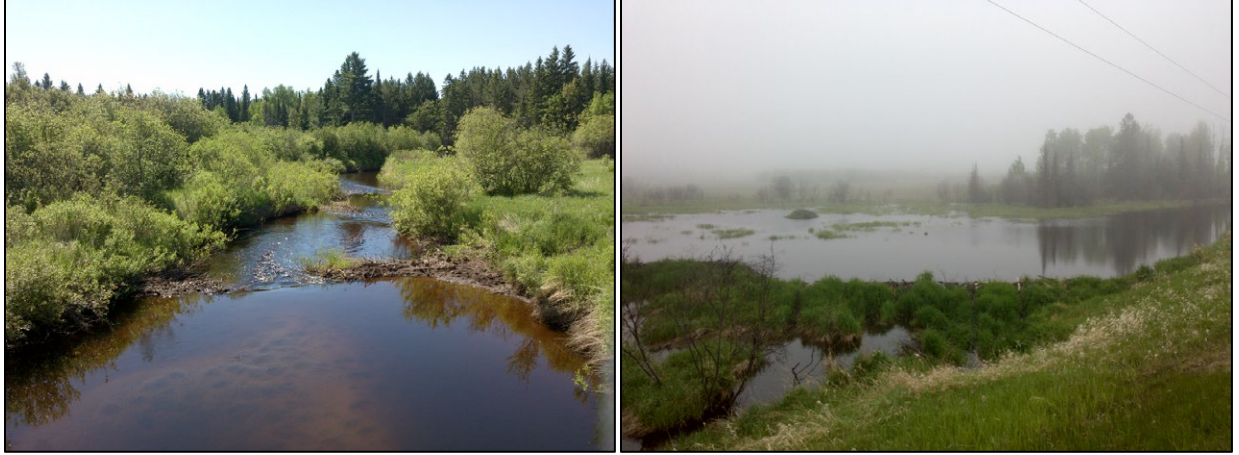
Figure 66. Active (right) and inactive (left) beaver dams affect water quality and stream channel/floodplain conditions throughout the Beaver River watershed

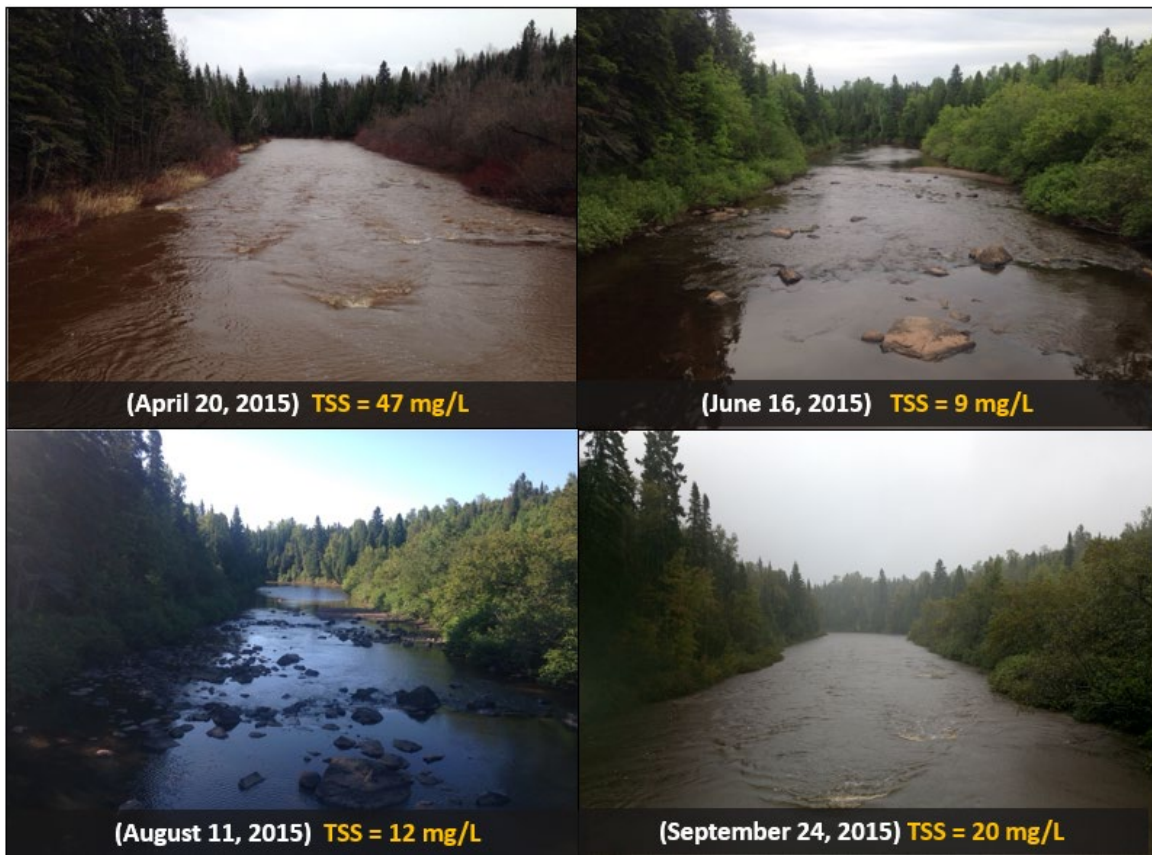
Figure 71. Examples of Beaver River at various flows and TSS concentrations during 2015, looking downstream from flow gaging station.

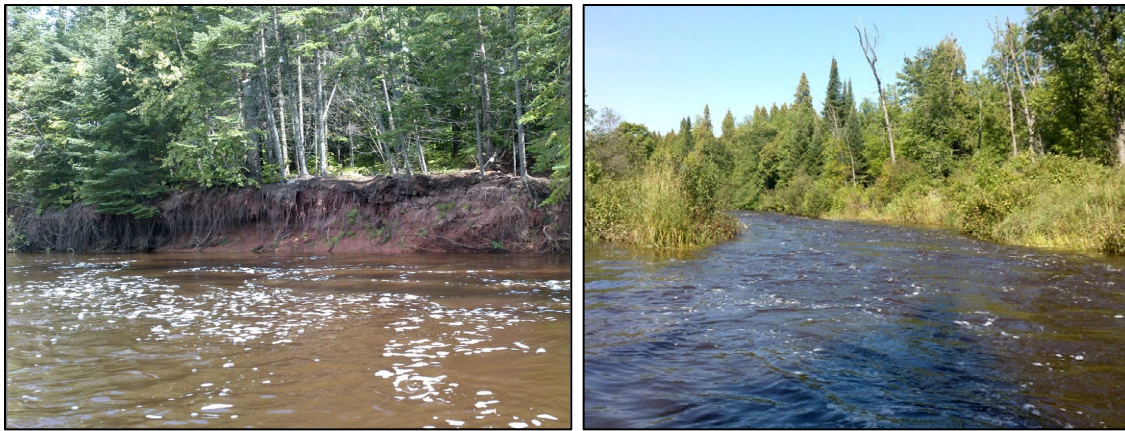
Figure 78. Representative streambanks from an unstable, highly erosion prone reach (left) and a stable, very low erosion prone reach (right). Both of these sites were located between Glen Avon Falls and the Highway 4 crossing of the Beaver River.

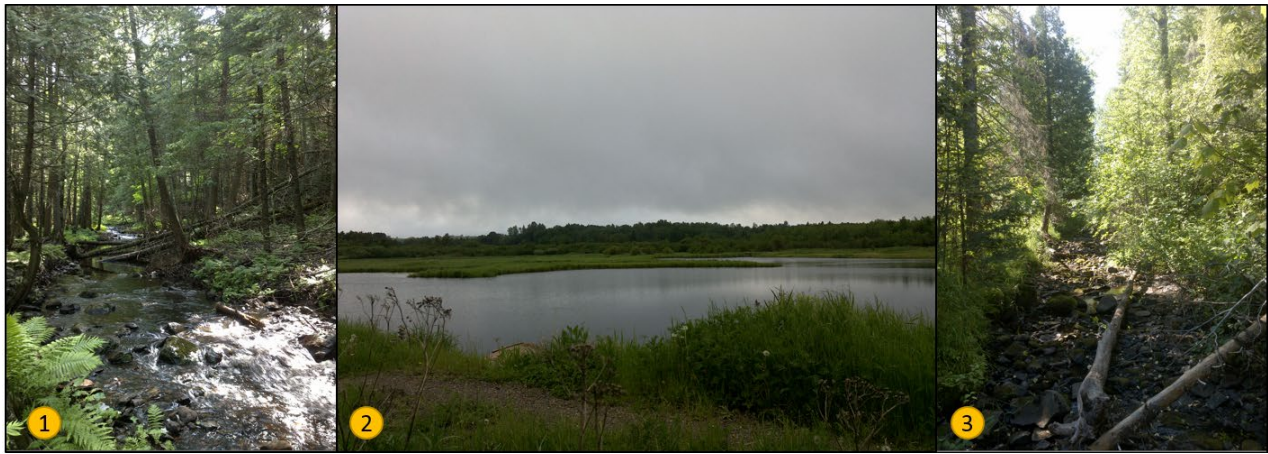
Figure 94. 1. Upper Talmadge River near Lavis Road. This station sustained temperatures within the “growth” range for Brook Trout 97% (2014 season) and 100% (2015 season) of the time during the June 1-Aug 31 monitoring period. 2. The Duluth Retriever Club pond, approximately 4.5 acres in size. In 2015, the summer average water temperature was 4.6 °C warmer downstream of the impoundment compared to an upstream monitoring location (17.2°C vs 21.1°C). 3. Despite the low flow conditions in the Talmadge River (shown here at station 11LS038), water temperatures remained within the growth range for Brook Trout >80% of the summer at almost all of the monitoring stations during this study.

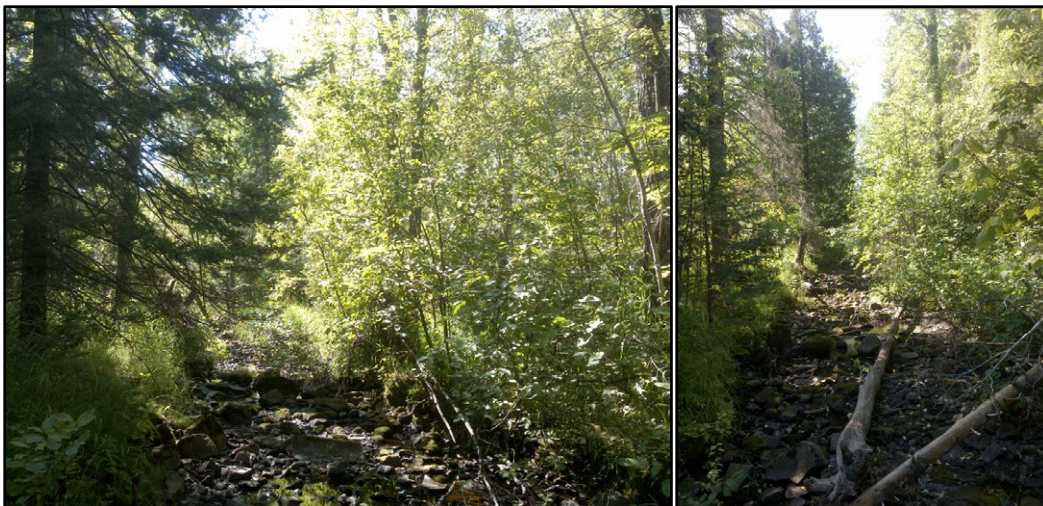
Figure 97. Low flow conditions at Talmadge River biological monitoring station 11LS038 in September of 2013. Despite the low flows, DO concentrations were adequate when sampled from shallow pools.
