Lake Superior South Watershed Stressor Identification Report

Evaluating potential causes of degraded fish and aquatic macroinvertebrate communities in the
Lake Superior South Watershed

Document number: wq-ws5-04010102a

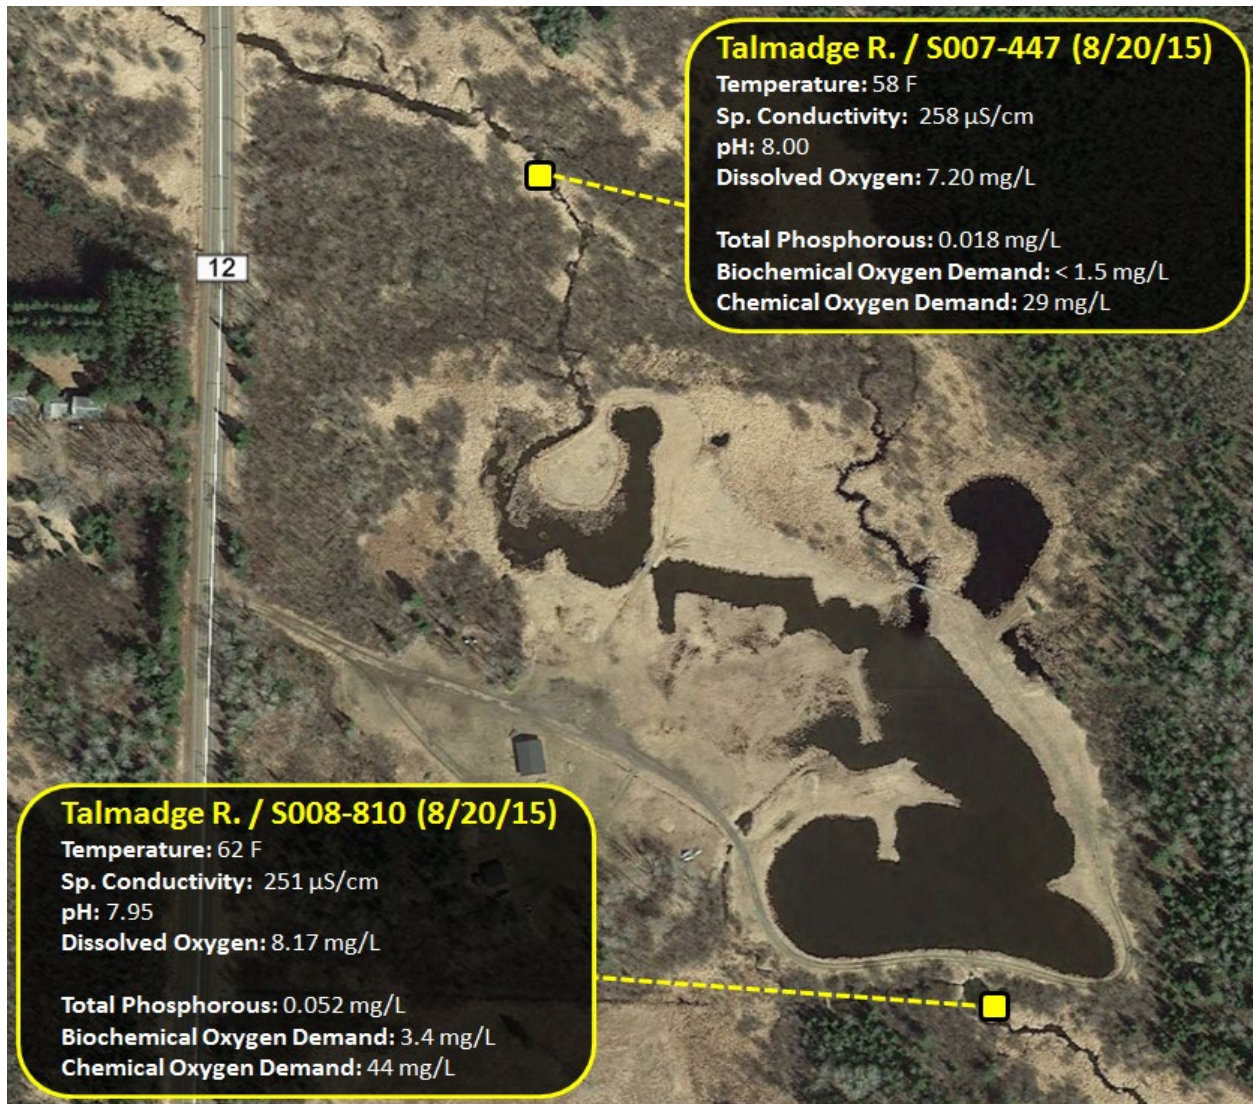
Figure 100. Summary of 8/20/15 sampling effort above and below the Duluth Retriever Club pond on the Talmadge River

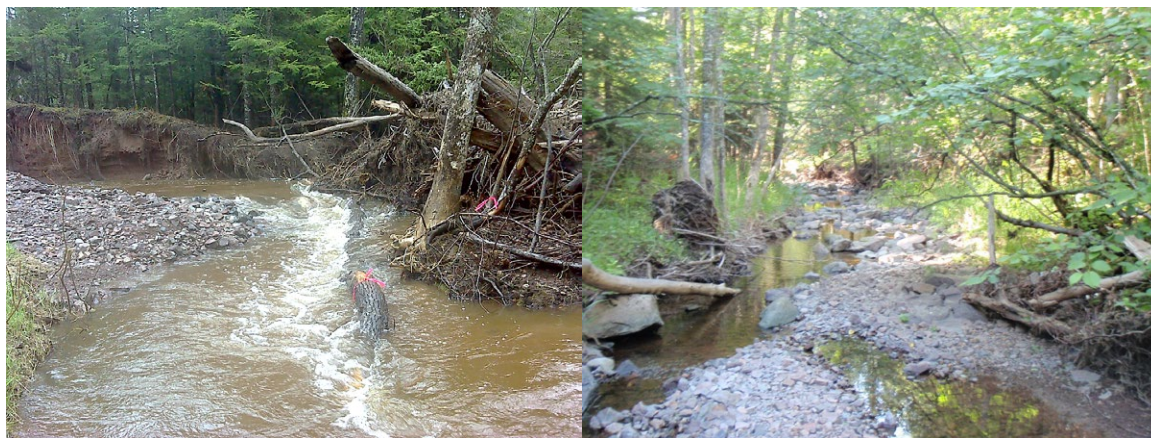
Figure 103. Examples of bank erosion and lack of pool habitat at Talmadge River station 13LS110

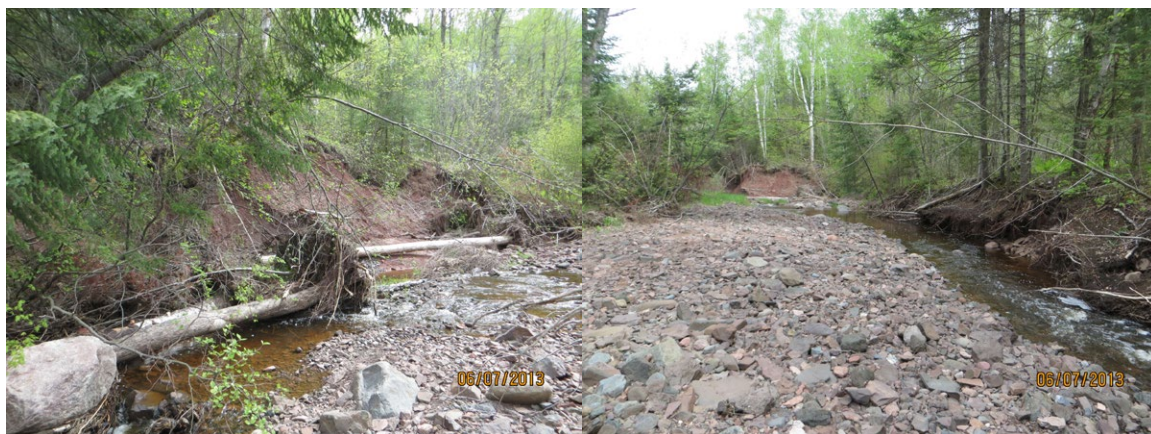
Figure 104. Examples of channel instability leading to high width to depth ratio and habitat loss at station 13LS110 on the Talmadge River

Low flow channel width/depth (w/d) ratio and inner berm area are key components for maintaining quality habitat during the critical summer and winter periods. High w/d ratio channels at low flow are more susceptible to warming during summer low flows and are more likely to develop anchor ice or freeze solid during the winter season. Several of the photos in Figure 104 depict the high w/d ratio of station 13LS110 during summer low flow periods. Channel widening and aggradation processes, particularly in response to the two flood events in the early summer of 2012, have resulted in a channel that is over-widened and offers marginal to poor habitat for sensitive fish.

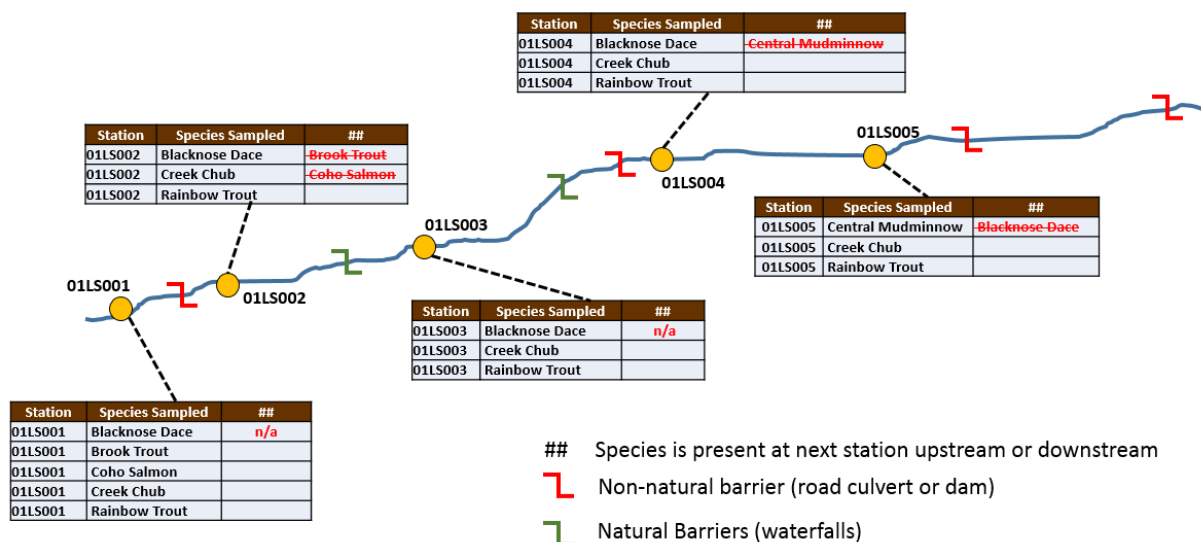
Figure 107: Schematic diagram of the 2001 fisheries survey locations, species observed, and relative positions of natural and non-natural barriers. The majority of the species sampled in the Talmadge River were found at all monitoring stations with a few exceptions

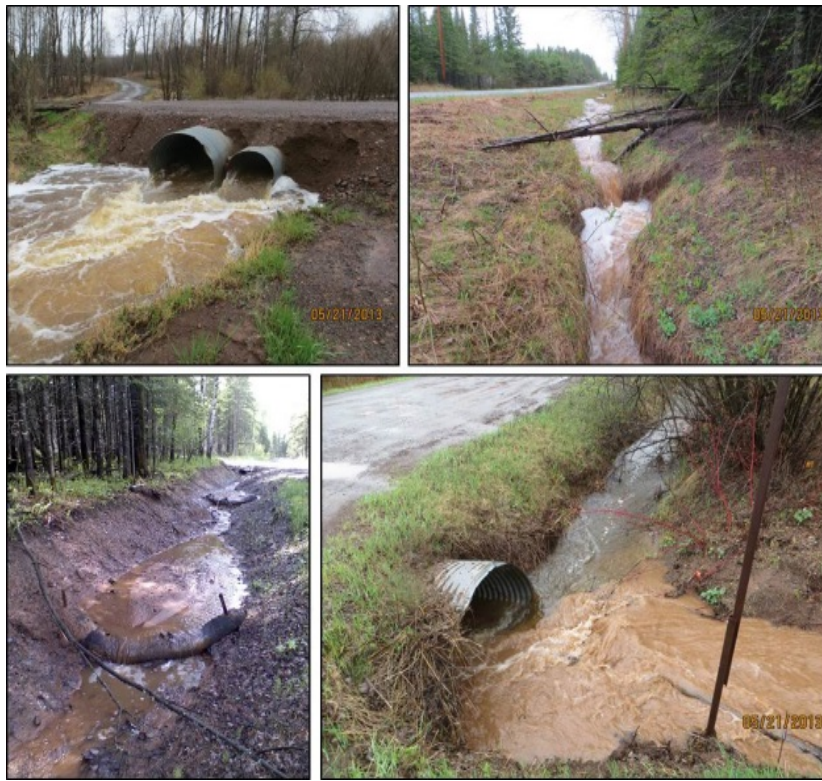
Figure 108. Examples of potential sediment sources from the road and ditch network in the Talmadge River watershed. Top left: sand and gravel entering the stream from a poorly designed road crossing. Top right: a headcut on a ditch in a neighboring watershed. Bottom left and right: water quality impacts from ditch “cleaning” efforts.

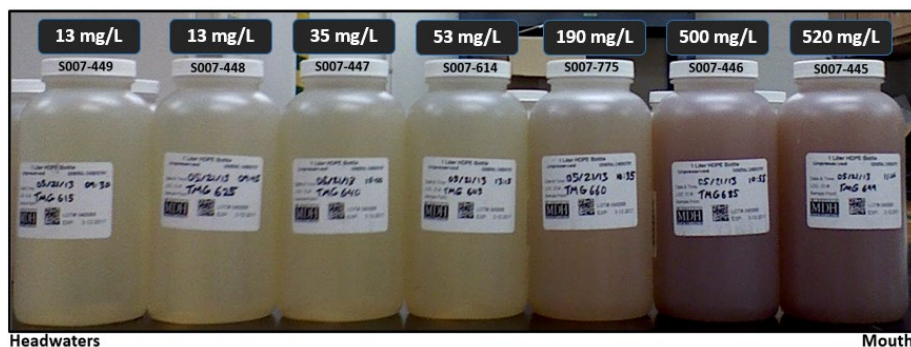
Figure 112. Results and appearance of May 21, 2013 TSS samples collected longitudinally from upstream (left) to downstream (right)

During periods of high flow streams often exhibit higher levels of turbidity. The larger discharges during snowmelt and storm events increase stream power and erode stream banks more than periods of low flow. For this reason, conducting longitudinal TSS sampling during these events is vital to locating stream reaches that serve as sources of suspended sediment in a watershed. Monitoring data from four early season snowmelt or rain events in 2013 and 2014 were used to develop longitudinal summaries of TSS and Secchi Tube data for the Talmadge River (Table 26). The results show that TSS concentrations generally increase from upstream to downstream. There were large increases in average TSS from S007-447 to S007-614 (16.7 to 31.1 mg/L) and from S007-614 to S001-755 (31.1 to 60.9 mg/L). The largest increase by far though was from Cant Road (S001-755) to the Highway 61 Expressway (S007-446), where the average TSS concentration from those four sampling events increased from 60.9 mg/L to 158.2 mg/L. At those same set of four sites, the average Secchi tube transparency correspondingly decreased from 75cm -> 61cm -> 50.3cm -> 29.8cm.

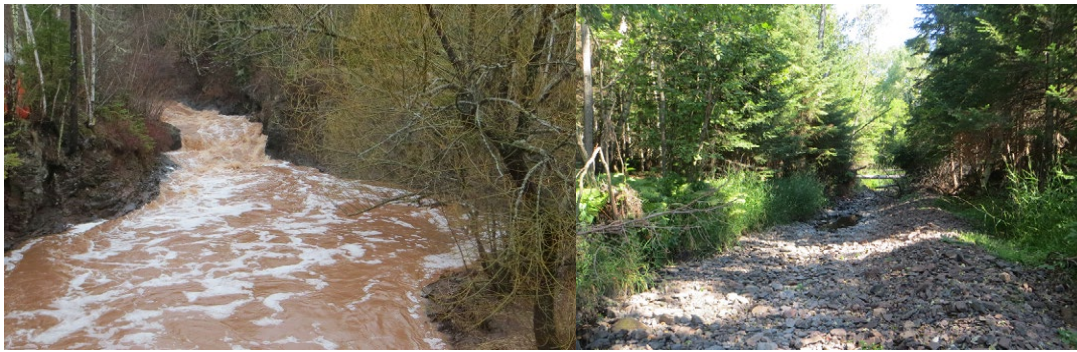
Figure 119: Contrast of low and high flow conditions in the lower reaches of the Talmadge River watershed. Stranded pools are seen under low flow conditions of year 2013 (lower right).

The Talmadge River hydrology is flashy, meaning that water levels rise and fall very rapidly, particularly in the mid-to-lower watershed where it flows at steep gradients through clay till and bedrock towards Lake Superior. The low-permeability soils and bedrock in the watershed contribute to increased surface runoff rates resulting in fast, turbulent streamflow following precipitation events. Bankflow flows are estimated at 100 cfs and occur at approximately 1.3-year reoccurrence intervals, primarily occurring during snowmelt and high-intensity rain events. In general, groundwater storage is shallow due to the thick clay soils, shallow depth to bedrock, and lack of deep storage, particularly in the lower watershed. Wetlands are the primary source of storage. It is typical for flows of less than 1 cfs to occur during the late summer of a normal climate year. Stream depths are shallow throughout much of the system during dry periods. During low and very low flow periods flows can become interstitial, with stranded pools of water hydraulically connected by slow moving subsurface waters. Contrast of low and high flow conditions in the lower reaches of the watershed is shown below in the images of Figure 119 .

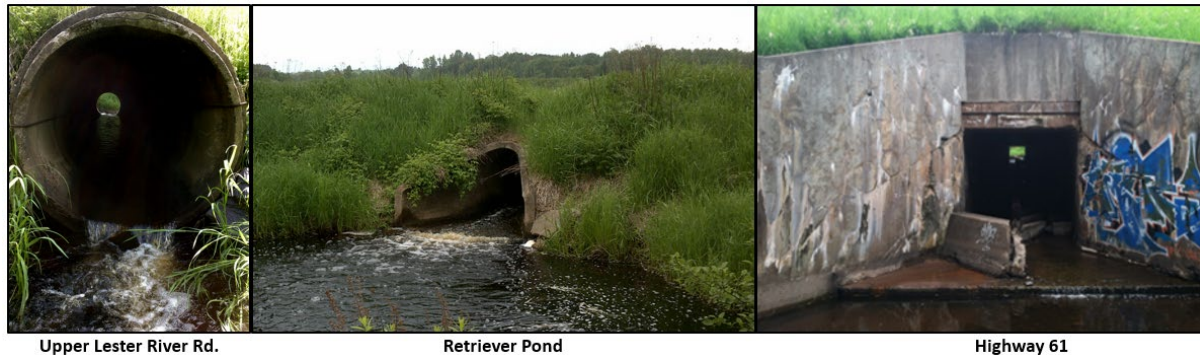
Figure 122. Examples of fish passage barriers in the Talmadge River watershed in need of restoration

Several culverts in the Talmadge River watershed were found to be undersized and/or perched. These poorly designed or deteriorated crossings are a detriment to aquatic organism passage and are causing localized channel instability and habitat loss. Three priority culverts to replace are shown in Figure 122. Of the three shown, the crossing at Highway 61 is likely the highest priority for replacement given that it is a known impediment to the Steelhead Rainbow Trout that migrate up the Talmadge River in the Spring and Fall. Culvert replacement plans should adhere to the MESBOAC design procedure and other guidance published in this 2011 report:

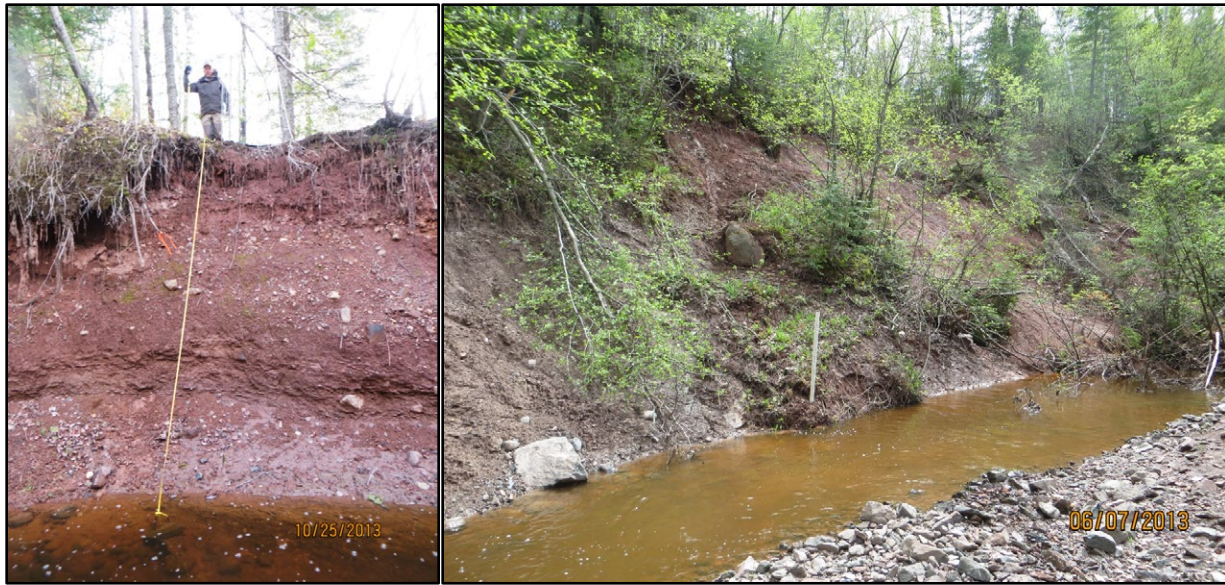
Figure 124. Significant bank erosion and bluff failure in the lower Talmadge River. A large portion of the TSS load was predicted to originate from this reach during BANCS model assessments, and sampling of TSS verified those predictions.

Areas of significant bank and bluff erosion exist on the Talmadge River between McDonnell Road and the Highway 61 expressway (see examples in Figure 124). Sediment inputs from this reach are the primary driver of the current TSS/turbidity impairment and cause stress to aquatic life through various pathways. The streambank erosion assessments and predictions detailed in Section 6.2.5 should be consulted to prioritize potential bank stabilization or reach-scale restoration projects that would reduce sediment loading from these sources. A reach-scale restoration project has already been completed near Highway 61 to reduce bank erosion and improve physical habitat (Figure 125).

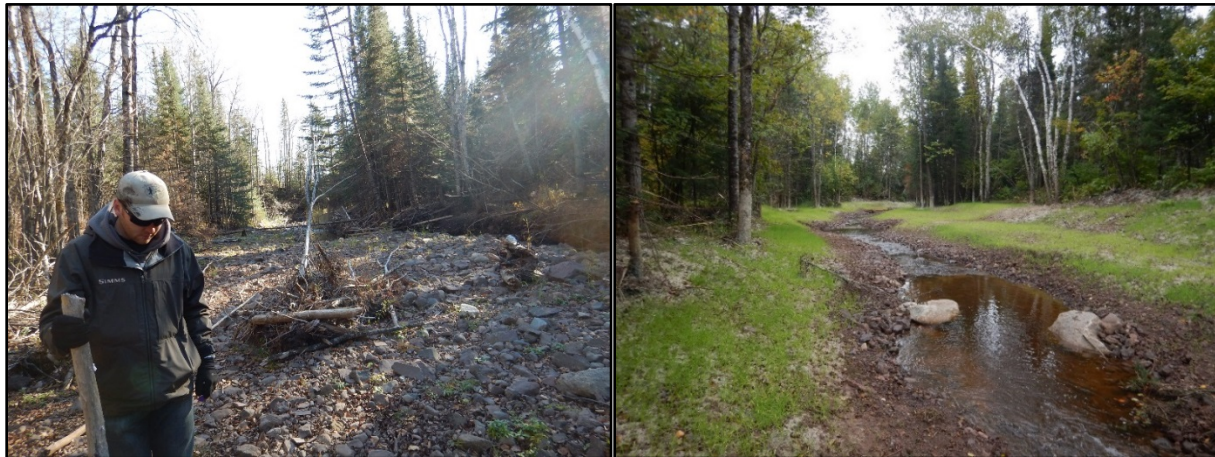
Figure 125. Before and after pictures of a stream channel/floodplain restoration project completed on the lower Talmadge River. The photo on right was taken shortly after the completion of the project. Native grasses, plants, and trees were planted in the floodplain.

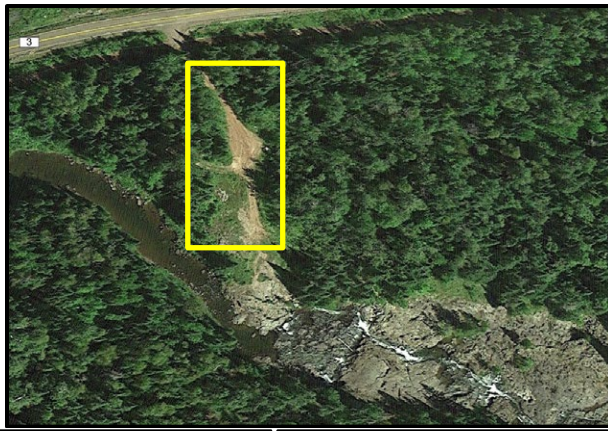
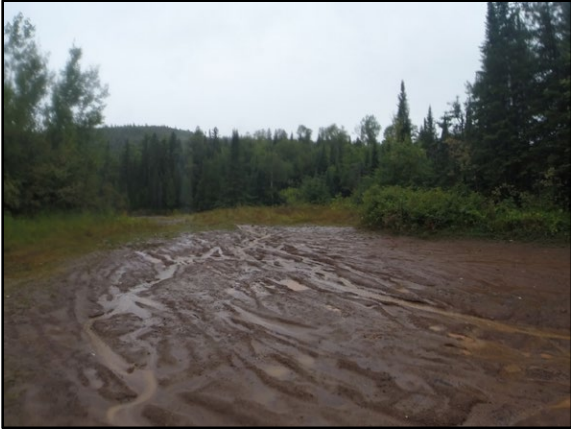
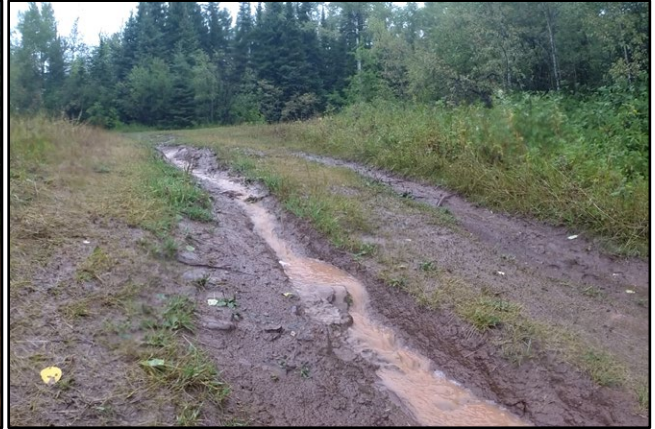
Figure 127: Surface erosion and sediment delivery at parking area at Glen Avon Falls. A parking area and hiking trail could be developed for better access and reducing sediment delivery and impacts to the riparian area.

Roads, trails, and parking lots can introduce sediment from complete failure, loss of road fill, surface erosion, and ditch-line erosion. Several roads and trails are contributing sediment to streams within the Beaver River watershed. Although these sources are rather minor compared to sediment loading from streambank erosion, the maintenance and/or repair of failing roads and trails target a preventable problem and can be cost-effective. One potential project area is the access road to Glen Avon falls off CSAH 3. The access road is an unmaintained off-road trail that is composed of clay soils and courses down a steep grade to the Beaver River at the top of the falls (Figure 127). During rain events and snowmelt periods this access road develops gullies that carry sediment downslope and into the river. Implementation funding could be used to stabilize and revegetate this area and provide easier access to view the falls.

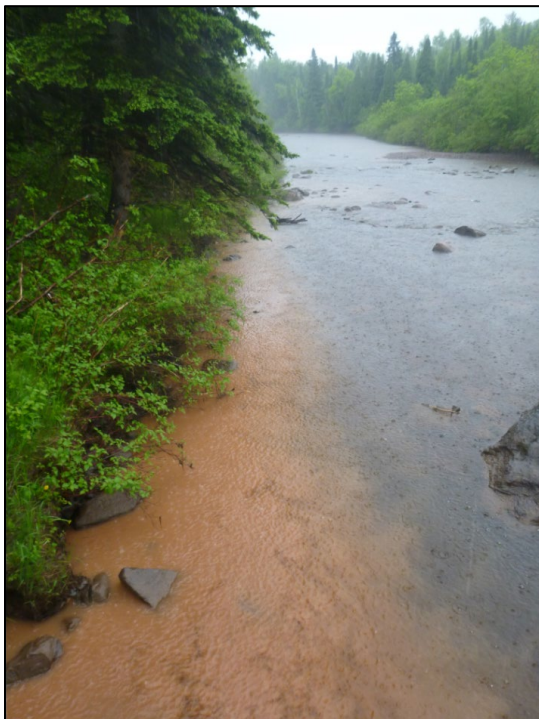
Figure 128. Runoff from ATV trail entering Beaver River at station S007-971

Sediment delivery to the Beaver River is also occurring via ATV trails in the watershed. A sediment plume was observed entering the river from gullies originating on the trail (Figure 128). These sediment sources are not significant in comparison to bank erosion and natural gullies and ravines that exist in the watershed. However, they are preventable with additional maintenance and planning.
