# Crow Wing River Watershed Stressor Identification Update 2023

A study of local stressors limiting the biotic communities in the Crow Wing River Watershed.

**Document number:** wq-ws5-07010106b

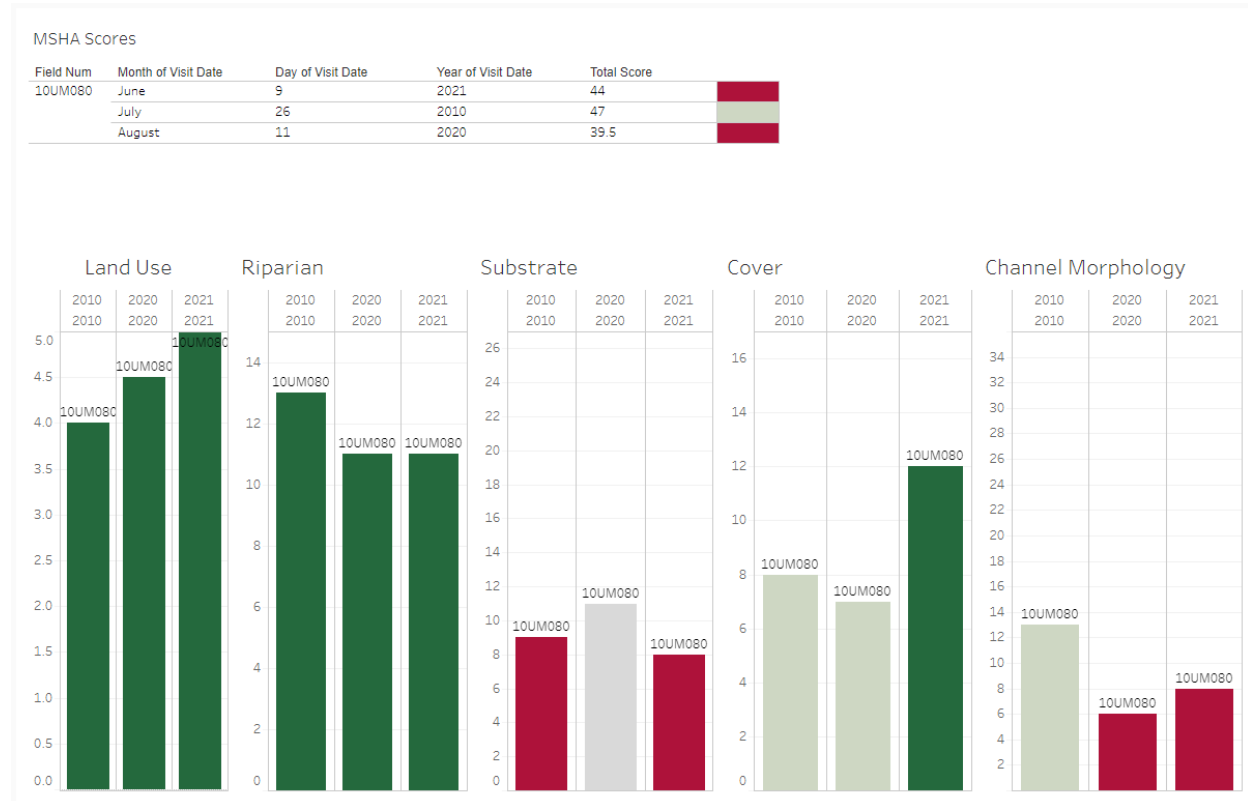
**Figure 5: MSHA Habitat scores for Farnham Creek**

Habitat was classified as fair/poor on Farnham Creek, through the Minnesota Stream Habitat Assessment (MSHA) evaluations during the fish and macroinvertebrate samples (Figure 9). During water quality sampling events in 2021 it was observed that there were beaver impoundments downstream of 56<sup>th</sup> St SW near 10UM080. Field observations from 2010 also noted beaver impoundments during the 2010 biological sampling events. This section of stream has been historically ditched and flows through a large woody wetland, perfect habitat for beaver activity. Stream substrate was dominated by sand, silt and some clay during the 2010 and 2020 site visit.

In general, the MSHA evaluations score poor on Farnham Creek; however, there is a stark difference in the habitat availability between the upstream biological monitoring station (10UM080) and the downstream station (99UM022) (Figure 5). The most significant differences between the two stations can be seen in the cover and channel morphology categories. The substrate at 10UM080 was dominated by sand and silt, with the presence of clay also noted. The substrate at 99UM022 was dominated by sand, with the presence of silt noted. In 1999 there was boulder, cobble, gravel and sand at 99UM022. All the later substrate notes on sand and silt at this location. Sand being supplied by failing stream banks is covering any coarse substrate. Healthy fish communities need coarse substrate in order to build nests and spawn. Excessive fine sediment also affects juvenile fishes, as the sediment is stirred into the water column creating TSS, it can easily tear sensitive juvenile fish gills. Similarly, many sensitive macroinvertebrates also have specialized gills that are used to breathe DO. Excessive fine sediments can damage these gills, similar to juvenile fishes, making the creek inhabitable for sensitive species. In addition to the differences in substrate between the two biological monitoring stations, channel morphology also changed between the two stations. The channel morphology score at 10UM080 indicated that the channel development was poor (shallow pools, slow velocity runs, and no riffles). In contrast, the channel morphology score at 99UM022 was fair, as no riffles were present within the reach, and the pools were small (10% of the reach). Sensitive fish and macroinvertebrates require well defined pools, riffles, and runs to feed, spawn, and to use as refuge during high precipitation events. Lack of habitat is a stressor to the aquatic life within 10UM080 and 99UM022 due to poor channel morphology and substrate.

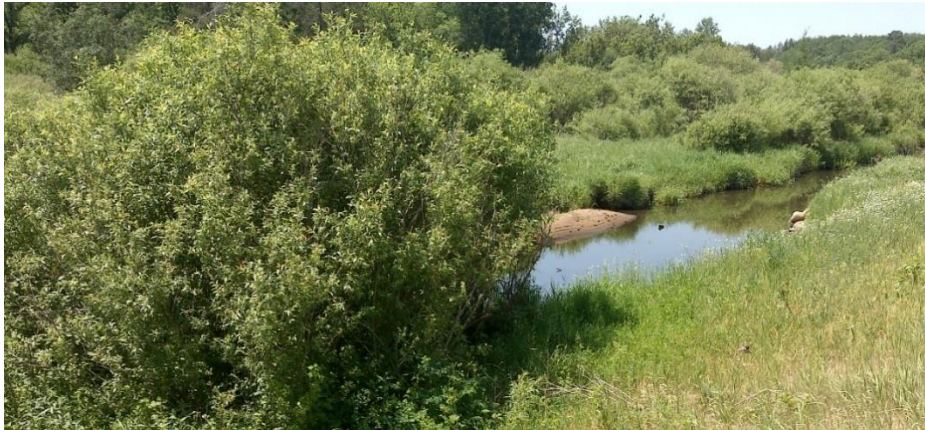
Sand deposition observed downstream of road crossing. 06/10/2021

Over time, there have been many changes on the landscape that have changed the natural hydrology and geomorphology of Farnham Creek, and the entire subwatershed. The most significant historical changes to the landscape have been land conversion from mature forests to hay/pasture and woody wetlands and the channelization of the natural streams and wetlands. Farnham Creek has been straightened along the entire length of the AUID. Historically, Farnham Creek was comprised of multiple wetlands and small stream channels. The channel was altered to drain the landscape, starting from the Northeast and ending downstream of Farnham Lake where Farnham Creek flows into the Crow Wing River. This new channel cut through multiple wetlands, creating a direct connection throughout the subwatershed. This channel alteration accelerates stream flow, resulting in higher flows during precipitation events which achieves the agricultural land use drainage goals, but causes instability. Water leaves the landscape quickly, resulting in periods of higher flow than what would have naturally occurred. As the landscape drains, water that was once held in the upstream wetlands is flushed downstream, carrying low DO water throughout the reach. Then, as these flows quickly drain, the flow regime quickly transitions to slow moving groundwater inflow, reaching very low conditions starting early in the summer. Although 2021 was a dry summer, Farnham Creek was already mostly very slow and low by the end of May. This reach is very low gradient and has very slow stream velocities for large portions of the summer.

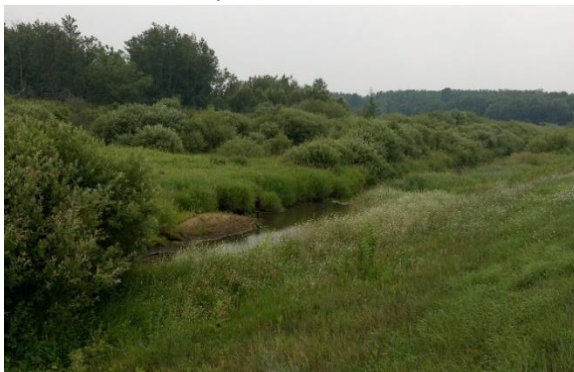
DS 7/14/2021 very low flow

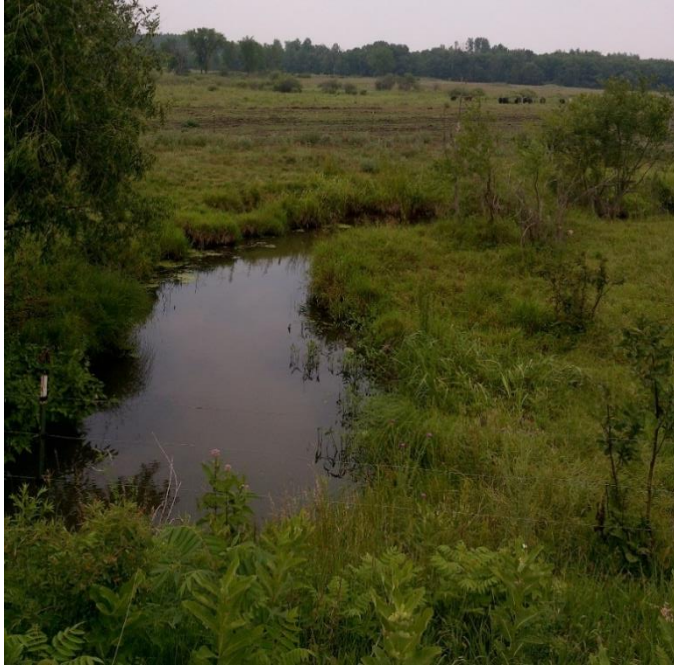
US 07/14/2021 cattle in pasture

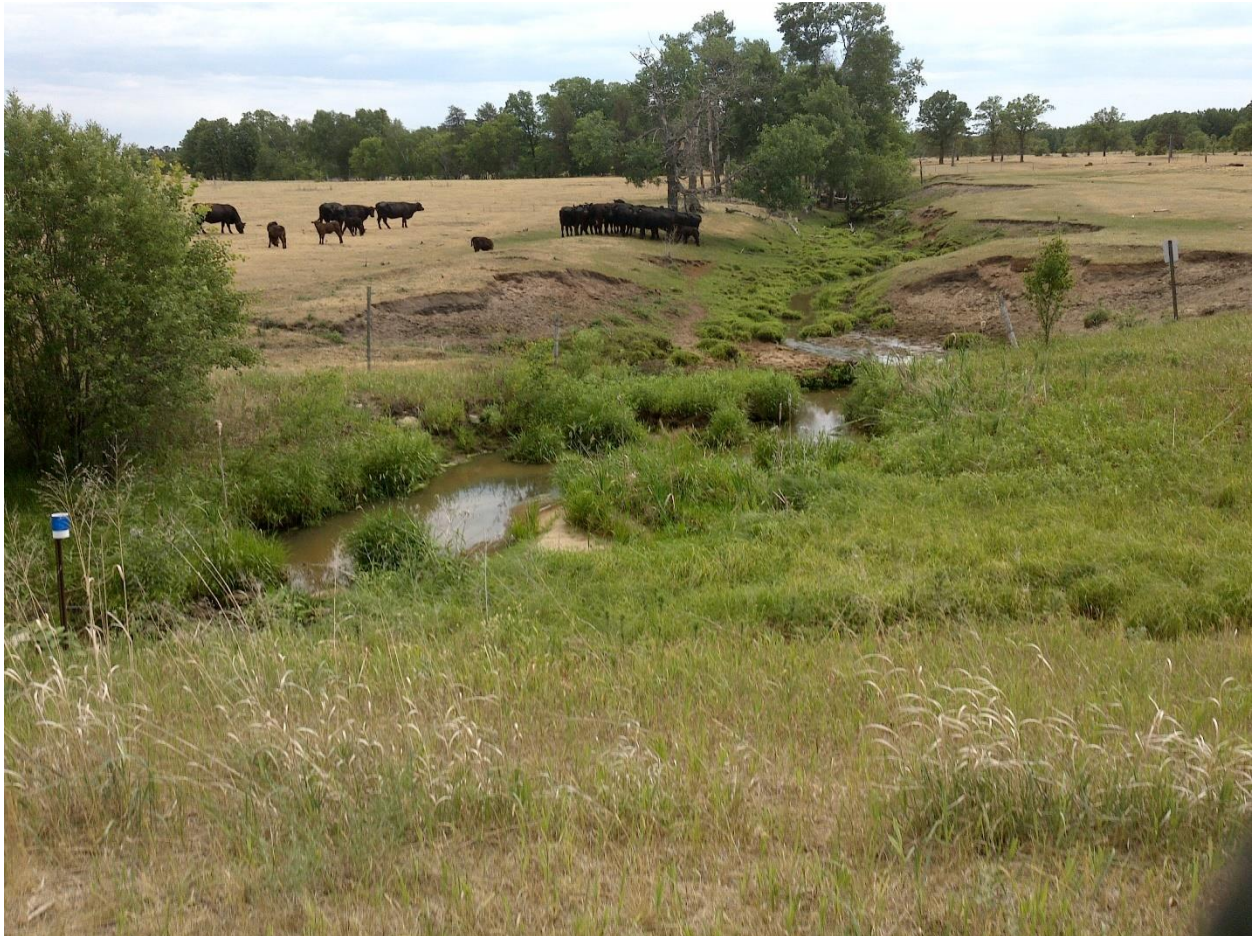
**Figure 8: Tributary to Beaver Creek biological monitoring site 10UM106 and Equis site S011-719. Photo taken on 6/17/2021 when stream was a flowing at a trickle. Cattle have direct access to stream allowing sediment and nutrients to freely access stream.**

Macroinvertebrate samplers noted excess sediment in pools, animal access to stream, animal trampling of banks, low DO (0.99 mg/L) and mid channel bars. The macroinvertebrate sample was dominated by a tolerant scud with few caddisflies and Odonates present. The fish were sampled at site 10UM106 on 6/17/2010 and scored an IBI of 76 which was well above the general use threshold. The fish sample included 3 sensitive dace species, along with burbot and blacknose shiner, which are also sensitive species. This score listed AUID 688 as a general use stream. As a general use stream the expectation is that the biological life in the stream will meet the associated IBI score in order to be removed from the impaired waters list.

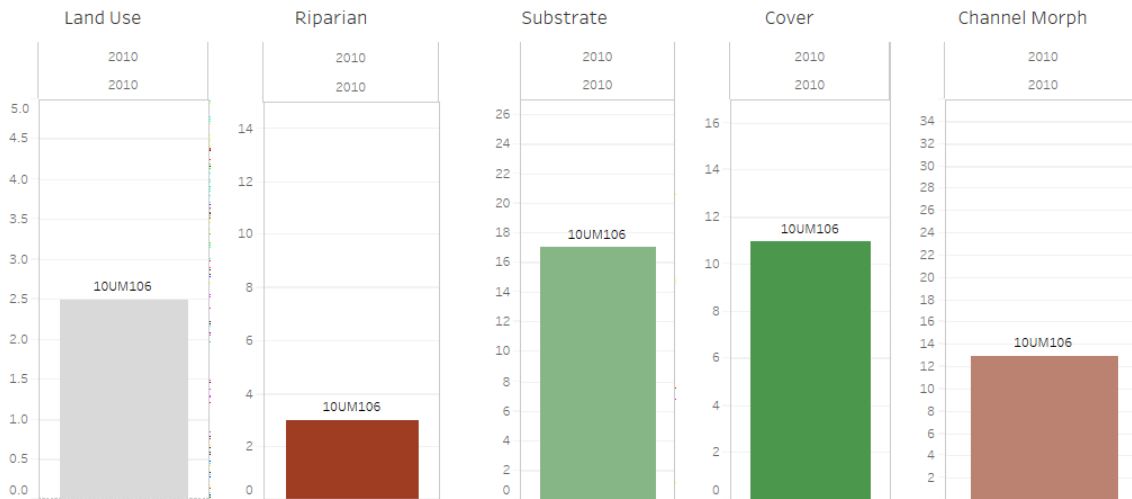
Station Id	Month of Visit Date	Day of Visit Date	Year of Visit Date	Total Score
10UM106	June	17	2010	46.6

There was one habitat assessment conducted at 10UM106 on 6/17/2010 during the fish visit. This site scores poorly in riparian cover and channel morphology. There are active cattle pastures both upstream and downstream side of CSAH12 near water quality station S011-719. The entire reach shows signs of active bank erosion from cattle access along with mid channel bar formation from excess sediment entering the stream due to bank erosion from cattle trampling of banks. The substrate was dominated

by sand with small gravel exposed in riffle areas. Stream pools were determined to be >4 times deeper than the shallowest depth and sinuosity was considered poor. Cover type during the 2010 site visit was determined to moderate with 25% to 50% of the reach having cover from 4 types of cover types. During 2021 and 2022 site visits it was documented that the stream was actively eroding along its banks, mainly due to cattle access to the stream banks and limited vegetation growth along the banks due to overgrazing. The active bank erosion is causing the formation of mid channel bars, filling of pools and general lack of in-stream depth diversity. Figure 10 shows the active erosion on the downstream side of CSAH 12. Photo on the left was taken on 4/28/2021 and the photo on the right was taken on 6/08/2022.

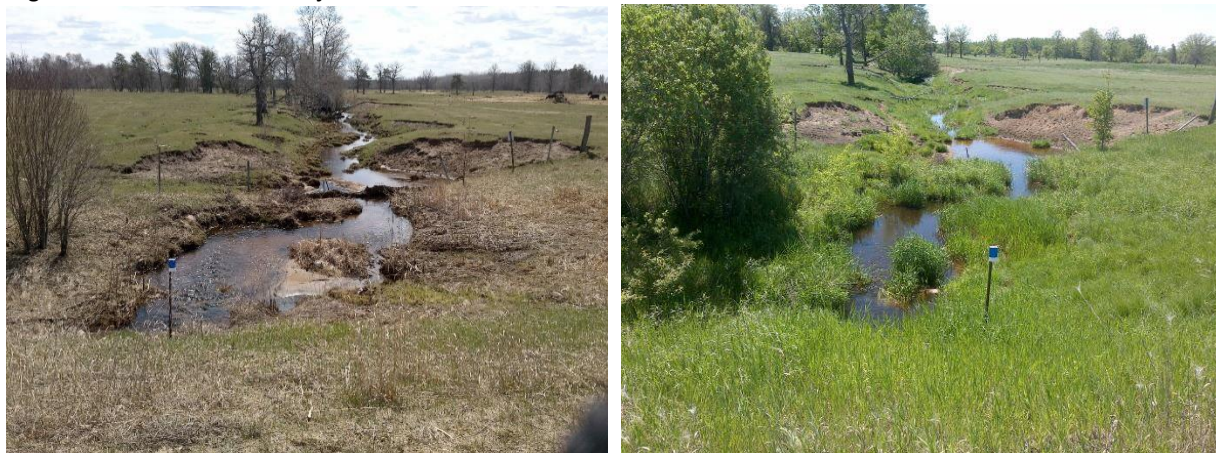
**Figure 10: Active bank erosion just downstream of CSAH12 at S011-719.**

Lack of habitat is a stressor to the aquatic life within 11UM106 due to poor channel morphology and substrate.

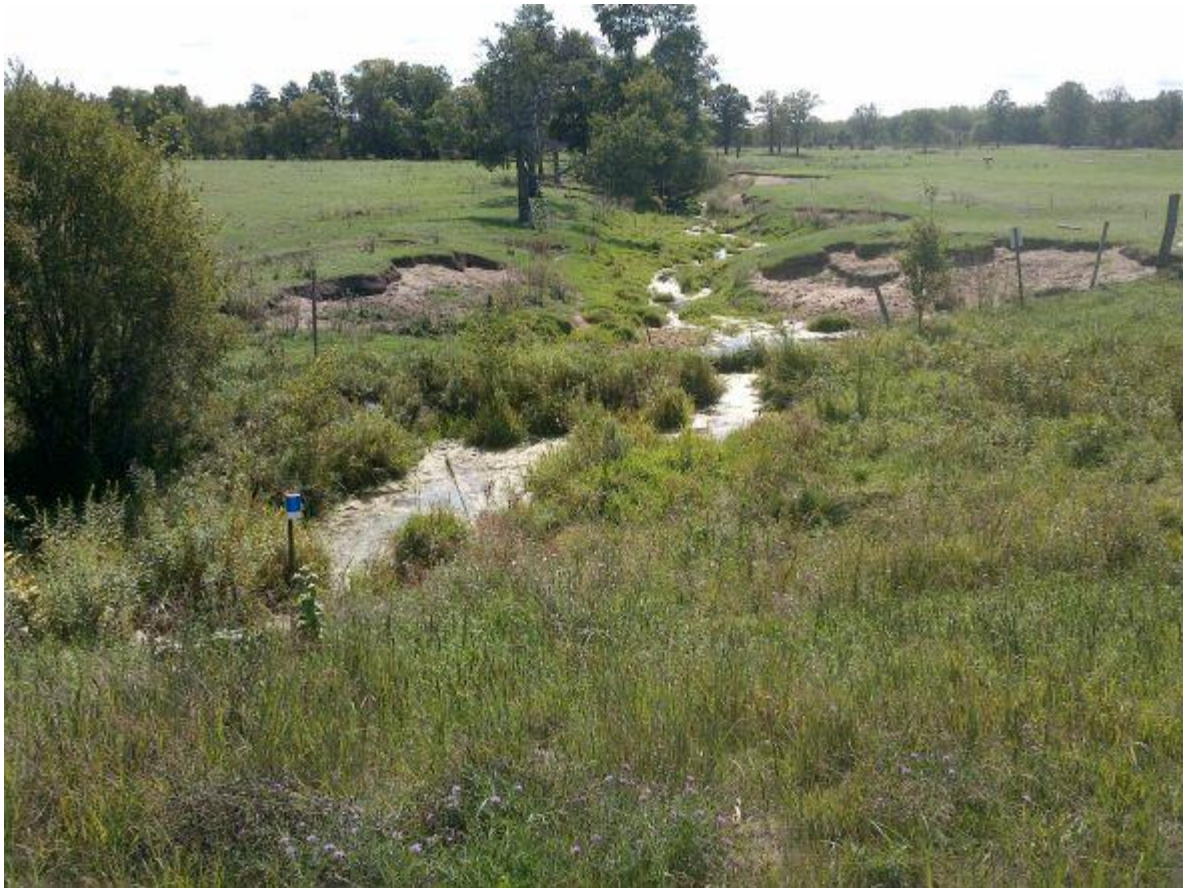
Figure 11: Tributary to Beaver Creek at S011-719 on 9/9/2021. Most of the summer of 2021 streamflow was less than 0.5 cfs.

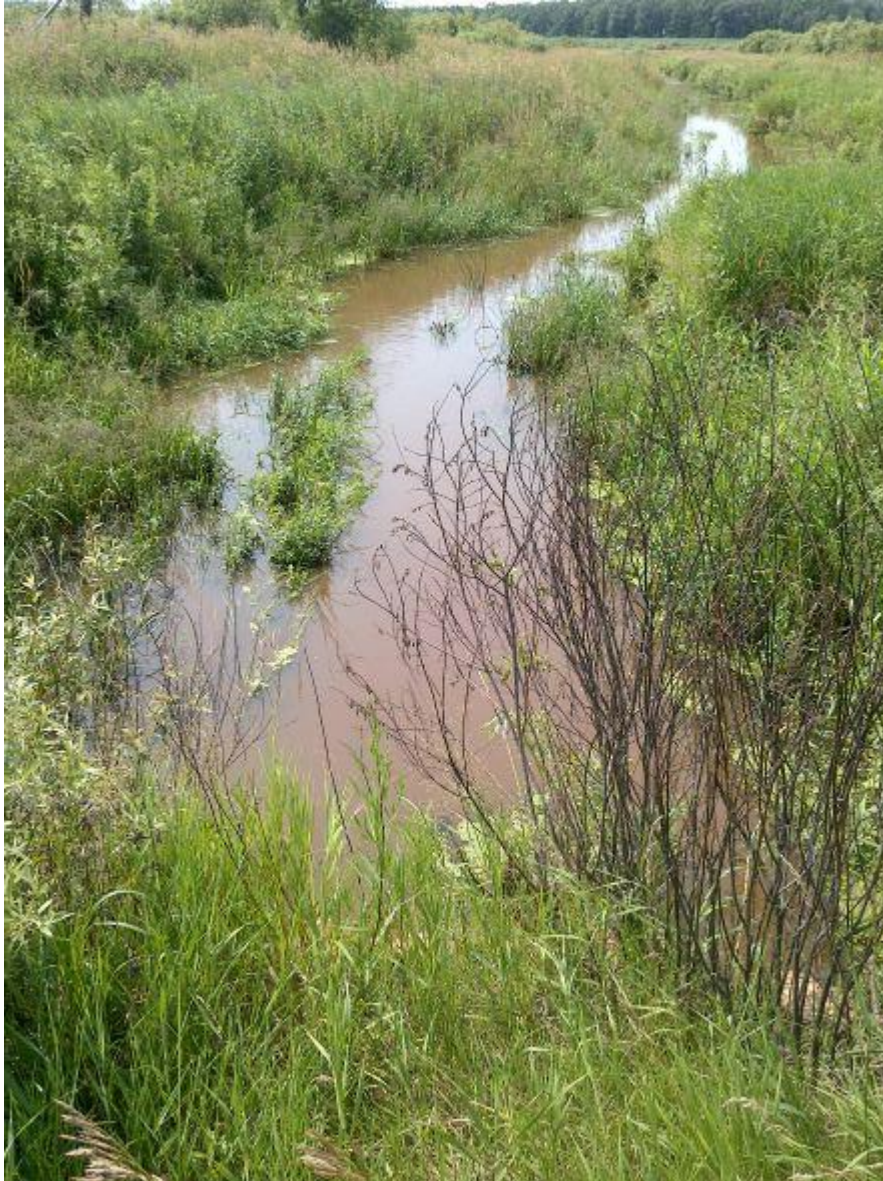
Figure 14: Big Swamp Creek with iron floc in stream channel.

TSS data is limited to four samples in 2022 (Table 5). The values were well below the standard. The iron precipitate can cause elevated TSS values and strips DO out of the water column. TSS is not considered a stressor to the macroinvertebrates.

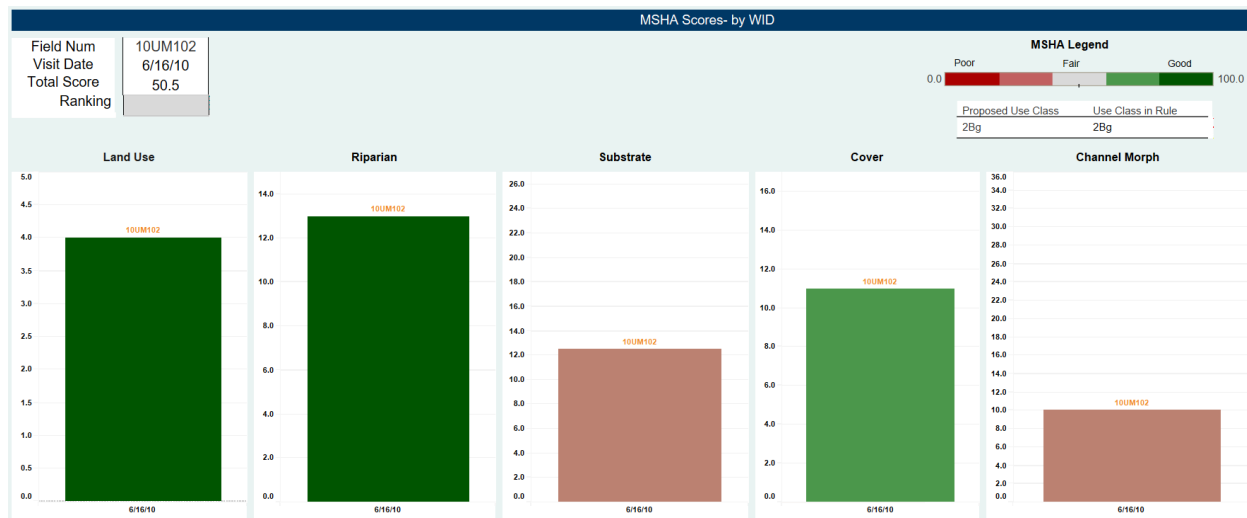
Figure 15: MSHA habitat scores for Tributary to Big Swamp Creek.

Due to the historic channelization of Tributary to Big Swamp Creek, and fair MSHA score, the assessment of Tributary to Big Swamp Creek was brought into the UAA process. It was determined that the habitat of Tributary to Big Swamp Creek has the ability to support good quality habitat for aquatic life, as a result of the MSHA score. Therefore, Tributary to Big Swamp Creek was assessed using the General Use TALU criteria.

Although the MSHA score was fair overall, substrate and channel morphology scored particularly low as noted in Figure 15. Substrate was the first low scoring component of the MSHA score, as indicated by the dominance of sand and silt. Healthy fish communities need coarse substrate in order to build nests and spawn. Excessive fine sediment also affects juvenile fishes, as the sediment is stirred into the water column creating TSS, it can easily tear sensitive juvenile fish gills. Similarly, many sensitive macroinvertebrates also have specialized gills that are used to breathe DO. Excessive fine sediments can damage these gills, similar to juvenile fishes, making the creek inhabitable for sensitive species.

sinuosity and poor channel development impedes the fish and macroinvertebrate’s ability to inhabit the creek throughout the summer, especially during high flow events, which can flush these communities downstream. The lack of good channel morphology is caused by the channelization of the creek, as the manipulation of the channel has been designed to move water quickly, by mechanically removing channel sinuosity, pools, and riffles. Lack of habitat is a stressor to the aquatic life in Tributary to Big Swamp Creek.

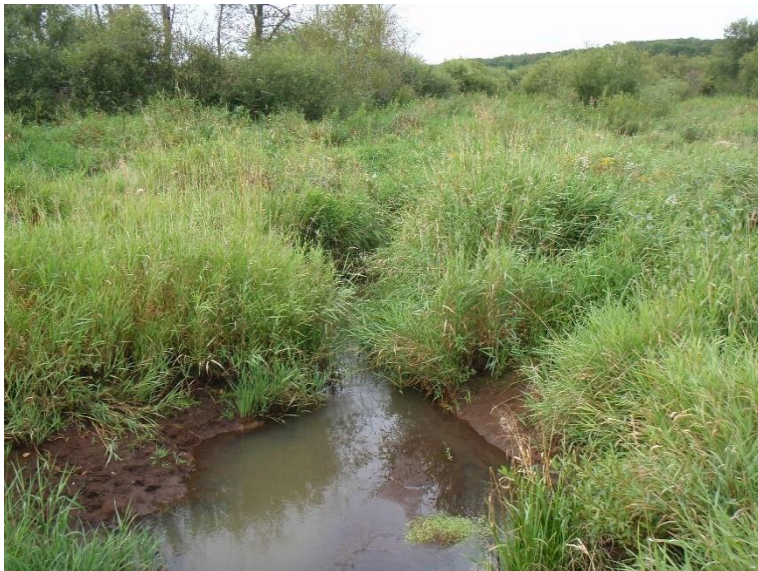
**Figure 16: Tributary to Big Swamp Creek on September 2, 2010. Prior to the repair of the channel the channel was narrow and there was some bank habitat to sample for macroinvertebrates.**

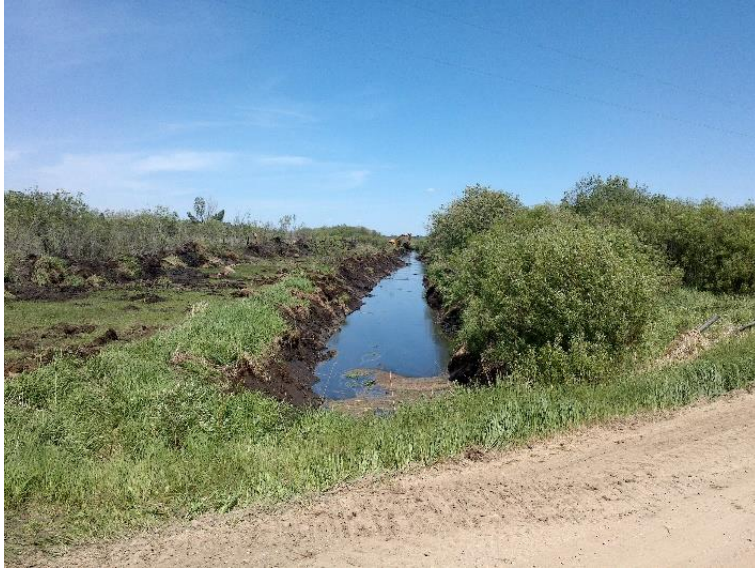
**Figure 17: Tributary to Big Swamp Creek on 6/04/21, showing an almost dry channel with only 1 in of water in the channel. Channel had just been maintained in this section.**

In May of 2021, a ditch maintenance project was occurring along the stream reach. This maintenance removed any available habitat that was in the stream prior to spring of 2021. The maintenance effort has enlarged the channel capacity and will promote sediment buildup and a lack of stream depth variability for the future. The current channel size is most likely much larger than the historic stream channels that existed prior to the channelization, and is showing signs that the channel is receiving excess sediment from the banks or the landscape, as sand was the only substrate noted within the MSHA evaluation. It is possible that this excess sediment would have historically settled out within the wetlands that made up most of the riparian pre-settlement, but due to the channelization, the sediment is flushed downstream during precipitation events. Therefore, due to the altered hydrology and geomorphology of Tributary to Big Swamp Creek causing the channel to dry up, it is considered to be the primary stressor within Tributary to Big Swamp Creek.

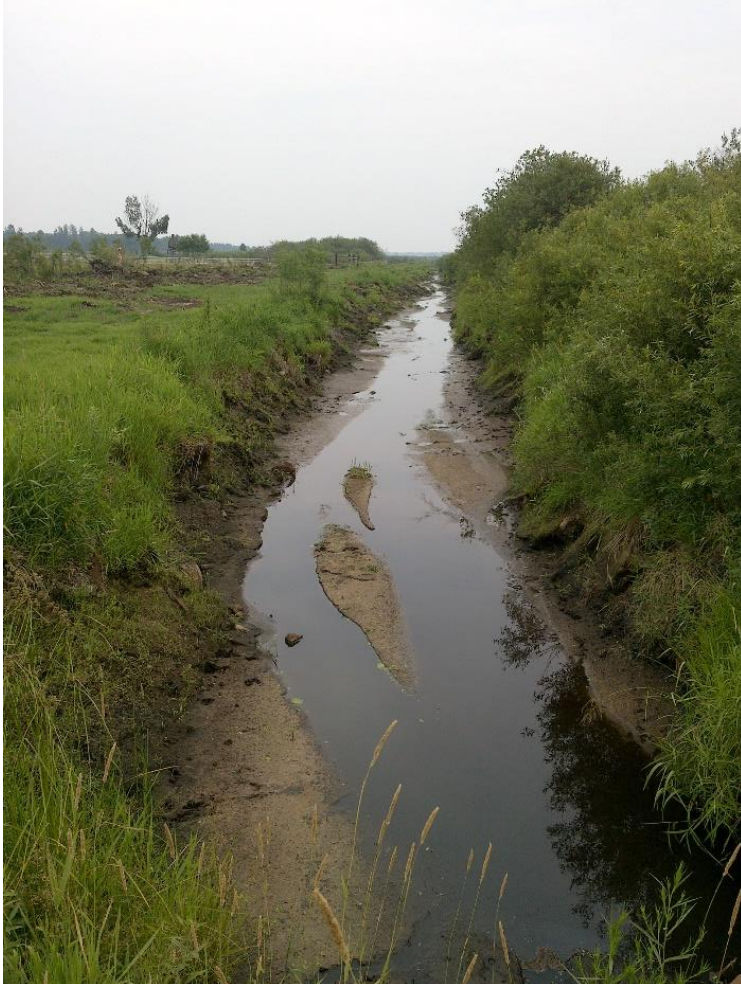
**Figure 18: Tributary to Big Swamp Creek intermittent flow in the middle of July 2021.**

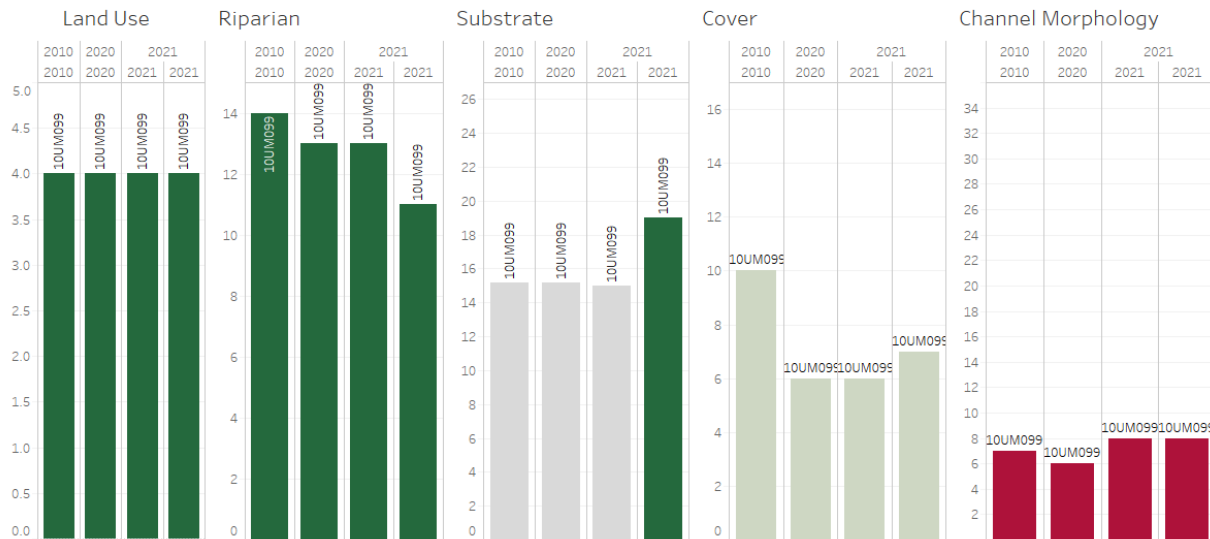
MSHA Scores				
Field Num	Month of Visit Date	Day of Visit Date	Year of Visit Date	Total Score
10UM099	June	17	2021	46
		29	2010	50.200000763
	July	8	2021	49
	August	11	2020	44.200000763

Due to the historic channelization of Tributary to Crow Wing River, and fair MSHA score, the assessment of Tributary to Crow Wing River was brought into the UAA process. It was determined that the habitat of Tributary to Crow Wing River has the ability to support good quality habitat for aquatic life, as a result of the MSHA score. Therefore, Tributary to Crow Wing River was assessed using the General Use TALU criteria.

Although the MSHA score was fair overall, cover and channel morphology scored particularly low as noted in Figure 21. Cover was the first low scoring component of the MSHA score, as indicated by the

lack of deep pools, boulders, and overhanging vegetation. Healthy fish communities need cover to escape predation. Excessive fine sediment also affects juvenile fishes, as the sediment is stirred into the water column creating TSS, it can easily tear sensitive juvenile fish gills. Similarly, many sensitive macroinvertebrates also have specialized gills that are used to breathe DO. Excessive fine sediments can damage these gills, similar to juvenile fishes, making the creek inhabitable for sensitive species.

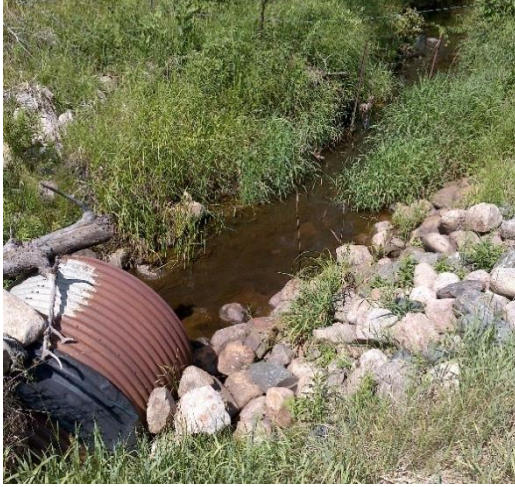
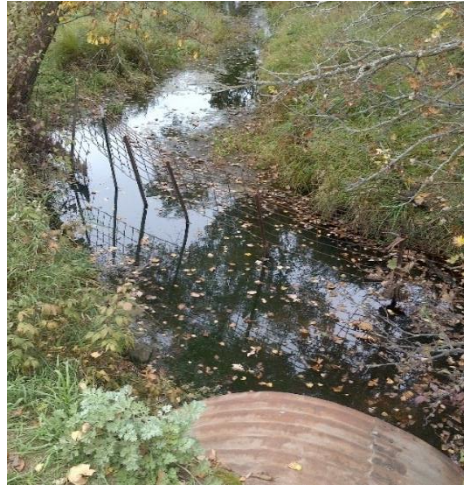
This channel alteration accelerates stream flow, resulting in higher flows during precipitation events which achieves the agricultural land use drainage goals, but causes instability. Water leaves the landscape quickly, resulting in periods of higher flow than what would have naturally occurred. As the landscape drains, water that was once held in the upstream wetlands is flushed downstream. Then, as these flows quickly drain, the flow regime quickly transitions to intermittent, reaching stagnant conditions starting in the summer (Figure 22). Although 2021 was a dry summer, Tributary to Crow Wing River was already mostly dry by the early July. The water that was present in the channel was very shallow groundwater seeping into the channel.

**Figure 22: Tributary to Crow Wing River experienced low flows during the summer of 2021.**

**June 28, 2021 low flow (upstream)**

**October 8, 2021, low flow (downstream)**

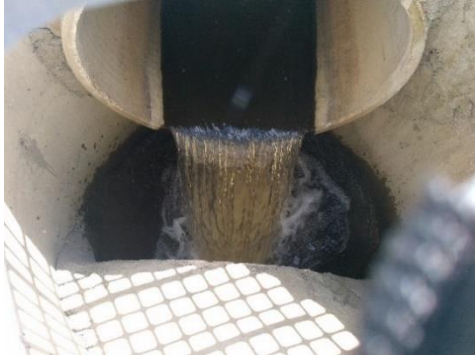
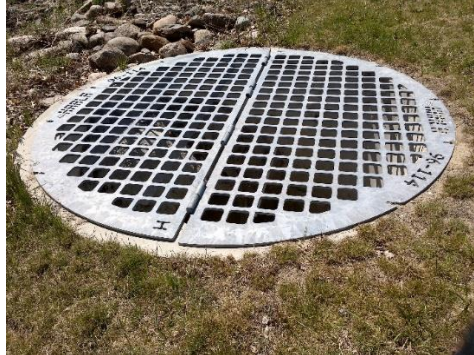
**Figure 23: 5/13/2021 manhole drop structure at road crossing CR110 (CR7). Top of emergency spillway. Complete fish barrier**

The culvert with the drop structure is located on the farthest downstream end of the stream and appears to be a grade control structure to help prevent erosion on the downstream outlet of the culvert. The gradient in this stretch of stream is high and prior to this recently installed structure the downstream section of stream was eroded. Aerial photo analysis shows that the structure was installed between 2013 and 2016 as seen in the photos below.

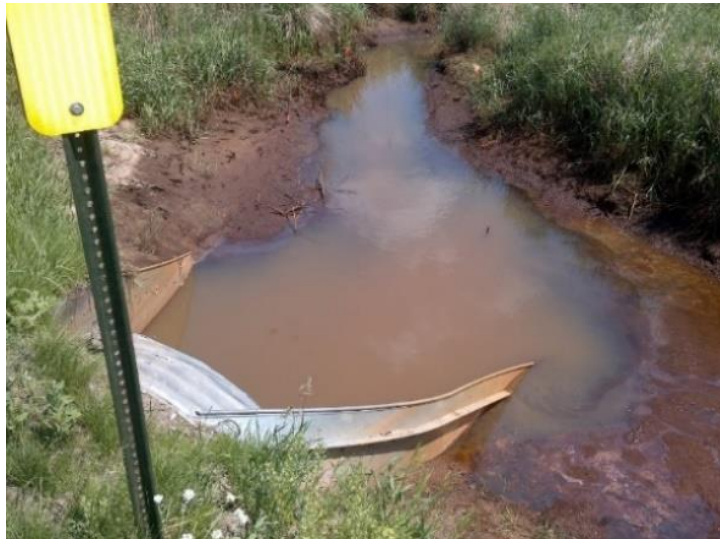
**Figure 26: June 10, 2021, photo on upstream side of culvert. Showing iron in water and iron precipitate along stream edges.**

TSS data is limited to 6 samples with both samples in 2010 being well above the 30 mg/L standard (Table 9). The 2022 values were well below the standard but in 2022 there was more flow in the stream than in 2010. The iron precipitate can cause elevated TSS values and strips DO out of the water column. TSS is considered a secondary stressor to the macroinvertebrates.

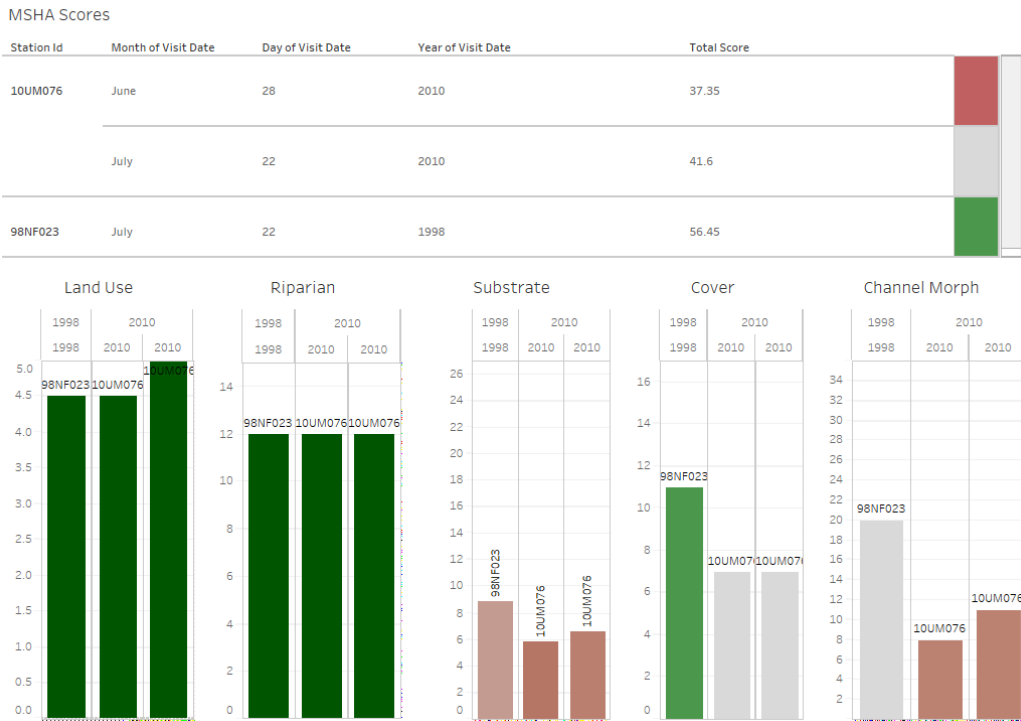
**Figure 27: MSHA habitat scores for Unnamed Ditch.**

Due to the historic channelization of Unnamed Ditch, and fair MSHA score, the assessment of Unnamed Ditch was brought into the UAA process. It was determined that the habitat of Unnamed Ditch has not degraded to a point where it cannot support good quality habitat for aquatic life, as a result of channelization. Therefore, Unnamed Ditch was assessed using the General Use TALU criteria. Although the average MSHA score was fair overall, substrate and channel morphology scored particularly low, which lowered the overall MSHA score (Figure 27). Substrate was the first low scoring component of the MSHA score, as indicated by the dominance of clay and silt. Healthy fish communities need coarse substrate to build nests and spawn. Excessive fine sediment also affects juvenile fishes, as the sediment is stirred into the water column creating TSS, it can easily tear sensitive juvenile fish gills. Similarly, many sensitive macroinvertebrates also have specialized gills that are used to breathe DO. Excessive fine sediments can damage these gills, like juvenile fishes, making the ditch inhabitable for sensitive species. Gravel was not present within the channel. Since this channel appears to be nearly 100% created in the upstream reaches, there was probably never any coarse substrate available.

Channel morphology was another low scoring component of the MSHA evaluation. The MSHA indicated that there was fair channel depth variability, poor sinuosity, and moderate channel stability. Fish and macroinvertebrates need channel depth variability to use as cover from predation and refuge during high precipitation events. Minimal change in the channel depth combined with fair sinuosity impedes the fish and macroinvertebrate’s ability to inhabit the creek throughout the summer, especially during high flow events which can flush these communities downstream. The lack of good channel morphology is caused by the channelization of the creek, as the manipulation of the channel has been designed to move water quickly, by mechanically removing channel sinuosity, pools, and riffles. Lack of habitat is a stressor to the aquatic life in Unnamed Ditch.

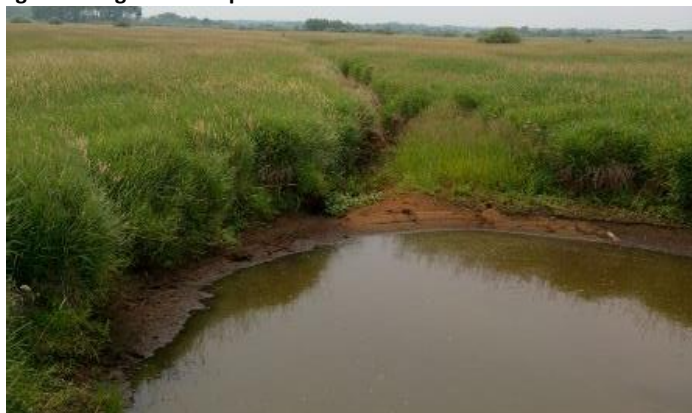
**Figure 28: Unnamed Ditch. Channel was dry on 7/14/2021. Channel stayed dry through September of 2021 and dried out again in August and September of 2022.**

Due to the channelization of Unnamed Ditch, the ditch does not have a natural stream pattern that can be assessed for stability. Utilizing the biological monitoring sampling pictures and MSHA evaluations of stream bank condition, the banks appear to be stable and not actively eroding. The current channel size is most likely similar in size to the historic stream channels that existed prior to the channelization, but the new channel is much shorter, which drains the channel quickly. Due to these hydrologic and geomorphic alterations of the historical stream channel, altered hydrology is a stressor to the aquatic life within Unnamed Ditch. During the September 2010 macroinvertebrate sampling event, water levels were also very low, and the stream was full of iron precipitate (Figure 29). This shows that the stream frequently goes dry or nearly dry. Lack of baseflow in the late summer and fall is the greatest stressor to the macroinvertebrates.

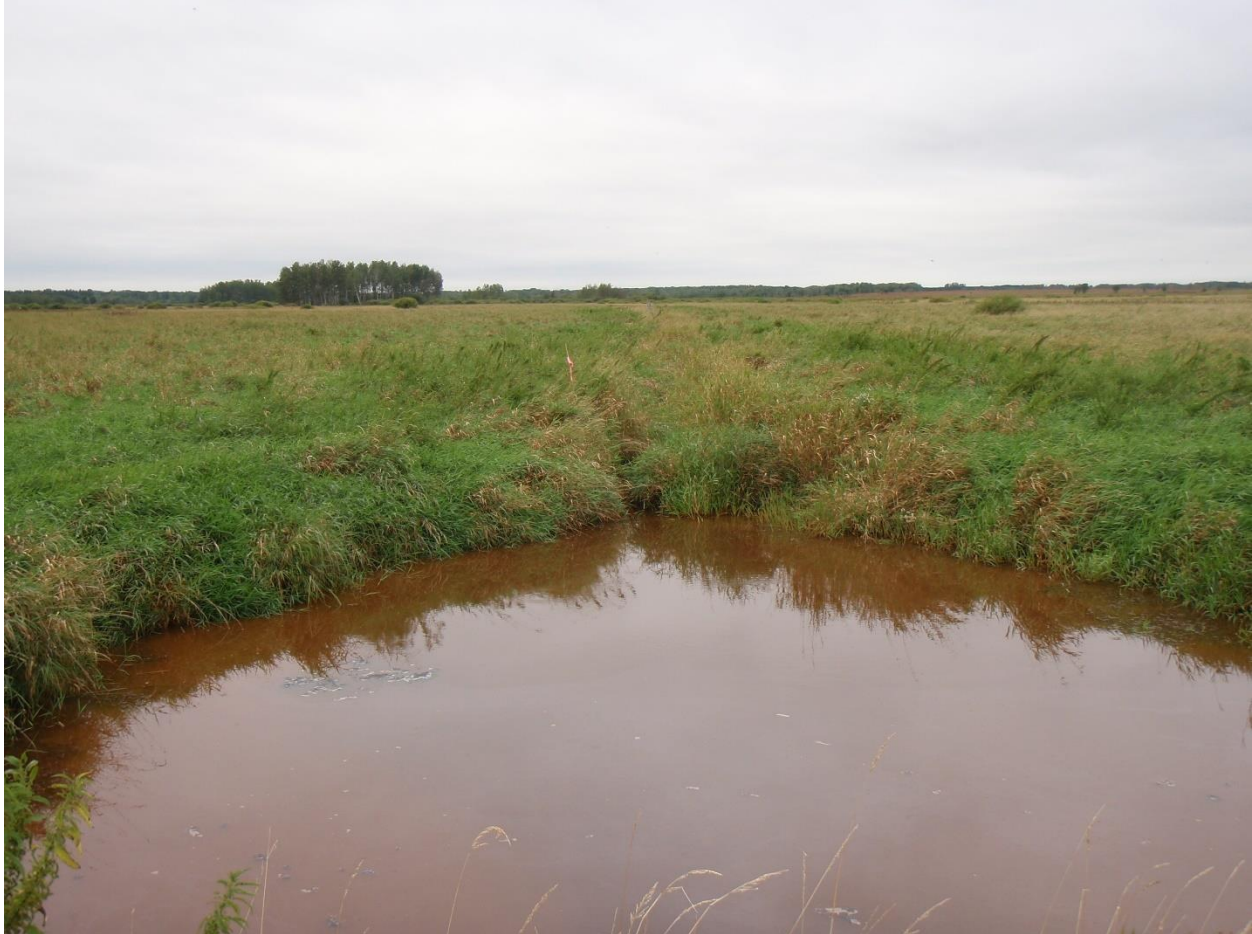
**Figure 29: Macroinvertebrate sampling event on September 2, 2010. Water levels are low, and the channel is full of iron precipitate and has very low DO concentrations.**
