Minnesota River – Headwaters Watershed Stressor Identification Report

Stressor identification for biological impairments in the Minnesota River – Headwaters

Document number: wq-ws5-07020001a

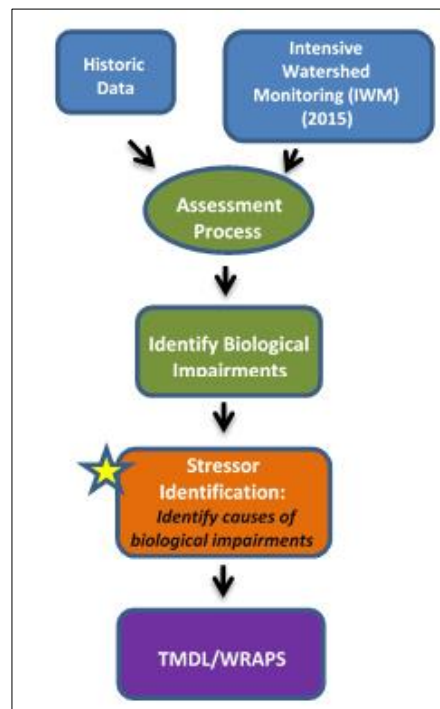
Figure 1. Process map of Intensive Watershed Monitoring.

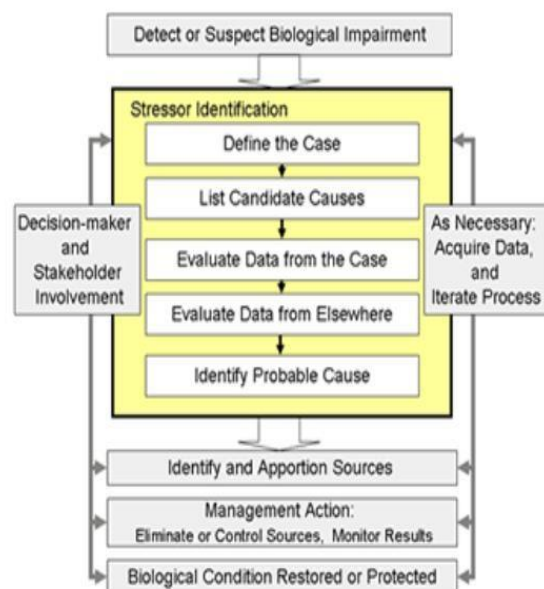
Figure 2. Stressor identification process (Cormier et al. 2000).

The MPCA follows the U. S. Environmental Protection Agency (EPA)'s process of identifying stressors that cause a biological impairment, which has been used to develop the MPCA's guidance to stressor identification (Cormier et al. 2000; MPCA 2008). The EPA has also developed an updated, interactive web-based tool, the Causal Analysis/Diagnosis Decision Information System (CADDIS; EPA 2010). This system provides an enormous amount of information designed to guide and assist investigators through the process of Stressor Identification. Additional information on the Stressor Identification process using CADDIS can be found here:

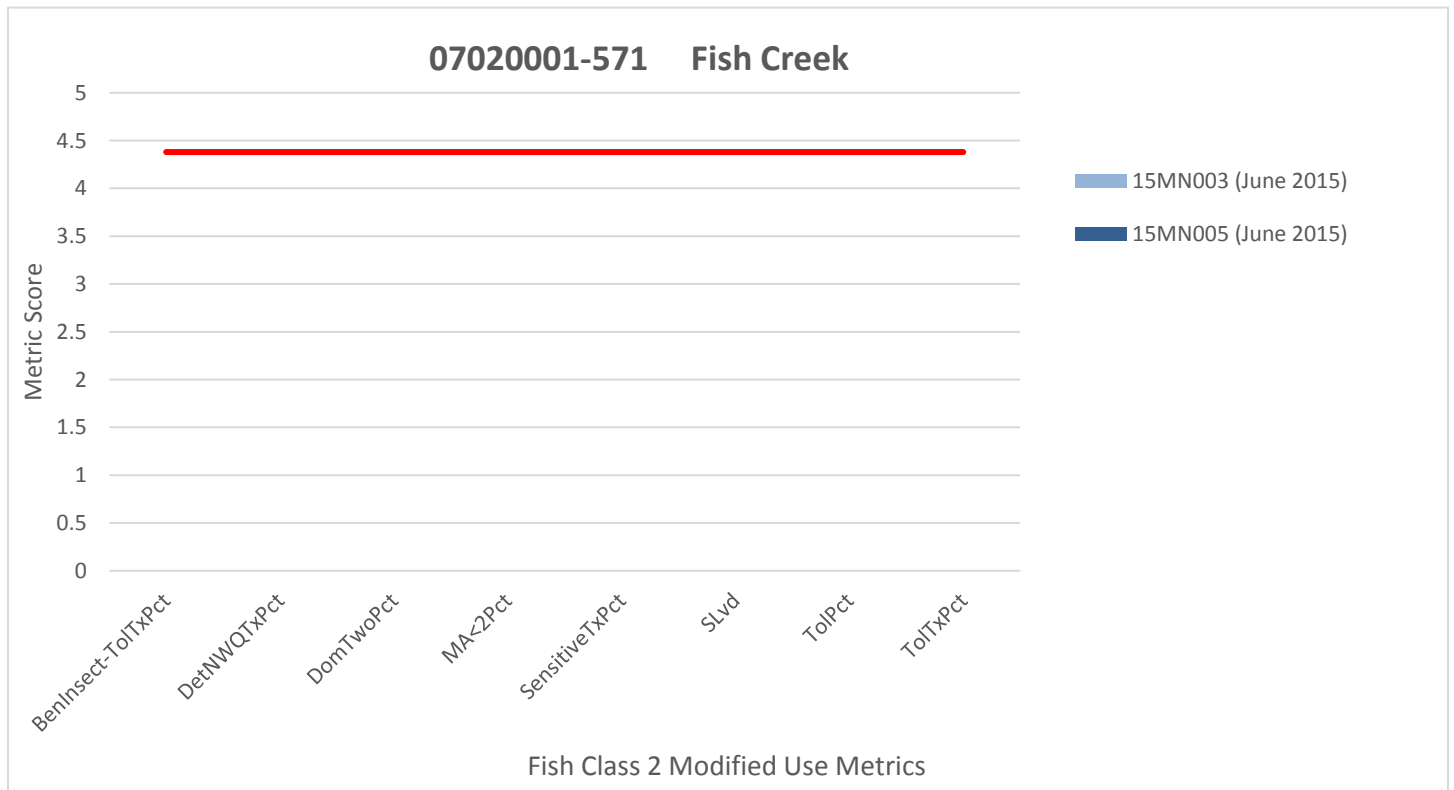
Figure 17. Fish Class 2 metric scores for bio sites 15MN003 and 15MN005

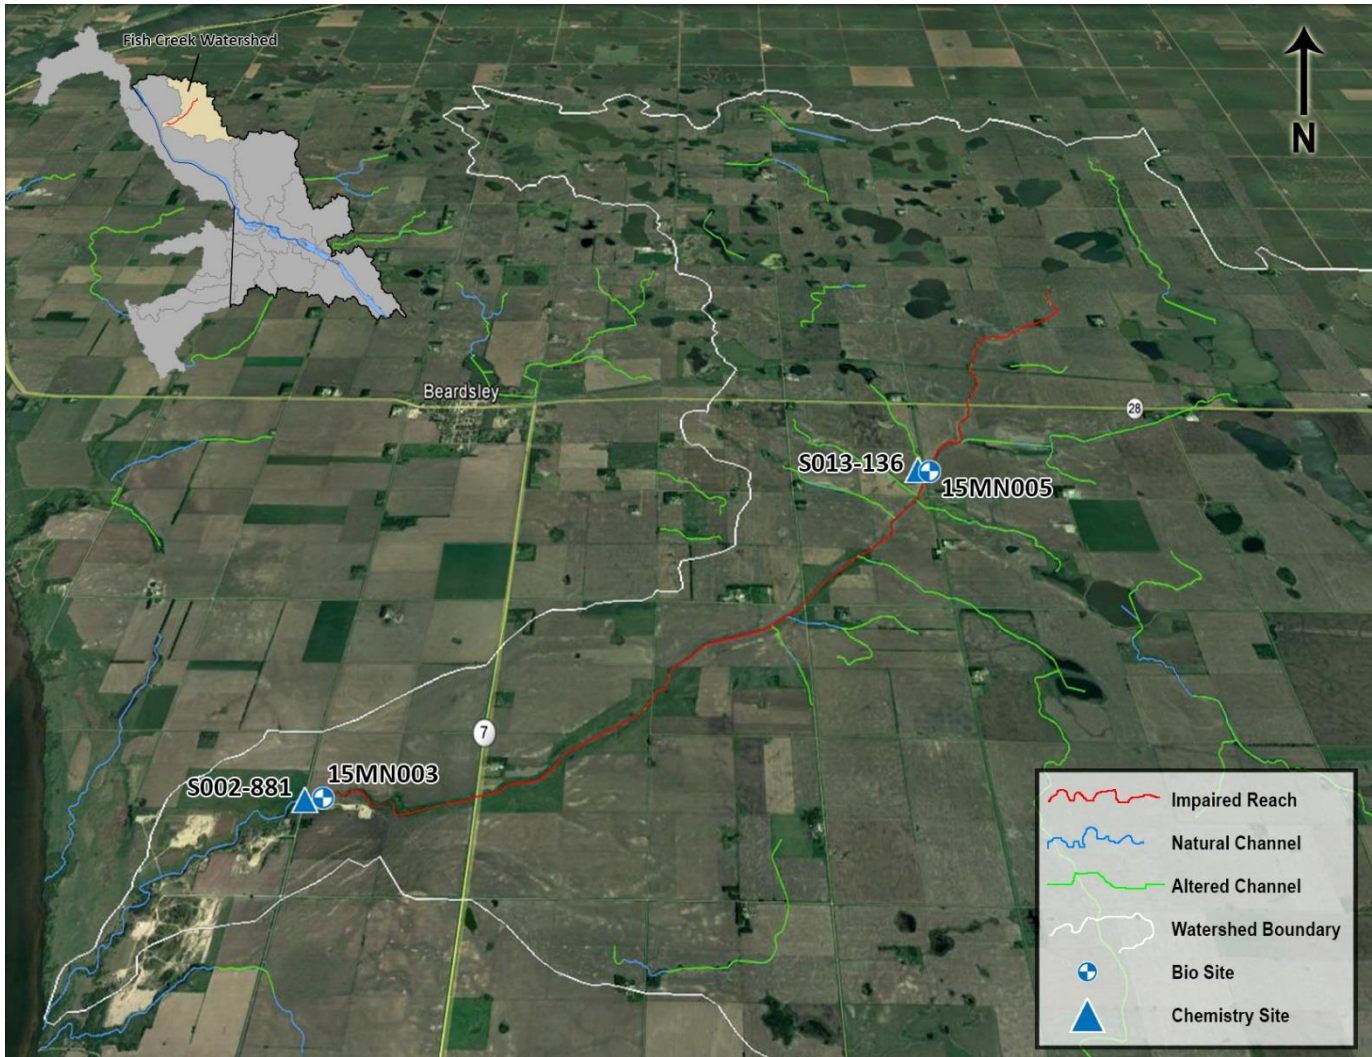
Figure 19. Satellite image showing reach 0702001-571 and altered streams within its watershed

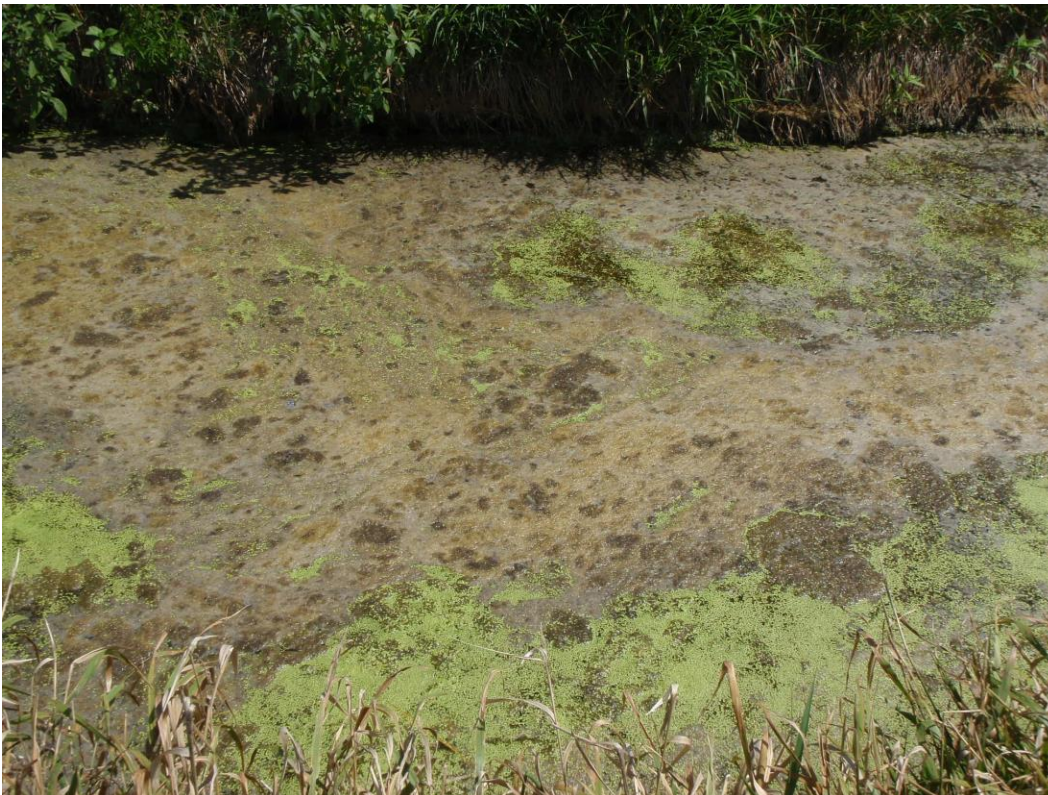
Figure 28. Photo of dead and decaying algae at bio site 15MN005

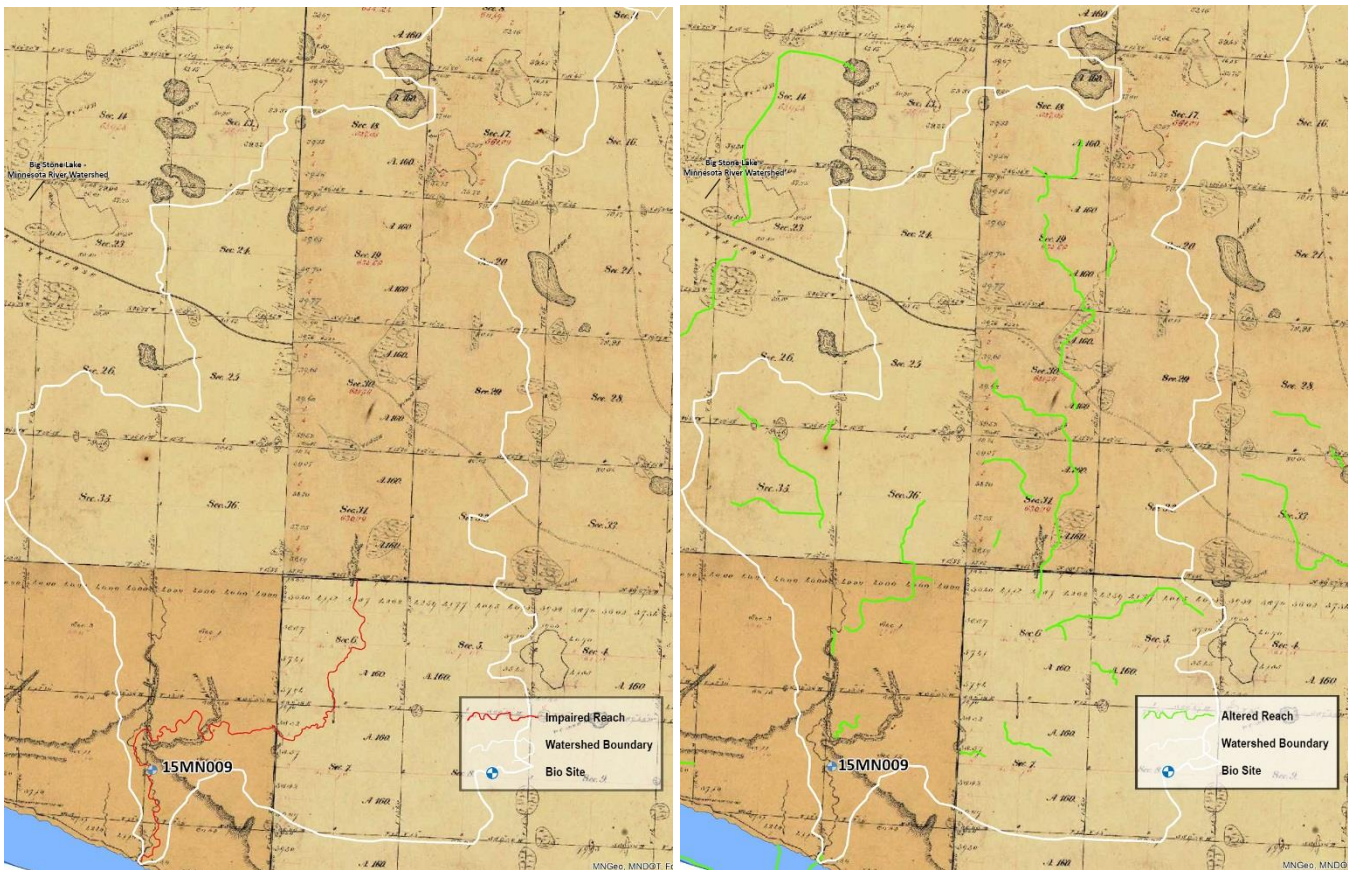
Figure 32. Original Plat map with impaired reach 07020001-568 and Original Plat map with altered streams/ditches

Based on the poor scores of most of the biological metrics, low flow periods shown in the HSPF model, as well as historic surveying data, Hydrologic alteration is a stressor in Meadowbrook Creek. The primary impact in this reach from Hydrologic Alteration is seen by the changes in nutrient overloading of phosphorus and the subsequent effects to eutrophication and DO levels, which is exasperated by low flows during periods of low precipitation.

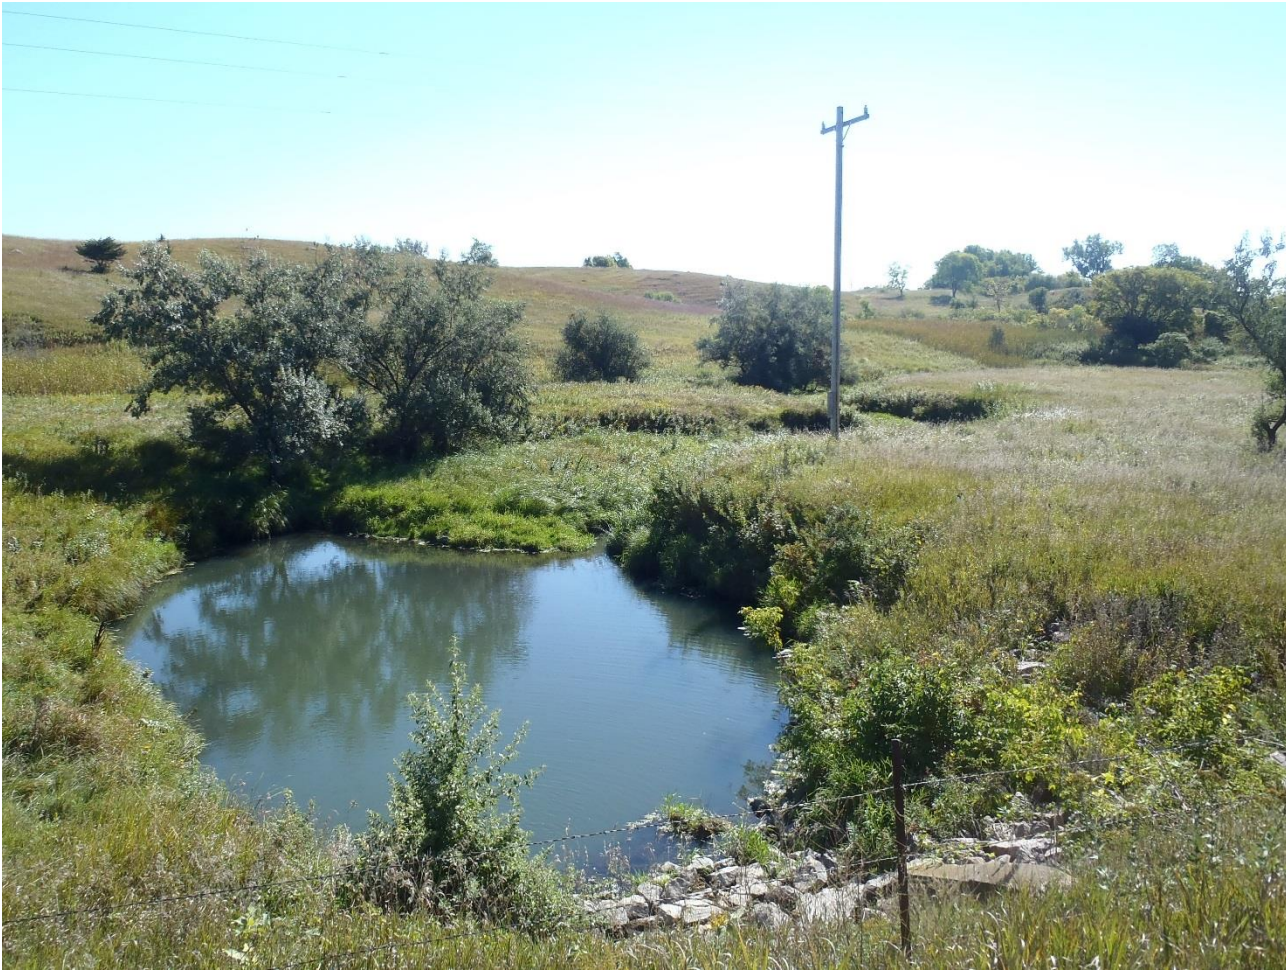
Figure 35. Photo of bio site 15MN009 showing cloudy green water

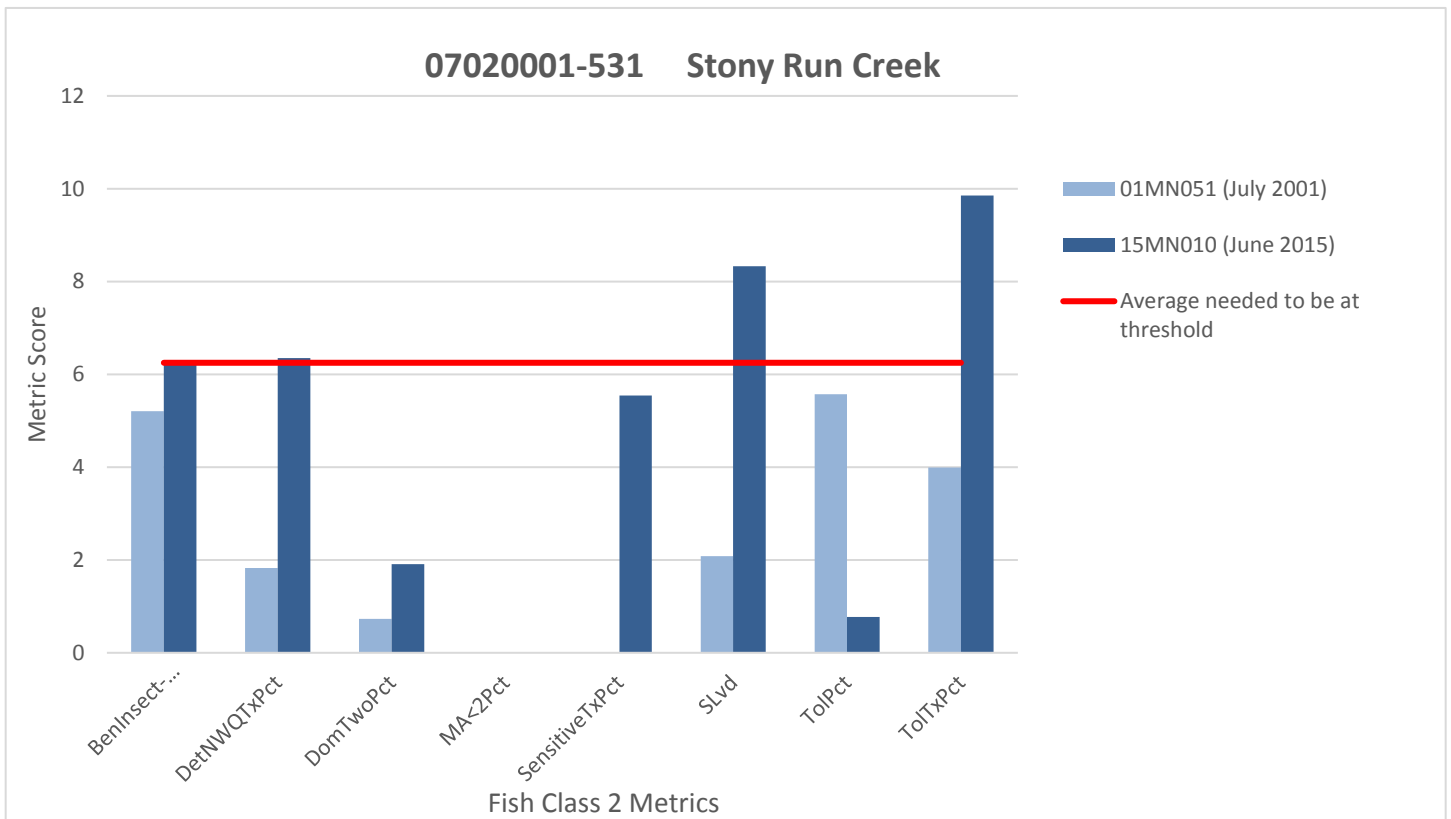
Figure 37. Fish Class 2 metric scores for bio sites 01MN051 and 15MN010

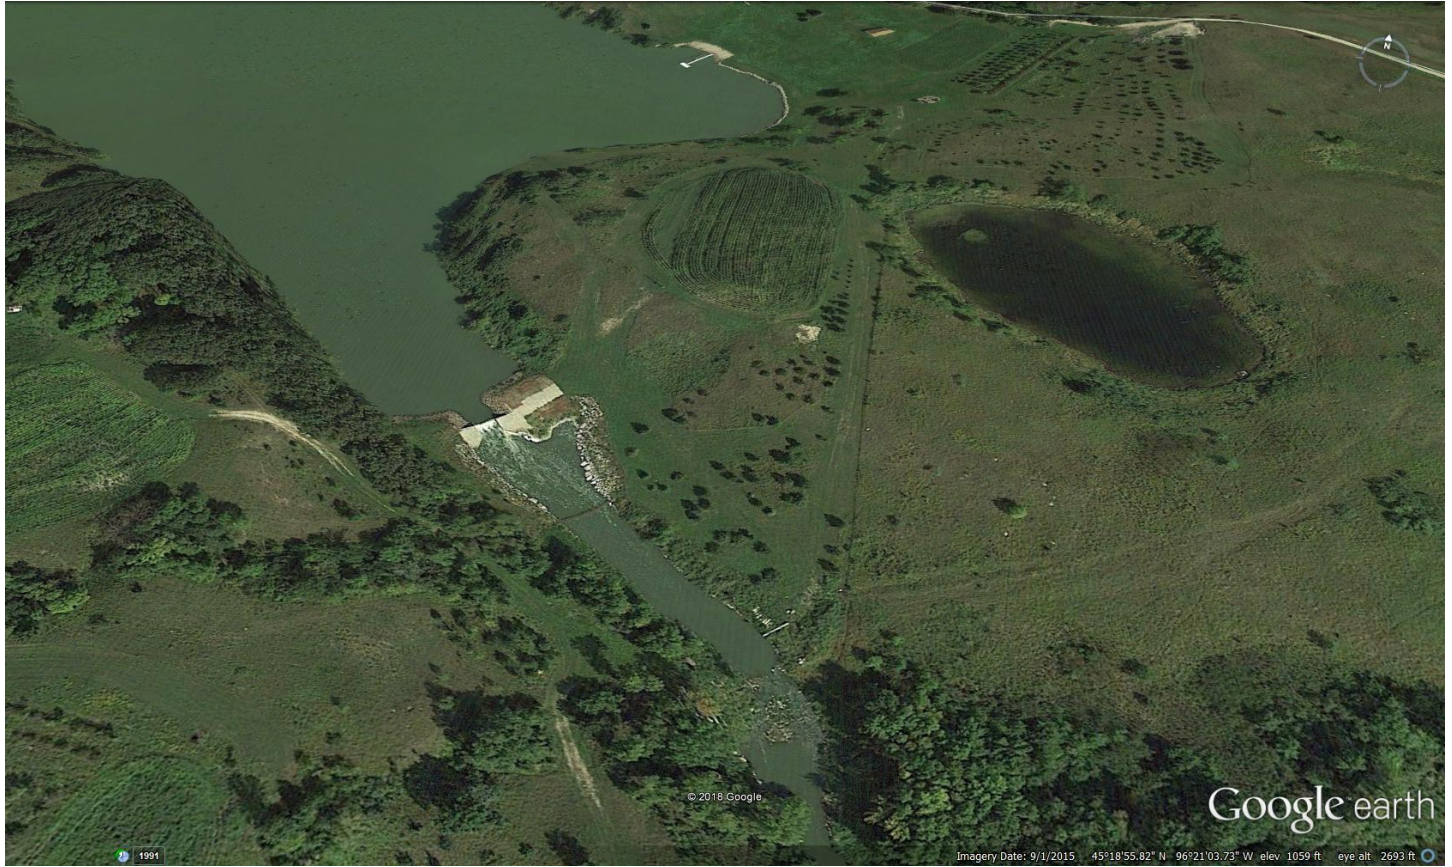
Figure 42. Google Earth image of the outlet structure that controls water levels on Long Tom Lake

The Minnesota River – Headwaters Watershed Characteristic Report classified reach 07020001-531 as a C5c (DNR, 2019). This stream type is described as a slightly entrenched, meandering, sand-dominated, riffle/pool channel with a well-developed floodplain (Rosgen 1996). C5 stream types have a very high sensitivity to disturbance, sediment supply, and streambank erosion potential (DNR, 2019). The bank height ratio was calculated as stable at 1.1 and the entrenchment ratio is only slightly entrenched at 11.9. The stream channel appears to be relatively stable in lower Stony Run Creek. This stability is likely being helped by the grade control that the lakes and reservoirs provide by slowing down and regulating the water flowing downstream. The last lake in the chain, Long Tom Lake, has a concrete structure that controls the lake level (Figure 42).

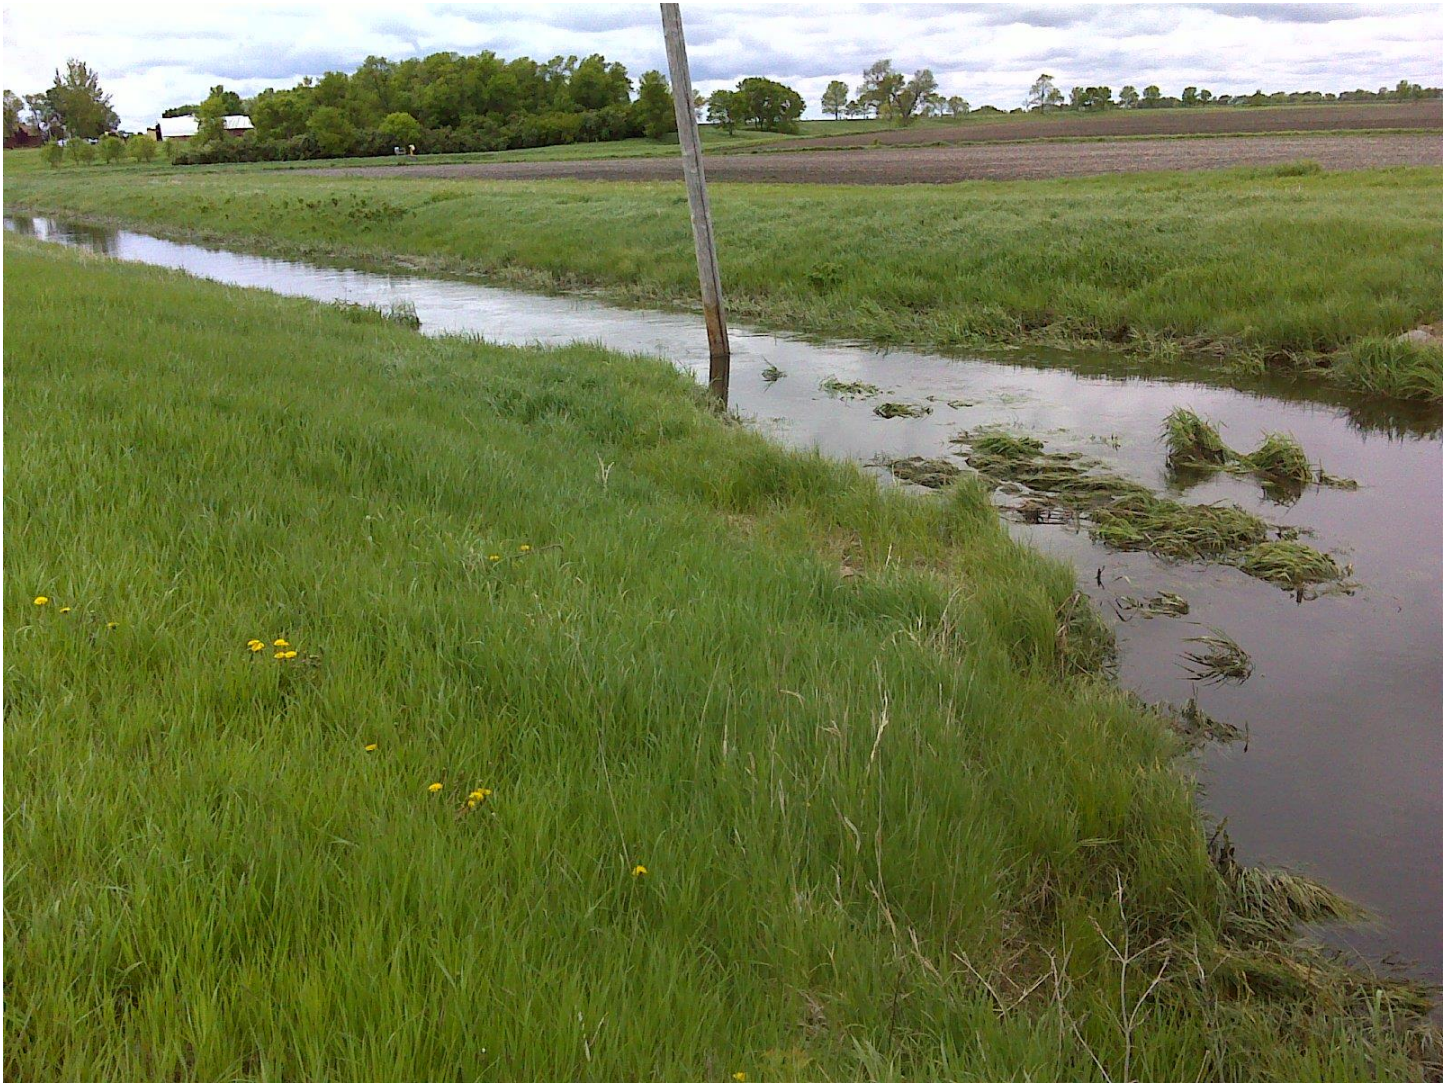
Figure 48. Photo of reach 07020001-559 showing channelization of the stream looking downstream from bio site 15MN012

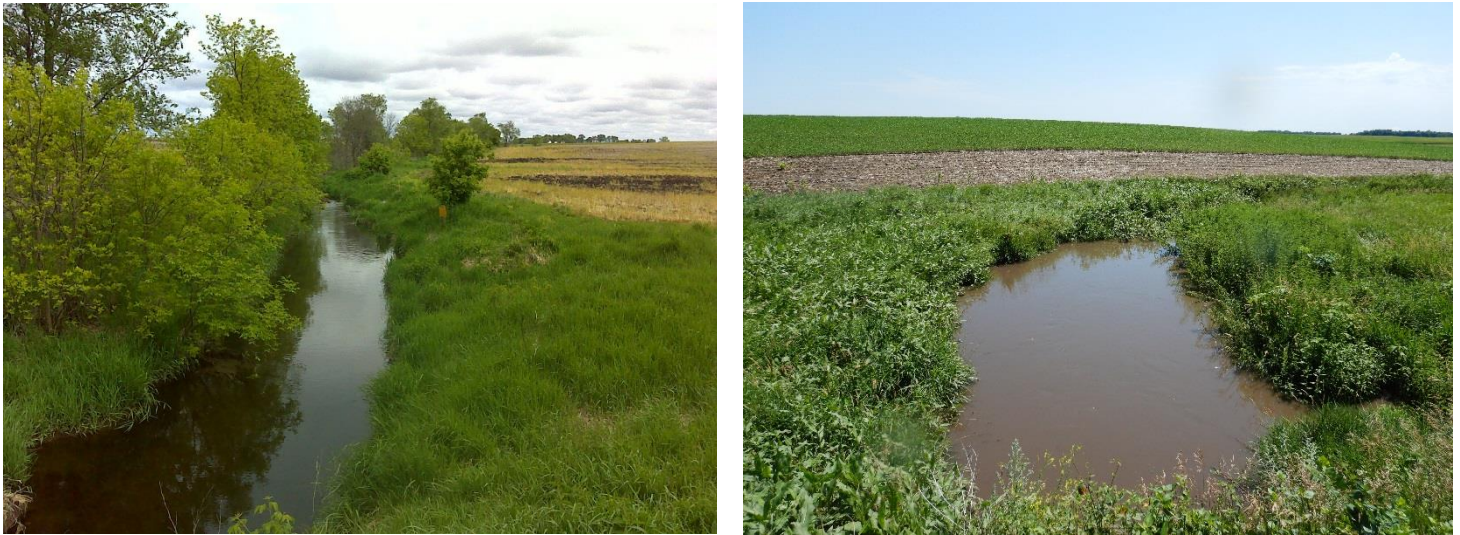
Figure 55. Photo of reach 07020001-560 at bio site 15MN013 showing a channelized section (left) and an unnatural bend running alongside a agricultural field (right)

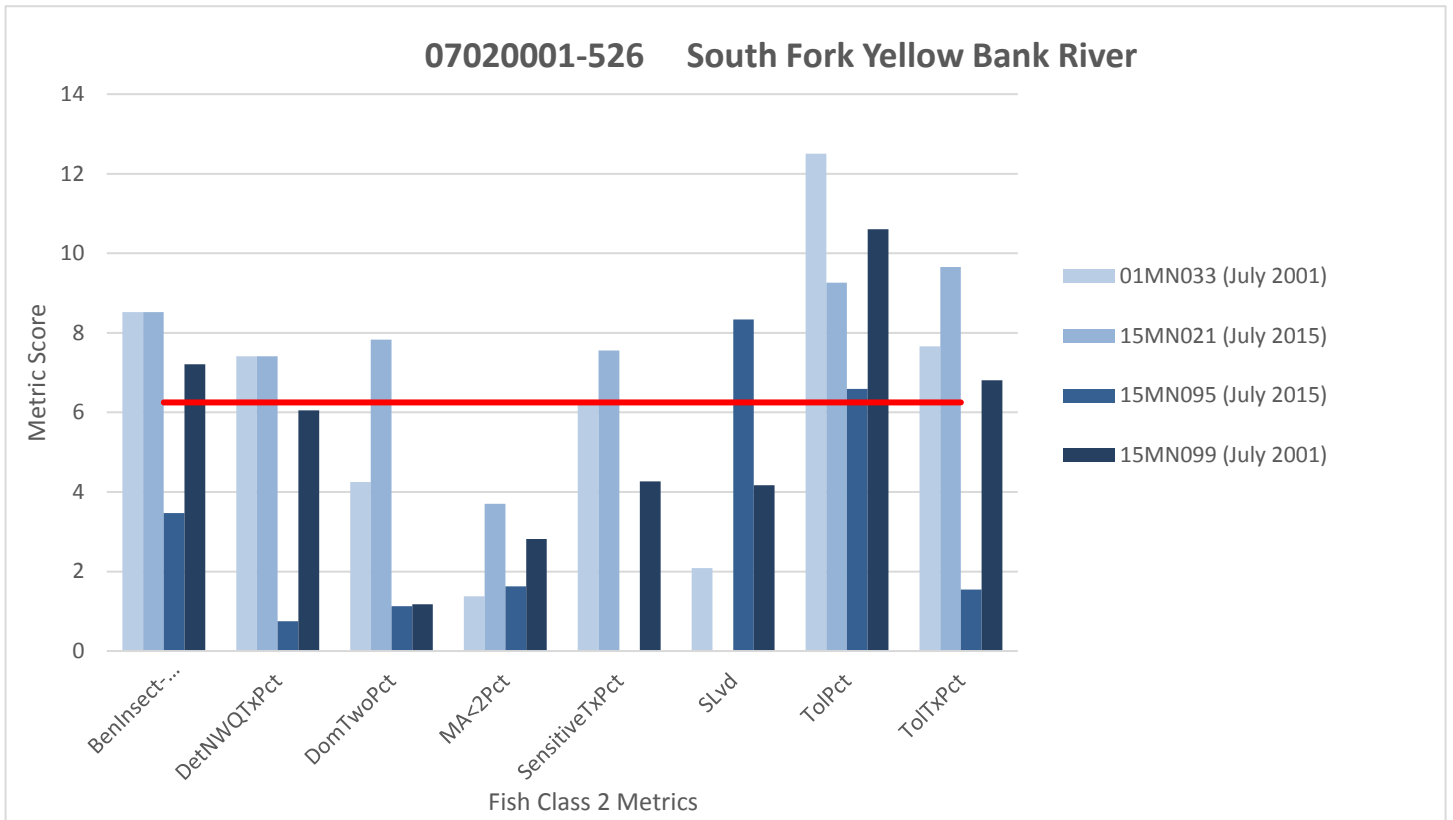
Figure 66. Fish Class 2 general use metric scores for bio sites 01MN033, 15MN021, 15MN095, and 15MN099

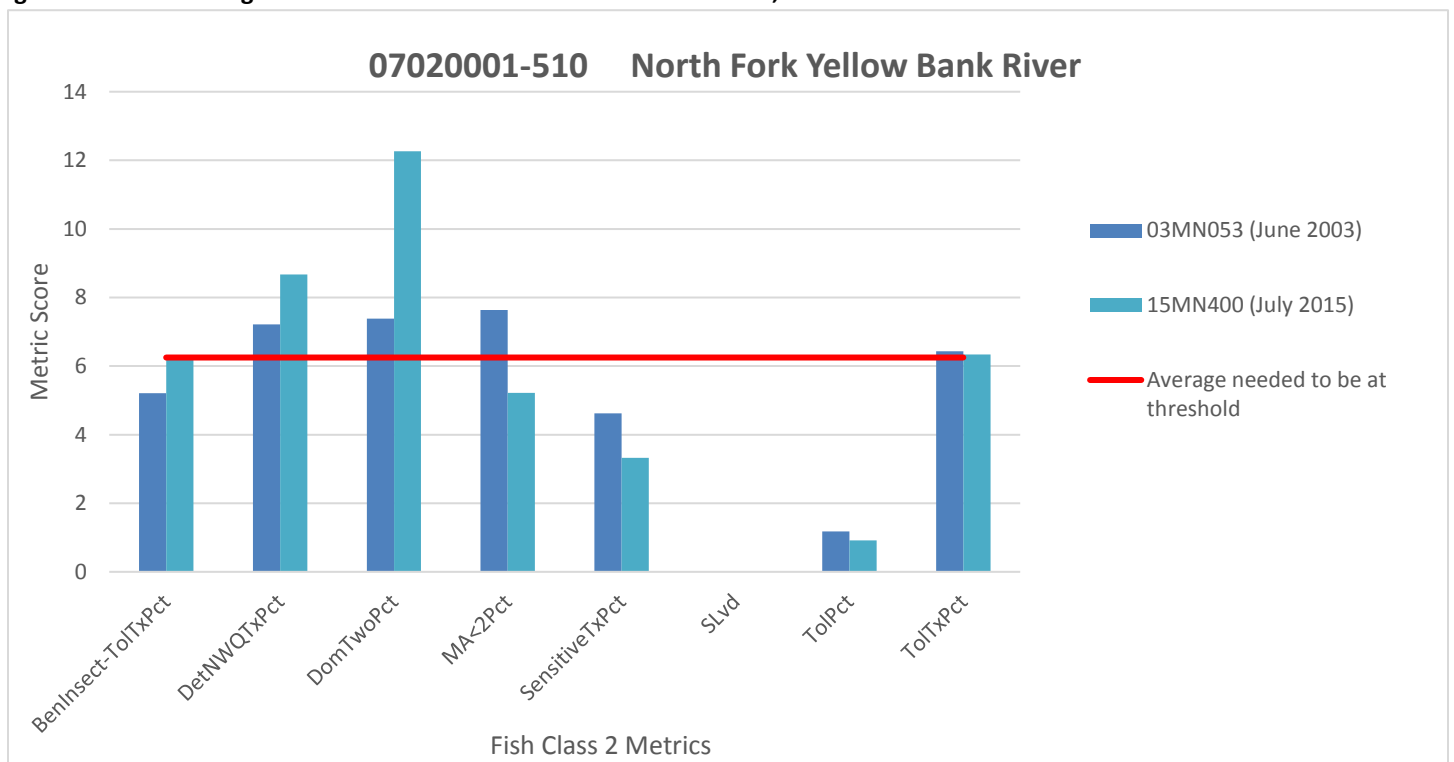
Figure 73. Fish Class 2 general use metric scores for bio sites 03MN053, 15MN400

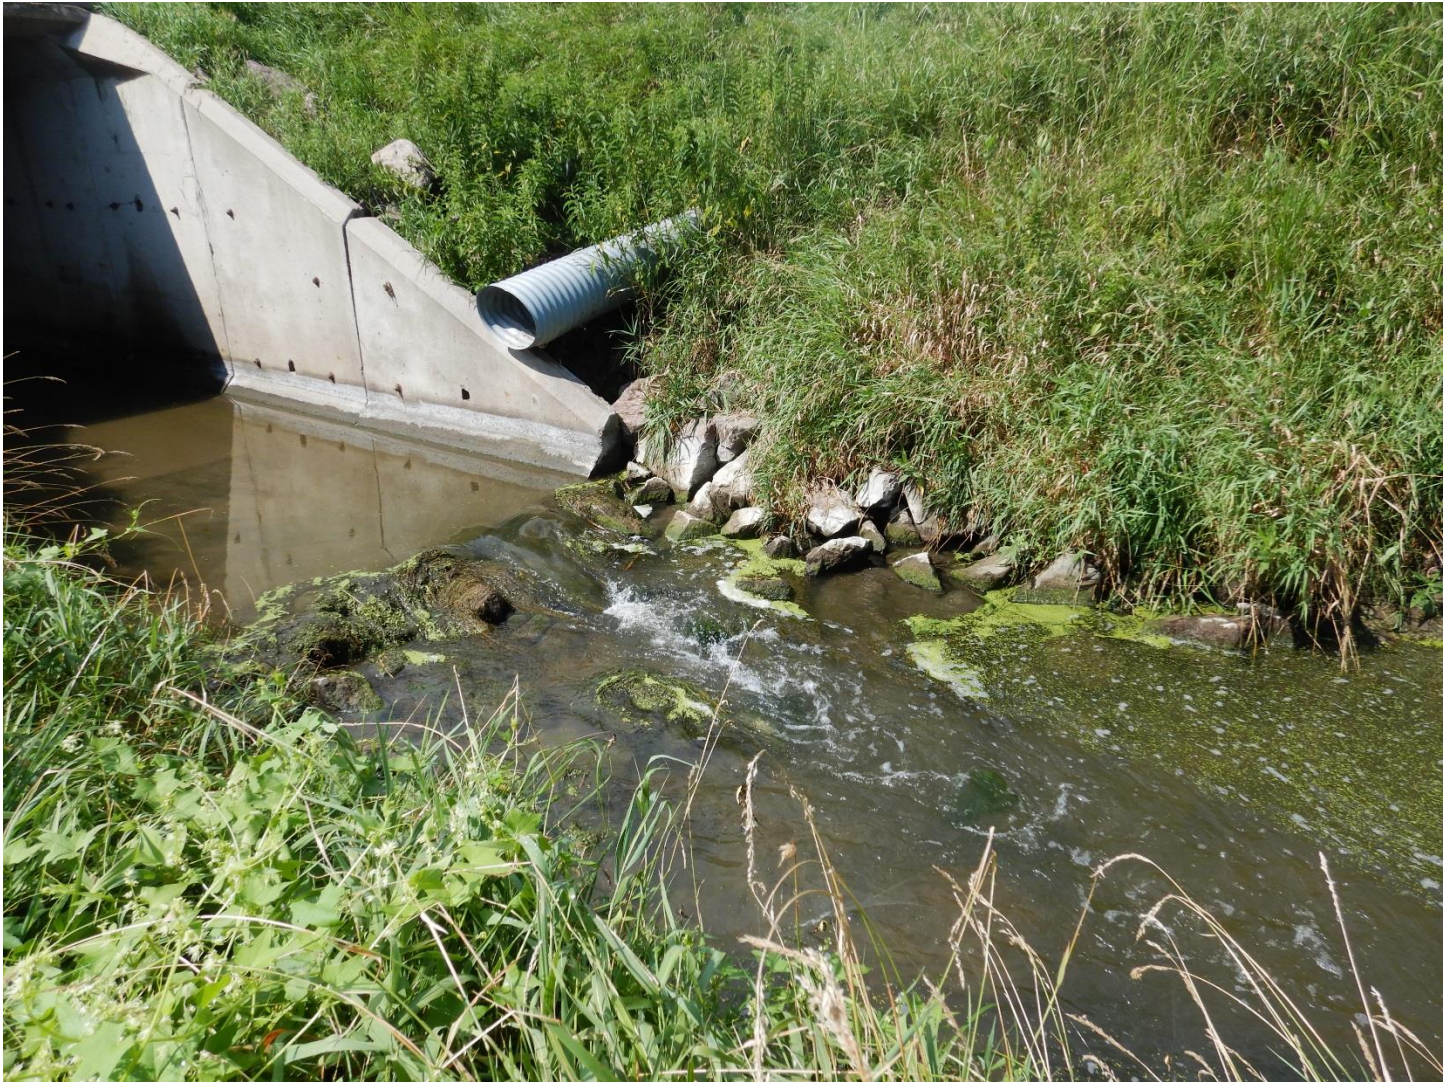
Figure 95. Photo taken of reach 07020001-569 showing algae caught up on rocks directly downstream of a culvert near bio site 10EM067
