Snake River Watershed

Stressor Identification Update

March 2021

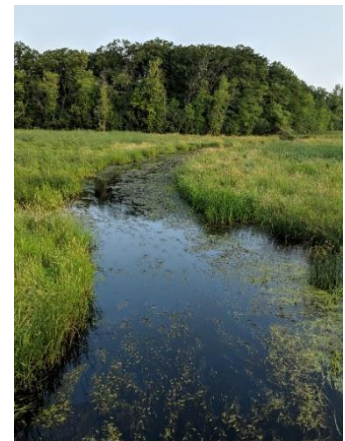
- DO and eutrophication issues are prevalent throughout Mission Creek, but especially at the end downstream of County Highway 11. DO concentrations tend to drop to harmful levels and fluctuate greatly, which negatively impacts aquatic life. Phosphorus concentrations increase downstream of County Highway 11 resulting in excessive plant growth (Figure 2). The proximity of agricultural fields along with the low gradient nature of the stream allows for eutrophic conditions. Best management practices to prevent phosphorus from entering the stream system in this section, as well as upstream, are needed.

Figure 2: Excess plant growth in Lower Mission Creek.

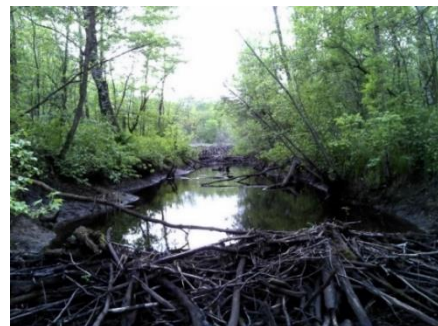
- Altered Hydrology and Connectivity are the driving stressors to aquatic life in Unnamed Creek. There is a series of beaver dams (Figure 3) located along this reach that is impacting the flow and sediment transportation, and degrading the habitat conditions. Beaver dam removal would likely result in improved flow, connectivity, and habitat conditions.

The habitat conditions in Unnamed Creek worsened at site 06SC018 from 2006 to 2016. This was primarily due to the increased amount of sediment along the reach. The beaver dams present are likely limiting proper sediment transport, allowing coarse substrates to be covered and degrading the overall habitat conditions. Removal of the beaver dams would likely result in improved habitat conditions in this reach.

Figure 3: Multiple beaver dams located in Unnamed Creek at site 06SC018.

| Stressor | Priority | Comment |
|---|---|--|
| Flow Alteration/Connectivity | High | Evaluate and remove/replace culverts that are perched and impeding fish movement. Removal of beaver dams will also encourage more flow that will prevent sedimentation and habitat degradation. Evaluate cost/benefit of dams within the watershed. |

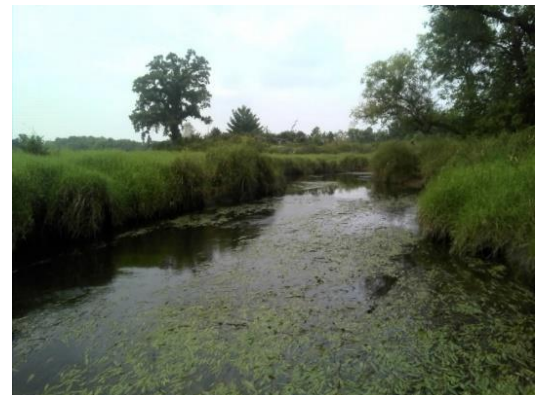
- Upstream of Mud Creek is Mud Lake. Mud Lake is impaired due to the eutrophic conditions of the lake that violate the standards set for the ecoregion. Both elevated phosphorus and chlorophyll-a (Chl-a) concentrations confirmed this impairment. Given the close relationship that DO and eutrophication have, these sources are likely causing or contributing to the low DO and eutrophic (Figure 4) conditions that Mud Creek experiences as well. Given this impairment, the likelihood is that the sources of the excess phosphorus in Mud Creek (-567) are Mud Lake and the upstream watershed that has land use comprising of 89% hay/pasture and 6% cropland (Wenck 2013).

Figure 4: Excessive plant growth in Mud Creek.

| Stressor | Priority | Comment |
|---|---|--|
| DO and Eutrophication | High | Collect information as needed for streams that are lacking necessary DO and eutrophication-related information including DO flux, chl- <i>a</i> , and BOD samples, while also utilizing a variety of nutrient reducing BMPs targeting headwater reaches, and upstream lakes (Mud Lake). |
