# Bois de Sioux River Watershed

## Watershed Restoration and Protection Strategy

### Stressor Identification Report

Assessment of stress factors affecting aquatic biological communities

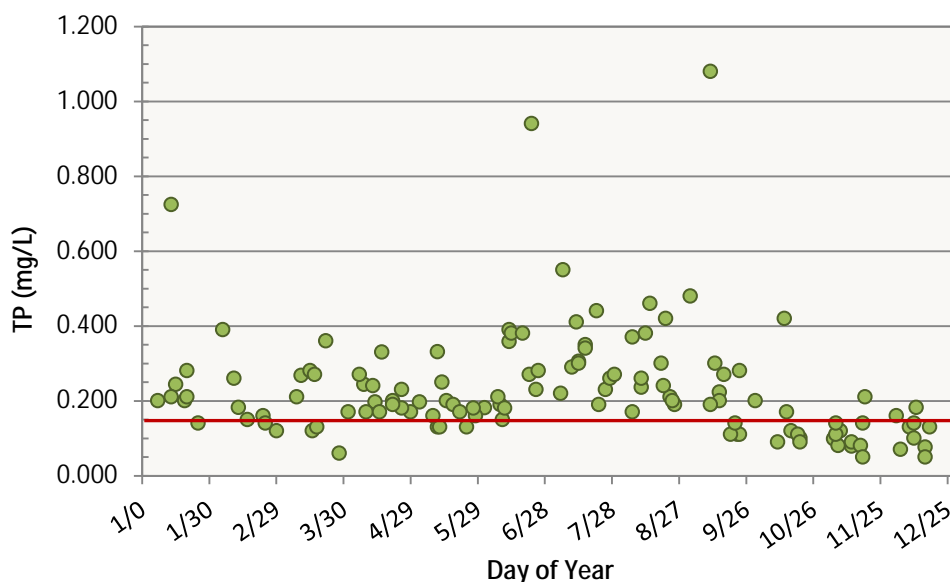
Figure 9. Historical TP data for site S000-089, from 1962-1977. The red line is the TP regional standard.

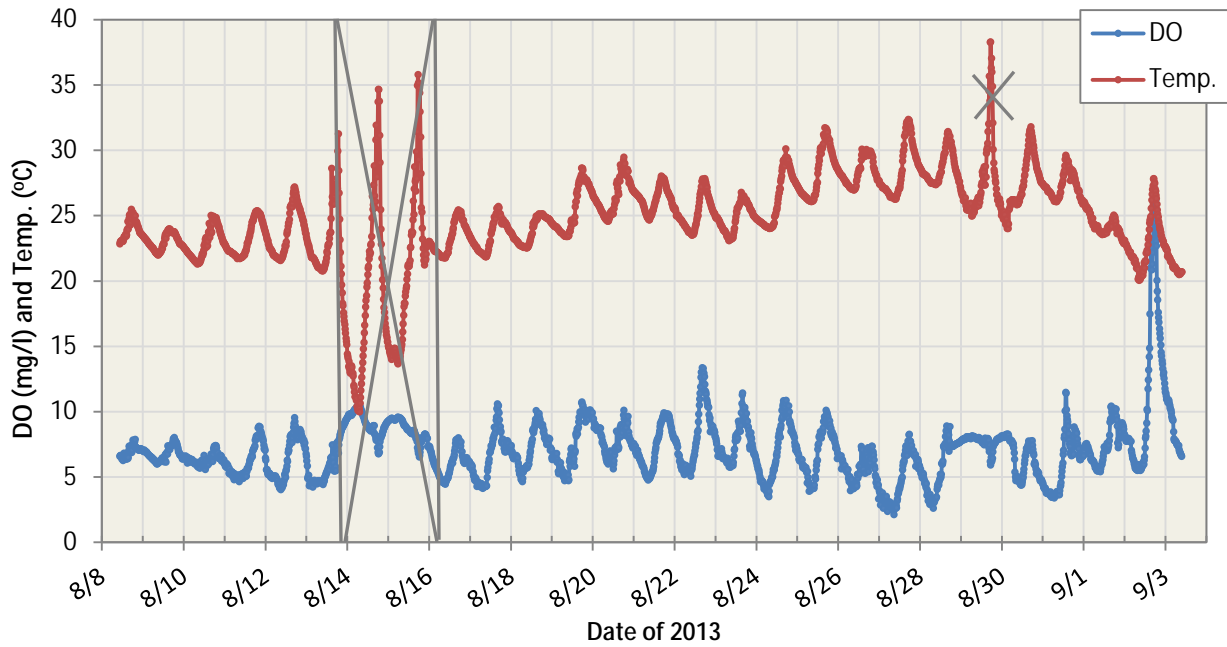
Figure 10. Sonde readings during the August 8 - September 3, 2013 deployment in the Bois de Sioux River near Breckenridge. The periods crossed out are suspected to be incorrect readings, perhaps due to vegetation caught on the sonde's probes.

During the 2013 deployment, DO levels typically dipped to the 4.5 mg/L range, though minimum levels on some nights were slightly above 5 mg/L. The minimum level recorded for this period was 2.12 mg/L, certainly a stressful concentration for fish and other aquatic organisms. The DO conditions were better (comparing almost the same dates of the year) in 2014, where the DO minimums in early August were always above 6 mg/L. However, the DO flux on most days was approximately 5-6 mg/L, a level that has been shown to correlate with impaired Minnesota biological communities (Heiskary et al., 2013). The dissolved oxygen saturation levels were also significantly above 100%, meaning there was excessive algal abundance (almost no macrophytes exist in AUID-501) pumping in large amounts of oxygen during sunlight hours. The maximum DO saturation level was approximately 200%, a potentially-problematic level for aquatic organisms (Marking, 1987, Weitkamp and Katz, 1980). In 2015, the DO levels generally stayed above 5.0 mg/L, though on two days the minimums dropped below 4, with one of them as low as 1.72 mg/L. The DO flux was more problematic. On four days, the DO flux was about 8 mg/L. These high-flux days were associated with the lowest flows that occurred during this deployment period. These same days experienced the highest DO concentrations. Many of the days experienced peak DO percent saturation levels of 130% or higher, and several exceeded 160, with the maximum reading of 201.9% occurring on July 19 at 7:00pm.

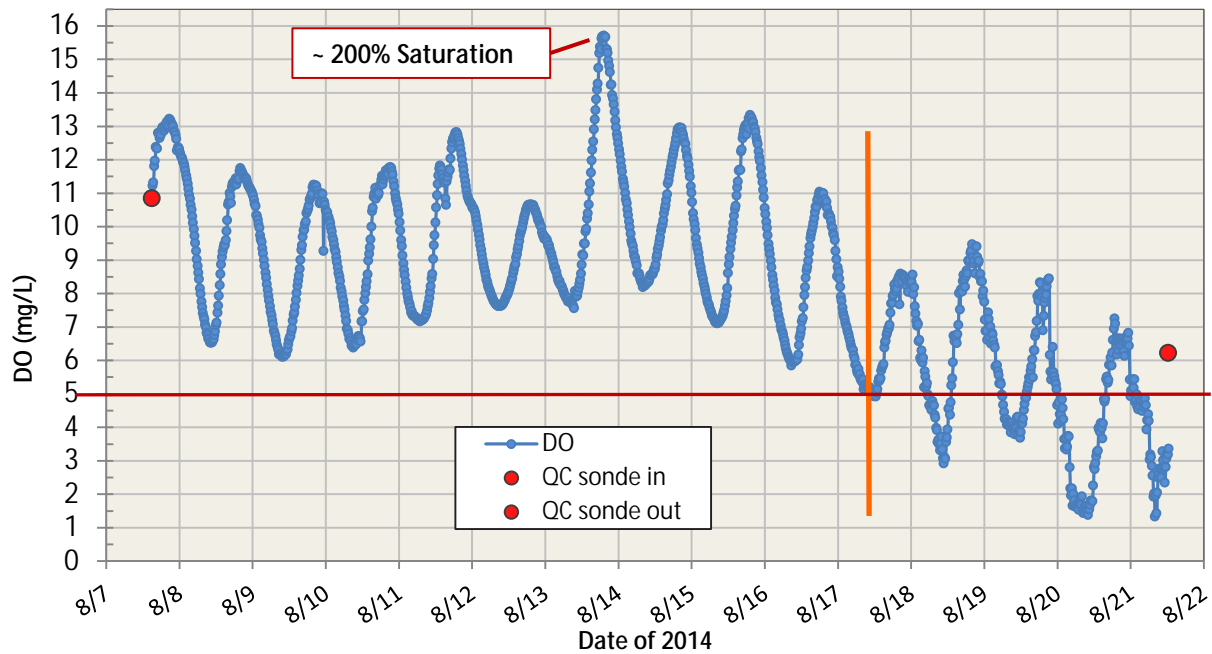
Figure 11. Sonde deployment during August 7 - August 22, 2014 in the Bois de Sioux River at CSAH-6. Data to the right of the orange bar appears to be compromised (calibration drift of instrument).

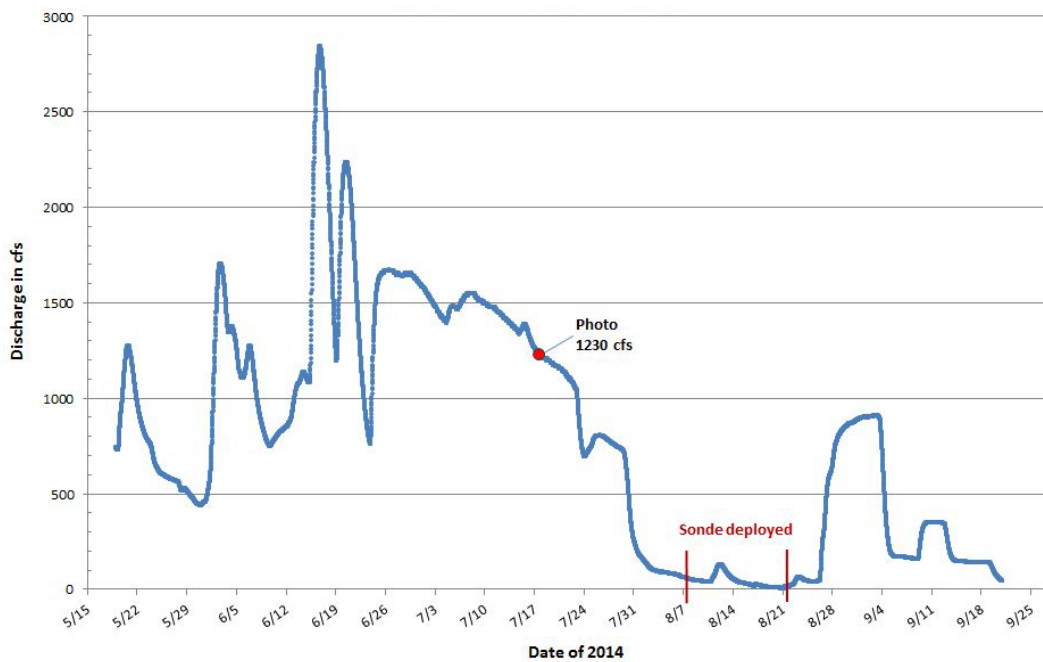
Figure 12. Flow conditions at the 2014 CSAH-6 sonde deployment station. This site is also a USGS gaging station site.

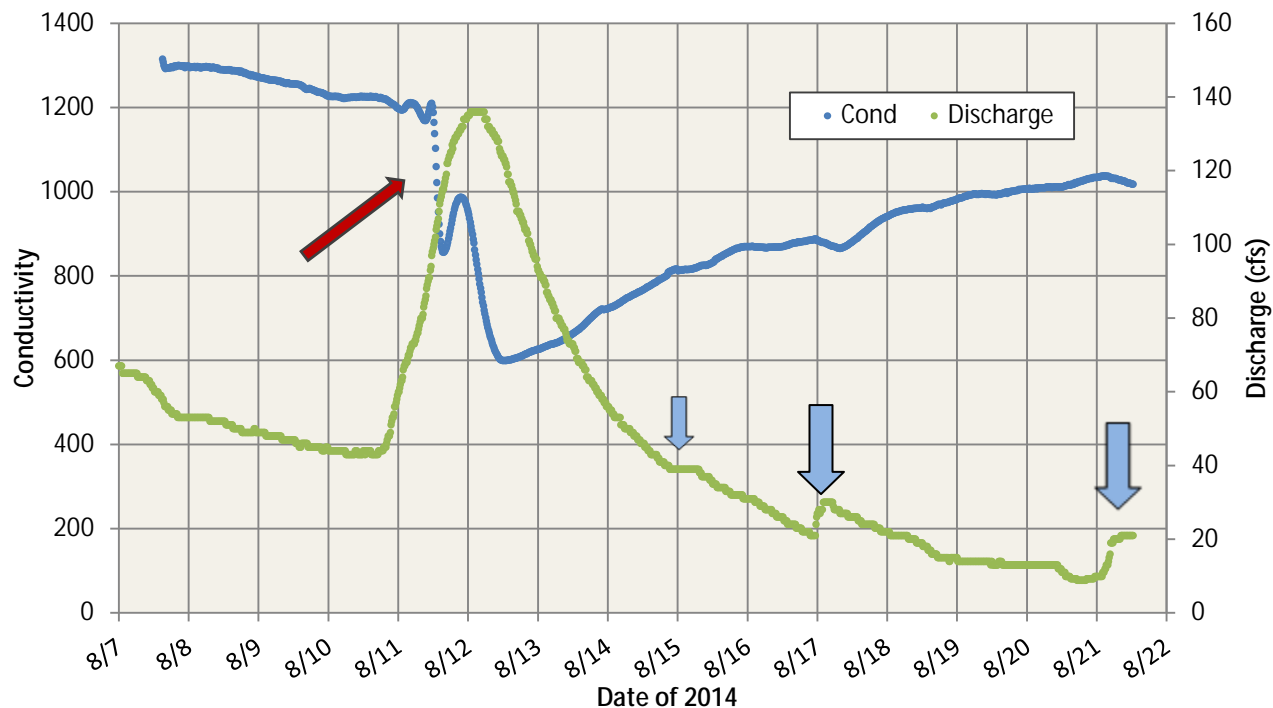
Figure 16. Conductivity and USGS flow data at CSAH 6 gaging station during sonde deployment. Red arrow points to quick drop in conductivity, and blue arrows denote rain events which increase flow. There were no significant rain events the days surrounding the August 11 - 12, 2014 abrupt changes in conductivity and flow.

In addition to hydrological alterations stemming from extensive land drainage, a further alteration of natural flow conditions in the river is the damming of Lake Traverse and reservoir releases. These releases complicate the analysis of water quality parameters, since pulses of lake (reservoir) water are periodically flushed through the river. Flow levels in the Bois de Sioux River change rapidly and strongly. The conductivity data recorded during the 2014 sonde deployment captured the effect on water quality during one such rapid fluctuation. At about 17:45 on August 10, 2014, flow volumes rapidly rose, tripling the flow volume in about 30 hours (Figure 16). Then, from the peak flow, volumes decreased to the pre-peak flow over four days. There does not appear to be a precipitation event that explains this flow change (Table 11).

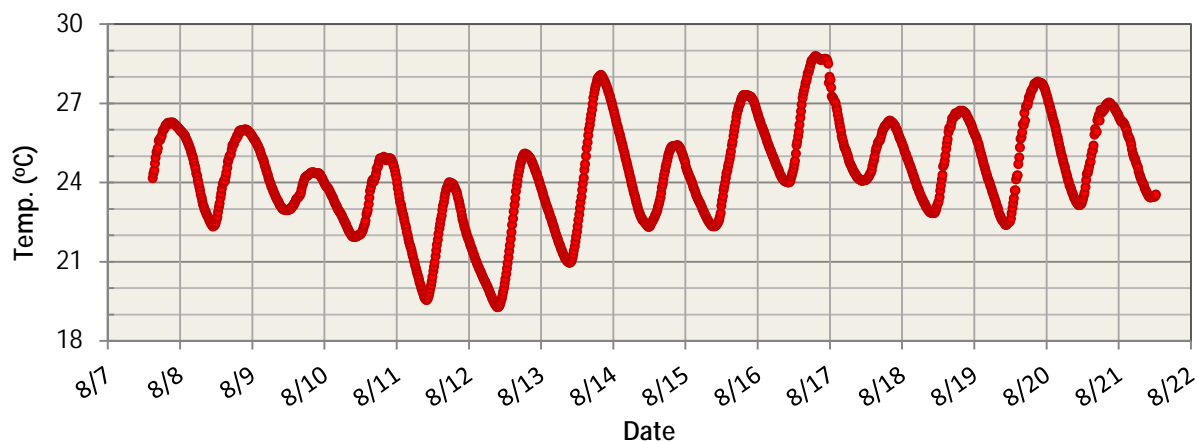
Figure 18. Water temperature readings from 2014 sonde deployment at S000-553 (CSAH-6).

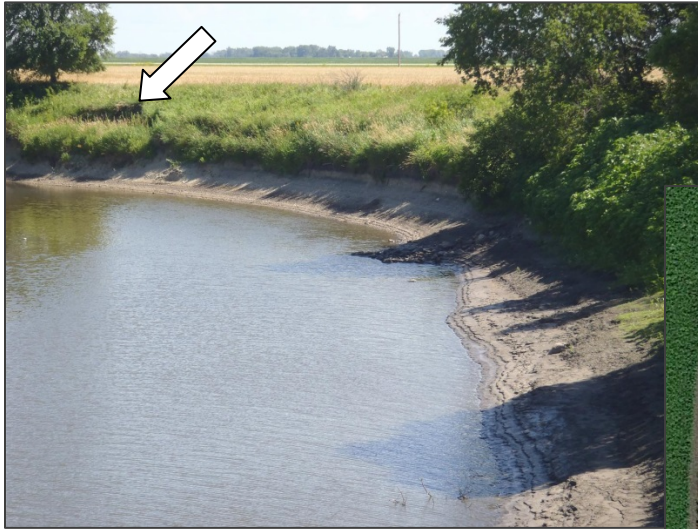
Photo 1. Looking downstream from the CSAH-6 bridge. The arrow points to a large piece of bank material caving into the channel.

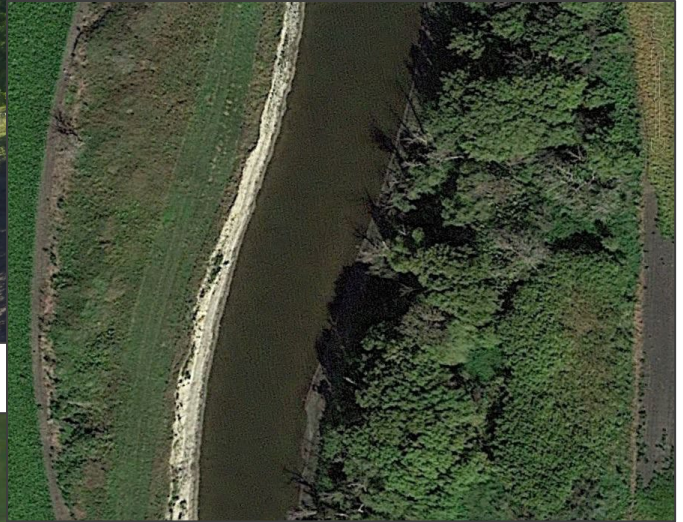
Photo 2. High, steep eroding bank on left side of channel along AUID-501.

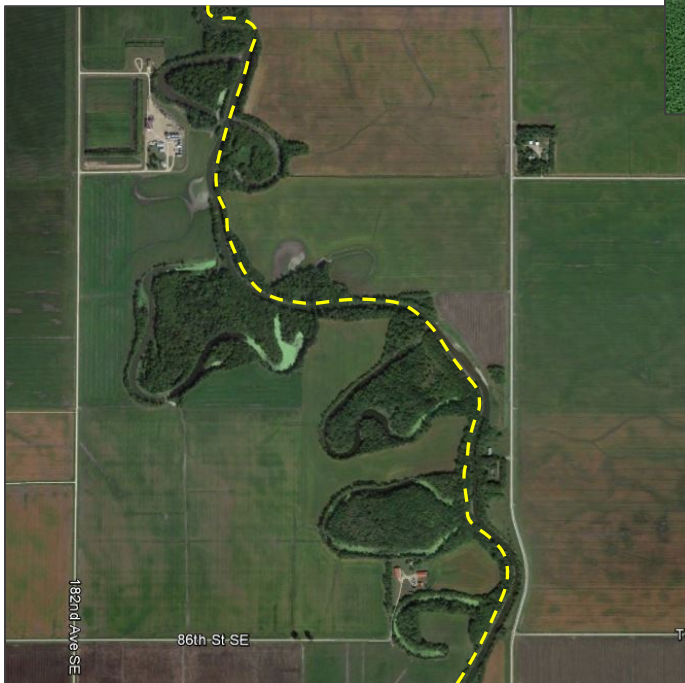
Photo 3. Channelization to remove meanders from the river's pathway. The yellow line traces the current altered channel path.

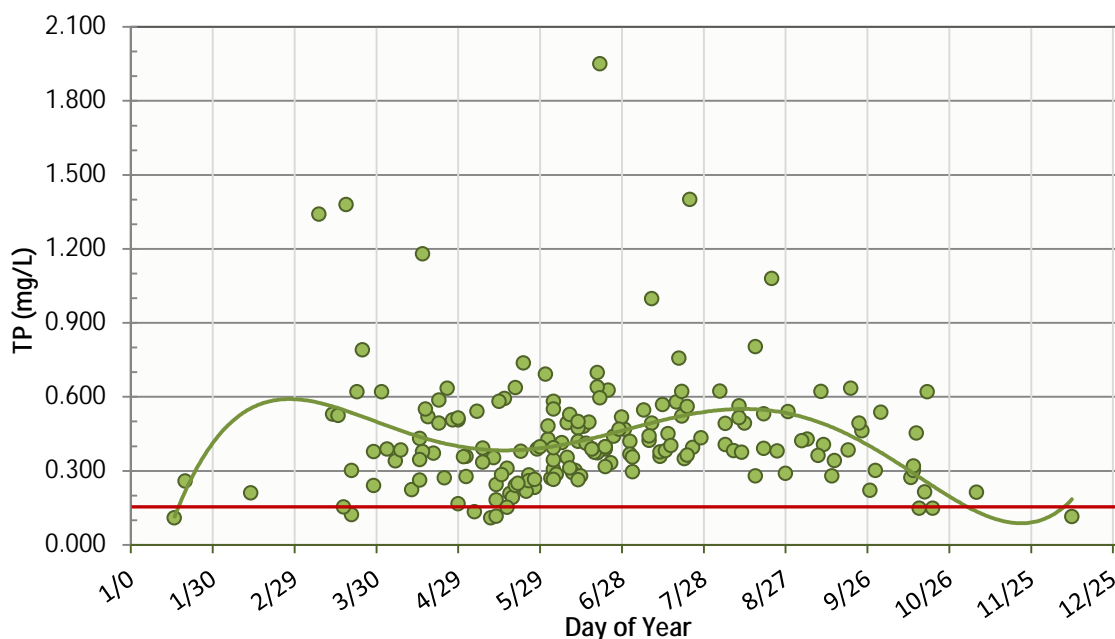
Figure 20. Total phosphorus concentrations at S001-029 (US Highway 75, 10RD005). Data are from the periods 1985 - 1989, and November 2001 - October 2014. The red line is the Minnesota standard for TP, of which OP is just a fraction. The green line is a 5<sup>th</sup> order polynomial regression line, with an  $R^2$  value of 0.1122.

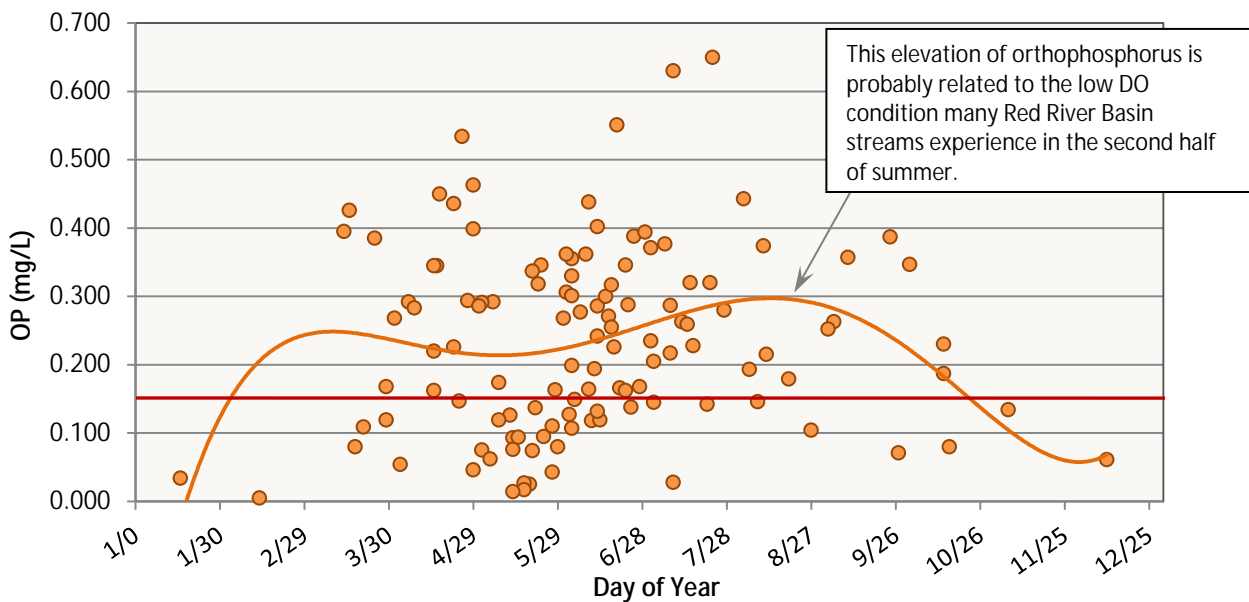
Figure 21. Orthophosphorus concentrations at S001-029 (US Highway 75, 10RD005). Data were collected over the period of November 2001 – October 2014. The red line is the regional standard for TP. The orange line is a 5<sup>th</sup> order polynomial regression line, with an R<sup>2</sup> value of 0.0895.

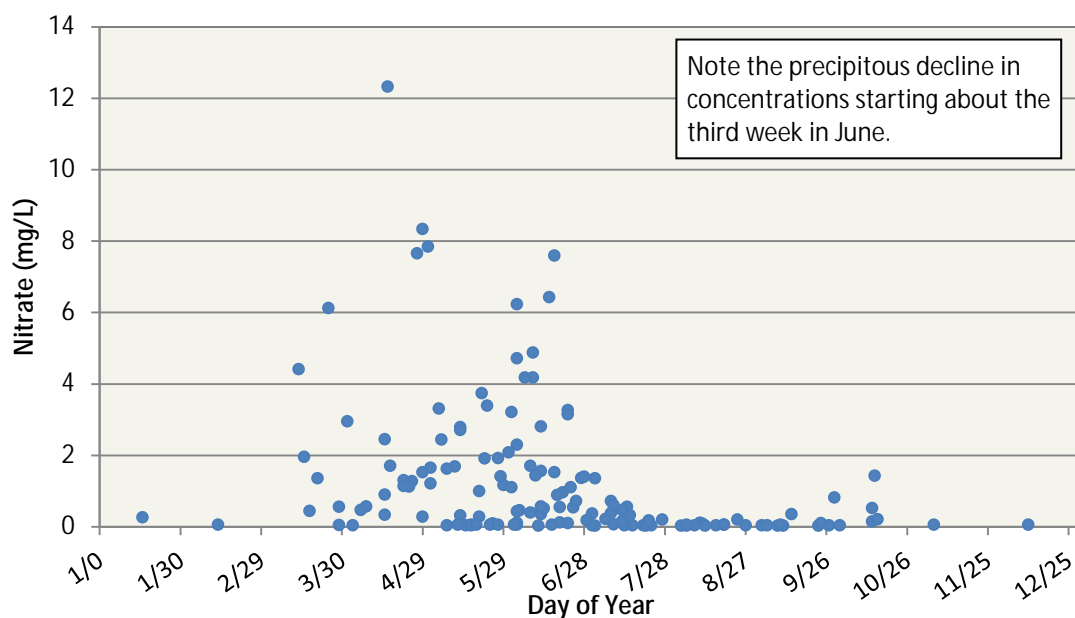
Figure 22. Nitrate concentrations at S001-029 (US Highway 75, 10RD005) over the period of November 2001 – October 2014.

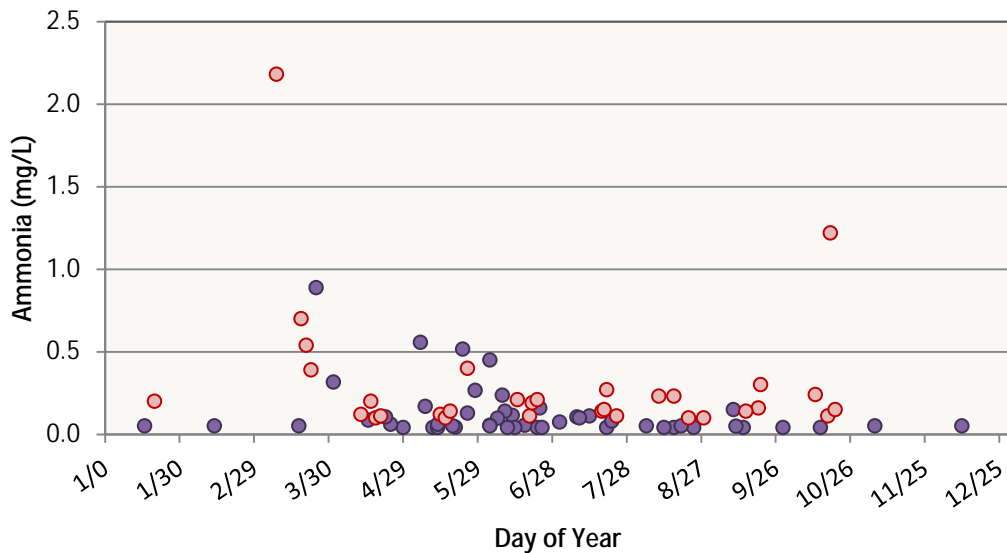
Figure 23. Ammonia concentrations from the late 1980s (light red points) and 2001-2010 (purple points) at S001-029 (US Highway 75, 10RD005).

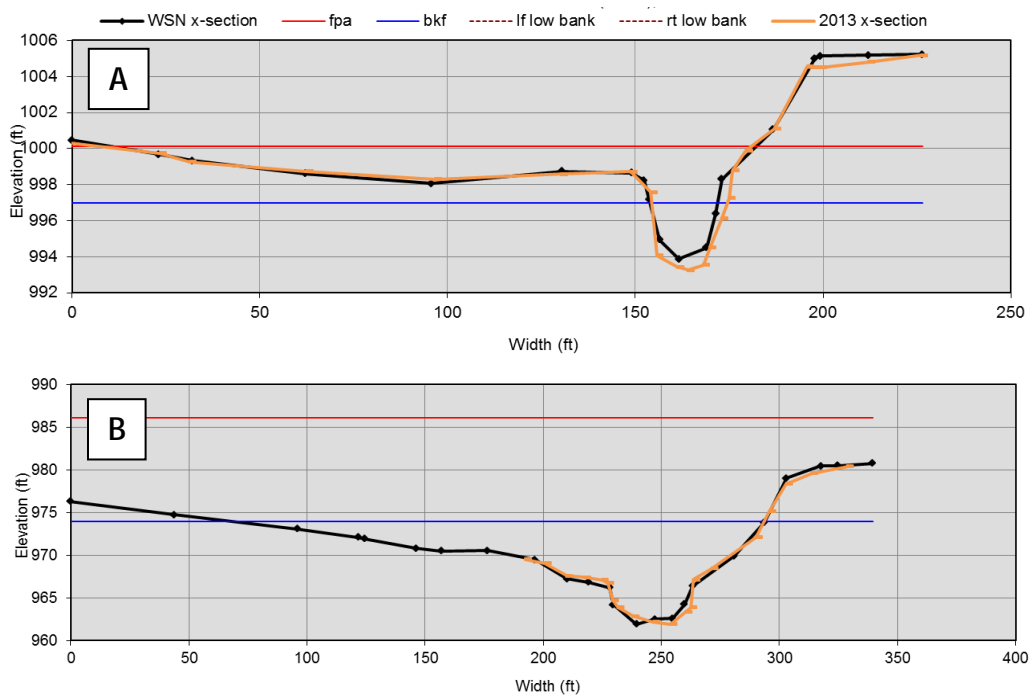
Figure 24. Historical (2001) and 2013 cross-sectional surveys of sites 4 (A) and 6 (B).

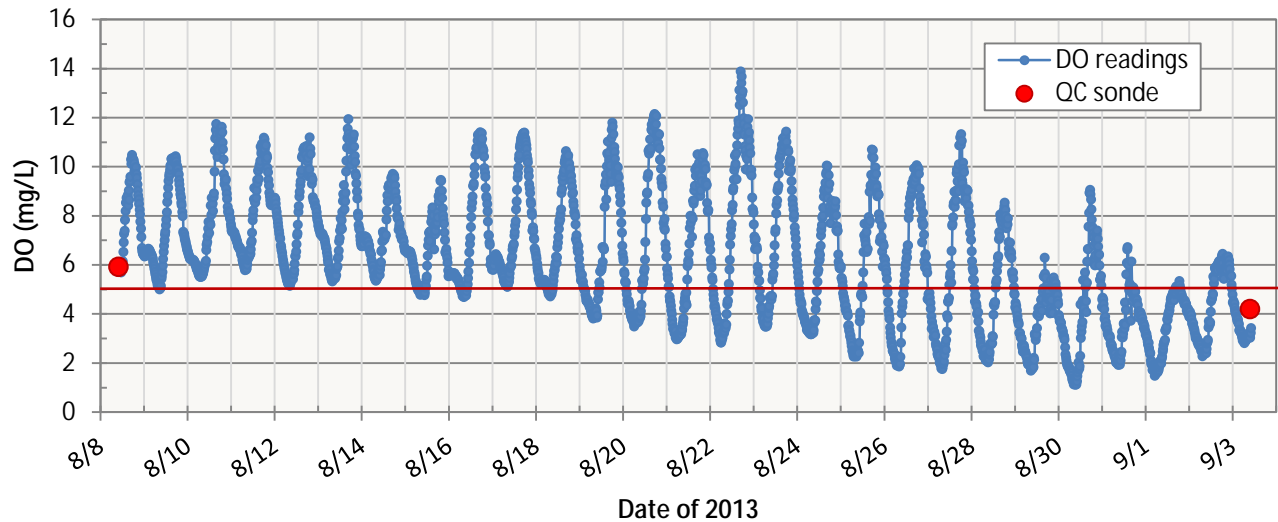
Figure 25. Sonde DO statistics for the August 8 - September 3, 2013 deployment at 10RD005 (State Highway 75). The red line represents the Minnesota standard.

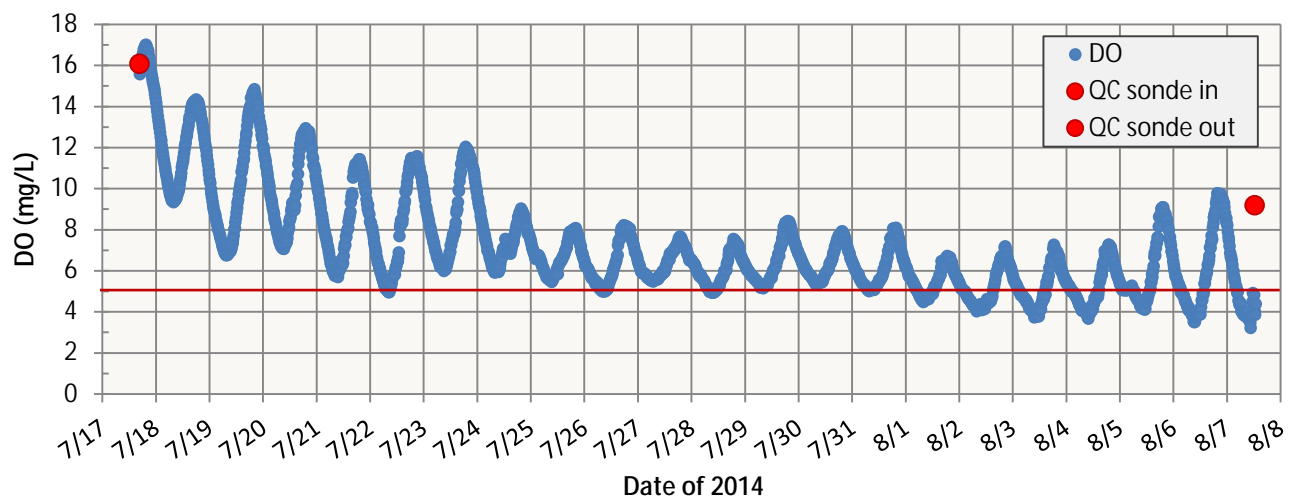
Figure 26. Sonde DO statistics for the July 17 - August 7, 2014 deployment at 10RD005 (State Highway 75). The red line represents the Minnesota standard.

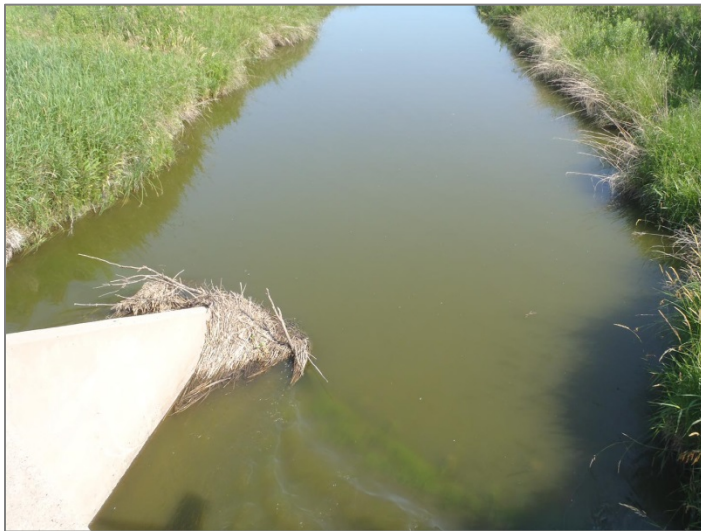
Photo 4. Looking upstream on JD-12 at CR-2, showing the green color of the water on July 7, 2015 when the Chl-a sample was collected.

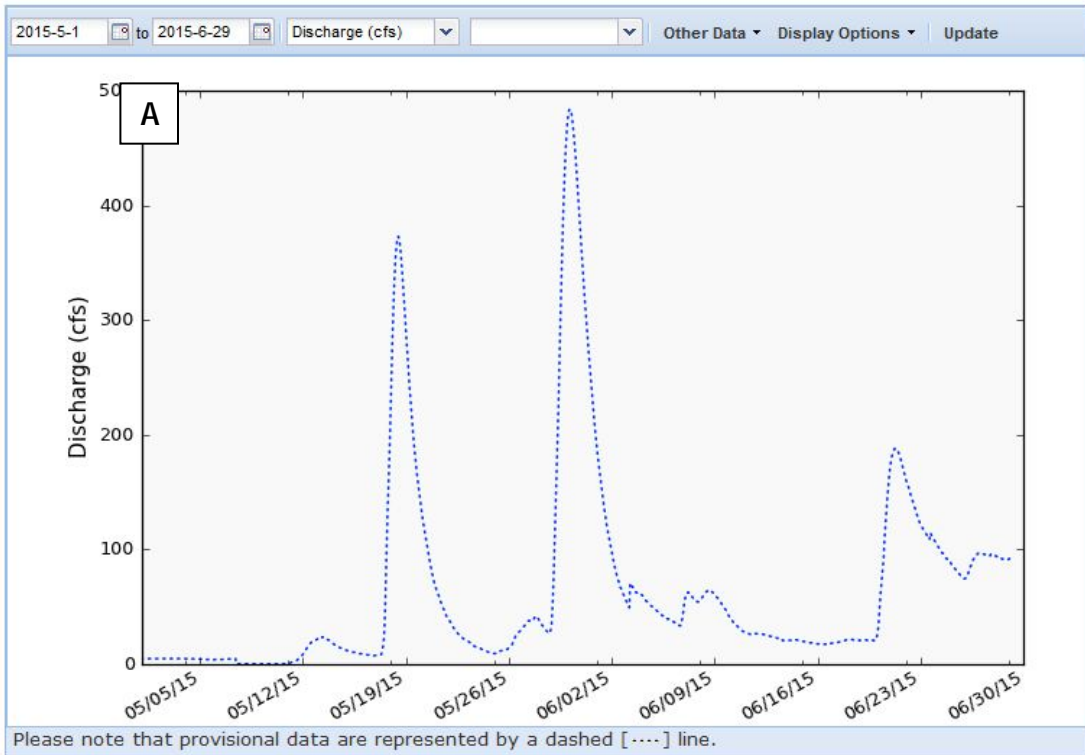
Figure 28. A) Hydrograph in cfs for USGS gage at Campbell, Minnesota from May 1, 2015 to June 29, 2015. B) The hydrograph in stage (feet).

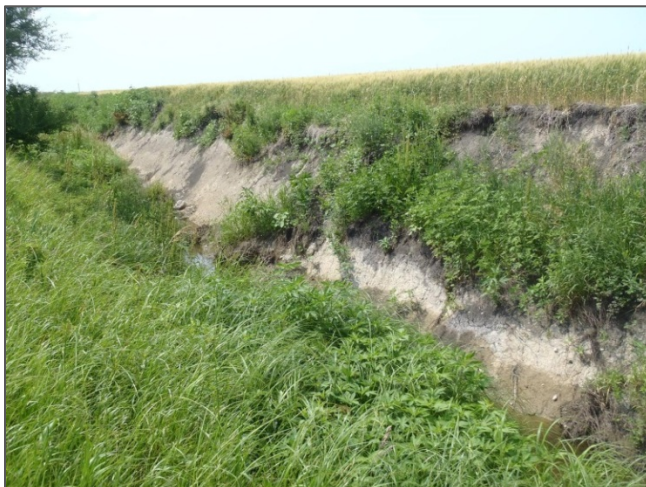
Photo 6. A ditch that is too narrow and deep to be stable. Clods of soil are falling down from the field edge, contributing topsoil into the ditch that will be washed into streams. There is also no buffer along this field edge.

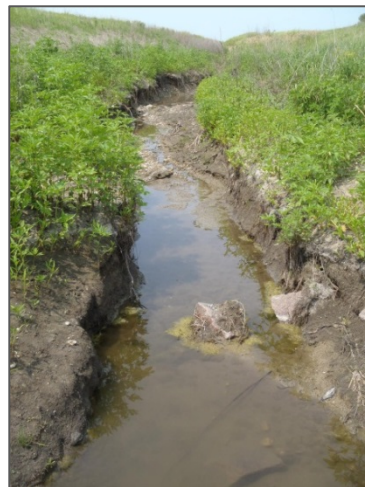
Photo 7. This ditch has incised and clearly contributes sediment to the South Fork Rabbit River, which it meets right at the bottom of this photo.

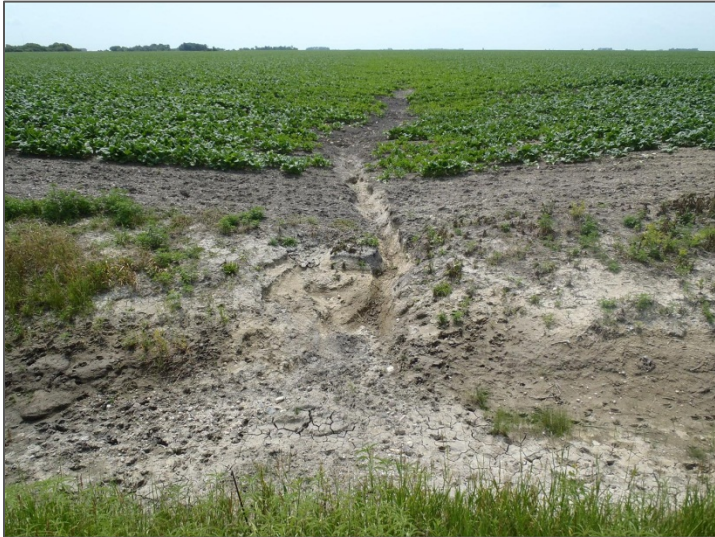
**Photo 8. Surface erosion from an unvegetated field swale along State Highway 75. A significant delta of soil has been deposited in the ditch, where it can move downstream farther. There were several of these from this**

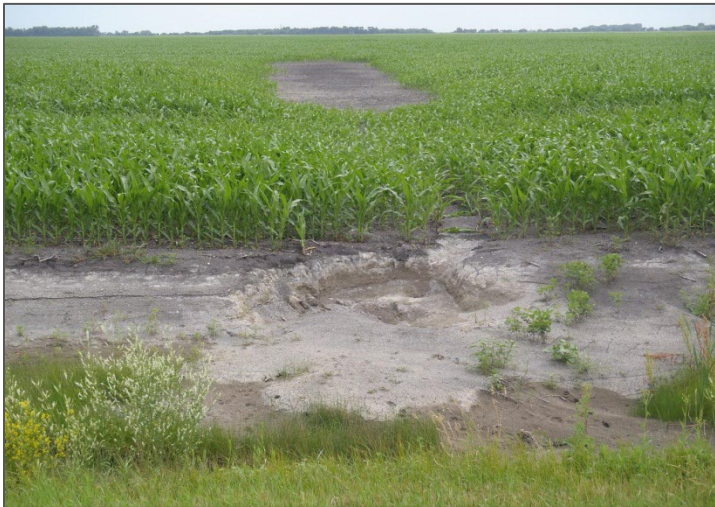
**Photo 9. Other fields with similar unprotected drainage topography were found while driving throughout the BdsRW.**

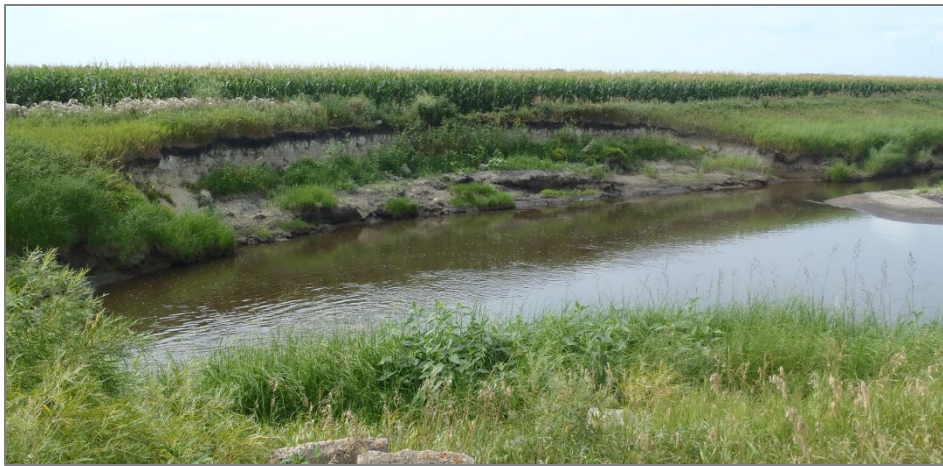
Photo 11. The ground view of the eroding southern bank in photo 10.

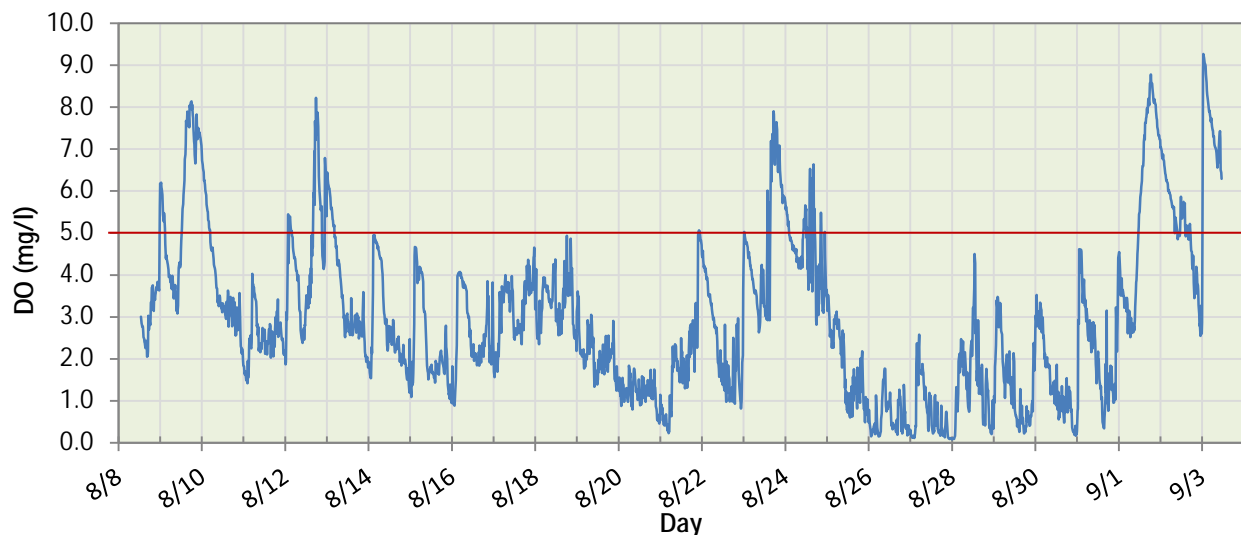
Figure 29. DO readings during the August 8 - September 3, 2013 sonde deployment at 280<sup>th</sup> Avenue. The red line is the DO standard.

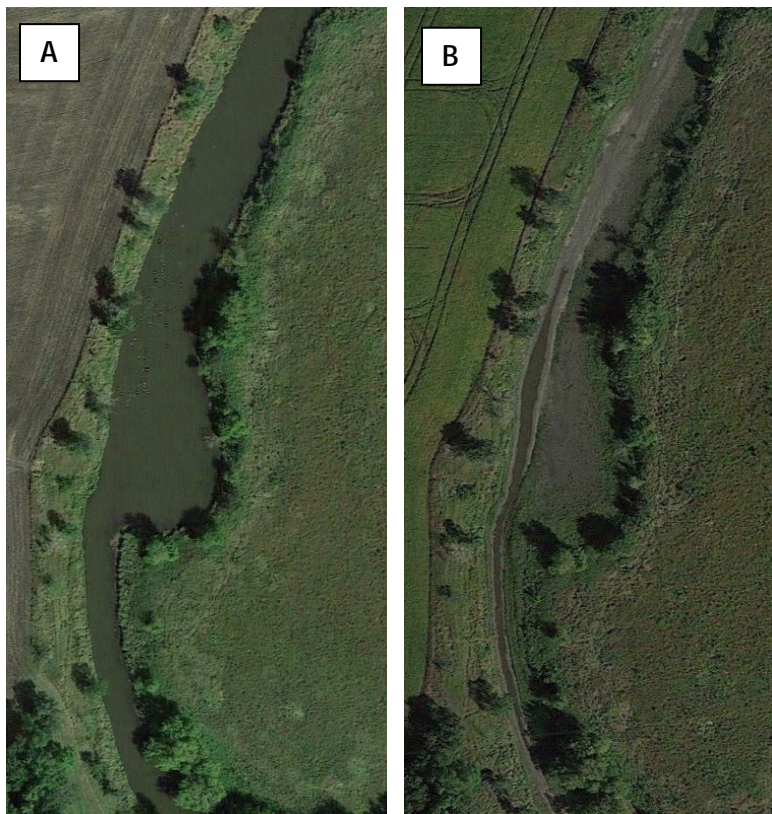
Photo 12. South Fork Rabbit River. A) September 12, 2013. B) September 15, 2014. Very different water volumes are present on almost the same day in late summer, one year apart. Only isolated pools have water in 2014.

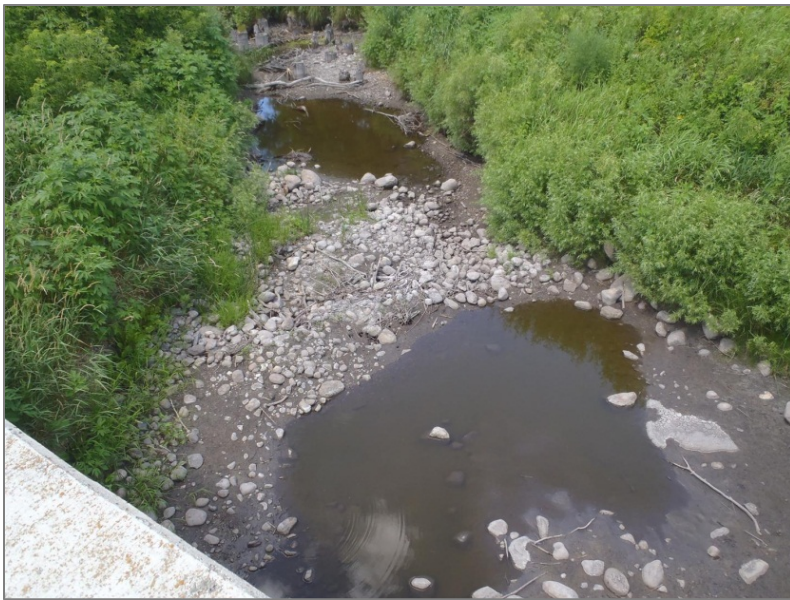
Photo 13. South Fork Rabbit River at 490<sup>th</sup> Street on July 21, 2015. Water only was found ponded in the deeper areas of the channel.

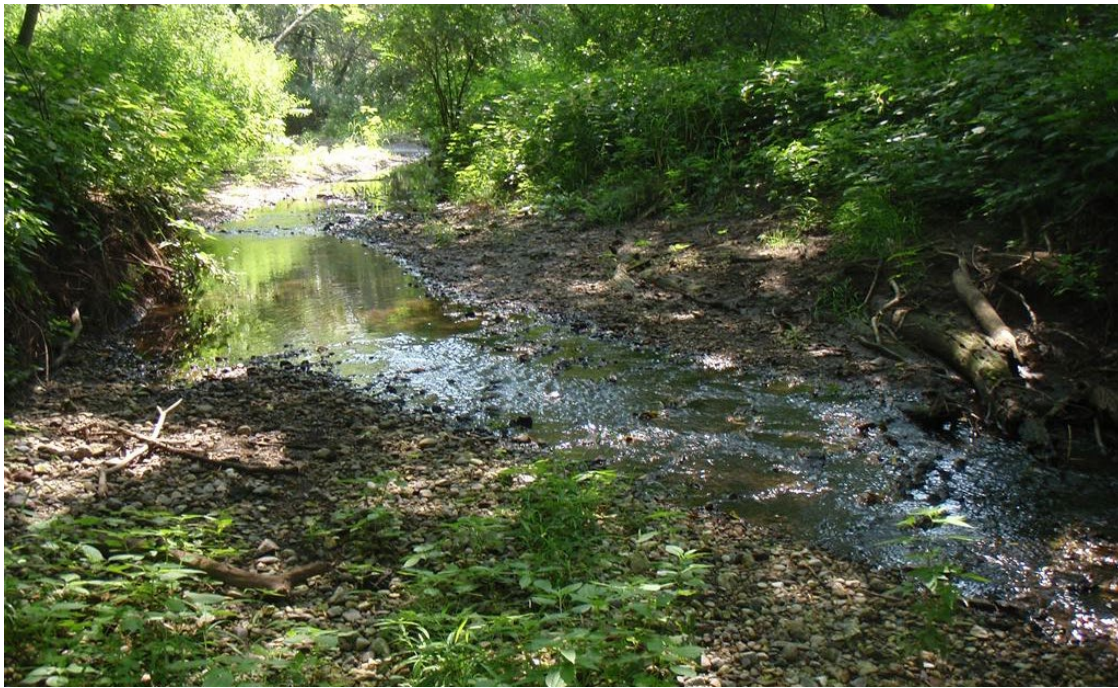
Photo 14. August 4, 2010. A nice cobble riffle - particularly good habitat for macroinvertebrates. The pool above was only a few inches deep, not a positive for fish.

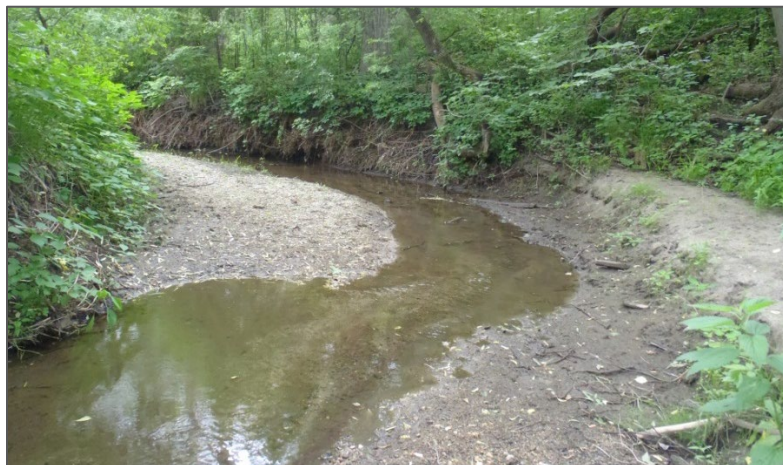
Photo 15. Flow volume on June 9, 2010 is quite low, and water depths are only a few inches deep.

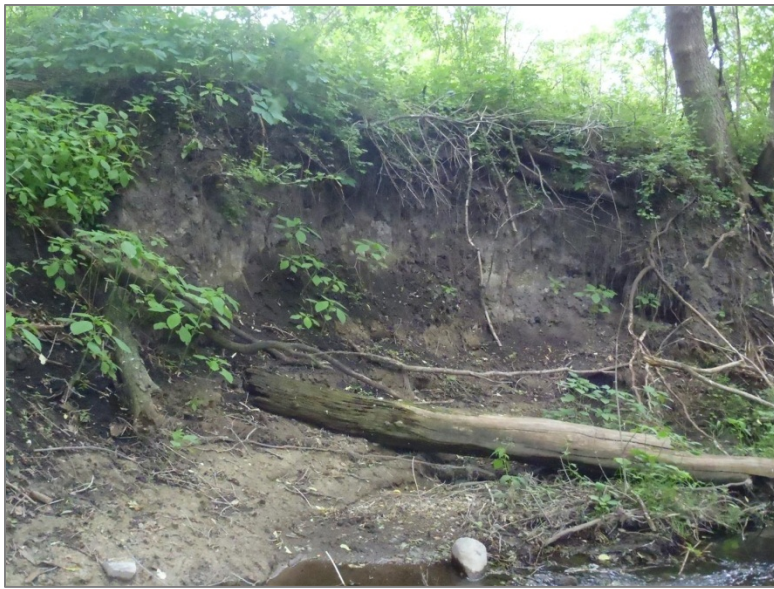
**Photo 16.** This badly-eroded bank, just upstream of State Highway 27, is evidence of channel instability. The top of the bank is about seven to eight feet above the water level in the photo.

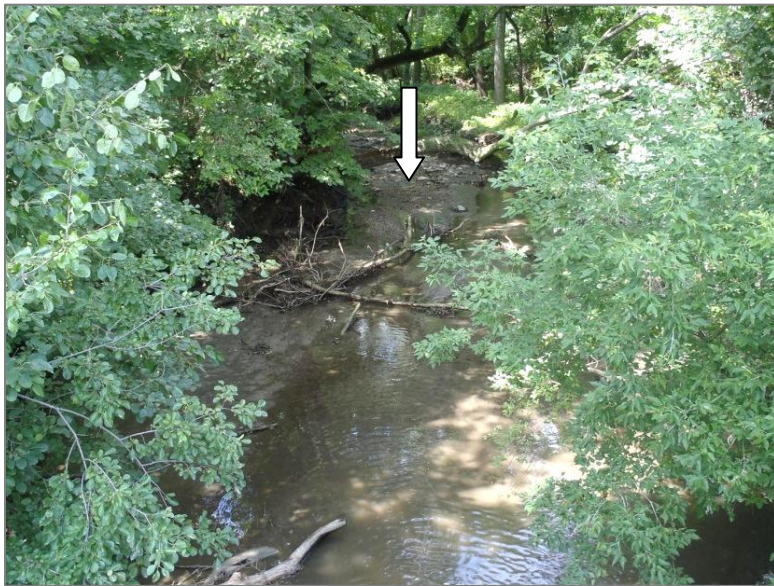
The downstream side of Highway 27 is over-widened and has a very high width/depth ratio below the culvert, at least for the approximately 50m visible from the road shoulder. There was much exposed stream bed, and the area just below the culvert was about three inches deep all the way across the very wide channel (Photo 17). The substrate here was fine particulate material. Downstream, some cobble can be seen.

**Photo 17.** The view from Highway 27 looking downstream. On the left side of the channel, deposition of sediment is occurring (arrow). The whole “pool” in the foreground is only about 5cm deep, though perhaps 15m wide.

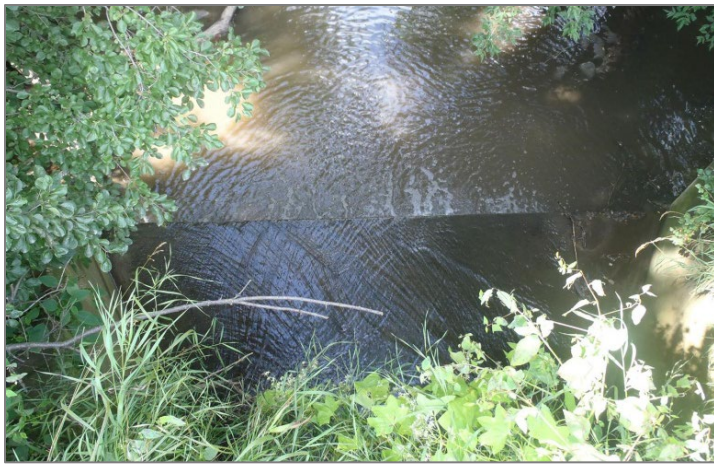
The biological site was located just above Highway 27, meaning there is only one road crossing separating the site from Lake Traverse. The culvert bottom on the outlet side is perched about a foot above the downstream water level. This culvert serves as somewhat of a grade-control structure for the reach upstream of the highway, which may be helpful in reducing incision and bank erosion along the reach, but is also a barrier to fish migration into the reach above Highway 27 (Photo 18). At low flows it is certainly a barrier, and at higher flows, the water velocity coming off this lip probably precludes migration of smaller, non-game species of fish. It is possible that originally the culvert was not perched, but that the downstream channel has incised, dropping the elevation of the channel bed.

**Photo 18.** The culvert bottom (a cement apron) is perched above the stream bottom, resulting in a vertical drop in water surface levels of about a foot.

Connectivity and hydrological alteration (leading to channel instability and probably low baseflow volumes) are the main stressors here. Without fixing the connectivity issue at Highway 27, it is unlikely that addressing other stressors will be very beneficial to the stream fish community. There is probably very limited overwintering habitat in this small stream system, and so the stream would need connection to the lake and lowest reaches of the stream so that fish overwintering in those locations could repopulate the stream above Highway 27. That is actually how small streams are annually re-populated in much of Minnesota. A riffle could be constructed at the outfall of the Highway 27 culvert, angling the stream bed upward to meet the cement apron. The wide, flat apron may need some modification too, to add depth for fish to swim across when flow is lower (as in photo 18).

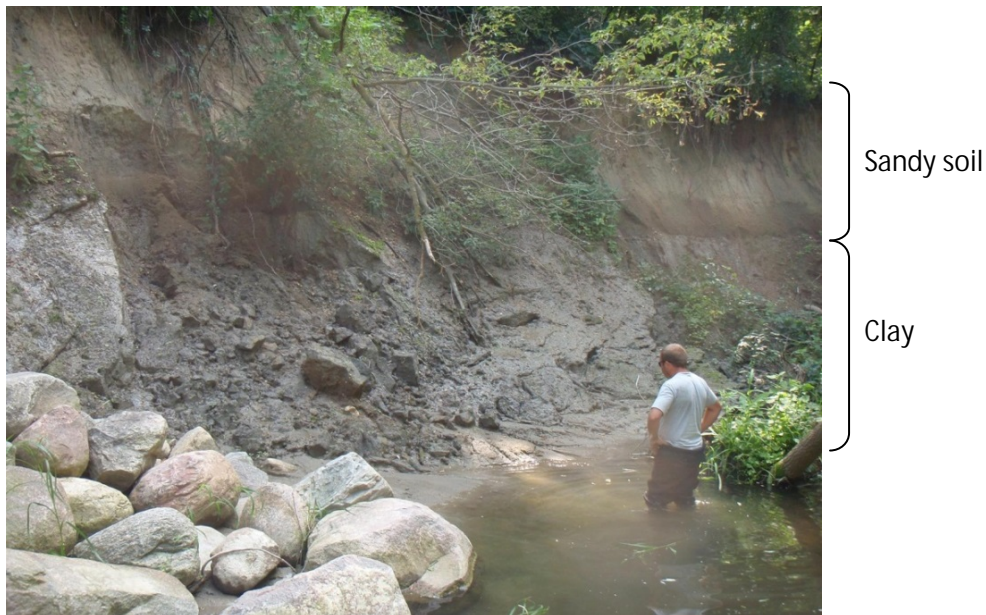
Photo 19. Mass wasting along the channel just downstream of the Township Road 18 crossing. The upper material is sandy, while the lower material is groundwater-saturated clay.

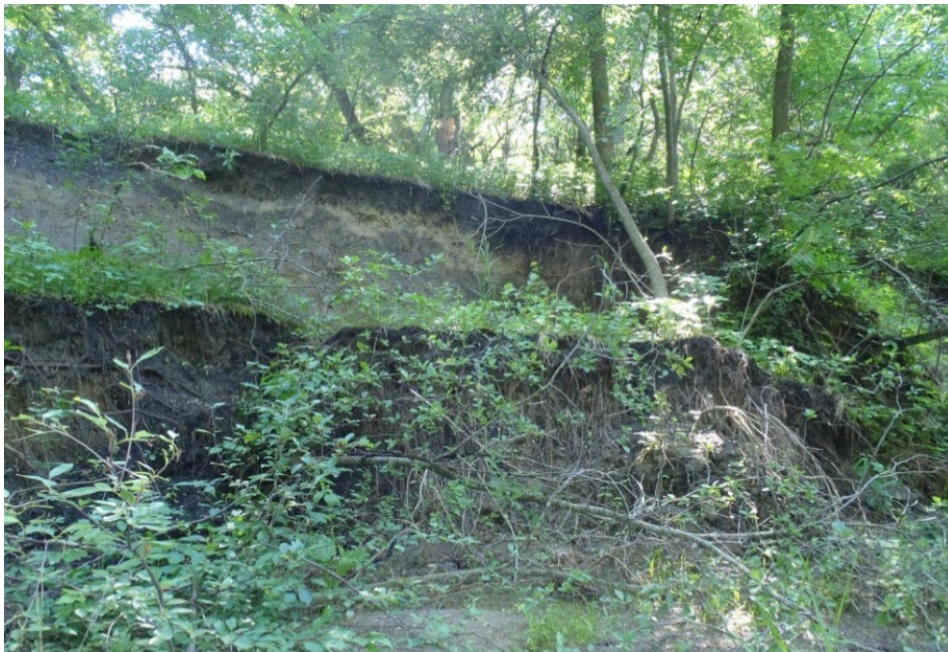
Photo 20. A massive chunk of soil and its vegetation has recently dropped into the stream bed from the forest floor high above, where the dark topsoil layer is showing.

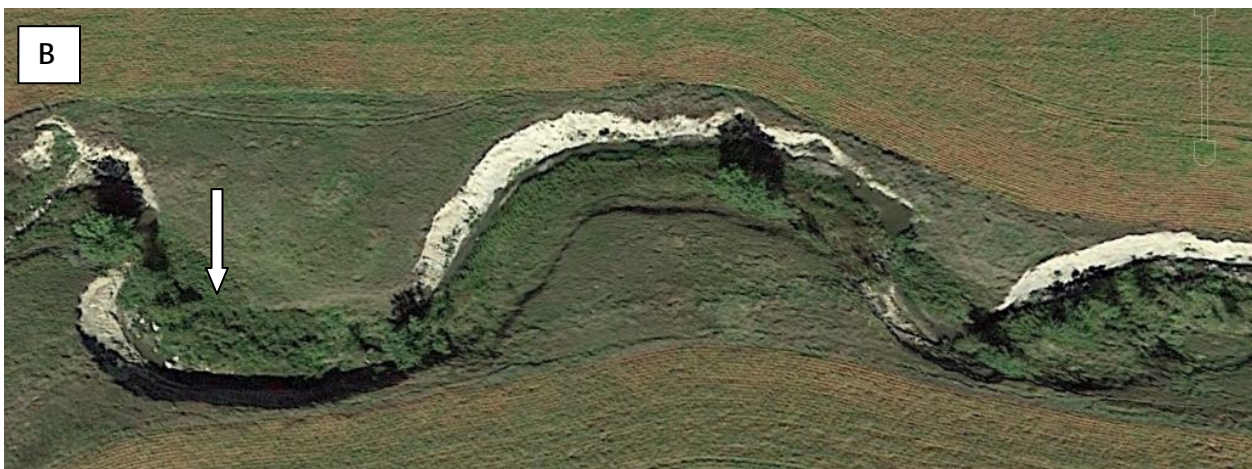
Photo 21. This location is about 1/2 to 3/4 miles upstream of Township Road 18. A) The whitish areas along the channel are raw soil banks that are eroding, which is occurring on both the ditched section on the right and the non-ditched section on the left side. B) A closer view of part of photo A, showing the steepness and height of the raw banks. Note the small size of the baseflow channel (arrow) relative to the actively-eroding valley.

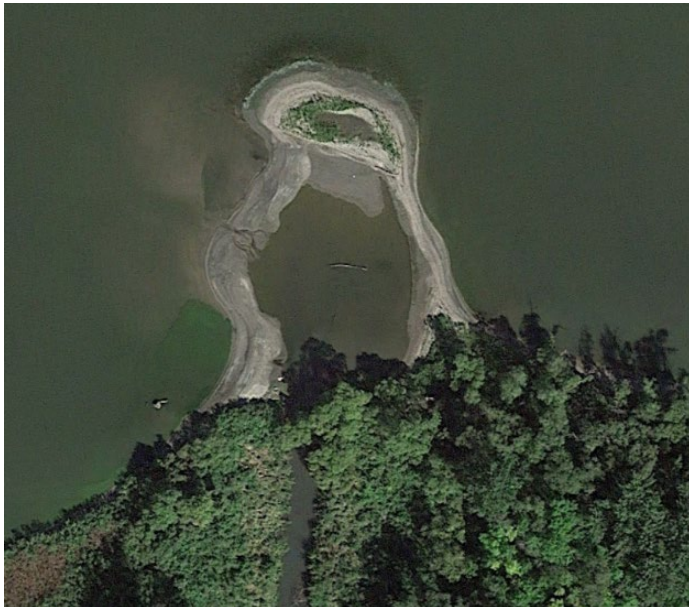
**Photo 22.** Evidence of the abundant sediment carried by AUID-540 - a large sediment delta has formed in Lake Traverse at the mouth of Traverse County Ditch 52 (AUID-540).

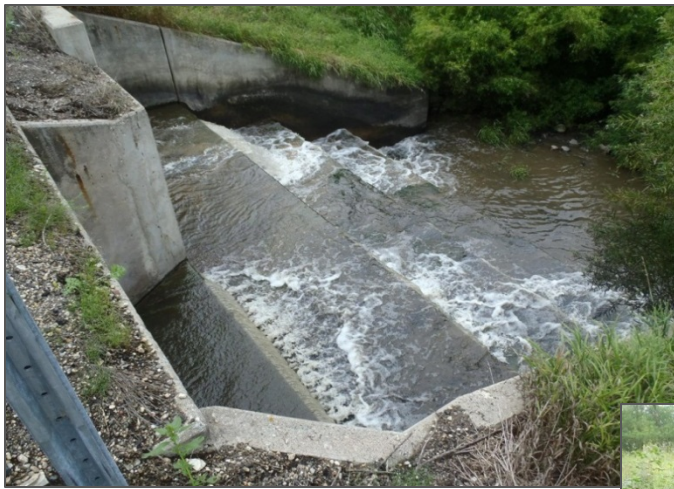
Photo 23. Drop structure on the downstream side of the box culverts at Highway 27 with four vertical drops.

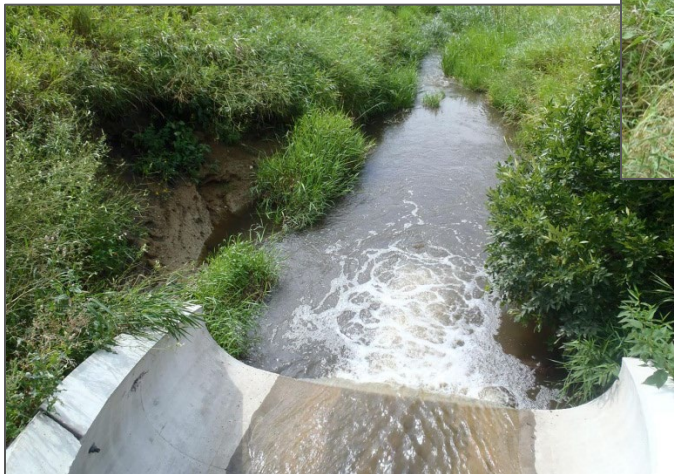
Photo 24. The culvert outlet at the Township Road 18 crossing is elevated by about two feet above the stream water level.
