# Bois de Sioux River Watershed

## Watershed Restoration and Protection Strategy

### Stressor Identification Report

Assessment of stress factors affecting aquatic biological communities

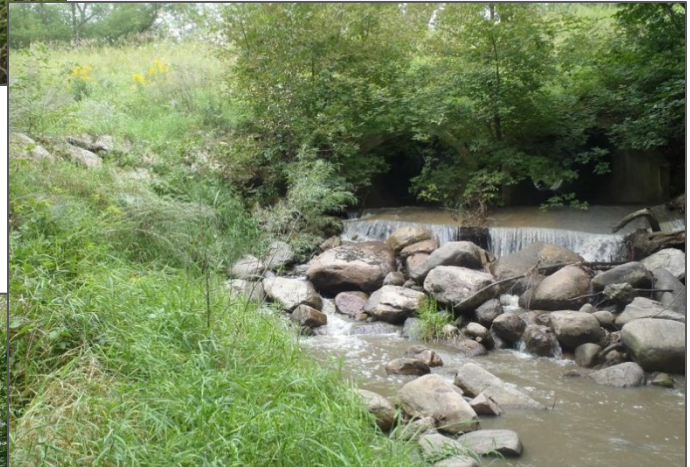
Photo 25. This new culvert on CR-66 is installed with the downstream end perched above the ditch's water level, making it impassable for fish needing to go upstream.

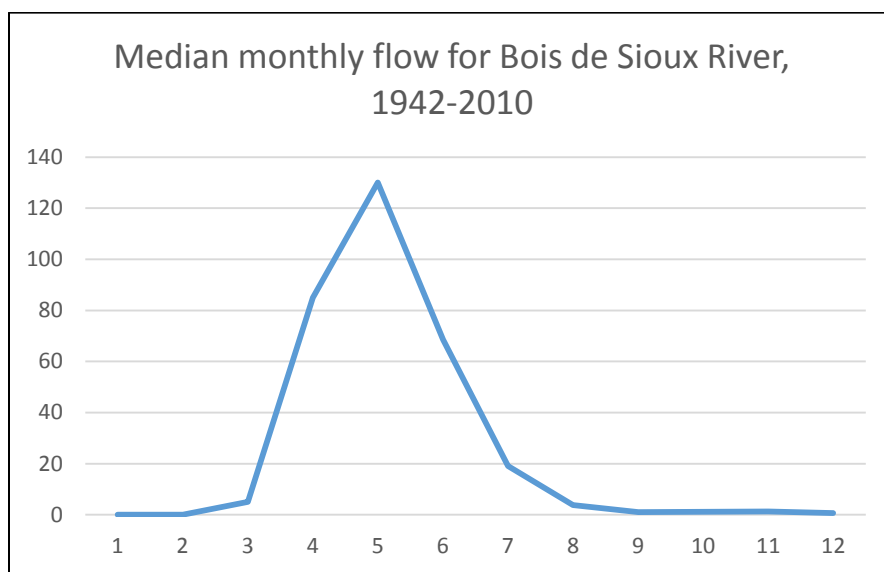
**Figure 3. Seasonal variation in streamflow for the Bois de Sioux River at White Rock, SD. Streamflow data shown is median monthly flow in cubic feet/second (cfs) at (USGS gauge 05050000).**

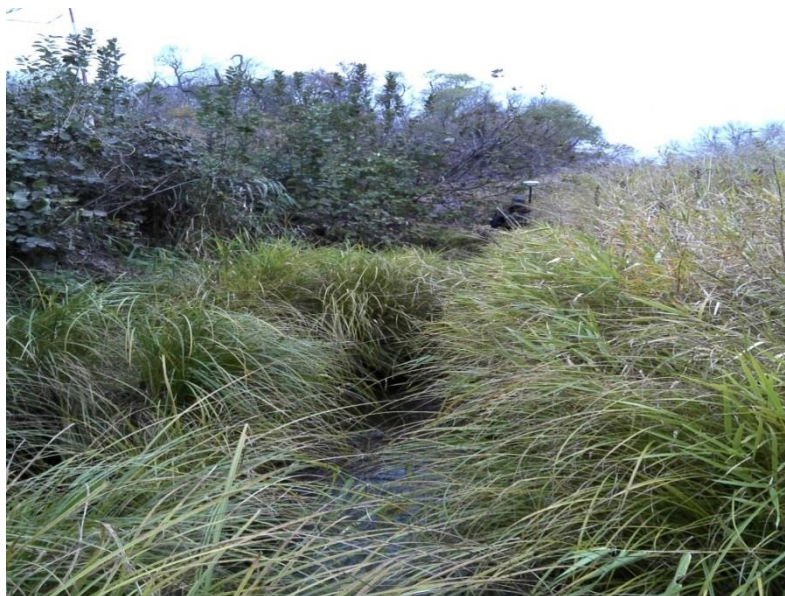
<b>Channel Type</b>	E4
<b>Est. Bankfull El.</b>	1039.2'
<b>Channel Slope</b>	0.53%
<b>Sinuosity</b>	1.1
<b>Bankfull Width</b>	10.7'
<b>W/D Ratio</b>	5.2
<b>Material (D50)</b>	5.4 mm
<b>BEHI Rating</b>	Low/Moderate
<b>NBS Rating</b>	Low
<b>MADRAS Score</b>	35

Due to channel incision, most flow events are contained within the stream banks, resulting in very low width to depth ratios. Two small headcuts were observed within the channel, but overall instream erosion was minimal. Separate BEHI analyses were completed for two eroded banks measuring 60-feet long and 32-feet long and scored Very High and High respectively. Field observations include; good buffers on both sides of the channel, CRP was evident on adjacent ag lands, low distances of wind fetch, barrier to biotic movement observed, and light grassy type aquatic plant communities were present.

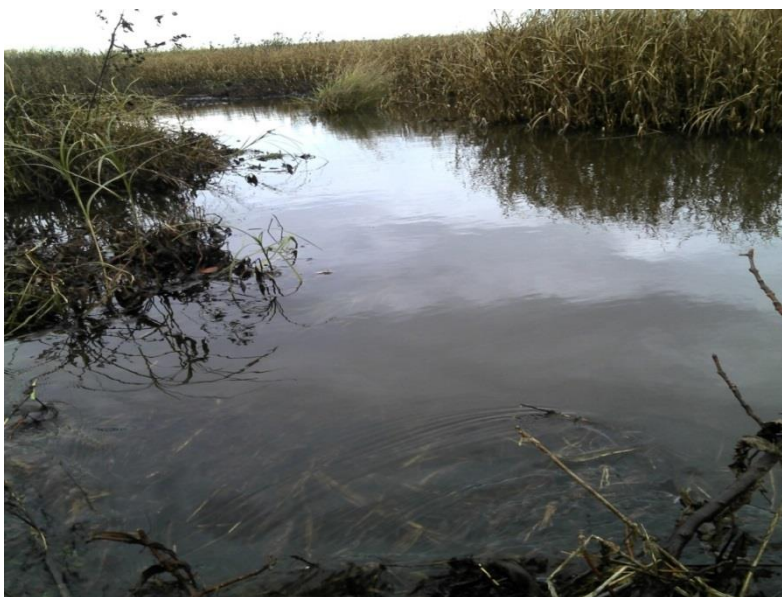
<b>Channel Type</b>	C6c-
<b>Est. Bankfull El.</b>	974.7'
<b>Channel Slope</b>	0.018%
<b>Sinuosity</b>	1.6
<b>Bankfull Width</b>	146.7'
<b>W/D Ratio</b>	91.8
<b>Material (D50)</b>	Silt
<b>BEHI Rating</b>	Moderate
<b>NBS Rating</b>	High
<b>MADRAS Score</b>	22

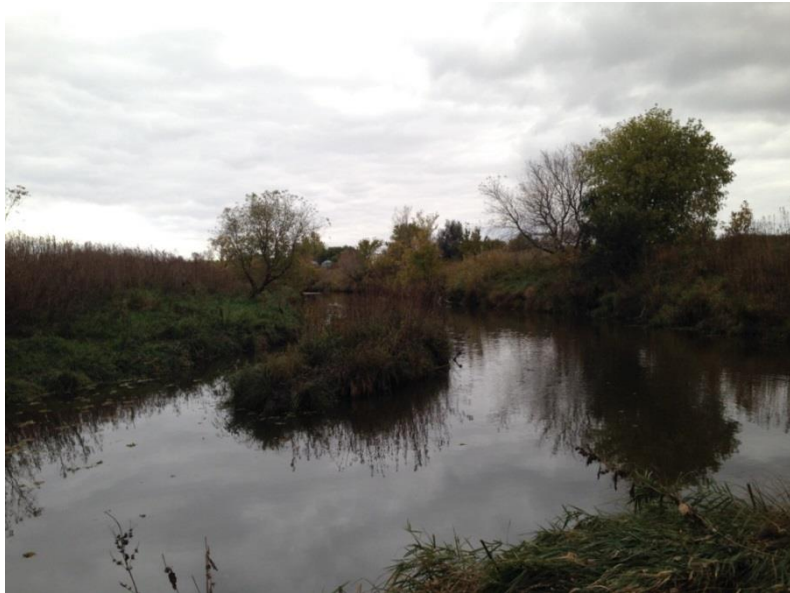
<b>Channel Type</b>	C5c-
<b>Est. Bankfull El.</b>	974.0'
<b>Channel Slope</b>	0.058%
<b>Sinuosity</b>	1.2
<b>Bankfull Width</b>	123.0'
<b>W/D Ratio</b>	17.9
<b>Material (D50)</b>	18.0 mm
<b>BEHI Rating</b>	Moderate
<b>NBS Rating</b>	High
<b>MADRAS Score</b>	None

This very low gradient river contains a substrate dominated by silt and clay particles. Very little instream habitat exists and no defined riffles or pools were observed.

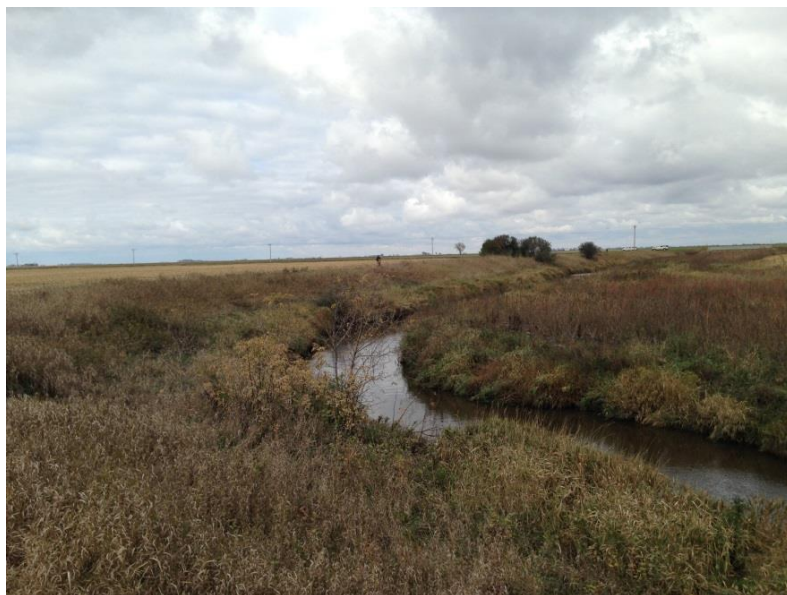
<b>Channel Type</b>	E5
<b>Est. Bankfull El.</b>	980.7'
<b>Channel Slope</b>	0.1%
<b>Sinuosity</b>	1.5
<b>Bankfull Width</b>	29.0'
<b>W/D Ratio</b>	8.3
<b>Material (D50)</b>	1.3 mm
<b>BEHI Rating</b>	Moderate
<b>NBS Rating</b>	Low
<b>MADRAS Score</b>	37

Substantial and stable buffer comprised predominately of *Phalaris arundinacea* and  $\leq$  *Spartina pectinata*. Low relative stream power with predominately silt bottom.

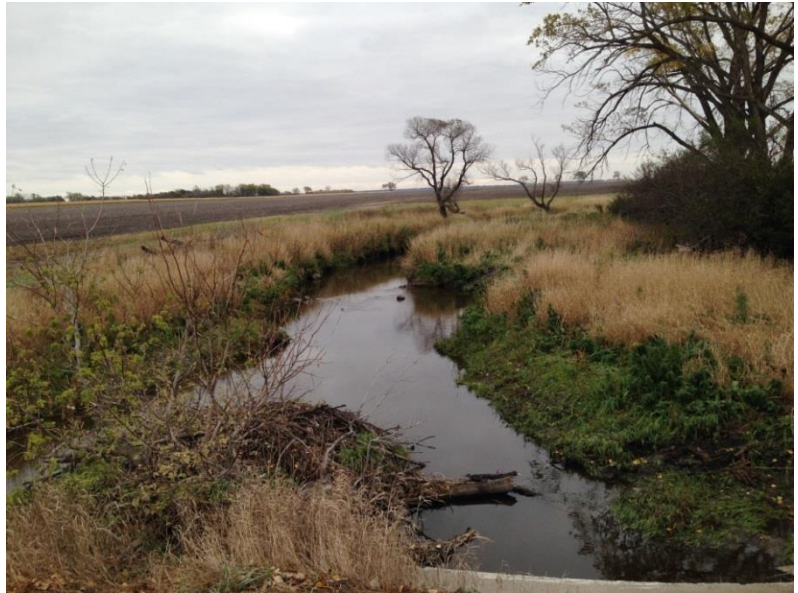
<b>Channel Type</b>	E5
<b>Est. Bankfull El.</b>	996.9'
<b>Channel Slope</b>	0.061%
<b>Sinuosity</b>	1.1
<b>Bankfull Width</b>	21.7'
<b>W/D Ratio</b>	8.2
<b>Material (D50)</b>	0.25 mm
<b>BEHI Rating</b>	Moderate
<b>NBS Rating</b>	Low
<b>MADRAS Score</b>	32

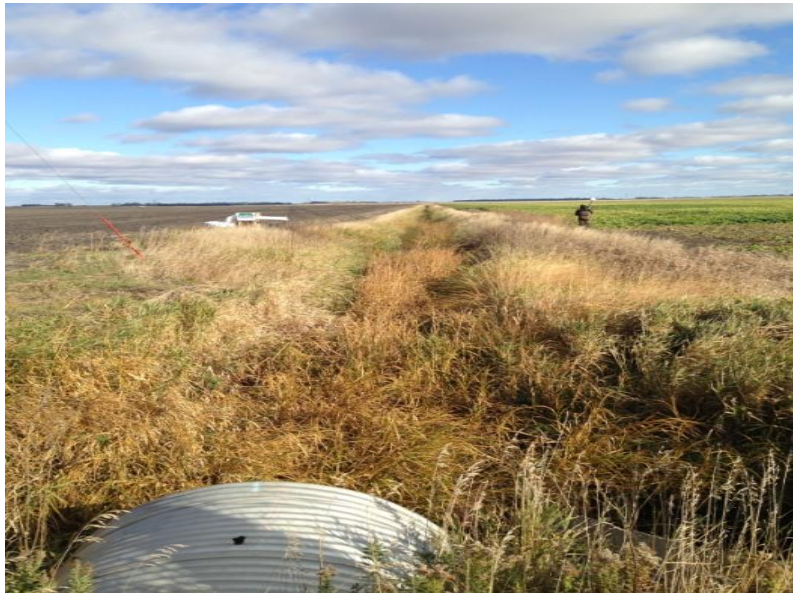
<b>Channel Type</b>	Ditched
<b>Est. Bankfull El.</b>	1015.3'
<b>Channel Slope</b>	0.38%
<b>Sinuosity</b>	1.1
<b>Bankfull Width</b>	26.5'
<b>W/D Ratio</b>	9.6
<b>Material (D50)</b>	0.27 mm
<b>BEHI Rating</b>	Moderate
<b>NBS Rating</b>	Moderate
<b>MADRAS Score</b>	13

330<sup>th</sup> Avenue bisects surveyed reach. CMP and RCP road culverts perched by 12''± & 8''± respectively. Pockets of courser bed material exist downstream of crossing where gradient is higher. Habitat was poor.

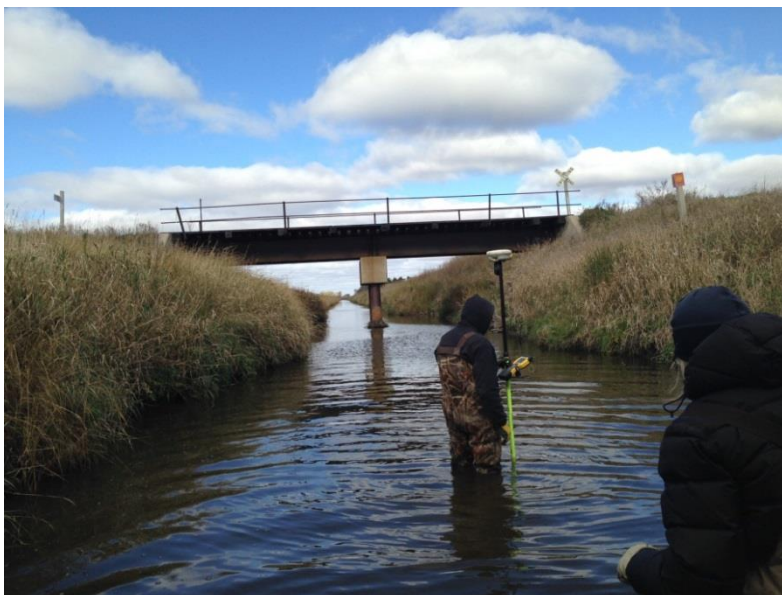
<b>Channel Type</b>	Ditched
<b>Est. Bankfull El.</b>	1006.0'
<b>Channel Slope</b>	0.033%
<b>Sinuosity</b>	1.0
<b>Bankfull Width</b>	48.0'
<b>W/D Ratio</b>	9.5
<b>Material (D50)</b>	Silt
<b>BEHI Rating</b>	Moderate
<b>NBS Rating</b>	Moderate
<b>MADRAS Score</b>	28

State Highway 55 and parallel rail road immediately north of highway bisect surveyed reach. Surveyed reach was parallel to and likely entirely within the R.O.W of County Road B. Relatively stable ditch contained a subtle 2-stage ditch bench. Habitat was poor.

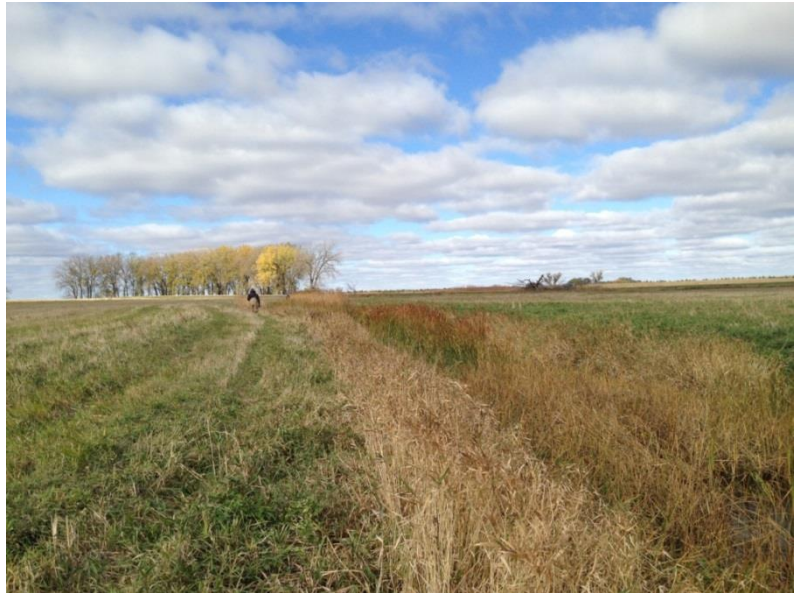
<b>Channel Type</b>	Ditched
<b>Est. Bankfull El.</b>	1064.0'
<b>Channel Slope</b>	0.12%
<b>Sinuosity</b>	1.0
<b>Bankfull Width</b>	46.9'
<b>W/D Ratio</b>	22.9
<b>Material (D50)</b>	Silt
<b>BEHI Rating</b>	Low
<b>NBS Rating</b>	Moderate
<b>MADRAS Score</b>	17

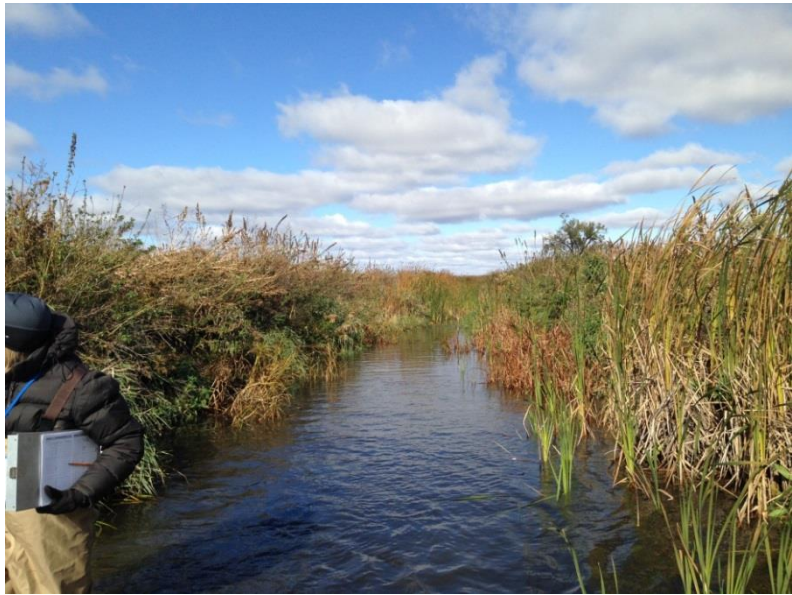
<b>Channel Type</b>	Ditched
<b>Est. Bankfull El.</b>	1061.4'
<b>Channel Slope</b>	0.041%
<b>Sinuosity</b>	1.1
<b>Bankfull Width</b>	39.8'
<b>W/D Ratio</b>	14.9
<b>Material (D50)</b>	0.27
<b>BEHI Rating</b>	Moderate
<b>NBS Rating</b>	Moderate
<b>MADRAS Score</b>	22

2000' downstream of Site 13 (East), with slightly larger drainage area. Contrast to Site 13 (East) this reach has little to no buffer with immediately adjacent row crop.

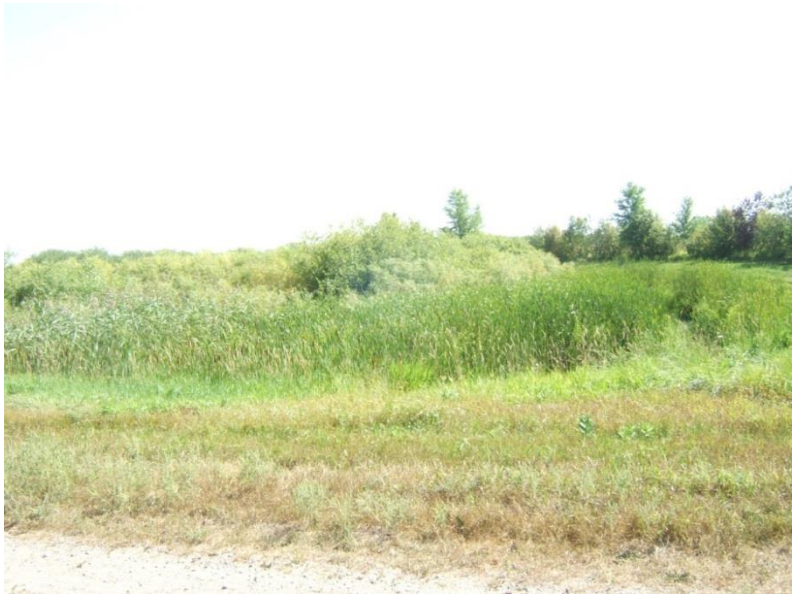
<b>Channel Type</b>	C6c-
<b>Est. Bankfull El.</b>	962.9'
<b>Channel Slope</b>	0.0031%
<b>Sinuosity</b>	1.7
<b>Bankfull Width</b>	185.6'
<b>W/D Ratio</b>	163.5
<b>Material (D50)</b>	Silt
<b>BEHI Rating</b>	Very Low
<b>NBS Rating</b>	Very Low
<b>MADRAS Score</b>	15
