Lake Superior Streams Sediment Assessment: Phase I

A report prepared for the Minnesota Pollution Control Agency

Linse Lahti, Bradley Hansen, John Nieber, and Joe Magner

August 28, 2013

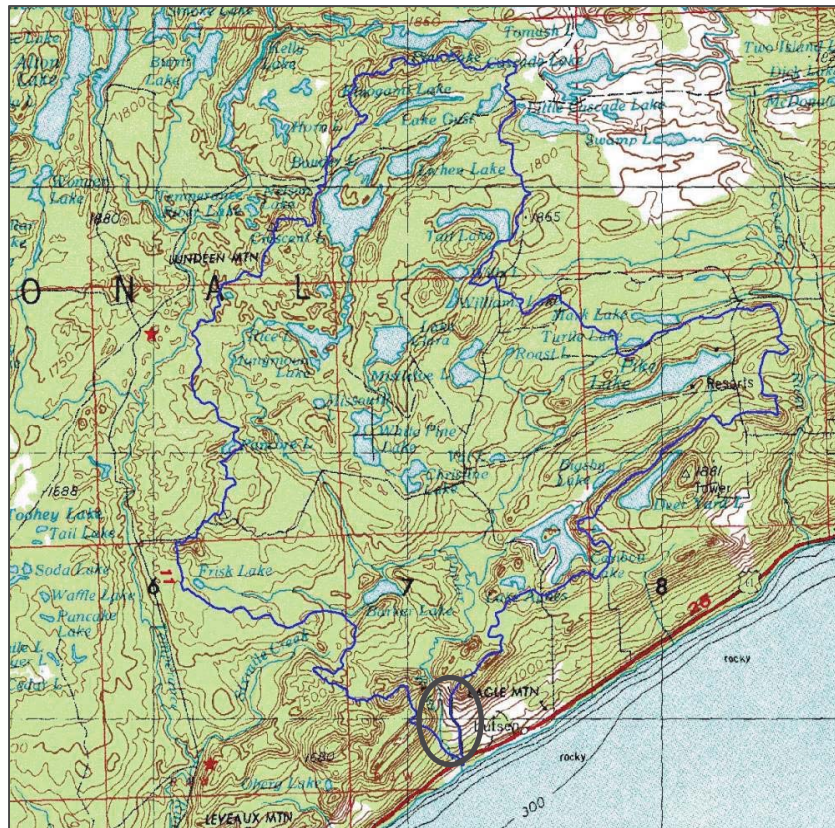
Figure 49. Topographic map with the outline of the Poplar River located along the north shore of Lake Superior. The red oval outlines the area of interest with regard to the turbidity impairment, that is, the Lower Poplar River watershed. (Figure 1 from Nieber, 2013).

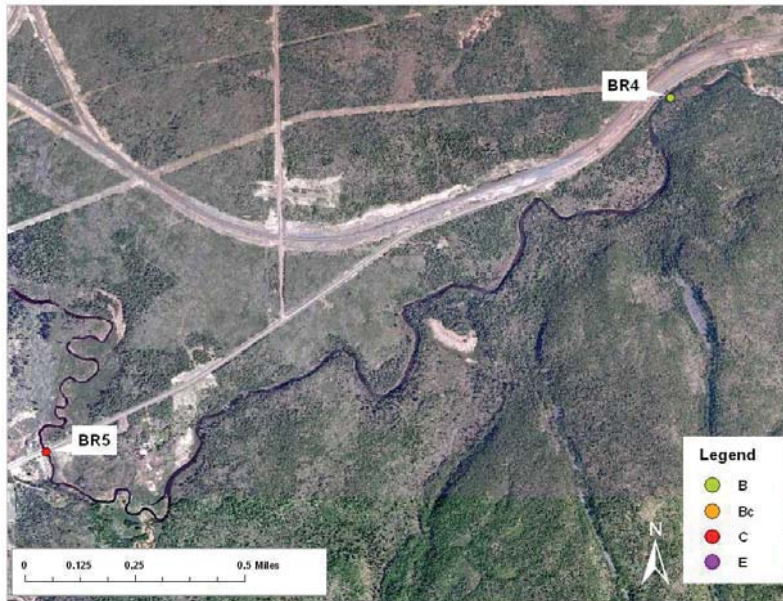
Figure 57. Old lake bed and glacial till landscape.

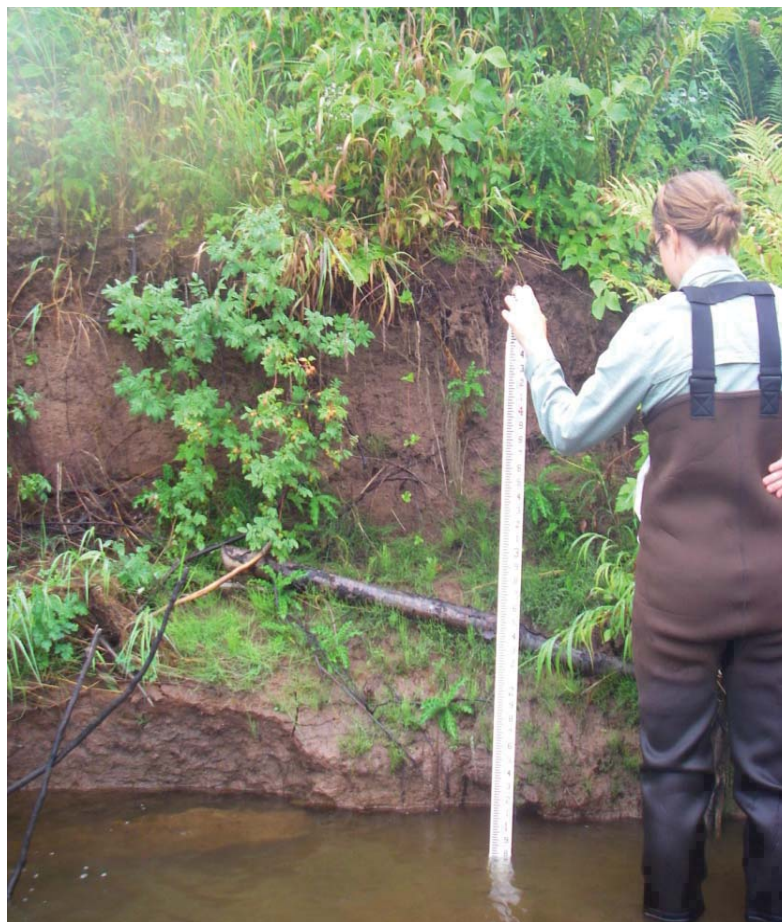
Figure 58. Stream bank in an old lake bed C4 channel (the BR5 site).

Figure 58. Streambank in an old lake bed C4 channel.

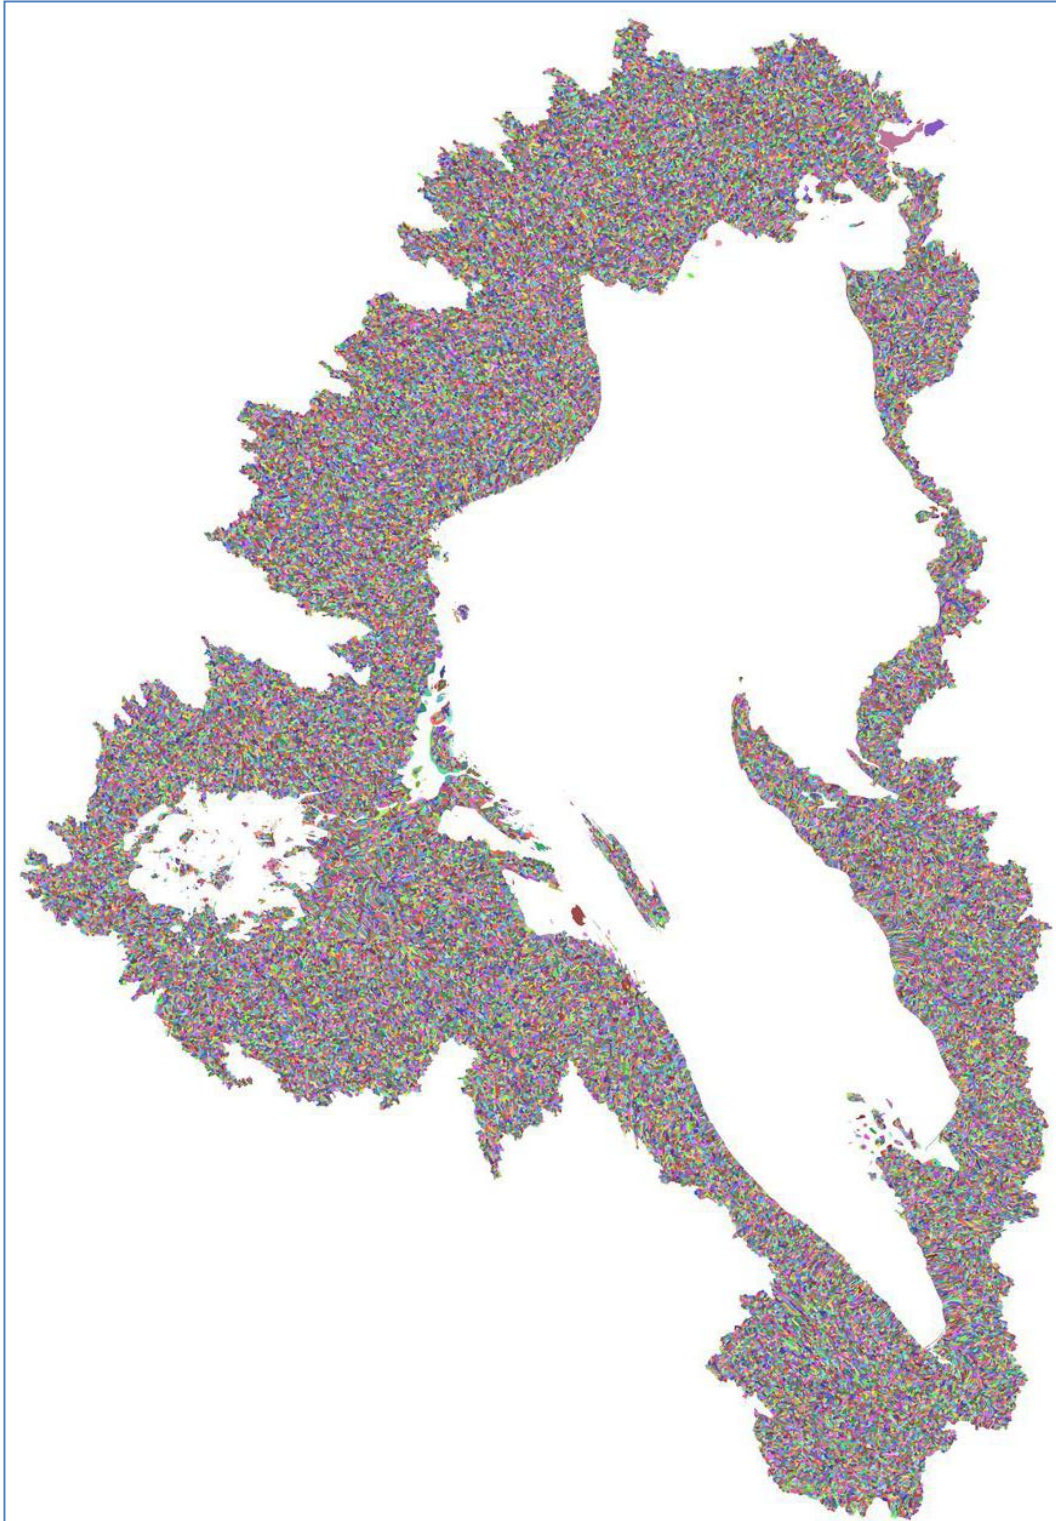
Figure 1. Subcatchments of the Lake Superior basin.

The ArcHydro procedure resulted in the delineation of approximately 131,000 subcatchments in the Lake Superior basin (Figure 1). The average size of each subcatchment was 93 ha (230 ac). Subcatchments were combined based on their Hydro-IDs to identify watersheds emptying into Lake Superior. Approximately 7,000 Lake Superior tributary watersheds (hereafter referred to as simply ‘watersheds’) and the adjacent coastal areas that drain directly into the lake (interfluves)

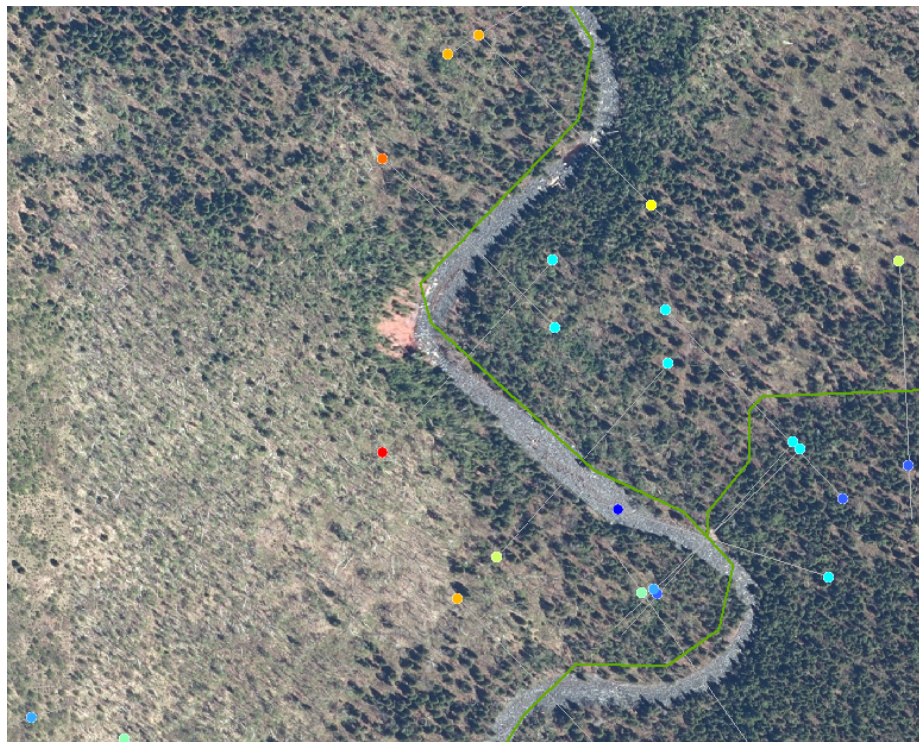
Figure 7: Slump in area indicated as high risk by stream context point methodology.

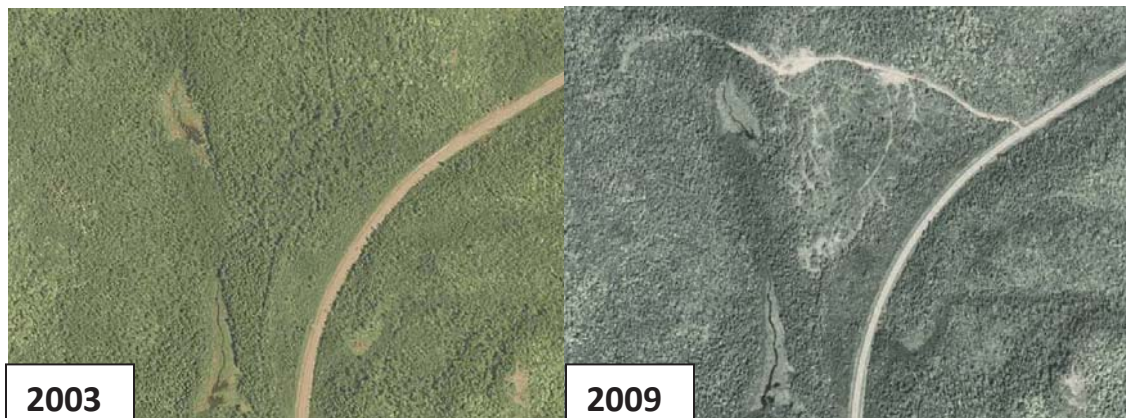
Figure 21. Comparison of land use change detected in Beaver watershed, road survey sites B01-B03 are found on the new road featured in the 2009 photo

The most notable land use change occurred at a nearby creek location in the Beaver watershed, in which three road survey locations were not present in 2003, but was evident in 2009. Describing increases in development by way of the forest road (presumably due to logging) that created the road survey sites B01, B02, B03 (Figure 21).

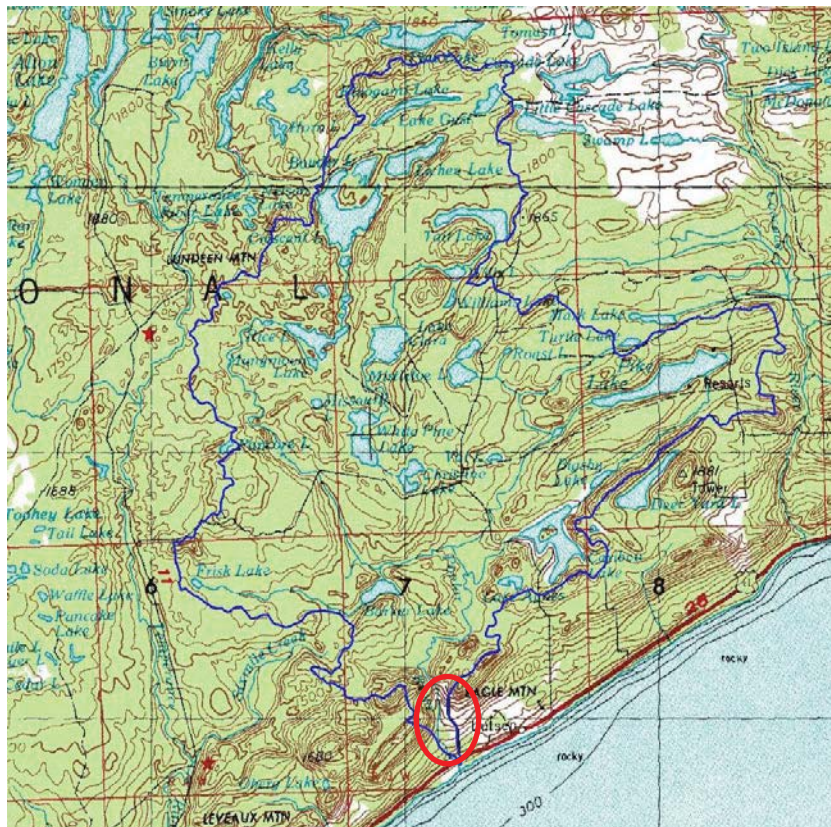
Figure 1. Topographic map with the outline of the Poplar River located along the north shore of Lake Superior. The red oval outlines the area of interest with regard to the turbidity impairment, that is, the Lower Poplar River watershed.

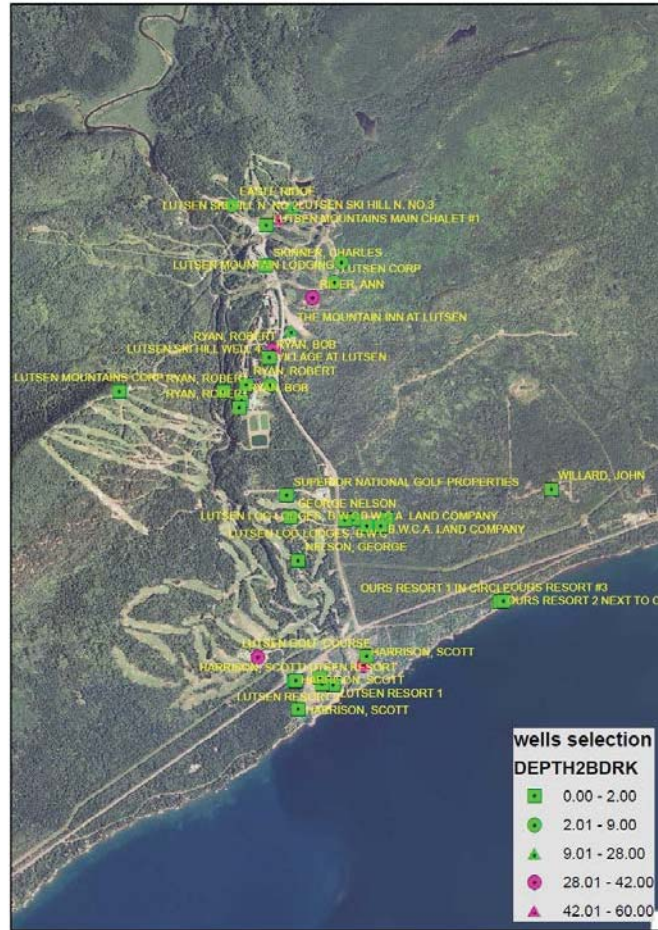
Figure 4. Map showing the depth to bedrock as indicated from the well logs for the locations shown.

The WEPP model facilitates the accounting of the effect of a restricting layer at the base of the soil profile on the soil profile water balance by allowing one to specify whether such a layer exists, and then also allows one to specify the depth of the layer and the saturated hydraulic conductivity of the layer. The resulting water balance is very sensitive to the assignment of the restricting layer saturated hydraulic conductivity value. If that value is sufficiently small, the resulting lack of downward percolation will allow for water buildup in the soil profile, leading then to saturated soil conditions and consequently to surface runoff generation by the Dunne mechanism. Since the soils in the area were determined to have very high saturated hydraulic conductivities for the soil surface, it is unlikely that surface runoff will be generated by the Horton mechanism for any but the most intense storm events in summer periods.

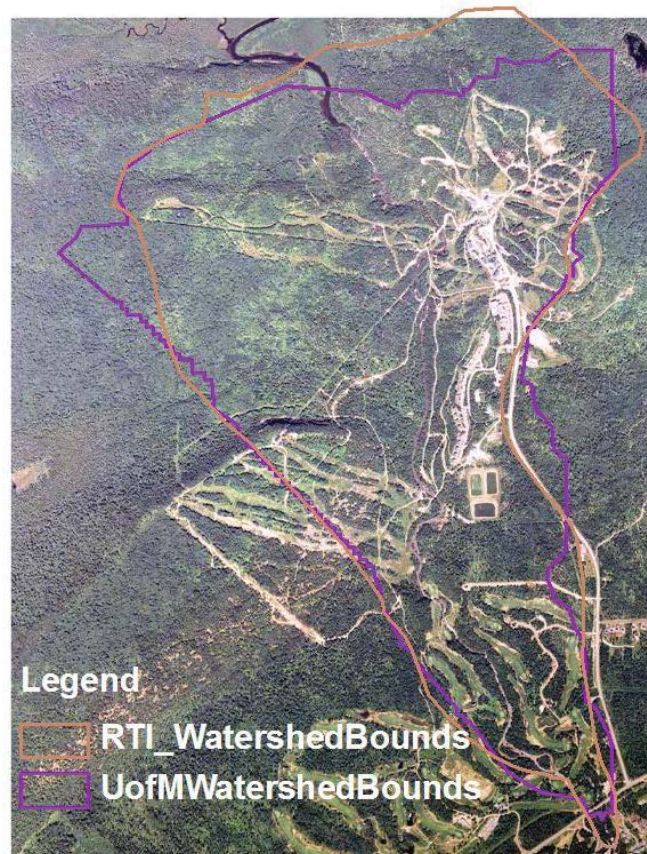
Figure 9. Watershed delineations for the Lower Poplar River watershed. One delineation is for the current effort (UofM) while the other one is for the RTI study (RTI, 2008).

The ArcHydro tool was used in ArcView to construct the boundary of the Lower Poplar River Watershed. The resulting delineation for the UofM effort is shown in Figure 9 along with the delineation produced by the RTI study (RTI, 2008). The differences in the boundaries extents are clear, especially at the northern part of the watershed. Since both studies applied the same input data (30 m resolution DEM, Minnesota Department of Natural Resources data deli) to delineate the watershed for the study area, the differences in watershed area and shape are unexpected. It is conceivable that, the two studies having been conducted at different times (2007 and 2010), some of the input data, especially the DEM data, could have been modified or even upgraded. In their delineation of watershed and sub-catchments, the RTI study located the outlet point more southerly compared to the UofM study; this is evident in the more downstream extension (towards Lake Superior) of the watershed in the RTI study, adding more area to the watershed compared to that by the UofM study. These factors might explain the difference (200 acres) in the areas of the delineated watershed as evaluated in the two studies.

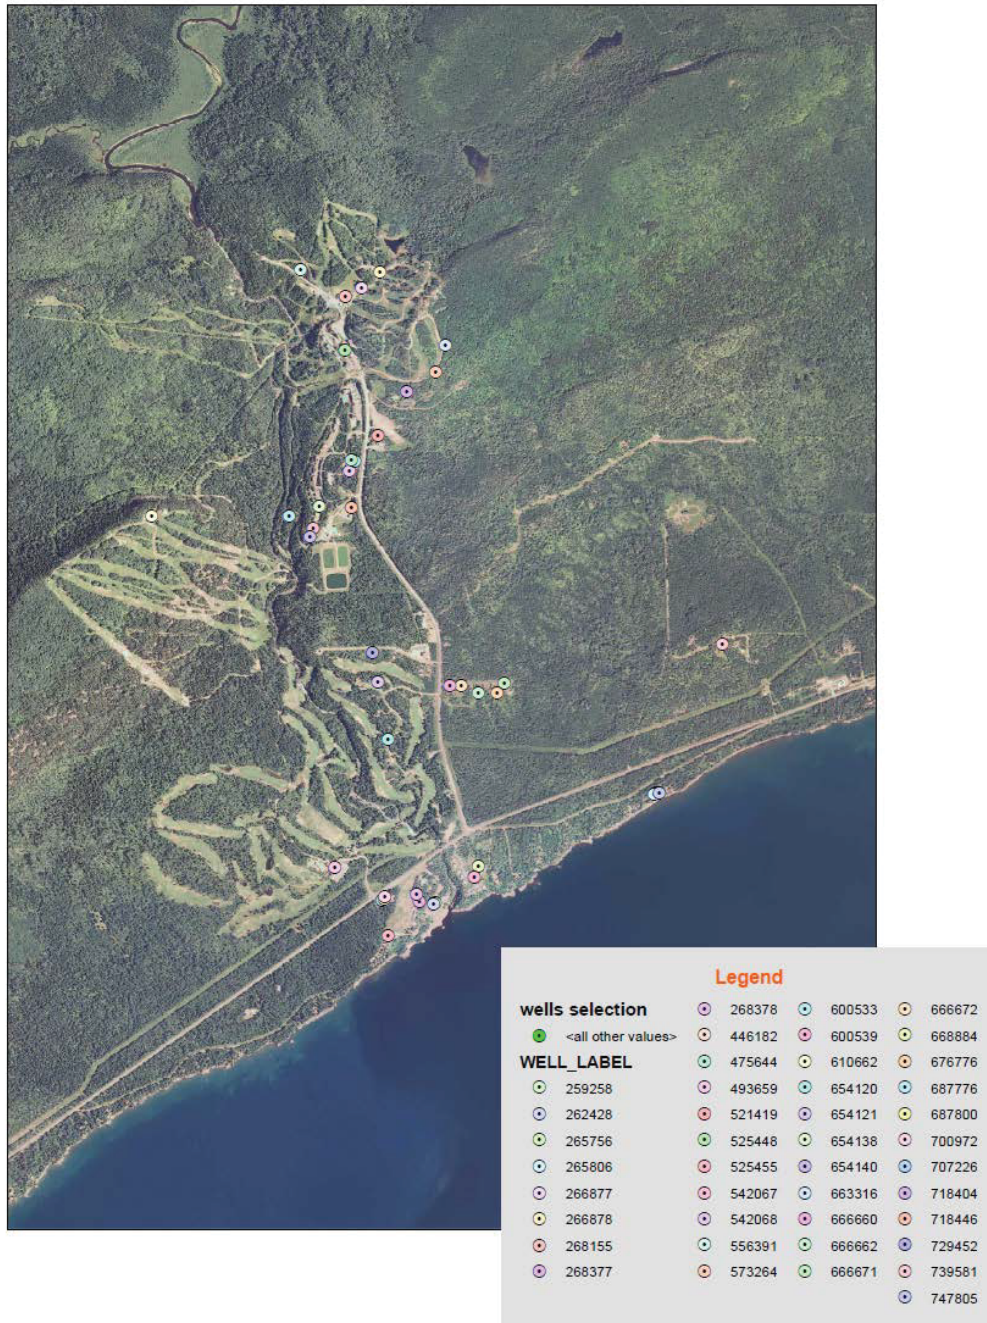
Figure A.2. Map showing location of drilling logs in the Lower Poplar River watershed. These logs are available from the Minnesota Geological Survey.

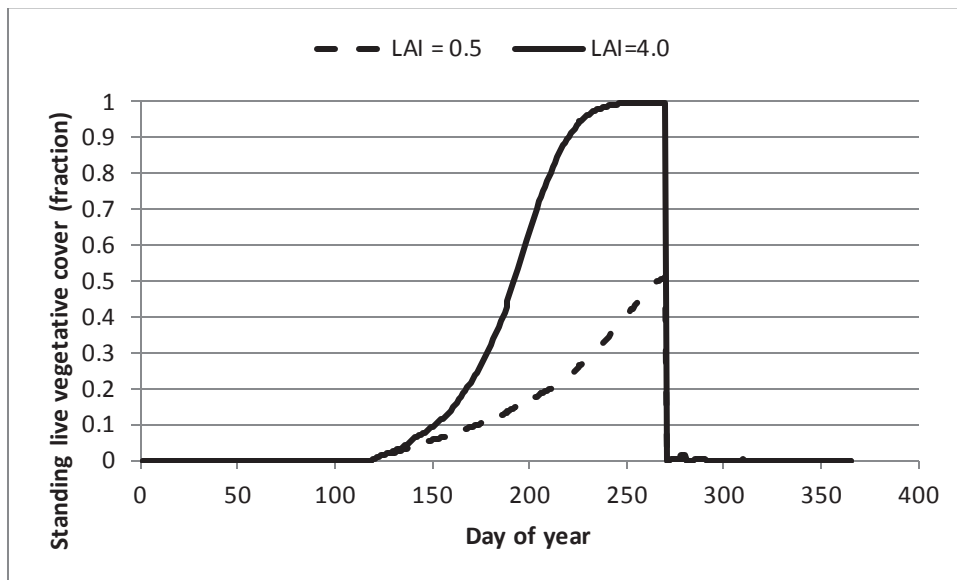
Figure B.1. Variation of surface cover provided by standing vegetation for two cases of maximum leaf area index, 0.5 and 4.0. Both of these cases are for short grass prairie.
