Poplar River Watershed

Total Maximum Daily Load Report: Turbidity Impairment

Minnesota Pollution Control Agency
October – 2013

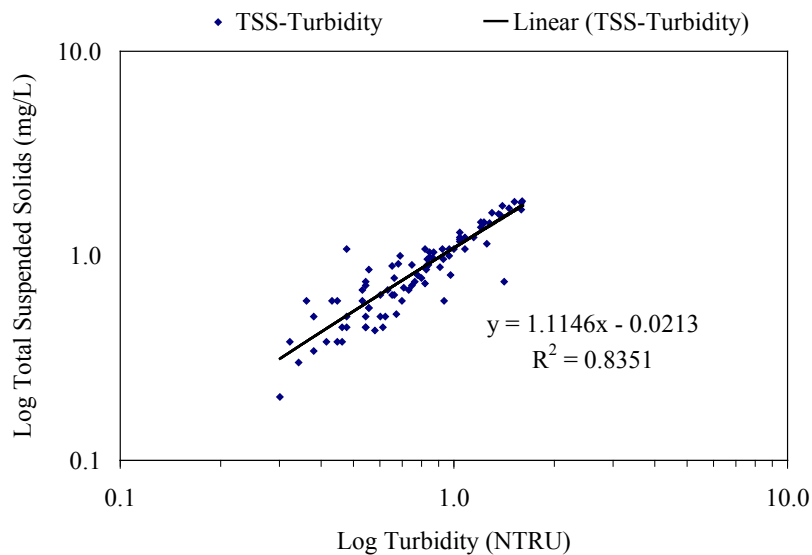
Figure 2.2 Turbidity-TSS Correlation Using only Values Less Than or Equal to 40 NTU at the Downstream Site (S000-261) Using Log-Transformed Data Collected During 2001–2006

Turbidity as a standard analytic method was originally designed to be limited to a measurement range of 0 to 40 NTU with higher turbidities being measured using dilution (MPCA, 2006b). Measurement of turbidity in samples with very high NTU values can increase error. A second approach to limiting variability in developing the turbidity-TSS relationship was to develop the correlation using paired samples under conditions where the turbidity value is less than or equal to 40 NTU. Figure 2.2 provides a linear regression on TSS and turbidity data collected downstream using NTRU methods only, and under conditions where the turbidity value is less than or equal to 40 NTU. Based on this correlation, 10 NTU is equivalent to 12.39 mg/L TSS. Given the correlations of 11.64 mg/L TSS using all data and 12.39 mg/L TSS using turbidity data less than 40 NTU, **for the purposes of this report, a value of 12 mg/L TSS will be used as the equivalent TSS concentration for the 10 NTU water quality standard.**

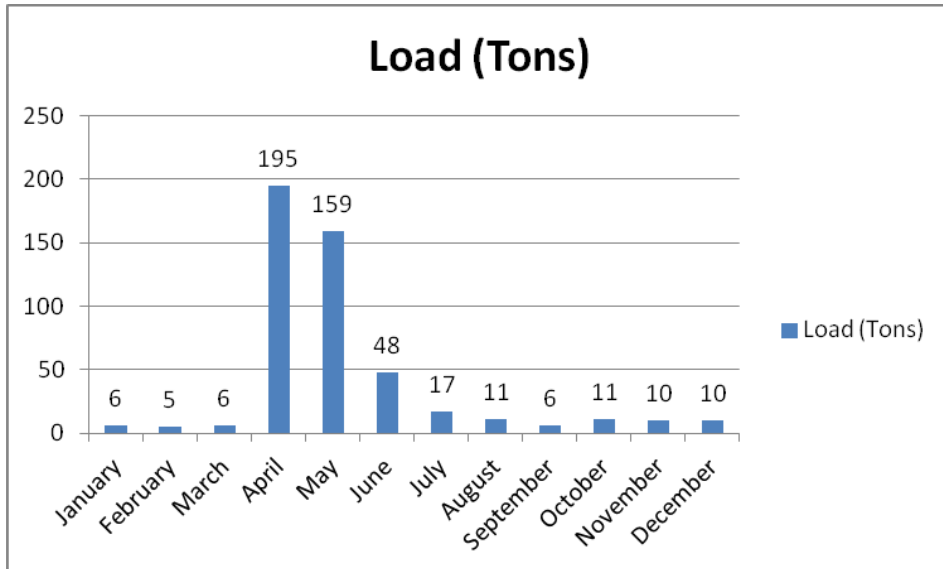
Figure 3.1 Estimated average monthly load at the upstream station (S001-753).

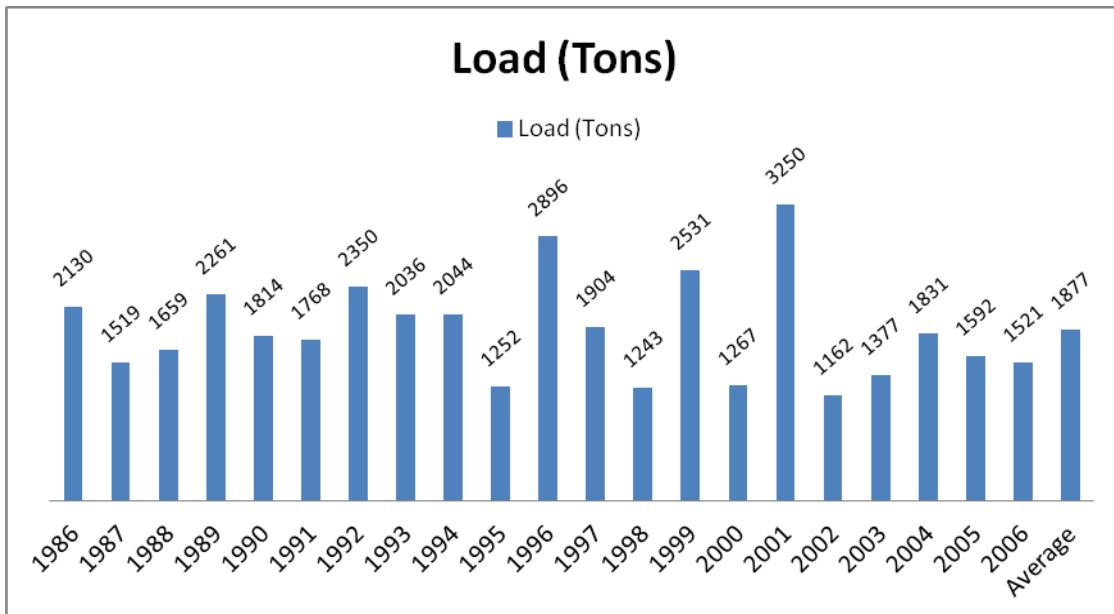
Figure 3.2 Estimated annual loads and average at the downstream station (S000-261).

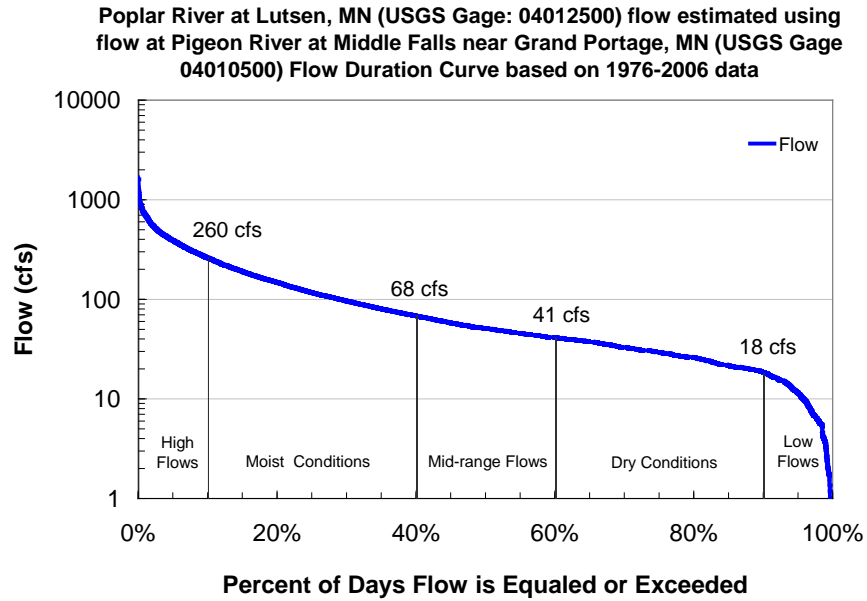
Figure 3.4 Flow Duration Curve for the Poplar River at Lutsen, MN. A Thirty-Year Flow Period (1976-2006) in the Poplar River was used to generate the Flow Curve. Flows Between 1976 and 2001 were Estimated in the Poplar River Using Pigeon River at Middle Falls Near Grand Portage, MN Flows and an Established Flow Correlation Between the Two Gage Stations

Once the relative rankings were calculated for flow, monitoring data were matched to flow by date to compare observed water quality to the flow regime during which it was collected. This analysis can help define the flow conditions under which excursions occur and identify the sources of the impairment. Concentrations that plot above the target TSS concentration of 12 mg/l and in the interval between 90% and 100% of days in which flow is exceeded indicate the possible influence of a steady-input source contribution. Concentrations that plot in the interval between 10% and 60% suggest the presence of storm-driven and steady-input source contributions. A combination of both storm-driven and steady-input sources occurs in the transition zone between 60% and 90%. Concentrations that plot above 95% or below 10% represent values occurring during either extreme low- or high-flow conditions. As observed in Figure 3.5, the majority of TSS measurements over 12 mg/L occurred at higher flows that have a frequency of occurrence of about 45%. This frequency of flow event is equivalent to a streamflow of 60 CFS.

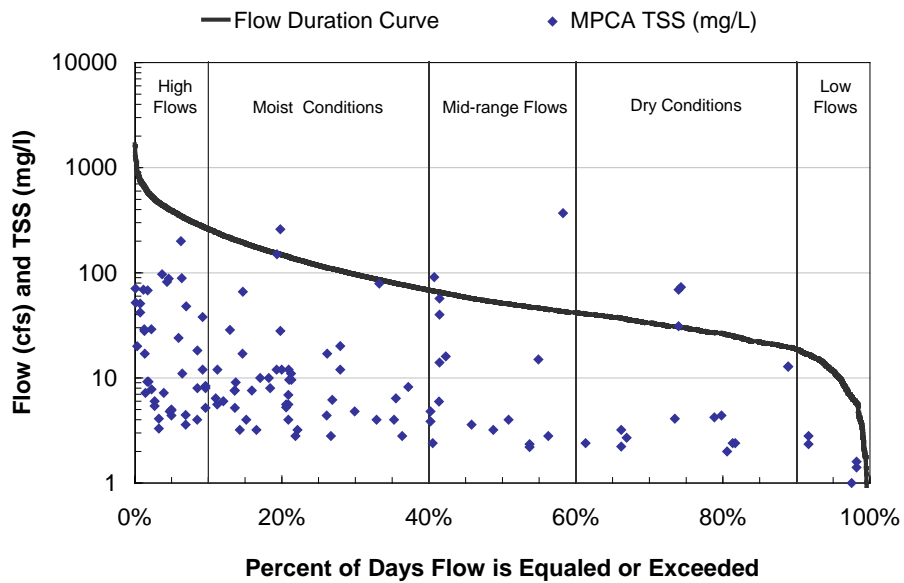
Figure 3.5 Flow Duration Curve for the Poplar River at Lutsen, MN and TSS Data Collected at the Lower Poplar MPCA Station (S000-261) During 2001-2006

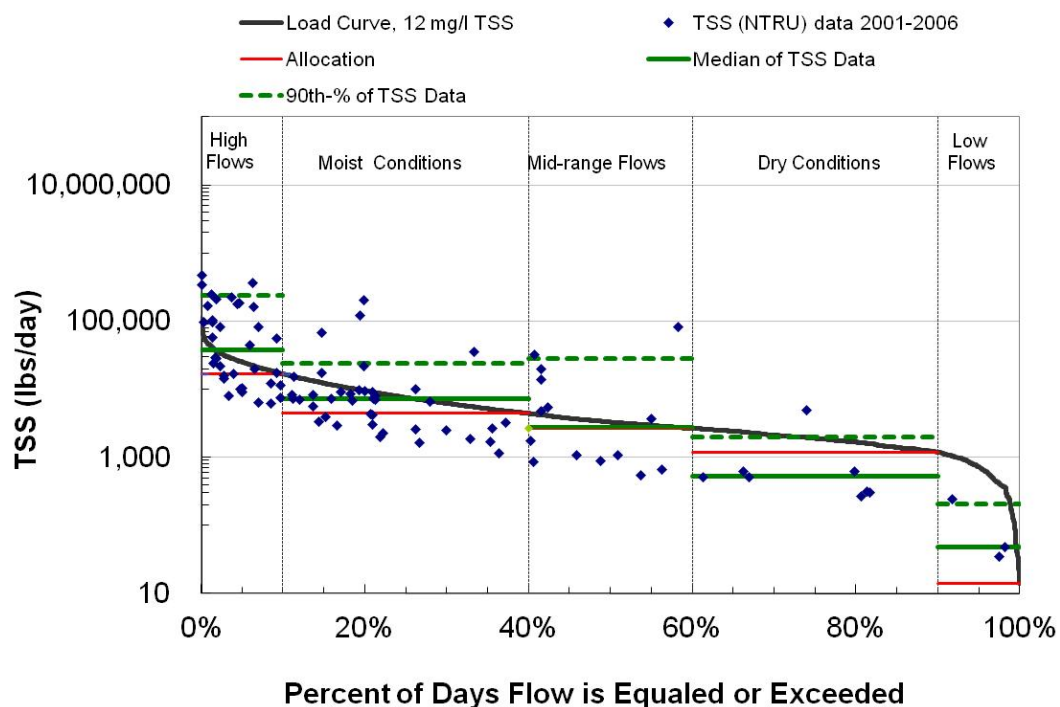
Figure 3.6 Load Capacity Curve for the Poplar River at Lutsen, MN using TSS as a Surrogate for Turbidity in the Poplar River. Median values are also represented for the flow ranges.

Using TSS as a surrogate for turbidity, the streams' loading capacity under each flow condition was determined by multiplying the TSS-equivalent (12 mg/l) of the turbidity water quality standard by flow.

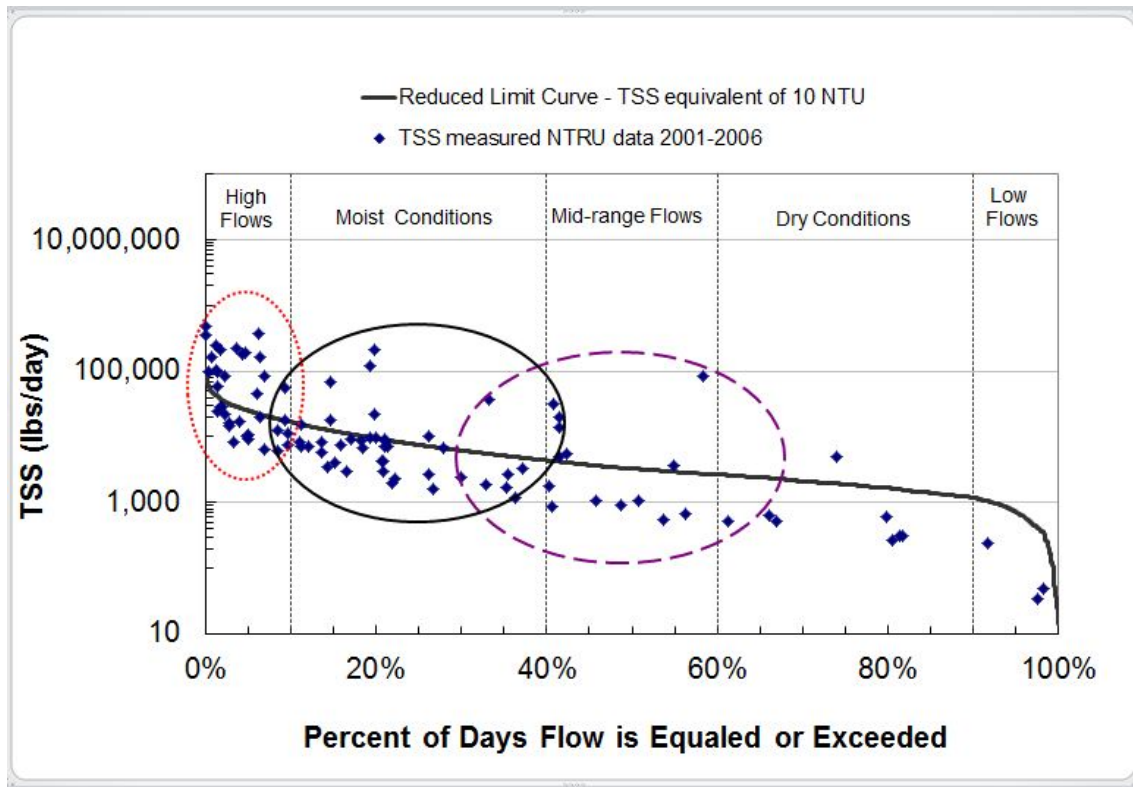
Figure 4.1 Load Duration Curve for the Poplar River at Lutsen, MN Identifying Flow Ranges for TSS Source Identification

The load duration curve developed for the downstream location showed that exceedances to the turbidity standard occur under moderate to high flow conditions (Figure 4.1). In general, few exceedances were observed under dry and low flow conditions below 40 cfs. Under conditions where flows were at or above 60 CFS (flow frequency of ~ 45% recurrence), the number of exceedances increased. Most turbidity violations occurred under high flows greater than 250 cfs (flow frequency of ~ 10% reoccurrence).

1. Mid-range flows usually represent the rise of a hydrograph as it progresses out of the dry condition range and enters into wetter conditions. The zone of land use that is most likely to contribute during this period would be the riparian corridor of the river. This is because limited upland soil saturation and quite possibly soil erosion has yet to take place during the early period of storm events or in smaller events that can only deliver localized eroded soils (purple dashed oval in Figure 4.1).

2. Moist condition flows generally indicates the area where material loading typically originates from both upland soils which under these wetter conditions are now saturated and begin contributing to the more efficient transport of eroded materials and continue to move riparian corridor eroded materials (solid black oval in Figure 4.1).

3. High flows usually represent the material loading which indicates bank or river bluff contributions. Sufficient energy exists at these flow regimes to cause mass wasting and the breakdown of consolidated materials such as glacial lake clay deposits (red

dotted oval in Figure 4.1).

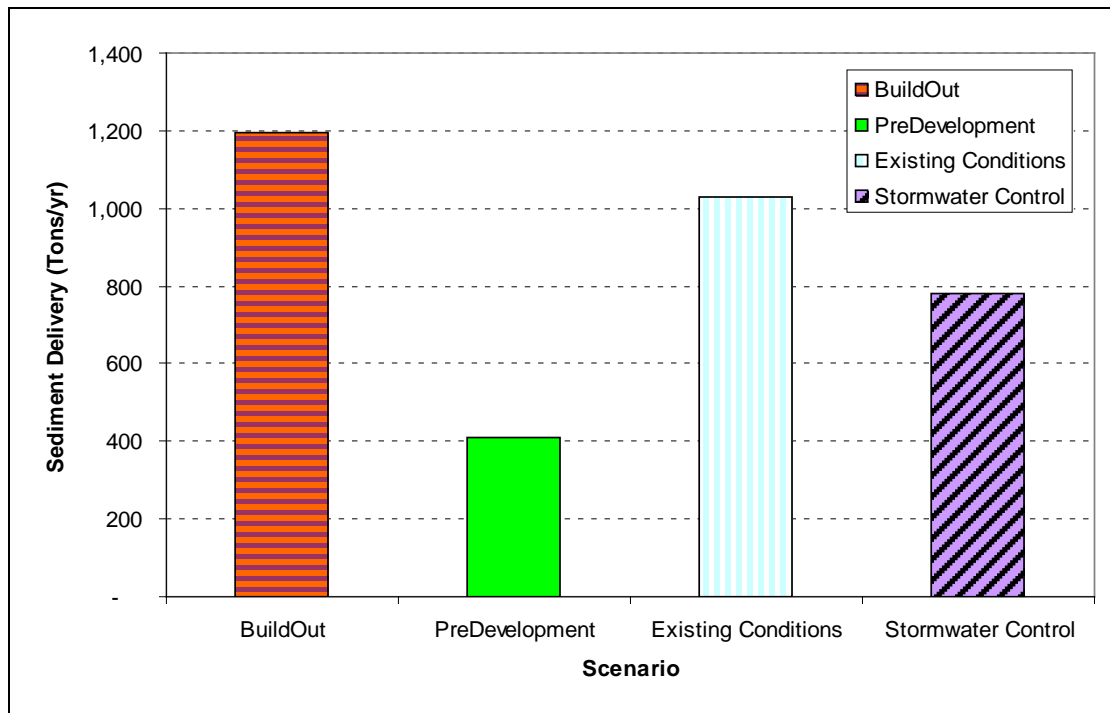
Figure 5.2 Scenario Comparison- Average Sediment Delivery (Tons/Year) WEPP 2006.5

The predicted sediment load from the four scenarios of alternate land uses are reported in Figure 5.2. They indicate that additional development, as described by landowners as likely future development, may contribute to increased sediment load if no nonpoint source controls are implemented. At maximum, those future projects impact 140 acres of land in a mix of residential and commercial improvements. Details can be found in the AUAR document. The scenario “Stormwater Control” indicates that with improved vegetative cover and runoff controls, erosion can be reduced well below existing conditions. It does not indicate that these are regulated stormwater sources. The “Predevelopment” scenario was completed to provide a prediction of the sediment load if no resort or ski area existed within the watershed. This scenario demonstrates that even with no land use alteration a significant amount of sediment would be delivered to the Poplar River.

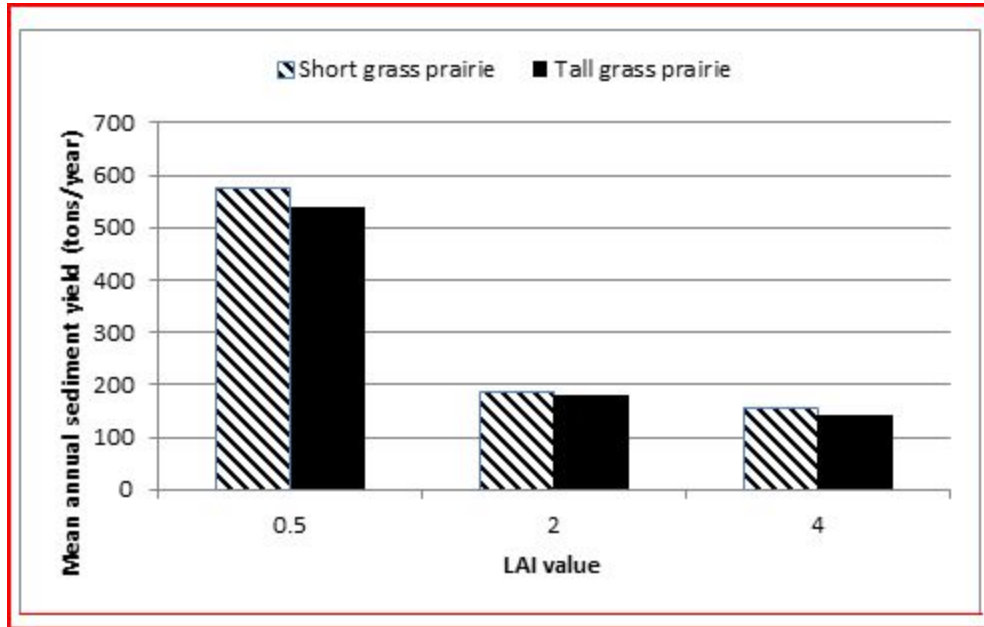
Figure 5.3. Cumulative mean annual sediment yield from ski slopes under various cover conditions

Note: Biomass growth potential of grass is reflected by the leaf area index (LAI). Two vegetation classifications are considered, short grass prairie and tall grass prairie. LAI values include 0.5, poorest quality conditions: 2.0 and 4.0 indicate best growth and cover conditions. A larger LAI value results in a smaller mean annual sediment yield.

The application of artificial snow was also evaluated. In general, more snow translated to increased sediment. However, the vegetated cover condition, the biomass residue condition and slope length mitigated total sediment produced. See Table 5.2 which summarizes the modeling exercise.
