# Deer Creek Watershed

## Total Maximum Daily Load Report: Turbidity Impairments

Minnesota Pollution Control Agency  
June 2013

# ***Deer Creek Watershed Total Maximum Daily Load Report: Turbidity Impairments***

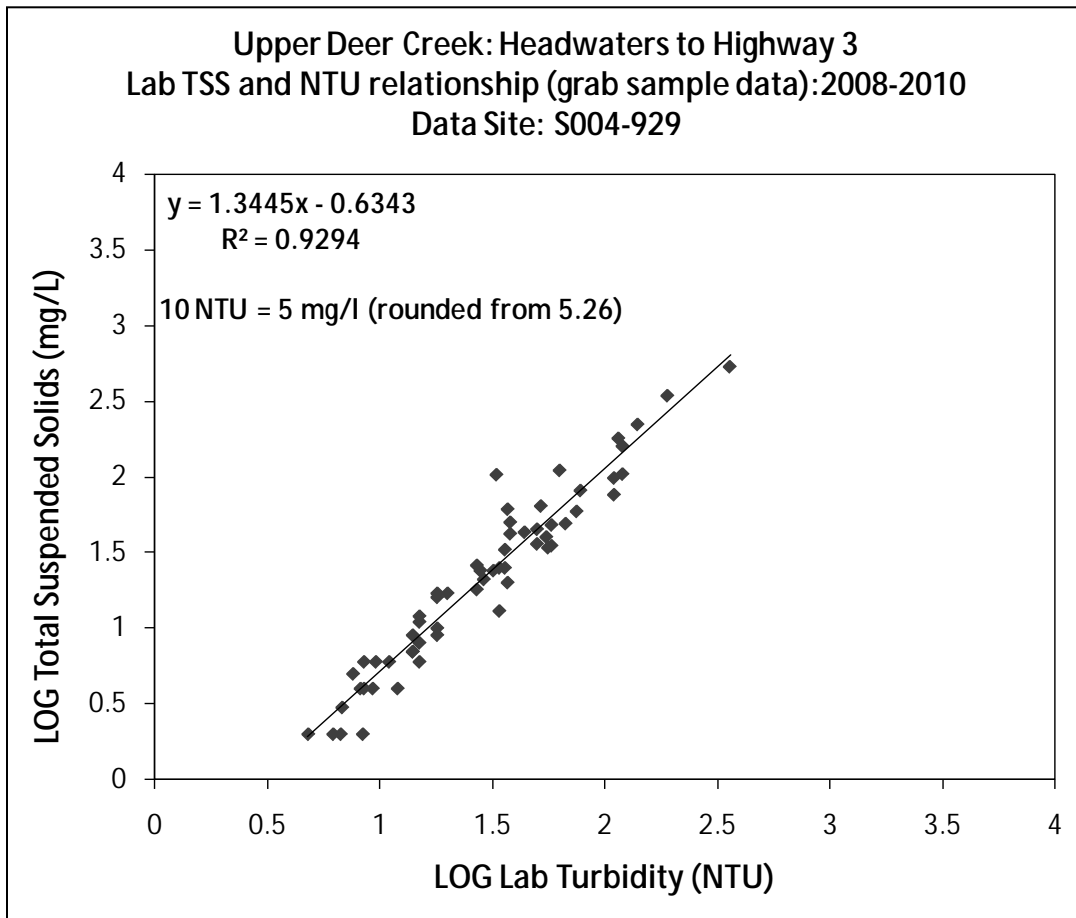
Figure 3.2 Upper Deer Creek at Hwy 3 NTU to TSS Relationship

The NTU to TSS relationship was used to convert the 10 NTU standard to a TSS measurement for the water quality duration curves. For the Hwy 3 sampling location the 10 NTU standard is converted to a TSS concentration of 5 mg/L. At the Hwy 23 sampling location a concentration of 4 mg/L TSS represents the 10 NTU standard. The 4 mg/L standard will be applied to determine TMDL loading capacities since it is the most conservative surrogate concentration for the turbidity standard and the Hwy 23 sampling station is most representative of the overall watershed.

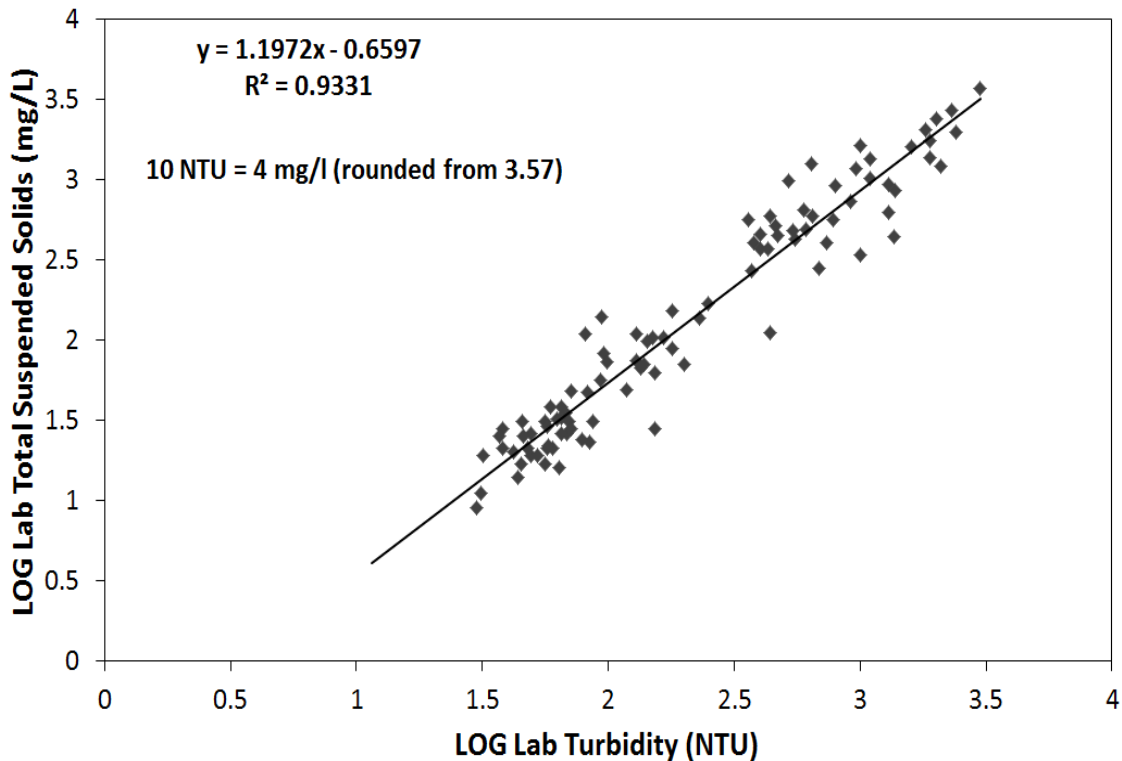
**Figure 3.3 Lower Deer Creek at Hwy 23 NTU to TSS Relationship**

**Deer Creek: Headwaters to Highway 23**  
**Lab TSS and NTU relationship (grab sample data): 2004-2010**  
**Data Site: S003-250**

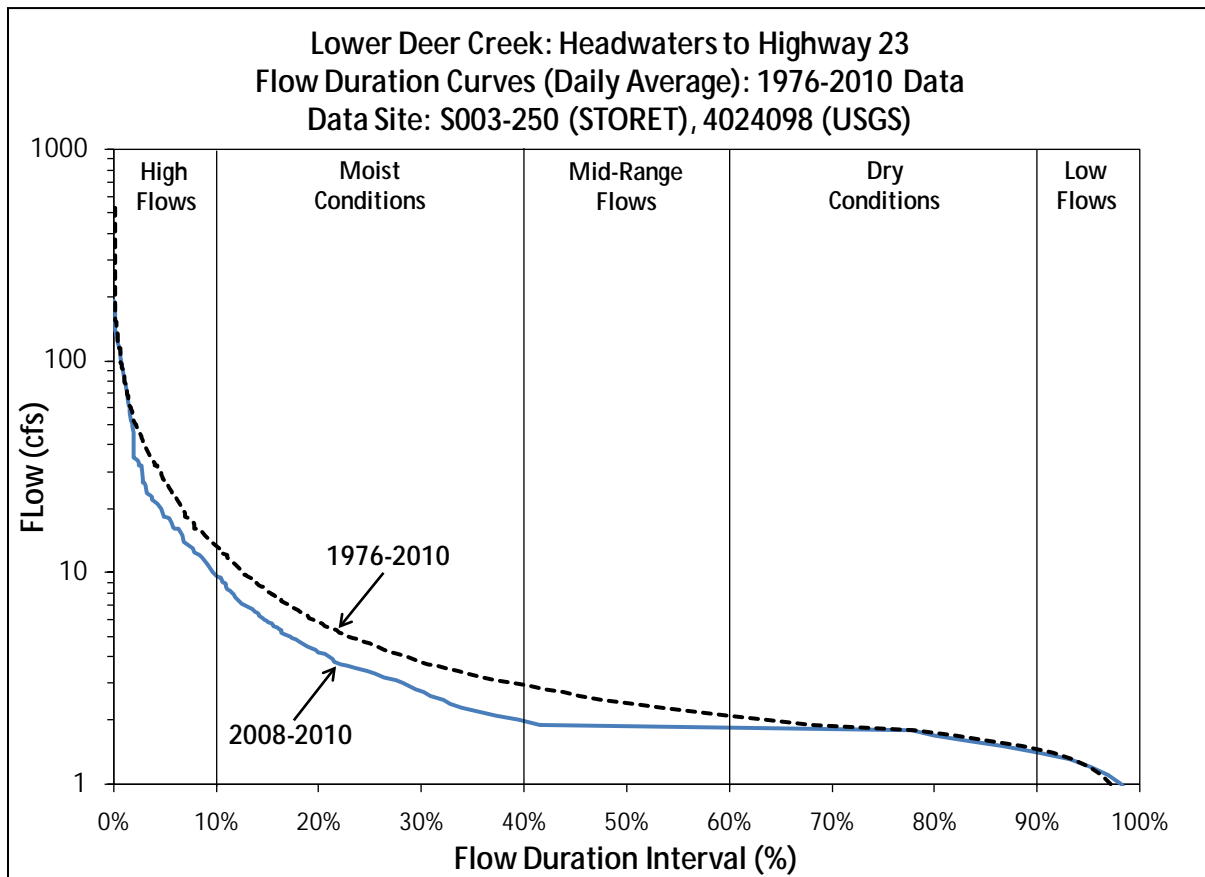
**Figure 3.4** Flow duration curve: Lower Deer Creek station

Flow duration curves were developed for the Lower Deer Creek station for years 2008-2010. This dataset was compared with historical data collected by both the MPCA and the USGS for years 1976-2010 (Figure 3.4). The flow duration curves rank each flow based on its percentile rank. A flow duration interval of 10% represents a value where only 10% of the flow rates are higher. A 90% interval represents a low flow rate where 90% of measurements are higher. The results show flow rates during 2008-2010 as generally lower than the historical data. High flows and flow rates under dry and low flow conditions more-closely match historical values, while moist condition and mid-range flows are slightly lower during 2008-2010 than previous years. For development of the TMDL rates were divided into five categories: high flows (0-10%), moist conditions (10-40%), mid-range flows (40-60%), dry conditions (60-90%) and low flows 90-100%).

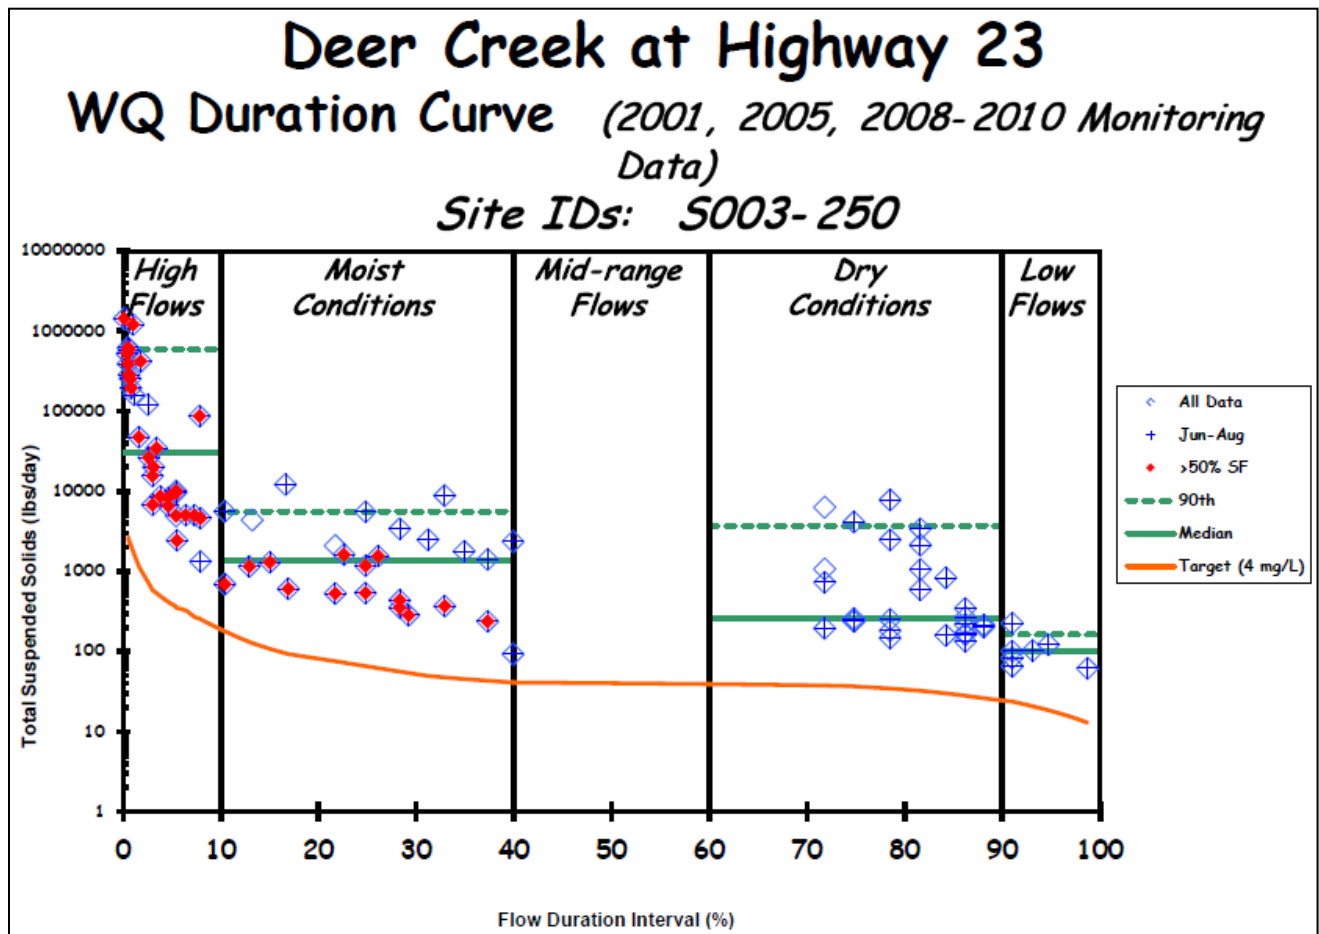
Figure 3.5 TSS Load duration curve for Lower Deer Creek (2008-2010)

Load duration curves were created for three years of combined data (2008-2010) at the Lower Deer Creek station located near Hwy 23 (Figure 3.5 and Figure 3.6). Load duration curves plot the corresponding TSS load (lbs/day) calculated using the 15 minute interval flow rate (cfs) and TSS concentration (mg/L), converted from the NTU turbidity measurement, against the flow percent rank (%) for each measurement. At the Deer Creek Highway 23 station the highest TSS loads occurred during the high and moist flow zones. Median loads over the three year period were calculated as 13314, 810, 94, 228, and 128 lbs/day for the high, moist, mid, dry and low flow zones respectively.

The 10 NTU standard was calculated by taking the product of the 4 mg/L TSS equivalent and the flow rate at various percentages. This curve is displayed with an orange line in Figure 3.5. Also present on Figure 3.5 are the 90<sup>th</sup> percentile and median loads for the 5 flow zones. All measurements recorded between 2008 and 2010, at the lower Deer Creek station, were above the turbidity standard.

The higher loads in the moist and high flow zones are the result of both increased flows and elevated TSS concentrations (see Figure 3.6). Median concentrations for the three year period were recorded as 79, 31, 9, 20 and 24 mg/L for the high moist, mid, dry and low flow zones, respectively. The 90 percentile TSS concentrations were 604, 74, 9, 78 and 38 mg/L for the high moist, mid, dry and low flow zones respectively. Figure 3.6 also shows that the TSS observations in the three lower flow zones were significantly higher than the TSS concentration that corresponds to the turbidity standard, resulting in TSS loads that were also higher than the loading capacity (as shown in Figure 3.5) for the mid-range to low flow conditions.
