# Thief River Watershed Total Maximum Daily Load

A description of the restoration measures necessary to bring the Thief River and its tributaries into compliance with Minnesota water quality standards for total suspended solids and *E. coli*.

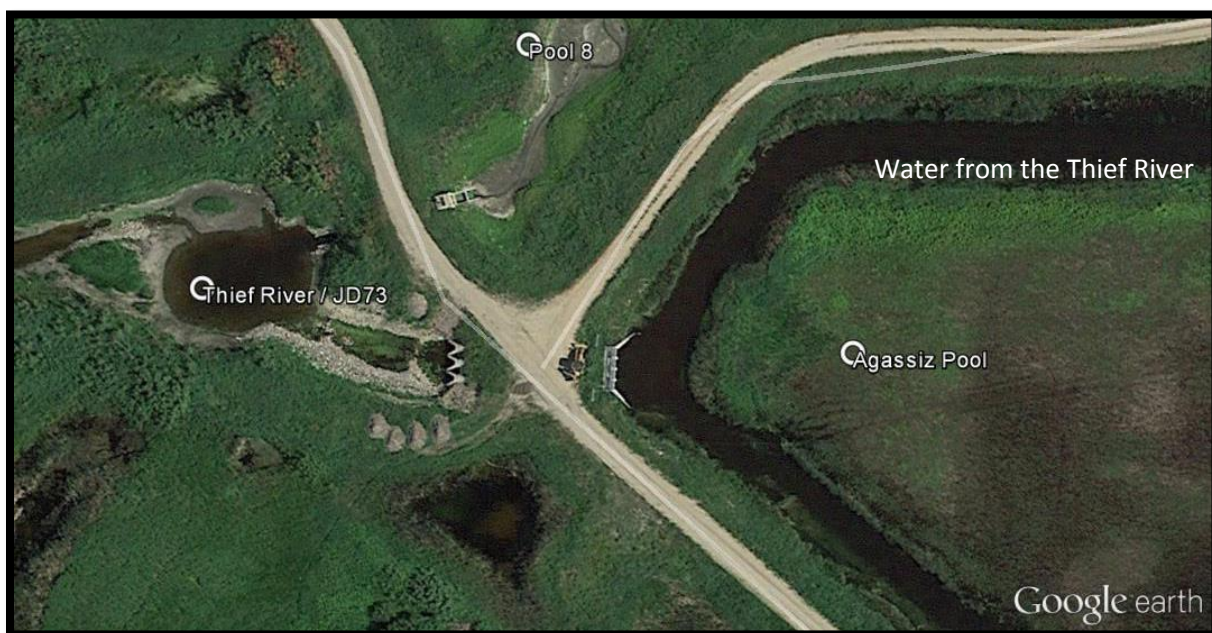
Figure 3-2. Aerial view of the northwest outlet of Agassiz Pool that became operational in 2008

The Thief River Watershed (Figure 3-1) covers approximately 1090 square miles in northwest Minnesota. The Thief River itself is split into two major reaches. It begins at the outlet of Thief Lake and flows to Agassiz NWR, where the river channel enters and supplies water to Agassiz Pool. A portion of the flow can travel along the northwestern dike of the pool and exits the pool via a relatively new (operational in 2008) northwest outlet structure (Figure 3-2).

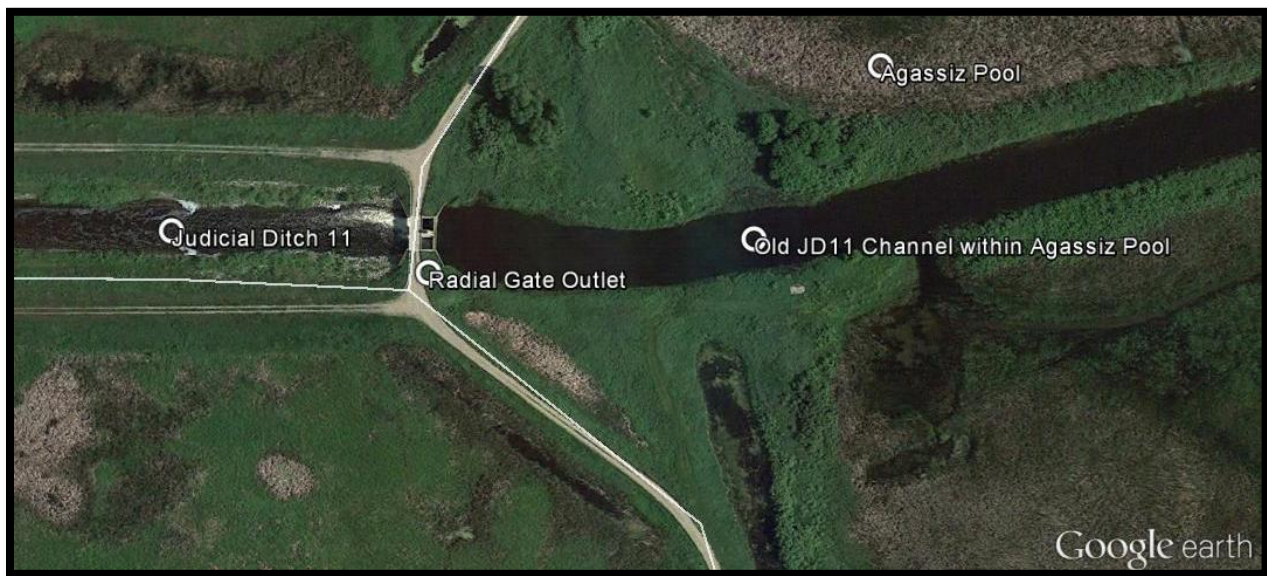
Figure 3-3. Aerial view of the radial gate outlet of Agassiz Pool along Judicial Ditch 11

The Thief River begins at the outlet of Thief Lake. It flows south until it enters Agassiz Pool. Agassiz Pool also receives water from the Mud River (from the east) and other smaller ditch systems. Water is discharged from the primary outlet of Agassiz Pool via two 14-foot wide radial gates (Figure 3-3) and a 2.63-foot screw gate outlet into Judicial Ditch 11 (JD11). After flowing through a 2.3-mile reach of JD11, water re-enters the Thief River.

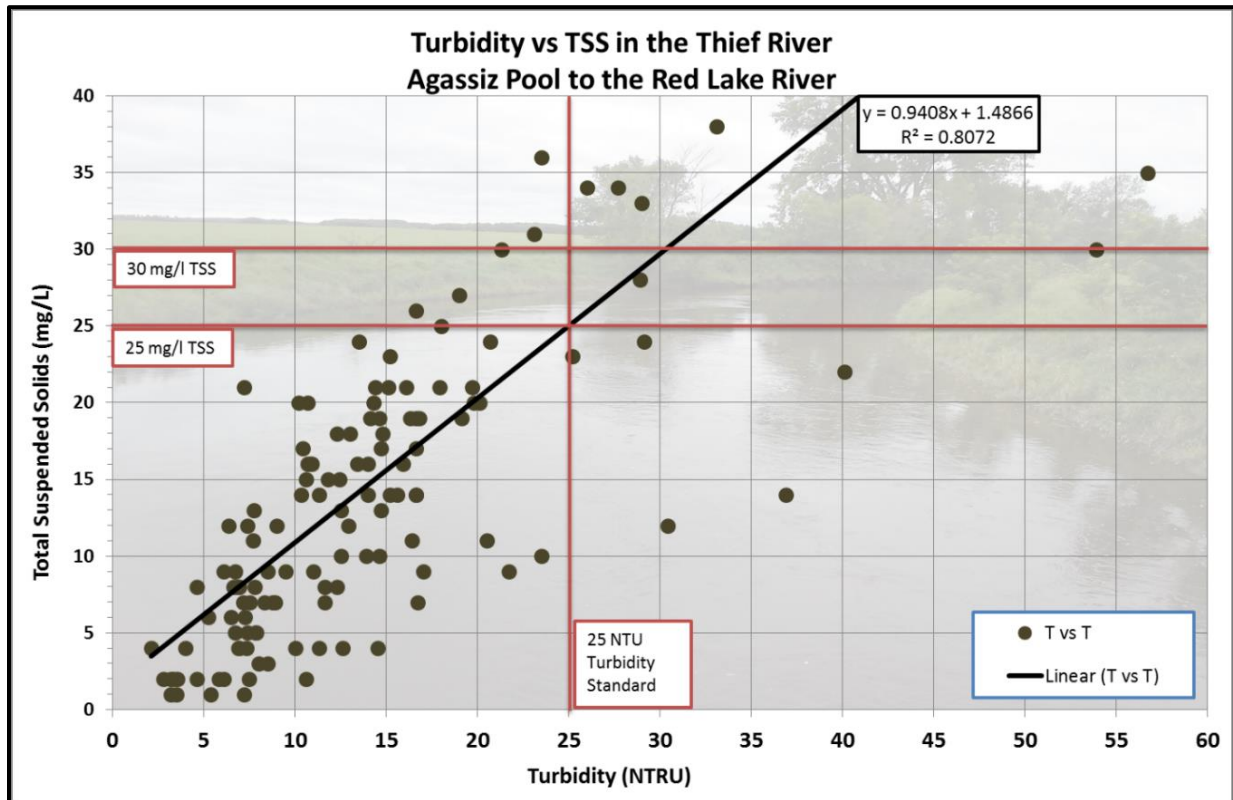
Figure 3-16. Turbidity vs. TSS in the Thief River Watershed.

The new 30 mg/l standard seems to be appropriate for this reach of the Thief River. Data from the turbidity-impaired reach of the Thief River (Agassiz Pool Outlet to the Red Lake River) was analyzed to determine a relationship between turbidity and TSS. The comparison of simultaneously collected TSS and turbidity measurements in Figure 3-16 shows that the 30 mg/l TSS standard provides a similar level of protection as the turbidity standard once did.

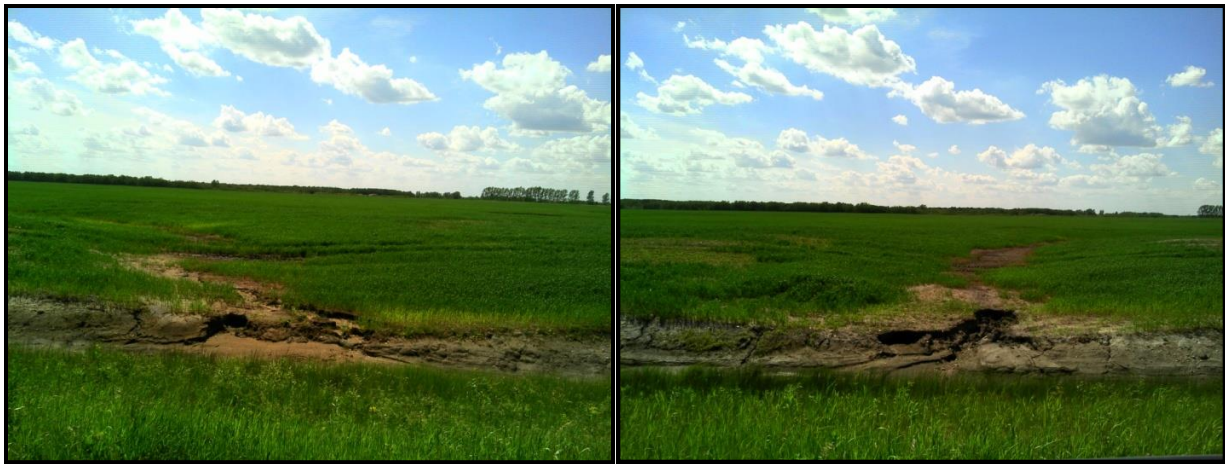
Figure 3-21. Photos of erosion problems that could be prevented by implementation of the 16.5-foot buffer requirement.

There is significant room for improvement in the completeness and the quality of riparian buffers along the Thief River and its tributaries. Multiple examples of the consequences of poor riparian buffers have been documented with georeferenced photos. Two of those examples are shown in Figure 3-21. Riparian buffers are now required by law along public waterways and public drainage systems in the state of Minnesota. Governor Mark Dayton's landmark buffer initiative was signed into law in 2015 and amended in 2016. The law establishes new perennial vegetation buffers that are an average of 50 feet wide along public waters, and an average of 16.5 feet wide along public ditches that will help filter out phosphorus, nitrogen, and sediment. The new law provides flexibility and financial support for landowners to install and maintain buffers.

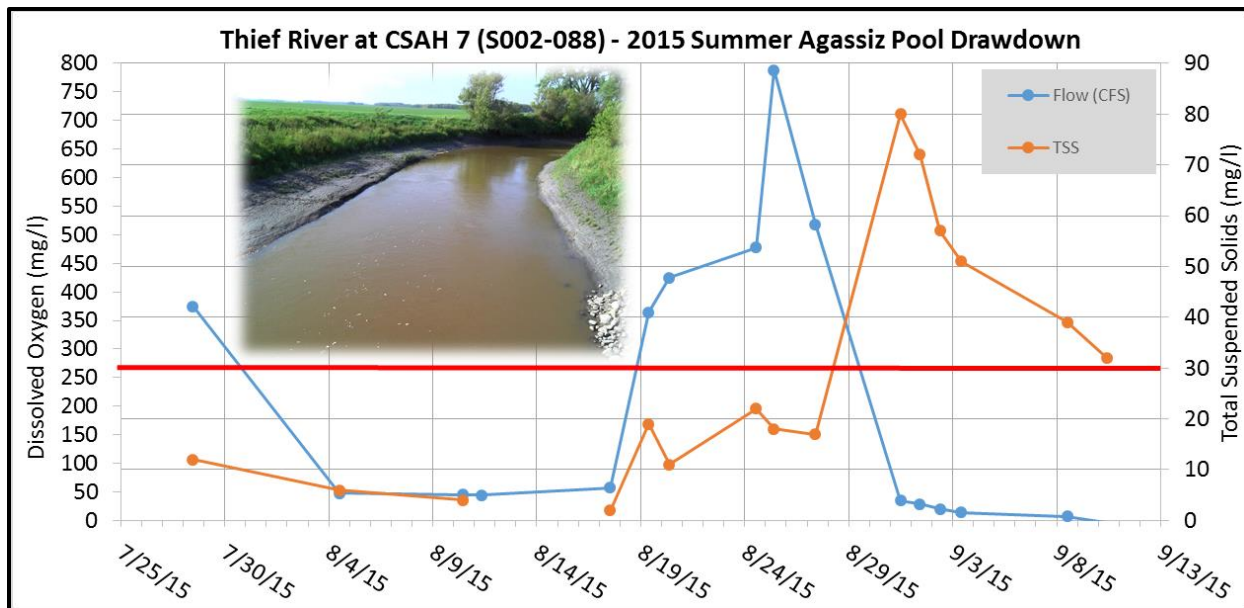
Figure 3-25. 2015 intensive sampling on the Thief River during the Agassiz Pool Drawdown

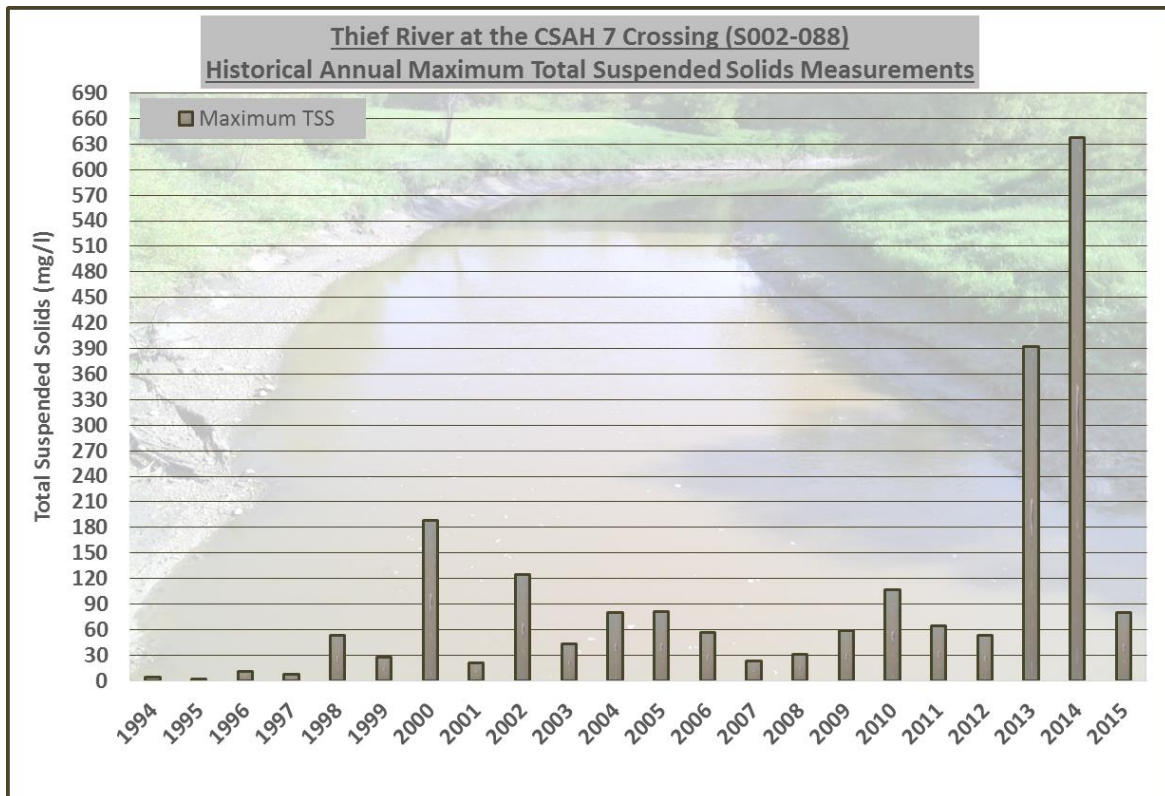
Figure 3-26. Historical annual maximum total suspended solids concentrations

turbidity and TSS levels in the Thief River to new extremes (2013 and 2014 maximums shown in Figure 3-26) and has generated high sediment concentrations as water levels recede within the pool.

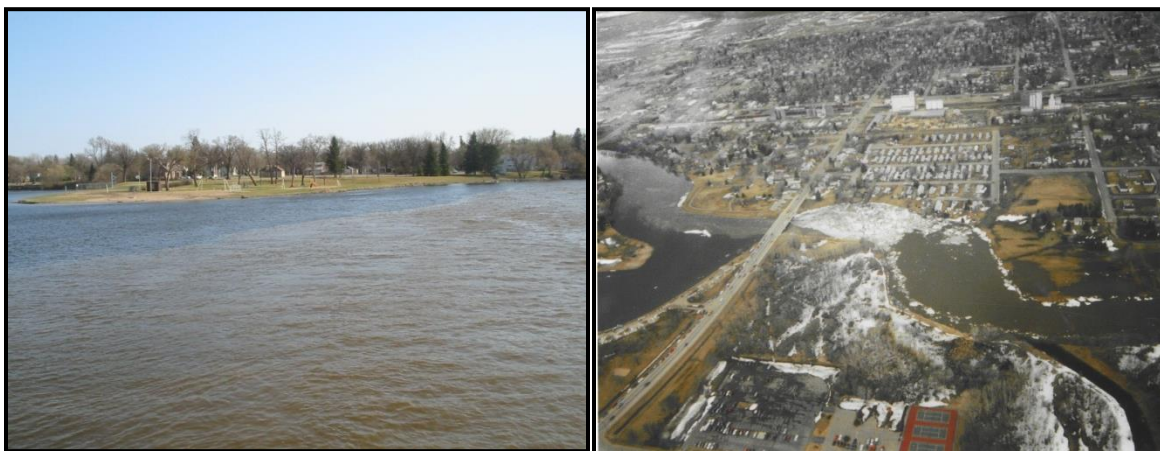
**Figure 3-29. Sediment plumes from the Thief River entering the Red Lake River and the Thief River Falls Reservoir.**

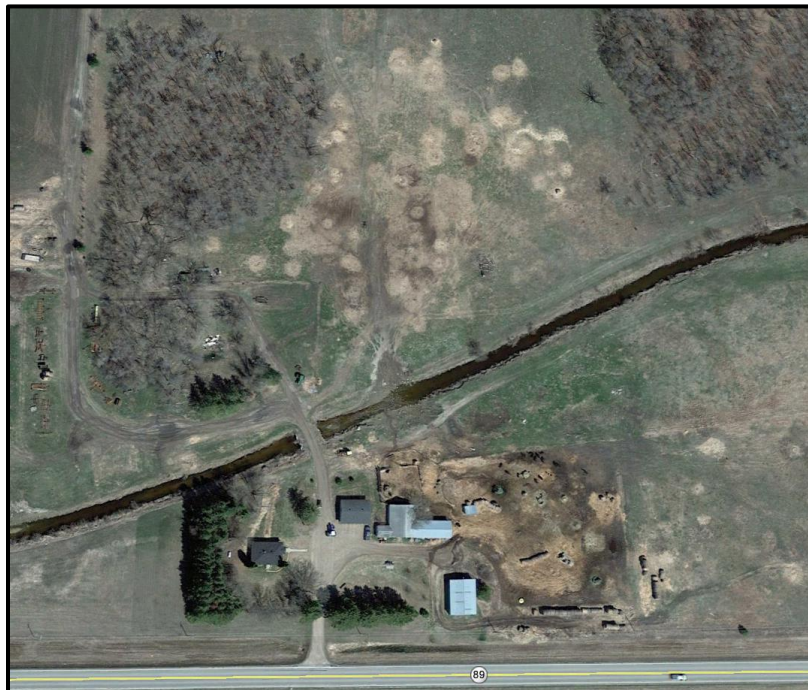
Figure 3-35. Livestock operation along the Mud River upstream of Grygla (1.3 miles east of town on Highway 89) that could be directly contributing to periodic high *E. coli* concentrations.

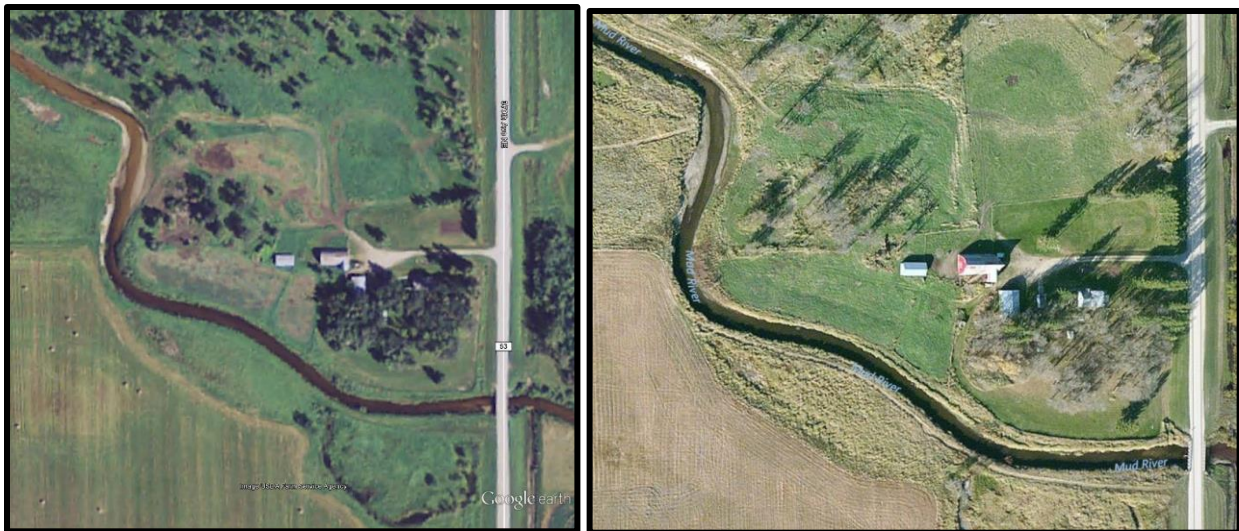
Figure 3-36. 370th Ave NE livestock operation active in 2011 (left) and no longer active in 2015 (right).

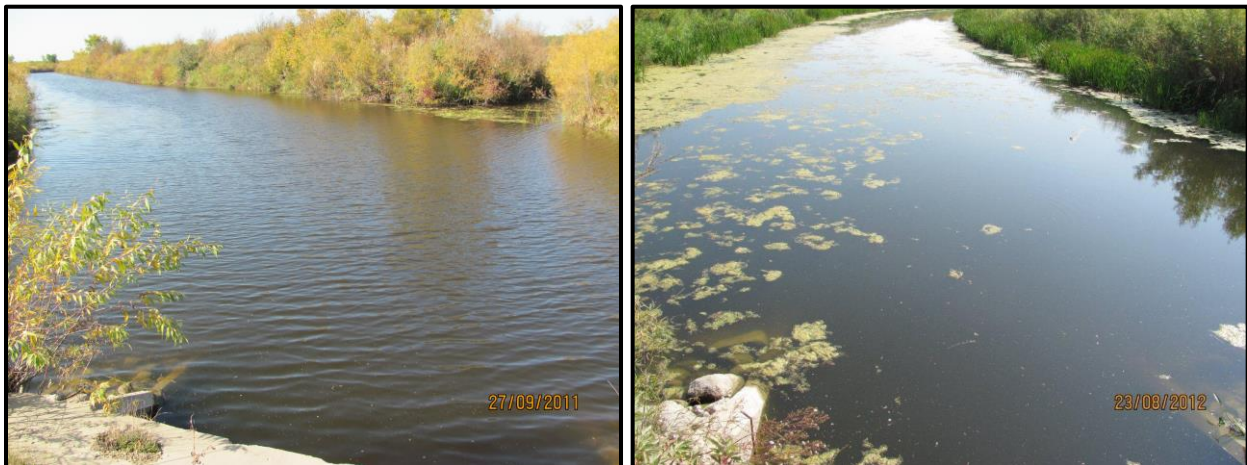
Figure 3-46. Ponded water at the 300th Ave NE crossing of the Moose River. Note the pondweed accumulating in the photo on the right.

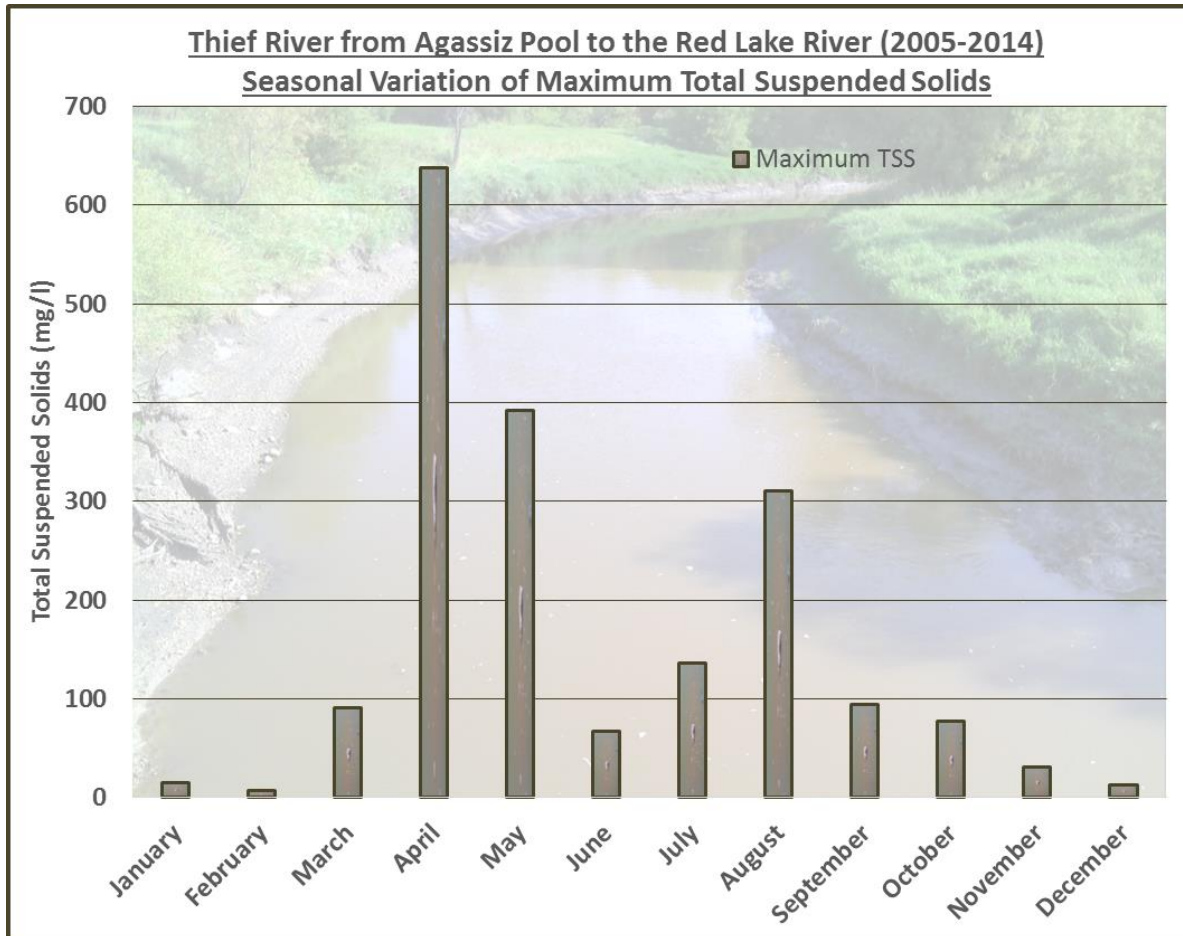
Figure 4-2. Monthly maximum TSS concentrations in the Lower Thief River (09020304-501)

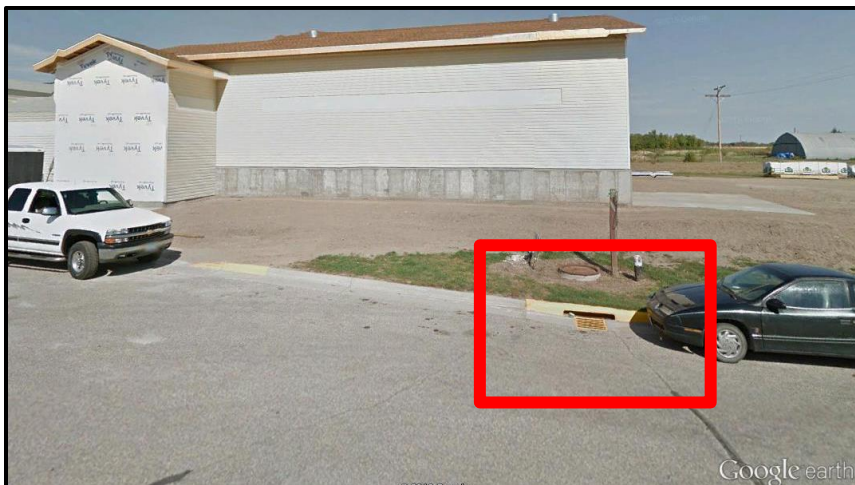
Figure 8-1. Stormwater inlet near an agricultural supply company in Grygla

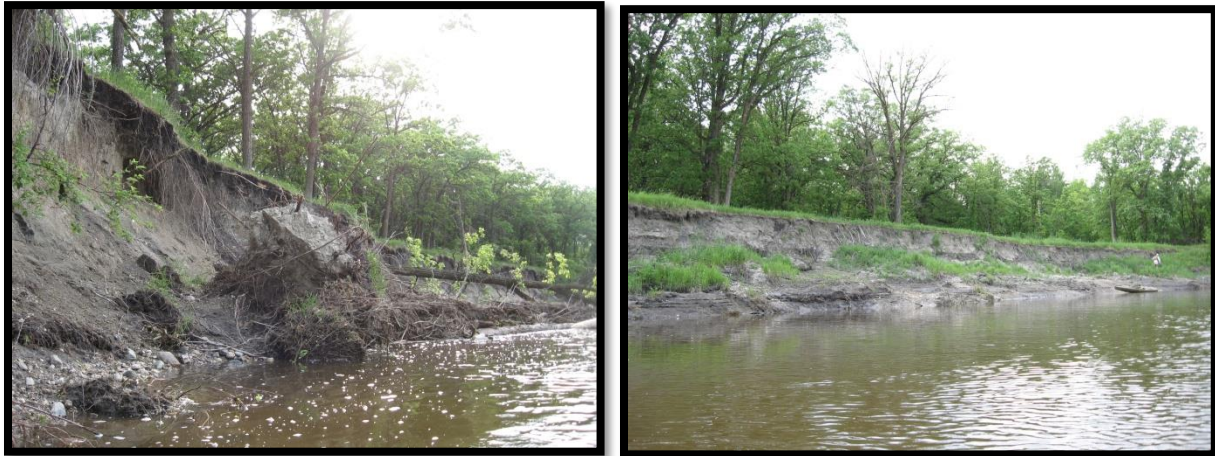
Figure 8-2. Photos of actively eroding streambanks along the Thief River

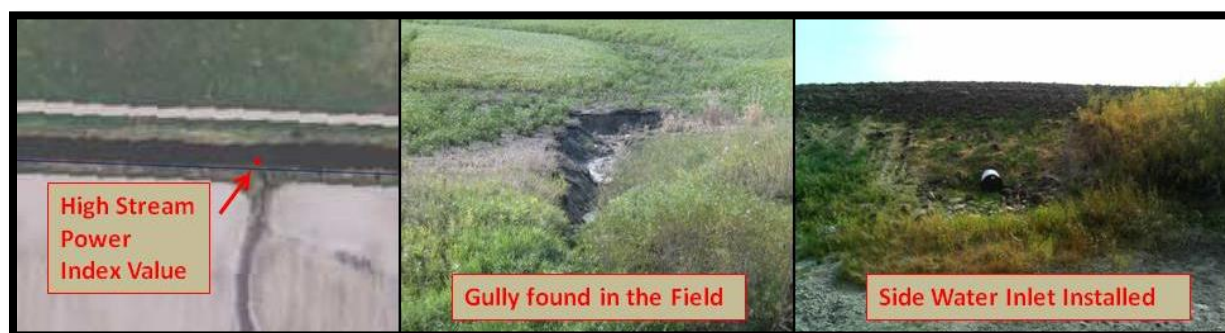
Figure 8-4. Utilization of Stream Power Index results to plan side water inlet installations
