# Pomme de Terre River Watershed Biotic Stressor Identification

A study of local stressors limiting the biotic communities in the Pomme de Terre River Watershed.

Minnesota Pollution Control Agency

June 2012

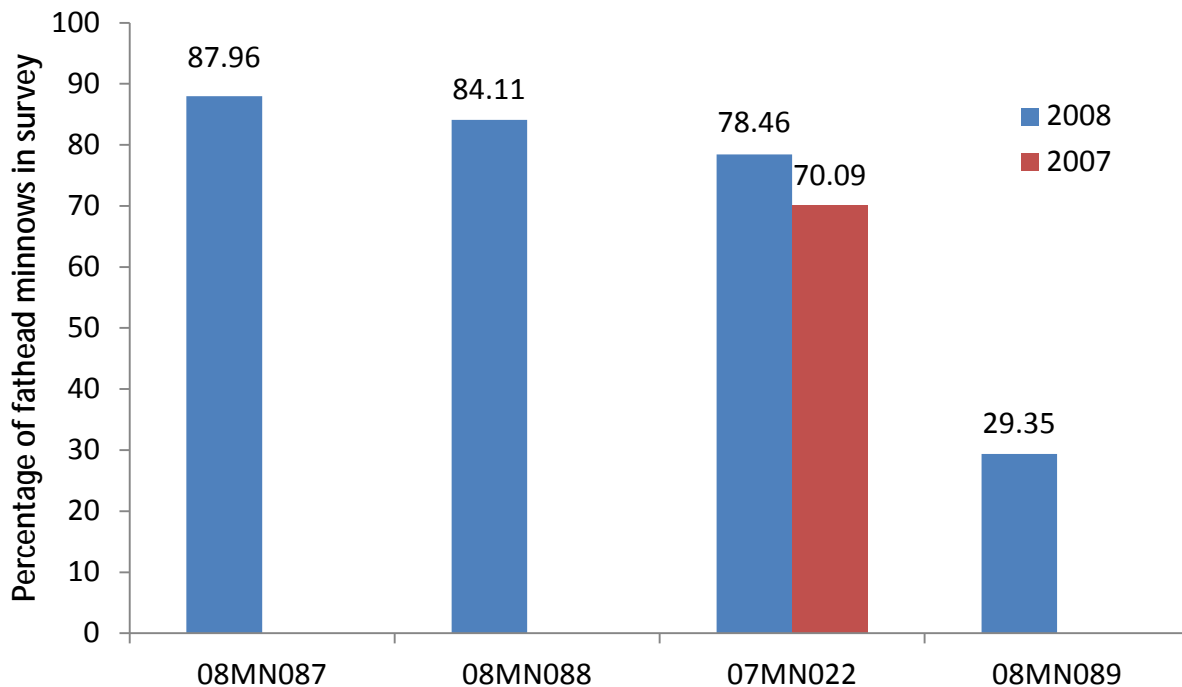
Figure 25. Percentage of fathead minnows in 2007 and 2008 fish surveys on Dry Wood Creek

Throughout Dry Wood Creek, fathead minnows dominated the fish communities surveyed in 2007 and 2008 (Figure 25). Site 08MN089 had fewer fathead minnows, but it is the most abundant taxa. Fathead minnows are tolerant of low dissolved oxygen levels. The other high abundant taxa are orangespotted sunfish, white sucker, and common carp (22.8 percent, 17.9 percent, and 10.3 percent respectively). These taxa are also tolerant to adverse conditions. Very few EPT were found in the invertebrate communities of Dry Wood Creek which are intolerant to low dissolved oxygen (Table 9).

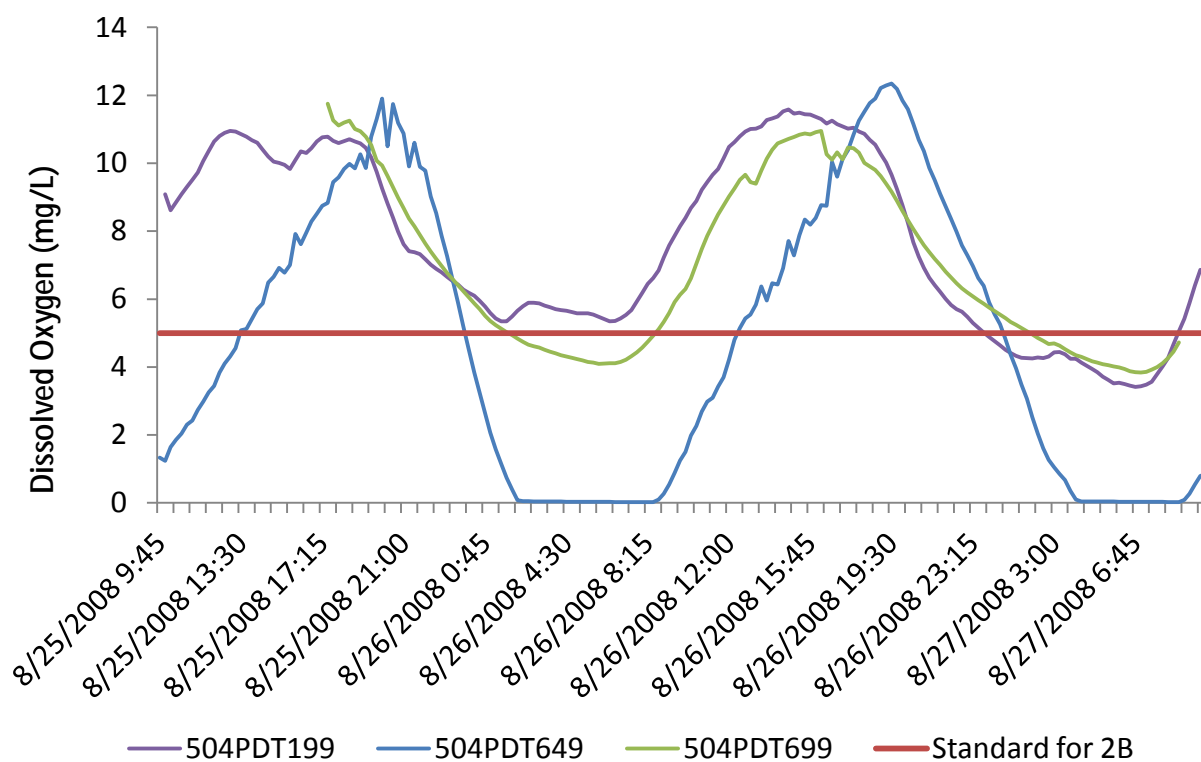
Figure 26. Measurements of dissolved oxygen from August 25 to 27, 2008 for three sites in Dry Wood Creek

In 2008, as a follow up to the 2007 condition monitoring in the Dry Wood Creek watershed, three YSI sondes were deployed for a short period from August 25 - 27 (Figure 26). All three locations measured below the standard for Class 2B streams at least one time during the deployment. At site 504PDT649, measured dissolved oxygen concentration was below 1 mg/L for 7.25 hours (32 measurements) during the early mornings of August 26 and 27.

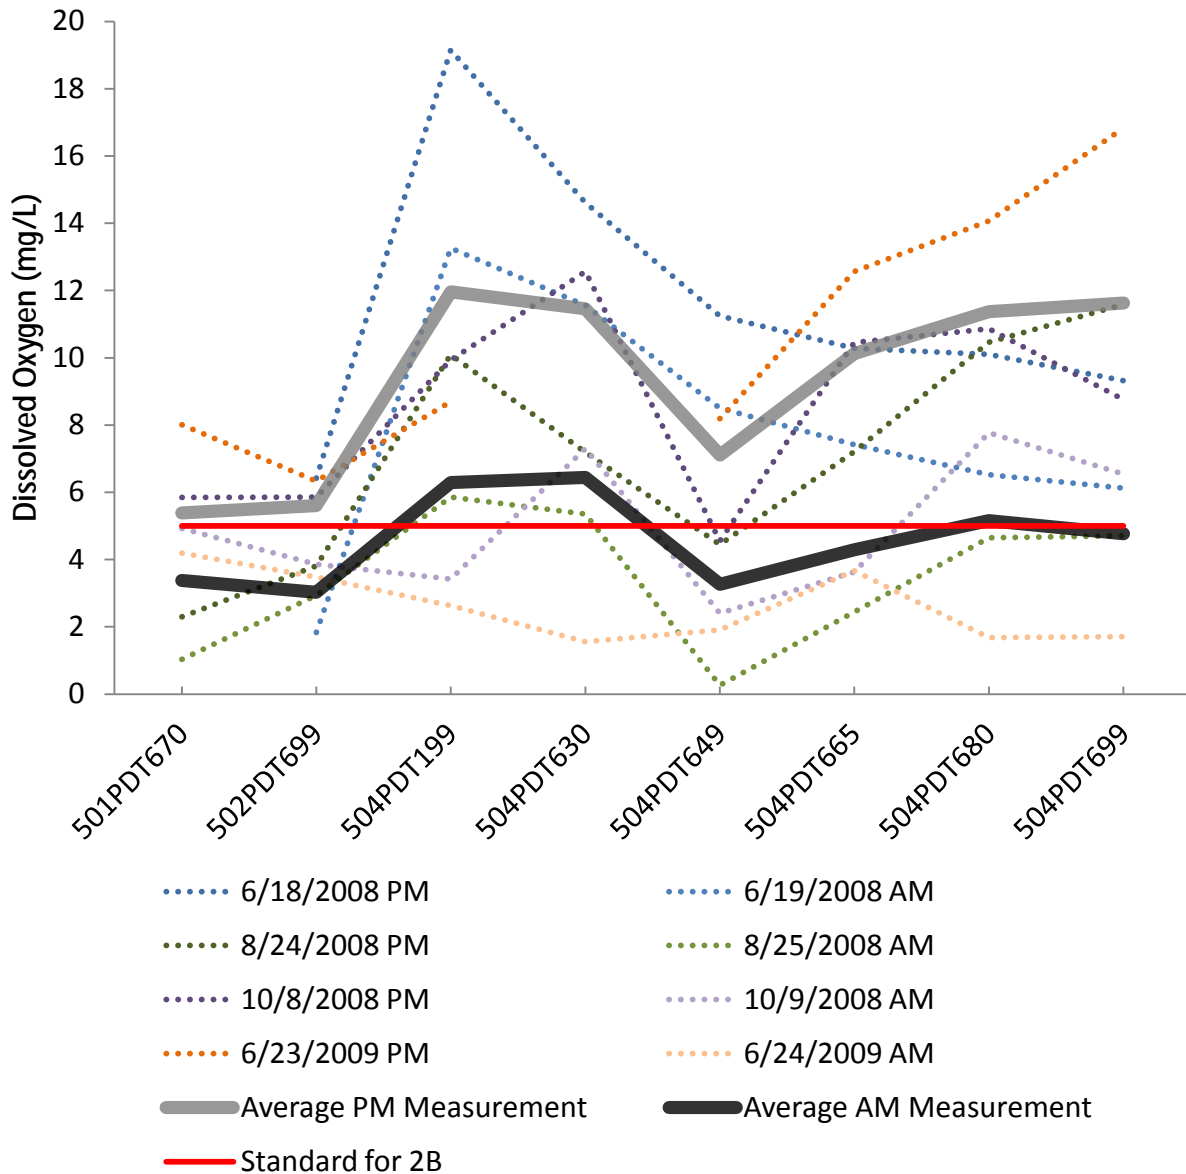
Figure 27. Dissolved Oxygen longitudinal synoptic measurements in Dry Wood Creek

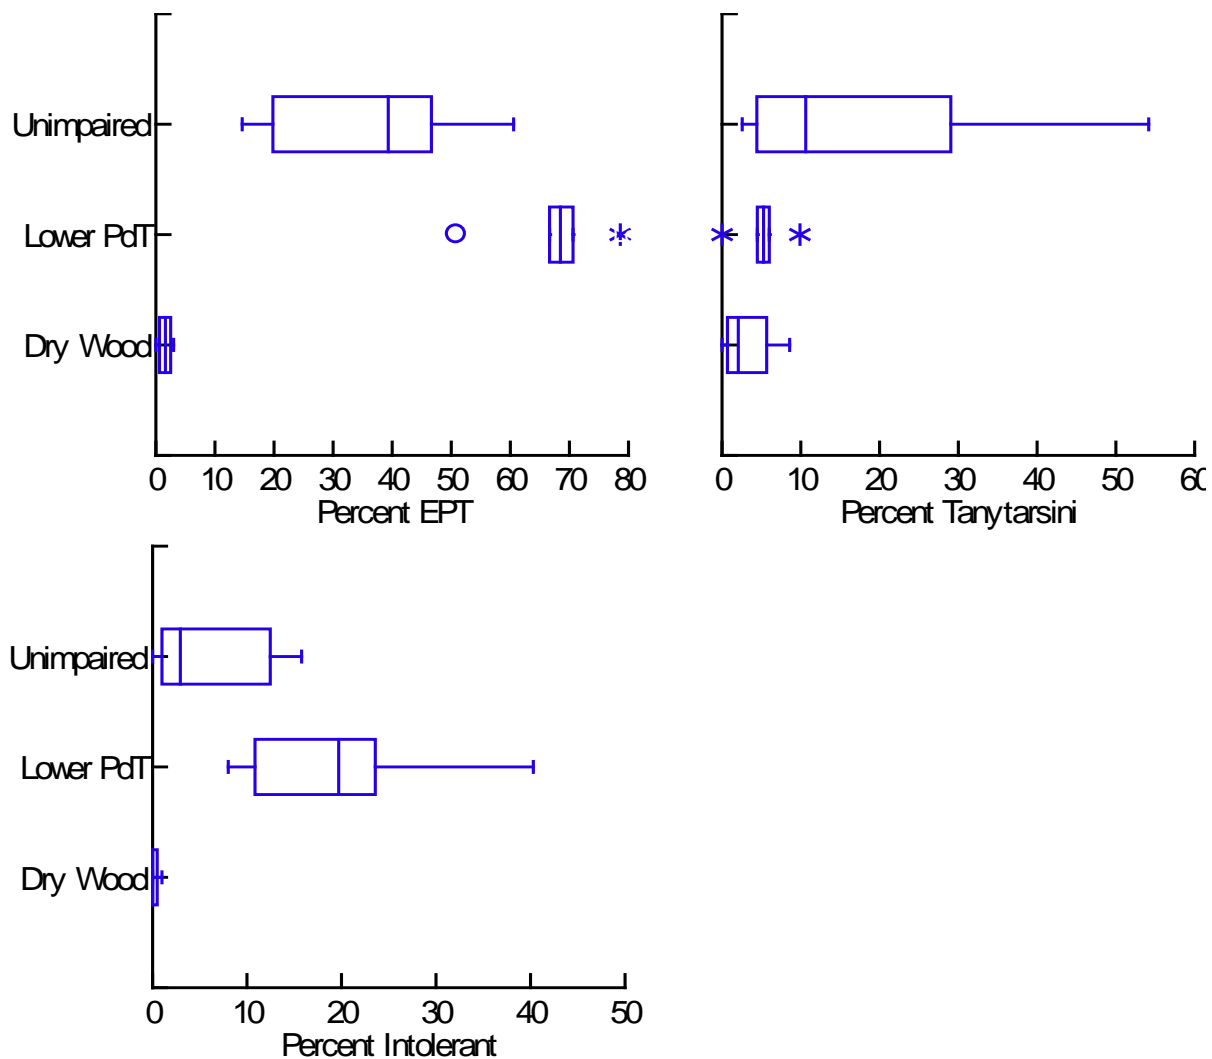
Figure 35. Invertebrate metrics that commonly decrease with increase nutrients

Percent EPT, percent Tanytarsini, and percent intolerant are invertebrate metrics that are expected to decrease with increased nutrients and all respond as expected in Dry Wood Creek (CADDIS, Figure 35). Invertebrate metrics that are expected to increase as nutrients increase are percent mollusca and crustacean, percent dominant, percent scrapers and percent tolerant. In Dry Wood Creek, percent dominant and percent tolerant increased when compared to unimpaired reaches of the Pomme de Terre River watershed (Figure 36). The percent mollusca and crustacean metrics do not show a difference and the percent scrapers metric does not show the expected response. The scrapers may not be increased because the algae found in Dry Wood Creek is observed to be mostly within the water column and not found on hard surfaces where it would be available to invertebrates that feed via scraping.

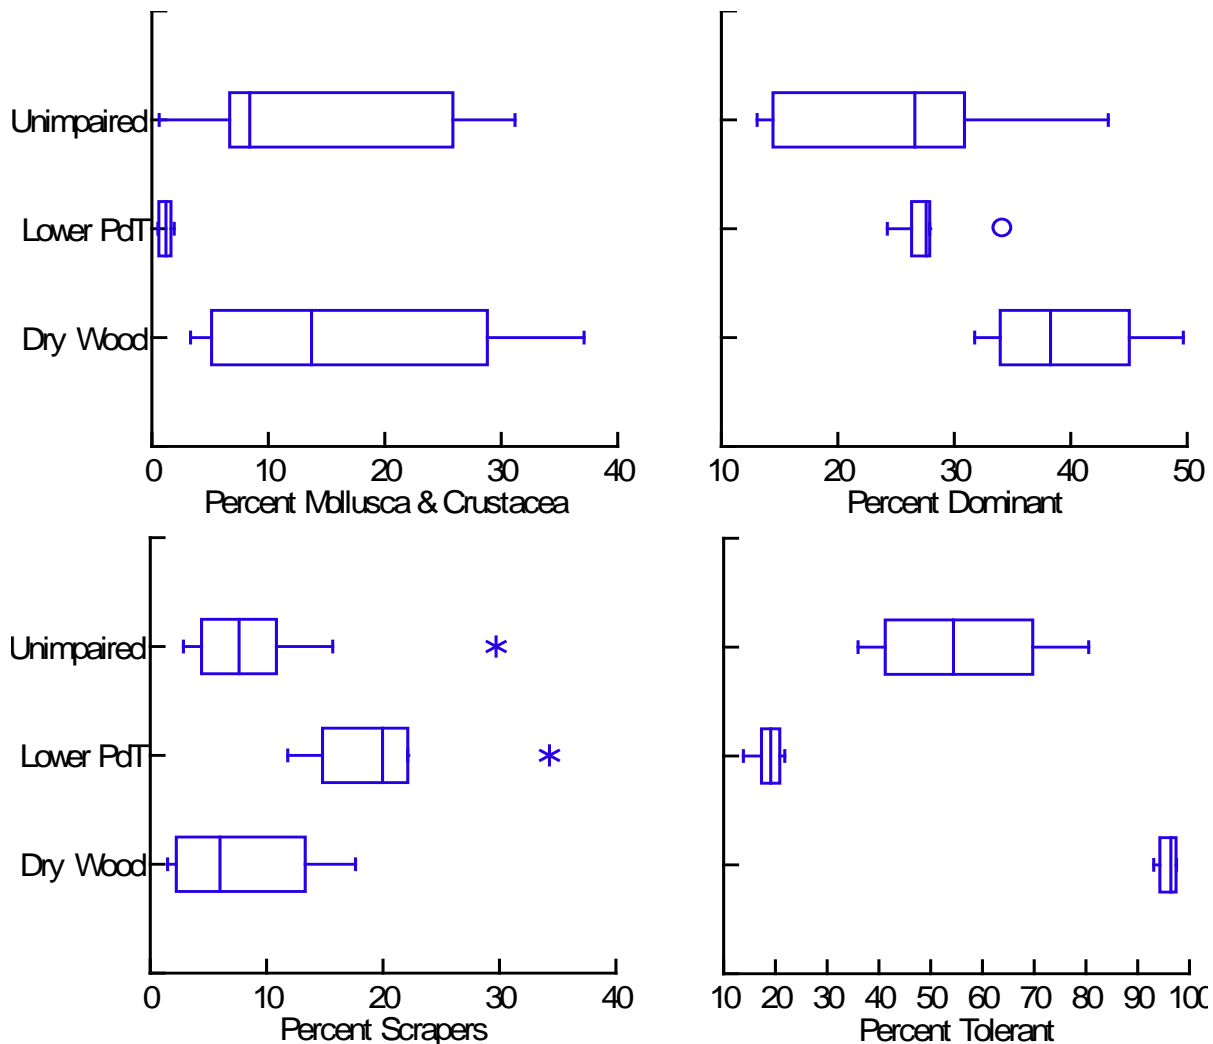
Figure 36. Invertebrate metrics that commonly increase with increase nutrients

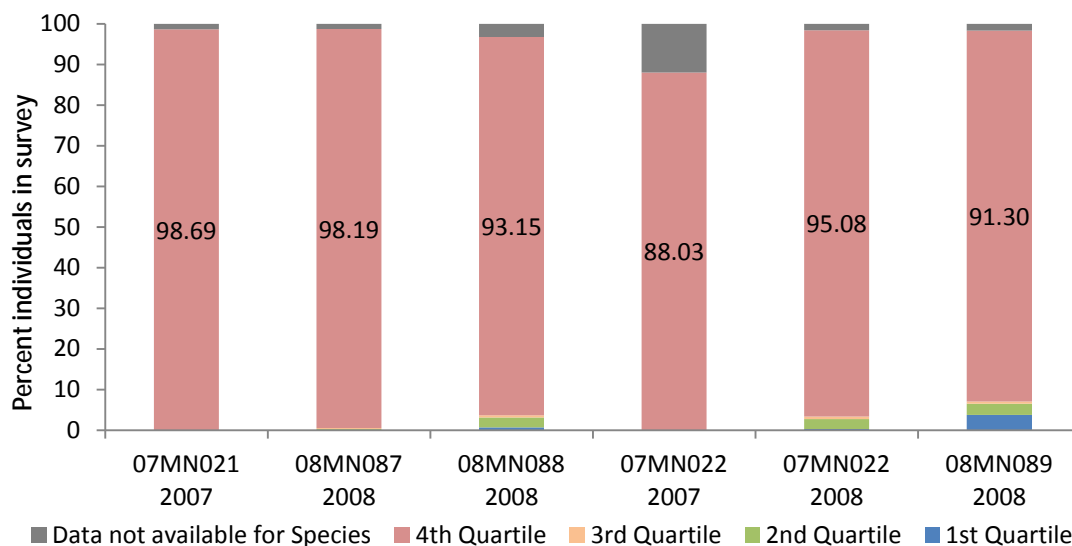
Figure 37. Percent fish individuals by biological site in Dry Wood Creek, for each quartile based nitrate tolerance indicator values (Meador and Carlisle, 2007)

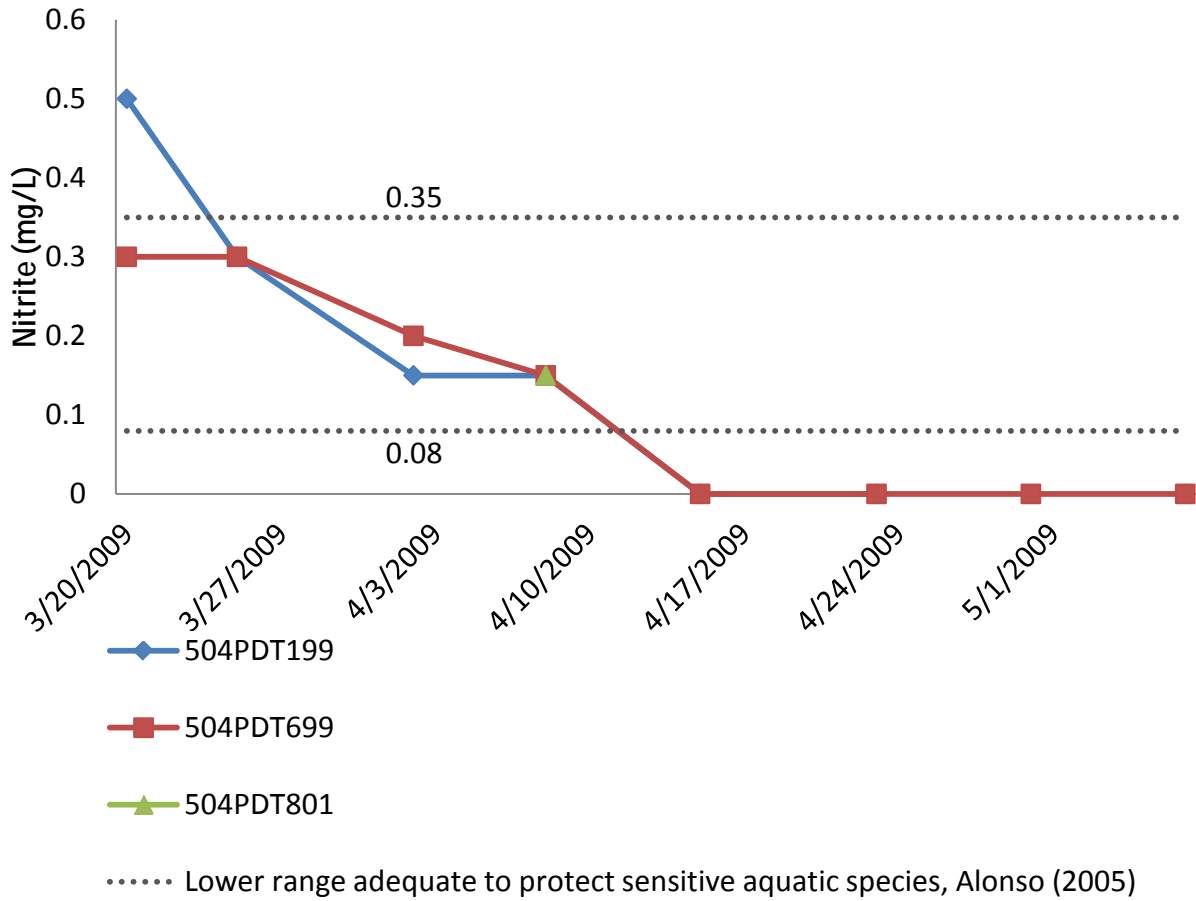
Figure 40. Nitrite measurements collected via test strips in 3 locations in Dry Wood Creek watershed

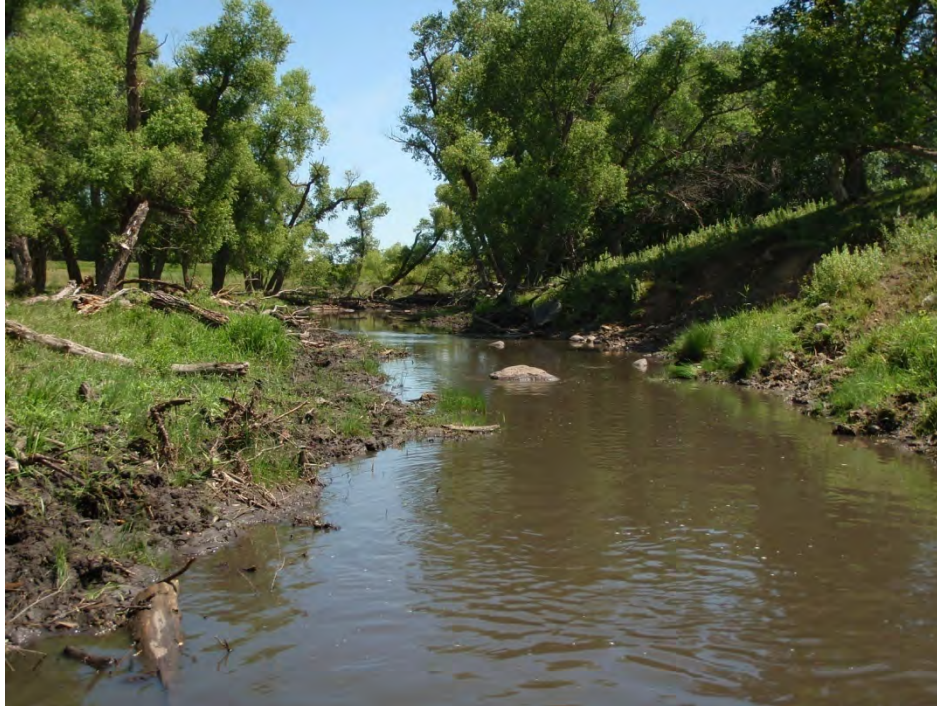
Figure 46. Station 08MN087 Picture

Dry Wood Creek at station 08MN087 is classified as a C4c- stream type, characterized by a gravel bed, low entrenchment ratio with good connectivity to the flood plain, moderate to low width depth ratio, moderate sinuosity, and low slope. The reach is protected from down-cutting by riffles with subpavement materials that are resistant to degradation. Some of these riffles may have been placed by landowners for stream crossings. The width/depth ratio of 10.9 falls in the upper 10 percent of the range for this stream classification which might reflect the impacts of stream channel alteration upstream or previous onsite grazing in this reach. The slightly wider channel would have the capacity to move more water. The hydraulically controlling riffles and stable stream bed in this reach help resist down cutting. This leaves the stream banks as the weakest link in adjusting to the higher annual discharge flows being documented for the Pomme de Terre River Watershed.

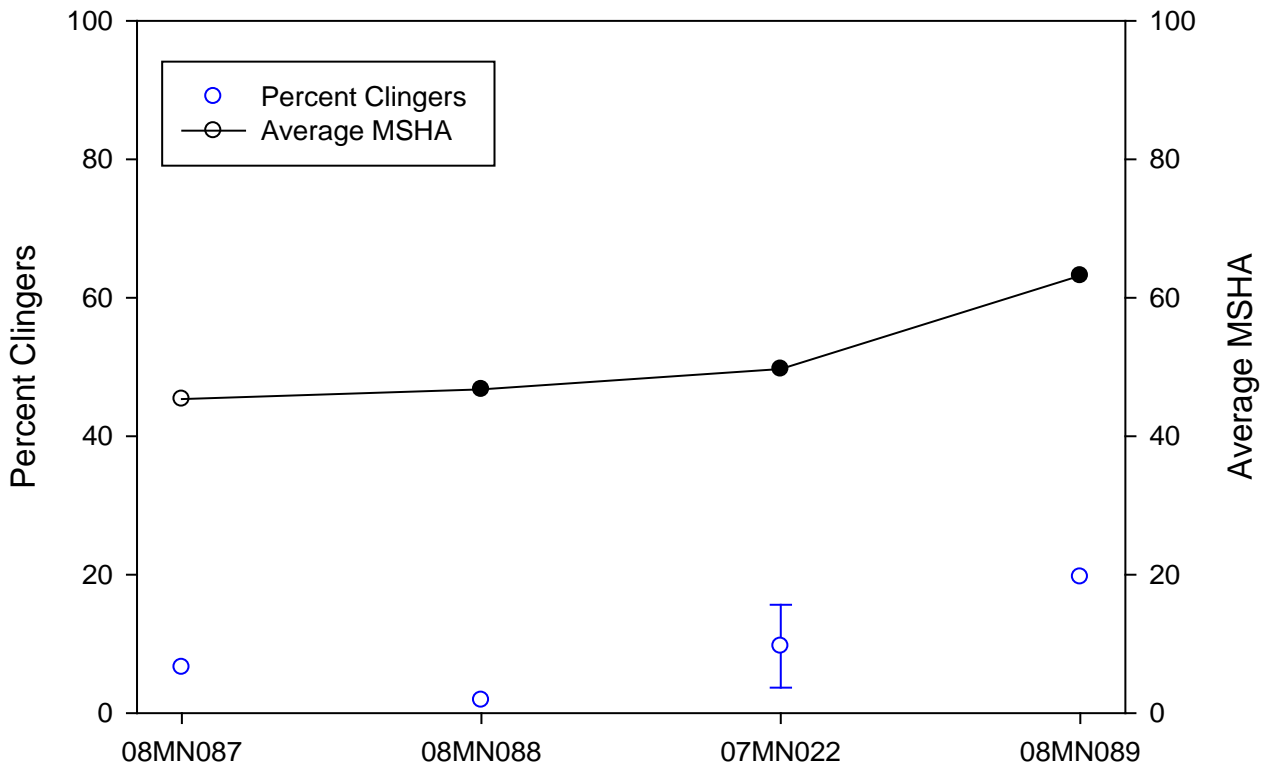
Figure 51. Percent clingers and average MSHA scores in Dry Wood Creek

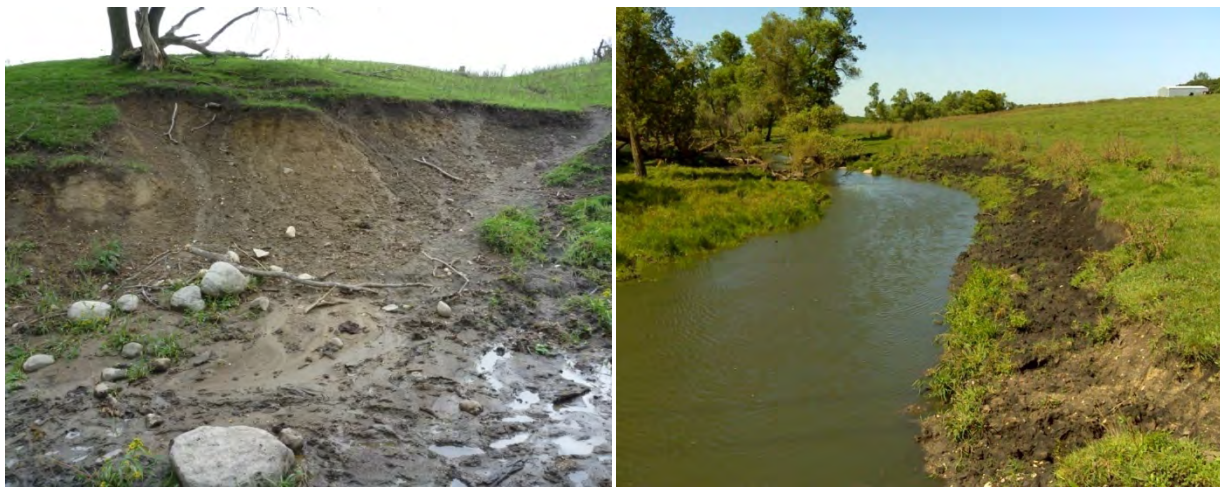
Figure 54. Pasture condition at site 08MN087

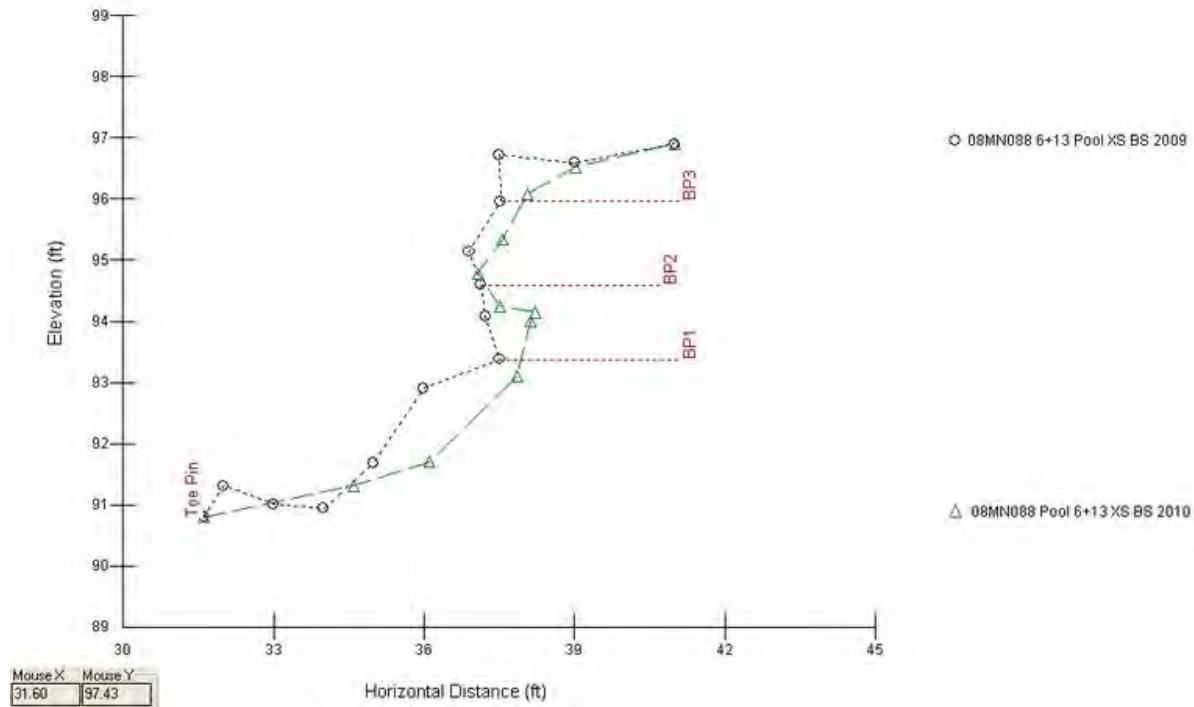
Figure 55. Site 08MN088 study bank showing measured average erosion rate of 0.726 ft/yr from 2009 to 2010

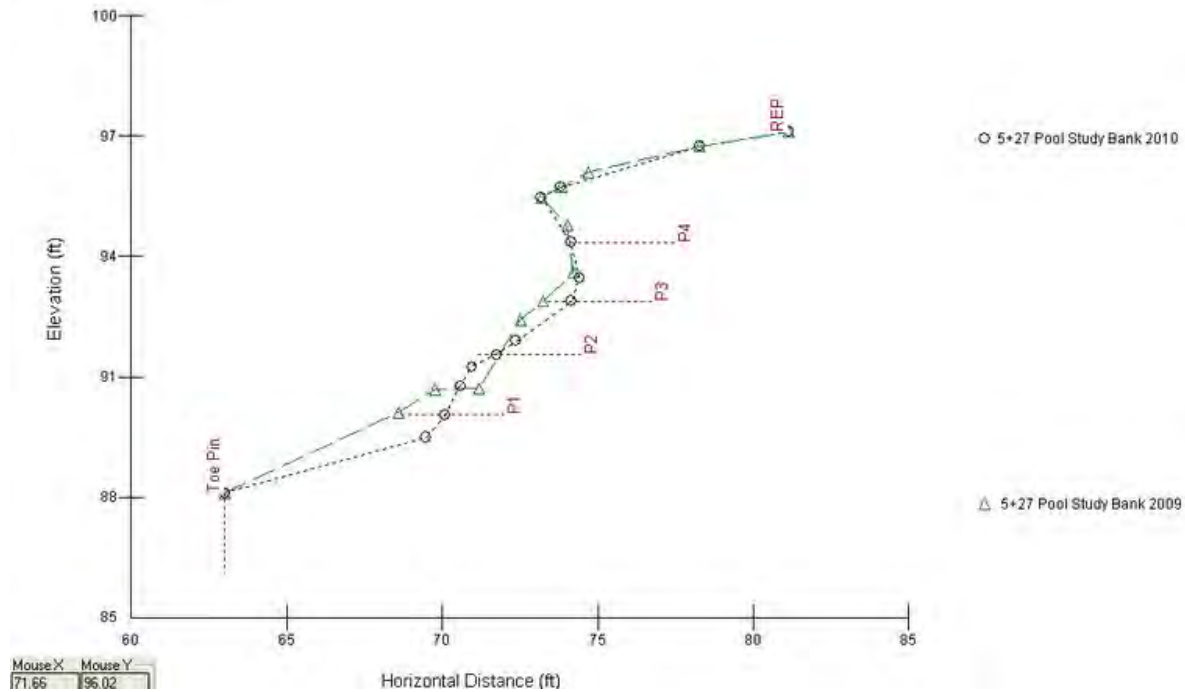
Figure 56. Site 08MN089 study bank showing measured average erosion rate of 0.533 ft/yr from 2009 to 2010

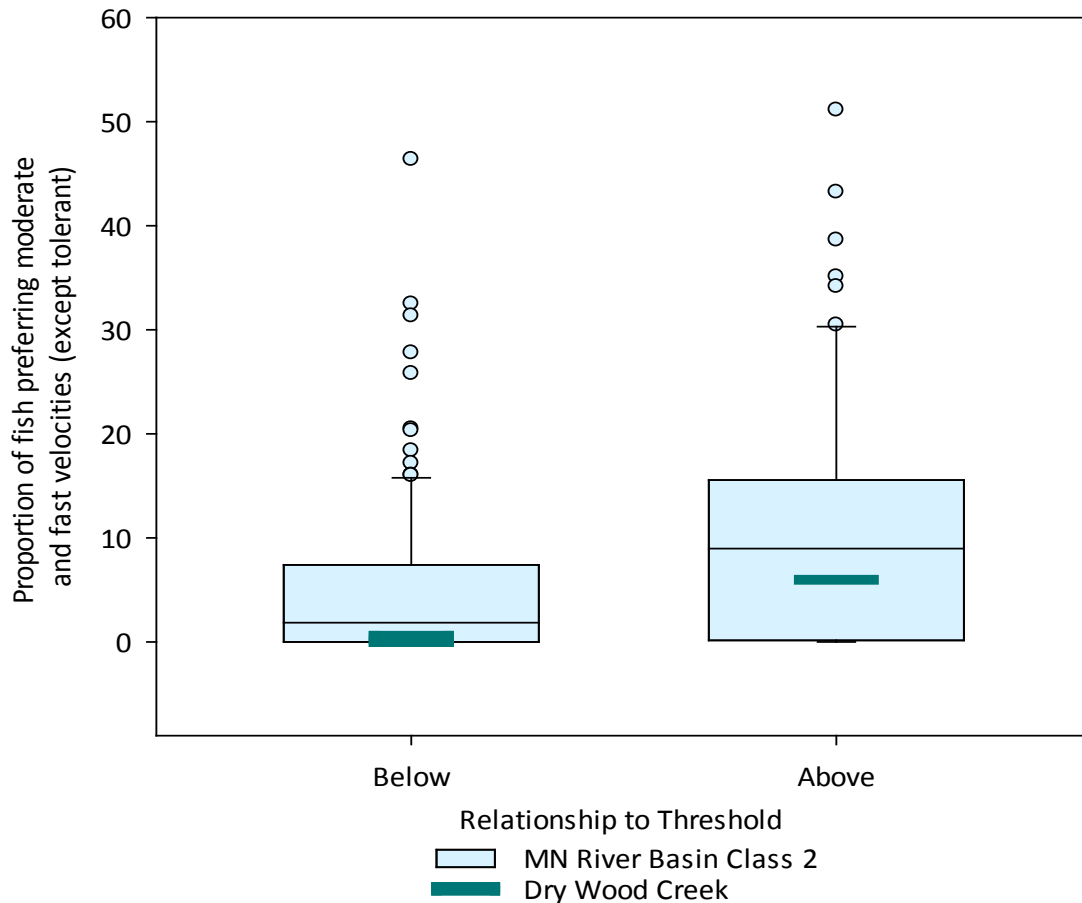
Figure 65. The proportion of fish preferring moderate and fast velocities (except tolerant) MN River Basin Class 2 Streams and Dry Wood Creek with respect to below and above the IBI threshold

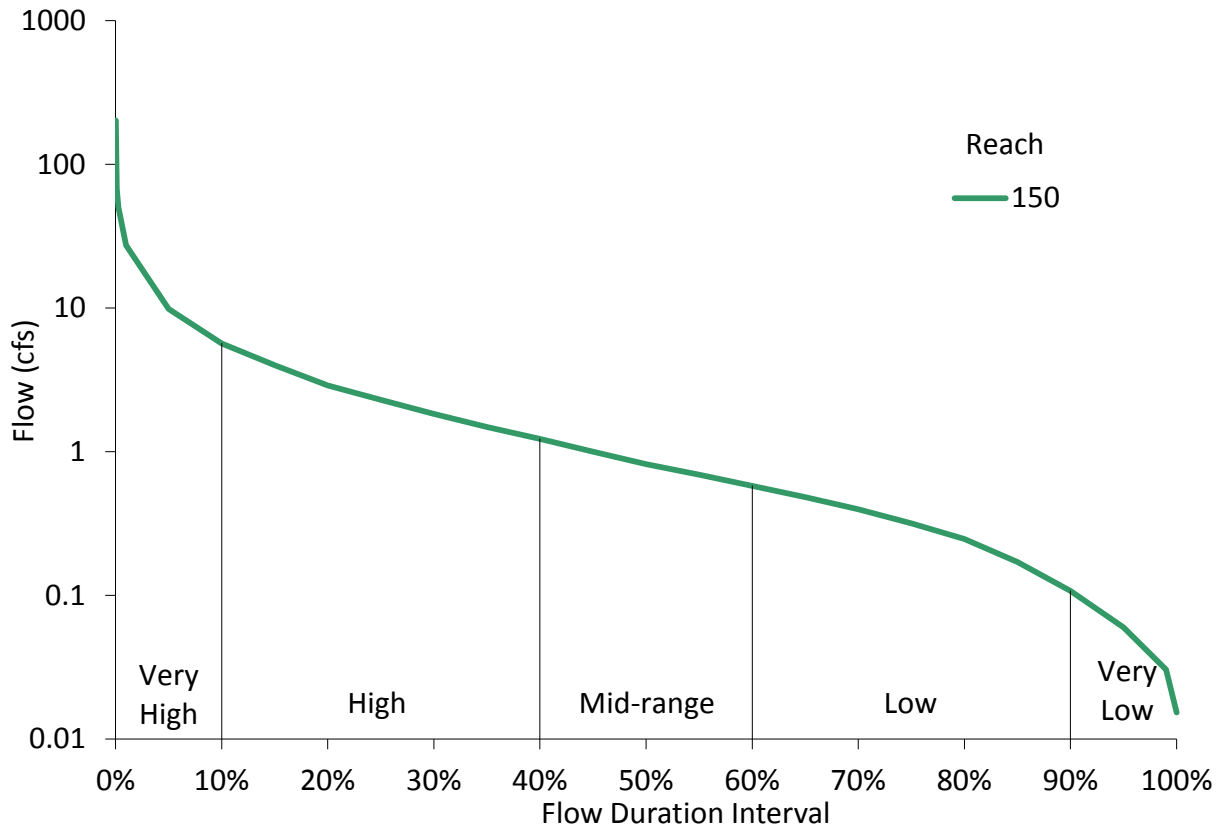
Figure 72. Flow duration curves for HSPF reach 150, unnamed creek

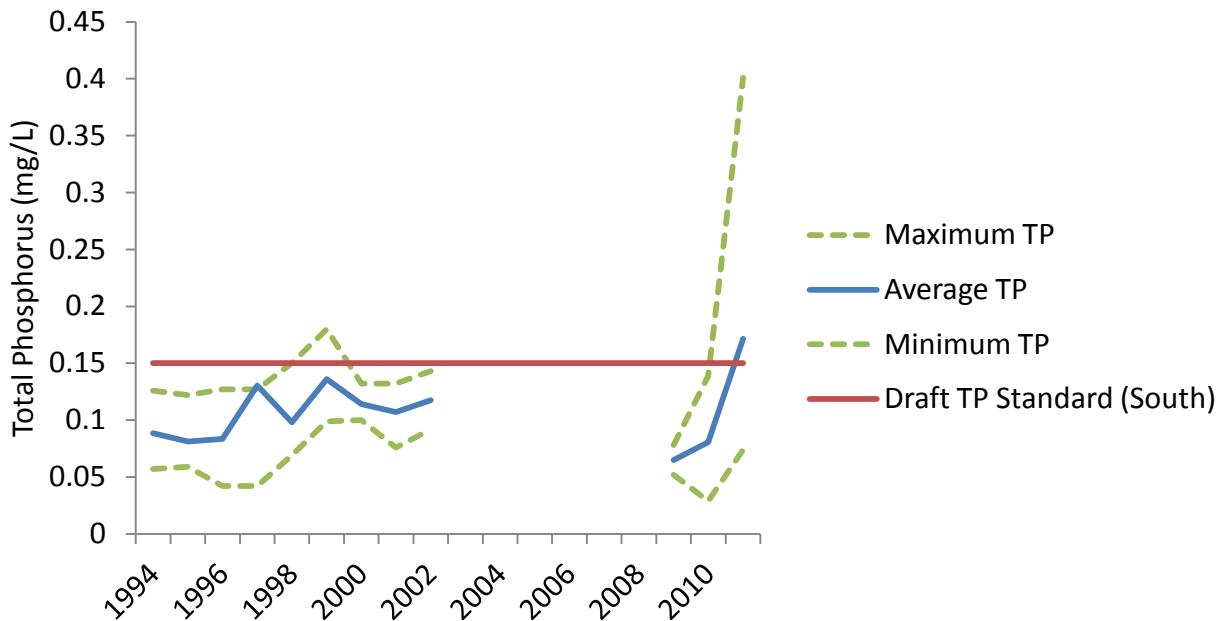
Figure 82. Total phosphorus concentrations for site 303PDT630

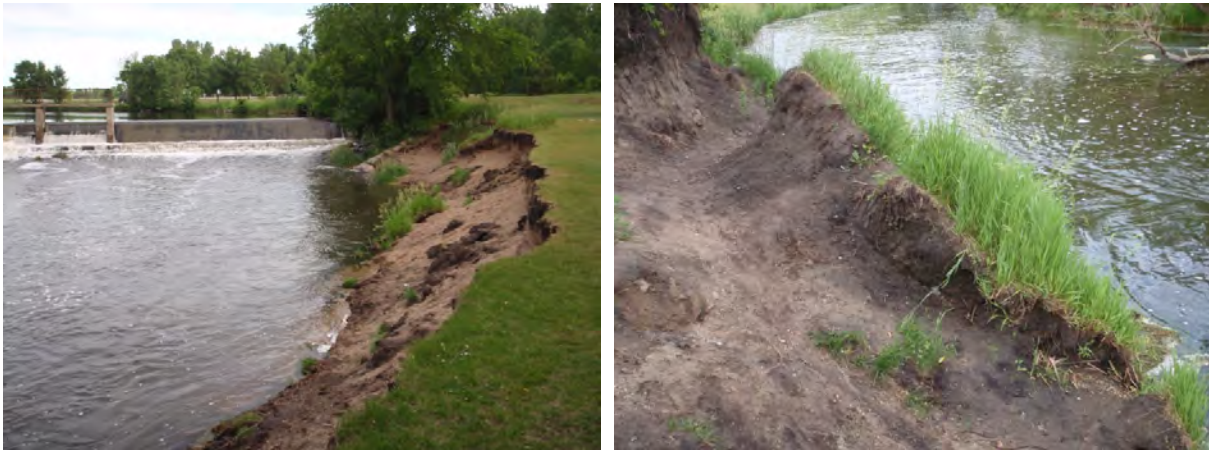
Figure 90. Photographs showing streambanks below Morris dam

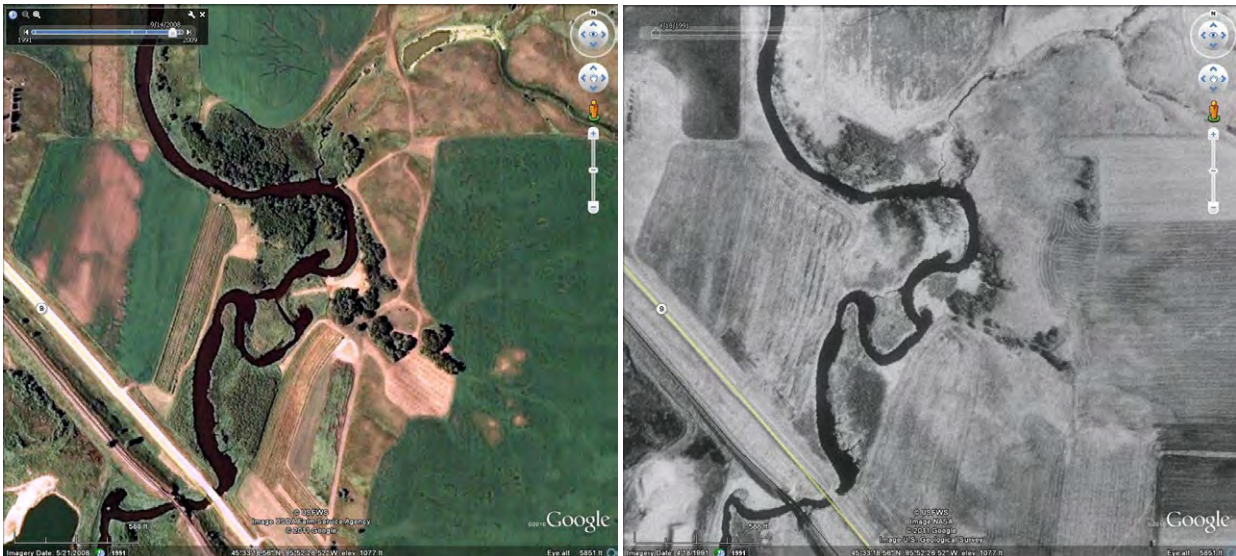
Figure 91. Aerial photographs of station 07MN009 from April 18, 1991, left; and September 14, 2008, right (Google, 2011)

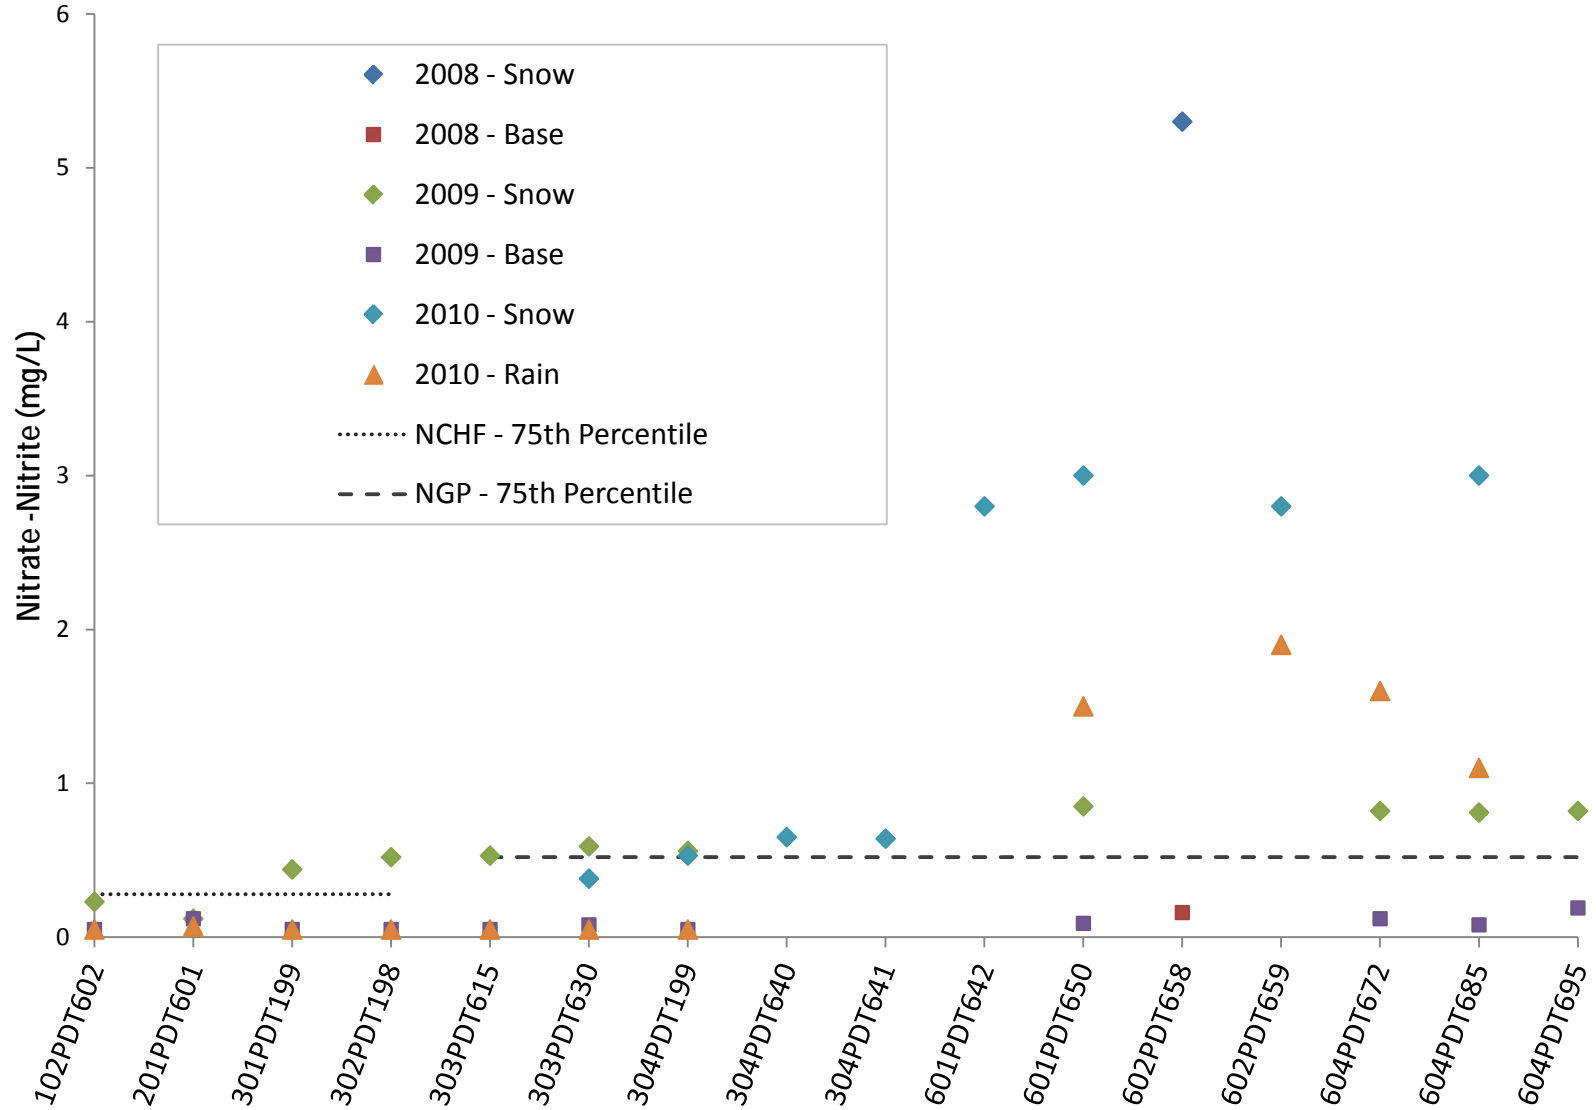
Figure 96. Nitrate-N measurements collected in the Pomme de Terre River, a longitudinal view from headwaters to downstream

There is convincing evidence that nitrate is a biotic stressor in the Lower PdT.

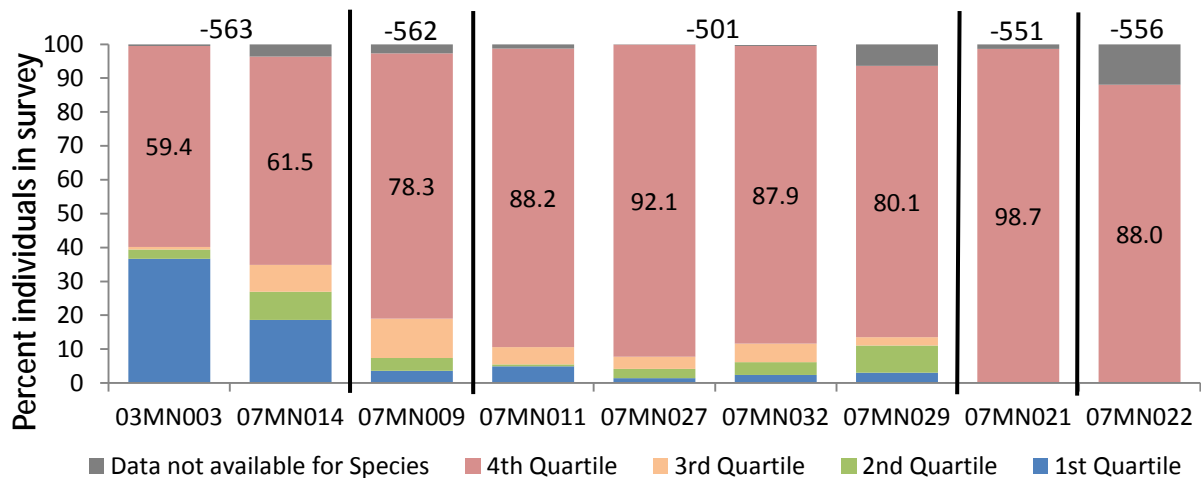
Figure 97. Percent individuals by biological site sampled in 2007 in impaired reaches, for each quartile based nitrate tolerance indicator values, separated by AUID, last three digits shown (Meador and Carlisle, 2007)

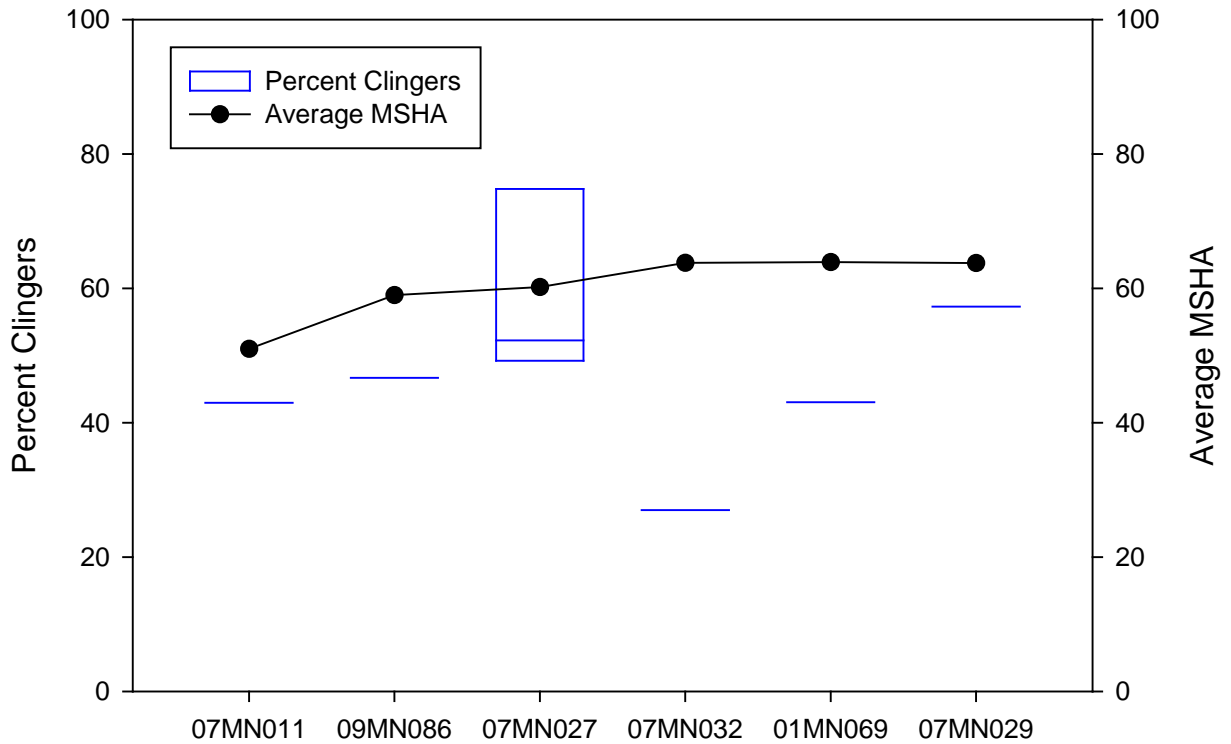
Figure 100. Percent clingers and average MSHA scores in the Lower PdT

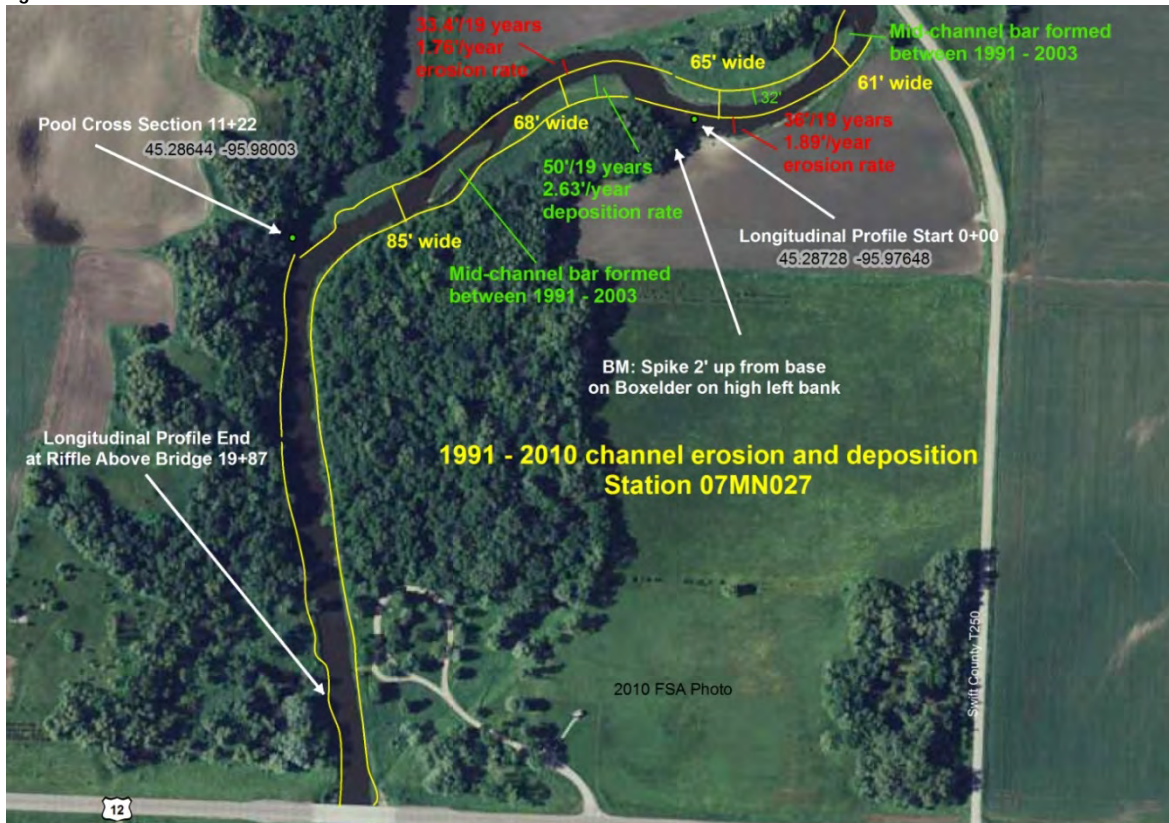
Figure 112. 2010 aerial photograph with 1991 overlay at station 07MN027
