Zumbro River Watershed Total Maximum Daily Loads for Turbidity Impairments

**U.S. Environmental Protection Agency
Region 5
Chicago, Illinois**

Minnesota Pollution Control Agency

January 2012

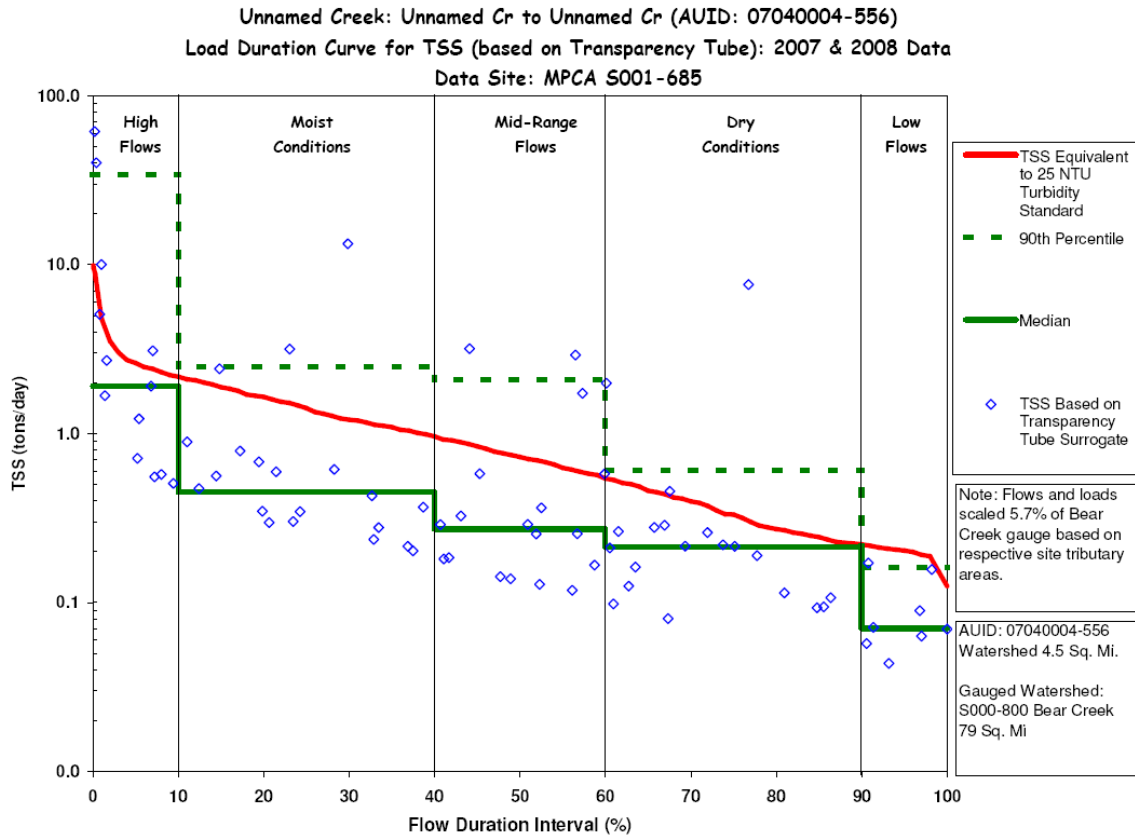
Figure 6. Load Duration Curve (AUID: 07040004-556).

The transparency tube duration curve (figure 6) for the available dataset indicates exceedance of the target in all flow ranges except low flows (90-100% flow duration interval). The allowable TSS load (based on the 25 NTU turbidity standard) is exceeded by 80 percent at high flows, 20 percent during moist conditions, 30 percent at mid-range flows, and 50 percent during dry conditions. Note that for transparency tube data there is an inverse relationship to turbidity, meaning that lower readings correspond to higher turbidity.

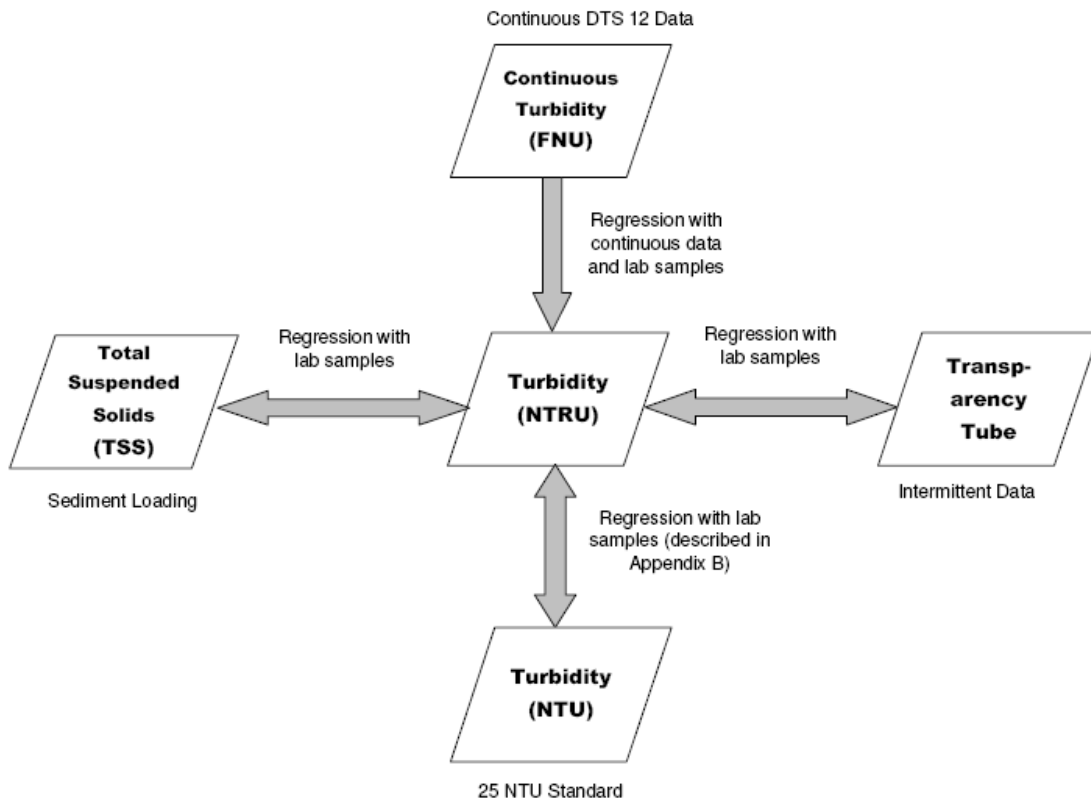
Figure D.1: Data Relationships Diagram

Continuous turbidity (FNU) and MDH Laboratory turbidity (NTRU): For each gauge/monitoring site, sample data taken to the lab (STORET database) in 2007 and 2008 was correlated by date and time to specific turbidity measurements (HYDSTRA database) using the VLOOKUP function in Microsoft's Excel software. One hour was subtracted from the Central Daylight times reported to STORET to match directly with the Central Standard times used in HYDSTRA. It was found that a linear regression best described the relationship between FNU and NTRU turbidity units. Figure D.2 is an example of a regression graph for Silver Creek.

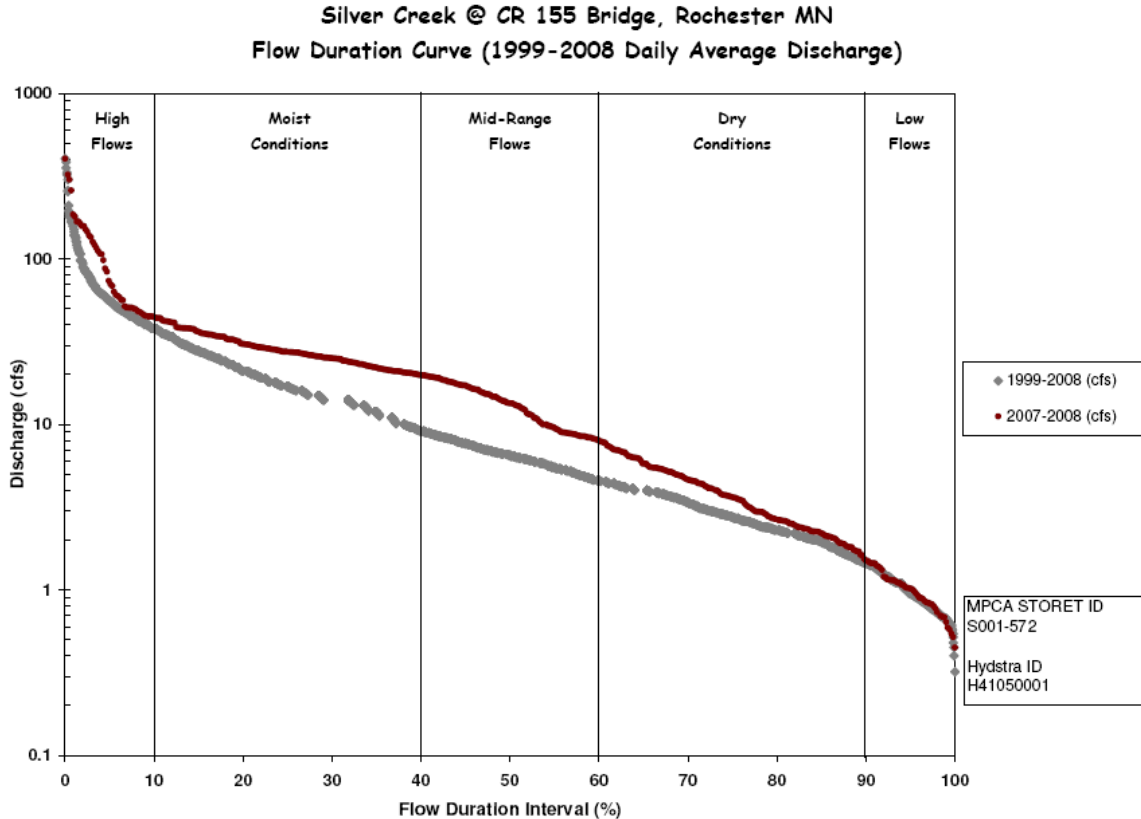
Figure D.4: Comparison of 2007-2008 Flows to Recorded Flows

Loading capacities for specific pollutants are related directly to flow rate. As flows increase, the loading capacity of the stream will also increase. Thus, it is necessary to determine loading capacities across the range of flow. To illustrate portions of the flow record it is useful to divide up the record into “flow zones.”
