Mississippi River-St. Cloud Watershed Stressor Identification Update, 2022

A study of local stressors limiting the biotic communities in the Mississippi River-St. Cloud Watershed.

Document number: wq-ws3-07010203e

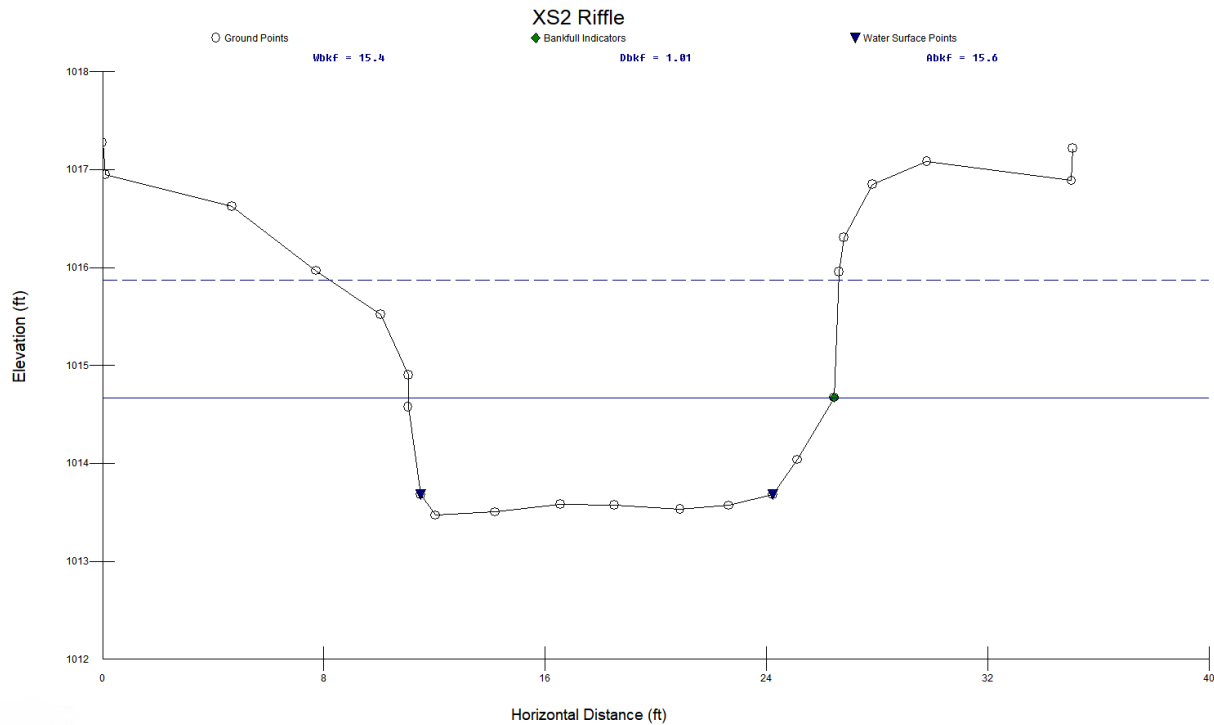
Figure 7 shows the flood prone elevation (2x bankfull depth) contained within the channel banks. A measured entrenchment ratio of 1.19 at the riffle classifies the channel as entrenched, no longer connected to the flood plain. As well as being entrenched, the reach is also considered deeply incised. Incision is measured by dividing the lowest bank height by the maximum bankfull depth (bank-height ratio). Streams with high bank height ratio values generally contribute disproportionate amounts of sediment from streambanks and channel beds due to high shear stress (Rosgen 2009).

Figure 7. Cross section of riffle showing bankfull elevation (solid line) and flood prone elevation (dashed line).

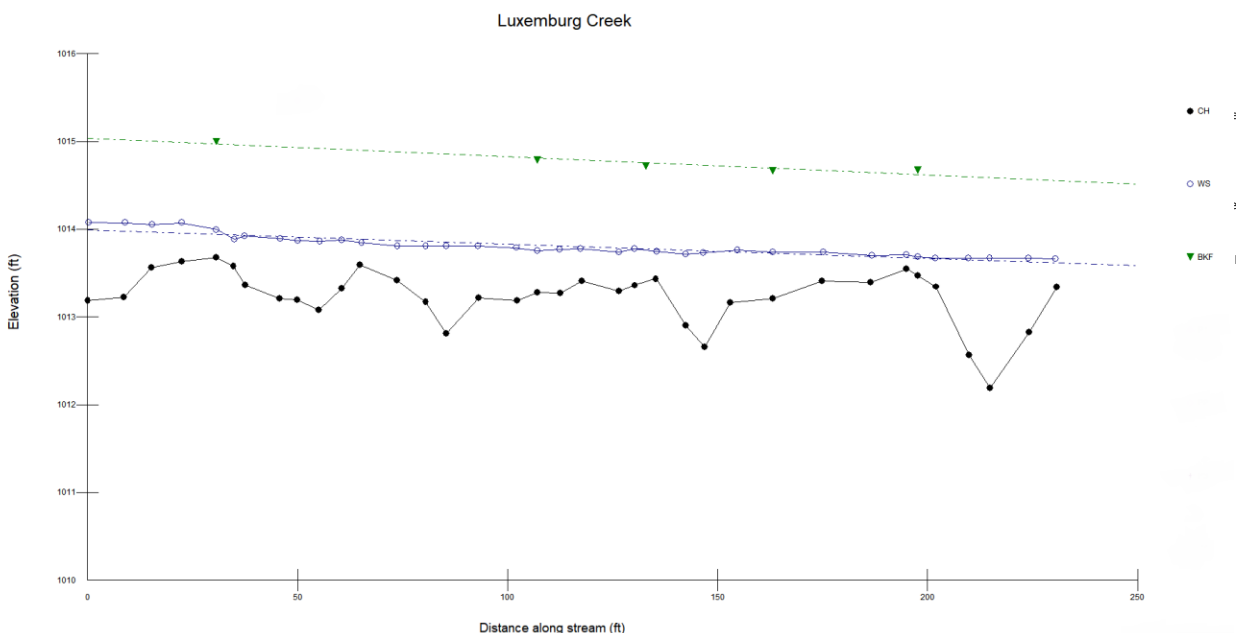
The longitudinal profile is 230 feet long, containing 4 riffles and 5 pools (Figure 8). The dimensionless ratio of max pool depth to riffle mean depth is a good measure for comparing pool depths. The ratio along the longitudinal profile is 2.0. Reference max pool to riffle mean depth ratios are usually 2.0 to 4.0, suggesting the pools are relatively shallow.

Figure 8. Longitudinal profile of survey, including bankfull.

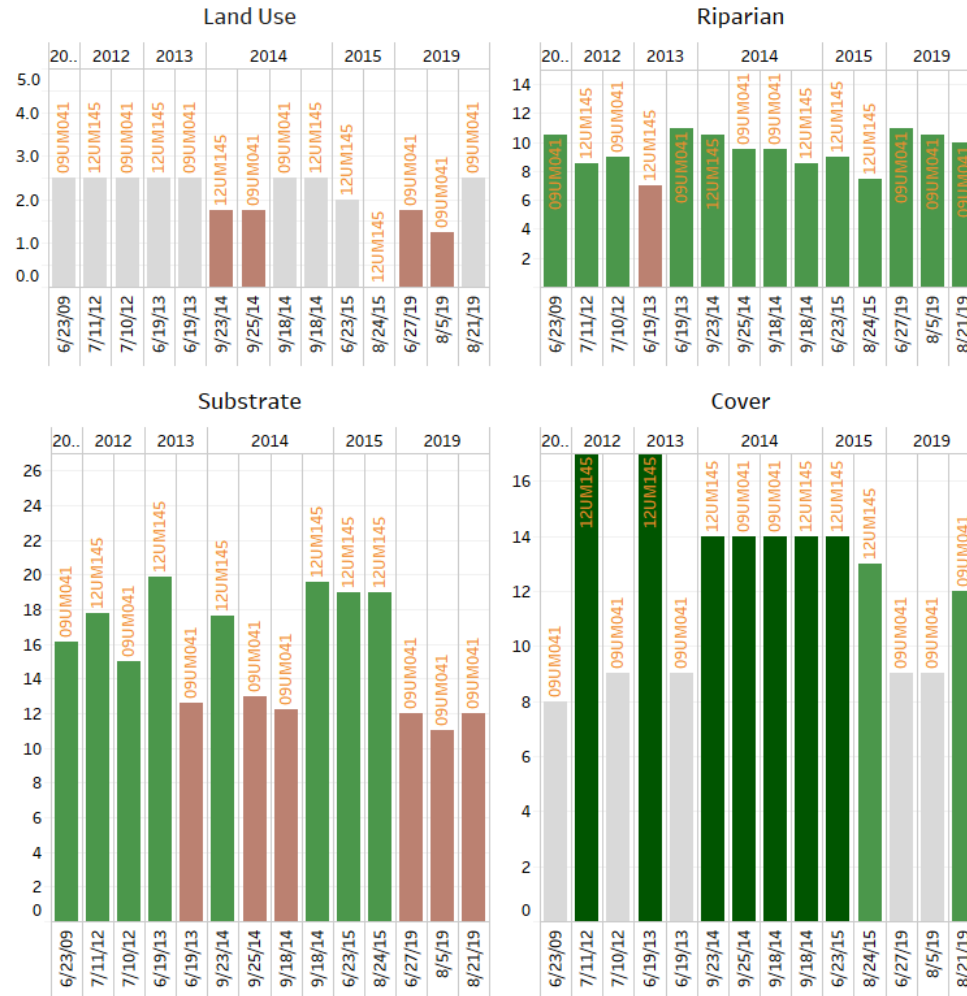
Figure 13. MSHA habitat scores for Johnson Creek.

In general, the MSHA evaluations score well on Johnson Creek, however, there is a stark difference in the habitat availability between the upstream biological monitoring station (12UM145) and the downstream station (09UM041; Figure 13). The most significant differences between the two stations can be seen in the substrate and channel morphology categories. The substrate at 12UM145 was dominated by gravel and sand, with the presence of cobble and boulders also noted. The substrate at 09UM041 was dominated by sand, with the presence of silt noted. Healthy fish communities need coarse substrate in order to build nests and spawn. Excessive fine sediment also affects juvenile fishes, as the sediment is stirred into the water column creating TSS. This can easily tear sensitive juvenile fish gills. Similarly, many sensitive macroinvertebrates also have specialized gills that are used to breathe DO. Excessive fine sediments can damage these gills, similar to juvenile fishes, making the creek uninhabitable for sensitive species.

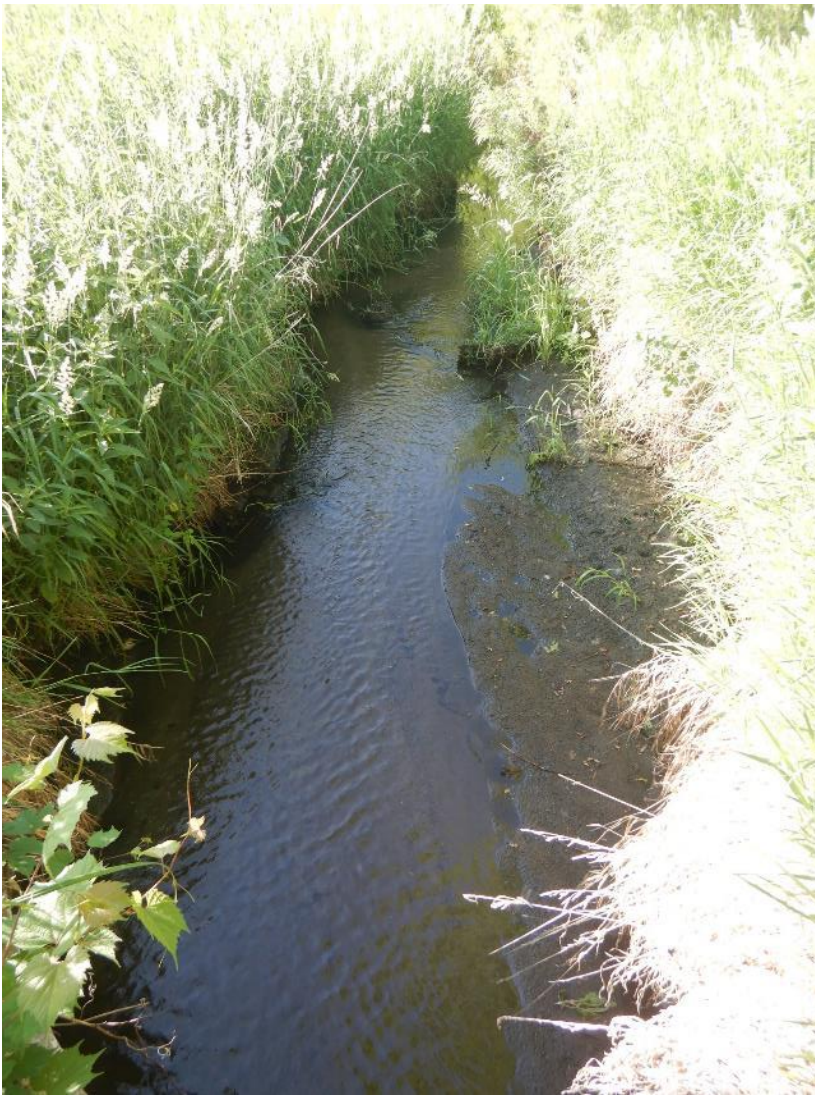
Starting from Mund Lake and ending in Maria Lake, the historical stream channel was channelized to drain the landscape. This new channel cut through multiple wetlands, creating a direct connection between the two lakes. This channel alteration accelerates stream flow, resulting in higher flows during precipitation events which achieves the agricultural land use drainage goals, but causes instability. Water leaves the landscape quickly, resulting in periods of higher flow than what would have naturally occurred. As the landscape drains, water that was once held in the upstream wetlands is flushed downstream, carrying low DO water throughout the reach. Then, as these flows quickly drain, the flow regime quickly transitions to intermittent, reaching stagnant conditions starting early in the summer (Figure 22, Figure 23). Although 2021 was a dry summer, Plum Creek was already mostly dry by the end of May.

Figure 22. Plum Creek on 6/10/21, showing an almost dry channel with only 1 inch of water in the channel.

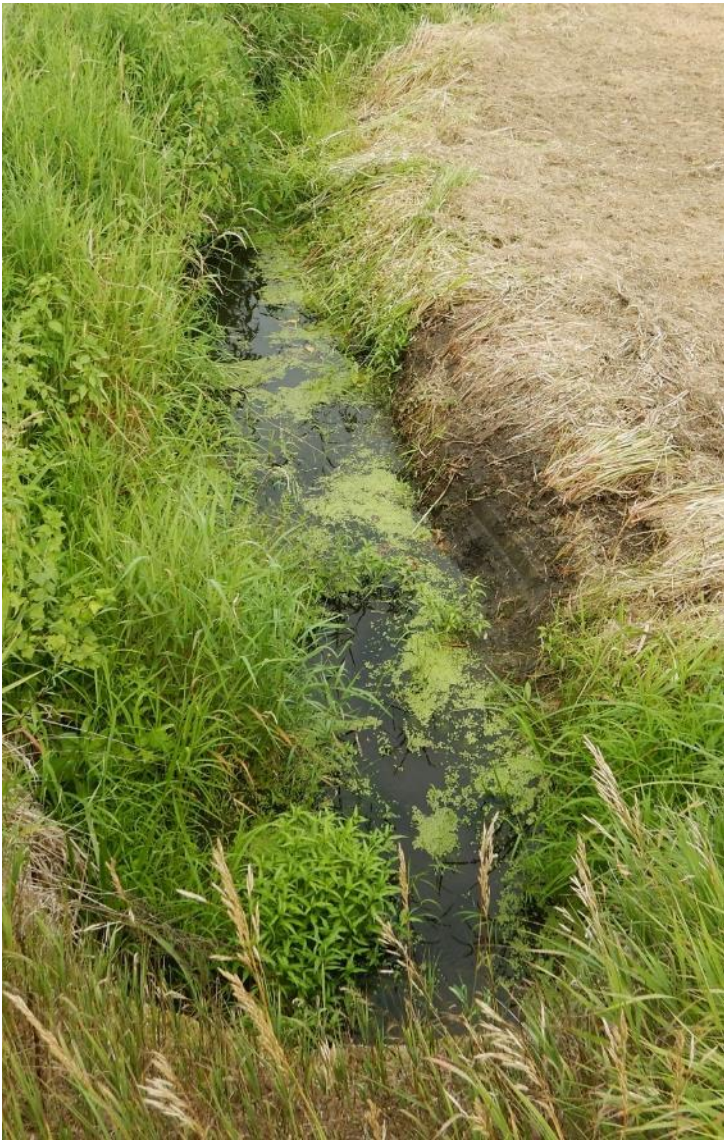
Figure 23. Plum Creek intermittent flow at the end of June 2021.

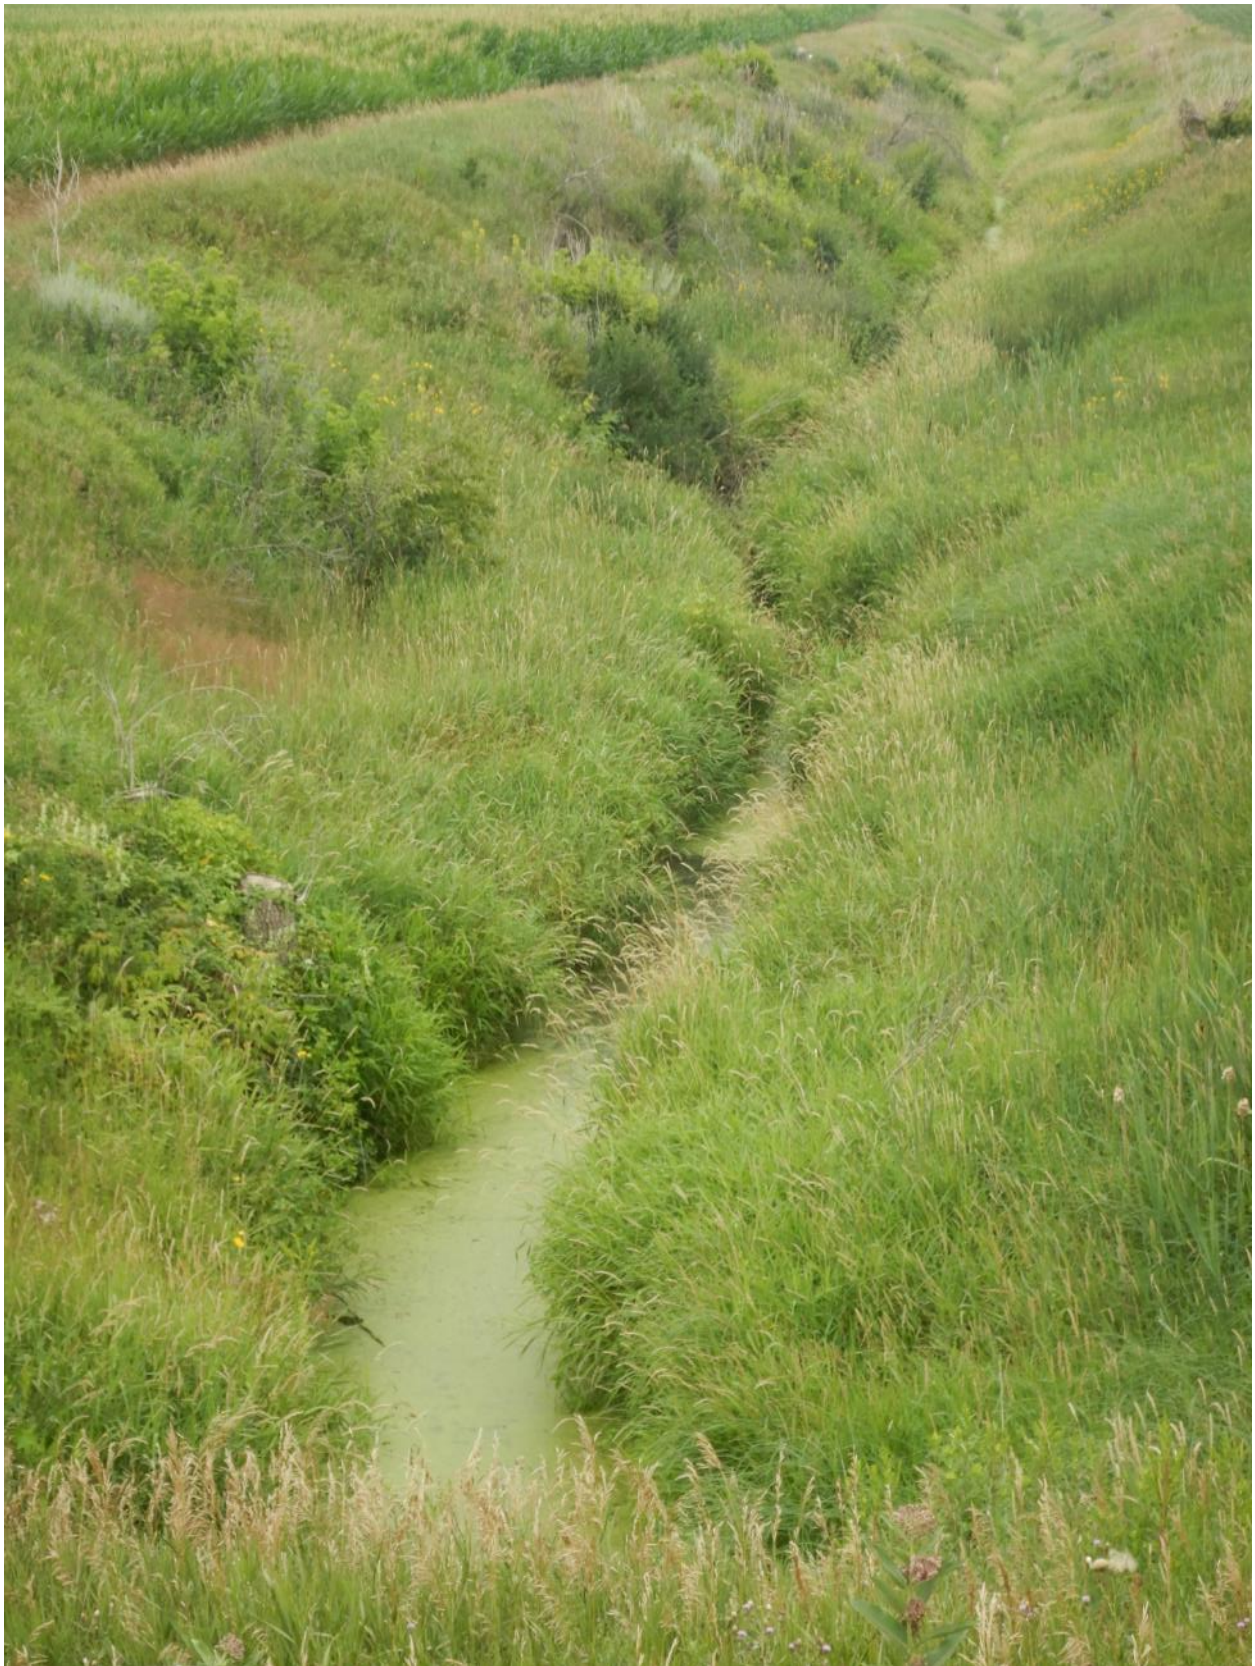
Over time, there have been many changes on the landscape that have changed the natural hydrology and geomorphology of County Ditch 44, and the entire subwatershed. The most significant historical changes to the landscape have been land conversion from mature forests to cultivated fields and the channelization of the natural streams and wetlands. County Ditch 44 has been straightened along the entire length of the AUID. Historically, the stream channel that now makes up County Ditch 44, did not exist. The channel flowed north from Clear Lake, and flowed into the Clearwater River, just south of Watkins. The new channel was excavated to straighten the channel straight east, which allowed a large wetland complex to be filled in, and converted to agriculture. This channel alteration accelerates stream flow, resulting in higher flows during precipitation events which achieves the agricultural land use drainage goals, but causes instability. Water leaves the landscape quickly, resulting in periods of higher flow than what would have naturally occurred. As the landscape drains, the flow regime quickly transitions to low flow, reaching stagnant conditions starting early in the summer (Figure 27).

Figure 27. Stagnant flow in County Ditch 44 starting in June.

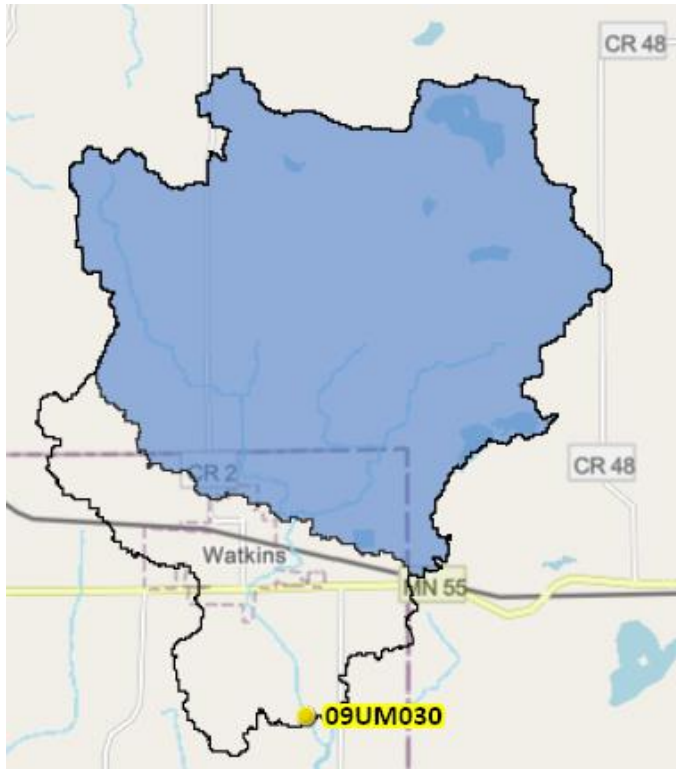
Figure 32. County Ditch 20 current drainage area, with additional drainage area from channelization denoted in blue. Credit: USGS Stream Stats.

This channel alteration accelerates stream flow, resulting in higher flows during precipitation events, which achieves the agricultural land use drainage goals, but causes instability. Water leaves the landscape quickly, resulting in periods of higher flow than what would have naturally occurred. As the landscape drains, the flow regime quickly transitions to low flow, reaching stagnant conditions starting early in the summer (Figure 33).

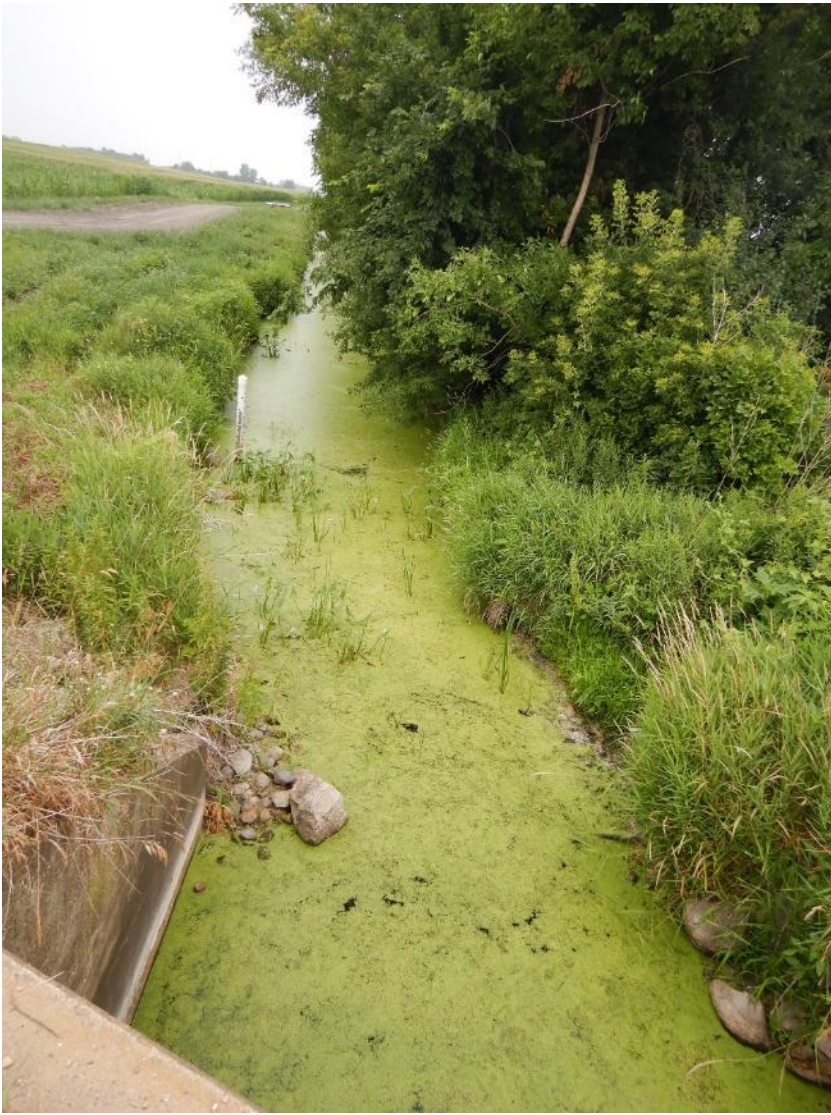
Figure 33. Stagnant flow conditions within County Ditch 20, early summer 2021.

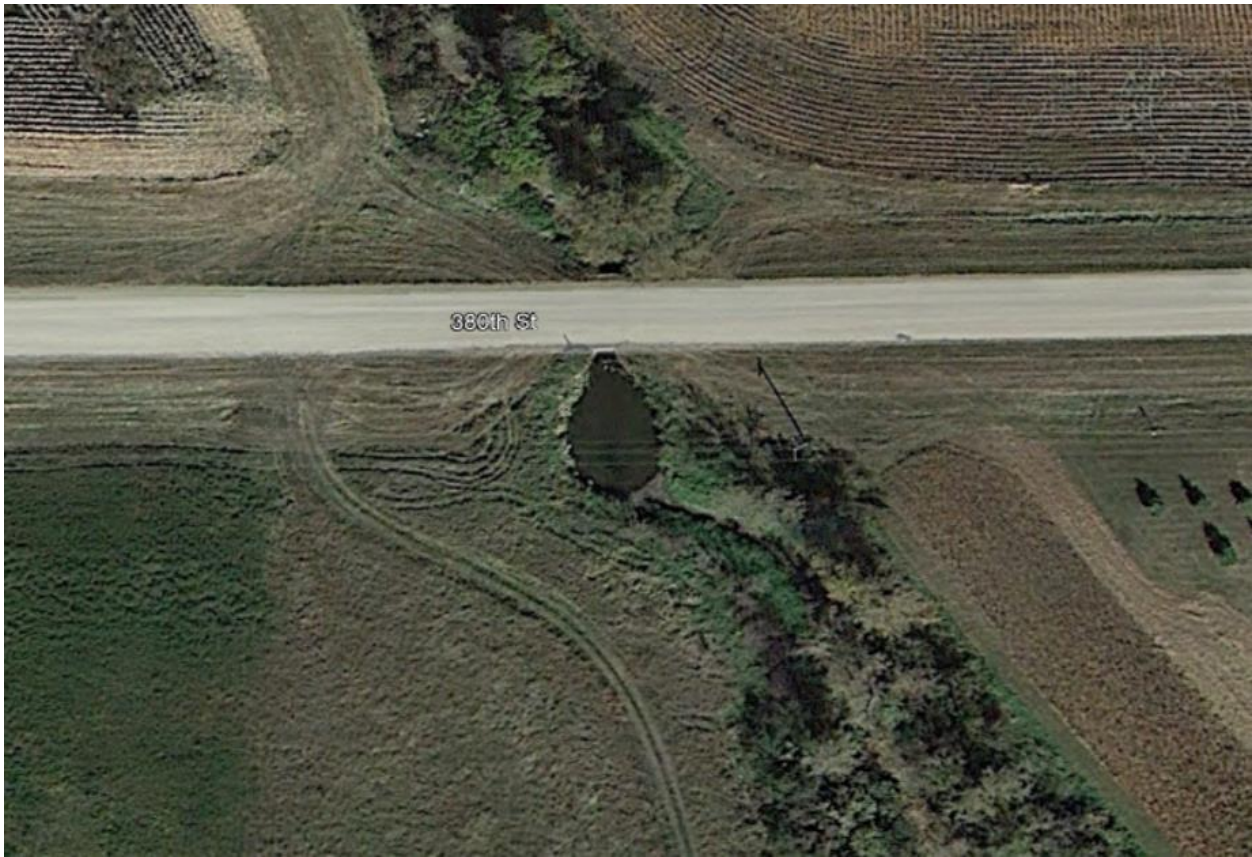
The culvert crossing by 09UM030 off 380th Street does not appear to be a fish barrier. However, there is a pool just downstream of the culvert which does indicate that there may be a barrier. Looking at aerial photography (Figure 34), it does appear that this bend in the ditch channel can back up at times, which may be caused by beaver activity. No beaver activity was noted by SID staff, so connectivity as a stressor to the aquatic life within County Ditch 20 is inconclusive at this time.

Figure 34. Plunge pool on the downstream end of the culvert crossing off 380th Street.

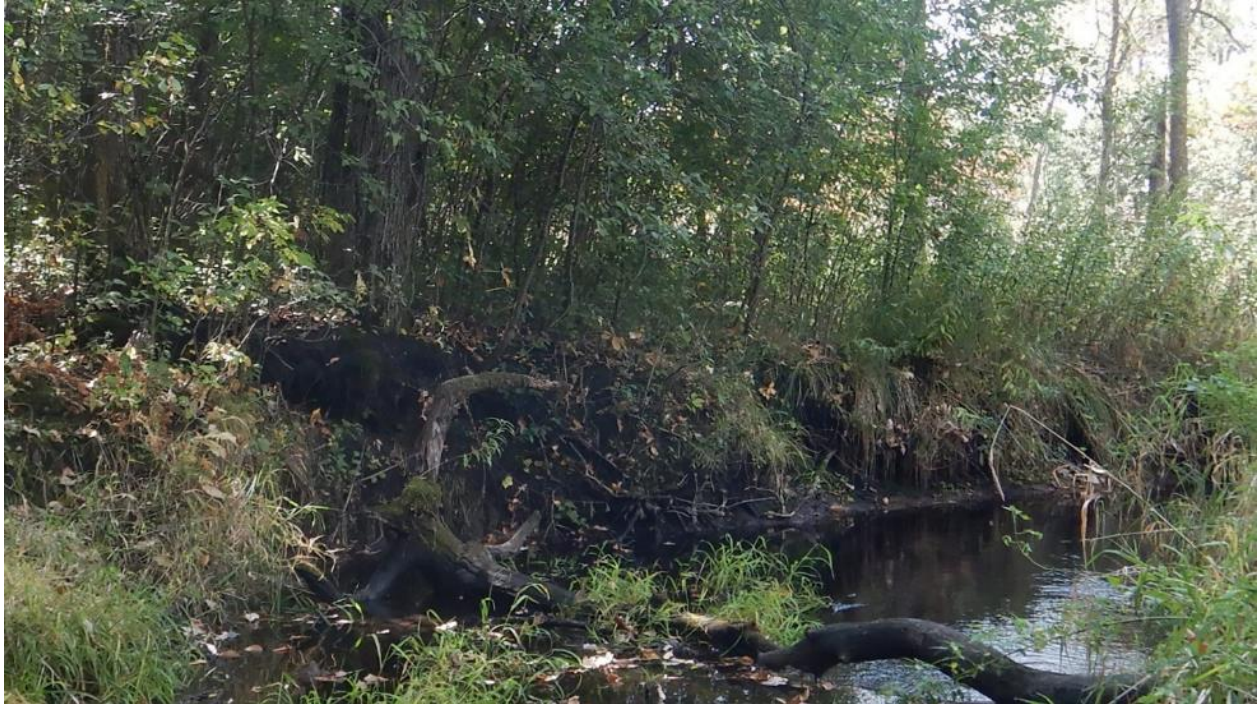
This channel alteration within the headwaters was cut through several wetlands, which has caused a greater volume of water to flow into Threemile Creek at a higher velocity than what would have naturally occurred. Due to the additional stream power caused by the additional water and higher velocity, the banks of the creek have eroded (Figure 39, Figure 40), causing the channel to over-widen, as noted by the evidence of point bars, which would not exist if the channel were narrower and had the ability to self-clean.

Figure 39. Eroding stream bank on the -564 reach of Threemile Creek.

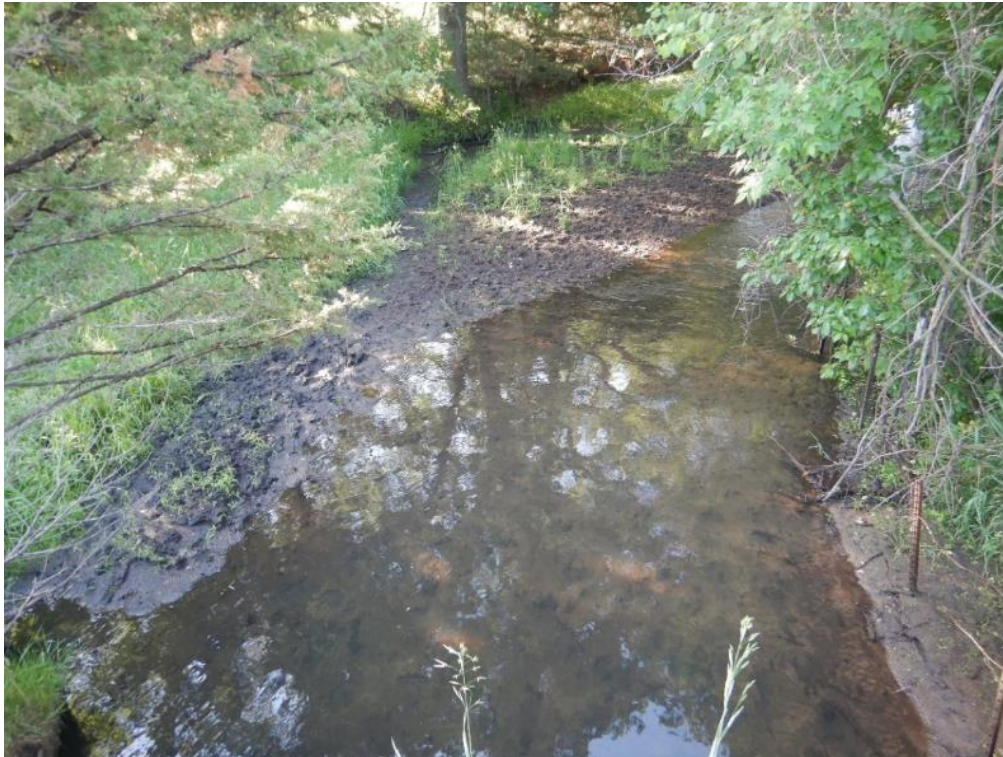
This over-widening has been further complicated in the downstream section of Threemile Creek, where the culvert crossing under CR 45 has been used as a cattle crossing, allowing the cattle to use the stream as a corridor, further over-widening the stream (Figure 41, Figure 42, Figure 43).

Figure 41. Channel erosion caused by cattle trampling, downstream of CR 45.

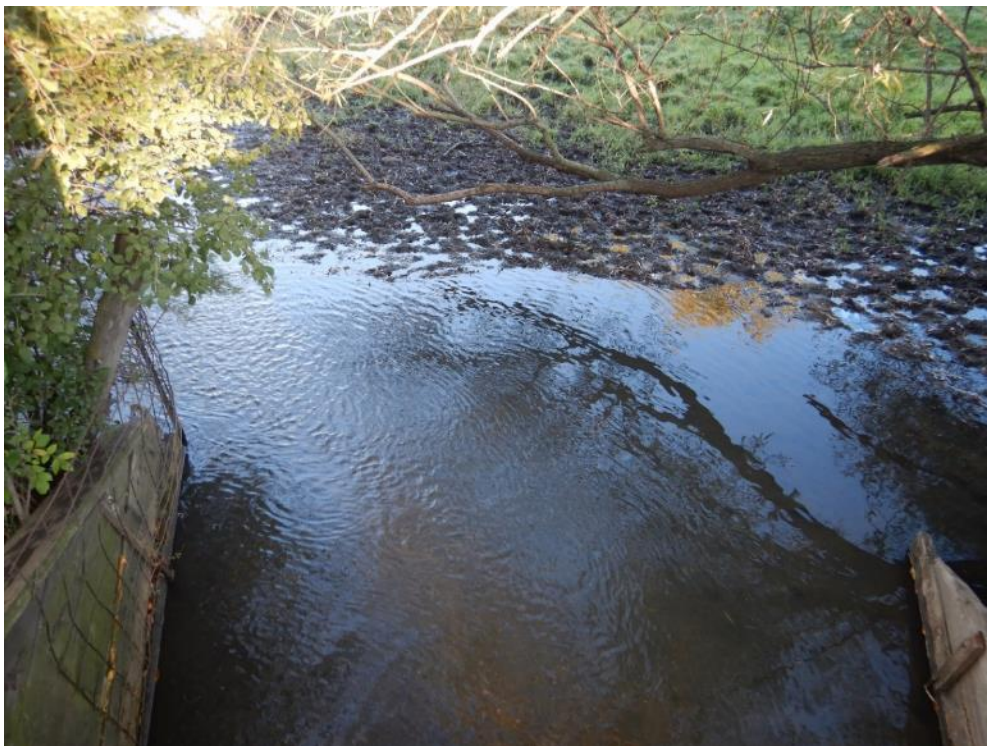
Figure 42. Channel erosion caused by cattle trampling, upstream of CR 45.

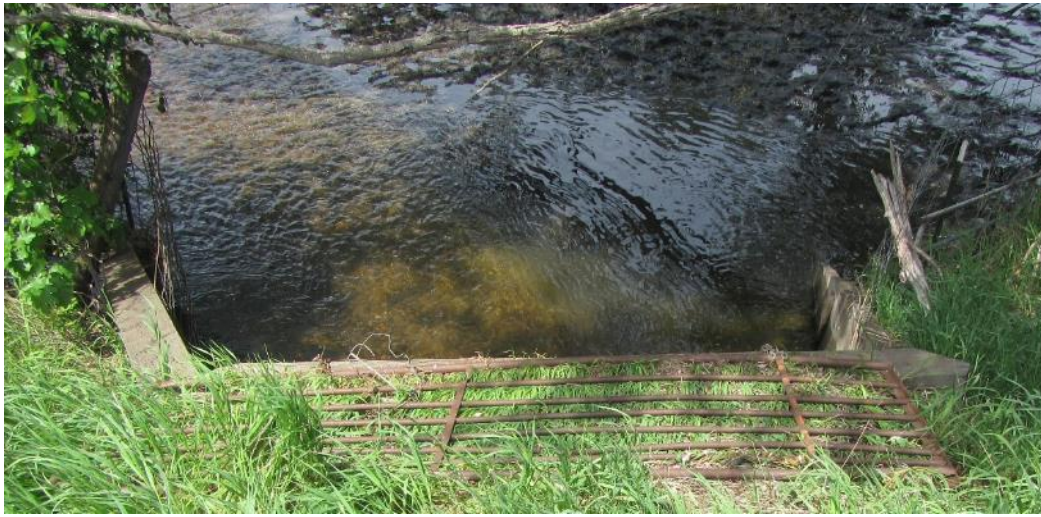
Figure 43. Cattle gate connected to the CR 45 culvert, using the culvert for cattle passage under CR 45.

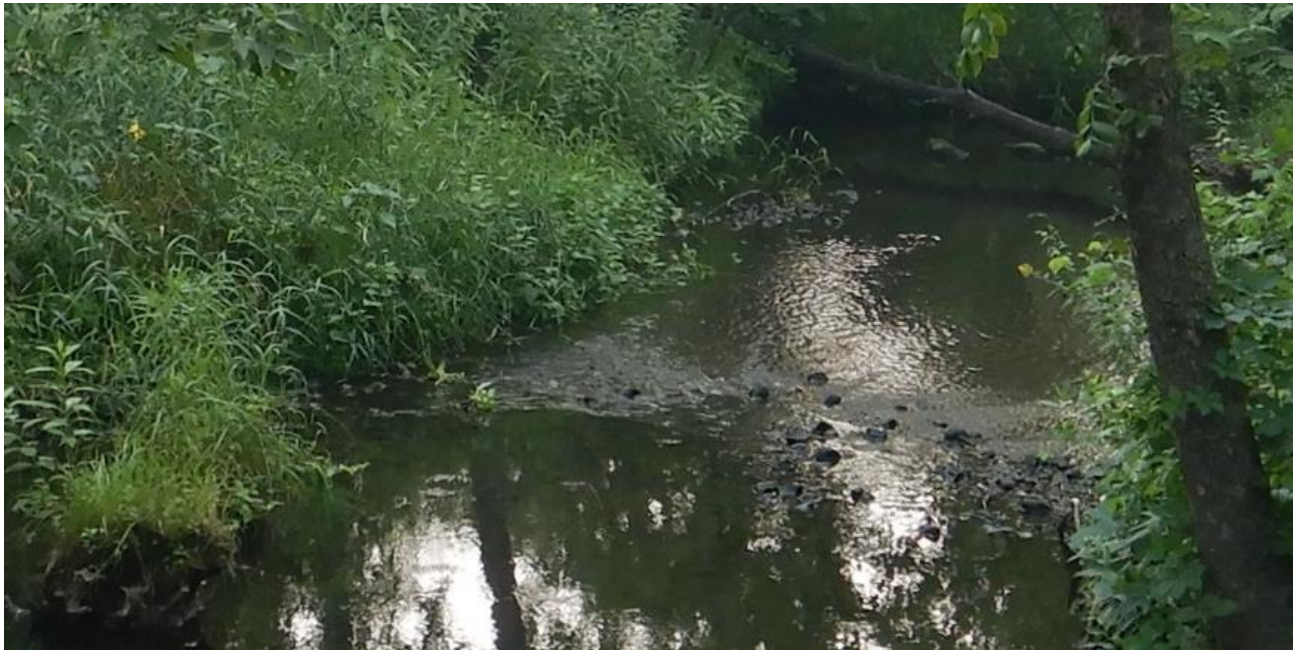
Figure 44. Shallow riffle located downstream of 35th Ave.

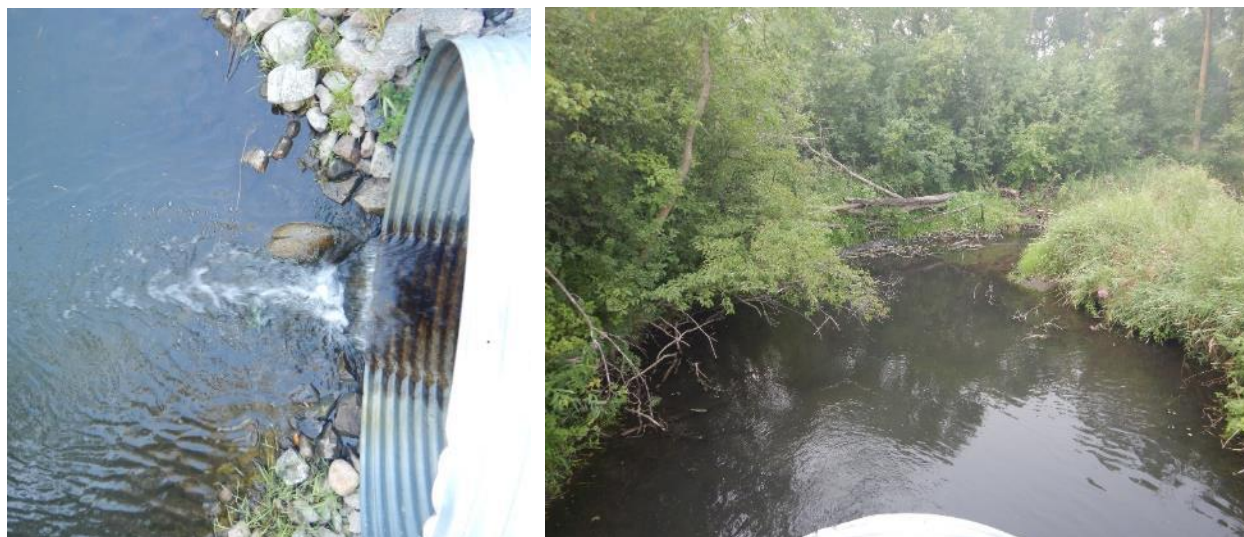
Figure 45. Perched culvert off 160th St.

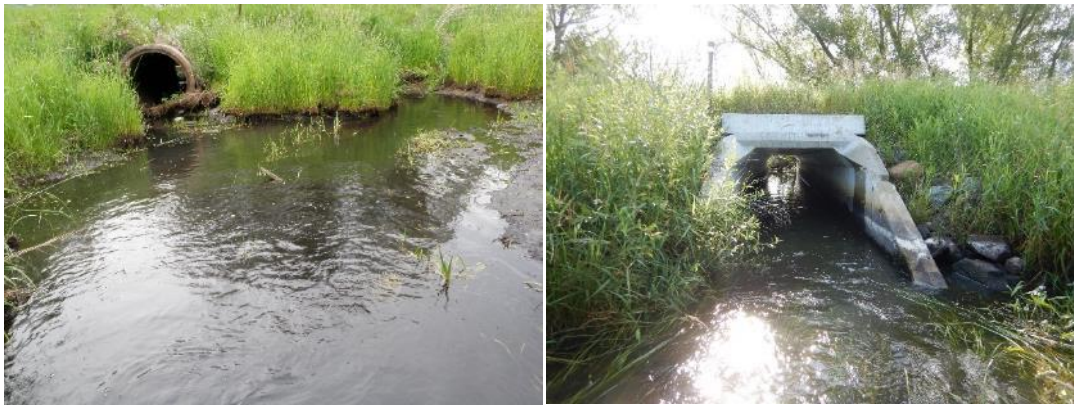
Figure 48. Culvert crossing replacement at the 45th Ave SE crossing from June 2009 to July 2019.

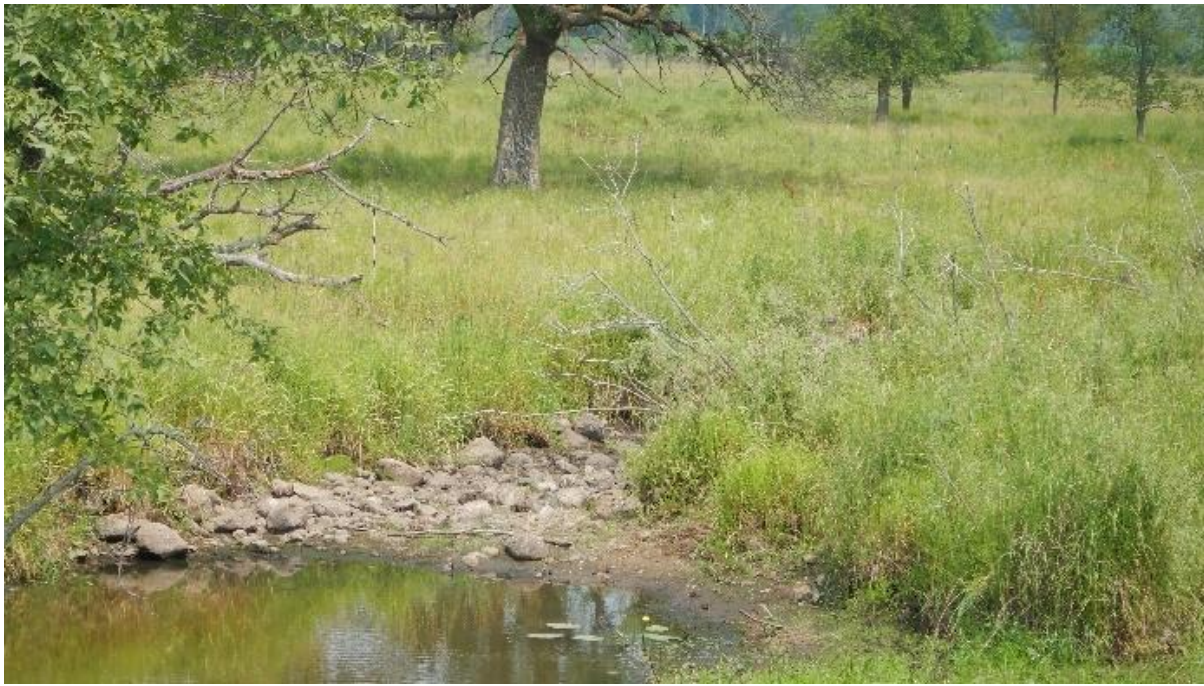
Figure 54. Dry stream channel on the downstream side of CR 52.

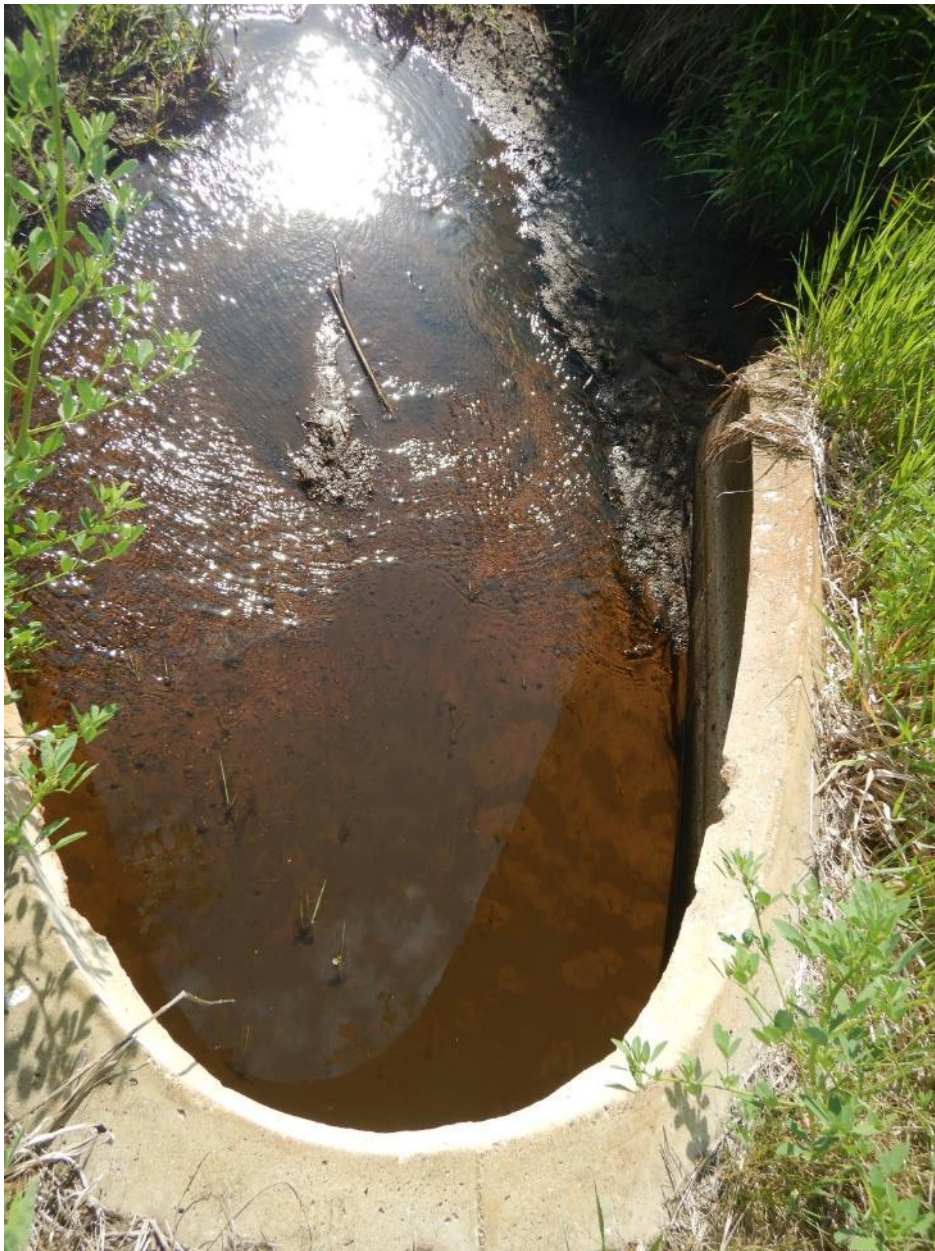
Figure 59. County Ditch 22 almost dry in early June 2021.

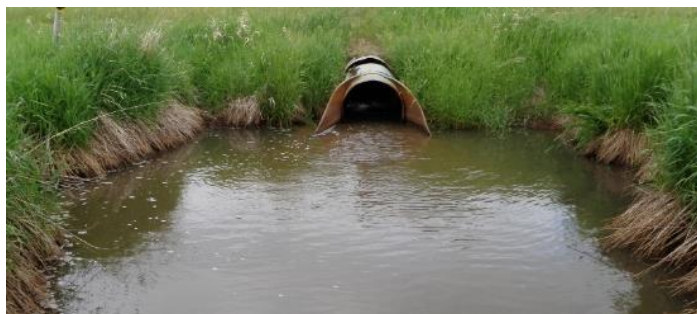
Figure 60. Culvert crossing off CR 11 in 2009.

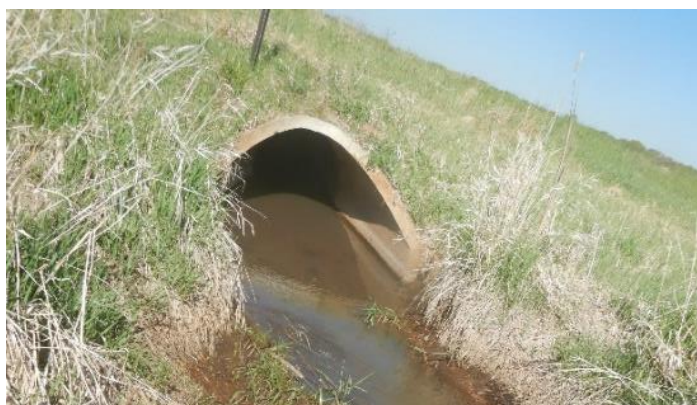
Figure 61. Culvert crossing off CR 11 in 2021.

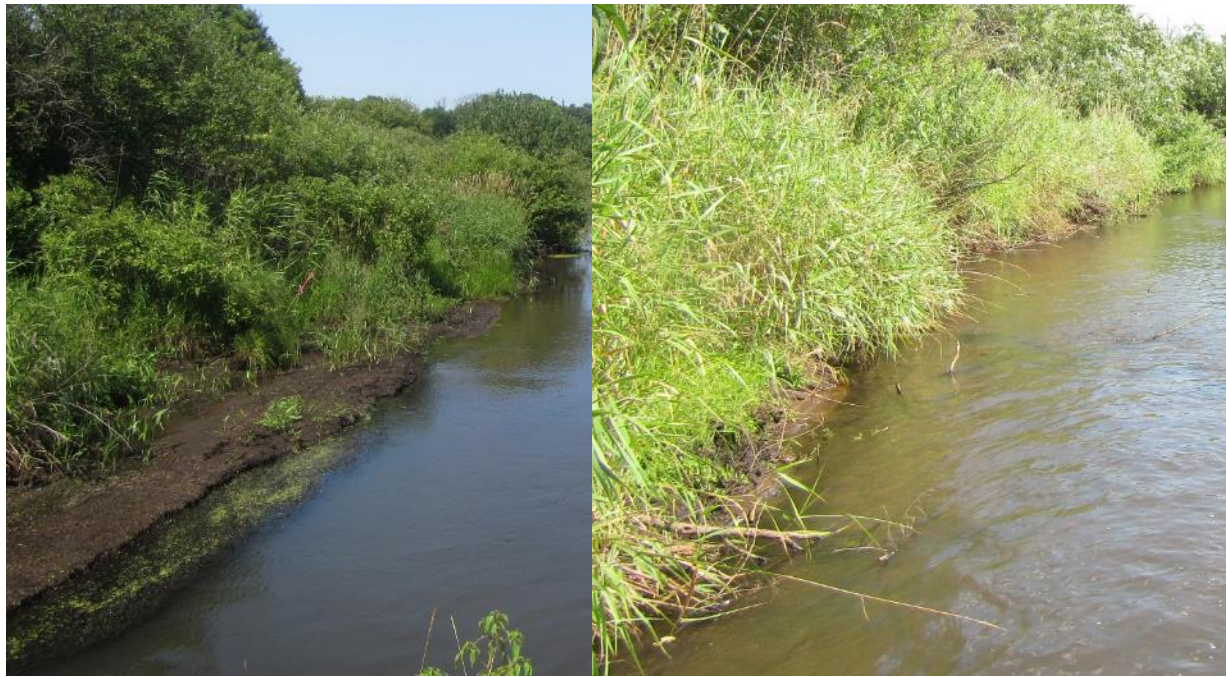
Figure 70. Excessive sedimentation at 09UM013 (left) and at 09UM026 (right).

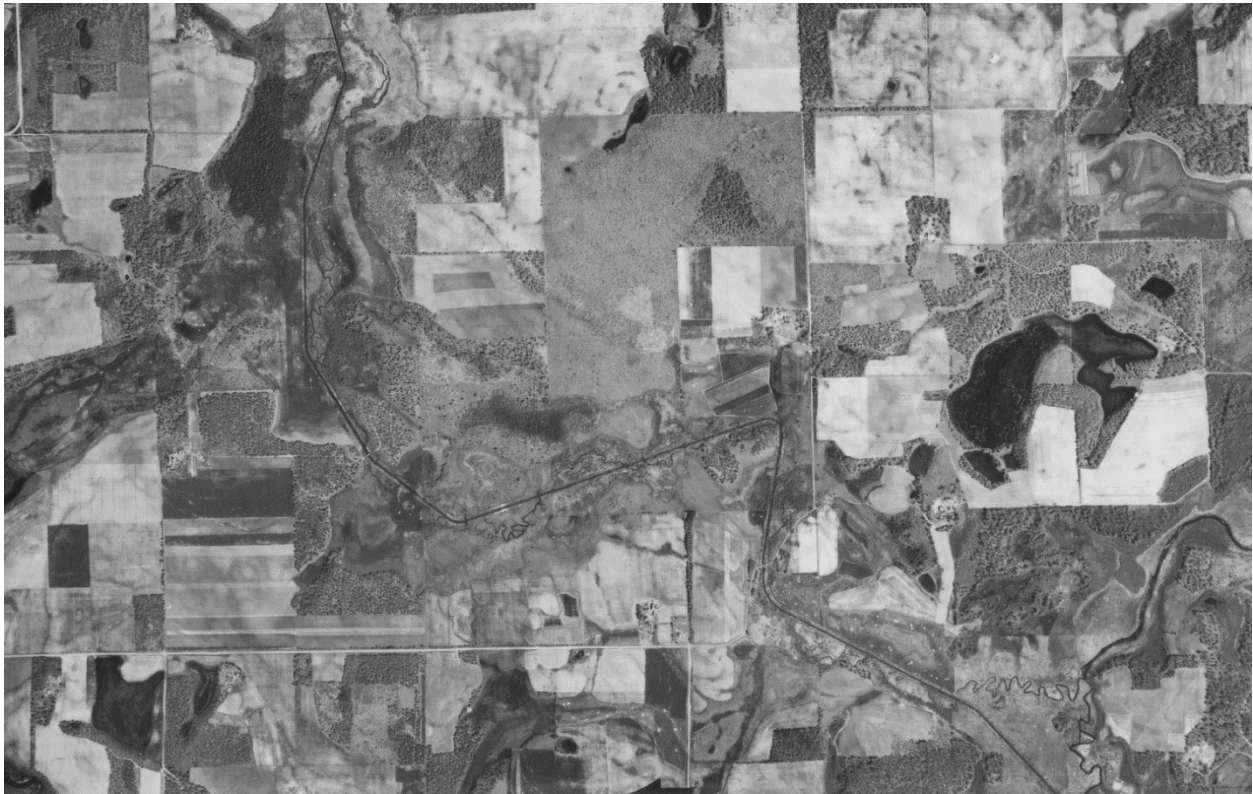
Figure 71. 1939 aerial photo of the channelization of the Snake River. Photo available at <https://geo.lib.umn.edu/Sherburne/y1939/BJL-9-7.jpg>.

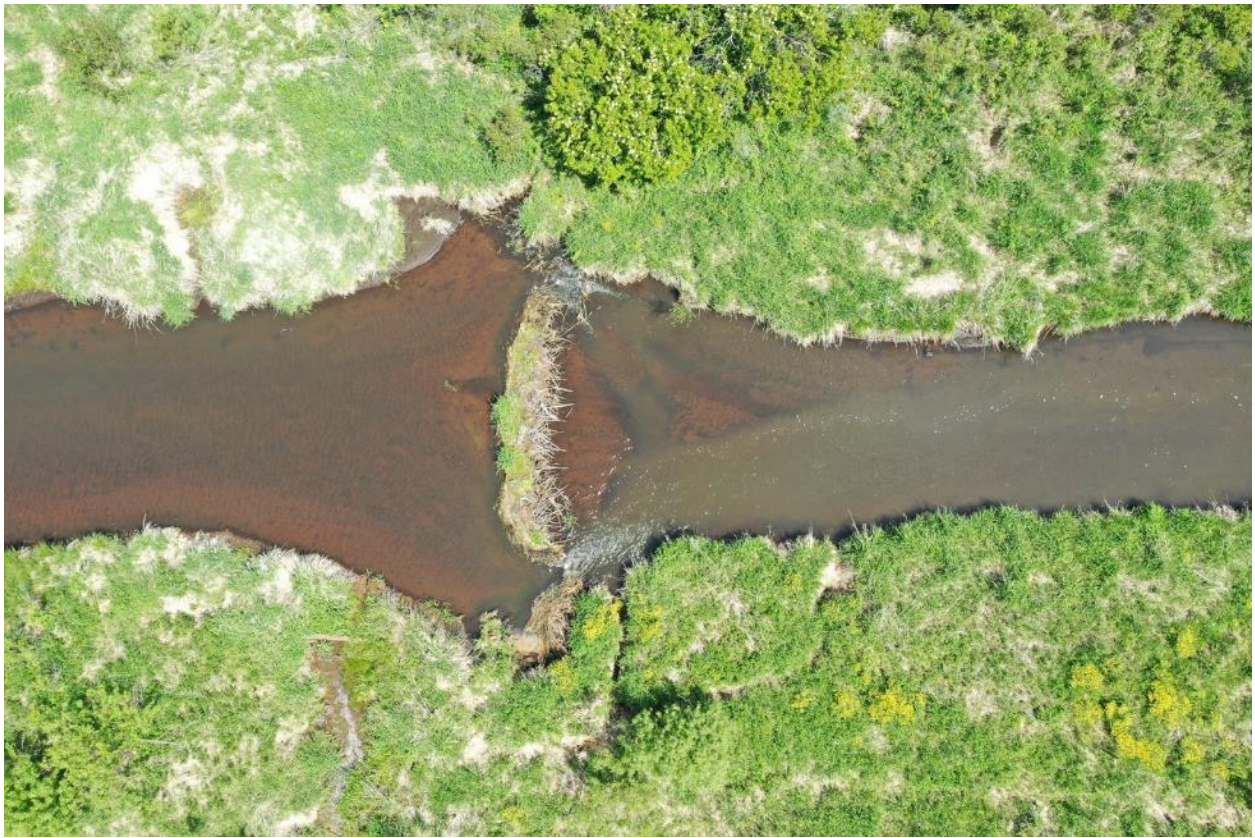
In addition to the over-sized channel contributing to the sediment issues within the Snake River, beaver activity is prevalent throughout the subwatershed. Current and historic dams can be found throughout the Snake River, and not only create connectivity barriers for fish, but also hold back sediment, and divert flow into the banks (Figure 73 and Figure 74).

Figure 73. Overview of one of the old beaver dams within the Snake River, showing the TSS coming from the banks.

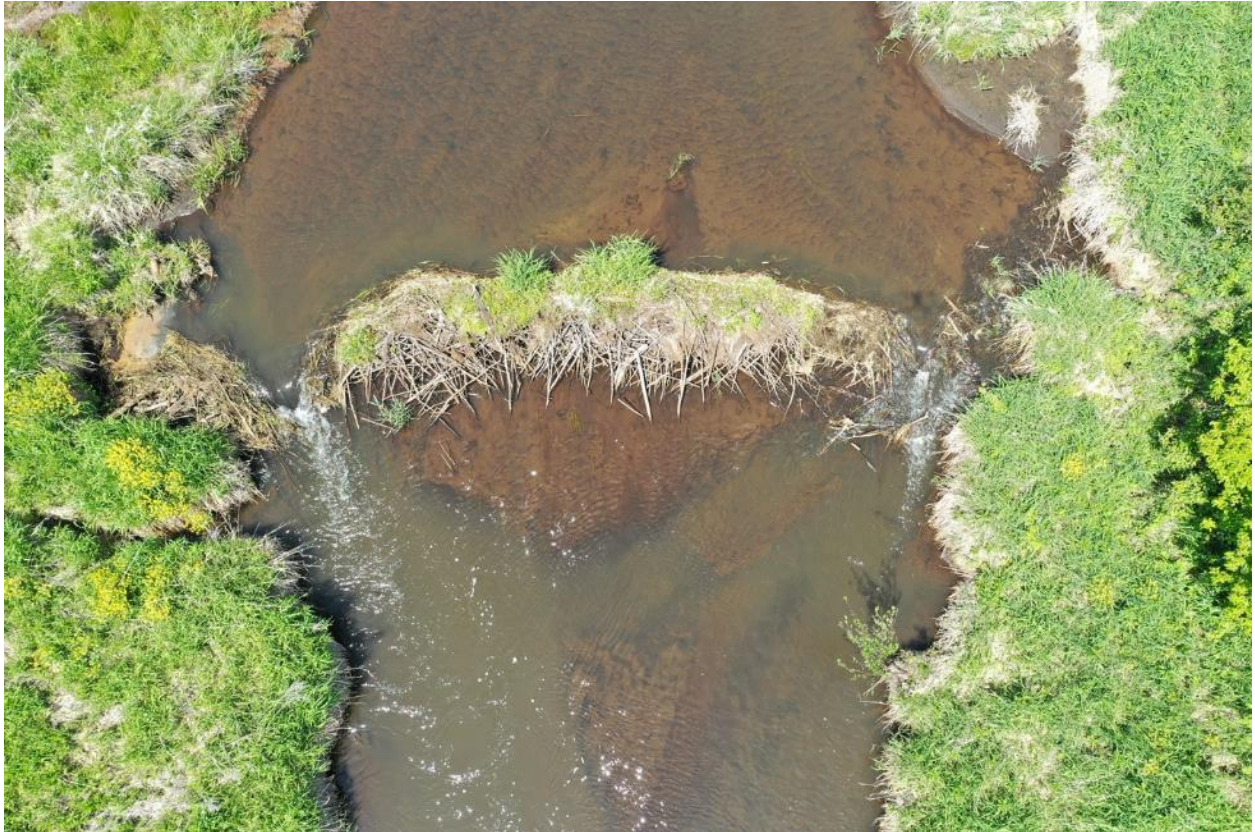
Figure 74. Closer view of the old beaver dam, showing the velocity fish barrier and the suspended sediment.

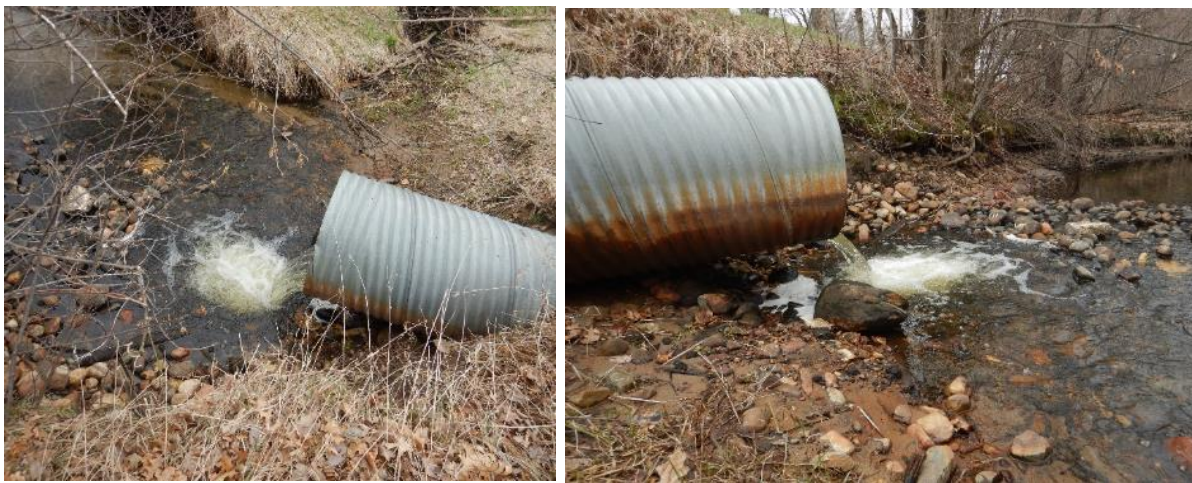
Figure 75. Perched culverts on small tributary streams flowing into the Snake River.
