Mississippi River-St. Cloud Watershed Stressor Identification Update, 2022

A study of local stressors limiting the biotic communities in the Mississippi River-St. Cloud Watershed.

Document number: wq-ws3-07010203e

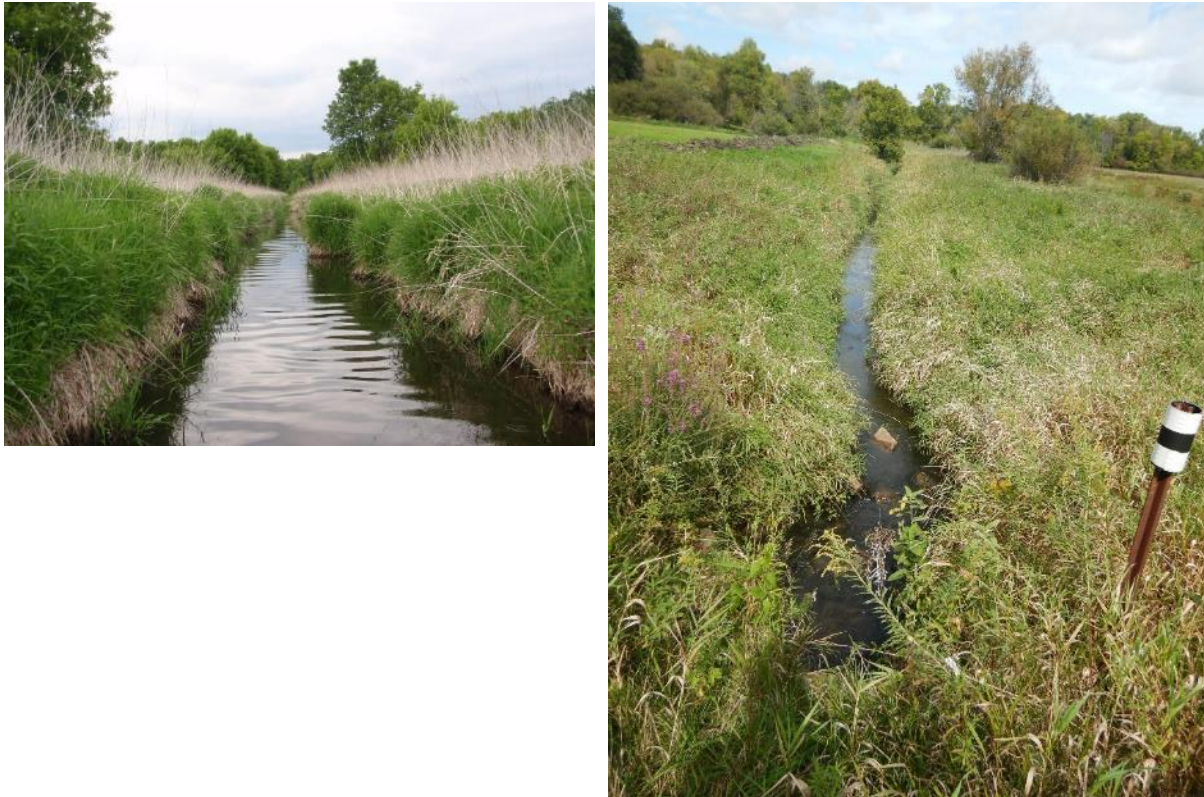
Figure 83. Water levels within Unnamed Ditch - Sherburne County Ditch #1 in the spring and mid-summer.
