# Mustinka River Watershed Restoration and Protection Strategy Report

This Watershed Restoration and Protection Strategy (WRAPS) report summarizes past monitoring, water quality assessments, and other water quality studies that have been conducted in the Mustinka River Watershed. In addition, it outlines ways for local groups to prioritize projects that can be implemented in the watershed to improve water quality. The WRAPS report contains a large amount of information. The purpose of the following table is to provide a Quick Reference guide for users to quickly identify what information can be found in each section of the report.

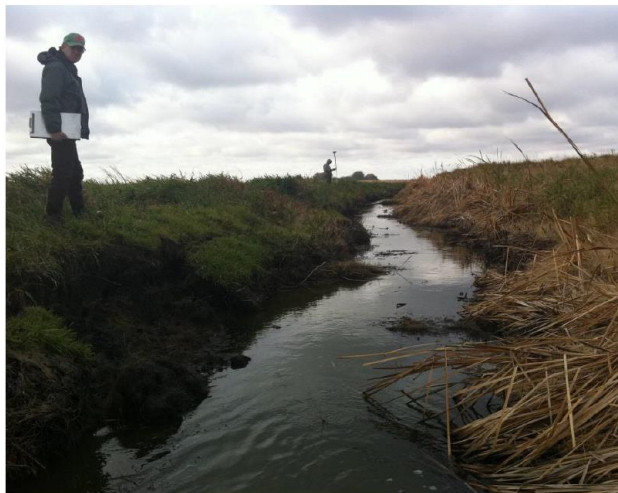
GEOMORPHIC SUMMARY	
Est. Bankfull El.	1036.2'
Channel Slope	0.15%
Sinuosity	1.0
Bankfull Width	62.5'
W/D Ratio	70.7
Material (D50)	0.06 mm
BEHI Rating	High
NBS Rating	Very High

- Bankfull width is extraordinary wide due to ditch geomorphology, reach position within a wetland complex and Red River Valley flooding characteristics; thus the W/D ratio is also very high; this phenomenon is common throughout this study area

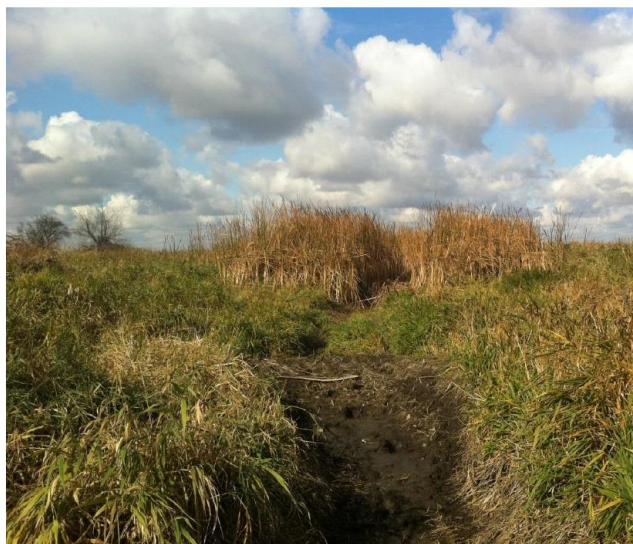
REACH INFORMATION	
Stream/River	East Fork Twelvemile
County	Traverse
Drainage Area	17 sq. miles
Date	-
Field/Site ID	54
Bio Monitoring	No

GEOMORPHIC SUMMARY	
Est. Bankfull El.	-
Channel Slope	-
Sinuosity	-
Bankfull Width	-
W/D Ratio	-
Material (D50)	-
BEHI Rating	-
NBS Rating	-

- Did not survey – no perennial flow and frequently no discernible channel; large cattail wetland flowage;

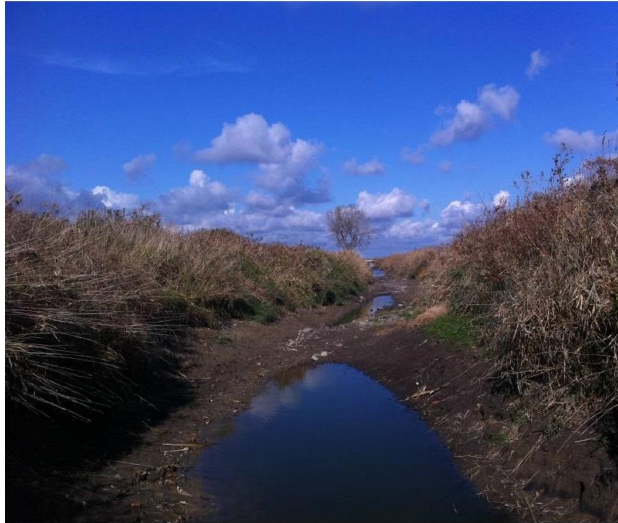
Est. Bankfull El.	-
Channel Slope	-
Sinuosity	-
Bankfull Width	-
W/D Ratio	-
Material (D50)	-
BEHI Rating	-
NBS Rating	-

- Did not survey – no perennial flow

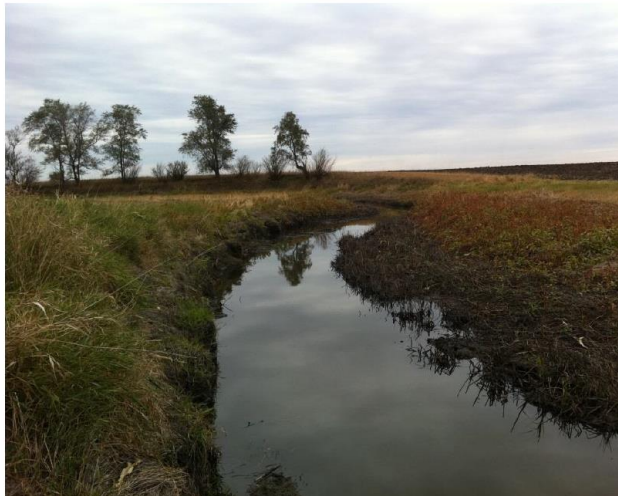
Est. Bankfull El.	1040.79
Channel Slope	0.08%
Sinuosity	1.1
Bankfull Width	71.1
W/D Ratio	65.9
Material (D50)	0.062 mm
BEHI Rating	High
NBS Rating	High

- Good buffer (width and quality)
- Some floodplain vegetation killed off by recent sustained high water

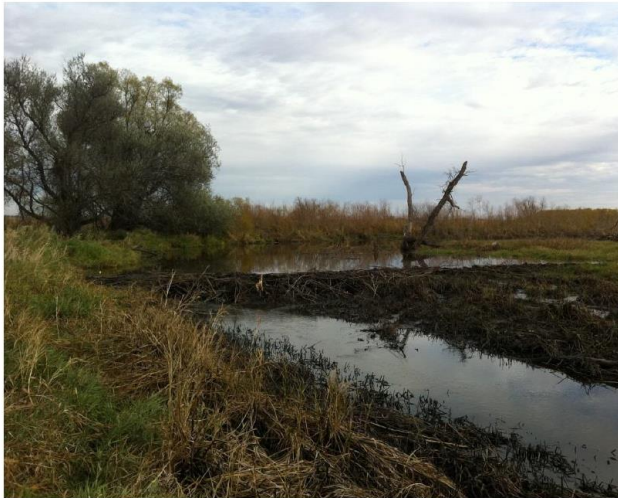
REACH INFORMATION	
Stream/River	Twelvemile
County	Traverse
Drainage Area	110 sq. miles
Date	-
Field/Site ID	59
Bio Monitoring	No

GEOMORPHIC SUMMARY	
Est. Bankfull El.	-
Channel Slope	-
Sinuosity	-
Bankfull Width	-
W/D Ratio	-
Material (D50)	-
BEHI Rating	-
NBS Rating	-

- Did not complete survey, reach influenced by active beaver dam

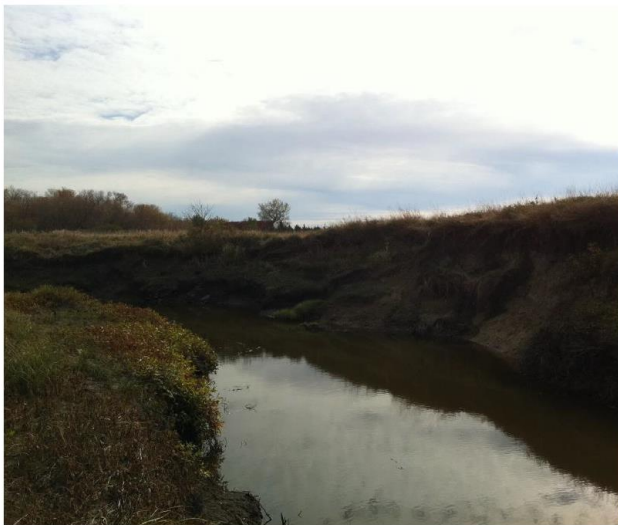
GEOMORPHIC SUMMARY	
Est. Bankfull El.	1014.1'
Channel Slope	0.03%
Sinuosity	1.5
Bankfull Width	33.3'
W/D Ratio	9.1
Material (D50)	0.27mm
BEHI Rating	High
NBS Rating	High

- More entrenched than other study reaches;
- Channel evolution (lateral) is resulting in a number of severely eroding banks within reach

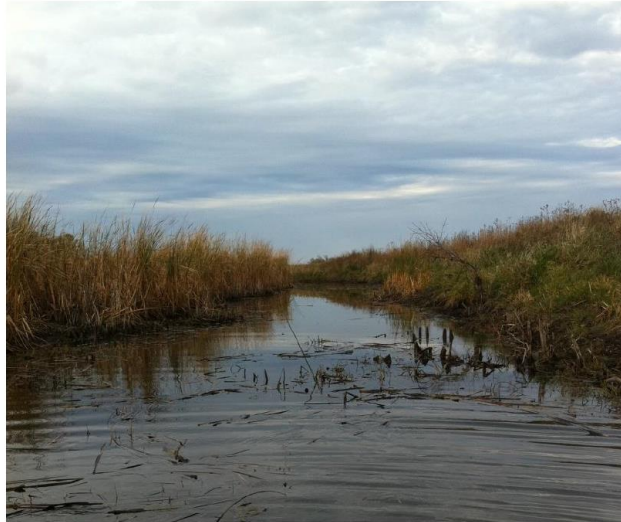
Est. Bankfull El.	-
Channel Slope	-
Sinuosity	-
Bankfull Width	-
W/D Ratio	-
Material (D50)	-
BEHI Rating	-
NBS Rating	-

- Did not complete survey – water levels were too high and soils were unconsolidated; possible downstream beaver dam?

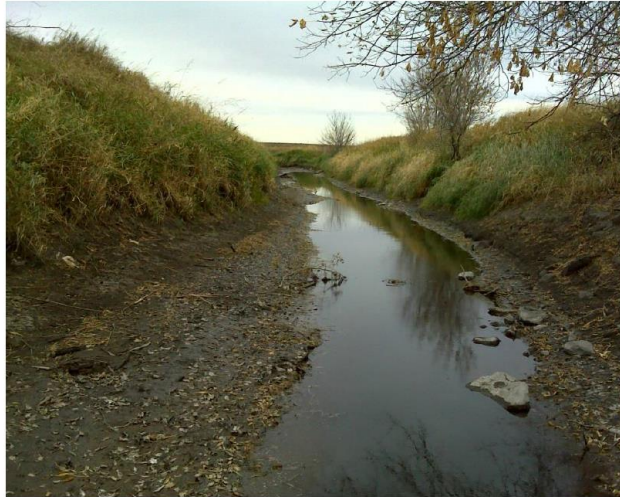
REACH INFORMATION	
Stream/River	W. Branch Twelvemile
County	Traverse
Drainage Area	73 sq. miles
Date	10/24/2011
Field/Site ID	75
Bio Monitoring	No

GEOMORPHIC SUMMARY	
Est. Bankfull El.	1081.4'
Channel Slope	0.06%
Sinuosity	1.0
Bankfull Width	21.8'
W/D Ratio	10.2
Material (D50)	0.06 mm
BEHI Rating	Moderate
NBS Rating	Very Low

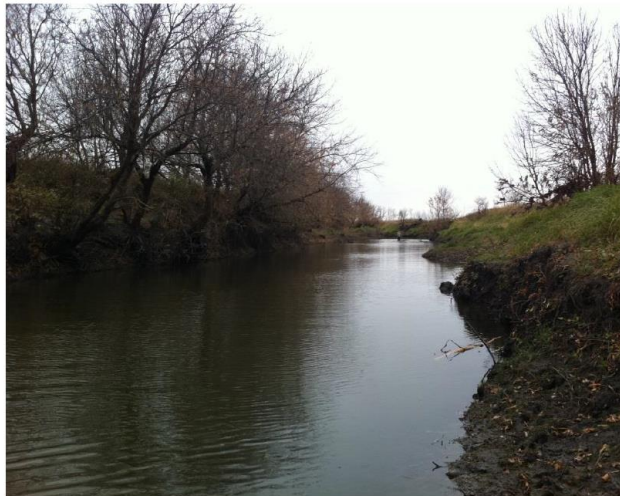
REACH INFORMATION	
Stream/River	Twelve Mile
County	Traverse
Drainage Area	514 sq. miles
Date	10/25/2011
Field/Site ID	76
Bio Monitoring	Yes

GEOMORPHIC SUMMARY	
Est. Bankfull El.	997.1
Channel Slope	0.002%
Sinuosity	1.3
Bankfull Width	53.6'
W/D Ratio	10.2
Material (D50)	0.68 mm
BEHI Rating	High
NBS Rating	Moderate

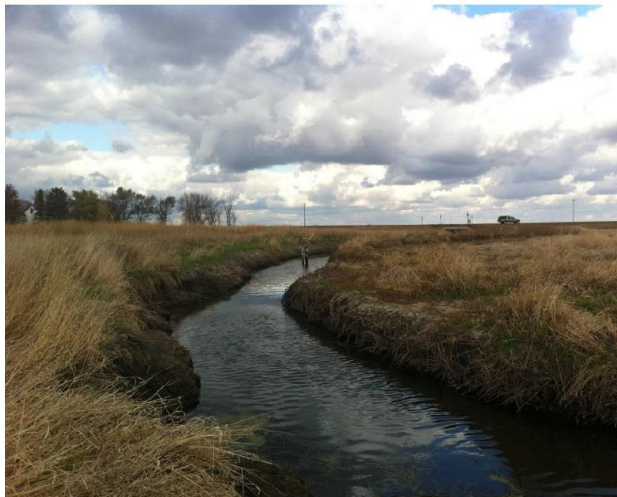
Est. Bankfull El.	1033.2'
Channel Slope	0.02%
Sinuosity	1.1
Bankfull Width	31.6'
W/D Ratio	26.1
Material (D50)	0.06 mm
BEHI Rating	Low
NBS Rating	Low

- Some signs of aggradation, gravel was overlaying silt, longitudinal profile was silt dominated;
- Good buffer;  $\geq 150'$  from stream centerline

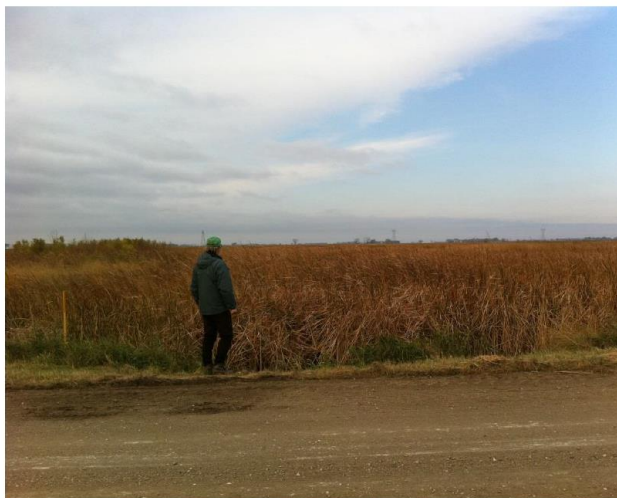
Est. Bankfull El.	-
Channel Slope	-
Sinuosity	-
Bankfull Width	-
W/D Ratio	-
Material (D50)	-
BEHI Rating	-
NBS Rating	-

- Did not survey – no perennial flow and frequently no discernible channel; large cattail wetland flowage;

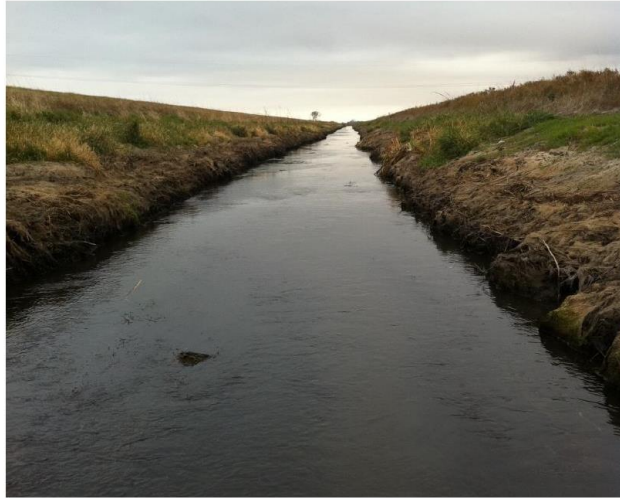
GEOMORPHIC SUMMARY	
Est. Bankfull El.	1040.8'
Channel Slope	0.17%
Sinuosity	1.0
Bankfull Width	15.6'
W/D Ratio	7.5
Material (D50)	0.06 mm
BEHI Rating	High
NBS Rating	Low

- Similar to site 95, higher gradient of this reach appears to be connected to relative greater habitat quality witnessed (less embeddedness, aquatic vegetation, greater pool depth and frequency)

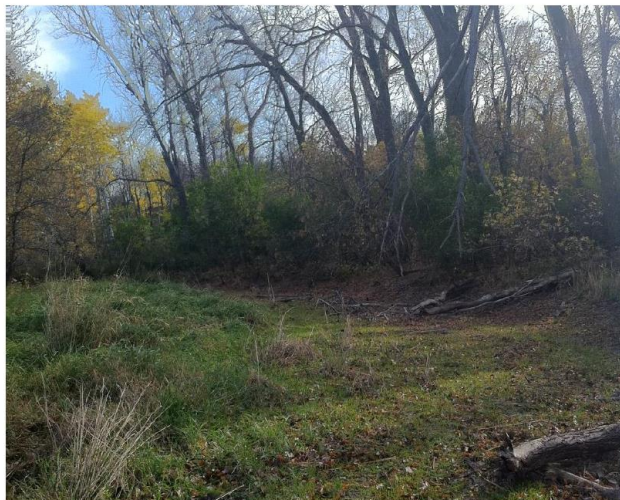
GEOMORPHIC SUMMARY	
Est. Bankfull El.	1004.5'
Channel Slope	0.06%
Sinuosity	1.6
Bankfull Width	28.3'
W/D Ratio	98.1
Material (D50)	0.06 mm
BEHI Rating	Very Low
NBS Rating	Very Low

- This stream was dry during the assessment. A large beaver dam exists on the upstream end of the reach and is affecting the hydrology downstream.
- The very high width/depth ratio is indicative of a wide, shallow channel and low floodplain.

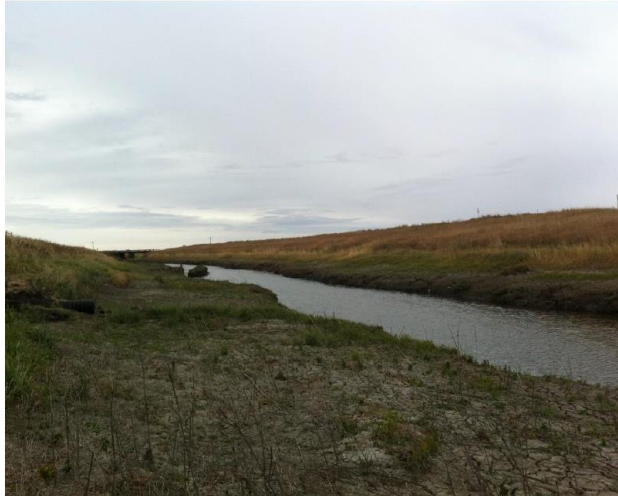
Est. Bankfull El.	980.68
Channel Slope	0.003%
Sinuosity	1.0
Bankfull Width	54.9'
W/D Ratio	14.9
Material (D50)	0.062 mm
BEHI Rating	Moderate
NBS Rating	Low

- Multiple side-inlet control failures in area
- Significant amount of floodplain vegetation killed off by recent sustained inundation

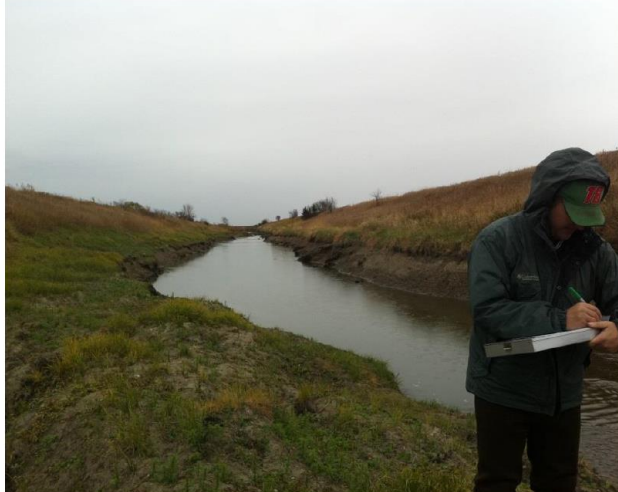
Est. Bankfull El.	990.4'
Channel Slope	0.11%
Sinuosity	1.0
Bankfull Width	61.9'
W/D Ratio	17.9
Material (D50)	16 mm
BEHI Rating	High
NBS Rating	Moderate

- Active channel evolution (lateral), which is resulting in a number of significant ditch bank failures; a separate BEHI and NBS was completed for bank failure within survey reach and scored Very High and High, respectively

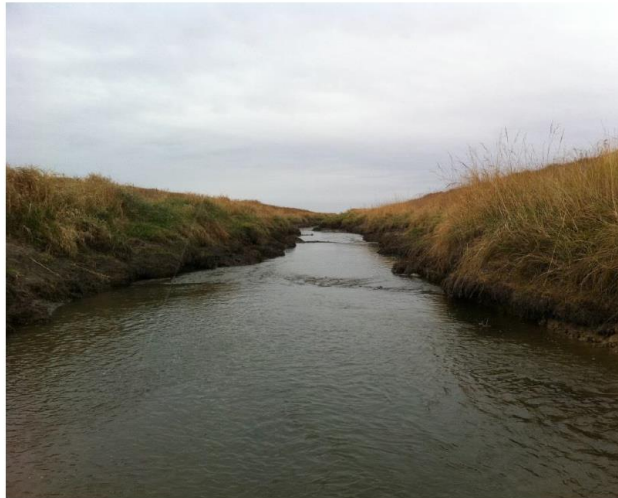
GEOMORPHIC SUMMARY	
Est. Bankfull El.	1036.2'
Channel Slope	0.05%
Sinuosity	1.0
Bankfull Width	57.1'
W/D Ratio	18.2
Material (D50)	1.5 mm
BEHI Rating	High
NBS Rating	High

- Similar to site 85, higher gradient of this reach appears to be connected to relative greater habitat quality witnessed (less embeddedness, aquatic vegetation, greater pool depth and frequency)

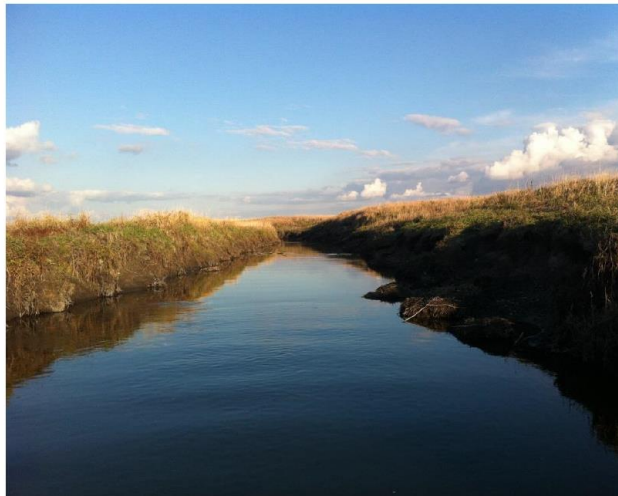
REACH INFORMATION	
Stream/River	Mustinka
County	Grant
Drainage Area	185 sq. miles
Date	10/26/2011
Field/Site ID	102
Bio Monitoring	No

GEOMORPHIC SUMMARY	
Est. Bankfull El.	1036.2'
Channel Slope	0.02%
Sinuosity	2.3
Bankfull Width	29.7'
W/D Ratio	13.0
Material (D50)	1.1 mm
BEHI Rating	High
NBS Rating	High

- A large beaver dam exists at the upper end of the reach and sediment is accumulating above the dam.
- A defined riffle/pool sequence exists below the dam with small cobble and boulders present.

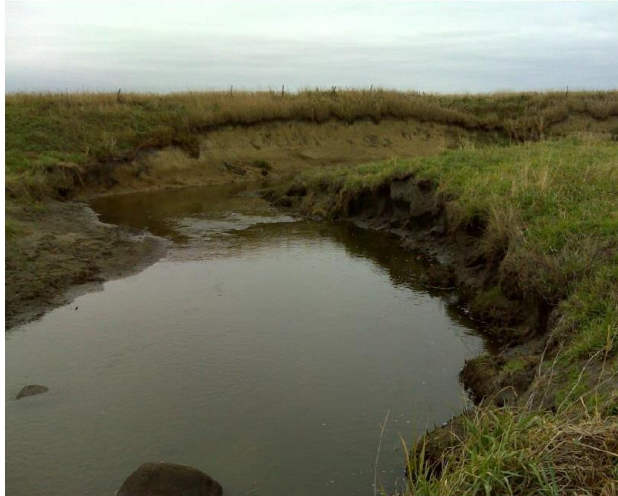
Est. Bankfull El.	1045.0'
Channel Slope	0.02%
Sinuosity	1.9
Bankfull Width	33.2'
W/D Ratio	11.3
Material (D50)	3.2 mm
BEHI Rating	High
NBS Rating	Low

- Eroded stream banks on outside bends of meanders typical in this reach.
- Defined riffle/pool sequence, pool depth greater than 3 feet.

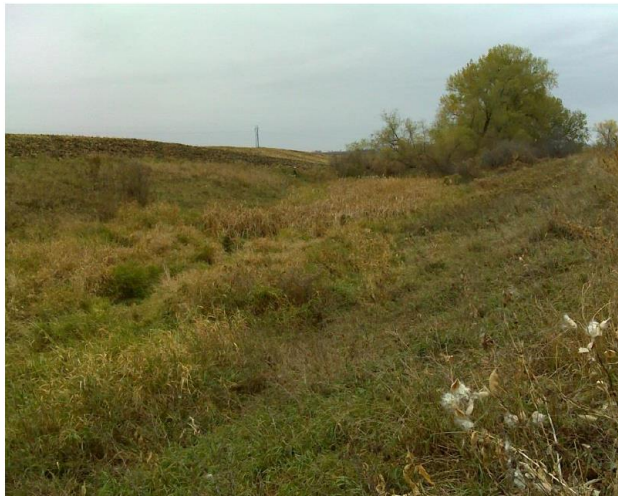
Est. Bankfull El.	1105.5'
Channel Slope	0.46%
Sinuosity	1.0
Bankfull Width	24.4'
W/D Ratio	69.0
Material (D50)	0.06 mm
BEHI Rating	Very Low
NBS Rating	Very Low

- This reach contains a very narrow and shallow stream that flows through a steep gradient grassy swale. Very little instream habitat exists in this reach.

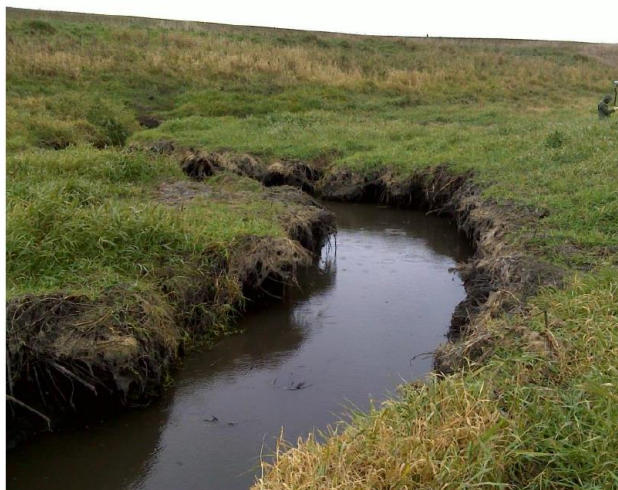
REACH INFORMATION	
Stream/River	Mustinka
County	Grant
Drainage Area	24.5 sq. miles
Date	10/25/2011
Field/Site ID	113
Bio Monitoring	Yes

GEOMORPHIC SUMMARY	
Est. Bankfull El.	1100.5'
Channel Slope	0.04%
Sinuosity	1.2
Bankfull Width	17.1'
W/D Ratio	25.5
Material (D50)	0.06 mm
BEHI Rating	Moderate
NBS Rating	Very Low

- Poor instream habitat, substrate consists of fine silt/clay.
- Floodplain is accessible during most storm events.

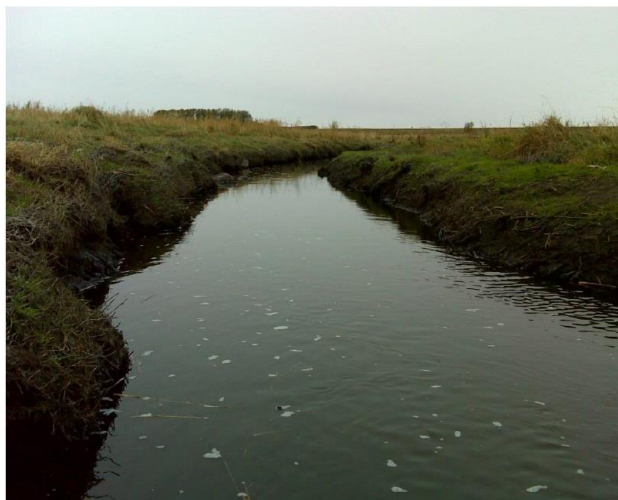
REACH INFORMATION	
Stream/River	Mustinka
County	Grant
Drainage Area	92 sq. miles
Date	10/25/2011
Field/Site ID	114
Bio Monitoring	No

GEOMORPHIC SUMMARY	
Est. Bankfull El.	1088.0'
Channel Slope	0.20%
Sinuosity	1.1
Bankfull Width	142.7'
W/D Ratio	214.6
Material (D50)	13.0 mm
BEHI Rating	Moderate
NBS Rating	Very Low

- Relatively steep gradient between prominent riffles containing coarse substrate (gravel and small cobble).
- Floodplain accessible during high flow events.

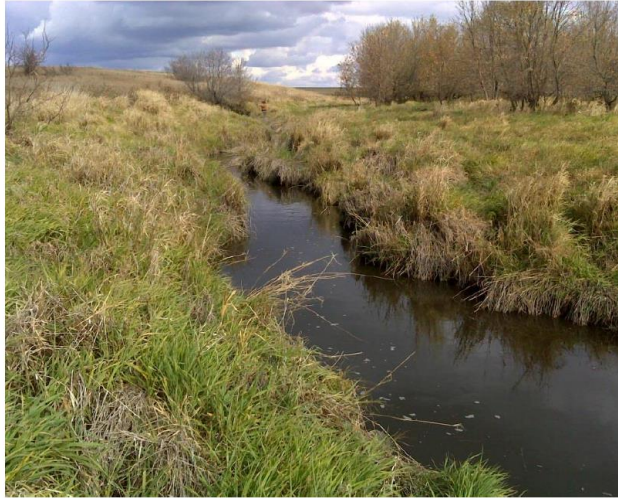
<b>Stream/River</b>	Eighteenmile
<b>County</b>	Traverse
<b>Drainage Area</b>	50 sq. miles
<b>Date</b>	10/26/2011
<b>Field/Site ID</b>	IBI A
<b>Bio Monitoring</b>	Yes

<b>Est. Bankfull El.</b>	986.6'
<b>Channel Slope</b>	0.01%
<b>Sinuosity</b>	1.1
<b>Bankfull Width</b>	18.4'
<b>W/D Ratio</b>	12.9
<b>Material (D50)</b>	1.3 mm
<b>BEHI Rating</b>	Moderate
<b>NBS Rating</b>	Very Low

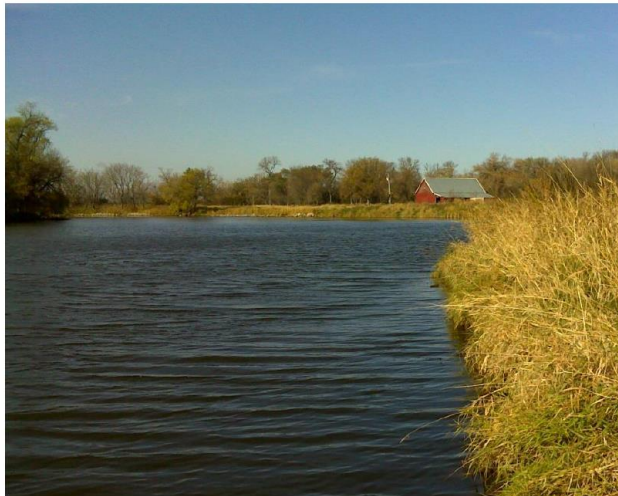
<b>Stream/River</b>	Mustinka
<b>County</b>	Traverse
<b>Drainage Area</b>	858.3 sq. miles
<b>Date</b>	10/26/2011
<b>Field/Site ID</b>	IBI B
<b>Bio Monitoring</b>	Yes

<b>Est. Bankfull El.</b>	979.0
<b>Channel Slope</b>	0.006%
<b>Sinuosity</b>	1.2
<b>Bankfull Width</b>	253.4'
<b>W/D Ratio</b>	41.0
<b>Material (D50)</b>	N/A
<b>BEHI Rating</b>	N/A
<b>NBS Rating</b>	Low

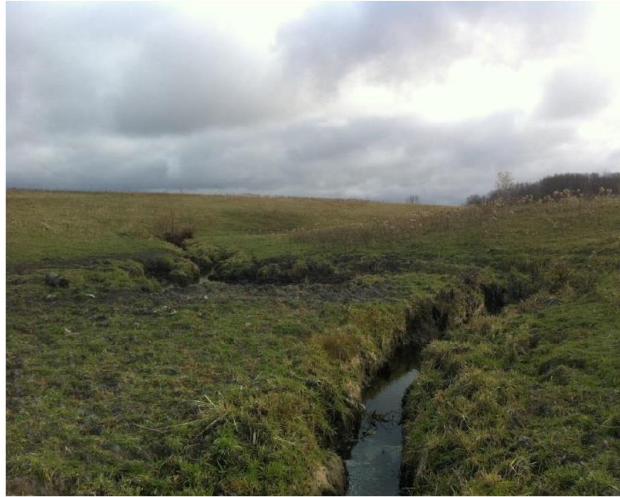
REACH INFORMATION	
Stream/River	Unknown
County	Grant
Drainage Area	10 sq. miles
Date	10/26/2011
Field/Site ID	IBI C
Bio Monitoring	Yes

GEOMORPHIC SUMMARY	
Est. Bankfull El.	1102.1'
Channel Slope	0.08%
Sinuosity	1.3
Bankfull Width	13.5'
W/D Ratio	11.2
Material (D50)	2.2 mm
BEHI Rating	Moderate
NBS Rating	Moderate

- Headwater, higher gradient stream
- Intensively grazed

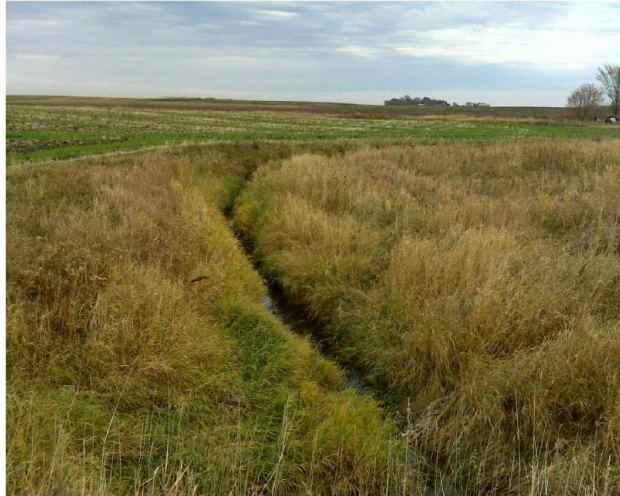
REACH INFORMATION	
Stream/River	CD-#8
County	Big Stone
Drainage Area	16.6 sq. miles
Date	10/24/2011
Field/Site ID	IBI D
Bio Monitoring	Yes

GEOMORPHIC SUMMARY	
Est. Bankfull El.	1099.0'
Channel Slope	0.37%
Sinuosity	1.3
Bankfull Width	9.8'
W/D Ratio	7.8
Material (D50)	4.0 mm
BEHI Rating	Moderate
NBS Rating	Low

- A wide buffer zone exists upstream of 720<sup>th</sup> Avenue. The “E” channel in this reach is very stable with undercut banks and pools providing instream habitat. The stream is ditched downstream of 720<sup>th</sup> Avenue and no buffer exists.

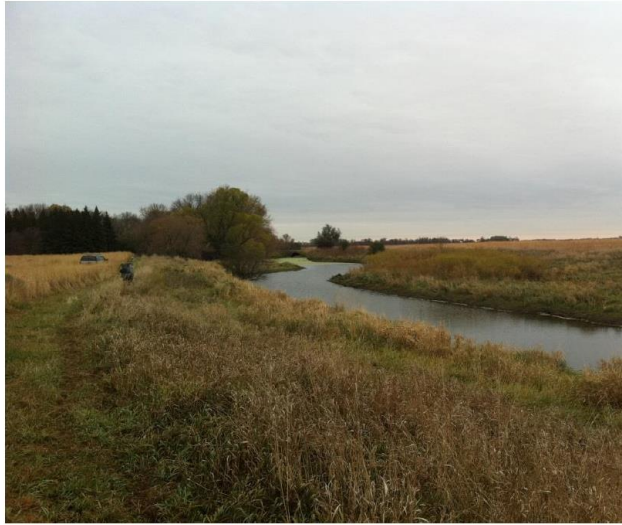
Est. Bankfull El.
Channel Slope
Sinuosity
Bankfull Width
W/D Ratio
Material (D50)
BEHI Rating
NBS Rating

- Did not survey; bottom unconsolidated and no longer an active flowage
- Former Mustinka River Channel, cut off by Army Corps bypass
