March 2020

Upper Iowa River and Mississippi River–Reno Watershed Restoration and Protection Strategy Report

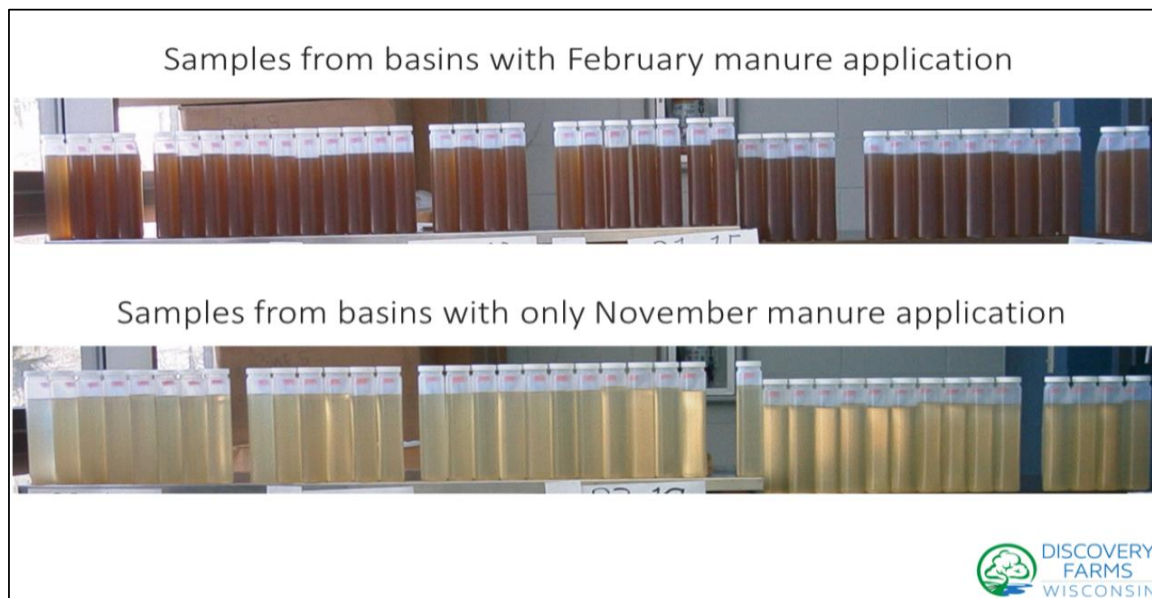
Figure 23. Comparison of runoff when manure is applied in early winter and late winter (photo from Discovery Farms).

by two to four times when compared to early winter applications (Discovery Farms 2019). One study completed by Discovery Farms Wisconsin provides a visual picture of the difference between early and late winter application of manure from two adjacent fields with similar slope and tillage practices (Figure 23). One field (bottom image) only had manure applied in November while the other field (top image) had manure applied in February.

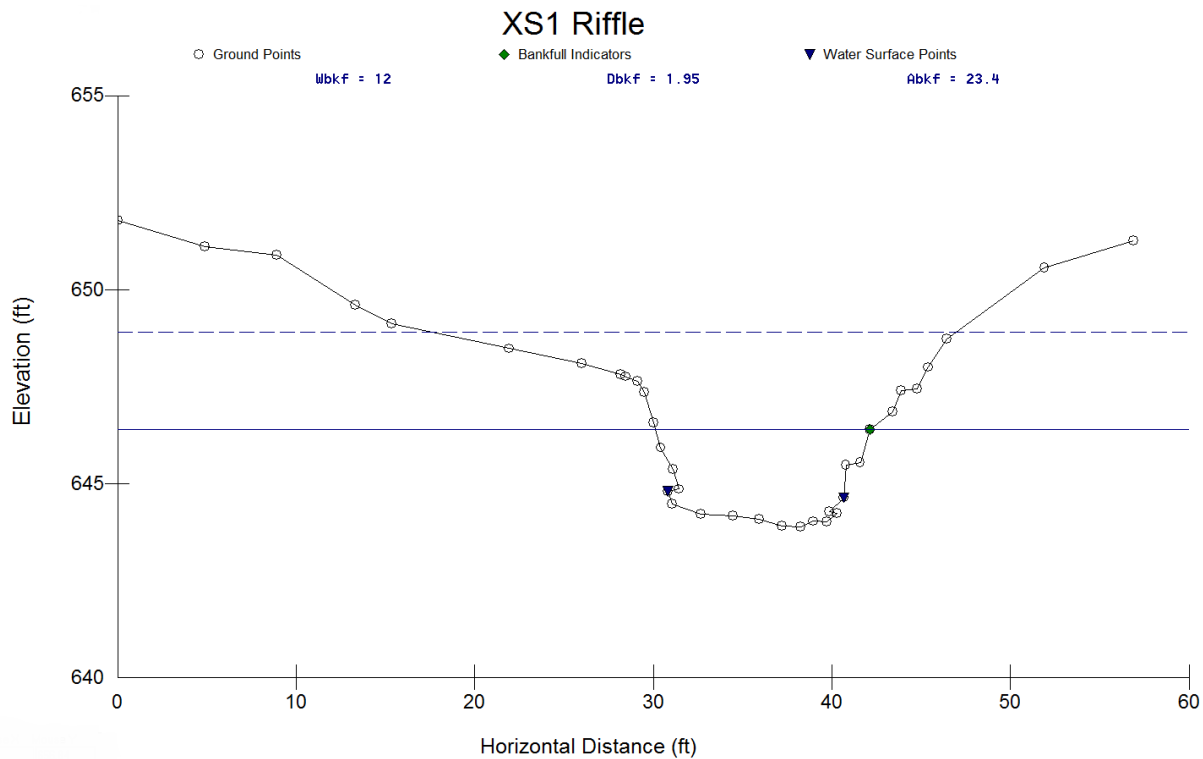
Figure 2. Cross section of riffle showing bankfull elevation (solid line) and floodprone elevation (dashed line)

Incision is the process of a stream abandoning an active floodplain and is measured by dividing the lowest bank height by the maximum depth at bankfull (Bank height ratio). The bank height ratio of the surveyed riffle is 1.33, classified as *moderately incised*. The lower base levels are lead to a narrowing of the floodplain; although, the reach is still considered as not entrenched.

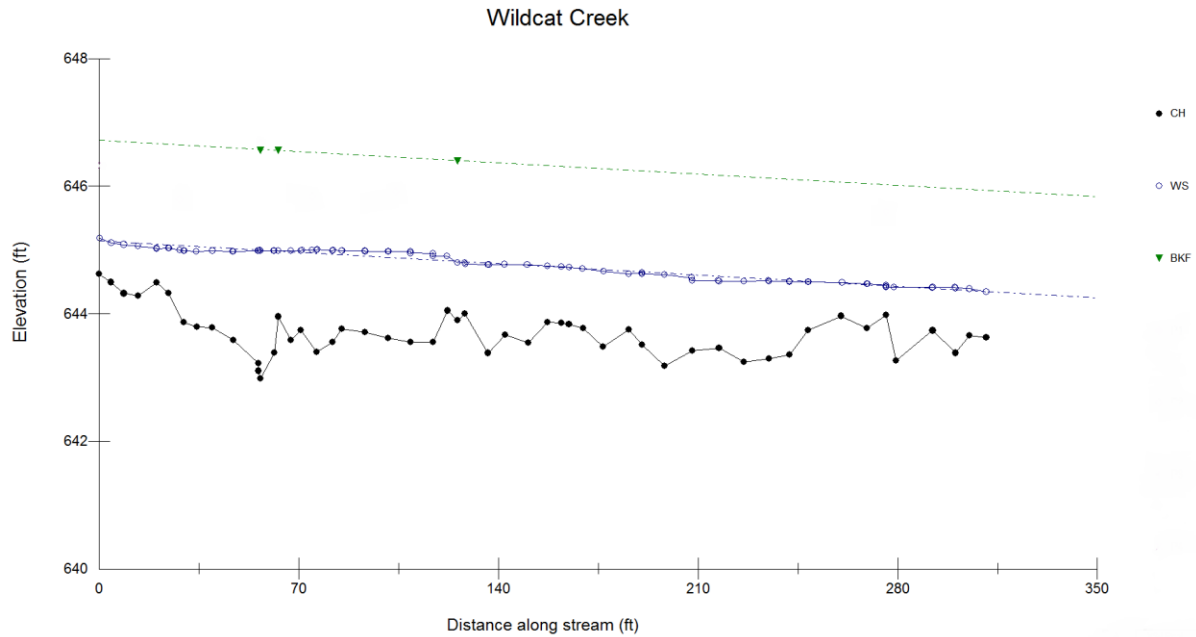
Figure 3. Longitudinal profile of survey

The longitudinal profile is 311 feet long and contains four riffles and four pools (Figure 3). Pool spacing and riffles are typical of E stream types in the area, but the profile indicates some deposition in pools (also noted in the Pfankuch rating).

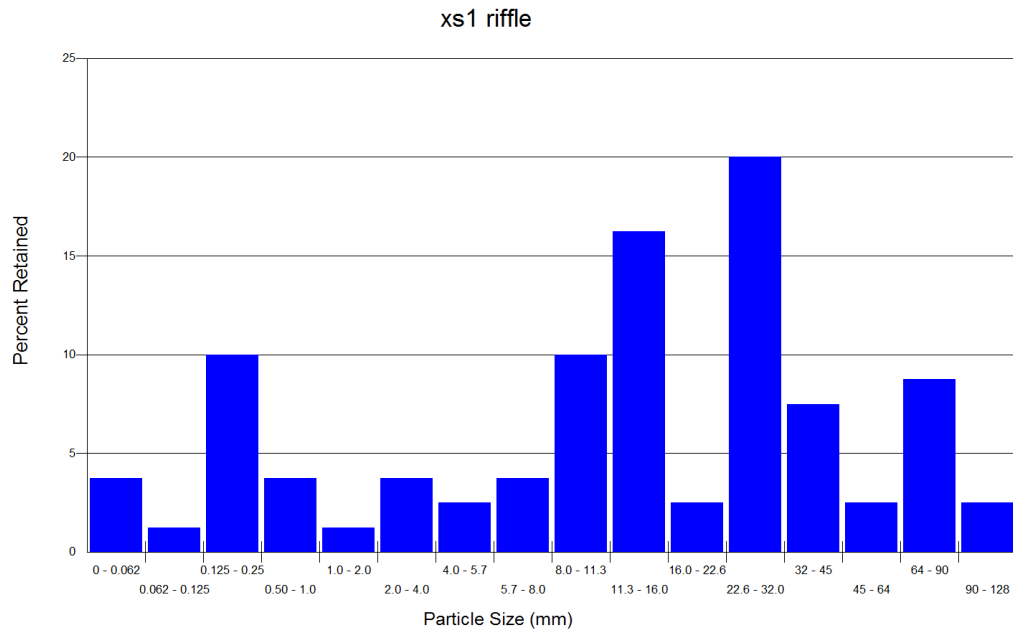
Figure 4. Particle distribution at riffle cross section

Pebble count at the riffle cross section has a slight bi-modal distribution. Median particle size is 14.19mm, with distribution peaks at 0.125mm and 22.6mm. This indicates fine sediment inundating the interstitial spaces of the gravel.

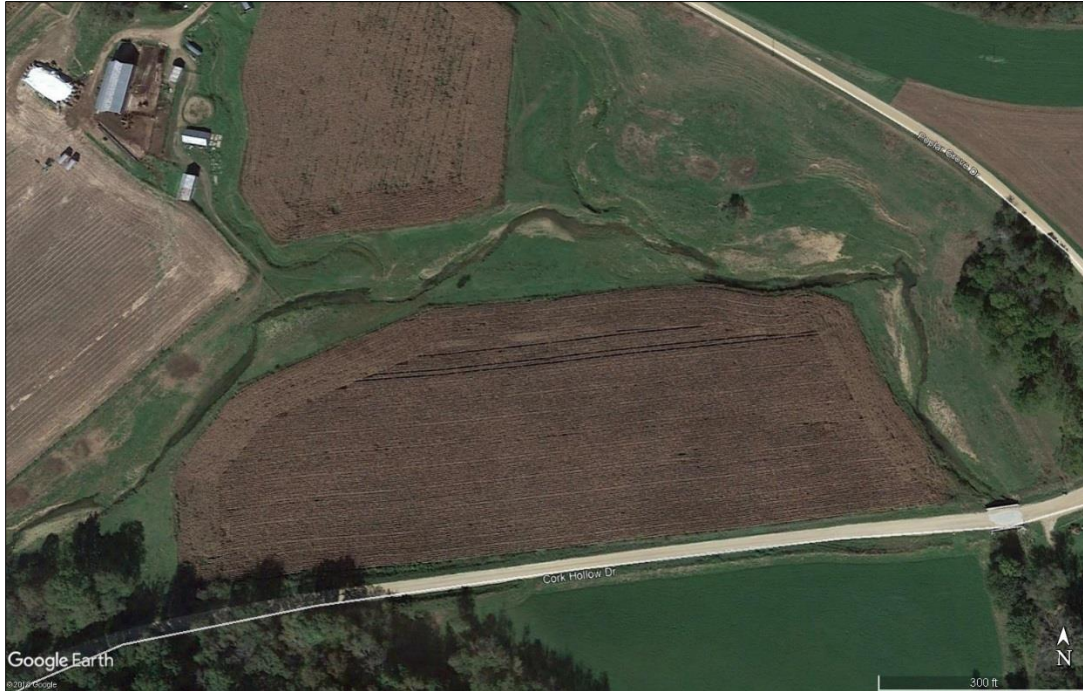
Figure 6. Example of a grazed area of the stream with signatures of erosion

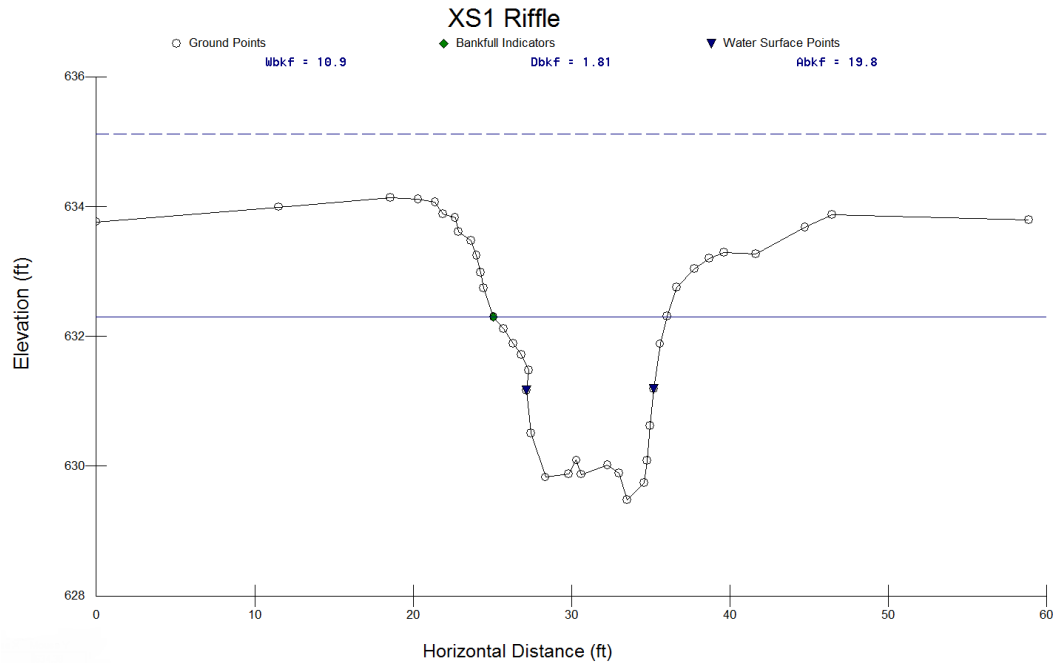
Figure 3. Cross section of riffle showing bankfull elevation (solid line) and flood prone elevation (dashed line)

Incision is a lowering of the channel elevation which increases the risk for accelerated bank erosion. Bank height ratio is the lowest bank height divided by the maximum depth at bankfull, which is a measure of incision. Figure 3 illustrates the amount of incision. Averaging the the entire bank height ratio of the profile is 1.27, or falls within the category of *slightly incised*. Floodprone width describes the amount of floodplain at elevations 2x bankfull depth. At this elevation clear creek has access to 470 feet of floodplain, which reduces streambank sheer stress by allowing the stream to spread out during flood events.

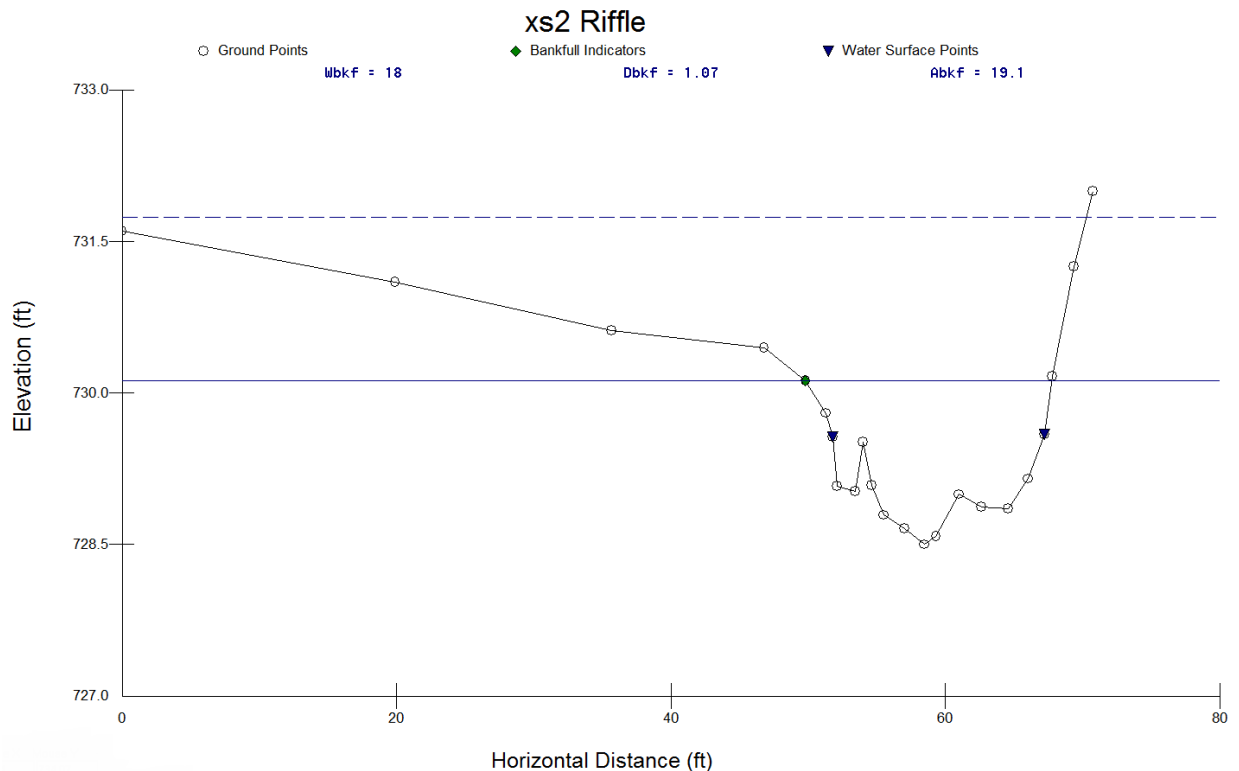
Figure 5. Cross section of riffle showing bankfull elevation (solid line) and flood prone elevation (dashed line) demonstrating the stable bank height ratio

Incision is a lowering of the channel elevation, potentially increasing the risk for accelerated bank erosion. Bank height ratio is a measure of channel incision, calculated by dividing the lowest bank height by the maximum at bankfull. The ratio of this survey is 1.0, which represents one aspect of channel stability and represents good connectivity to the floodplain for bankfull flows (Figure 5).

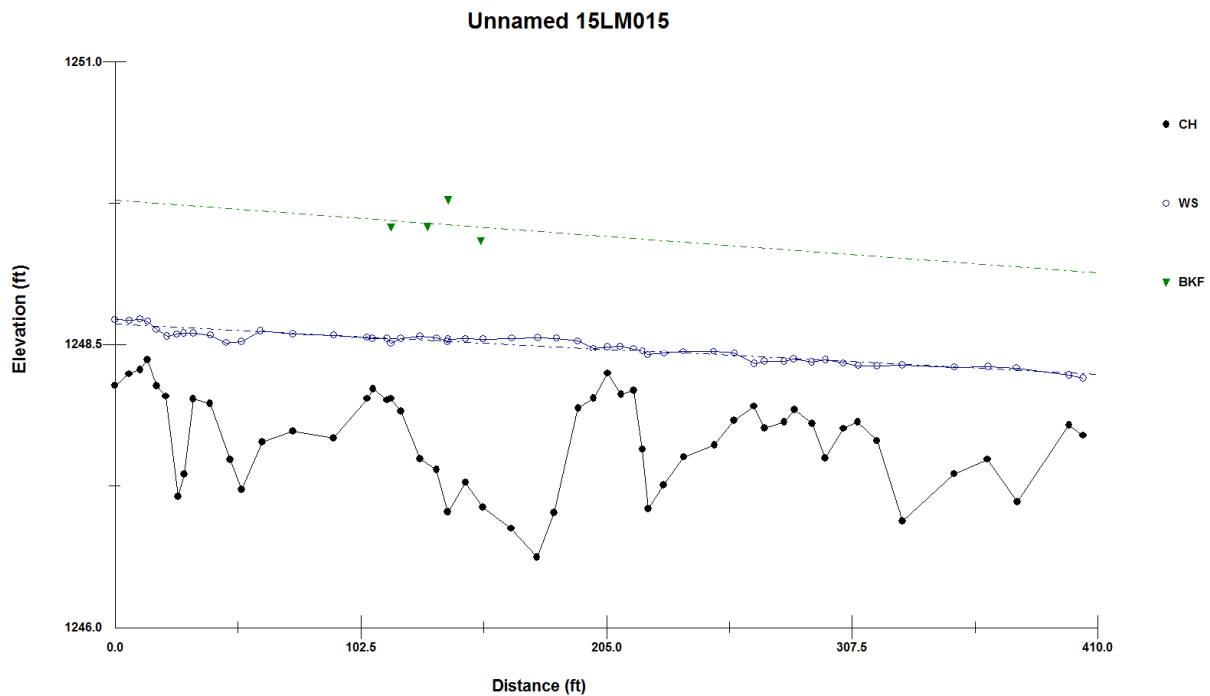
Figure 3. Longitudinal profile of survey

about 0.003, or twice the surveyed reach slope, which may be supplying stream power to maintain pools.

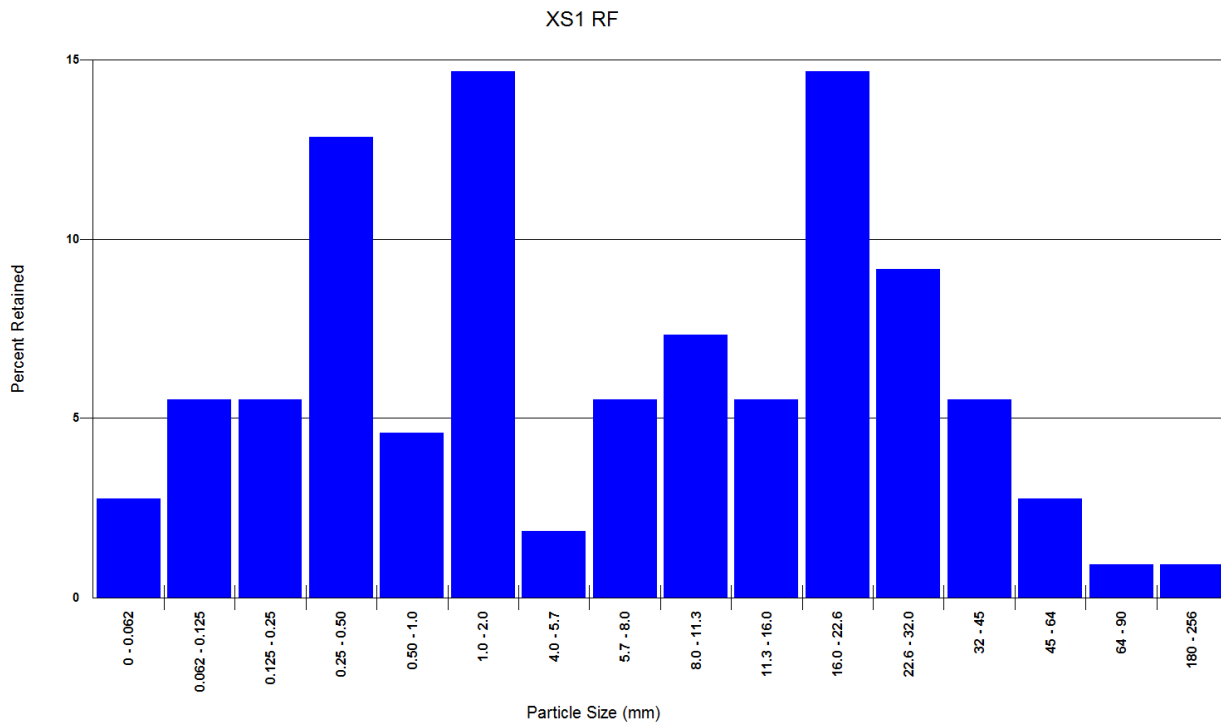
Figure 4. Particle distribution at riffle cross section

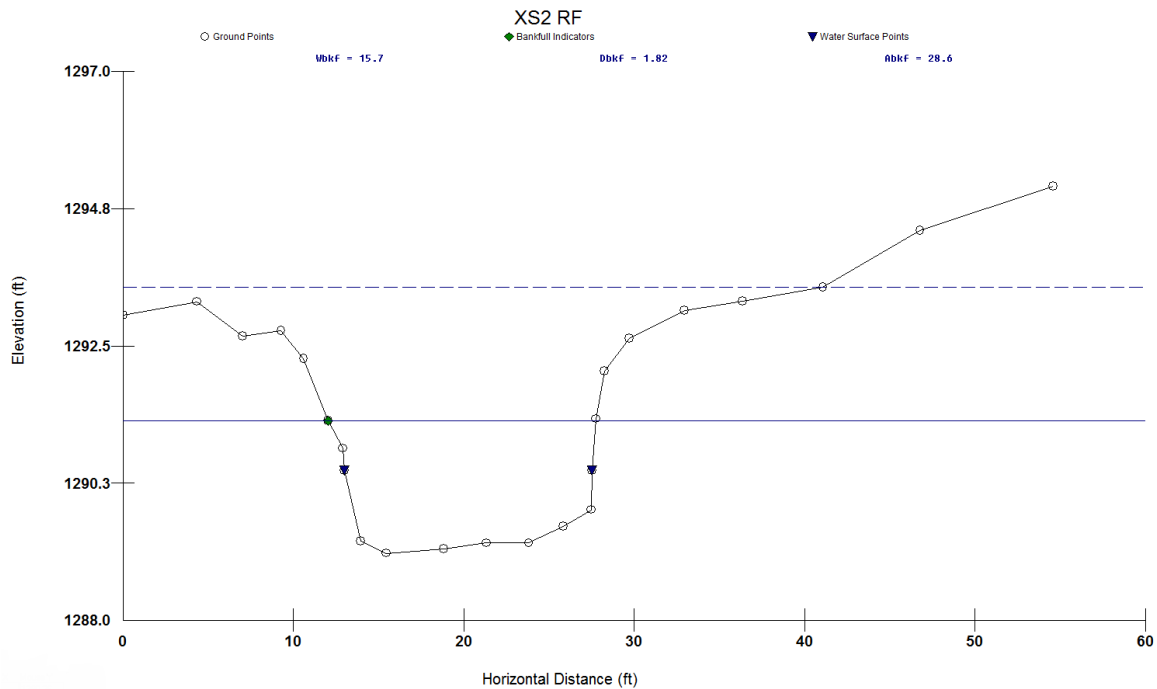
Figure 2. Cross section of riffle showing bankfull (solid line) and flood-prone elevations (dashed line)

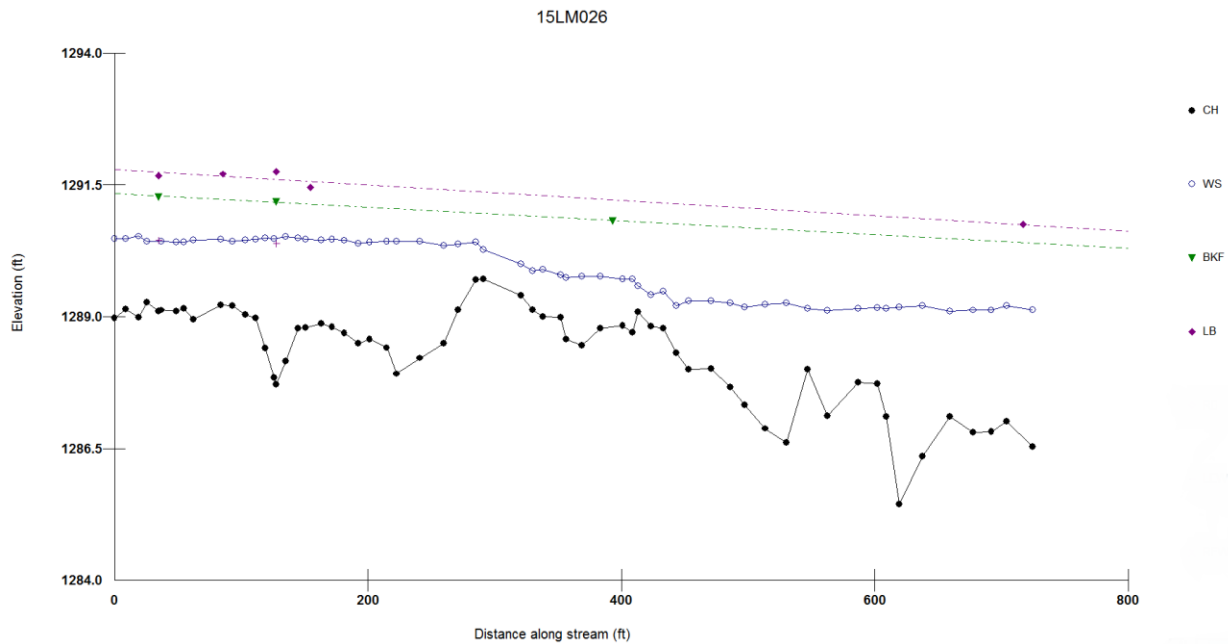
Figure 4. Longitudinal profile with bankfull (green) and lowbank (purple) slopes

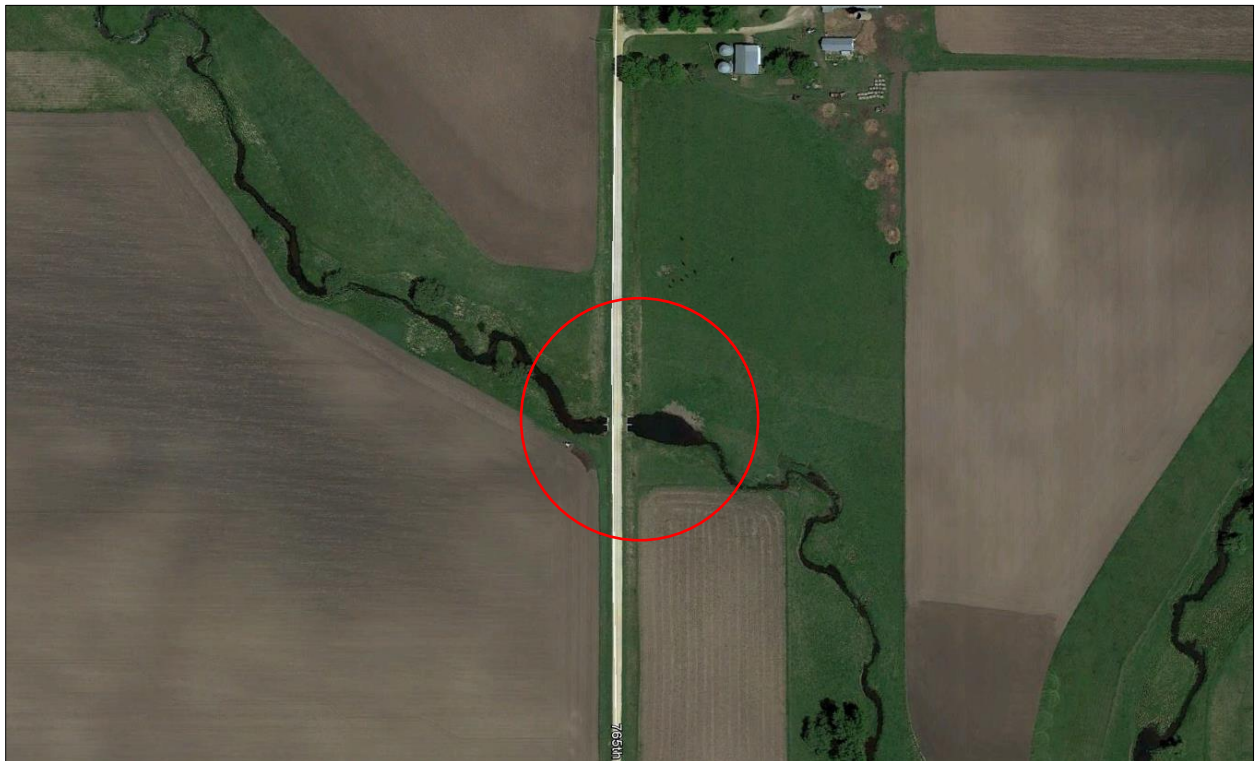
Figure 6. Over wide crossing downstream of survey, a potential stressor (Google Earth)

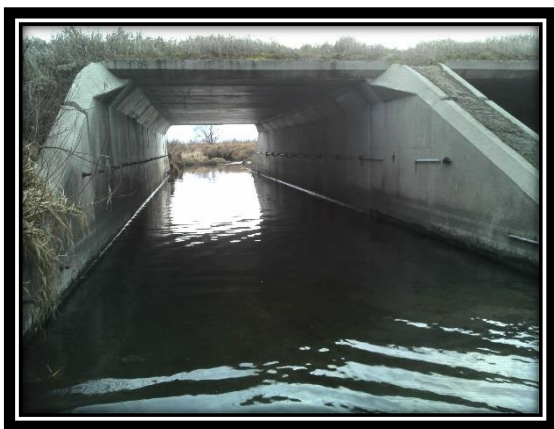
Figure 1 - Culvert on the Upper Iowa River

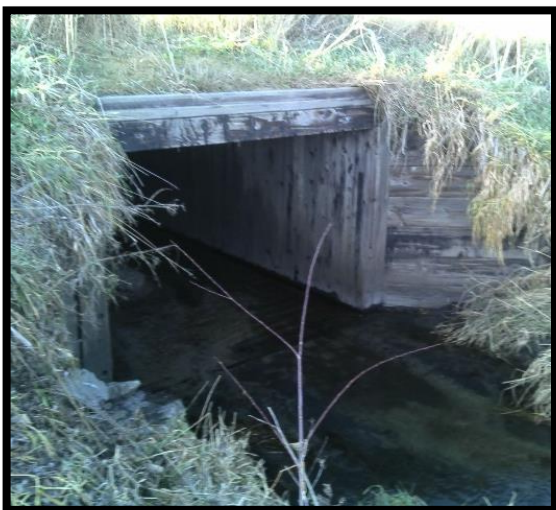
Figure5 – Wooden culvert on Fillmore County Highway 1

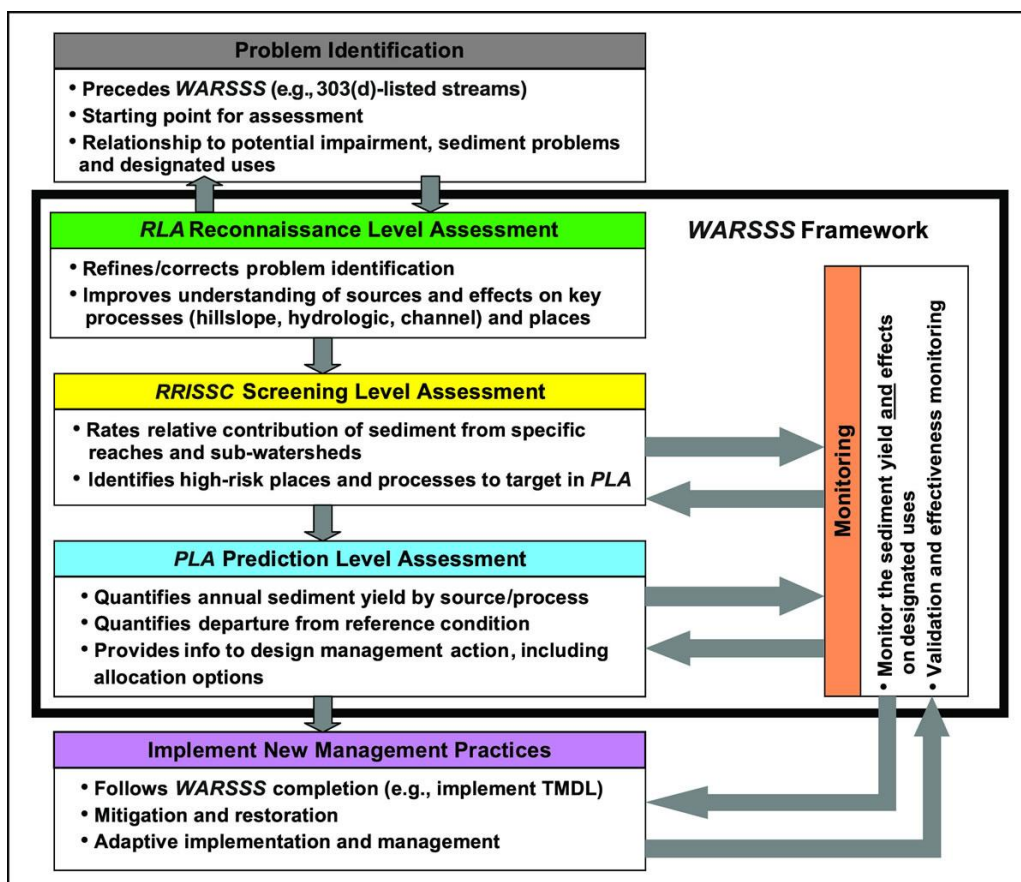
Figure 1. WARSSS phased approach flowchart (Rosgen 2009).

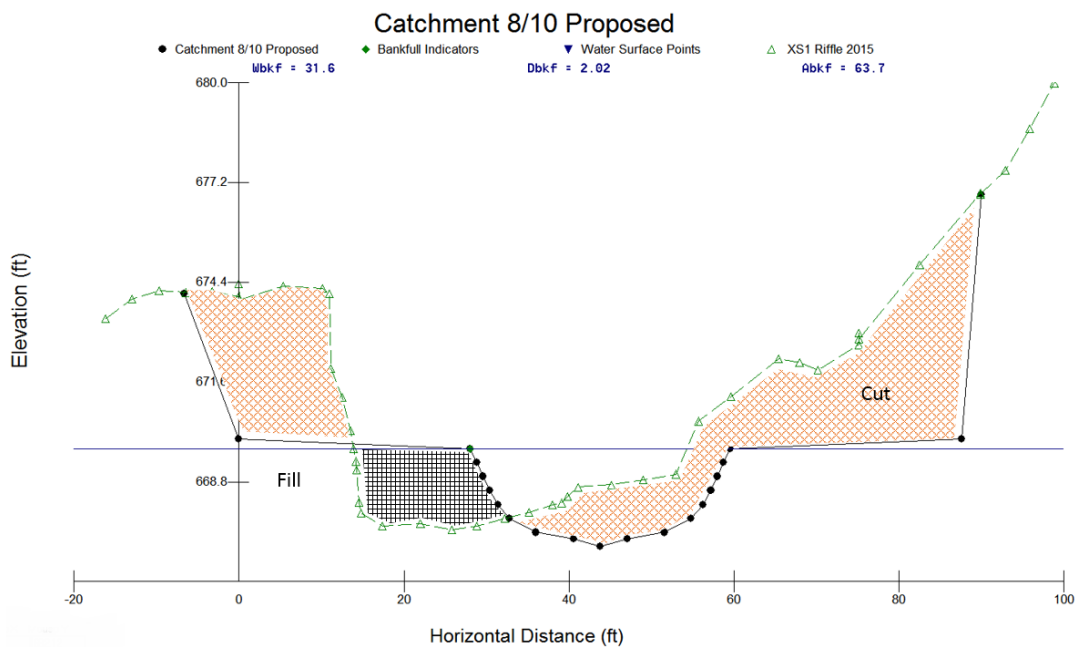
Figure 63. Proposed bankfull channel (below solid line) and floodplain cross-section for catchments 8 and 10.

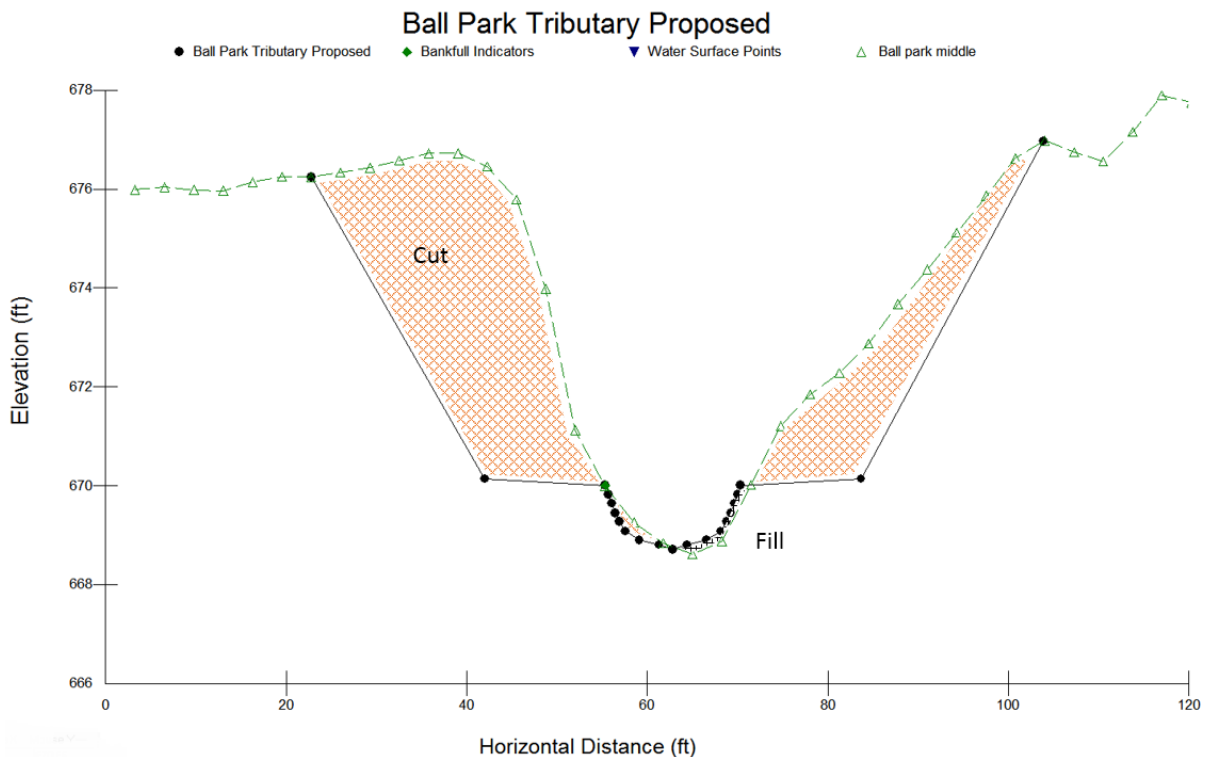
Figure 64. Ball Park Tributary channel restoration.
