WRAPS report summary

Watershed Restoration and Protection Strategy

Kettle & Upper St. Croix River (KUSC) Watersheds

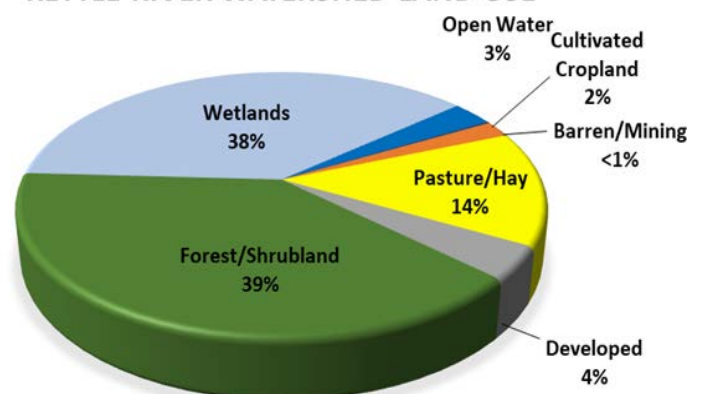
KETTLE RIVER WATERSHED LAND USE

- Size: 673,000 acres
- Counties: Aitkin, Carlton, Kanabec, Pine
- Ecoregion: Northern Lakes and Forest
- The land cover of the watershed is predominantly forest and shrub
- 126 lakes and 1,700 stream miles (Kettle & Upper St. Croix combined)
- The 8-digit hydrologic unit code (HUC): 07030003

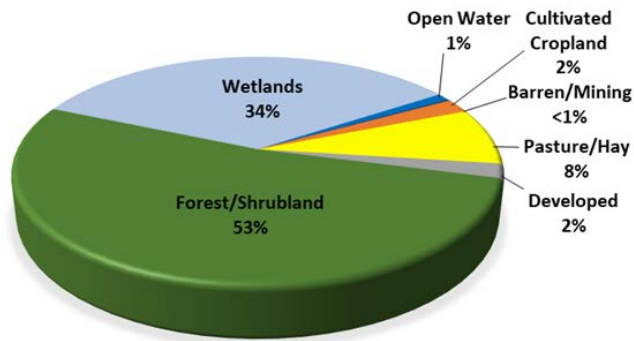
UPPER ST. CROIX RIVER WATERSHED LAND USE

- Size: 348,000 acres
- Counties: Pine
- Ecoregion: Northern Lakes and Forest
- The land cover is predominantly forest and shrub
- 126 lakes and 1,700 stream miles (Kettle & Upper St. Croix combined)
- The 8-digit hydrologic unit code (HUC): 07030001
