January 2021

Clearwater River Watershed

# Clearwater River Watershed Restoration and Protection Strategy Report

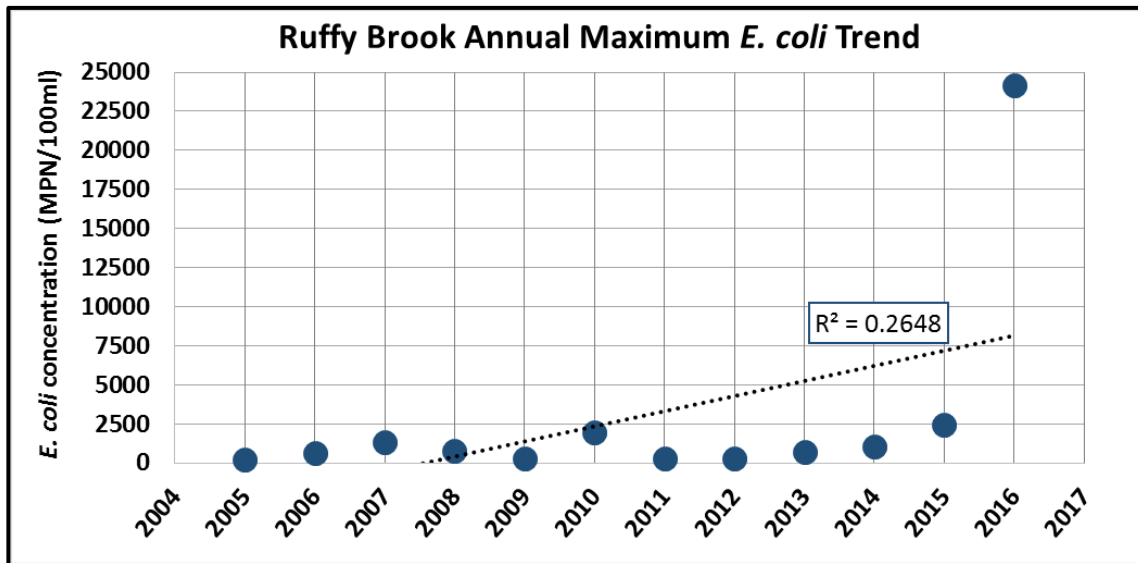
Figure 2-9. Time series of annual maximum *E. coli* concentrations in Ruffy Brook

The trend analysis for sites near the pour point of Ruffy Brook (Table 2-7) yielded mixed results. Although average DO levels have increased, concentrations of pollutants have increased. There is a possibility that recent changes in monitoring strategy have contributed to the increases. The frequency of sampling has increased during the Clearwater River WRAPS and SWAG projects. The long-term monitoring site location was moved downstream from S002-120 to S008-057. Record high concentrations of pollutants (for Ruffy Brook) were found in 2016 (24,916 MPN/100ml *E. coli*, 0.493 mg/L TP, and 397 mg/L TSS). At least one more year of *E. coli* sampling was needed to compile the minimum of 10 years of data for any individual calendar month that is needed to conduct Mann-Kendall trend analysis. Analysis of average annual *E. coli* concentrations did not reveal a trend. However, analysis of annual maximum *E. coli* concentrations revealed an increasing trend (Figure 2-9).

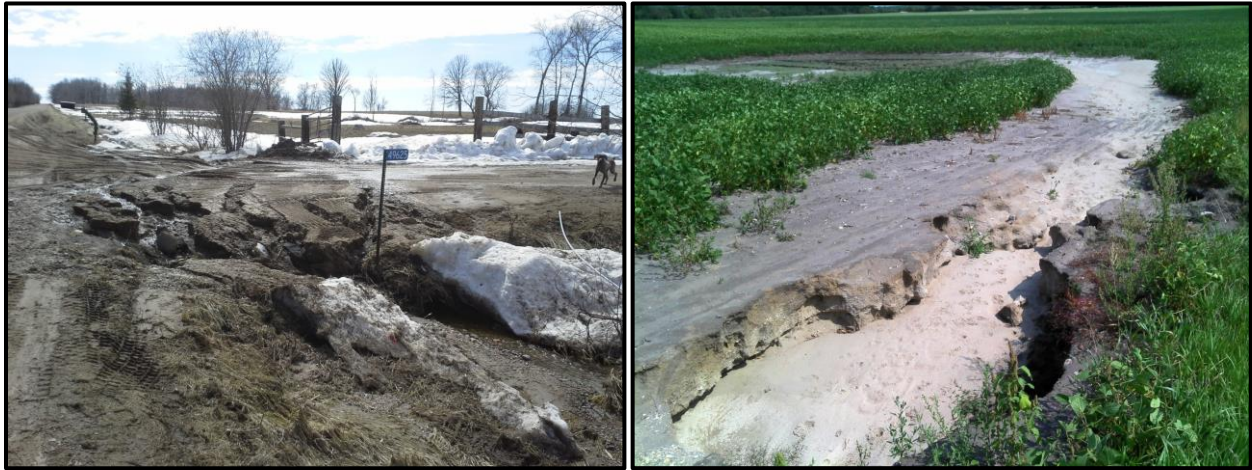
Figure 2-16. Photos of gullies and washouts that occurred during runoff events in the Clearwater River Watershed

Runoff events in the Ruffy Brook and Silver Creek watersheds have washed out driveways (Figure 2-16) where culverts have either been plugged or inadequately sized. Very high TSS concentrations have been recorded in the Clearwater River and its tributaries during spring runoff and June rain events.

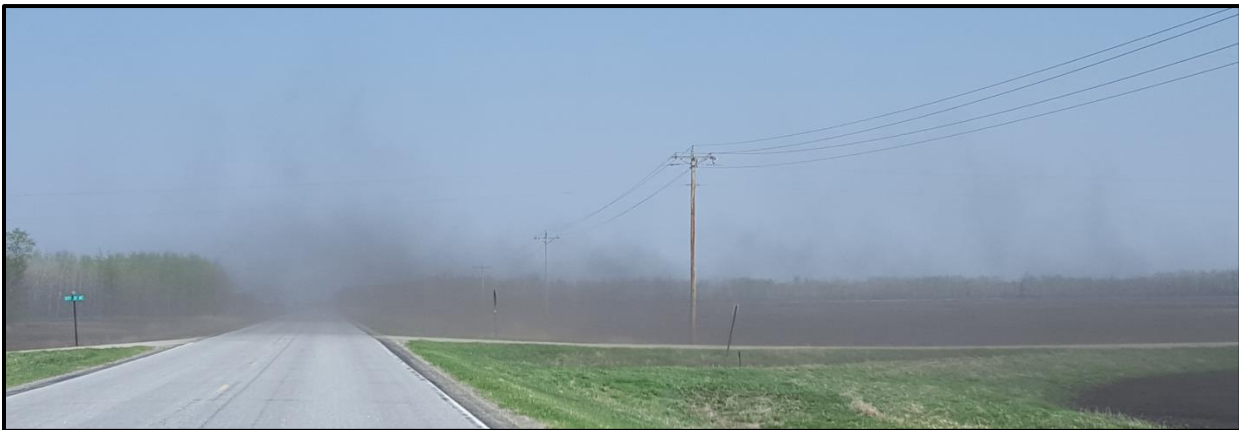
**Figure 2-17. Example of May wind erosion from cultivated fields (especially rolled fields) that can occur before vegetative plant growth is established**

Rolled fields (Figure 2-17) are particularly susceptible to wind erosion. Soybean fields are rolled to prevent damage to harvesting equipment. Rolling pushes rocks into the ground and breaks up clumps of soil that might damage cutters on equipment that is set close to the ground. According to an article from the University of Minnesota Extension Service (Dejong-Hughes 2016), this practice poses risks, including potential plant injury, soil sealing, added expense, and erosion.

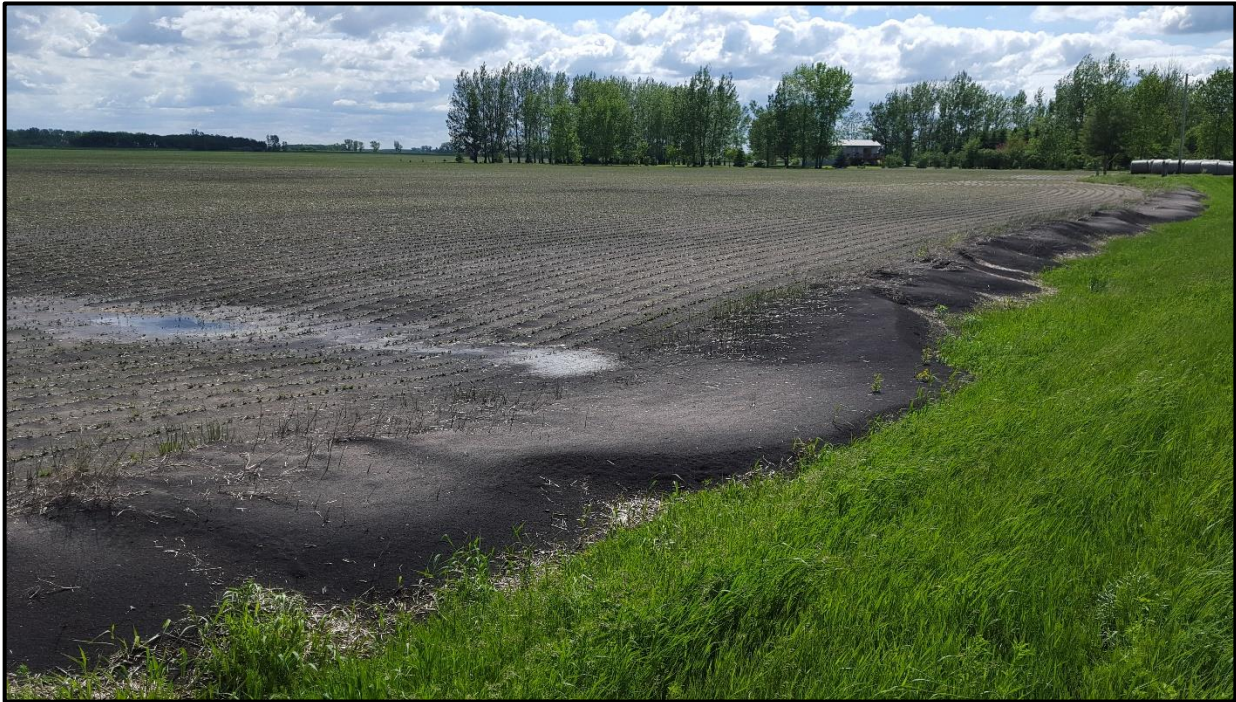
Figure 2-18. Sediment that has been eroded by wind and deposited into a ditch near the Clearwater River

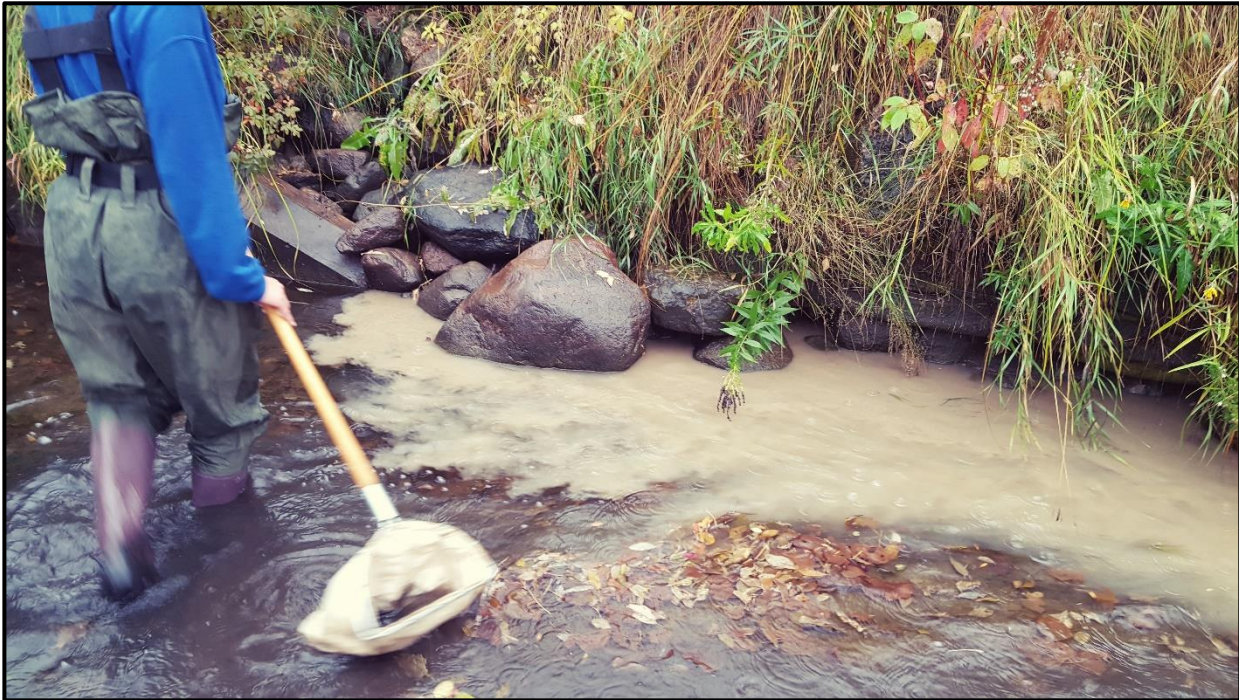
Figure 2-33. Pollutants entering the Hill River at the CR 119 crossing near Brooks along AUID 539

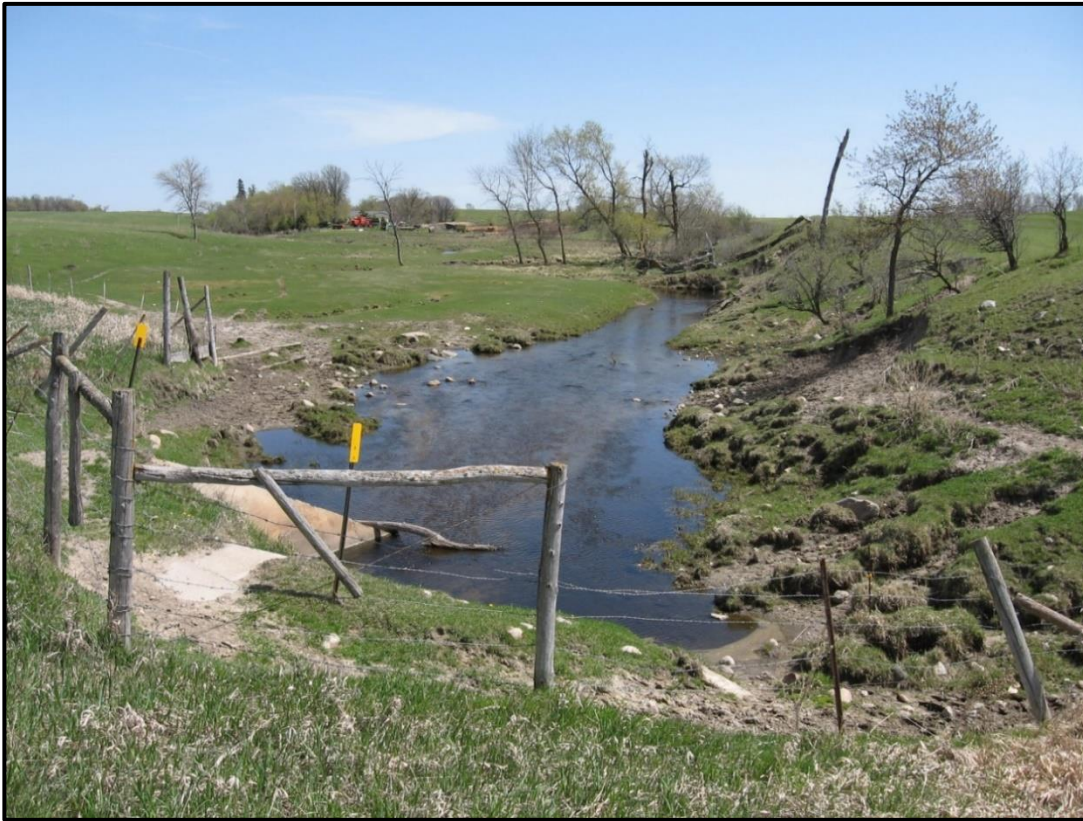
Figure 2-34. Poplar River at CSAH 27 with poorly vegetated banks due to livestock along AUID 518

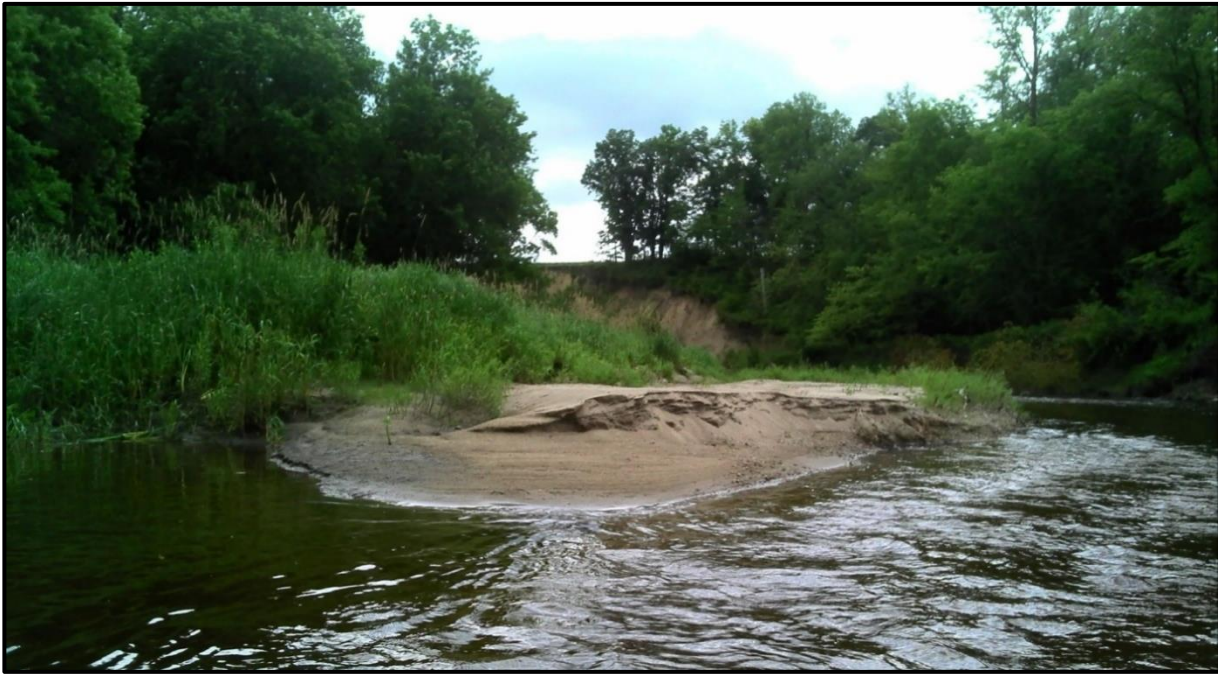
Figure 2-35. Erosion and sedimentation in the Lost River downstream of CR 118 (AUID 505)

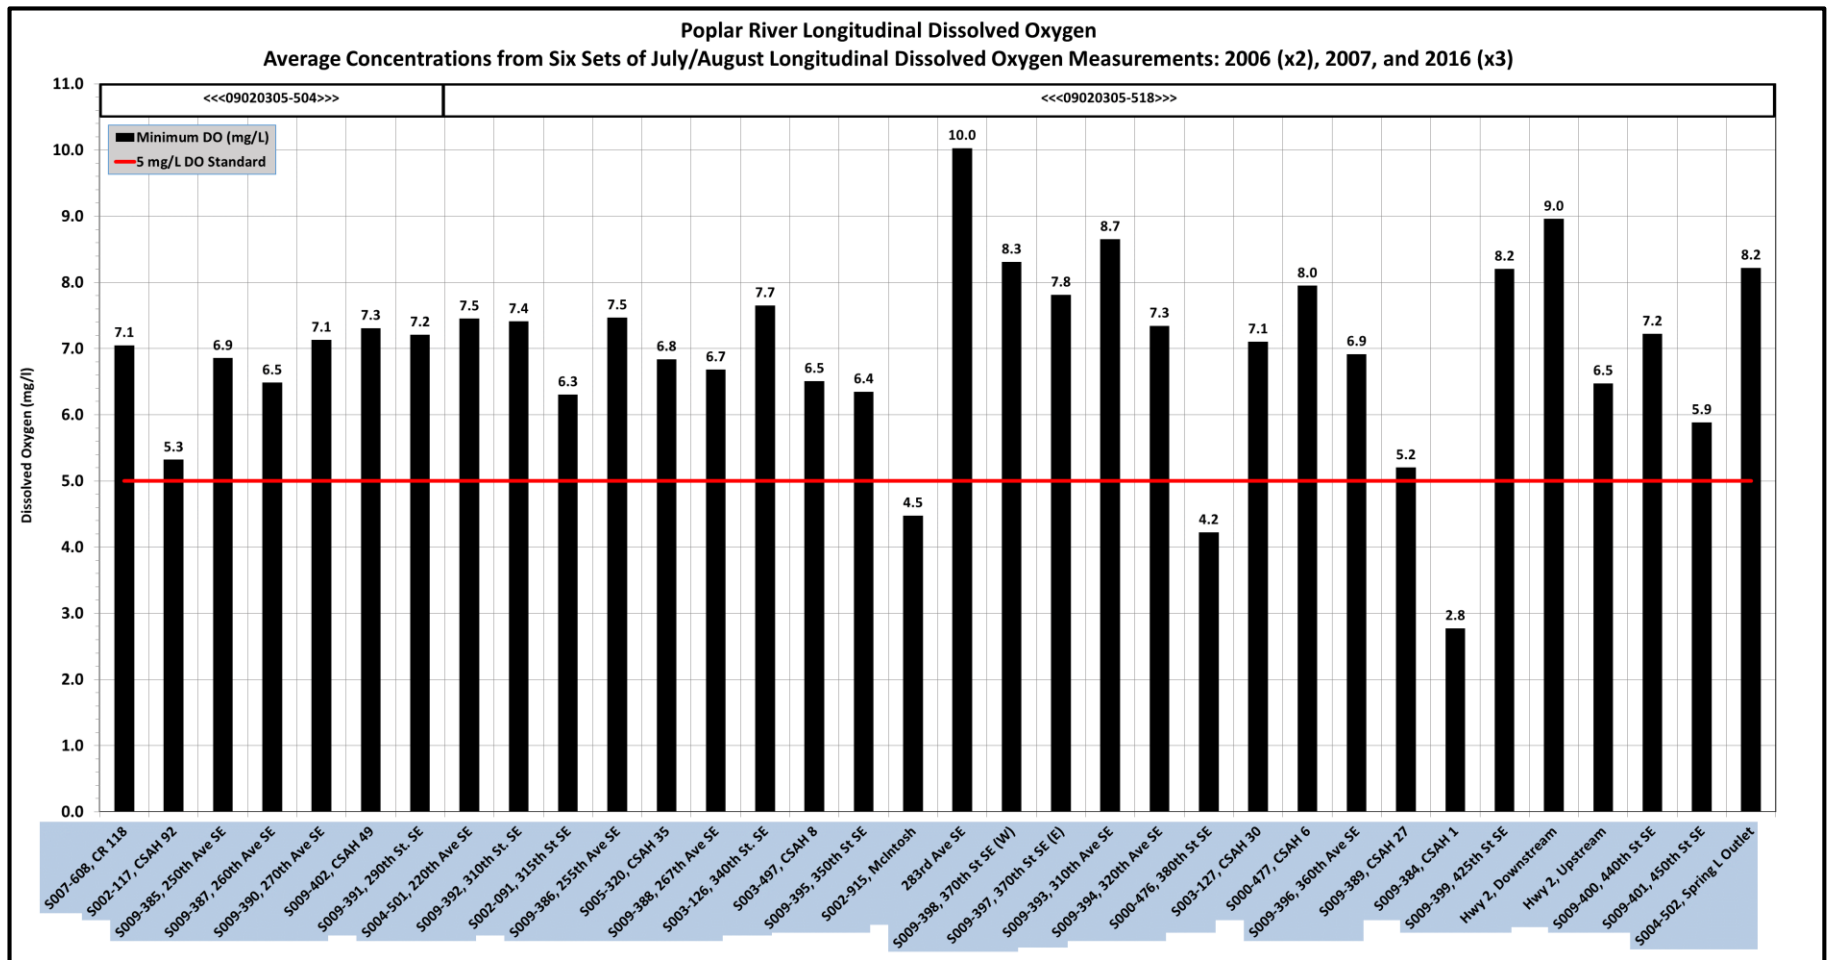
Figure 3-16. Summary of average DO levels that were recorded in longitudinal measurements along the Poplar River AUIDs 504 and 518.
