Lake Superior North Stressor Identification Report

A study of local stressors limiting the biotic communities in the Lake Superior North Watershed

Document number: wq-ws5-04010101a

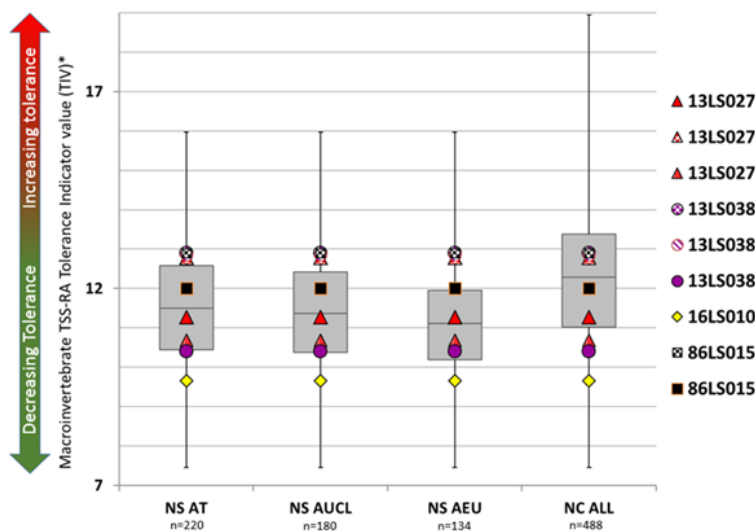
Figure 4. Example of TIV results as used in later sections of this report. Acronyms are described in Table 5.

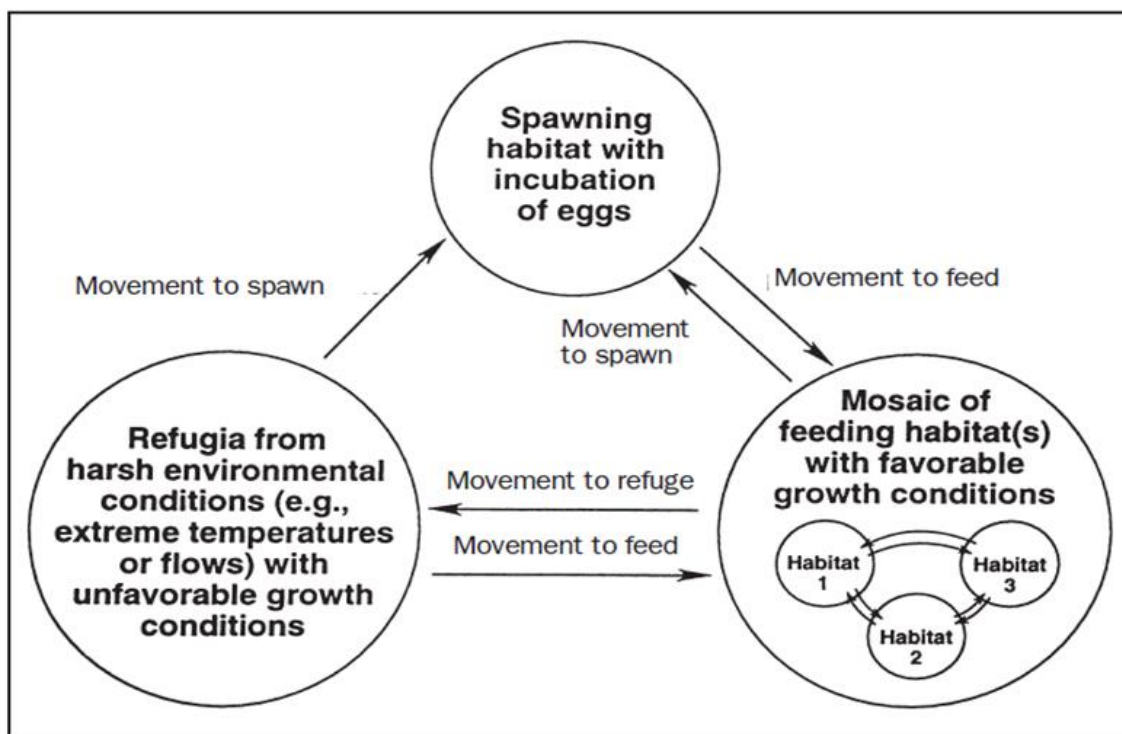
Figure 7. The basic life cycle of stream fish with emphasis on patterns of habitat use and migration (from Schlosser, 1991).

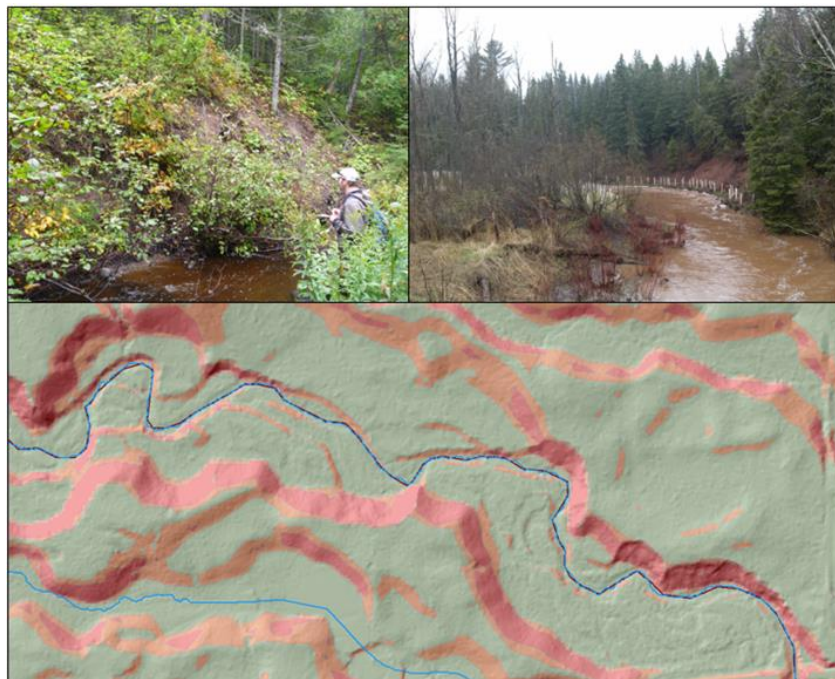
Figure 9. Examples of stream thalweg/valley wall intersection in red clay soils area of the Flute Reed River. Bank and bluff erosion is frequently observed in these areas.

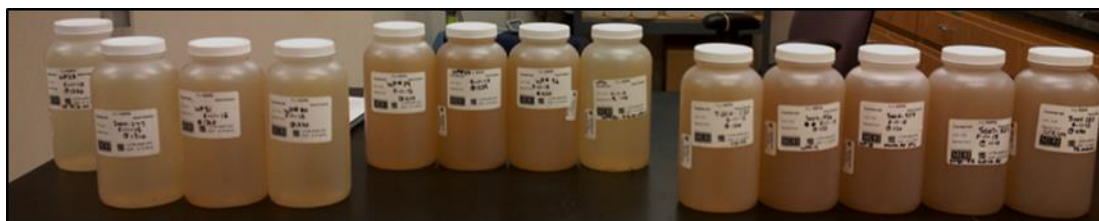
Figure 14. Visual demonstration of TSS increases from upstream (left) to downstream (right) from a May 11, 2015 sampling event. Bottles in the forefront are main stem stations, and bottles set back are tributary samples.

Longitudinal synoptic sampling of TSS was completed during four moderate to high flow events in 2015 and 2016. A total of 8-10 stations were sampled during these events, with several of these located on major tributaries to the Flute Reed River. The TSS standard of 10 mg/L was exceeded by at least three monitoring stations in each of the four synoptic sampling events. The highest TSS concentrations (range 17 mg/L - 181 mg/L) were observed during a May 2015 sampling event following a 2.2" rain over a 5-day period. All monitoring stations exceeded the 10 mg/L TSS standard during this sampling event with the exception of a station located in a headwaters tributary at station FT 9 (TSS=4.4 mg/L). Results from the two snowmelt events sampled in March and April of 2016 illustrated the difference in TSS concentrations during a pre-snowmelt event (water running over anchor ice) and a snowmelt event during a complete thaw, as TSS concentrations were 2-3 times higher during the complete snowmelt event (figure 14).

TSS concentrations only narrowly exceeded the 10 mg/L standard at several stations following a 1" rainfall in June of 2016 (figure 14). All six of the tributary stations sampled had TSS concentrations below 10 mg/L. Six of ten stations sampled on the main stem of the Flute Reed River met the water quality standard, and those exceeding the standard did so by a narrow margin. Stations exceeding the standard were located between stations, FR 6 and FR 4 (see map in Figure 12). Large beaver dams are present on the main stem and tributary streams in this area of the watershed, which may be linked to the higher TSS values. Beaver dams as a sediment sources are discussed further in section 4.4.8.

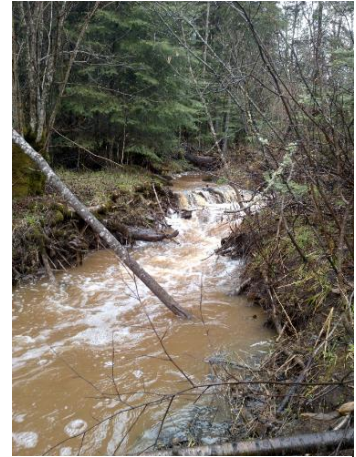
Figure 22. Active headcut on Flute Reed River tributary during high flow.

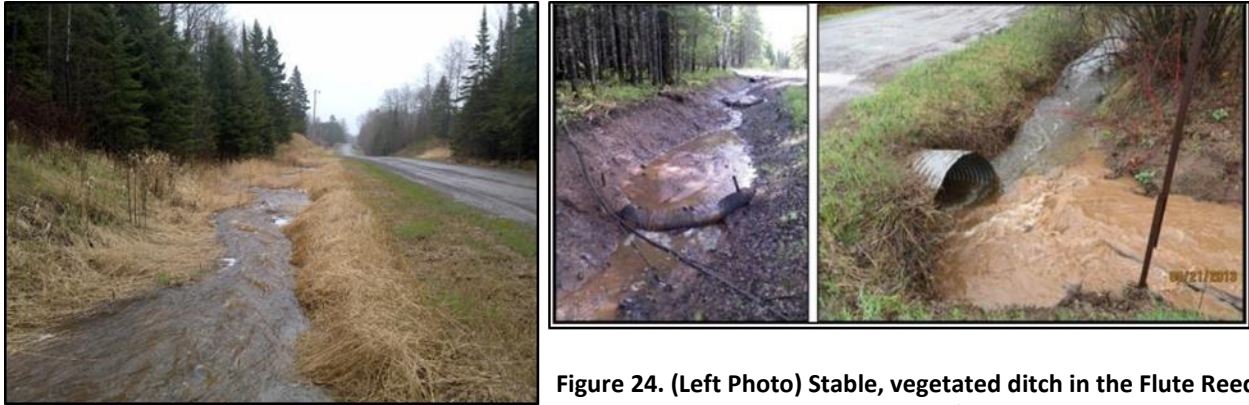
Figure 24. (Left Photo) Stable, vegetated ditch in the Flute Reed River watershed during a snowmelt/rain event. (middle Photos) Examples of ditch “maintenance” leading to instability and sediment loading in other watersheds along the North Shore of Lake Superior.

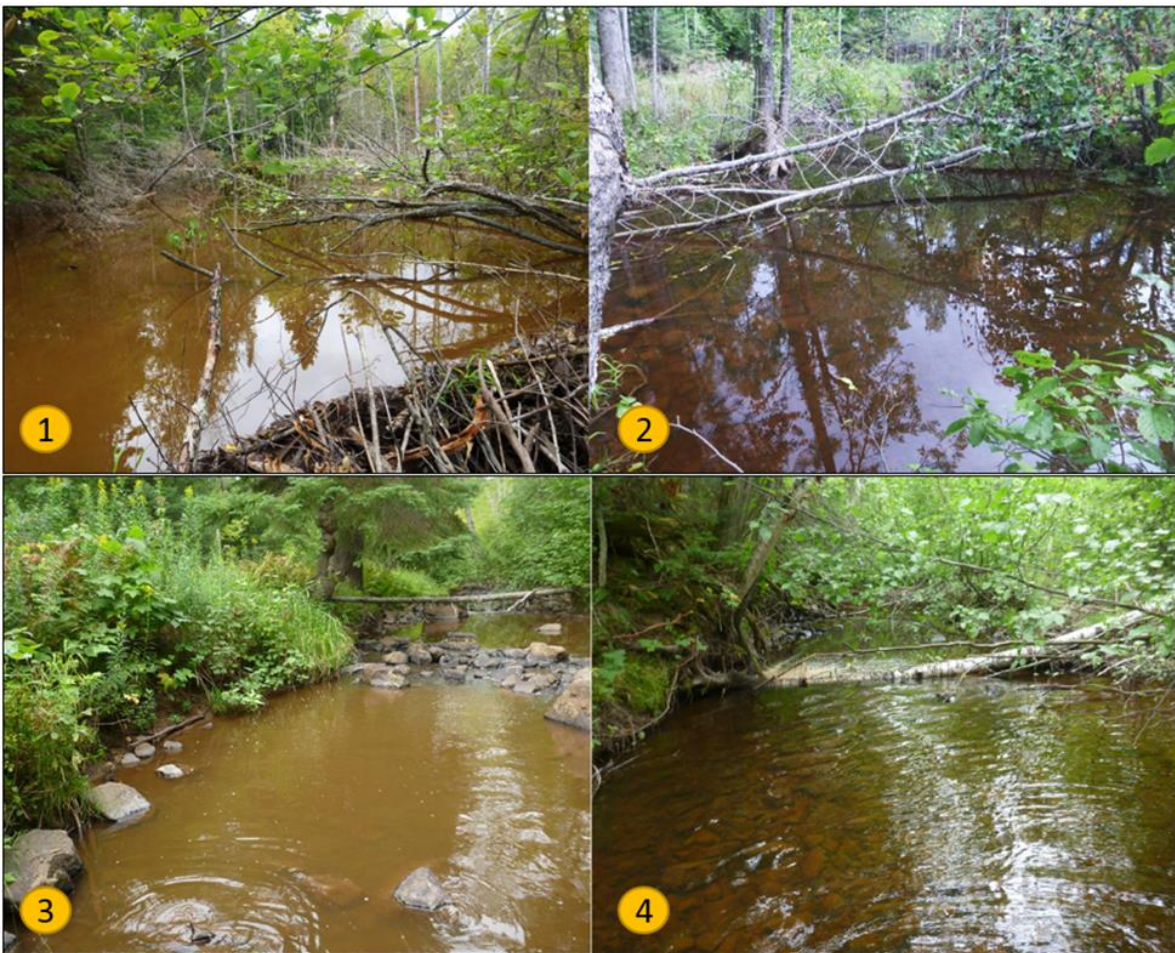
Figure 25. This series of photos was taken near a large beaver dam complex on the Flute Reed River. Photos #1 and #3 shows turbid water conditions within and below an impoundment created by a 6’ beaver dam; photos #2 and #4 show improved water clarity upstream of the beaver dam complex. These photos suggest that beaver dams can be a localized source of increased TSS/turbidity in areas with large quantities of silt/clay substrate.

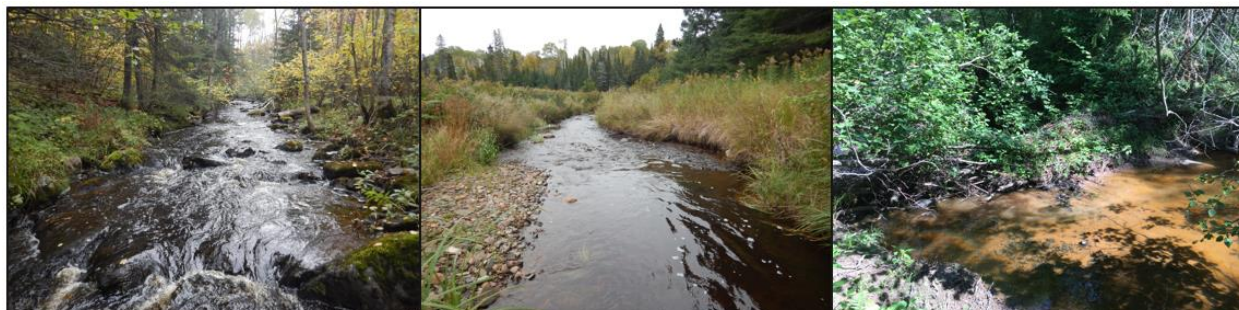
Figure 30. Scenes of physical habitat conditions on the Flute Reed River. (Left) Steep, cobble/boulder dominated reach; (Center) Low-gradient, gravel dominated reach within former beaver impoundment; (Right) Coarse substrate extremely embedded by sand and silt.

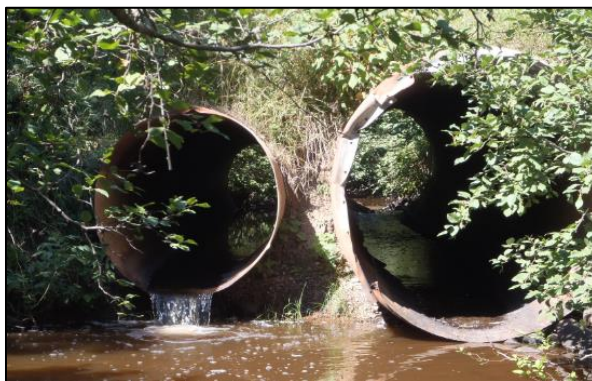
Figure 33. Undersized and perched culverts at Camp 20 Rd (CR 70).

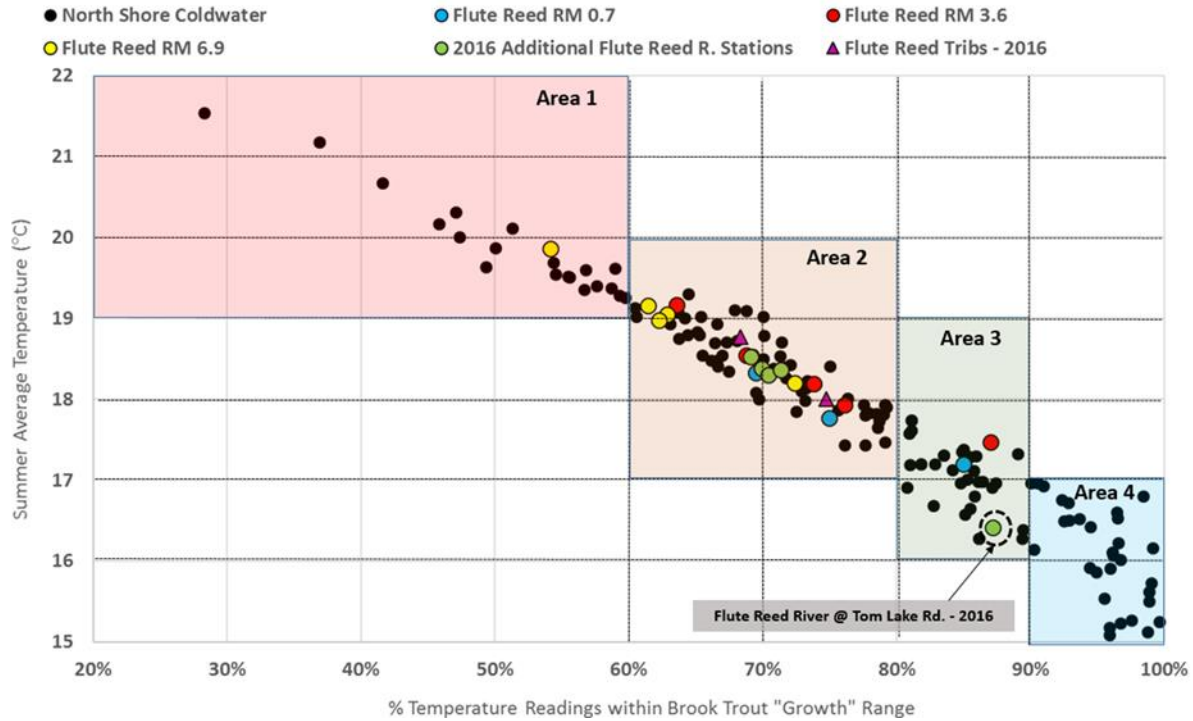
Figure 36. Plot of Summer Average Temperature vs. percentage Time in Brook Trout temperature growth range. Flute Reed monitoring stations are shown in colored markers, while all other North Shore coldwater stations are shown as black markers. Temperature “areas” are discussed further in section 3.1.

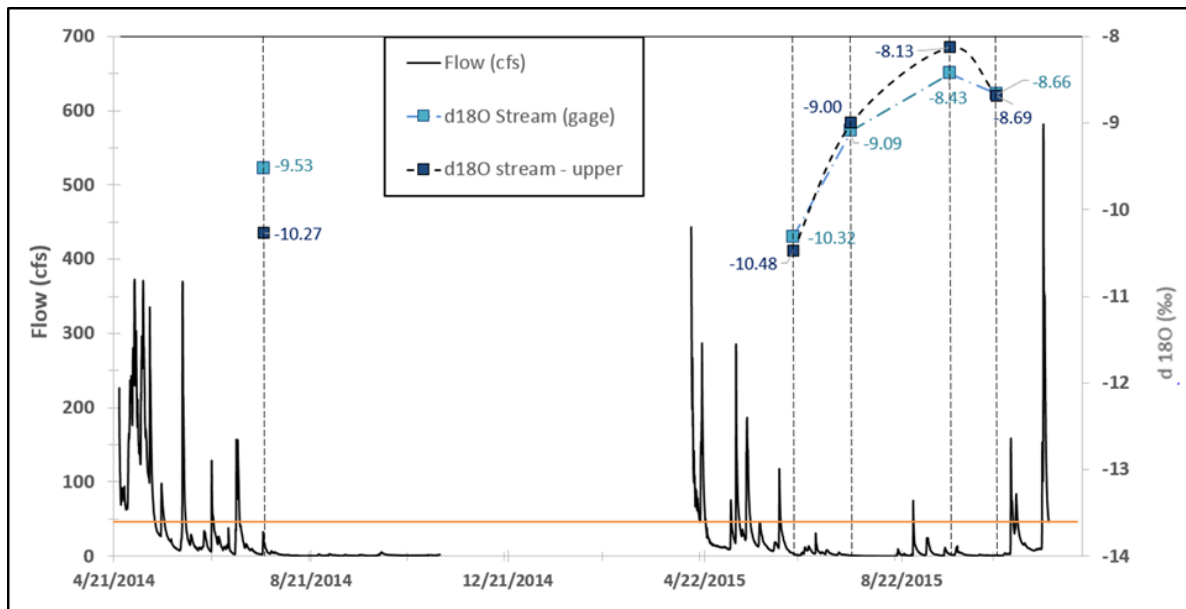
Figure 42. Oxygen isotopes for the Flute Reed River at two stream locations and a bank seep located at the gage in years 2016 plotted alongside the flow hydrograph. The orange line represents the lower limit for very high flow conditions.

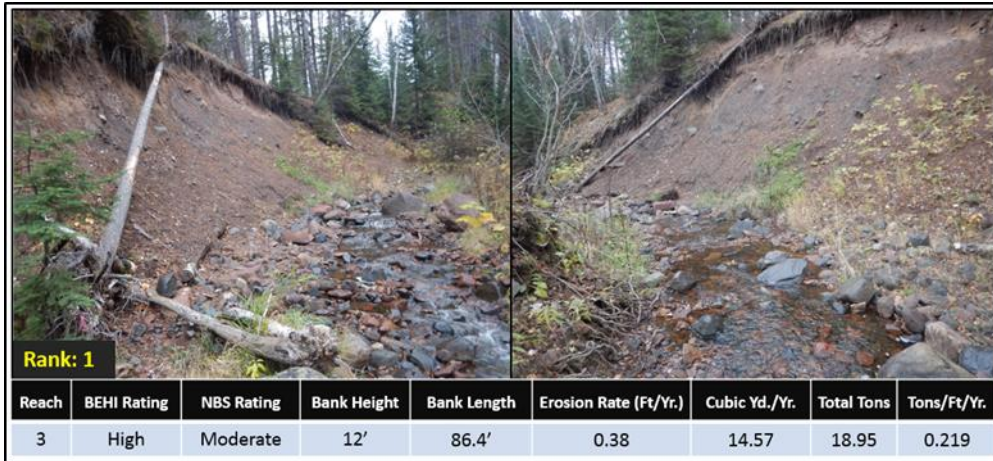
Figure 50. Photos and several attributes for the top three sediment sources based on BANCS model results. A table of the top ten sediment sources related to bank/bluff erosion are listed in the table at the bottom.

Rank	Reach	River Right or Left	BEHI	NBS	Height	Length	Total Tons	Tons/Ft./Yr.	% of Total
1	3	Right	High	Moderate	12	86.4	18.95	0.219	5.3%
2	11	Left	High	Moderate	10	83.5	15.26	0.183	4.3%
3	9	Right	High	Moderate	10	75.7	13.85	0.183	3.9%
4	3	Right	Moderate	Moderate	7.5	123	11.34	0.092	3.2%
5	2	Right	Moderate	Low	3.5	436.5	11.24	0.026	3.1%
6	7	Right	High	Moderate	8	73.7	10.8	0.146	3.0%
7	9	Right	High	Moderate	7	80.9	10.3	0.128	2.9%
8t	2	Left	High	Moderate	5	103.3	9.4	0.091	2.6%
8t	9	Left	Moderate	High	12	38.9	9.4	0.243	2.6%
10	9	Left	Moderate	Low	5	196.8	7.2	0.037	2.0%

Approximately 33% of the total predicted annual bank erosion is generated by 10 individual streambanks or unstable bluffs (Figure 50). The majority of these features are valley wall slumps with high erosion potential, bank heights of over 7 feet, and lengths of 40 feet or longer. In addition to erosion caused by stream processes, several large bluffs are eroding due to freeze-thaw cycles and groundwater bank seeps.

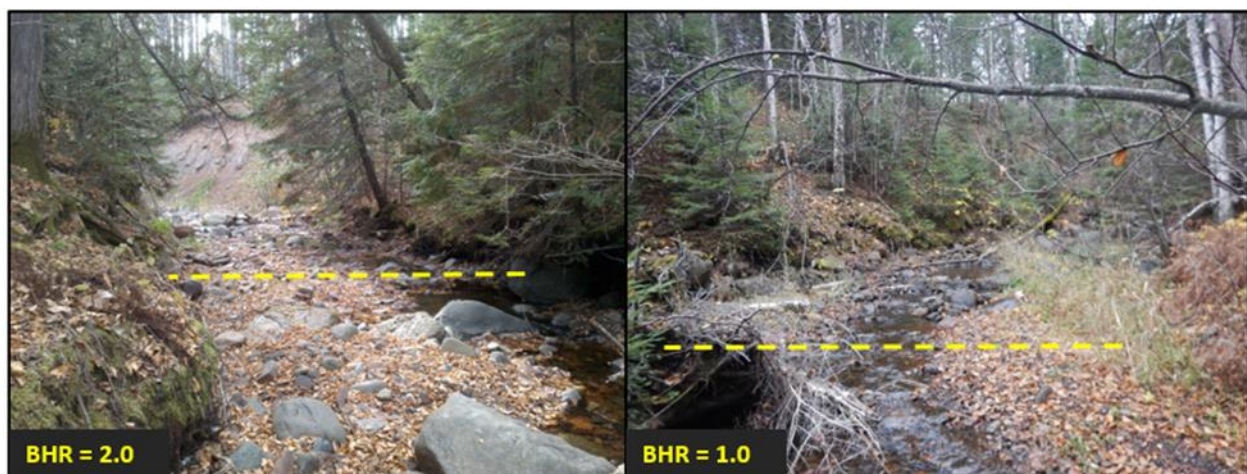
Figure 52. Examples of BHR values of 2.0, deeply incised (left), and 1.0, stable and connected to floodplain (right), in Woods Creek. Yellow line approximates bankfull height. Predicted erosion rates were higher in reaches with high BHR values.

As expected, the predicted bank erosion rates in Woods Creek show a positive relationship with bank-height ratio (Figure 51). An increase in BHR generally results in increased shear stress and stream power, and has the potential to lower the streambed and enlarge the channel (Rosgen, 2006). BHR values in Woods Creek ranged from 1.0 (connected to floodplain, Figure 52 right photo) to a high of 2.0 (deeply incised, Figure 52 left photo). BHR values were highly variable in Woods Creek, often changing many times in several hundred feet of stream channel. The dominant BHR value was used in the cases where variability was high. The relationship of BHR to predicted erosion rates in Woods Creek clearly demonstrate the importance of floodplain connectivity in steep gradient, high stream power systems. Stream restoration activities in the Woods Creek watershed should aim to increase floodplain connectivity in sections that remain severely incised.

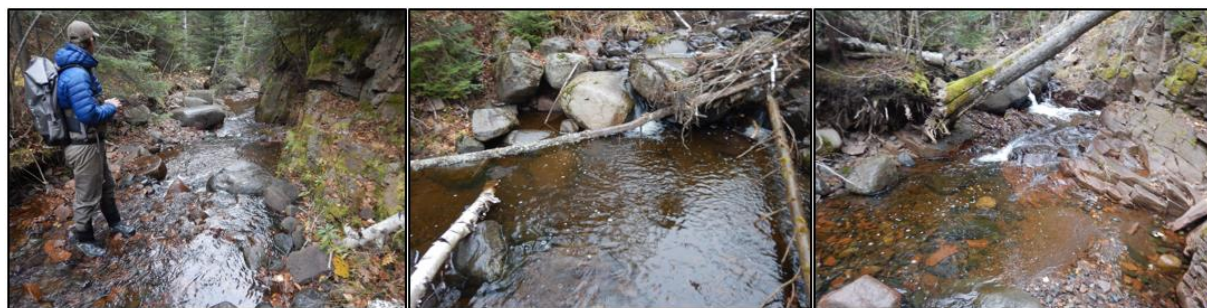
Figure 54. Examples of quality habitat observed in Woods Creek between Reach 5 and Reach 10. Narrow channel maintains adequate water depth at low flow (left), boulder pile step pool habitat and large woody cover (middle), and step pool habitat/clean gravel substrate for spawning (right).

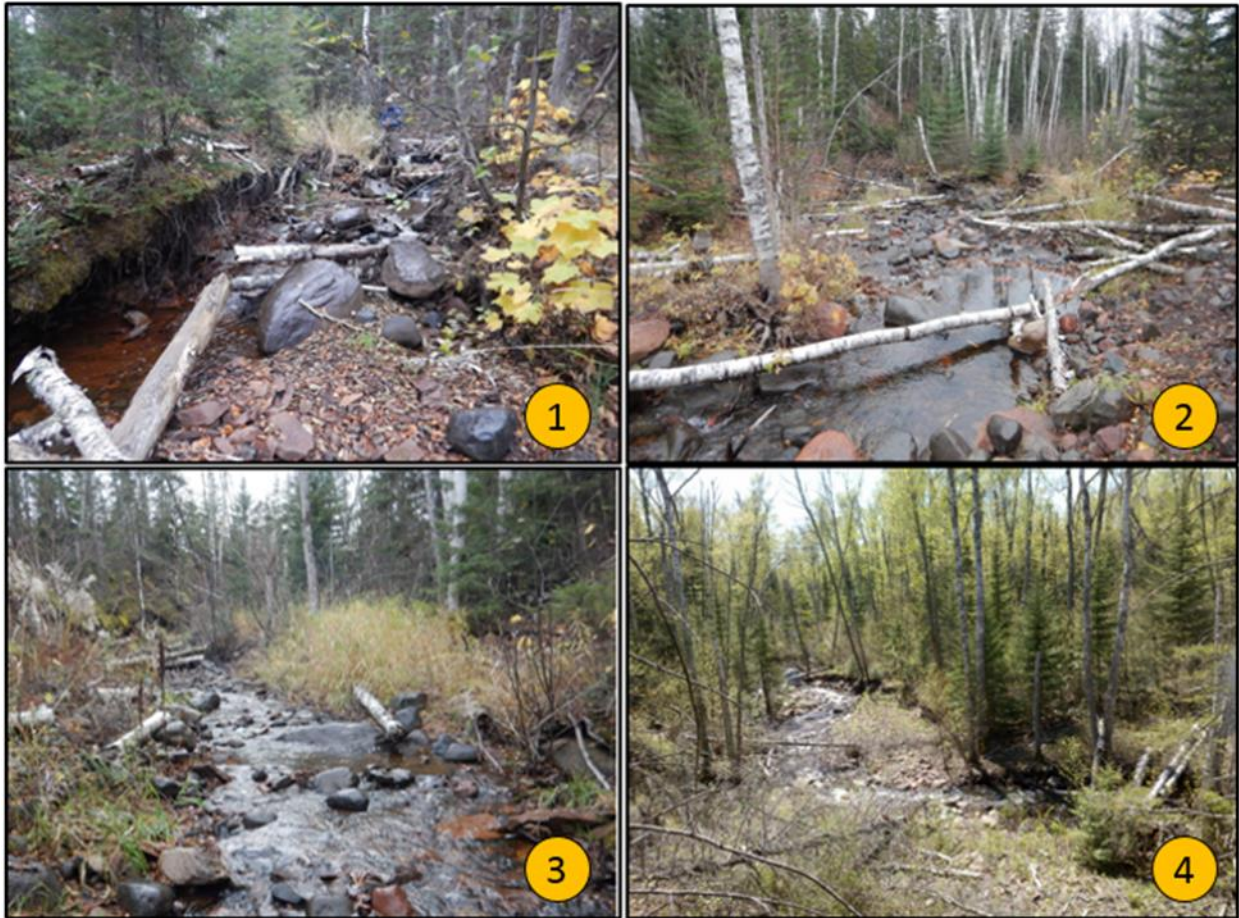
Figure 55. Evidence of channel evolution towards a stable condition. Several channel evolution phases are evident in Woods Creek (1) high width/depth ratio, no floodplain or stable vegetation (2) high width/depth ratio, floodplain with patchy, but stable vegetation, (3 and 4) low to moderate width/depth ratio, defined thalweg, increased sinuosity, connection to a vegetated floodplain.

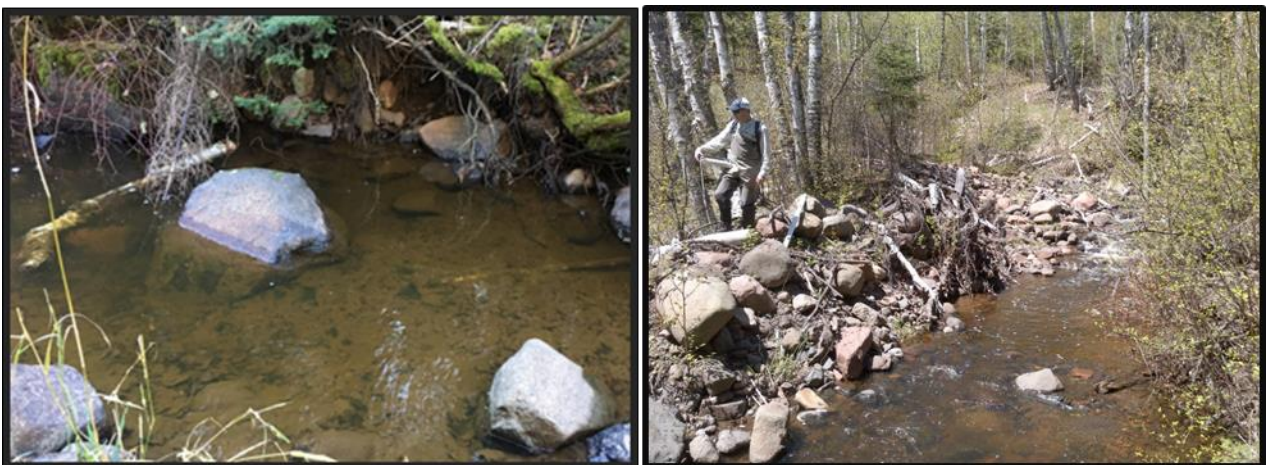
Figure 56. Fine sand substrates embedded coarse gravel and cobble material in Reach 13 (left); Boulder and cobble material deposits on floodplain in reach 8 (right) are indicators of the extremely high stream power generated by the steep slope and entrenched valley of Woods Creek.

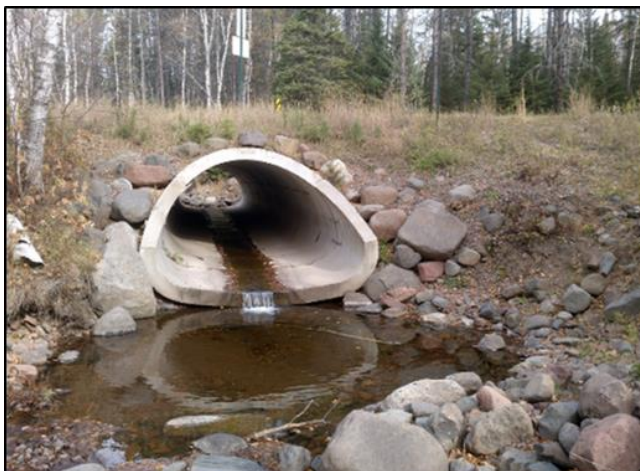
Figure 58. Woods Creek crossing under CR 58 crossing (left) and CR 60 (below). The CR 58 crossing is a barrier to fish migration and a priority for restoration.

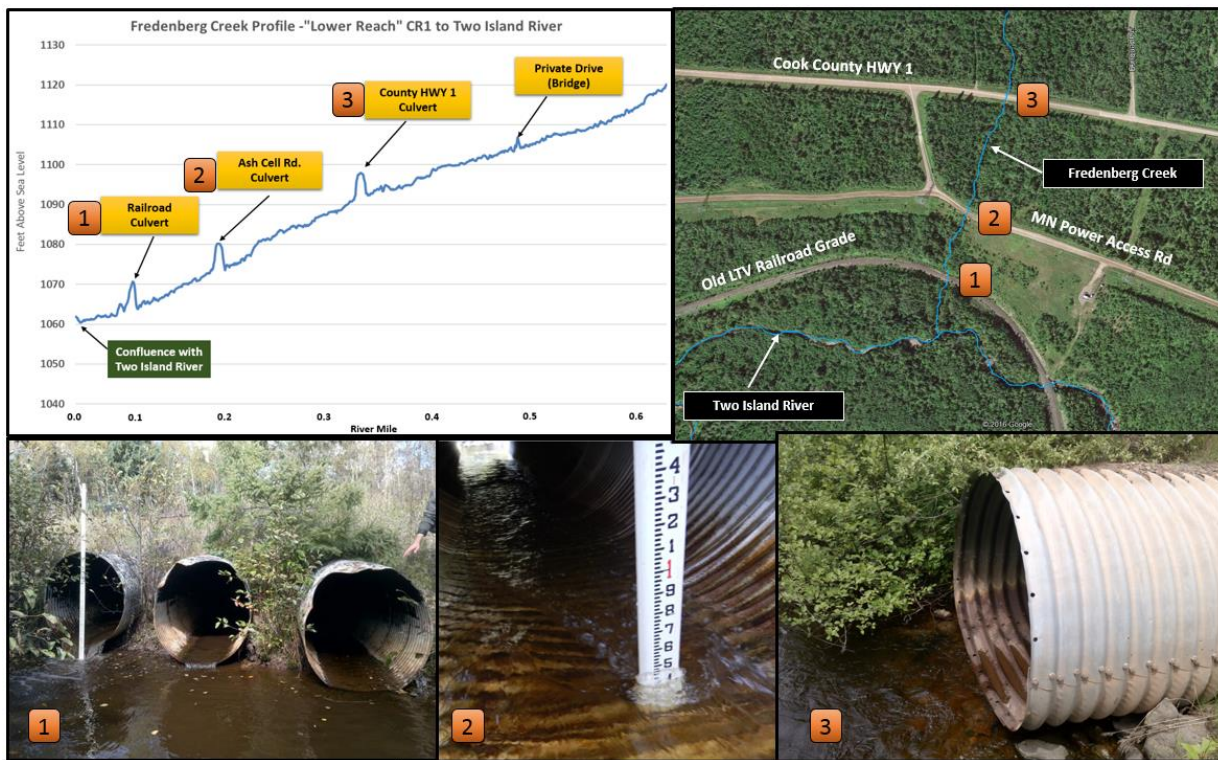
Figure 59. Longitudinal profile of Fredenberg Creek and location of the three undersized and poorly installed road culverts that act as partial to full barriers to the migration of wild Brook Trout, other non-game fish species, and terrestrial and semi-aquatic species that use riparian corridor habitats (e.g. turtles, otters).

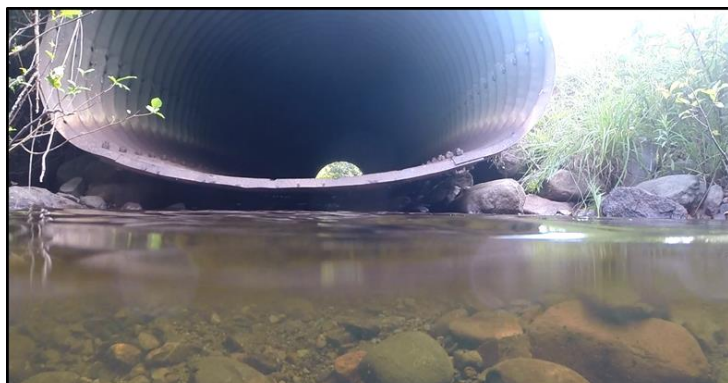
Figure 60. Water level view of perched and undersized road culvert at Cook County HWY 1. The culvert is fractured in numerous locations along its length beneath the road allowing water to flow freely beneath the road grade.

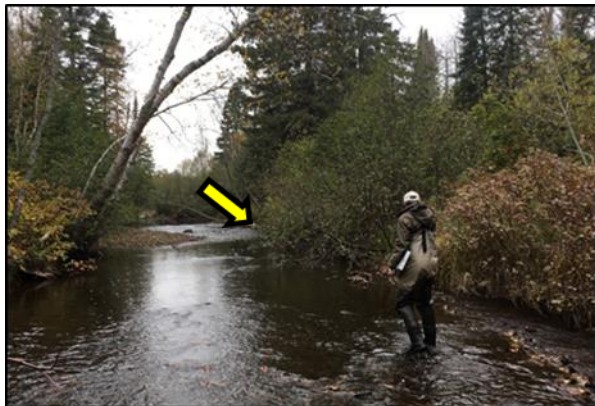
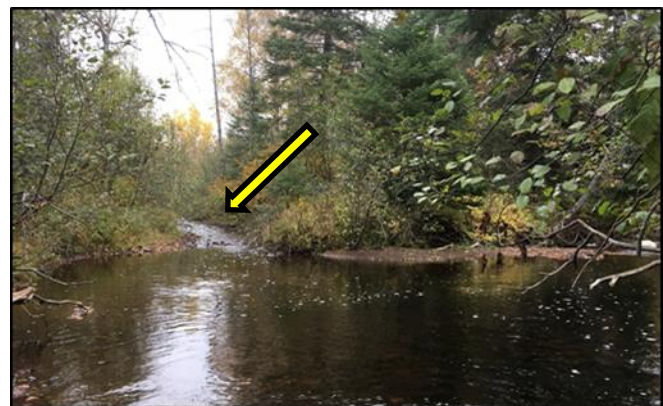
Figure 63. Photos of the Two Island River/ Fredenberg Creek confluence area. Confluence indicated by yellow arrow.

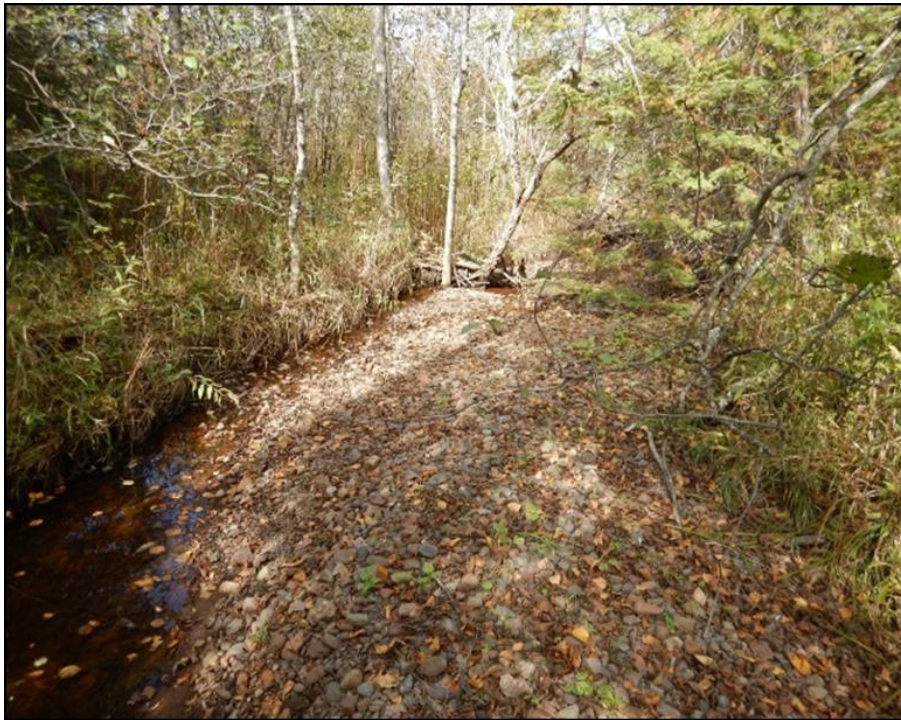
Cross-section data upstream of the CR1 crossing indicate aggradation to the stream channel, most likely due to the narrow culvert. Culverts that are much narrower than the width of the channel impound water at higher flows. This lowers the effective slope and increases the width/depth ratio, decreasing the sediment transport capability of the stream and increasing deposition during these high flows events. Over time, the channel will fill in and evolve into a new stream type. Cross section #1 (Figure 67 and 68) shows that the channel has evolved into a braided D4 stream type, which is common in reaches where the rate of sediment supply far exceeds the rate of sediment transport. Fredenberg Creek at this location has a width/depth ratio of nearly 90 and shows signs of excessive deposition and annual shifts in streambed morphology. The pools have almost completely filled in with sediment; in fact, the profile shows that the only defined pool in the reach is the massive plunge pool immediately below the culvert.

Figure 67. Photo showing the effects of excessive deposition in Fredenberg Creek upstream of CR1.

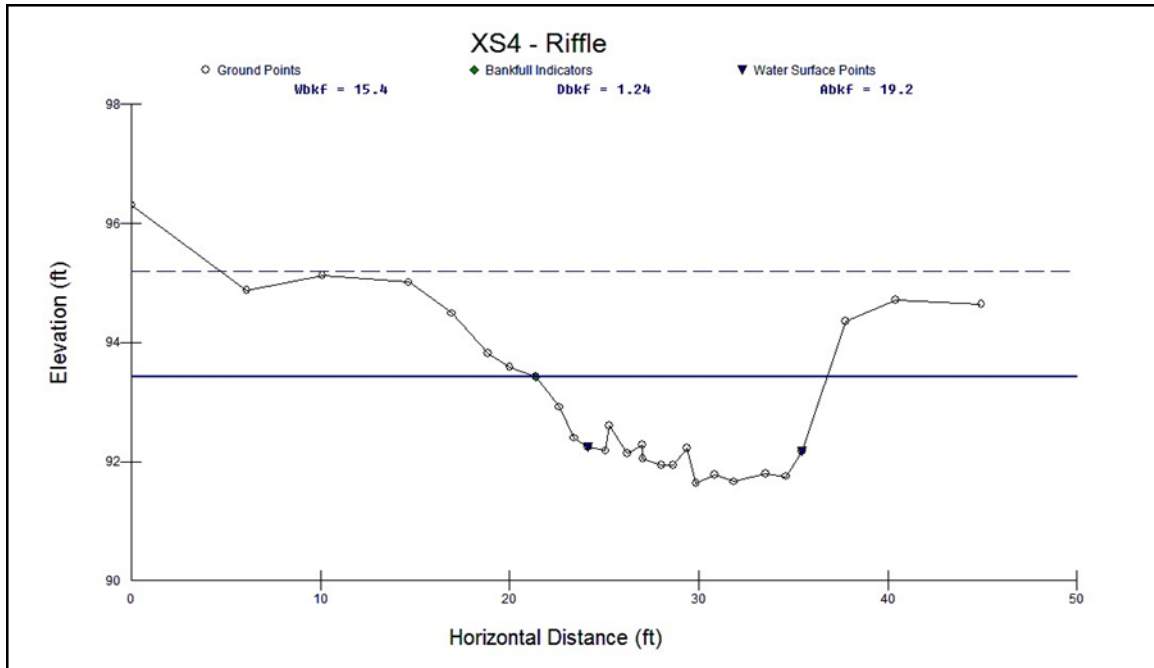
Figure 69. Channel cross-section of Fredenberg Creek approximately 70 feet downstream of CR1.

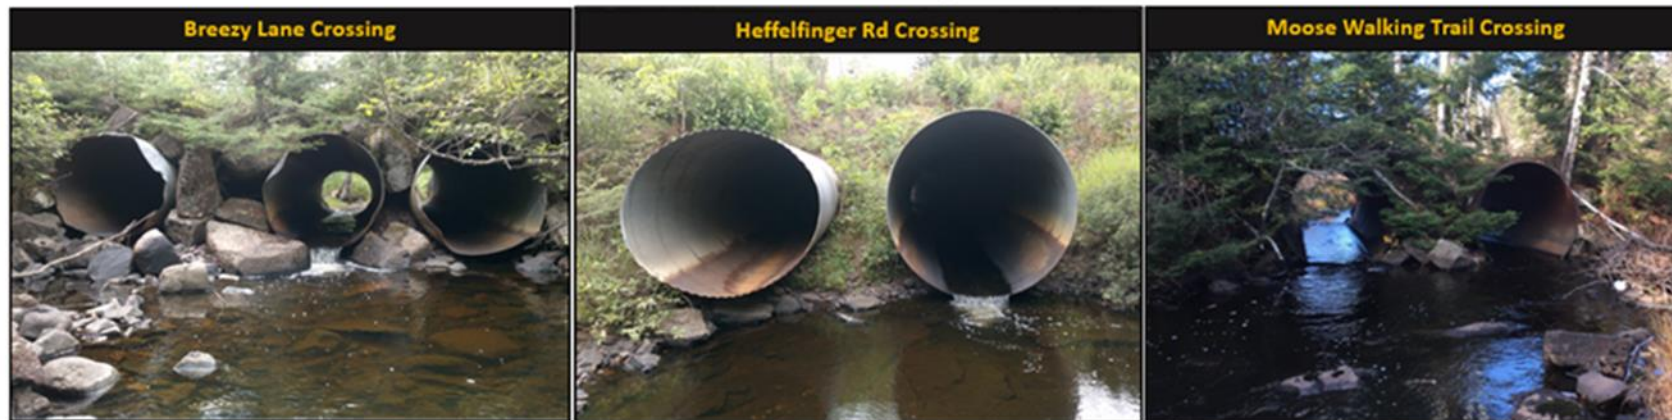
Figure 71. Profile of Hockain Creek generated with 1-m LIDAR elevation and watercourse data (top). Crossings of Hockamin Creek at three locations; Breezy Lane, Heffelfinger Rd, and Moose Walk Trail. The crossings at Breezy Lane and Heffelfinger Rd are barriers to aquatic organism passage and should be replaced.

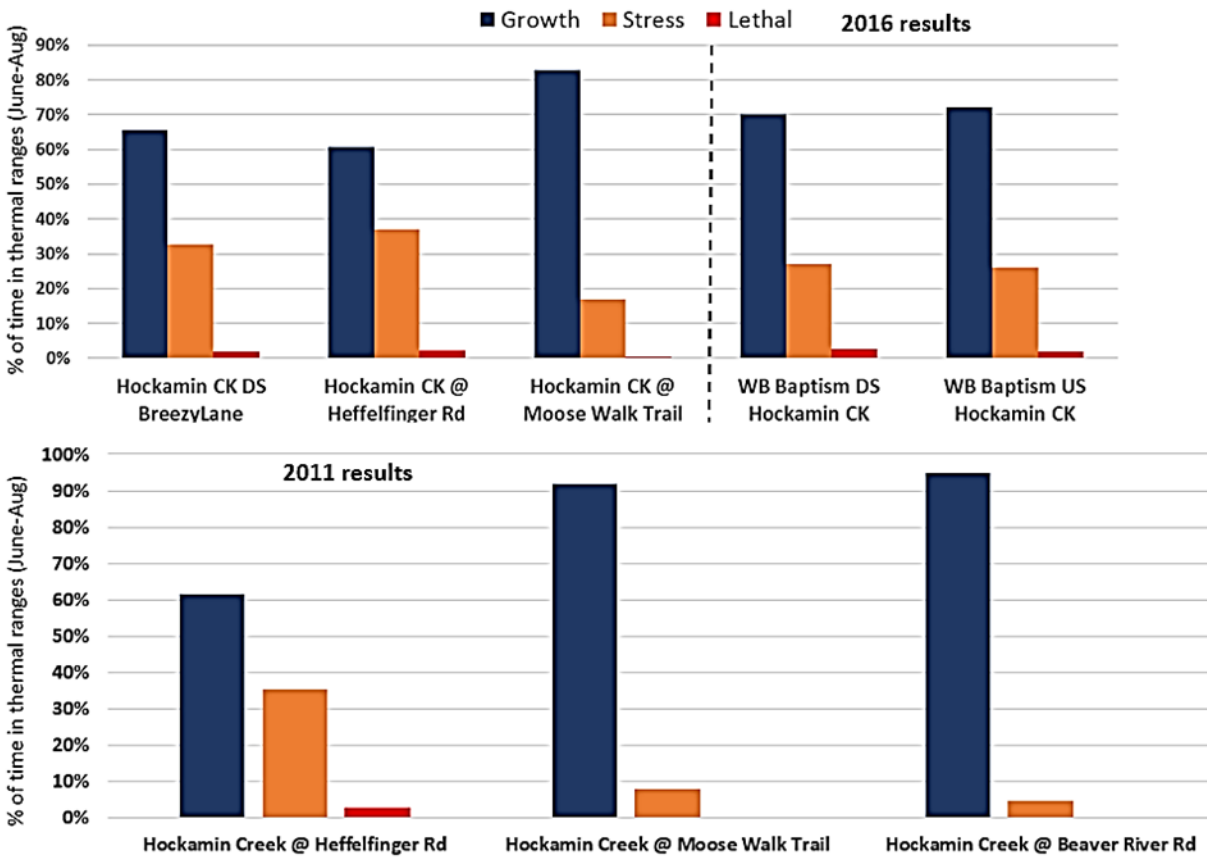
Figure 72. Water temperature summaries for several monitoring stations on Hockamin Creek and West Branch Baptism River.

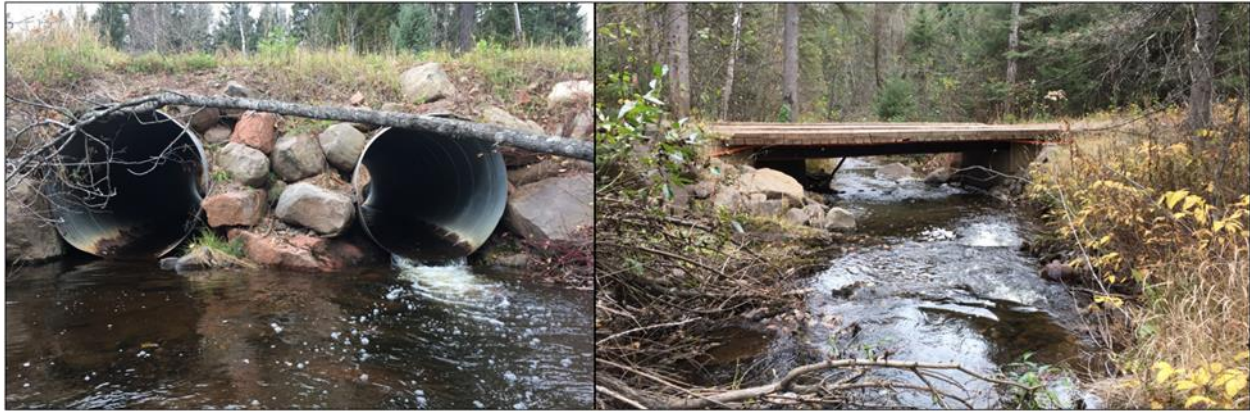
Figure 75. Perched and improperly set culverts at the Cooper Rd crossing create a partial barrier to fish passage (left), while a span bridge located just downstream allows full fish passage and helps maintain channel stability.

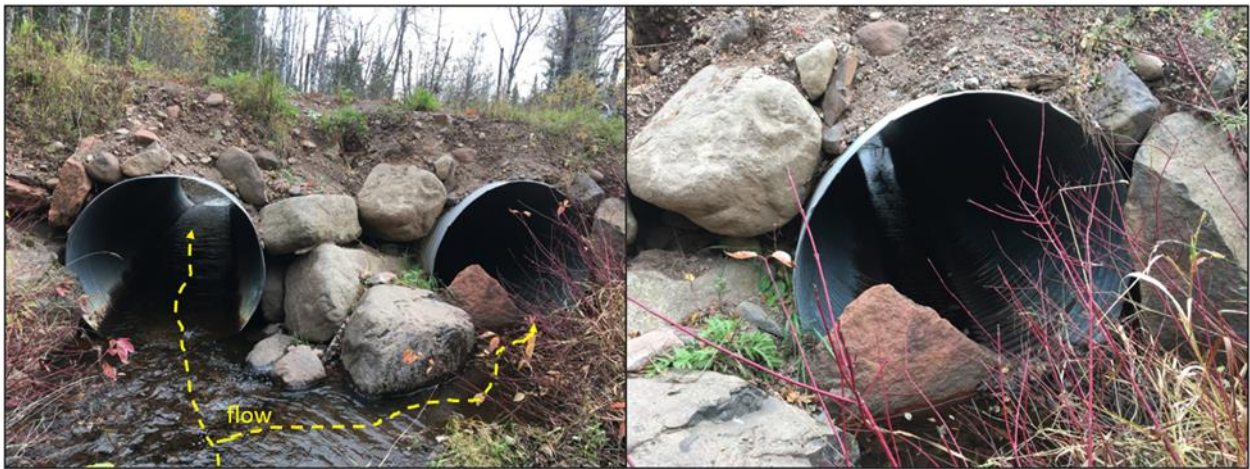
Figure 76. Looking downstream at Cooper Rd crossing of Lindstrom Creek. Blockages of the river-right culvert disrupt sediment transport and alter current velocities and water depth and velocity within the structures.

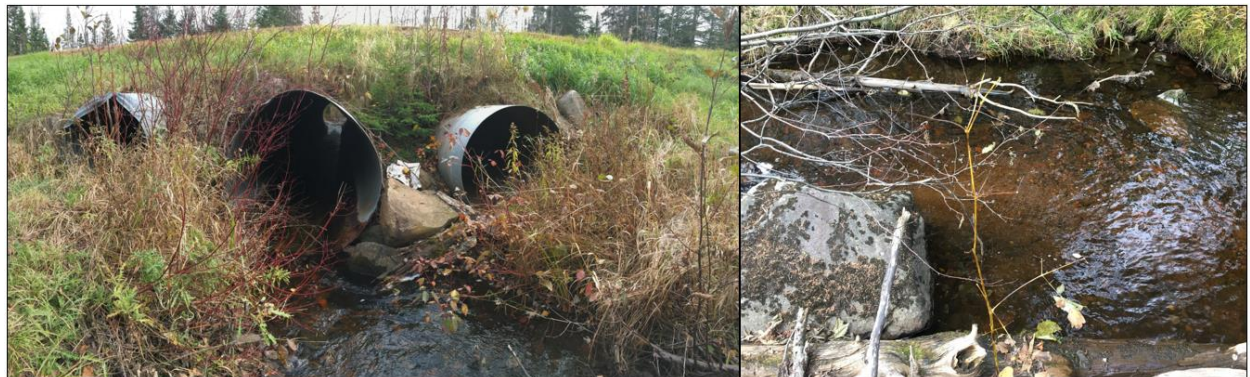
Figure 77. Perched and improperly set culverts at the Cooper Rd crossing create a partial barrier to fish passage (left), while a span bridge located just downstream allows full fish passage and helps maintain channel stability.

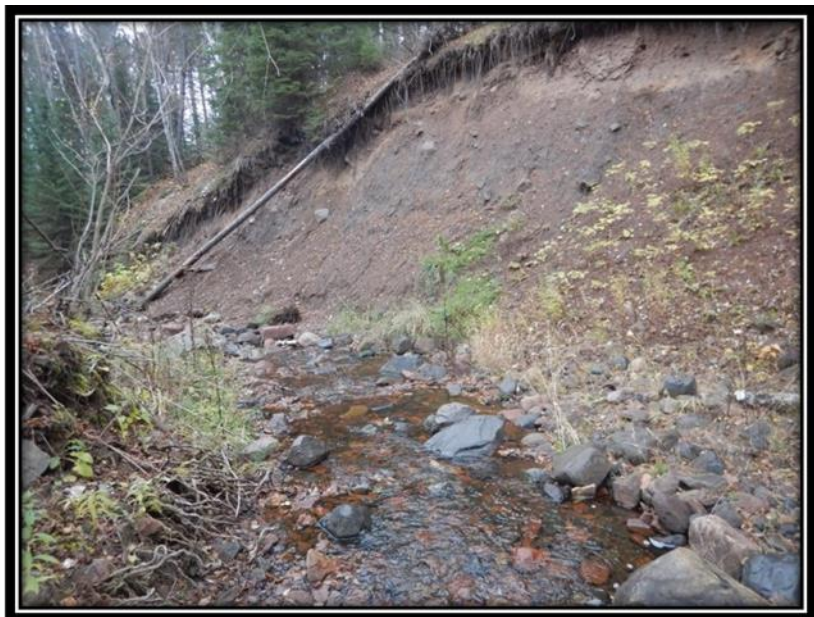
Figure 83. Eroding bank in the lower reaches of Woods Creek that could be stabilized using a low-impact restoration approach as described above.

**Low-Impact
Restoration Option #2:**
Reduce sediment supply by creating rock and log structures (j-hooks, stream barbs, vanes, etc.) that redirect high flows and decrease shear stress at the toe of the largest eroding banks.

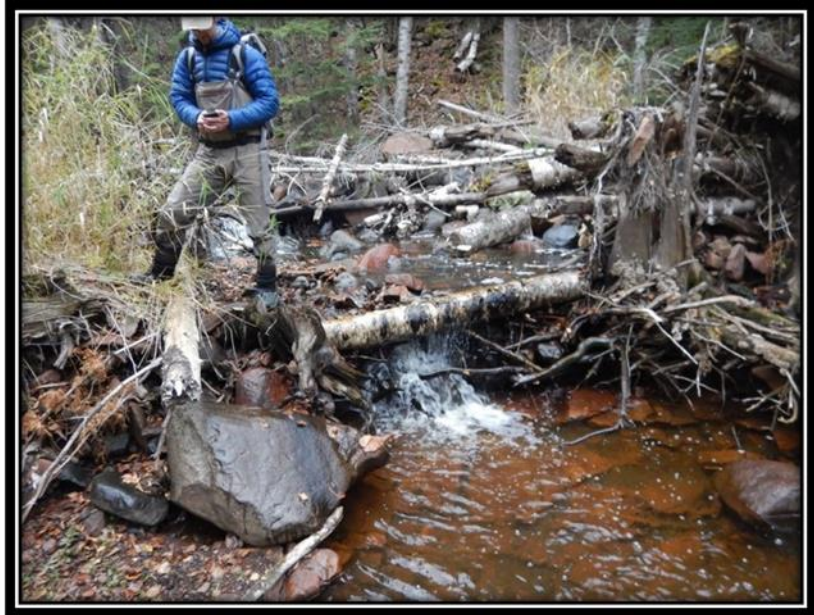
Figure 84. Examples of braided and over-widened section of Woods Creek that could be improved using low-impact restoration options as described above.

**Low-Impact
Restoration Option #4:**
Reposition rocks and logs in areas where the stream is braided or over-widened and pools are filling due to a lack of sediment transport capability. The goal will be to center flows, reduce width/depth ratios, and scour deeper pools for fish habitat.

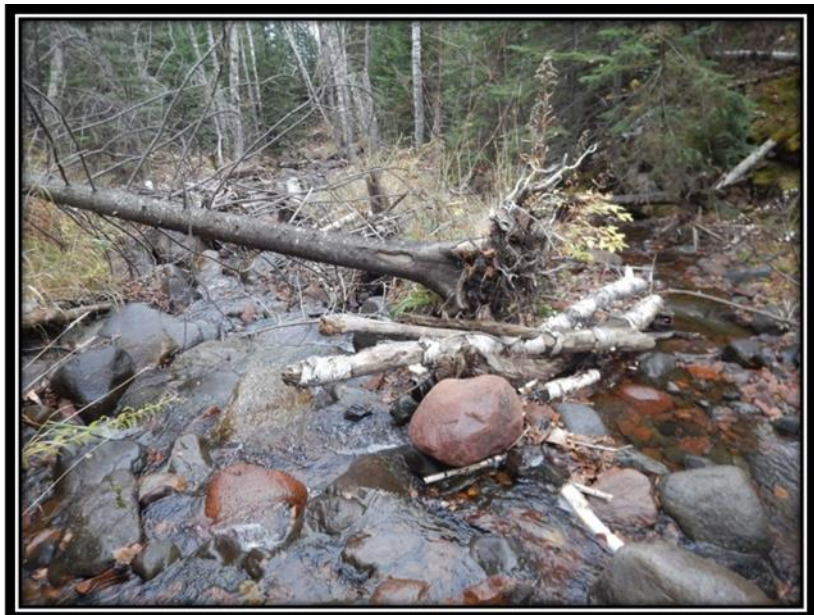
Figure 85. Example of head-cut on Woods Creek that could be stabilized using a low-impact restoration approach as described above.

**Low-Impact
Restoration Option #3:**
Install rock-clusters or other structures to hold grade and stop advancing headcuts or to prevent future downcutting of the channel bed.

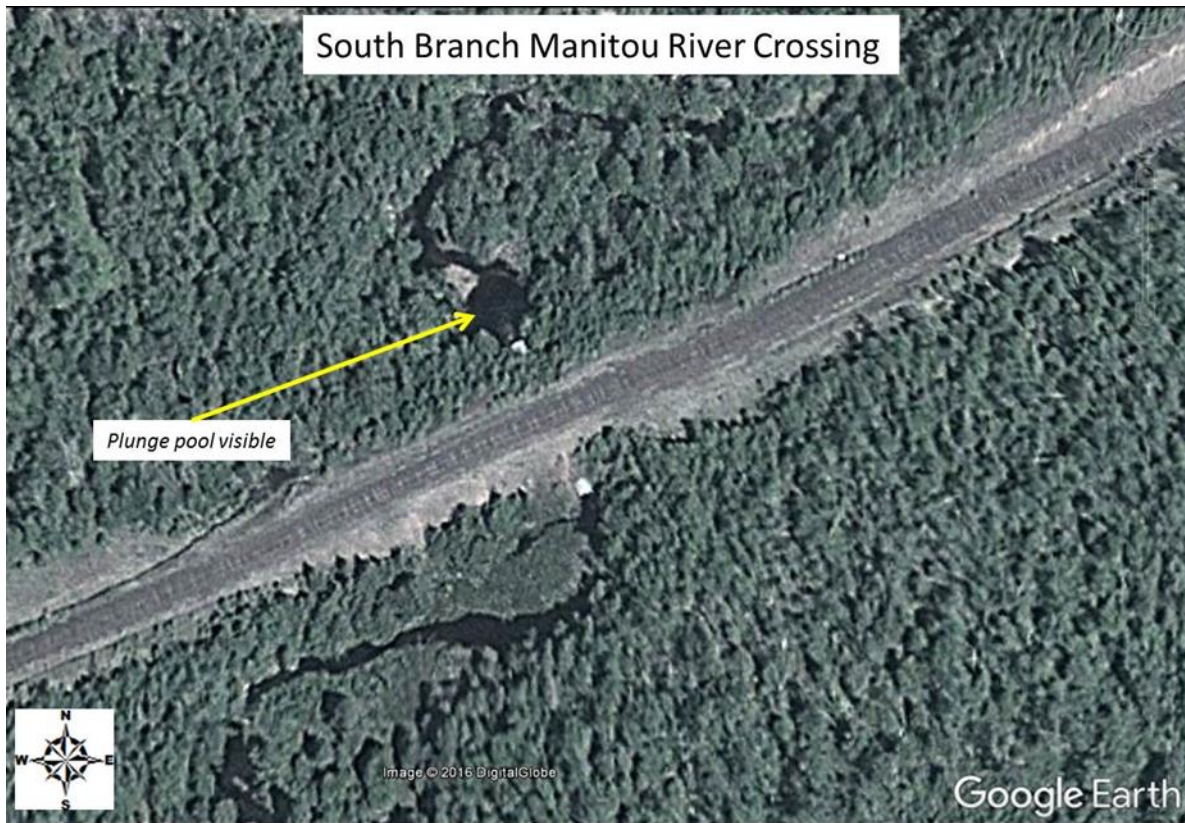
Figure 96. Aerial photo of the South Branch Manitou River RR lower crossing, showing plunge pool downstream of culvert.

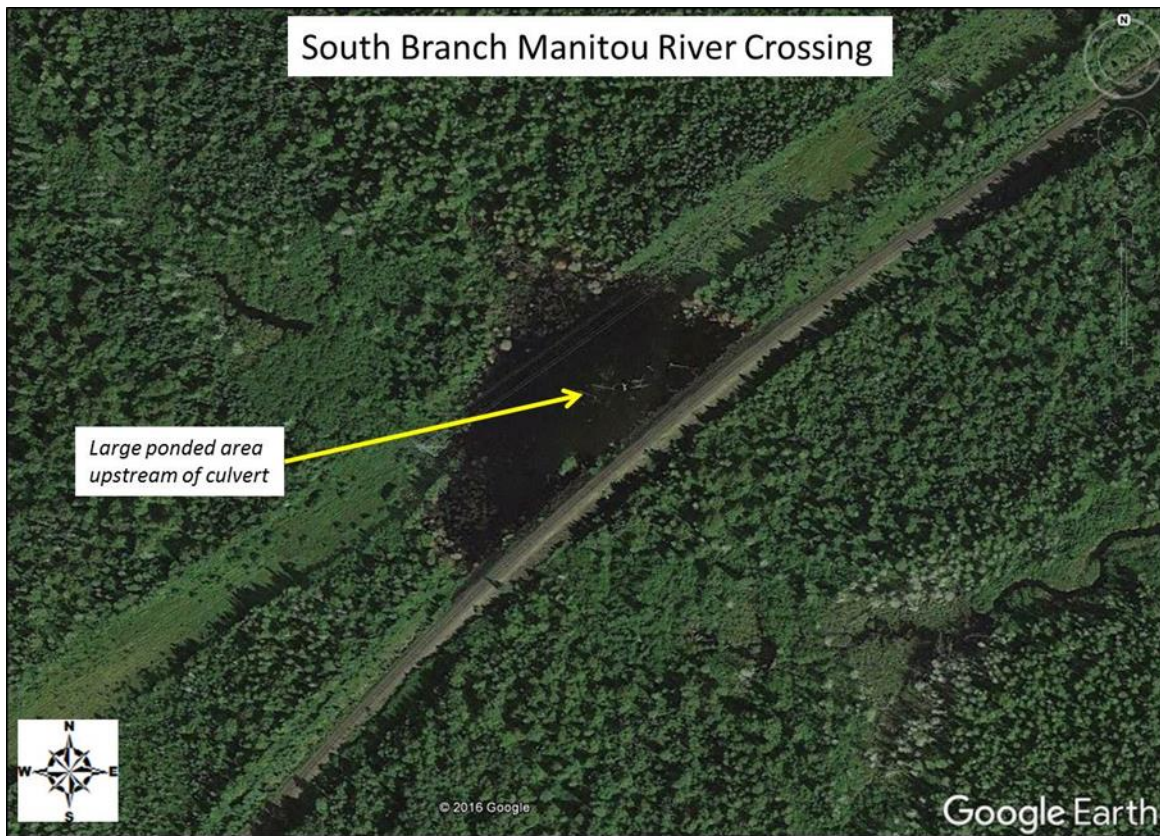
Figure 98. Aerial photo of the South Branch Manitou River RR upper crossing, showing large ponded area upstream
