Lake Superior North Stressor Identification Report

A study of local stressors limiting the biotic communities in the Lake Superior North Watershed

Document number: wq-ws5-04010101a

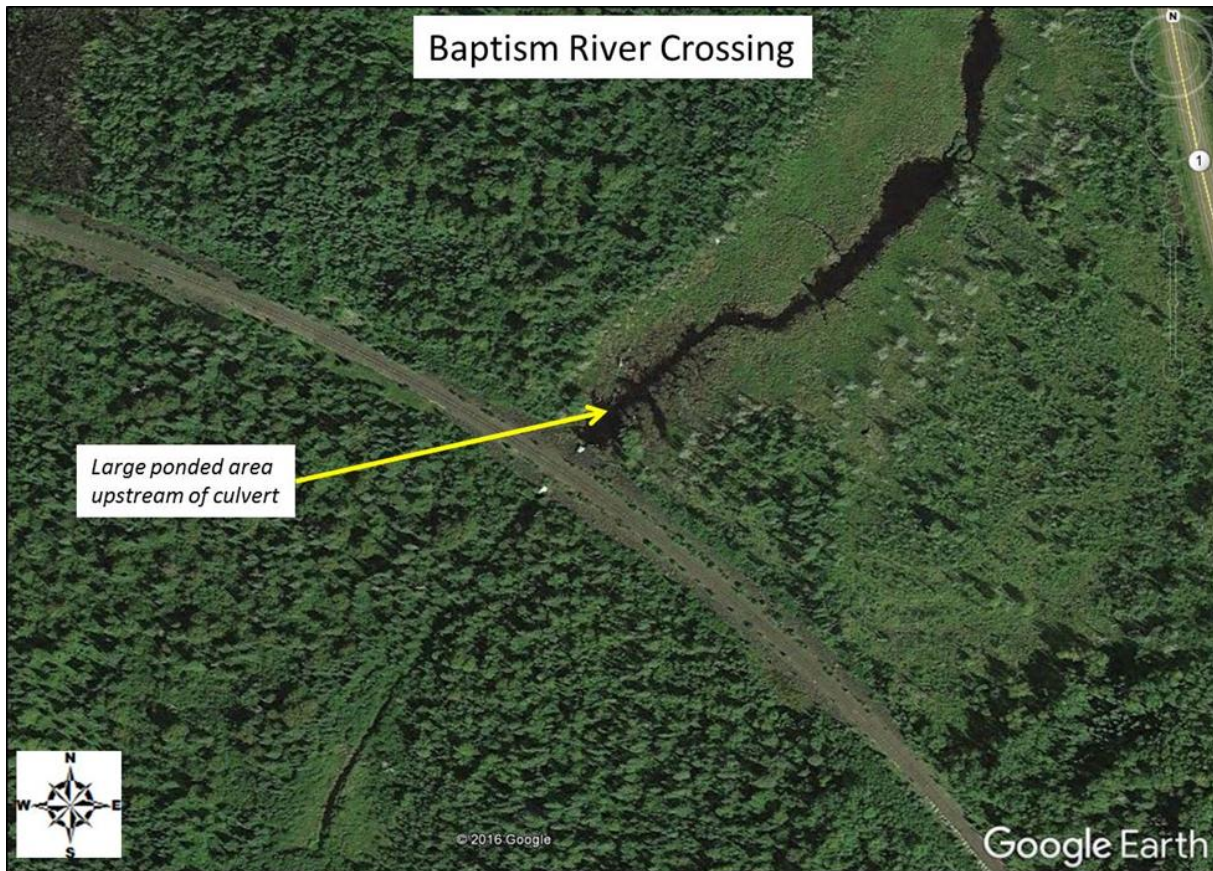
Figure 100. Aerial photo of the Baptism River RR crossing, showing large ponded area upstream of culvert.

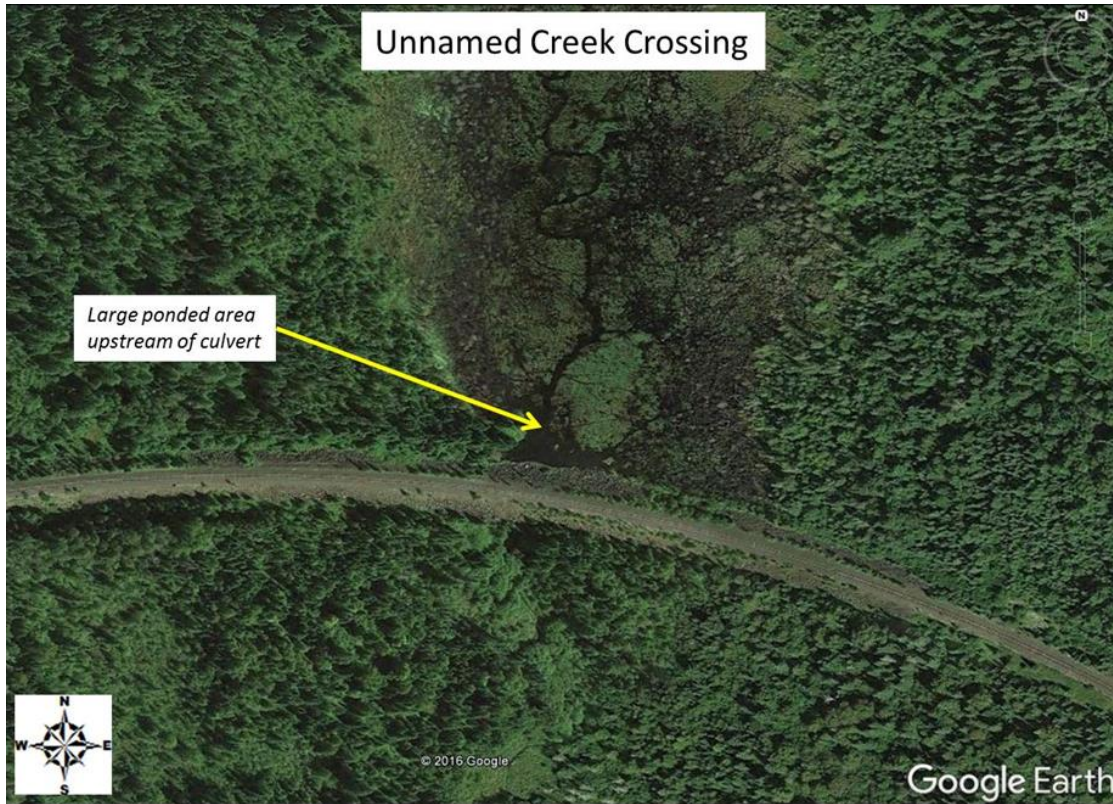
Stream:	Unnamed Creek
Longitude:	-91.337764°
Latitude:	47.519229°
Potential Problem(s):	Upstream culvert invert set too high, or debris jam located at culvert invert
Evidence of problem:	Aerial photo shows large upstream ponded area, LiDAR profile shows upstream pooling and aggradation and 1.5' water surface elevation drop in the culvert
Length of upstream channel affected:	500 ft
Approximate culvert length:	90 ft
Approximate water surface slope within culvert:	1.7%
Approximate prism height:	24 ft

Figure 102. Aerial photo of the Unnamed Creek RR crossing, showing large ponded area upstream of culvert.

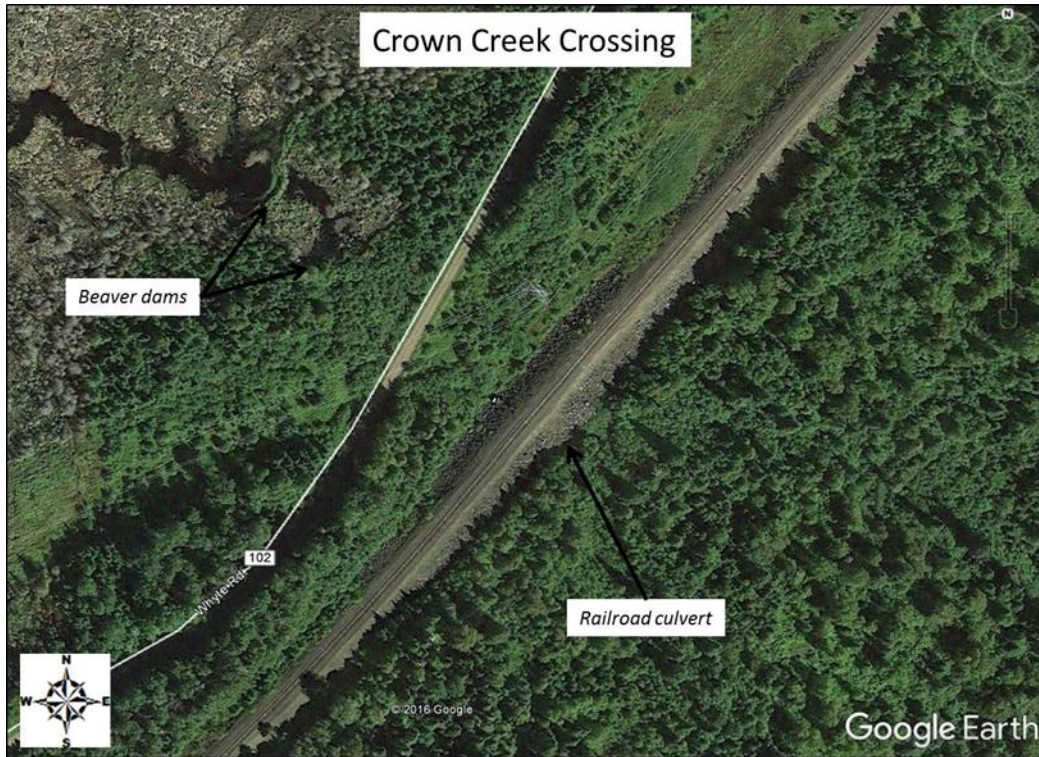
Stream:	Crown Creek
Longitude:	-91.421882°
Latitude:	47.507649°
Potential Problem(s):	Upstream culvert invert set too high, or debris jam located at culvert invert
Evidence of problem:	Aerial photo is inconclusive, but LiDAR profile shows upstream aggradation and 5.0' water surface elevation drop in the culvert
Length of upstream channel affected:	50 ft
Approximate culvert length:	95 ft
Approximate water surface slope within culvert:	5.3%
Approximate prism height:	27 ft

Figure 104. Aerial photo of the Crown Creek RR crossing. Crown Creek is difficult to see near the crossing.
