North Fork Crow River Watershed Stressor Identification Report

Assessment of stress factors affecting aquatic biological communities and other aspects of streams and rivers

Document number: wq-ws5-07010204d

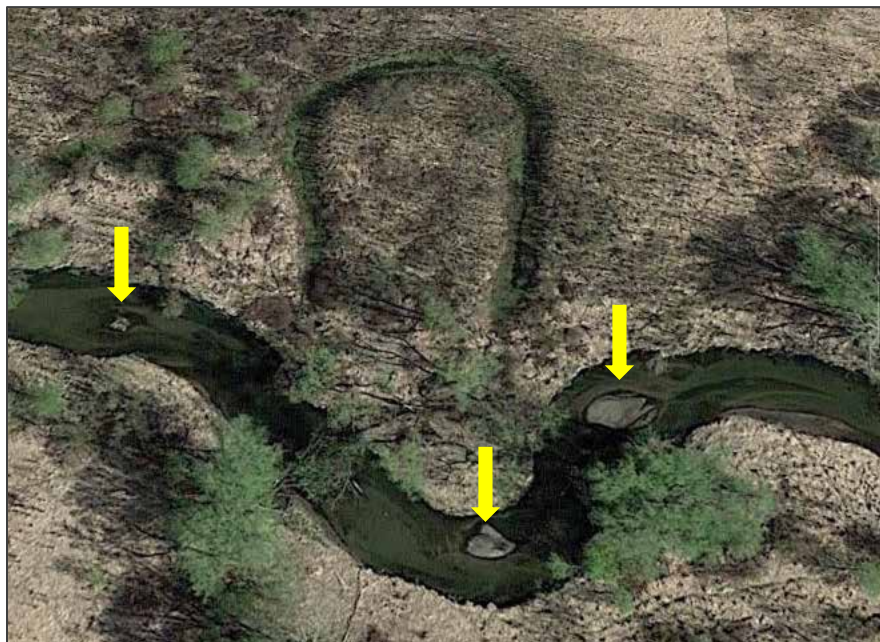
Figure 6. Middle Fork Crow River and old oxbow channel. Arrows point to mid channel bars, deposition of excess sediment that is a sign the river is receiving excessive sediment and is aggrading its channel bed.

Review of 2015 aerial photography to analyze geomorphology and channel stability showed definite signs of excessive sediment deposition in the channel, as well as some channel instability as seen in eroding banks at various locations. Bank instability has been caused by cattle trampling of banks while accessing the river, and in other places due to river flows acting on inadequately-protected banks, where protective vegetation has been altered or field buffers are too narrow. In addition, other locations were found to have very narrow stream buffers which may be allowing field runoff to carry sediment into the river. All of these are sources of excess sediment to AUID-511. Though the UAA analysis found habitat should be sufficient to allow for passing biological communities, it is likely that excess bedded sediment has resulted in loss of important stream bed habitat by smothering coarser material, and creating relatively uniform depth by filling pools. Therefore, excess sediment is considered a stressor in AUID-511.

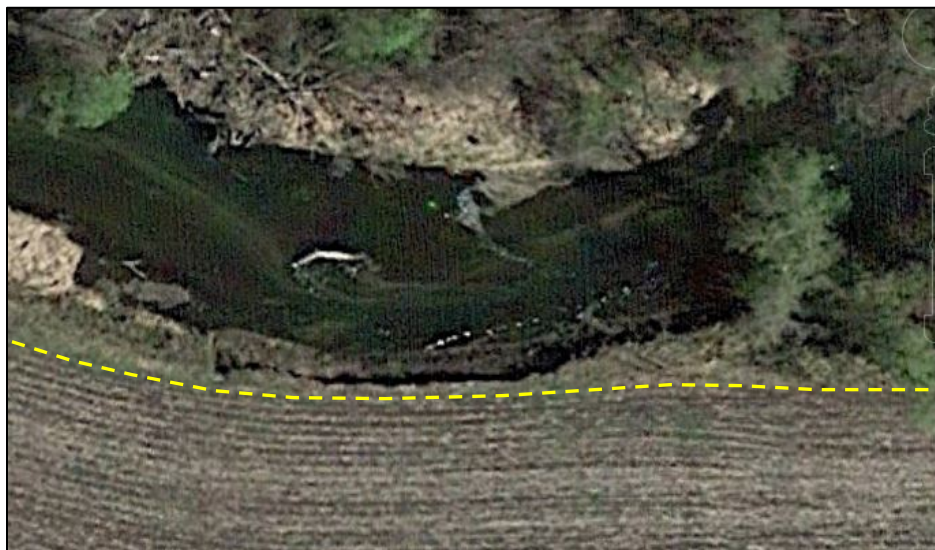
Figure 7. Example of bank erosion along a field edge with almost no buffer (Photo is spring 2015). Such erosion is a source of excess sediment. This erosion is upstream a ways from location shown in Figure 6. The dashed yellow line is the edge of active cultivation.

Some stretches of AUID-511 have excellent, wide natural buffers, while some other areas are farmed to within several feet of the stream bank (at least as of 2015). The enactment of the recent Buffer Law may have led some landowners to widen the buffers along the river. Re-establishing some woody vegetation along the banks would also provide additional means of stabilizing the banks against erosion. If areas of inadequate buffering still occur, addressing those would be beneficial. It would also be very beneficial to work with landowners to fence cattle out of the stream and provide off stream watering. This will also help correct the bacterial impairment in AUID-511. These enhancements of the riparian area will also help to reduce nutrient inputs from fields and pastures. It is not known how influential the discharged industrial and municipal wastewater discharges are on the biological communities. Hydrological modeling coupled with records of monitored levels of discharged material would provide some insight. Re-meandering the river would be a way to improve habitat, though there are somewhat limited locations where this would be possible without moving into riparian areas that are currently farm fields.

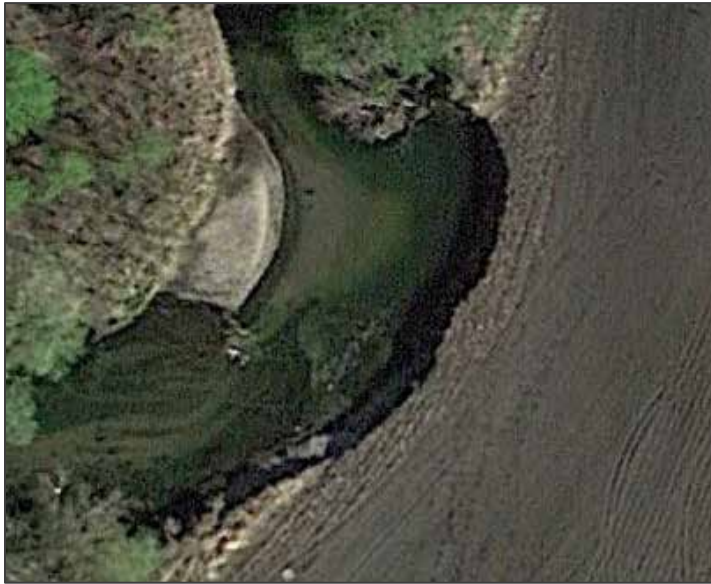
Figure 8. Erosion from inadequate buffer and armoring vegetation, resulting in field loss, which happened since the previous fall's harvest, as tillage marks can be seen leading to missing land. Photo is from April 2015.

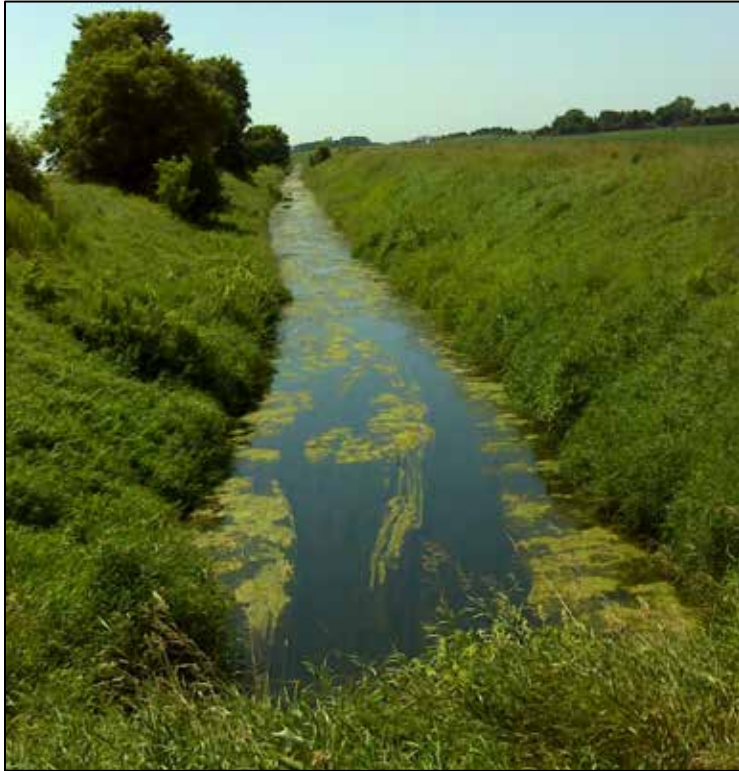
Photo 1. Algae-choked channel at S010-555 on August 6, 2019.

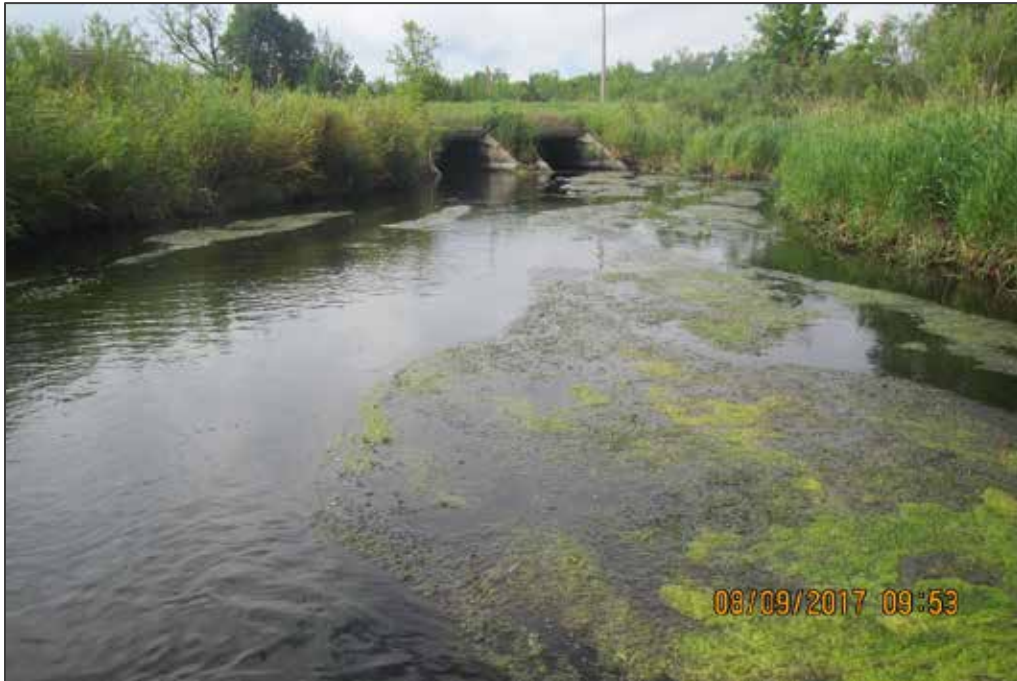
Photo 3. August 9, 2017 photo at the downstream end of the biological site reach, showing extensive mats of filamentous algae that develops over the summer in AUID-539.

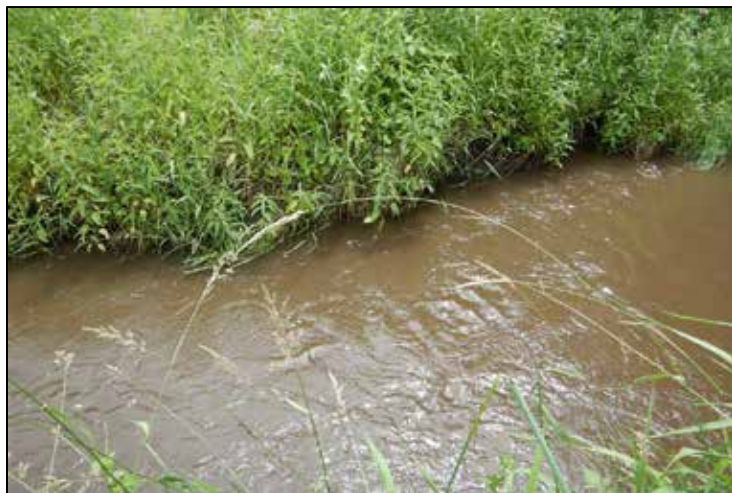
Photo 4. Stream conditions in AUID-553 on June 27, 2019, when samples found very high TP and TSS levels.

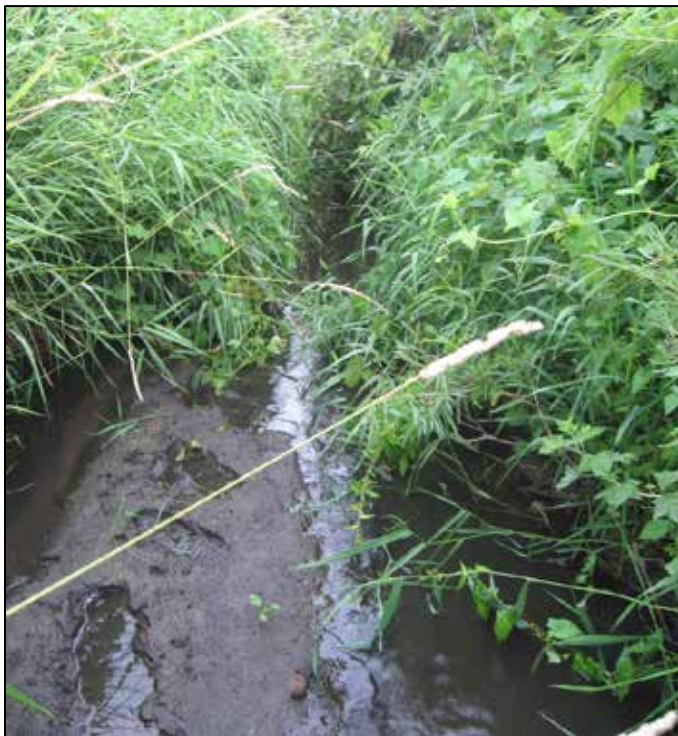
Photo 5. Substrate at 07UM041 is almost exclusively sand. Excess deposition of fine material in the middle of the channel, as here, suggests unnaturally high sediment loading to the stream.

The total and sub-component scores are shown in Table 30. Total MSHA scores were averaged for the three visits to 07UM041, resulting in a score of 37.5, which is at the well down into the range of the "Poor" category. The poorest-scoring sub-component scores were "Surrounding Land Use", "Channel Morphology" and "Substrate", particularly the first two. This is very typical of ditches, which typically have little sinuosity, uniform bed topography, lack of distinct channel features like pools or riffles, and fine particulate substrate. These characteristics were all found at 07UM041. Substrate was almost exclusively sand and silt (Photo 5).

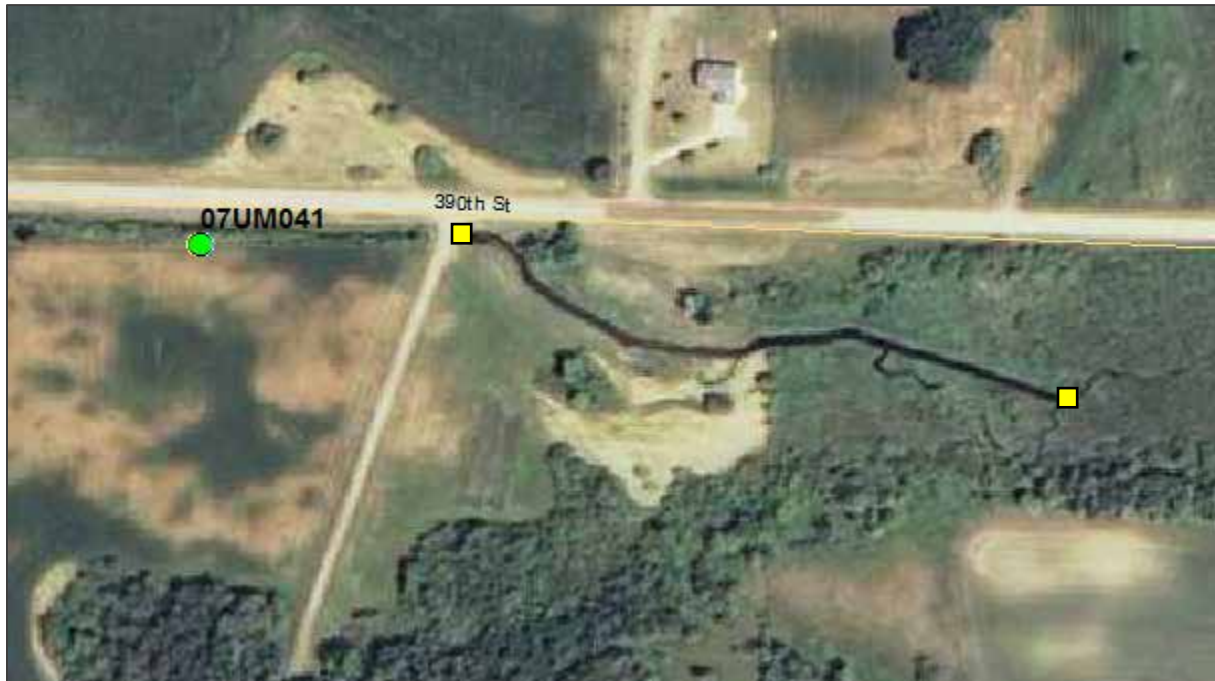
Figure 19. The channel near 07UM041 was recently straightened (between the yellow squares) as shown in this 2008 aerial photo.

No geomorphology fieldwork was conducted on AUID-553. Some recent new ditching occurred about 2007 just downstream of the biological reach, removing the sinuosity of the previously natural channel (Figure 19).

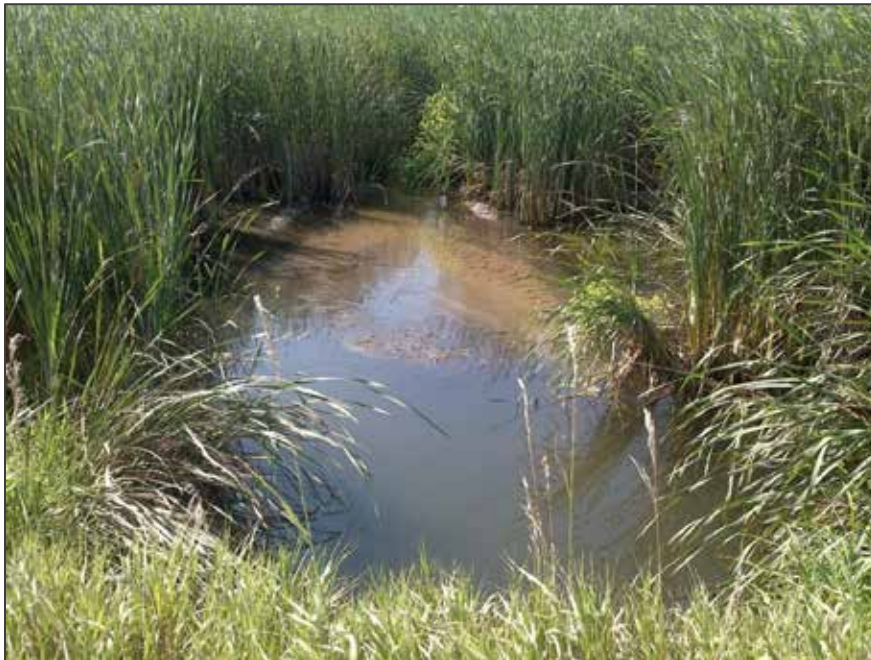
Photo 7. Deep sediment deposit on the upstream side of 390th Street. The water in the center of the photo is only about an inch deep.

There are two carp barriers downstream of the bio site, one at the head of the wetland that leads to Lake Koronis (390th Street), and one at the downstream end of the wetland immediately upstream of Lake Koronis (CR-20). On the upstream side of 390th Street, there is substantial sediment deposit that leads to the channel being braided in the cattails (Photos 7 (aerial) and 8). These prevent larger species from migrating up into the stream from Lake Koronis in the spring. In addition, the 2015 aerial photography shows a beaver dam about a half mile downstream of 07UM041, which is another barrier, though it is not known if it was functional in 2017 (Photo 7). Lastly, the large wetland near Lake Koronis may be a barrier in itself to some species as there are places in the wetland where a distinct channel disappears.

Photo 6. AUID-553 at the 390th Street crossing and upstream wetland. The yellow box is the area photographed in Photo 7. The yellow arrows point to the beaver dam.

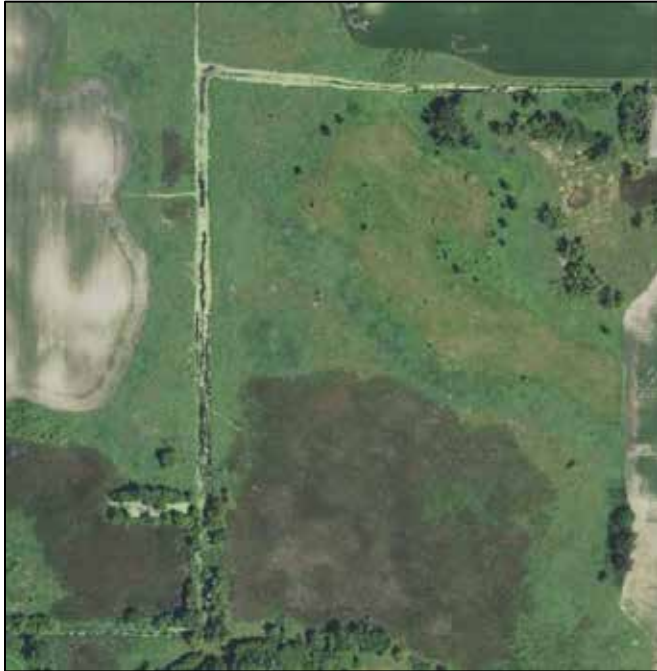
Figure 22. Extremely abundant aquatic plant growth can be seen in the ditched channel about one mile upstream from 07UM019, as it flows through a wetland/grassland area, exacerbated by the wider than natural channel allowing for high sun exposure, along with extra nutrients from landscape runoff.

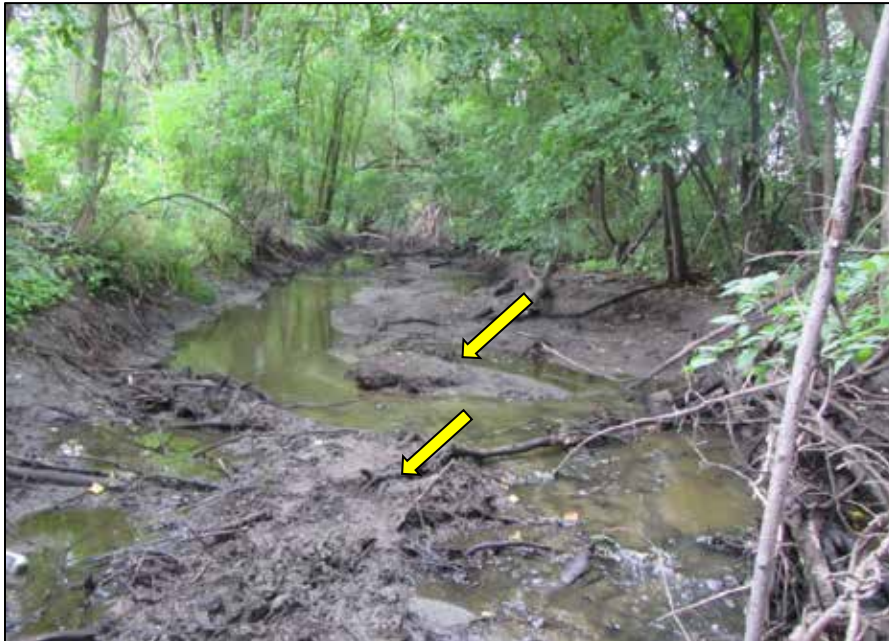
Photo 8. The channel of AUID-557 in the biological reach is physically very unstable. Excess sediment is a significantly degrading habitat. Arrows point to mid-channel sediment deposition.

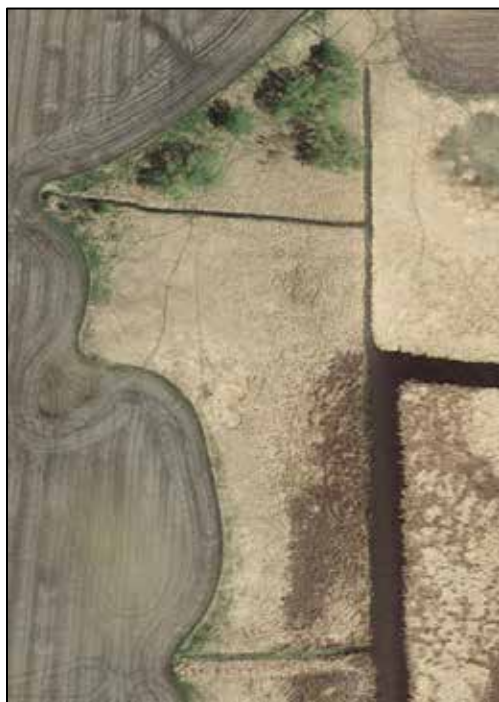
Figure 24. Small direct ditches (perhaps tile line outlets) inputting field runoff directly to the channel.

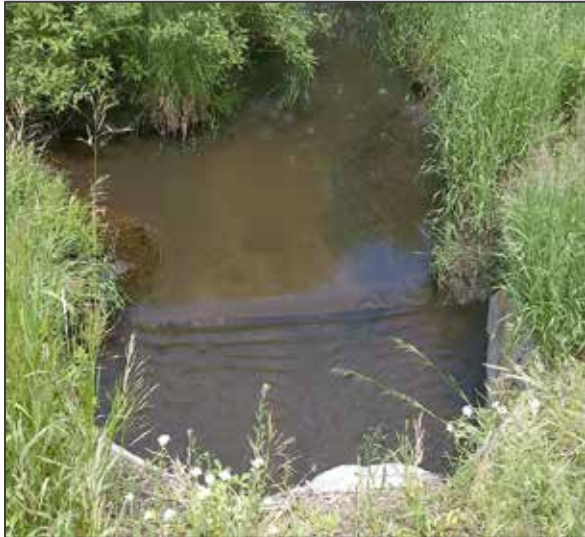
Photo 9. The upstream side of the culvert at 365th Street (07UM019). The lip of the culvert is up off the bottom of the stream bed and velocity can be seen picking up immediately upon reaching the culvert.

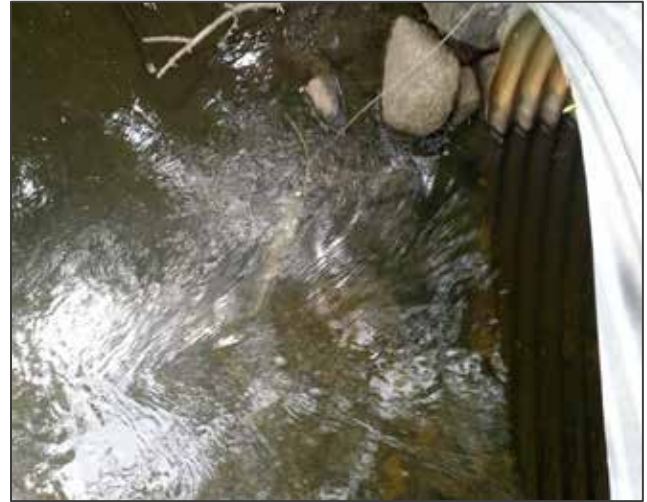
Photo 10. The downstream end of the culvert at 360th Street (09UM070) showing the fast water emerging from the culvert.

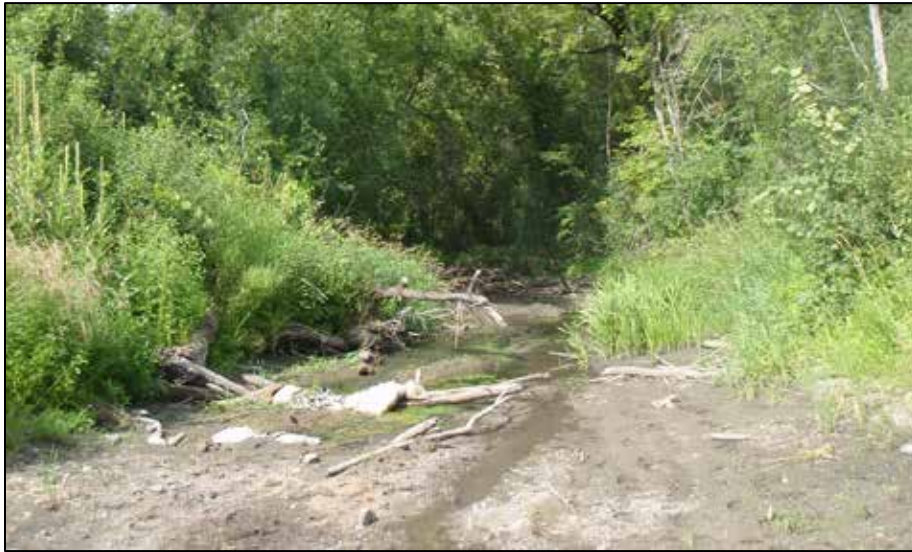
Photo 11. There are times that water levels get extremely low in Collinwood Creek, as in this photo from August 4, 2009, taken at the upper end of the biological monitoring reach (07UM015).

There has been significant modification of the natural hydrology of the sub-watershed, both due to historical large-scale vegetation cover changes (perennial vegetation to cultivated fields), as well as straightening of the full length of the AUID, which reduced sinuosity and thus water moves through the system more quickly. Channel size was also likely increased when the ditching was done originally. This speeding of the water movement through the landscape may have an influence on the relatively frequent intermittency of the creek (Photo 11). A short term flow gage (three years) was established on Collinwood Creek during 2017-2019 just upstream of 07UM015. There were no flows as low as 2009, but there were prolonged periods in mid-late summer when flow levels were down to the 5-6 cfs range in 2017 and 2018 (Figure 31).

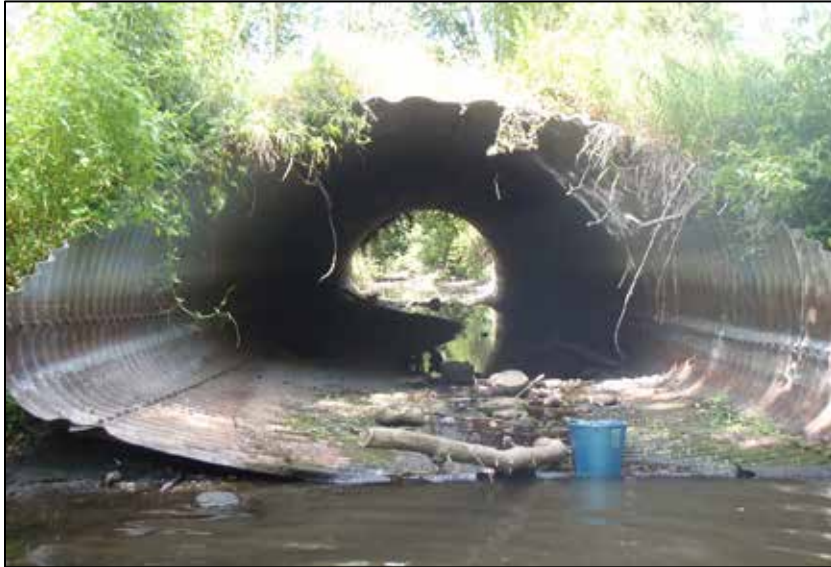
Photo 12. The culvert on 250th Street, at the downstream end of 07UM015 sits at too high an elevation to allow for fish passage at lower water levels. Date of photo is August 4, 2009.

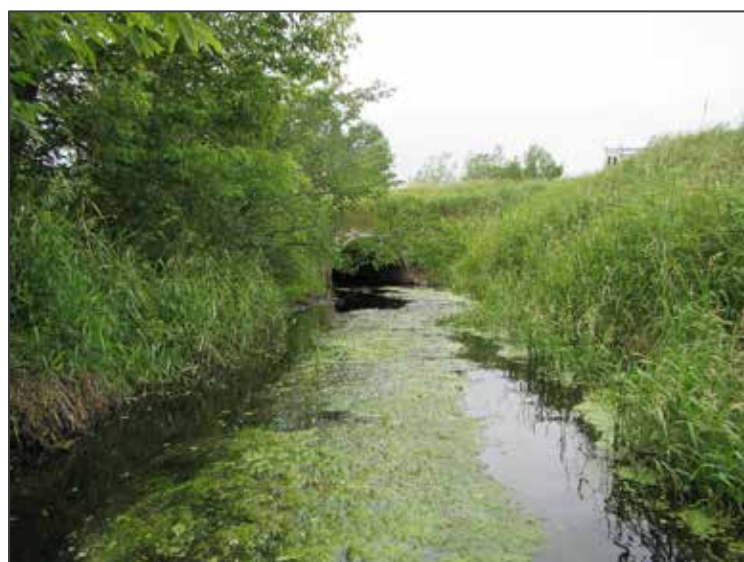
Photo 13. The channel within the biological sampling reach on June 27, 2017 showing the extensive vegetation and filamentous algae mats growing upon it.

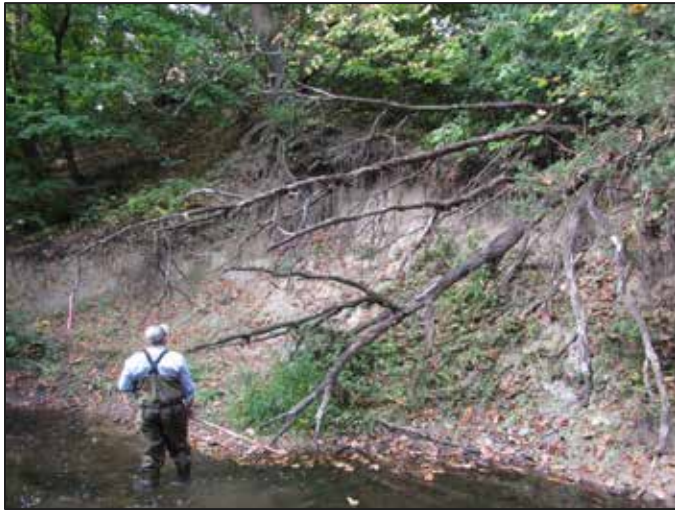
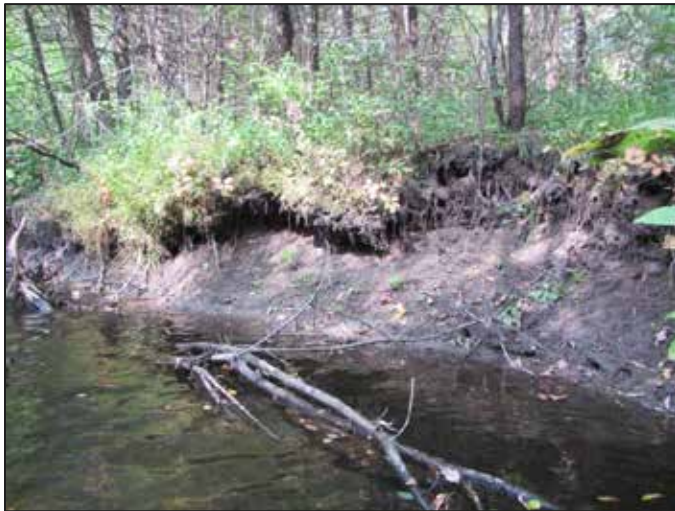
Photo 14. Two bank sections in the biological sampling reach are examples of bank instability and sediment input to the creek and Little Waverly Lake downstream.

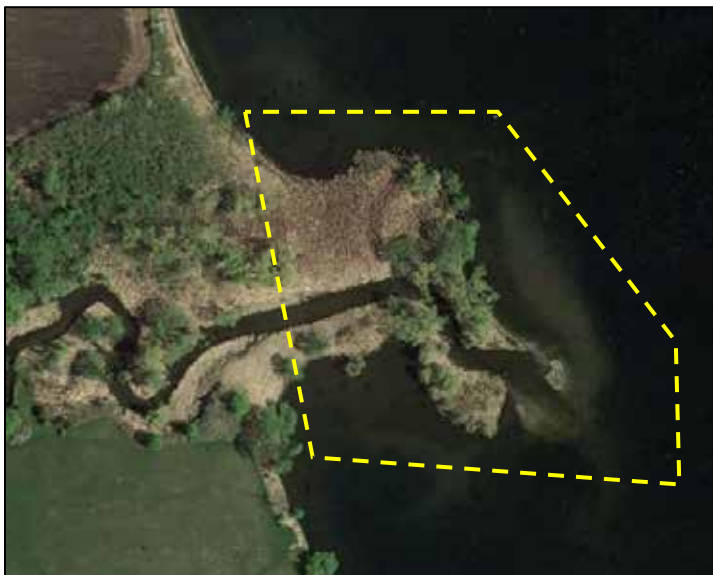
Photo 15. A sediment delta (within the yellow box) has formed where Twelvemile Creek enters Little Waverly Lake. Turbid stream water can also be seen in the lake.

The physical channel is highly related to the hydrology of the sub-watershed's landscape. As mentioned above, hydrology has been substantially changed from its original flow paths and amounts. The added water burden in the channel has caused channel instability in places. Significant bank erosion was noted and photographed by the biological crews (Photo 14). The cobble substrate in this section of stream has prevented significant downcutting of the channel, but pressure has been put onto the banks, and this has caused instability, and the resulting input of sediment into the stream and downstream into the lake (Photo 15). Additional areas of bank erosion can be seen in aerial photos, both upstream and downstream of the biological site, particularly where riparian woody vegetation has been changed to grass.

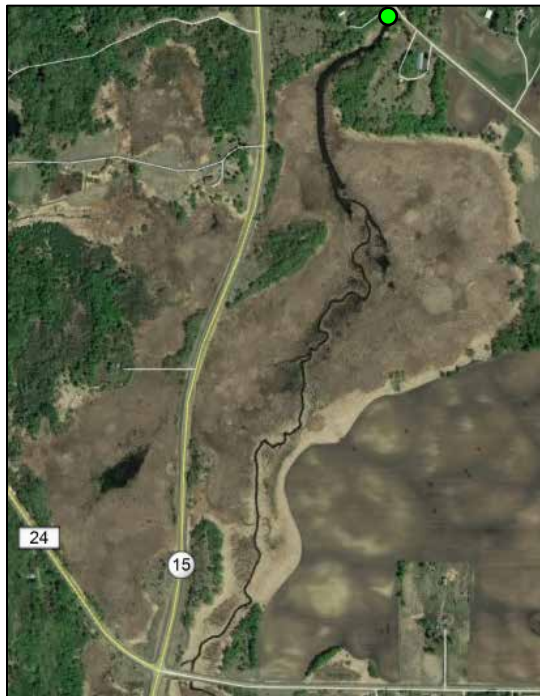
Figure 38. Aerial photography of the reach leading to and including the biological sample site 07UM030 near the top of the image, showing very large wetland that the channel flows through. Riparian habitat upstream within AUID-751 is similar.

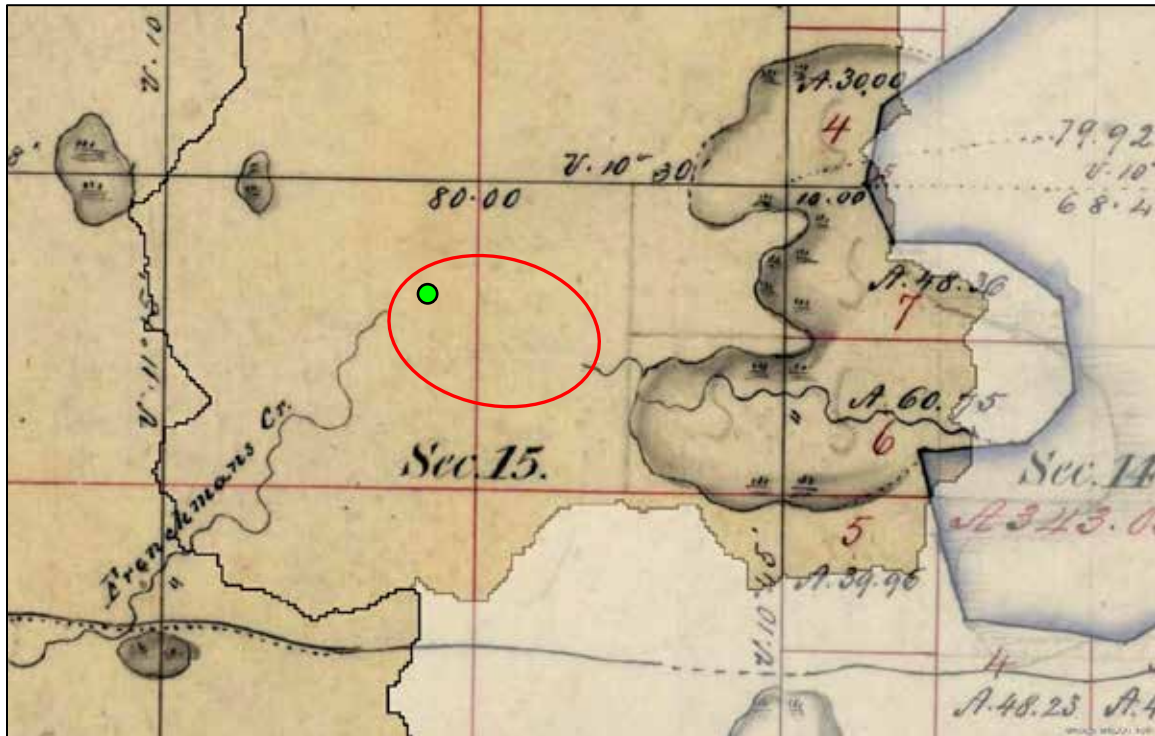
Figure 46. The original survey plat sketch shows that there may not have been a channel through the wet meadow where there now is a ditch (area circled in red). Outflows from the lake may have dissipated throughout the meadow, and then coalesced again to form the downstream part of the channel, which on this original map is named Frenchmans Cr. The green dot is the center point of the biological sampling reach.

There has been significant modification of the natural hydrology of the sub-watershed, both due to historical large-scale vegetation cover changes (forest to cultivated fields), as well as straightening of the channel that reduced sinuosity and thus speeds movement of water through the landscape/stream system. This AUID may not have been a contiguous channel in pre-settlement times (Figure 43). There is no evidence from viewing the LiDAR elevation data that a natural, sinuous channel existed through the wetland just upstream of 07UM048, which confirms the original survey drawings shown in Figure 43. Channel size was also likely increased when the ditching was done originally (Figure 44). These changes have very likely made French Creek a more flashy system, with quicker, stronger pulses of water moving through the system following sizeable rain events, and may result in lower baseflow volumes during drier times.

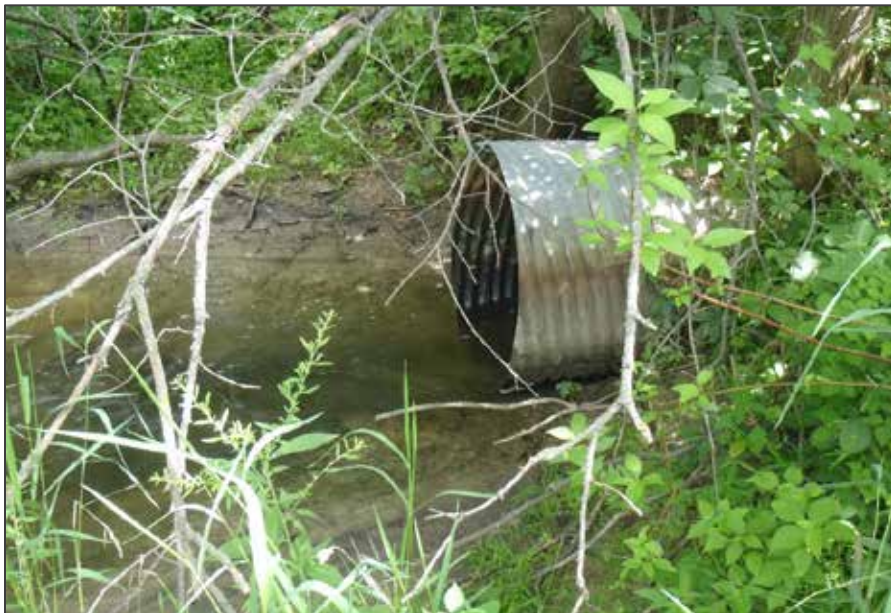
Photo 18. Downstream end of the culvert at Peloquin Avenue NW.

There are four culvert crossings between the North Fork Crow River and the biological site on the downstream AUID-760. Two of the crossings are on public roads (CR-37 and Peloquin Avenue NW), and two are on private drives. From aerial photography, both of the private drive culverts appear to have scour pools on the downstream side, suggesting that culvert sizing is not correct, and thus these may be fish migration barriers. The culvert at CR-37 is passable, while the Peloquin Avenue NW culvert is somewhat suspect of being a partial barrier. It is undersized and set at too high an elevation per guidance by MnDOT (2019). At lower flows, it is passable (Photo 18). There is also a private crossing within the biological reach and road crossing at the upstream end of the biological reach on CSAH-3. From crew photos, the private culvert does not appear to be a barrier. The CSAH-3 crossing was visited and is not a migration barrier. A third upstream culvert crossing is near French Lake on Oliver Avenue. While not visited on the ground, aerial photos show it is likely passable, though this crossing is not that likely to influence the fish community at the biological site even if it were a barrier.

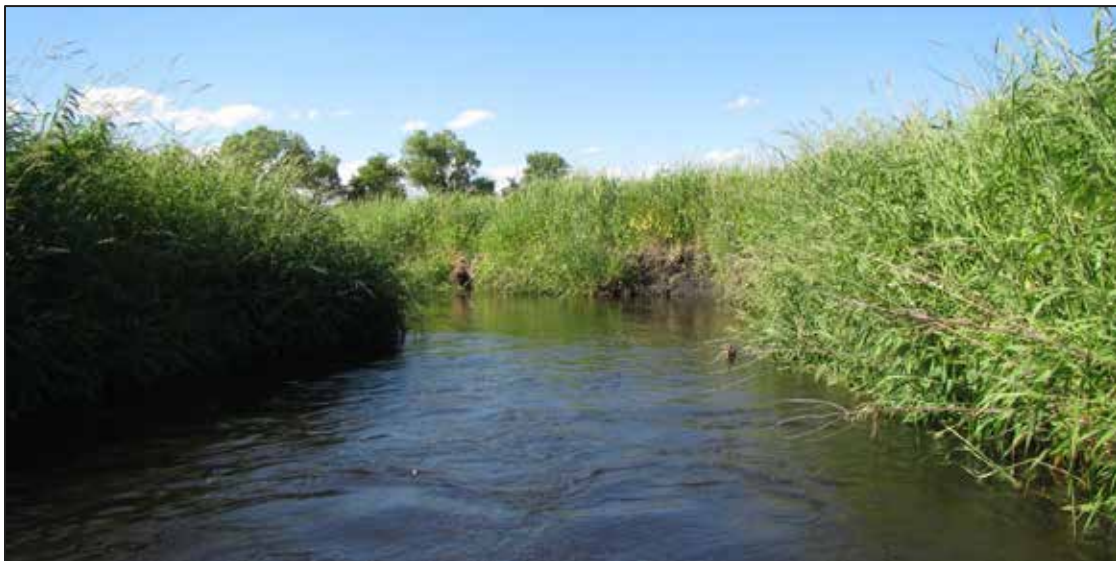
Photo 19. The biological monitoring staff documented that there are periodic locations where bank failure is occurring along the 07UM026 reach, depositing sediment into the stream and leading to vertical raw banks that are not protected from additional erosion.

The geomorphology reach is located in this new AUID-749, at the same location as biological monitoring site 07UM026. The geomorphology reach was immediately downstream of the biological sample reach. The Pfankuch assessment scored in the range considered "Fair" for stability. Sand was the dominant substrate type, with gravel being the largest substrate type present. The Rosgen protocol found the physical channel to be fairly healthy, with slight incision, allowing much of the high flow events to spill out onto a wide floodplain to dissipate the water's energy so as not to tear apart the channel. Such channels typically provide good and stable habitat for aquatic organisms. However, bed materials were judged to be moving and re-depositing more than is natural, which detracts from habitat quality. This could be the result of the incision mentioned above, as there is more energy working against the stream bottom, having greater ability to move especially the finer particles like sand. The results suggest that altered hydrology from upstream ditching is possibly leading to moderate problems in AUID-749 (Photo 19).

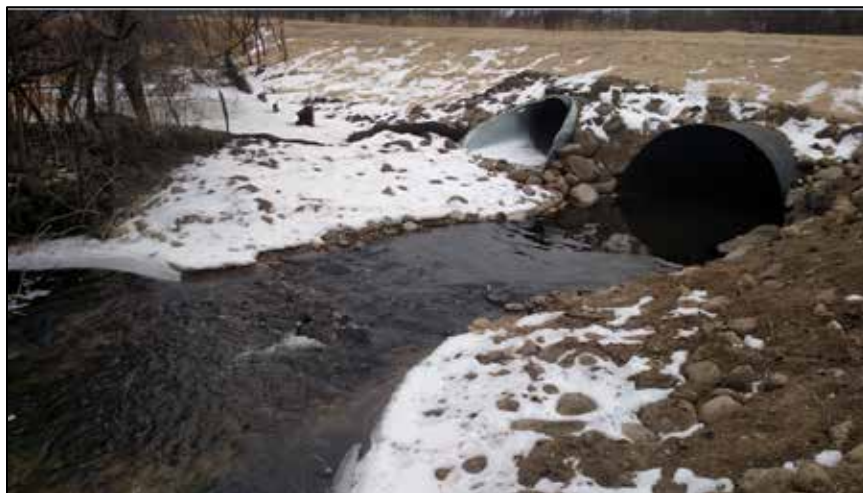
Photo 20. Downstream side of new culverts on Sucker Creek at 650th Avenue, southeast of Litchfield. The main culvert is properly sized and set at the appropriate elevation to allow natural continuity of the stream through the culvert. The floodplain culvert allows for high streamflow to pass and protect the roadway.

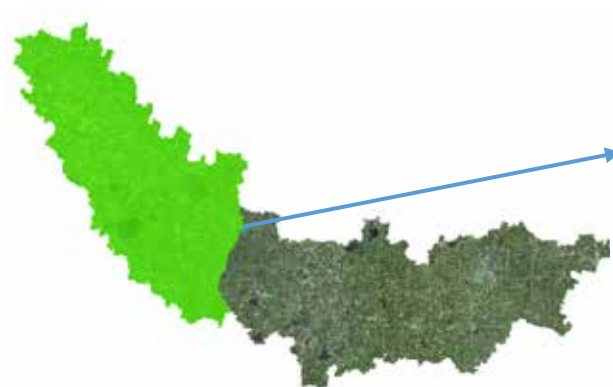
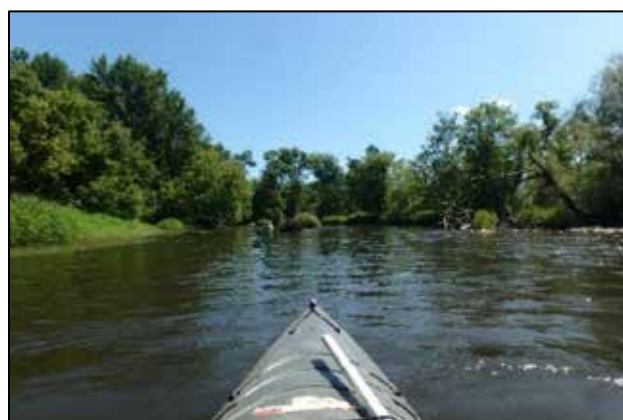
Geomorphic Reach Information			
Stream Name	North Fork Crow River	Drainage Area	658.75 mi ²
MPCA AUID	07010204-507	Stream Type	C5c-
County	Meeker	Valley Type	Unconfined Alluvial U-AL-FD
Section, Township, Range	Sec 27, 28, 34, T121N, R31W	Water Slope	0.0006 ft/ft
Entrenchment Ratio	10.65 (slightly entrenched)	Sinuosity	1.36
Width/Depth Ratio	17.24 (moderate to high)	Pfankuch Stability Rating	74 (good)
Bank Height Ratio	1.0 (stable)	Particle size (D50)	1.06 mm (sand)

The North Fork Crow River geomorphic survey consisted of 2.25-mile reach from 592nd Avenue to MN Highway 22 in Meeker County. The survey was completed in late-July 2018 at moderate to high flow volume. The data were collected utilizing a SonTek RiverSurveyor in combination with a Trimble R10 GPS to collect longitudinal profile and cross-sectional data. Three riffle cross-sections and two pool cross-sections were surveyed and riffle and full reach particle size data were collected. The purpose of the survey was to document the unaltered, natural stretch of low-gradient river with floodplain connectivity, minimal bank erosion, high quality riparian conditions, and diverse habitat to document potential reference conditions.

The North Fork Crow River through this mid-mainstem reach meanders through a wide, alluvial valley with an intact riparian corridor. The pattern and riparian conditions have remained constant over the last approximately 30-years. There is no sign of past channelization based on aerial photograph review (Figure 49).

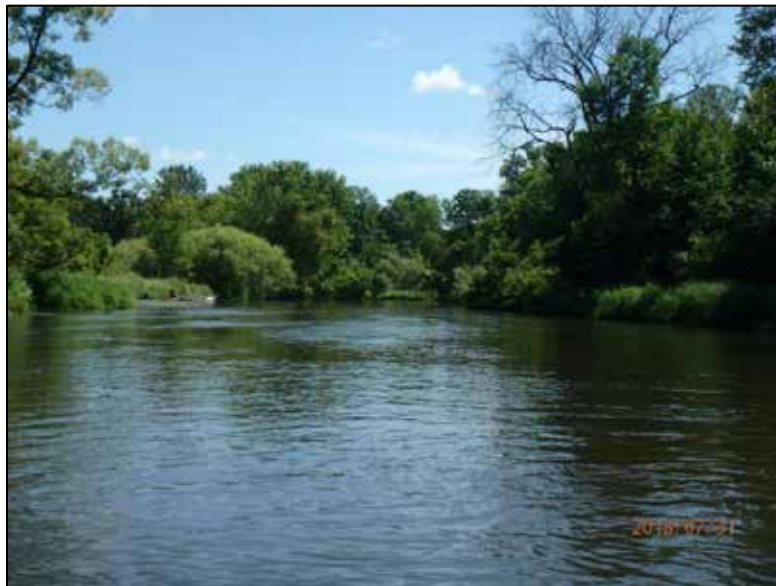
Figure 55. Image of typical channel width and riparian conditions throughout the survey reach.

The longitudinal profile indicated the mean riffle depth was 4.16 ft and the maximum riffle depth was 5.17 ft (Figure 51). The mean pool depth to bankfull elevation was 6.58 ft and the maximum was 8.95 ft over the 2.29-mile longitudinal profile. The downstream riffle and pool cross-sectional surveys are shown in figures 53 and 54. The SonTek RiverSurveyor may result in less accurate riffle and pool depths when compared to the typical survey grade equipment. The longitudinal profile revealed continuous floodplain connectivity and minor channel incision. There was little evidence of streambank erosion, based on visual observations and photographs captured during kayak reconnaissance and survey. Actual bank erosion measurements were not collected. The kayak reconnaissance included an additional four-mile reach downstream. In the reach from MN Highway 22 to 328th Street, the valley is mapped with outwash materials. Adequate floodplain and high quality riparian conditions existed in this reach too. However, there were more wetlands, oxbows, and side channels observed throughout the downstream stretch. A key strategy for this area of the North Fork Crow River will be maintaining and protecting the wide, perennial vegetated buffer and floodplain to help sustain stream stability, ecological functions, and diverse habitat. This reach of the North Fork Crow River has been identified as a priority for stream protection, according to Stream Protection Priorities for Watershed Restoration and Protection Strategies (WRAPS) data set available within the [Watershed Health Assessment Framework \(WHAF\)](#) interactive map. It is currently fully supporting for the aquatic life assessment, and designated with a higher risk of becoming impaired in the future. Photos of this section of the North Fork Crow River in shown in Figures 55 and 56.

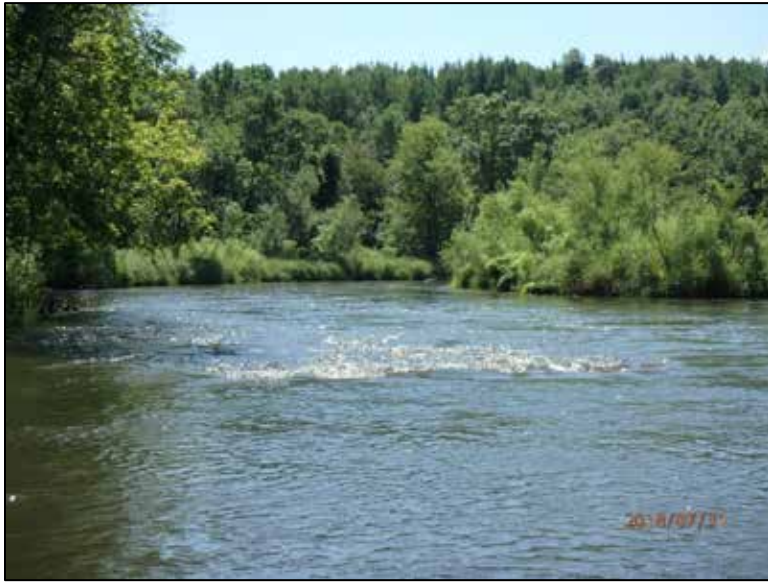
Figure 56. An image of a riffle feature in a straight section as the thalweg crosses over toward the outside bend flowing to the pool downstream.

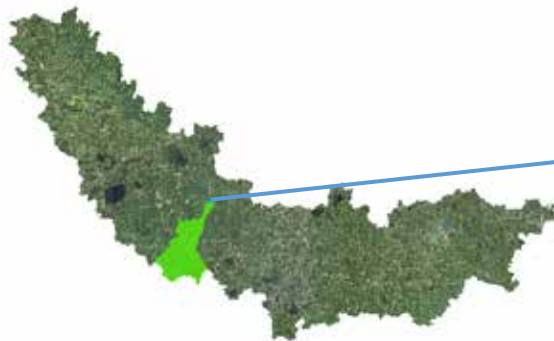
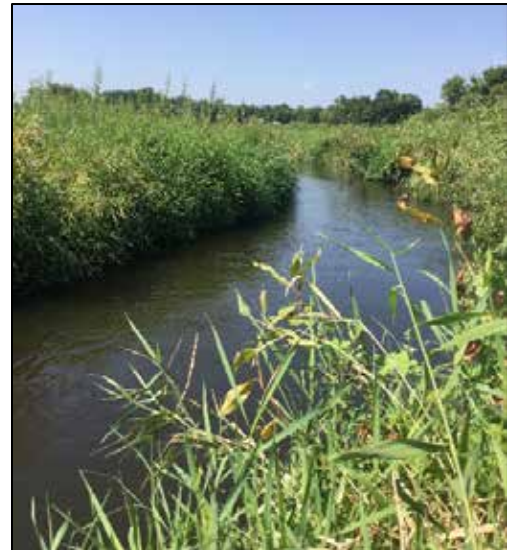
Geomorphic Reach Information			
Stream Name	Grove Creek	Drainage Area	50.58 mi ²
MPCA AUID	07010204-514	Stream Type	E5
County	Meeker	Valley Type	Unconfined Alluvial U-AL-FD
Section, Township, Range	Sec 32, T121N, R31W	Water Slope	0.00075 ft/ft
Entrenchment Ratio	33 (slightly entrenched)	Sinuosity	2.42
Width/Depth Ratio	5.9 (low)	Est. Reach Erosion Rate	3.54 tons/yr
Bank Height Ratio	1.21 (slightly incised)	Pfankuch Stability Rating	78 (fair)

The Lower Grove site is a sinuous E5 stream with a 200-300 foot (ft) wide buffer, dominated by reed canary grass. There is no sign of past channelization based on air photo review. However, the stream was more sinuous in the past with irregular meanders scrolls (Figure 57). The Lower Grove Creek geomorphic survey reach is downstream of 340th Street and consisted of a longitudinal profile, two riffle cross sections, one pool cross section (Figure 58), pebble count, and bank erosion estimates and validation.

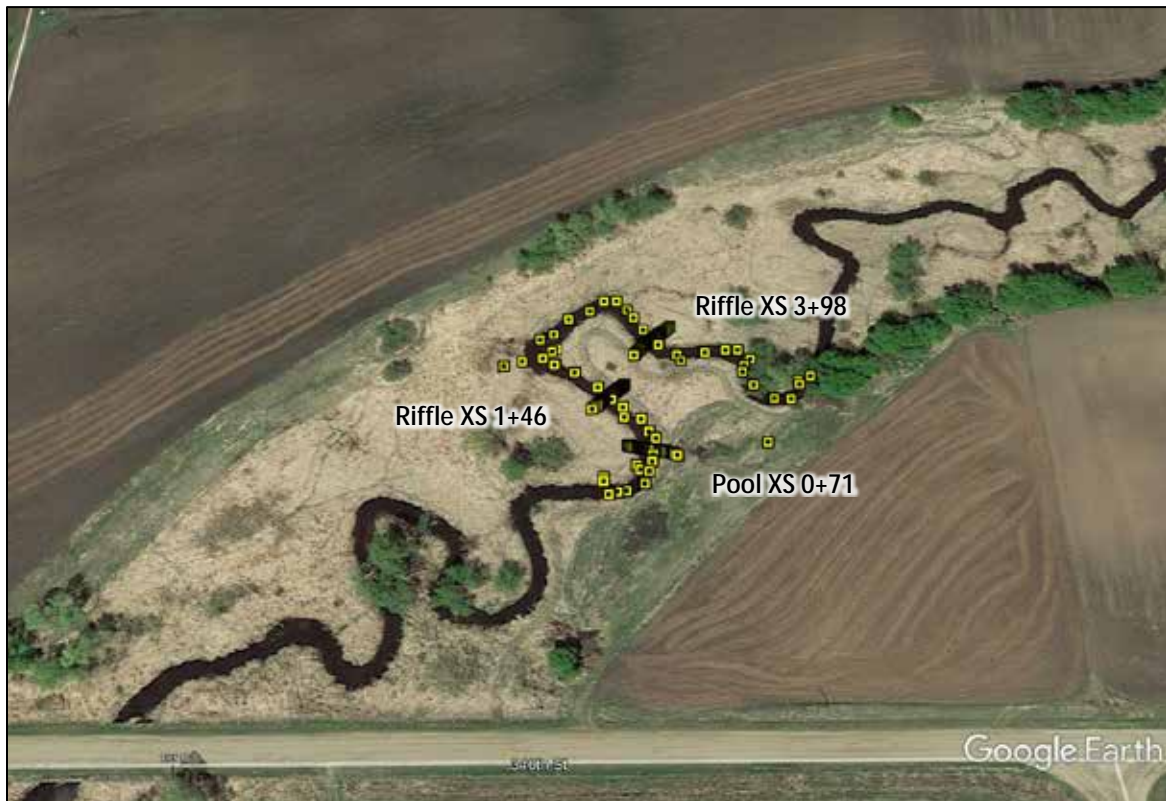
Figure 58. Location of Lower Grove Creek geomorphic site; 2018 image courtesy of Google Earth. Riffle XS 1+46 is the classification riffle.

The classification riffle had a low width-to-depth ratio; 5.9 is an optimal w/d ratio for E channels to allow them to transport sediment most efficiently. The channel had only a slight degree of incision and had overall floodplain connectivity at flows above bankfull stage, an attribute not common in southern Minnesota streams, as most are more deeply incised. The study reach is within a few miles of the confluence with the North Fork Crow River and the valley is wide and unconfined. Soils are mapped as coarse loamy alluvium, according to the online [web soil survey](#). There was evidence of recent substantial sand movement and deposition along the streambed. The D50 of the reach was 0.48 mm with 50% consisting of sand. Other substrate documented in the pebble counts include gravel, silts and clay.

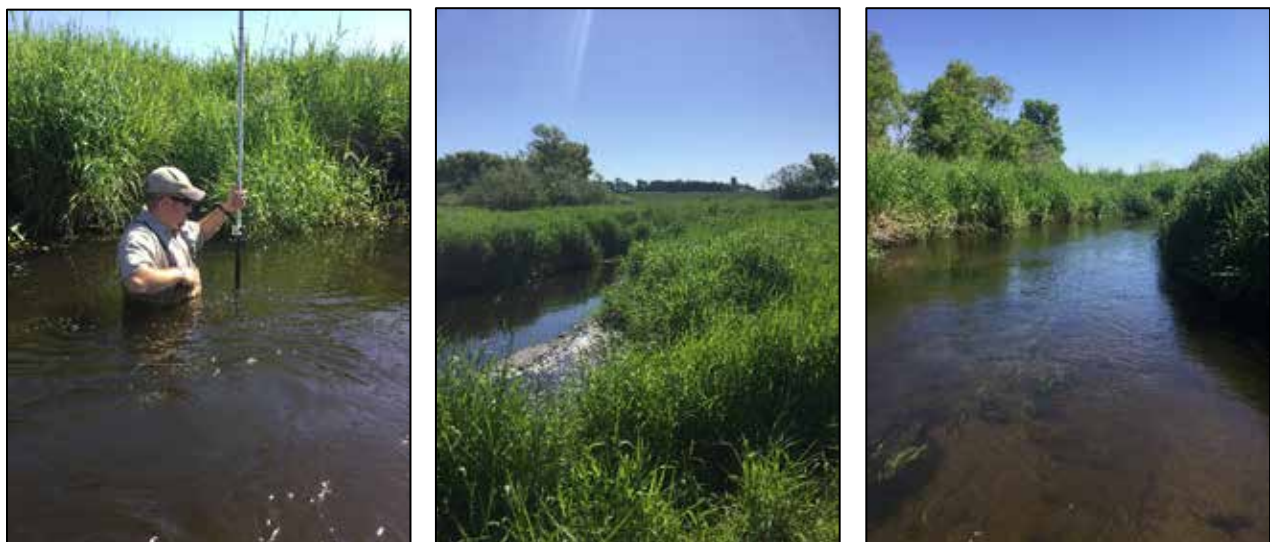
Figure 61. Images captured on June 5, 2017, during the longitudinal profile survey.

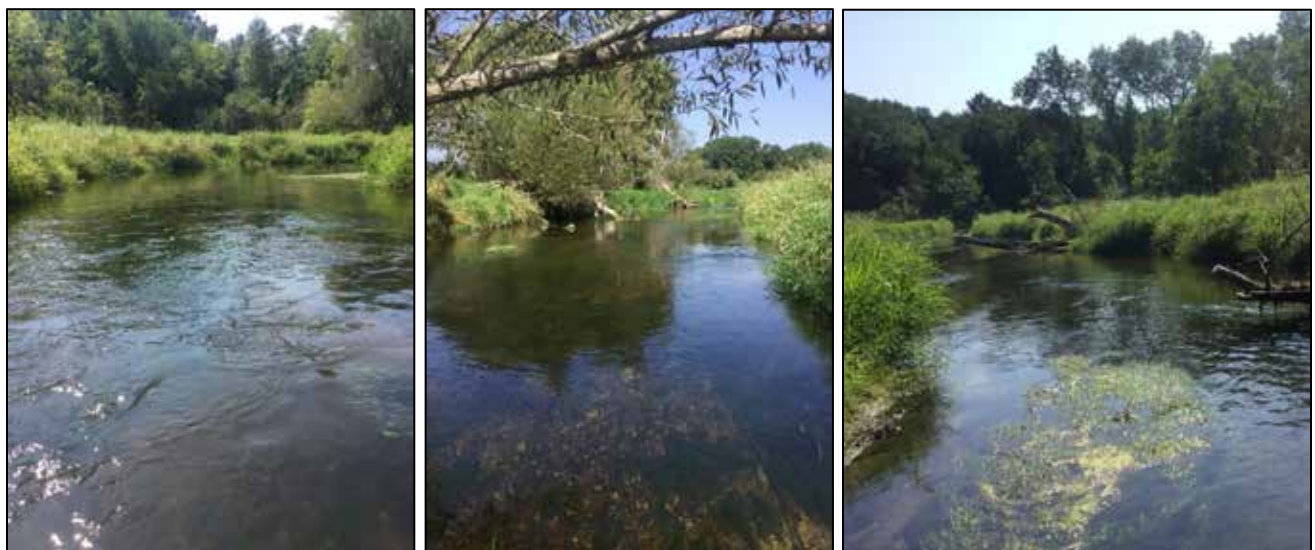
Figure 66. Images captured on August 23, 2018, during the longitudinal profile survey.
