North Fork Crow River Watershed Stressor Identification Report

Assessment of stress factors affecting aquatic biological communities and other aspects of streams and rivers

Document number: wq-ws5-07010204d

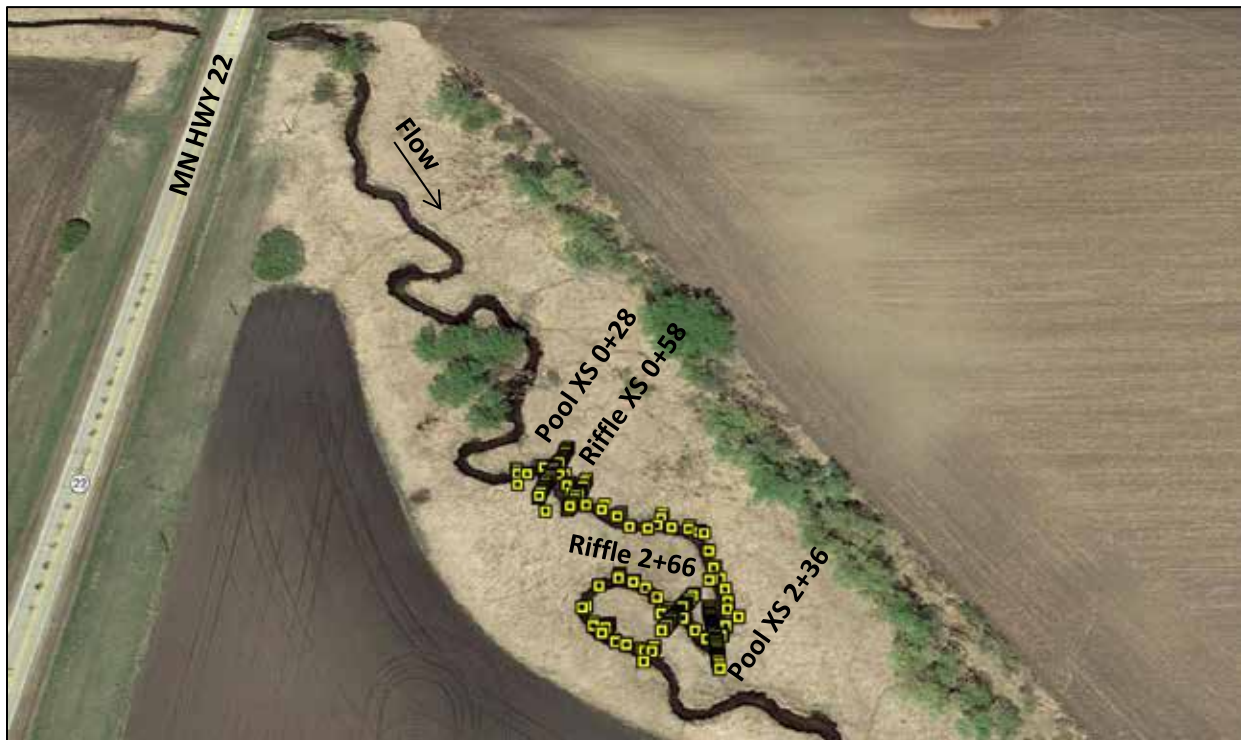
Figure 67. Location of Battle Creek geomorphic survey site; 2018 image courtesy of Google Earth. 2+66 is the classification riffle.

The Battle Creek geomorphic survey reach downstream of Minnesota State Highway 22 consisted of two riffle cross sections, two pool cross sections (Figure 67), a longitudinal profile (Figure 68), pebble count, and bank erosion estimates. Upstream of MN Highway 22, the stream was channelized in the past. However, throughout the survey reach the channel is a naturally meandering E channel with a relatively wide (i.e., 200-300 feet (ft)), and had a dense reed canary grass dominated buffer strip and floodplain connectivity. The Battle Creek survey site has a narrow and deep channel with a predominately sand streambed. The substrate particle size D50 for the reach equals 1.85mm, or very coarse sand. The riffle cross section at station 2+66 was most representative and used as the classification riffle. This classification riffle indicated a low width-to-depth E channel with a slight degree of incision. The longitudinal profile indicated the mean riffle depths are 2.60 ft and the maximum riffle depths are 2.83 ft. The mean pool depths to bankfull stage are 3.62 ft and the maximum is 4.29 ft over the 401 ft longitudinal profile.

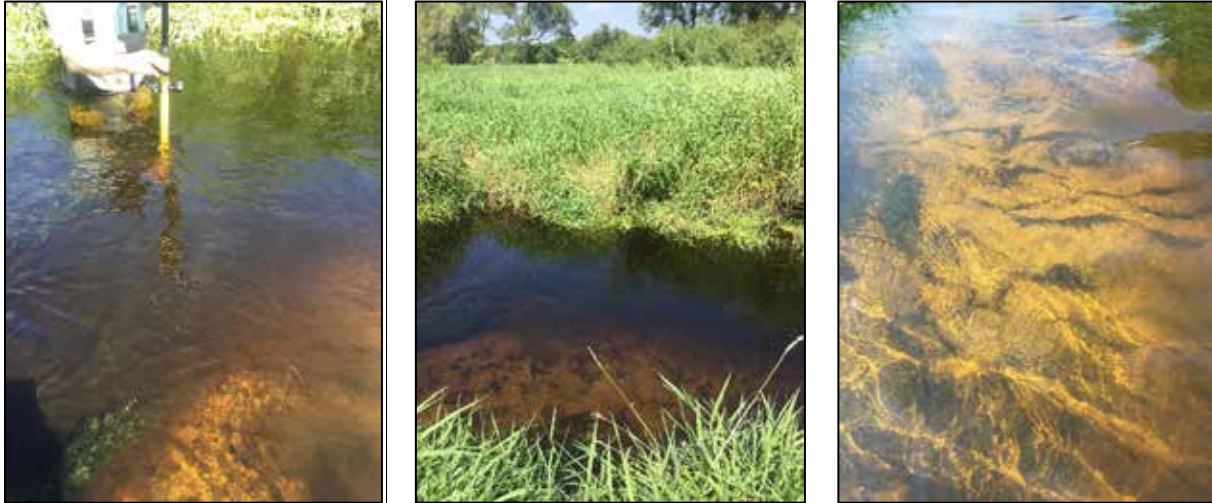
Figure 70. Pool Study XS resurvey, August 22, 2018. Sandy deposition and point bar development.

Cross Section and Year	Bankfull Area (sq ft)	Width Bankfull (ft)	Mean Depth (ft)	Max Depth (ft)
Pool Study XS 2017	56.7	18.3	3.09	4.27
Pool Study XS 2018	46.3	19.3	2.4	4.32

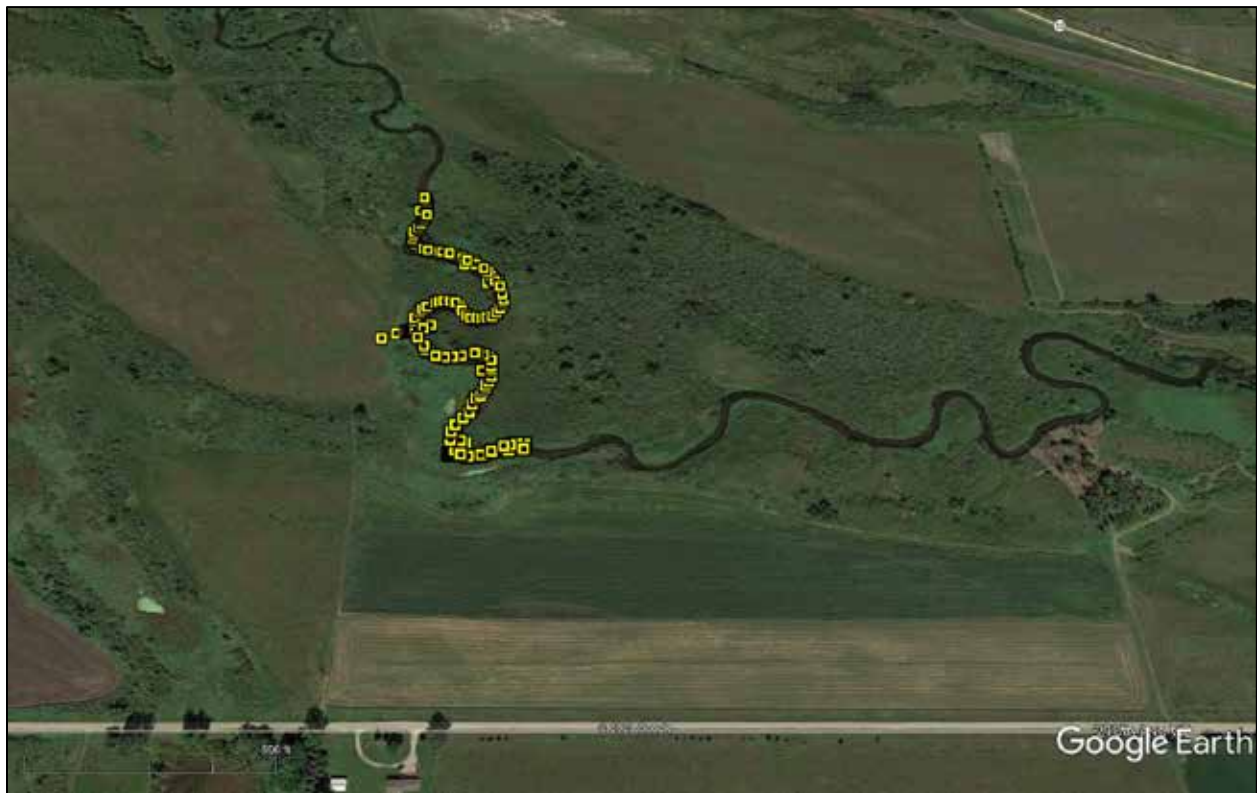
Figure 72. Location of Regal Flats Wildlife Management Area, North Fork Crow geomorphic site; 2016 image courtesy of Google Earth.

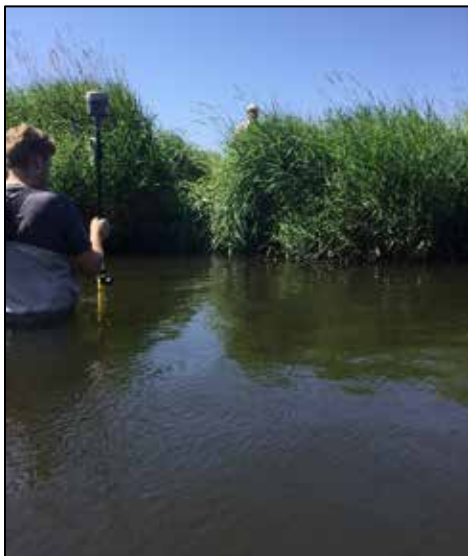
Figure 78. 2019 pool cross section, right bank.

The pool cross section at station 18+89 was surveyed in 2018 and 2019 to document changes and validate predicted streambank erosion rates (Figure 75). The right bank, or outside bend, erosion estimate was 0.42 ft/yr in 2018. The sandy bank materials were noted and a bank material adjustment of five was given. At this time, the Colorado curve is utilized within the Bank Assessment for Non-point source Consequences of Sediment (BANCS) model to estimate annual erosion. The 2019 resurvey was higher than the predicted amount with a measurement of 1.797 ft/yr (Figure 76). When comparing the 2019 photo to the 1991 historic air photo, the bank retreated 26 feet over the 28-year timespan (Figure 77). There were no additional banks scored for an overall estimated bank erosion reach contribution. In general, there was thick reed canary grass, willow saplings, and other herbaceous vegetation overlapping the banks and the bank height ratio was nearly one throughout the surveyed reach (Figure 78). Additional photos of the geomorphic study reach are shown below (Figure 79).

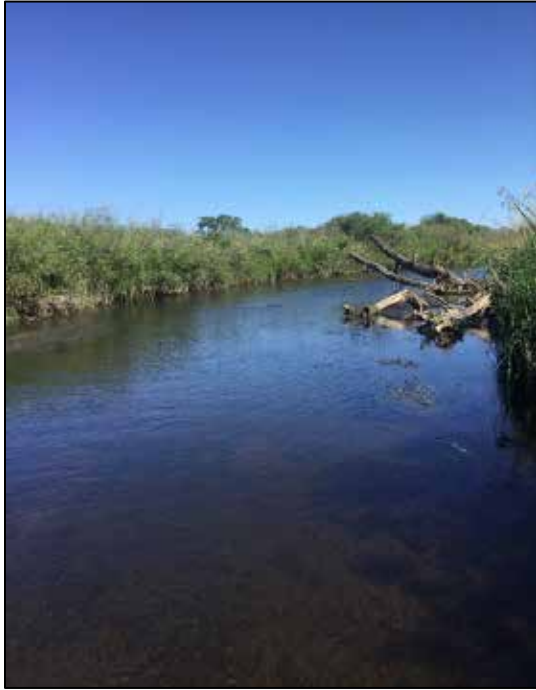
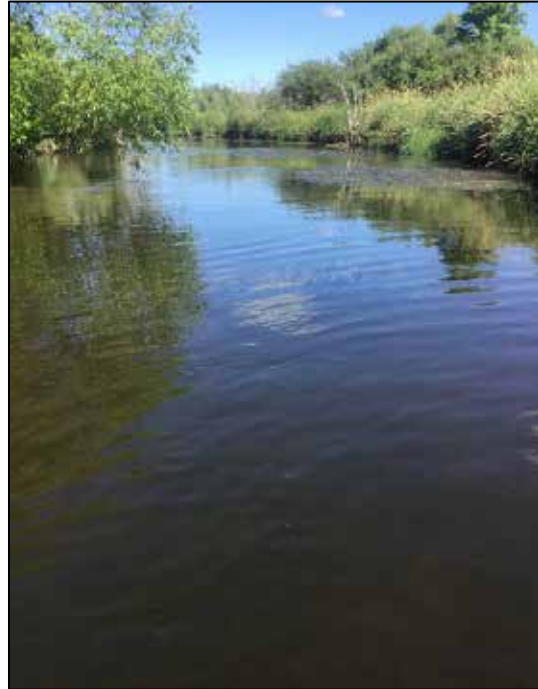
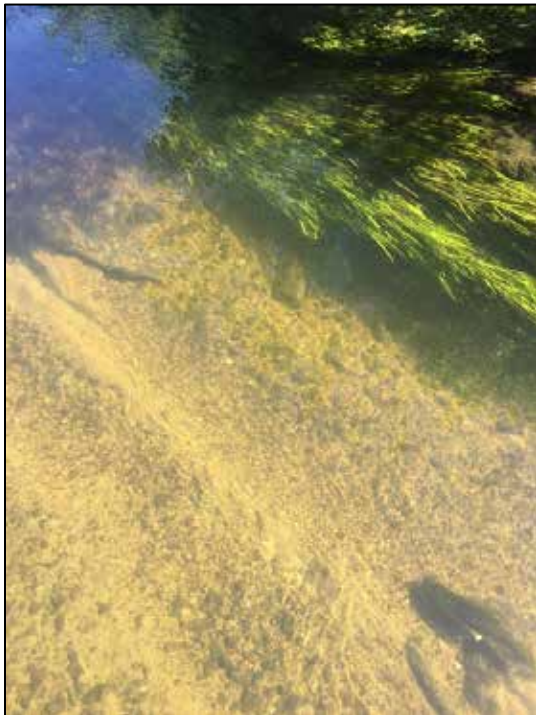
Figure 79. Images captured on July 17, 2018 during the longitudinal profile survey.

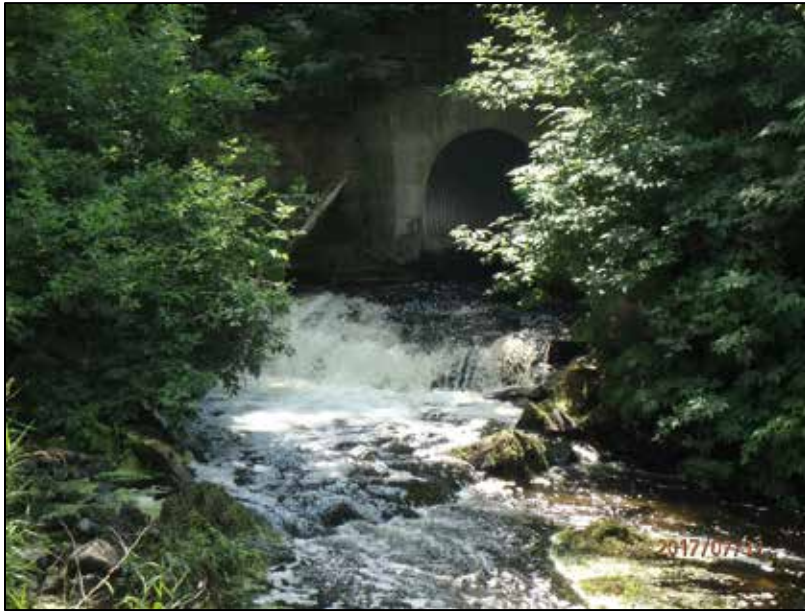
Figure 80. Perched culvert below the railroad grade, located 0.5 miles upstream of U.S. Highway 12 on Grove Creek, creating a fish passage barrier.

A historically altered reach upstream of U.S. Highway 12 was surveyed in July 2017. The Grove Creek geomorphic survey near the speedway consisted of a 1,680 foot (ft) longitudinal profile, riffle and pool cross section, and pebble count. Before surveying, an initial stream walk-over confirmed a perched culvert at the railroad tracks (Figure 80).

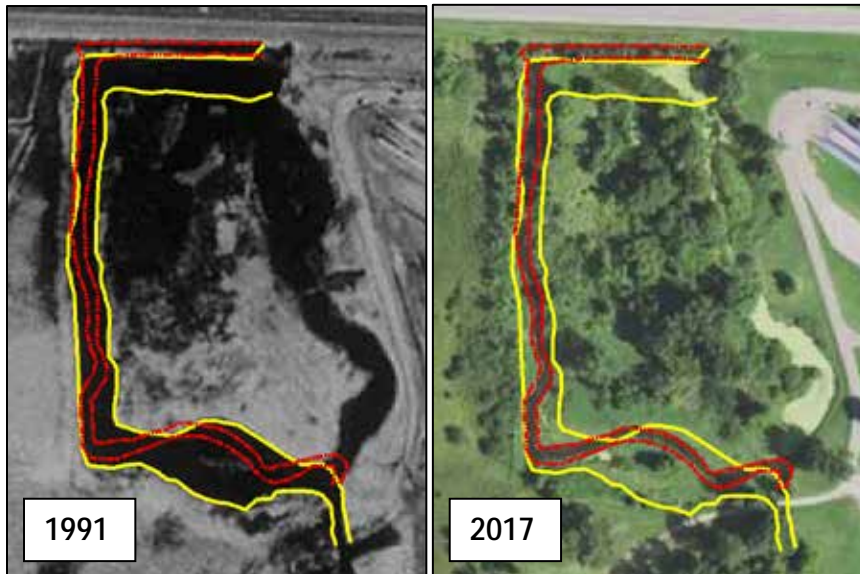
Figure 82. Yellow lines outline 1991 channel and 2017 is the red dashed line.

The geomorphic survey was conducted just south of U.S. Highway 12. At a time between 1979 and 1991 major channel and floodplain alterations occurred creating unstable channel conditions, backwater effects, and excess sedimentation over time (Figures 81 and 82). The alterations resulted in an over wide, shallow stream channel lacking habitat and natural streambed features. However, since the changes that occurred over 30 years ago, the stream is beginning to evolve with natural bed features as the channel is narrowing up, forming subtle meanders and a series of riffles and pools. However, the channel is far from reaching equilibrium or stability. The survey started downstream of a private crossing and followed the perennial, primary flow channel toward the west and north (Figures 83).

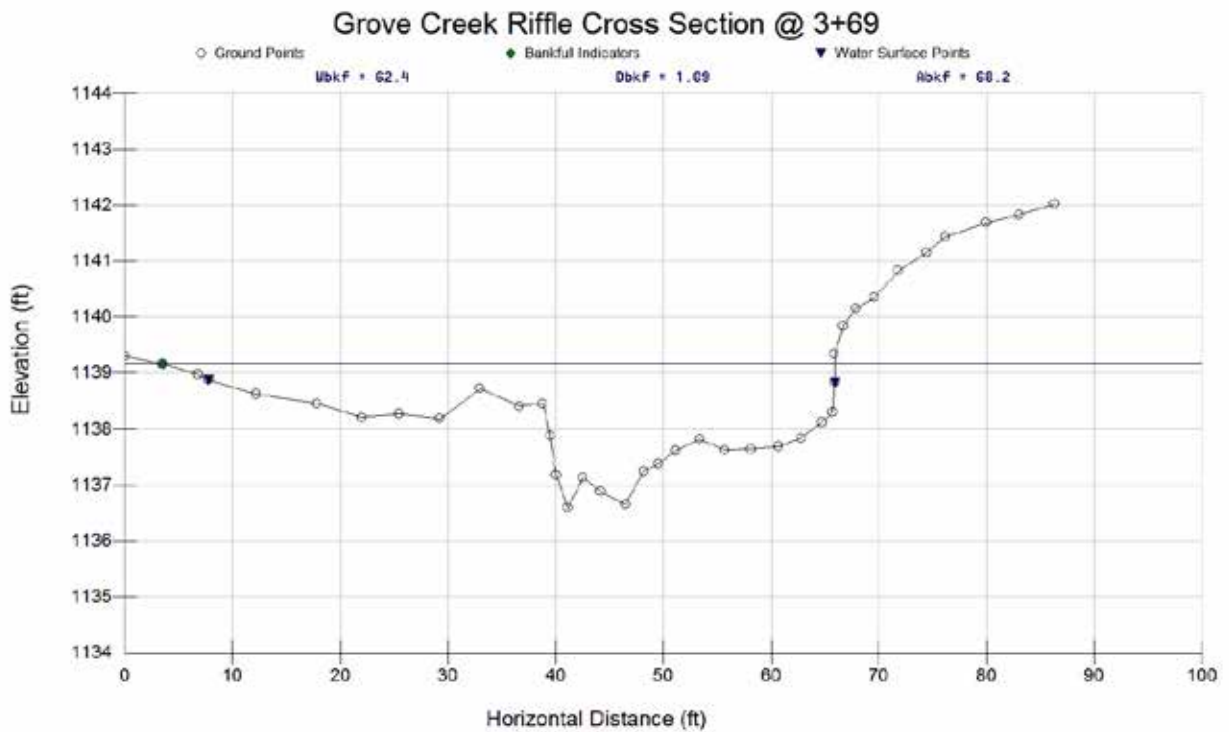
Figure 85. Grove Creek riffle cross section at 3+69. The stream is too wide, but appears to be narrowing over time.

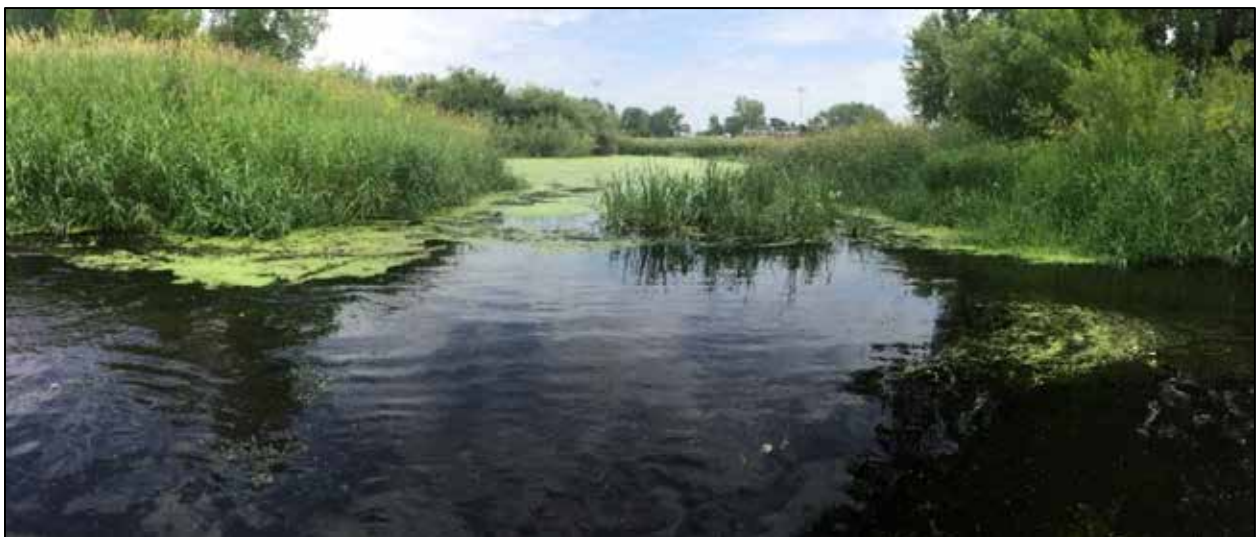
Figure 87. Along the upper reach survey, collecting a bankfull survey elevation point (left) and lower reach survey in right-of-way with narrower channel (right).
