Rum River Watershed Stressor Identification Report

A study of the stressors limiting the aquatic biological communities in the Rum River Watershed.

Minnesota Pollution Control Agency

August 2016

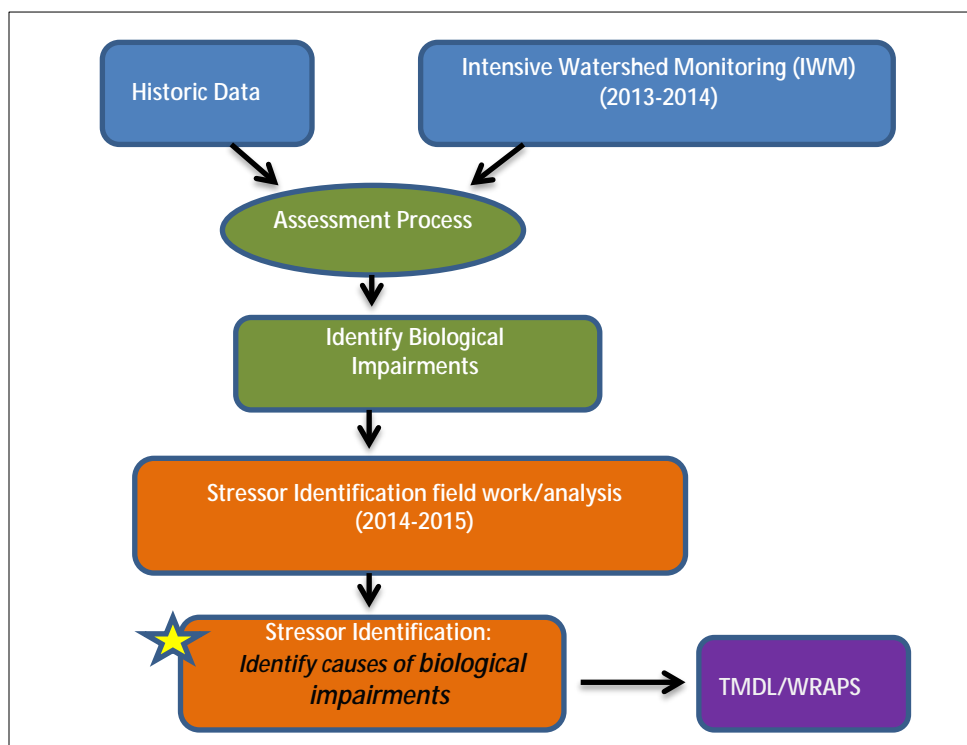
Figure 1.1-1: Process map of Intensive Watershed Monitoring, Assessment, Stressor Identification, and TMDL processes.

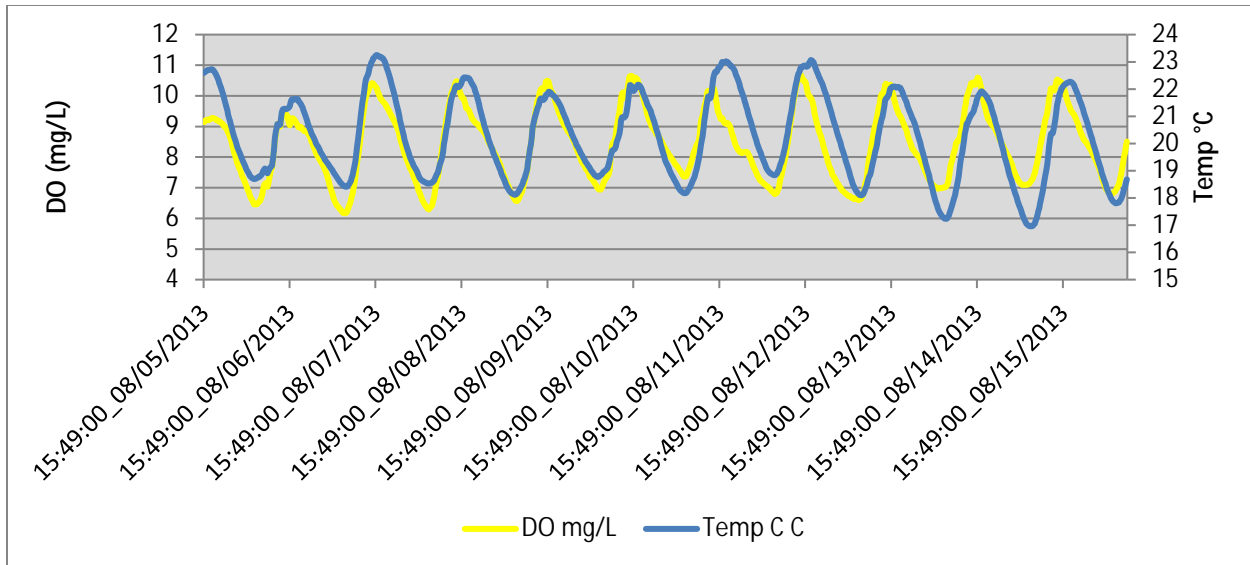
Figure 4.1-1: Continuous DO and stream temperature data from Estes Brook during the assessment monitoring period for the Rum watershed. There are no periods of DO falling below the 5 mg/L standard. Daily DO flux ranges from 2.5 to 4 mg/L per day.

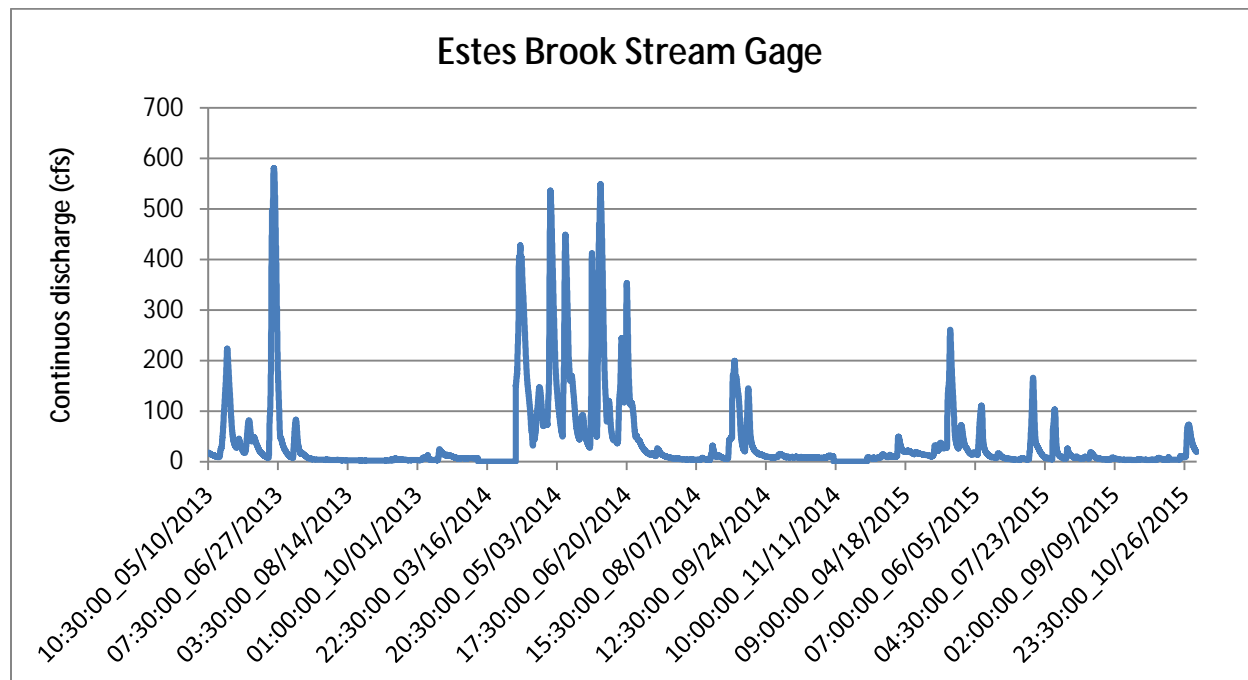
Figure 4.1-5: Continuous stream discharge collected at Estes Brook in 2013 through 2015. Stage data was collected at this station and then converted using a site specific rating curve.

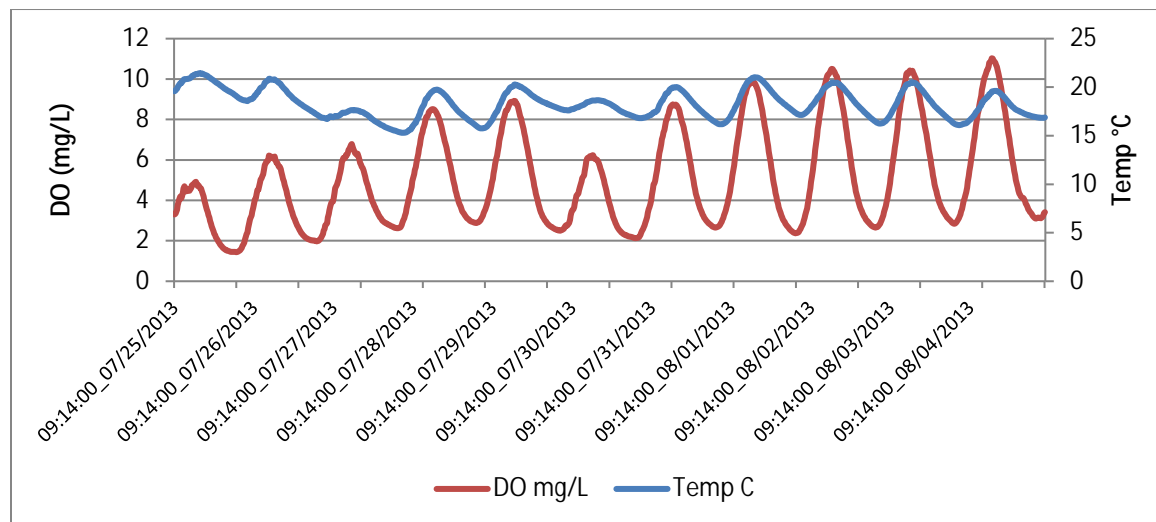
Figure 4.2-2: Continuous DO data collected by a YSI[®] sonde that was deployed in the stream for 11 days in 2013.

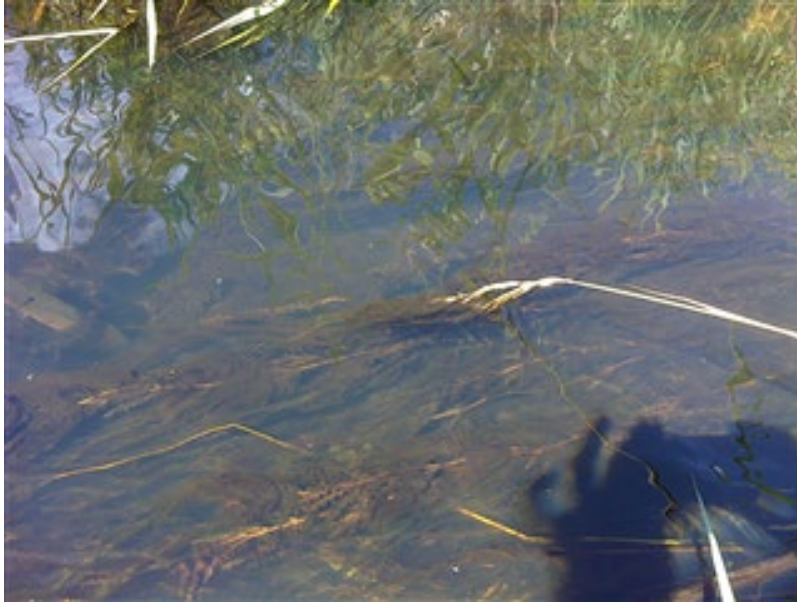
Figure 4.2-4: Trott Brook at sampling location 13UM042. Photo was taken during the SID visit in 2015. Photo shows rooted submerged vegetation along with extensive periphyton growth along the channel bottom.

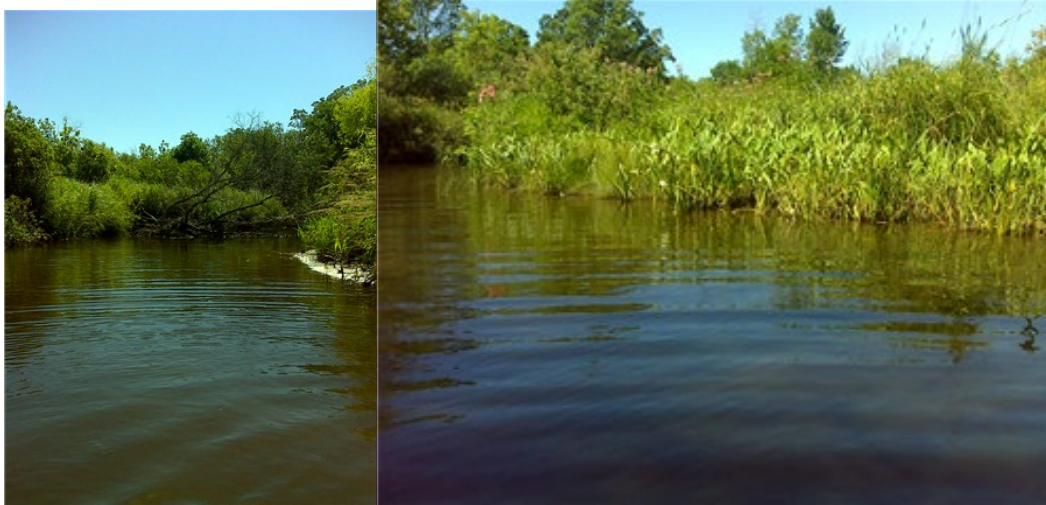
Figure 4.3-4: Tibbetts Brook photos taken during the SID investigation at site 13UM043. Photos indicate not much flow velocity and stagnant water conditions. The site is impounded by a downstream beaver dam.

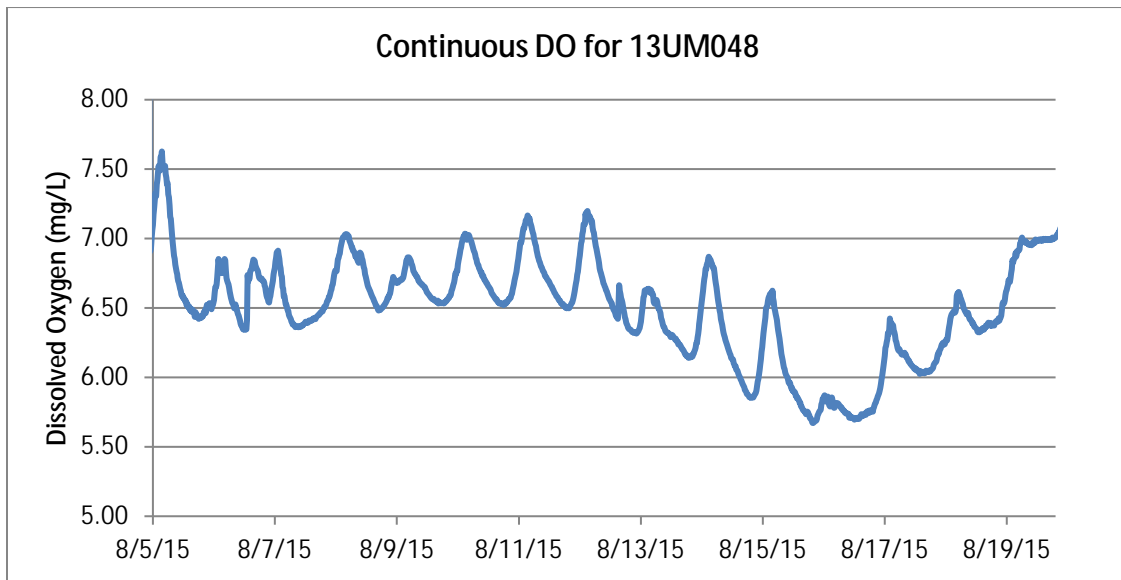
Figure 4.4-1: Continuous DO data collected on the West Branch Rum River from August 4, 2015 through August 22, 2015. Sonde was deployed to record the daily minimum DO concentrations and compute daily DO flux.

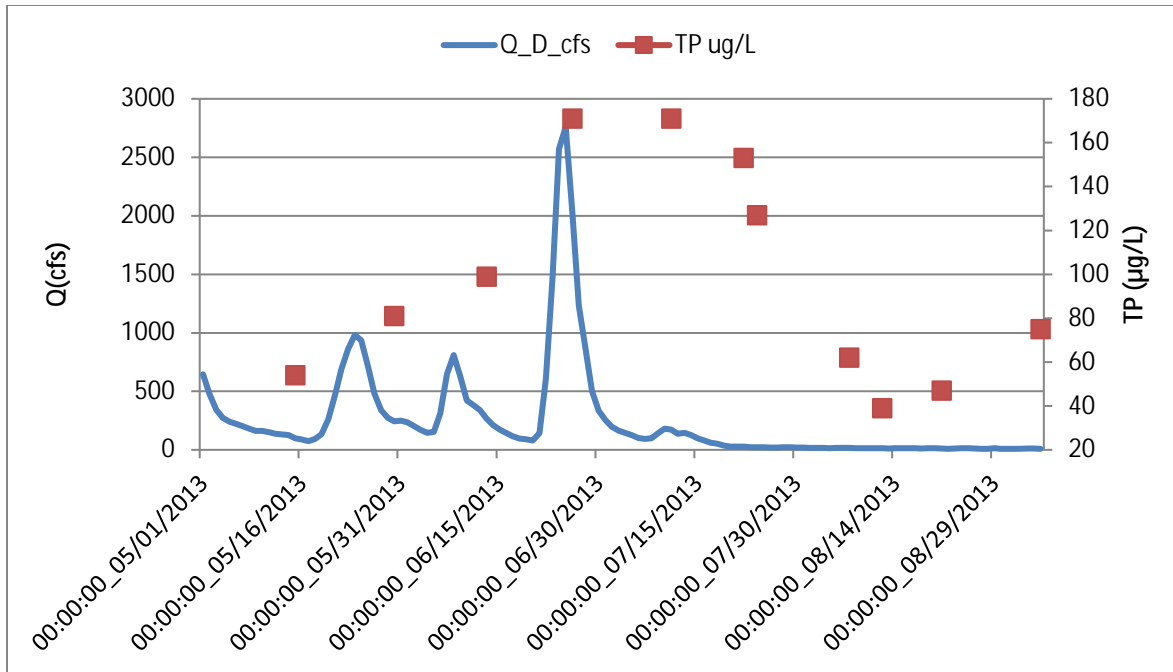
Figure 4.4-5: Daily discharge data from West Branch Rum River from May 1, through August 31, 2013. The stream is very flashy and does not retain base flow very long. TP concentrations are plotted against stream discharge.

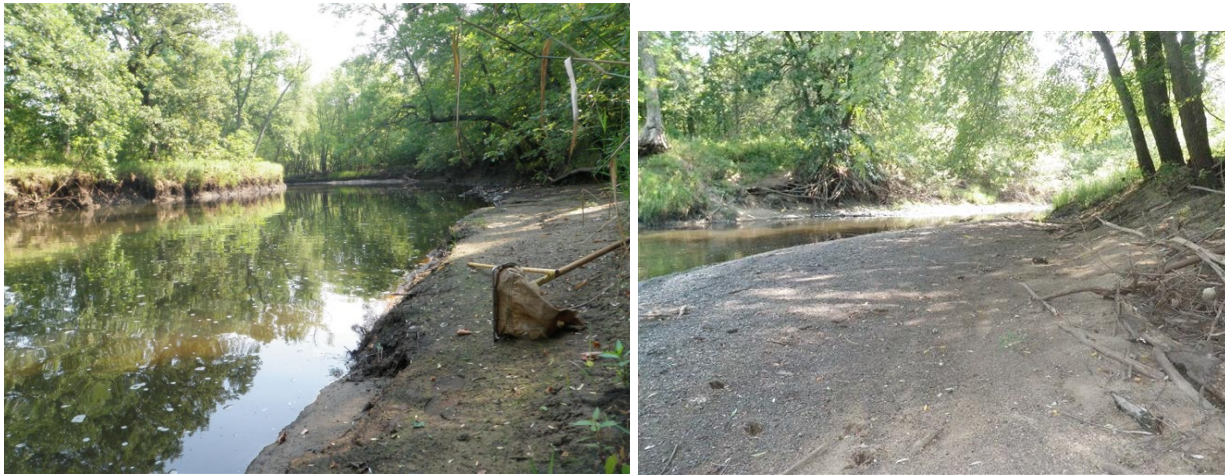
Picture 1: West Branch Rum River during the macroinvertebrate sampling visit on August 19, 2013. Stream flow was very low and some of the habitat features appear dry.

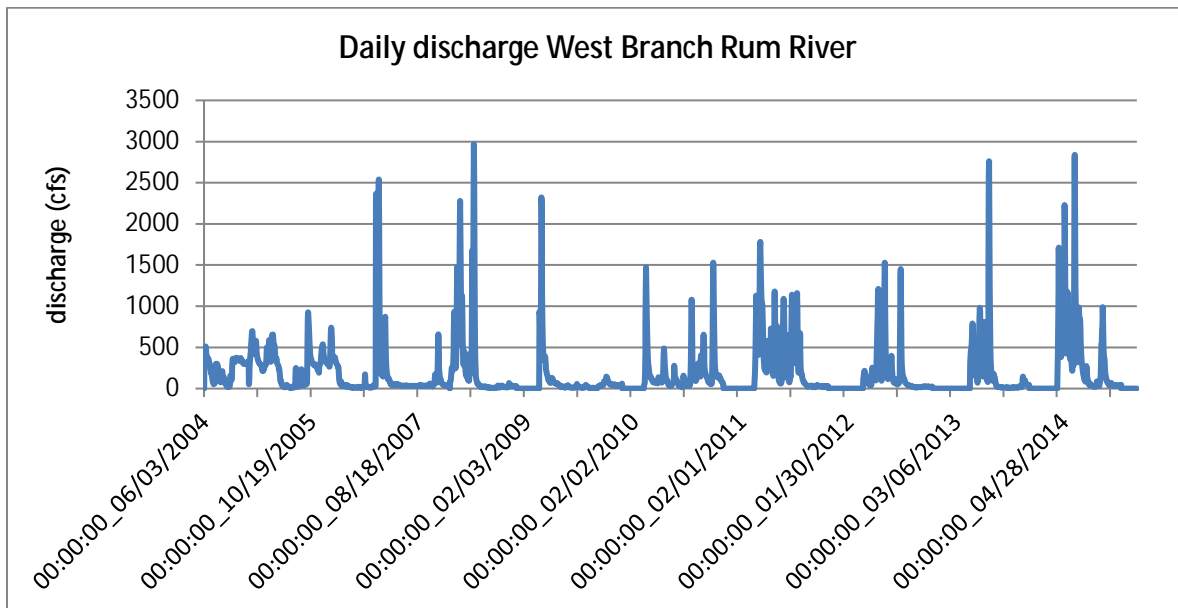
Figure 4.4-7: Daily discharge record for west Branch Rum River. Data starts in 2004 and continues through 2014. Discharge during August of 2013 was very low when compared to early summer periods.

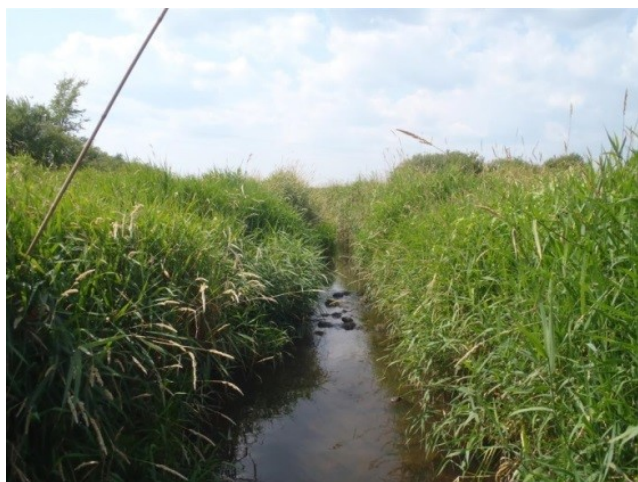
Picture 2: Station 13UM075; August 12, 2013 fish visit showing stream conditions during sampling

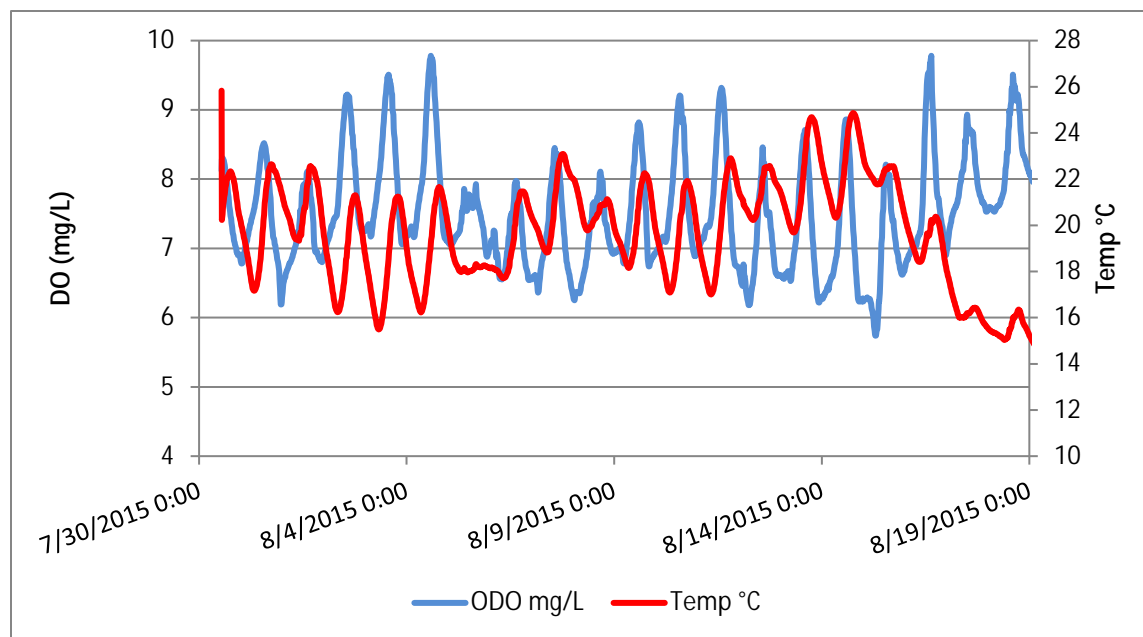
Figure 4.5-1: A YSI[®] sonde was deployed at 13UM075 for 20 days. Data was collected at 15 minute intervals.

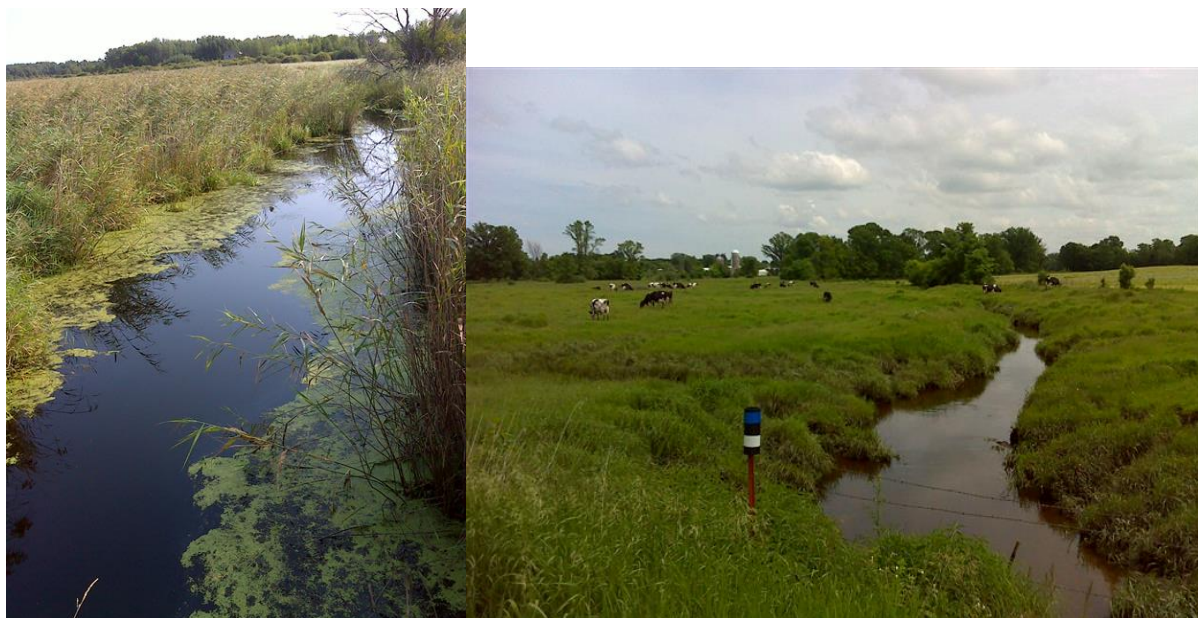
Increased duckweed growth can be seen in the photo below. This photo was taken on August 26, 2015, at EQUIS site S008-630; the corresponding TP concentration was 0.117 mg/L. The photo also shows that the stream can get very low flow late in the summer when there is not a lot of precipitation.

This area of Vondell Brook also has some cattle pastures that are located along the stream corridor. The free access to the cattle will allow for nutrient and sediment transport to occur. A large portion of Vondell Brook and its tributaries are also channelized and run adjacent to agricultural row crop fields and various pastures. This land use will contribute to the elevated TP concentrations. Review of macroinvertebrate metrics can help explain if elevated TP is changing the macroinvertebrate community. As TP increases there would be a response of increased periphyton growth which should be seen as an increase in scraper macroinvertebrates. The scraper groups feed on periphyton. The Class 4 average in the Rum River Watershed (RRW) for scraper taxa richness is 5.6 and site 13UM049 was 6. Another macroinvertebrate metric that can be used to determine if eutrophication is affecting the biology is taxa richness of Mollusca (snails/clams). The Class 4 average for Mollusca is 4.8 in the RRW and the Mollusca taxa richness at 13UM049 is 4. A response to elevated nutrients by the fish community

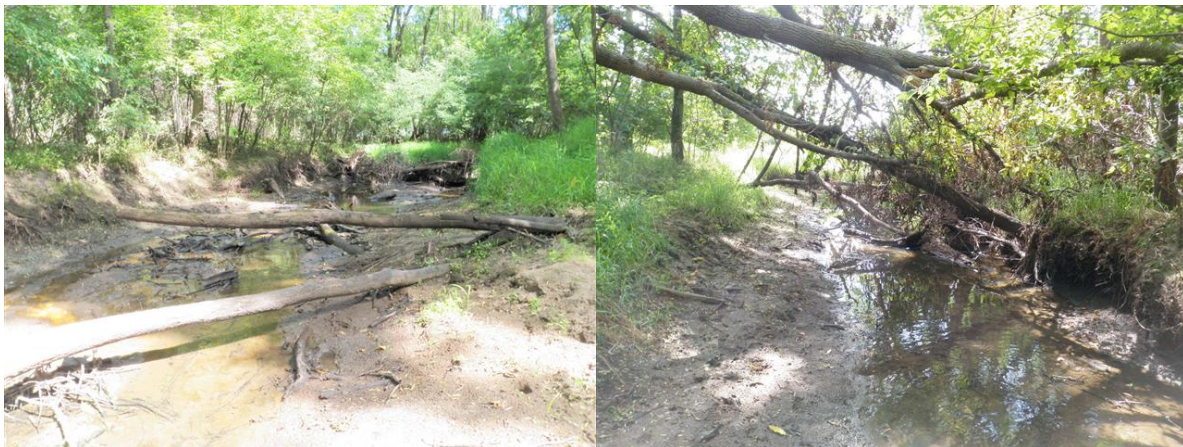
Figure 4.6-5: Photos of site 13UM049 downstream of the 85th Avenue road crossing. This site is between two road crossings which may be having a localized impact on the channel hydrology.

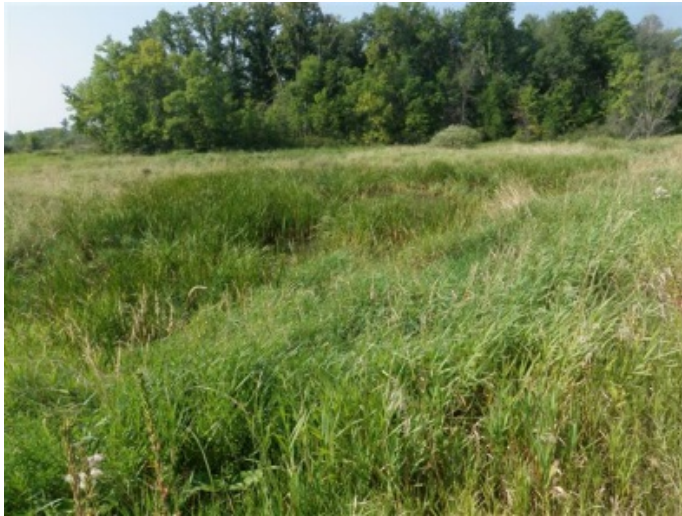
Biological sampling was conducted at site 13UM061 in 2013. On June 18, 2013, a fish sample was collected that scored a 36. On August 20, 2013, a second sample was attempted but the stream had insufficient flow to sample. Another sample was attempted September 17, 2015, but the stream was too deep at the time. Six fish taxa were collected on June 18, and the dominant two taxa were common shiner and central mudminnow. The stream is classified as a low gradient (Class 7) stream for F-IBI purposes. The threshold for this stream class is 42. During the second visit on August 20, 2013, the channel had no flow and notes indicate that cattails were growing within the channel. No

macroinvertebrate sample was collected on August 20, 2013, for the same reasons. The picture below is from the August 20, 2013 visit.

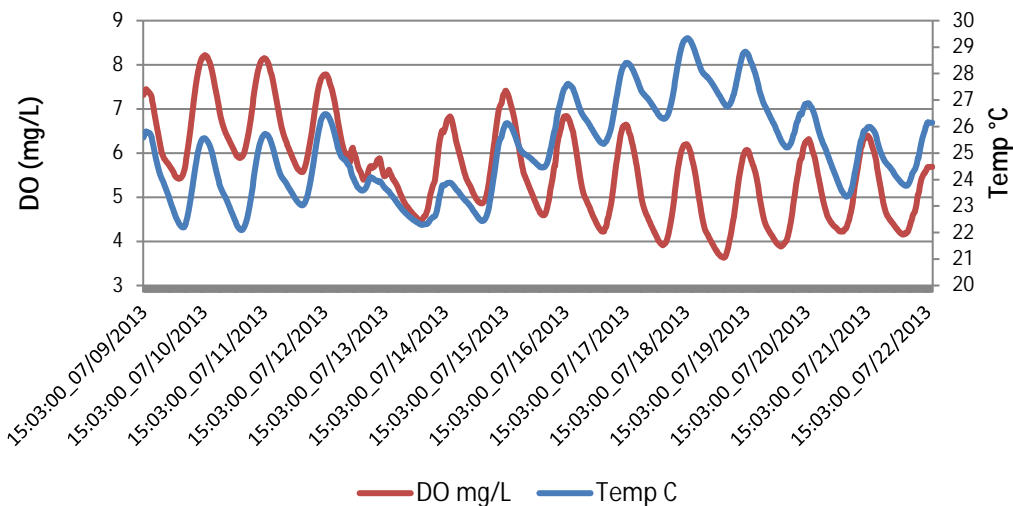
Figure 4.7-1: Continuous DO and temperature data collected using a YSI[®] sonde deployed from July 9, 2013, through July 22, 2013.

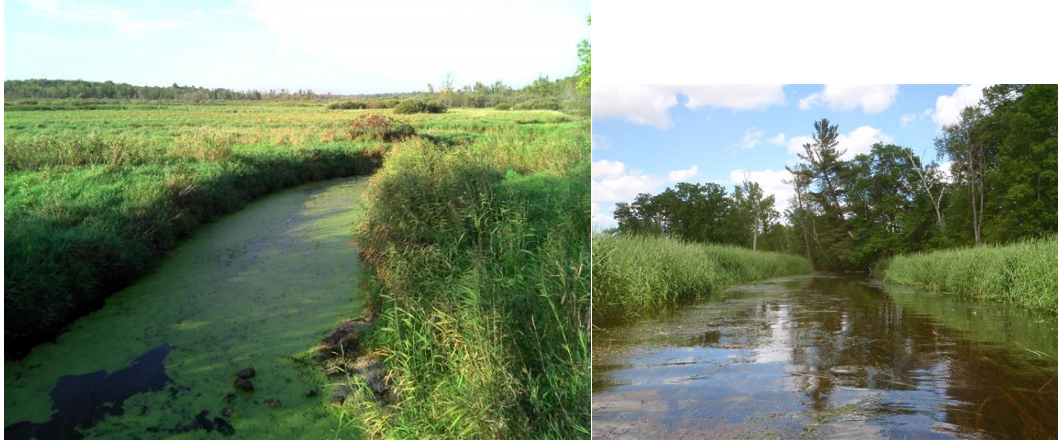
Figure 4.7-3: Elevated submerged macrophyte growth and duckweed growth in Stanchfield Creek. This growth is a direct response from the elevated TP concentrations in the stream.

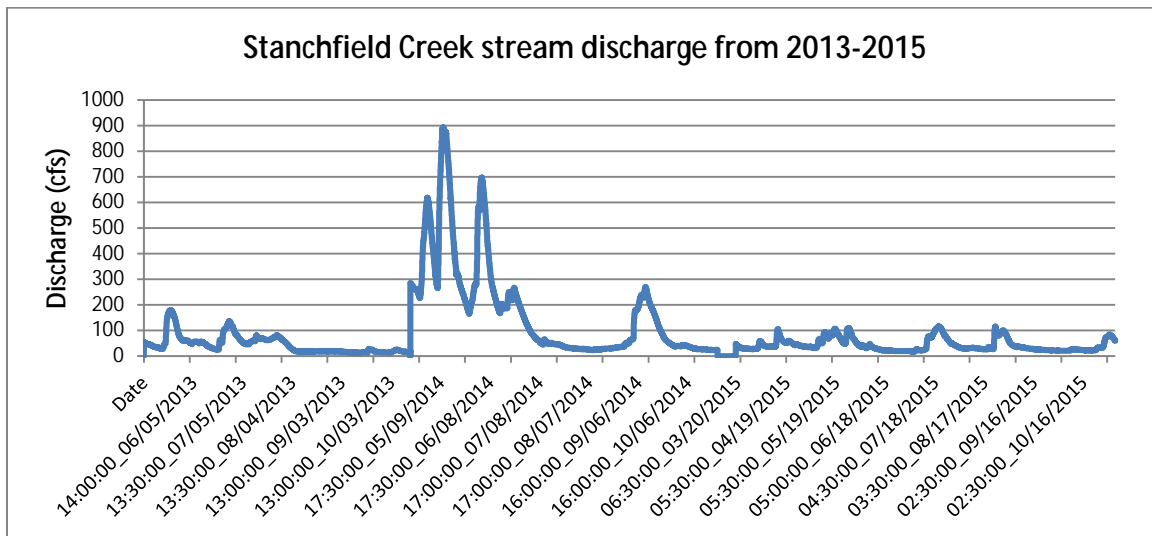
Figure 4.7-4: Discharge record for Stanchfield Creek near Springvale, Minnesota. A continuous record was collected from 2013 through 2015.

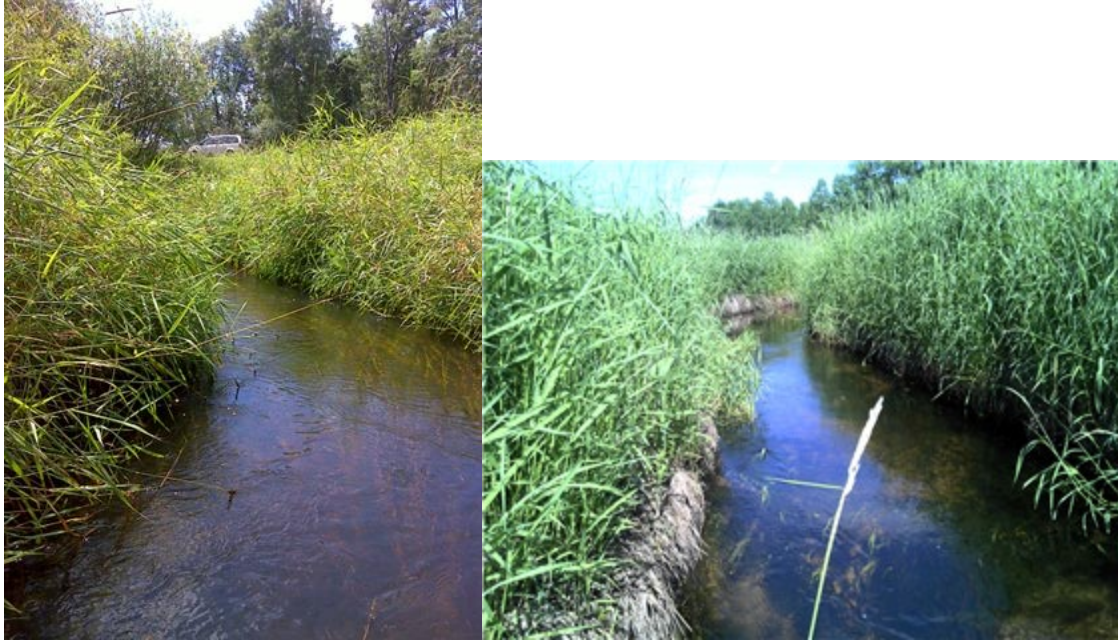
Figure 4.8-2: Isanti Brook pictures showing the riparian cover along with channel development. Habitat features appear to be diverse and habitat does not appear to a stressor.

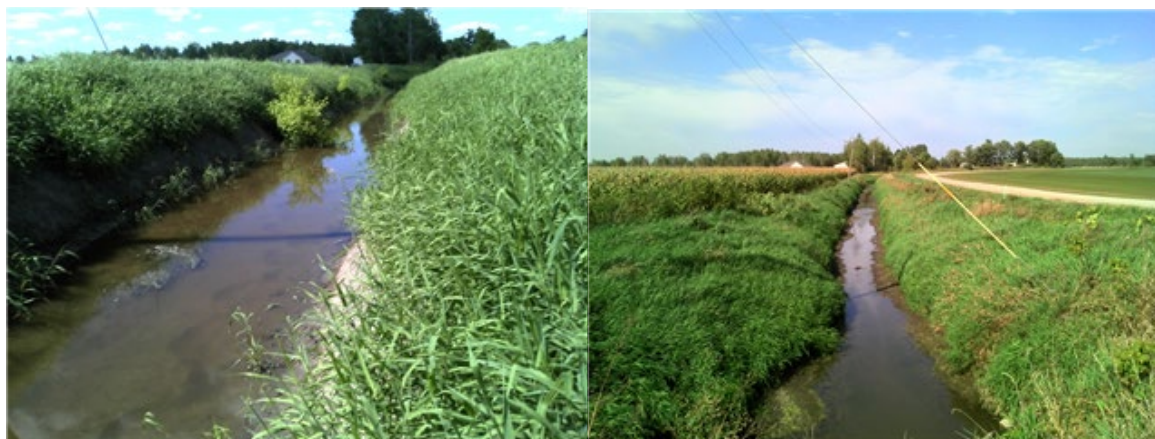
Figure 4.9-1: Washburn Brook condition photos. Photo on left you can see the boot tracks left in the silt after the fish crew walked upstream. There is no stream features in this reach so there are no pools or riffles or even a difference in water depth.

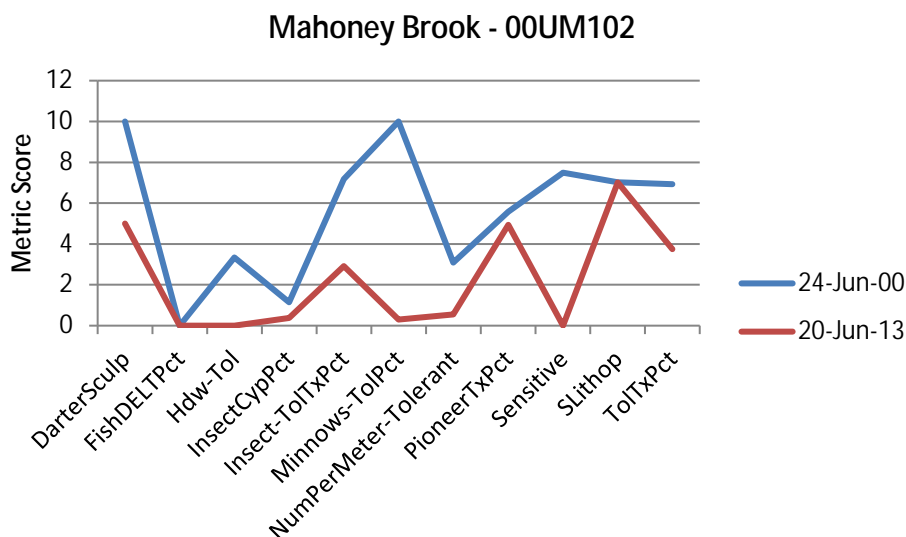
Figure 4.10-1: Metrics used to calculate the F-IBI scores for Northern headwaters streams (Class 6). The red line represents the 2013 sampling date.

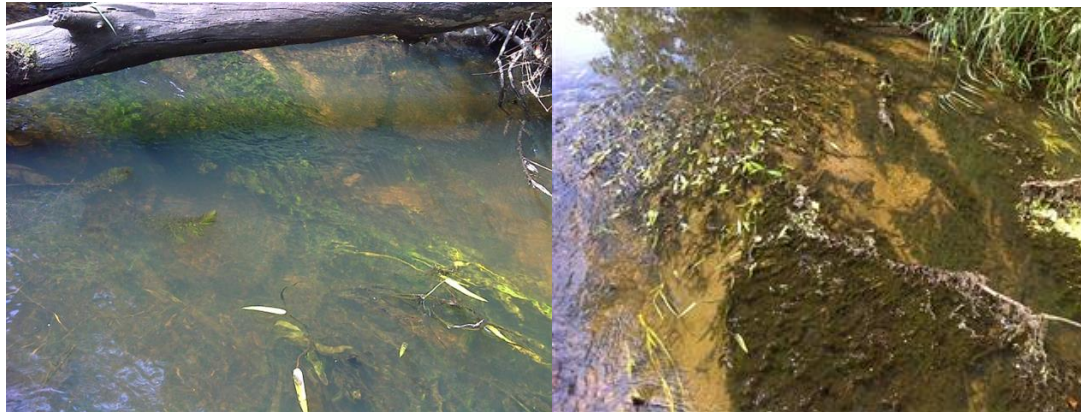
Figure 4.10-5: Mahoney Brook showing an example of submerged aquatic macrophyte growth in stream. As the plant material dies back there is oxygen consumption due to decomposition.
