Lower St. Croix River Watershed

Stressor Identification Update
March 2023

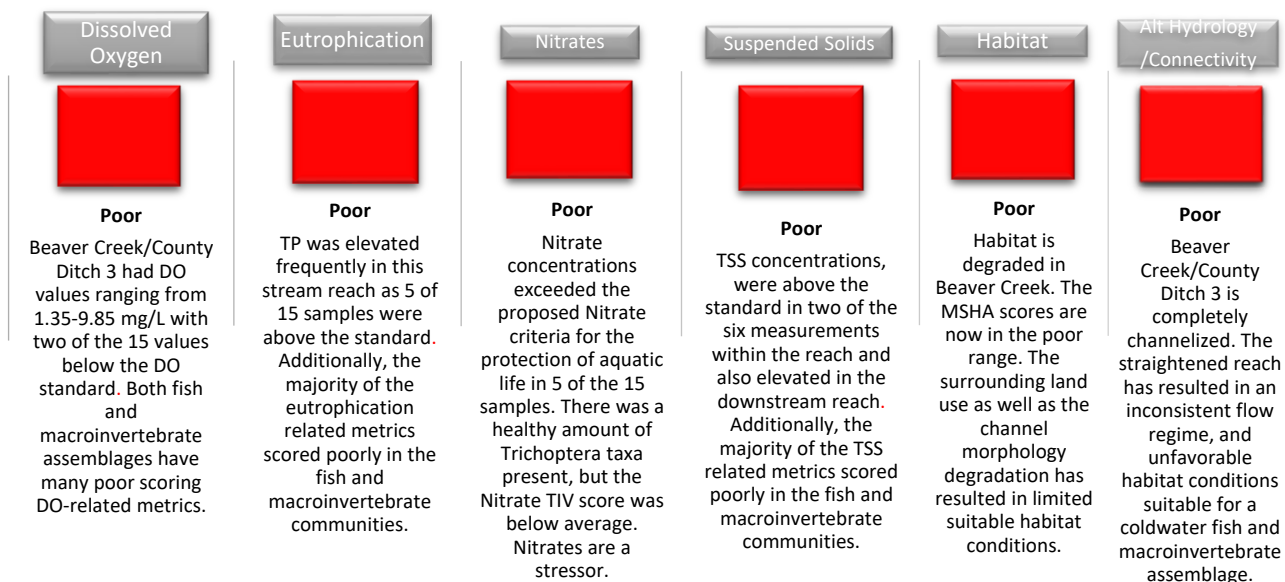
Figure 4: Biological stressor determinations for Beaver Creek/County Ditch 3. Red boxes indicate poor conditions and therefore, a stressor to aquatic life. Yellow boxes indicate fair conditions and indicate a secondary stressor. Green boxes indicate good conditions and not a stressor to aquatic life. Grey boxes indicate that the parameter is inconclusive as a stressor.

SID monitoring in the Beaver Creek/County Ditch 3 (-546) did not occur during C1. The goal of C2 SID work was to get additional information on DO, eutrophication, nitrates, connectivity, and stream transparency. C2 SID work focused on and identified DO, eutrophication, habitat, nitrates, suspended solids and flow connectivity/alteration as stressors.

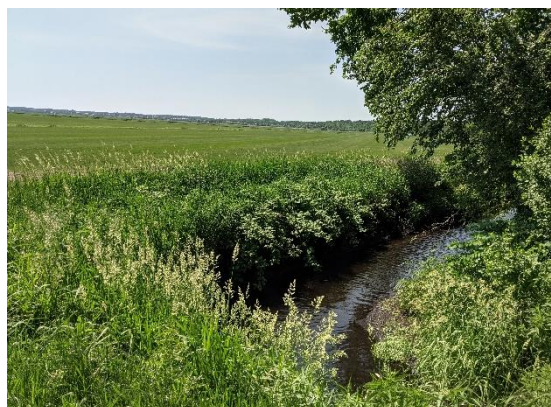
Figure 5: Land Use in Beaver Creek/County Ditch 3.

- Habitat conditions were considered fair to poor in Beaver Creek/County Ditch 3, with scores decreasing an average of 17 points from 2007 through 2019. Factors limiting the habitat along this reach were the land use (Figure 5) and lack of riparian buffer, the predominant sand substrate, moderate embeddedness, poor sinuosity, sometimes limited depth variability, and fair channel development. The channelization of this stream reach is a significant reason for the poor habitat in this reach.

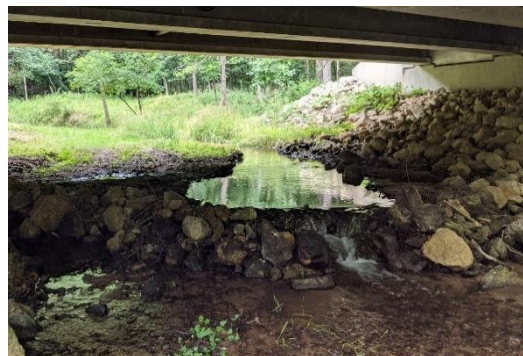
Figure 12: Rock dam below CSAH 21 in Trout Brook.

- Connectivity is a stressor in Trout Brook. A large rock dam located below CSAH 21 is preventing the upstream migration of fish species upstream (Figure 12). Removal of this rock dam will allow for proper fish migration and movement throughout Trout Brook.
