# Mustinka River

## Watershed Restoration and Protection Strategy

### Stressor Identification Report

Assessment of stress factors affecting aquatic biological communities

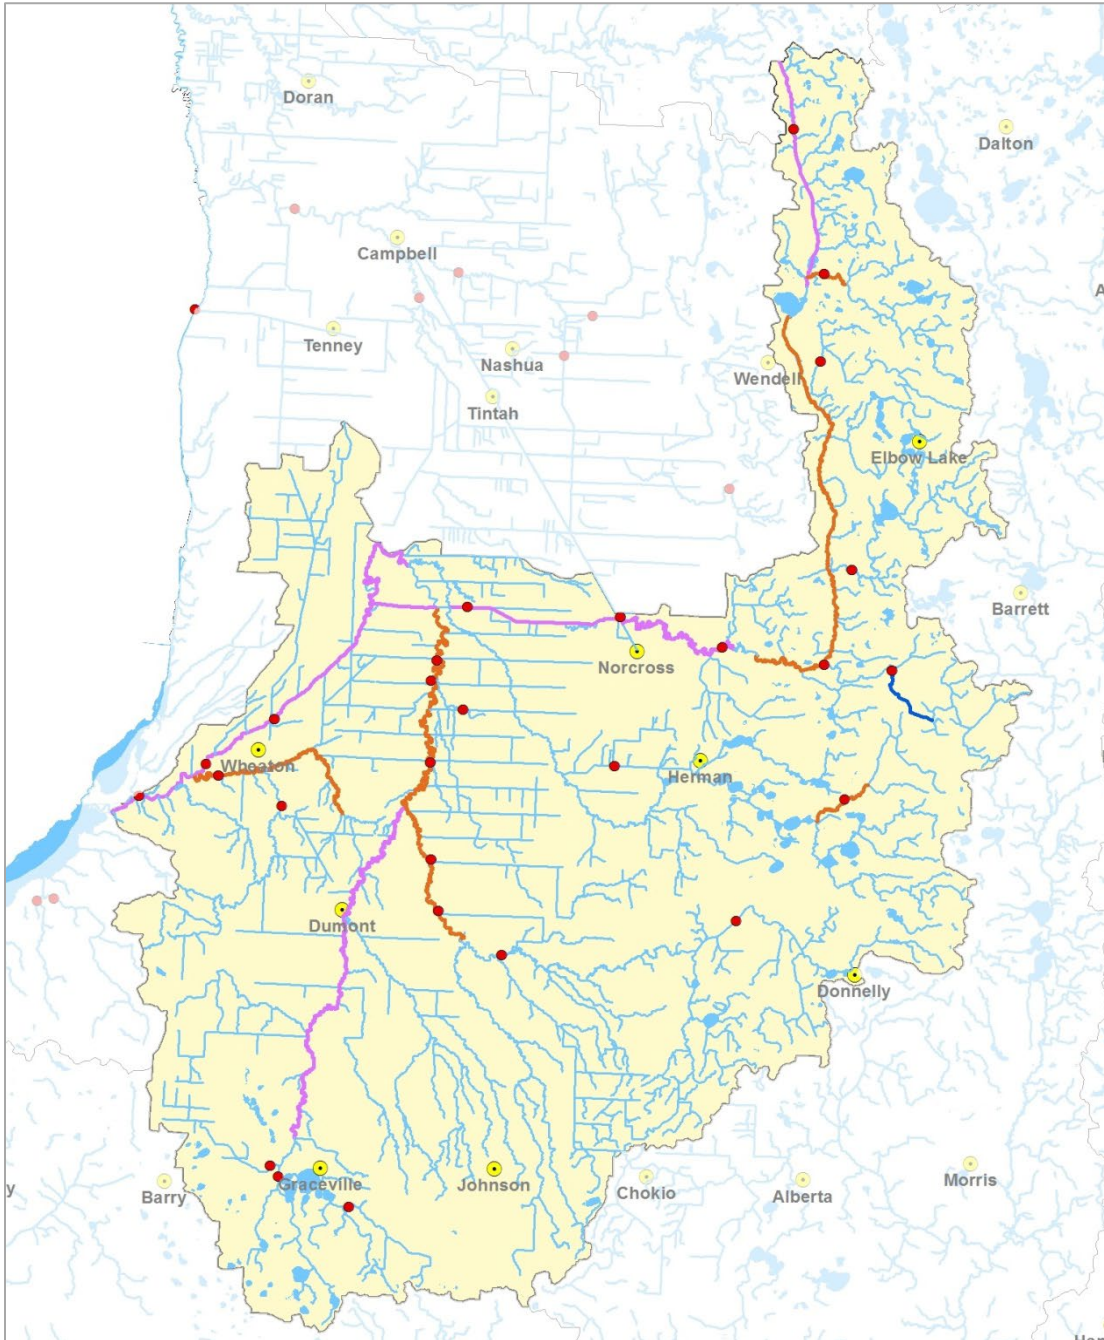
Figure 1. Reaches with Aquatic Life Use impairments. Orange reaches represent measured biological impairments. The dark blue reach is a biological impairment that is being deferred due to the extent of ditches in the AUID. The purple reaches have conventional chemistry parameter impairments, but not a measured biological impairment.

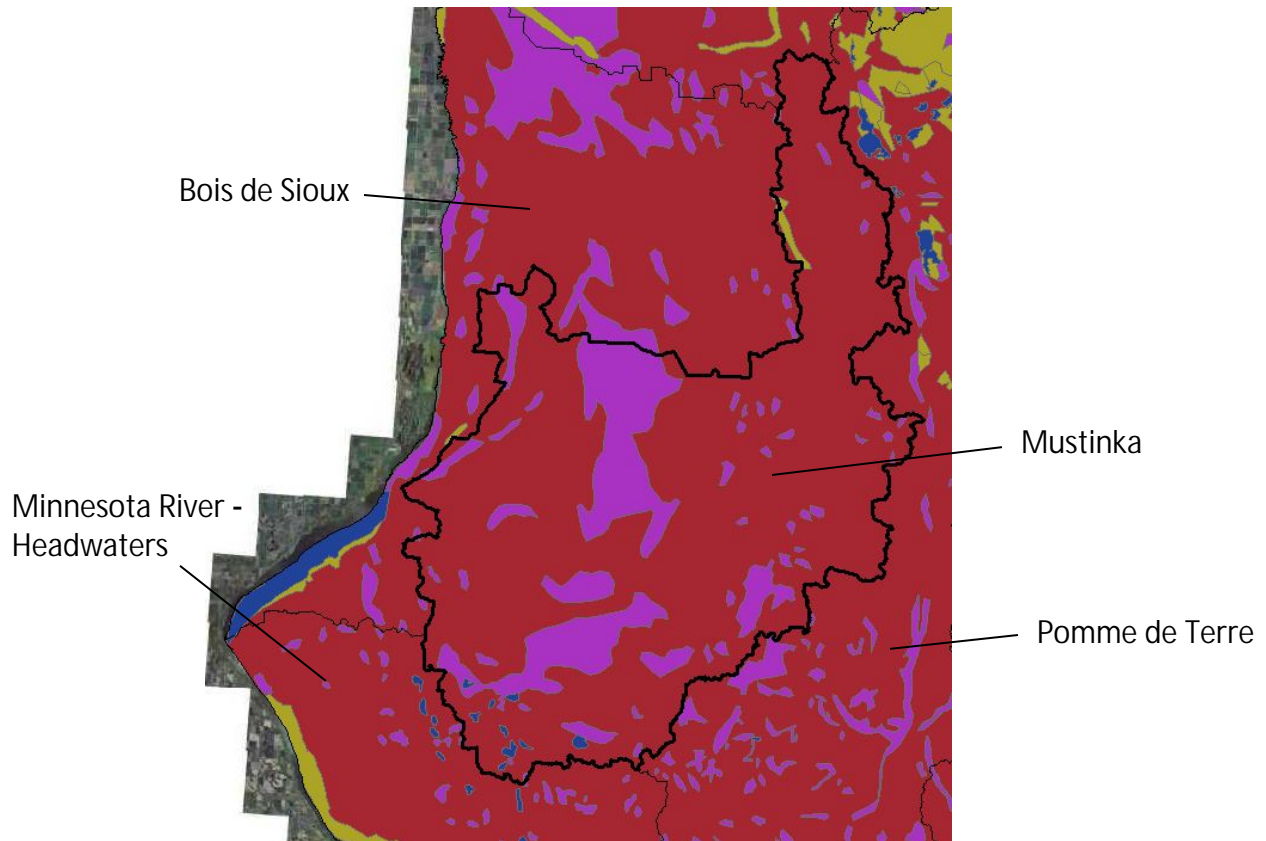
Figure 2. Original vegetation of the MRW and adjacent land, (Marchner, 1930). Red represents Grassland Prairie, purple represents Wet Prairie, blue represents Lakes, and gold represents River Bottom Forest.

The original, pre-settlement landscape was almost exclusively prairie (Figure 2). The landscape of the MRW is decidedly devoted to agriculture, the primary focus of which is row crop production. Relative to the agricultural parts of central Minnesota, there is little animal agriculture in the MRW. Animal agriculture in the Red River Basin typically exists on the beach ridge lands where soils are not as conducive to row crop production. The percentages of various categories of land cover are presented in Table 1. Photo 1 shows the extent of land area that is cultivated in the Lake Plain area of the MRW.

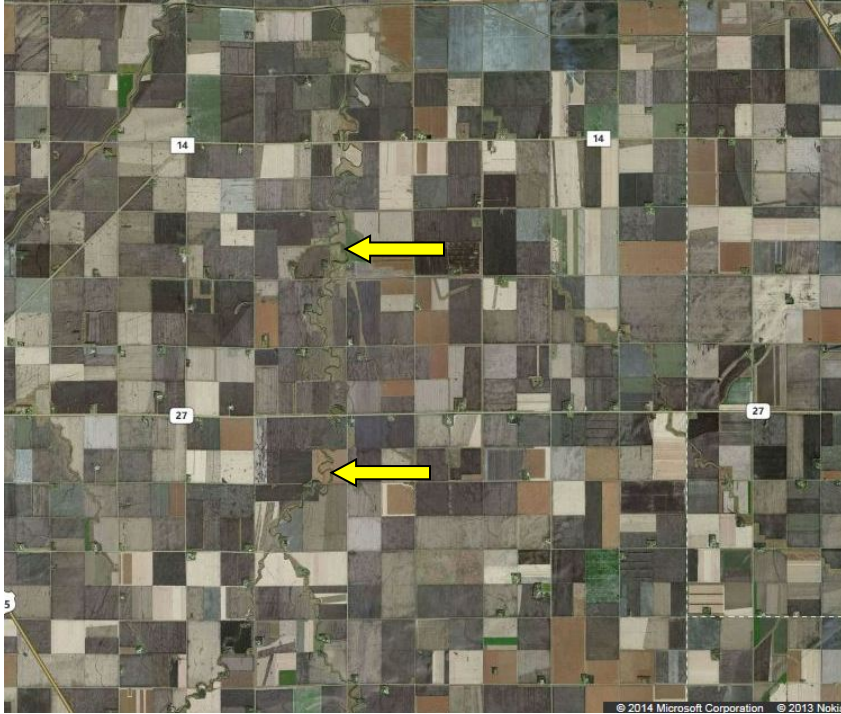
Photo 1. Extent of agricultural land coverage in the MRW just east of Wheaton, Minnesota. The arrows point to the south-to-north running Twelvemile Creek.

The Red River Valley is well known for its extensive agricultural land use. Agricultural activities, particularly when operating over extensive areas of the landscape (Photo 1), are well established as being anthropogenic stressors of water quality. A large quantity of professional research articles exists with study results associating landscape changes from natural to agricultural land uses with water quality degradation and/or negative affects to biological communities (e.g., Fitzpatrick et al., 2001; Houghton and Holzenthall 2010; Diana et al., 2006; Sharpley et al., 2003, Blann et al., 2011, Riseng et al., 2011). The desktop review of the MRW's land use, shown previously (Table 1) indicates that approximately 87% of the land cover is in cultivated crops. Therefore, it was reasonable to determine that an investigation into known agriculture-related stressors (e.g., nutrients, sediment, altered hydrology) as contributors to impairments in the MRW should be undertaken.

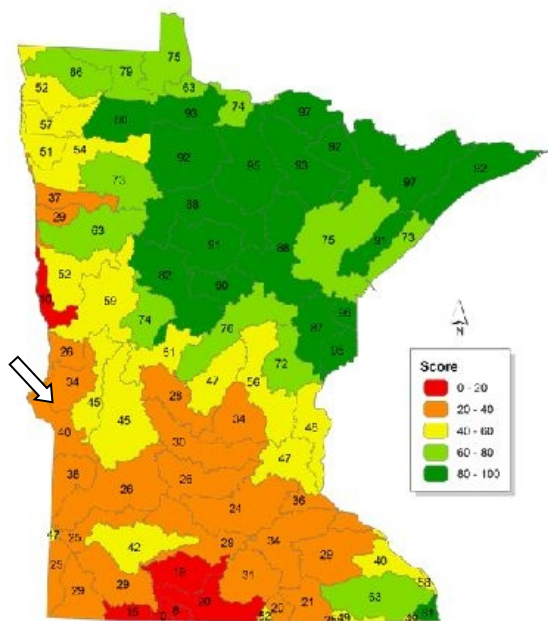
Figure 3. Scores and categorical ranking of the 81 Minnesota Major Watersheds for the MDNR Non-point Source Pollution Index.

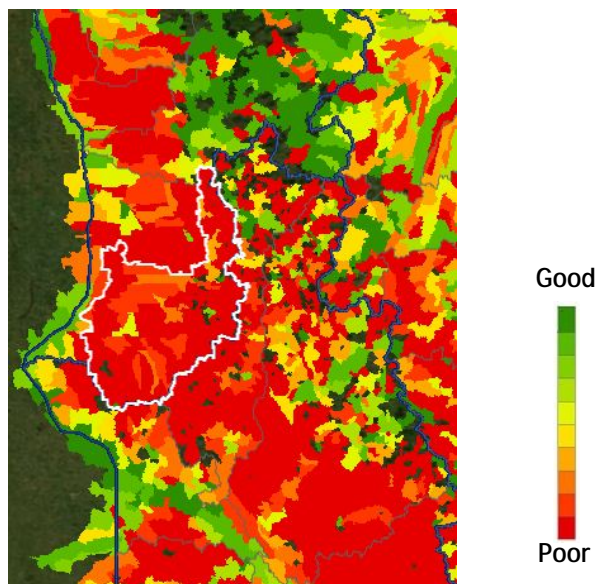
Figure 4. Hydrologic storage of subwatersheds in the MRW (white border) and surrounding area. The scoring is the degree of storage loss relative to all state of Minnesota subwatersheds.

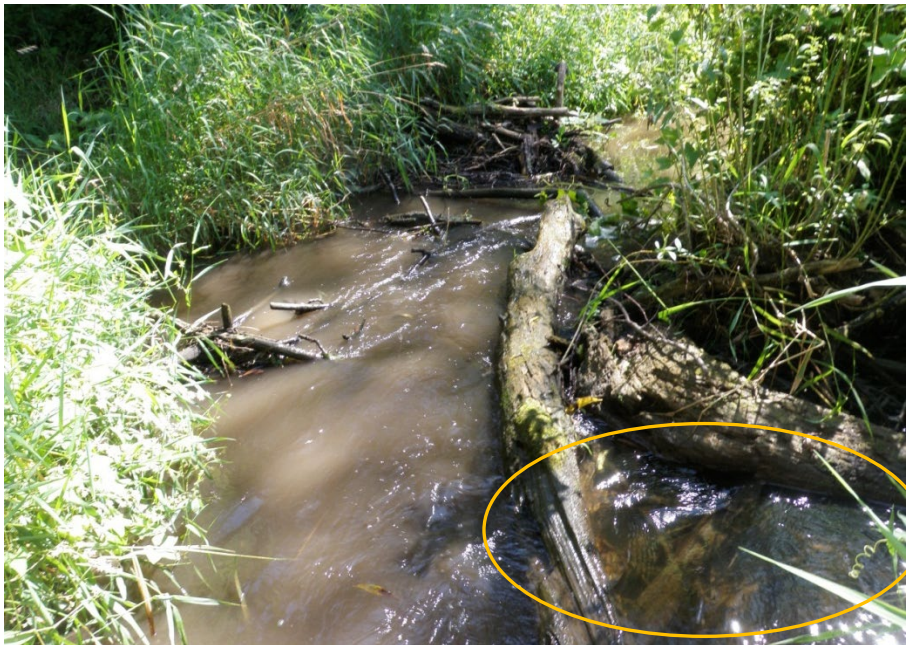
Photo 2. Photo from the August 9, 2010 macroinvertebrate visit. There is some good macroinvertebrate habitat here. Note that the water in the lower right is clear, and the left side is stirred up by the photographer showing the fine sediment that makes up the substrate. The circled area shows a good matrix of large, submerged wood in an area where there is significant water velocity - this is prime elimination of many of the sensitive taxa (EPT) habitat, as well as good fish habitat.

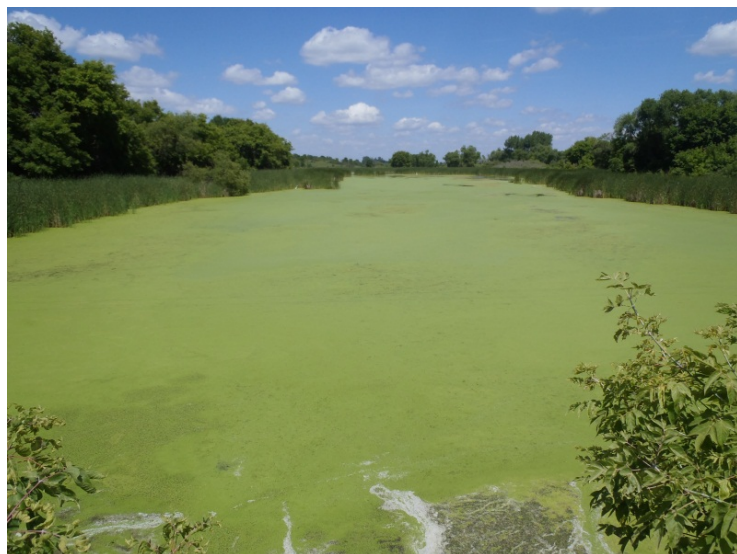
Photo 3. Mustinka River looking upstream from the 320<sup>th</sup> Street. crossing - just downstream from the mouth of Unnamed Tributary to Mustinka River. The surface is completely covered by duck weed.

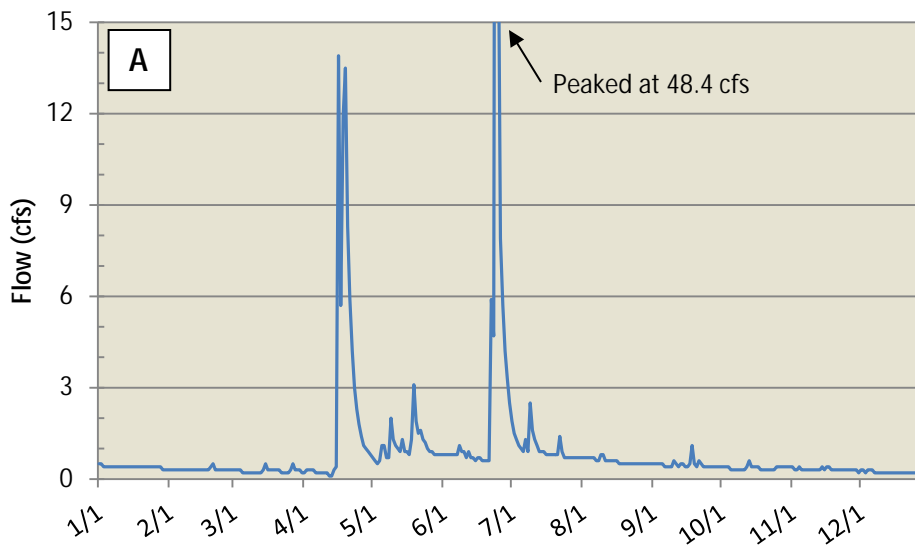
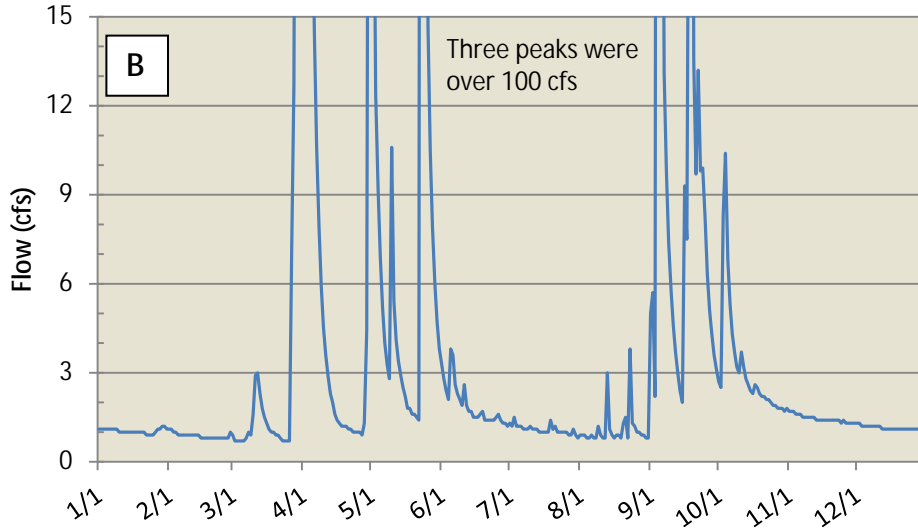
Figure 5. HSPF model flow output for site 10RD042 (CSAH 15). A. 2003 - a dry year, B. 2006 - a wetter year.

As mentioned, the sonde deployment attempts in both years found a dry channel. There was still significant water pooled in the deep hole at the CSAH 15 culvert, but upstream and down, there was only damp mud in the channel. This experience suggests that the stream commonly goes dry in mid-late summer. To further explore this scenario, the modeling contractor (EOR, Inc.) ran the Hydrologic Simulation Program Fortran (HSPF) model for the years 2001-2006, which calculated daily flow volume (cubic feet per second). Modeling results (Figure 5) predicted frequent no-flow (i.e., dry) periods in August, and actually over fall and winter as well. Though the model output shows a very small amount of flow at all times, the modeler noted that HSPF tends to over-predict flows in small headwater streams such as this. Thus these very small predicted flow volumes may actually be periods of no flow. Though the actual size of the over-prediction is not known, it seems reasonable to suspect that with the known over-prediction, the days below one cubic foot per second may actually have had zero flow, and the creek may have been dry. The number of days during the July through September period with flows predicted as one cubic foot per second is shown in Table 9. Implications of this hydrologic pattern are discussed in the conclusion section following.

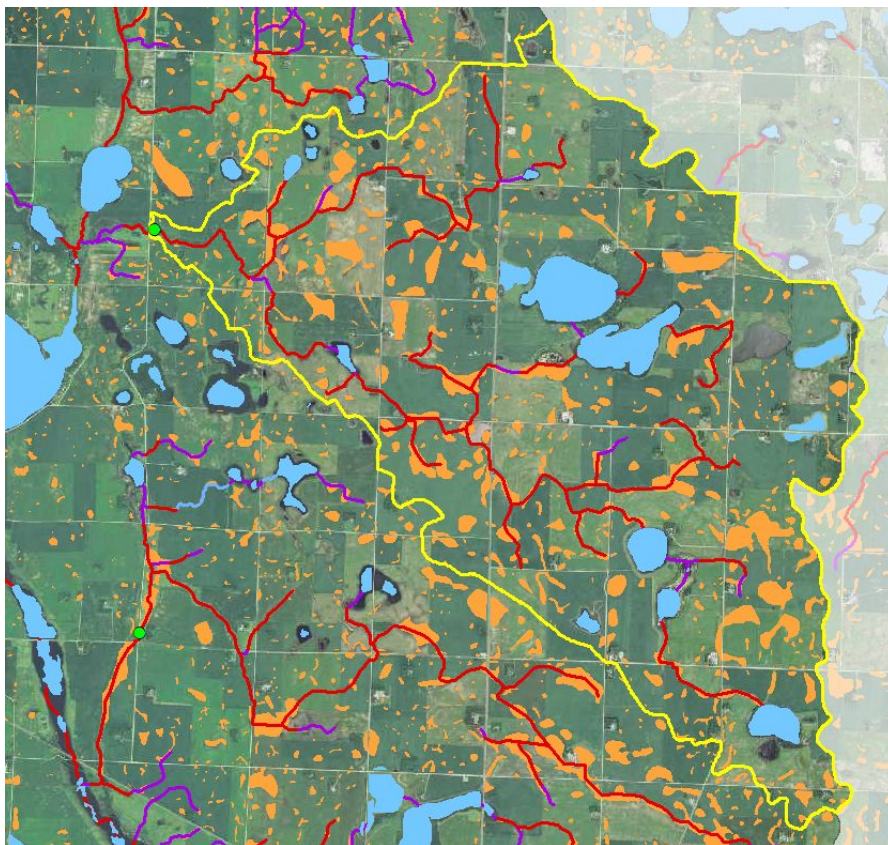
Figure 6. Altered hydrology in the subwatershed of 10RD042. The green dot is 10RD042, the yellow lines outline the contributing subwatershed, the red lines are either altered natural stream channels or constructed channels, purple lines are non-definable channels, and the orange shapes are locations where there were pre-settlement wetlands that are no longer wetlands (i.e., have been drained) or are partially drained.

Two visual ways to interpret the changes to hydrology in the subwatershed are to view the MPCA's Altered Watercourse Project GIS layer, and the National Wetlands Inventory Restorable Wetlands GIS layer. These layers are diagrammed in Figure 6. As can be seen, there have been extensive changes to both channels and wetlands, but it is complex to determine how these changes have altered hydrology. Some of the original wetlands were likely not contributing to stream flow, at least by surface runoff, as many RRB wetlands were part of small, isolated basins (i.e. in depressions of the landscape that didn't have a surface outlet). A rigorous computer modelling exercise would be required to determine how all the various factors affect the current hydrological regime, and how it differs from the historical regime. At this time, such a modelling effort has not been completed.

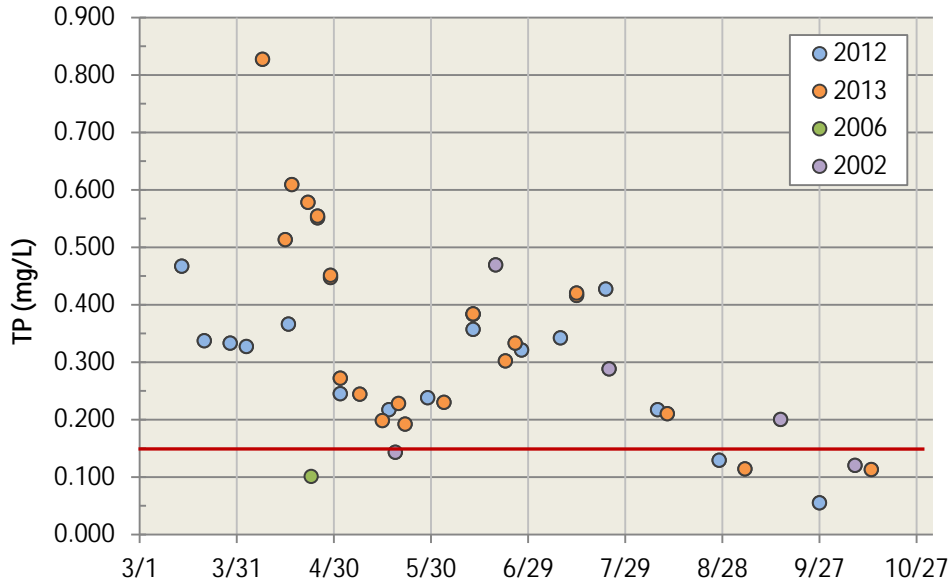
Figure 7. TP concentrations at S003-104 (= CSAH 13, = 10RD037). The red line is the newly-adopted Minnesota standard.

The June 16, 2010 water sample from the 10RD037 fish sampling visit found a TP concentration of 0.384 mg/L. TP data from this site from the period of 2002-2012 are shown in Figure 7. These data show problematic TP levels occurring over a broad period of the year, and over a number of years, highlighting this as a chronic issue. The newly-adopted TP standard was exceeded by 36 of the 44 samples (83.7%).

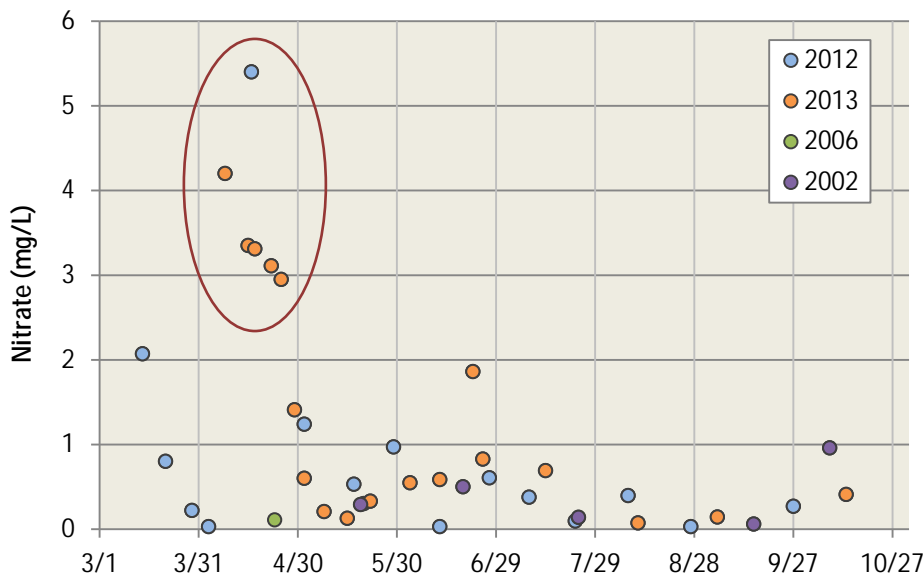
Figure 8. Nitrate concentrations at S003-104 (= CSAH 13, = 10RD037). The circled values are nearing the point where nitrate toxicity for aquatic organisms may occur.

Nitrate concentrations are generally at fairly good (i.e., low) levels; however, there appears to be a seasonal aspect to the concentrations (Figure 8). Levels are significantly higher in April, during and just after snowmelt. This might be explained as a consequence of fall application of ammonia fertilizer to farm fields and the flushing of nitrates from the landscape during the spring runoff period. The concentrations at this time are approaching those considered to be toxic to aquatic organisms. The monitoring here is part of a long-term effort, and more data will be gathered each year, which will show whether this pattern is annually consistent or common, or was a one-time weather-related event.

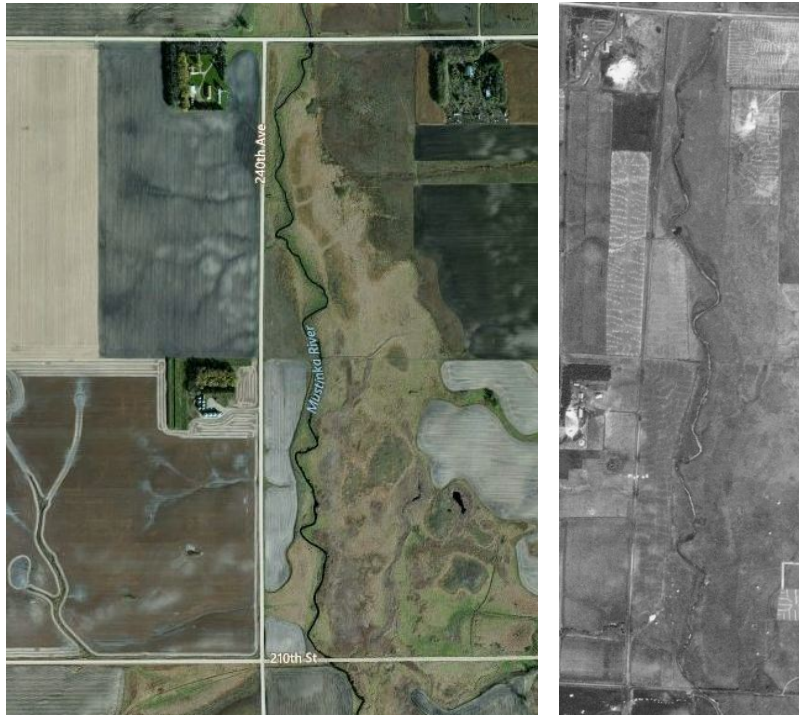
Photo 4. Meander pattern has not changed much between 1938 (R) and 2013 (L). The MPCA has determined, with moderate confidence, that this reach has been historically altered.

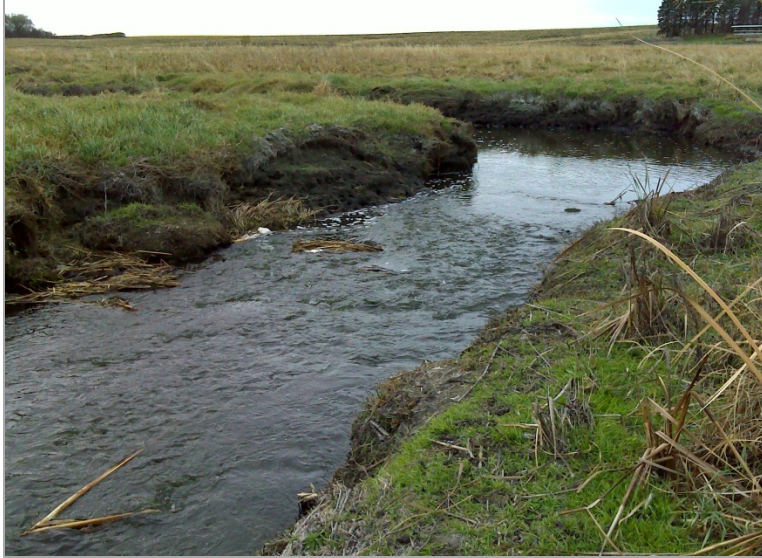
AUID-580 contained two EOR, Inc. geomorphology study locations, denoted EOR-114 and X-B (see Figure 34 in the appendix). At EOR-114, the channel appears to be over-widened, as the banks are eroding and raw, and have sloughing sod mats (Photo 5). A historical cross-section also confirms that there is some channel instability at this location; over the last decade, the channel cross-section has enlarged in both width and depth (Figure 9). Bank Erosion Hazard Index (BEHI) ratings were taken at seven locations in the EOR-114 reach (Table 11). Overall the erosion hazard rating is moderate, though one location was high. These geomorphic data suggest that a significant amount of the excess sediment and turbidity in AUID-580 is due to bank and bed erosion.

Photo 5. Geomorphology study site EOR-114, showing eroding and sloughing banks.

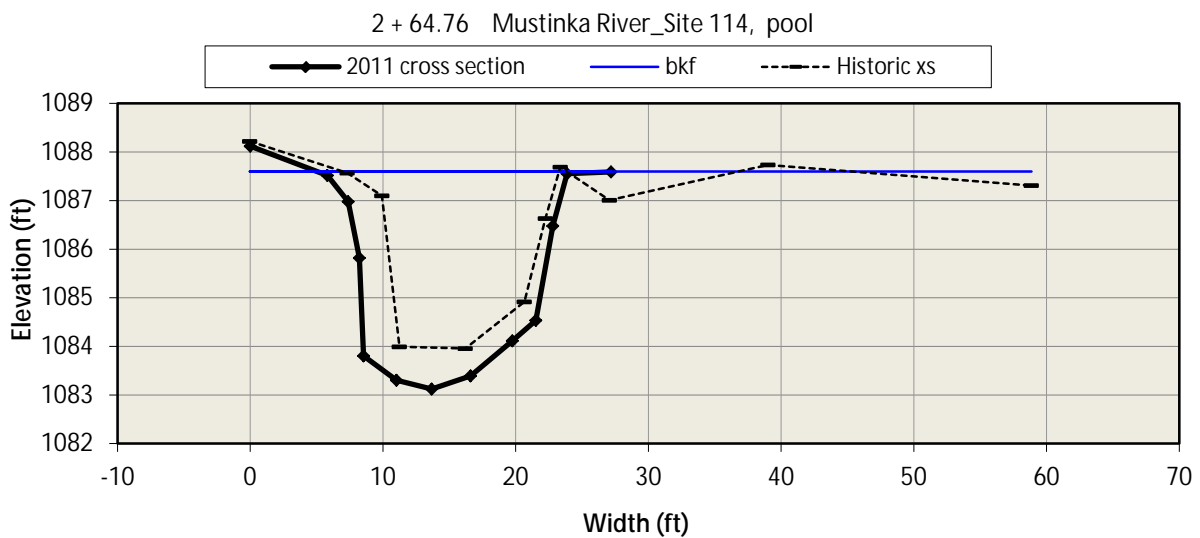
Figure 9. Comparative cross-section, surveyed in 2001 and 2011, showing channel enlargement.

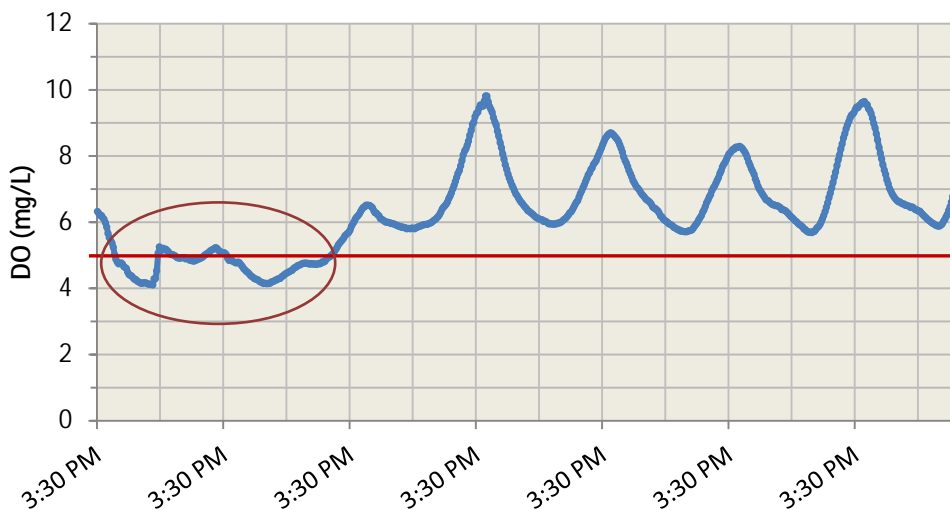
Figure 10. Sonde DO data for July 24 - 31, 2012, at 10RD037 (CSAH 13). The weather for the period covering the circled area was likely overcast during the day, and thus less photosynthesis occurred in the river. The red line represents the Minnesota standard.

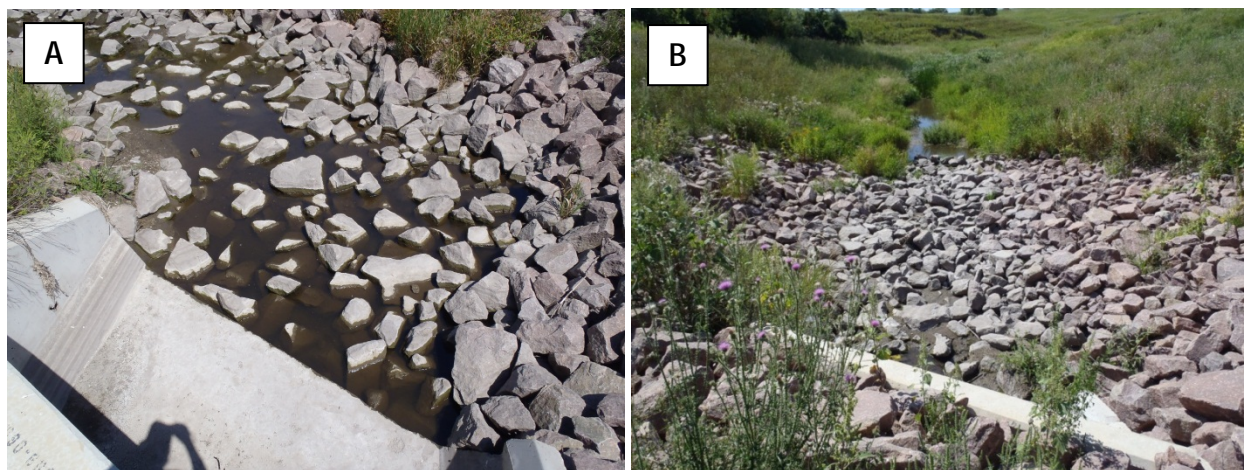
**Photo 6.** The channel a short distance below the biological site. A) On the upstream side of CR 33. There was only a minimal amount of standing water in the channel. B) On the downstream side, there is high gradient within the new, rip-rapped stream bed.

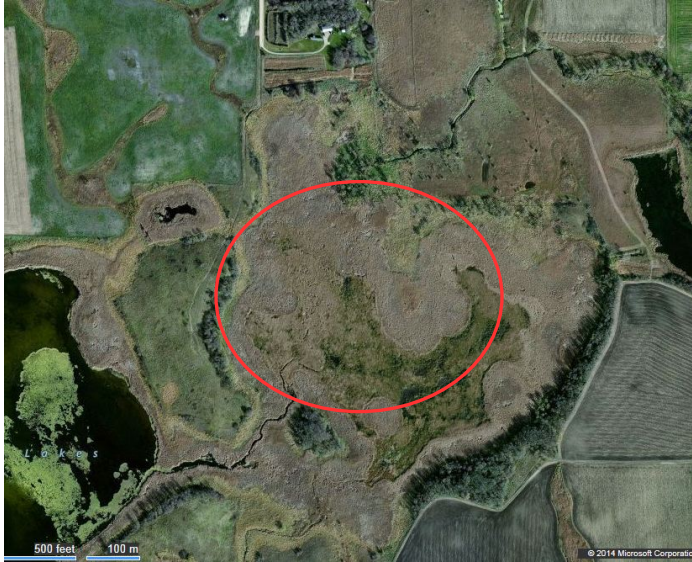
Figure 11. Wetland downstream of 10RD054. The channel seems to disappear within the circled area.

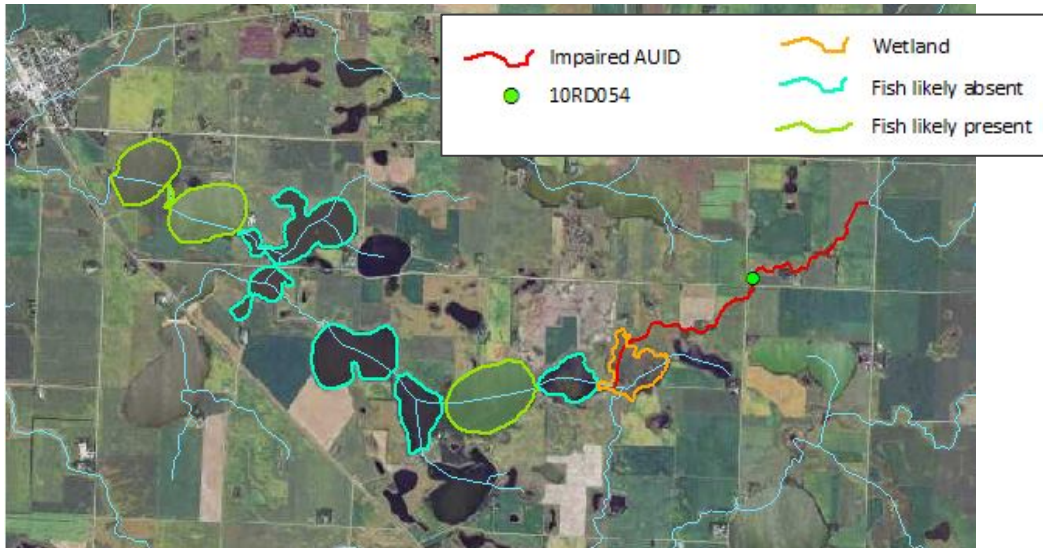
Figure 12. Chain of lakes below 10RD054 with varying levels of algal growth. The red channel is AUID-578.

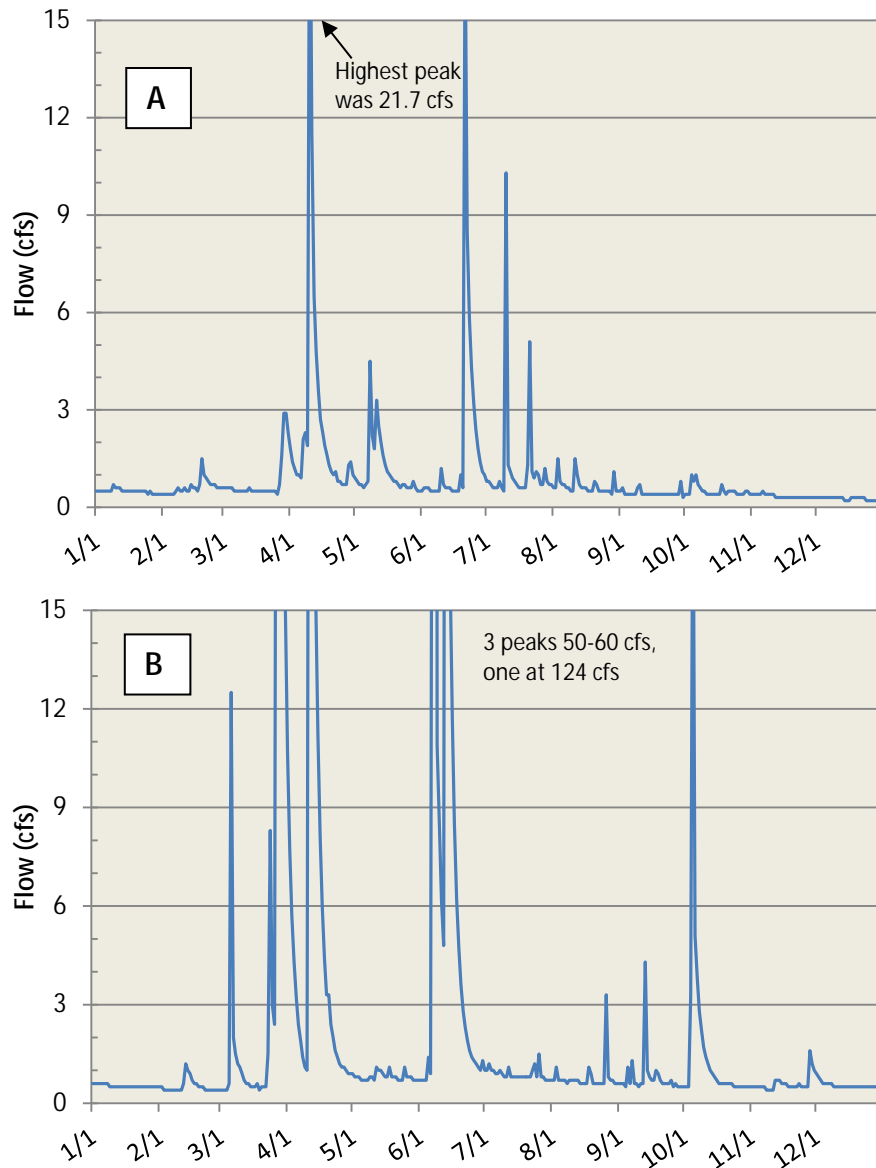
Figure 13. HSPF model flow output for Unnamed Creek site 10RD054 (CSAH 15). A. 2002 - a dry year, B. 2005 - a wetter year.

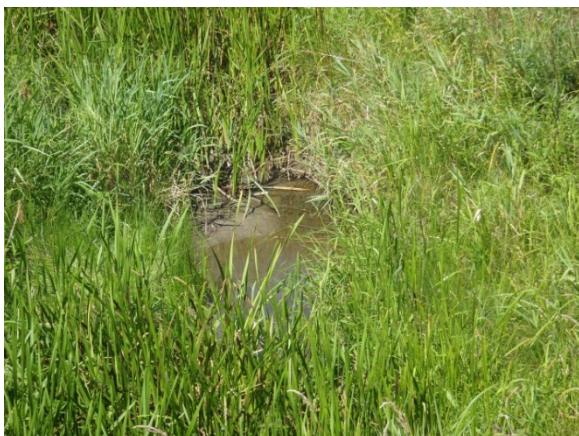
Photo 7. The channel within the 10RD054 biological reach on August 22, 2013.

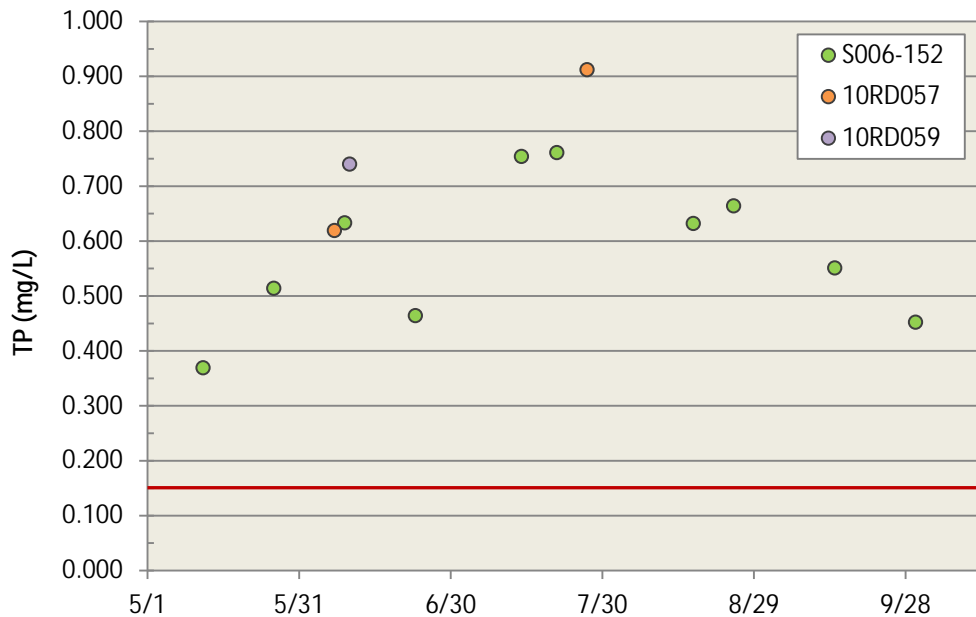
Figure 14. TP samples from 10RD057 (= S006-152) with one sample from 10RD059. The red line is Minnesota's newly adopted TP standard for this area of the state.

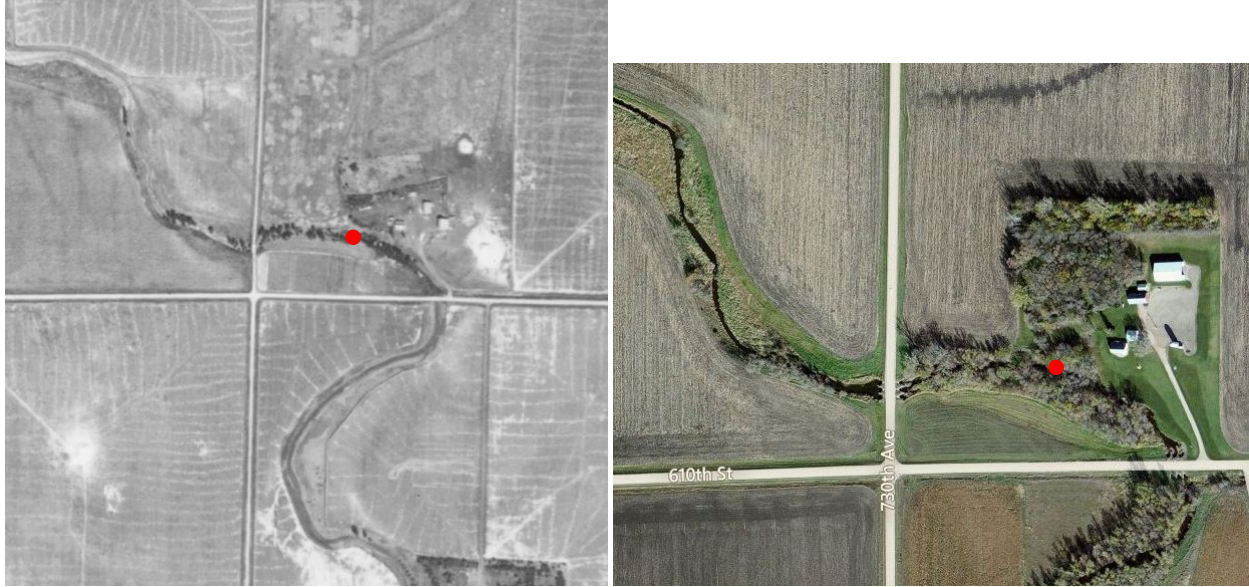
Figure 15. 1938 (L) and 2013 (R) aerial photos of 10RD057. The channel appears to have been smoothed all along this AUID. The forested patch that exists along the sampled reach presently was just beginning to grow up in 1938, likely the result of this early homestead adjacent to the young trees. The red dot denotes the center of the biological reach.

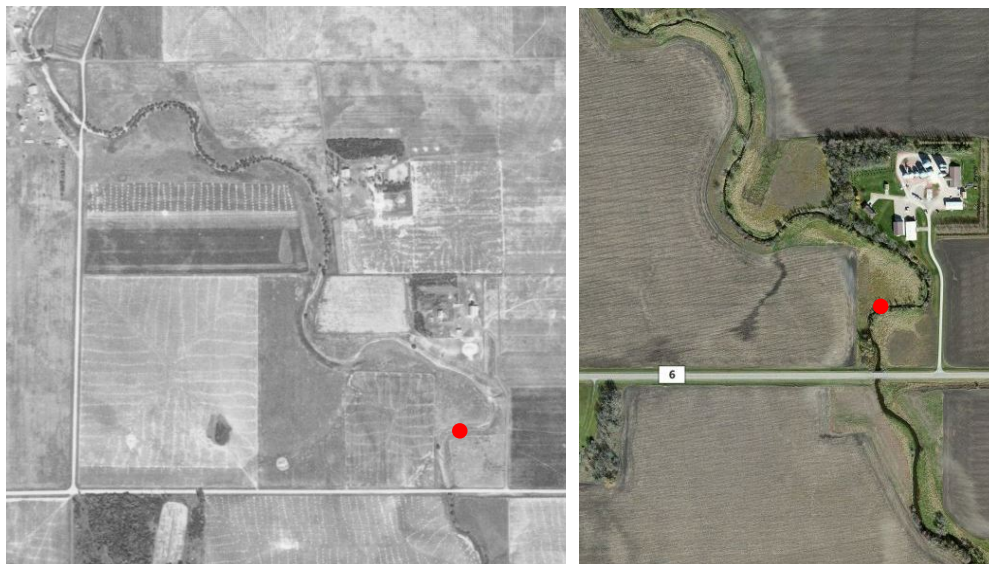
Figure 16. 1938 (L) and 2013 (R) aerial photos of site 10RD059. Note that unlike 10RD057, there are still few trees along the channel here. The red dot denotes the center of the biological reach.

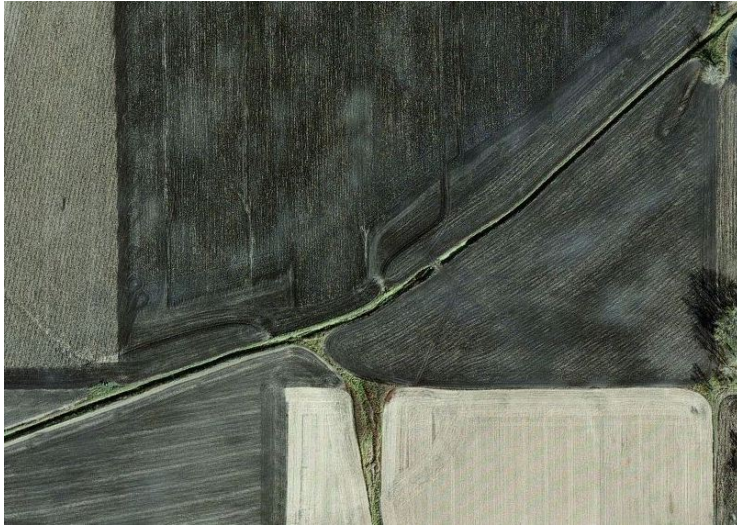
Photo 8. Photo of Twelvemile Creek upstream of AUID-514, showing lack of a riparian buffer.

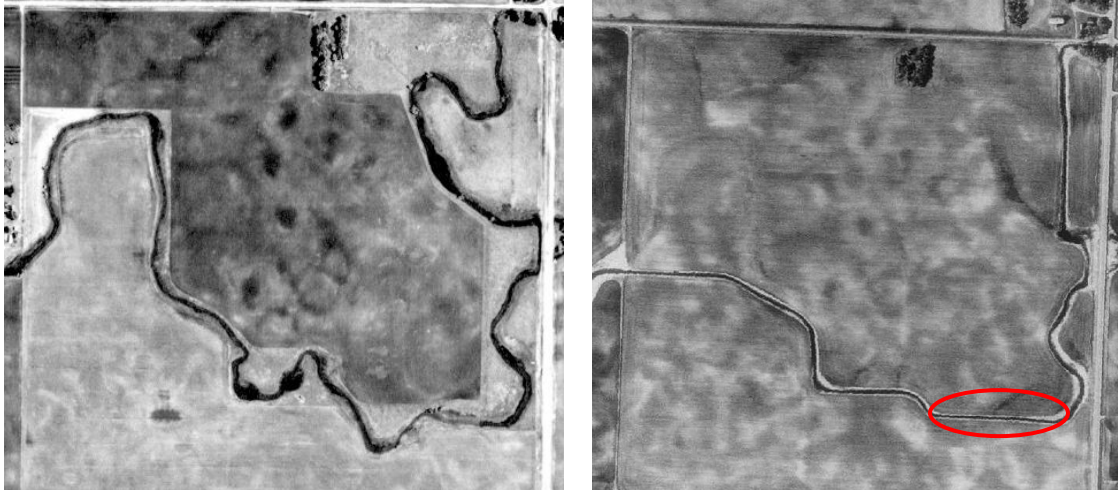
Figure 17. Channel alteration upstream of AUID-514. At left is the 1951 aerial photo, and at right, the 1991 photo. The red circled area is the EOR-51 geomorphology study site.

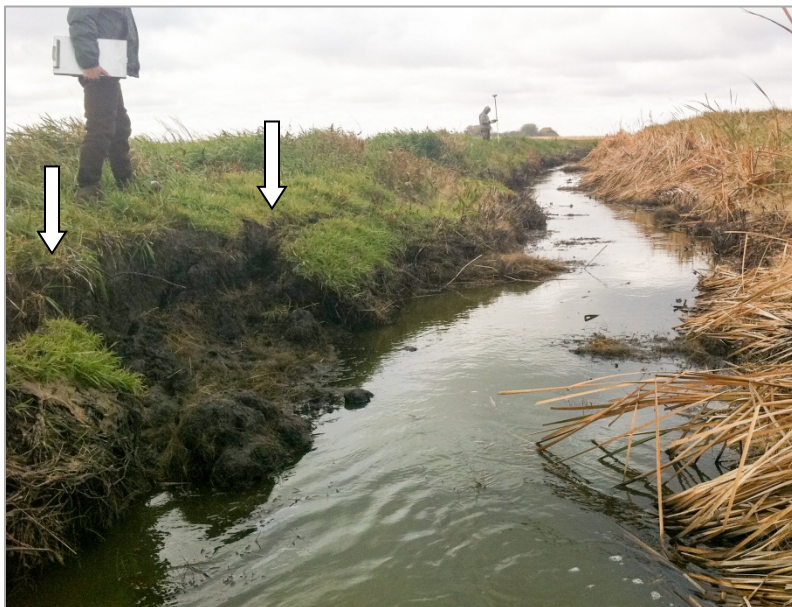
Photo 9. Bank destabilization within study reach EOR-51. Arrows point to formation of fissures, which will likely lead to a sizeable section of bank collapsing into the creek, as happened between the arrows. The roots of the short grasses here are insufficient to structurally hold the sharply-angled bank.

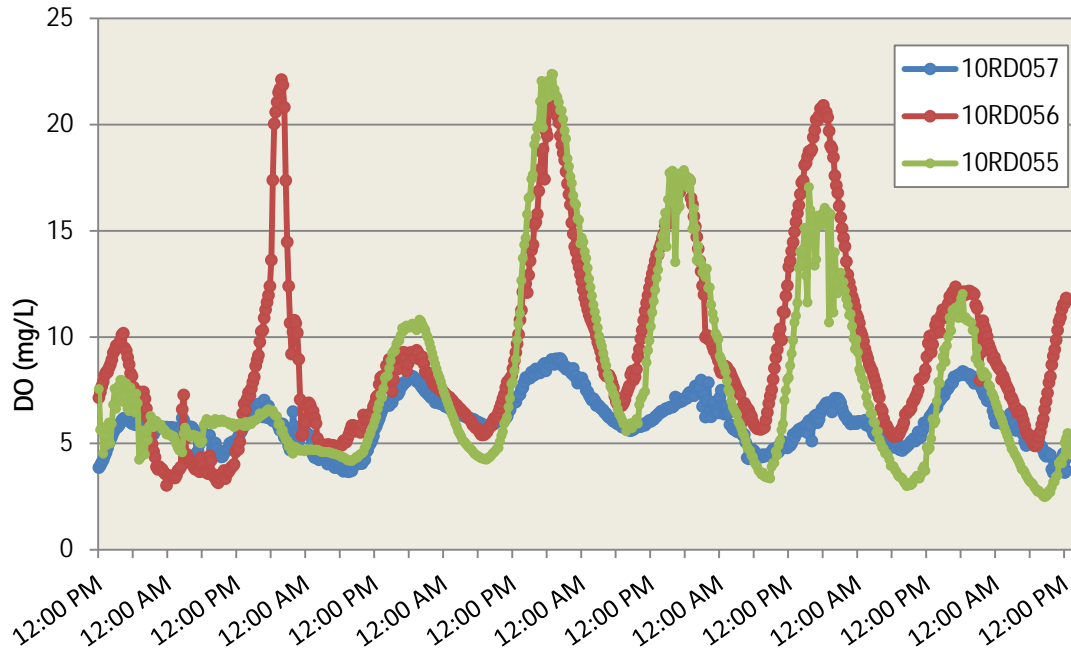
Figure 18. Sonde DO data from 10RD057, 10RD056, and 10RD055, July 24-31, 2012. The latter two locations are in the Twelvemile Creek AUID directly downstream of AUID-514.

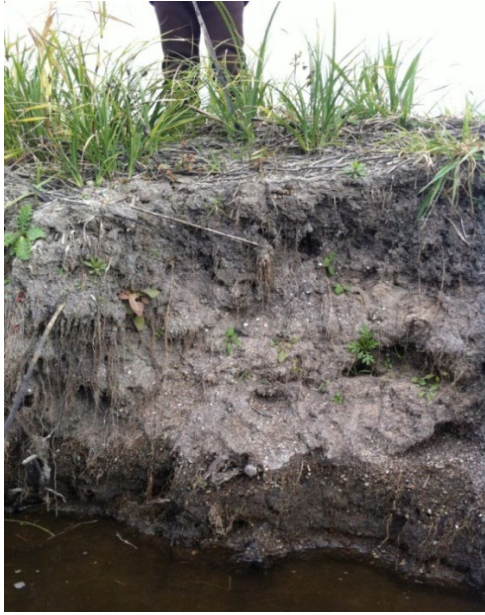
**Photo 10. Bank erosion within the geomorphology study reach. The banks are a significant source of sediment to the channel with the current hydrological regime. Riparian vegetation roots are inadequate to hold the streambank soil. The granular soil material (sand and small gravel) below the 12-inch topsoil layer is relatively susceptible to erosion by stream currents.**

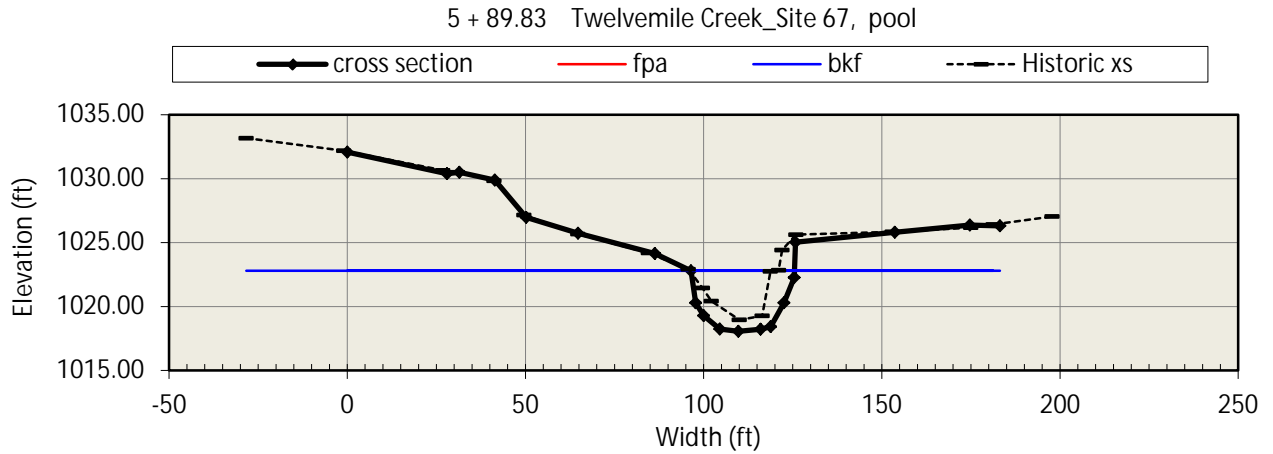
Figure 19. 2002 and 2012 surveyed cross sections at the identical location (site EOR-67).

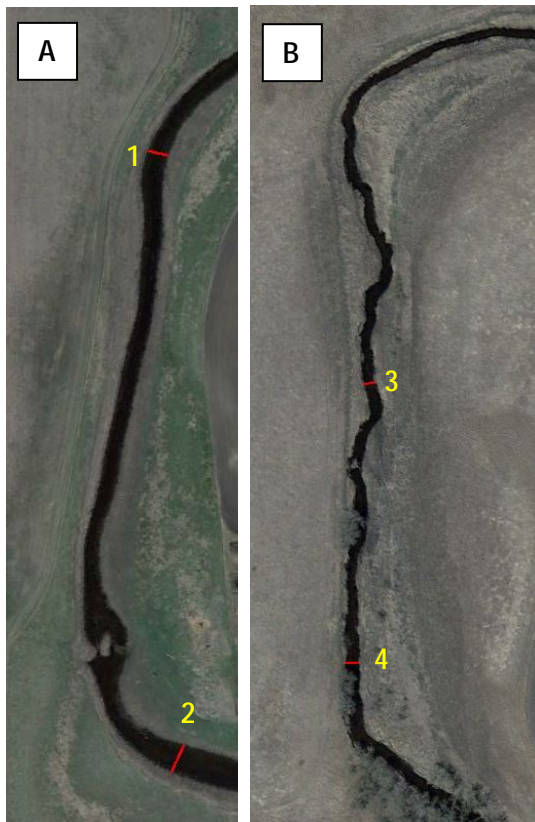
Figure 20. A site location within AUID-514. Photo A: The channel here is within a pasture. B: The channel just downstream of the pasture. Red lines denote channel widths measured by a computer tool. 1 = 37.6 ft., 2 = 54.3 ft., 3 = 16.6 ft., and 4 = 17.7 ft.

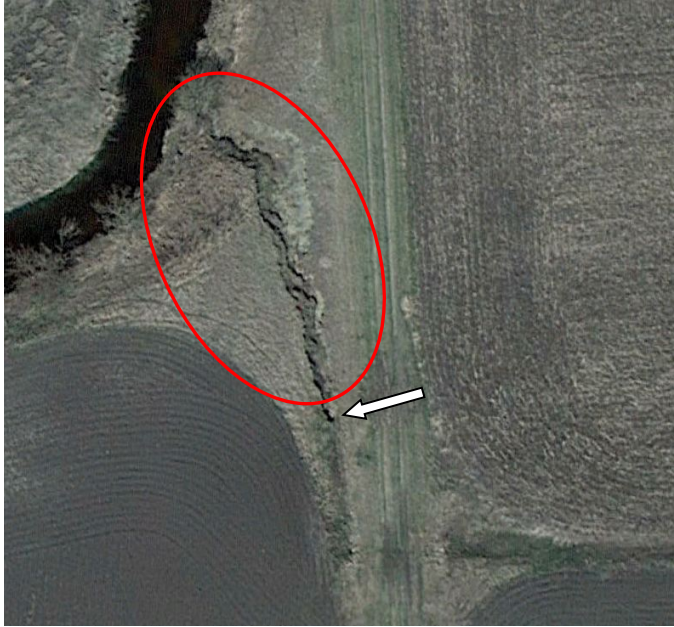
Figure 21. Field gully along the creek bank. The white arrow points to the nick point which is migrating away from the creek.

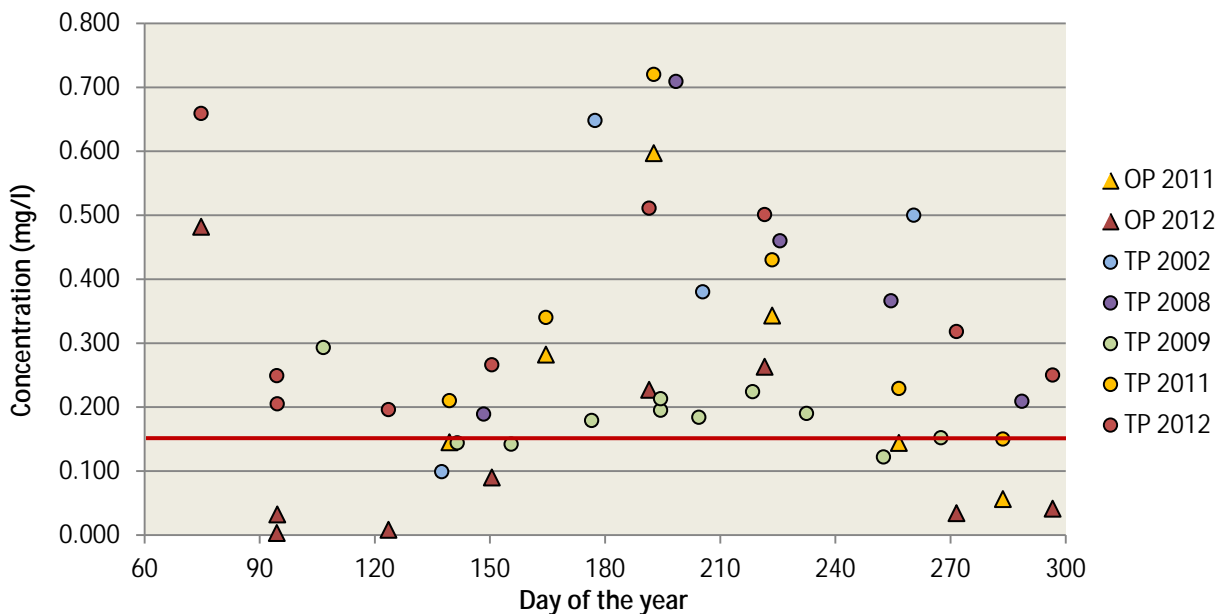
Figure 22. United States Environmental Protection Agency and orthophosphorus concentrations at S003-124 (co-located with 10RD055). Note that 2009 TP concentrations were much lower than in the other years. The red line is Minnesota’s newly - adopted river phosphorus (TP) standard.

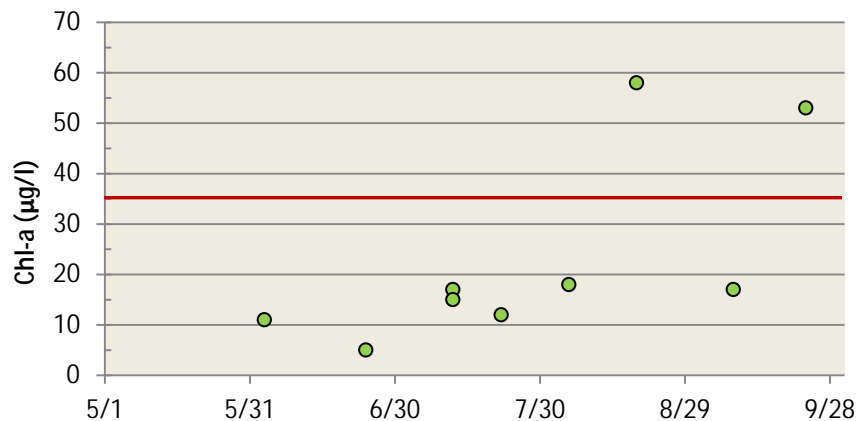
Figure 23. Chl-a concentrations (corrected for pheophytin) at S004-127 (10RD055) during summer 2009. The red line is the Chl-a component threshold of the newly-adopted river nutrient standard.
