# Mustinka River

## Watershed Restoration and Protection Strategy

### Stressor Identification Report

Assessment of stress factors affecting aquatic biological communities

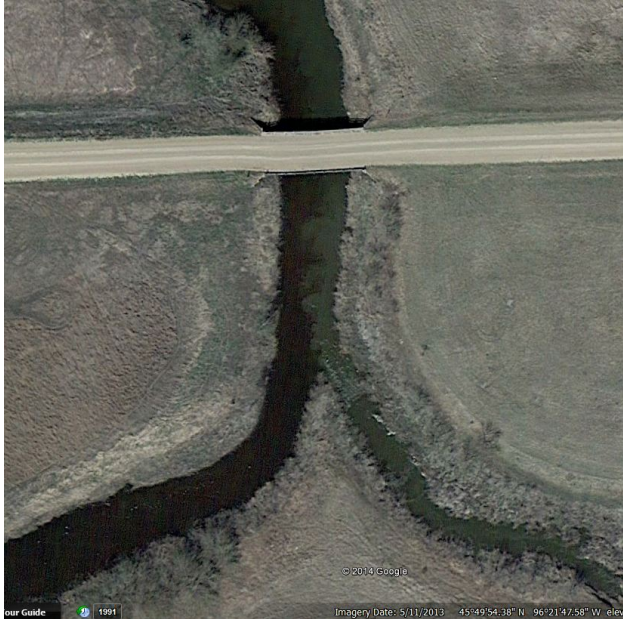
Figure 24. The confluence of Fivemile Creek (on right) with Twelvemile Creek. Note the turbid water (color difference) coming in from Fivemile Creek, which can be seen mixing with the water in Twelvemile Creek.

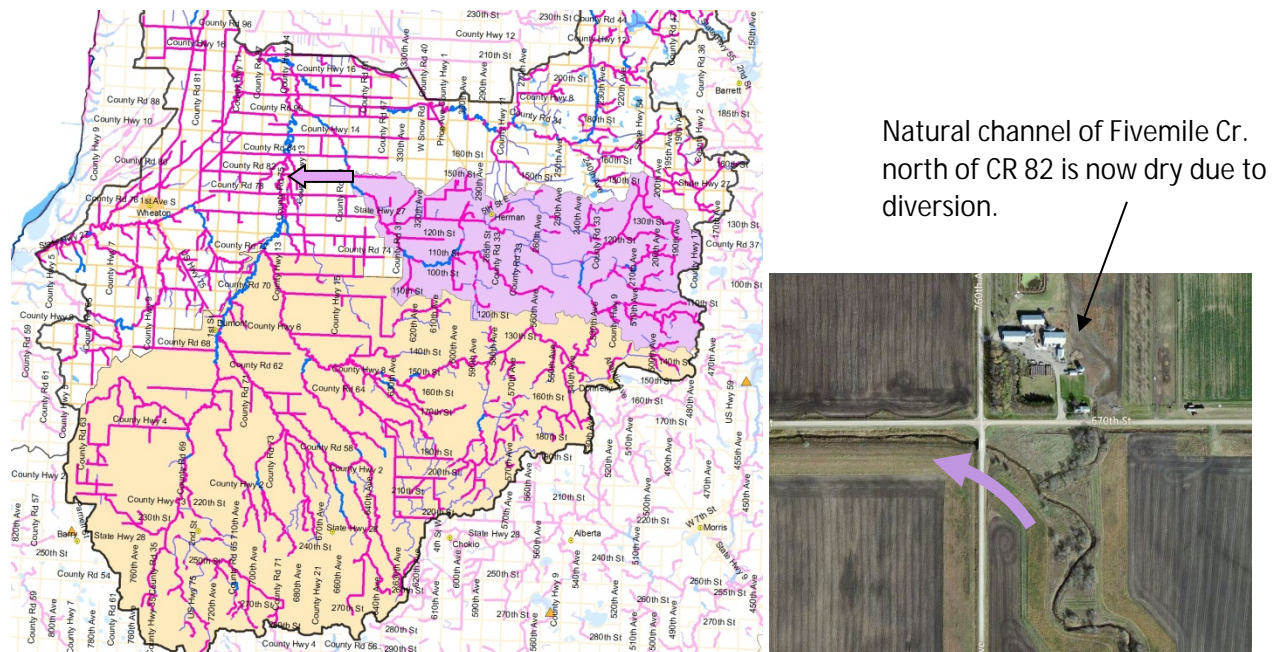
Figure 25. Map of the contributing area to the upstream end of AUID-557 (tan) and the area of the Fivemile Creek subwatershed that is diverted into Twelvemile Creek (purple). The purple arrow on left side follows the ditch that delivers the water from the Fivemile Creek subwatershed into Twelvemile Creek. The close-up photo on the right side shows the start of the diversion. The pink channels are those determined to have been modified to some degree in the past based on the MPCA Altered Watercourse Project. The blue channels are natural.

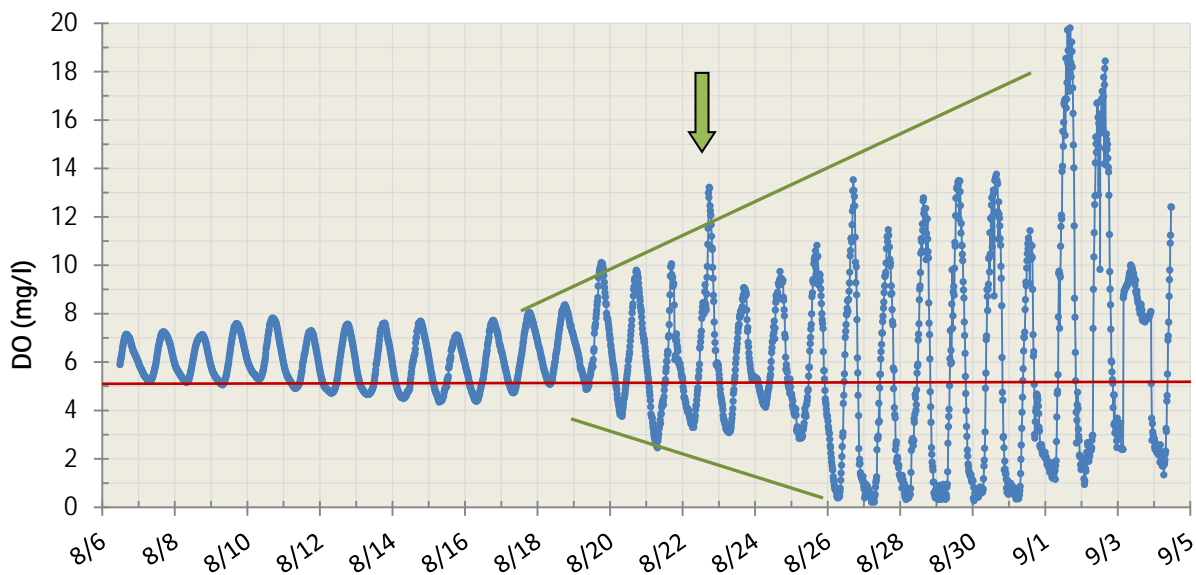
Figure 26. DO sonde record at 10RD056 for the period August 6 - September 9, 2013. The arrow indicates when the Chl-a sample was collected, the green lines are emphasizing the change in DO pattern, and the red line is the Minnesota DO standard.

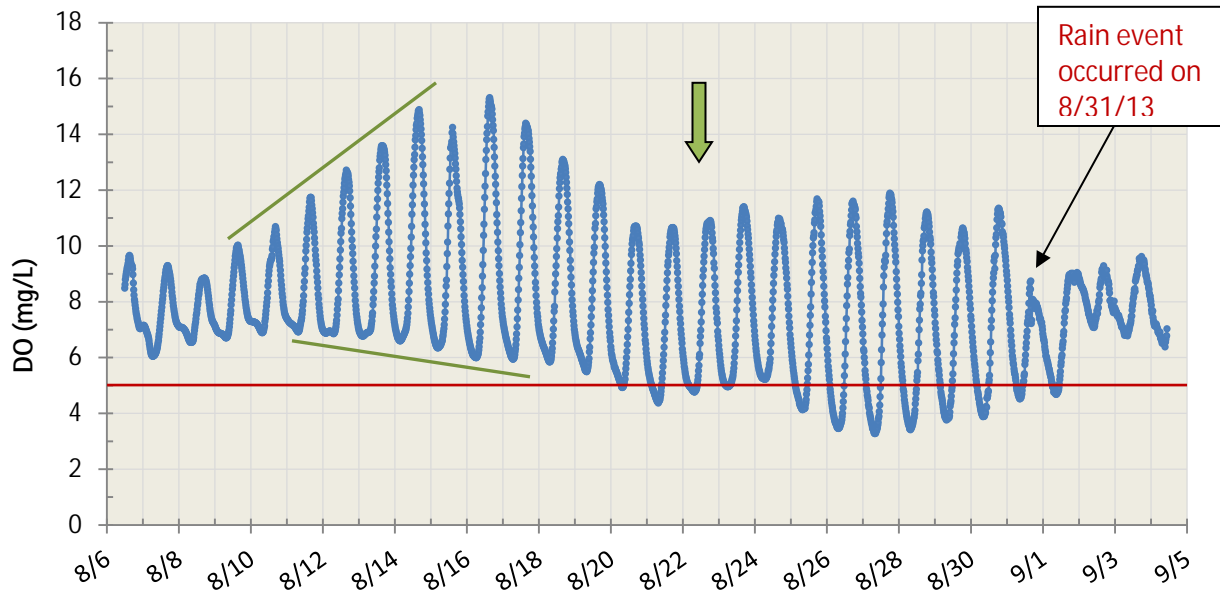
Figure 27. DO sonde record at 10RD055 for the period August 6 - September 9, 2013. The arrow indicates when the Chl-a sample was collected, the green lines are emphasizing the change in DO pattern, and the red line is the Minnesota DO standard.

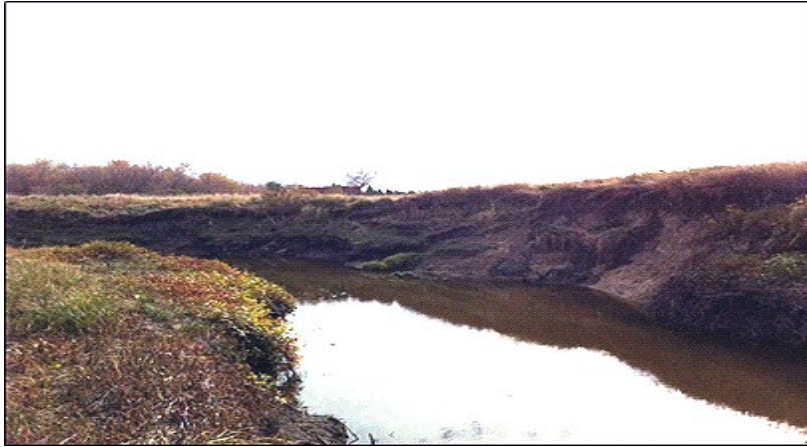
Photo 11. Raw bank with sloughing sod mats (mass wasting) in reach EOR-65.

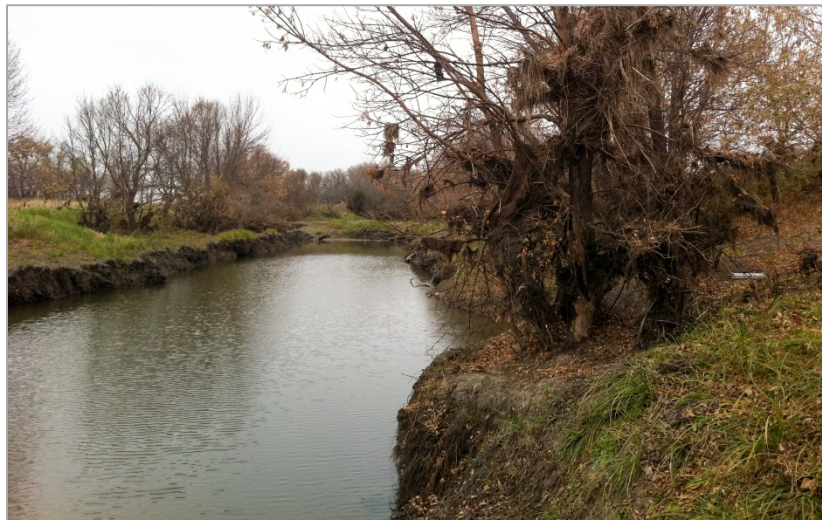
Photo 12. Widespread raw, eroding banks along the EOR-76 reach. The channel is overwidened here.

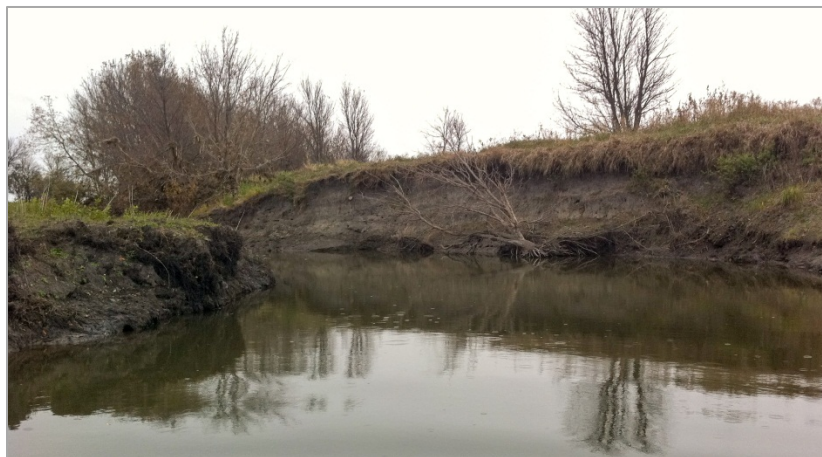
Photo 13. Bank erosion on both sides of river at a bend signals downcutting (incision) of the channel. The erosion of banks are contributing to the turbidity and bedded sediment problems.

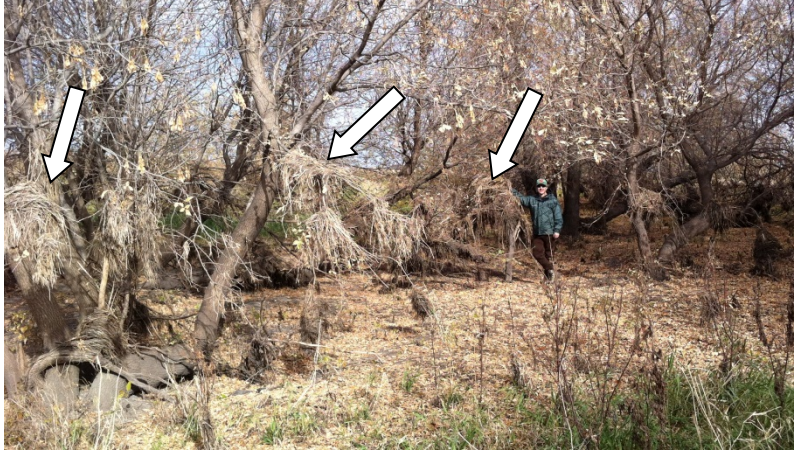
Photo 14. Vegetative debris caught in tree branches during a high water event.

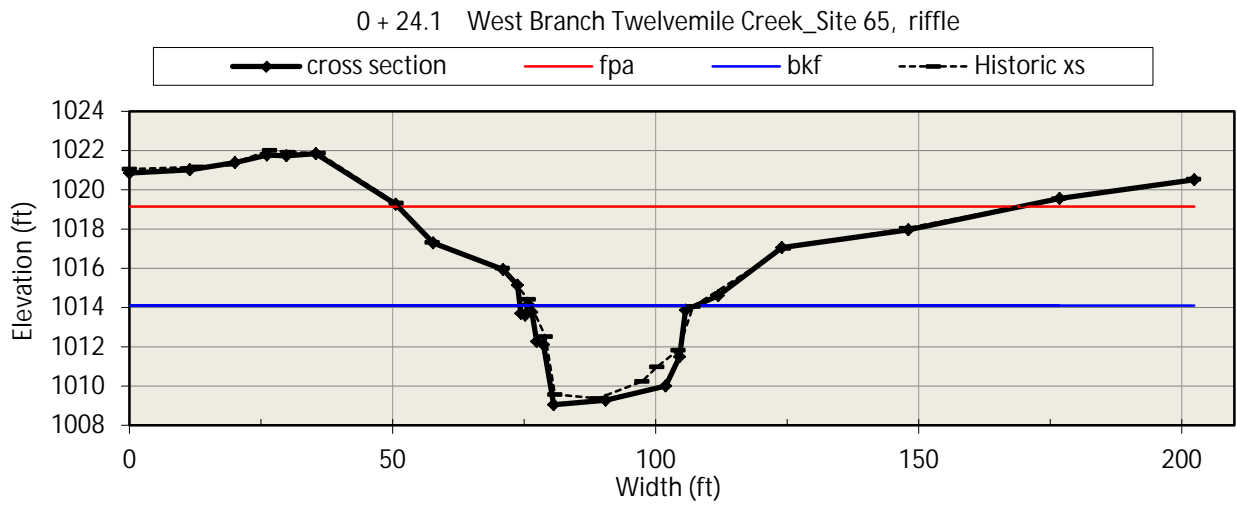
Figure 28. 2012 cross-section of EOR-65, with 2002 historical cross-section superimposed.

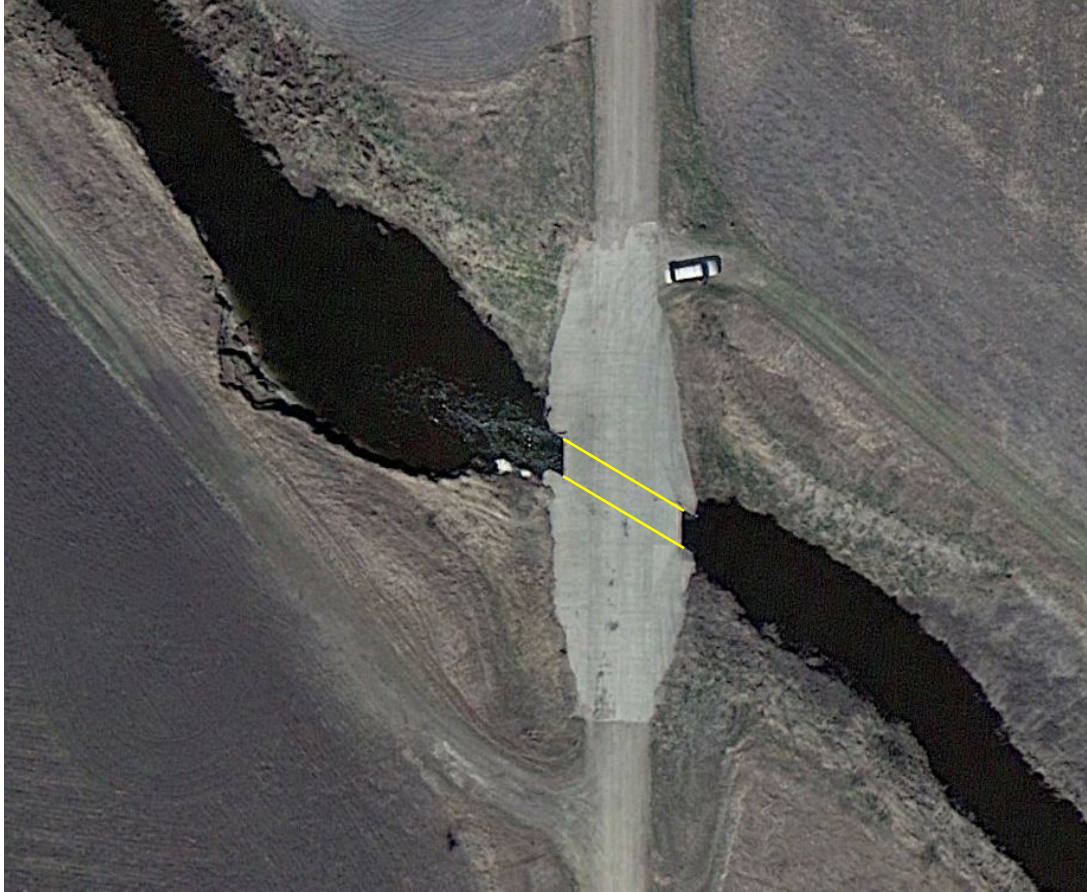
Figure 29. Culvert on Twp. Rd 105. The culvert is undersized, creating an increase in water velocity (note the water turbulence on the downstream (left) side of the culvert), and the associated eroding banks, especially the west bank. Note that the field access road will soon be impacted. The yellow lines show the culvert width, which is much narrower than the channel width.

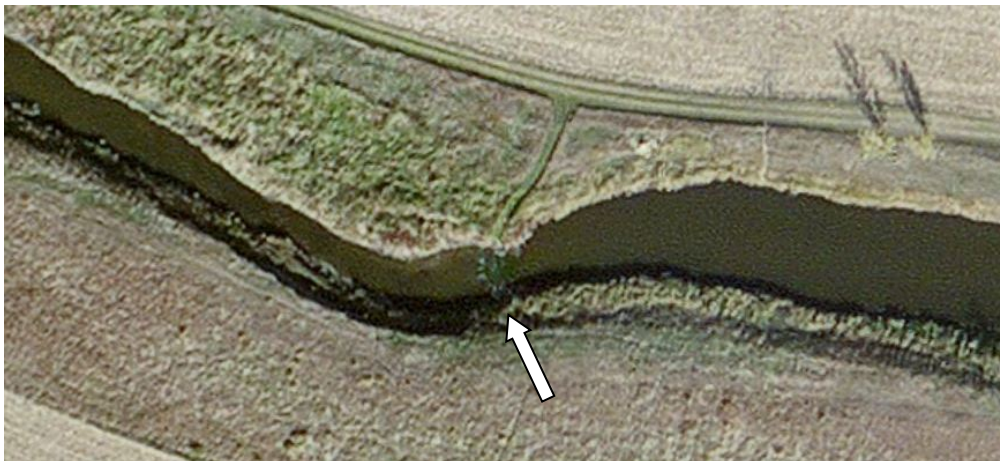
Figure 30. An apparently-created structure (trail leads to it), which may be a barrier to fish migration. Note the much wider channel on the upstream side, meaning the structure is ponding water. The convex shape of the structure is also diverting part of the flow into the south bank and causing erosion.

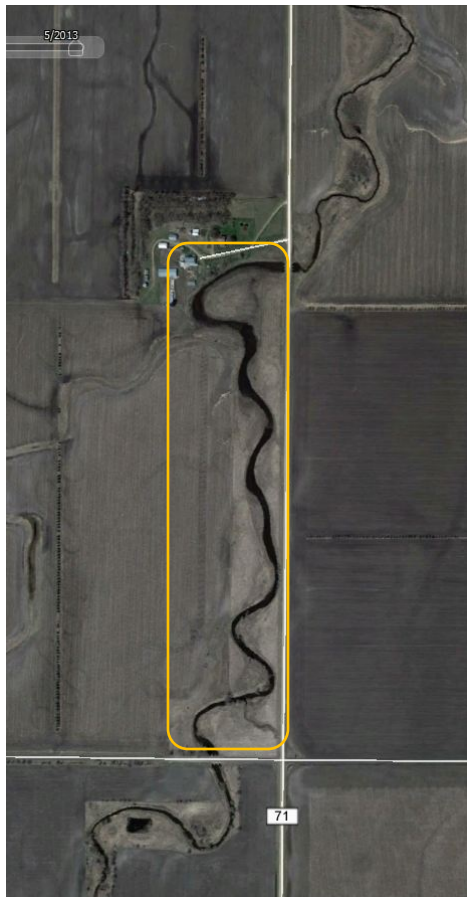
Figure 31. Altered channel morphology due to animal grazing. The orange rectangle contains a pastured area along the creek upstream of AUID-557, on the West Branch of Twelvemile Creek. Note how much wider the channel is within the pasture, relative to the upstream and downstream channel widths.

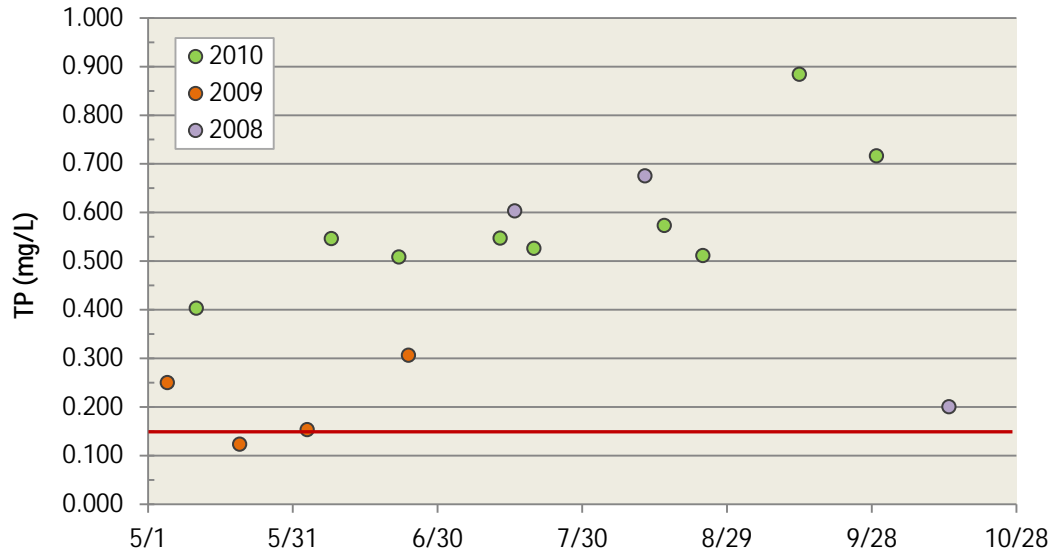
Figure 32. TP concentrations from 2008-2010. The red line is the newly-adopted TP standard for this area.

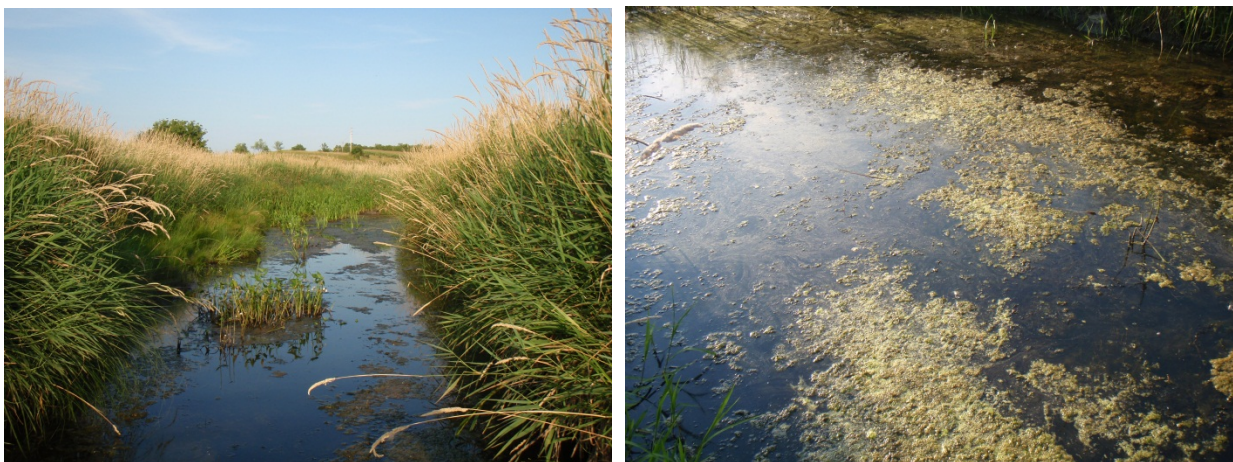
Photo 15. Excessive macrophyte and algae growth, resulting in DO issues and habitat smothering.

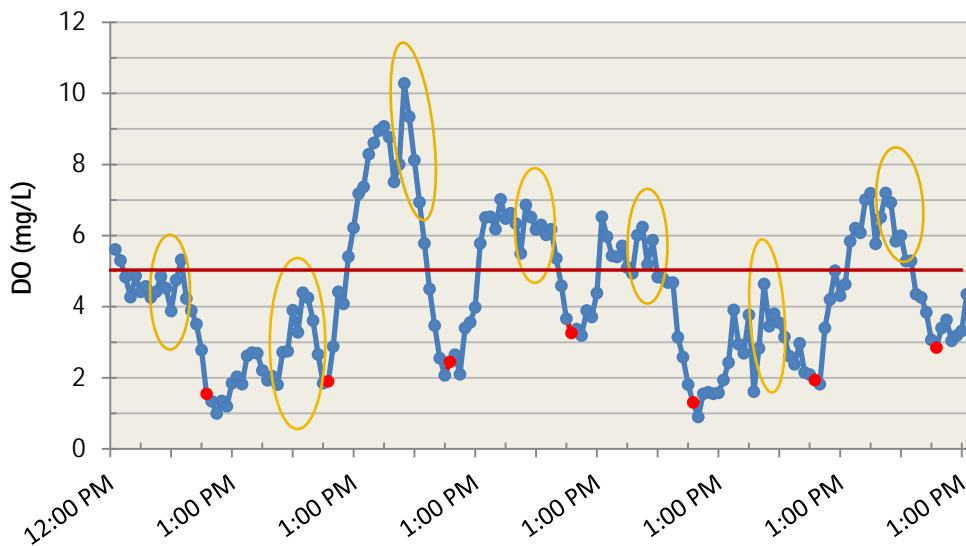
Figure 33. DO concentration at 10RD045 from July 23 - 31, 2012. The red line is the Minnesota DO standard. Orange circles denote an odd daily pattern of DO increase starting at dusk and lasting for a few hours, followed by the normal nocturnal decline with minimum shortly after dawn. The red-highlighted points are the 8 am data points.

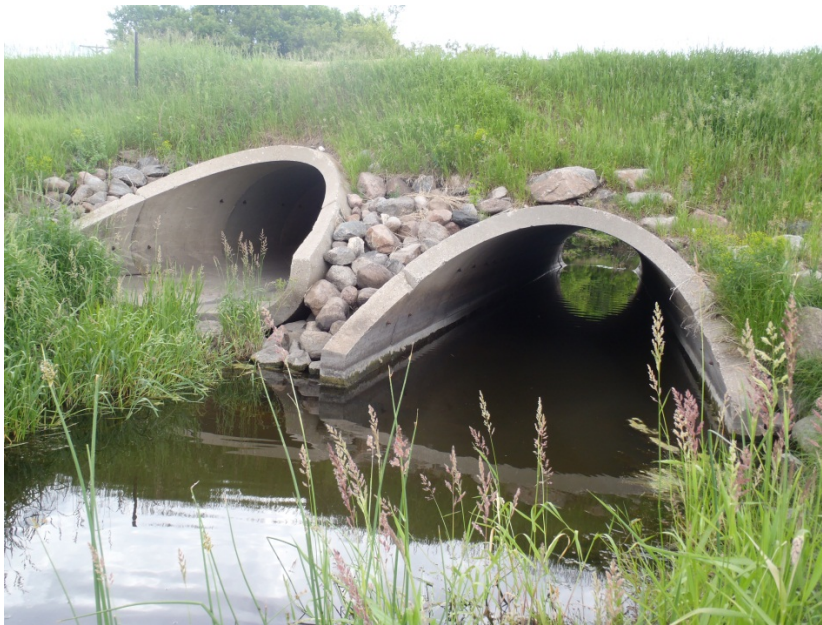
Photo 16. CSAH 7 culverts are very well-designed for fish passage (one culvert carries baseflow, and one culvert set at the floodplain elevation). This design maintains proper stream geomorphology, and reduces erosion of the streambed and banks.

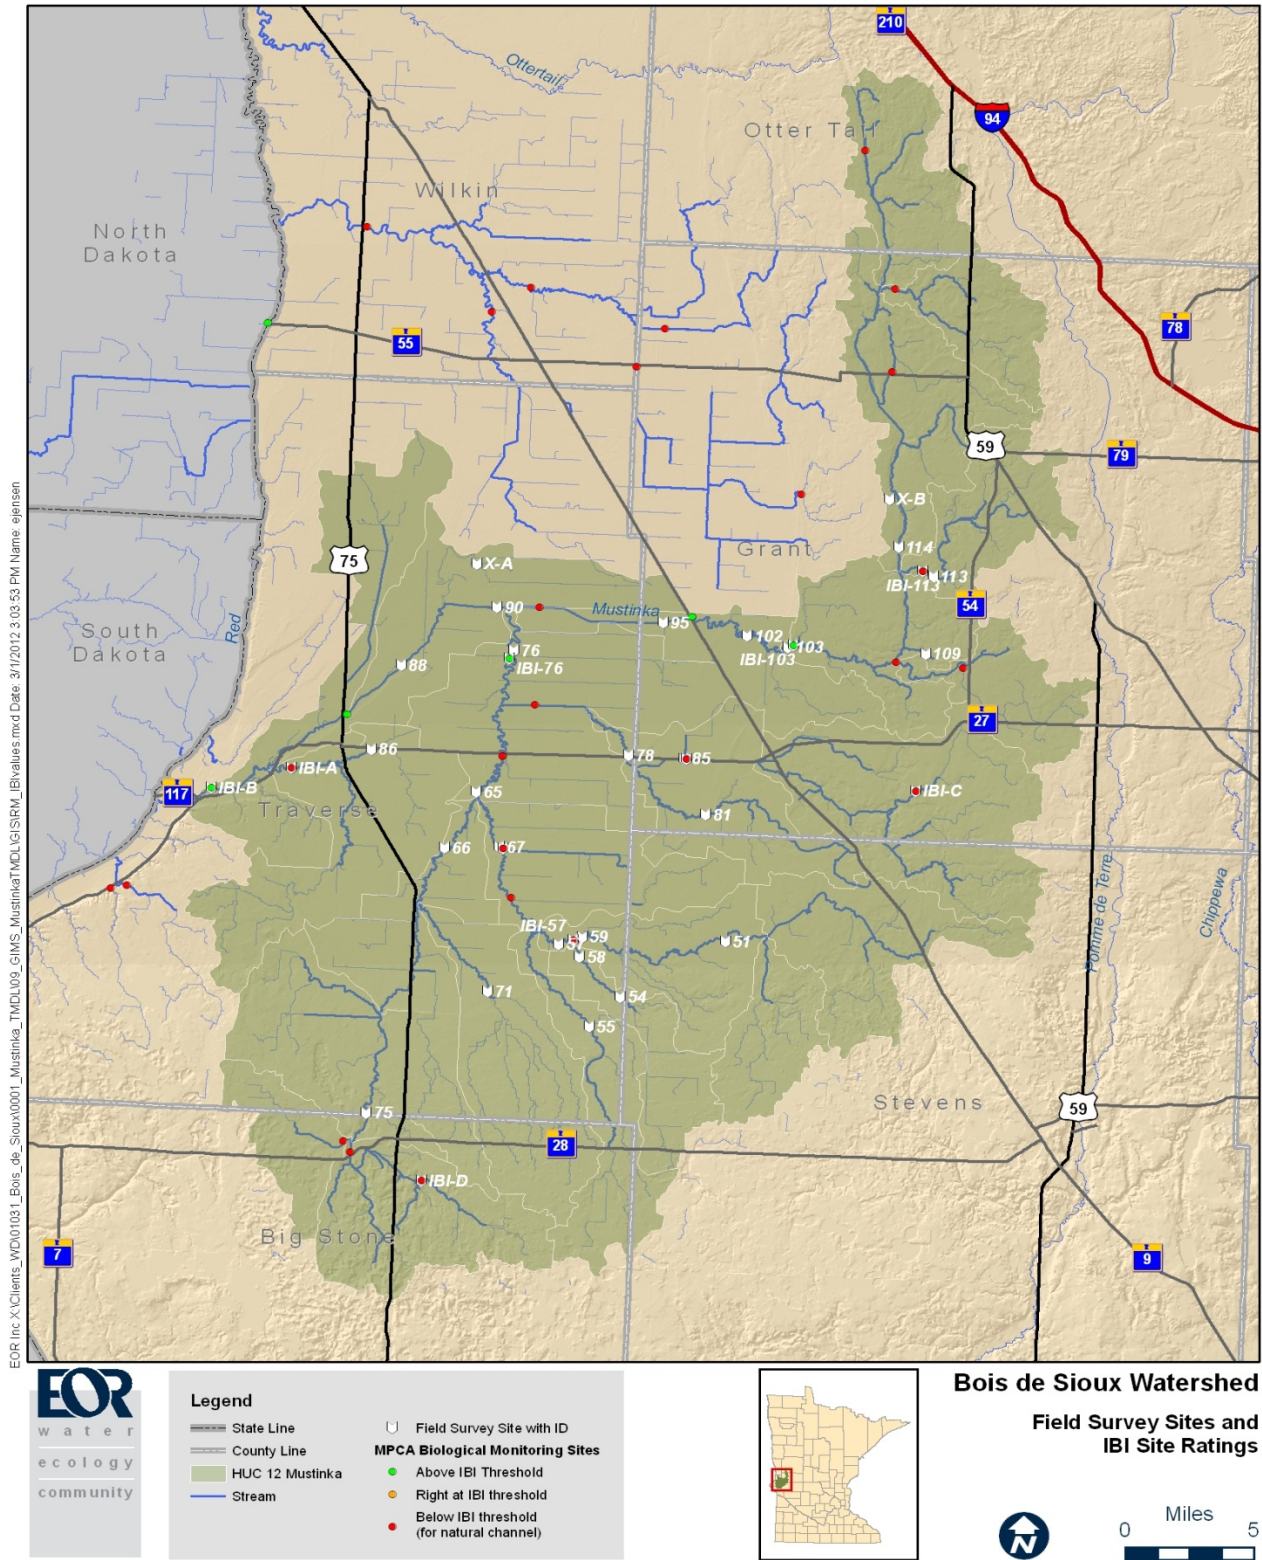
Figure 34. Survey Reaches and IBI Scores within the Mustinka Watershed.

AUID-580 contained two EOR, Inc. geomorphology study locations, denoted EOR-114 and X-B (see Figure 34 in the appendix). At EOR-114, the channel appears to be over-widened, as the banks are eroding and raw, and have sloughing sod mats (Photo 5). A historical cross-section also confirms that there is some channel instability at this location; over the last decade, the channel cross-section has enlarged in both width and depth (Figure 9). Bank Erosion Hazard Index (BEHI) ratings were taken at seven locations in the EOR-114 reach (Table 11). Overall the erosion hazard rating is moderate, though one location was high. These geomorphic data suggest that a significant amount of the excess sediment and turbidity in AUID-580 is due to bank and bed erosion.

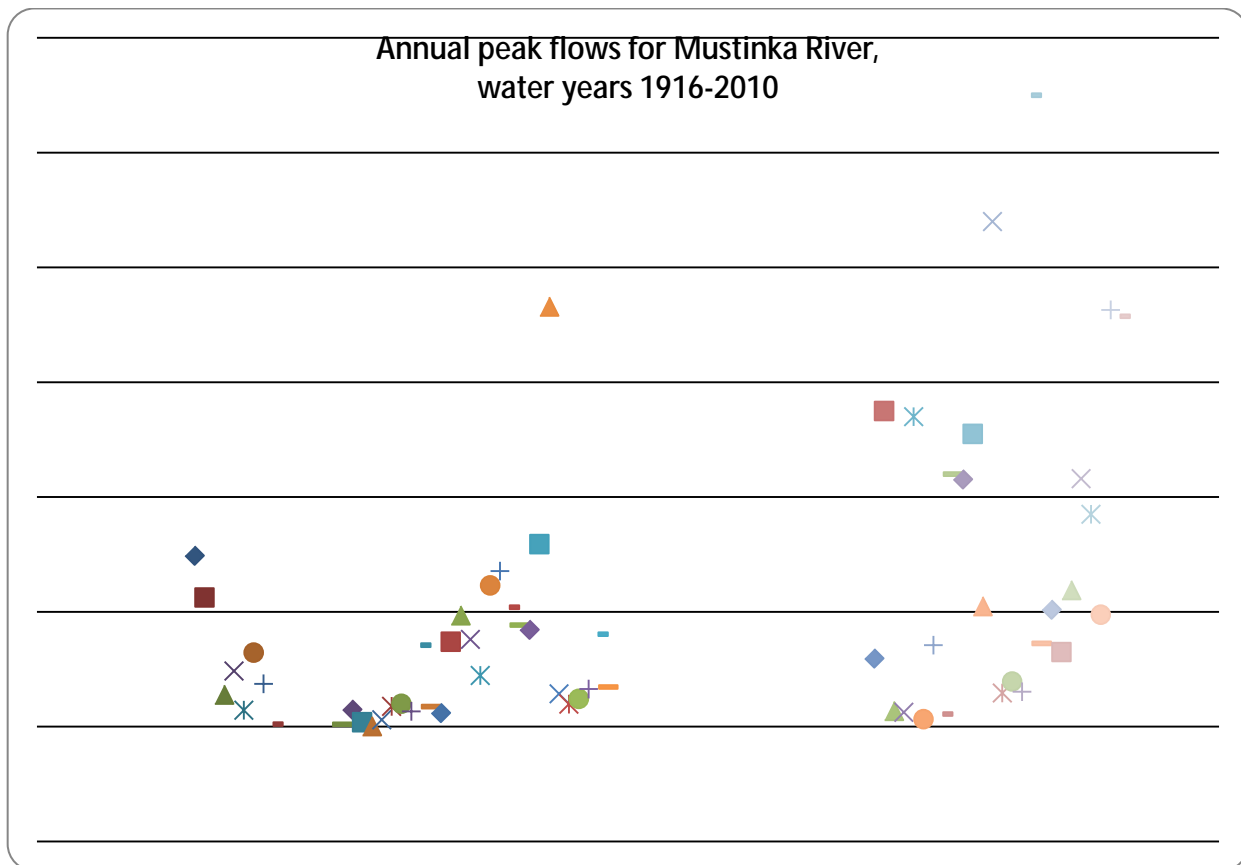
Figure 35. Annual peak flows in the Mustinka River (streamflow data was not collected from 1959-1984). Numerous large peak flows have occurred since 1985.

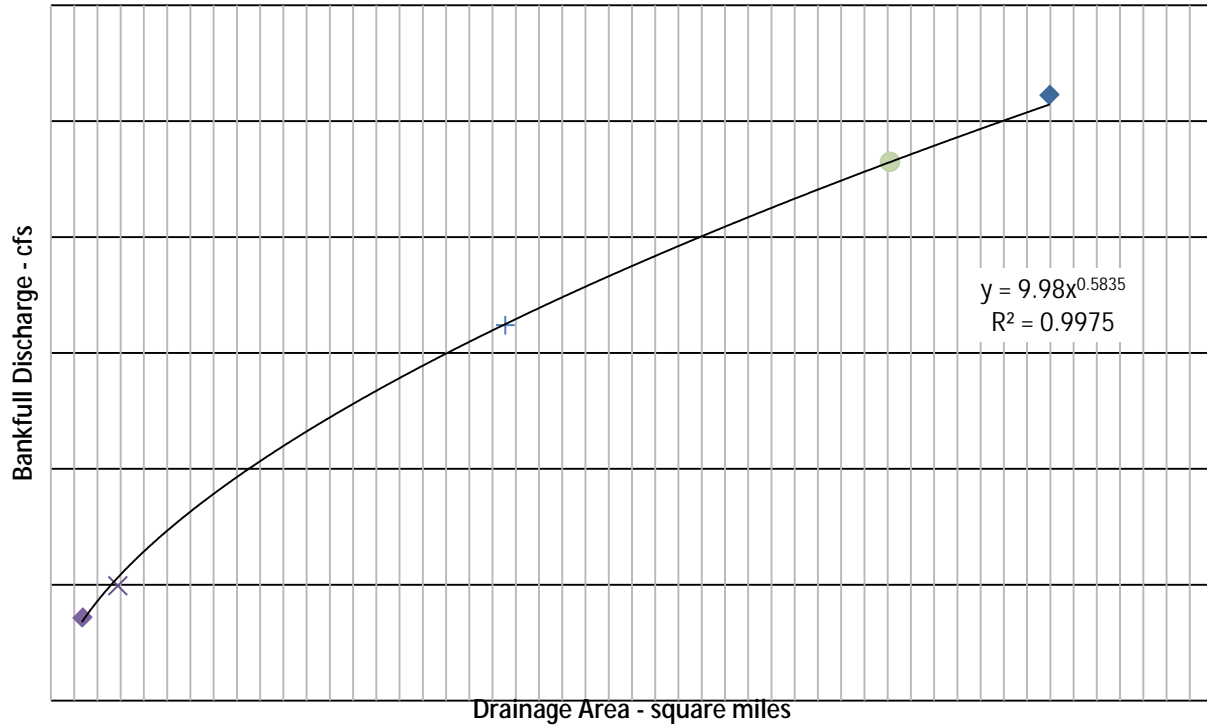
Figure 36. Regional curve for Mustinka River bankfull discharge generated using data from the USGS StreamStats program. The 1.5 year recurrence intervals were calculated from regional regression equations at points across the watershed.

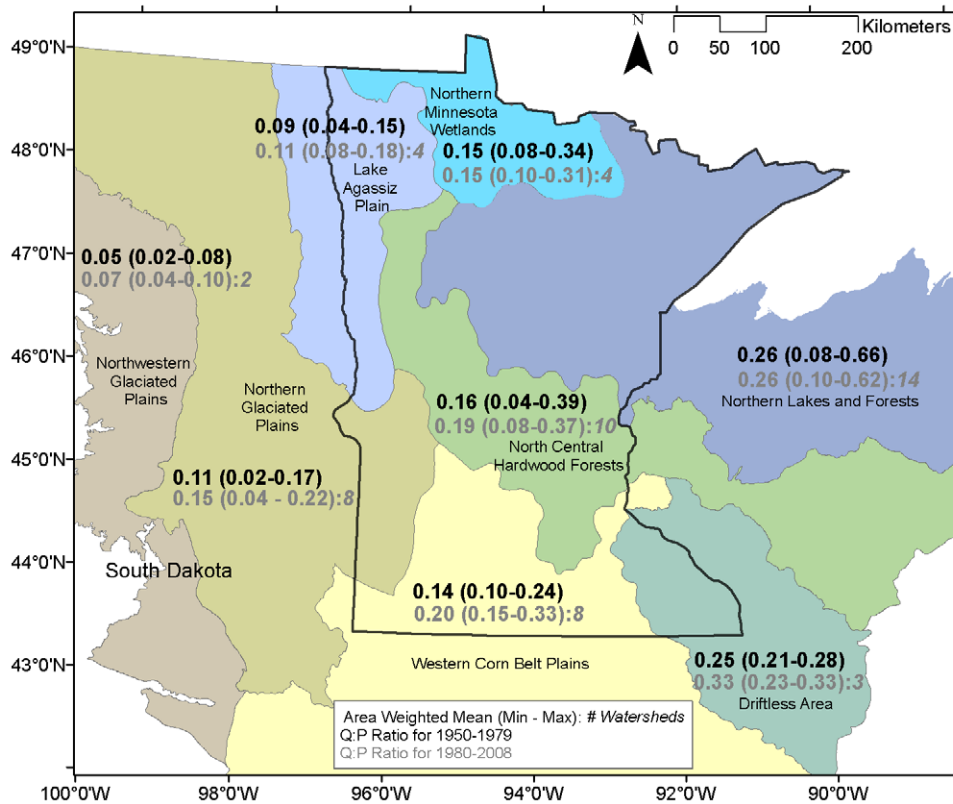
Figure 37. Change in the Q:P ratio for Minnesota (from Lenhart et al. 2011b). The values represent the average Q:P for several watersheds examined in the region from 1950-1979 (top number) and 1980-2009 (bottom number).
