Lake of the Woods Watershed Stressor Identification Report

A study of the stressors limiting the aquatic biological communities of watercourses in the Lake of the Woods Watershed.

Document number: wq-ws5-09030009a

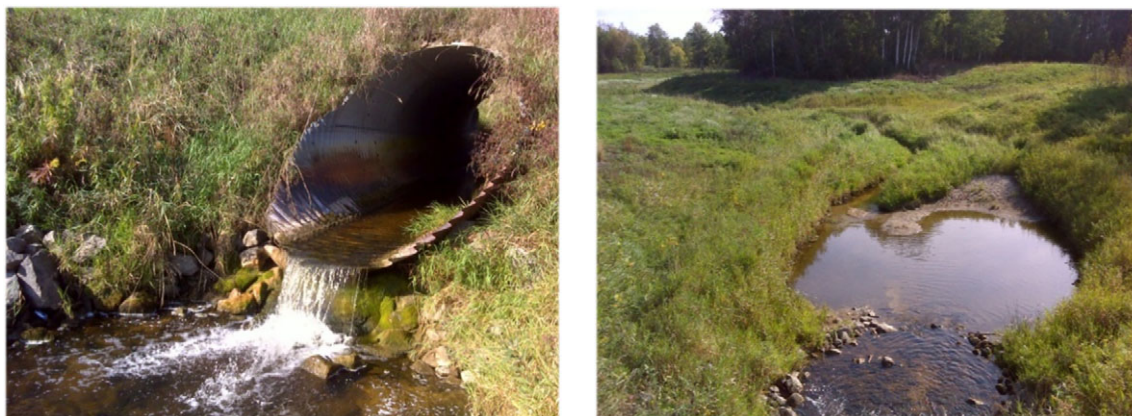
elevated approximately two feet above the creek. The perched culvert likely obstructs connectivity during low and, likely, moderate flow conditions. In addition to the assessment, MPCA SID staff performed a detailed review of a May 17, 2011, aerial photo (courtesy of Google Earth) of the reach. No additional connectivity-related issues were identified in the photo.

Figure 9. Photos of a perched culvert (left) and its associated plunge pool (right) at the CR 61 crossing along AUID 501.

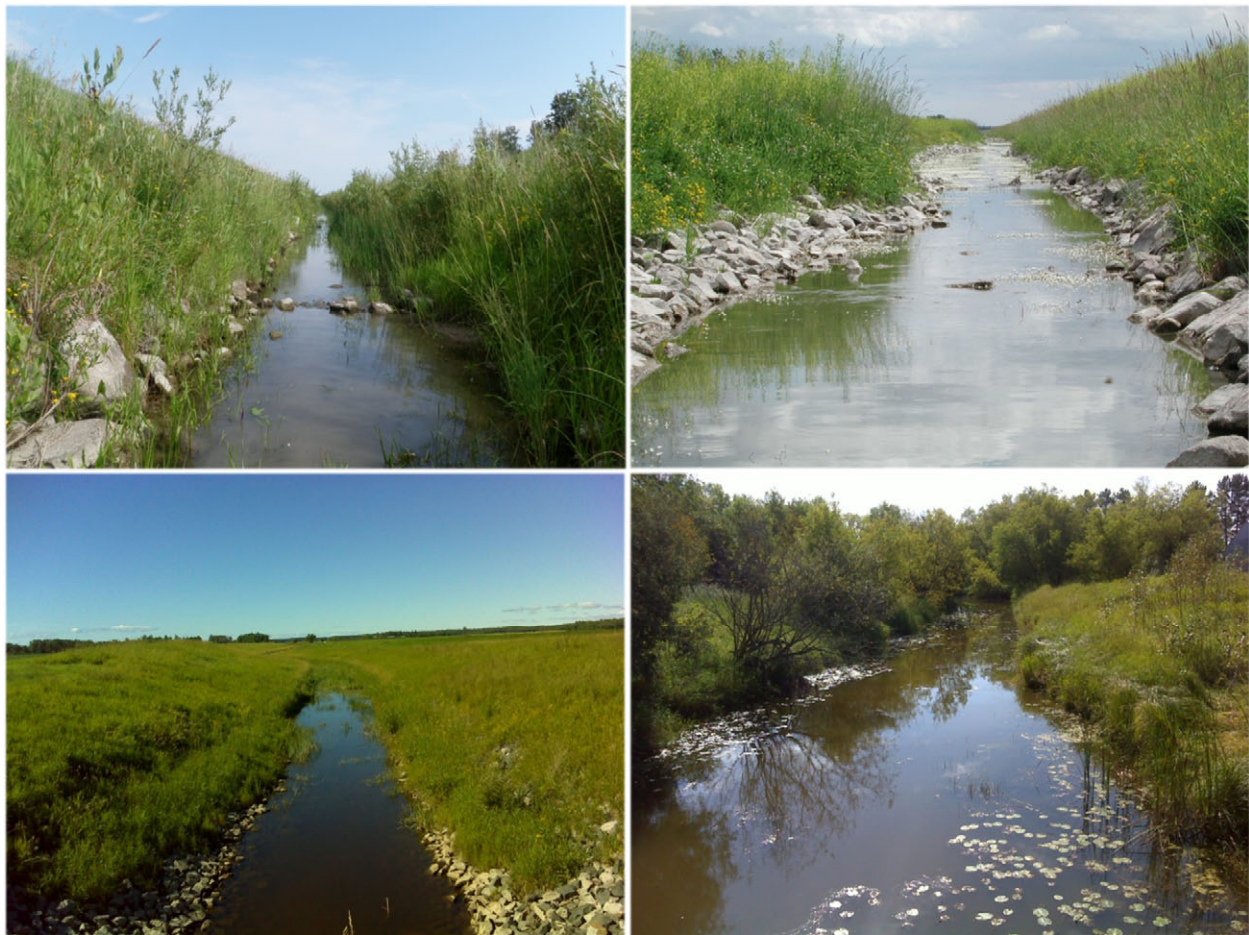
Figure 10. Photos of lentic and minimal flow conditions along AUID 501, including Station 12RN020 on July 12, 2012 (upper left); the County Road 12 crossing during the summer of 2007 (upper right); the County Road 12 crossing on August 4, 2015 (lower left); and the County Road 8 crossing on September 16, 2015 (lower right).

Approximately 20% of the total mean daily flow values were less than 1.0 cfs. A discharge of less than 1.0 cfs or less was recorded during each year. Additionally, the MPCA flow monitoring staff documented minimal flow at the site during the summer of 2007 (Figure 10). The MPCA SID staff conducted reconnaissance along the reach on three separate dates (i.e., July 22, 2015, August 4, 2015, and September 16, 2015) and noted flow conditions. Staff observed very minimal flow at the County Road 12 crossing on August 4, 2015 (Figure 10), as well as lentic conditions at the County Road 8 crossing on September 16, 2015 (Figure 10). According to local water resource managers in the LOWW (MPCA, 2015), the reach has a “flashy” flow regime, with

high and quick peak flows, along with prolonged periods of low discharge. Overall, the available data suggest that the reach experiences frequent periods of minimal to no flow.

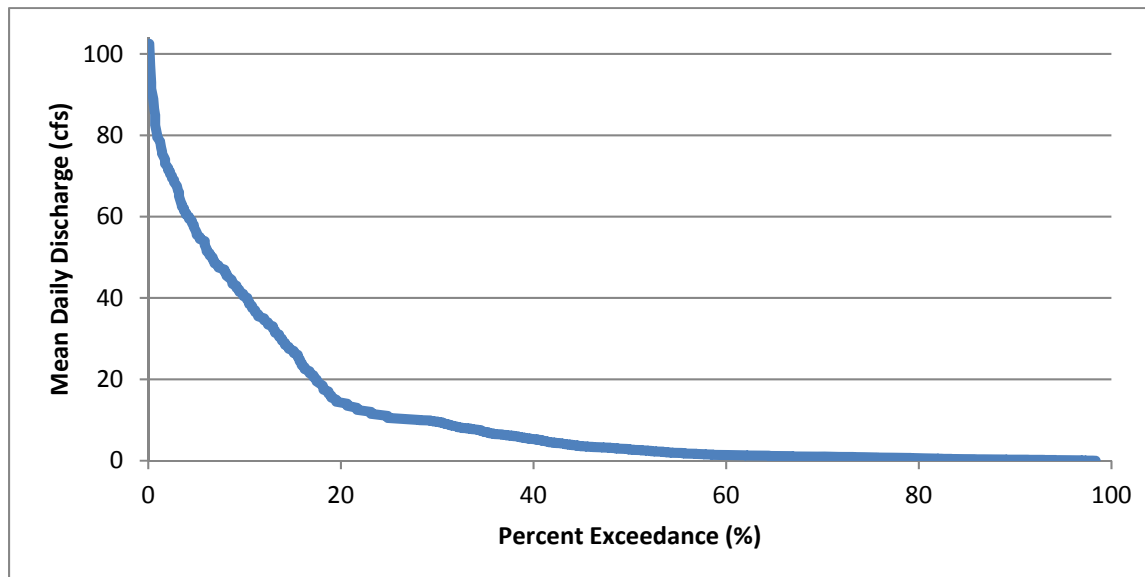
Figure 18. Flow duration curve for Site H80017001 (2012-2015) along AUID 504.

less than 1.0 cfs. The MPCA SID staff conducted reconnaissance along the reach on three separate dates (i.e., July 22, 2015, August 4, 2015, and September 16, 2015) and documented flow conditions. Staff observed lentic conditions at the Tangnes Road and Norris Roosevelt Road crossings (Figure 19), which are located in the vicinity of Station 05RN115. Overall, the available data suggest that at least the headwaters segment of the reach, which includes Station 05RN115, experiences frequent periods of minimal to no flow.

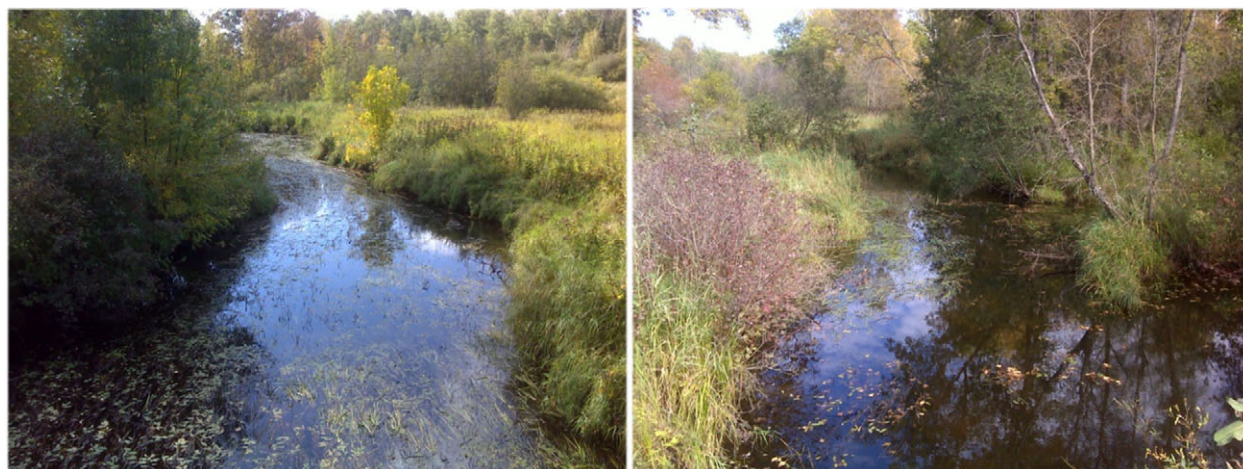
Figure 19. Photos of lentic conditions along AUID 504 on September 16, 2015, including the Tangnes Road crossing (left) and the Norris Roosevelt Road (right).

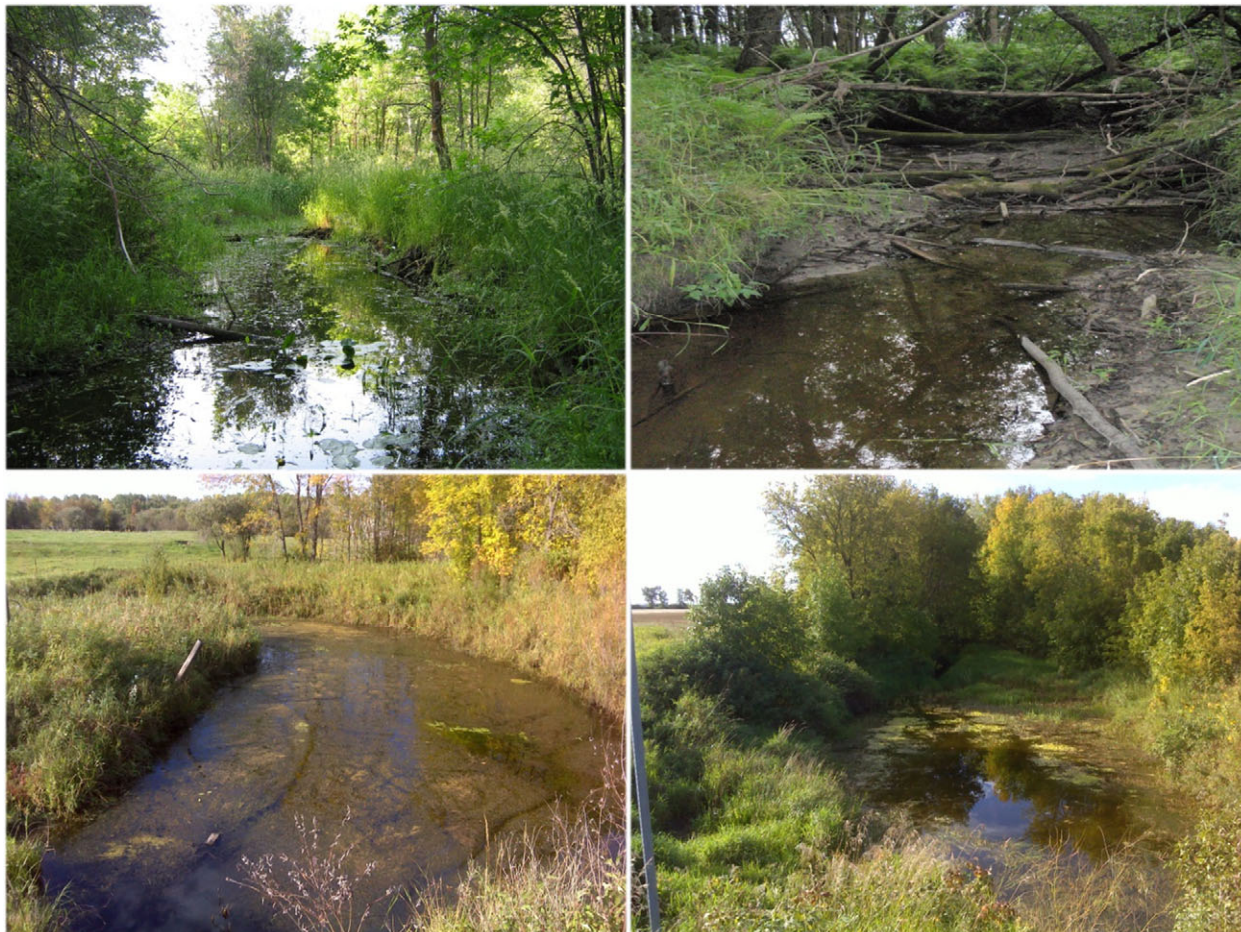
Figure 26. Photos of lentic conditions along AUID 505, including Station 05RN188 on June 19, 2006 (upper left); Station 12RN015 on July 31, 2012 (upper right), the CSAH 8 crossing on September 16, 2015 (lower left), and the CSAH 12 crossing on September 12, 2015 (lower right).

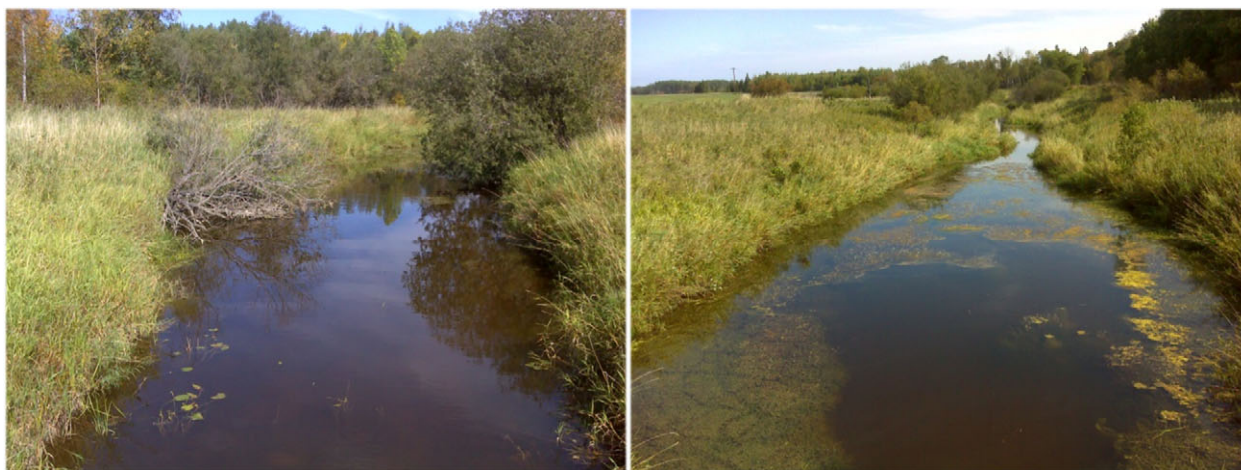
Figure 34. Photos of minimal flow conditions along AUID 515 on September 16, 2015, including the 40th Street NW crossing (left) and the 70th Avenue NW crossing (right).

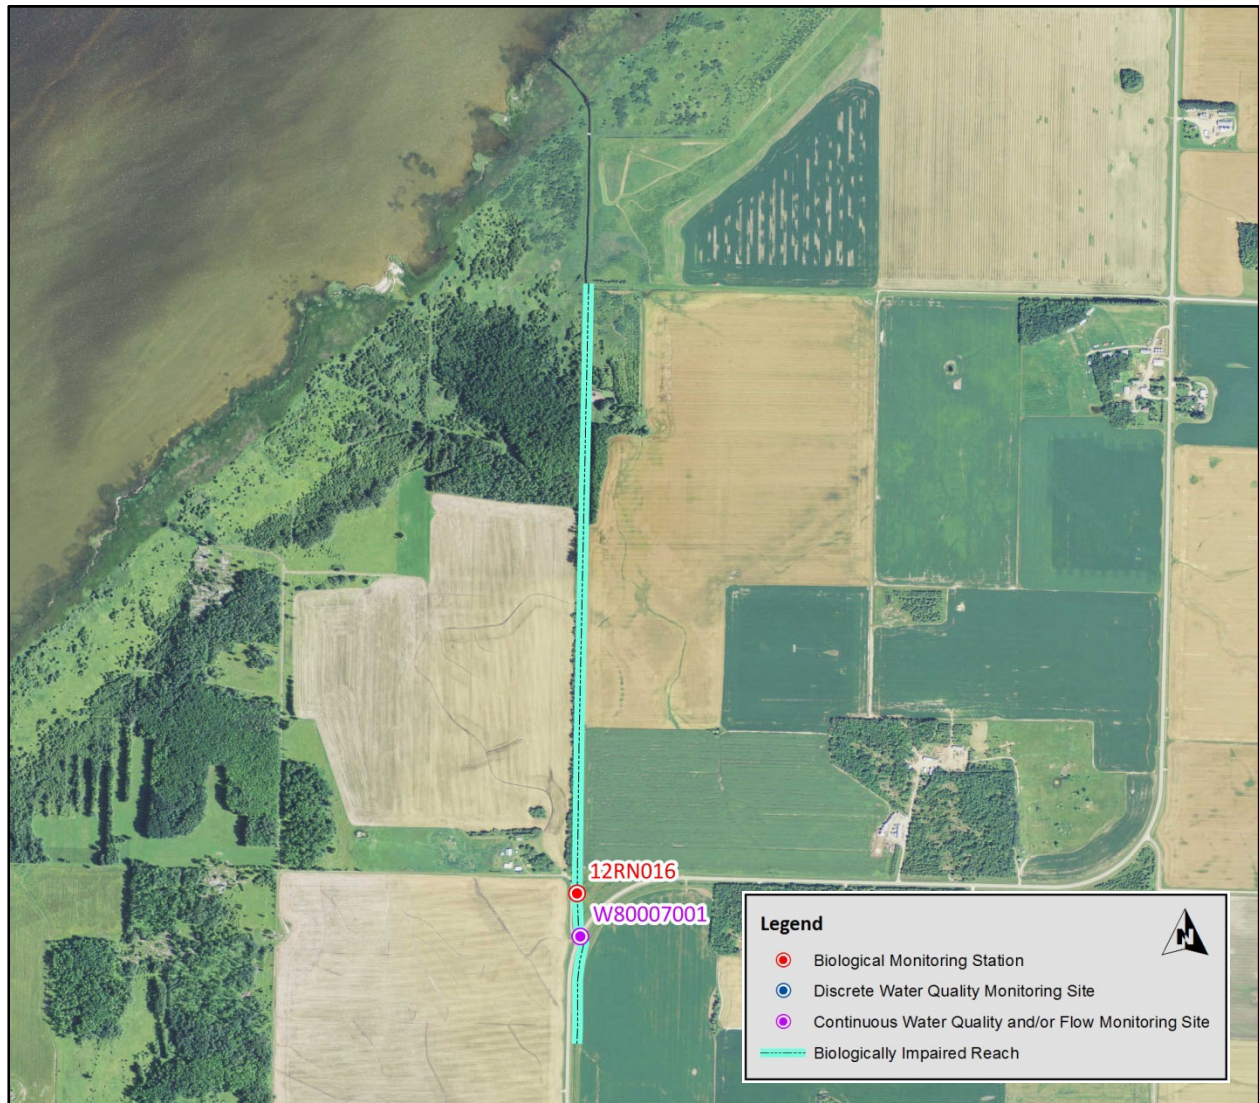
Figure 38. Map of AUID 523 and associated biological monitoring stations and water quality monitoring sites (2013 NAIP aerial image).

This reach represents an unnamed ditch (Figure 38), which extends from immediately upstream of the CSAH 17 crossing, to its confluence with an unnamed ditch along 56th Street NW; a total length of one mile. The reach has a subwatershed area of 16 square miles (10,088 acres). The subwatershed contains 20 miles of intermittent drainage ditch (e.g., AUID 523) and four miles of intermittent stream (DNR, 2015). According to the MPCA (2013), 83% of the watercourses in the subwatershed have been hydrologically altered (i.e., channelized, ditched, or impounded), including the entire length of AUID 523. The NLCD 2011 (USGS, 2011) lists wetlands (56%) as the predominant land cover in the subwatershed. Other notable land cover groups in the subwatershed included cultivated crops (21%), hay/pasture (11%), herbaceous (3%), forest (3%), developed (3%), and shrub/scrub (1%).

The fish community of AUID 523 was monitored at Station 12RN016 (0.1 mile downstream of the CSAH 17 crossing) on July 11, 2012(1) and August 27, 2014(2). The relative location of the station is shown in Figure 38. The station was designated as General Use within the Northern Headwaters F-IBI Class. Accordingly, the impairment threshold for the station is an F-IBI score of 42. The monitoring results for the station yielded F-IBI scores (38 and 25) below the threshold. According to Figure 39, seven individual metrics for Station 12RN016 scored below the mean value needed to meet the impairment threshold (i.e., DarterSculp, Hdw-Tol, InsectCypPct, Minnows-TolPct, NumPerMeter-Tol, Sensitive, and SLithop). A description of each metric is provided in the [Development of a Fish-Based Index of Biological Integrity for Minnesota's Rivers and Streams](#) (MPCA, 2014a). Overall, the fish assemblage of the stations was largely comprised of tolerant taxa (i.e., central mudminnow and white sucker).

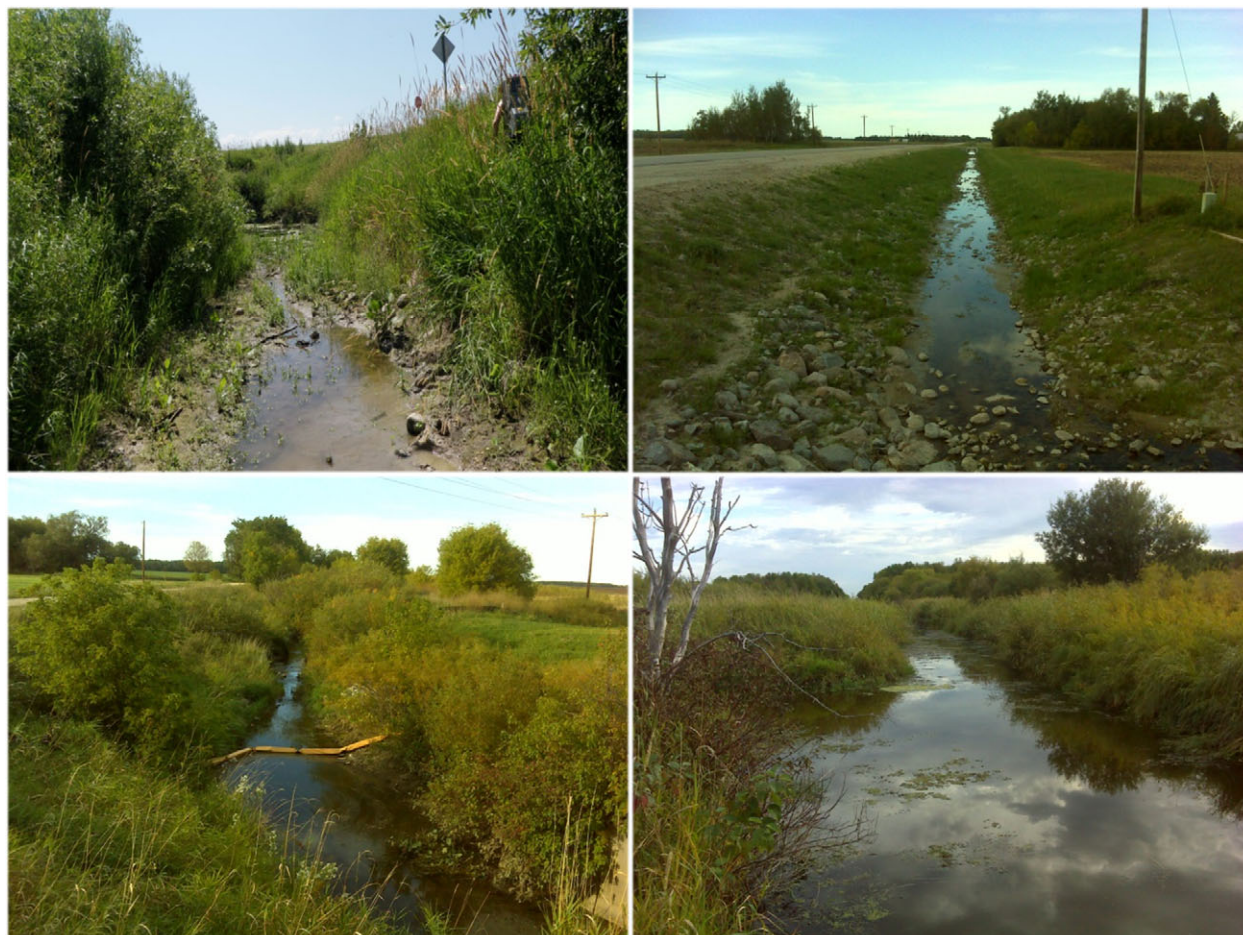
Figure 41. Photos of minimal flow and lentic conditions along AUID 523, including Station 12RN016 on July 11, 2012 (upper left); the CSAH 11 crossing on September 16, 2015 (upper right); the CSAH 17 crossing on September 16, 2015 (lower left); and near 56th Street NW on September 16, 2015 (lower right).

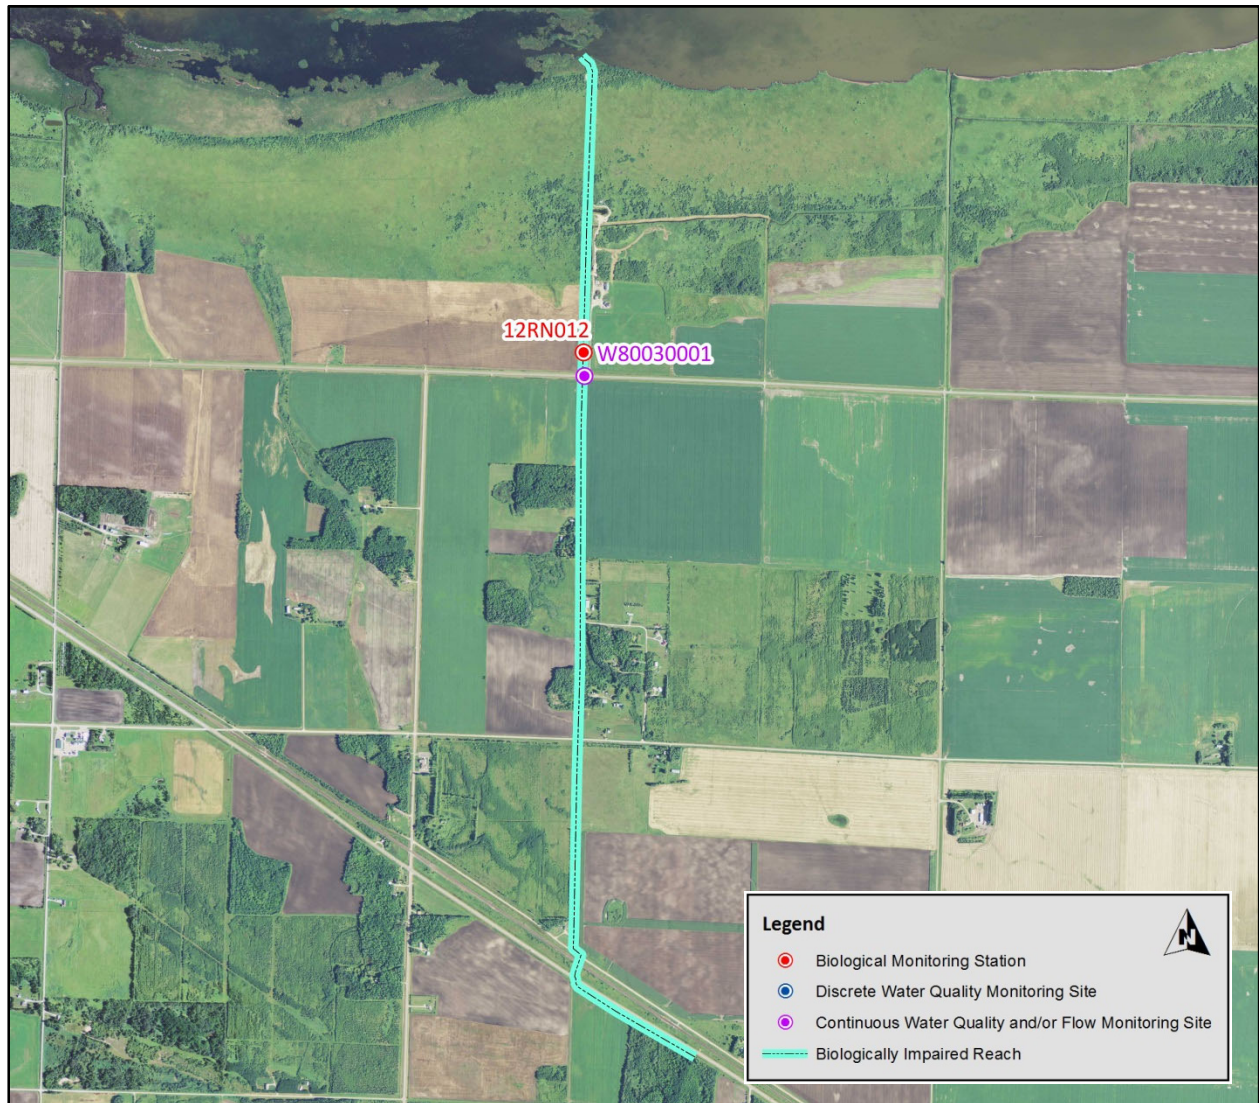
Figure 44. Map of AUID 560 and associated biological monitoring stations and water quality monitoring sites (2013 NAIP aerial image).

This reach represents County Ditch 20 (Figure 44), which extends from its headwaters, situated near Swift, to its outlet to Lake of the Woods; a total length of 3 miles. The reach has a subwatershed area of 10 square miles (6,228 acres). The subwatershed contains 11 miles of intermittent stream, 3 miles of perennial drainage ditch, and 2 miles of intermittent drainage ditch (DNR, 2015). According to the MPCA (2013), 50% of the watercourses in the subwatershed have been hydrologically altered (i.e., channelized, ditched, or impounded), including the entire length of AUID 560. The NLCD 2011 (USGS, 2011) lists wetlands (55%) as the predominant land cover in the subwatershed. Other notable land cover groups in the subwatershed included hay/pasture (16%), cultivated crops (14%), forest (6%), developed (5%), and herbaceous (3%).

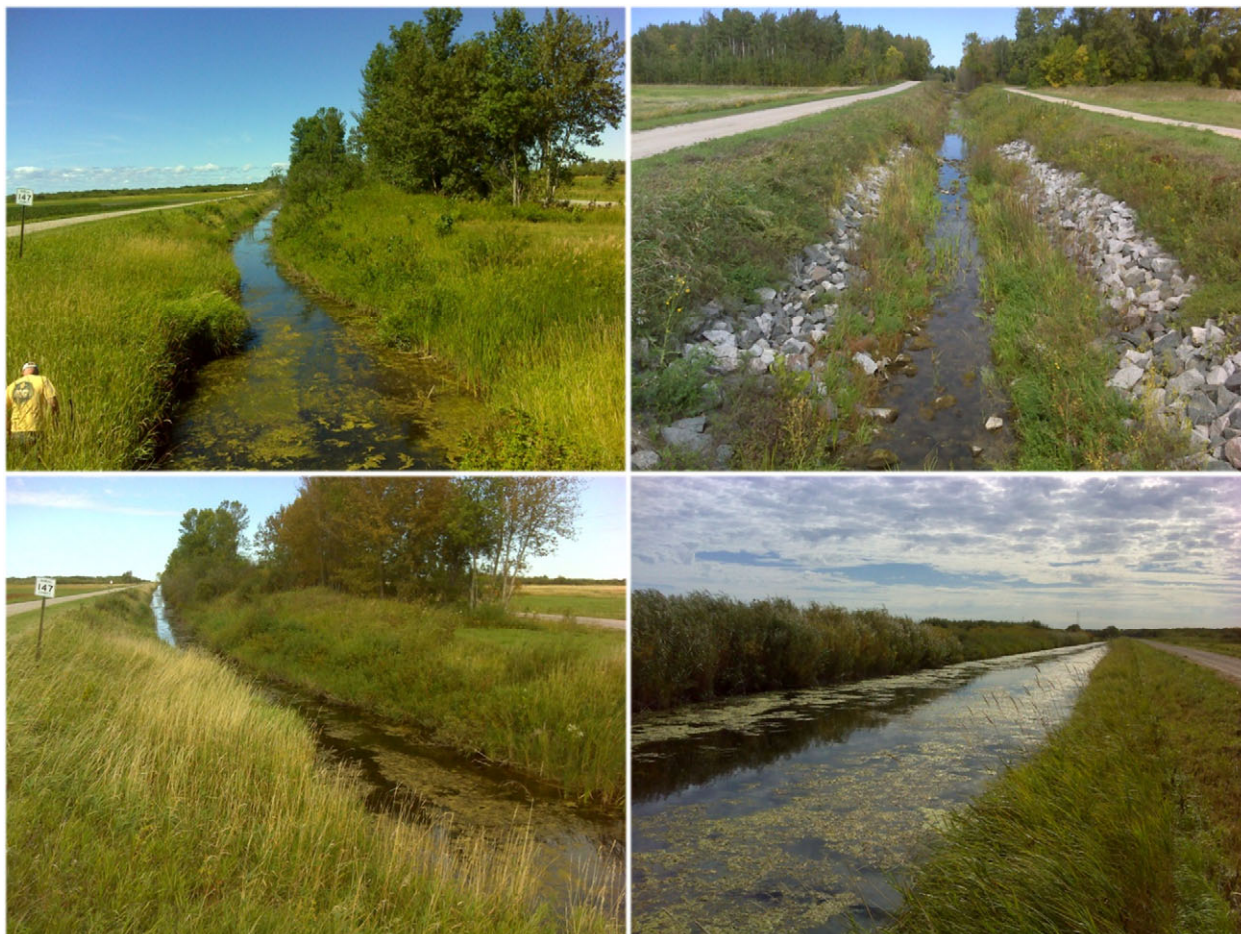
Figure 46. Photos of minimal flow and lentic conditions along AUID 560, including the CSAH 12 crossing on August 4, 2015 (upper left); the 320th Street crossing on September 16, 2015 (upper right); the CSAH 12 crossing on September 16, 2015 (lower left); and along CR 147 on September 16, 2015 (lower right).

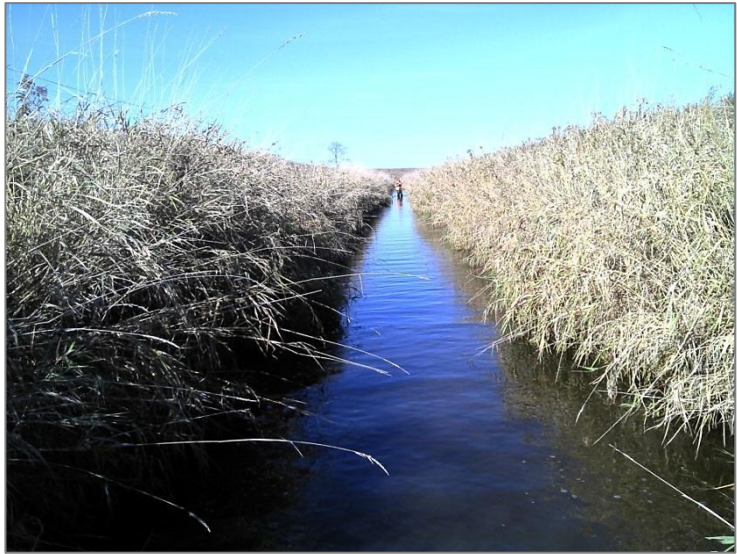
Figure 25. Site 10EM161 (photo taken on 10/19/15).

Although this reach of Williams Creek is stable, it has been channelized and is generally lacking in facets/habitat, which is likely the main stressor for this site (Figure 25). Even though the site is lacking in habitat, it does seem to have sufficient base flow. Additionally, connectivity does not appear to be a stressor here. There are six crossings between the site and Lake of the Woods, with the nearest crossing being approximately 0.6 miles downstream. An assessment of aerial photography does not appear to indicate any barriers to fish passage; however, this assumption should be confirmed during flood flows to ensure there are no velocity barriers.

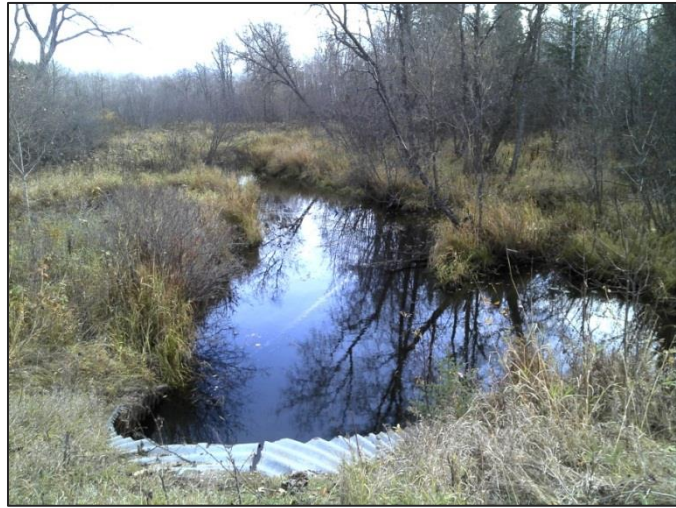
Figure 36. Site 05RN115 (photo taken on 10/20/15).

At this location the river had access to a floodplain, was not incised, and was only slightly entrenched. While this location exhibited good riffle-pool sequences, the sand and silt substrate does not provide for good spawning habitat. There also appeared to be sufficient base flows and pool depths to provide for fish holding cover. There is likely beaver activity throughout the reach that could be influencing fish migration, and which appears to be a likely stressor. With a bankfull width of approximately 22 feet, the corrugated metal culvert at the 680th crossing, downstream of the biological monitoring site, is slightly undersized at 9' high x 14' wide; however, the culvert is not perched and does not appear to be a fish passage barrier (Figure 36).

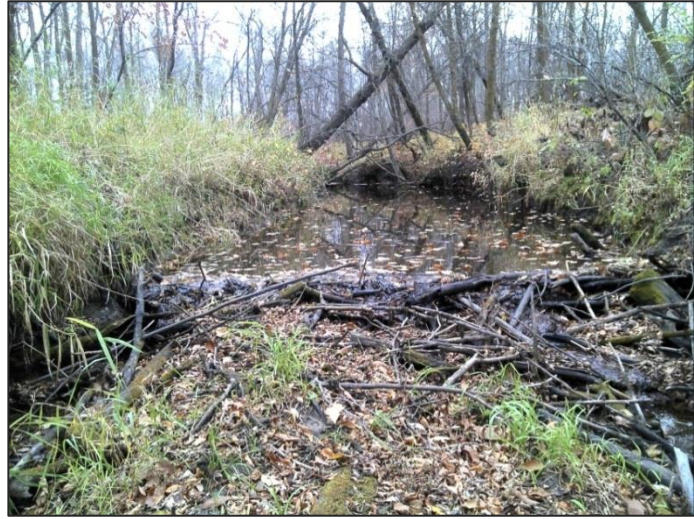
Figure 43. Site 12RN015 (photo taken on 10/20/15).

In the forested area near the biological monitoring station waypoint, the stream was an unstable E6 (borderline G6), but it appeared to transition to a G6 (gully) downstream through the grassed area. From the road crossing upstream to the biological monitoring station, the stream was both incised and entrenched. Overall, there was a general lack of quality substrate and habitat through this reach. Poor substrate and a lack of base flow (stagnant water was observed) appear to be the main stressors at this site.

There was also a beaver dam located just downstream of the biological monitoring station waypoint, so beaver activity could be influencing fish passage throughout this reach (Figure 43). There are two 8.8' high x 14' wide concrete arch culverts at the road crossing. With a bankfull width of approximately 15 feet, this is nearly double the needed capacity, and as a result the right culvert (looking downstream) is completely blocked by sediment; however, the culverts do not appear to be barriers to fish passage.

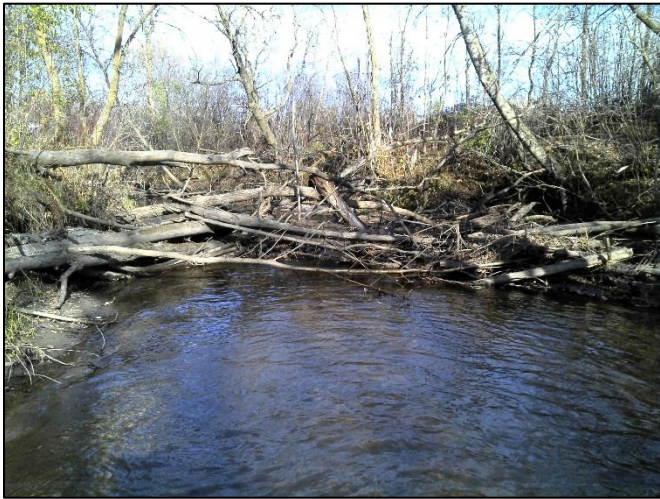
Figure 48. Site 12RN010 debris jam (photo taken on 10/20/15).

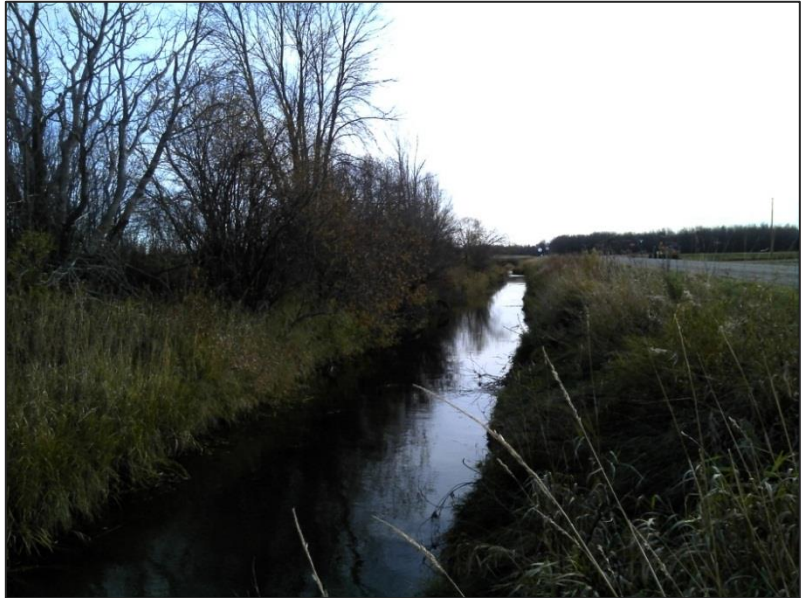
Figure 52. Site 12RN012 (photo taken on 10/20/15).

Although this reach of County Ditch 20 is stable, it is channelized and is generally lacking in facets/habitat, which is likely a stressor for this site (Figure 52). There was no discernable flow at the time of the site visit, likely a result of being in close proximity to Lake of the Woods. Lack of flow could also be contributing to thermal stress in this reach, especially in the absence of vegetation to provide channel shading. There are no crossings or beaver dams between this site and the lake, so fish passage barriers are not an issue.
