## Washington County Landfill Reconstruction Project: Progress Updates

This page provides information on the status of the Washington County Landfill reconstruction project. The MPCA's Remedy Decision Document was signed in June 2008. Check this page for future updates. The MPCA's site manager during the project is Pat Hanson, 651-757-2409 or [pat.hanson@state.mn.us](mailto:pat.hanson@state.mn.us).

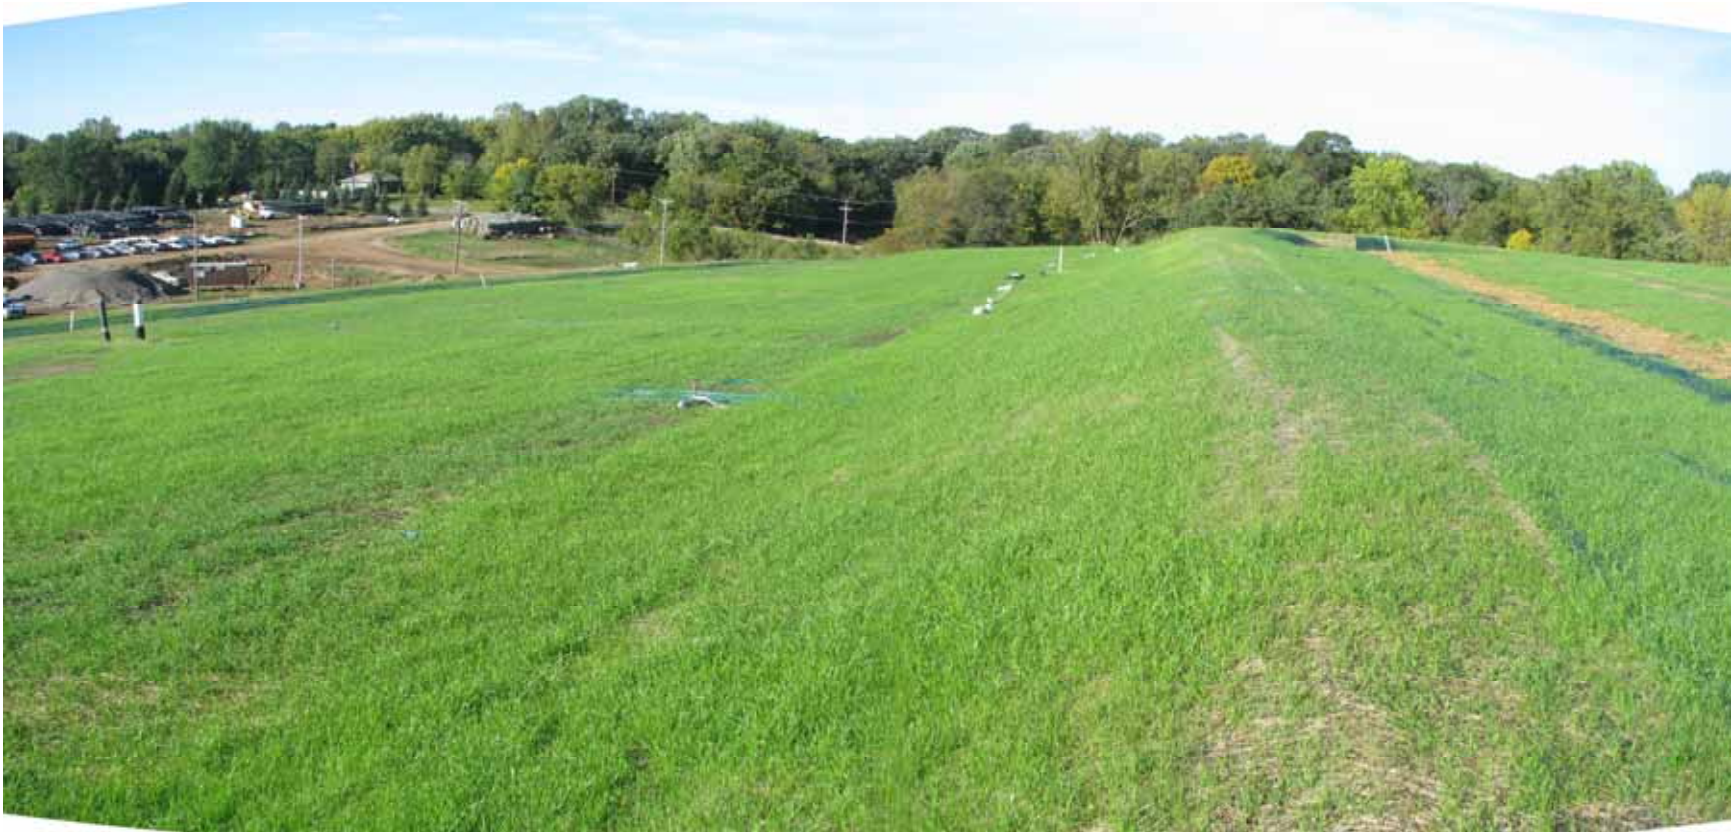
Photo below shows the first two completed cells with final cover and vegetation growing.

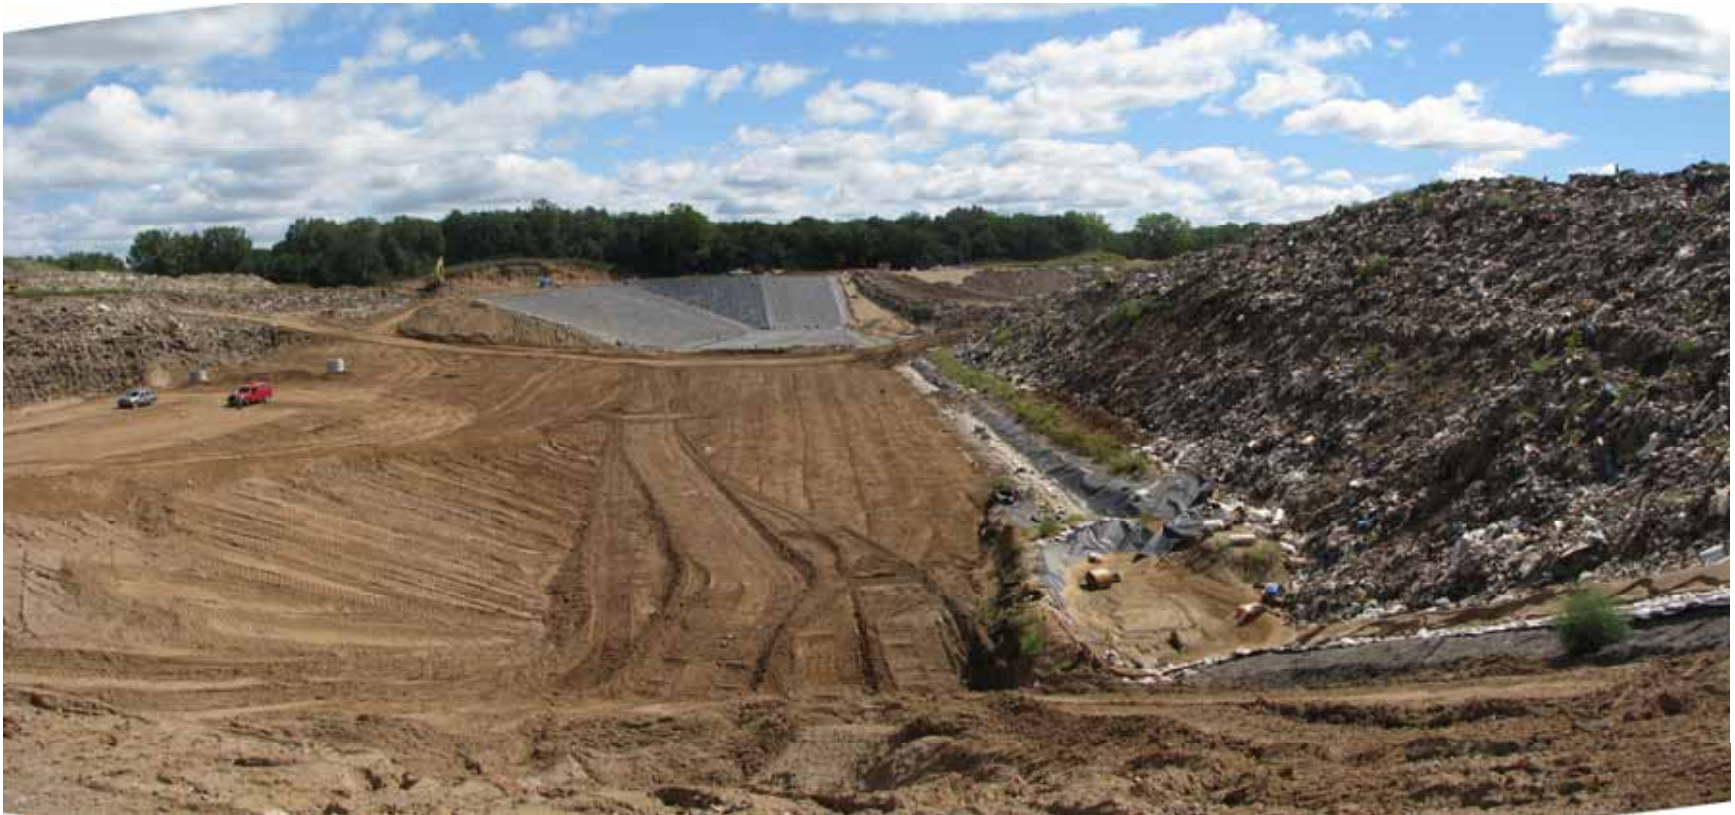
Contractor has covered the first new cell with topsoil, seeded the soil, and installed erosion control blanket. Temporary water-supply system with sprinklers was installed on the new cover to make sure the grass survives the hot weather and anticipated dry soil conditions this fall. The seventh cell has the liner installed and is ready to be filled with waste which can be seen in the back of the photo below. The eighth and final cell is being graded in preparation for liner installation which can be seen in the foreground. In the next month the contractor will be concentrating on moving the remaining waste material onto the new cells and installing the liner system in the last cell.

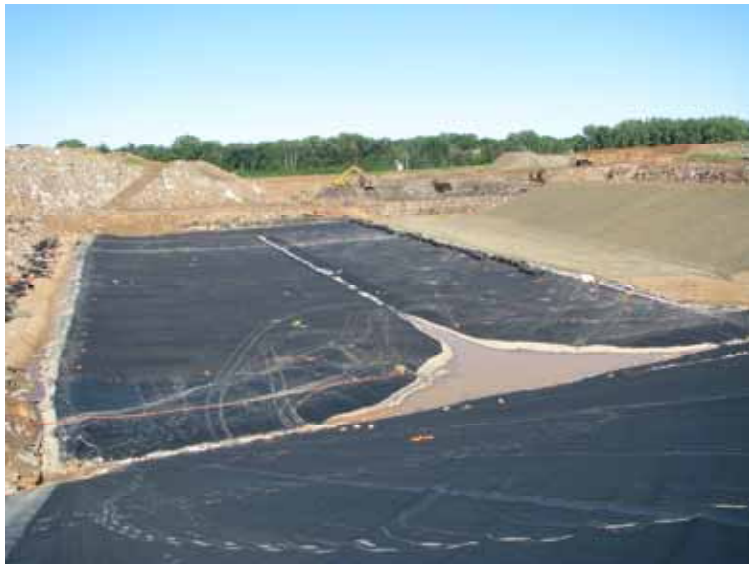
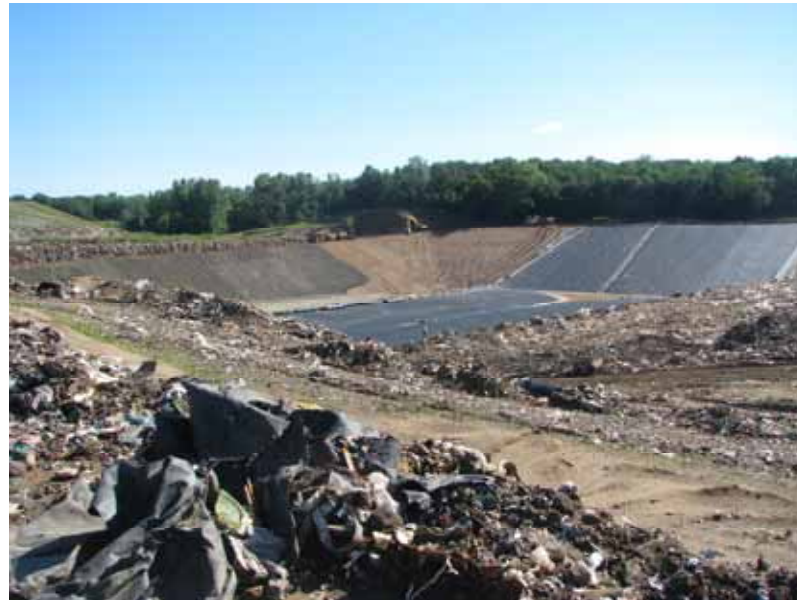
Photos below show contractor excavating waste, installing clay liner on the north side of the site. The area he is working is where the last two cells will be located.

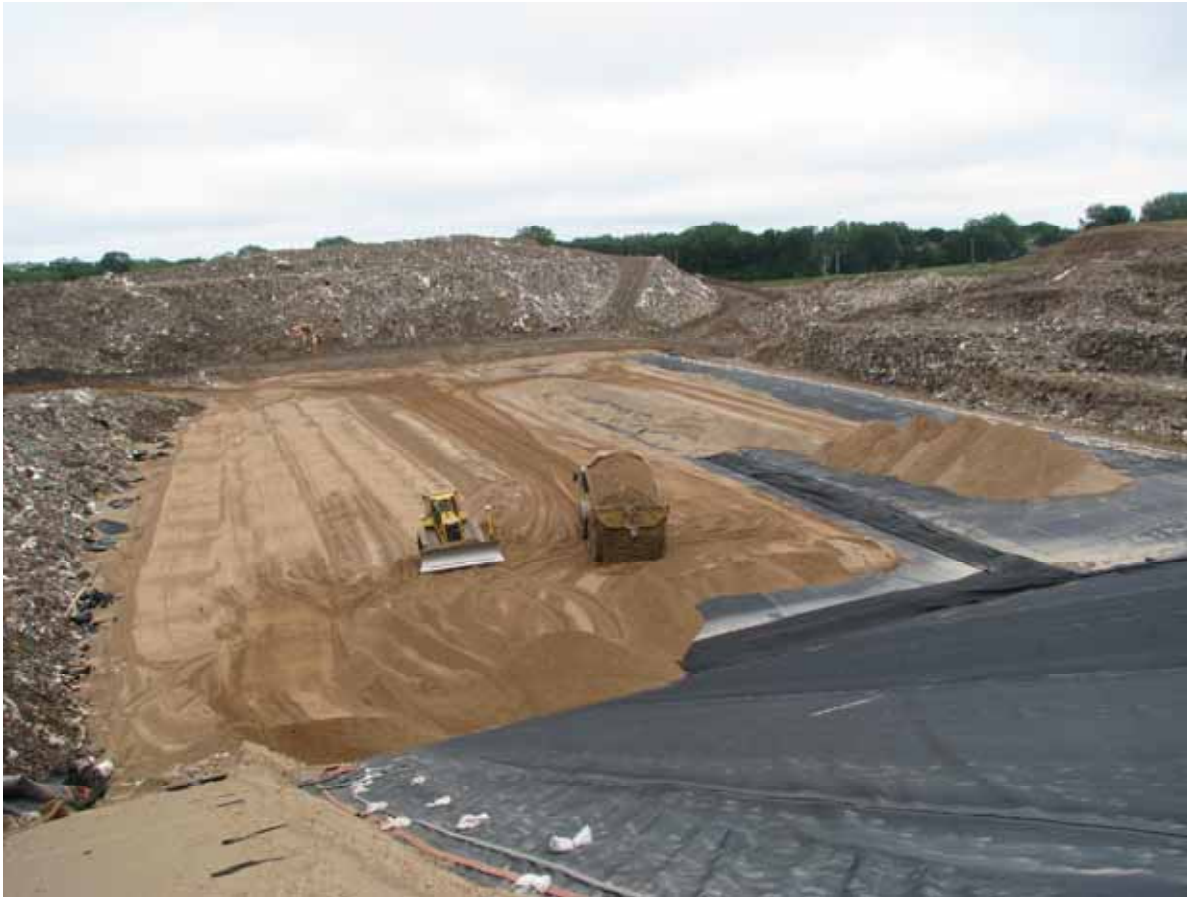
Photo below shows contractor placing two feet of sand over liner prior to placing garbage.

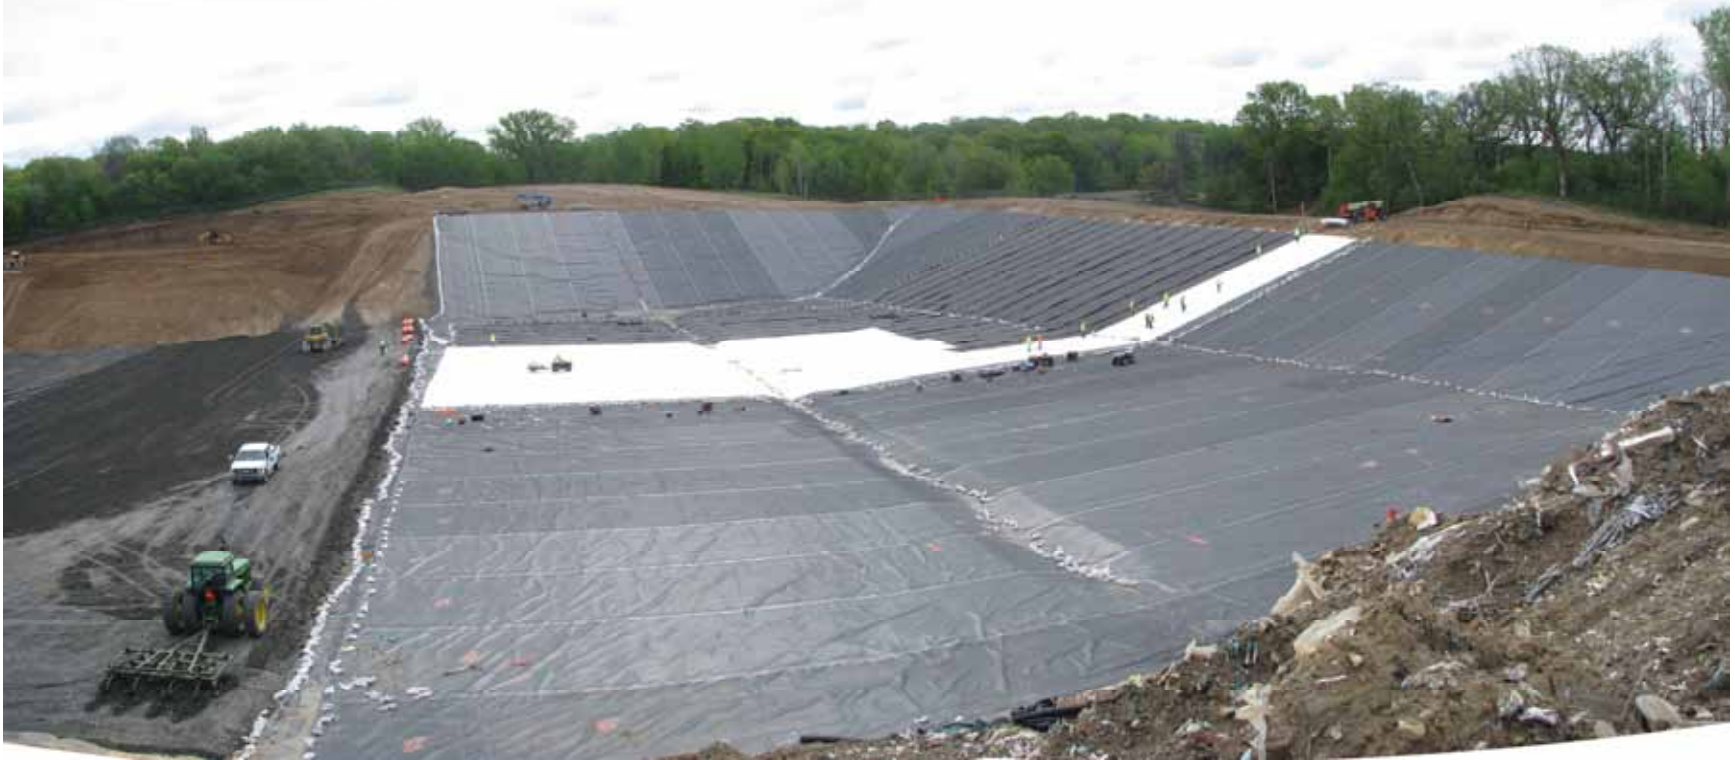
Photo below shows plastic liner installed on cell B and clay layer being installed on cell C.

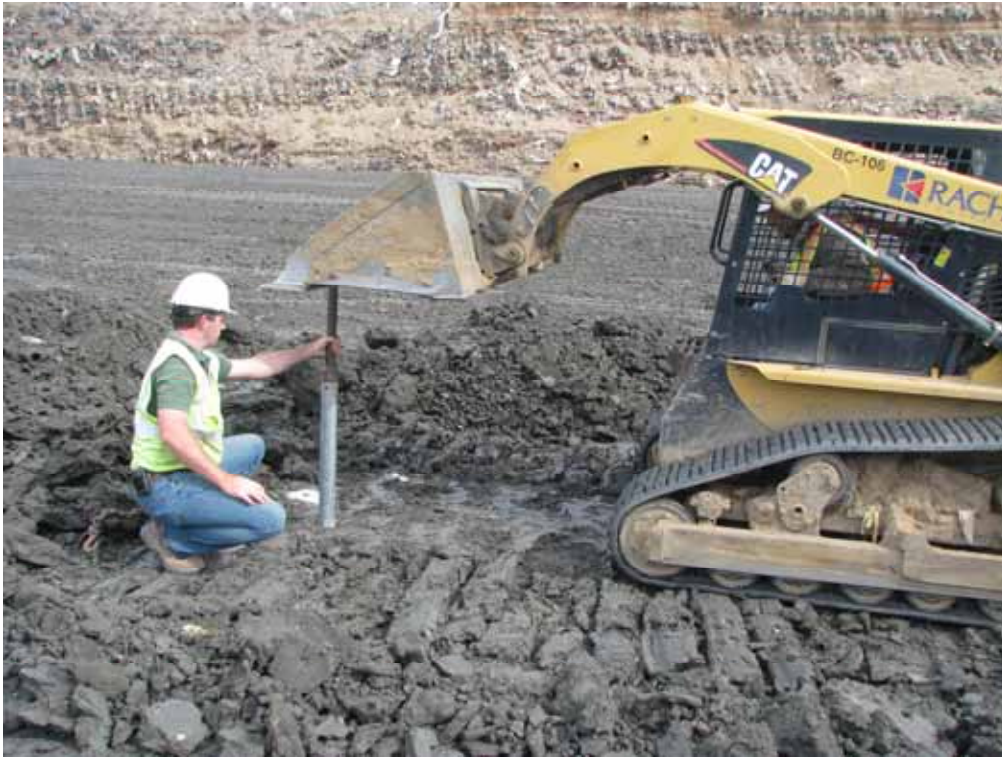
Photo below shows contractor testing clay liner in cell C.

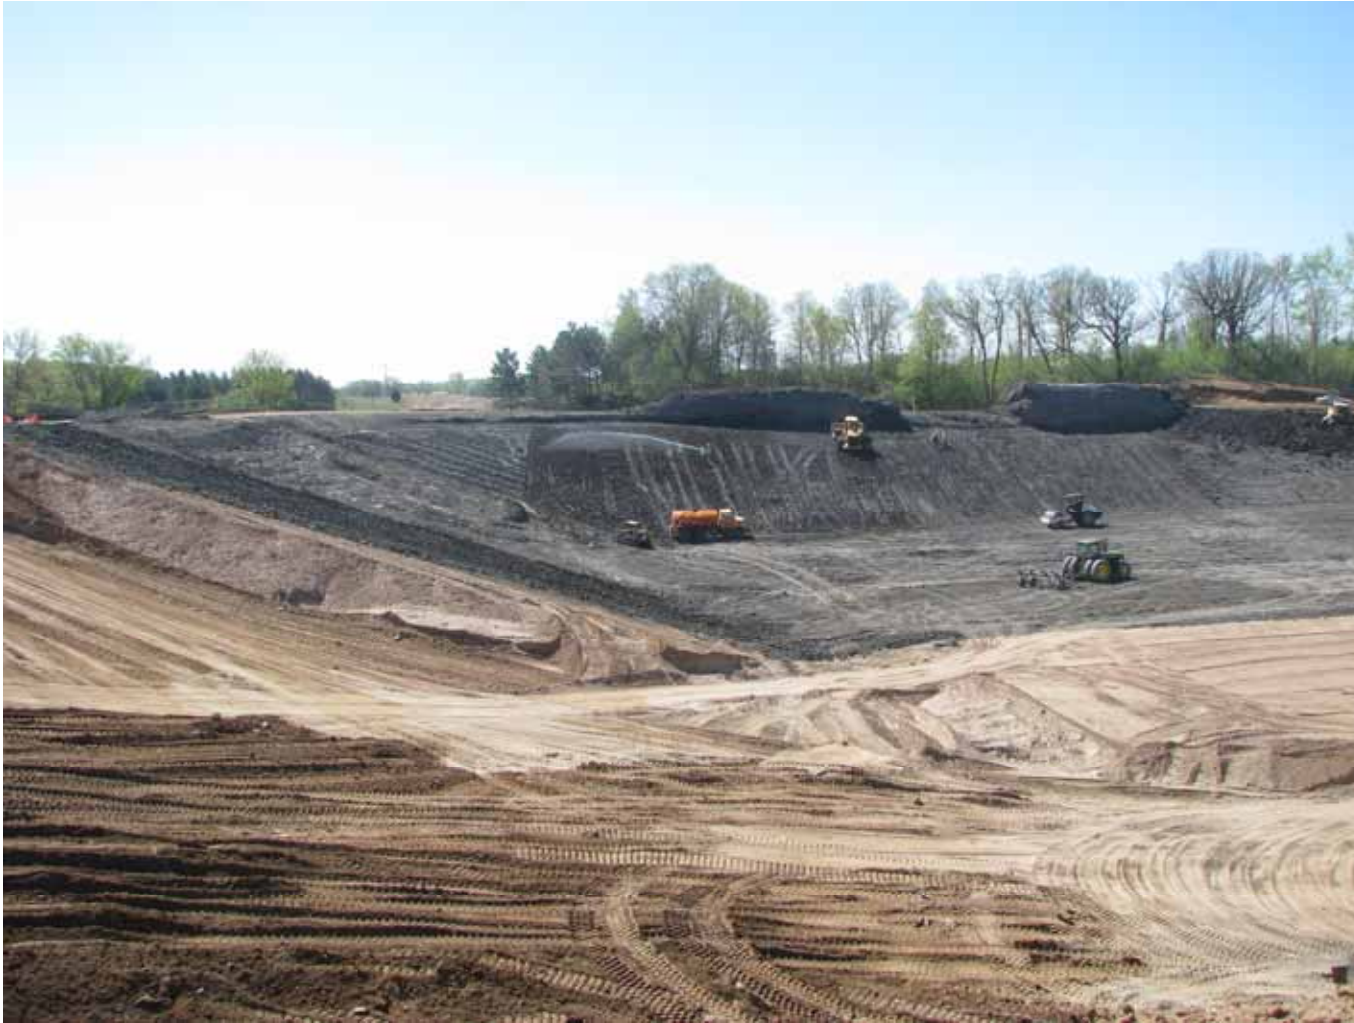
The dry, warm spring has accelerated construction activities at the site. Construction of Cell B clay liner is almost complete as of 4/23/10. Garbage continues to be excavated from Cells C and G and placed on the new lined area. Plastic liner construction in Cell B is scheduled to begin the week of April 26. Photo below shows various operations required to get proper moisture content and compaction of the clay.

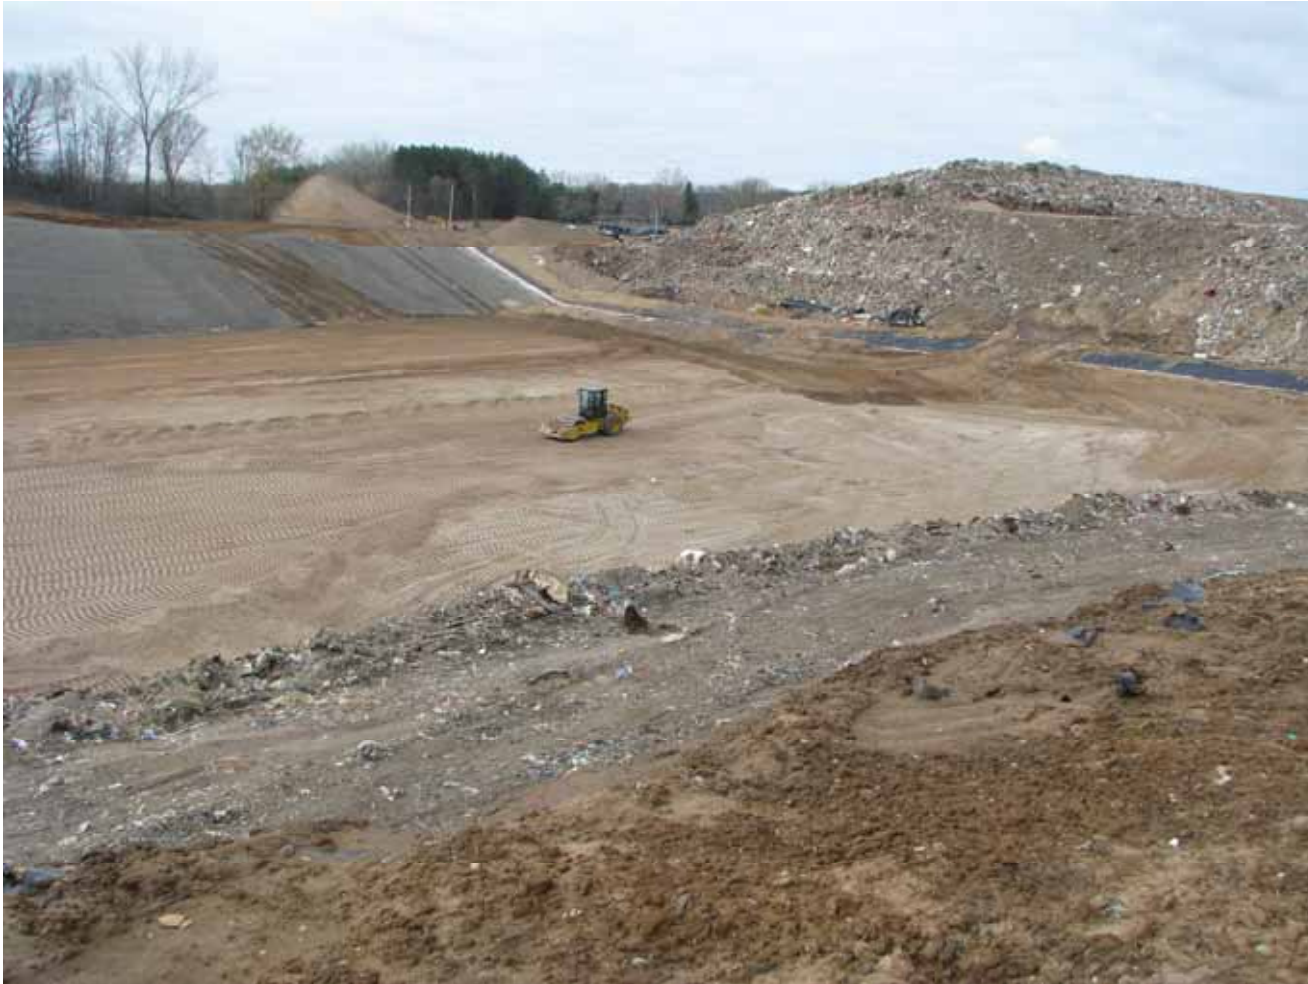
Contractor has started construction activities for 2010. Contractor spent last week grading site and screening on-site soil in preparation for start of liner construction in cell B this week. Contractor will also begin installing leachate recirculation piping in the cells that were completed last year. Photo below shows contractor grading cell B.

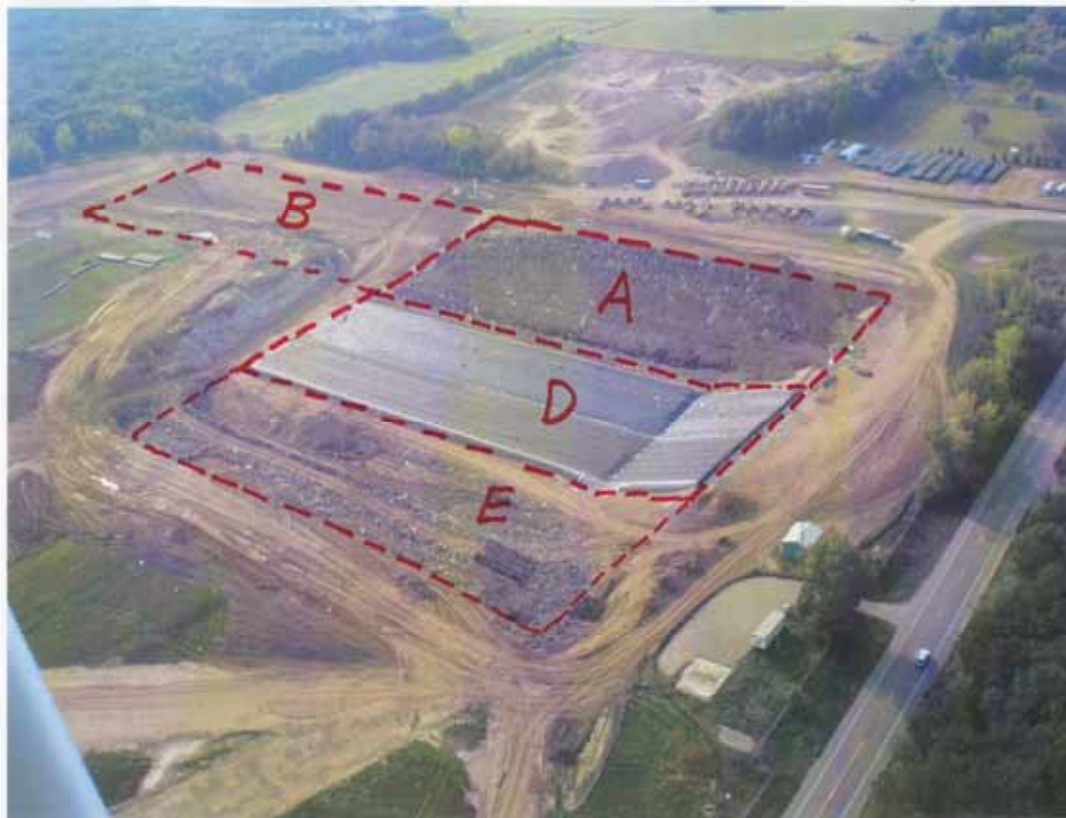
Contractor has completed the bottom liner in cell E and is waiting for test results before placing waste onto the new liner. He will then place six to eight feet of waste onto the liner and shut down for the winter. Picture below shows the site with the news cells outlined for reference. The car on the road is headed south on Jamaca Avenue.

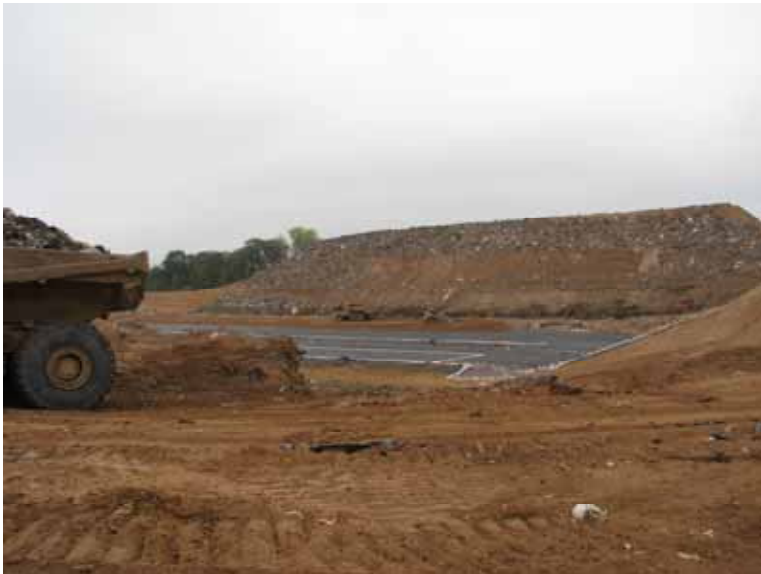
*Contractor moving waste (~10/5/09)*

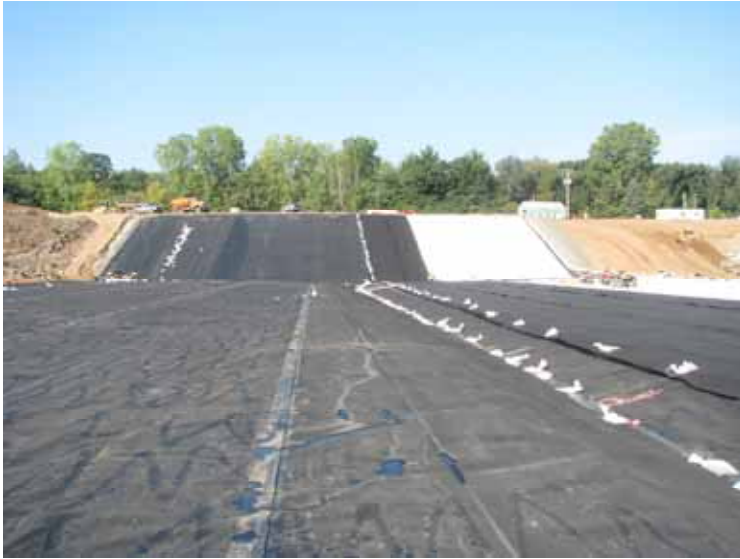
Photo below shows the new liner being installed in the second cell.

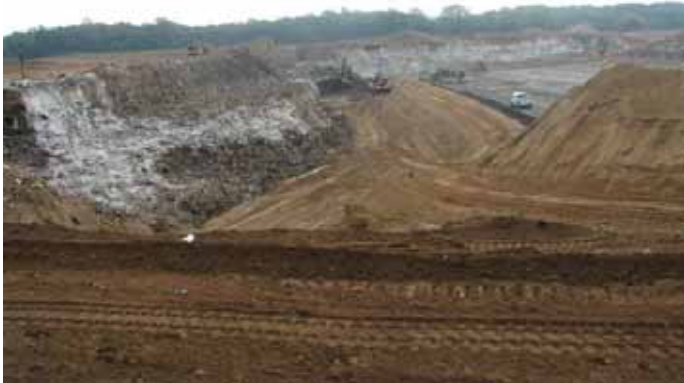
Waste from Cell E and Cell B continued to be moved to the completed Cell A. Cell D, the second cell to be lined, began having clay placed on the west side slope and bottom. Plastic liner is expected to begin deployment the week of 9/14/09. Photo below shows the clay in Cell D and a significant amount of waste removed from Cell E.

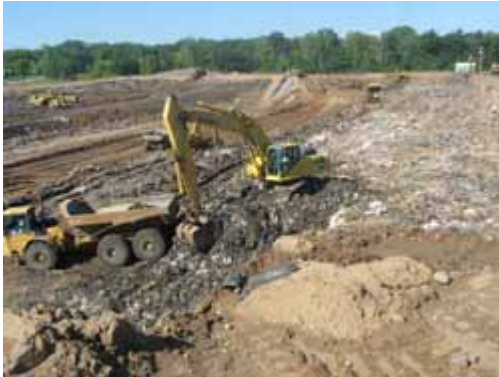
Rain has slowed progress again. The contractor continues to remove waste from the next cell location and relocate it in the newly constructed cell. There are currently seven off-road trucks and four scrapers hauling waste material. Most of the activity is confined to the south side of the site. The contractor hopes to have most of the waste removed from the next cell location by the end of next week. As work progresses, more trucks will be visible as the new cell grows in elevation. The photo below shows waste being removed and relocated to the new cell.

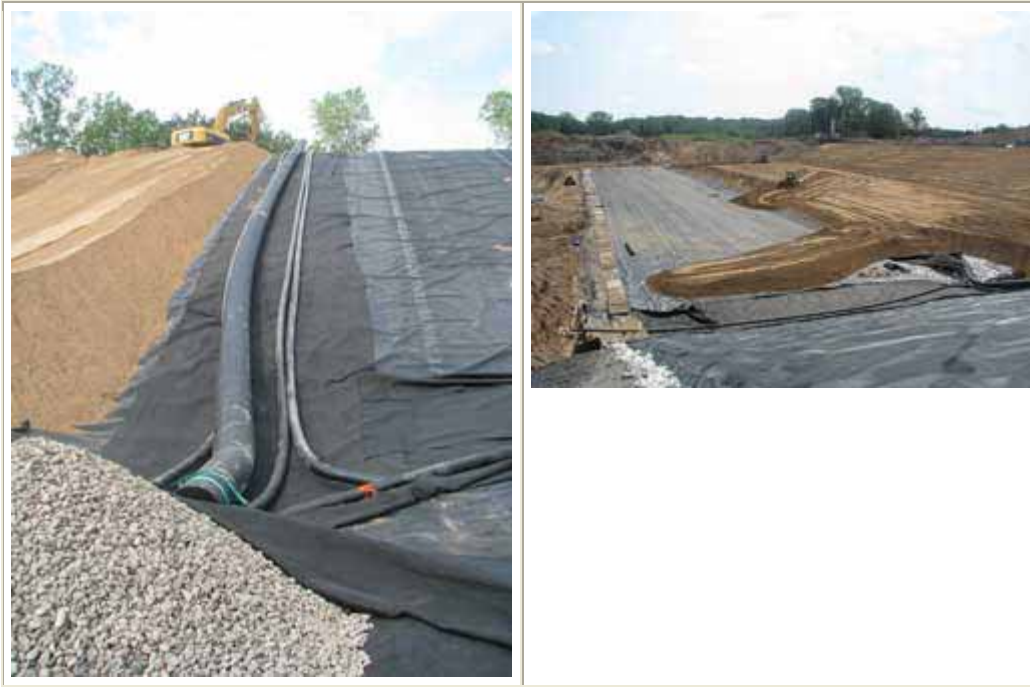
The photos below show the sand drainage layer being spread over the liner system, and the side-slope riser and cleanout pipes that will be used to remove leachate from the landfill.

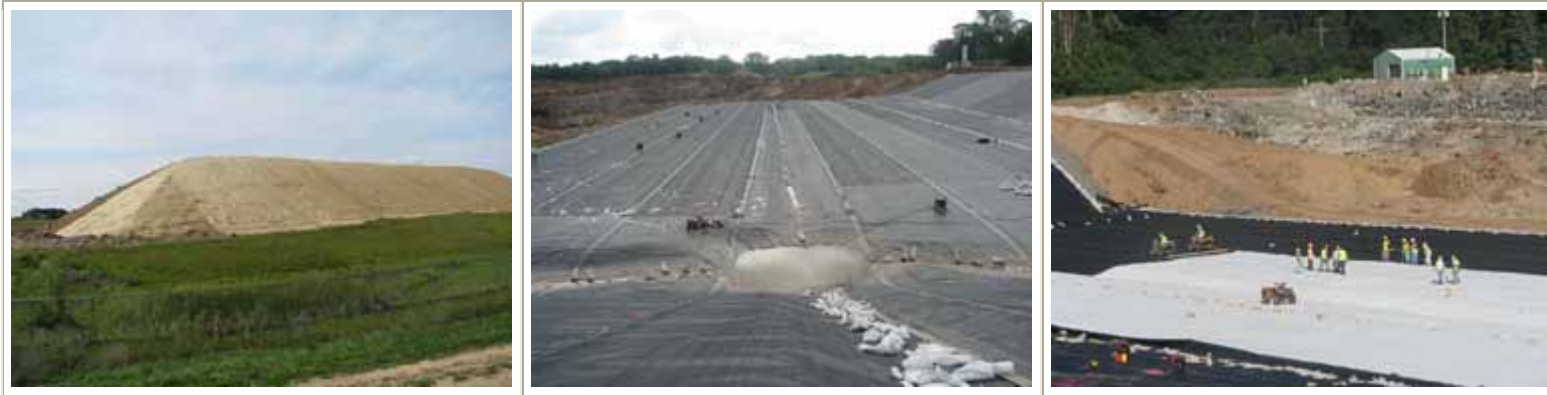
The photos below show the waste stockpile being covered/seeded and the liner crew working on the first cell.

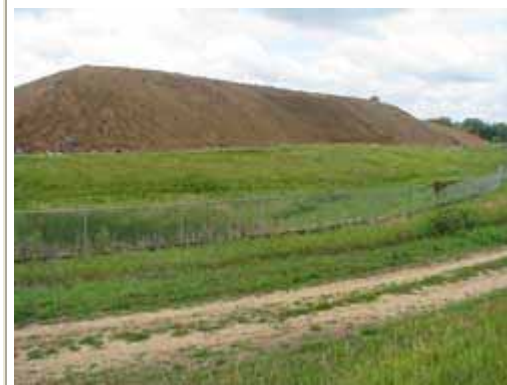
Contractor is completing waste move from first cell.

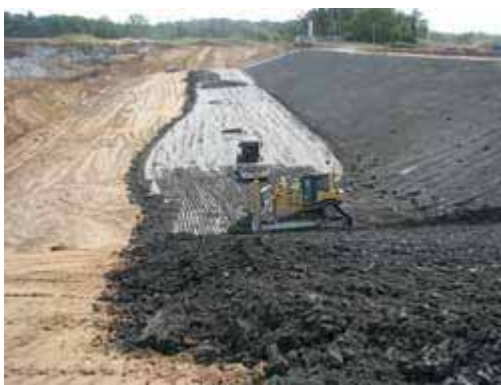
In this photo the contractor has removed all the waste and is down to the final grade elevation in the first new cell. He is now placing the clay layer over the native soil. The clay liner is the first layer of protection. The clay comes to the site in a loose form which the contractor here is spreading out with bulldozer. It is then compacted with a sheepfoot (spiked roller) to the required density, then rolled out smooth with a drum roller. The end result is seen on the finished side slope to the right of the picture. The next layer will be plastic liner over the smoothed-out clay, followed by more plastic liner.

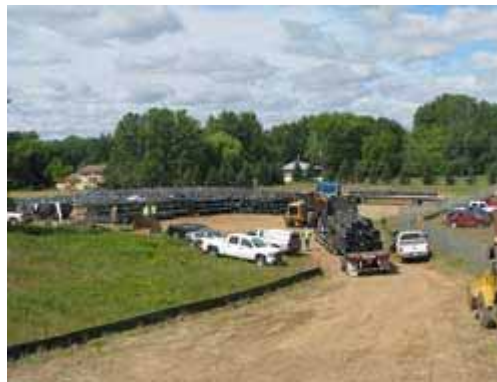
Liner rolls stockpiled on site.

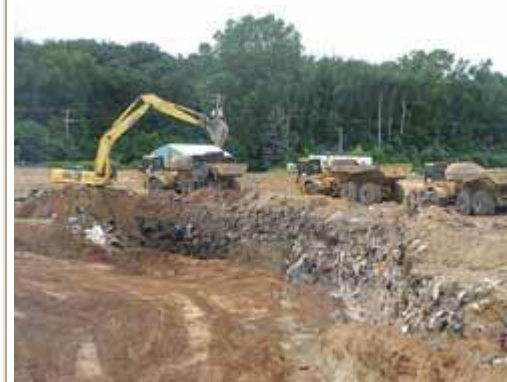
Excavation.

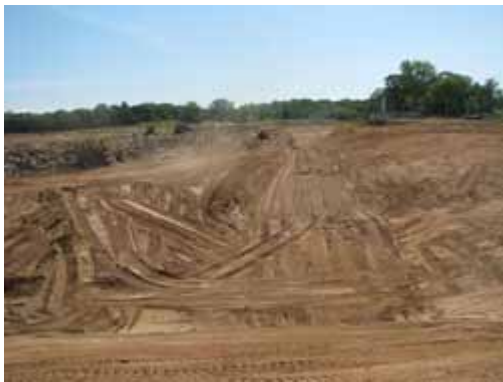
Cell A excavation looking east. South portion at final bottom elevation (not in groundwater). Contractor is excavating waste in north portion.

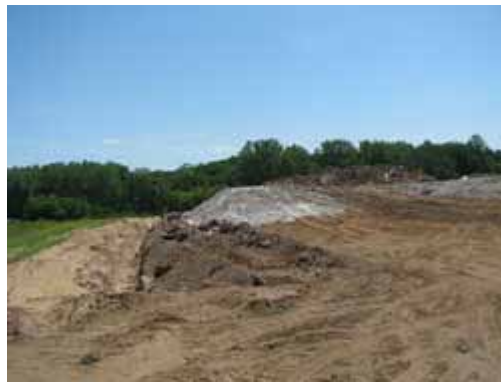
Northeast corner of landfill looking east. Waste stockpile located on top of existing landfill cover. Grey color is a spray-on product to seal surface, to reduce blowing litter and odor.

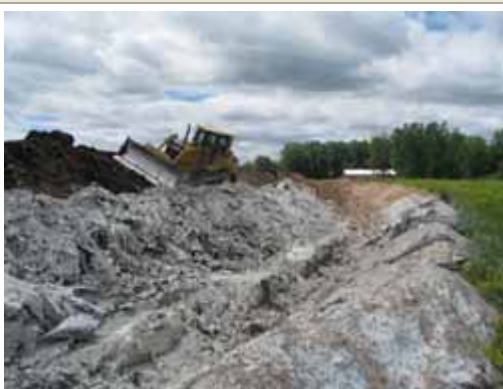
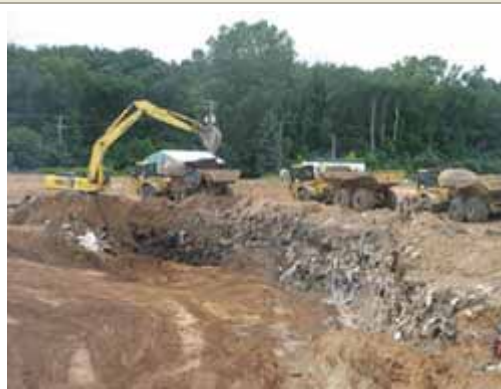
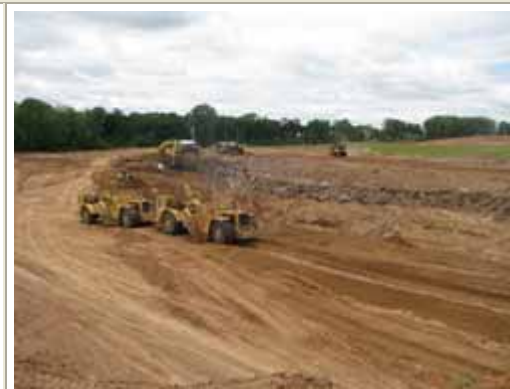
Contractor started moving waste at the site last week. Earlier this week they were about 50 percent done with digging out the first cell. Photos below show recent progress. The whitish residue covering exposed wastes is a spray-on solution consisting of clay, water, and cement, applied to control odors and litter (Posi-Shell Cover System).

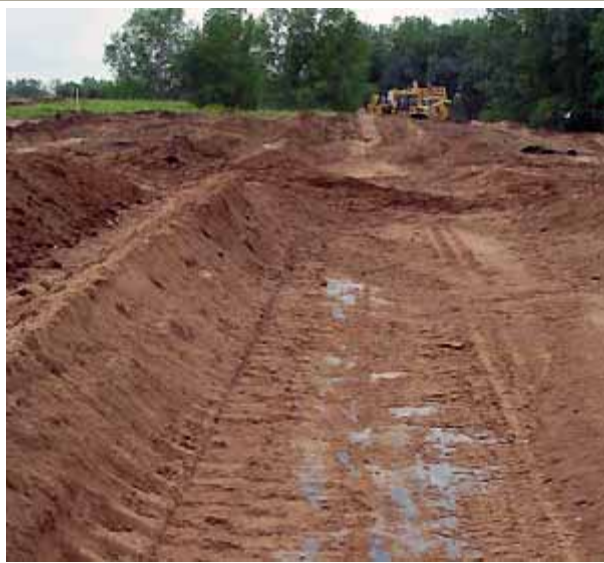
Cover soils have been removed, exposing the synthetic membrane that forms part of the landfill's existing cover system.

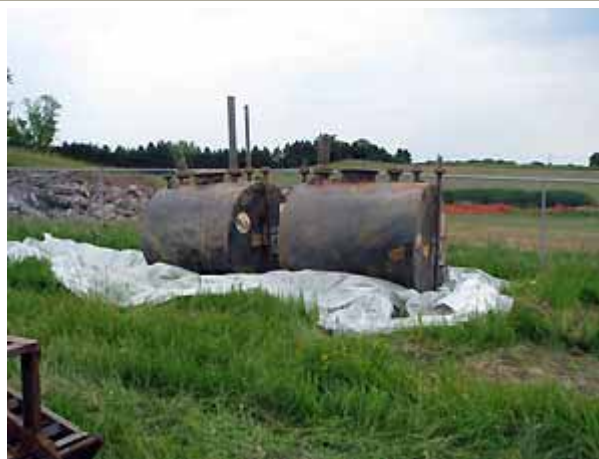
Old storage tanks unearthed from the landfill will be taken off-site for recycling and/or disposal if possible.

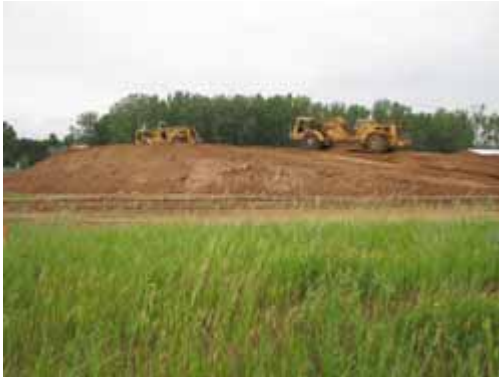
**June 16, 2009**

Looking east from southwest corner of landfill. Clean soil being excavated from what will be new Cell A.

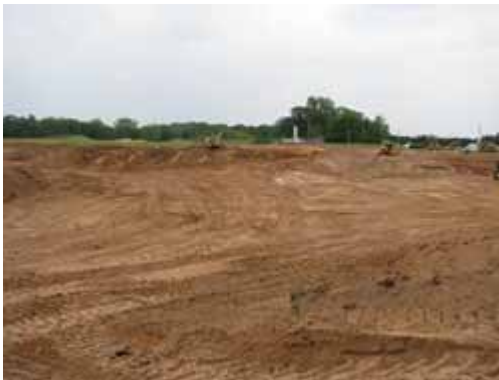
**June 9, 2009**

Looking southwest from the northeast corner of landfill. Reconstruction of first new waste cell is just beginning.

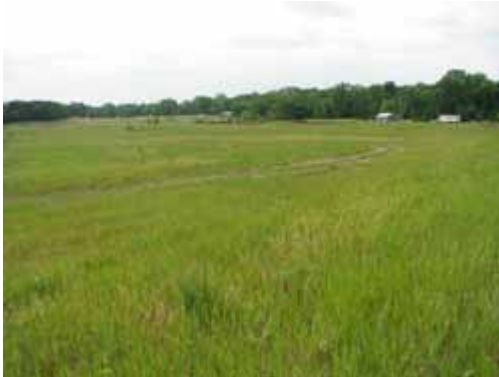
**June 6, 2009**

Looking southwest from the northeast corner of landfill. Reconstruction of first new cell just beginning.
