***REPORT OF INVESTIGATION ACTIVITIES AT
SELECT FIREFIGHTING FOAM TRAINING AREAS AND FOAM DISCHARGE
SITES IN MINNESOTA***

DELTA PROJECT NO. 19382-DEL0

**Minnesota Pollution Control Agency
520 Lafayette Road
St. Paul, MN 55155**

February 10, 2010

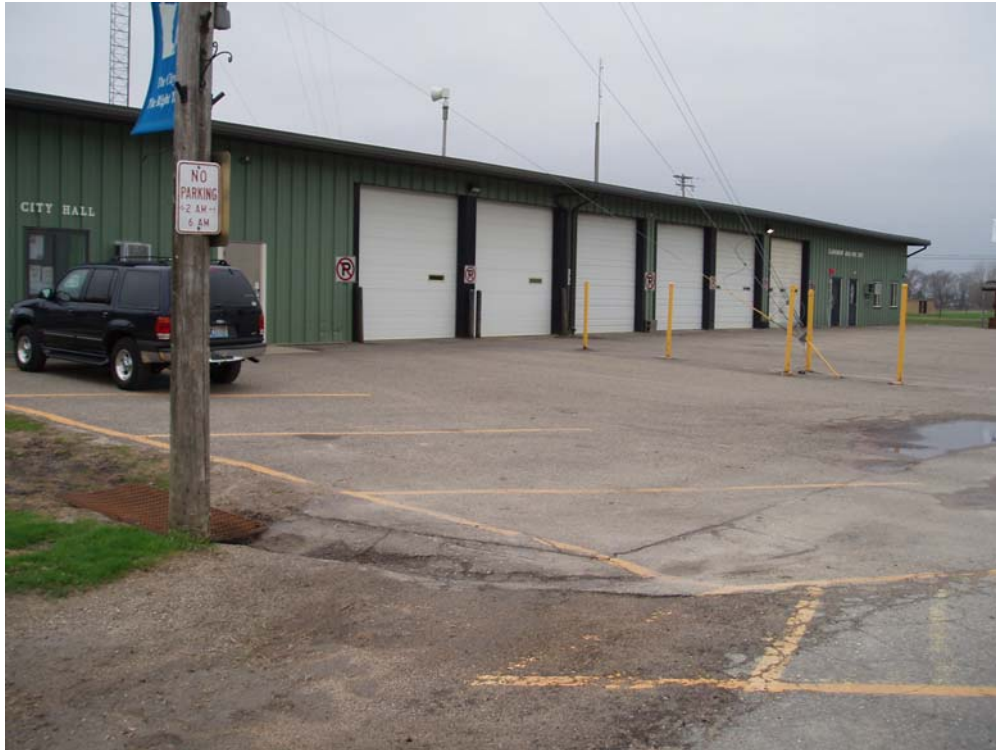
Photograph 1

Fire foam is sprayed on the asphalt pavement in front of the fire station doors. Spent foam drains toward the storm drain near the northeast corner of the property, near the utility pole in the photo. View facing southwest.

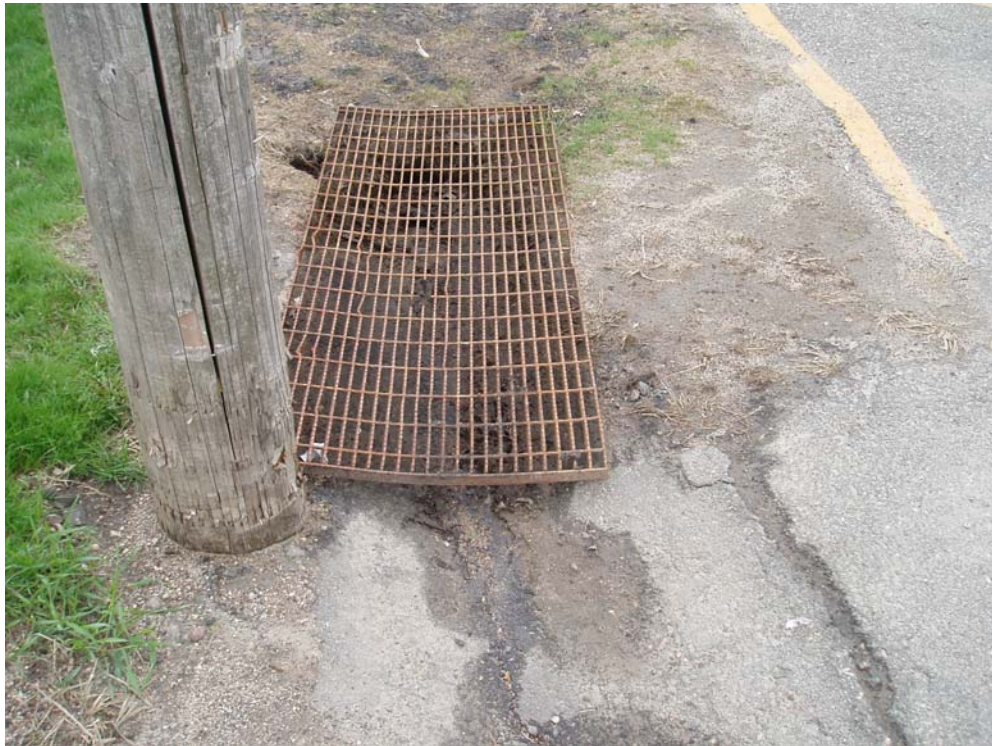
Photograph 2

Close-up of the storm drain in Photograph 1.

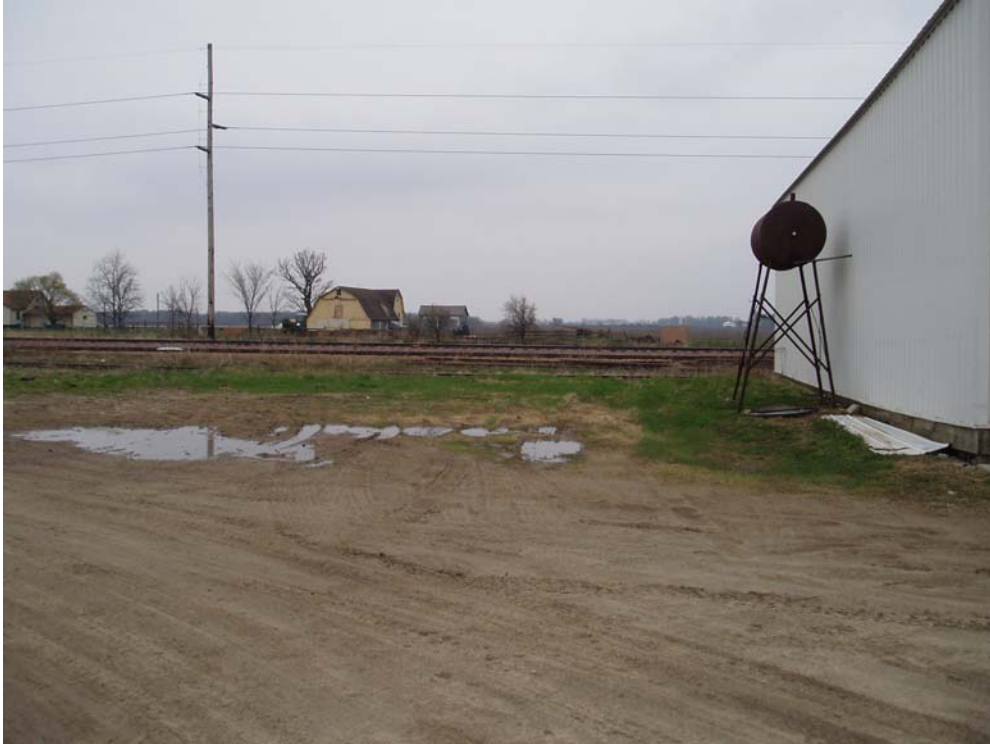
Photograph 3

Fire foam was sprayed on the east (left) side of the pole building at right, in and around the area where water is puddled in the photo. View facing south.

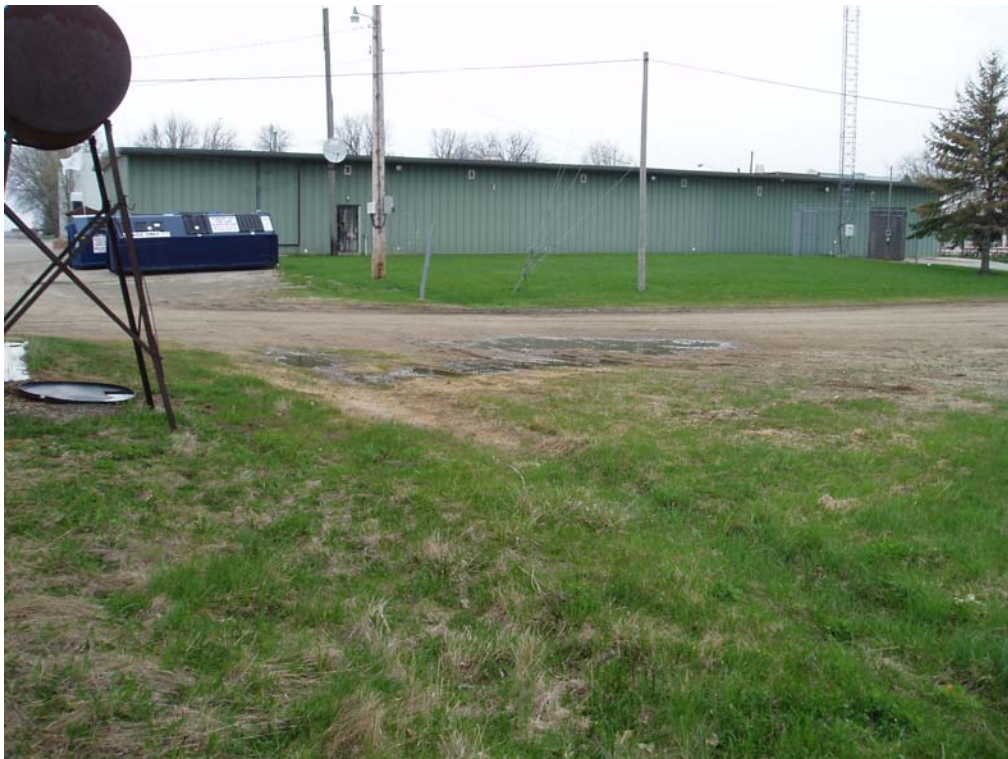
Photograph 4

View of the same training area as Photograph 3, view facing north. The Claremont Fire Station is in the background.

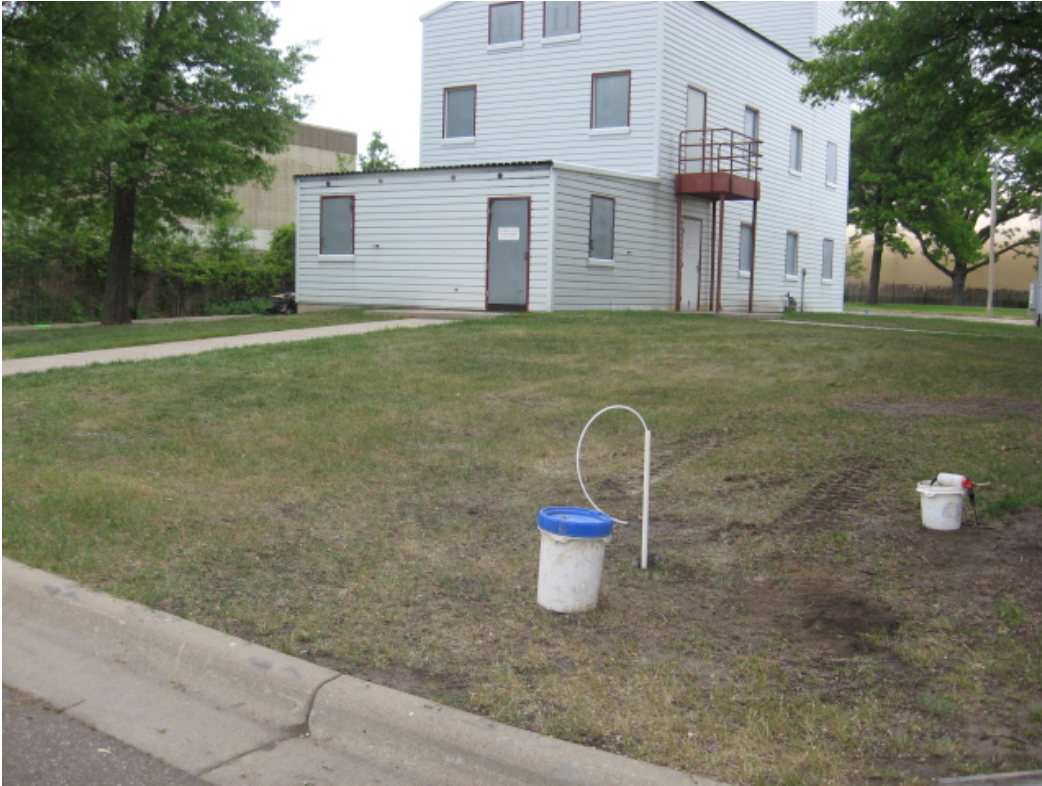
Photograph 1

The fire tower/building is (approximately) situated over a historical burn pit, where Class B foam was sprayed in fire training exercises. The temporary well casing in the foreground marks the location of boring B-2. View facing northwest.

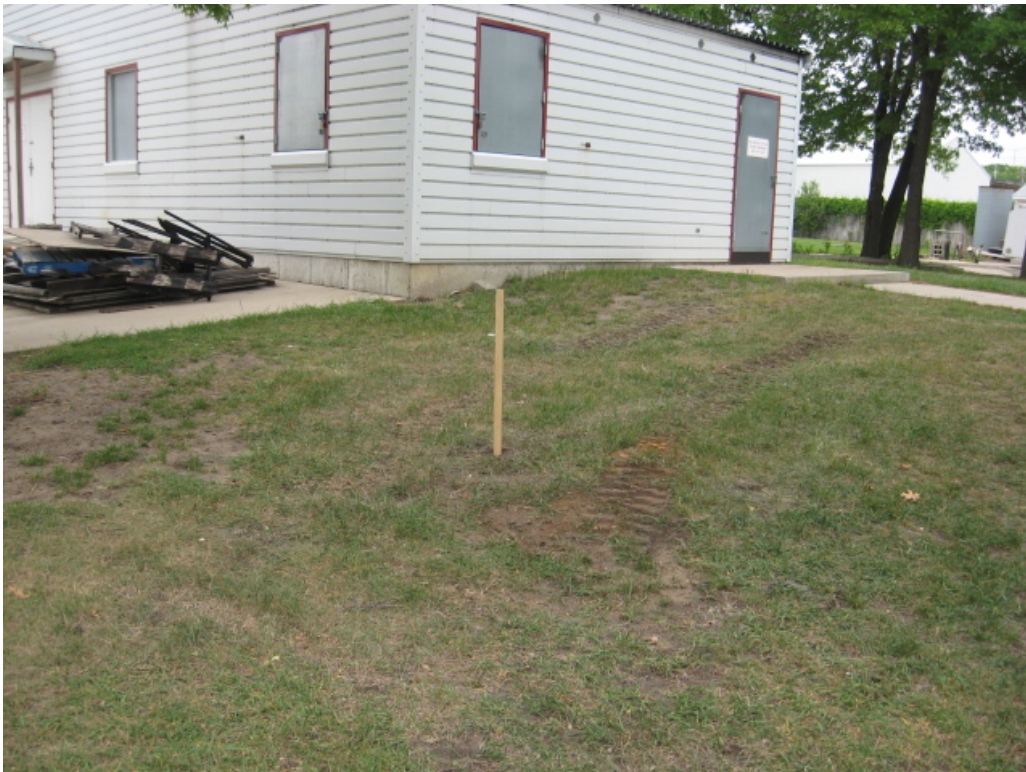
Photograph 2

The wooden stake off of the southwest corner of the fire tower/building marks the location of soil boring B-1.

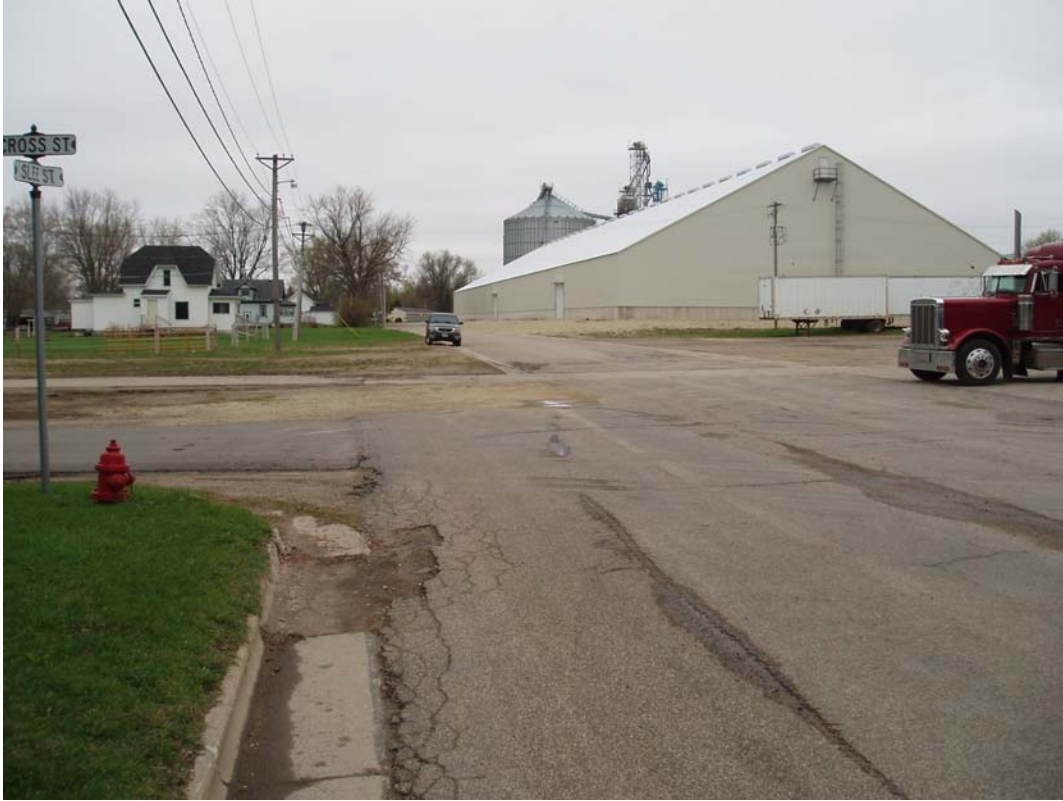
Photograph 1

Fire foam was sprayed on the east (left) side of the Slee Street, between Cross and and Pine Streets. View from north of the training area facing south.

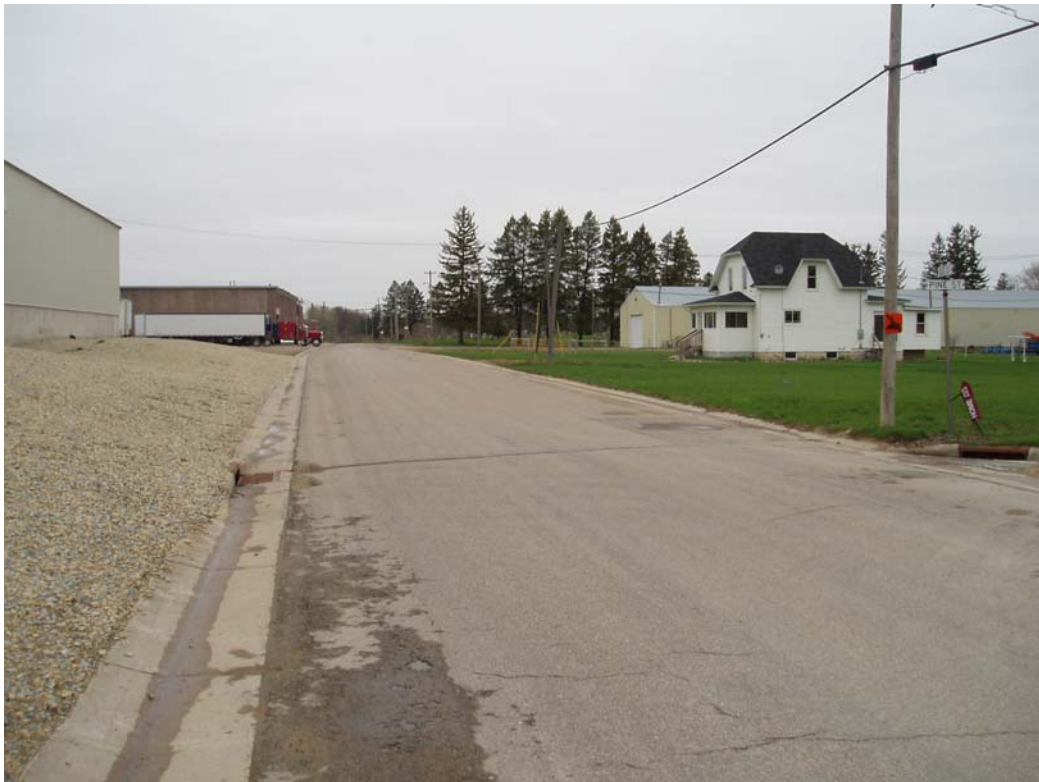
Photograph 2

View of the same training area along the east (right) side of Slee Street, from the south facing north.

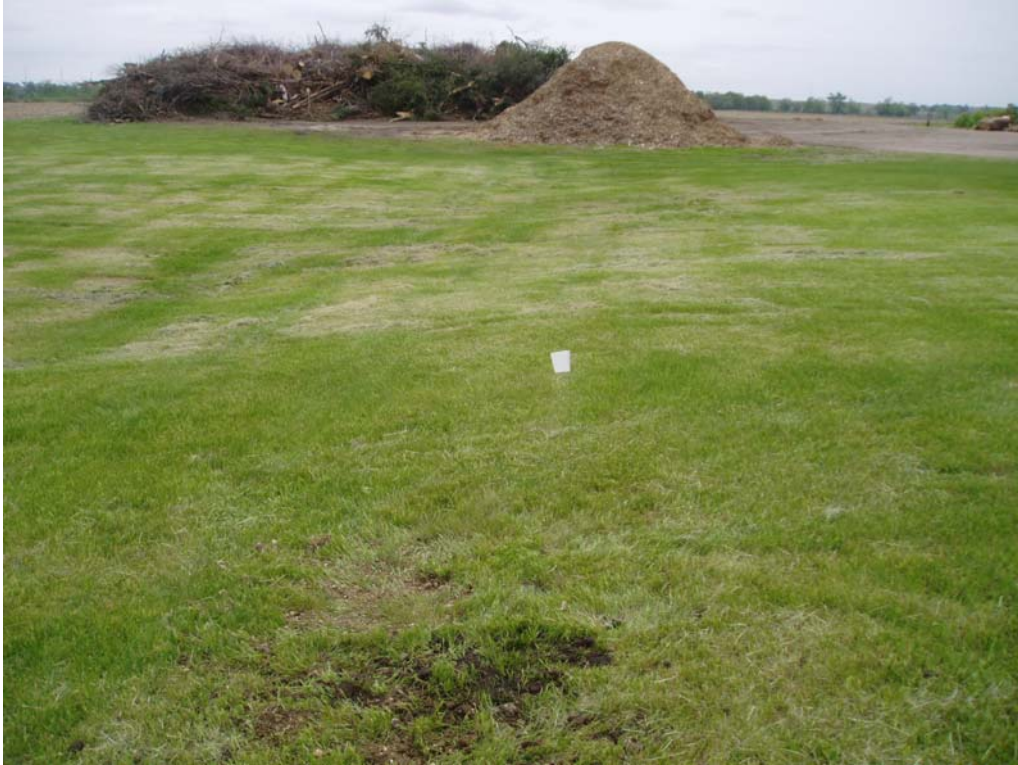
Photograph 1

Location of soil boring B-1, view facing east toward the tree/brush pile. B-1 was placed between the spot where the burn pan was situated and a nearby municipal well.

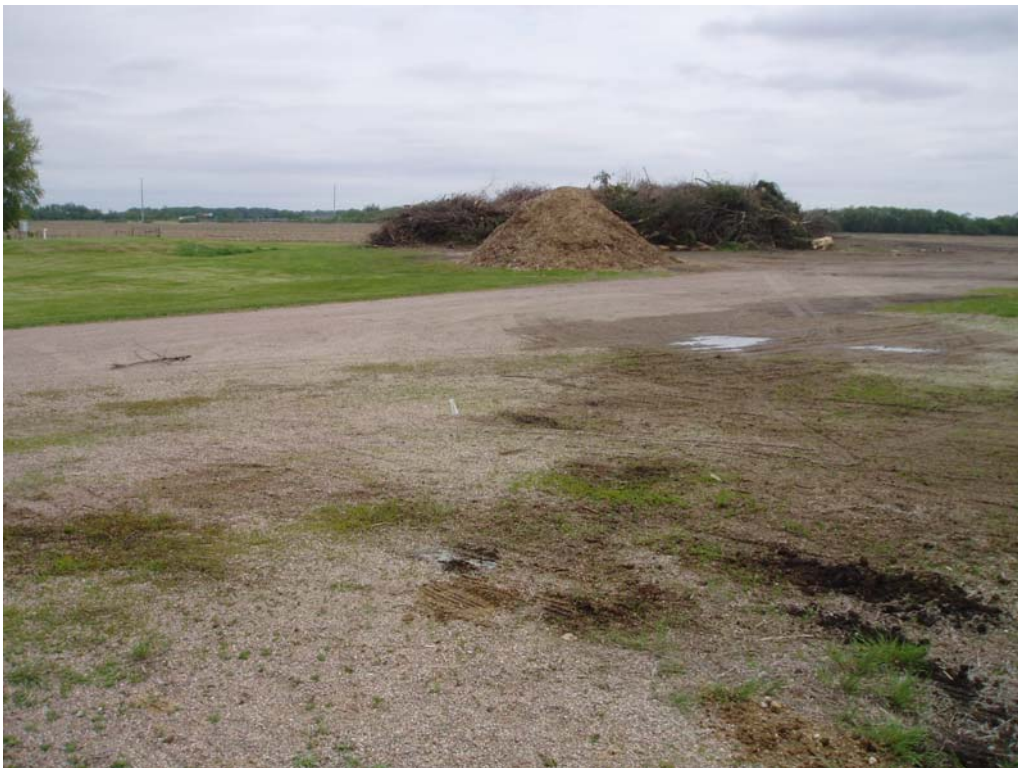
Photograph 2

Location of soil boring B-2, view facing northeast toward the tree/brush pile. B-2 was placed at the (approximate) spot where the burn pan was situated during the 2005 fire foam training event.

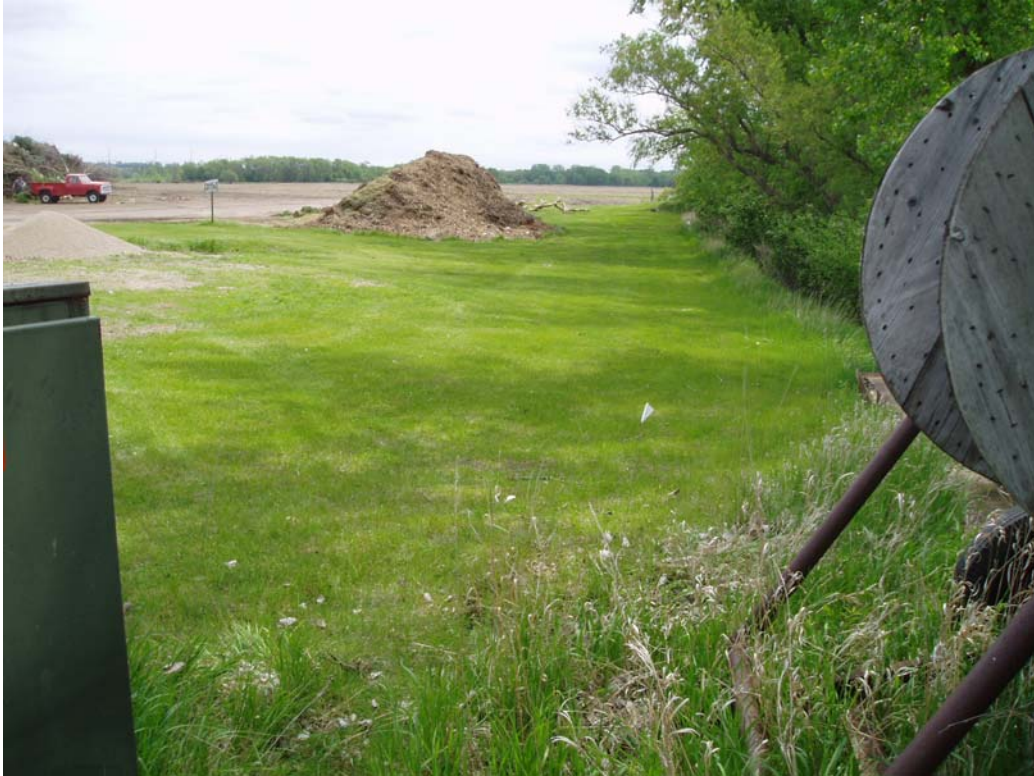
Photograph 3

Soil boring B-3 was located between B-2 and the south-adjoining pond, view facing east.

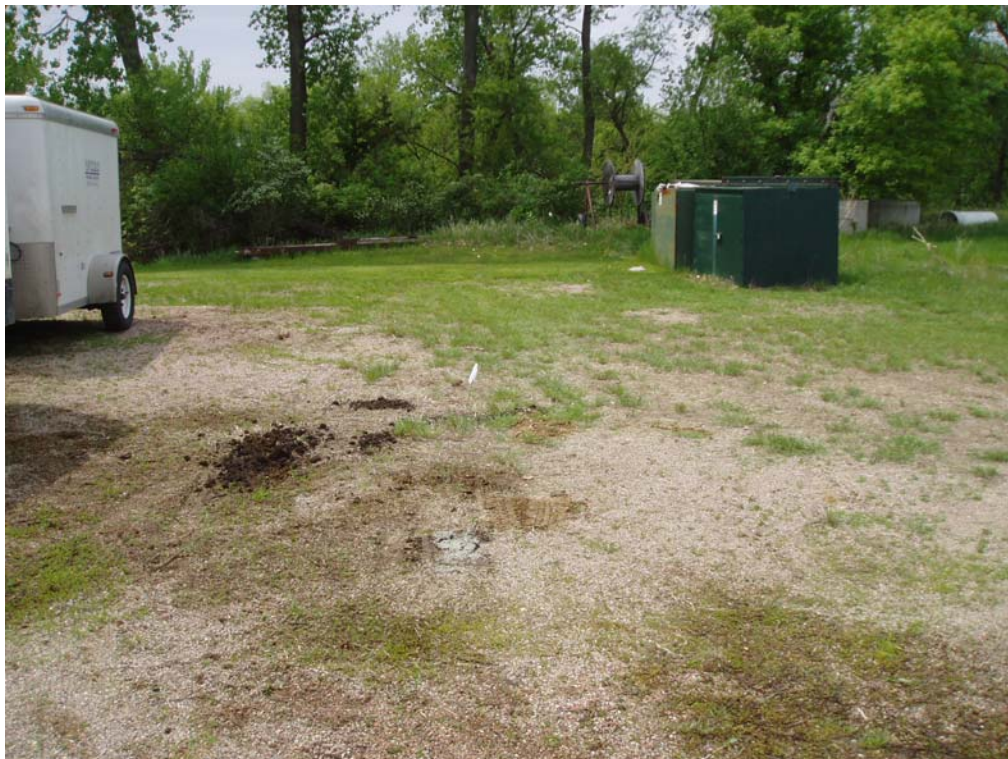
Photograph 4

Boring B-2 is in the foreground and B-3 is near the tree line. View facing south.

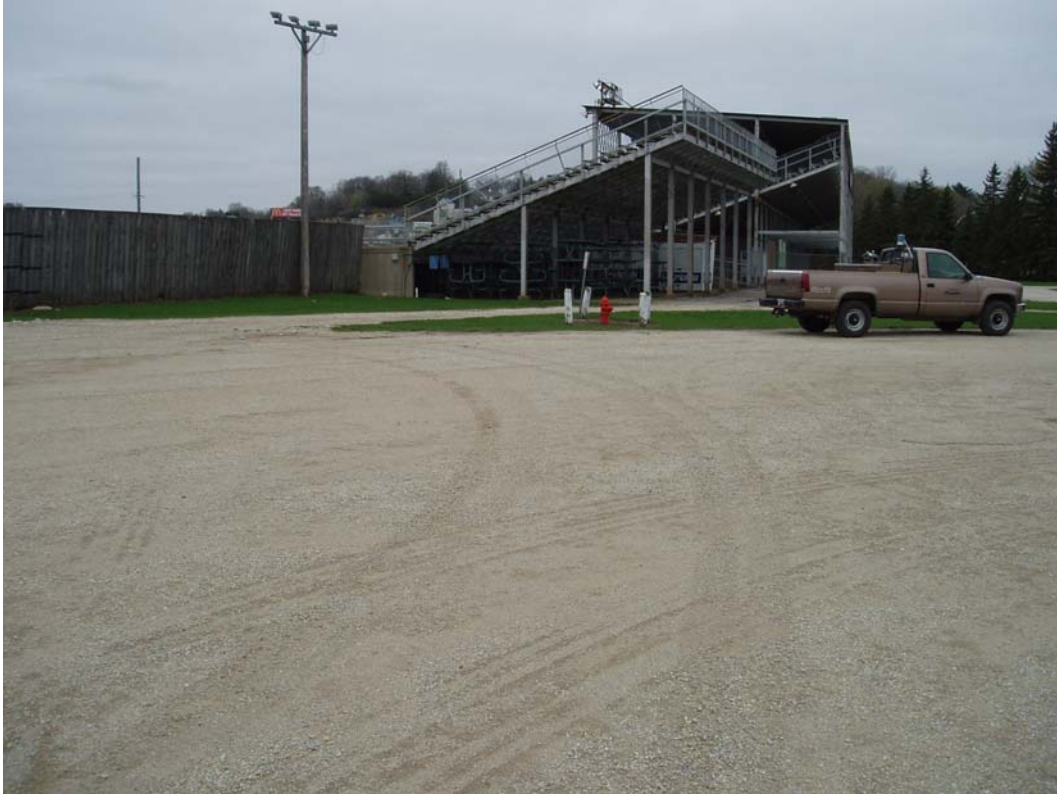
Photograph 1

Fire foam was sprayed on the gravel parking lot located northeast of the Fairgrounds grandstand. View facing south.

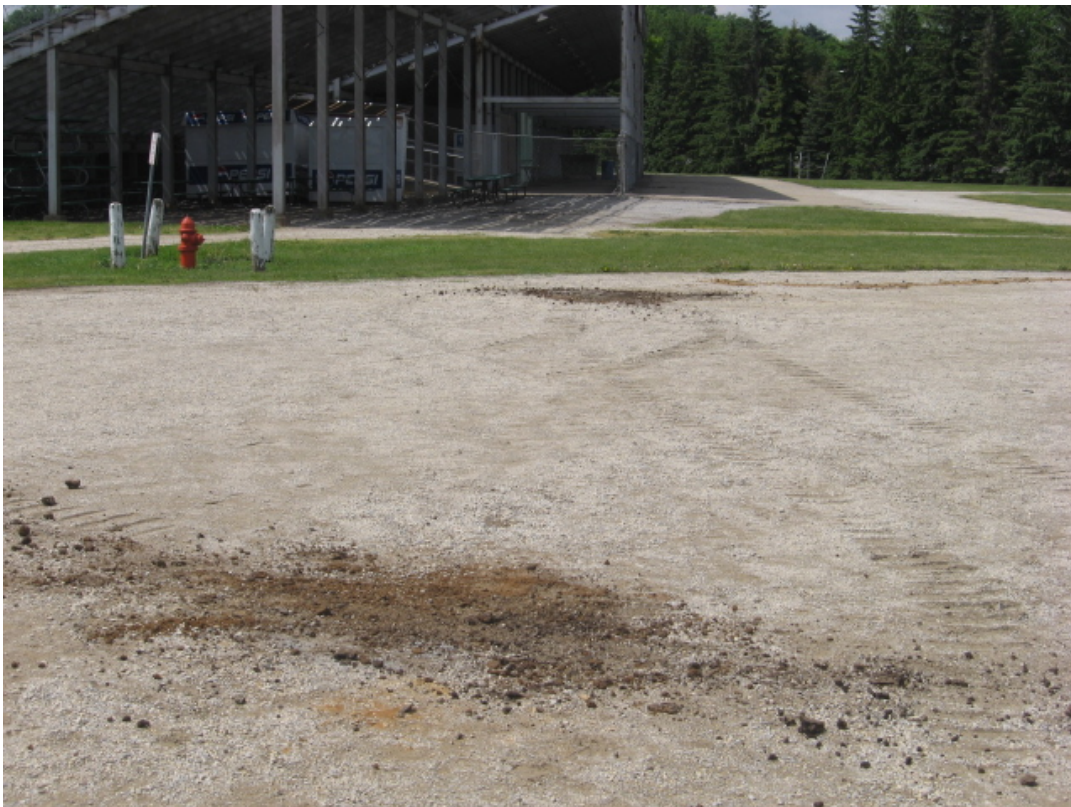
Photograph 2

Soil borings B-1 in the background and B-2 in the foreground.

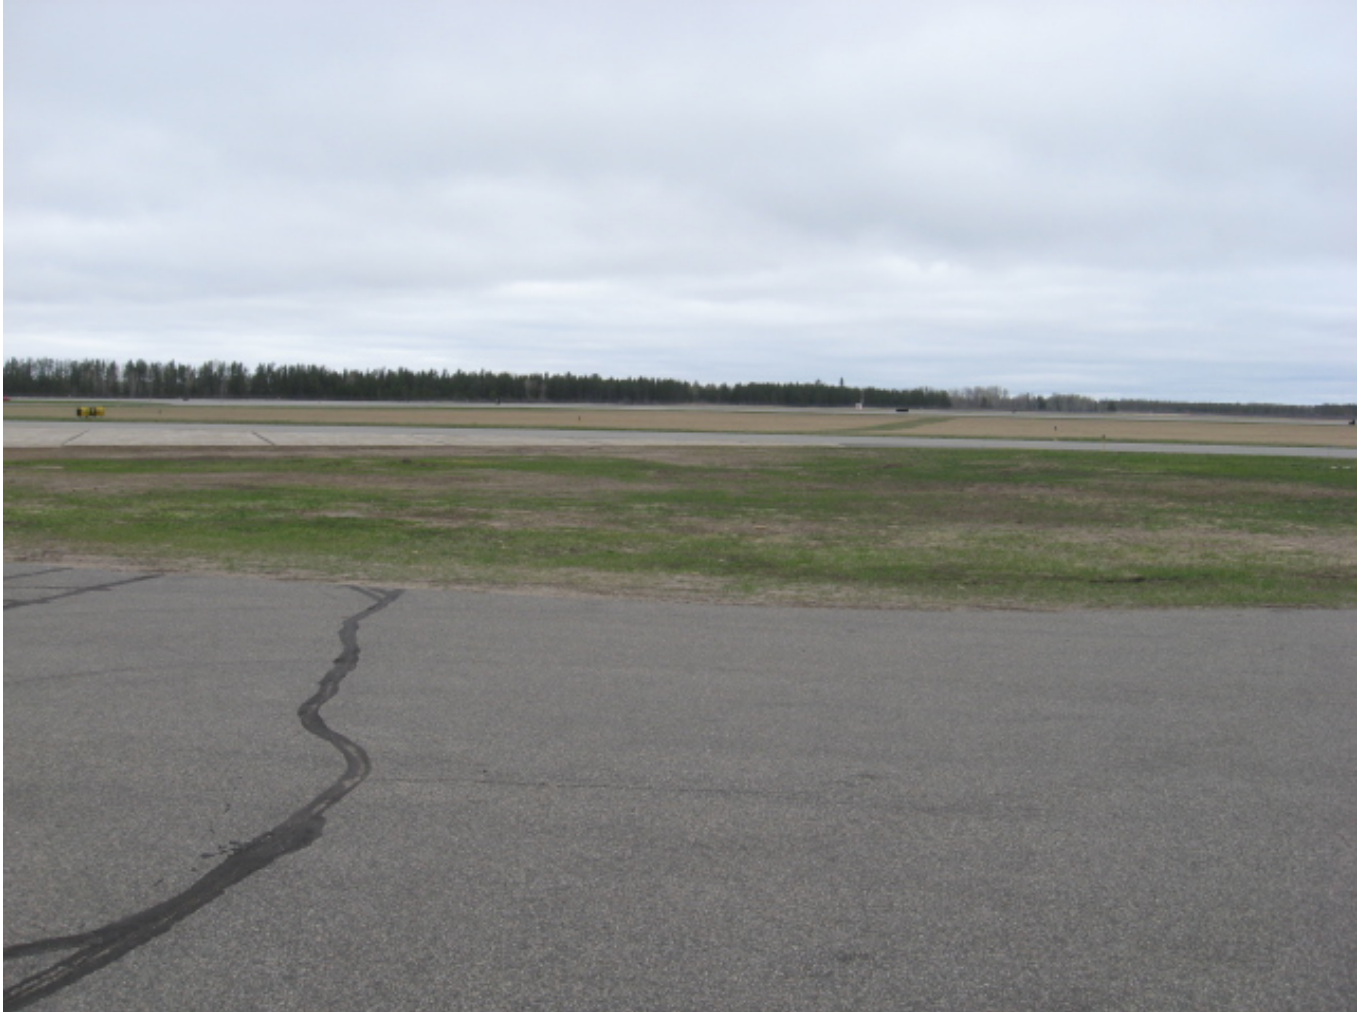
Photograph 1

View of the grassy training area where firefighting foam is discharged is located in front (northeast) of the airport fire station, view facing northeast. The airport's glycol collection system, including two underground storage tanks (USTs), is located in this area.

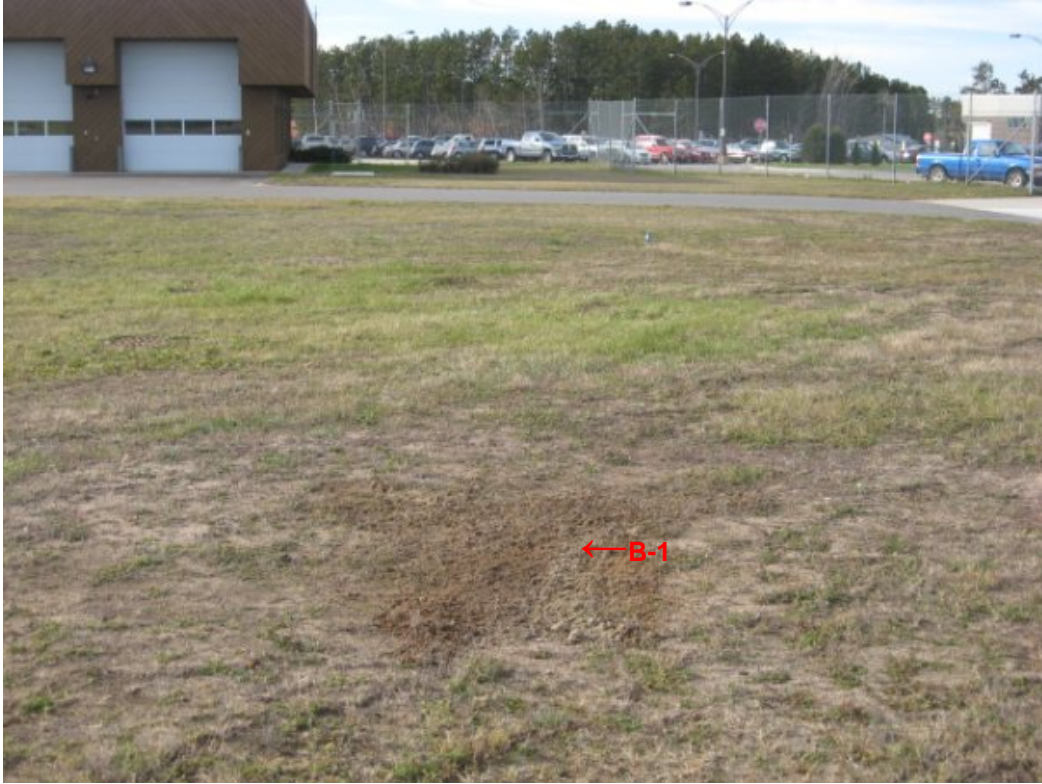
Photograph 2

Boring B-1 was advanced within the fire foam training area, 19 feet north of the glycol USTs.

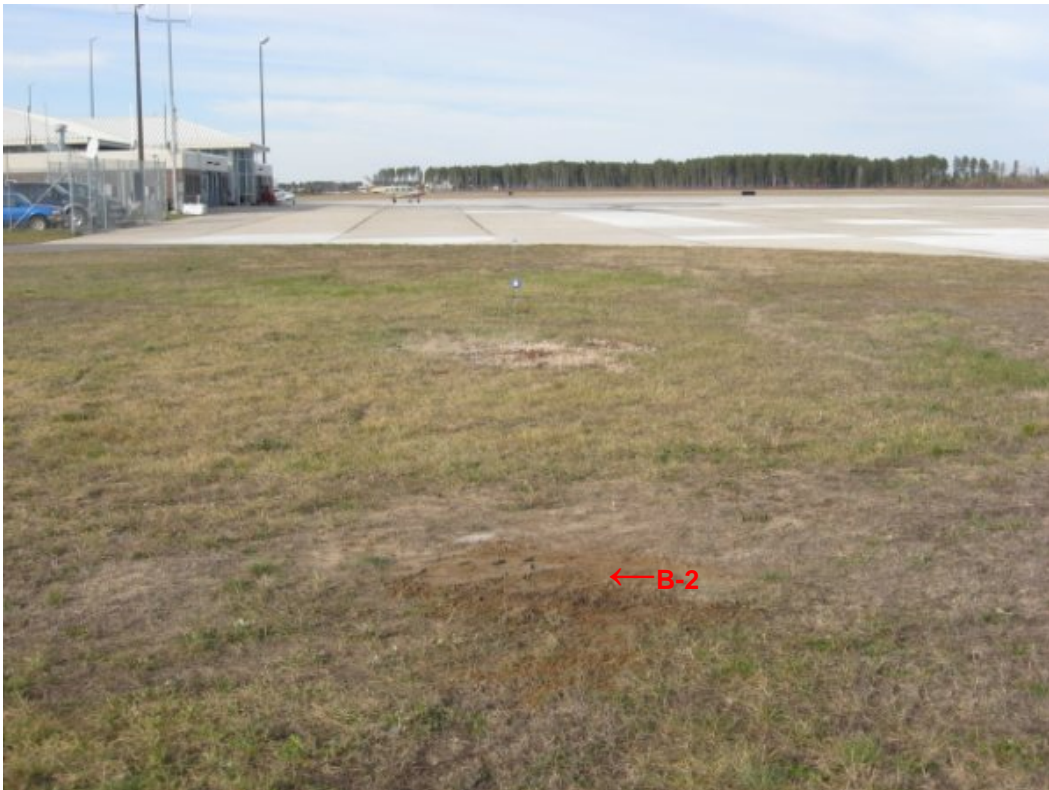
Photograph 3

Boring B-2 was advanced within the fire foam training area, 24 feet east of the glycol USTs.

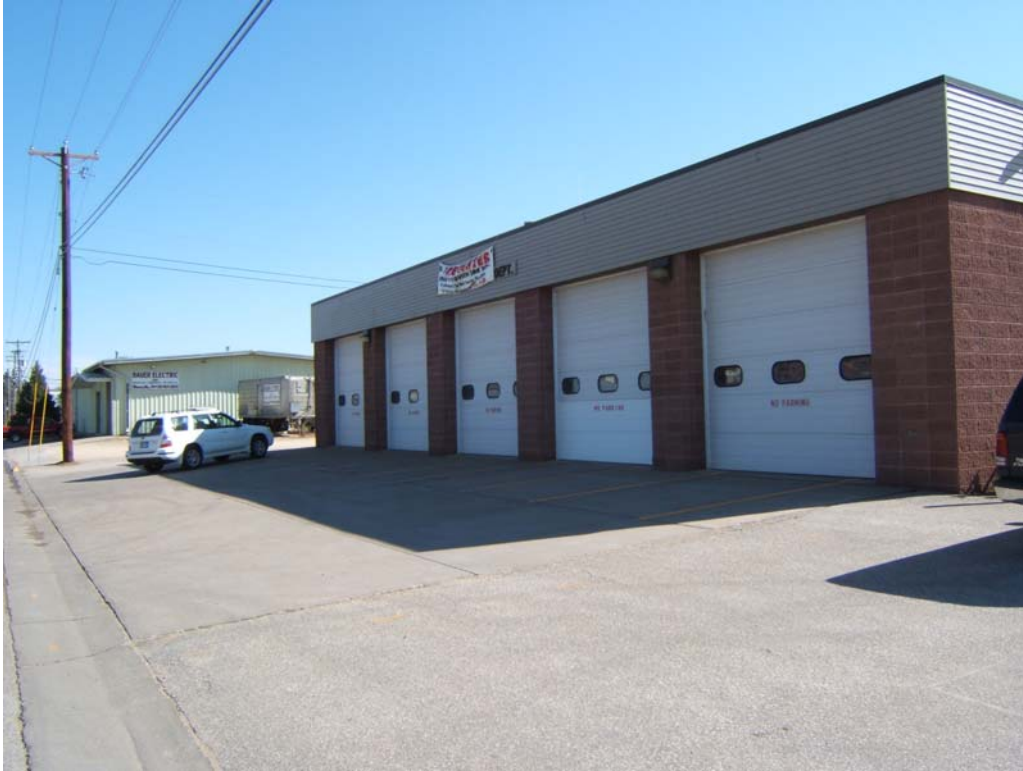
Photograph 1

Fire foam is sprayed onto the concrete apron in front of the fire station. Drainage is to 5th Street West at left. Photo view facing southeast.

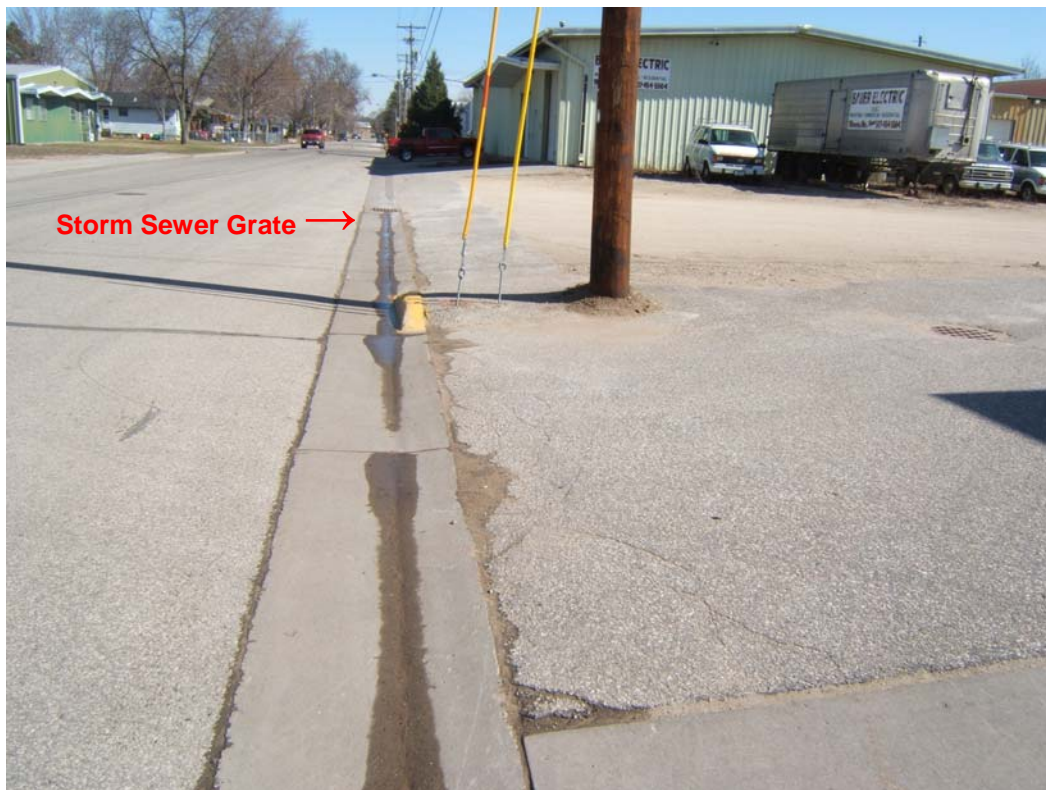
Photograph 2

Spent foam and water drain to a storm sewer grate in 5th Street West, approximately 60 feet to the southeast of the fire station.

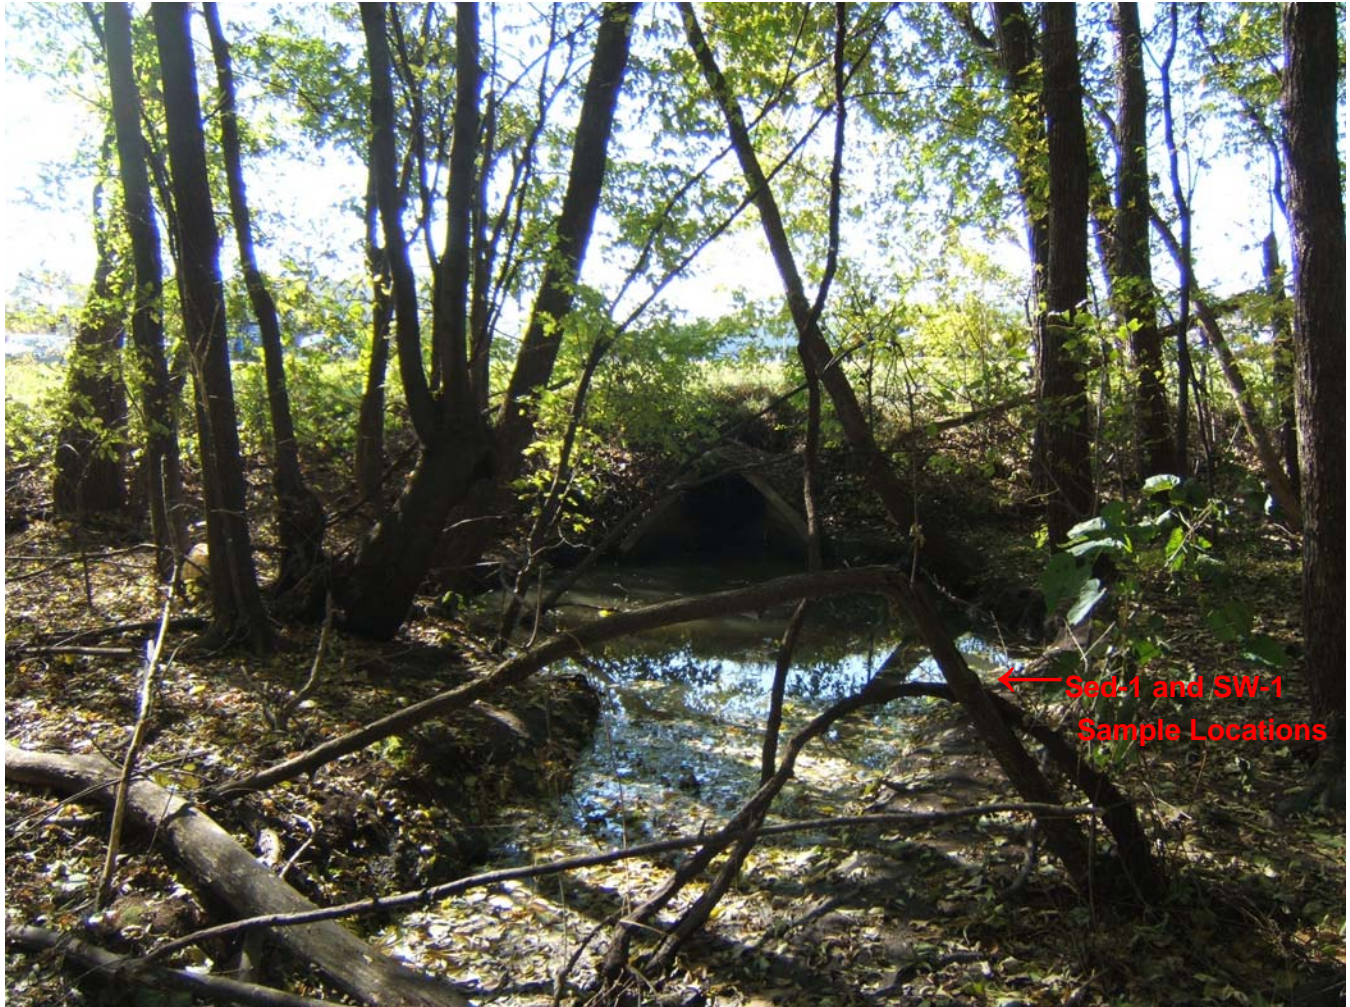
Photograph 3

Storm sewer outflow pipe and sediment and surface water sample locations. The storm sewer is at the north end of 39th Avenue, north of Theuer Boulevard, to backwaters of the Mississippi River.

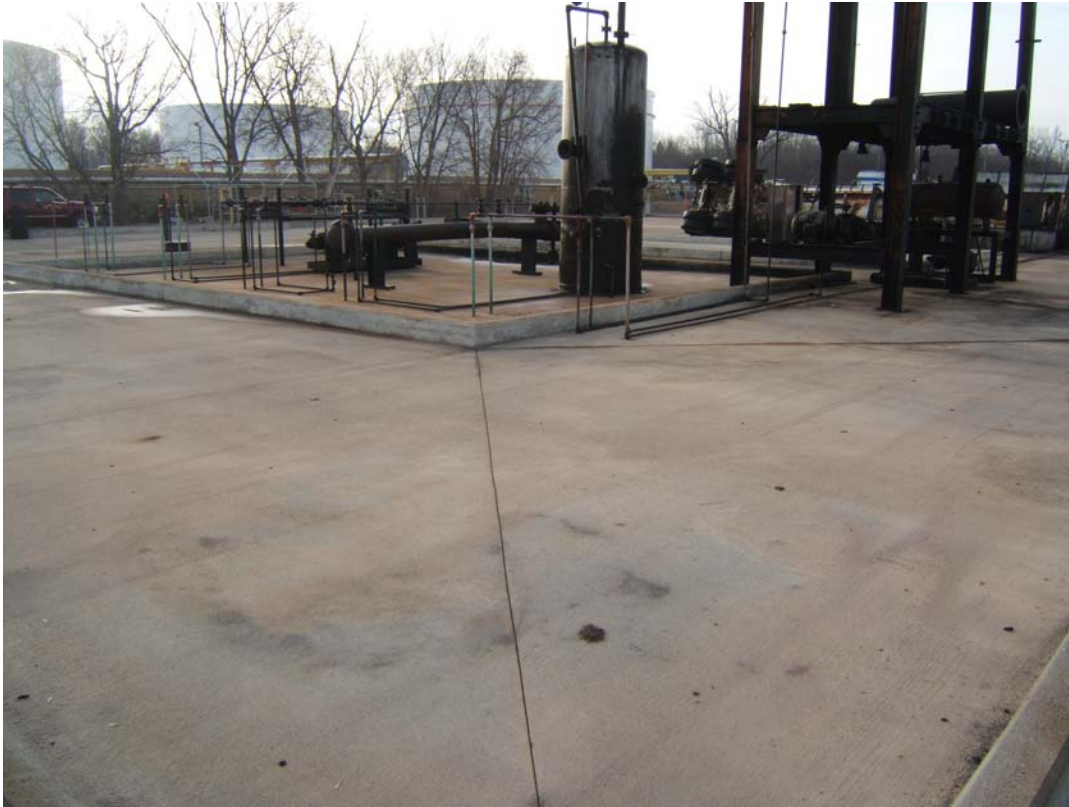
Photograph 1

Fire training area concrete pad and structures, view from the northwest corner facing southeast.

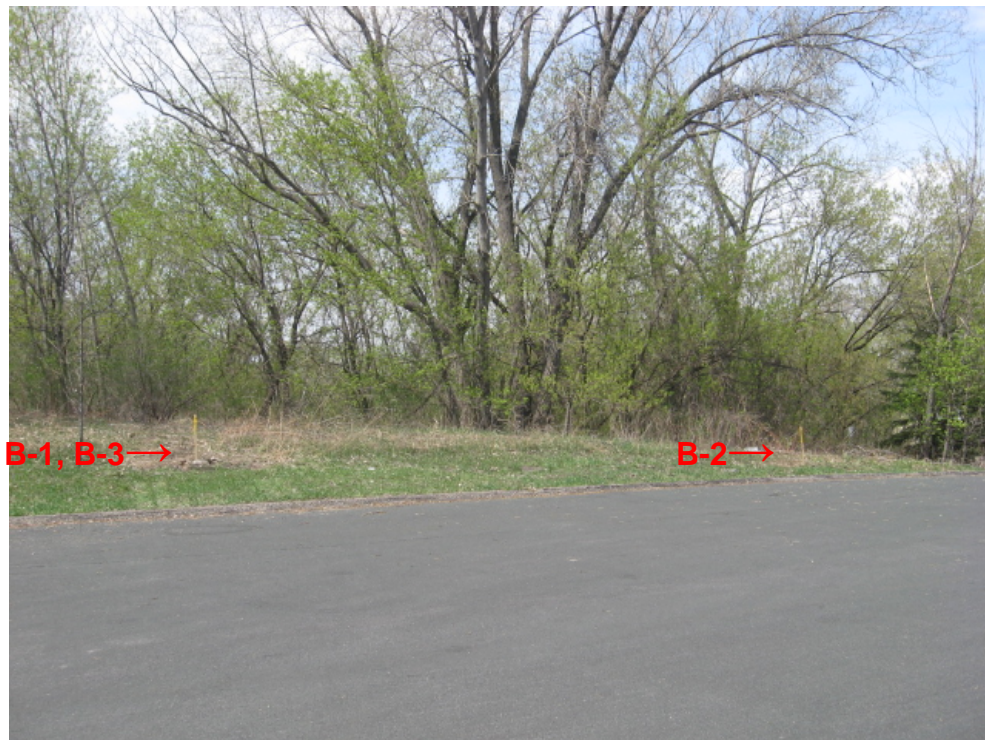
Photograph 1

Fire foam is sprayed from the edge of the asphalt into the wooded area. View facing northwest. Stakes mark soil boring locations B-1, B-3 and B-2.

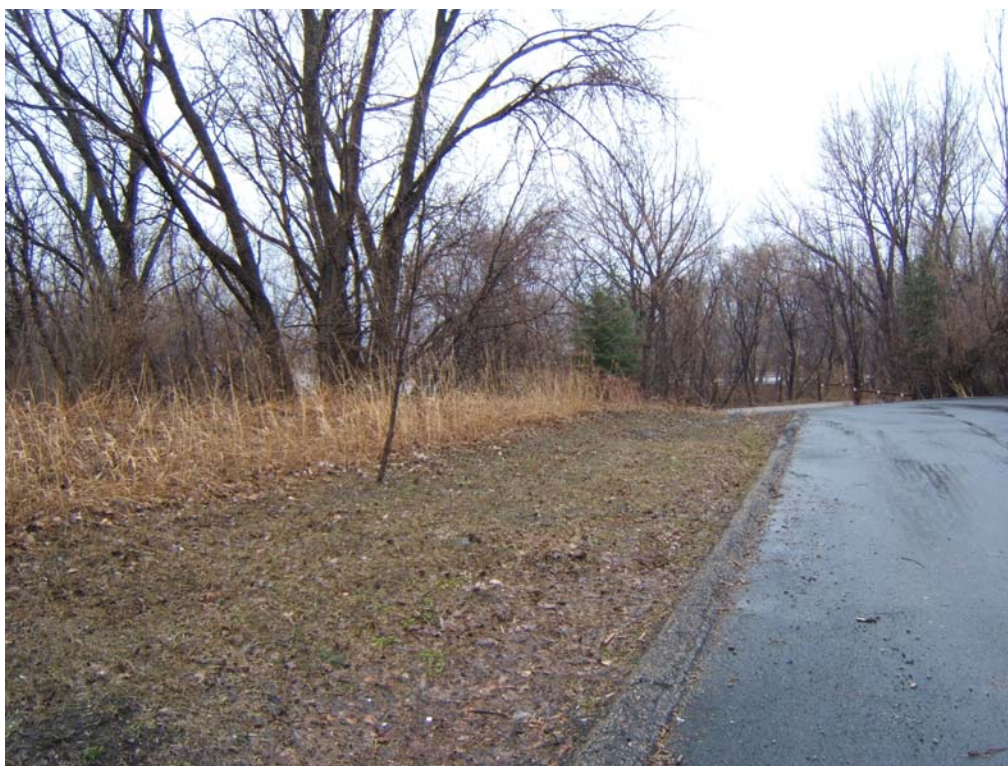
Photograph 2

View of the fire foam training area (at left) facing north. Runoff from the fire foam training area would drain downhill to the north.

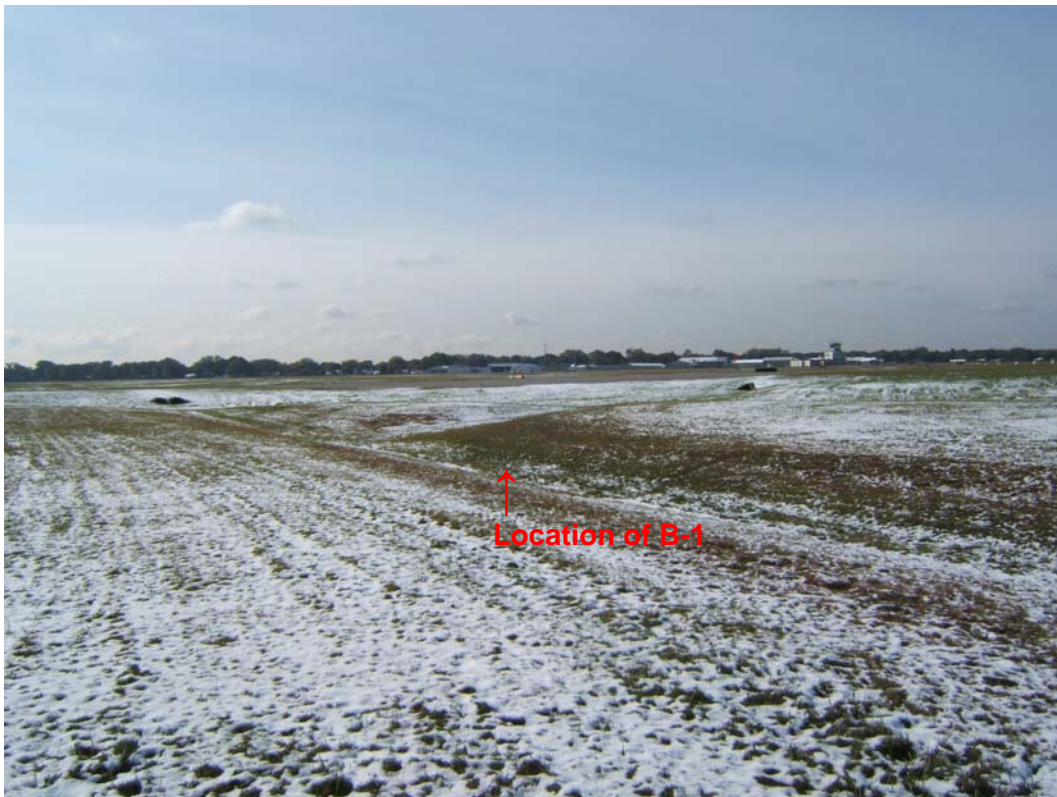
Photograph 2

Stormwater culverts near the northeast end of taxiway A and the location of boring B-1, view facing south.

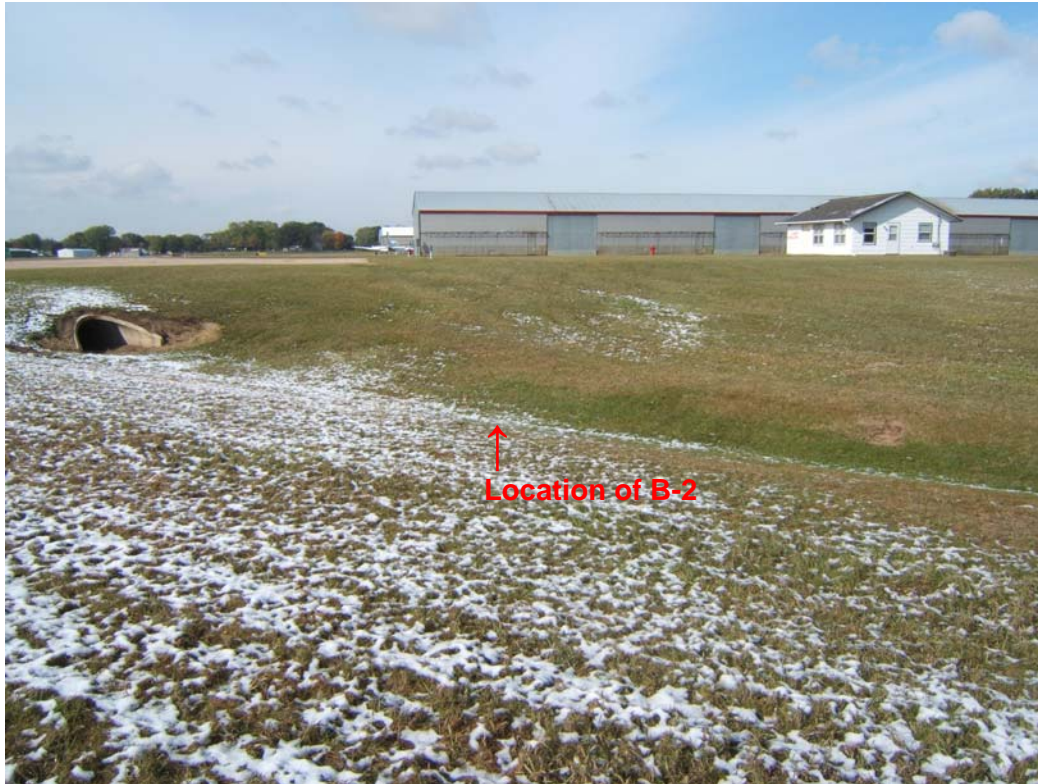
Photograph 3
Stormwater culvert near the east end of taxiway C and location of boring B-2, view facing westerly.

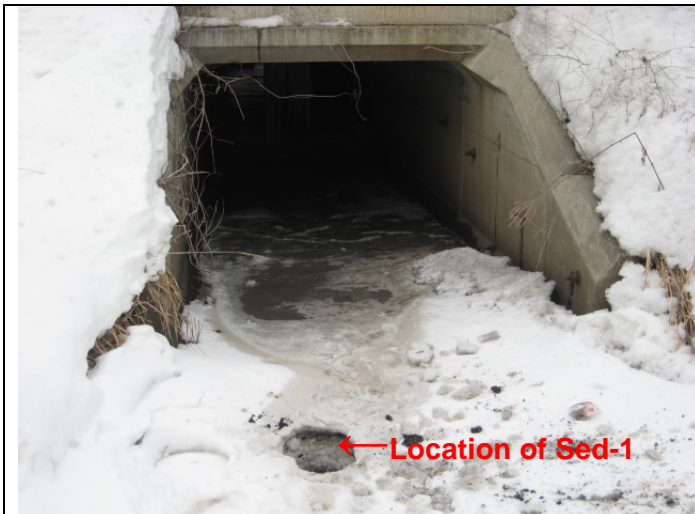
Photograph 4
Sediment sample Sed-1 was collected from Shingle Creek near the northeast corner of the Crystal Airport property.

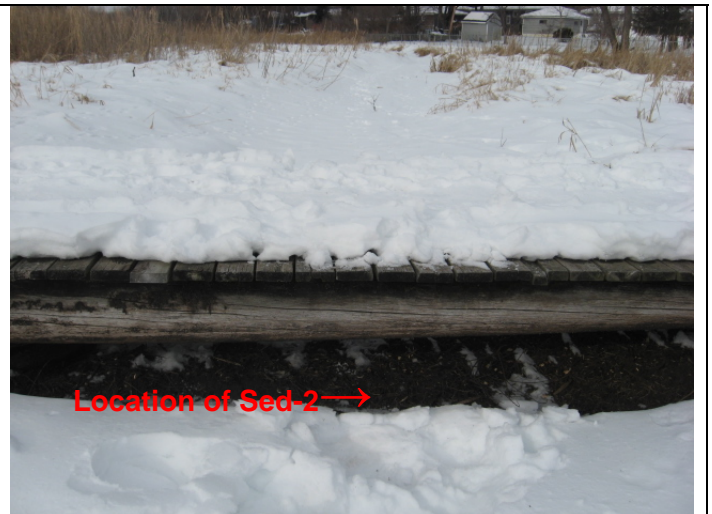
Photograph 5
Sediment sample Sed-2 was collected from beneath a foot bridge over Shingle Creek, at a location near the east corner of the Crystal Airport property.
