***REPORT OF INVESTIGATION ACTIVITIES AT
SELECT FIREFIGHTING FOAM TRAINING AREAS AND FOAM DISCHARGE
SITES IN MINNESOTA***

DELTA PROJECT NO. 19382-DEL0

**Minnesota Pollution Control Agency
520 Lafayette Road
St. Paul, MN 55155**

February 10, 2010

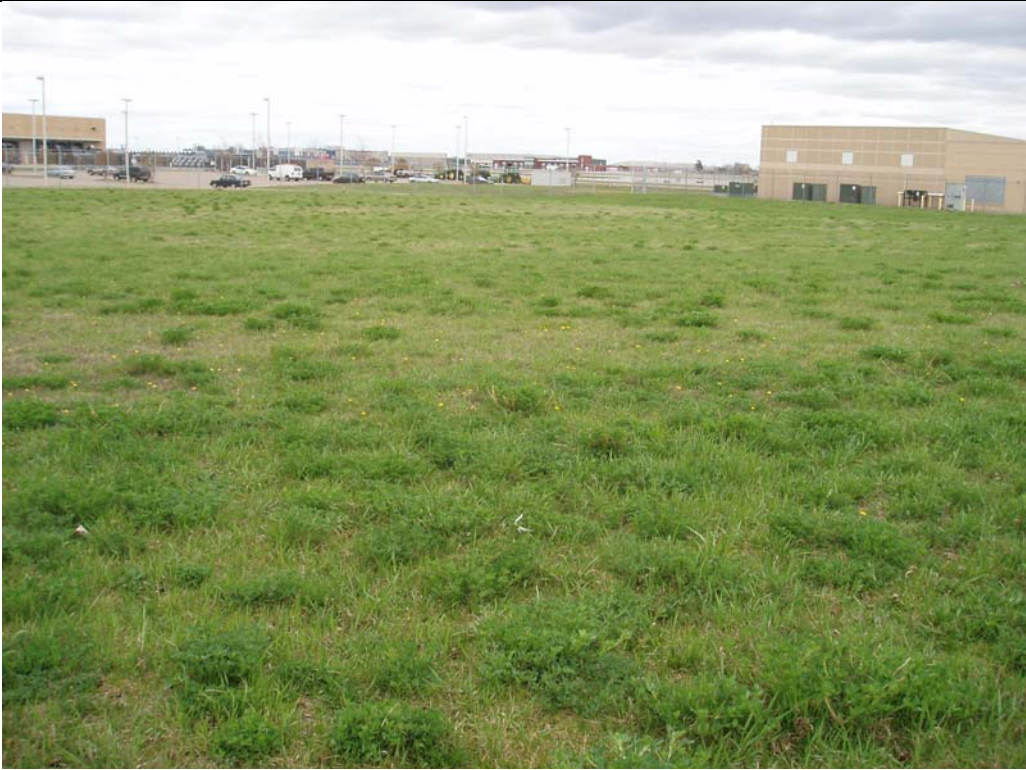
Photograph 1

The Post-1983 former fire foam training area is located east of Cargo Road, near the current glycol management facility, which is visible at right. Soil borings B-1 and B-2 were advanced here in May 2009. View facing east.

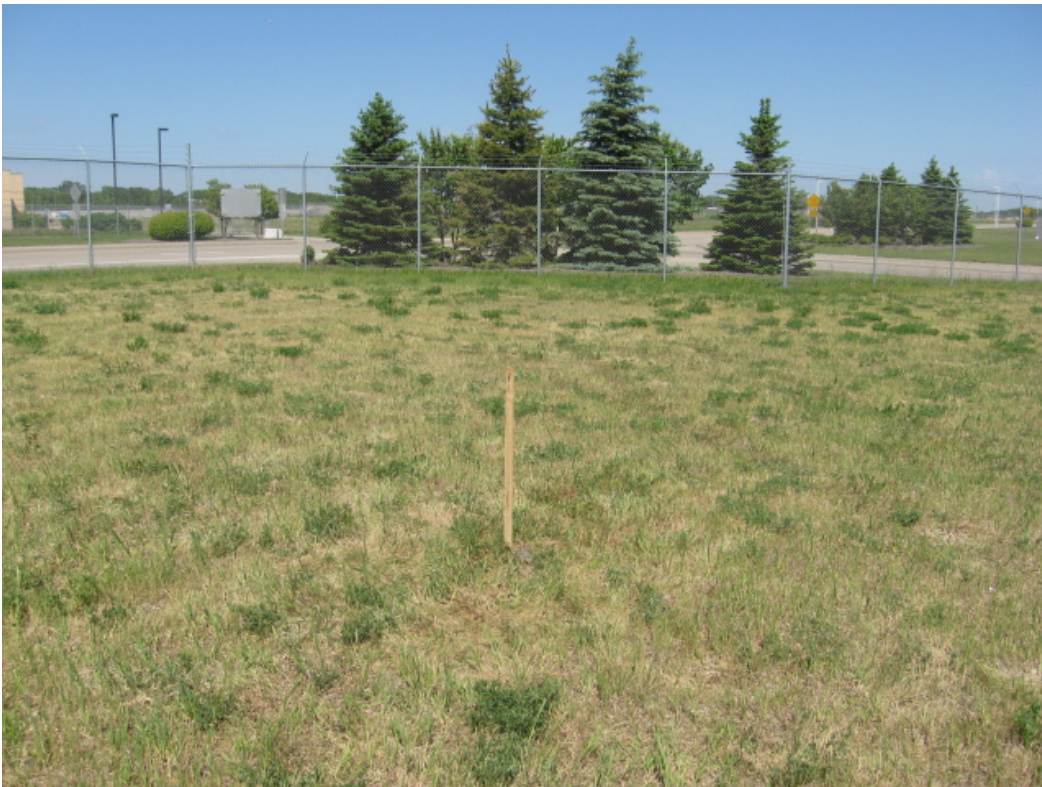
Photograph 2

Soil boring B-2 was advanced near the southeast corner of the post-1983 former fire foam training area. Soil boring B-1 was advanced closer to the fence. Cargo Road is visible in the background. View facing northwest.

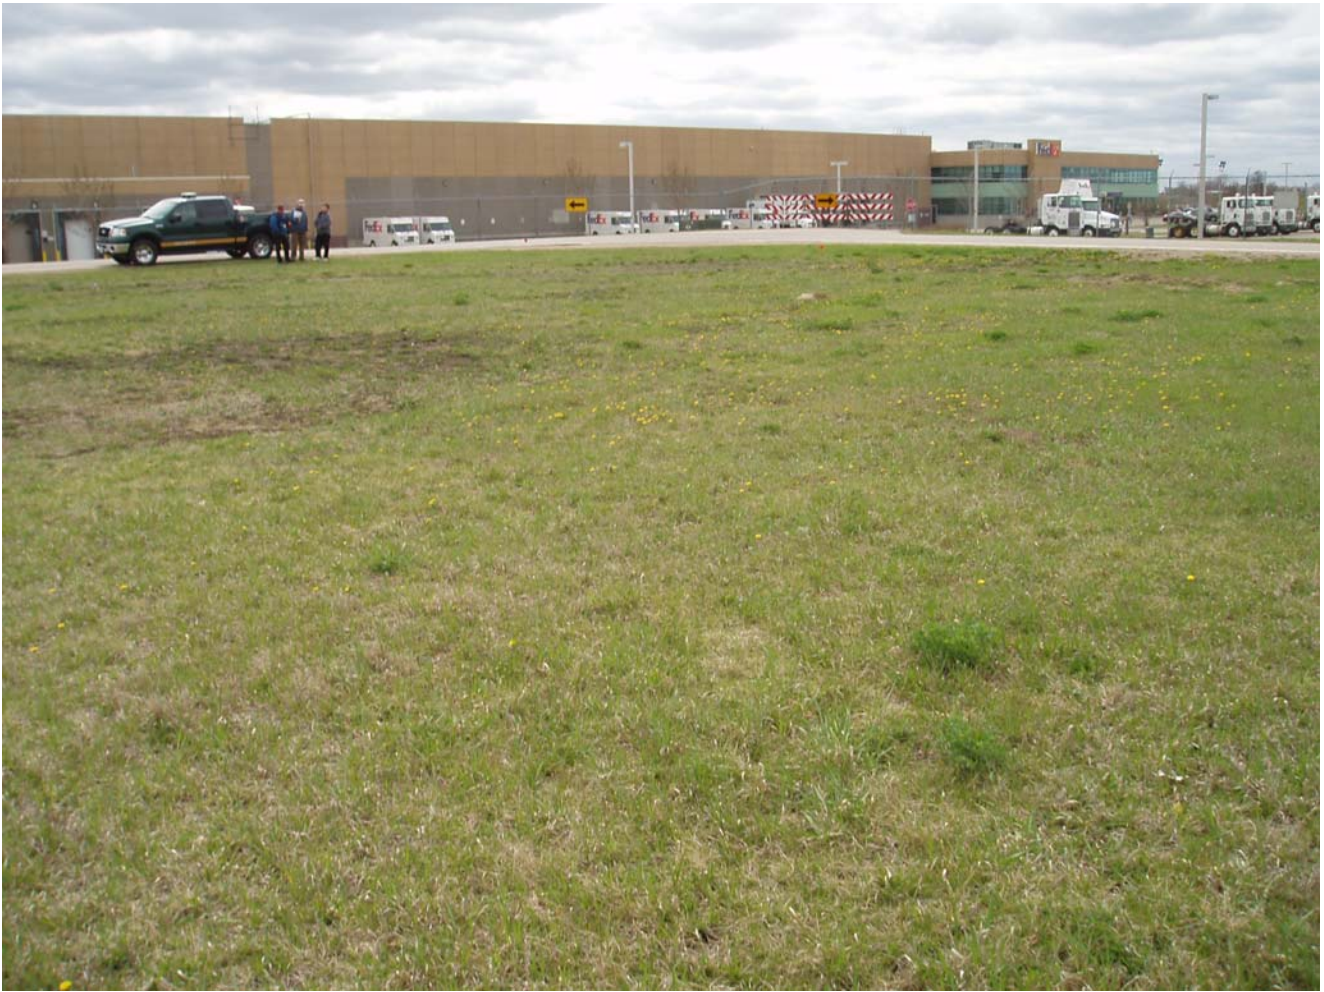
Photograph 3

The Pre-1983 fire foam training area is located northeast of the current FedEx facility. Soil borings B-3 and B-4 were advanced in this area in May 2009. Photo view facing southwest.

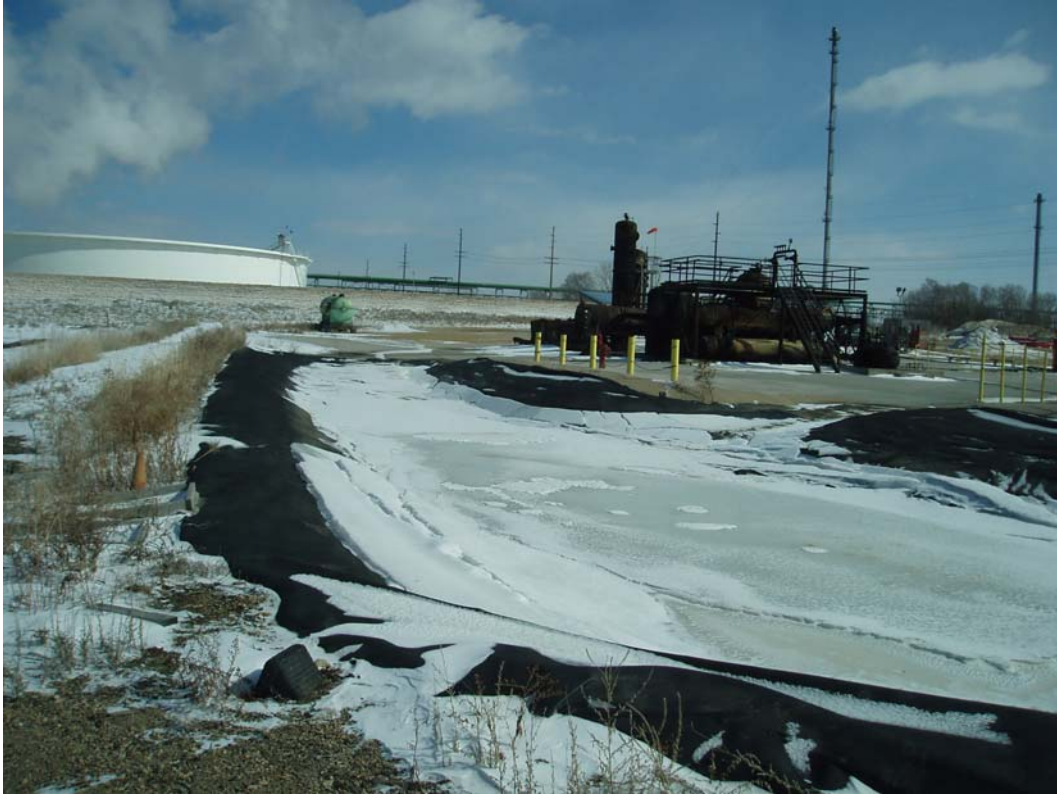
Photograph 1

Concrete-paved training area and HDP-lined retention pond, view from the northwest corner facing east.

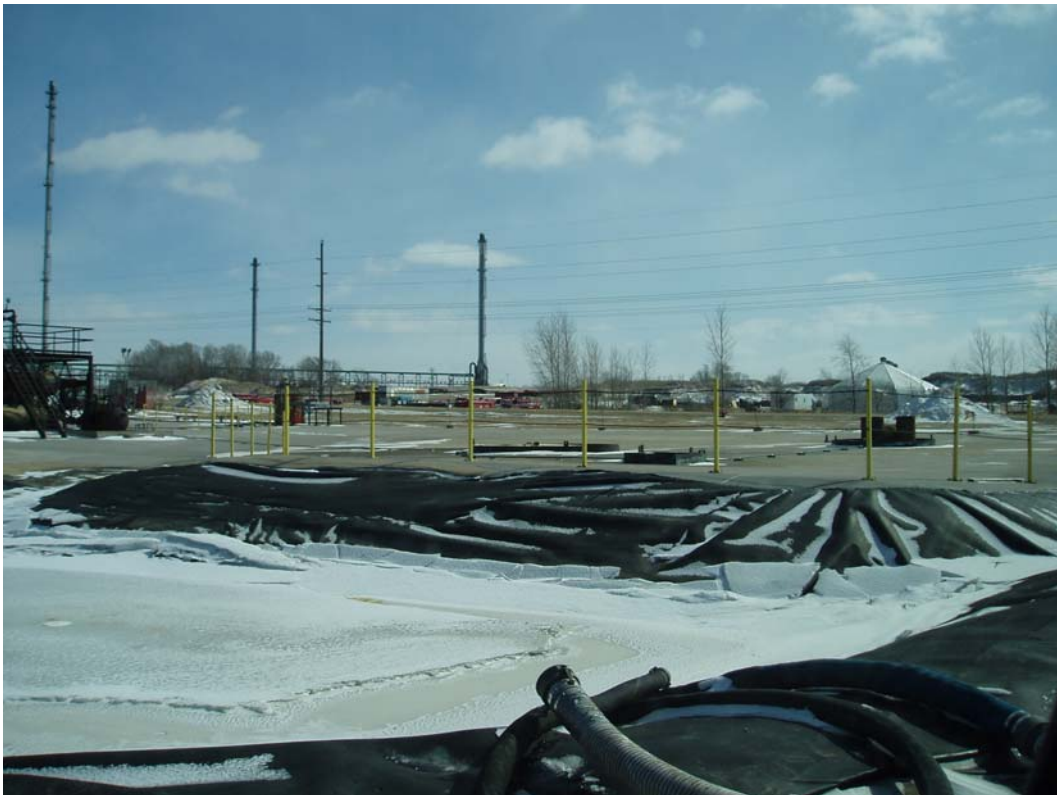
Photograph 2

View of the training area and pond from the northwest corner facing southwest.

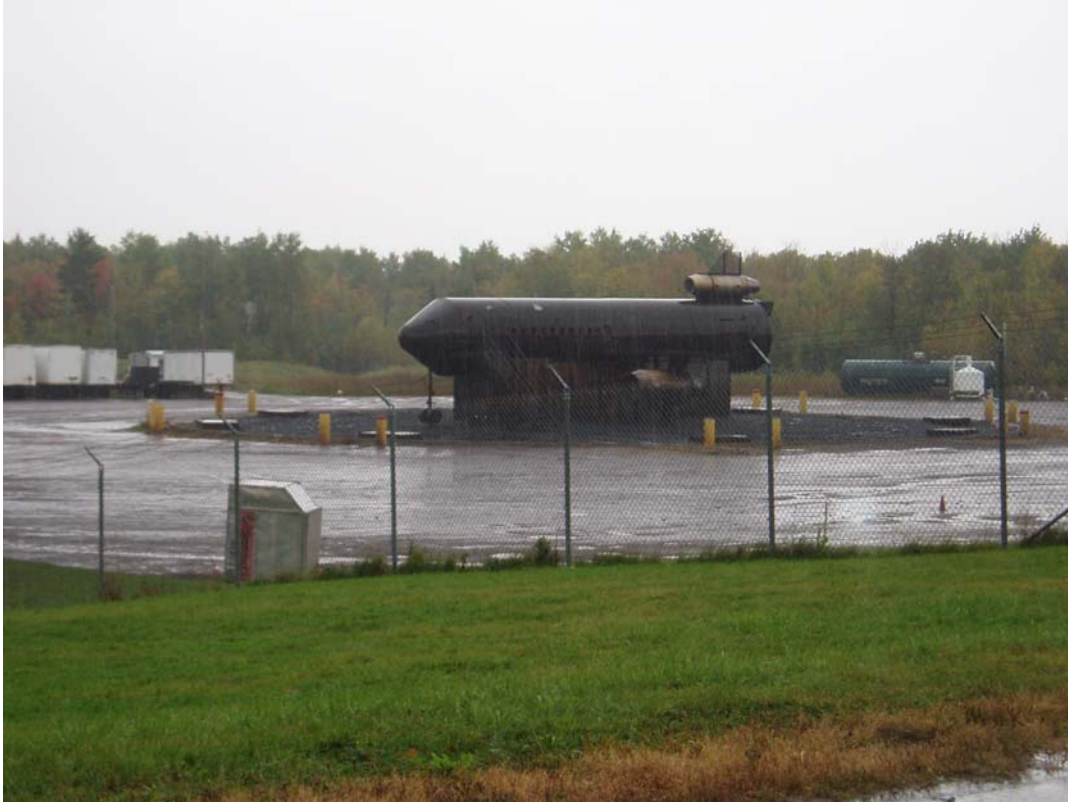
Photograph 1

The fire training area at the ERTC, view facing southeast. A 125-foot diameter, concrete-lined burn pit is situated beneath the mock airplane to catch water and spent foam from training exercises.

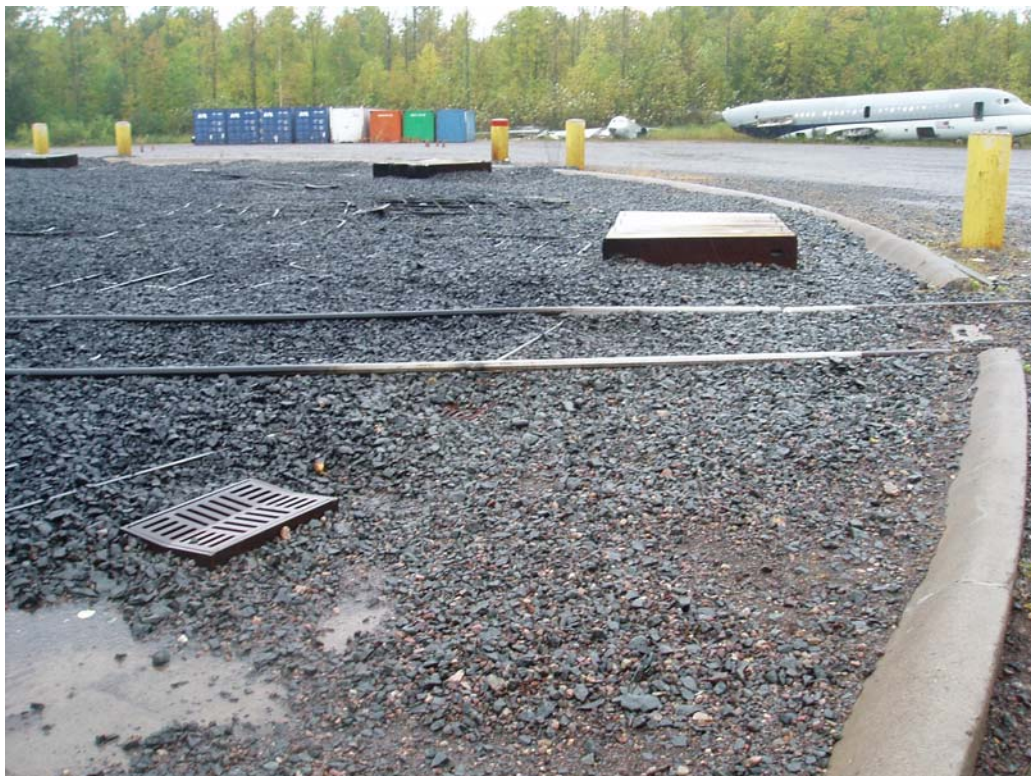
Photograph 2

Close-up of the gravel-covered surface of the burn pit. Concrete curbing outlines the burn pit.

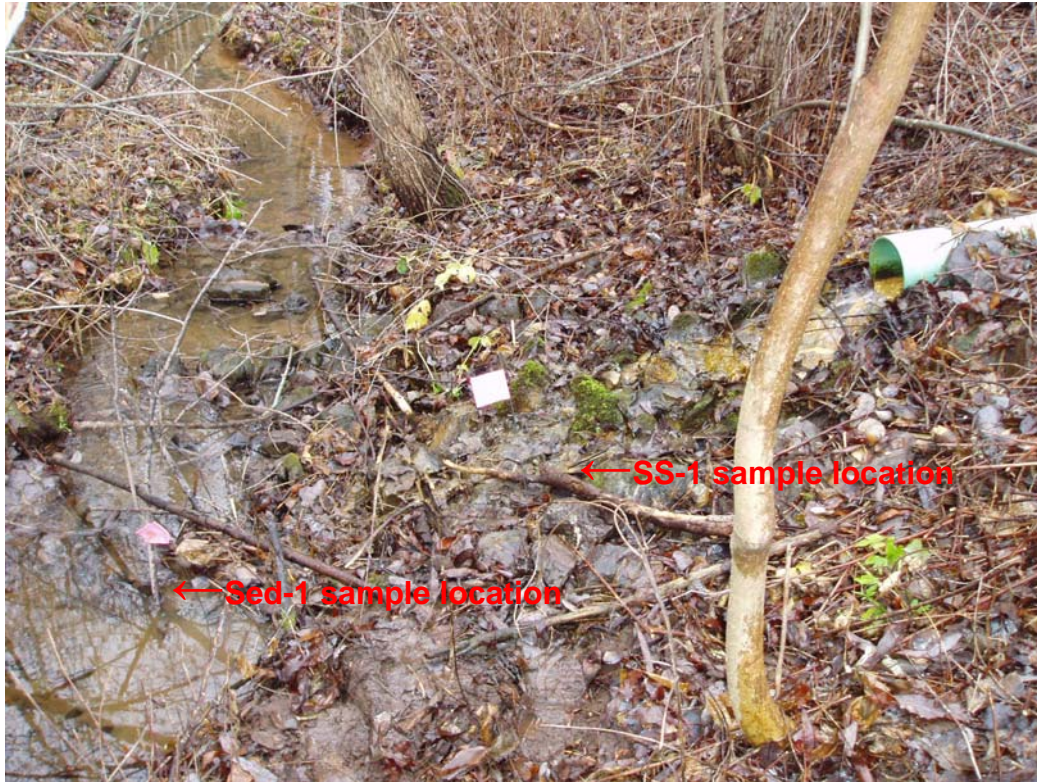
Photograph 3

Surface soil sample SS-1 and sediment sample Sed-1 were collected between the discharge from the drainage pipe which runs below the fire training area and the small creek at left. Photo view facing southeast.

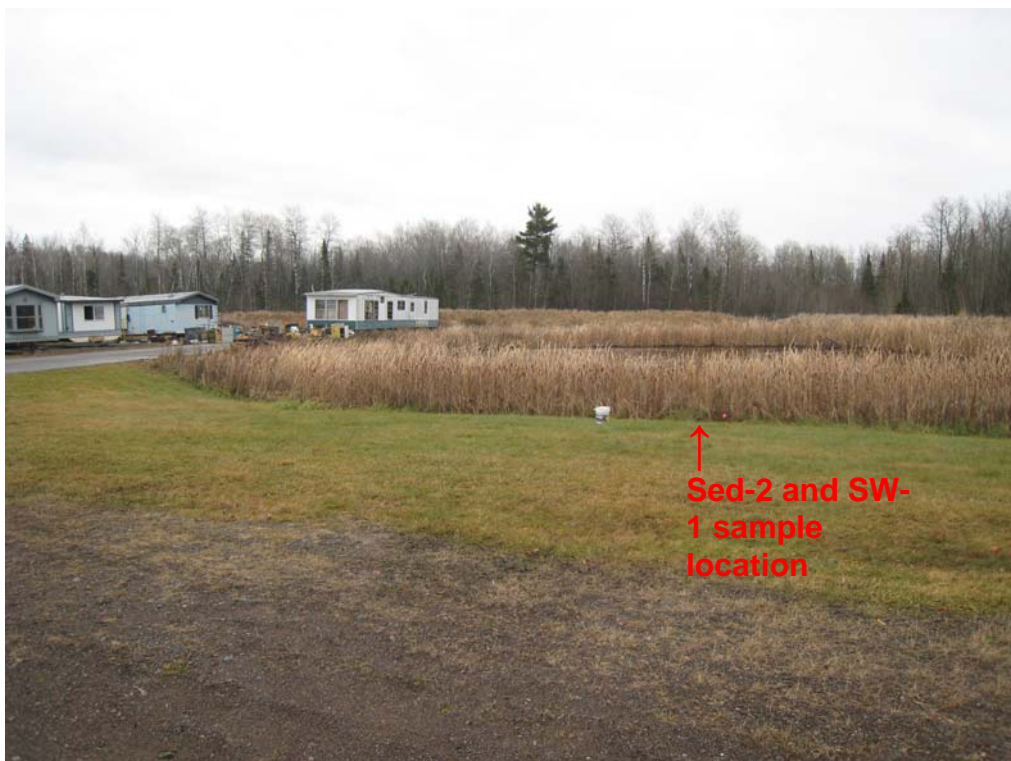
Photograph 4

Sediment sample Sed-2 and surface water sample SW-1 were collected at the west edge of the wetland, which is located southeast of the fire training area. View facing east.

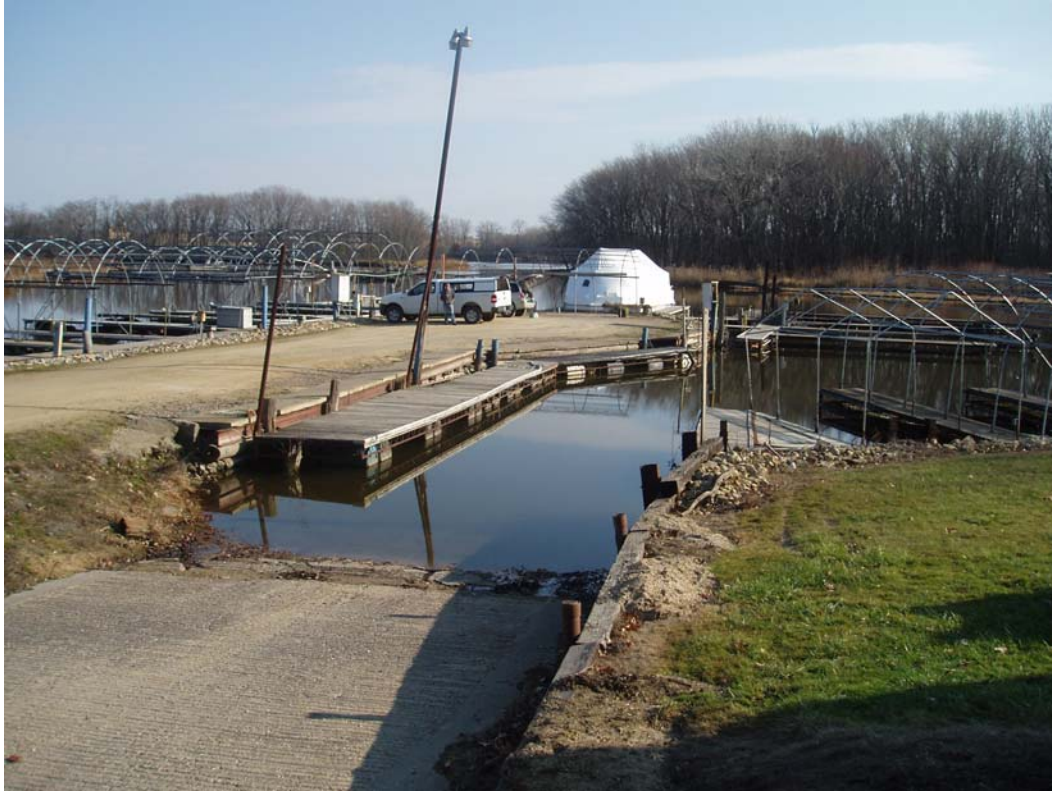
Photograph 1

View of the marina and boat ramp from shore, view facing east. Sediment sample Sed-3 was collected at the shallow area near the left (north) end of the boat ramp.

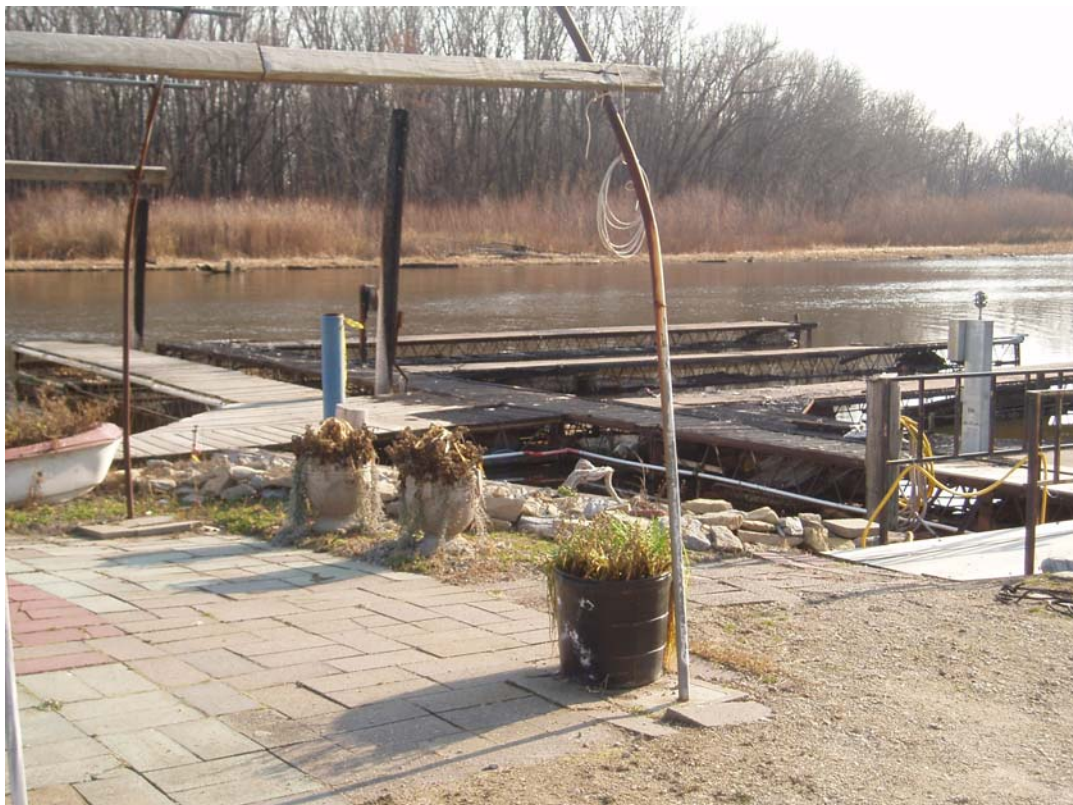
Photograph 2

Four boats and adjoining docks at upper right of the photo burned in the fire of September 26, 2009.

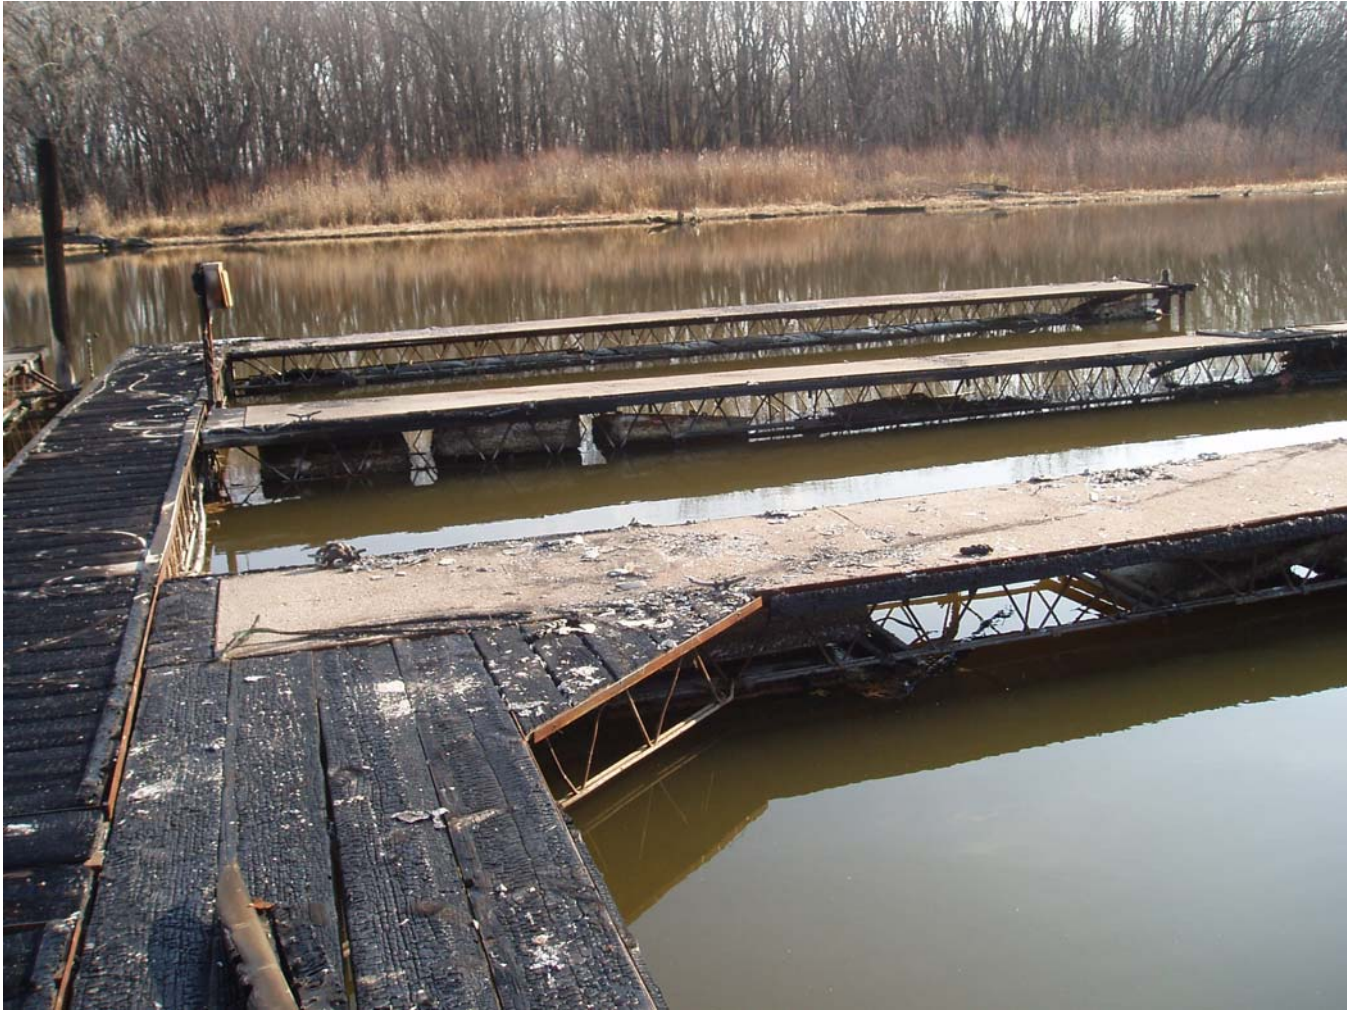
Photograph 3

River sediment sample Sed-1 and surface water sample SW-2 were collected on the east side nearest dock in the photo. Sediment sample Sed-2 was collected from the inside of the furthest dock. View facing east.

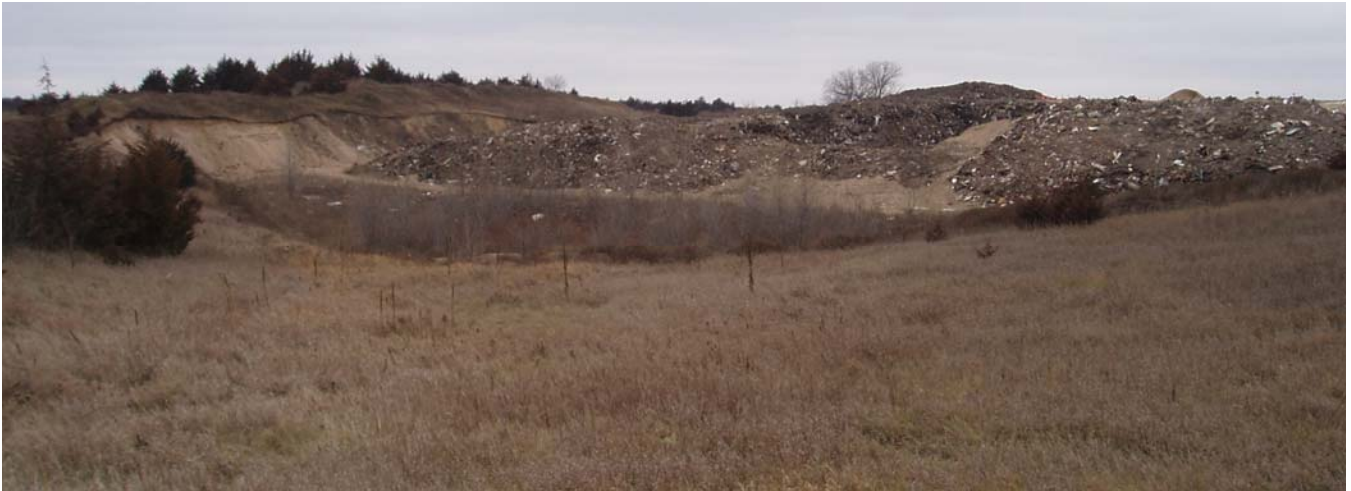
Photograph 1

View of the construction and demolition (C&D) debris area at the Kandiyohi County Landfill during the site reconnaissance on December 2, 2009, view facing west, photo taken from the landfill entrance road. Much of the C&D debris was pushed up and spread around the landfill to ensure the fire had stopped smoldering.

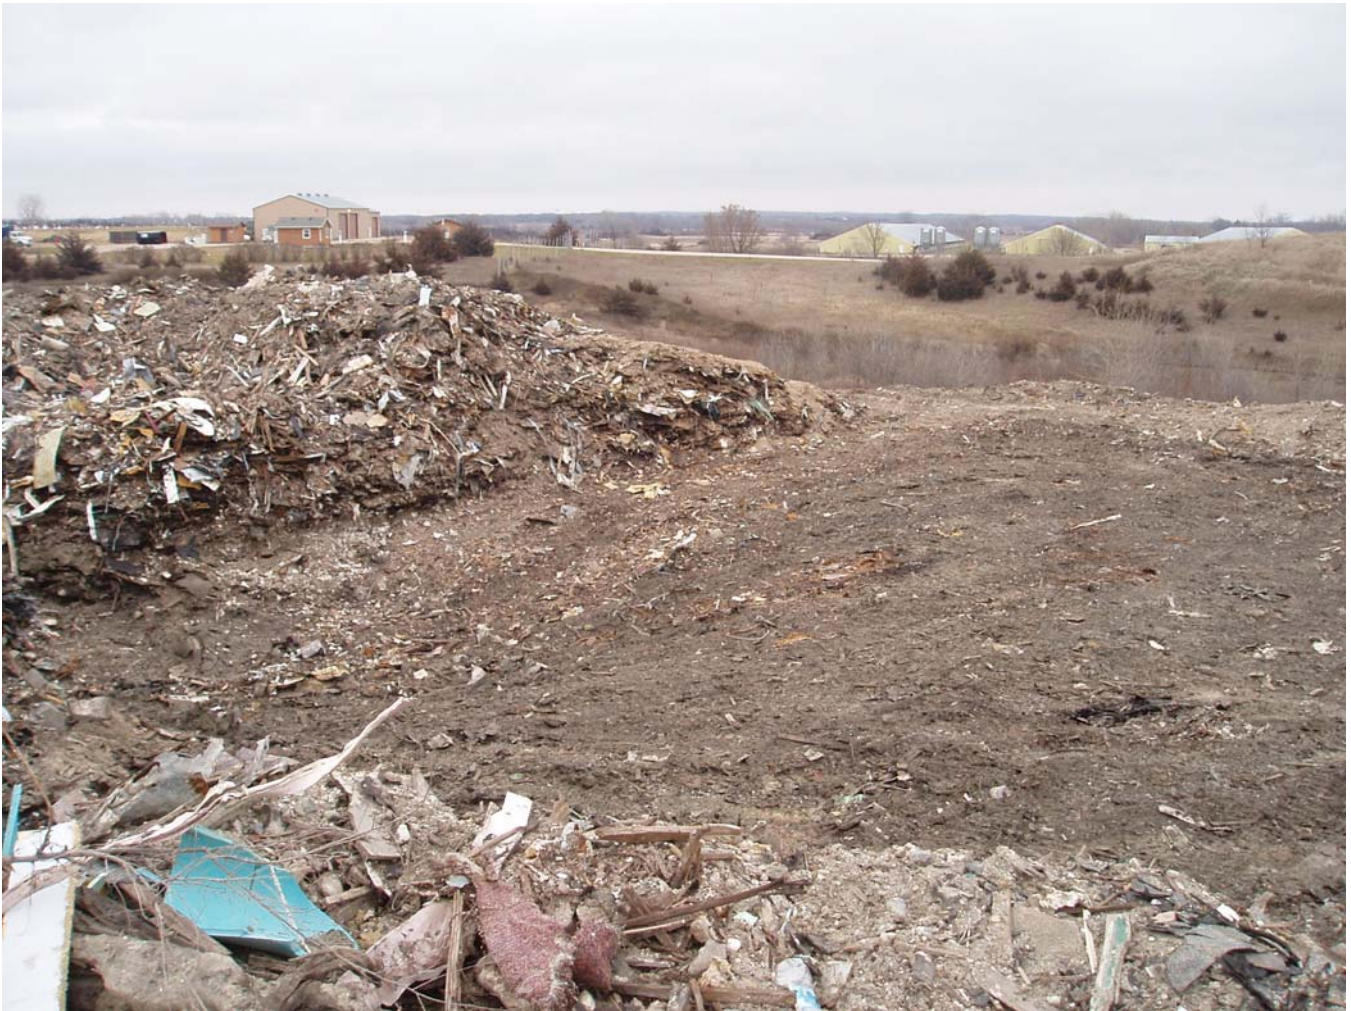
Photograph 2

View from the area above the site of the fire, view facing east. C&D debris was spread in this area.
