Appendix E
Ice Evaluation Report
Great Lakes Legacy Act Project – Spirit Lake Sediment Site
Former U.S. Steel Duluth Works
Saint Louis River, Duluth, Minnesota

SITE LOCATION
Spirit Lake Sediment Site -
Former U. S. Steel Duluth Works
Saint Louis River
Duluth, Minnesota

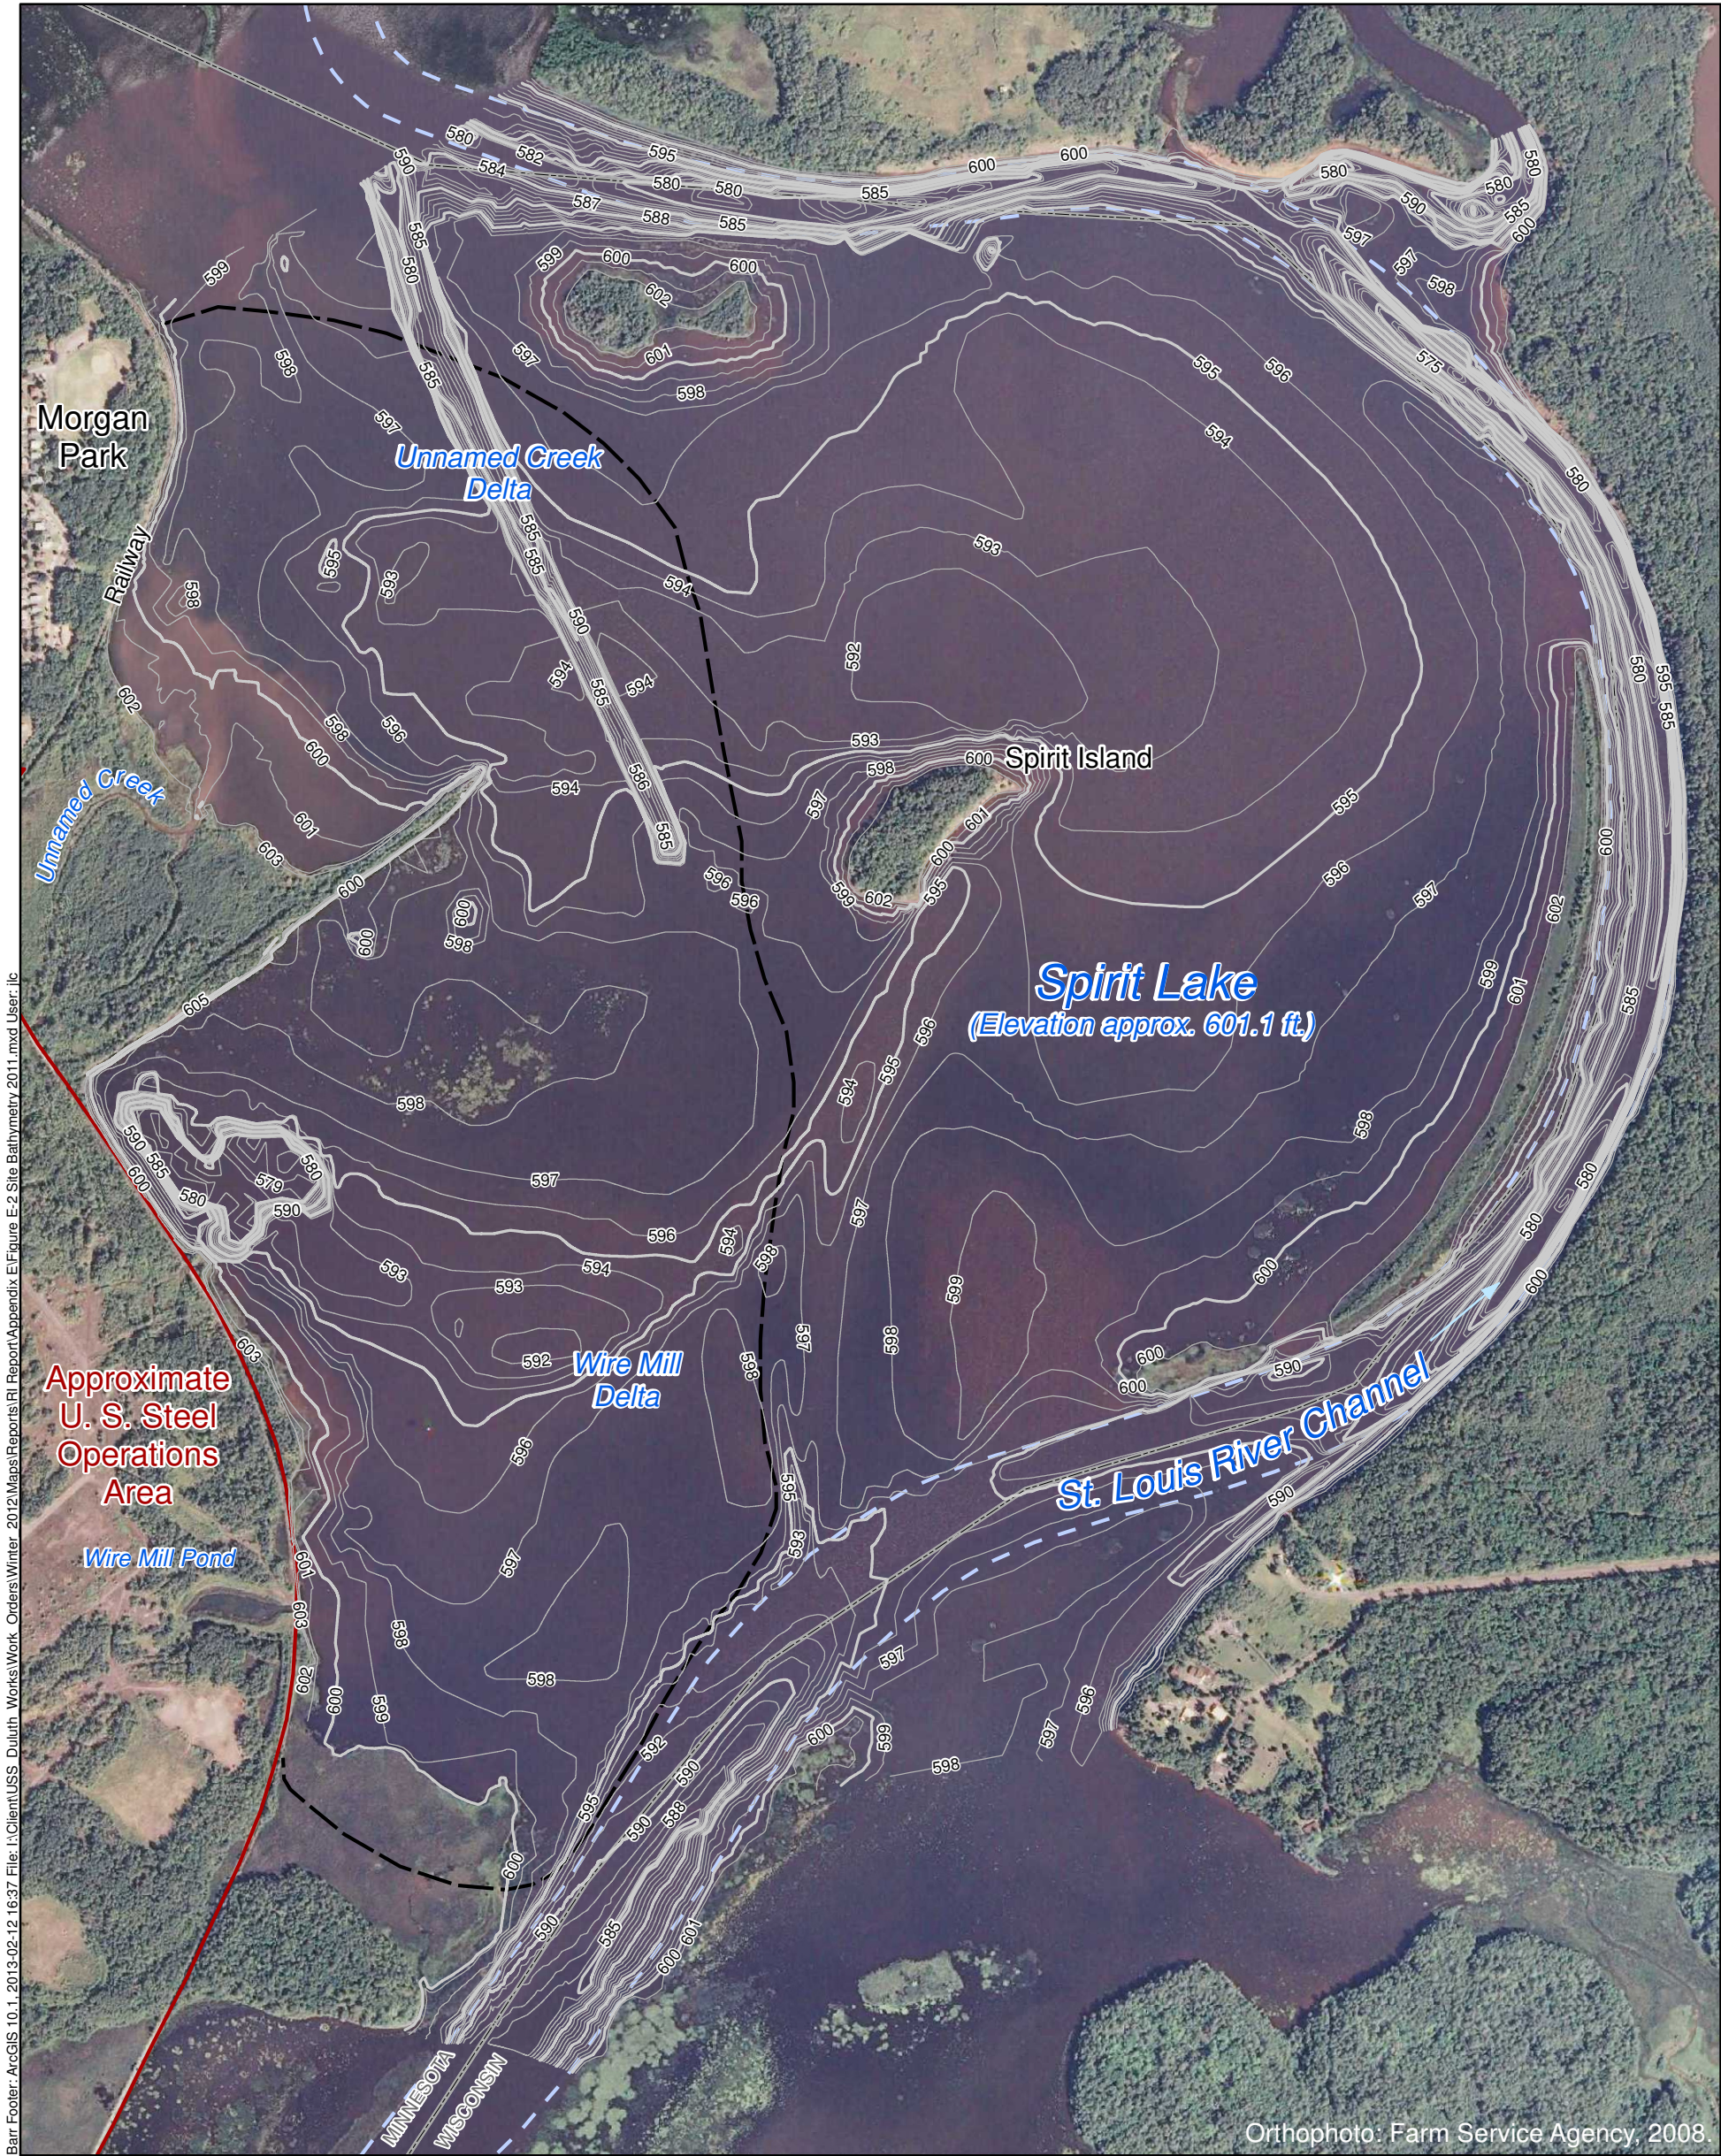
The Site is located in an open reach of the St. Louis River estuary referred to as Spirit Lake, near the Morgan Park neighborhood of Duluth, Minnesota. Spirit Lake is approximately one square mile in size with typical water depths ranging from 2 to 10 feet (Figure E-2). The adjacent river channel averages 15 to 25 feet of water depth, and several islands and emergent wetland areas are present at the edges of, and within Spirit Lake. Adjacent upland uses include the former U. S. Steel Duluth Works steel operations and the community of Morgan Park. Features in Spirit Lake include a man-made spit of land between the Unnamed Creek and Wire Mill deltas, a dredged channel at the outer edge of the Unnamed Creek delta, and a deep-water area in the northwest corner of the Wire Mill delta. Figure E-2 depicts these features and their locations.

SITE BATHYMETRY 2011
Spirit Lake Sediment Site -
Former U. S. Steel Duluth Works
Saint Louis River
Duluth, Minnesota

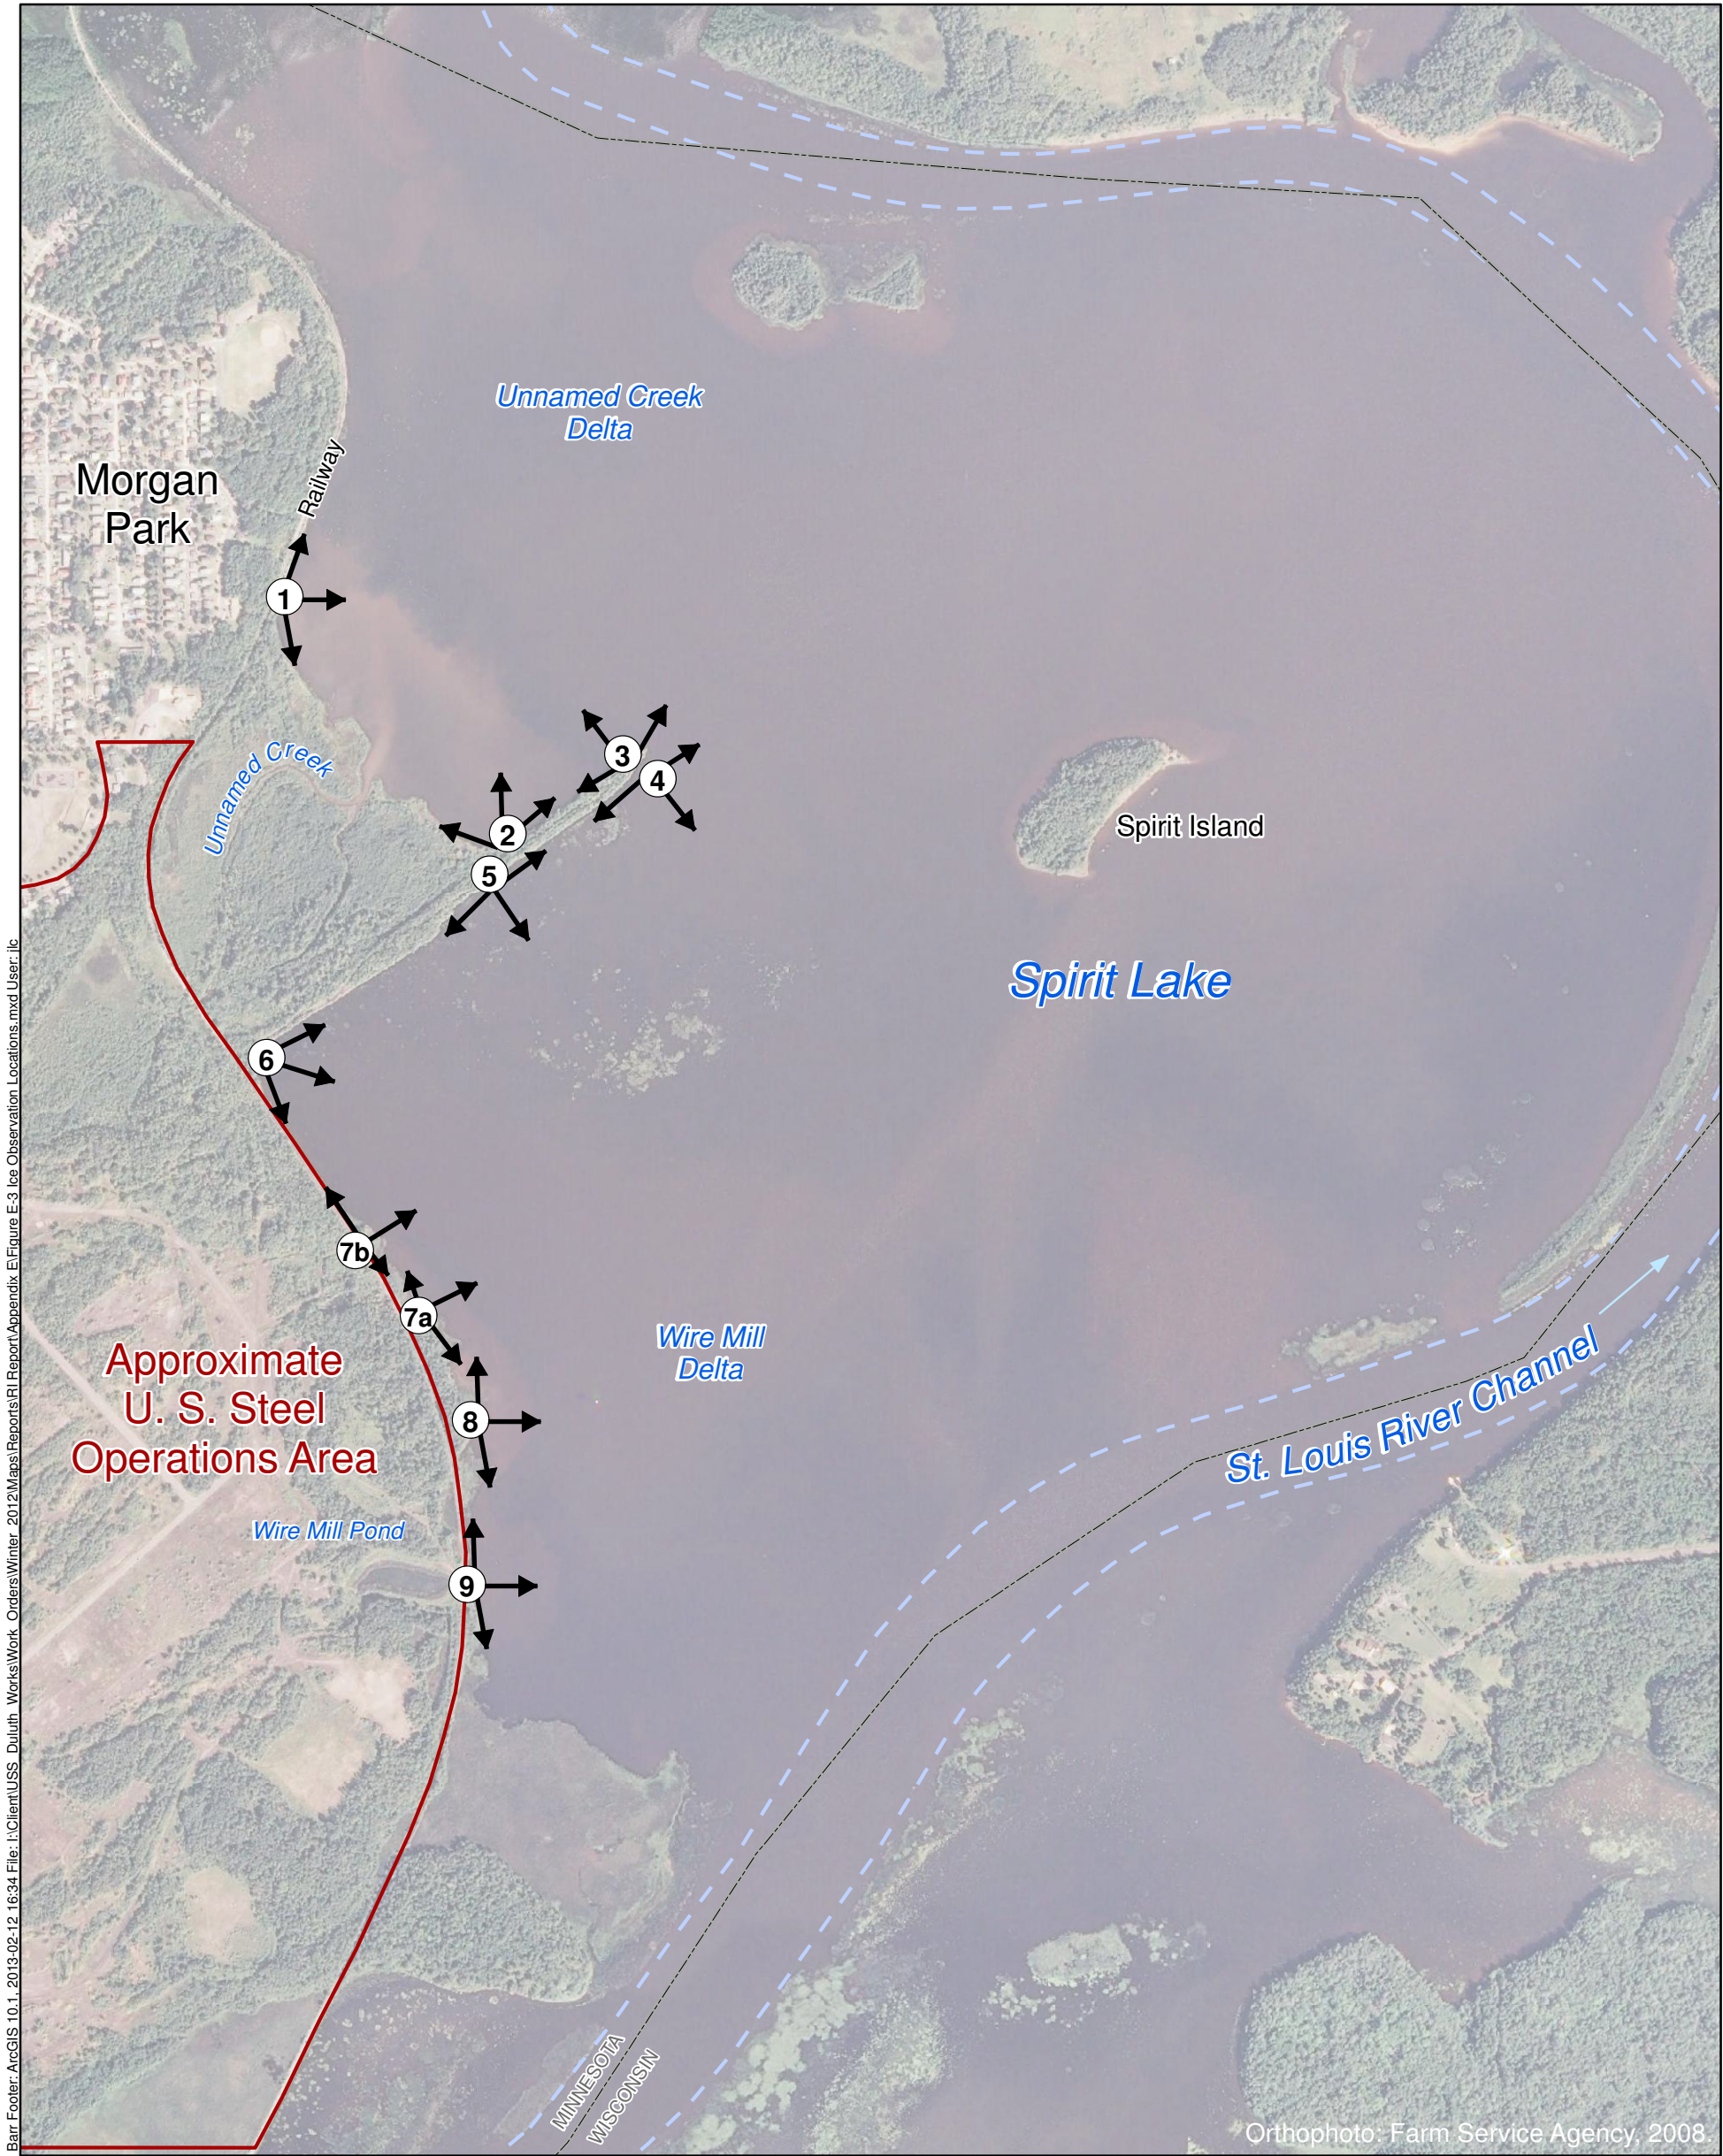
Figure E-3

Ice observation was conducted during March and April of 2011, spanning the period of transition from solid ice cover to open water. Ice observation stations were chosen to capture the conditions of the shorelines of the Site where ice formation and movement would most likely affect shallow sediments. The locations of the ten observation stations are depicted on Figure E-3, with arrows indicating the directions of observation at each station. A photographic log of ice conditions over time at each station, in each direction, is included as an appendix to this report (Appendix E-A).

**LOCATIONS OF
ICE OBSERVATION STATIONS
WINTER 2010/2011**
Spirit Lake Sediment Site -
Former U. S. Steel Duluth Works
Saint Louis River
Duluth, Minnesota

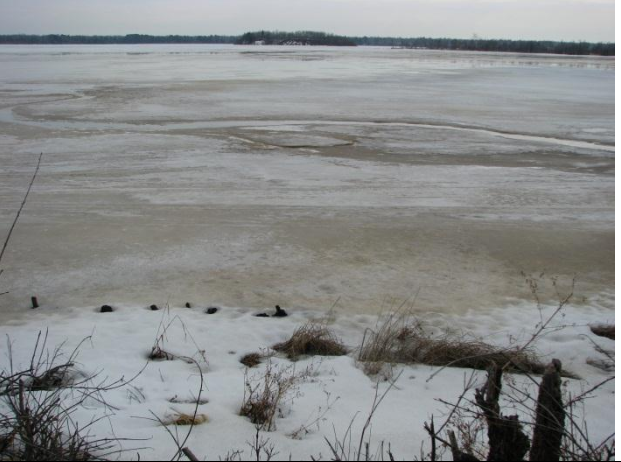
A photograph of a frozen lake with snow and some dry grass in the foreground. A line of trees is visible in the background.
<p>Station #1, Looking E 3/18/2011, 11:13</p>

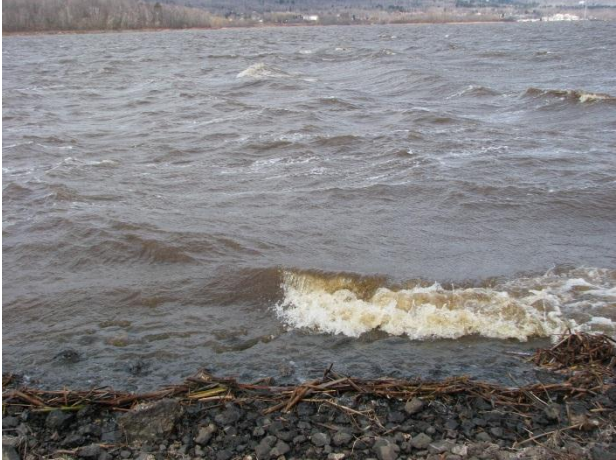
<div>Station #3, Looking NW 4/14/2011, 13:19</div> <div>

A photograph showing a body of water with a small, turbulent flow or waterfall cascading over a rocky ledge in the foreground. The water is brown and turbulent. The background shows a shoreline with trees and hills.</div>

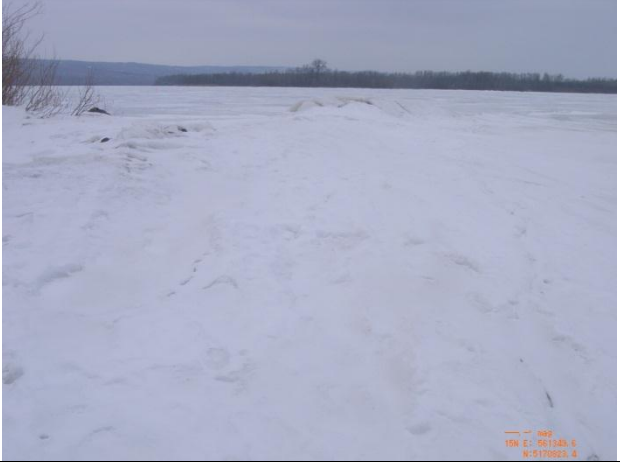
<p>Station #4, Looking NE 3/4/2011, 12:25</p>

The southern shoreline of the spit (northern edge of Wire Mill Delta) also had ice frozen to the bed, where it melted in-place. The area southeast of the spit (near observation Stations 4 and 5) is shallow with a significant amount of emergent vegetation that prevents thick ice from forming. Some small, localized sediment ridging was observed near Station 5, possibly due to early-winter wind driving ice into the shoreline. This ridging was not consistent or predominant along the southern shoreline of the spit. Also of note in this area is the tilting of the ice due to water level drop over the winter, with subsequent cracks running parallel to shore.

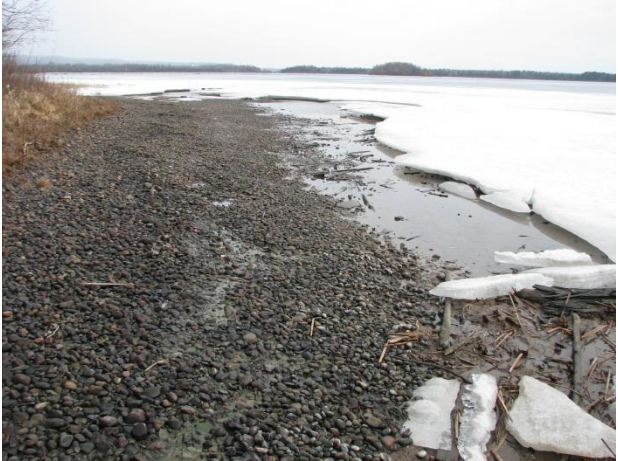
<div>Station #8 , Looking N 4/4/2011, 10:40</div> <div>

A photograph showing a rocky shoreline with a large, flat, white ice sheet extending from the water onto the beach. The sky is overcast.</div>	<div>Station #8 , Looking N 4/6/2011, 11:55</div> <div>

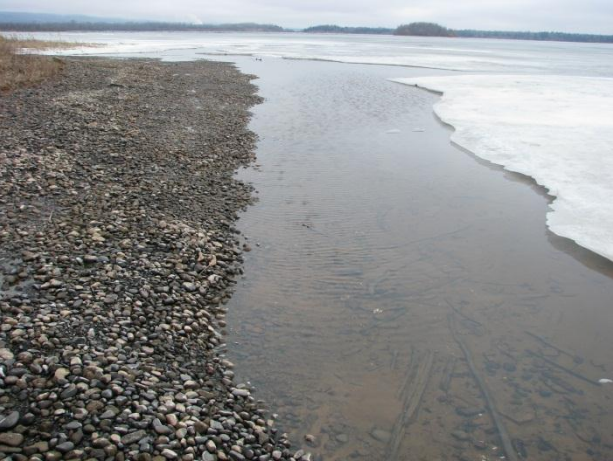
A photograph showing a rocky shoreline with a narrow channel of water between the beach and a large ice sheet. The sky is overcast.</div>	<div>Station #8 , Looking N 4/8/2011, 11:58</div> <div> A photograph showing a rocky shoreline with a narrow channel of water between the beach and a large ice sheet. The sky is clear and blue.</div>
<div>Station #8 , Looking N 4/14/2011, 12:53</div> <div>

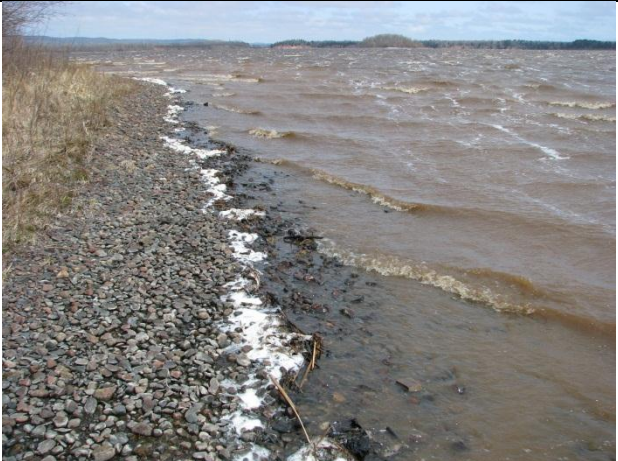
A photograph showing a rocky shoreline with a narrow channel of water between the beach and a large ice sheet. The sky is clear and blue.</div>
