June 27, 2012

RE: **Residential Water/GAC System Sampling and Site Data Review**
Bulinski Point
Ely, Minnesota
MPCA ID: SA#4493
BW J110583

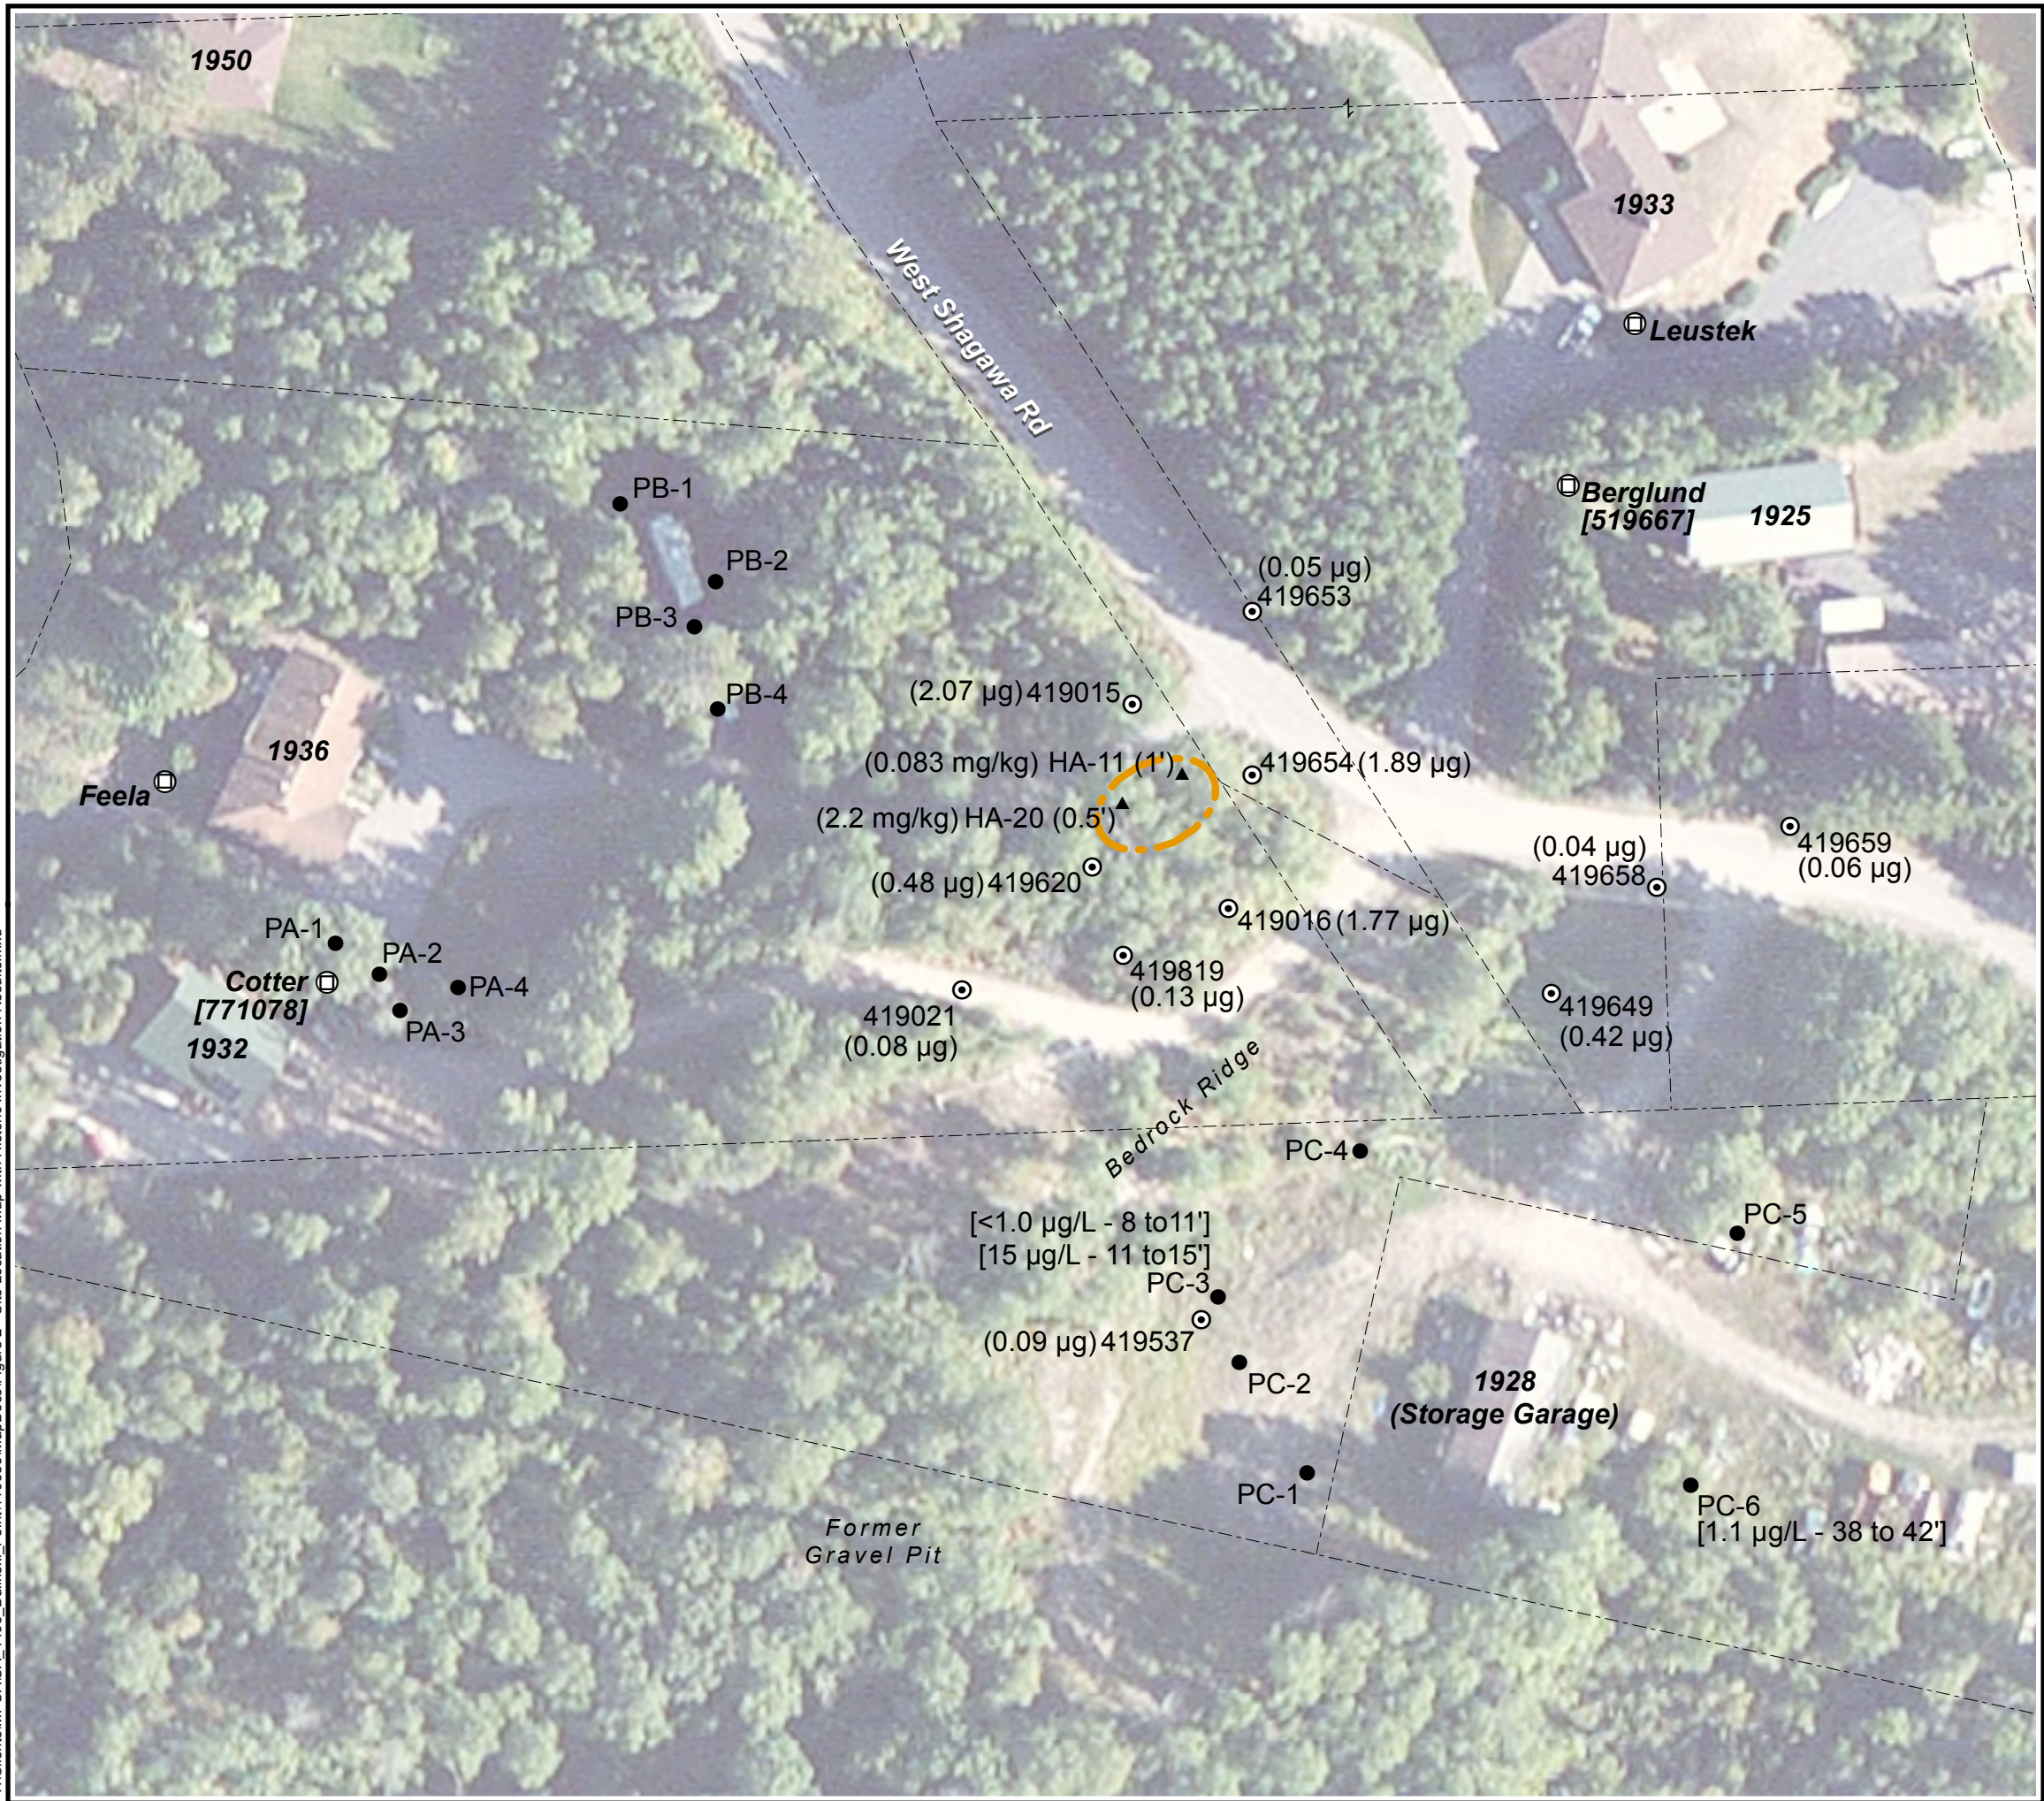
Figure 2 Site Map with Historic Investigation Results

along West Shagawa Road between the driveway to the Feela (former Wittrup) residence and entrance to the Bulinski property (**Figure 2** and **Historic Figure 1**). The Gore-Sorber data suggested that the source area may be located between the bedrock ridge and the Feela driveway; however, a definitive PCE source area was not identified. Terracon indicated that the lower PCE concentrations detected in screening survey modules along West Shagawa Road were likely indicative of the PCE plume migrating towards the Berglund and Leustek potable wells.

PCE vapors were detected at concentrations ranging from 0.03 to 2.07 μg in the area adjacent to the Feela (former Wittrup) driveway (**Figure 2** and **Historic Figure 1**), as identified in the April 2003 survey. The survey results identified a potential source of PCE contamination on the former Wittrup property, located adjacent to the south of the driveway entrance to the former Wittrup property from West Shagawa Road. The Gore-Sorber sampling results are summarized on **Historic Table 3**.

PCE was detected in soil samples HA-11 (1 foot) and HA-20 (0.5 feet) at concentrations of 0.083 milligrams per kilogram (mg/kg) and 2.2 mg/kg, respectively (**Figure 2** and **Historic Figure 2**). These PCE concentrations are below the MPCA established Tier 1 Soil Reference Value (SRV) of 72 mg/kg; however, they are above the MPCA Tier 1 Soil Leaching Value (SLV) of 0.068 mg/kg. PCE was not detected in the 10 other hand auger soil samples.

During the 2005 Source Area Investigation, PCE was detected in soil samples HA-11 (1 foot) and HA-20 (0.5 foot) at concentrations of 0.083 milligrams per kilogram (mg/kg) and 2.2 mg/kg, respectively. These results indicate that the surface soil is impacted by PCE in the suspected source area (**Figure 2**).

The previous investigation activities at the site have identified a potential PCE source area at 1936 West Shagawa Road (Feela), located adjacent to the south of the Feela driveway and west of West Shagawa Road (**Figure 2**). The discovery of abandoned PCE-labeled drums, historic occupancy of the property by the Wittrups (dry cleaning operators), and identified surface soil impacts indicate that the PCE release was likely caused by dumping and/or spilling dry cleaning solvents and/or associated wastes at 1936 West Shagawa Road (Feela).

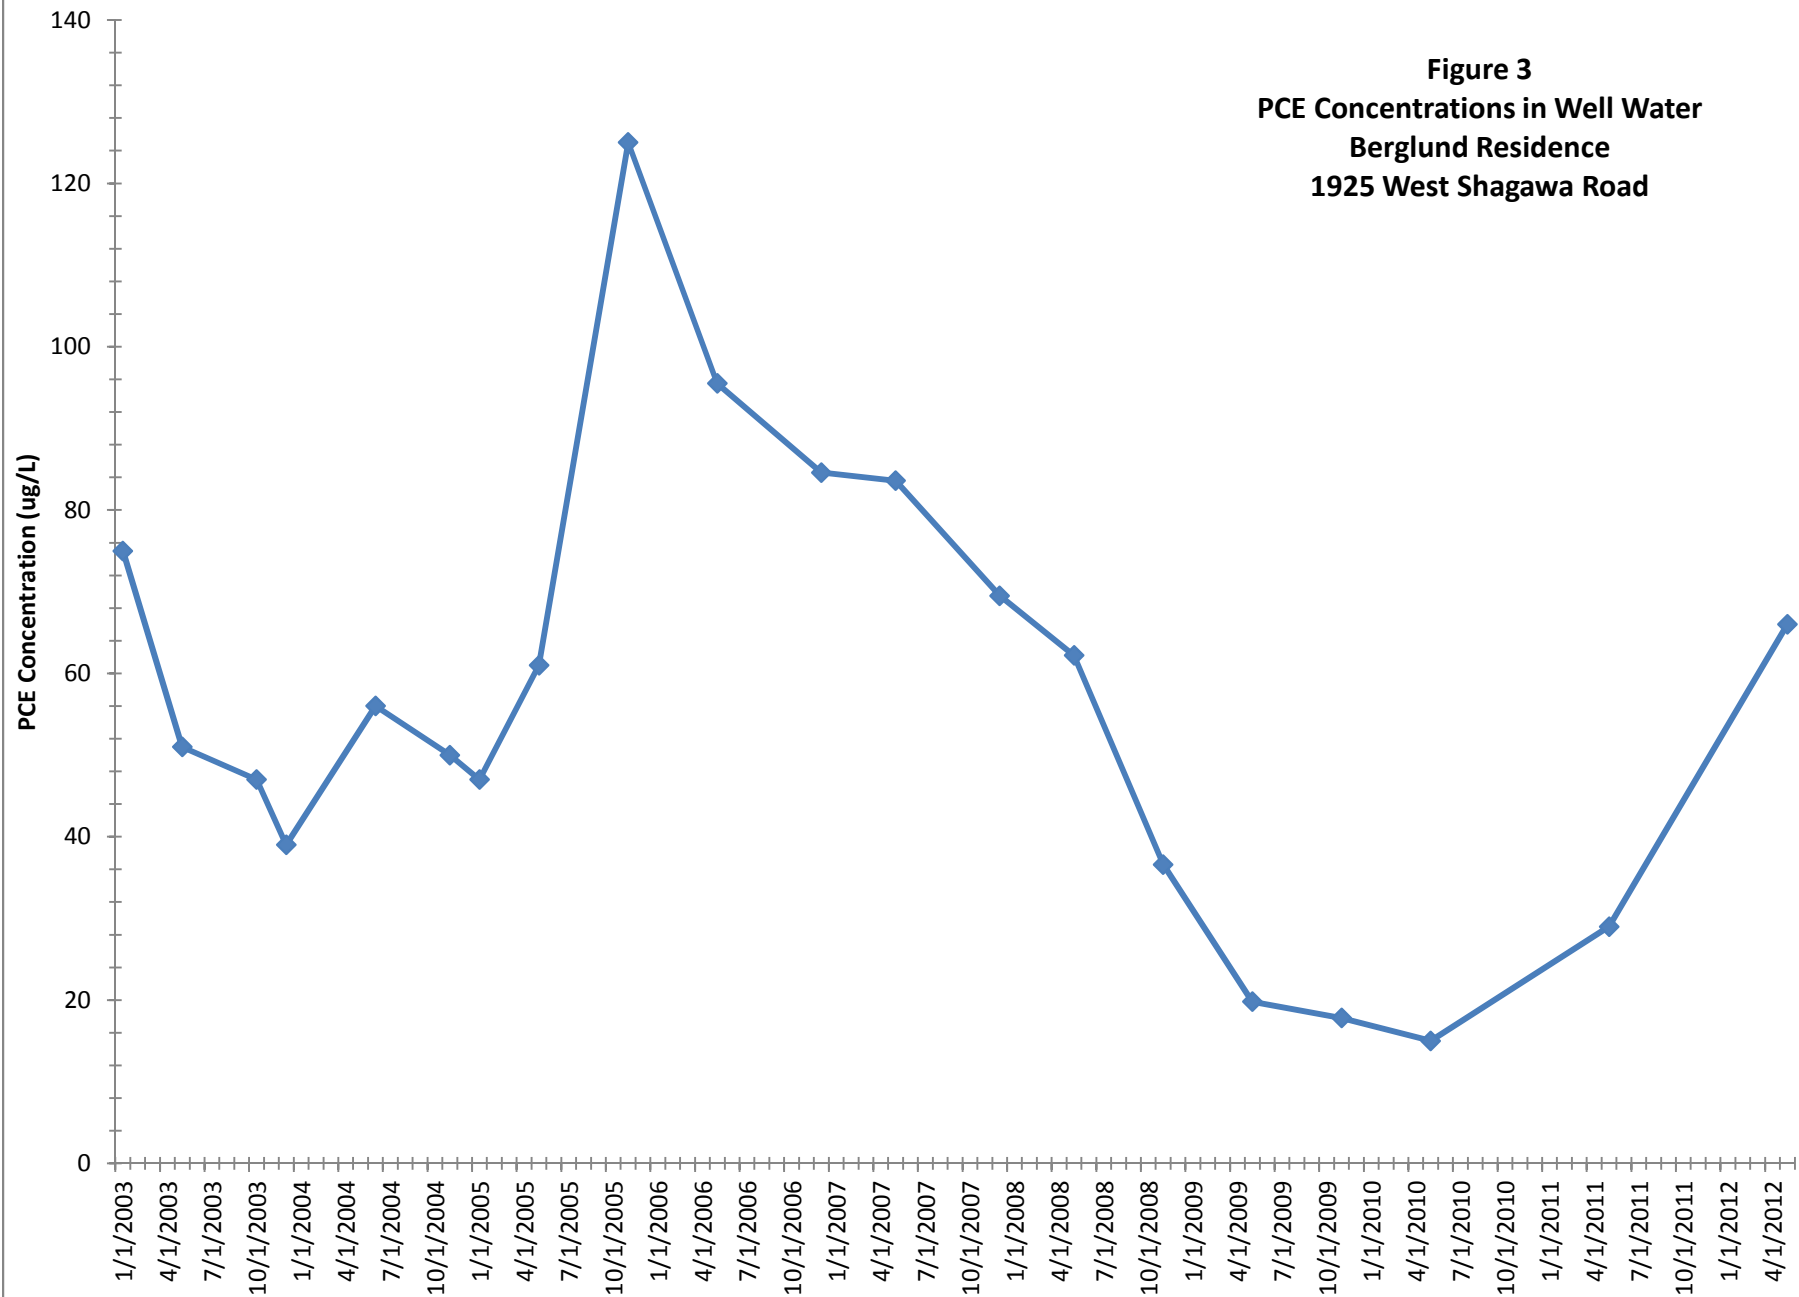
Figure 3
PCE Concentrations in Well Water
Berglund Residence
1925 West Shagawa Road

PCE concentrations in raw water samples collected from the Berglund well have ranged from 15 to 125 µg/L, with a concentration of 66 µg/L during the most recent sampling event on May 10, 2012. The PCE concentrations appear to be decreasing over time; however, the most recent PCE concentration of 66 µg/L is elevated compared to PCE concentrations since November 2008. A graph depicting PCE concentrations over time in the Berglund well is included as **Figure 3**.

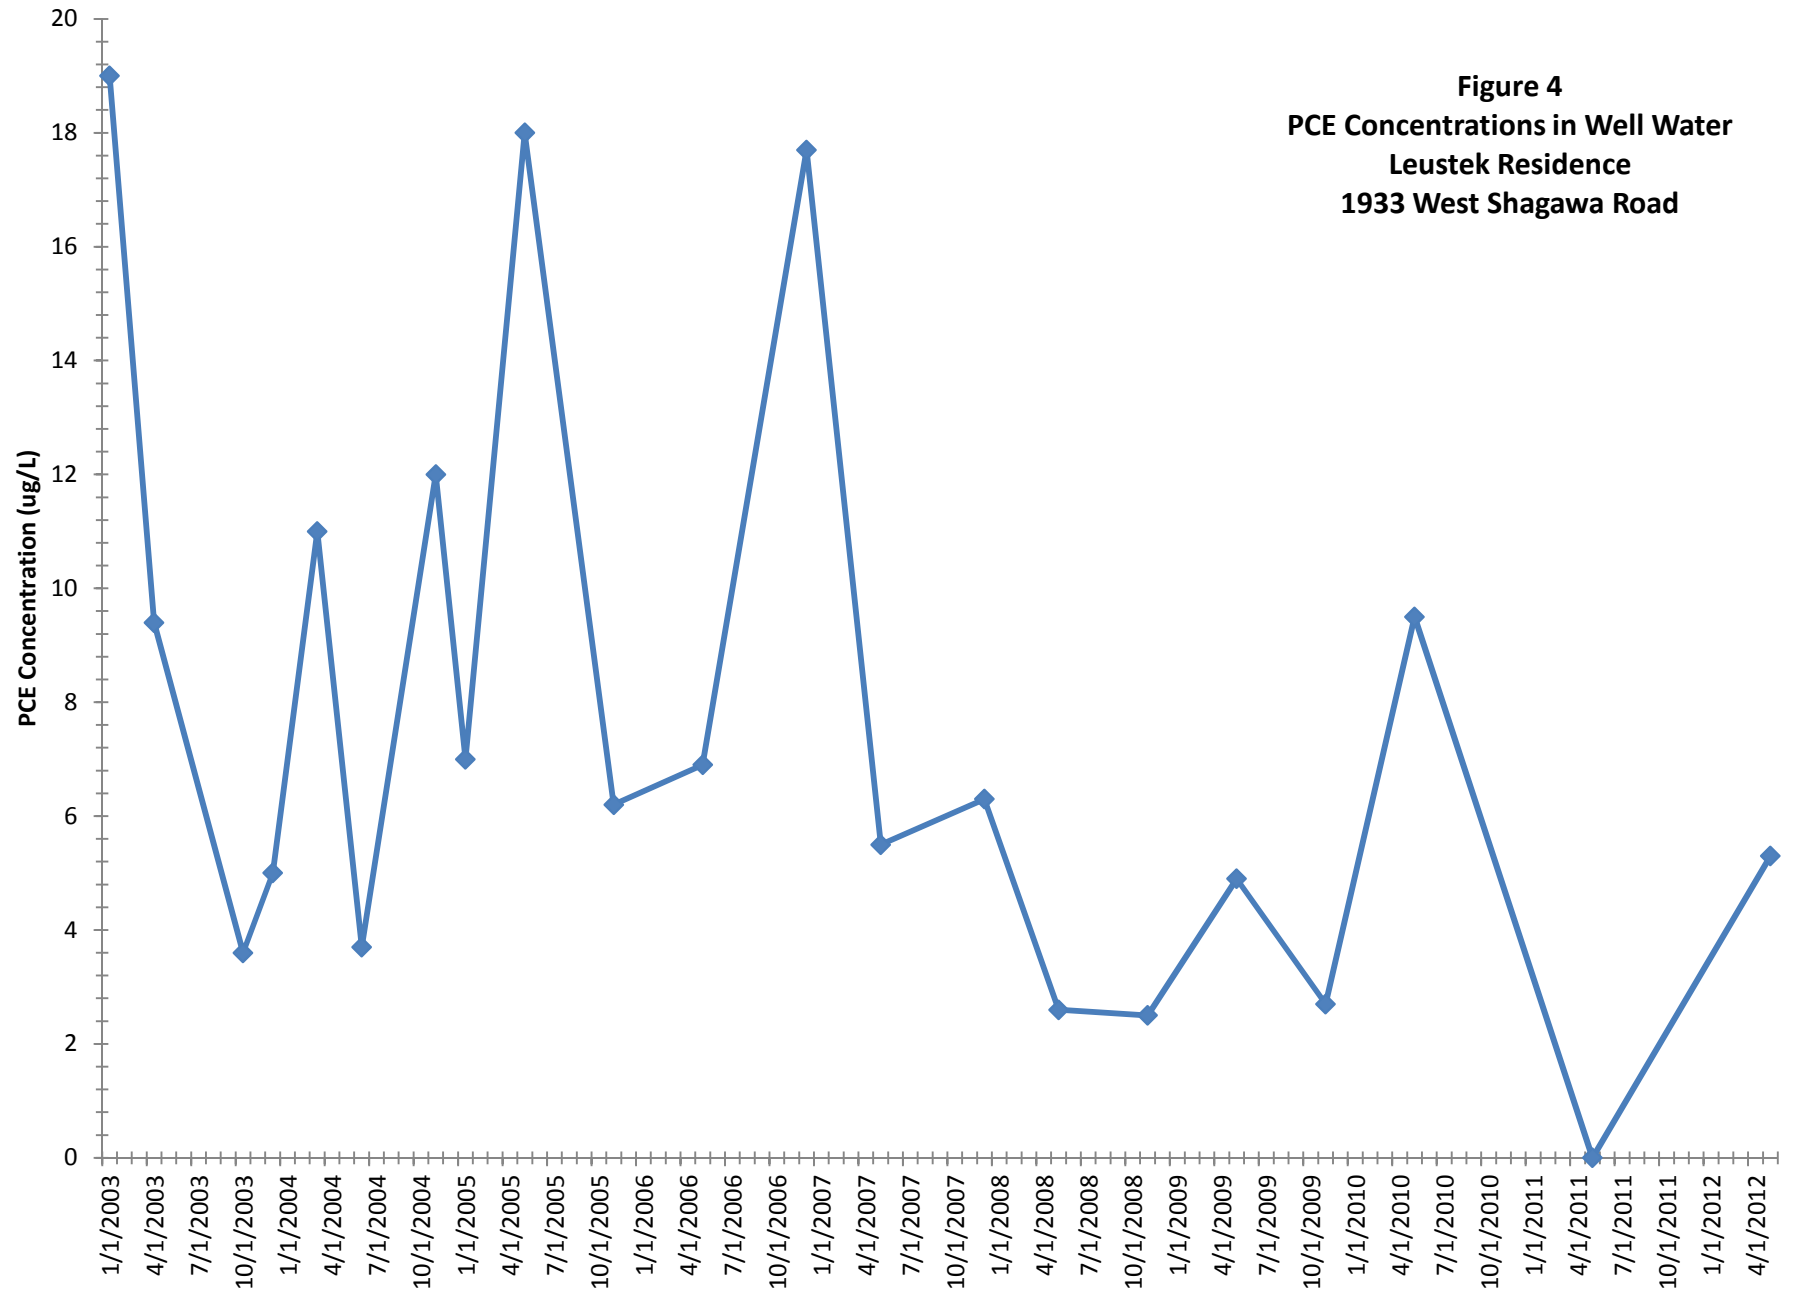
Figure 4
PCE Concentrations in Well Water
Leustek Residence
1933 West Shagawa Road

PCE concentrations in raw water samples collected from the Leustek well have ranged from non-detect to 19 µg/L, with a concentration of 5.3 µg/L during the most recent sampling event on May 10, 2012. The PCE concentrations appear to be decreasing over time. A graph depicting PCE concentrations over time in the Leustek well is included as **Figure 4**.

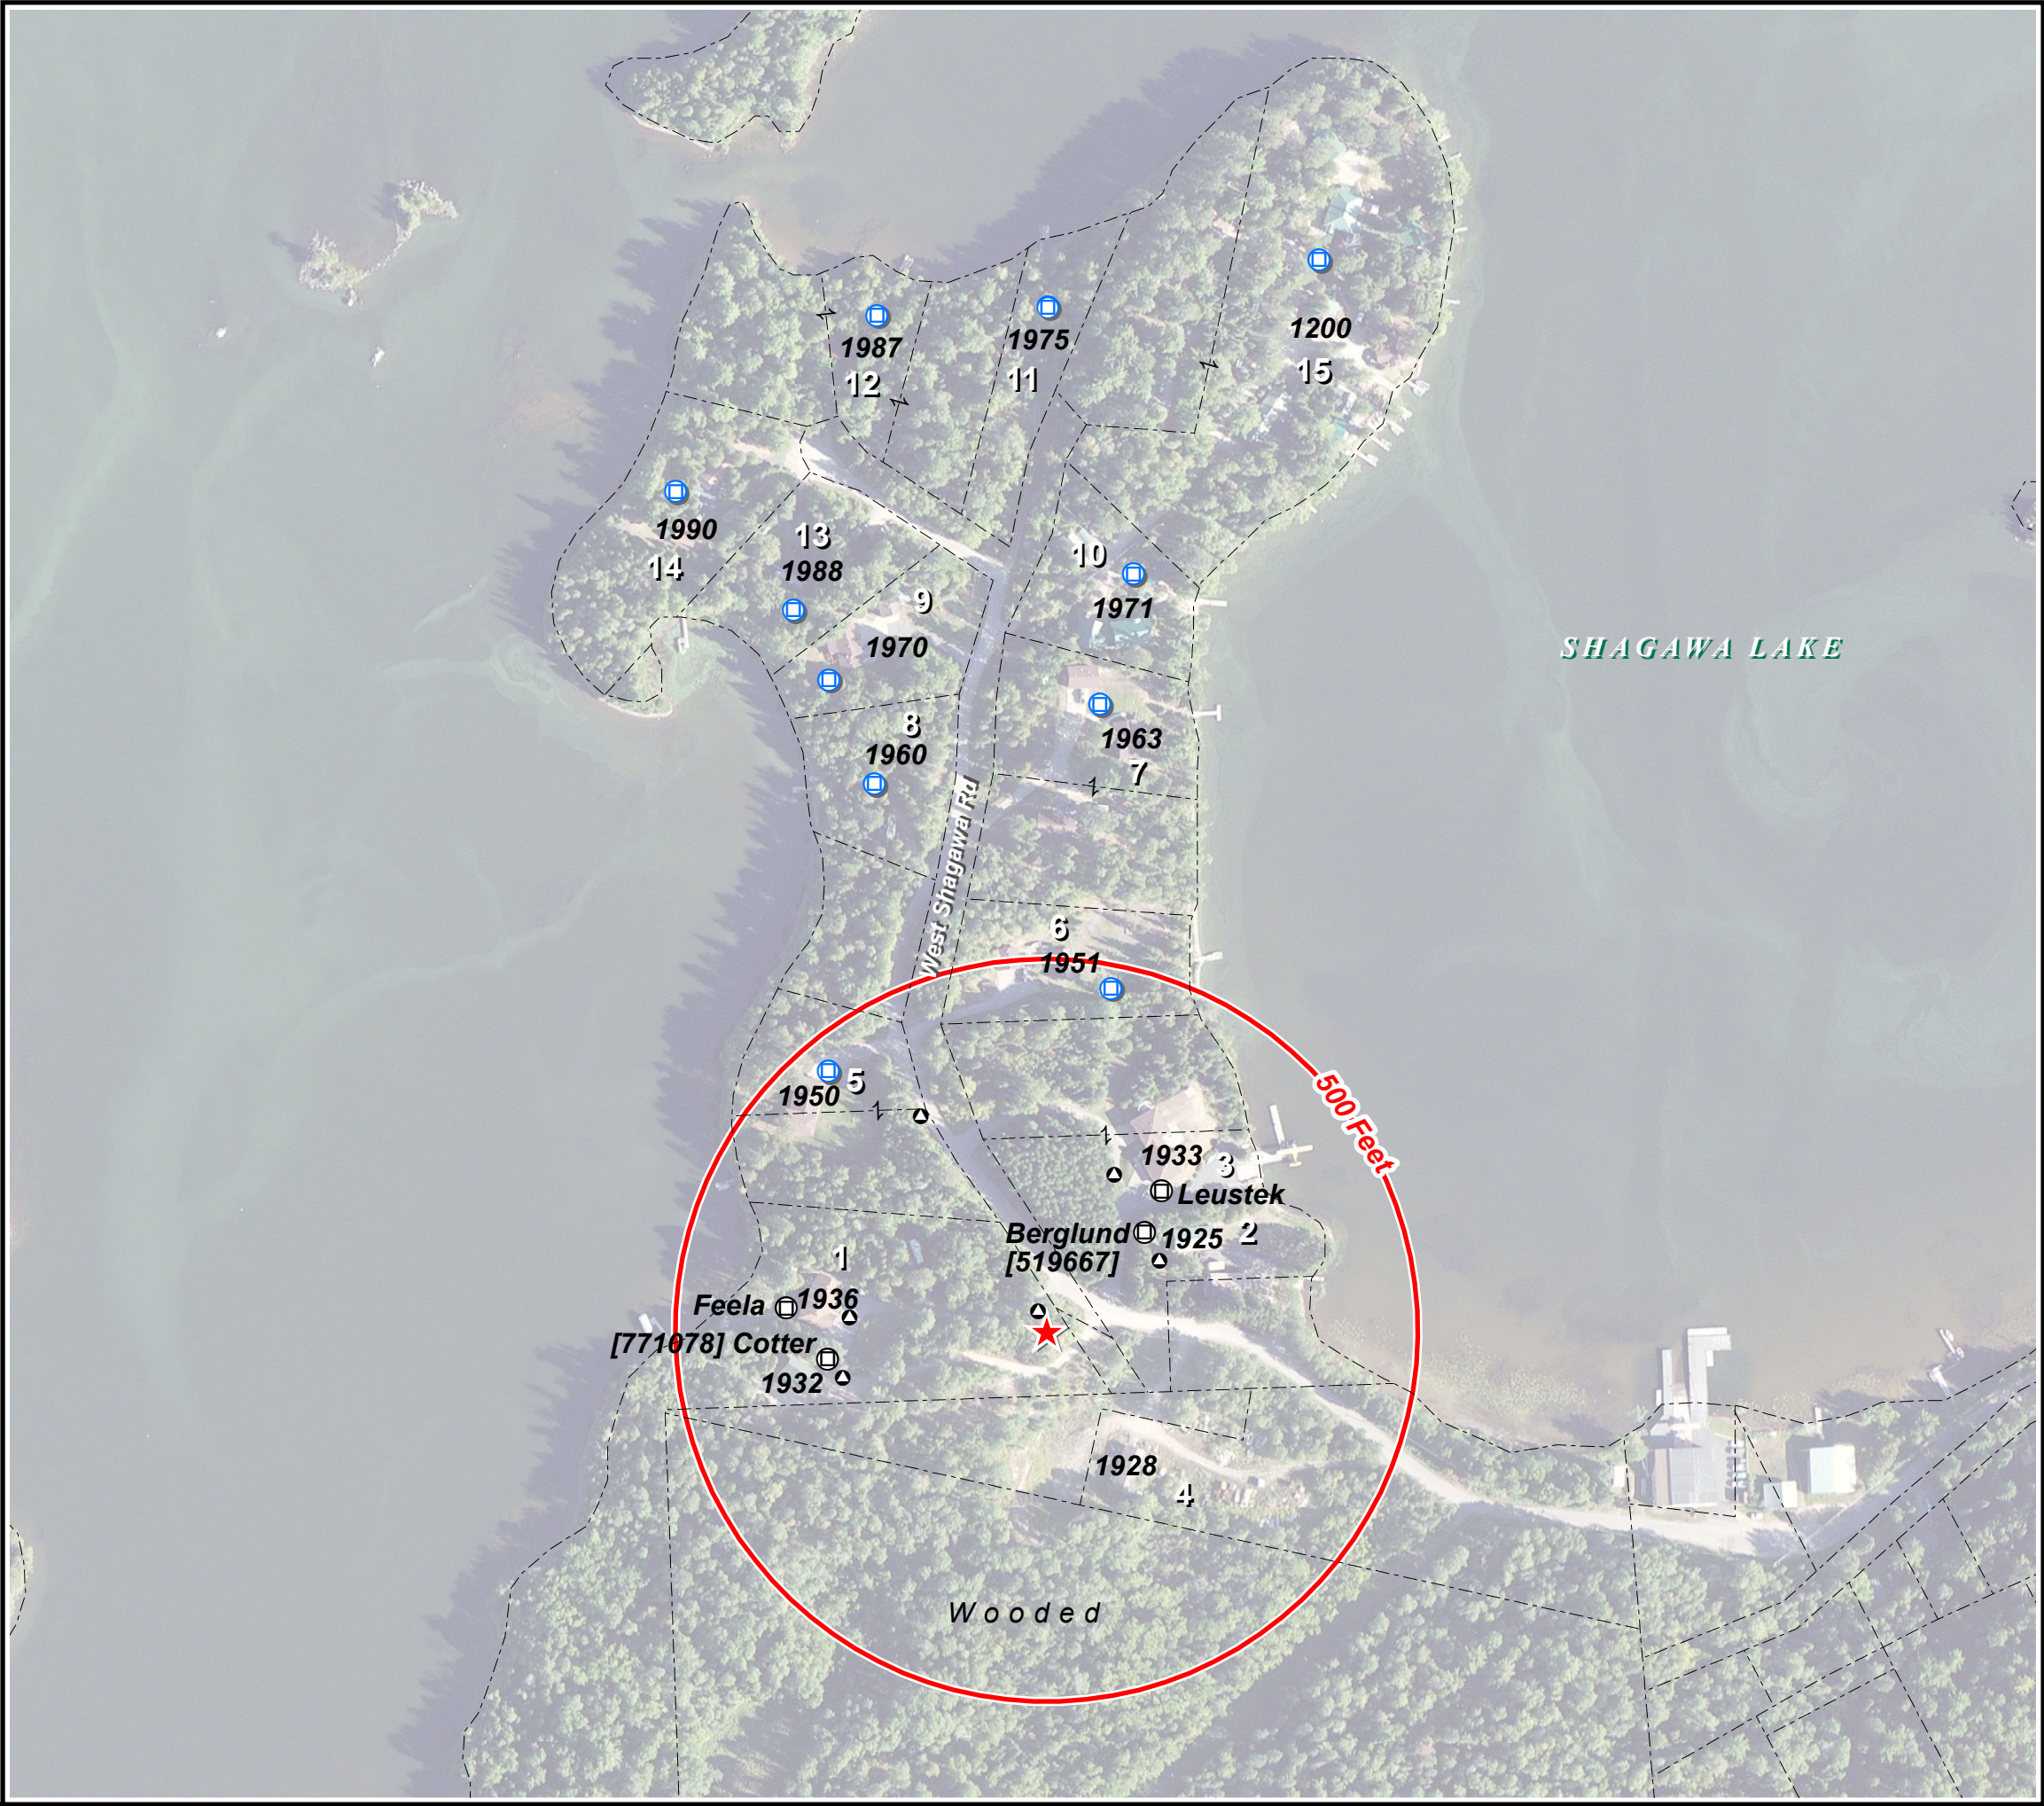
Figure 5
Potential Receptor Survey Map

- Perform a vapor intrusion assessment by collecting a soil gas sample in the suspected source area and at locations between the suspected source area and the five residences immediately surrounding the source area, including: 1925 (Berglund), 1932 (Cotter), 1933 (Leustek), 1936 (Feela), and 1950 West Shagawa Road. The proposed soil gas sampling locations are indicated on **Figure 5**.

¹ Property IDs correspond to labeled properties on Figure 5, Potential Receptor Map.
