**REMEDIAL INVESTIGATION REPORT**  
*PHASE 2*  
*FLUOROCHEMICAL (FC) DATA ASSESSMENT REPORT*  
*FOR THE*  
*COTTAGE GROVE, MN SITE*

**June 2007**

**3M Company**

**WESTON SOLUTIONS, INC.**  
**West Chester, Pennsylvania 19380**

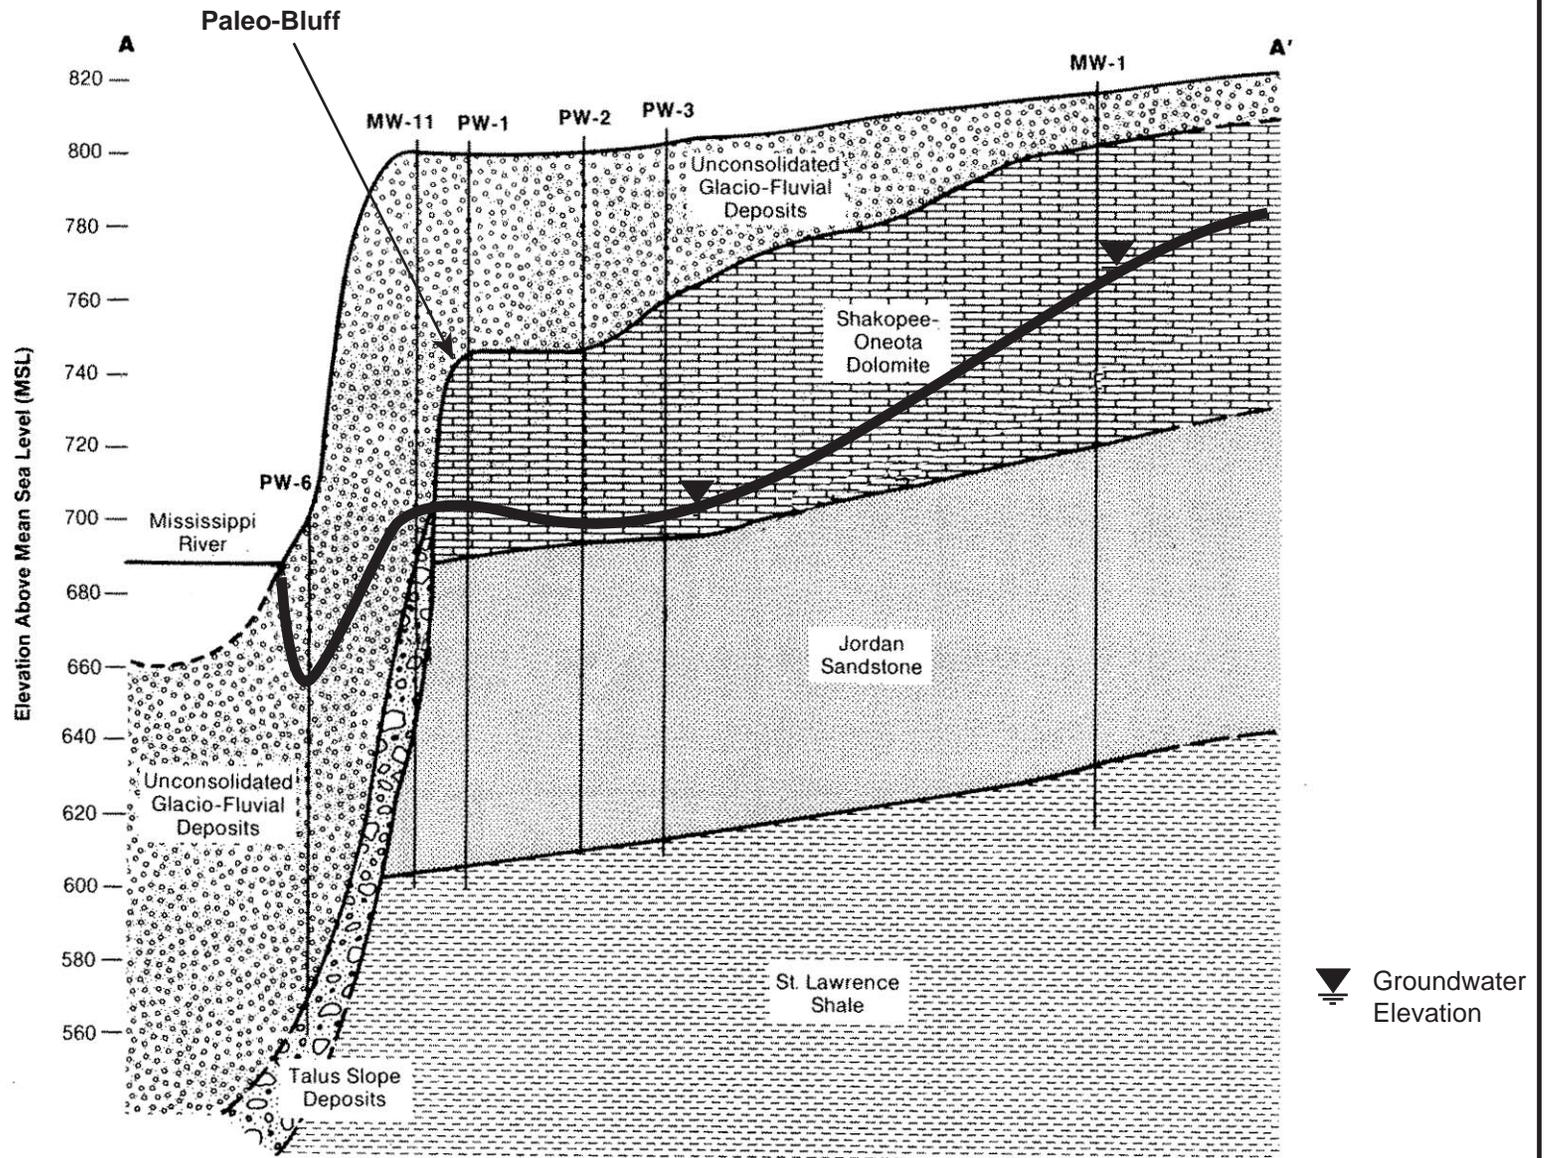
**FIGURE 2-3 GENERALIZED STRATIGRAPHIC CROSS SECTION A-A'  
COTTAGE GROVE SITE**

As shown on cross section A-A' (Figure 2-3), the Cottage Grove Site is directly underlain by fill material and unconsolidated glacio-fluvial deposits of probable Quaternary age. The transect used in the cross section is shown in Figure 2-4. In the northern portion of the property, unconsolidated deposits range from a few feet to a few tens of feet in thickness. Groundwater was not observed to be present in the unconsolidated deposits in this area. The unconsolidated deposits increase in thickness from north to south across the site and are over 100 feet thick near the Mississippi River where a buried bedrock valley exists. The bedrock surface closely mimics the present-day topography and the cliff line

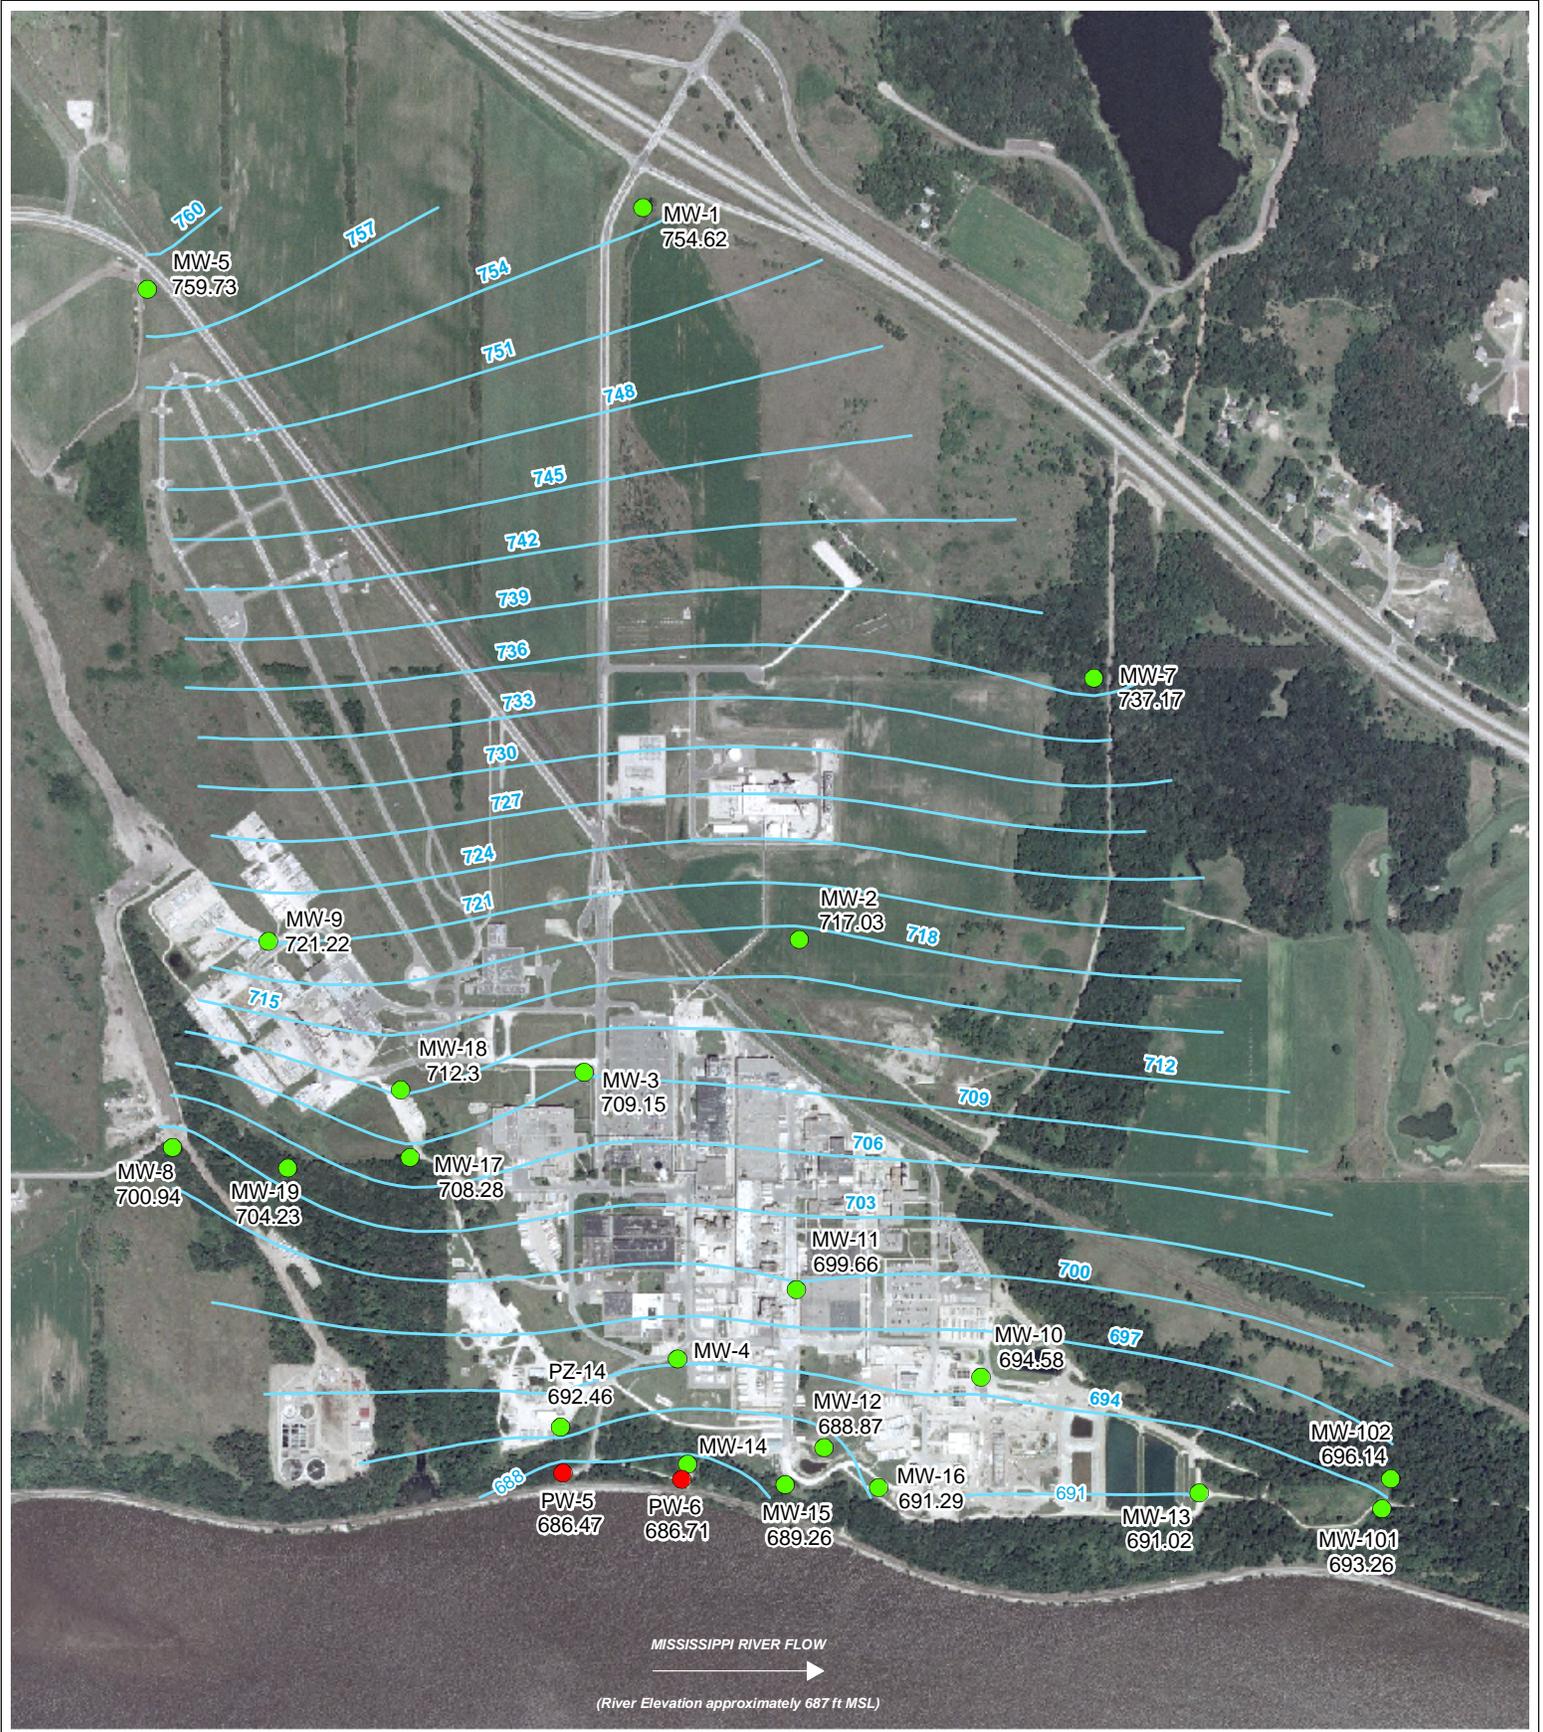
**FIGURE 2-6**  
**GROUNDWATER ELEVATION**  
**CONTOUR MAP**  
**NON-PUMPING CONDITIONS**  
**8 MAY 2006**  
**COTTAGE GROVE SITE**

Figure 2-6 depicts the configuration of the water table surface at the plant in May 2006 during conditions when PW-5 and PW-6 were not pumping. Groundwater elevation data indicate a southerly groundwater gradient toward the Mississippi River. The calculated hydraulic gradient is on the order of 0.01 ft/ft. Groundwater levels have been measured several times and the water table surface configurations have remained relatively consistent.

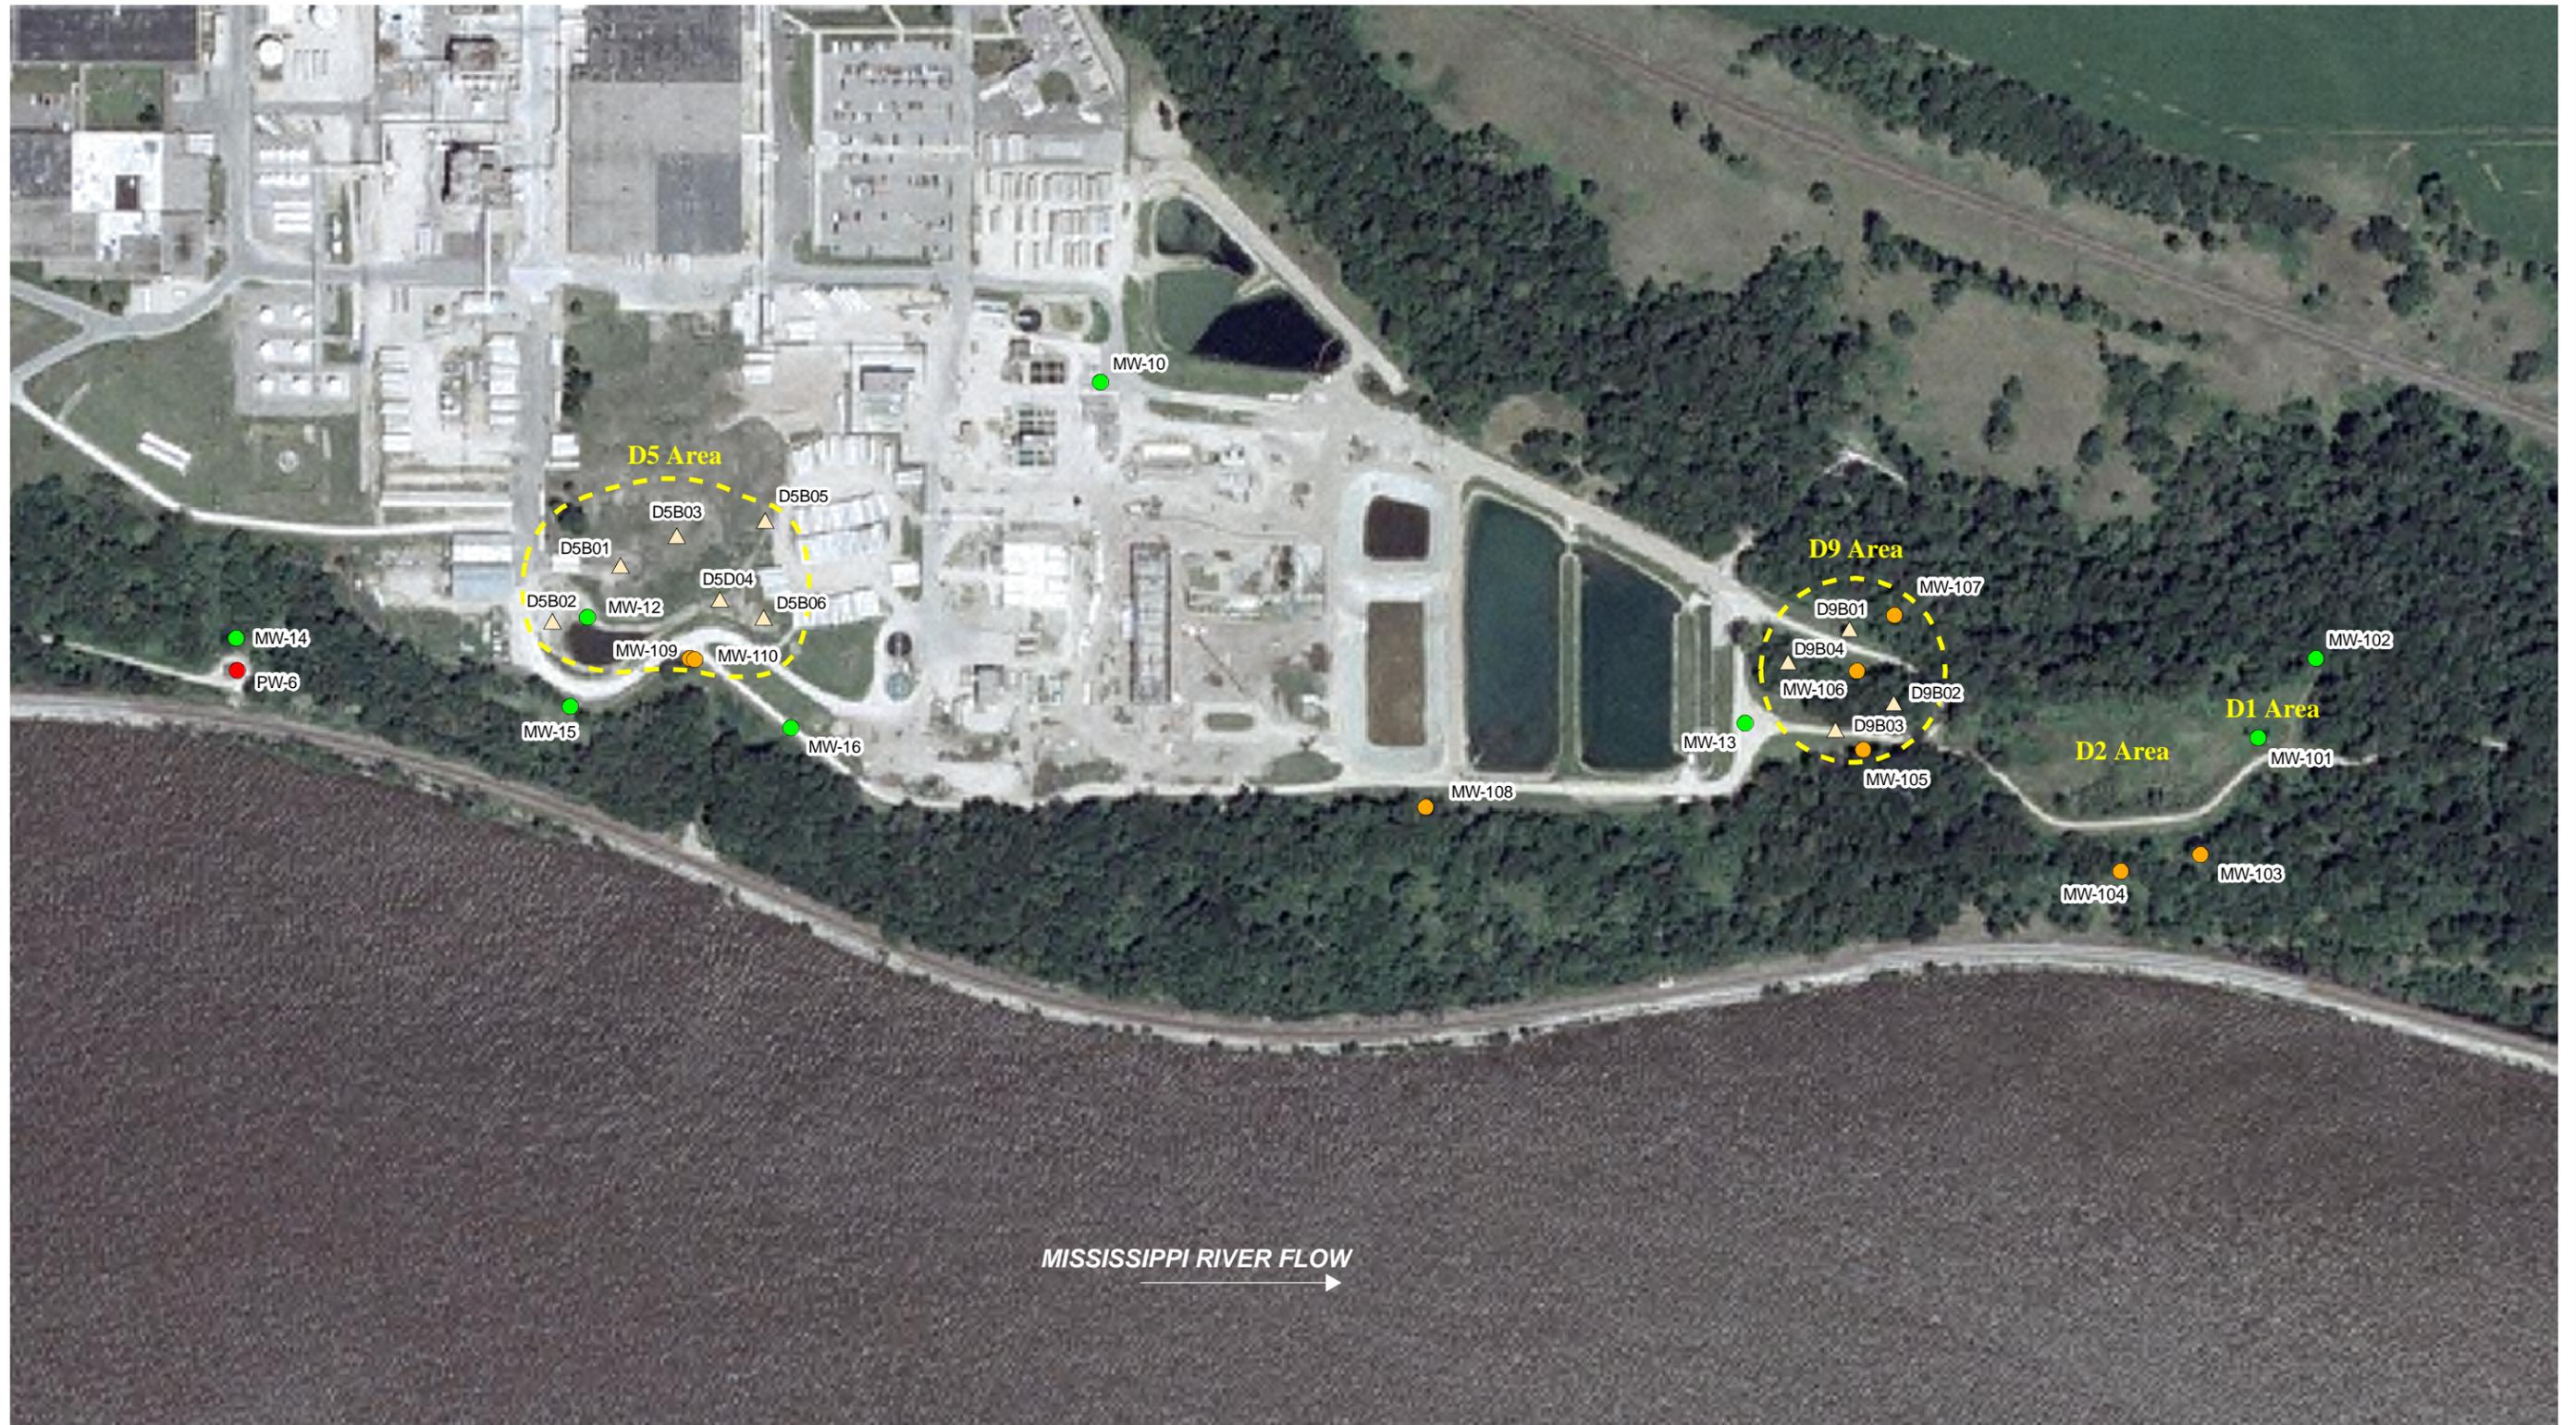
FIGURE 3-1  
 MONITORING WELL AND  
 SOIL BORING LOCATIONS - JUNE 2006  
 COTTAGE GROVE SITE

The monitoring wells are 2-inch ID with stainless steel screens and low carbon steel risers. The wells were installed using hollow-stem auger and split spoon sampling techniques. Continuous split spoon samples were collected and composited for laboratory analysis over 5 foot intervals to a depth of 25 feet. Below 25 feet, samples were collected every 5 feet to the total depth of the boring for lithologic description only. The borehole was logged by an experienced geologist noting color, texture, moisture content, and any odors or discoloration. The soils were also screened using an organic vapor meter (OVM) and readings were recorded on the soil boring logs.

In addition to soil samples collected for FC analyses during the monitoring well installation, ten soil borings (D5B01 through D5B06 and D9SB01 through D9SB04) were installed on June 20 and 21, 2006 in the D5 and D9 areas. The locations of the soil borings are shown in Figure 3-1 and the rationale for each boring is described in Subsection 3.3. Composite soil samples were collected at specified intervals to boring termination for descriptive logging and analytical testing. The soil was logged by the on-site WESTON geologist noting color, texture, moisture content, and any odors or discoloration. The soils were also screened using an organic vapor meter (OVM) and readings were recorded on the soil boring logs. A copy of the soil boring logs is provided in Appendix B.

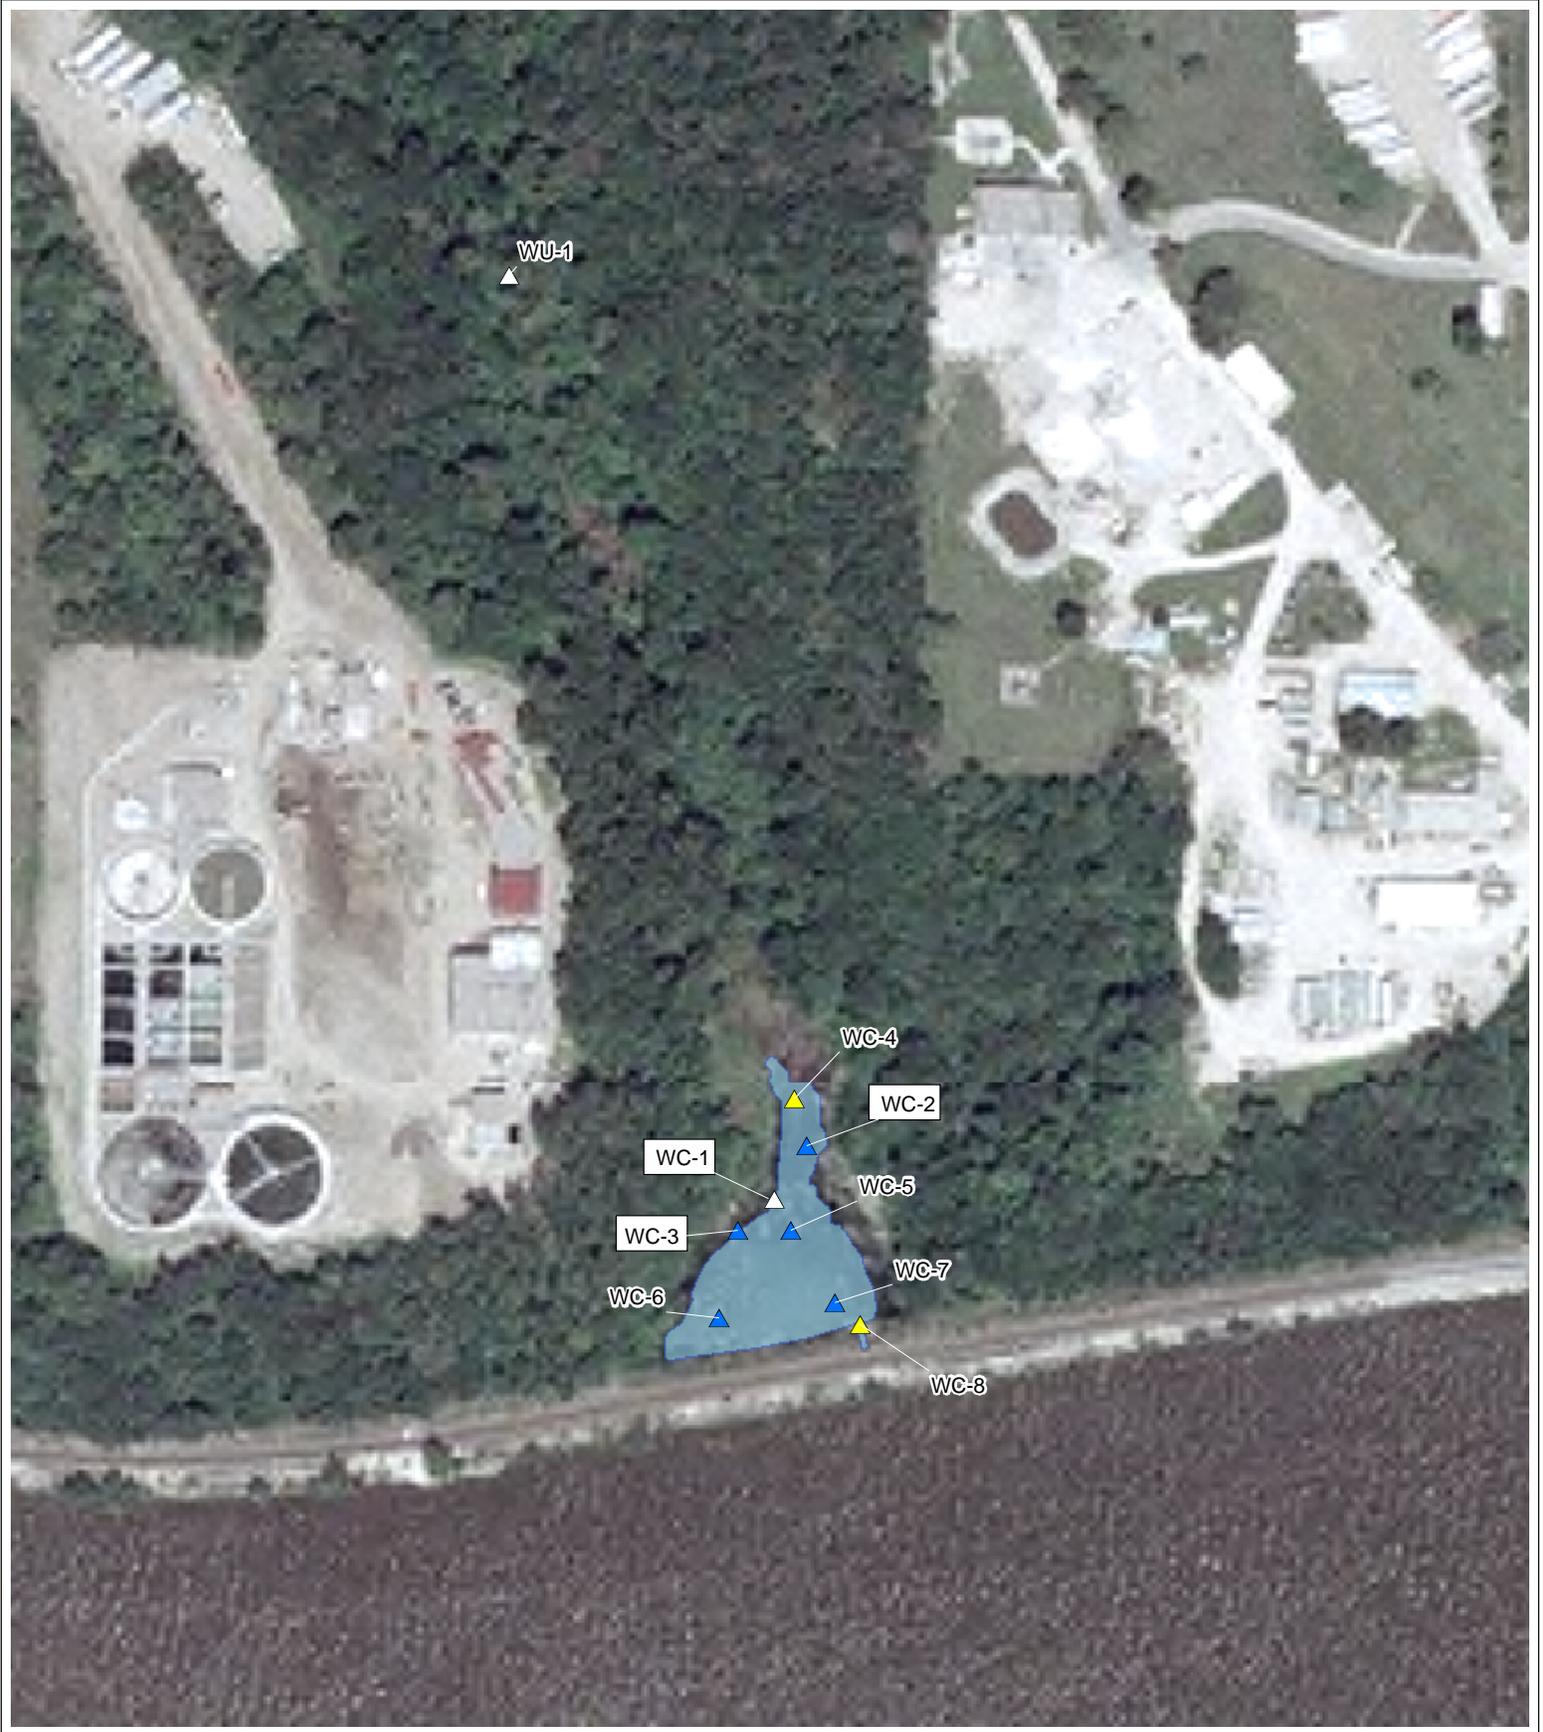
Figure 3-3  
Location of East and West Coves  
Cottage Grove Site

- West Cove 1 Acre
- WC-1 Phase 1 Sampling Locations
- Surface Water/Sediment Sampling Location
- Sediment Sampling Location
- Surface Water Sampling Location

As shown in Figure 3-3, the East and West Cove areas are surface water features adjacent to the Mississippi River and are located at the eastern and western ends of the Plant property. The East Cove receives regional surface water drainage and discharge water from the two NPDES-permitted discharges (cooling water and waste water treatment). The West Cove receives surface drainage from the Fire Training Area and the contractor storage yard to the east and north. From the west, surface drainage enters the west cove from the municipal sewage treatment plant area. The sewage treatment plant outfall discharges directly to the Mississippi River.

As depicted in Figures 3-3 and 4-7, the East Cove footprint is a 2 acre area that serves as the termination point for a drainageway located to the east of the Cottage Grove Site. It

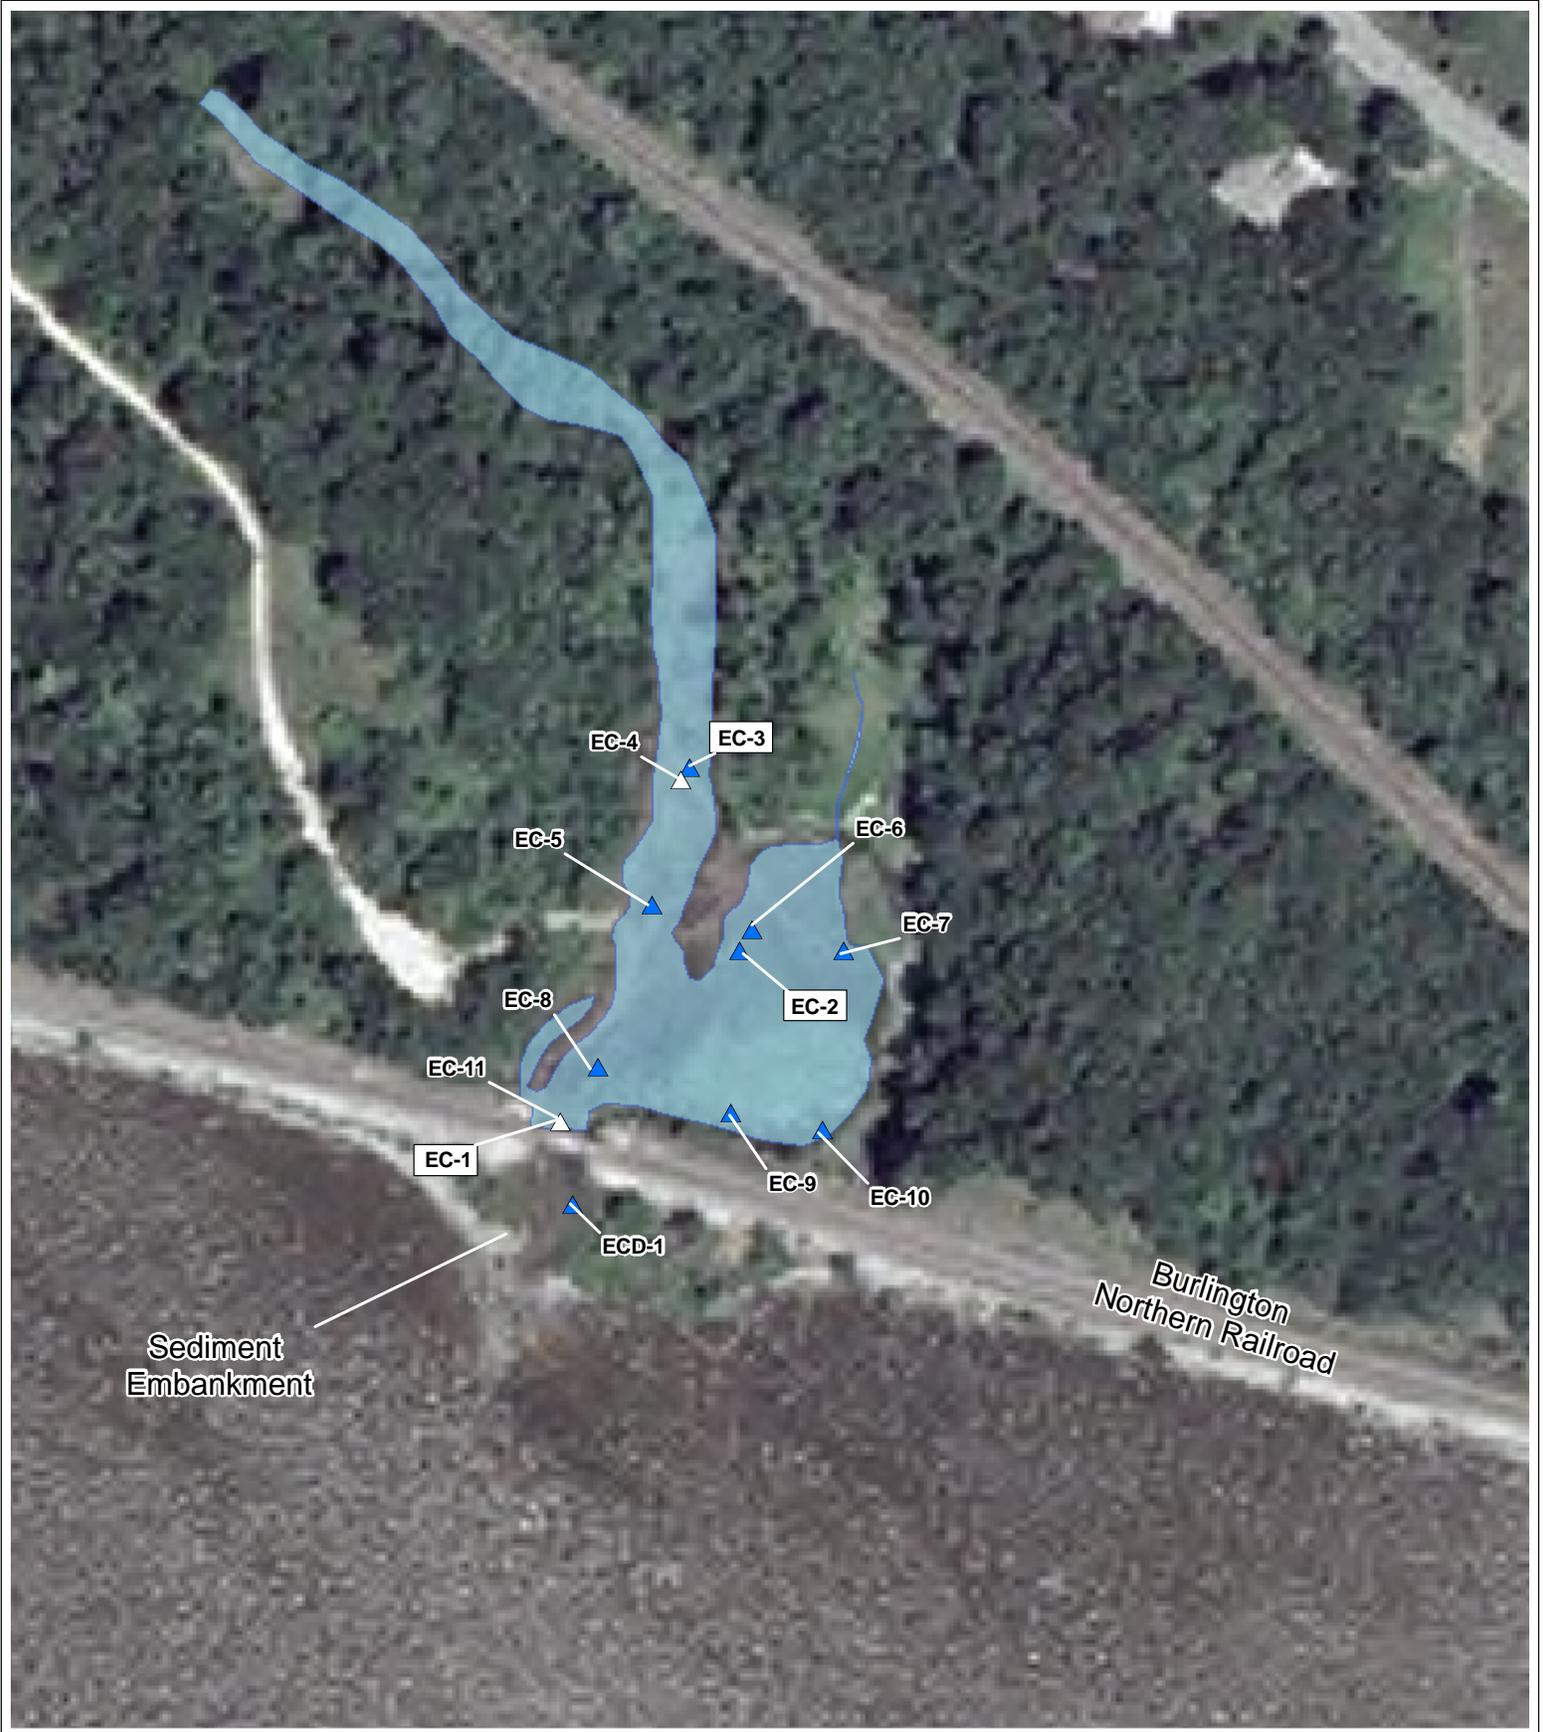
**FIGURE 3-4  
 SAMPLING LOCATIONS  
 WEST COVE  
 COTTAGE GROVE SITE**

- East Cove 2 Acres
- EC-1 Phase 1 Sampling location
- Surface Water/Sediment Sampling Location
- Sediment Sampling Location

In addition to coring to visually delineate the spatial extent of sediment deposits described above, subsamples were collected from selected core samples at locations in the West Cove and locations in the East Cove for FC analyses. The sampling locations are shown in Figures 3-4 and 3-5.

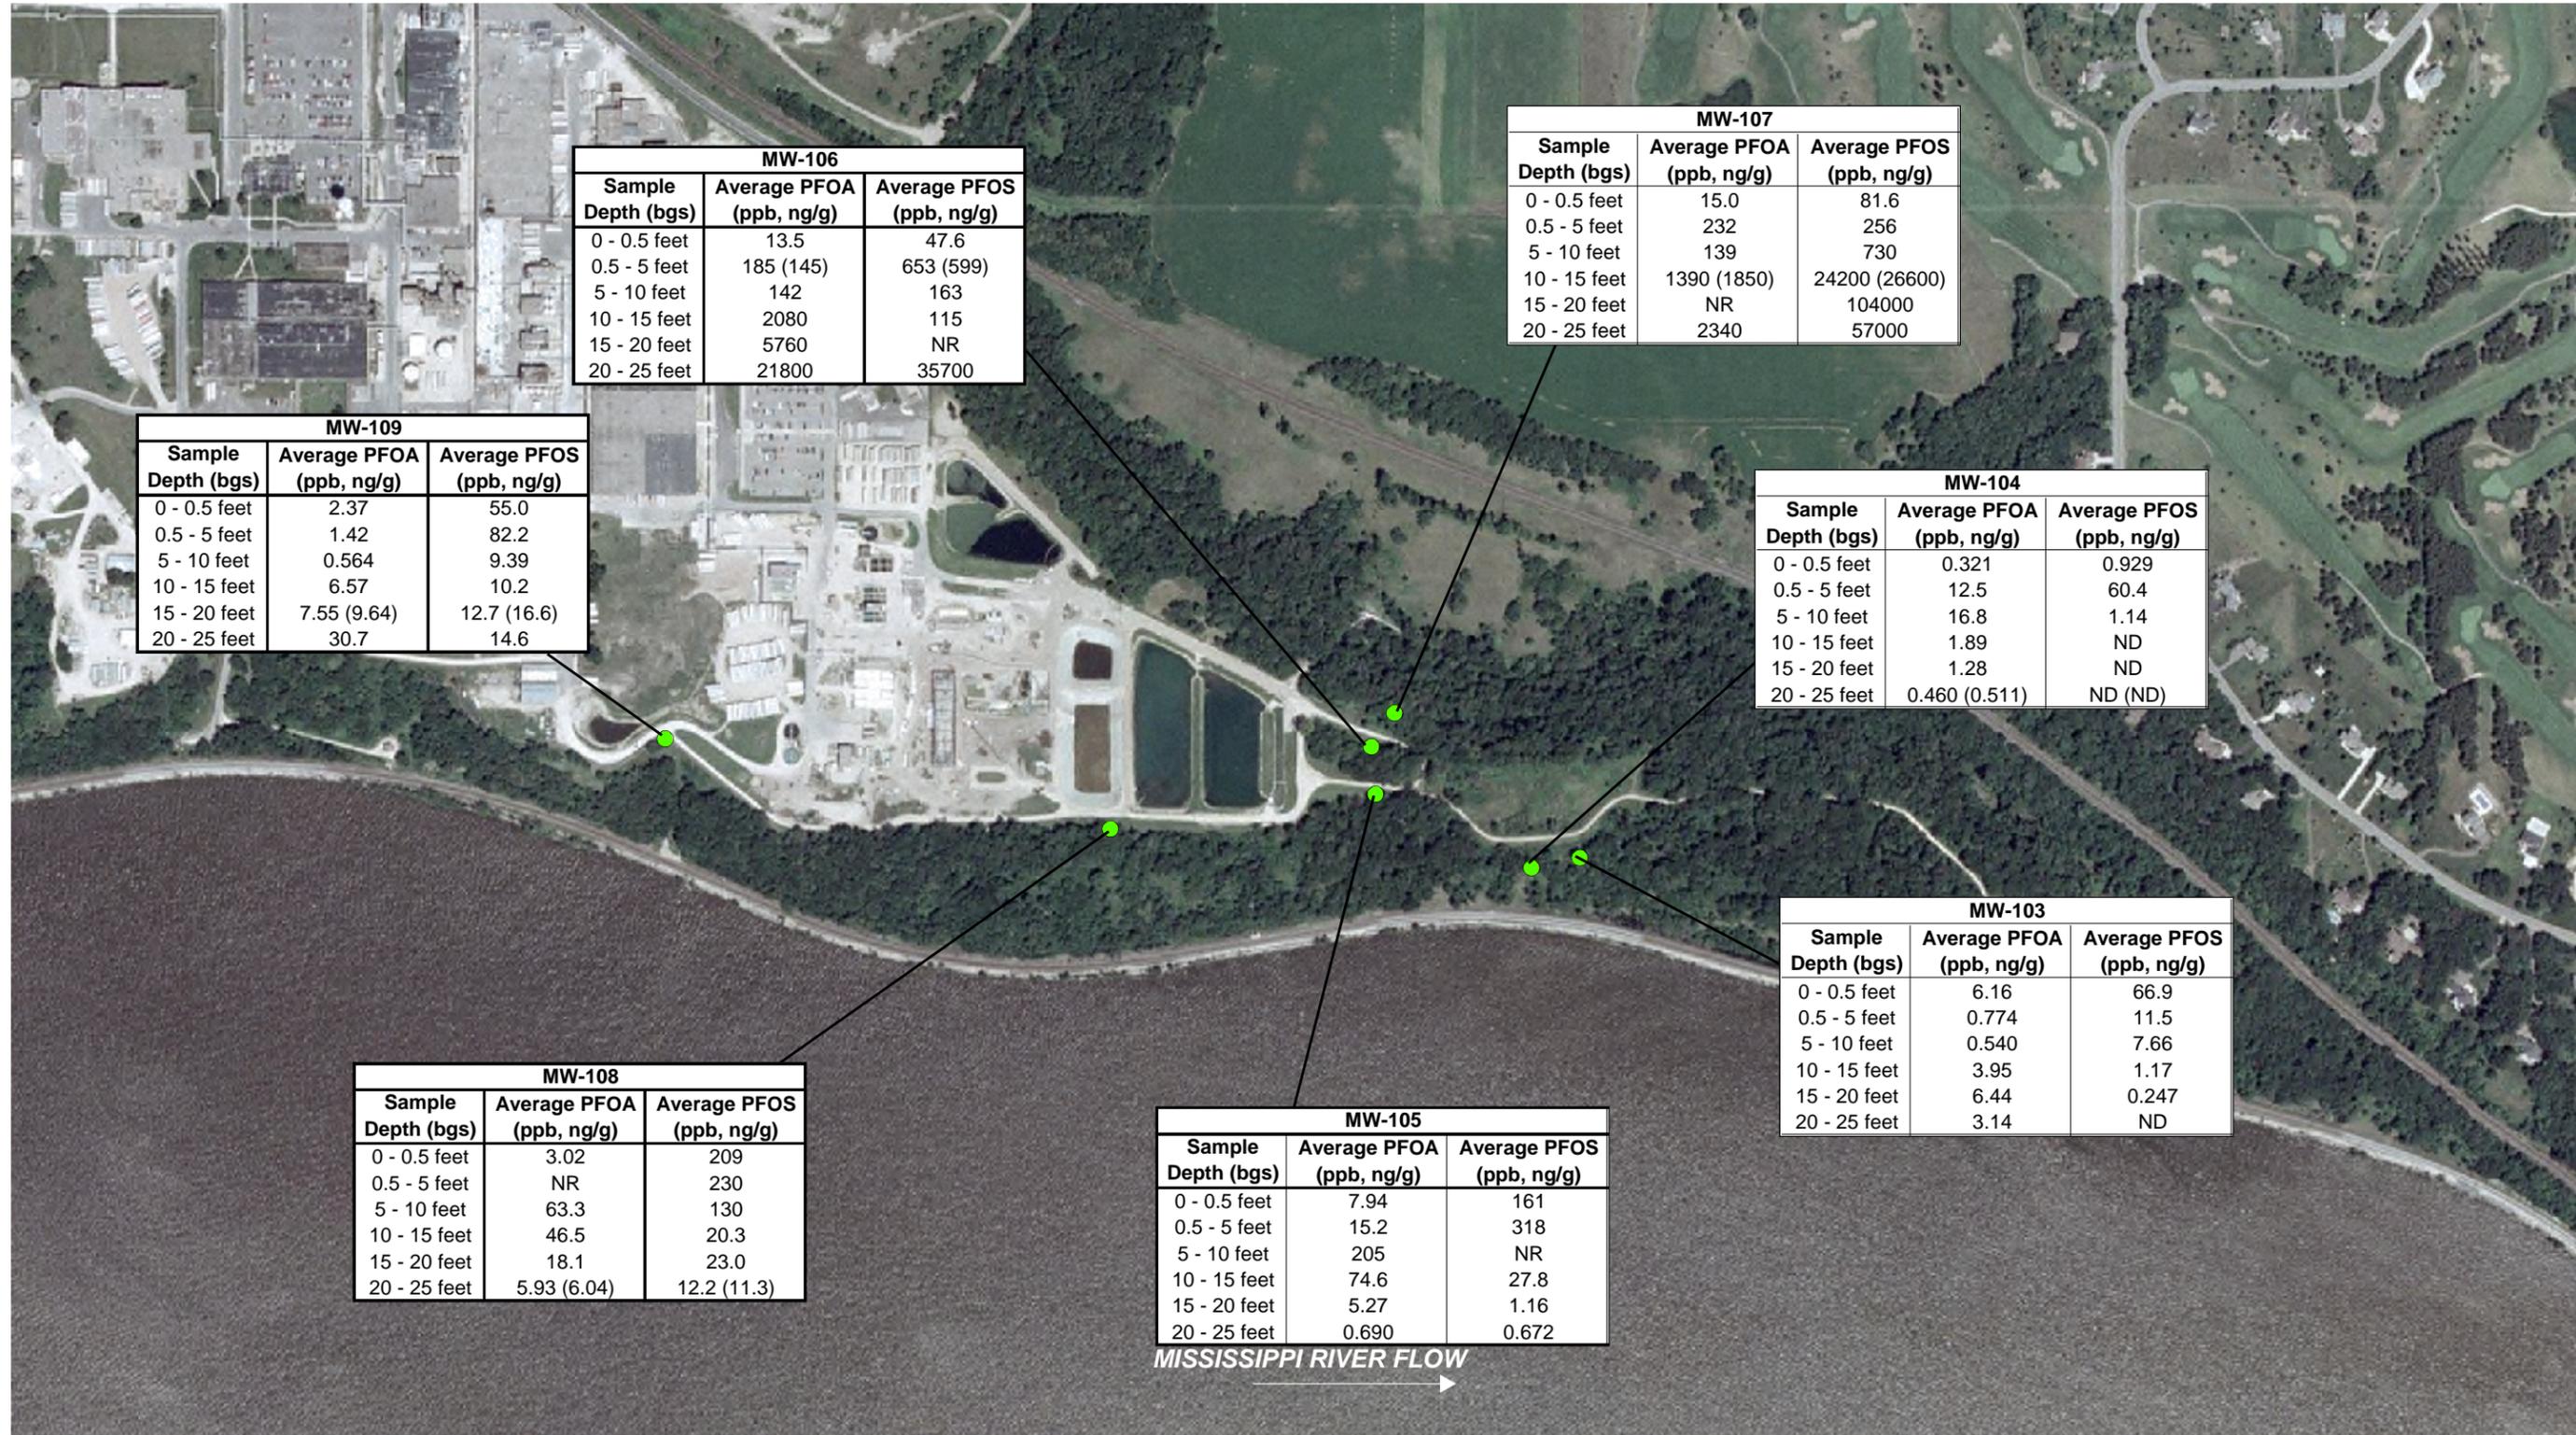
FIGURE 4-3  
 MONITORING WELL SOIL SAMPLES  
 PFOA AND PFOS CONCENTRATIONS  
 JUNE 2006  
 COTTAGE GROVE SITE

MW-106		
Sample Depth (bgs)	Average PFOA (ppb, ng/g)	Average PFOS (ppb, ng/g)
0 - 0.5 feet	13.5	47.6
0.5 - 5 feet	185 (145)	653 (599)
5 - 10 feet	142	163
10 - 15 feet	2080	115
15 - 20 feet	5760	NR
20 - 25 feet	21800	35700

MW-107		
Sample Depth (bgs)	Average PFOA (ppb, ng/g)	Average PFOS (ppb, ng/g)
0 - 0.5 feet	15.0	81.6
0.5 - 5 feet	232	256
5 - 10 feet	139	730
10 - 15 feet	1390 (1850)	24200 (26600)
15 - 20 feet	NR	104000
20 - 25 feet	2340	57000

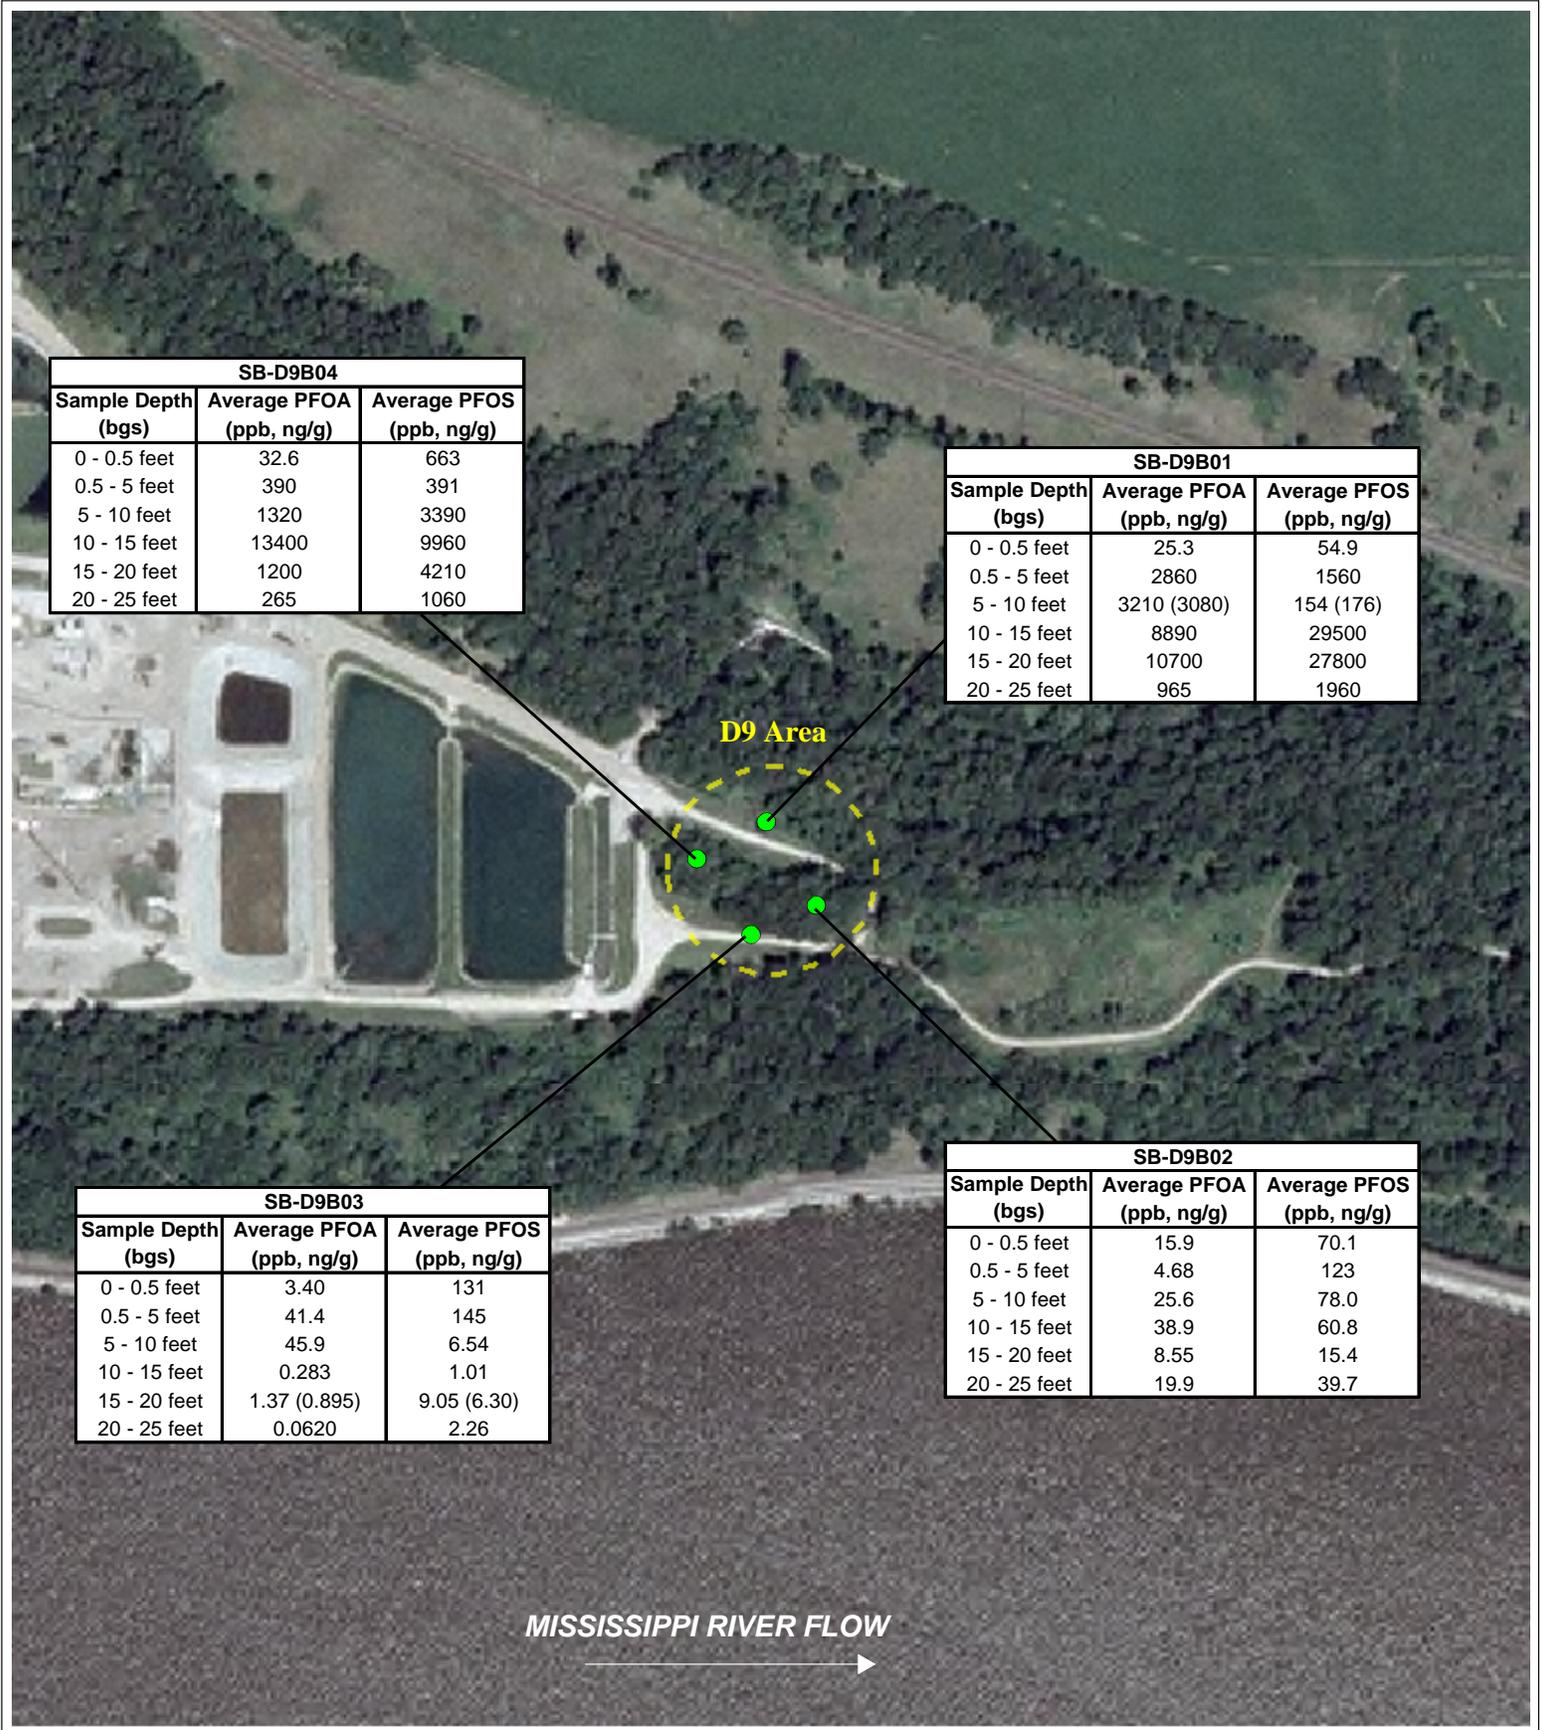
FIGURE 4-5  
 D9 AREA SOIL BORINGS  
 PFOA AND PFOS CONCENTRATIONS  
 JUNE 2006  
 COTTAGE GROVE SITE

SB-D9B04		
Sample Depth (bgs)	Average PFOA (ppb, ng/g)	Average PFOS (ppb, ng/g)
0 - 0.5 feet	32.6	663
0.5 - 5 feet	390	391
5 - 10 feet	1320	3390
10 - 15 feet	13400	9960
15 - 20 feet	1200	4210
20 - 25 feet	265	1060

SB-D9B01		
Sample Depth (bgs)	Average PFOA (ppb, ng/g)	Average PFOS (ppb, ng/g)
0 - 0.5 feet	25.3	54.9
0.5 - 5 feet	2860	1560
5 - 10 feet	3210 (3080)	154 (176)
10 - 15 feet	8890	29500
15 - 20 feet	10700	27800
20 - 25 feet	965	1960
