**REMEDIAL INVESTIGATION REPORT**  
*PHASE 2*  
*FLUOROCHEMICAL (FC) DATA ASSESSMENT REPORT*  
*FOR THE*  
*COTTAGE GROVE, MN SITE*

**June 2007**

**3M Company**

**WESTON SOLUTIONS, INC.**  
**West Chester, Pennsylvania 19380**

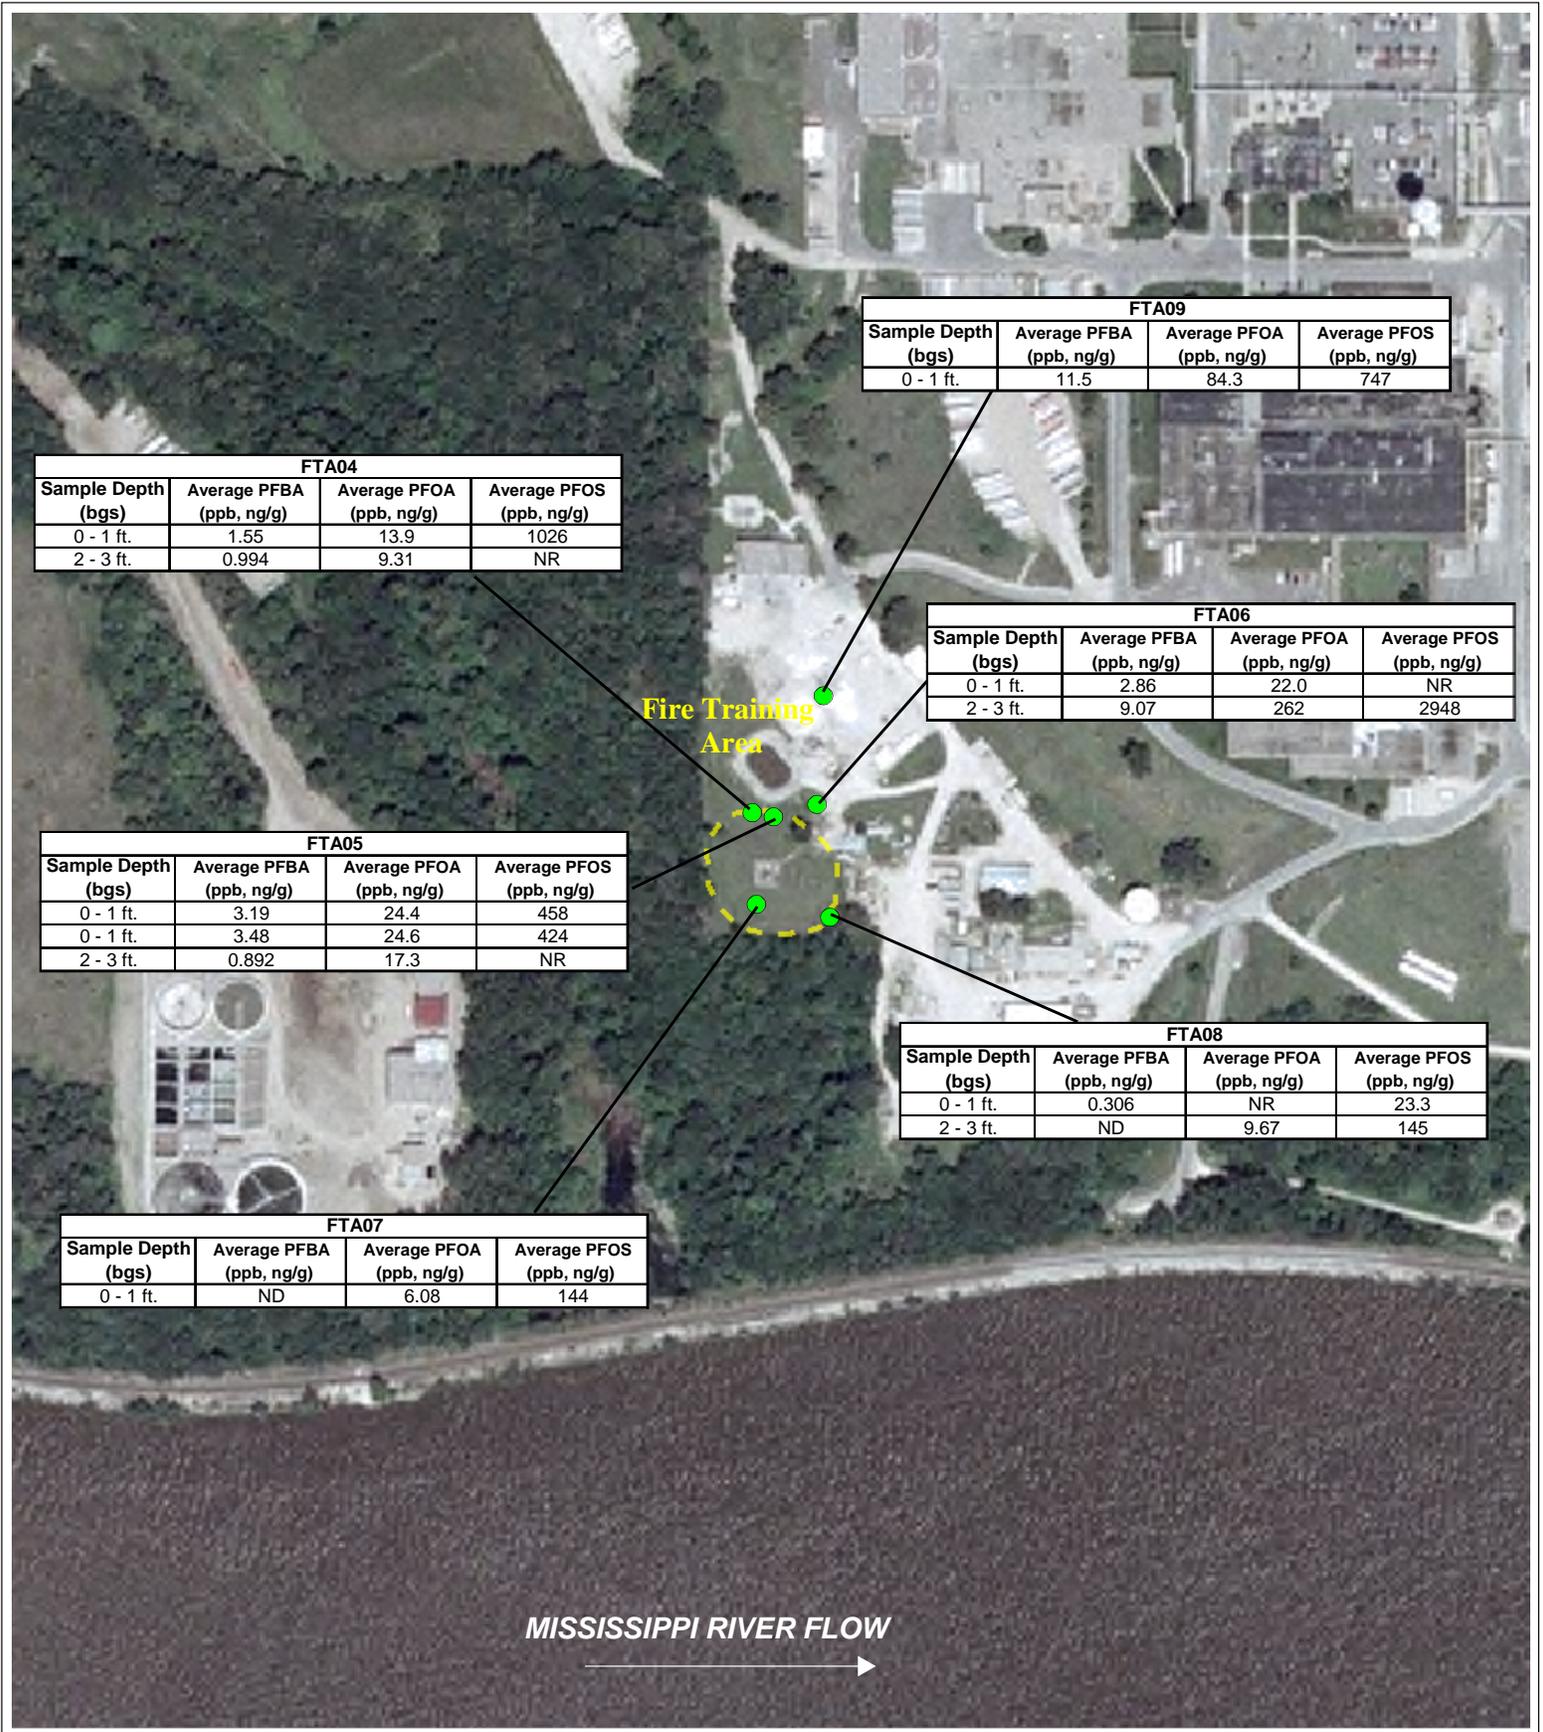
**FIGURE 4-6**  
**FIRE TRAINING AREA SOIL**  
**PFBA, PFOA AND PFOS CONCENTRATIONS**  
**SEPTEMBER 2006**  
**COTTAGE GROVE SITE**

- Higher FC concentrations are typically found in localized areas of drainage
- The higher concentrations are typically found in the shallow and surficial soils
- Addition of soils and earth disturbance around the new stormwater basin (during construction) has resulted in lower concentrations

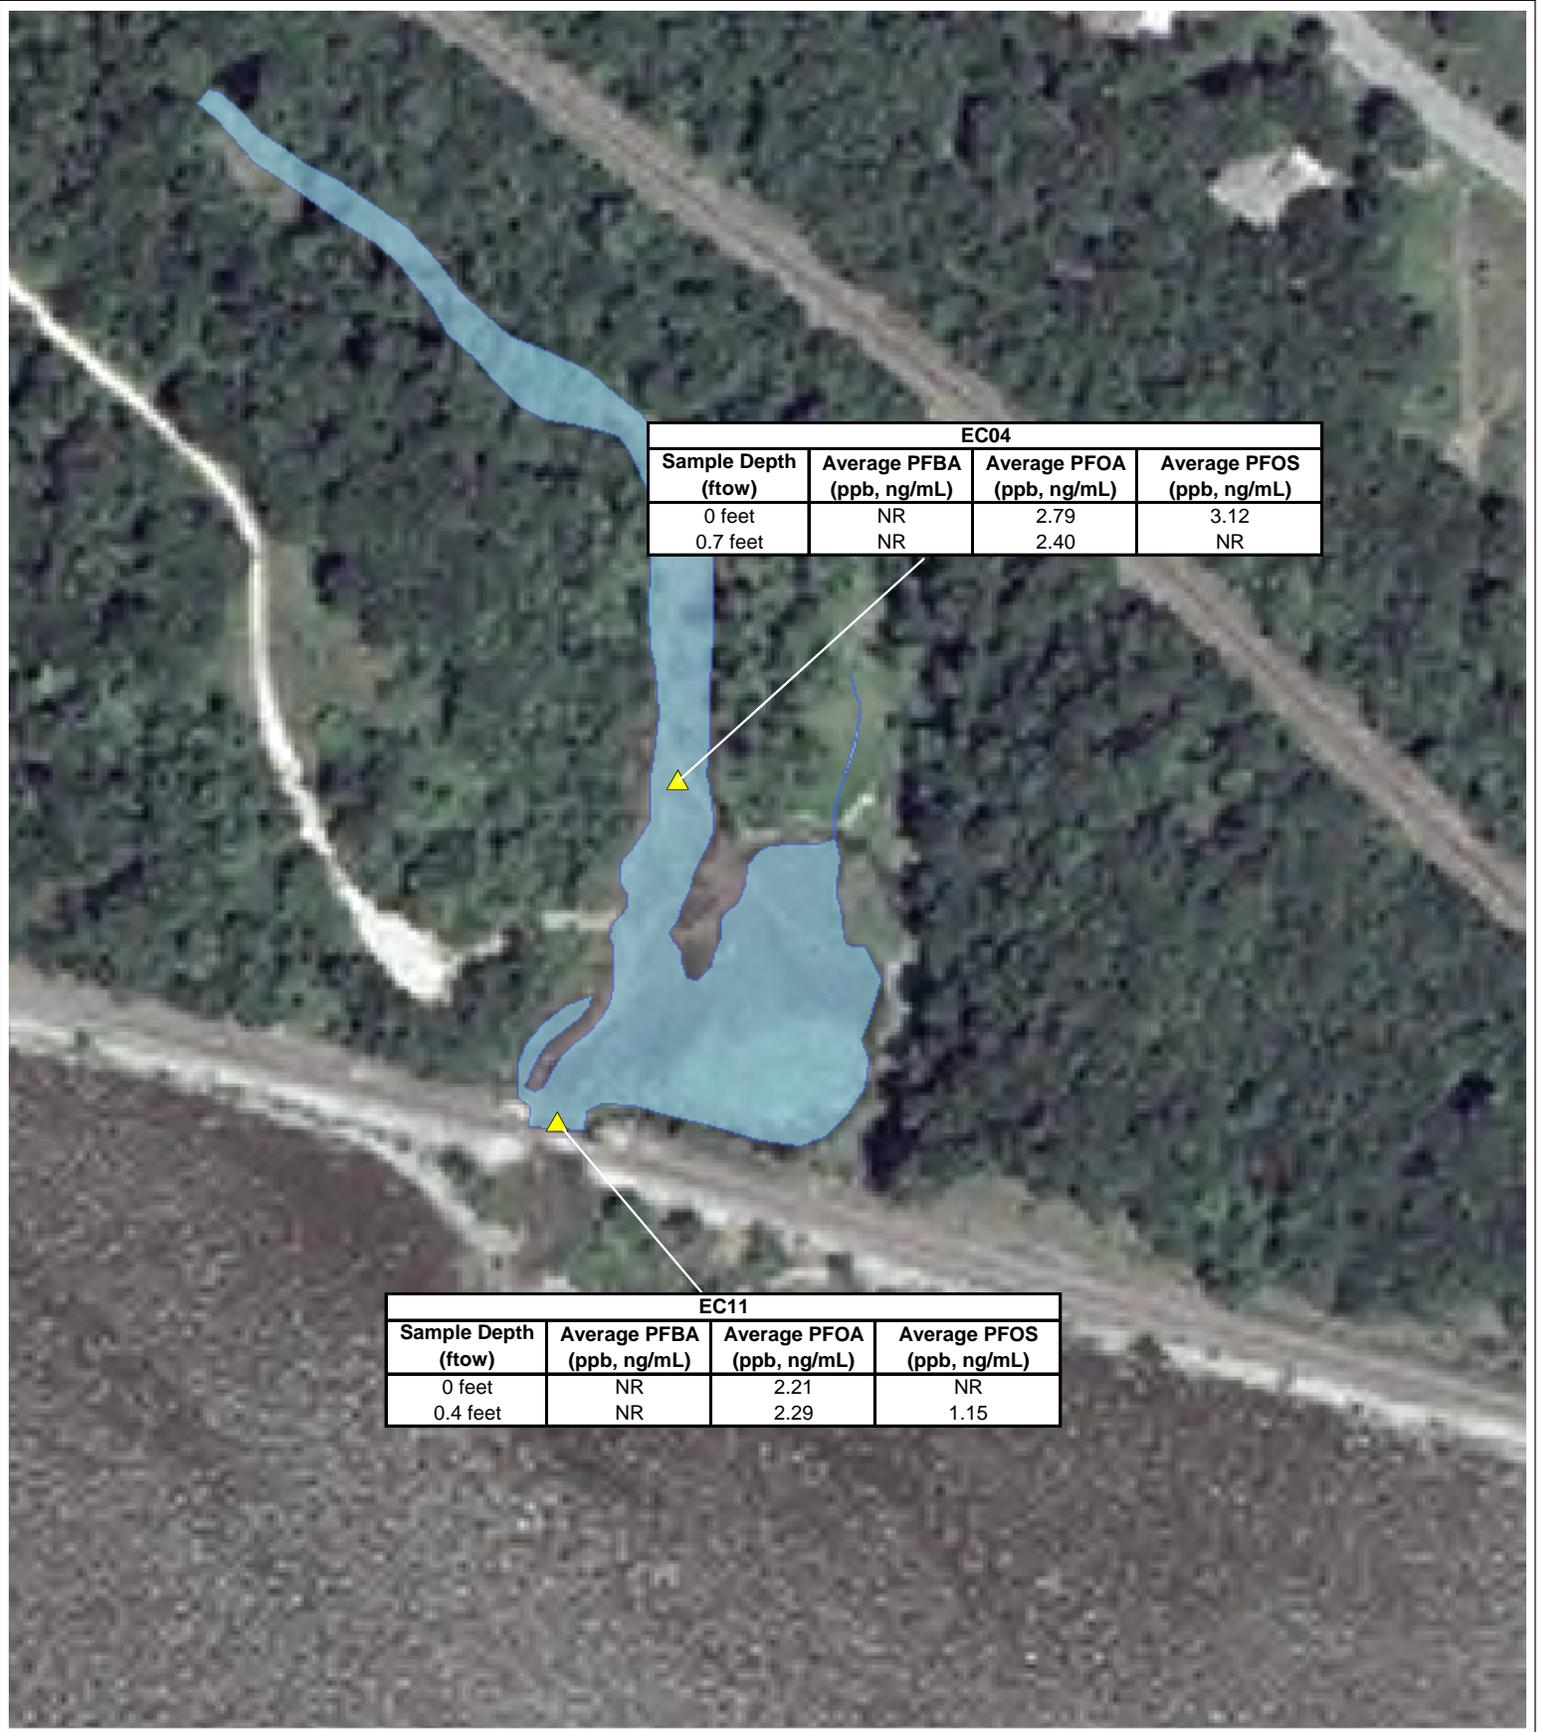
**FIGURE 4-8  
SURFACE WATER  
PFBA, PFOA AND PFOS CONCENTRATIONS  
EAST COVE  
SEPTEMBER 2006  
COTTAGE GROVE SITE**

EC04			
Sample Depth (ftow)	Average PFBA (ppb, ng/mL)	Average PFOA (ppb, ng/mL)	Average PFOS (ppb, ng/mL)
0 feet	NR	2.79	3.12
0.7 feet	NR	2.40	NR

EC11			
Sample Depth (ftow)	Average PFBA (ppb, ng/mL)	Average PFOA (ppb, ng/mL)	Average PFOS (ppb, ng/mL)
0 feet	NR	2.21	NR
0.4 feet	NR	2.29	1.15

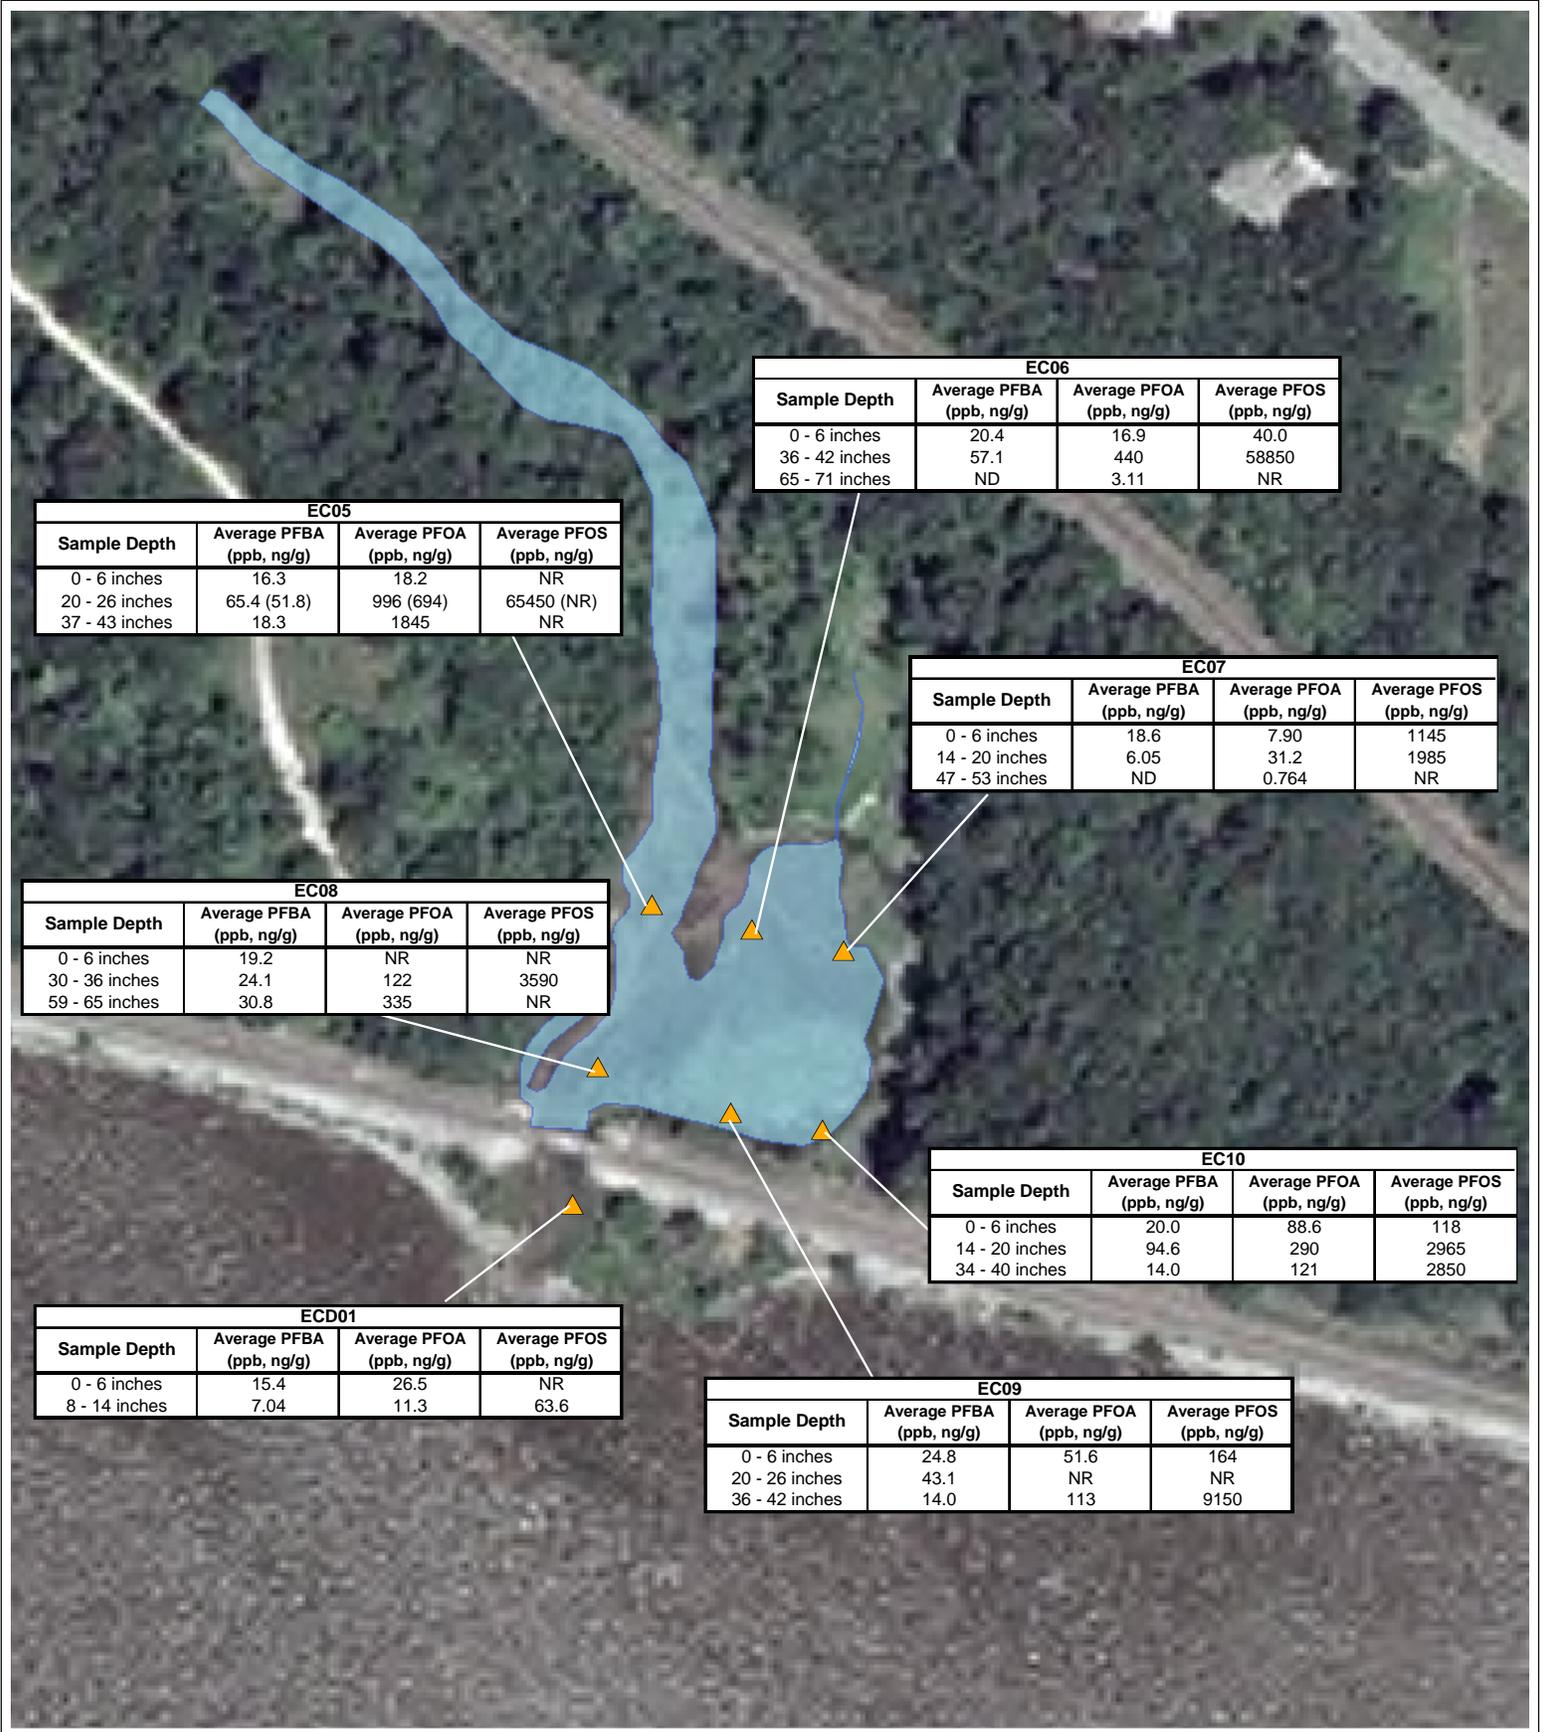
**FIGURE 4-9  
 SEDIMENT  
 PFBA, PFOA AND PFOS CONCENTRATIONS  
 EAST COVE  
 SEPTEMBER 2006  
 COTTAGE GROVE SITE**

- A total of three distinct layers were observed in sediment cores collected from the East Cove as observed in 7 probe locations in the lower part of the cove. These layers consisted of a firm top fine granular layer, and middle semi-solid fine silt layer (where a black residue layer was encountered), and a bottom sandy clay layer. The middle layer observed ranged from 2 inches to 2 feet in thickness, appearing to exist in pockets throughout the lower part of East Cove. This black residue layer was encountered at depths of 1.0 to 2.5 feet below the top of the sediment.

- The highest concentrations of PFOS and PFBA (65,450 ppb and 94.6 ppb, respectively) were detected in the middle sediment layer where black residue was observed. The highest concentration of PFOA 1,845 ppb was detected in the bottom sediment layer.

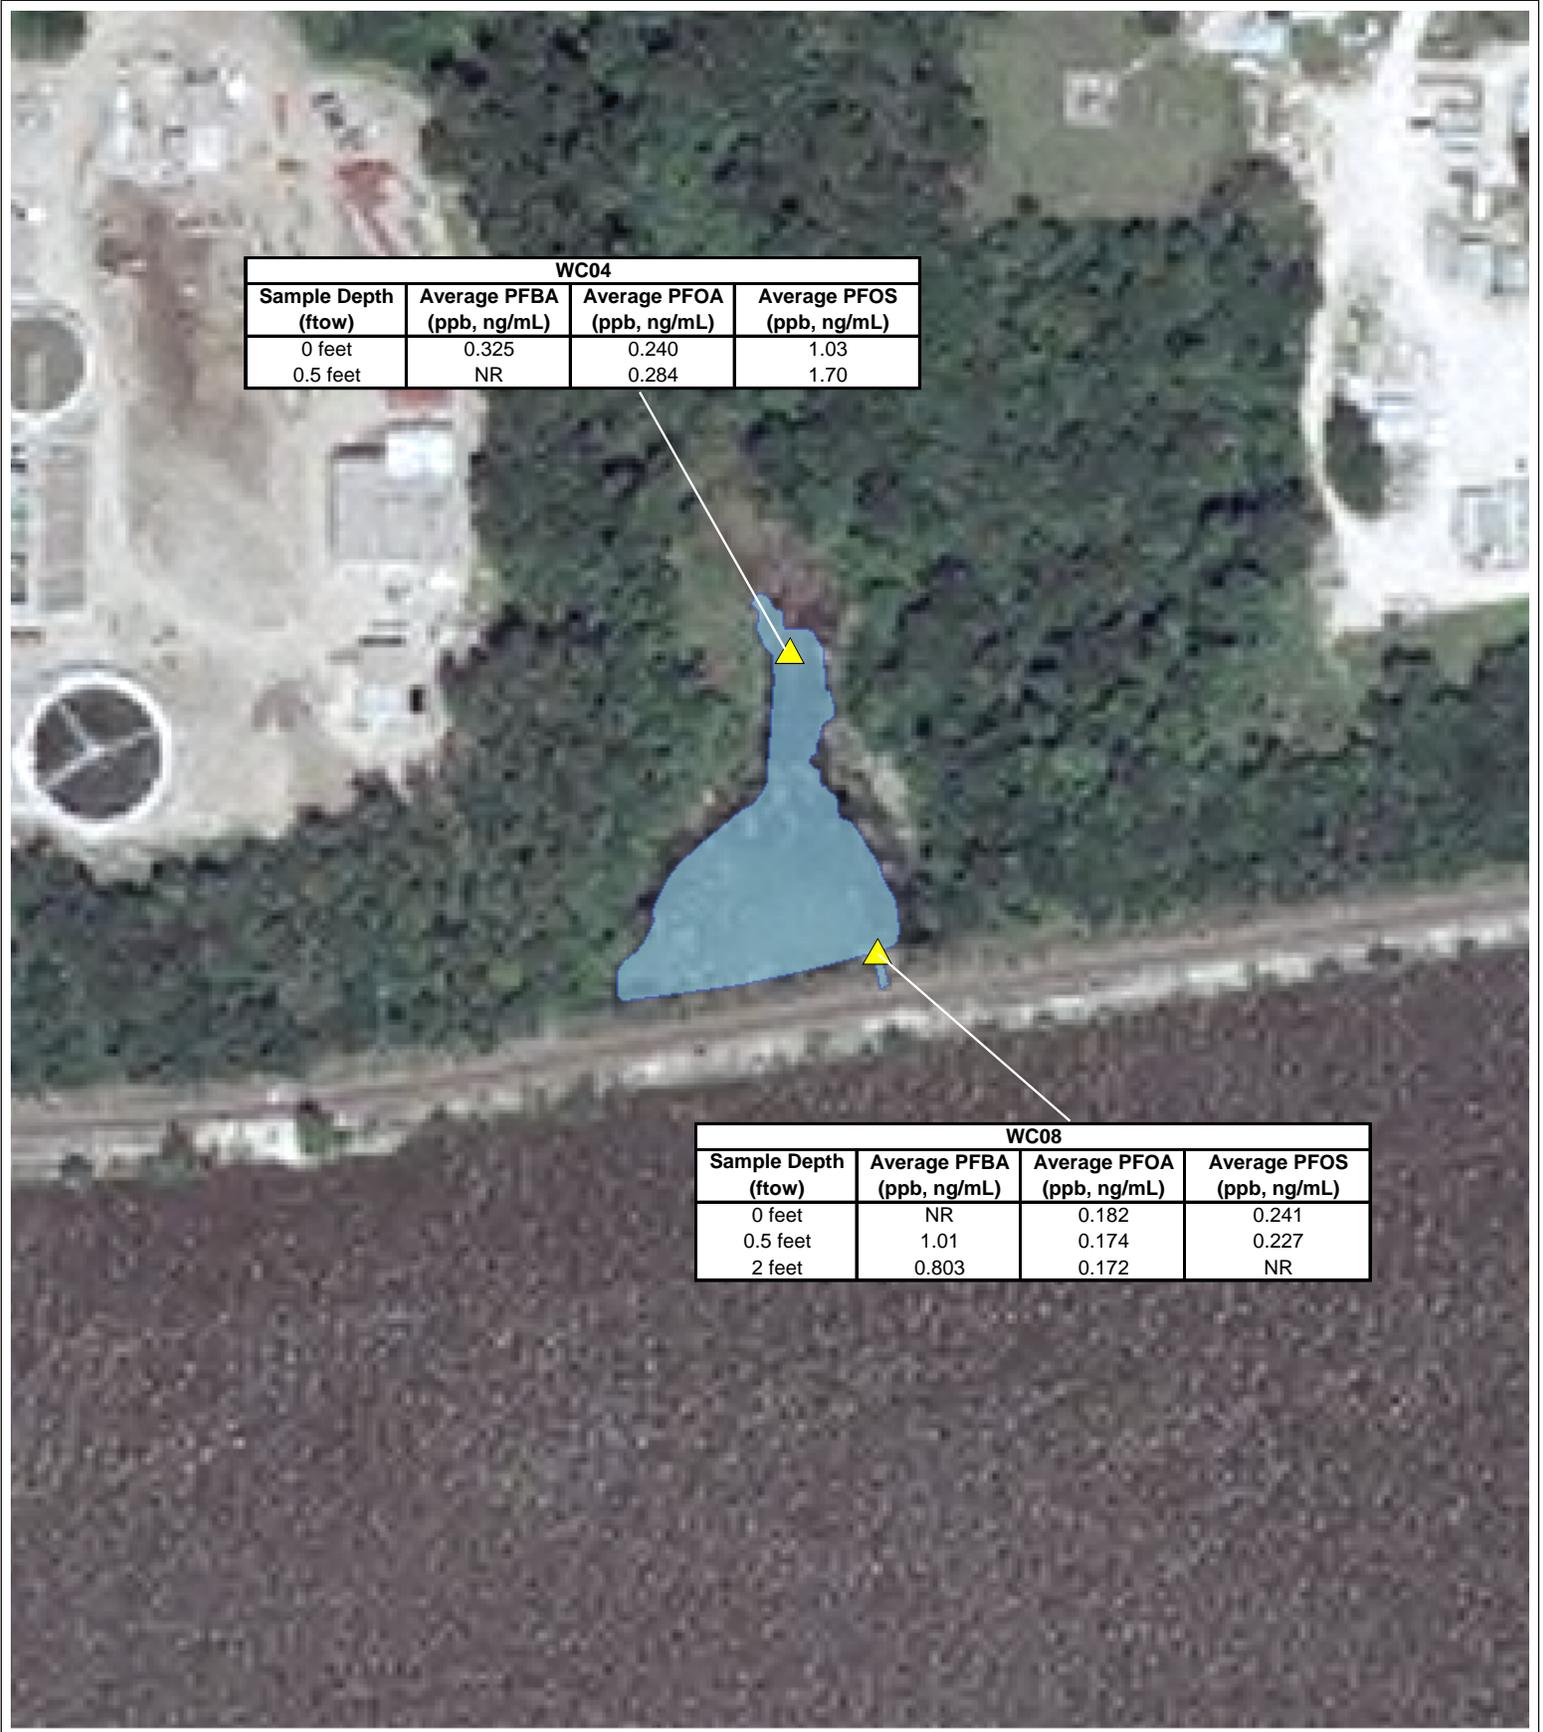
**FIGURE 4-11  
SURFACE WATER  
PFBA, PFOA AND PFOS CONCENTRATIONS  
WEST COVE  
SEPTEMBER 2006  
COTTAGE GROVE SITE**

WC04			
Sample Depth (ftow)	Average PFBA (ppb, ng/mL)	Average PFOA (ppb, ng/mL)	Average PFOS (ppb, ng/mL)
0 feet	0.325	0.240	1.03
0.5 feet	NR	0.284	1.70

WC08			
Sample Depth (ftow)	Average PFBA (ppb, ng/mL)	Average PFOA (ppb, ng/mL)	Average PFOS (ppb, ng/mL)
0 feet	NR	0.182	0.241
0.5 feet	1.01	0.174	0.227
2 feet	0.803	0.172	NR
