Effects of Liquid Manure Storage Systems on Ground Water Quality

April 2001

Minnesota Pollution Control Agency
Ground Water and Toxics Monitoring Unit
Environmental Monitoring and Analysis Section
Environmental Outcomes Division
520 Lafayette Road
St. Paul, Minnesota 55155-4194
(651) 296-6300 or (800) 657-3864

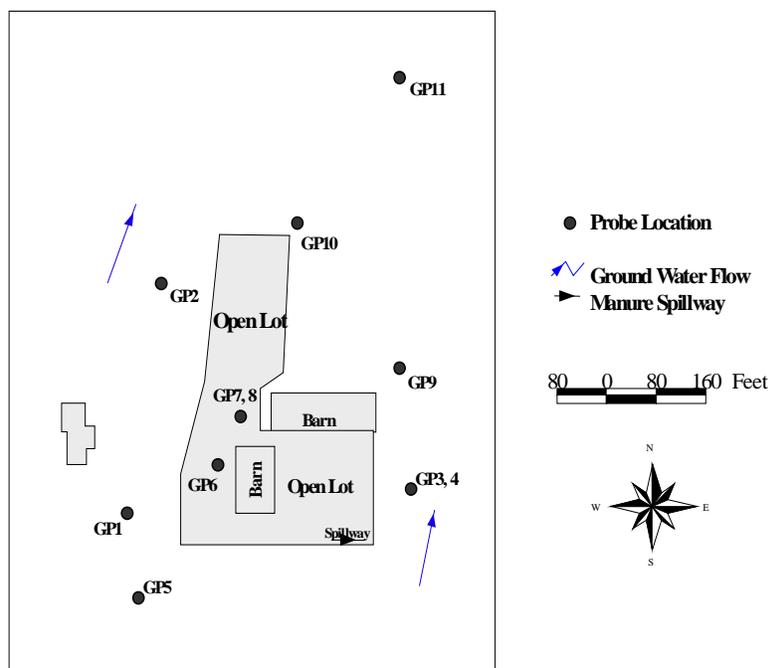
Figure 2: Location of temporary wells and direction of ground water flow at Site O1.

Figure 2 illustrates the location of temporary wells at Site O1. Ground water flow is to the north-northeast. Table 3 summarizes water quality data for each of the wells.

Well 10 was impacted by the feedlot, with concentrations of Kjeldahl nitrogen, ammonia, and organic carbon more than ten times greater than concentrations in up-gradient wells. Nitrate-reducing conditions occurred in this well, and nitrate was below the reporting limit of 0.020 mg/L. Well 11 had chloride and organic carbon concentrations that were more than double the concentrations in up-gradient wells, but the overall rank of 5.1 was low. We estimated a plume length of approximately 425 feet from the center of the feedlot to Well 11 (see Section 2.4 for a description of methods used in estimating plume length).

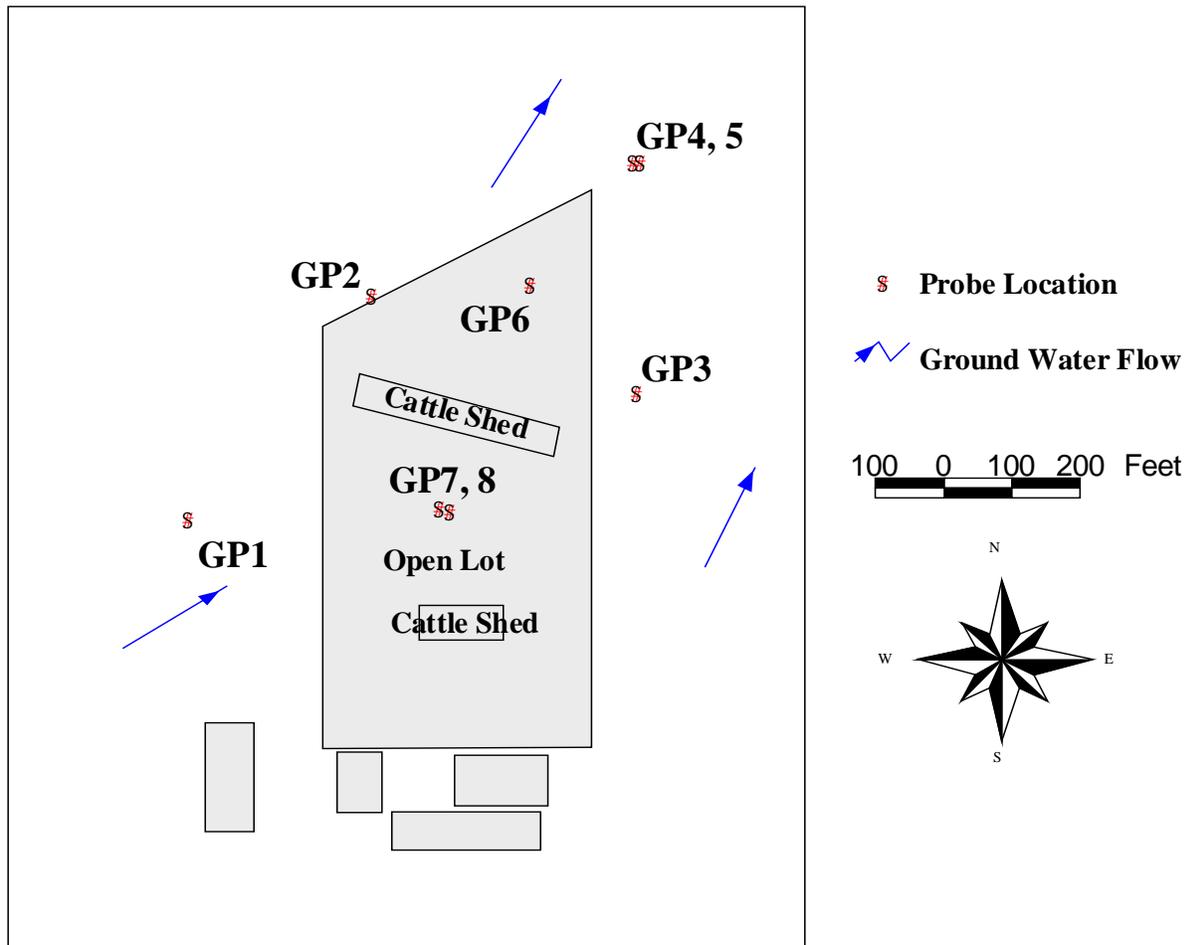
Figure 3: Location of temporary wells and direction of ground water flow at Site O2.

Figure 3 illustrates the location of temporary wells at Site O2. Ground water flow is to the northeast. Table 4 summarizes water quality data for each of the wells.

found at most other sites. Second, Site O2 operates as a temporary feedlot, where animals are removed on a periodic basis and manure and soil are scraped and removed. Because of the intermittent animal activity and the deep water table, soils at the site may not be excessively compacted and water leaching through the soil may be oxidized. Nitrogen therefore leaches as nitrate. Total nitrogen concentrations at Wells 4 and 5, located about 220 feet down-gradient of the feedlot, were about an order of magnitude greater than in Well 1. A nitrate plume therefore extends at least 220 feet from the feedlot.

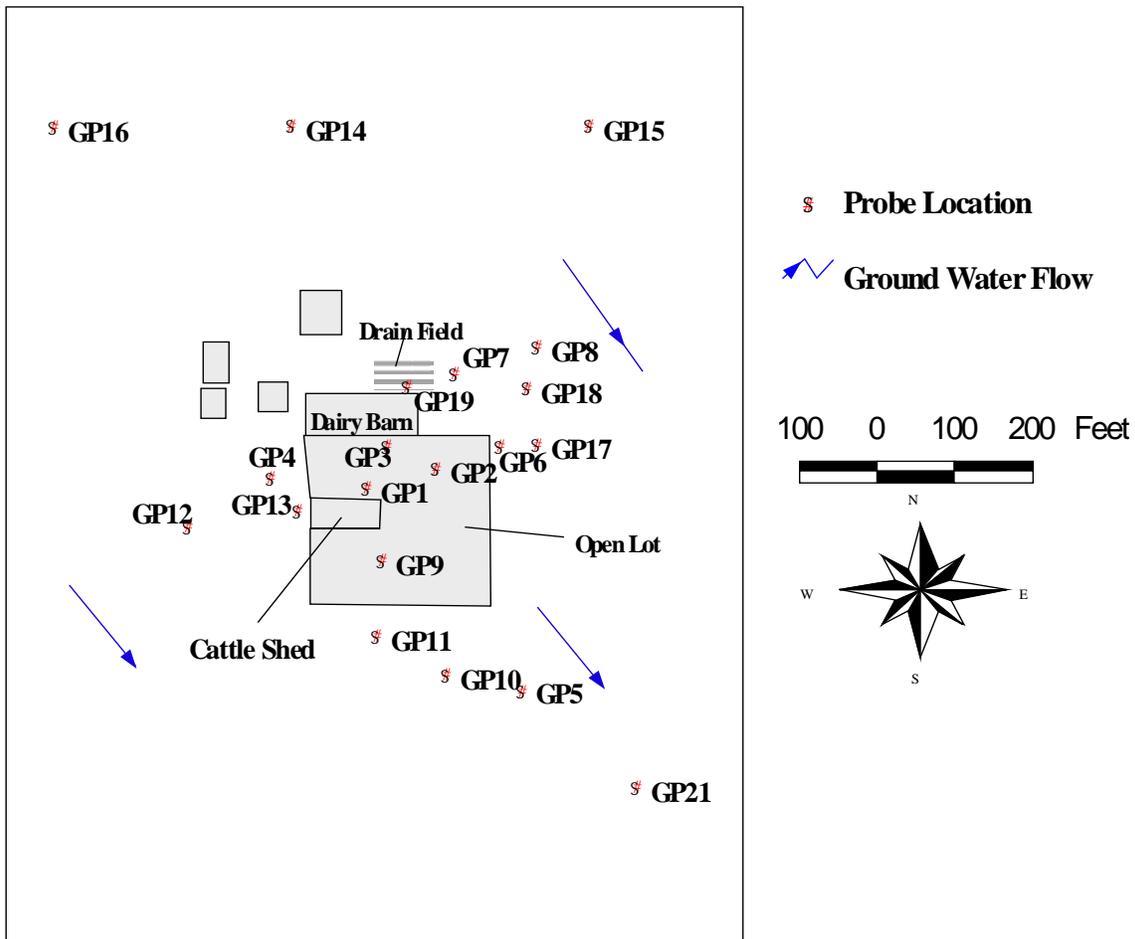
Figure 4: Location of temporary wells and direction of ground water flow at Site O3.

Figure 4 illustrates the location of temporary wells at Site O3. Ground water flow is to the southeast. Table 5 summarizes water quality data for each of the wells.

Wells 1, 3, and 9, located in or just down-gradient of the feedlot, are impacted by the feedlot. Average ranks in these wells exceeded 14, compared to 6.4 in Well 12. We observed ammonia concentrations as high as 35.9 mg/L and total nitrogen concentrations as high as 41.4 mg/L down-gradient of the feedlot. Concentrations of nitrate in up-gradient wells were more than 35 mg/L, except for Well 12. Well 12 is located in an area where crops are not grown, and it appears to be less affected by agricultural activities than Wells 4, 13, and 14. Concentrations of phosphorus, chloride, and iron were much higher beneath and just down-gradient of the feedlot compared to other locations. A plume appears to extend to Well 5, as indicated by elevated concentration of chloride compared to up-gradient wells. The average rank in Well 5 was 8.6. The average rank in Well 21, located about 600 feet down-gradient of the feedlot, was 4.6. A plume, therefore, extends somewhere between Well 5 and Well 21. We estimated a distance of 400 feet.

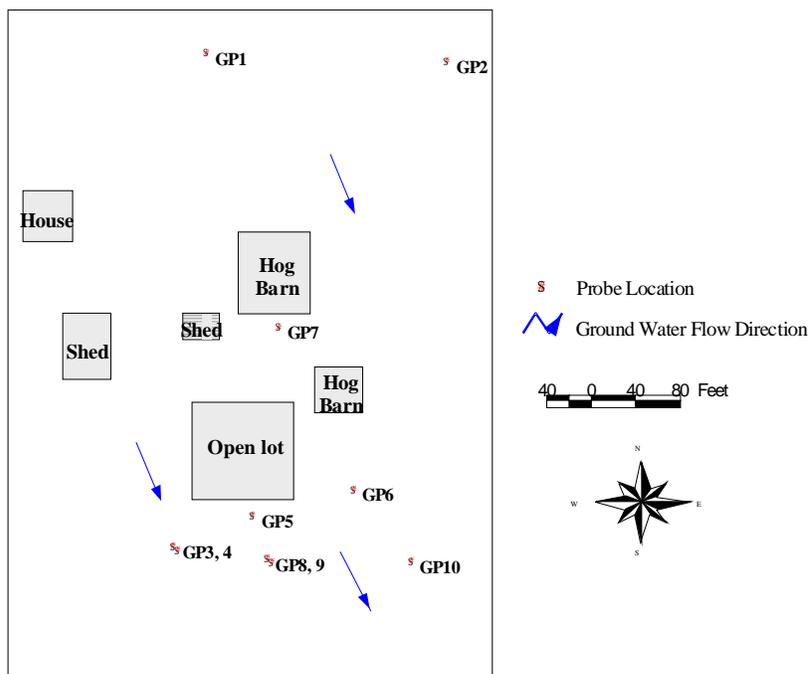
Figure 5: Location of temporary wells and direction of ground water flow at Site O4.

Figure 5 illustrates the location of temporary wells at Site O4. Ground water flow is to the southeast. Table 6 summarizes water quality data for each of the wells.

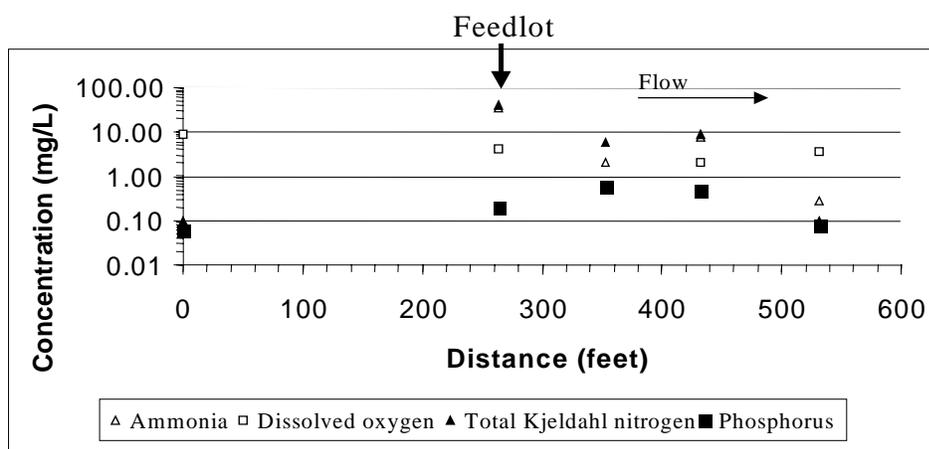
Figure 6: Distribution of chemicals along a ground water flow path passing beneath the open feedlot at Site O3. Concentrations are in mg/L.

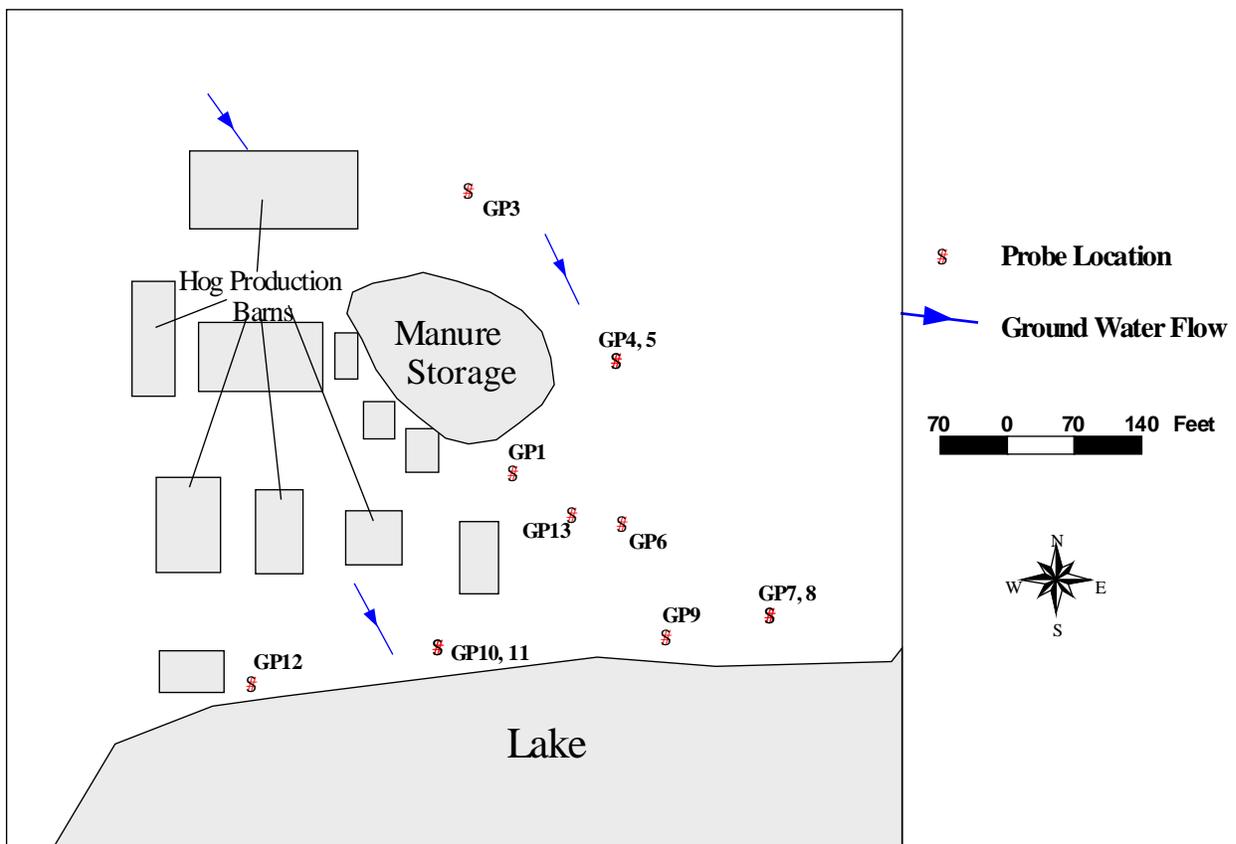
Figure 8: Location of temporary wells and ground water flow direction at Site U1.

wells. Nitrate-reducing conditions were observed in these wells, with Eh values of less than 180 mV, dissolved oxygen concentrations less than 1.1 mg/L, and nitrate concentrations less than 0.020 mg/L. A plume extended from the manure basin to the adjacent lake. This is a distance of about 320 feet along the ground water flow path. We assume the plume would extend much farther if the lake were not present, since concentrations of ammonia, total nitrogen, phosphorus, and organic carbon did not decrease with distance along the flow path. We did not take water quality samples from the lake to determine if ground water discharge was evident. Data from surface water sampling is difficult to interpret because of changes in geochemistry of water passing through the lake sediments.

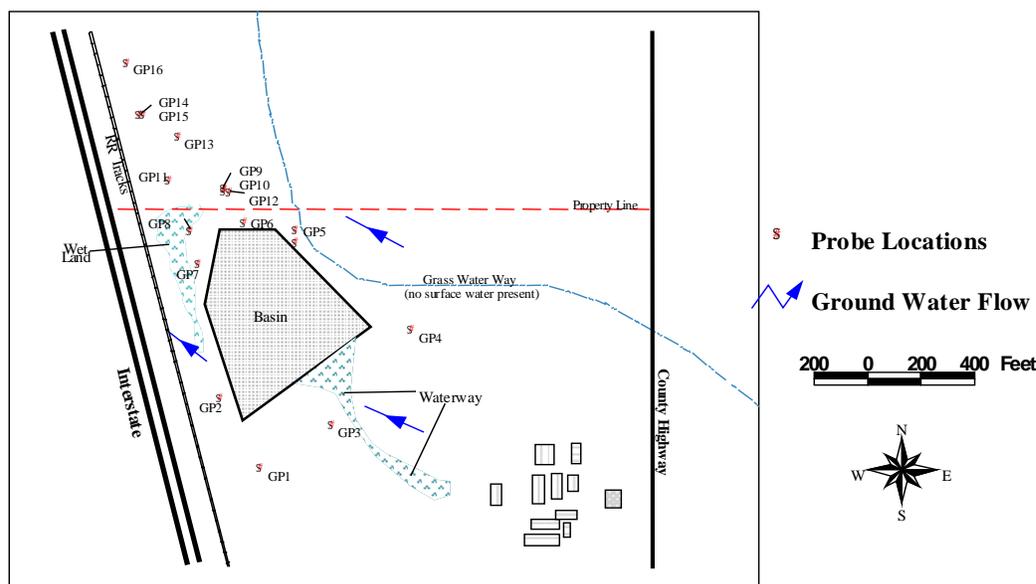
Figure 9: Location of temporary wells and ground water flow direction at Site U2.

Figure 9 illustrates the location of temporary wells at Site U2. Ground water flow is to the northwest. Table 10 summarizes water quality data for each of the wells.

Concentrations of nitrate were below the reporting limit of 0.020 mg/L in down-gradient wells. Concentrations in up-gradient wells were variable, ranging from 3.8 to 66 mg/L. The variability may be due to proximity of agricultural fields. The data indicate nitrate-reducing conditions down-gradient of the manure storage area.

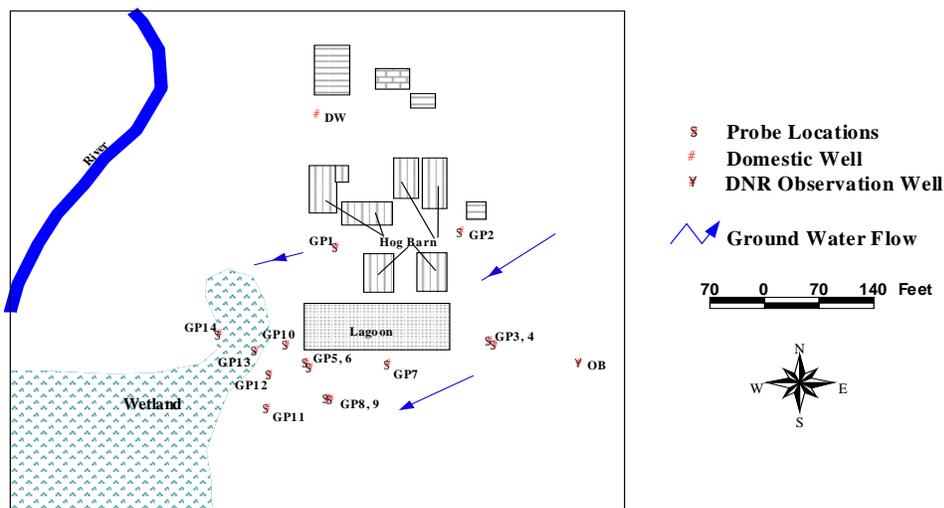
Figure 10: Location of temporary wells and ground water flow direction at Site U3.

Figure 10 illustrates the location of temporary wells at Site U3. Ground water flow is to the southwest. Table 11 summarizes water quality data for each of the wells.

Concentrations of *E. coli* bacteria do not correlate with the location of the unlined basin. Bacteria were found in Wells 3 and 4, which are up-gradient of the basin, and in Wells 10, 13, and 14, which are the furthest down-gradient wells. No bacteria were found in wells closest to the basin. Bacteria in up-gradient wells may be associated with spreading of manure, although we do not have information on the cropping history of fields adjacent to the manure storage

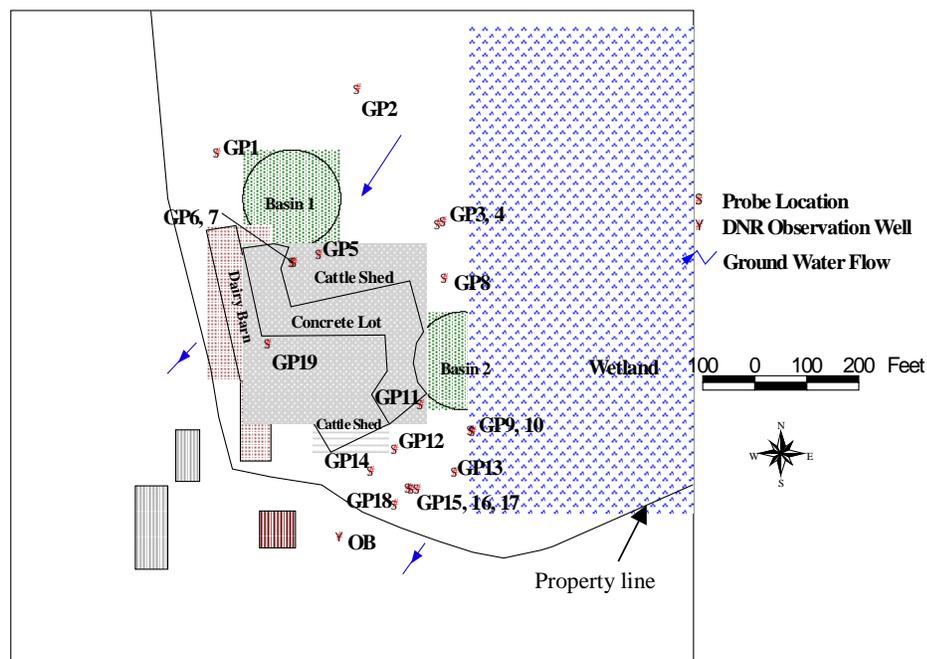
Figure 13: Location of temporary wells and ground water flow direction at Site E1.

Well 7, located immediately down-gradient of Basin 1, showed impacts from manure storage. Concentrations of ammonia, chloride, dissolved organic carbon, phosphorus, and Kjeldahl nitrogen were 66, 94, 39, 0.55, and 77 mg/L, respectively. This compares with concentrations of 0.05, 8.1, 1.0, 0.04, and 0.3, respectively, in Well 2, which was up-gradient of the feedlot. The Eh in Well 7 was very low (73 mV), while iron concentrations were high (22.4 mg/L), reflecting nitrate-reducing conditions. Well 6, which formed a nest with Well 7, was drilled five feet deeper than Well 7. No water quality impacts were evident in Well 6. A plume extends to Well 19, since concentrations of ammonia in this well were 8.78 mg/L. Well 19 was located about 275 feet from the center of Basin 1.

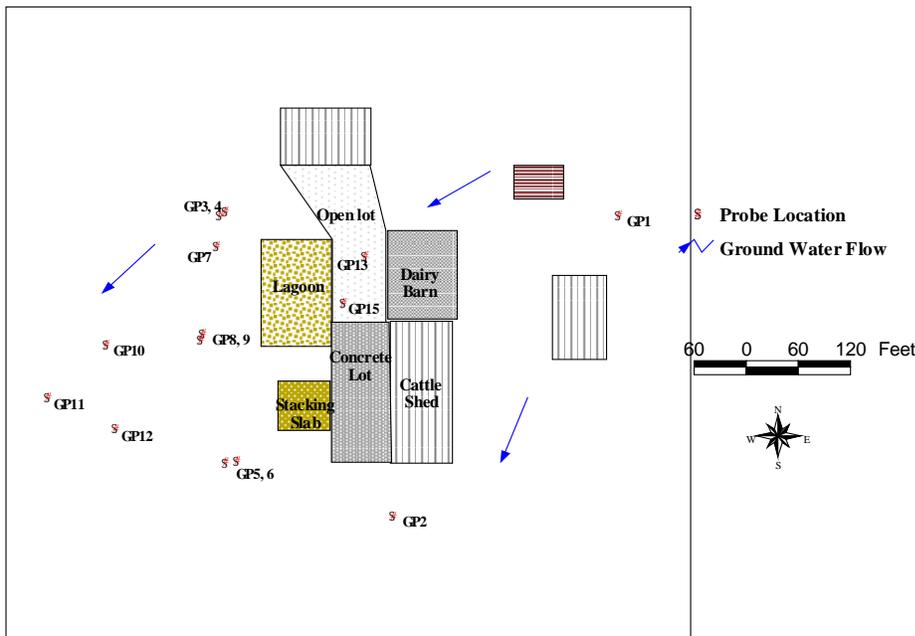
Figure 14: Location of temporary wells and ground water flow direction at Site E2.

Figure 14 illustrates the location of temporary wells at Site E2. Ground water flow is to the southwest. Table 15 summarizes water quality data for each of the wells.

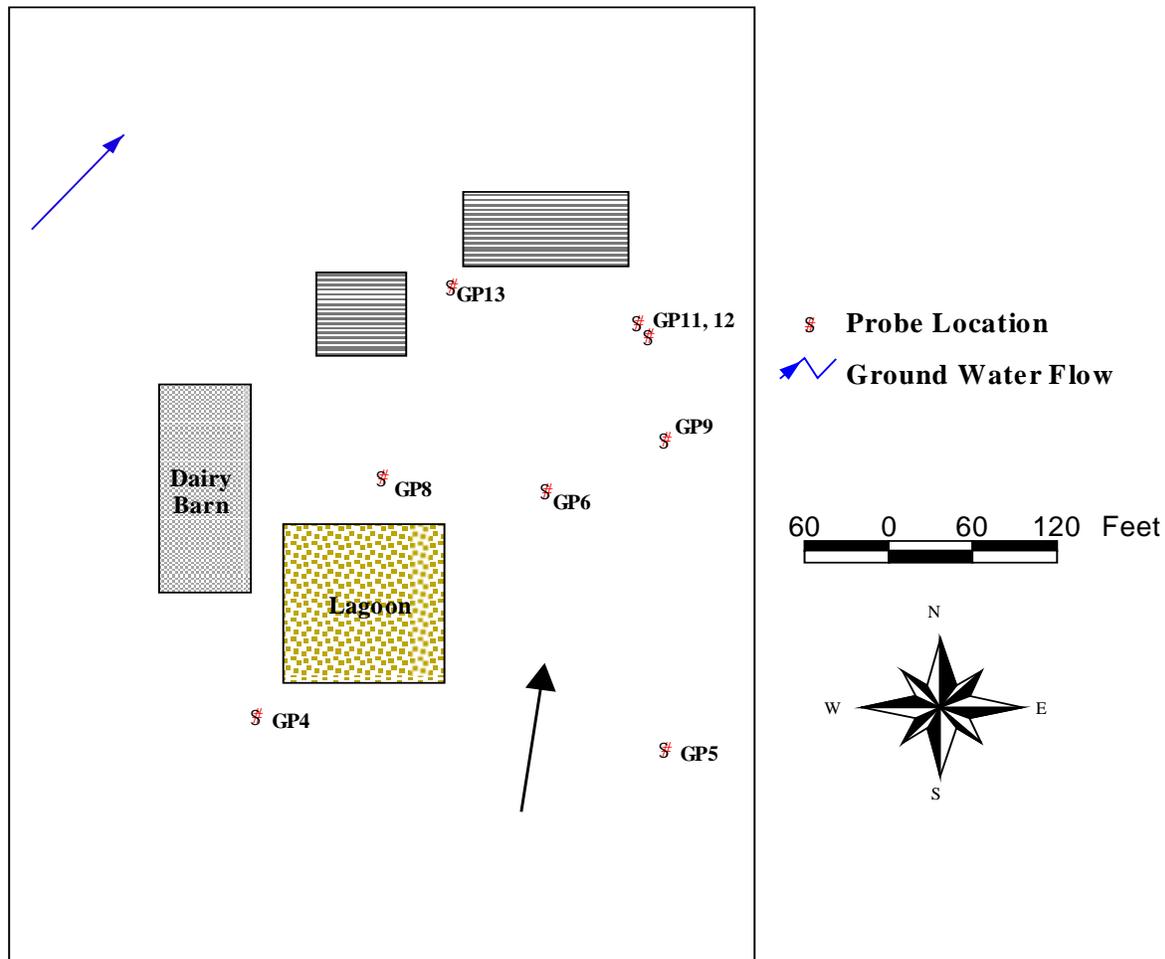
Figure 15: Location of temporary wells and ground water flow direction at Site E3.

Figure 15 illustrates the location of temporary wells at Site E3. Ground water flow is to the northeast. Table 16 summarizes water quality data for each of the wells.

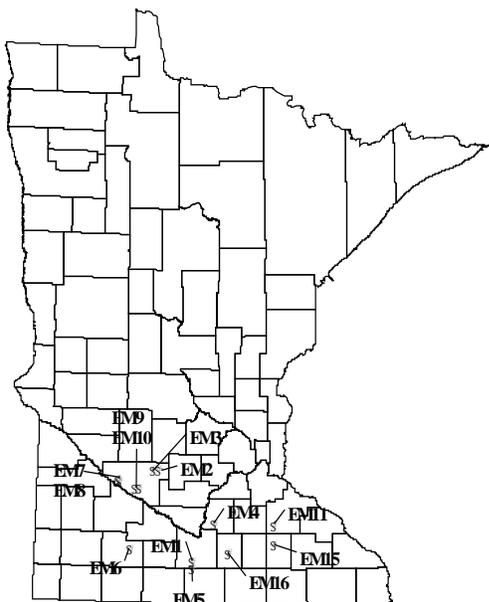
Figure 16: Location of sites having earthen-lined basins and permanent monitoring networks.

Permanent monitoring wells exist at ten sites with newly constructed earthen-lined manure storage systems. Five of these sites also have tile lines surrounding the manure storage system. An additional three sites have just tile lines. Each site had no previous history of animal operations. Sampling at each site occurred two or more times prior to addition of manure to the storage systems. Following addition of manure, quarterly sampling was planned at each of the sites. Figure 16 illustrates the location of the sites. Table 18 summarizes the characteristics of each site.

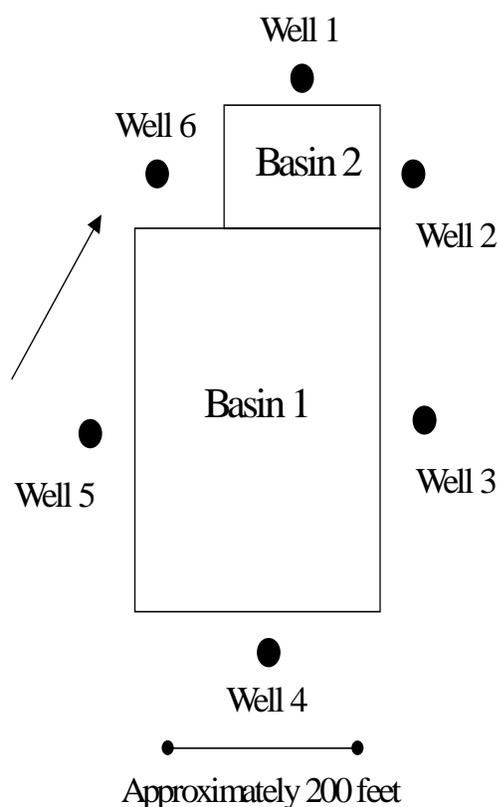
Figure 17: Location of monitoring wells, storage basins, and ground water flow direction (arrow) at Site EM1.

correlations with sampling event were observed in Well 2 for sulfate and nitrate, and in Well 1 for sulfate and chloride. Positive correlations with sampling event were observed in Wells 1 and 2 for specific conductance.

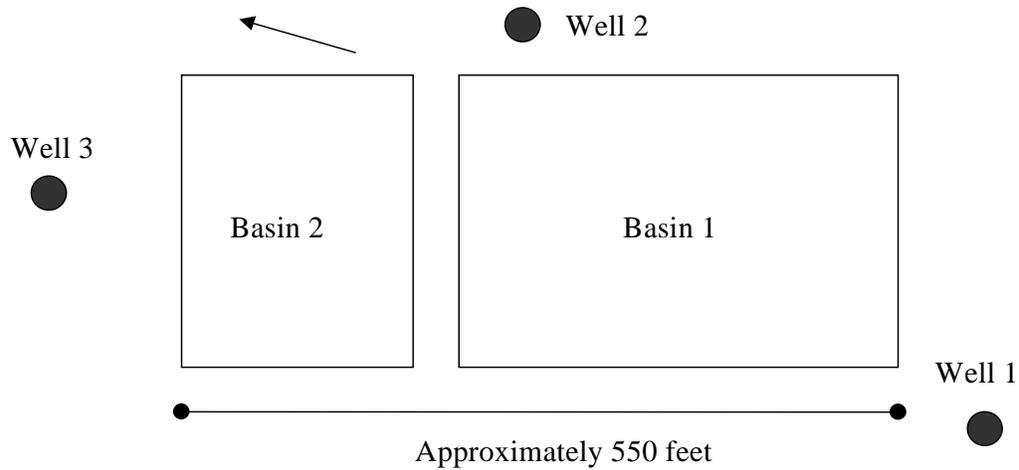
Figure 18: Location of manure storage basins, monitoring wells, and ground water flow direction (arrow) at Site EM2.

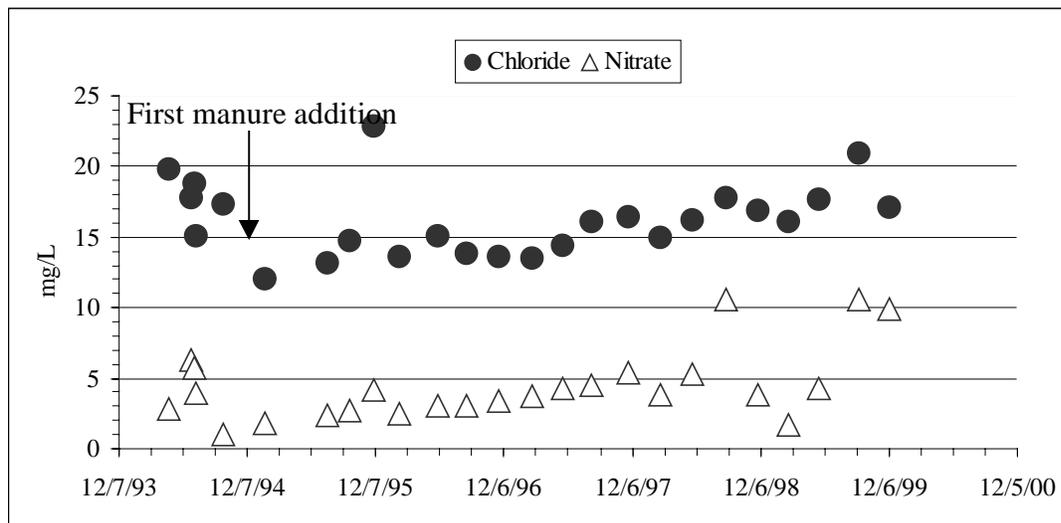
Figure 19: Concentrations of chloride and nitrate as a function of sampling date in Well 3 at Site EM2.

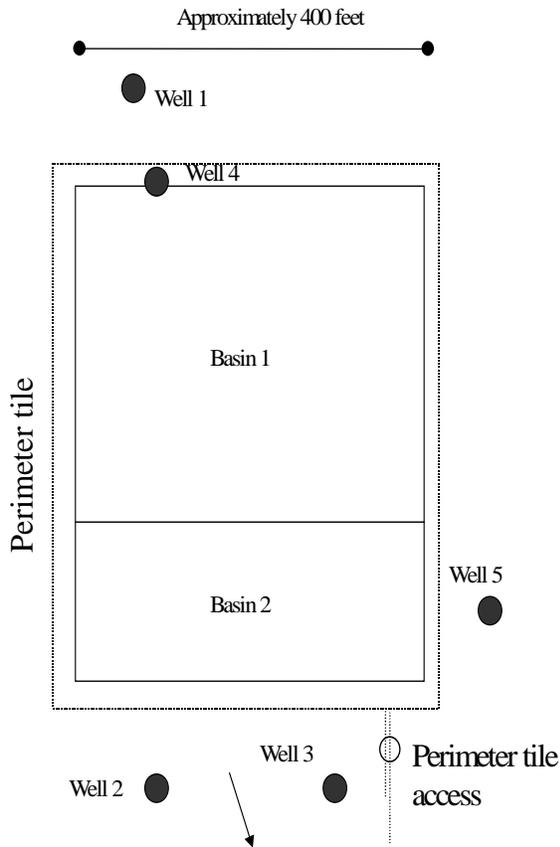
Figure 20: Location of monitoring wells, tile lines, storage basins, and ground water flow direction (arrow) at Site EM3.

To further explore potential impacts from the basins, we calculated nonparametric correlation coefficients between sampling parameters and sampling event (Table 21). There was a negative correlation between sampling event and concentrations of ammonia and nitrate in Well 3. Well 5, which is down-gradient of the manure basin, showed a strong negative correlation (-0.925) between sampling event and chloride concentration.

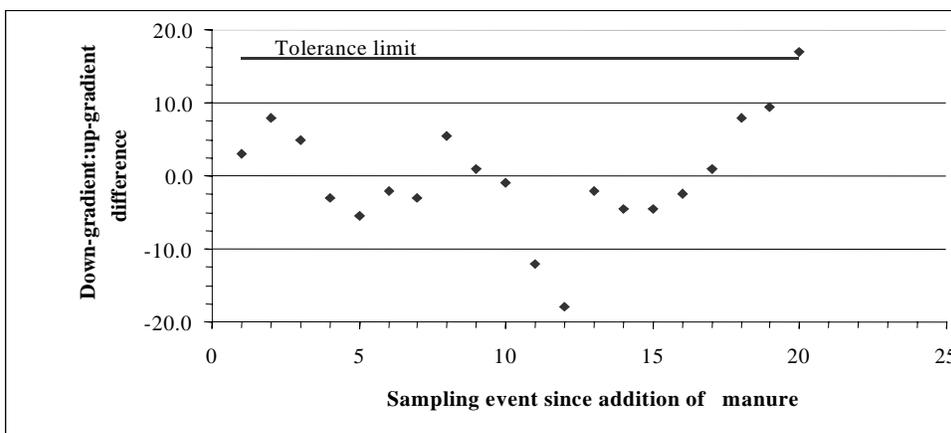
Figure 21: Difference between down-gradient (Wells 3 and 5) and up-gradient (Well 1) ranked concentrations of chloride at site EM3 since addition of manure. The 90 percent tolerance limit is included in the plot.

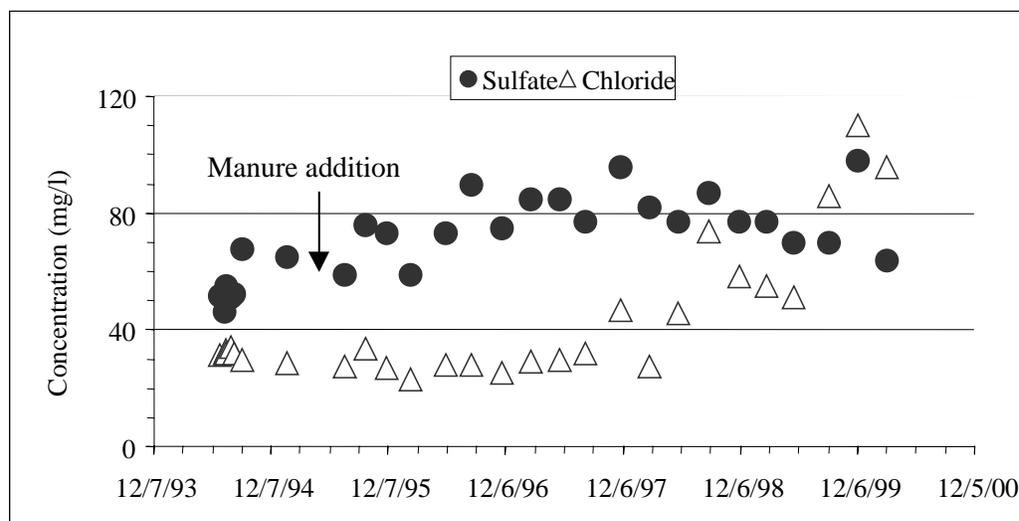
Figure 22: Concentrations of chloride and sulfate in the perimeter tile at Site EM3.

Concentrations of sulfate and chloride in the tile line were positively correlated ($R^2 = 0.664$ for sulfate and 0.514 for chloride) with sampling event, indicating increasing concentrations during the sampling period. Flow information was not available for the tile line. There were no seasonal differences in concentrations of chloride and sulfate. Figure 22 indicates the concentration of chloride has increased steadily since July 1997. The results suggest that the tile line may be intercepting ground water from the storage basin.

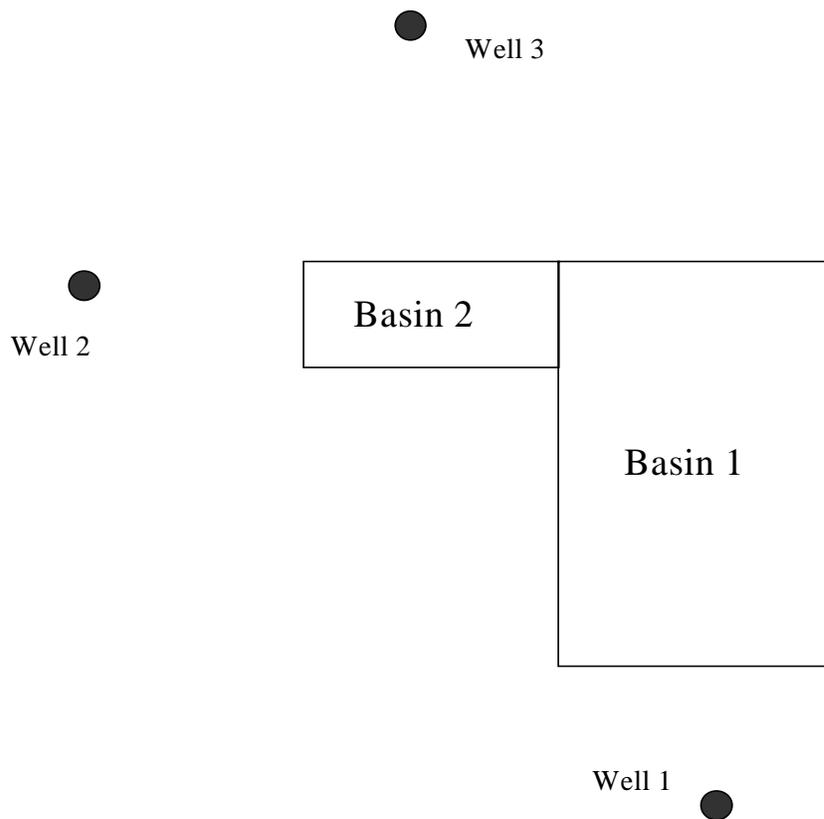
Figure 23: Location of wells and manure basins at Site EM4. Ground water flow direction is unknown.

Ground water flow direction has not been consistent at the site, making it difficult to determine which wells are up-gradient and down-gradient of the manure basin. Only one to three samples were collected each year since sampling began in 1996. There was no correlation between sampling event and chemical concentrations in wells.

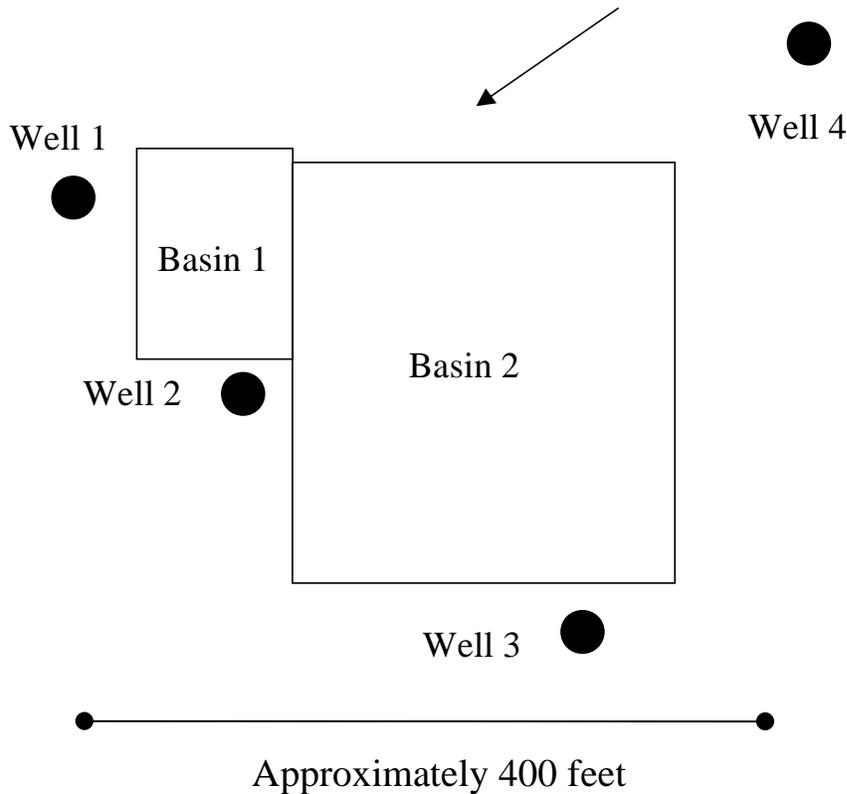
Figure 24: Location of monitoring wells, manure basins, and ground water flow direction (arrow) at site EM5.

We calculated nonparametric correlation coefficients between sampling event and chemical concentration. Table 22 summarizes results of this analysis. The data reveal no significant correlations between sampling event and chemical concentrations in the down-gradient well (Well 2).

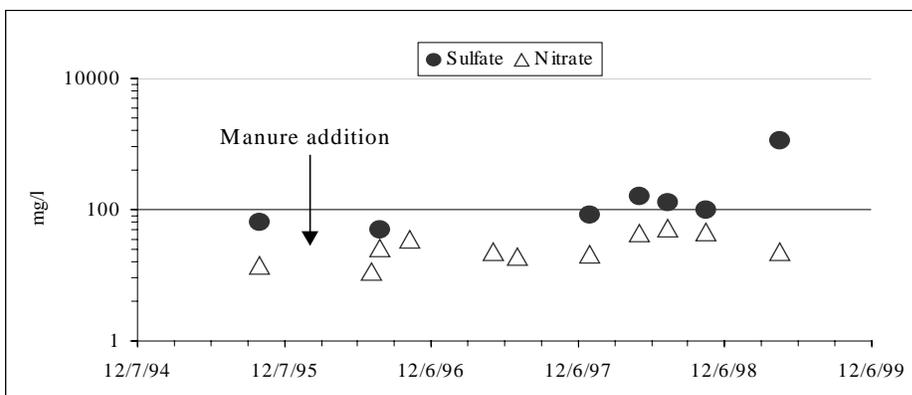
Figure 25: Concentrations of sulfate and nitrate in the perimeter tile at Site EM5.

Several sampling events for the tile line have been missed because of logistical reasons or no flow in the tile. Concentrations of sulfate and nitrate increased during the sampling period ($R^2 = 0.573$ for nitrate, and 0.821 for sulfate)(Figure 25). The correlation between sampling date and sulfate is partly due to a very high concentration of 1160 mg/L in April of 1999, although the nonparametric method tends to smooth out the effect of this value.

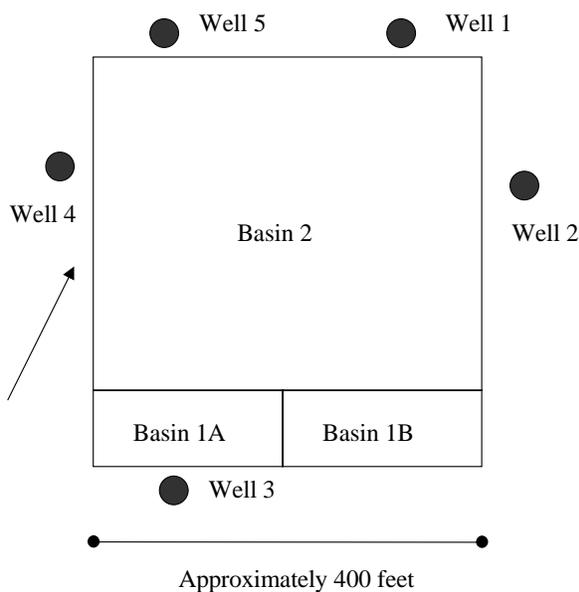
Figure 26: Location of monitoring wells, manure basins, and ground water flow direction (arrow) at site EM6.

We calculated nonparametric correlation coefficients between sampling event and chemical concentration. Table 23 summarizes results of this analysis. The data reveal no significant correlations between sampling event and chemical concentrations in down-gradient wells. Ground water impacts from the manure storage system were not evident at Site EM6.

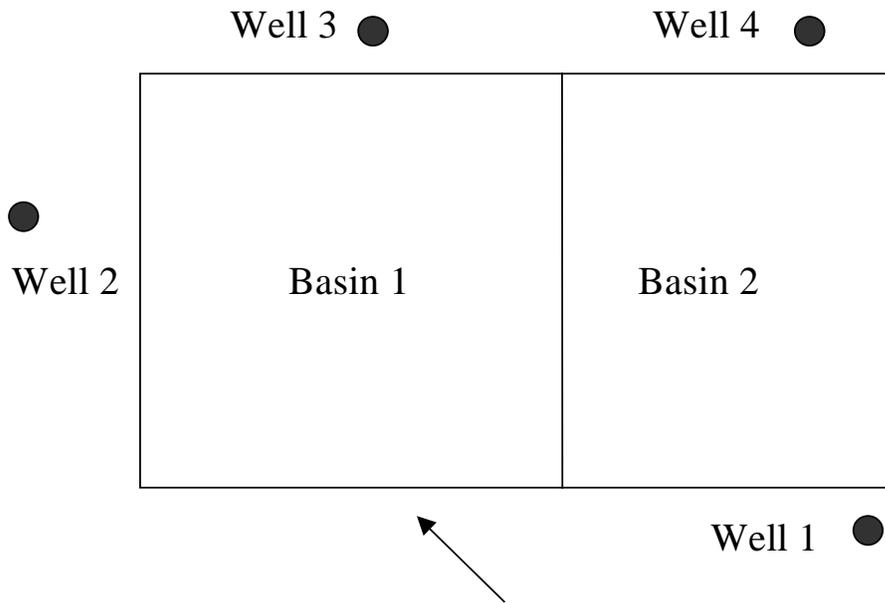
Figure 27: Location of monitoring wells, manure storage basins, and ground water flow direction (arrow) at Site EM7.

We calculated nonparametric correlation coefficients between sampling event and chemical concentrations (Table 24). Nitrate concentrations were positively correlated with sampling event in Well 1 (Figure 28). The source of nitrate is unclear but may be agricultural fields up-gradient of Well 1. Nitrate concentrations were not correlated with sampling event in down-gradient wells.

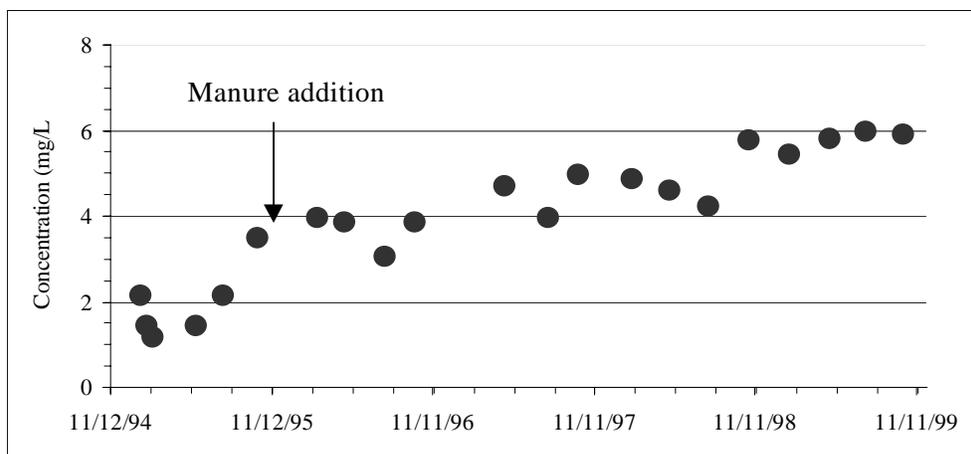
Figure 28: Nitrate concentrations and sampling date in Well 1 at Site EM7.

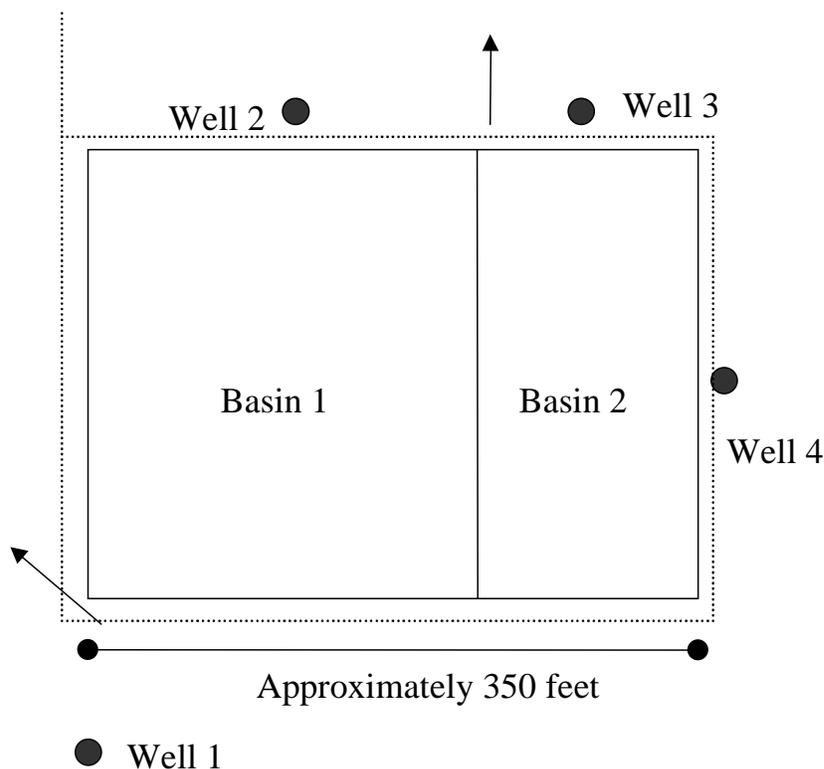
Figure 29: Location of manure storage basins, monitoring wells, and ground water flow direction (arrow) at site EM8. The dashed line illustrates the location of the tile lines.

Well 1 is up-gradient of the basins, while Well 2 is down-gradient. Using nonparametric methods, we calculated 90 percent confidence tolerance limits. We observed no significant differences between Wells 1 and 2 in concentrations of sulfate, chloride, nitrate, specific conductance, total Kjeldahl nitrogen, and ammonia. We observed significant negative correlations between sampling event and specific conductance and concentrations of sulfate and nitrate in Wells 1 and 2 (Table 25).

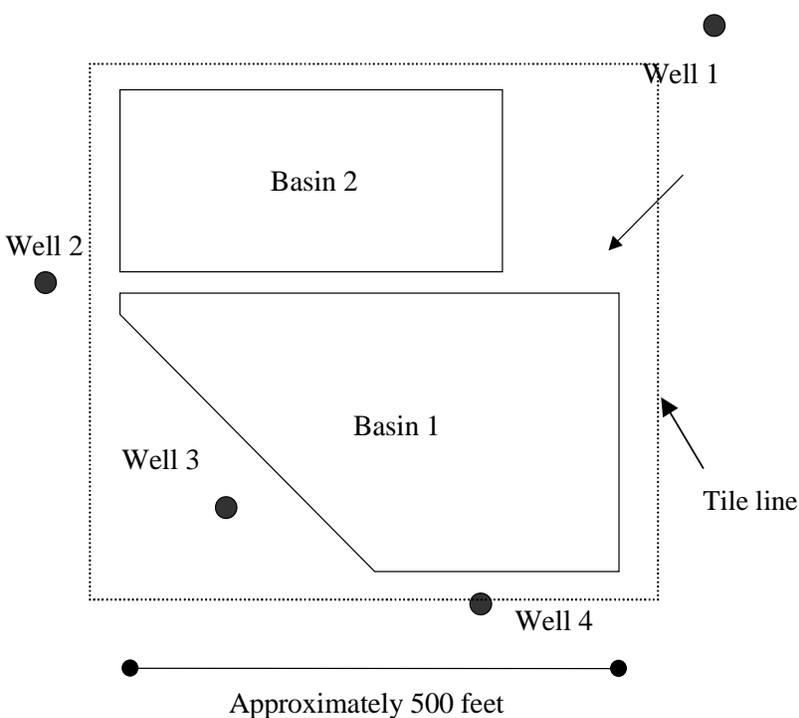
Figure 30: Location of monitoring wells, manure basins, and ground water flow (arrow) at Site EM9.

Well 1 is up-gradient of the manure basins and Well 3 is down-gradient. Comparing down- and up-gradient wells, we calculated 90 percent tolerance intervals for sulfate, chloride, nitrate, specific conductance, and ammonia. No concentrations exceeded the tolerance limit, indicating that concentrations are similar in up- and down-gradient wells. Sulfate concentrations were negatively correlated with sampling event in Well 1 ($R^2 = -0.622$), Well 3 ($R^2 = -0.765$), and Well 4 ($R^2 = -0.842$). Concentrations of Kjeldahl nitrogen and ammonia were higher in Wells 3 and 4 than in Wells 1 and 2, but these high concentrations existed prior to addition of manure in 1995.

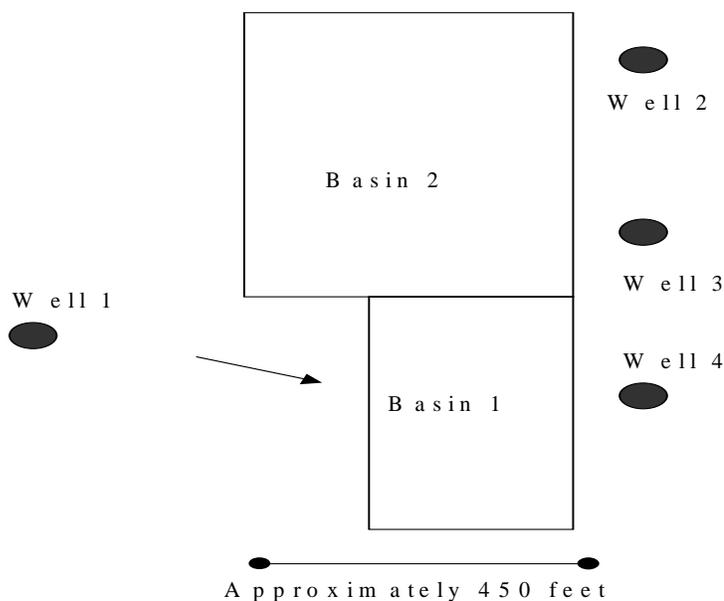
Figure 31: Location of monitoring wells, manure basins, and ground water flow direction (arrow) at Site EM10.

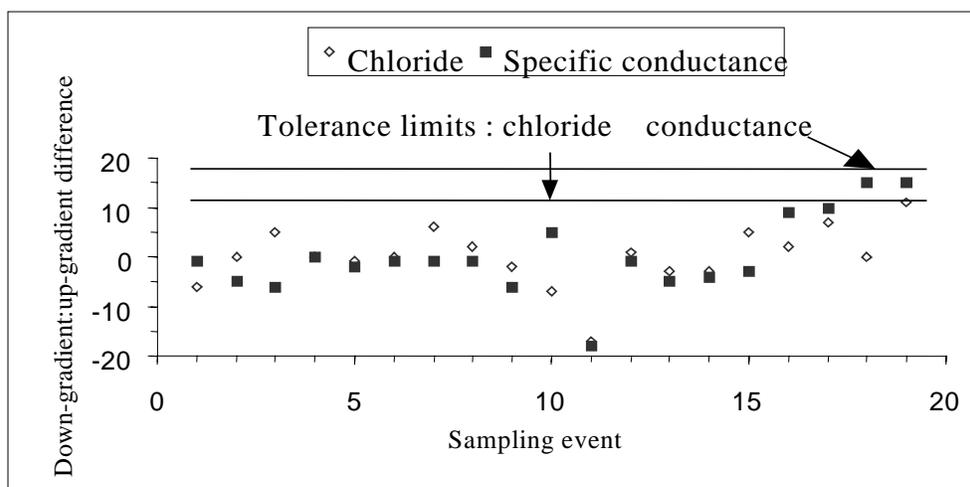
Figure 32: Tolerance limits for chloride and specific conductance at Site EM10. Well 1 is the up-gradient well and Wells 3 and 4 are the down-gradient wells.

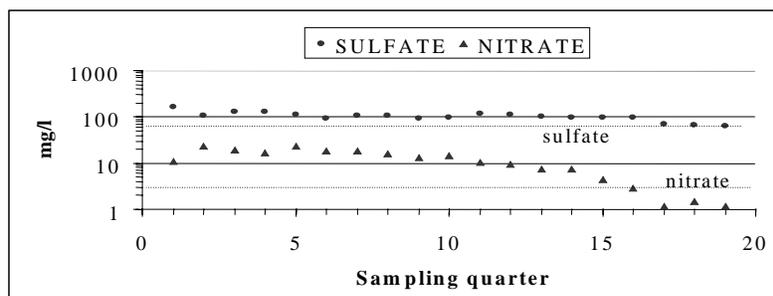
----- Lower 95% confidence interval

Figure 33: Distribution of sulfate and nitrate in Well 2 at Site EM10, as a function of sampling event. Lower 95% confidence intervals are used because chemical concentrations decreased with sampling event.

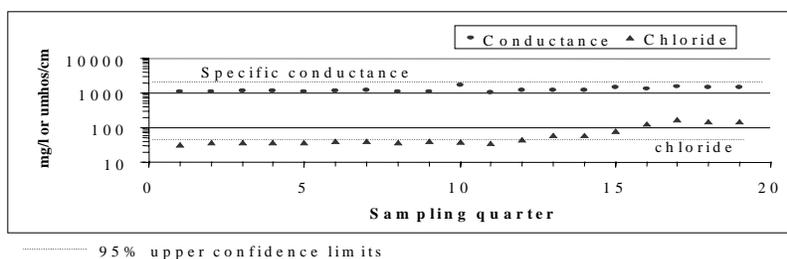
Figure 34: Distribution of chloride and specific conductance in Well 2 at Site EM10, as a function of sampling event. Upper 95% confidence intervals are used because chemical concentrations increased with sampling event.

The strongest correlations between chemical concentration and sampling event were for Well 2, which is side-gradient to the manure basins (Table 27). Concentrations of sulfate and nitrate were negatively correlated with sampling event in Well 2 ($R^2 = -0.736$ for sulfate and -0.884 for nitrate) (Figure 33). Sampling event was positively correlated with specific conductance ($R^2 = 0.692$) and chloride concentration ($R^2 = 0.849$) (Figure 34).

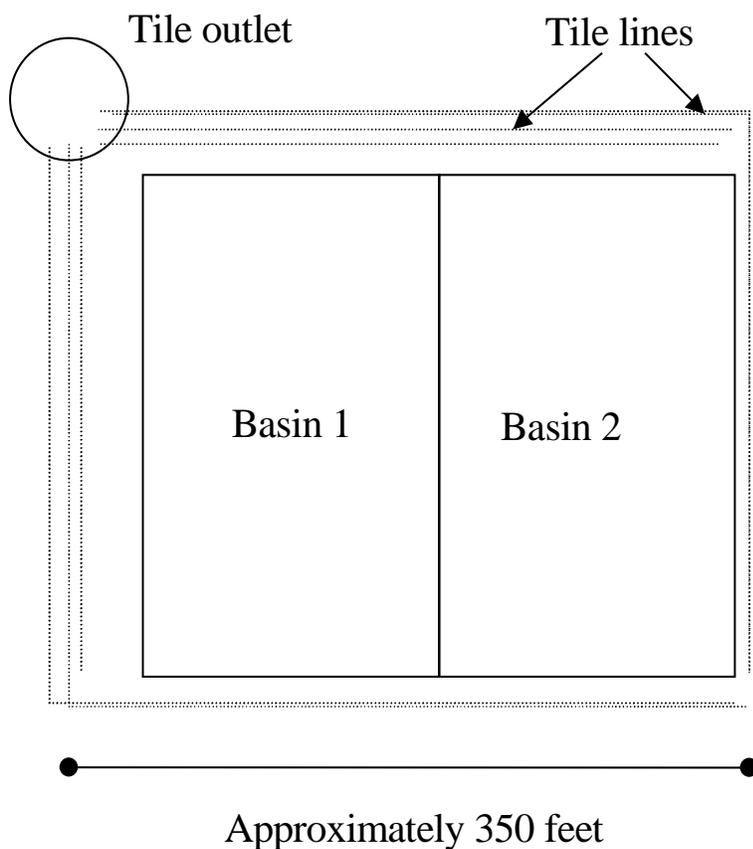
Figure 35: Location of manure basins, tile lines, and tile outlet at Site EM11.

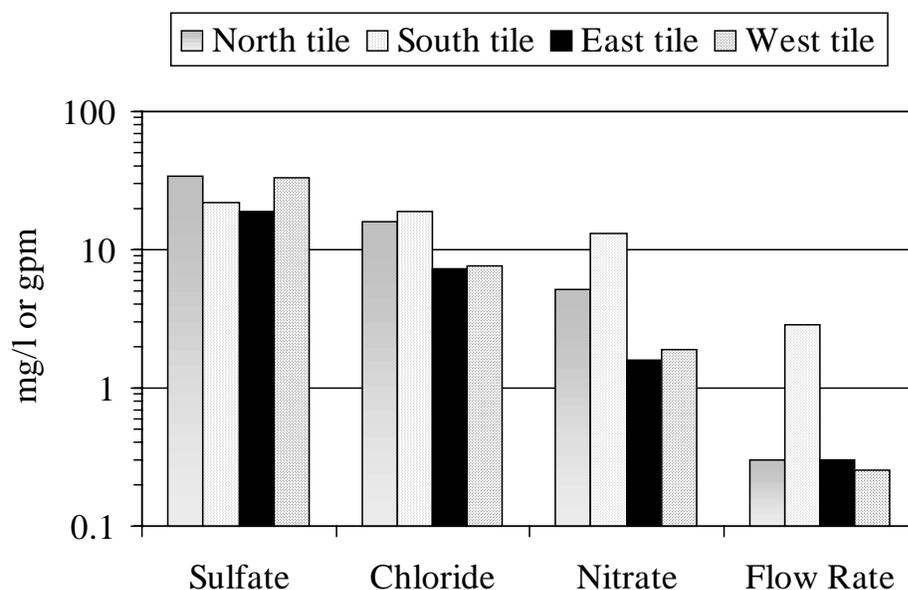
Figure 36: Flow rate and concentrations of sulfate, chloride, and nitrate in tile lines at Site EM11.

and for chloride in the north and east tiles. There were positive correlations between sampling event and concentrations of sulfate in the north and west tiles. Typically, increasing concentrations of chloride, increasing values for specific conductance, and decreasing concentrations of nitrate are evidence of impacts from manure storage systems. Other indicators may include increasing concentrations of Kjeldahl nitrogen, and phosphorus, and decreasing concentrations of sulfate. The chemistry of water entering the tile lines may provide evidence of a transition in water quality. Additional sampling of redox parameters, such as redox potential, dissolved oxygen, and reduced iron, may provide additional information about the redox status of water entering the tile lines.
