Effects of Liquid Manure Storage Systems on Ground Water Quality

April 2001

Minnesota Pollution Control Agency
Ground Water and Toxics Monitoring Unit
Environmental Monitoring and Analysis Section
Environmental Outcomes Division
520 Lafayette Road
St. Paul, Minnesota 55155-4194
(651) 296-6300 or (800) 657-3864

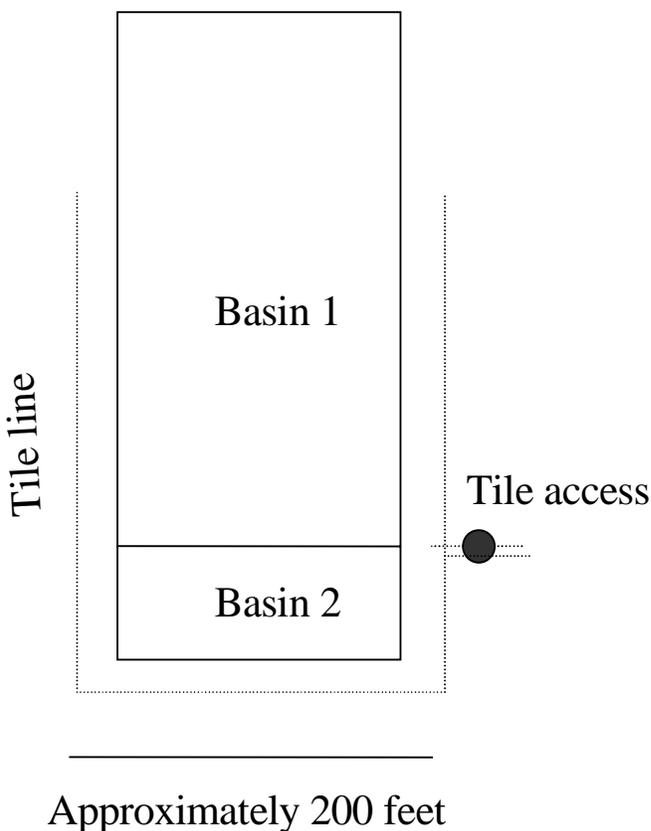
Figure 37: Location of manure storage basins and perimeter tile at Site EM15.

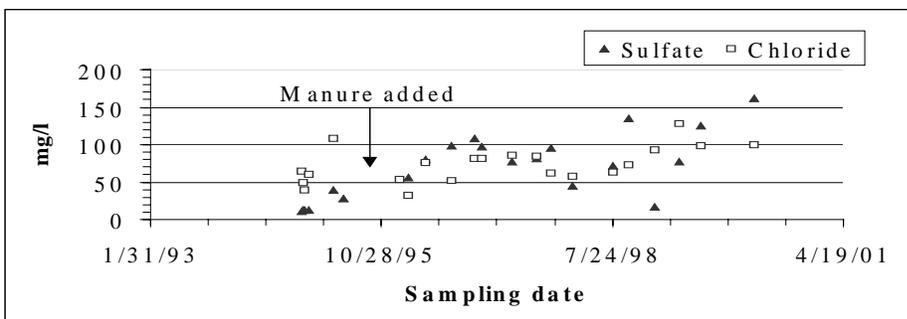
Figure 38: Concentrations of chloride and sulfate in the perimeter tile at Site EM15.

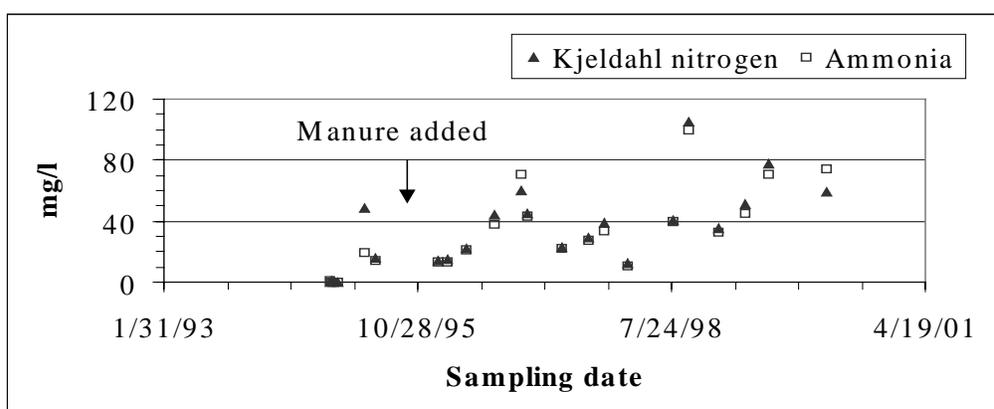
Figure 39: Concentrations of Kjeldahl nitrogen and ammonia in the perimeter tile at Site EM15.

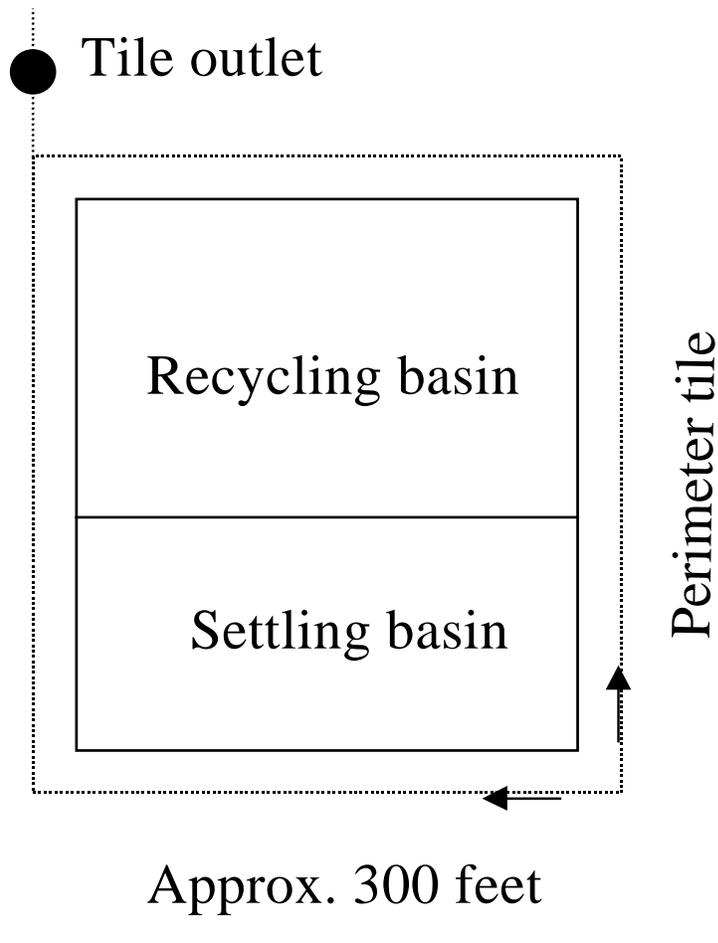
Figure 40: Location of manure storage basins and tile lies at Site EM16.

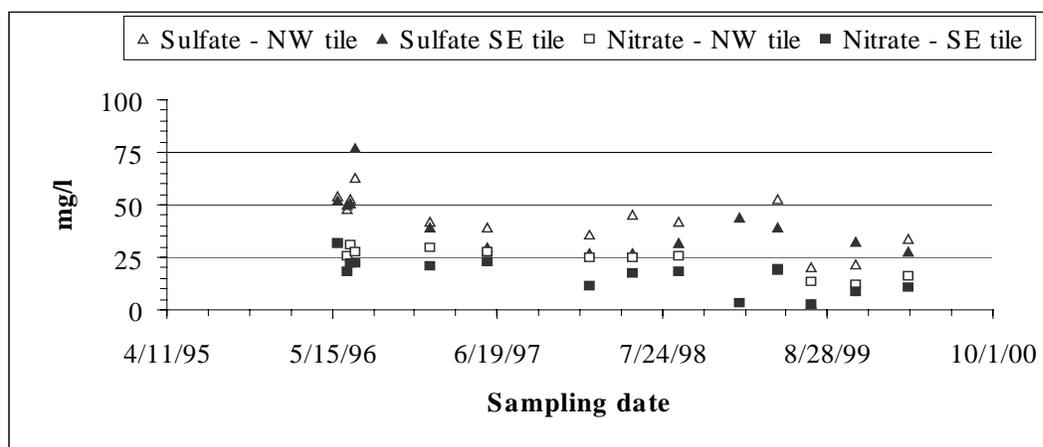
Figure 41: Concentrations of nitrate and sulfate in tile lines at Site EM16, as a function of sampling date.

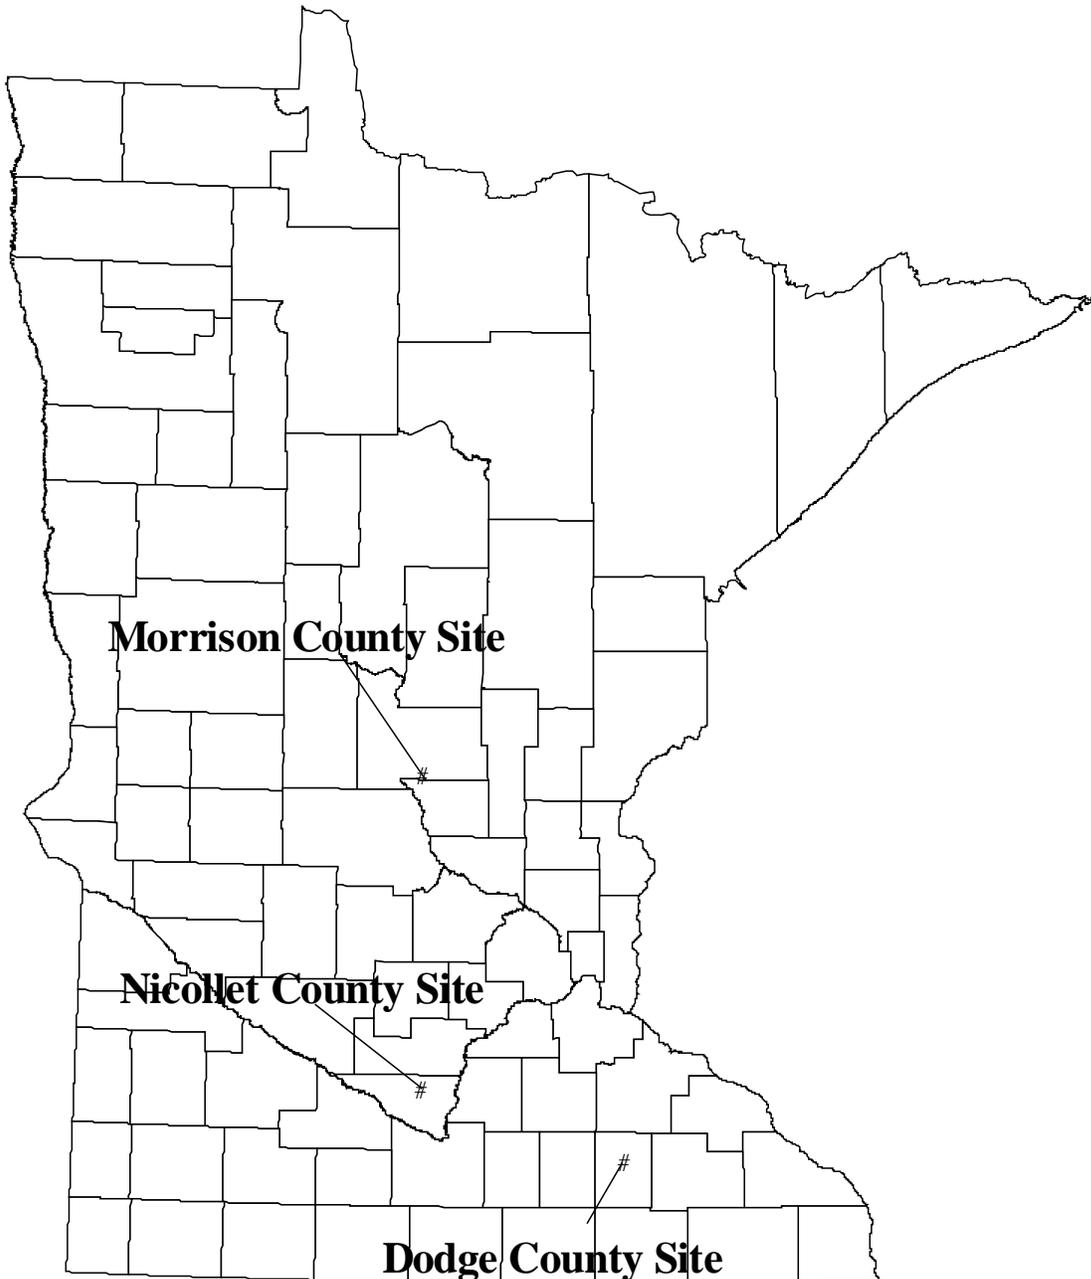
Figure 42: Location of sites with lysimeters.

Since 1998, we have monitored three sites that have leachate collection systems (lysimeters) installed beneath earthen-lined manure storage systems. Figure 42 illustrates the location of these sites. Collection of flow data for the basin bottoms and sidewalls was sporadic, and we cannot estimate seepage through the basins during 1998 and 1999. Table 30 summarizes seepage water quality at the three sites between 1998 and 2000. Data was collected at each of

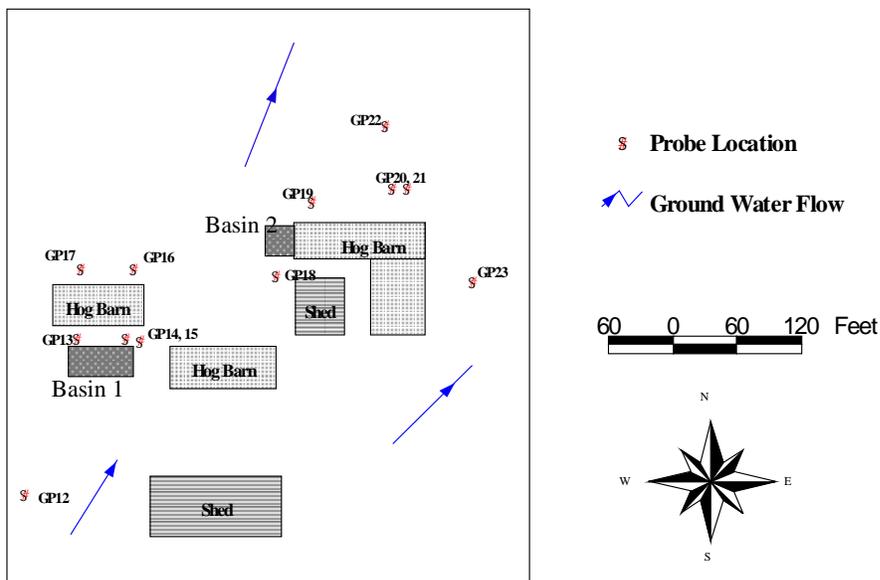
Figure 44: Location of temporary wells and ground water flow direction at Site C1.

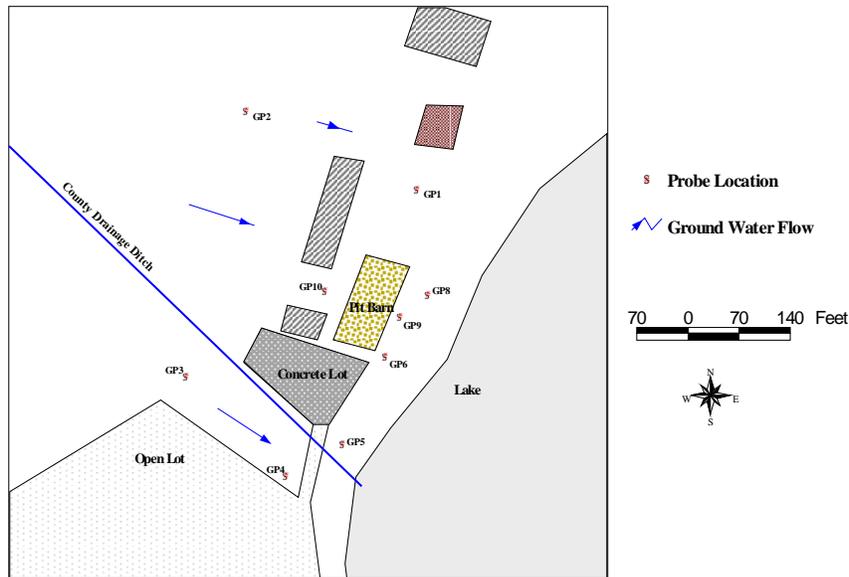
Figure 45: Location of wells and ground water flow direction at Site C2.

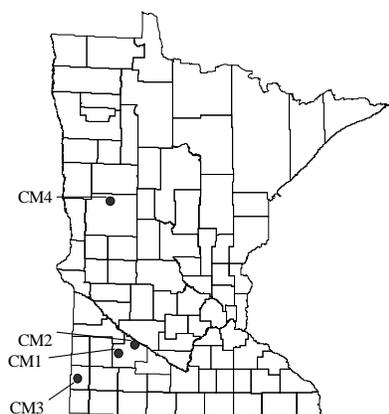
Figure 46: Location of sites having concrete-lined manure storage basins and permanent monitoring networks.

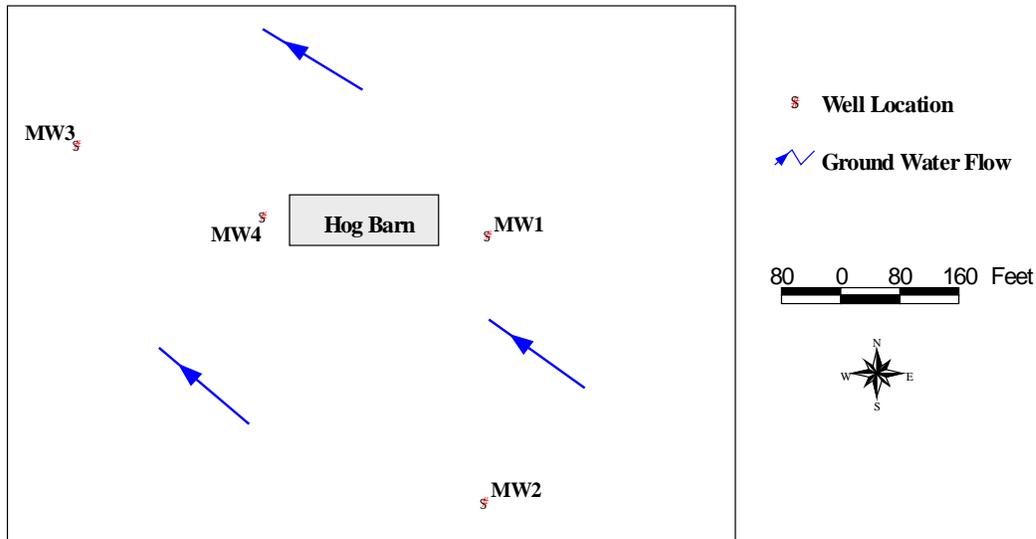
Figure 47: Location of monitoring wells at Site CM4. Manure is collected in a concrete basin beneath the hog barn.

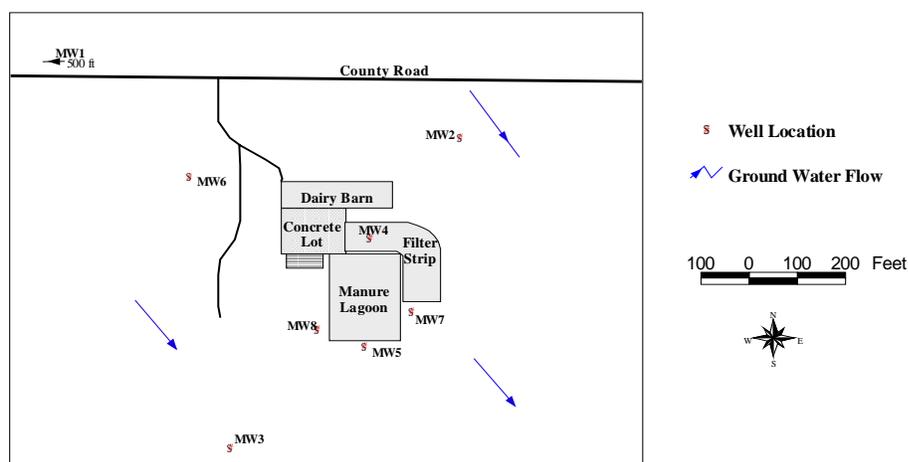
Figure 48: Location of monitoring wells and ground water flow at the site with a geosynthetic liner. Note that wells shown in Figure 48 represent permanent wells drilled after our initial investigation with temporary wells. The well locations in Figure 4 therefore differ from those shown in Figure 48.

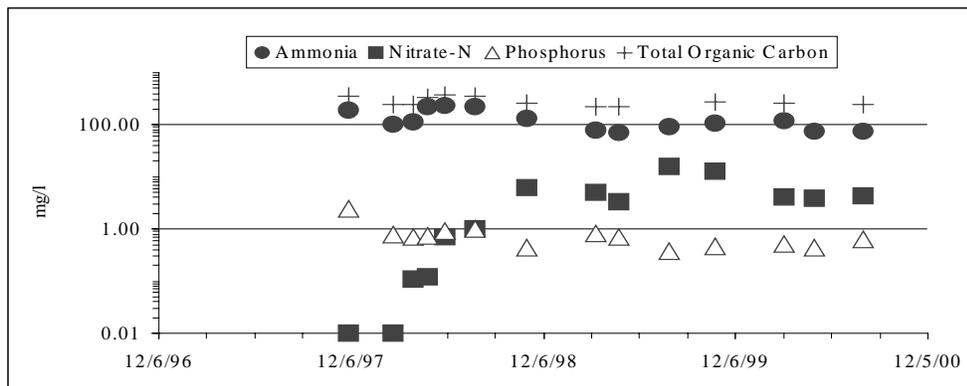
Figure 49: Concentrations of ammonia, nitrate, phosphorus, and organic carbon in Well MW4, located beneath the feedlot at the site with a geosynthetic liner.

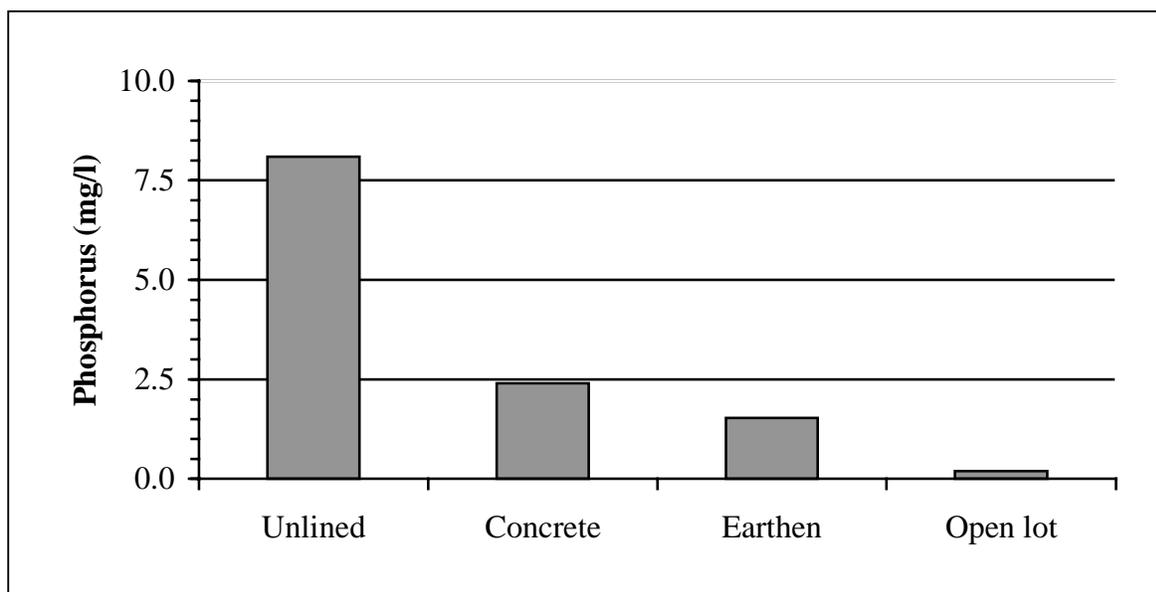
Figure 50: Median phosphorus concentrations for different manure storage systems.

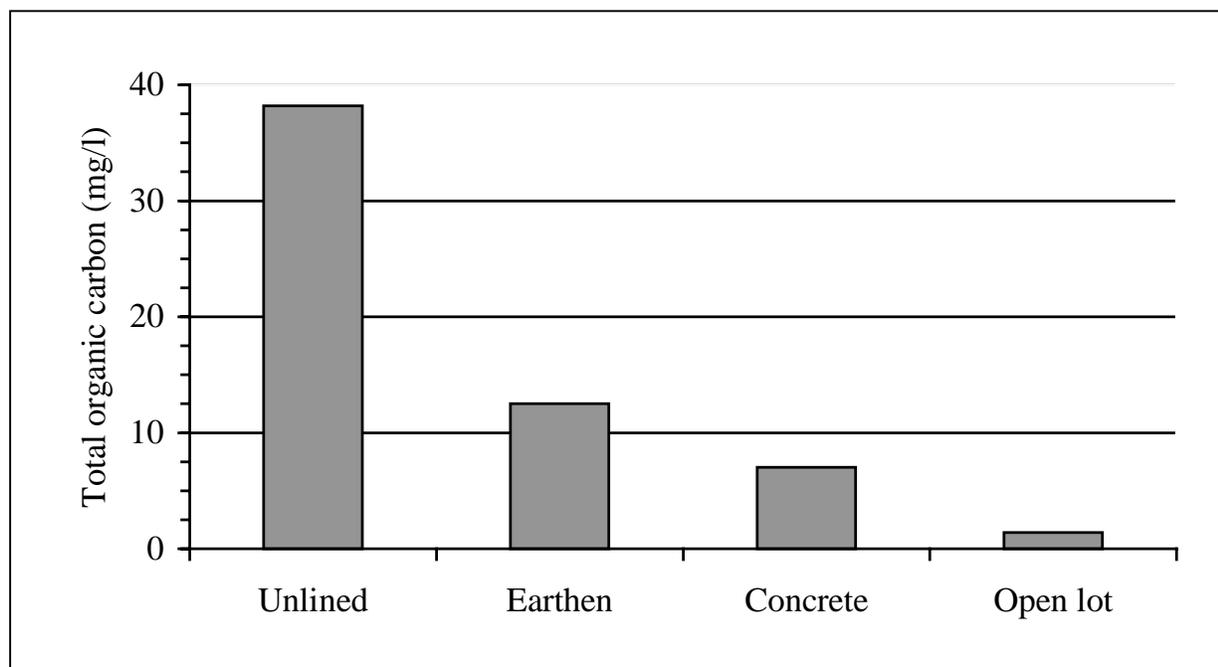
Figure 51: Average concentrations of total organic carbon under four different manure management systems.
