Skunk Creek Watershed

Minnesota's Lake Superior Basin

This report summarizes the first year (July 1, 2024, through June 30, 2025) of effectiveness monitoring efforts in the watershed and presents initial data results.

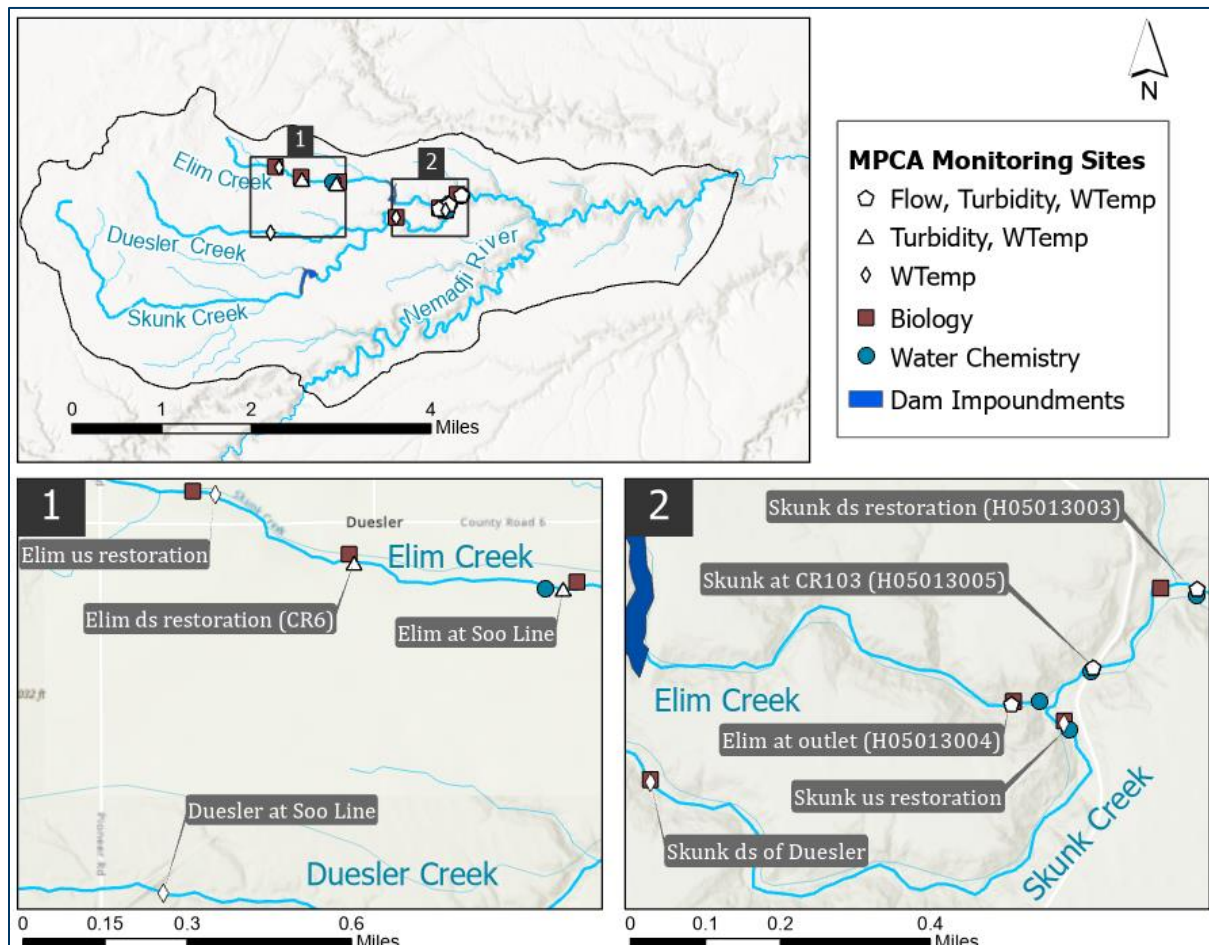
Figure 3. Monitoring sites (past/present) for streamflow, continuous turbidity and water temperature (WTemp), and water chemistry sampling.

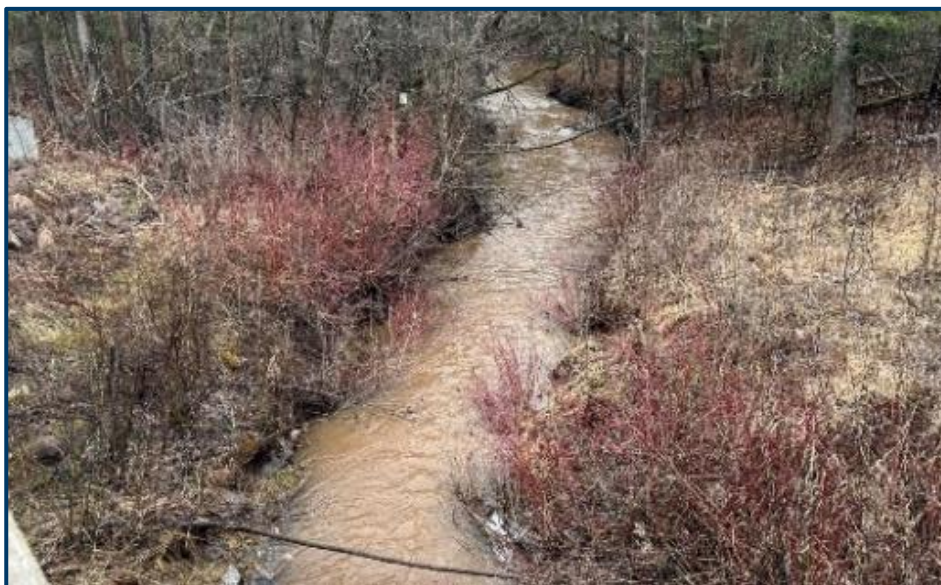
Since 2020, MPCA has been collecting 15-minute water level data using a radar sensor and calculating streamflow for Skunk Creek at the Carlton County Highway 103 bridge (Figure 4). This location is referred to as the *Skunk at CR103* site throughout this report. The WISKI identification number is H05013005. Water level and streamflow data collection continued during the 2024 open water season from April 8 to November 7.

Figure 4. Skunk Creek streamflow site, *Skunk at CR103* (H05013005).

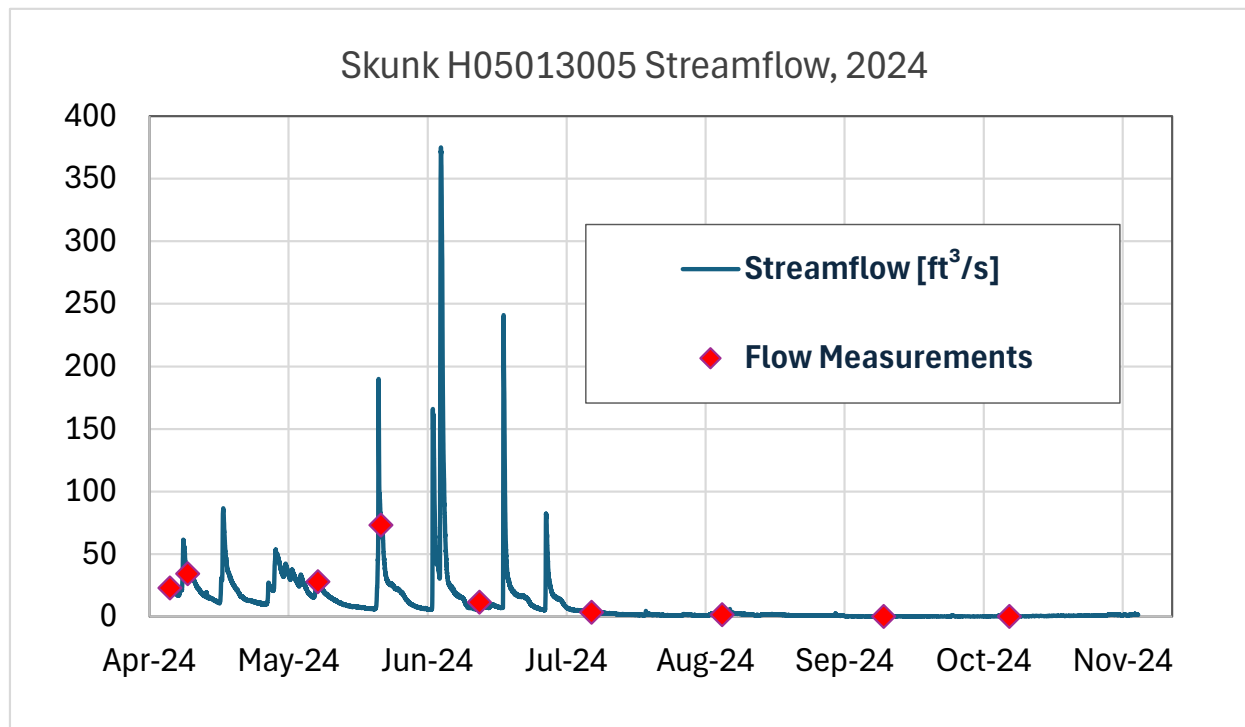
Discrete flow measurements were collected nine times throughout the 2024 season to validate and build a level-streamflow rating curve. Seven of those measurements were waded using a FlowTracker2 acoustic doppler velocimeter and two were collected by a moving boat method using a Sontek RS5 acoustic doppler current profiler. Discrete flow measurements captured all flow conditions (very low, low, moderate, high, and very high) in 2024 (Figure 5 and Table 1). Flow measurements from past years were also considered in the development of the rating curve. Daily streamflow values were quality coded fair to poor based on the number and quality of flow measurements used to develop respective sections of the curve. Flow measurements collected after the 2024 season will be used to further improve the rating curve for this gage. Four measurements were collected between April and June of 2025 covering low, moderate, high, and very high flow conditions.

Figure 5: Continuous streamflow in units of cubic feet per second (cfs or ft³/s at Skunk gage H05013005 and discrete flow measurements in the 2024 open water season.

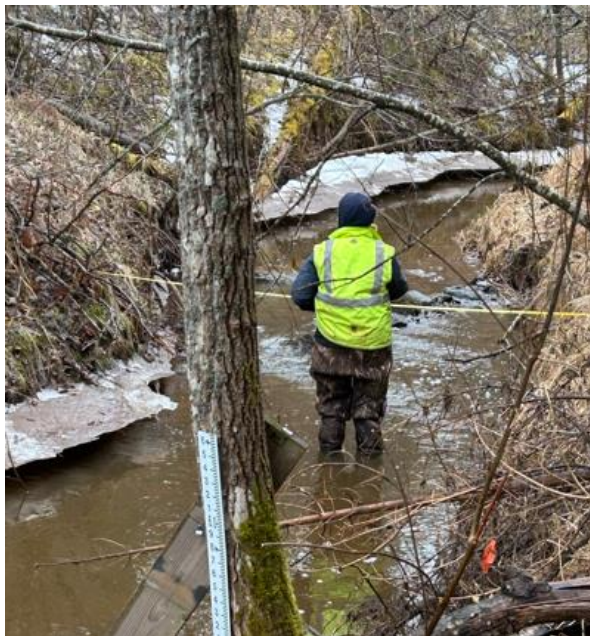
Figure 6. The MPCA measuring streamflow at Elim at outlet gage (H05013004).

The gage setup at this location consists of a pressure transducer to measure continuous water level, a staff gage to record field measured level, and a DTS-12 turbidity sensor to record continuous turbidity and water temperature. The pressure transducer and staff gage became unstable on August 31, days after installation, and resulted in erroneous water level values through September 11, 2024, when the problem was identified. The equipment was remounted, and the gage collected good data through November 7, 2024, when the pressure transducer was removed for the winter season.

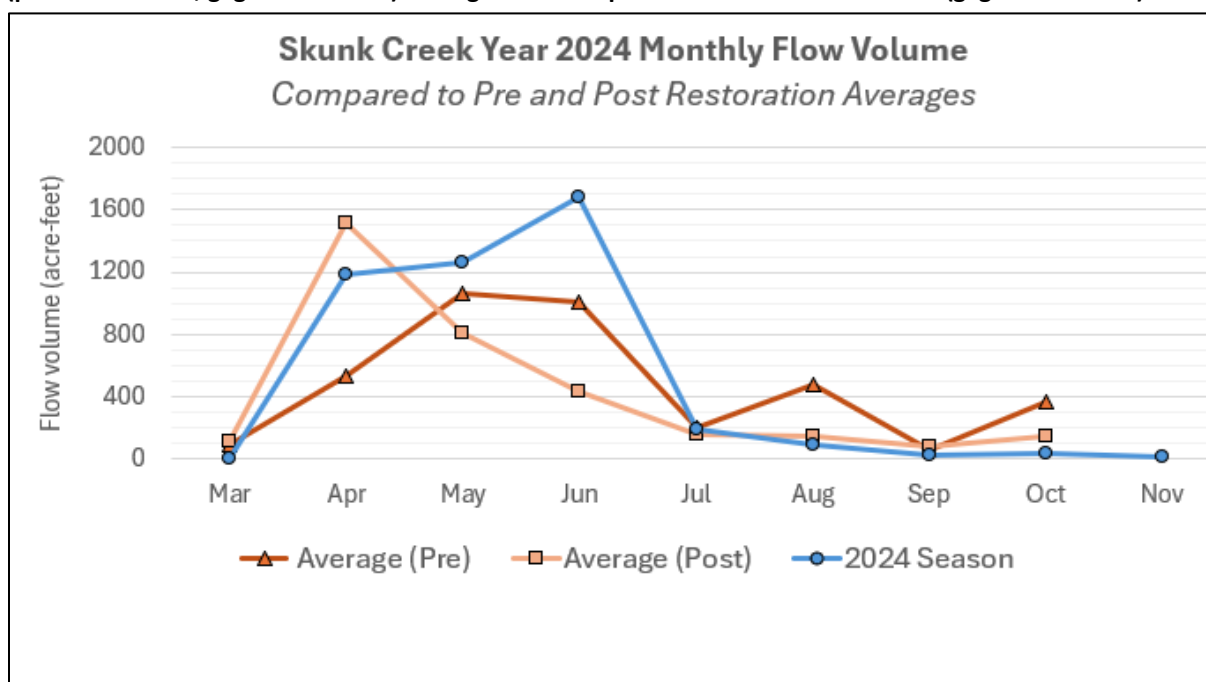
Monthly flow volumes at the Skunk Creek gage H05013005 in 2024 align with DNR Climatology reports that March through June finished as the seventh wettest on record for the area with a 4.85-inch precipitation surplus; and that normal precipitation in July and August was followed by the driest September on record and below normal precipitation in September and October. Results for the 2025 season will be reported in next year's annual summary.

Figure 7. Flow records for years 2009-2013 (pre-restoration on Skunk Creek, gage H05013003) and 2020-2024 (post-restoration, gage H05013005) averaged and compared to the 2024 flow record (gage H05013005).

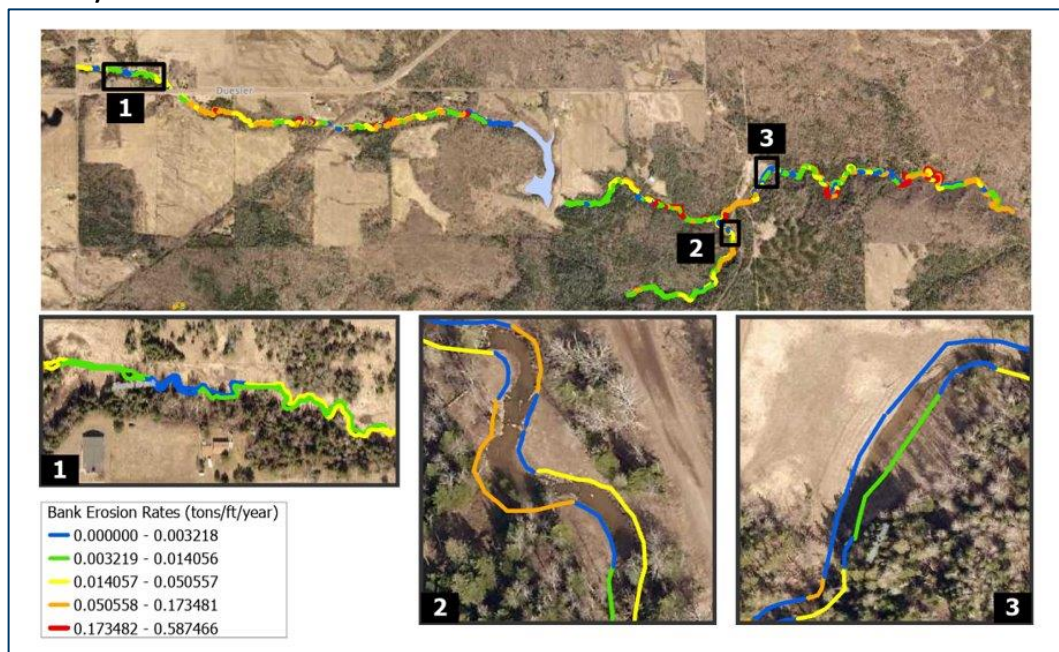
Rapid Bank Assessment for Nonpoint source Consequences of Sediment (BANCS) is a model that predicts annual erosion rates by incorporating field observations of bank erosion hazards (based on attributes such as bank height, root density, bank material, etc.) and near bank stress (rates the energy exerted by the stream against the bank). Rapid BANCS data was collected in the watershed (Figure 8) by DNR in the spring through fall seasons of 2024. These data were used to determine erosion rates, which ranged from low (blue) to high (red) across the Skunk Creek Watershed.

Figure 8. Bank erosion rates are shown across the watershed and within restorations in subset maps: 1. Elim Creek dam removal restoration, 2. Skunk Creek bank stabilization/restoration and 3. Skunk Creek culvert-weir removal/restoration.

Generally, erosion rates were low to moderate in the restored reaches; however, moderately high erosion rates were documented within the upstream Skunk Creek restoration (Figure 8, Inset map 2) and with less severity in the downstream Skunk restoration (Figure 8, Inset map 3). To further explain areas of higher erosion and stream function within restoration reaches, the Minnesota Stream Quantification Tool (MNSQT) was applied.

Other technical aspects of the design (e.g. bankfull benches at incorrect elevations, no toe-wood in the middle meander, and misplaced J-hooks) are cause for concern and are reducing the stability and functionality of the reach. Additionally, the end of the restoration is not adequately tied into the existing downstream channel. These results suggest that overtime this reach will be prone to additional erosion. Current elevated bank erosion rates are documented in Figure 8, inset map 2.

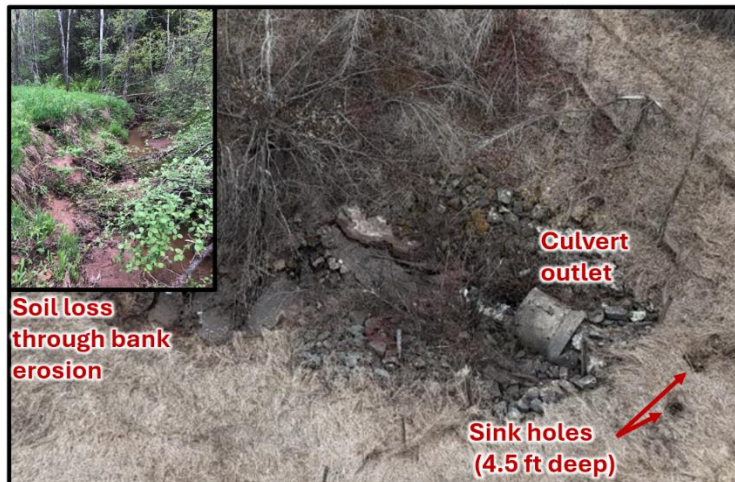
This reach of Elim is impacted by a perched culvert under the Soo Line Recreational Trail. The replacement of the culvert is being proposed as a future project due to sediment loss and the forming of sink holes around the pipe outlet (Figure 9).

MNSQT pool spacing ratio scores as “not functioning” and BEHI/NBS combination scores within “functioning at risk”. There is evidence of undercutting banks and incision in the cross sections, both related to erosion. The pool spacing ratio also indicates instability. The dominant BEHI/NBS combination within the surveyed segment is Moderate/Moderate (moderate erosion on both right and left banks) and shortly downstream shifts to High/Moderate (high on one bank, moderate on the other) or High/High (high erosion on both banks).

Figure 9. Soo Line Trail culvert outlet at Elim Creek. Two sink holes have formed near the outlet and there is evidence of eroding and undercutting banks and channel incision.

Lastly, a degrading and perched culvert and related stream bank stability issue were identified on Elim Creek at the state Soo Line Recreational Trail crossing during the 2024 monitoring season. The soil material around the pipe culvert outlet is beginning to "unravel" causing sink holes in the landscape. The eroding sediment is being depositing into the downstream channel, which is incised, and several streambanks are undercut and eroding. Since this discovery, Carlton SWCD is working with other County and State partners to secure funding with the intent to replace the failing culvert within the next five years.

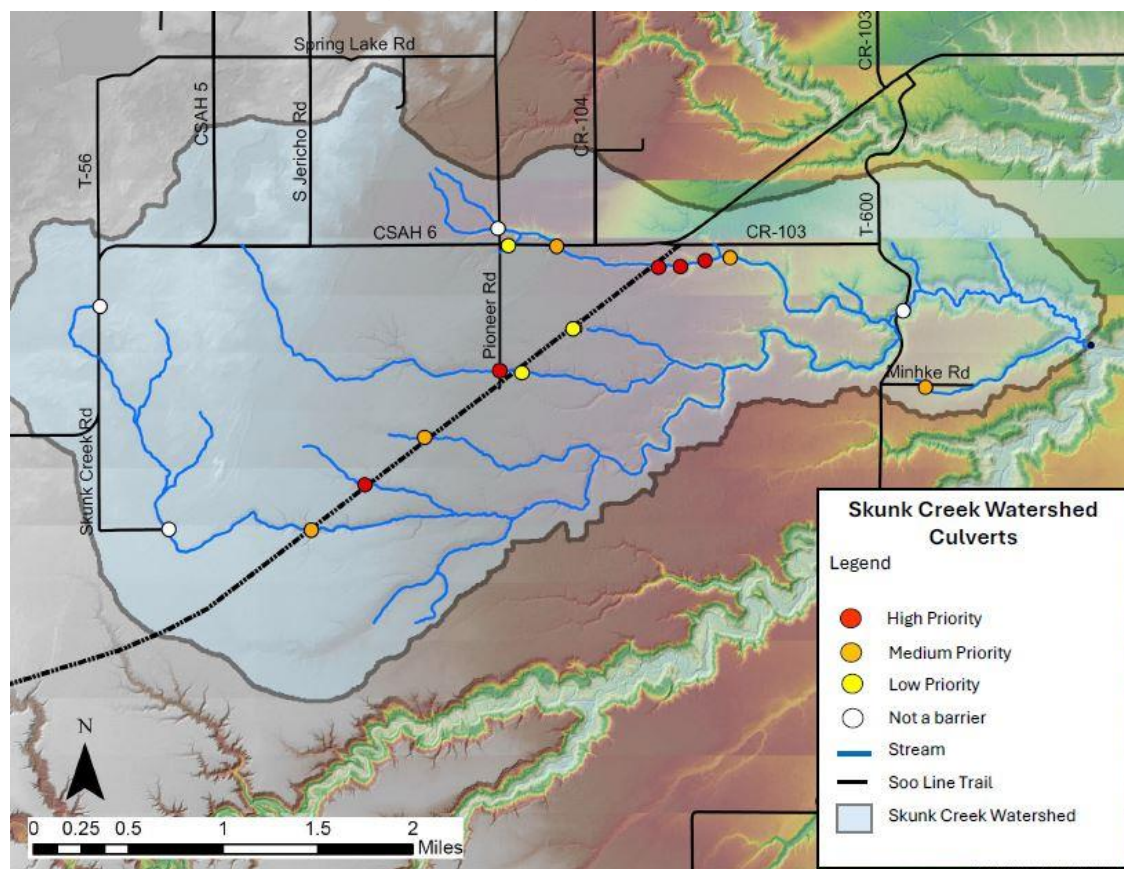
The survey and SCPM located 17 crossings within the Skunk Creek Watershed (Figure 10), that includes 7 in the Elim Creek Watershed, 3 in the Duesler Creek Watershed, and 7 in the main Skunk Creek Watershed. Of these crossings, 13 (76%) were identified as barriers. There are 1.4 crossings per stream mile and 1.8 barriers per stream mile. This density of crossings and barriers per stream mile is comparable to that of watersheds within the city of Duluth (Mission Creek = 1.3 crossings per stream mile, and 1.2 barriers per stream mile). The density is increased by the Soo Line Recreational Trail and private crossings. Priority crossings for removal, replacement, or repair within the Skunk Creek Watershed are spread throughout the watershed and include five high priority and five medium priority crossings. The highest priority crossings for removal, replacement, or repair are concentrated in the Elim Creek Watershed. An additional high priority crossing is located on Duesler Creek.

Figure 10. Stream Crossing Prioritization map in Skunk Creek Watershed. Identifies crossings that are barriers to sediment transport and aquatic organism passage.

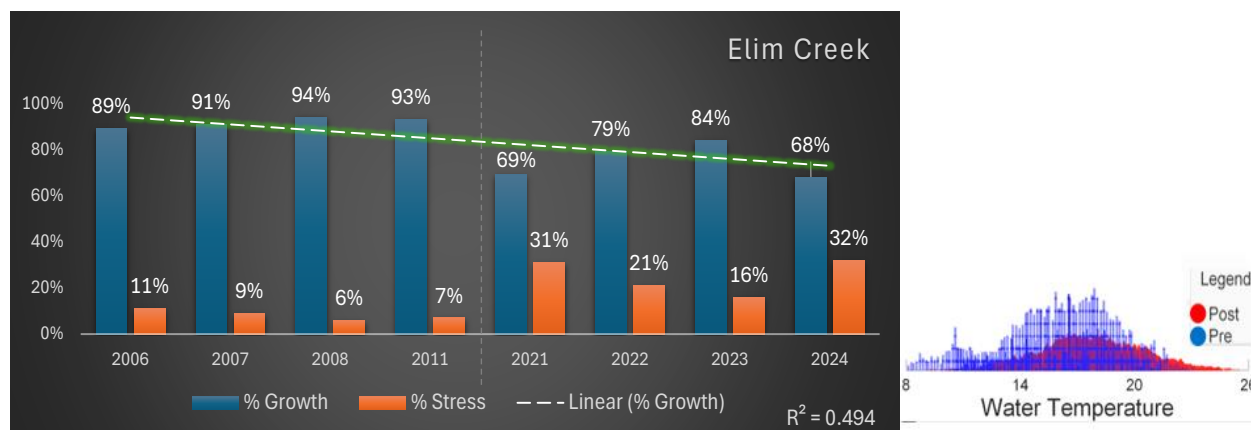
Comparing to historical data, the percent of summer water temperatures within the optimal growth range for brook trout has decreased over time at both Elim at outlet site (Figure 11) and the reach that includes both Skunk at CR103 and Skunk ds restoration sites (Figure 12) with a moderately strong

Figure 11. Elim Creek thermal stats (% Growth and % Stress) for data years between 2006 and 2024 (Left) and density plot (Right) for the same period at *Elim at outlet* site H05013004.

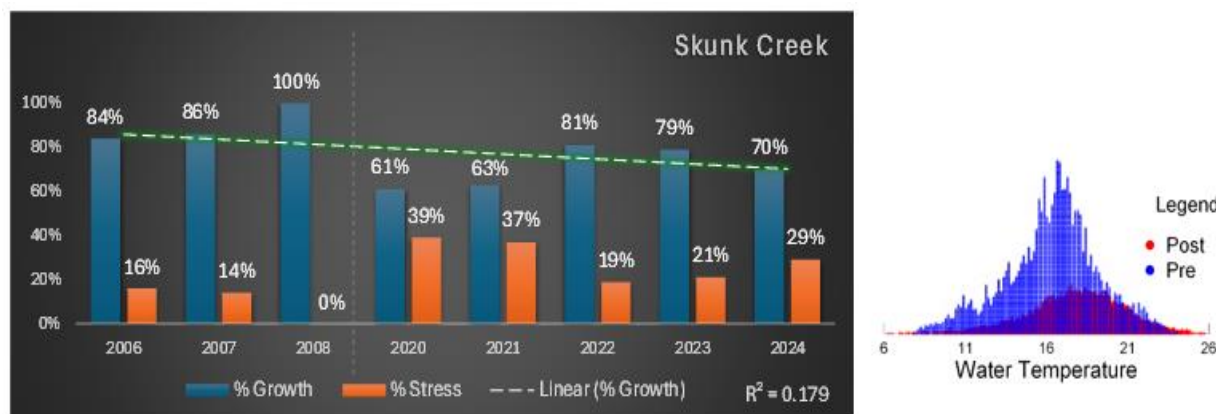
Figure 12. Skunk Creek thermal stats (% Growth and % Stress) for data years between 2006 and 2024 (Left) and density plot (Right) for the same period in the stream reach that extends from *Skunk at CR103* site H05013005 downstream to *Skunk ds restoration* site H05013003.

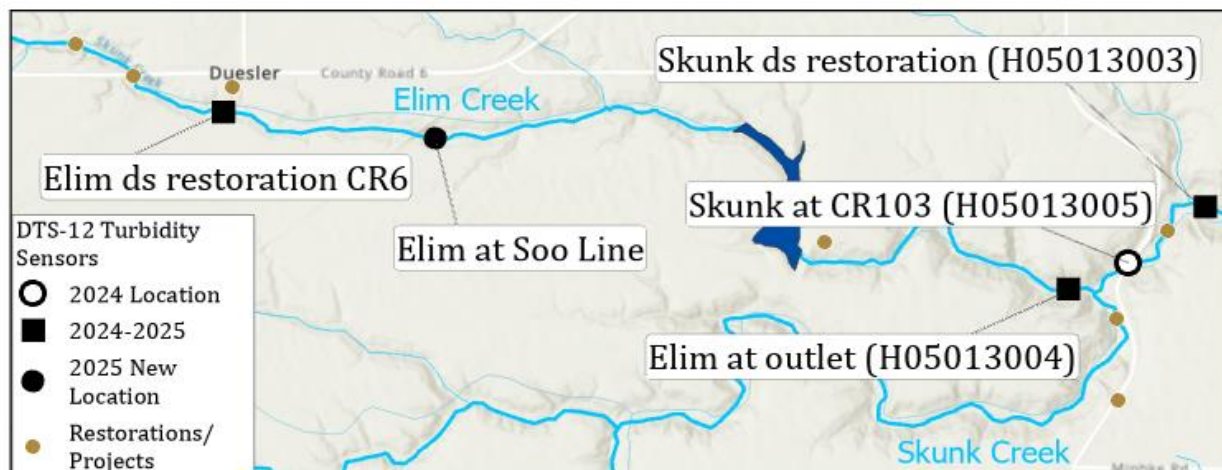
An adjustment was made to the continuous turbidity monitoring design in 2025. Three sensors were redeployed in the same locations as the 2024 placement, and the fourth sensor was moved to a new location (Figure 13). The sensor for site *Skunk at CR103* was moved downstream of the Soo Line Recreational Trail crossing on Elim Creek where a project to replace a failing culvert is currently being considered. The intent is to collect pre-project data for future effectiveness analysis. Continuous data for the 2025 season will be reported in the 2026 annual report.

Figure 13. Continuous turbidity locations, 2024 and 2025. Black squares = sensors placed in the same location both years, while circle symbols show the movement of a 2024 sensor (white) to a new location (black) in 2025.

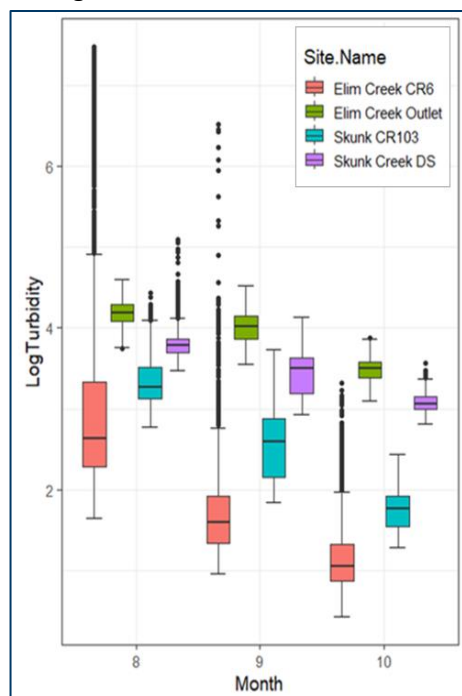
Turbidity at all four 2024 sites (Figure 14) generally decrease over the August to September period. Elim Creek at CR6 (pink) has the lowest interquartile values of the four sites, which can be explained by its small drainage area and sandier geology. Higher outliers at that site were potentially caused by construction activity immediately upstream at the culvert-to-bridge removal site and will be re-evaluated again at the end of the 2025 data year.

Figure 14. Continuous turbidity whisker plots show spatial variability within Skunk and Elim Creeks August through October 2024.

Downstream of the Elim dam at *Elim at outlet* site (green), the interquartile range increases from the upstream site, likely due to both the clayey geology and contributing sediment from stream downcutting and areas of high bank erosion (displayed in Figure 8).

Turbidity levels noticeably decrease downstream of the Elim-Skunk confluence at *Skunk at CR103* (blue) and then slightly increase at *Skunk ds restoration* (purple) within the 2018 culvert removal restoration reach. Erosion from an incised and unrestored stream section between the two Skunk Creek restorations is a potential cause of the increase.

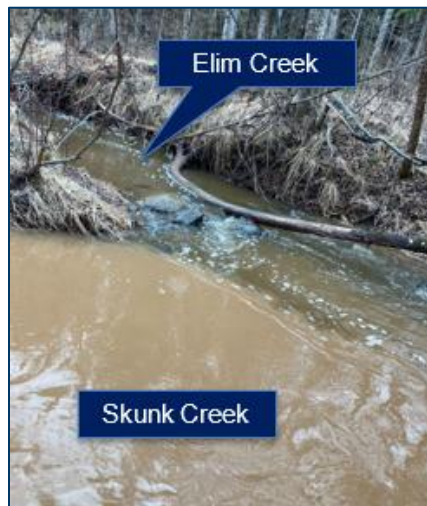
Figure 15. Elim Creek flowing into a more turbid Skunk Creek.

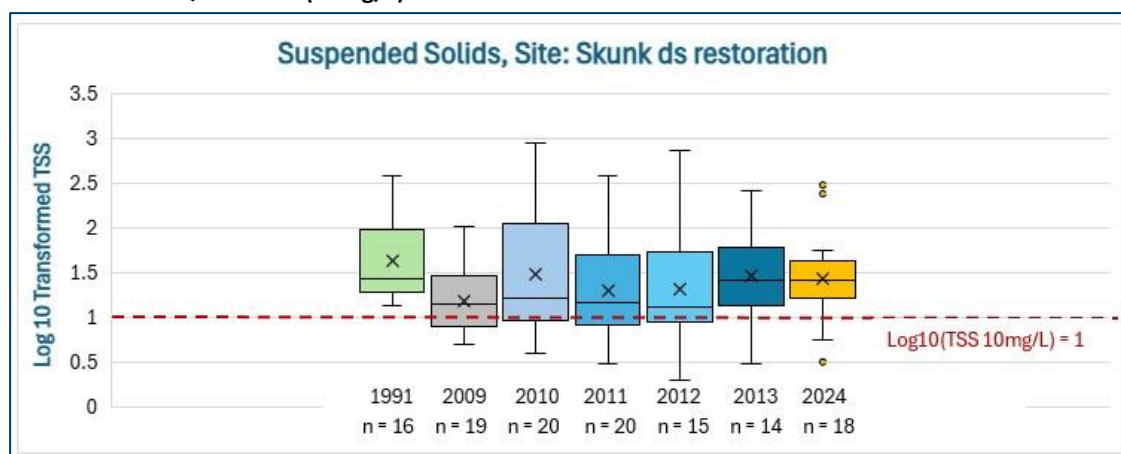
Figure 16. Whisker plot of log transformed TSS for Pre (1991-2013) and Post (2024) project years at site *Skunk ds restoration* (ID: S005-617). Only years with 14 samples or more were graphed. Red dashed line = Log transformed WQ standard (10mg/L)

While 2024 post-restoration median values (Figure 16) are comparable to pre-restoration median values, both Figure 16 and Figure 17 display a decrease in maximum TSS concentrations in 2024 compared to pre-restoration years. Reduced concentrations of samples collected within high and very high flow regimes (Figure 17) further infer potential success of stream restorations and other watershed projects in reducing extreme erosion and associated TSS concentrations.

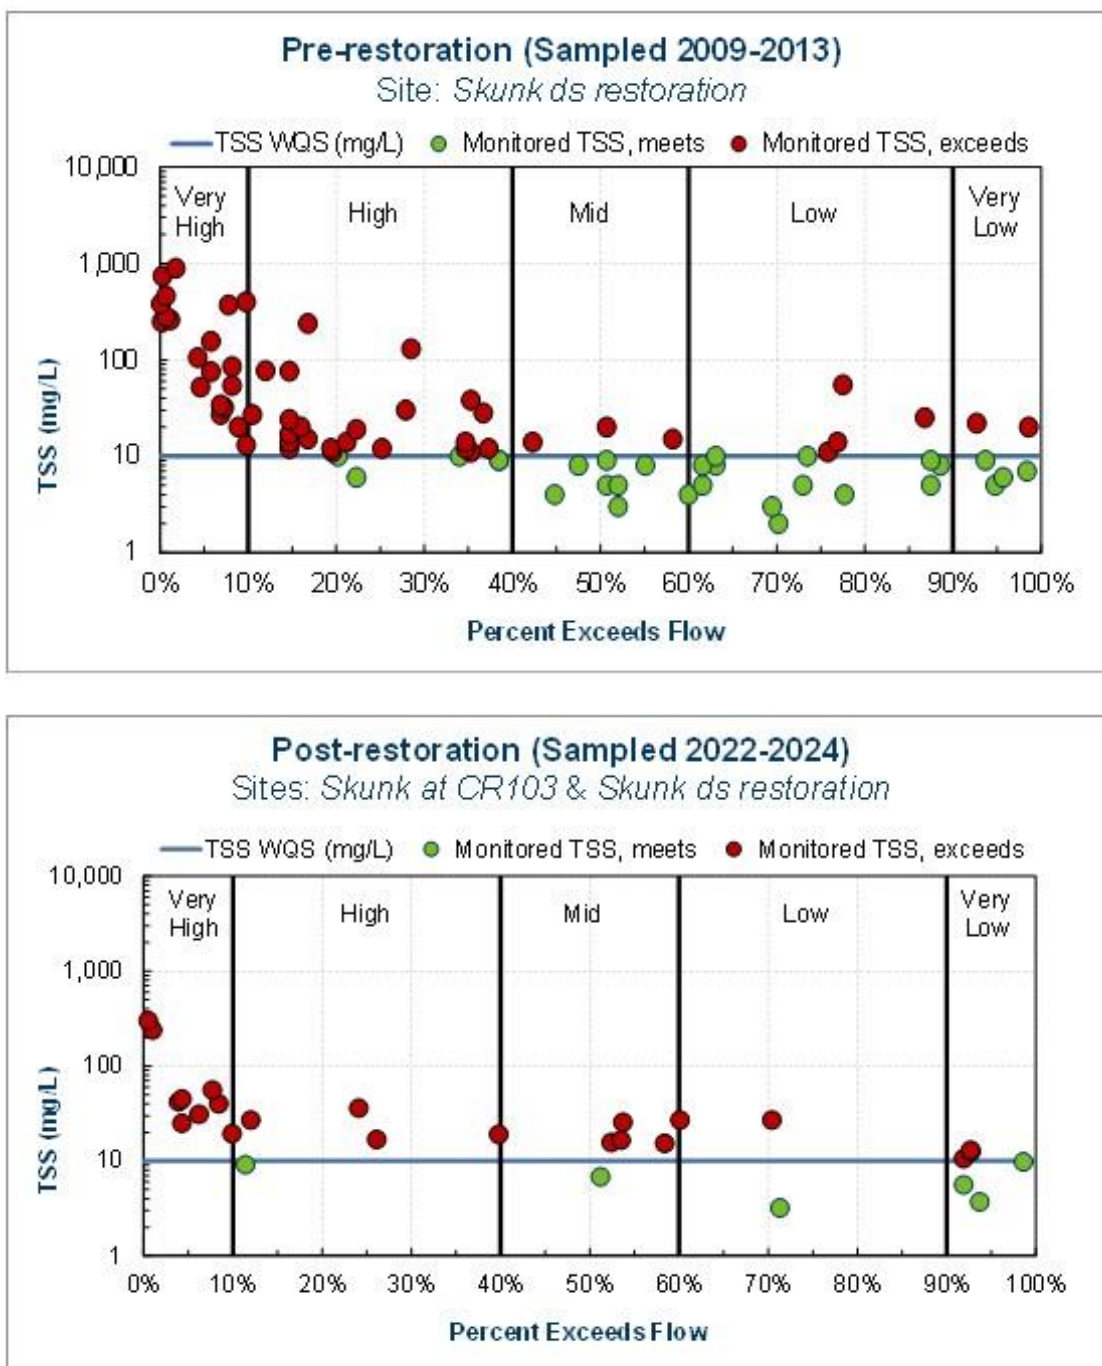
Figure 17. TSS water quality duration curves pre- and post-restoration for Skunk Creek sites *Skunk ds restoration* (ID: S005-617) and *Skunk at CR103* (ID: S002-600) which are located 250 meters apart. Graphs show the number of samples that meet and exceed water quality target (10 mg/L) for five flow regimes.

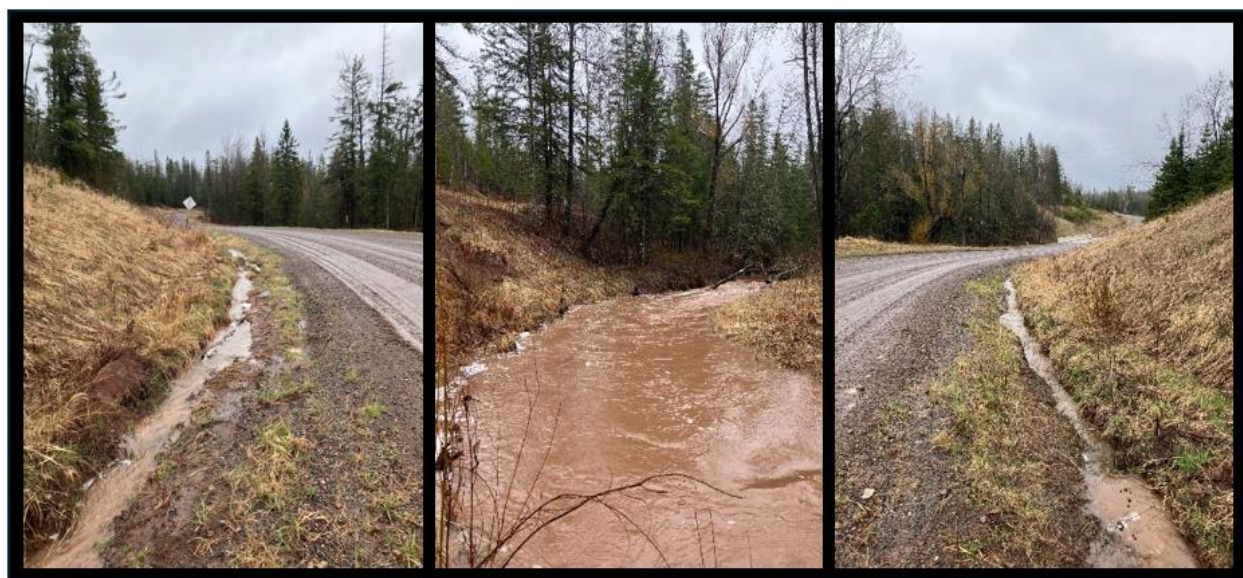
Secchi tube measurements and photographs were collected in roadside ditches and/or tributaries near roadway runoff and sediment control project sites four times in 2024 and five times in 2025, targeting periods when ditches were flowing. Frequently secchi measurements coincided with water quality sample collection. Photographs of a 1.25" rainfall event on May 2, 2025, are shown in Figure 19. Secchi readings in flowing ditches will continue throughout April 2028, at which time, the value and need for such data will be re-evaluated.

Figure 19. Observed clarity at Right: north ditch to Skunk Creek at CR103 crossing, Middle: Skunk Creek upstream of the CR103 crossing, and Left: south ditch to Skunk Creek at CR103 crossing.
