# Skunk Creek Watershed

## Minnesota's Lake Superior Basin

### Project objectives

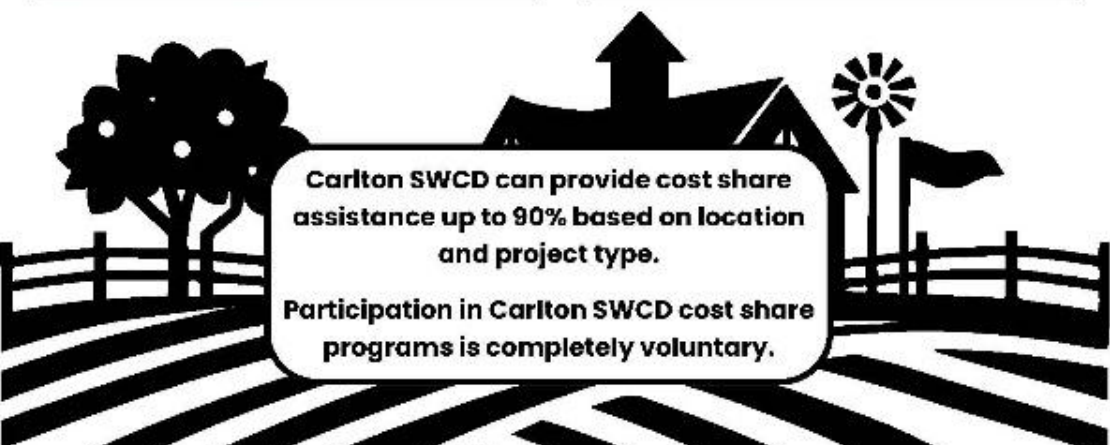
**Prescribed Grazing** improves manure distribution and plant productivity, benefiting soil health, reduces soil erosion, and compaction while controlling livestock access to identified areas.

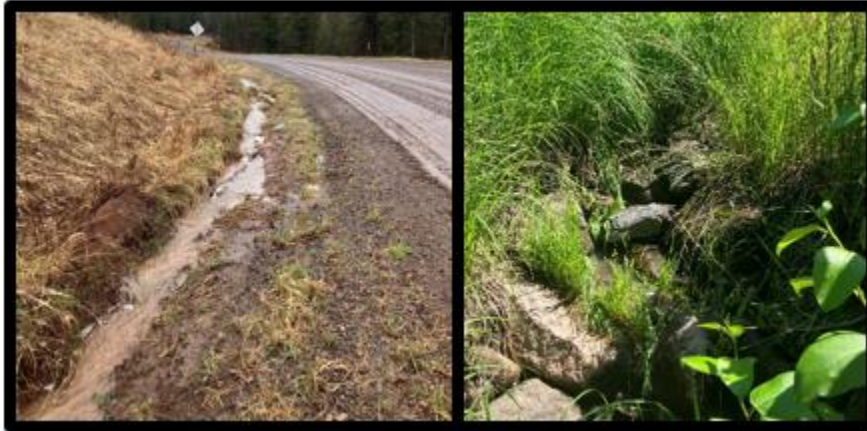
**Figure 4. Roadway runoff documented during spring (left) and summer (right) precipitation events.**

Secchi tube measurements and photographs were collected in roadside ditches and/or tributaries near roadway runoff and sediment control project sites seven times in 2025, targeting periods when ditches were flowing. Examples of flowing ditches after one-inch rain events are displayed in Figure 4 and show visual differences in roadway runoff for spring and summer events. The integrity of the roadway remained intact for both events. Analysis of the secchi tube data will be completed at the end of the four-year contract.
