# POPLAR RIVER SEDIMENT SOURCE ASSESSMENT

**University of Minnesota  
March 30, 2010**

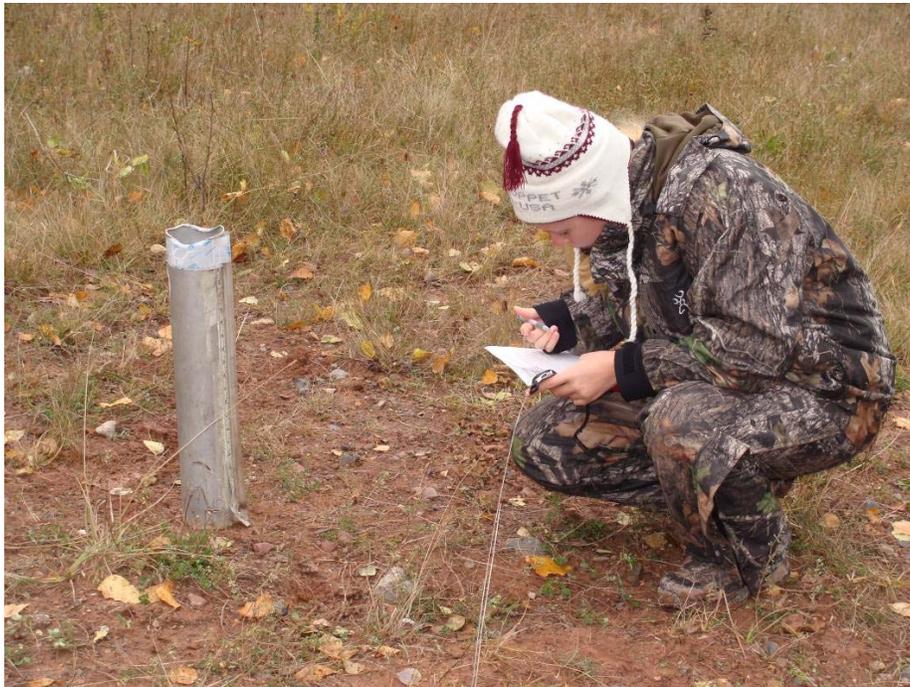
Figure 3. Measuring infiltration rate using MPD infiltrometer on a ski slope (October 2009)

Field infiltration tests were done to improve the runoff calculations of the model. Infiltration rates were determined using a modified Phillip-Dunne (MPD) infiltrometer (Nestigen, 2007) as shown in (Figure 3). The MPD infiltrometer is a falling head technique used to measure the hydraulic properties of the shallow subsurface soil (Philip 1993 Nestigen 2007). The resulting measurements describe hydraulic conductivities of the tested soil layer and capillary pressures at the infiltration wetting front. The instrument consisted of an open ended cylinder constructed out of 2mm thick aluminum pipe with a 10 cm diameter, elbow joint, piezometer tube, and a metric measuring tape to measure hydraulic head.

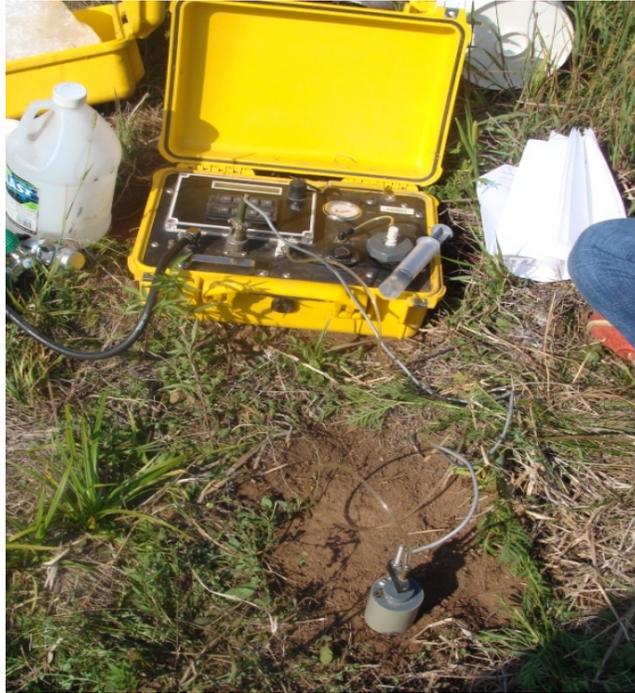
Figure 4. Cohesive strength meter measuring critical shear on a ski slope.

Soil critical shear stress tests measure the force required to detach soil particles from their undisturbed consolidated condition (Figure 4). These values are useful in determining erosion rates from stream channels, ravines and in this project ski slopes. Soil shear was measured with a Cohesive Strength Meter (CSM). The CSM utilizes a vertical jet of

water to erode the sediment surface within a water-filled 30 mm diameter chamber pushed into the soil surface. The velocity of the jet pulse is increased systematically through time. Bed erosion is inferred from the drop in the transmission of infrared light caused by the suspension of sediment inside the chamber. Variations in transmission are logged and plotted against the increase jet pressure to determine the critical shear stress.

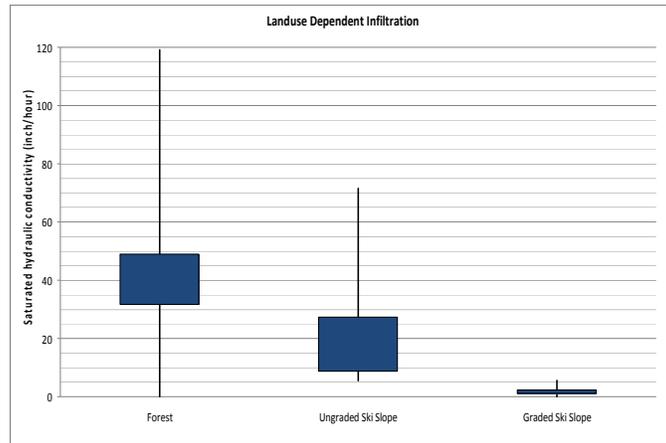
Figure 5. Infiltration rates of forest areas, graded and ungraded ski slopes

Infiltration is an important input into any watershed model because of the significant influence it has on predicting runoff. To better quantify the runoff potential from ski slopes and forested areas thirty-three infiltration tests were completed. The tests were done in pairs with measurements made on the ski slope and in the forested area immediately adjacent to the ski slope runs. Additional infiltration tests were conducted on ski slopes that had been graded. The test results are shown in Figure 5. Infiltration rates were about two times greater in the forested areas versus the ski slopes and about 40 times greater than ski slopes that were graded. The much lower value for graded ski slopes is probably due to the exposure of much heavier subgrade soils. The values from all thirty-three tests are found in Table A1, located in the Appendix A. No tests were completed on the areas of the ski slopes that received the fill generated from grading.

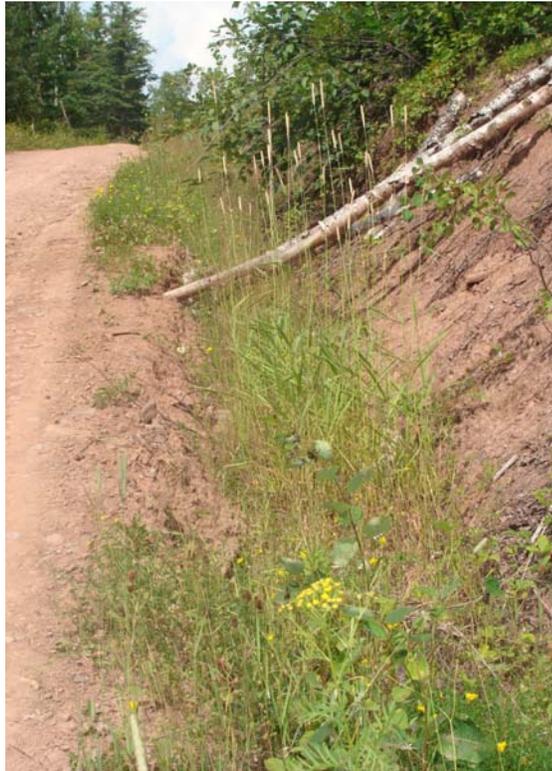
**Figure 6. Shallow ditch and road cut**

The total land surface of roads in the lower watershed was measured as 17.34 acres. This is more than the 8.8 acres report by RTI and the 6.78 acres reported by NAWE. The surface area of the roads used in the calculation of the RII index included the exposed surfaces of the roads plus the ditches and cut banks (Figure 6). Ditches and cut banks are small exposed surfaces that will not be captured by the WEPP model. Incorporating them into the RII index was a way to capture the sediment generated by these features. This could explain the area of roads computed by the RII index being two times greater than reported by RTI. The rate of erosion of 12.6 tons/acre is close to the 12.4 tons/acre-yr report by NAWE. How roads function to intercept and concentrate flow will be discussed in more detail in the section on flow paths.

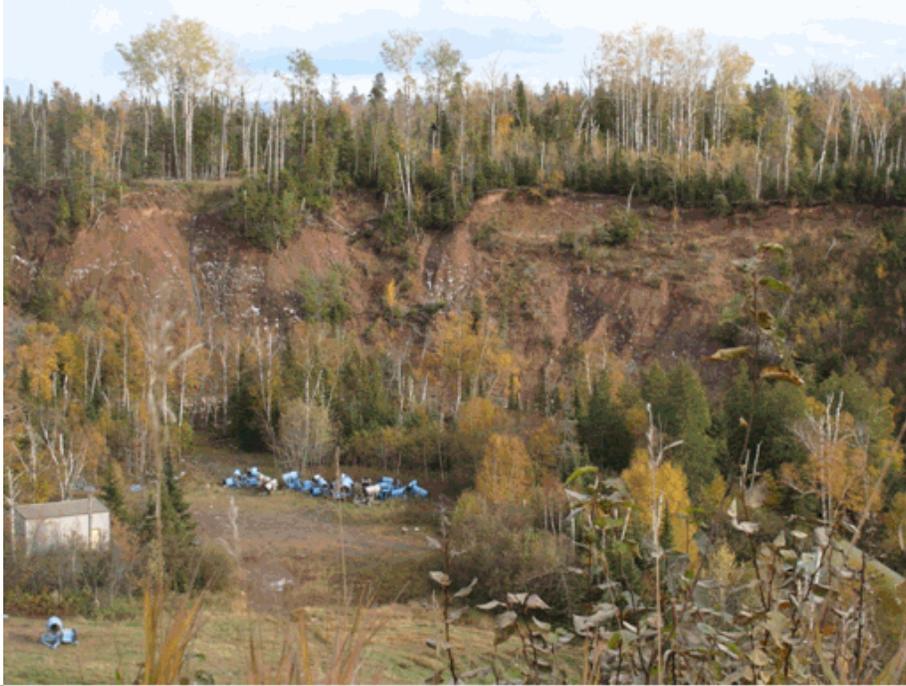
**Figure 8. Mega-slump**

The surface area of the mega-slump was calculated from seven transects shot from the river channel to the top of the slump using a total station in combination with GPS coordinates. The average height of the mega-slump was 83 feet. The average slope was 76%. The surface area was calculated at 2.02 acres. Adding the surface area of the mega slump to the surface area of the other four slumps at an angle of 70% equals a total surface area for all slumps as 4.58 acres. This is 2 acres more than the area used by NAWA and RTI. This difference will factor in the calculation of the sediment load generated from slumps.

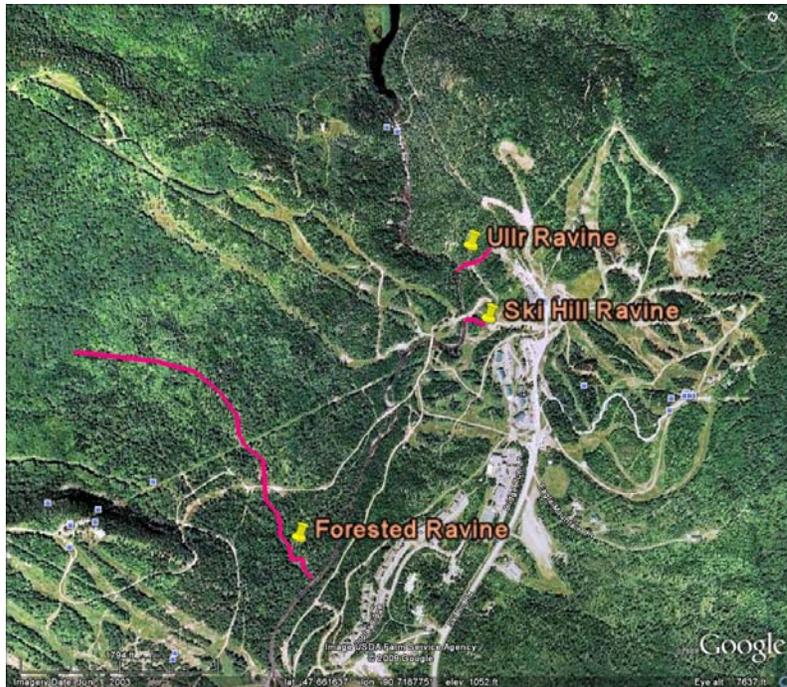
**Figure 10. Ravine locations**

Three ravines were identified on the Lower Poplar watershed that could prove difficult to accurately model. They will be identified as Ullr, Ski Hill and Forested ravines. A description of each ravine is given in Table 9 and their locations are noted in Figure 10. Data collection on the ravines consisted of cross-sections, critical shear measurements and particle size analysis.

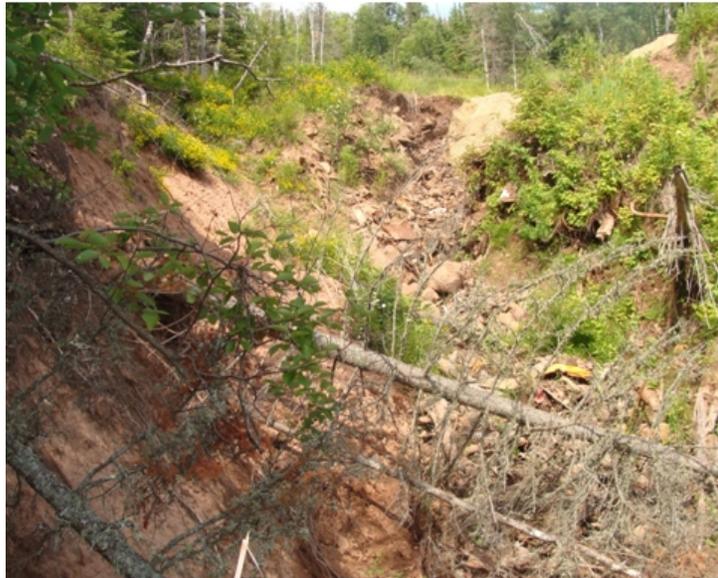
**Figure 11. Ullr ravine**

Both Ullr (Figure 11) and Ski Hill ravines are similar in location on the watershed and their formation. They both have steep slopes top to bottom of 45% to 50% and are connected directly to the river. Both were a result of flow from their upper watersheds concentrating on the near bank steep slopes.

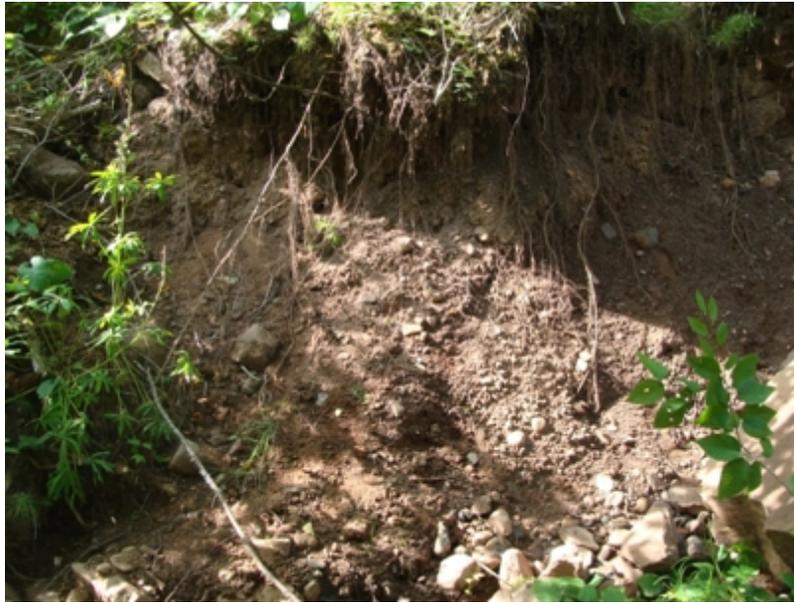
Figure 12. Forested ravine eroding bank

Forested ravine has a drainage area of 232 acres and a length of approximately 3,500 feet. The land use in this sub-watershed is all forested with one main road and a few trails. The main sediment source from this ravine is the channel banks and bed (Figure 12 and 13). The ravine appears to be down cutting into the glacial till with three active head cuts moving upslope in the upper reaches of the watershed.

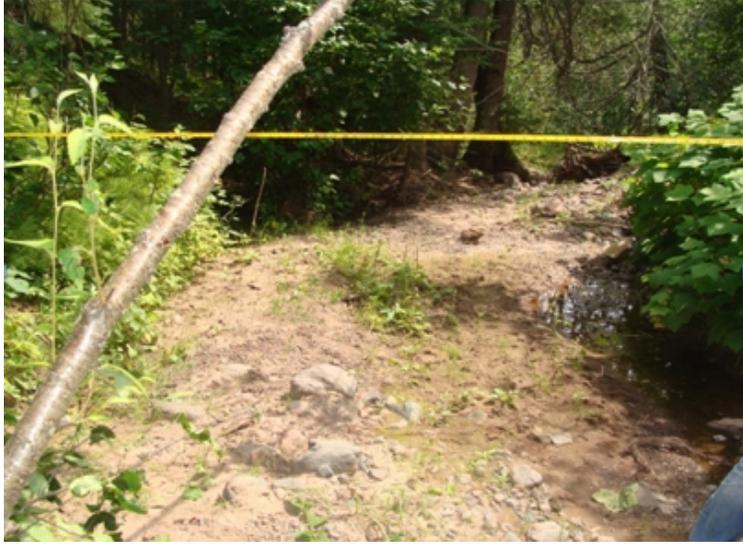
**Figure 13. Forested ravine channel bed**

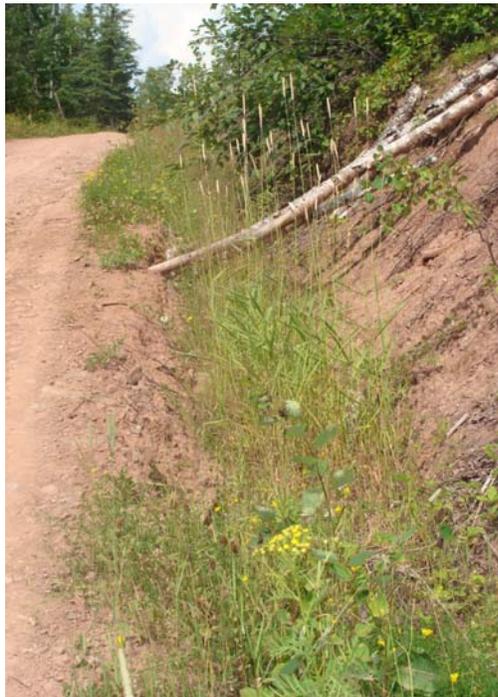
Figure 18. Shallow ditch and road cut running across slope (August 2009)

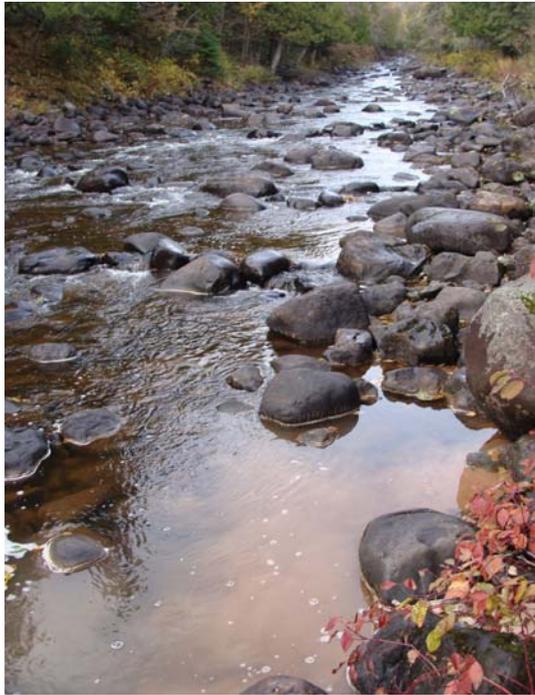
Figure 19. Runoff generated from flow path from 1 inch snow melt (October 2009)

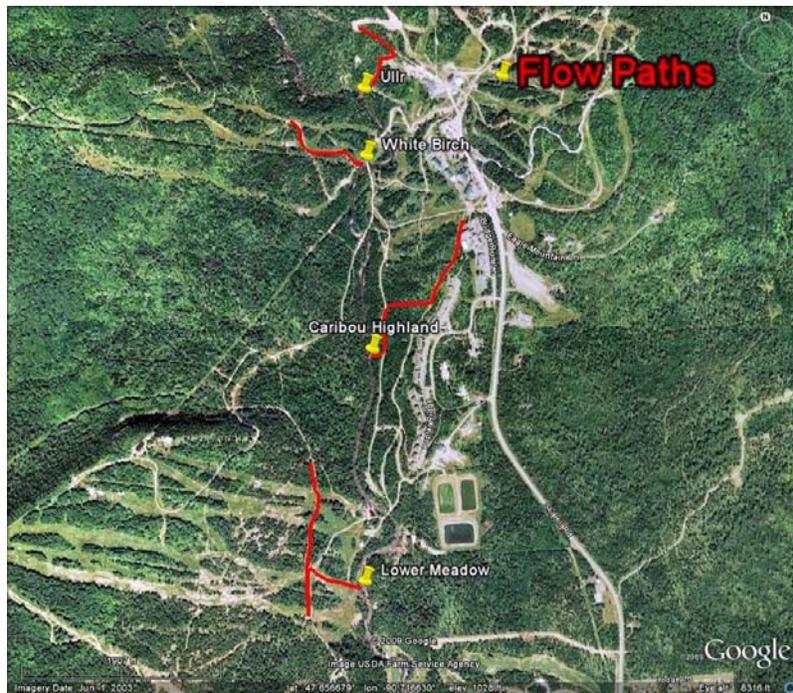
Figure 20. Location of Flow Pathways

The topographic detail of the maps used as input for the WEPP model is not detailed enough to pick out these small changes in topography. The model will assume all flow continues overland down slope in a dispersed fashion. Because of this the effects of these flow paths on the sediment load to the river may have to be modeled separately. The locations of four flow paths are shown in Figure 20. A description of each of the flow paths is given below.

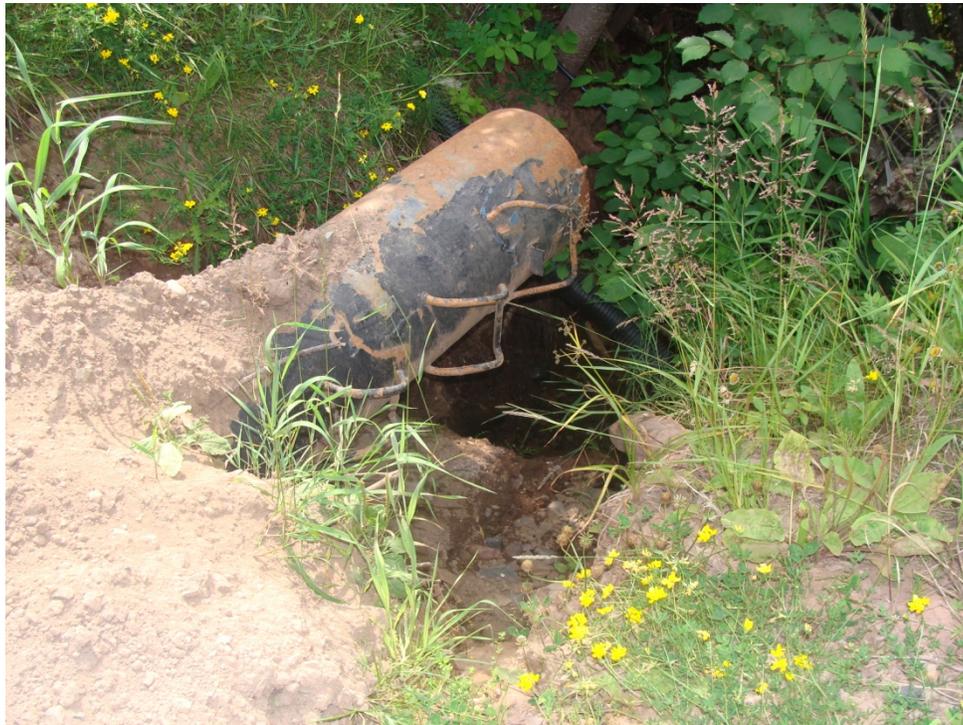
**Figure 21. Perched culvert.**

Water running down slope off the developed area around Caribou Highlands is intercepted by a service road. The water flows southeast down the road ditch with an exposed upper bank until it passes under the road at a culvert. The outflow end of the culvert is perched six to eight feet above the ground surface (Figure 21). This is causing a scour hole that will eventually threaten the integrity of the road. After leaving the culvert the water down-cuts through an existing forested ravine forming a depositional plume at the base of the slope (Figure 22). At the base of the ravine the water is intercepted by a service road running parallel to the Poplar River. The water flows southeast in this road ditch until it outlets through another culvert directly into the river (Figure 23).

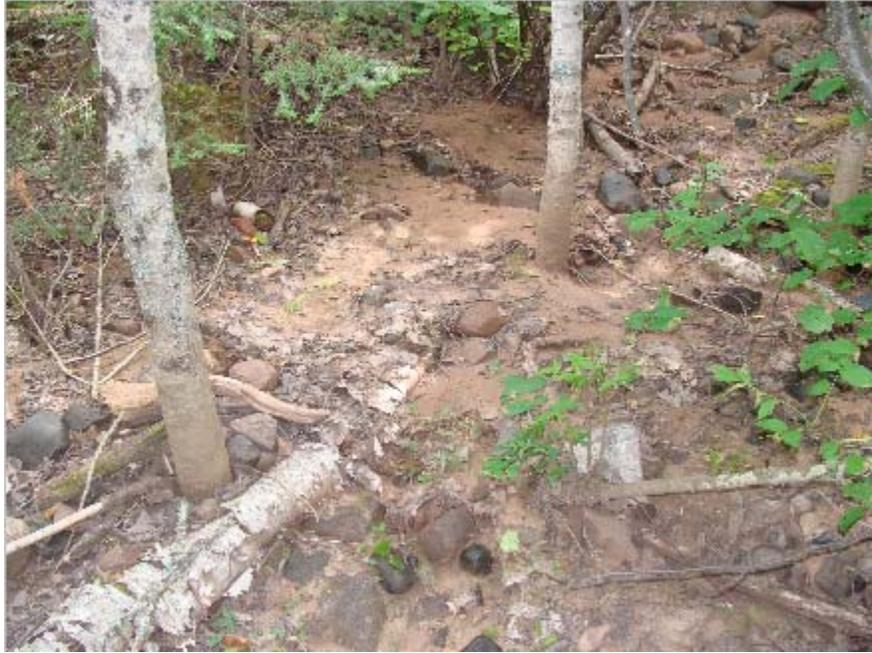
**Figure 22. Deposition from road cut at base of forested ravine**

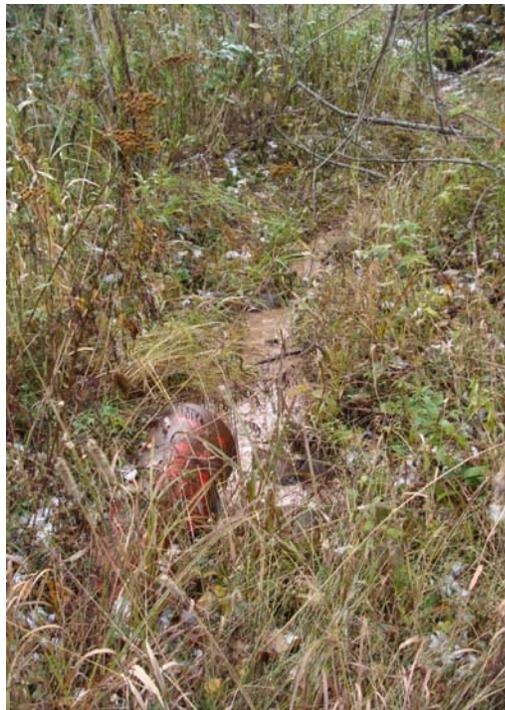
**Figure 23. Culvert flowing directly to river.**

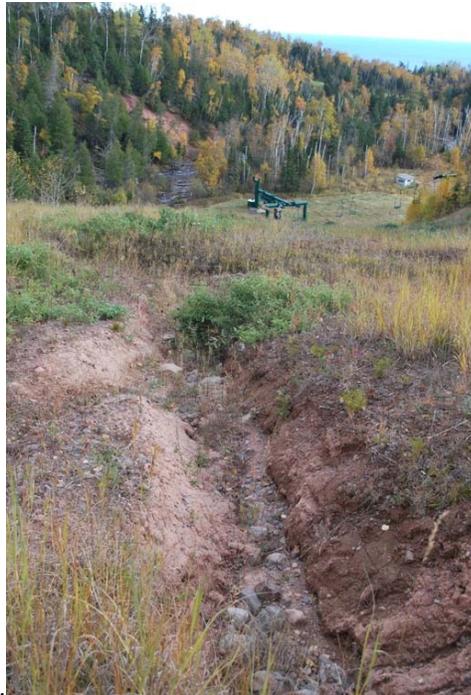
**Figure 24. Gully cutting down Lower Meadow ski run**

Water flowing down slope from the area around ski slopes of Moose Crossing, Bob and Cougar is intercepted by a service road running perpendicular to the slopes above. The water flows southeast across slope in an un-vegetated road ditch until it turns east and flows directing down slope over the Lower Meadow ski run. The water has started to cut a two foot deep gully down Lower Meadow (Figure 24). It has cut right through or flowed around the berms.

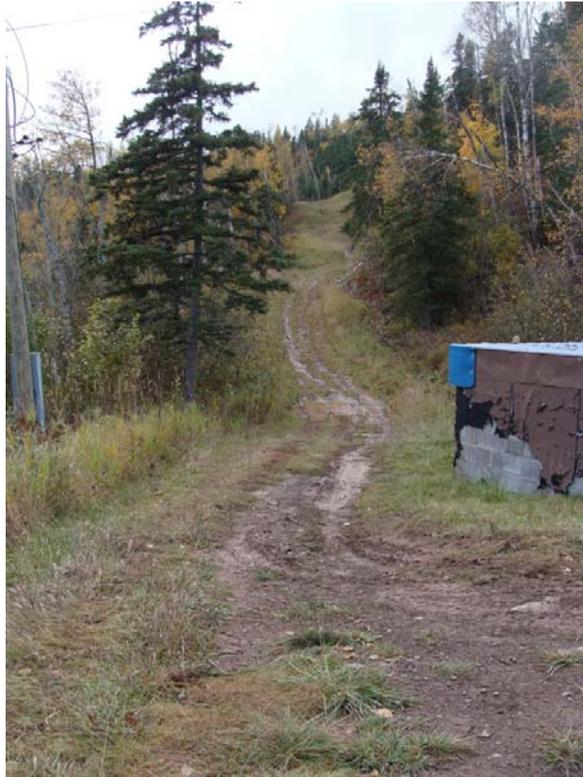
**Figure 25. White Birch service road**

There are two flow paths and one ponded area near the base of Mystery Mountain. One flow path is a road cutting across ski slopes White Birch, Jack Alder and Log Chute. It crosses White Birch ski run, which in the summer serves as a service road, and is starting to cut a gully from the White Birch ski run down a very steep slope directly to the river. The second flow path flows directly down hill on the White Birch service road until it crosses the road at the base of the hill and flows directly into the river (Figure 25). There is also a ponded area that collects runoff water from the Mystery Mountain ski slopes of White Birch, Jack Alder and Log Chute. This pond is shallow and outlets directly into the river when over topped with runoff(Figure 26).

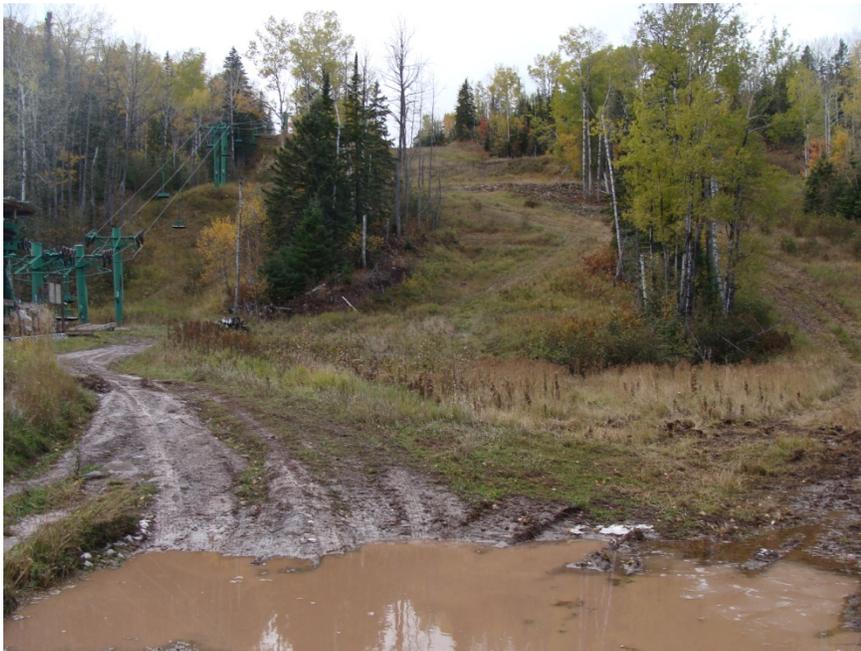
**Figure 26. Ponded area at base of ski slopes with direct access to river**

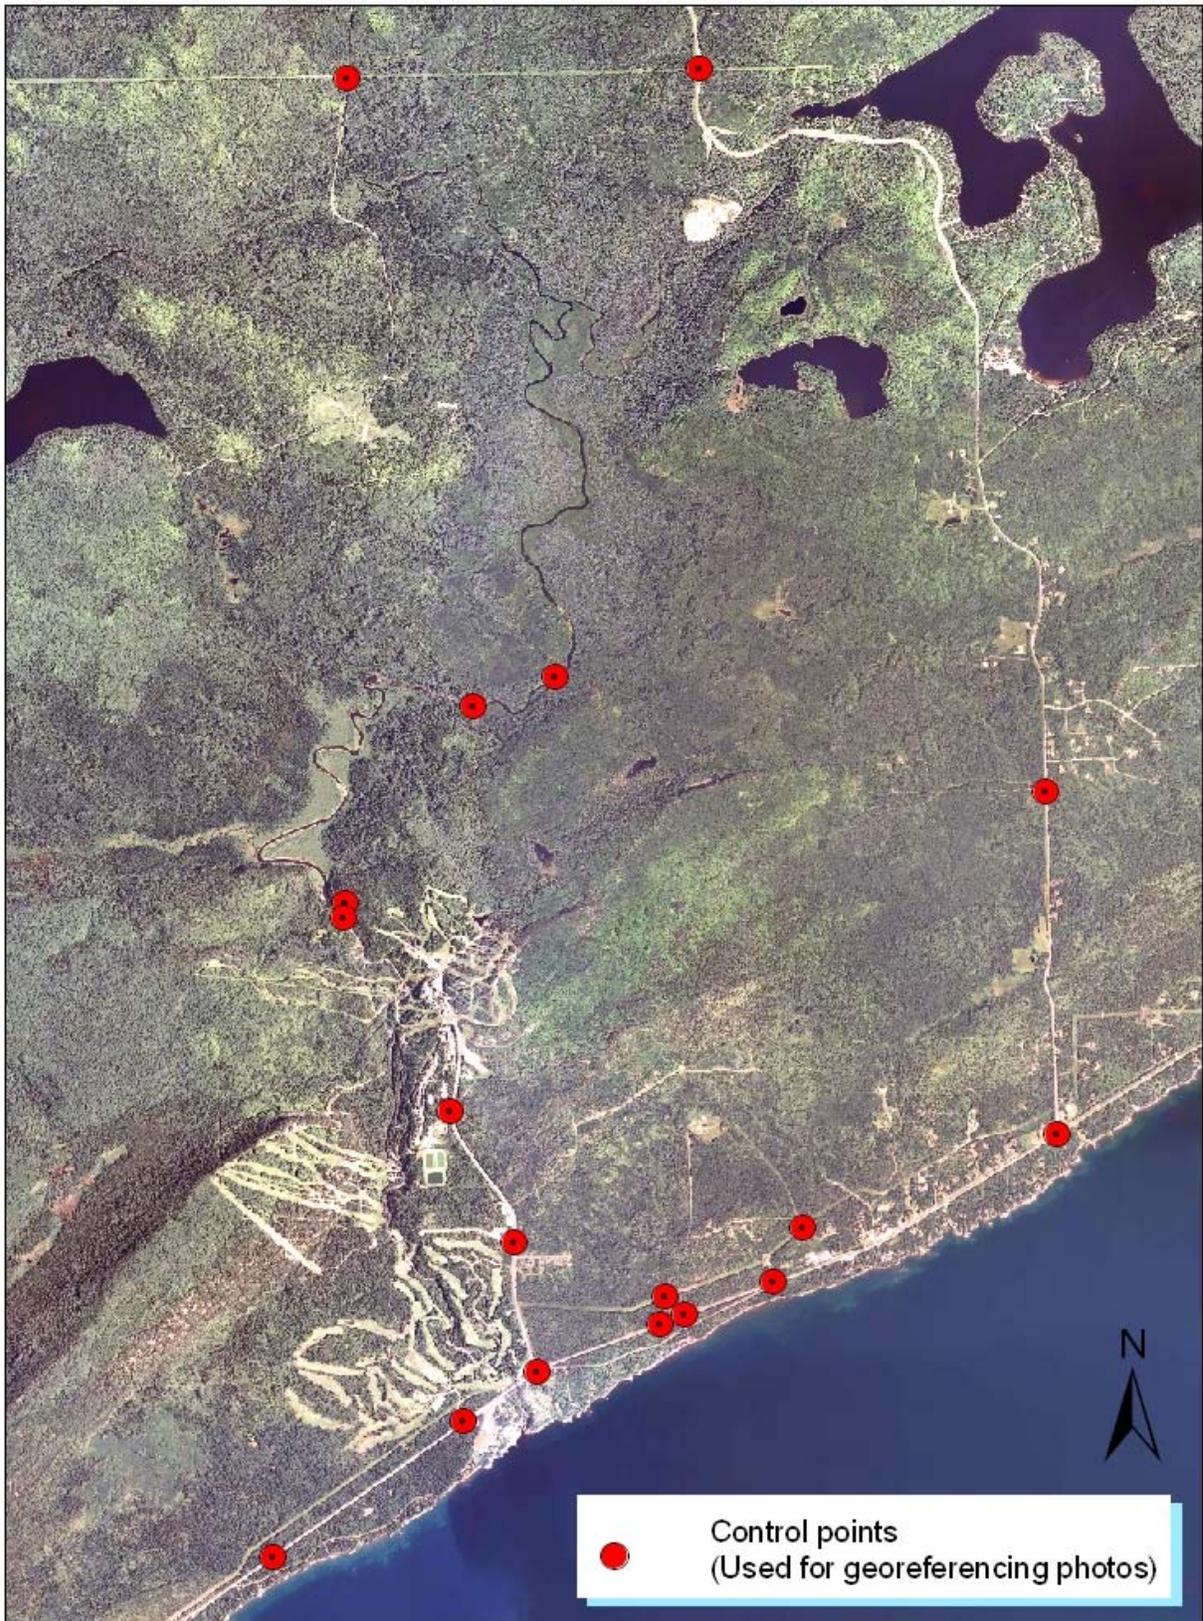
Figure A2. Points used for referencing aerial photos in ArcGIS
