Poplar River Water Quality Restoration

Implementation Plan for Turbidity Reduction
Submitted for approval January 2014

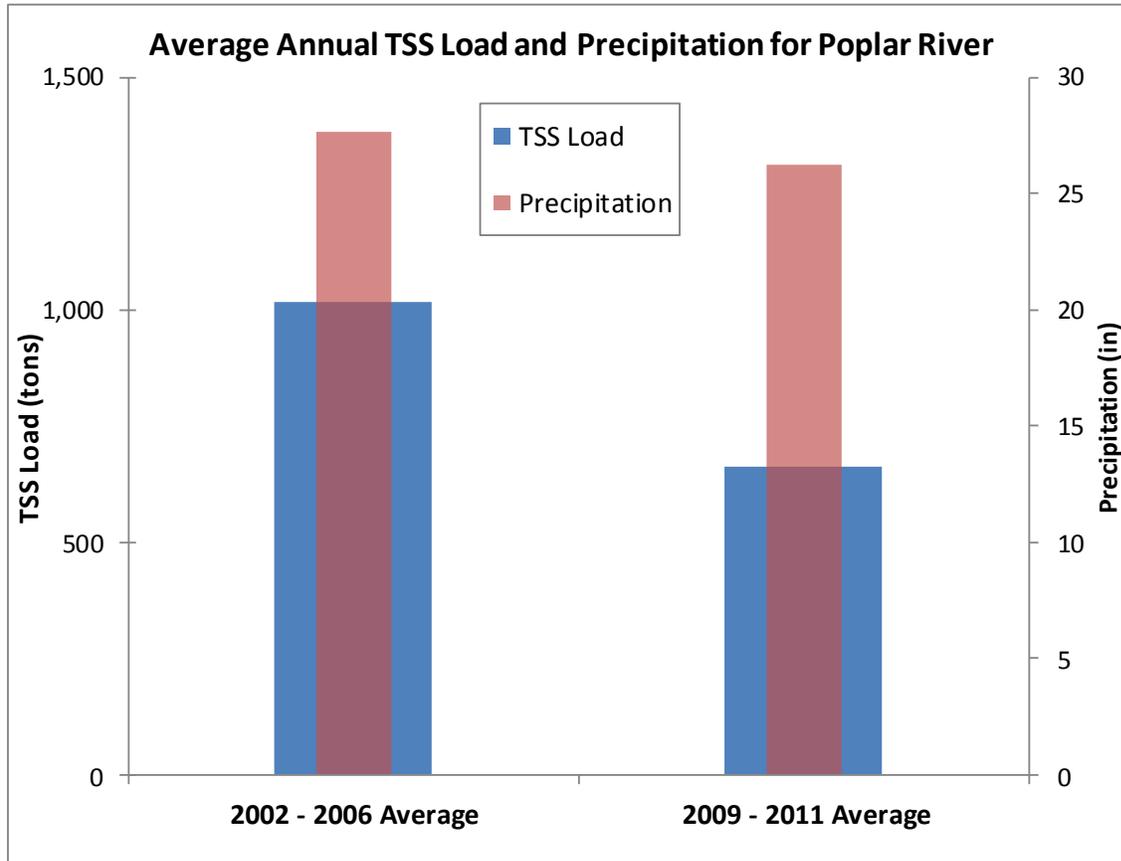
Figure 2. Sampling results and load comparisons

The calculated annual total suspended solids (TSS) loads have been lower in recent years than in the first half of the decade. This difference is shown in the attached graph where the average TSS load for the years 2002 through 2006 was about 1,000 tons per year while the average load for the years 2009 through 2011 was about 660 tons per year. This difference suggests that the TSS load has decreased about 35 percent. In contrast, the average annual precipitation for the two periods is fairly similar (26.3 versus 27.7 inches).

This simple comparison suggests that the BMPs implemented since 2006 have resulted in improved water quality conditions in the Poplar River. With the maturing effect of BMPs implemented in 2011 and 2012 along with implementation of additional BMPs currently planned, a continued decrease in
