# Duluth Urban Area Streams Total Maximum Daily Load

Restoring and protecting urban streams in Duluth and surrounding areas.

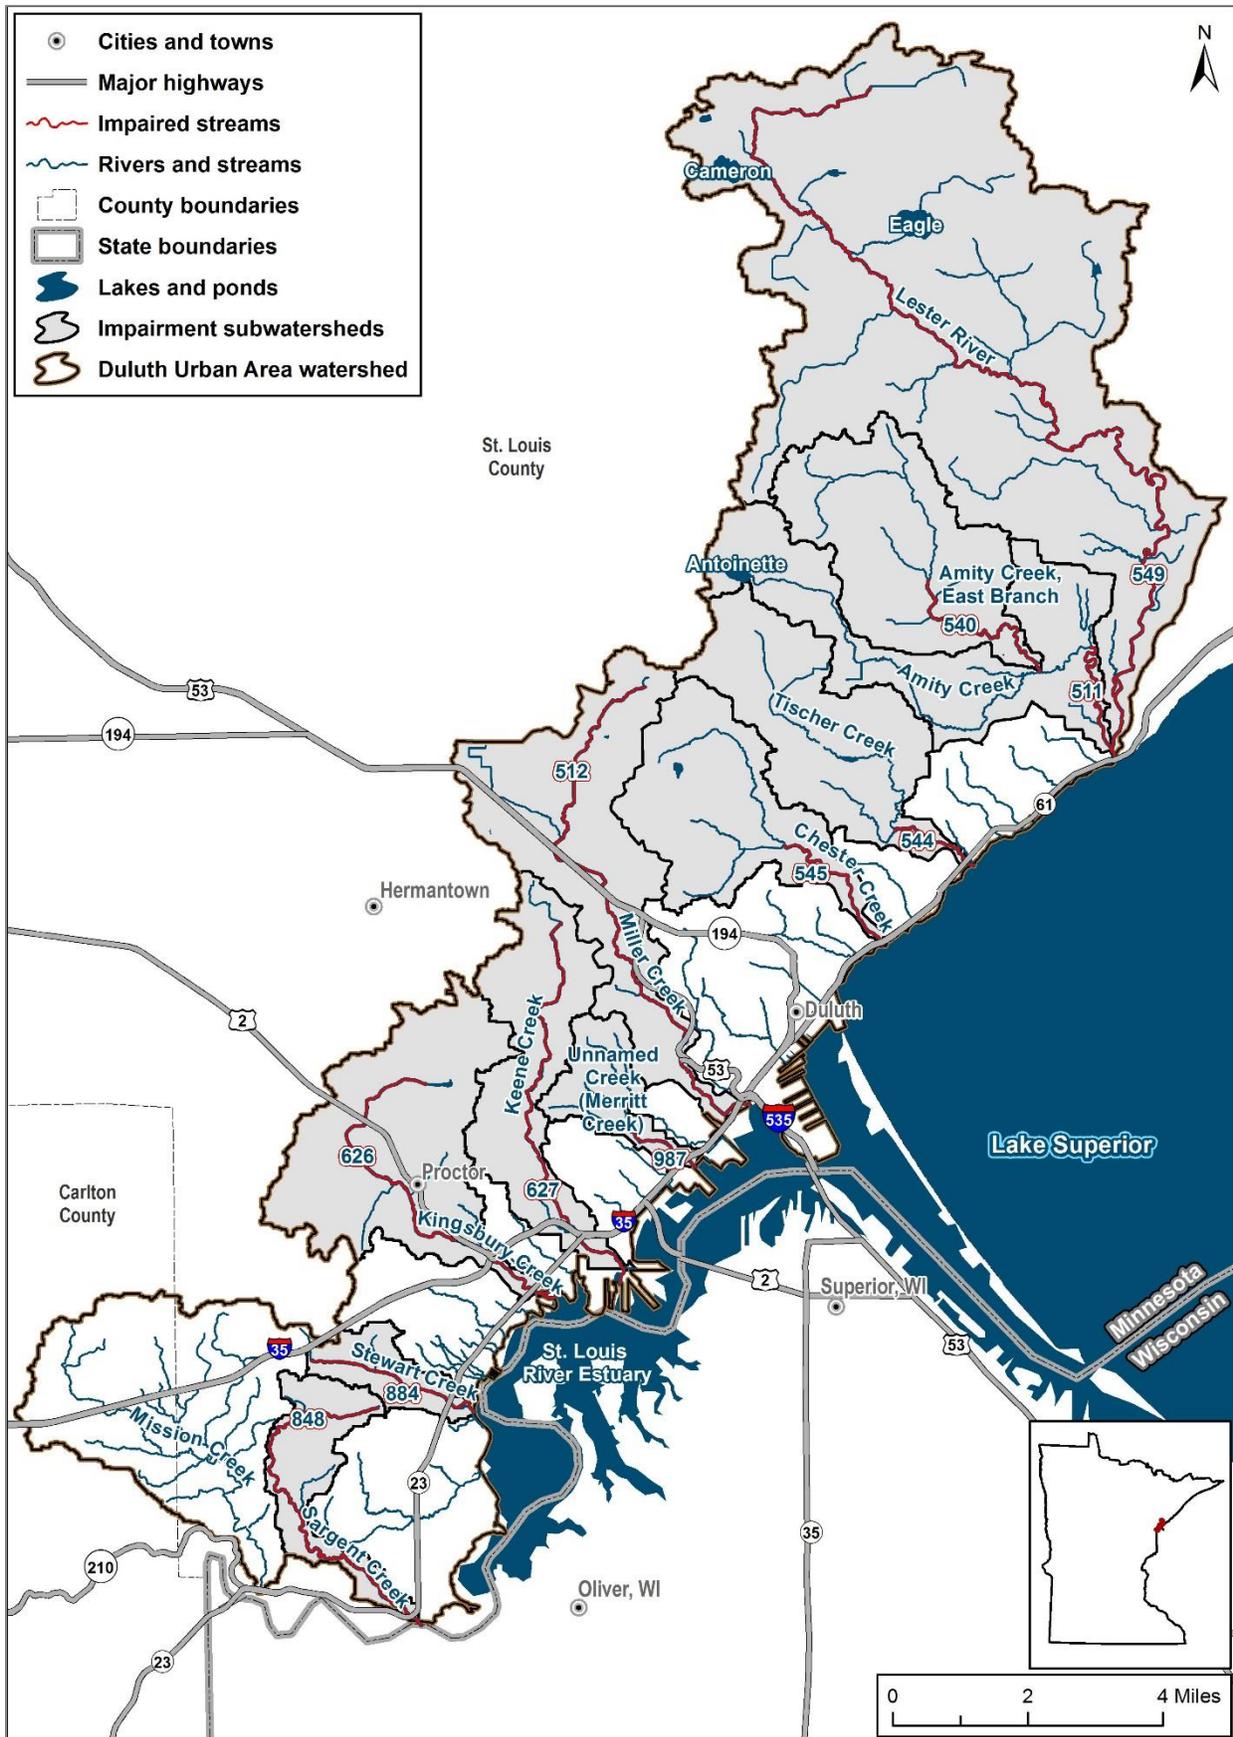
Figure 2. Duluth Urban Area stream impairments and subwatersheds (2018 303d list of impaired water bodies).

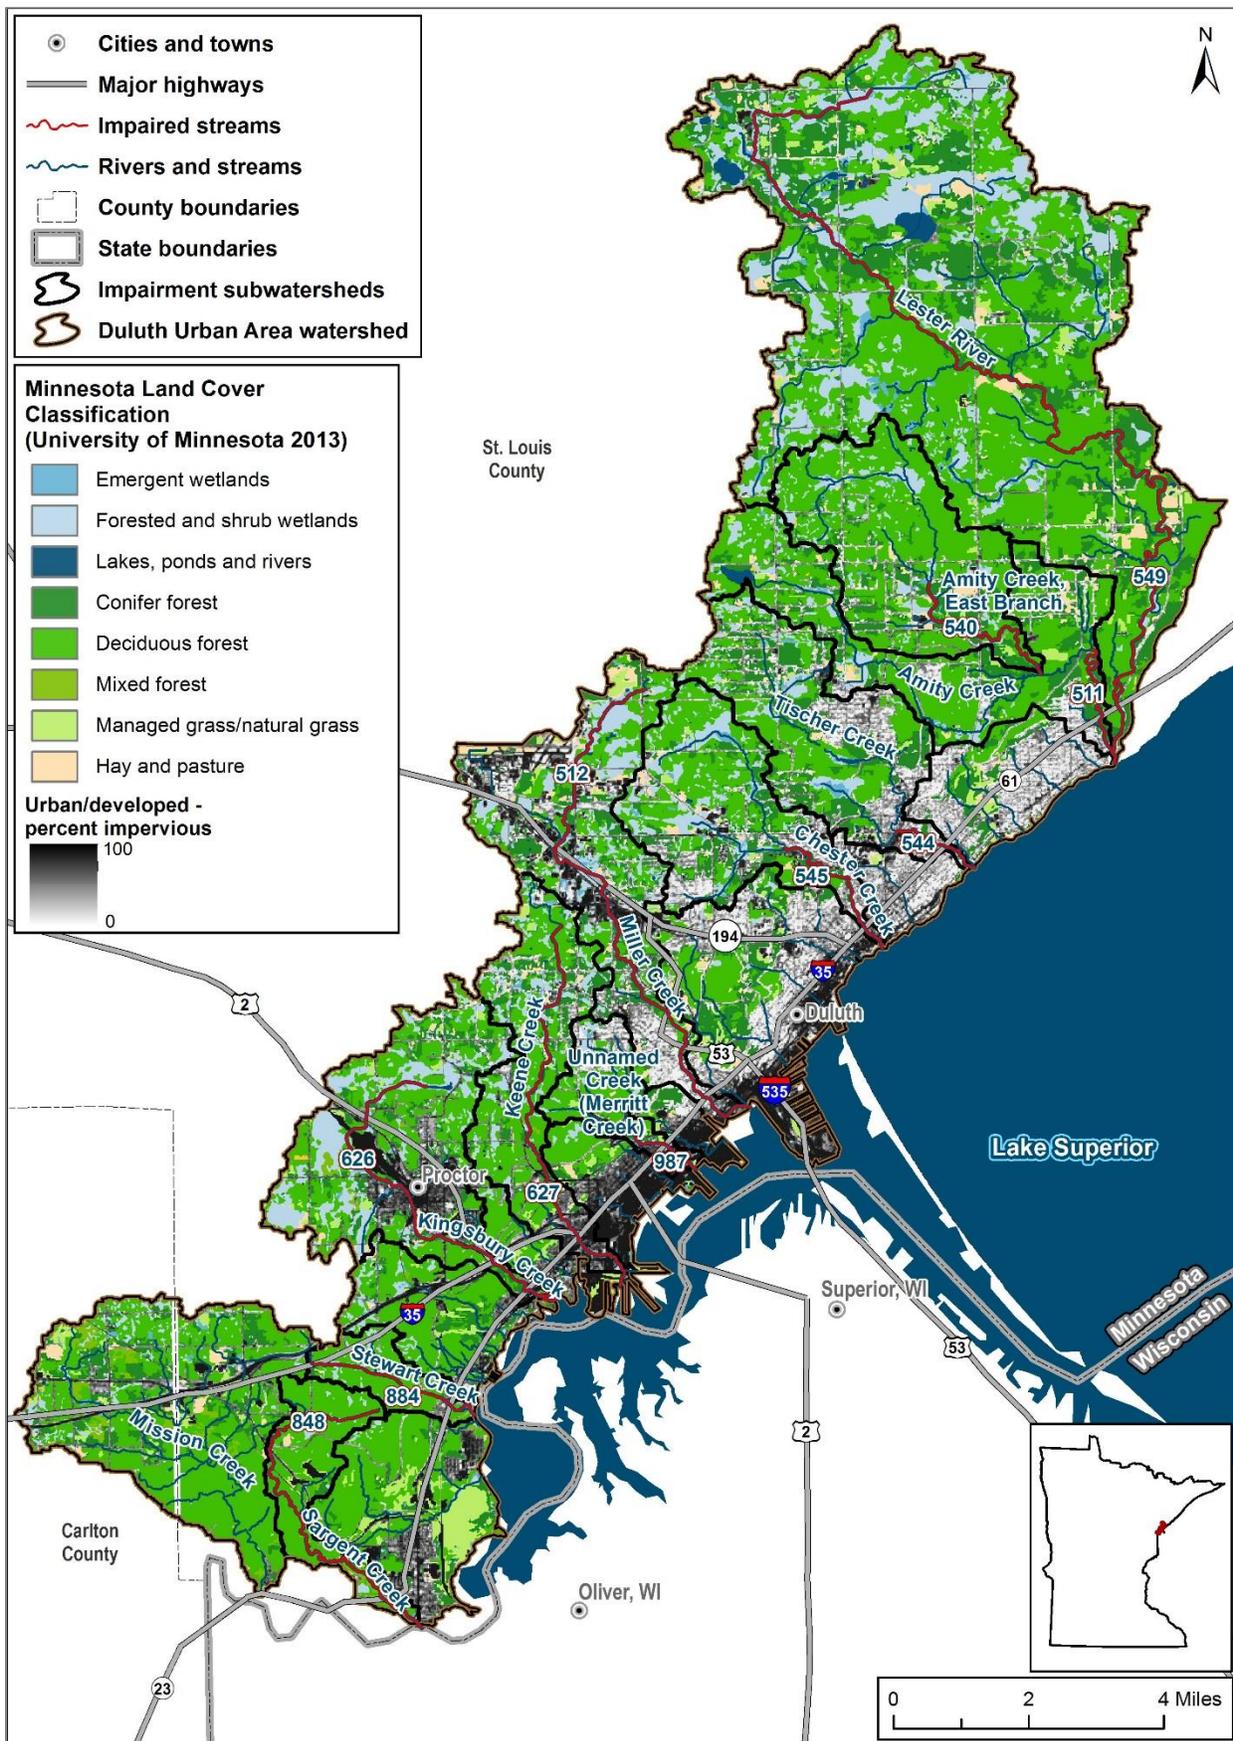
Figure 3. Land use and land cover in the Duluth Urban Area.

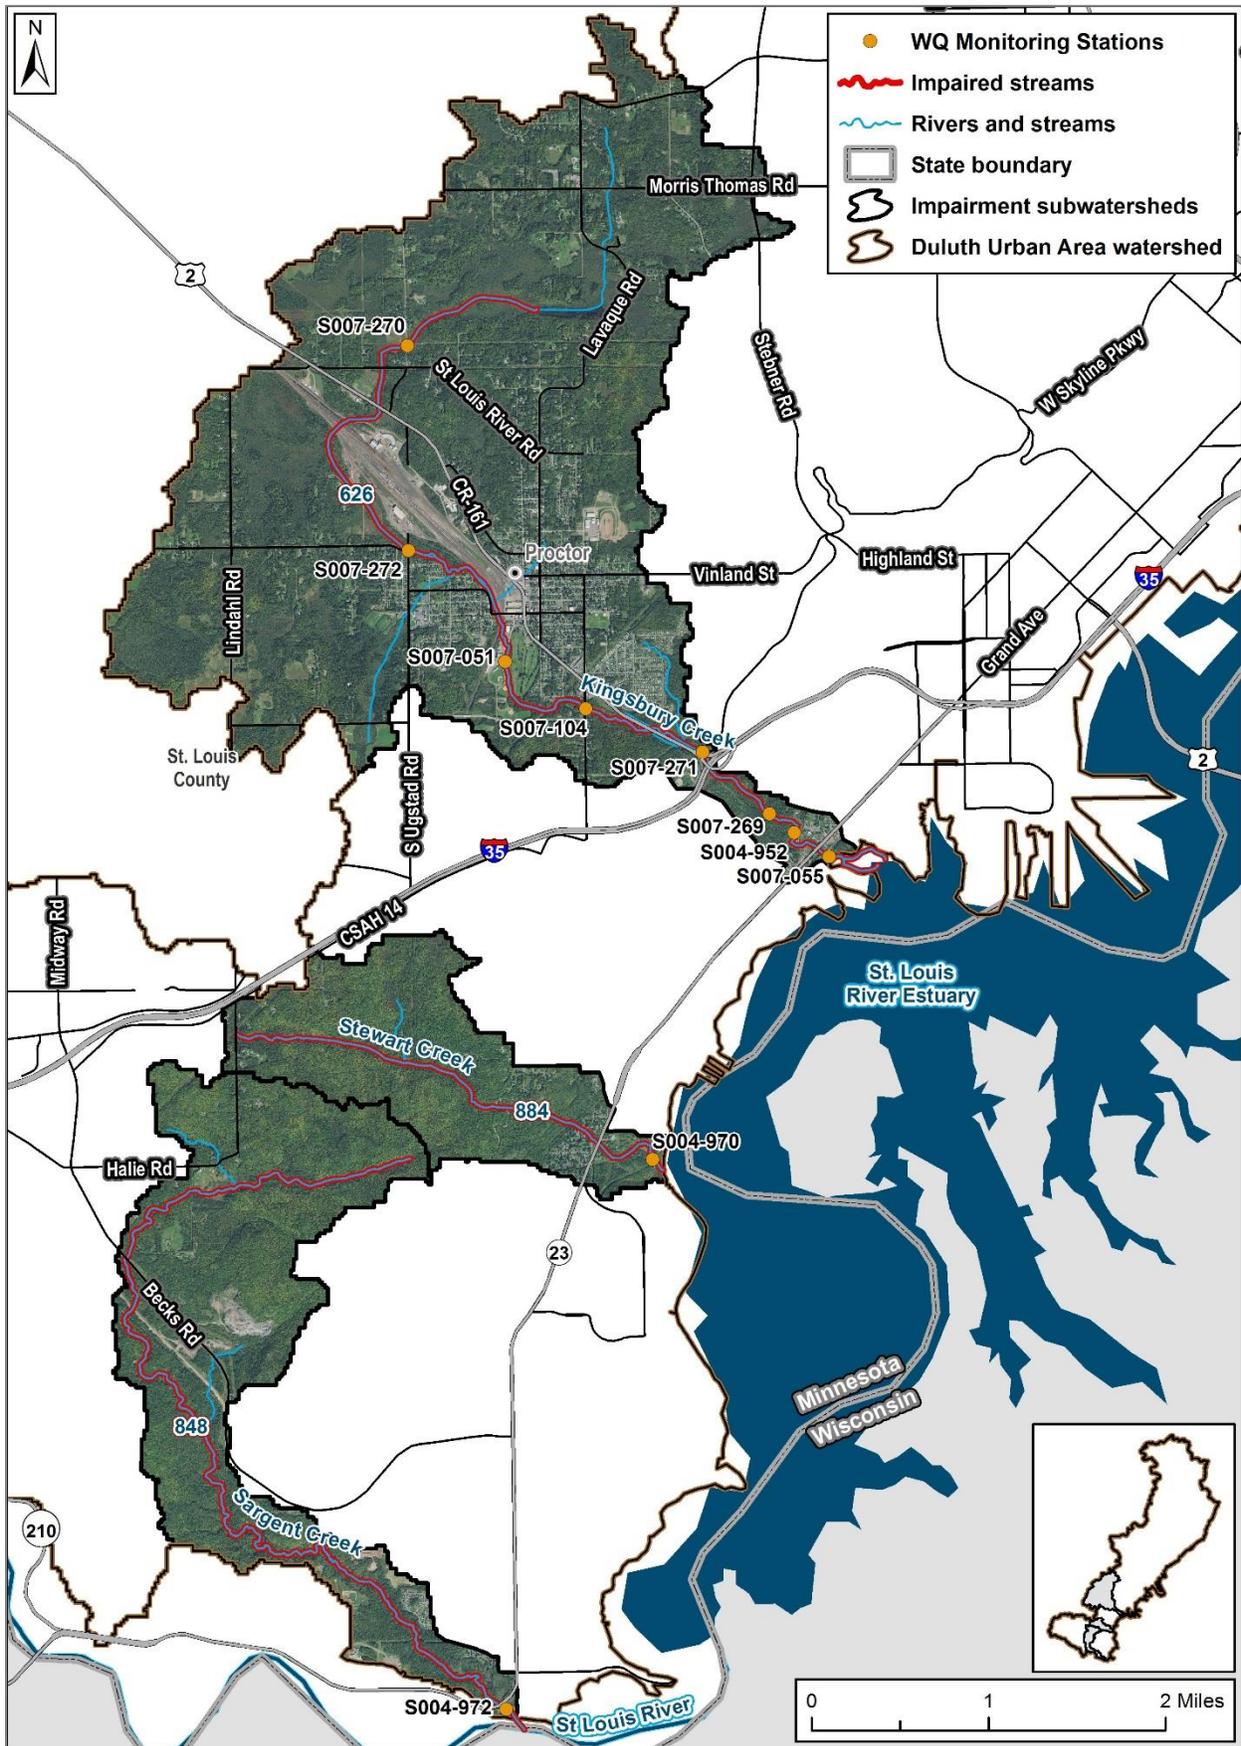
Figure 4. Water quality monitoring locations within the Kingsbury Creek, Stewart Creek, and Sargent Creek subwatersheds.

There are eight monitoring stations on Kingsbury Creek (Figure 4). Average annual TSS concentrations in Kingsbury Creek ranged from 12 to 101 milligrams per liter (mg/L), and greater than 10% of samples exceeded the 10 mg/L TSS standard in each year that was monitored (Table 9). Monthly means (during the months in which the standard applies) varied from 33 to 839 mg/L, with the highest concentrations on average observed in April (Table 10). The standard was exceeded during mid-range to very high flows, with higher concentrations occurring under very high flows (Figure 8).

There is one monitoring station located at the downstream end of Sargent Creek (Figure 4). Two samples exceeded the individual sample standard in 2009 (Table 13), and the monthly geometric mean standard was exceeded in June through August (Table 14). Both exceedances occurred under mid-range flow conditions. No samples were collected during very high flow conditions (Figure 10).

There is one monitoring station located at the downstream end of Stewart Creek (Figure 4). Exceedances of the individual sample standard were not observed (Table 15). The monthly geometric mean standard was exceeded during the month of July (Table 16). *E. coli* concentrations were highest under high and midrange flows. No samples were collected during very high flow conditions (Figure 11).

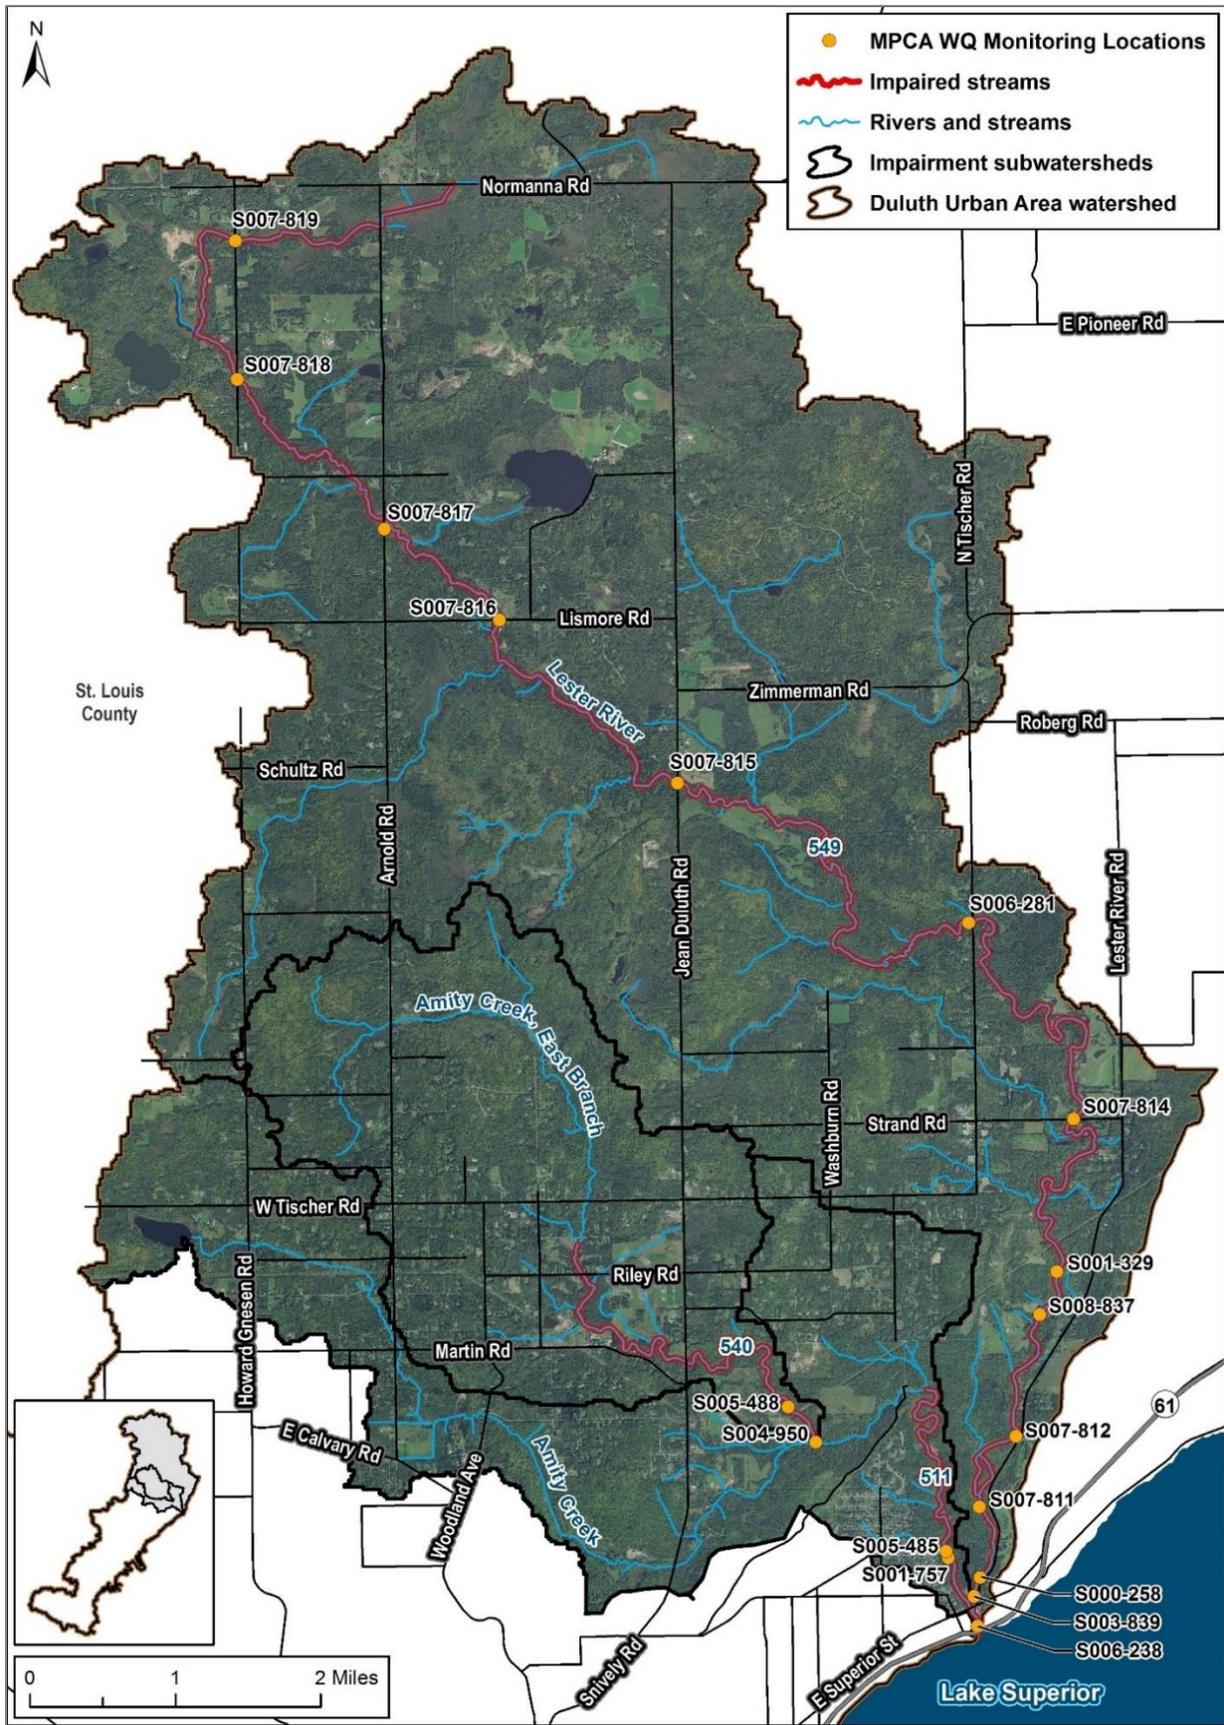
Figure 6. Water quality monitoring locations within the Lester River, Amity Creek, and East Branch Amity Creek subwatersheds.

There are two monitoring stations located along the impaired reach of East Branch Amity Creek (Figure 6). Annual mean TSS ranged from 7 to 33 mg/L, and the TSS standard of 10 mg/L was exceeded in greater than 10% of samples during all monitoring years (Table 25). Monthly means (during the months in which the standard applies) varied from 2 to 68 mg/L, and concentrations on average were highest in May and October (Table 26). TSS concentrations were highest under very high and high flow conditions (Figure 16).

There are 14 monitoring stations located along Lester River (Figure 6). Annual mean TSS concentrations ranged from 1 to 51 mg/L, with a marked increase in annual means during 2014 through 2016 (Table 27). Greater than 10% of samples exceeded the 10 mg/L TSS standard in four of the six monitored years. During the months in which the standard applies, monthly means ranged from 5 to 57 mg/L. Concentrations on average were highest in March (Table 28). TSS concentration increased with flow, with the highest concentrations under very high and high flow conditions (Figure 17).

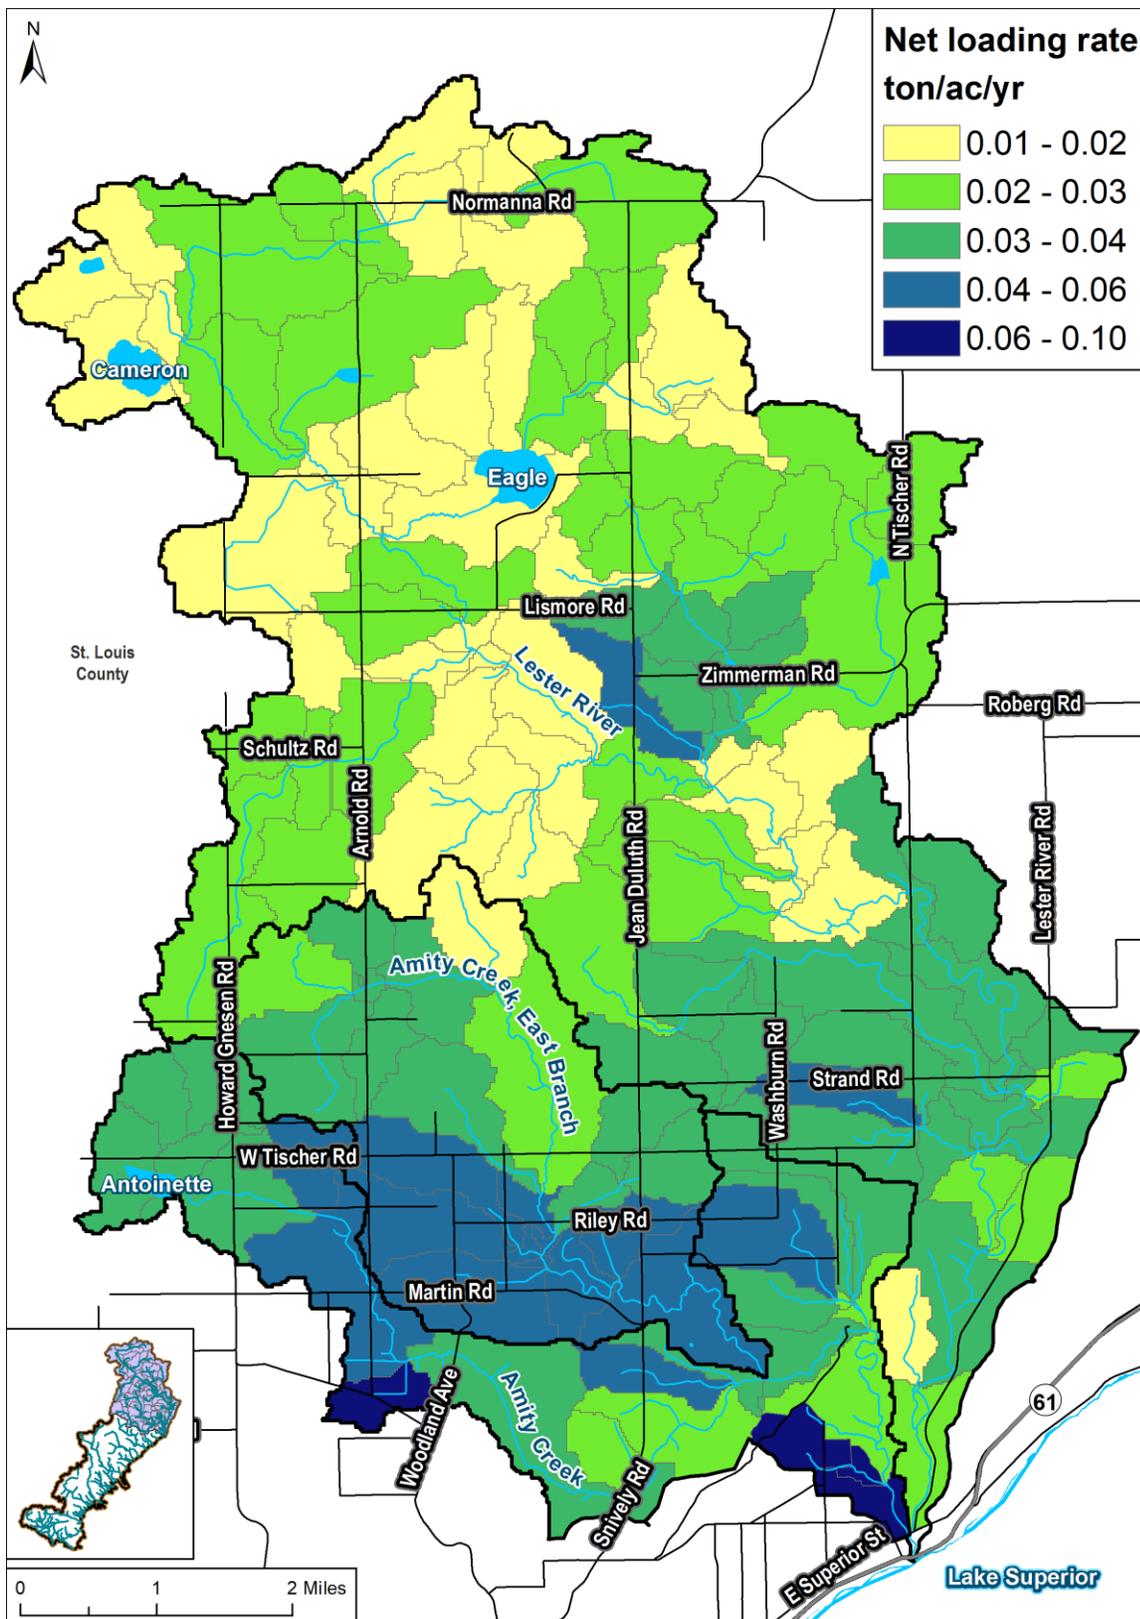
Figure 19. Annual average sediment loading rates in Lester River, Amity Creek, and East Branch Amity Creek watersheds (1995-2016; Tetra Tech 2019).

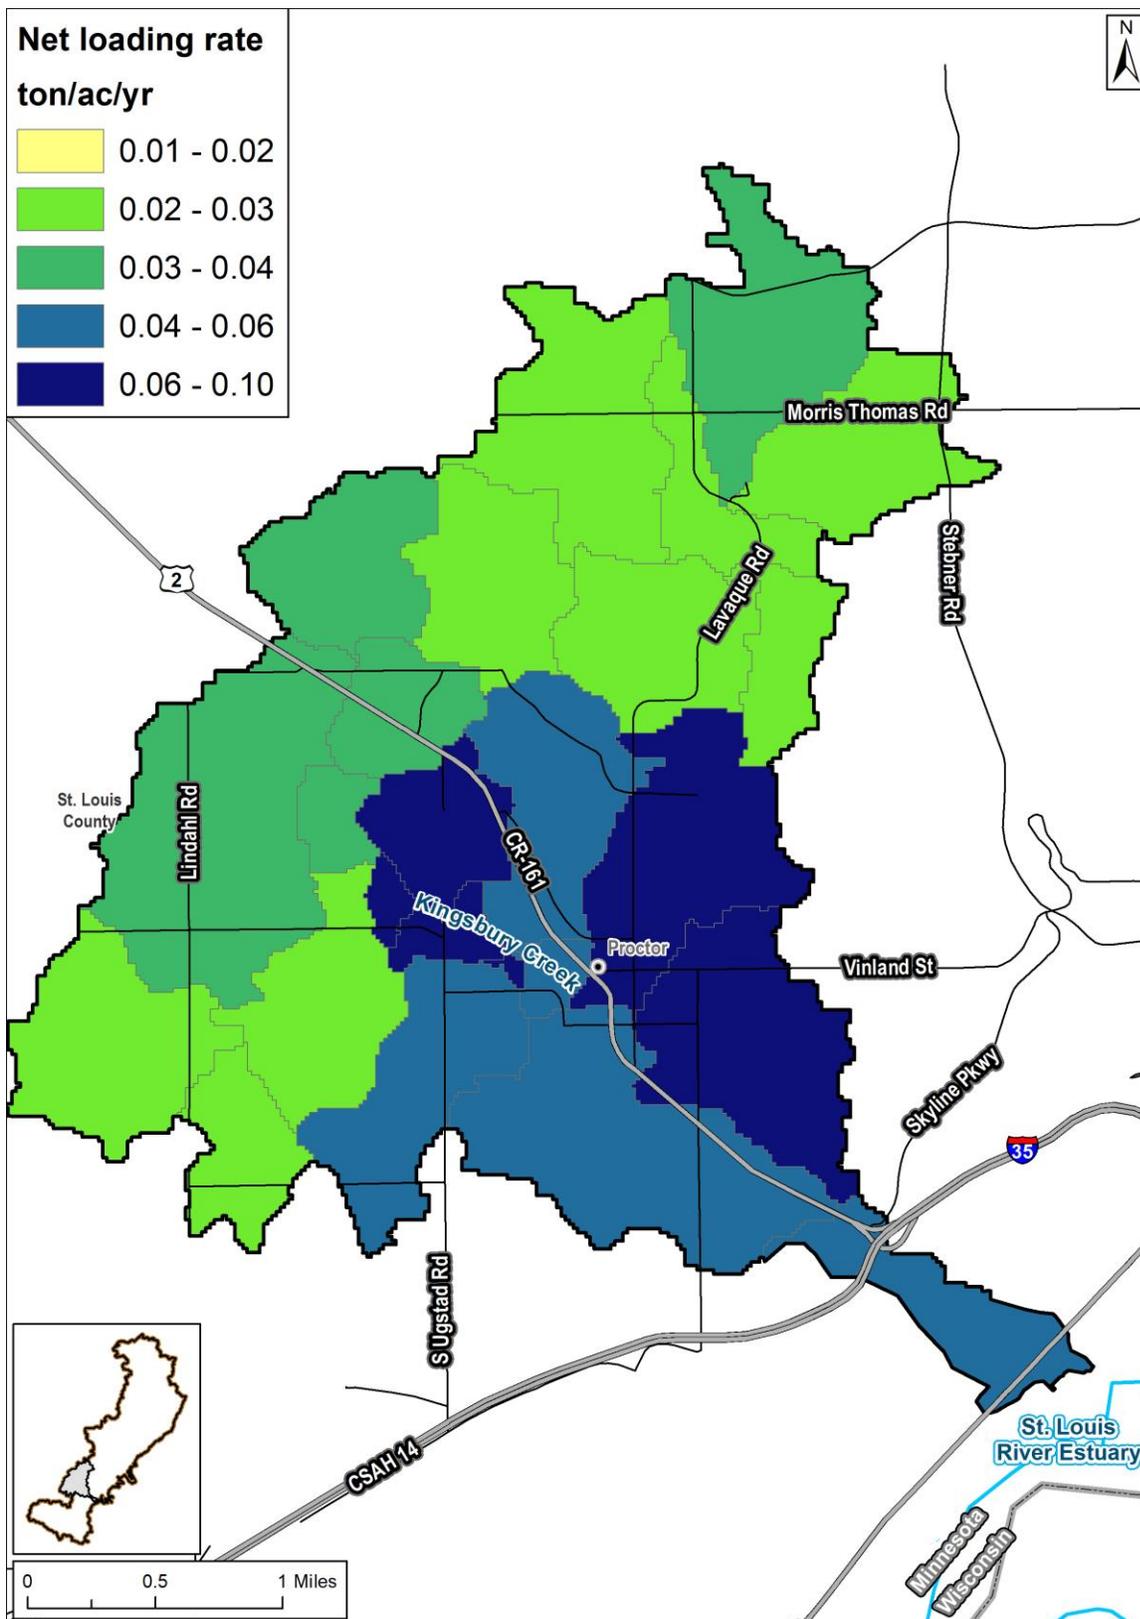
Figure 20. Annual average sediment loading rates in Kingsbury Creek Watershed (1995-2016; Tetra Tech 2019).

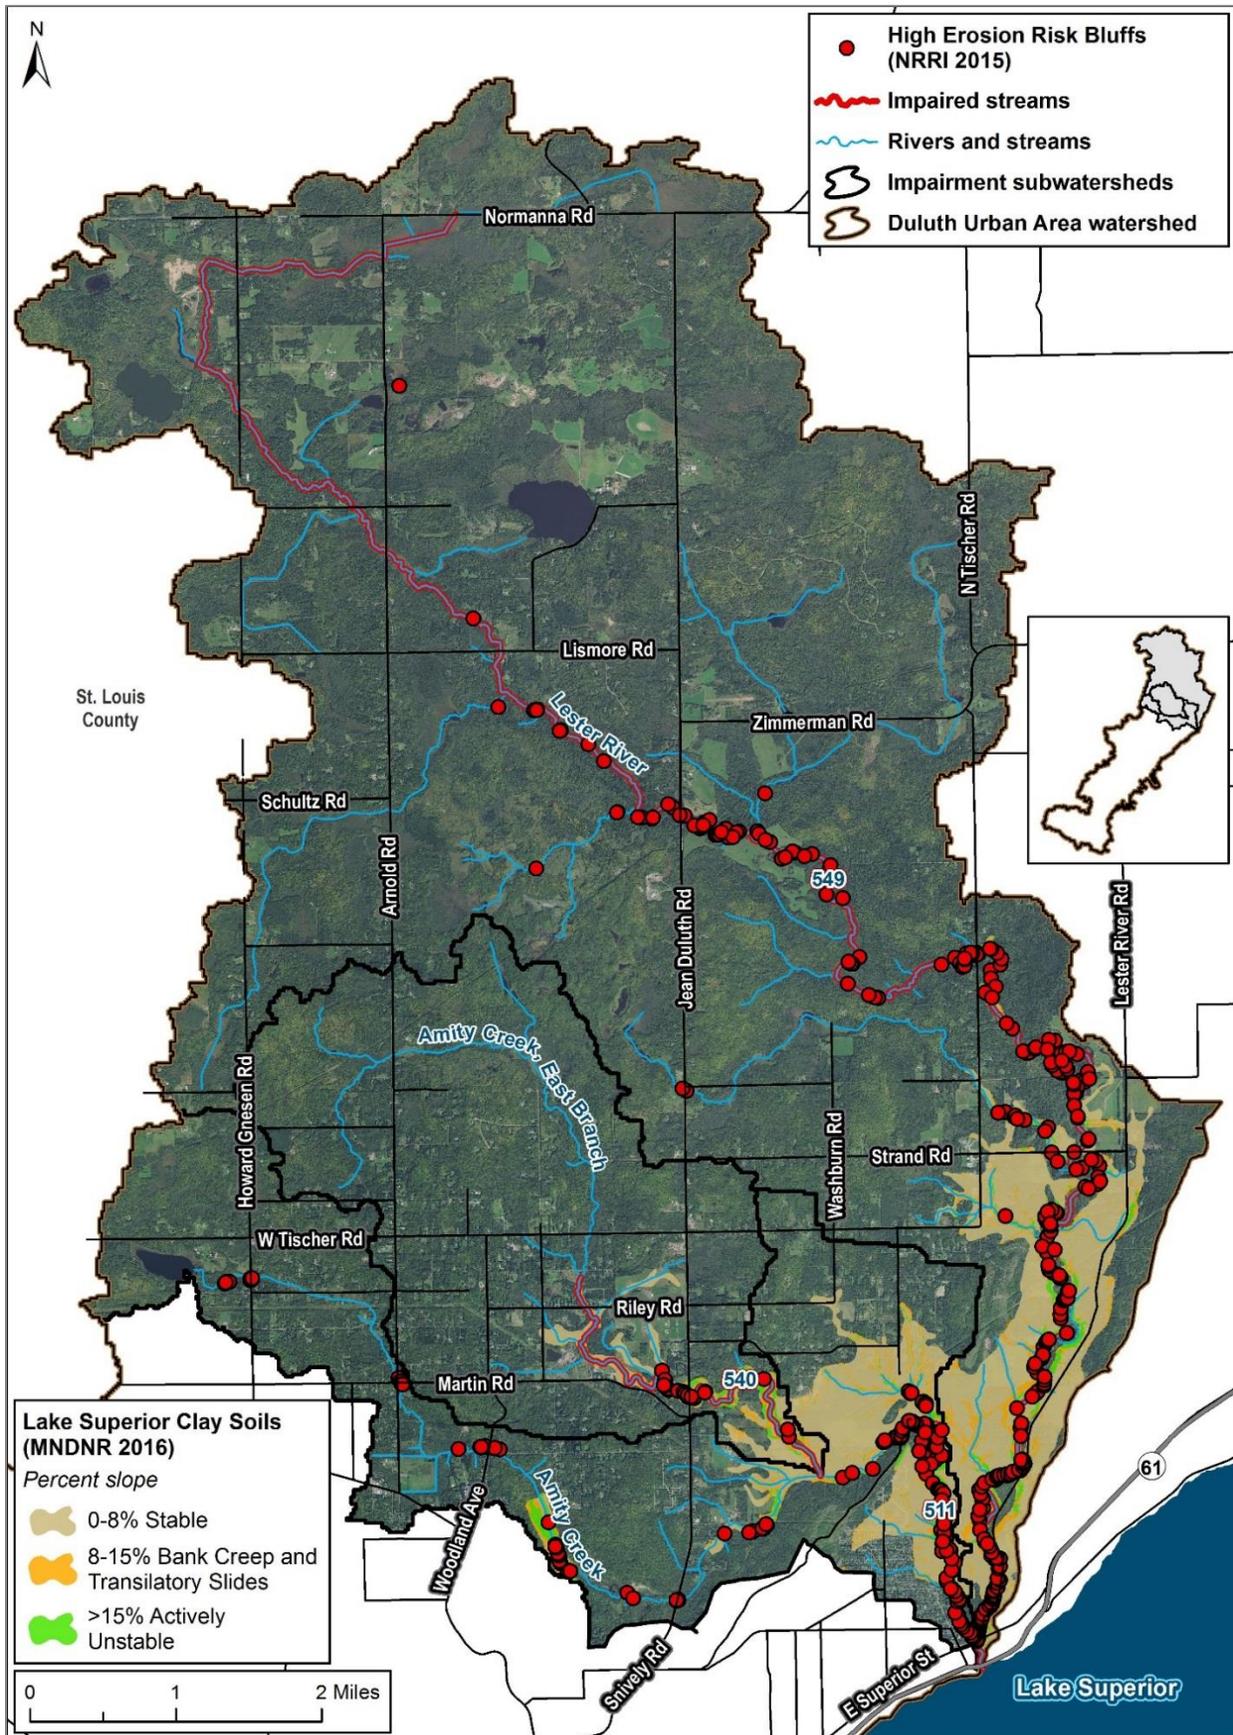
Figure 23. Potential sediment source areas identified in the Lester River and Amity Creek subwatersheds.

With the majority of the Lester River and Amity Creek East Branch subwatersheds made up of forest and wetland, developed land uses in the Amity Creek Subwatershed are likely potential watershed sources of sediment for both streams. Amity Creek contains 29 total stream crossings or an average of 1.1 stream crossings per stream mile, all of which are potential sources of sediment (SSLSWCD 2017). Figure 23 includes the location of clay lacustrine soils and identified high erosion risk bluffs (NRRRI 2015).

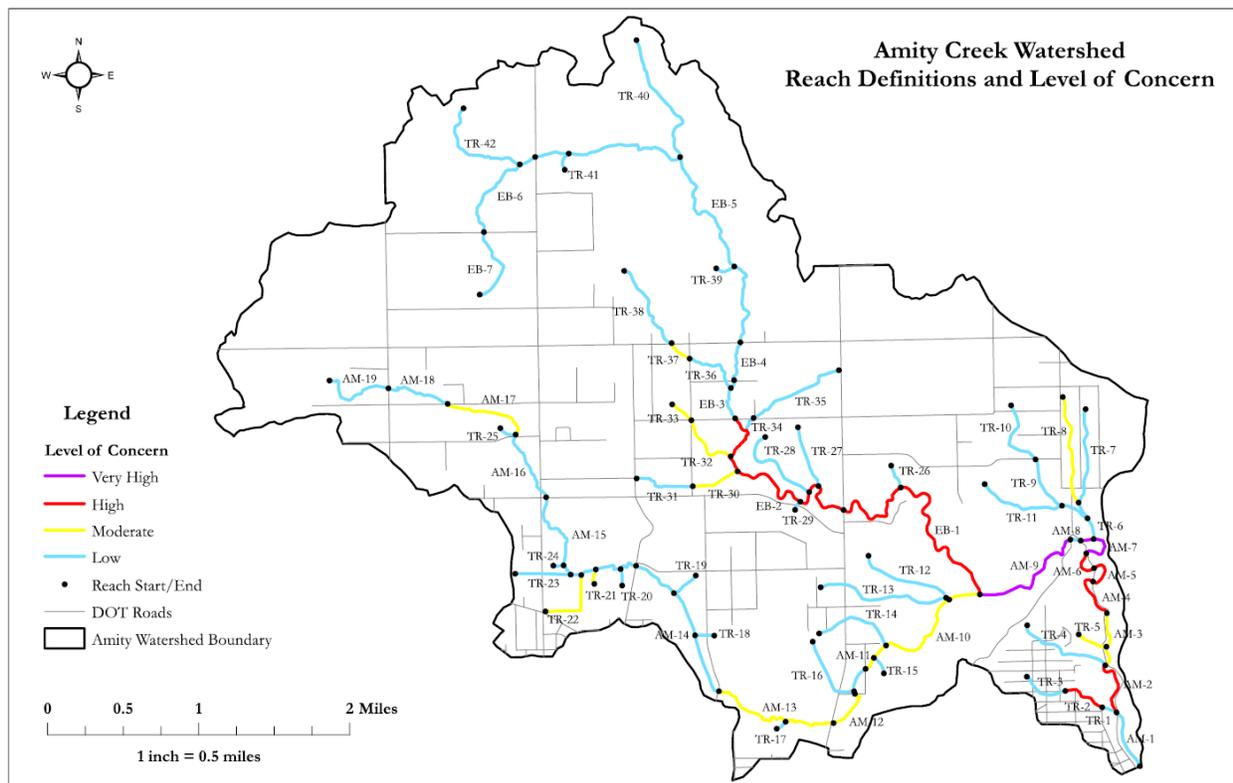
Figure 24. Amity Creek Subwatershed reaches with identified level of concern (from Jennings et al. 2017).

In addition to watershed loading, stream channel instability and bank erosion are causes of water quality impairment on the three reaches (Figure 24). A stressor identification study for Amity Creek and East Branch Amity Creek was completed in 2017 (Jennings et al. 2017; see Appendix B) to evaluate sources of sediment and identify priority areas for restoration (Figure 24). Stream reaches were classified for level of concern based primarily on geomorphic stability as evidenced by bank erosion and channel evolution.

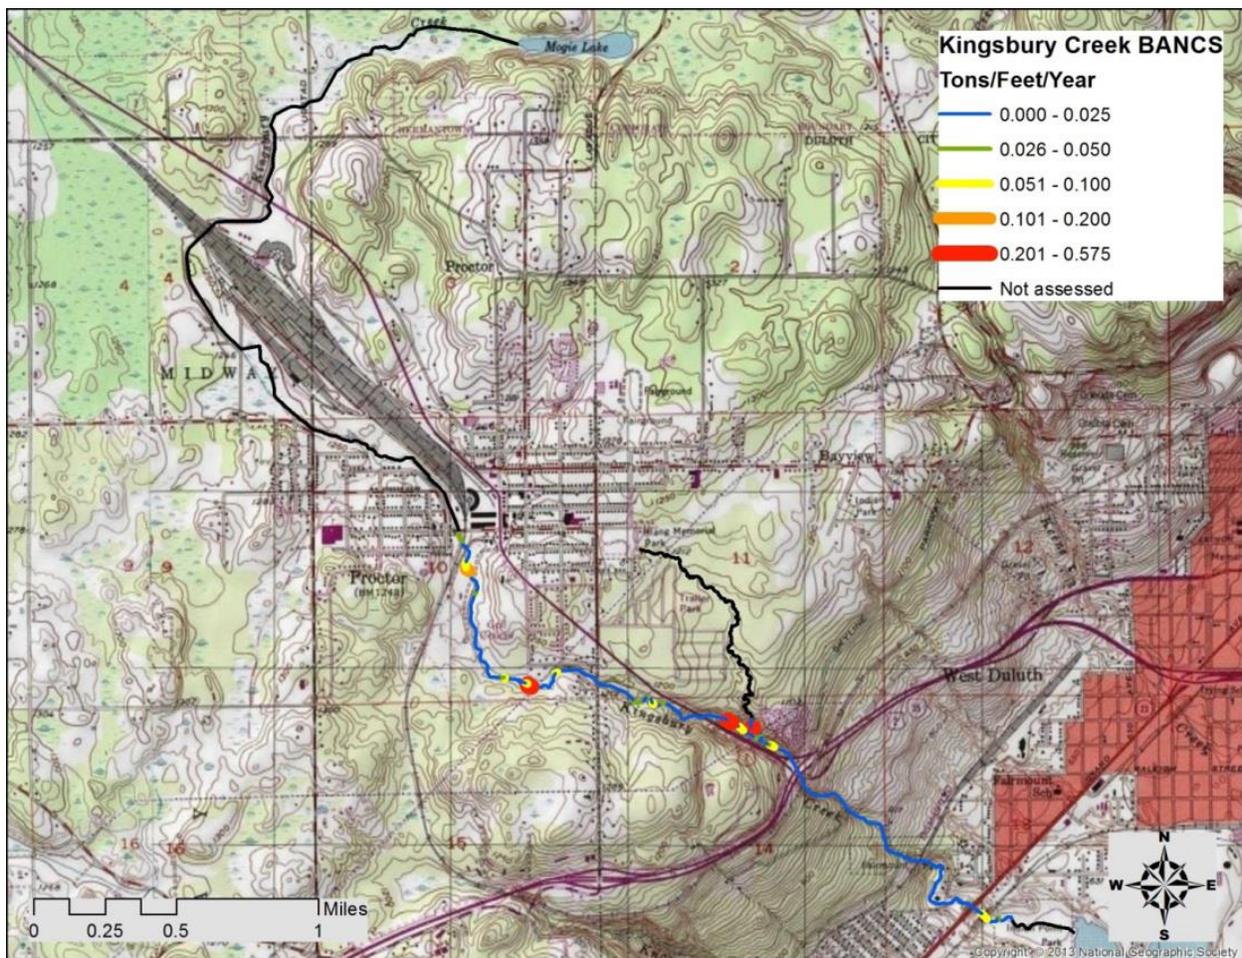
Figure 27. BANCS modeling in Kingsbury Creek (MPCA 2016).

A BANCS assessment conducted on approximately half of the creek shows that 44% of the predicted sediment load from bank erosion is coming from five stream banks (Figure 27). TSS data and the longitudinal snowmelt sampling, however, show that a significant amount of sediment is being sourced upstream of Point Drive, but no BANCS assessment was conducted to support this at this time (MPCA 2016).

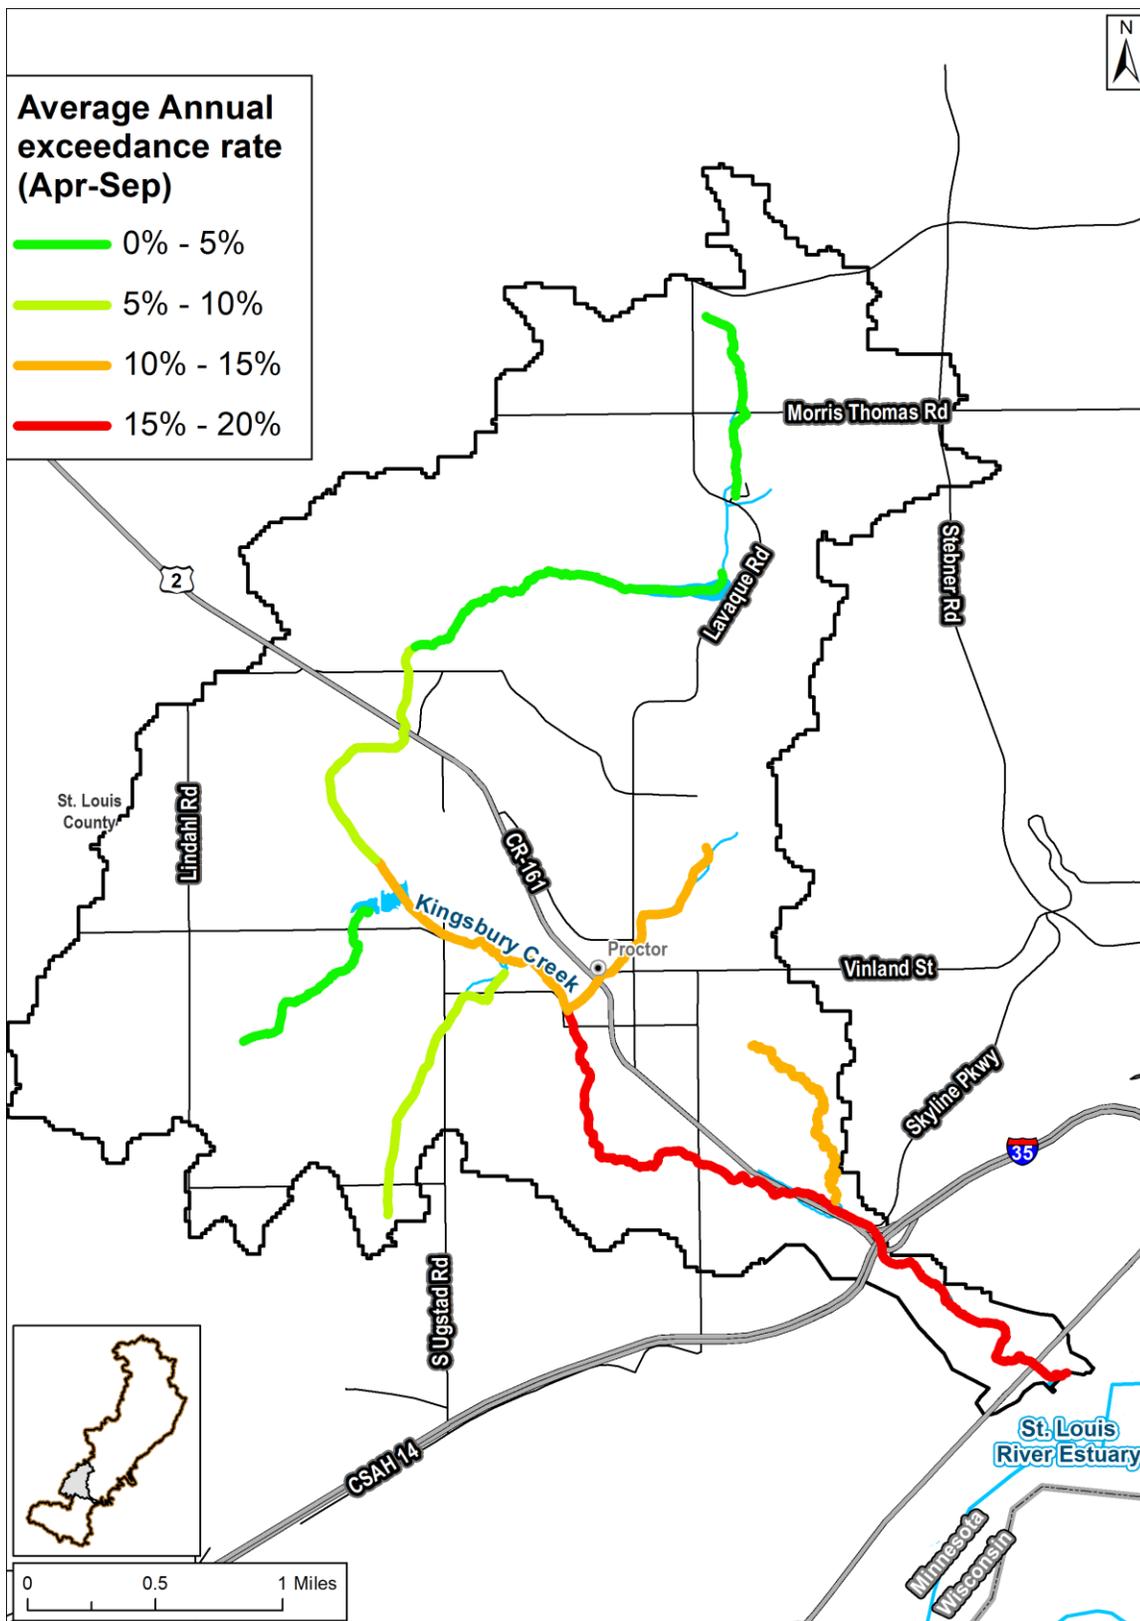
Figure 29. Percent of time TSS water quality standard is exceeded in Kingsbury during the model simulation (Apr-Sept 1995-2016).

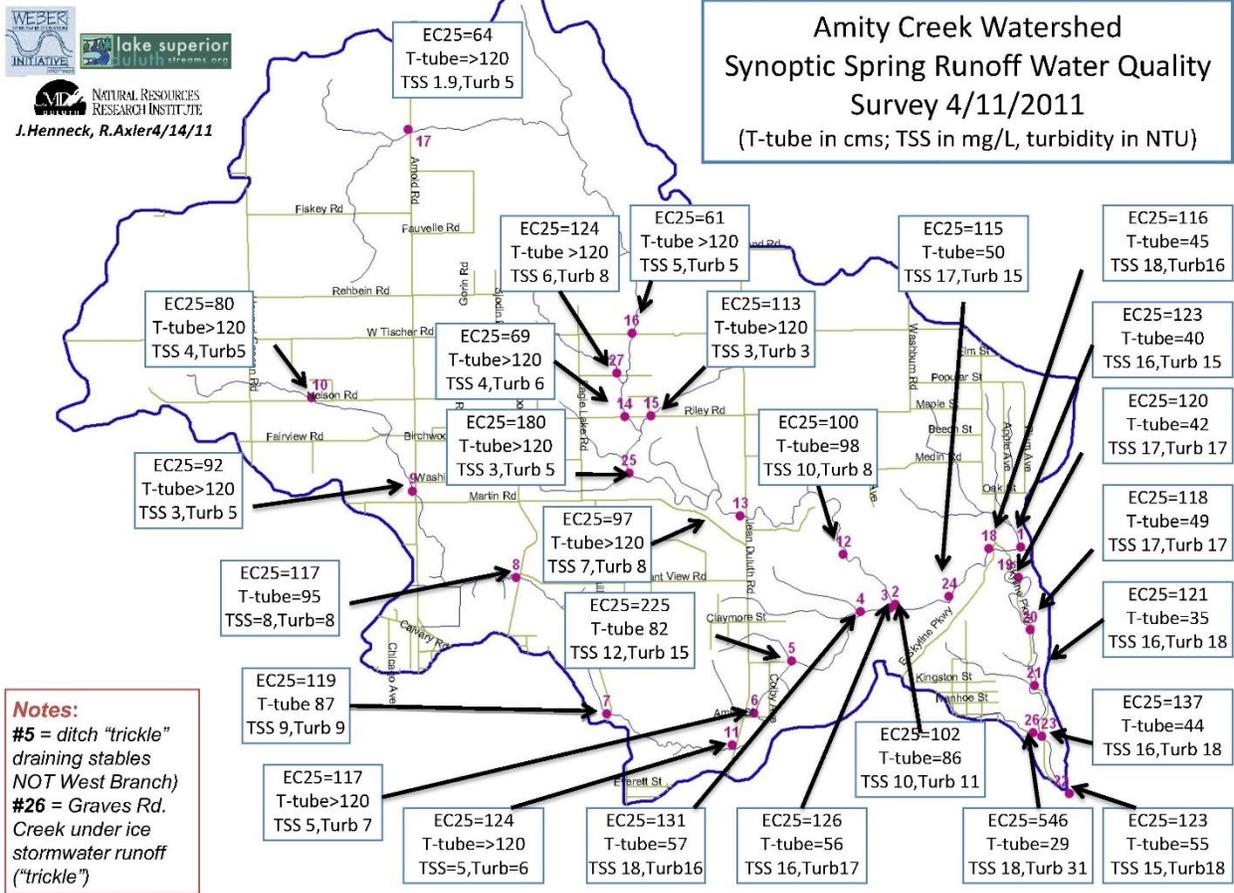
Figure 31. Synoptic sampling results, 4/11/2011.

Synoptic sampling was conducted throughout the Amity Creek Watershed on four dates: 4/11/2011, 3/20/2012, 5/24/2012, and 9/16/2013 (Lakesuperiorstreams.org 2019; Figure 31-Figure 34). At 27 locations in the watershed, specific electrical conductivity, transparency tube, turbidity, and TSS were monitored within an eight-hour period. Assessments in 2011 and 2012 occurred during high flows. In 2013, sampling was conducted during baseflow conditions.

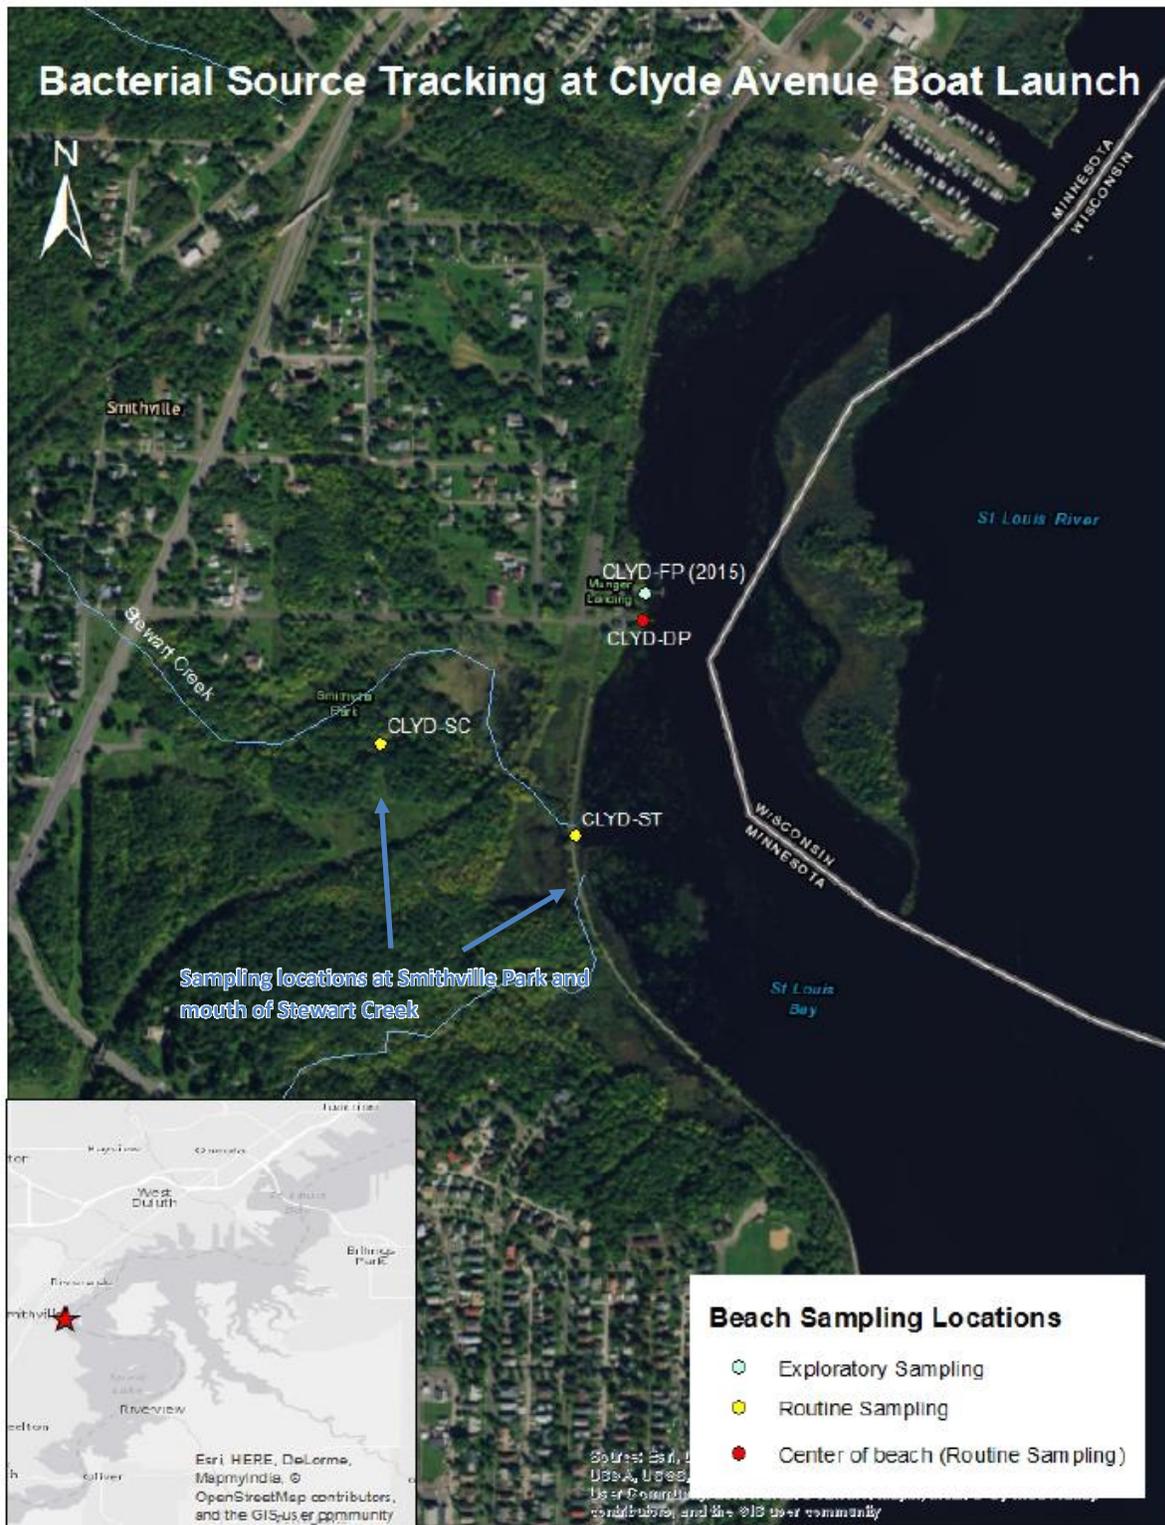
Figure 36. Sampling locations along Stewart Creek for the Clyde Avenue Beach bacterial source assessment (Prihoda et al. 2017).
