# Duluth Urban Area Streams Total Maximum Daily Load

Restoring and protecting urban streams in Duluth and surrounding areas.

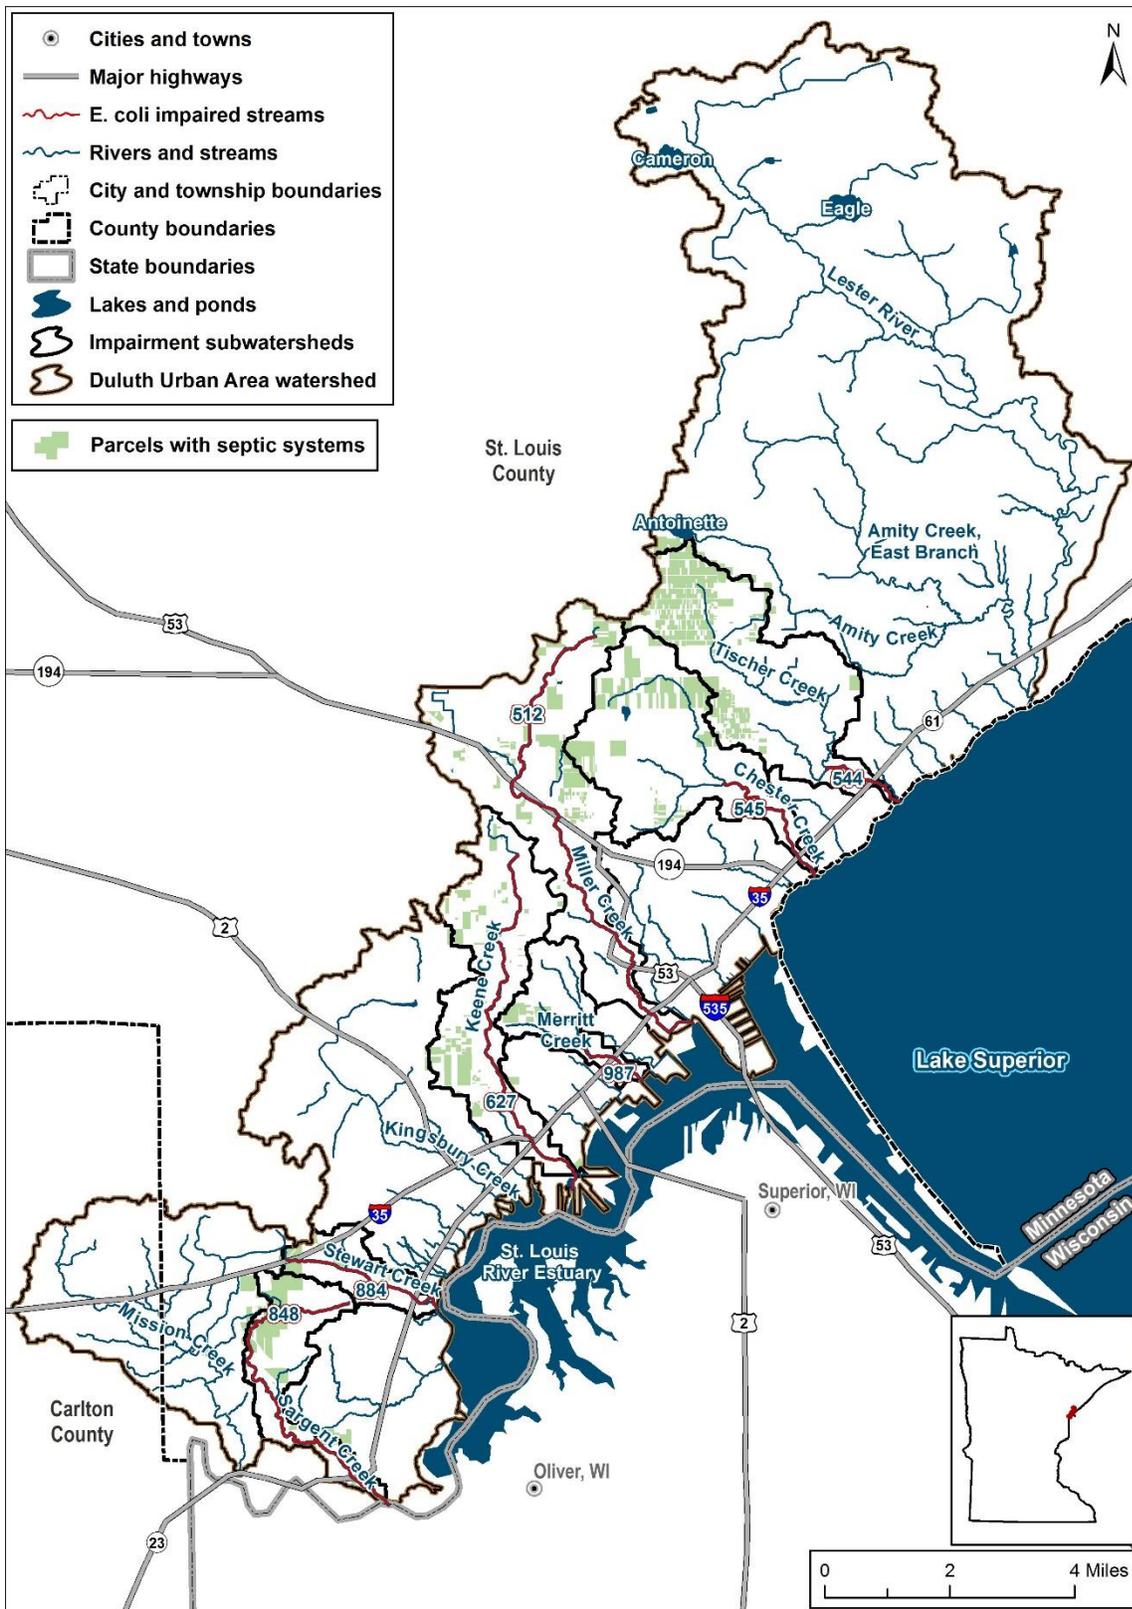
Figure 37. Parcels in *E. coli* impaired watersheds determined to likely have a septic system.

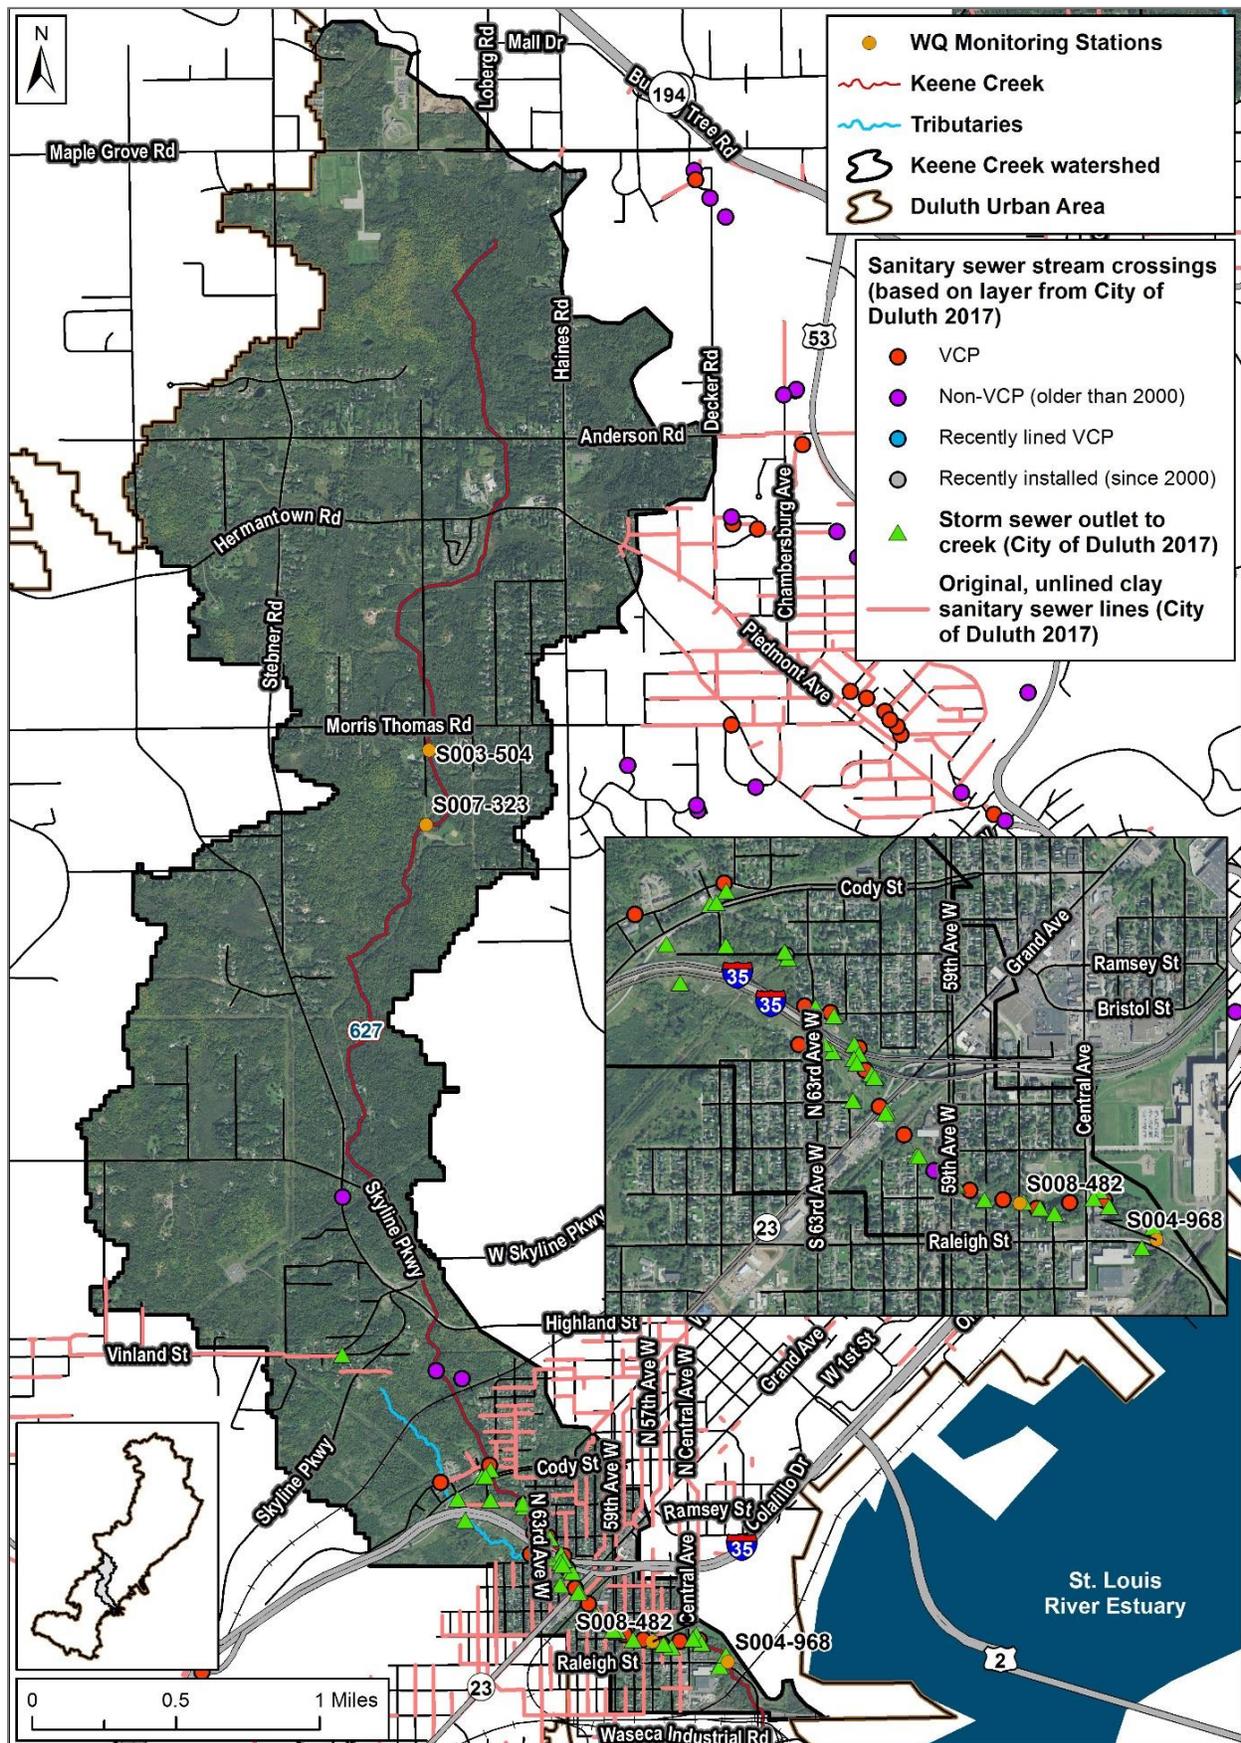
Figure 38. Potential wastewater infrastructure sources of *E. coli* in Keene Creek.

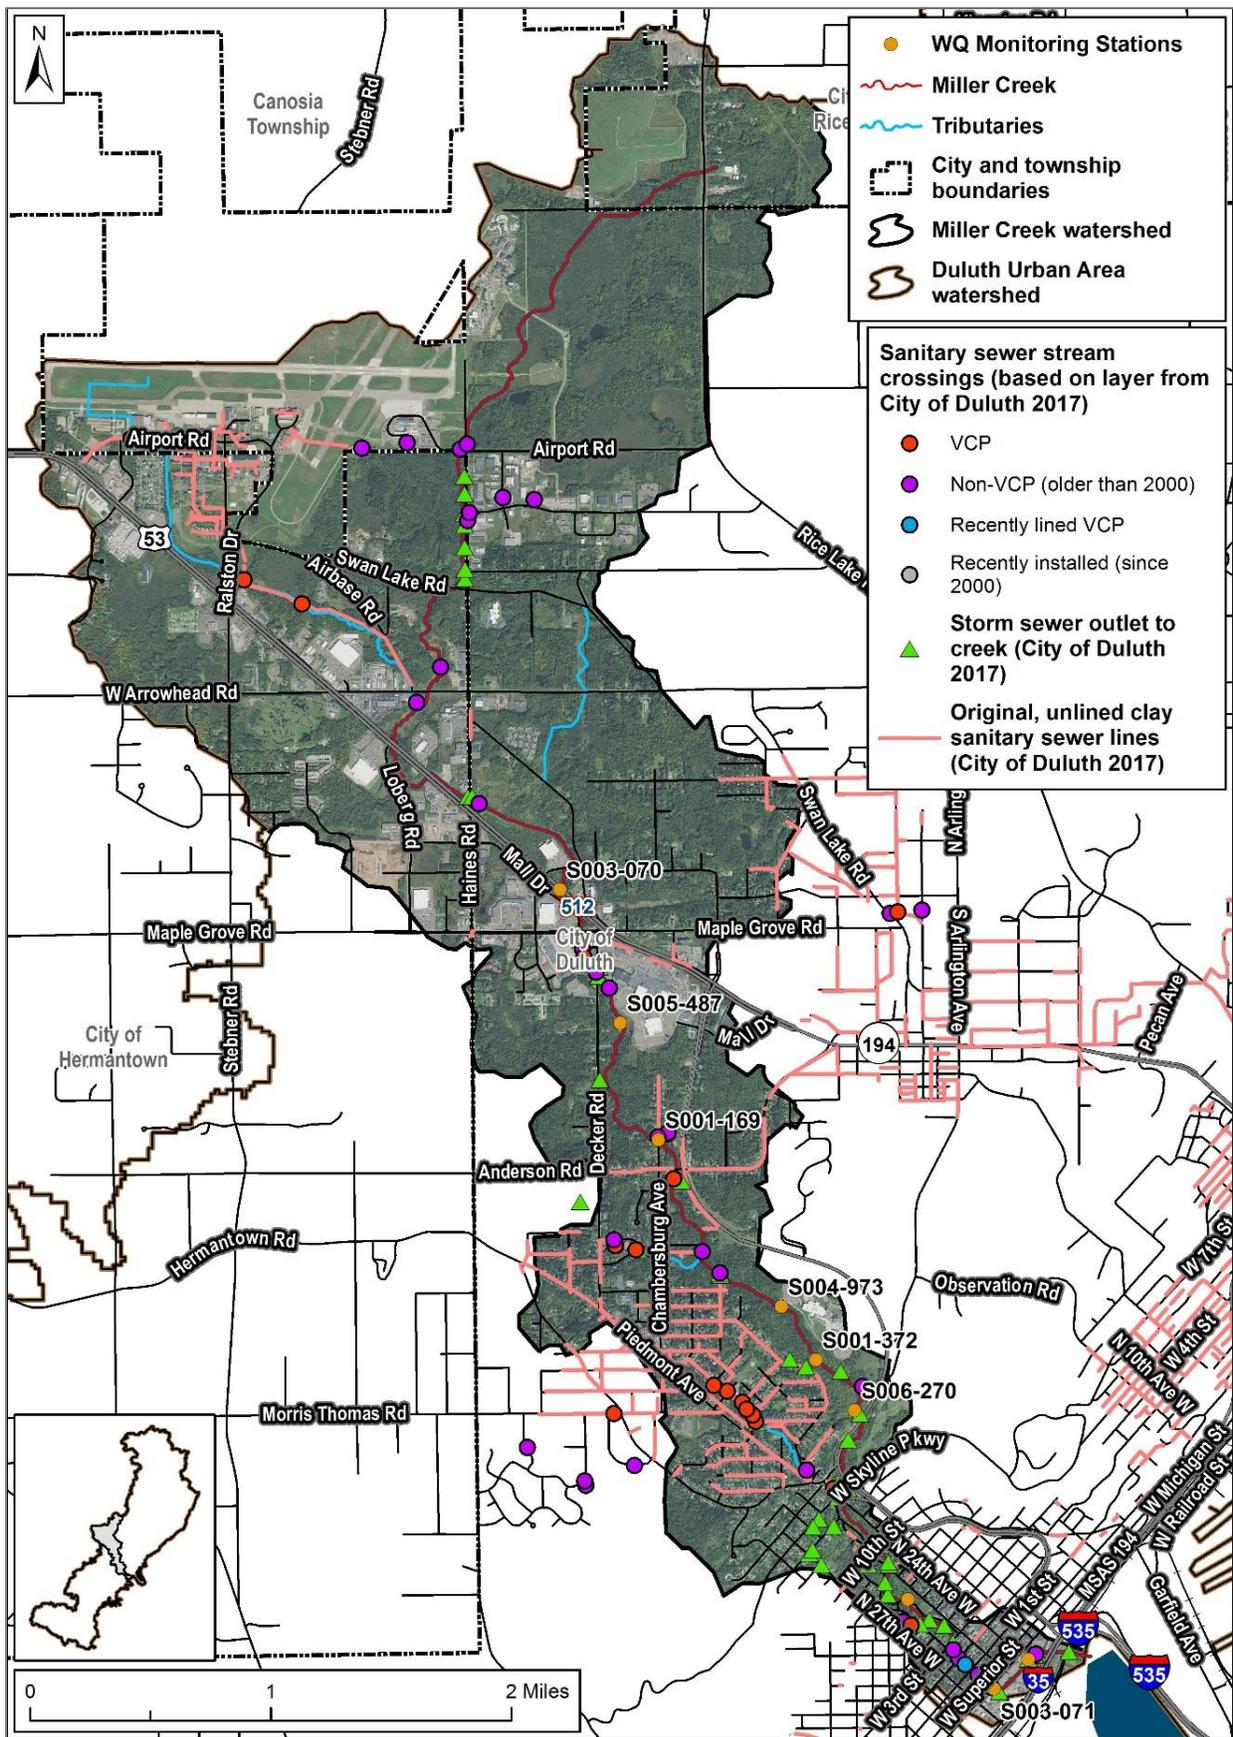
Figure 39. Potential wastewater infrastructure sources of *E. coli* in Miller Creek.

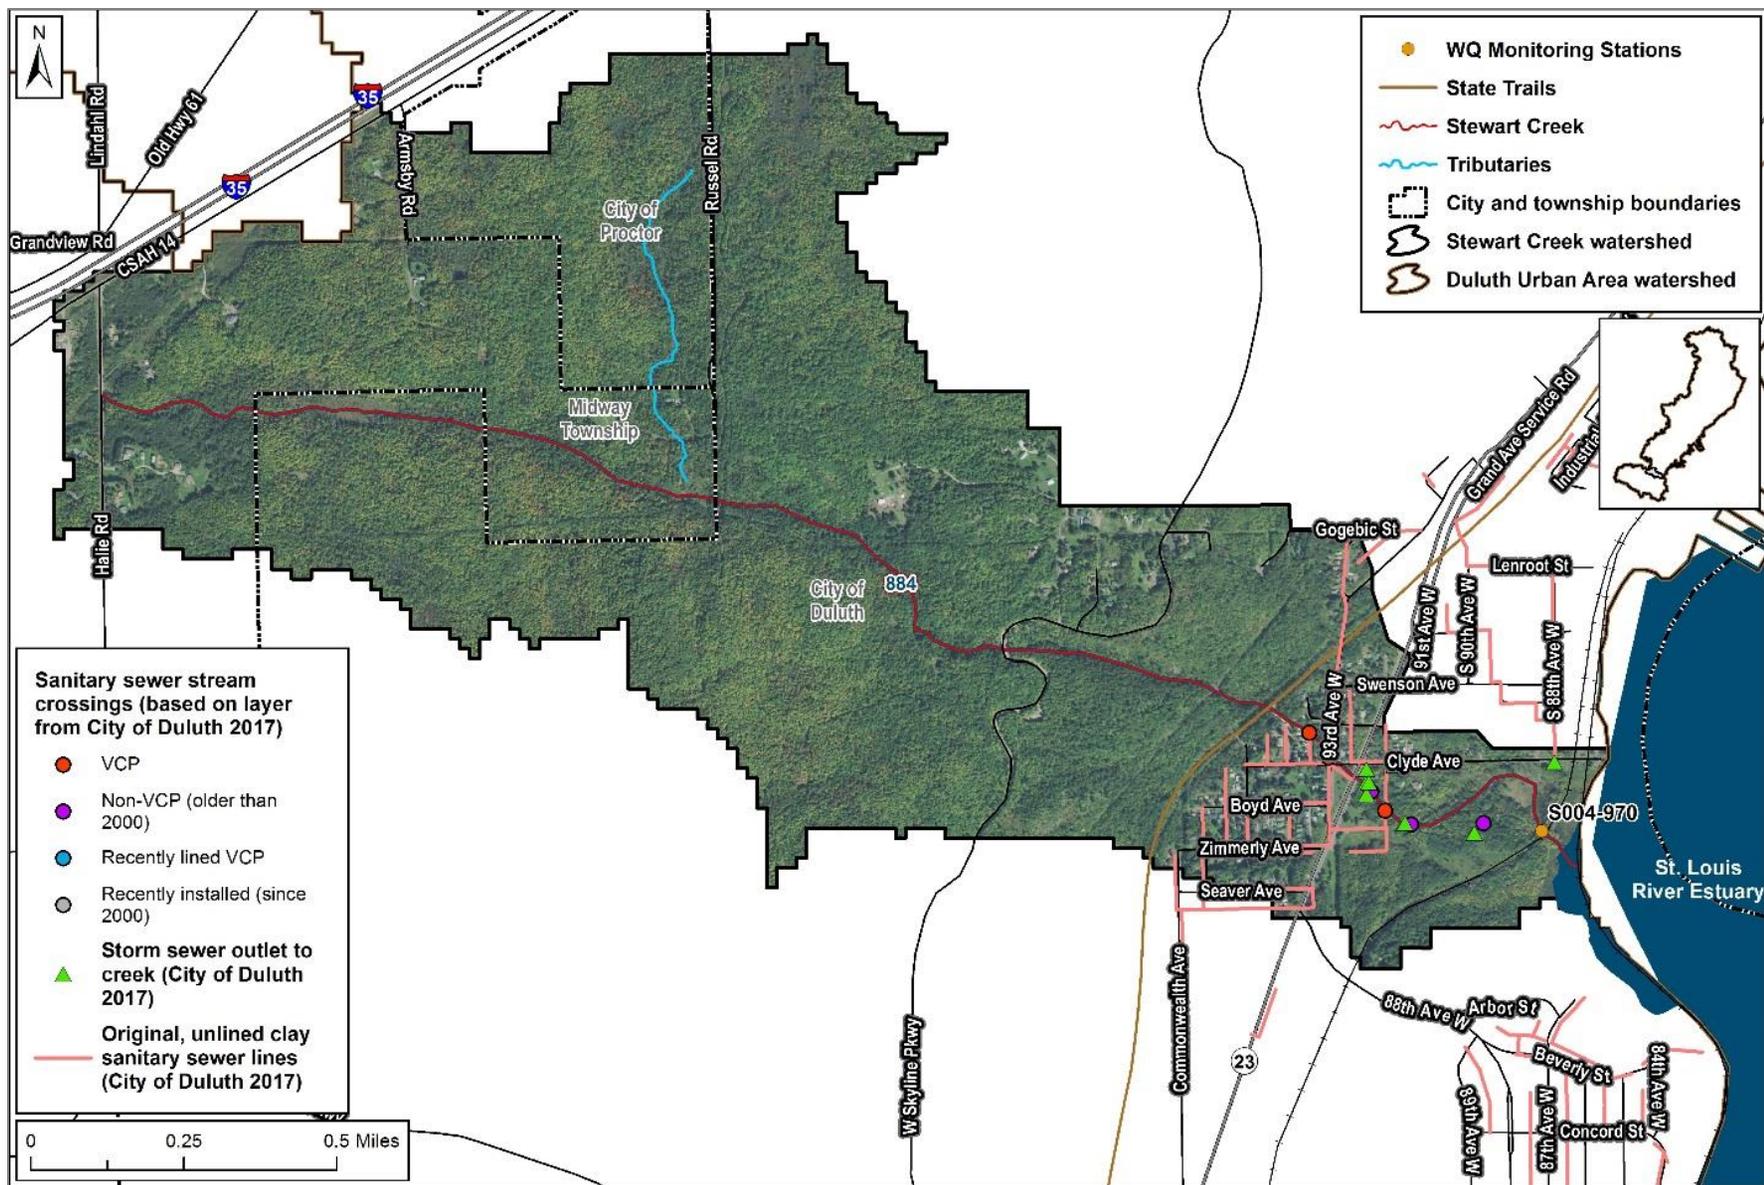
Figure 41. Potential wastewater infrastructure sources of *E. coli* in Stewart Creek.

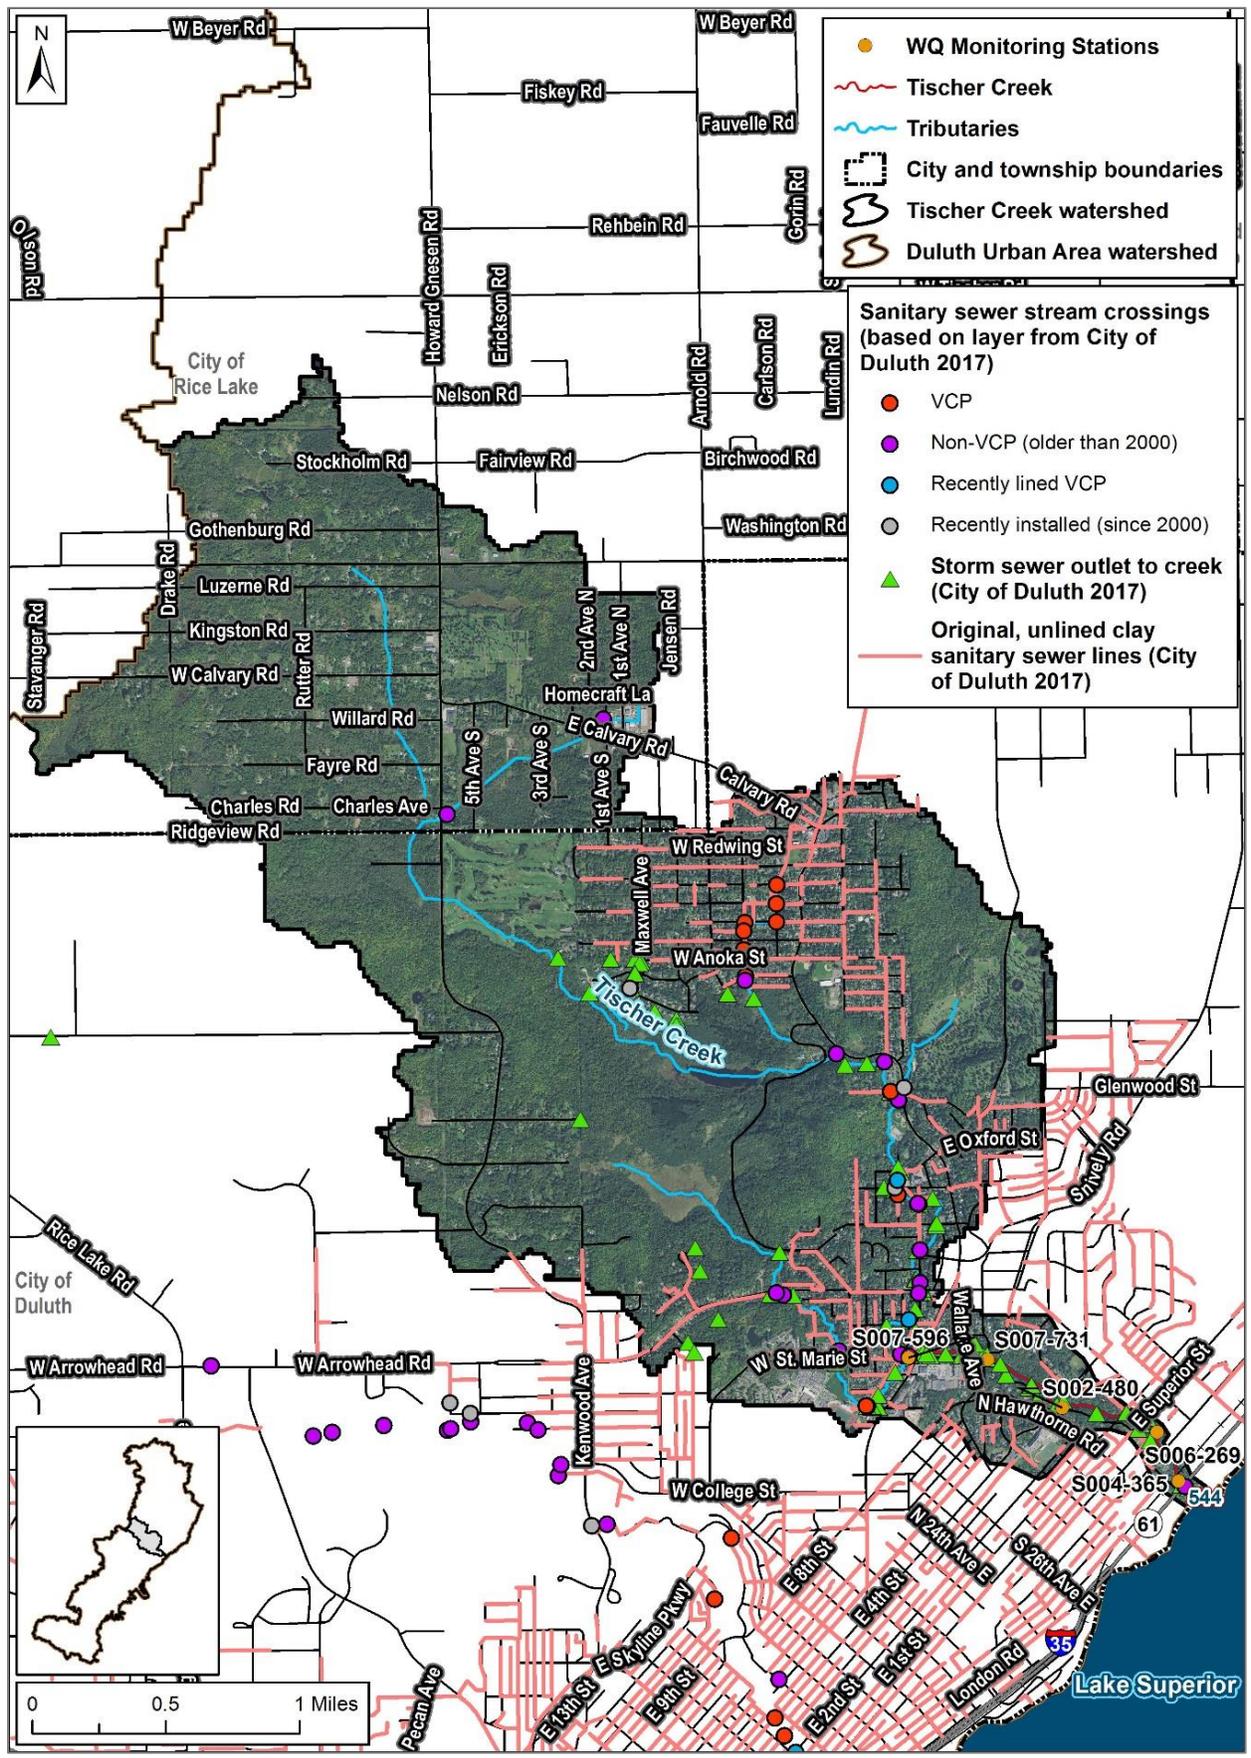
Figure 44. Potential wastewater infrastructure sources of *E. coli* in Tischer Creek.

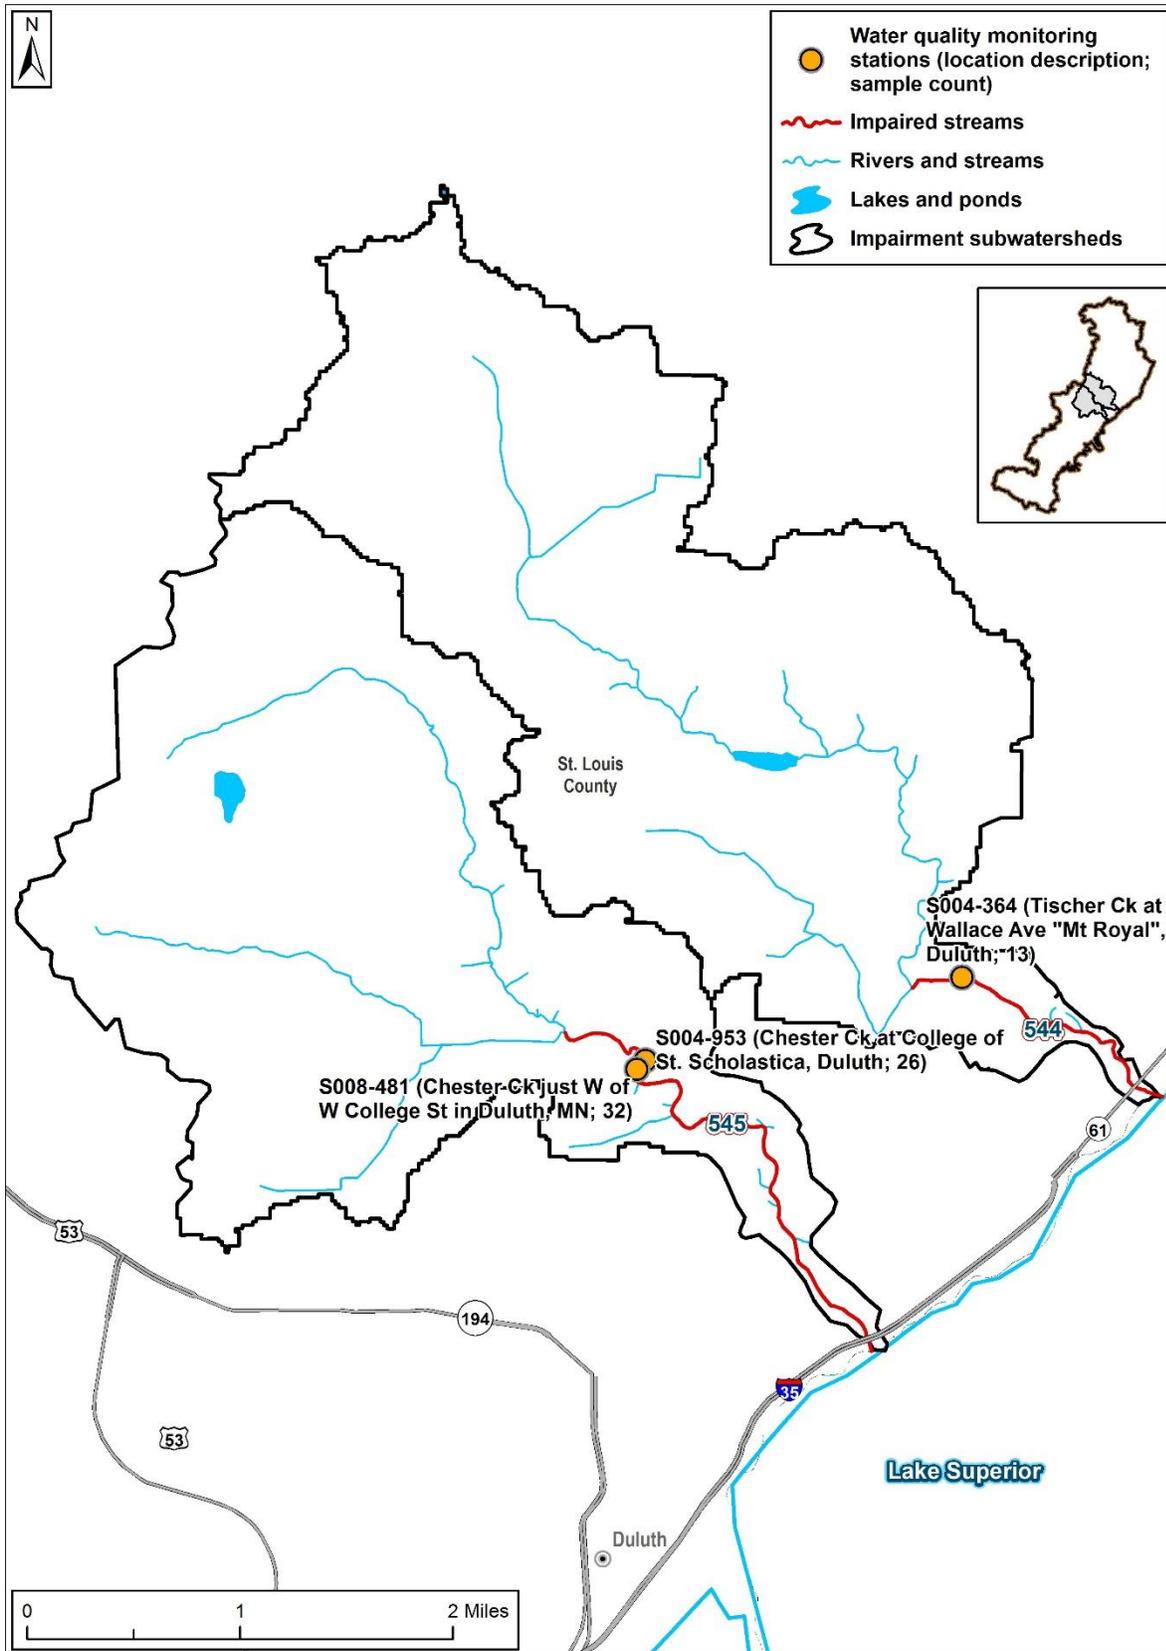
Figure 45. *E. coli* monitoring sites in the Chester Creek and Tischer Creek watersheds.

*E. coli* results are available for one monitoring site along Tischer Creek - Tischer Creek at Wallace Ave "Mt Royal" (S004-364; Figure 45). Therefore, an evaluation of longitudinal patterns was not possible. *E. coli* results were also evaluated with daily precipitation records for three pairs of years: 2008–2009 (Figure 50), 2011–2012 (Figure 51), and 2015–2016 (Figure 52). Generally, *E. coli* concentrations increase considerably on dates during or immediately following precipitation. In a few cases, an elevated concentration was detected during a dry weather period (e.g., August 26, 2012 in Figure 51).

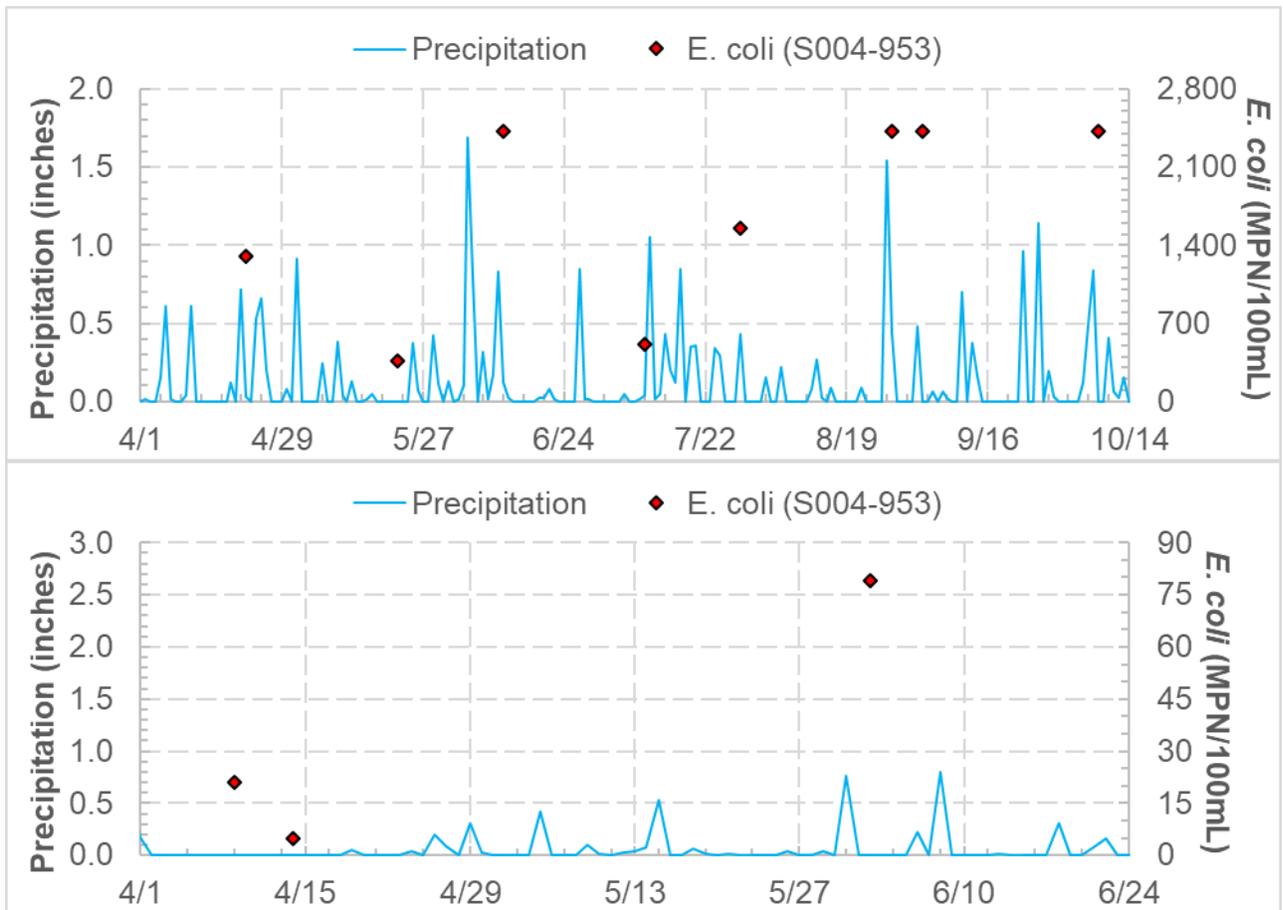
Figure 47. Precipitation at the Duluth International Airport and *E. coli* levels at monitoring site S004-953 on Chester Creek in 2008 (top) and 2009 (bottom).

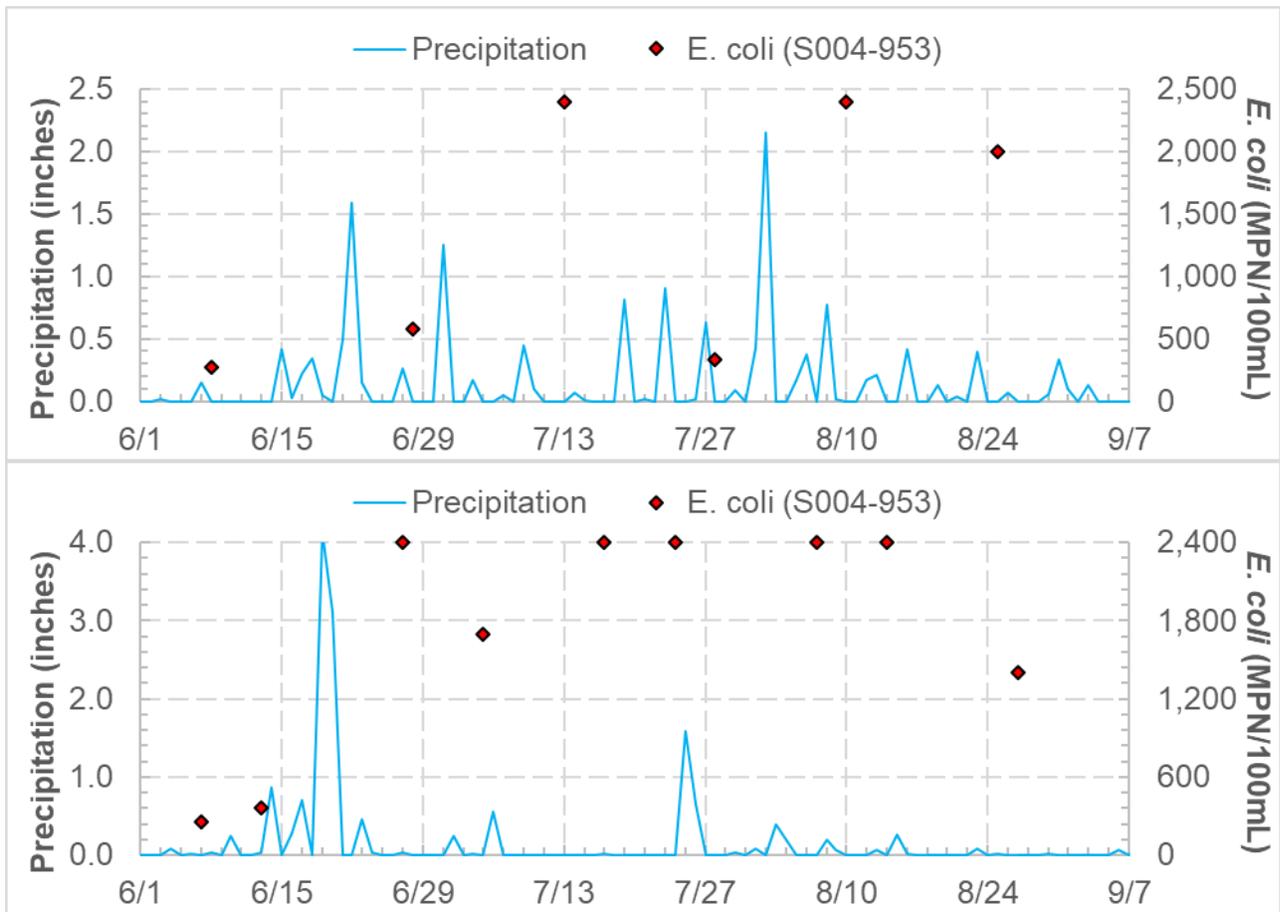
Figure 48. Precipitation at the Duluth International Airport and *E. coli* levels at monitoring site S004-953 on Chester Creek in 2011 (top) and 2012 (bottom).

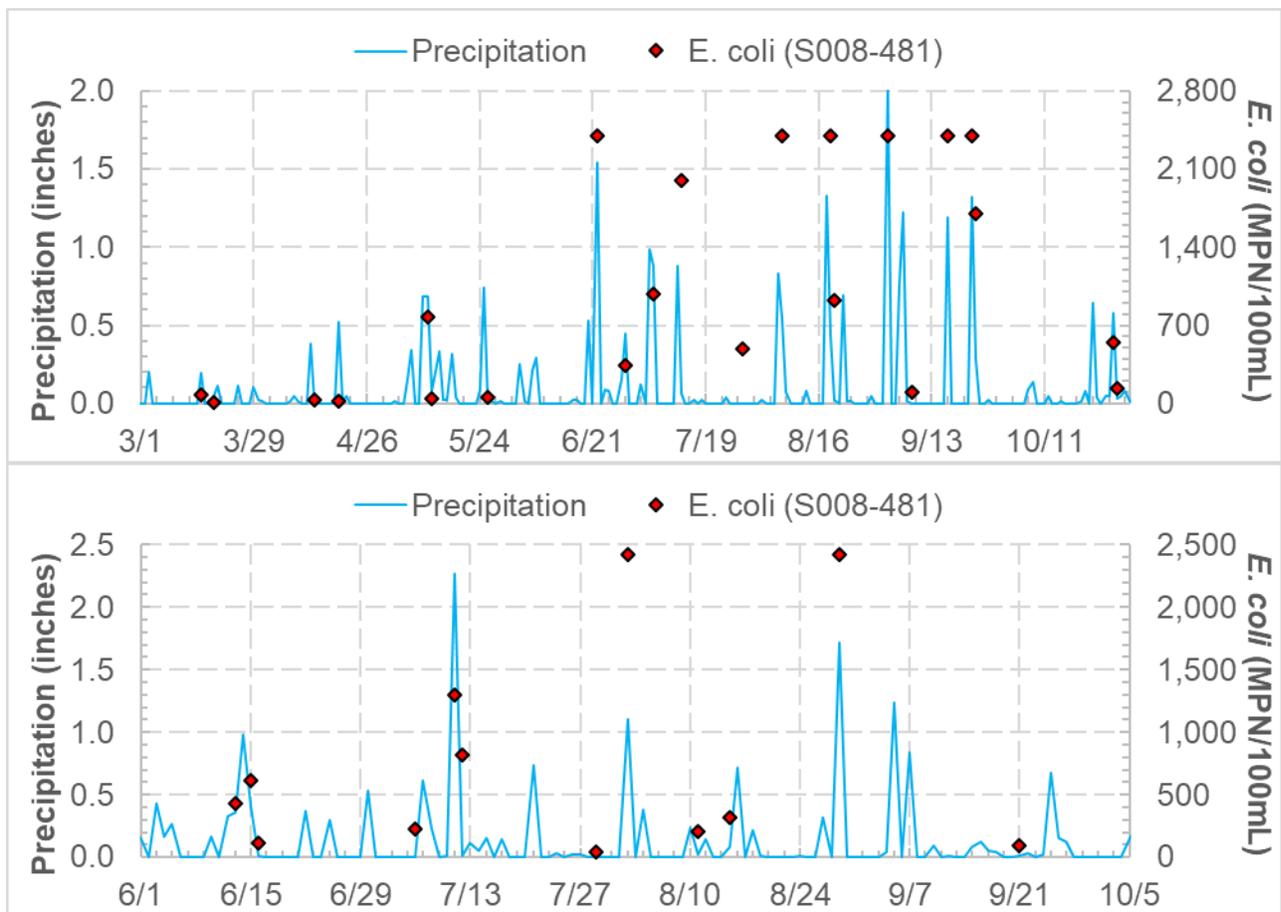
Figure 49. Precipitation at the Duluth International Airport and *E. coli* levels at monitoring site S008-481 on Chester Creek in 2015 (top) and 2016 (bottom).

Elevated *E. coli* concentrations were detected at both sites on days with or immediately following a precipitation event. Additionally, several sets of samples were collected at site S008-481 after a precipitation event, and show decreasing *E. coli* levels on the second consecutive day of sampling; see June 15–16, 2016, and July 11–12, 2016 (Figure 49).

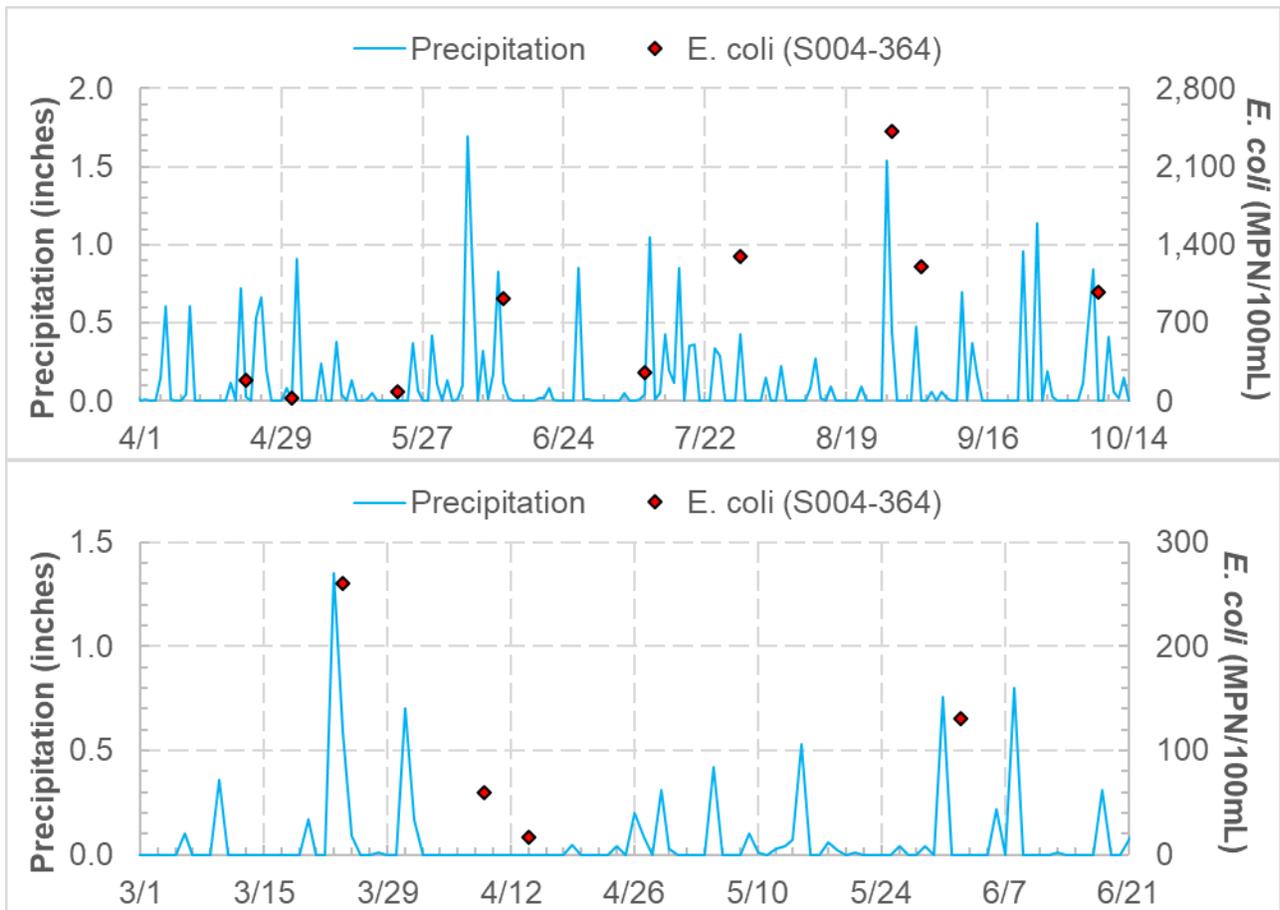
Figure 50. Precipitation at the Duluth International Airport and *E. coli* levels at monitoring site S004-364 on Tischer Creek in 2008 (top) and 2009 (bottom).

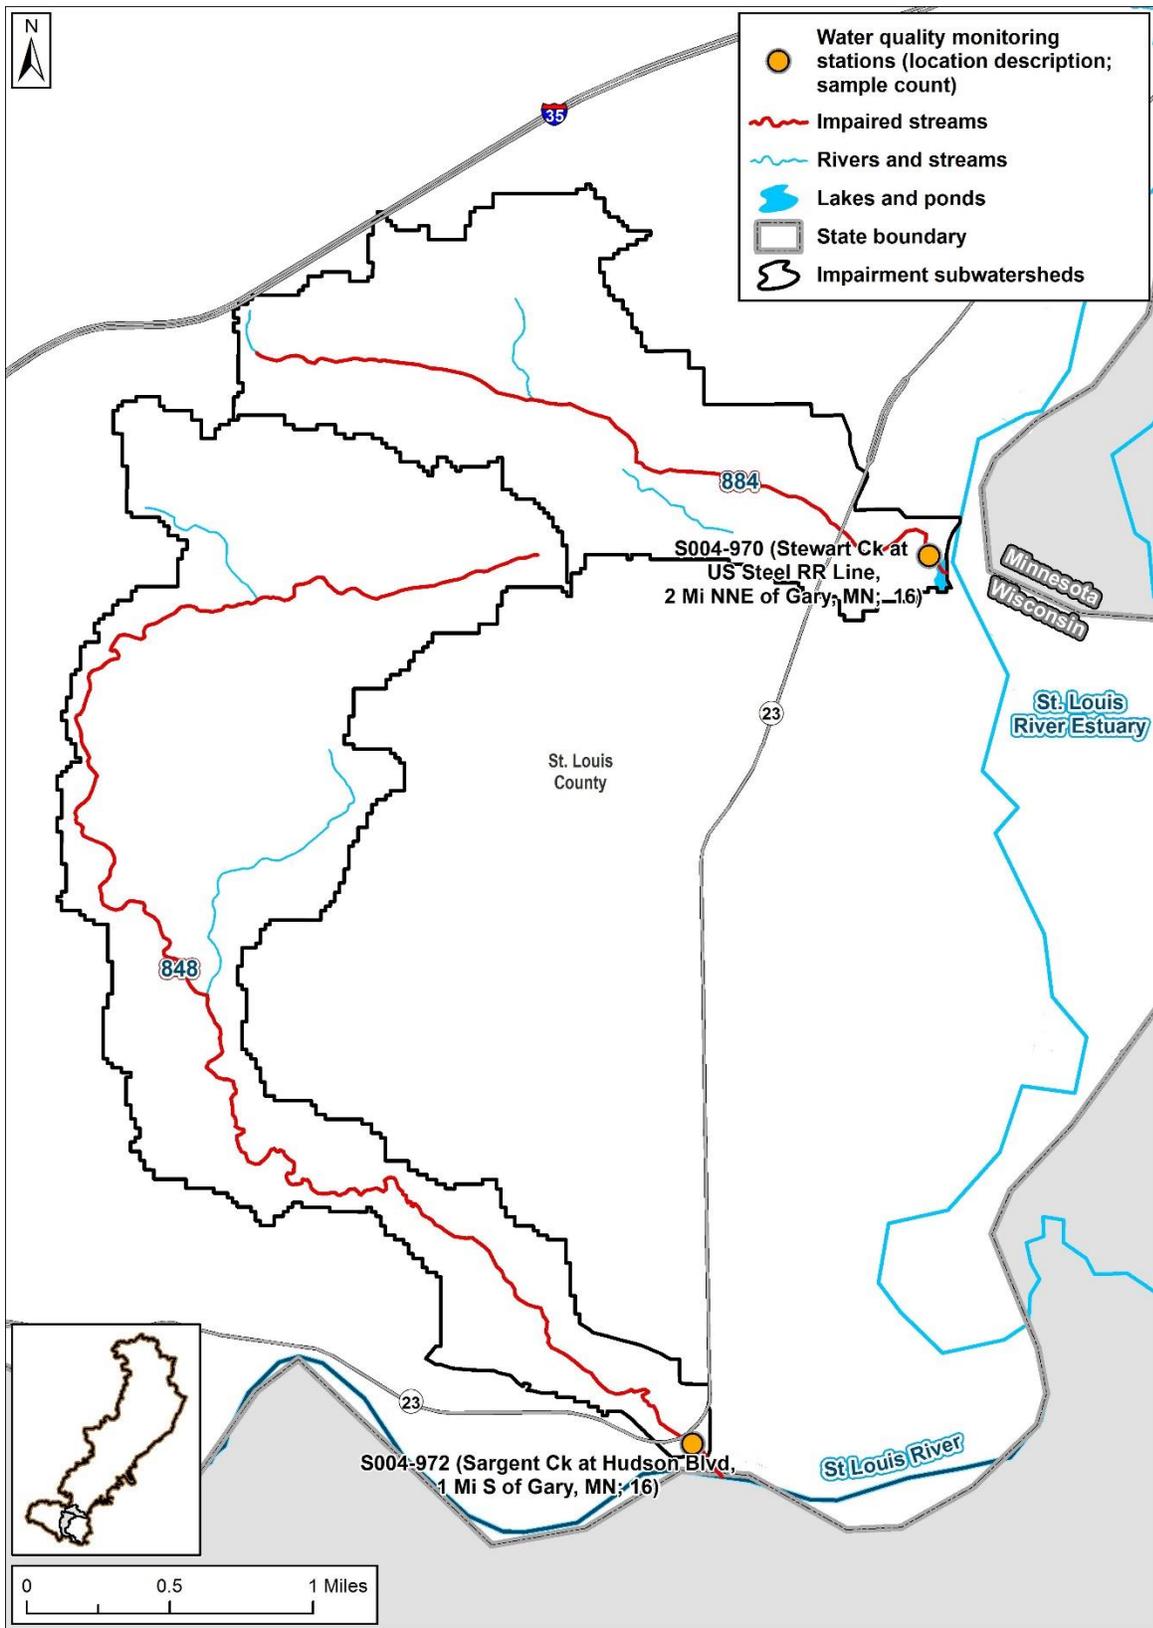
Figure 56. *E. coli* monitoring sites in Stewart Creek and Sargent Creek watersheds.

*E. coli* results are available for one monitoring site on Stewart Creek (Figure 56); therefore, an evaluation of longitudinal patterns was not possible. Results were also evaluated with daily precipitation data from the Duluth International Airport (Figure 57). Elevated concentrations in 2009 and 2010 typically occurred during or after precipitation events.

*E. coli* results are available for one monitoring site on Sargent Creek (Figure 56); therefore, an evaluation of longitudinal patterns was not possible. Results were also evaluated with daily precipitation data from the Duluth International Airport (Figure 58). Elevated *E. coli* concentrations typically occurred during or after precipitation events.

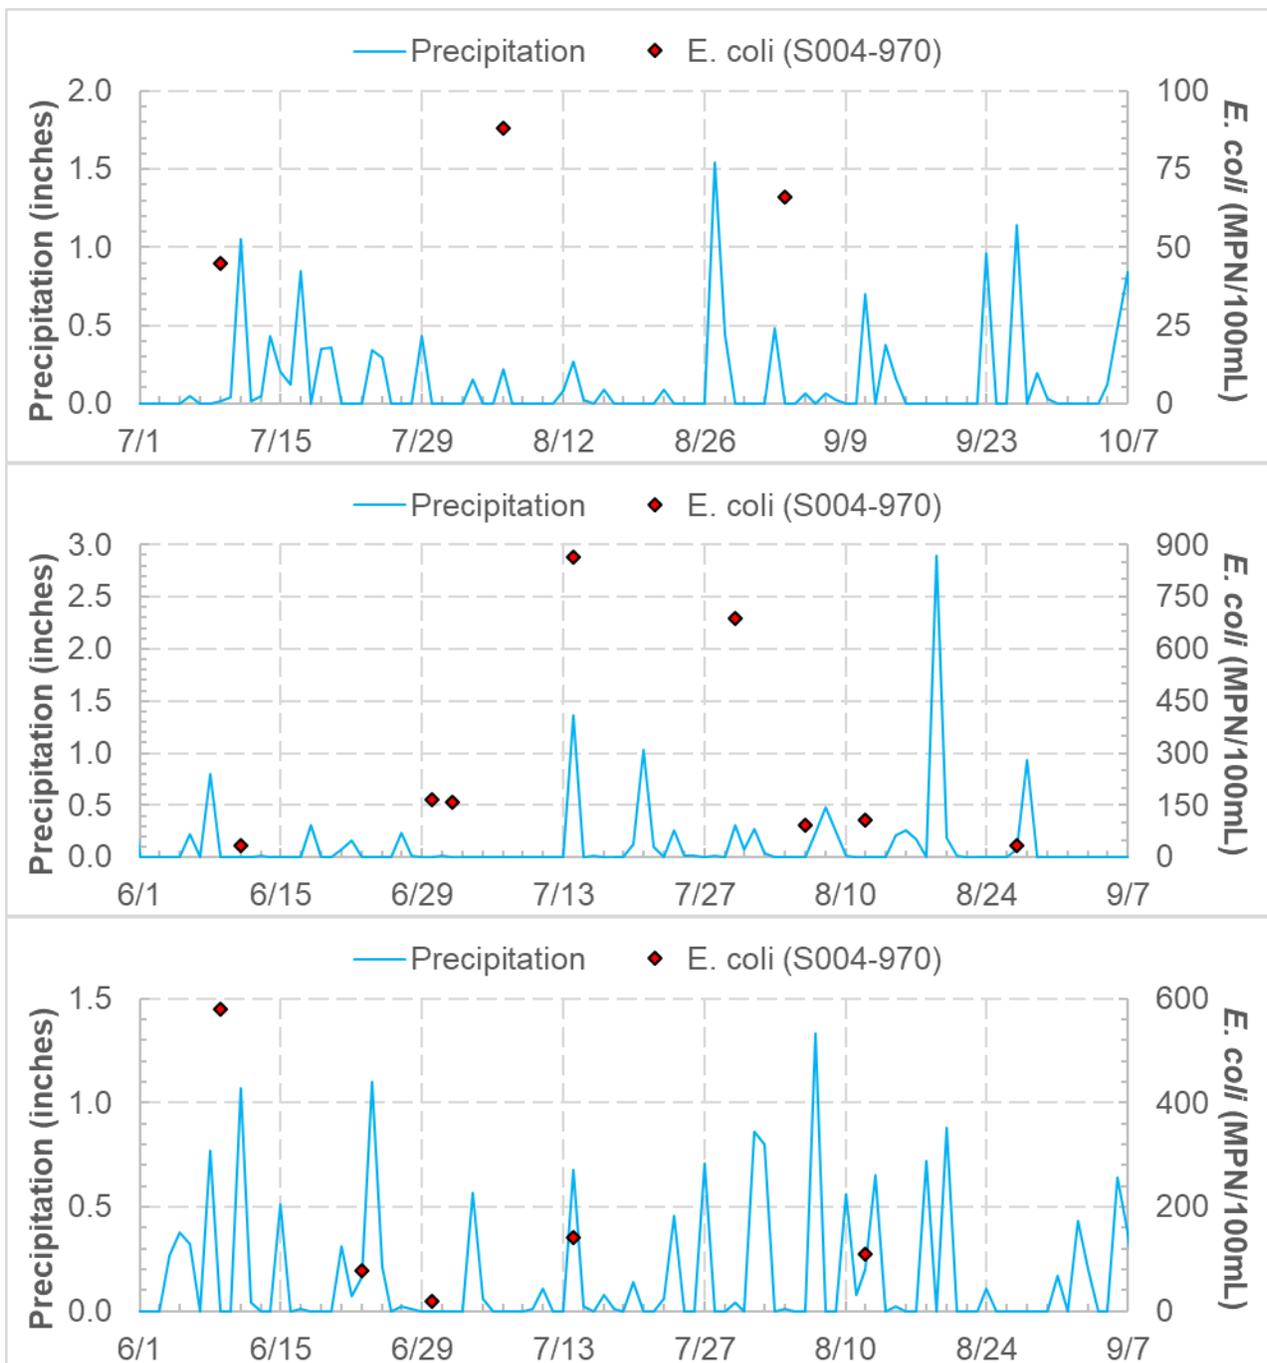
Figure 57. Precipitation at the Duluth International Airport and *E. coli* levels at monitoring site S004-970 on Stewart Creek in 2008 (top), 2009 (middle), and 2010 (bottom).

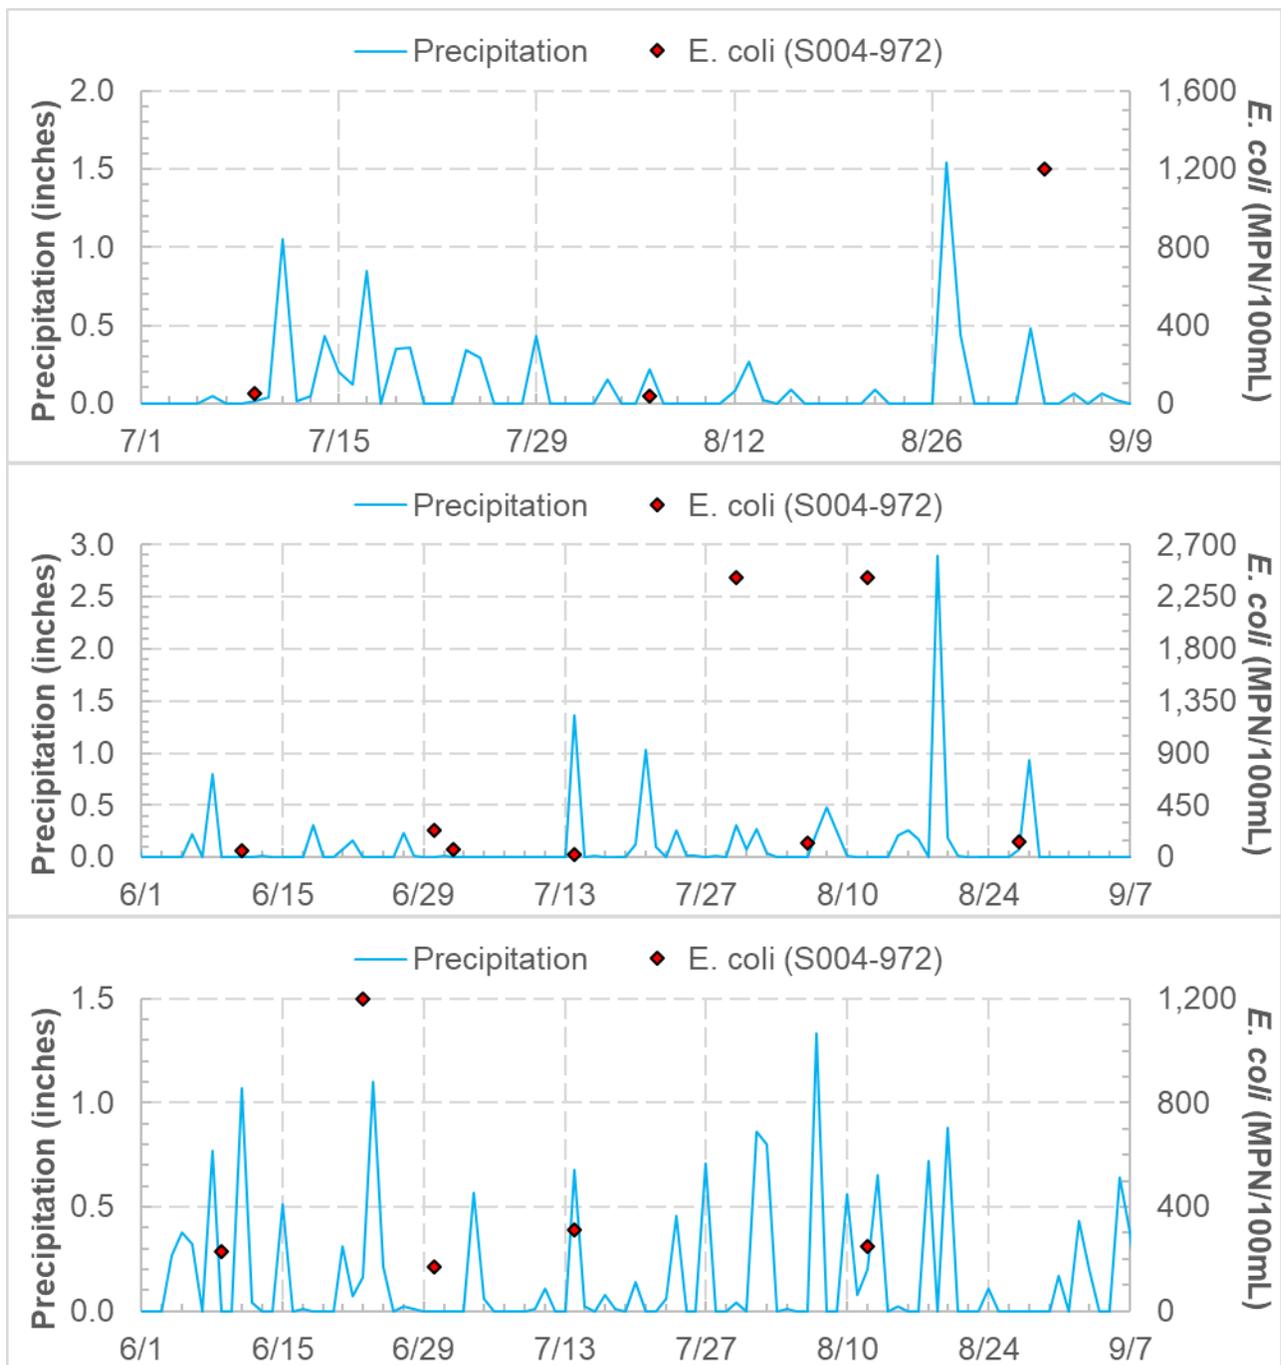
Figure 58. Precipitation at the Duluth International Airport and *E. coli* levels at monitoring site S004-970 on Sargent Creek in 2008 (top), 2009 (middle), and 2010 (bottom).
