# Duluth Urban Area Streams Total Maximum Daily Load

Restoring and protecting urban streams in Duluth and surrounding areas.

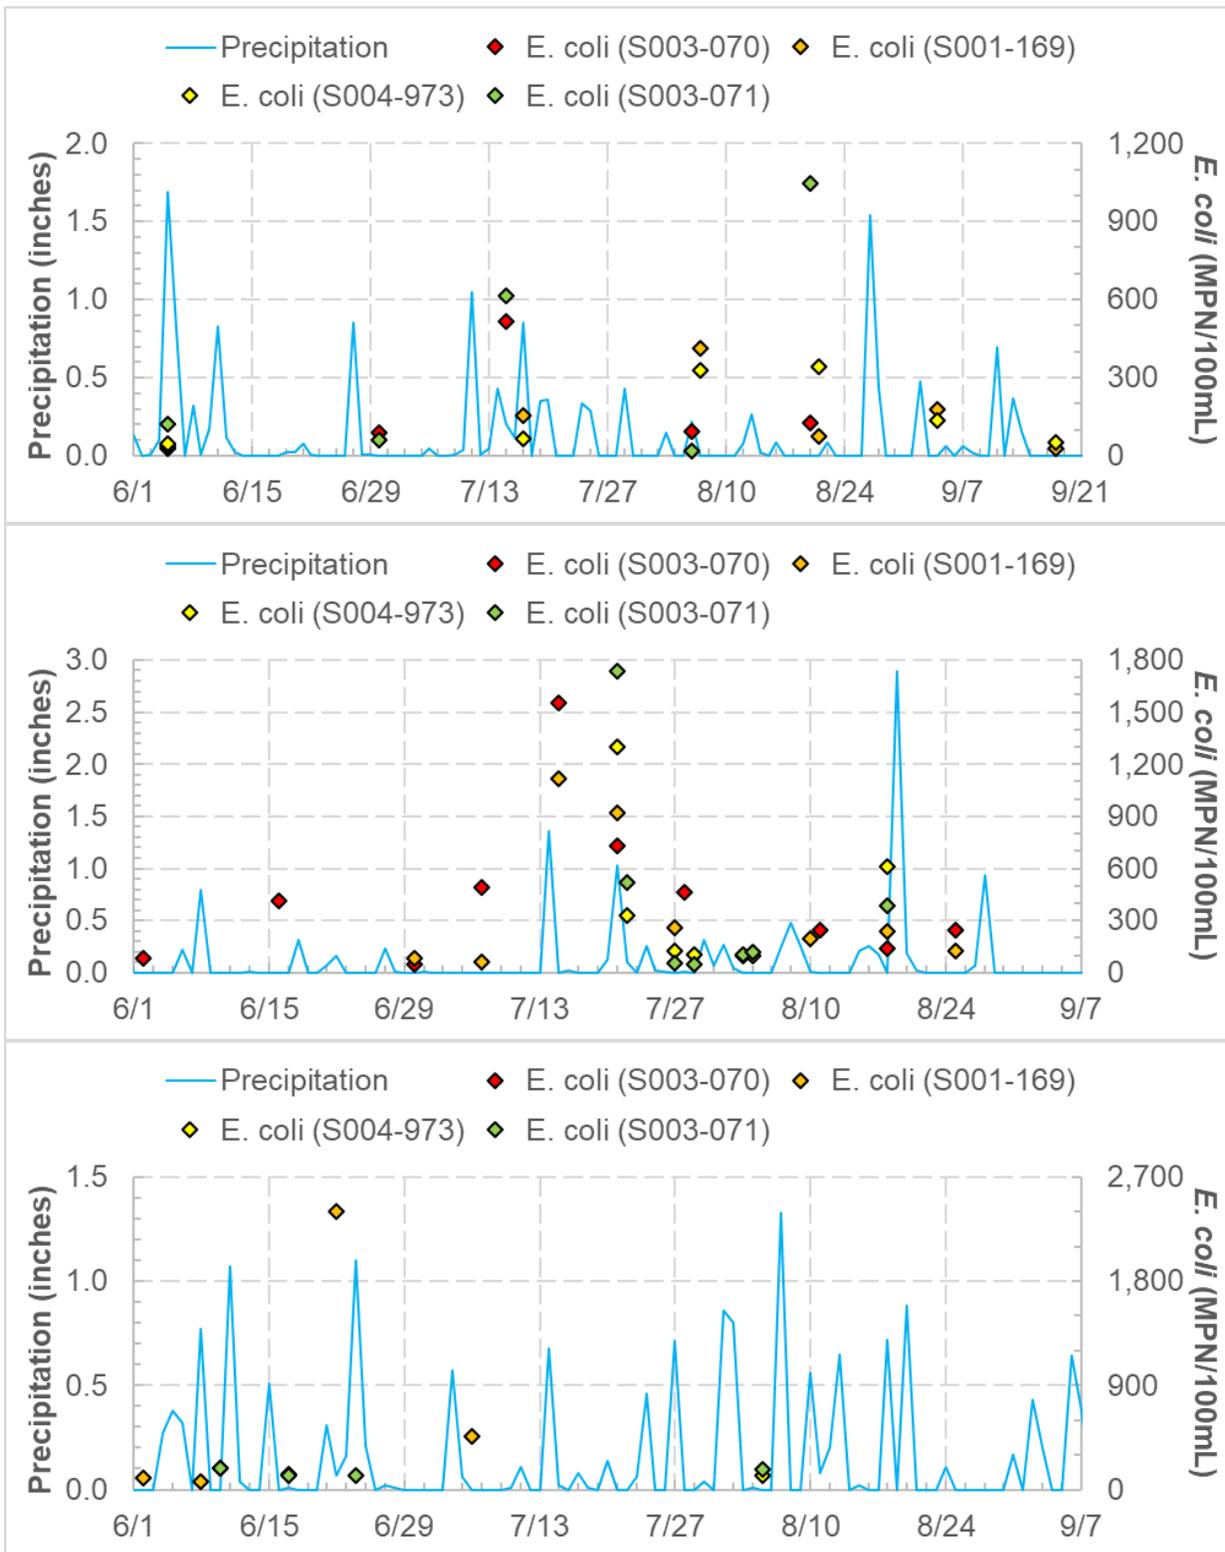
Figure 60. Precipitation at the Duluth International Airport and *E. coli* levels at monitoring sites S003-370, S001-169, S004-973, and S003-071 on Miller Creek in 2008 (top), 2009 (middle), and 2010 (bottom).

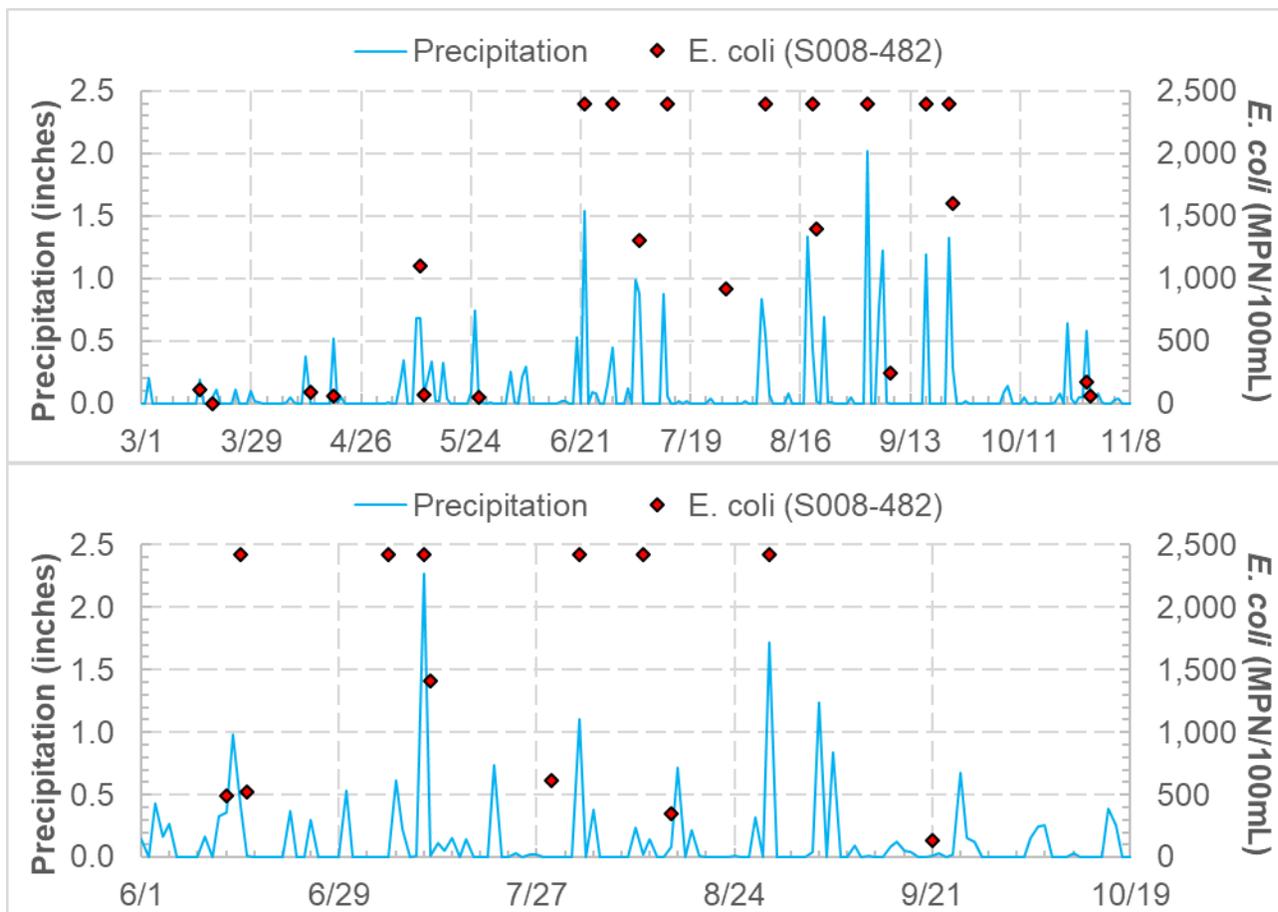
Figure 63. Precipitation at the Duluth International Airport and *E. coli* levels at monitoring site S008-482 on Keene Creek in 2015 (top) and 2016 (bottom).

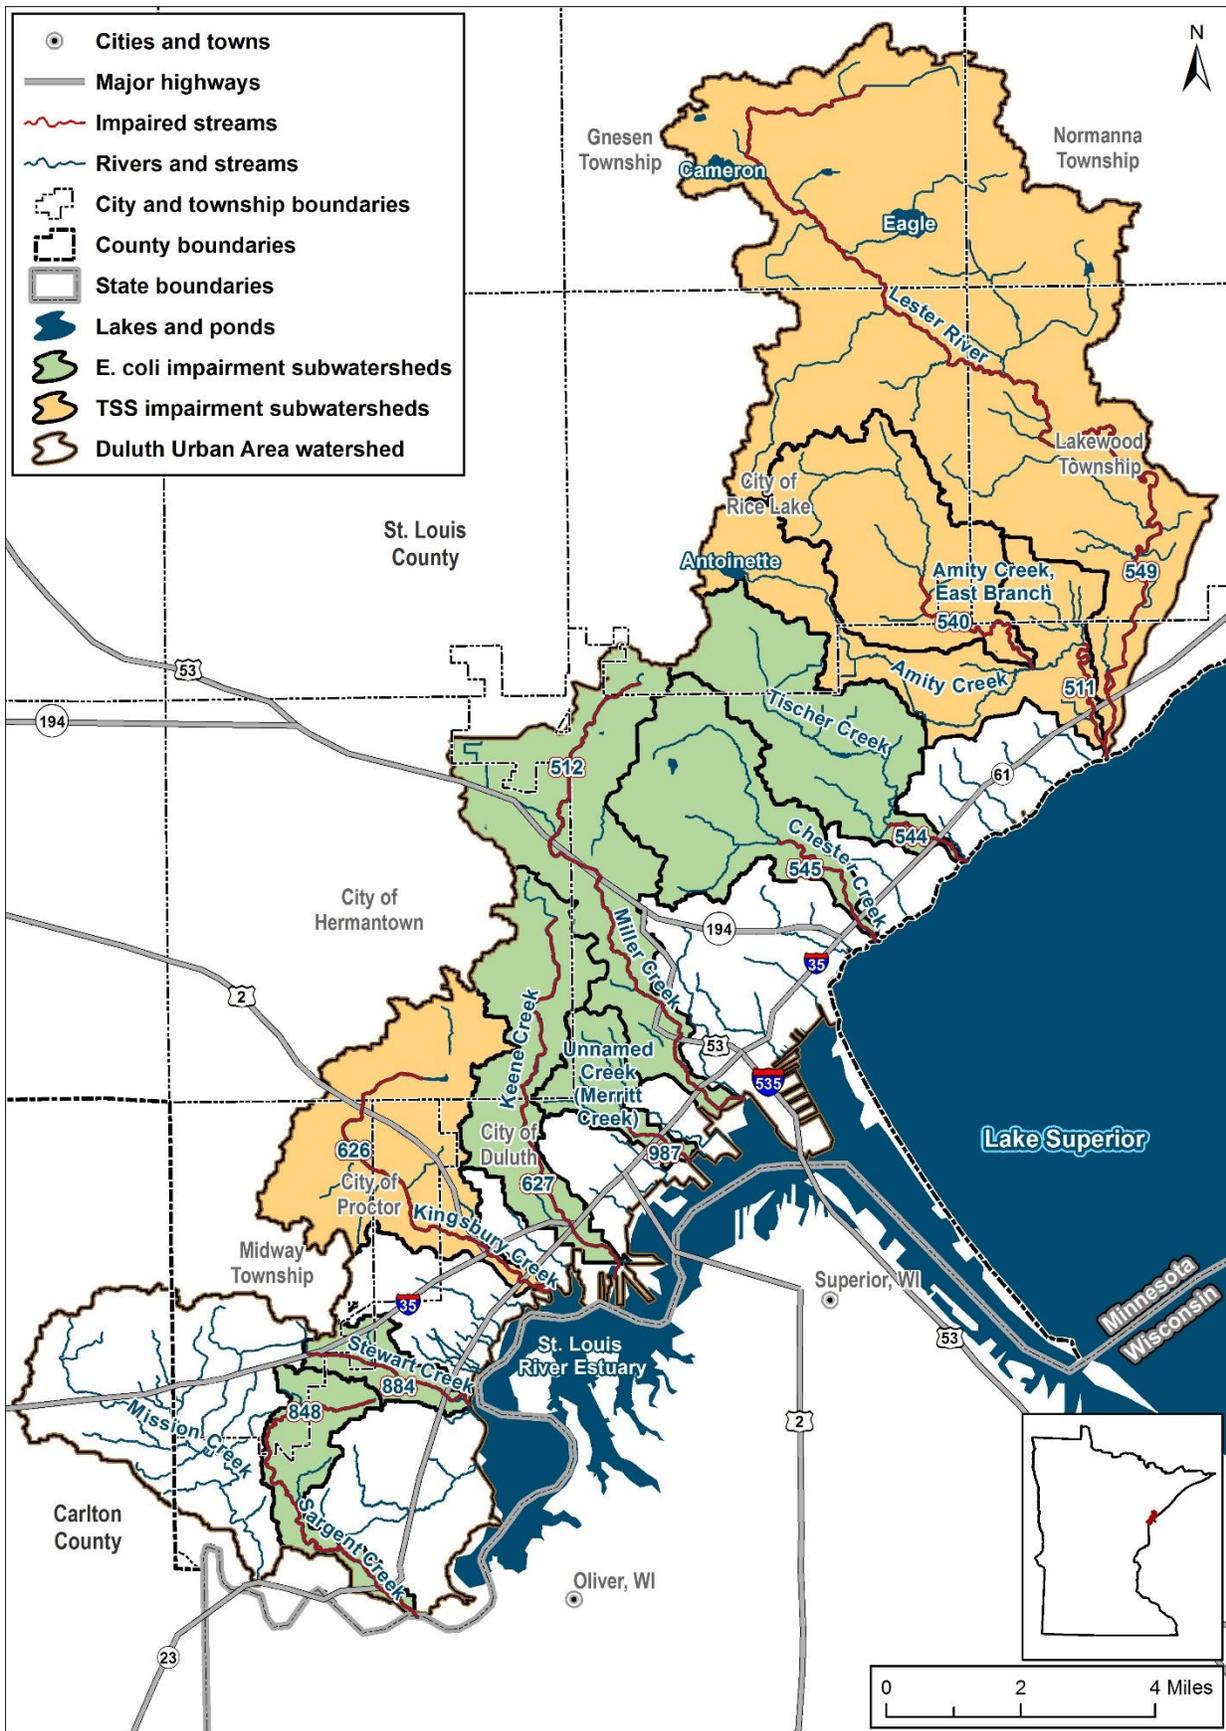
Figure 64. Impaired segments receiving TMDLs.

Table 3 and Figure 64 summarize the TMDLs developed as part of this study.

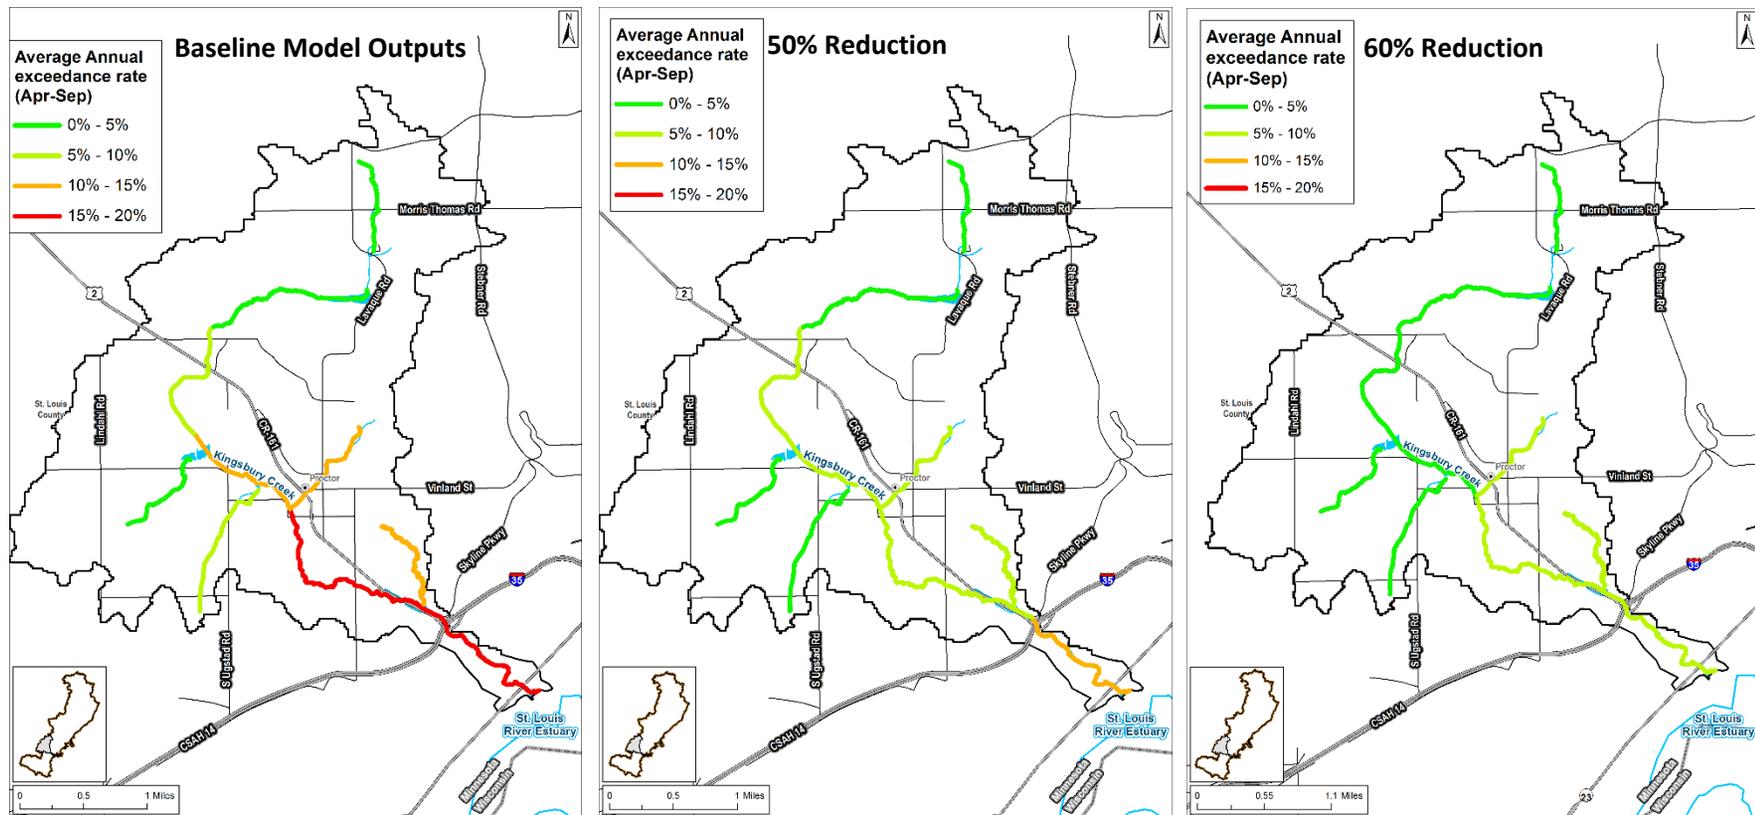
Figure 65. Kingsbury Creek - Percent of time TSS water quality standard is exceeded (April – September, 1995-2016).

Percent load reductions for each sediment-impaired water are derived from these modeling scenarios, and are based on achieving the water quality standard that allows exceedance of the concentration target (10 mg/L TSS) no more than 10% of the time between April 1 and September 30. The final TMDL scenarios include a 60% reduction for all developed land covers and near-channel sources in the four sediment-impaired watersheds, with a 90% reduction in the most downstream reach of Lester River. The far right image in Figure 65 (60% reduction scenario) illustrates the final TMDL scenario for Kingsbury Creek; Figure 67 illustrates the TMDL scenario for Amity Creek, East Branch Amity Creek and the Lester River. One tributary to Amity Creek shows exceedances of the water quality standard for more than 10% of the time; however, the impaired segment is downstream of this tributary and shows compliance with the standard. Therefore, no additional reductions are proposed for this tributary. The source attributions for the TMDL scenario are provided in Figure 68.

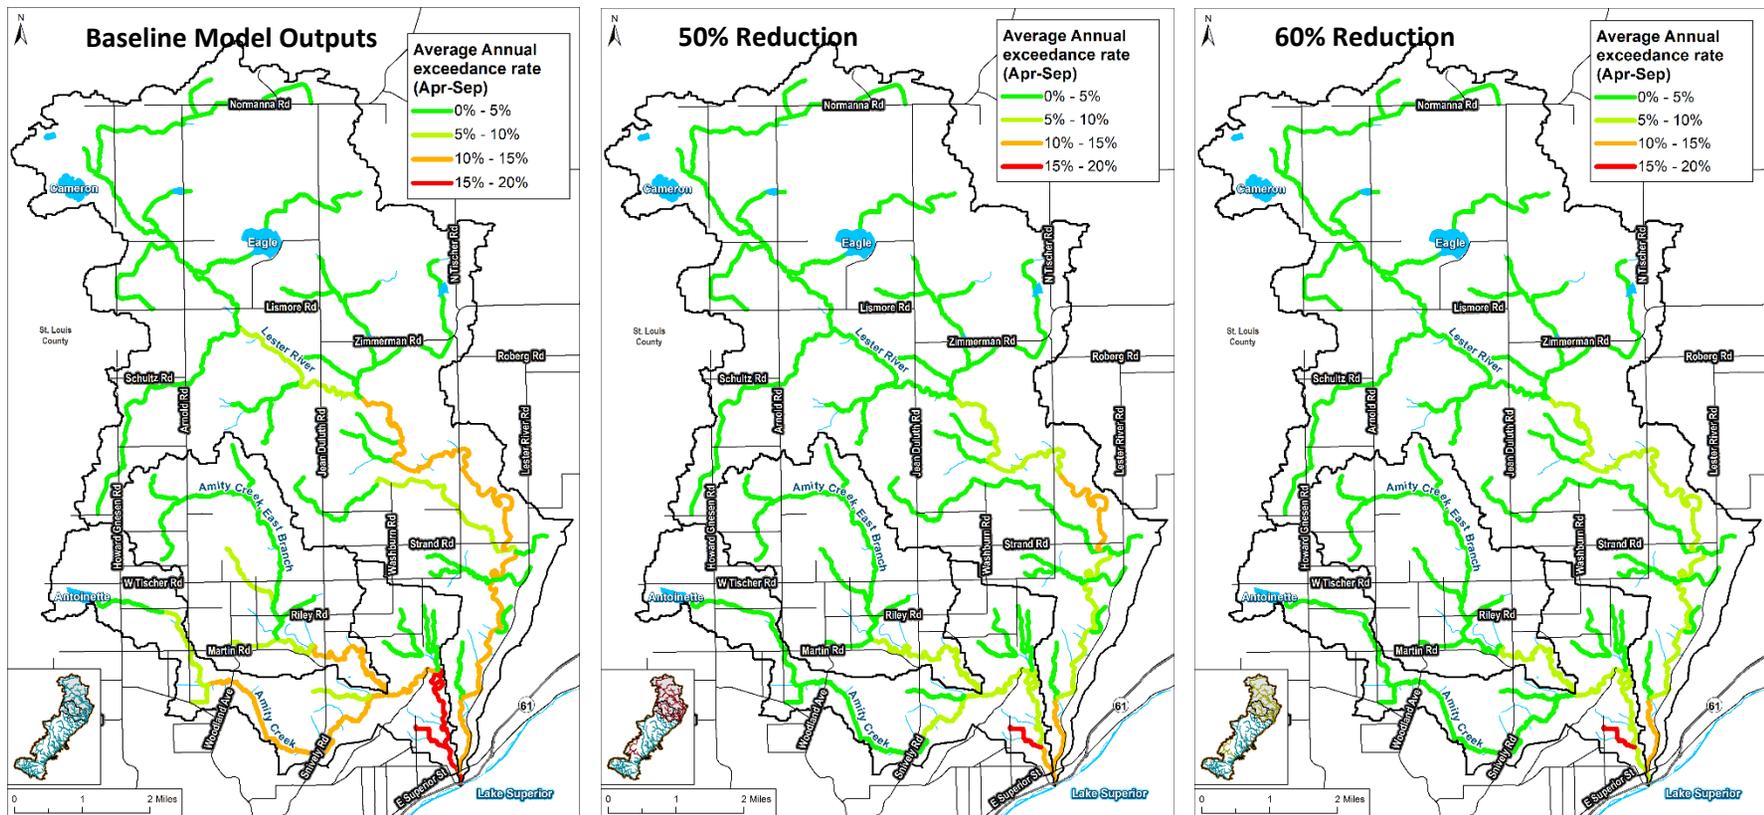
Figure 66. Amity Creek and Lester Creek - Percent of time TSS water quality standard is exceeded (April – September, 1995-2016).

Green reaches have less than 10% exceedances of the TSS water quality standard based on the model output; orange and red segments have greater than 10% exceedances of the TSS water quality standard based on the model output. The goal is to achieve less than 10% exceedances in the impaired water.

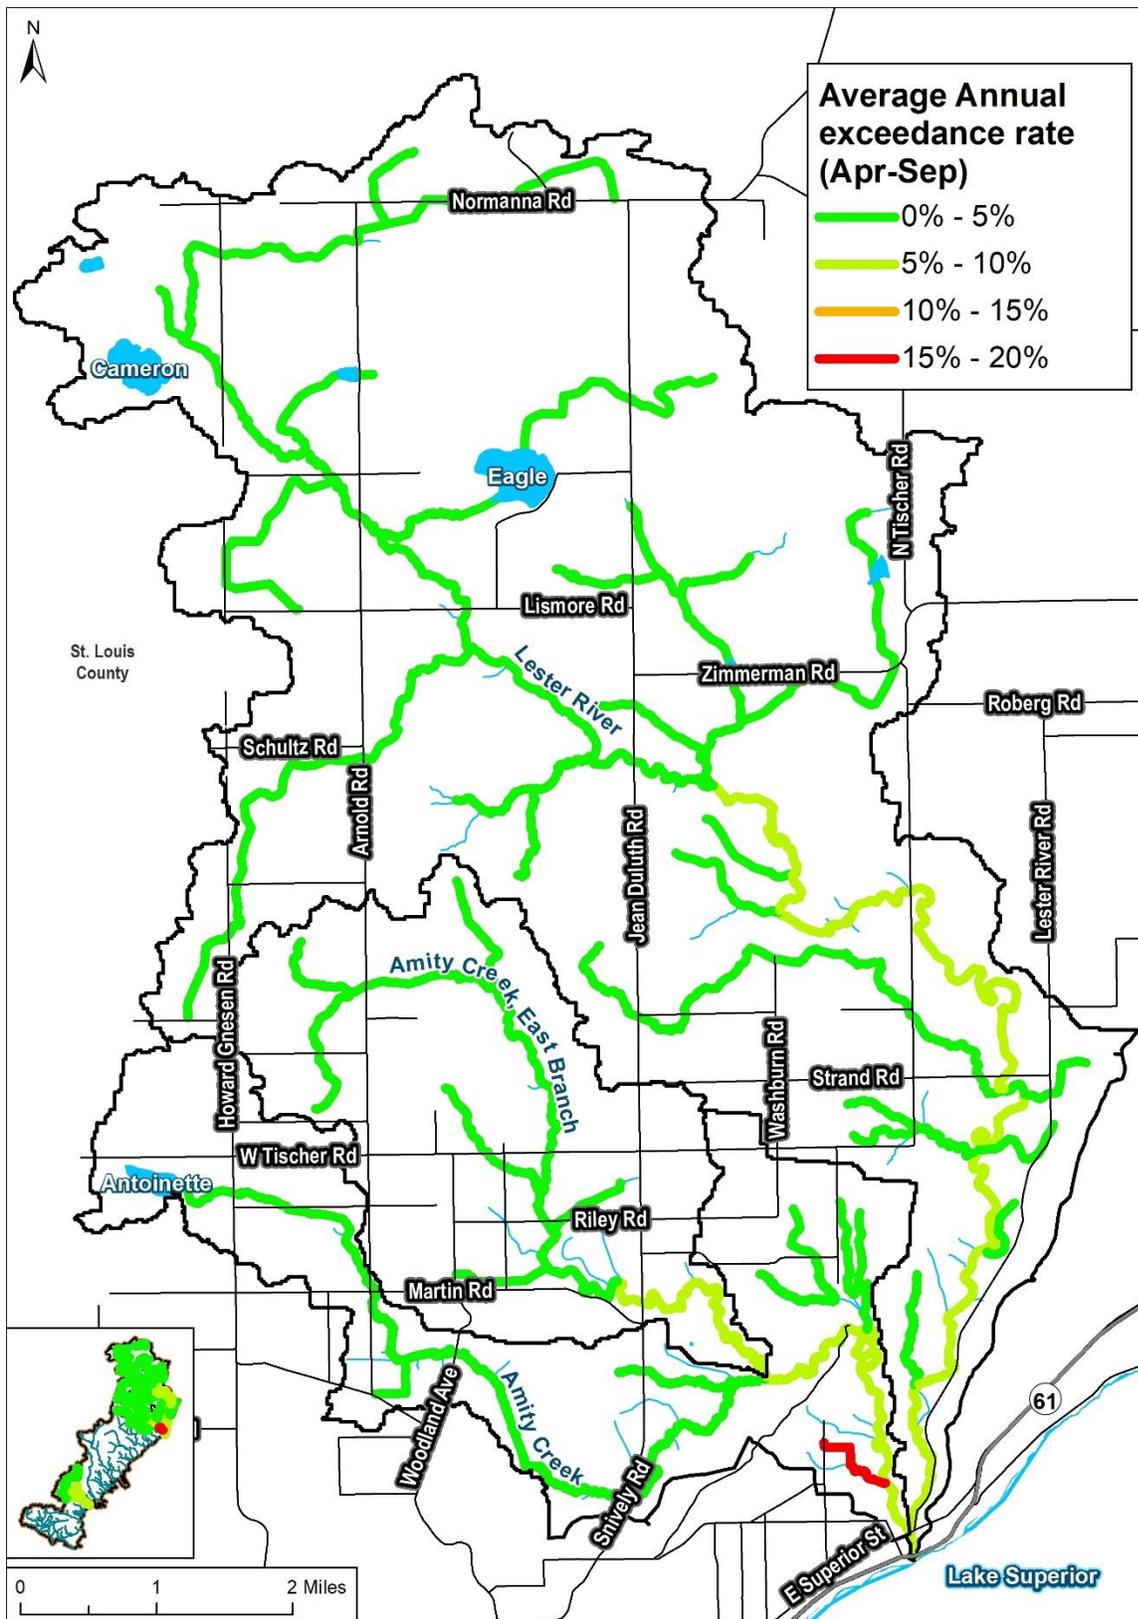
Figure 67. TMDL scenario results for Amity Creek and Lester River watersheds.

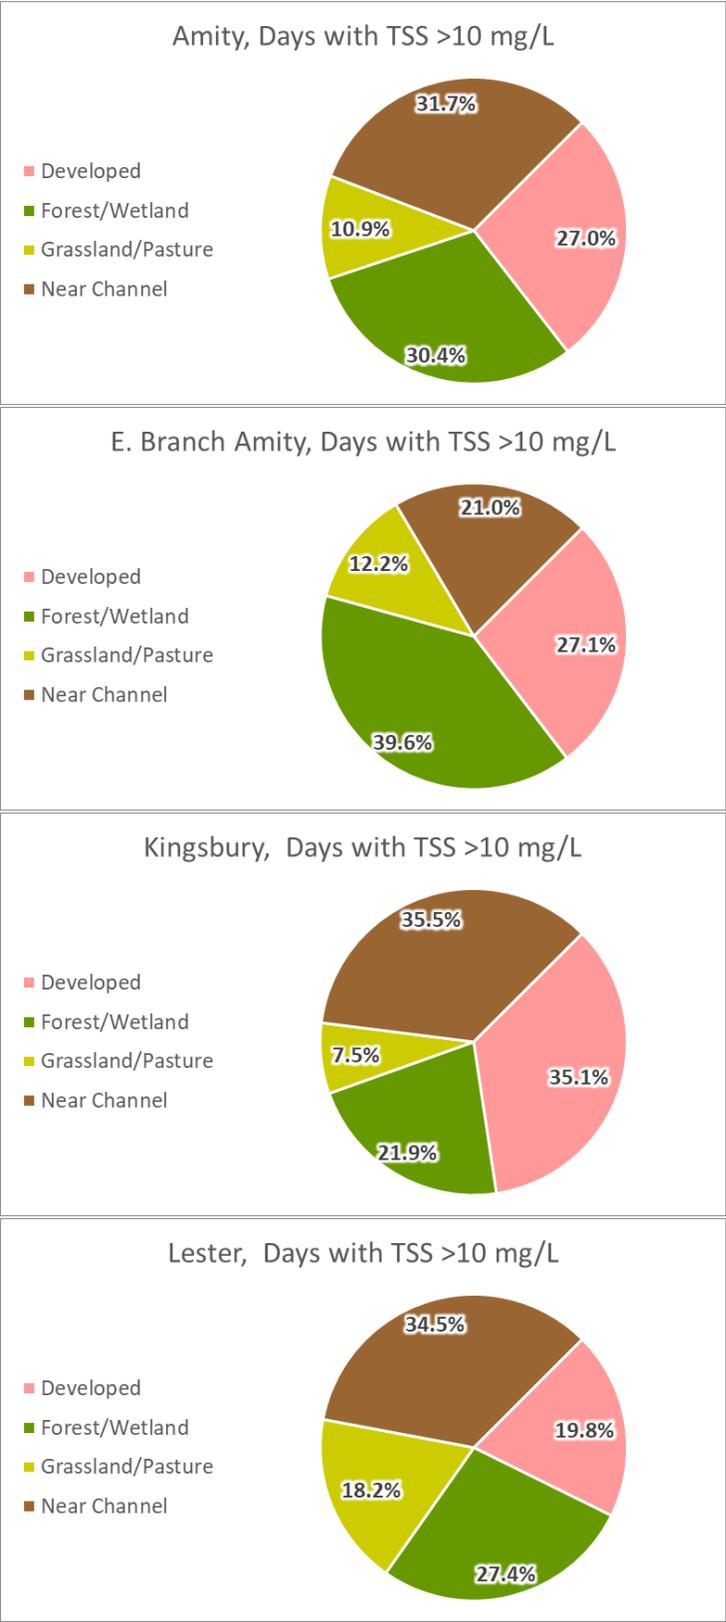
Figure 68. Sources of TSS when modeled under the TMDL scenario.

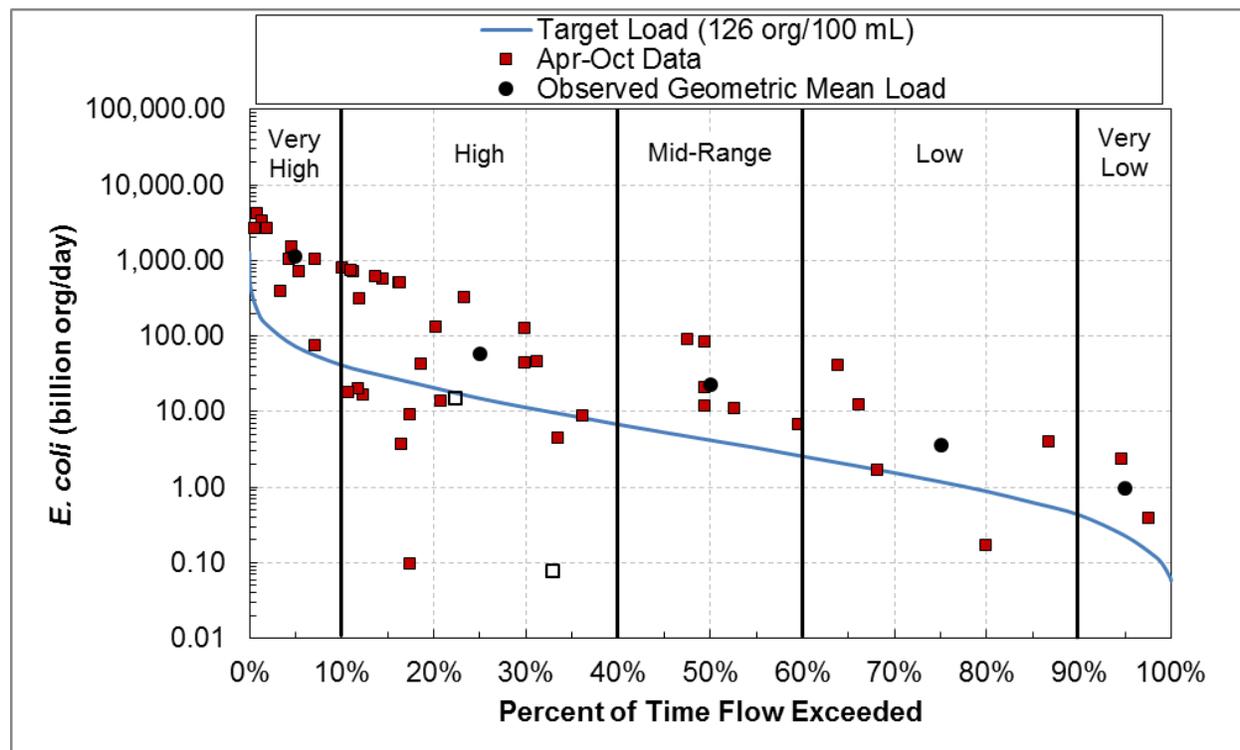
Figure 73. *E. coli* load duration curve, Keene Creek (04010201-627).

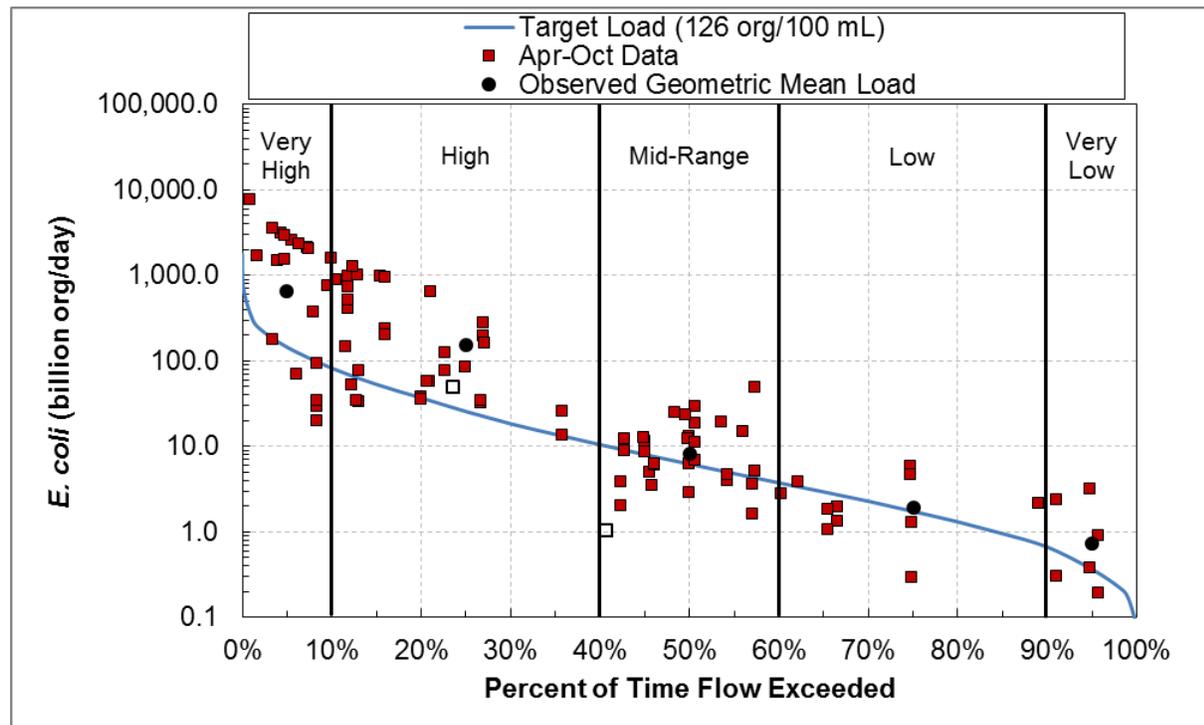
Figure 74. *E. coli* load duration curve, Miller Creek (04010201-512).

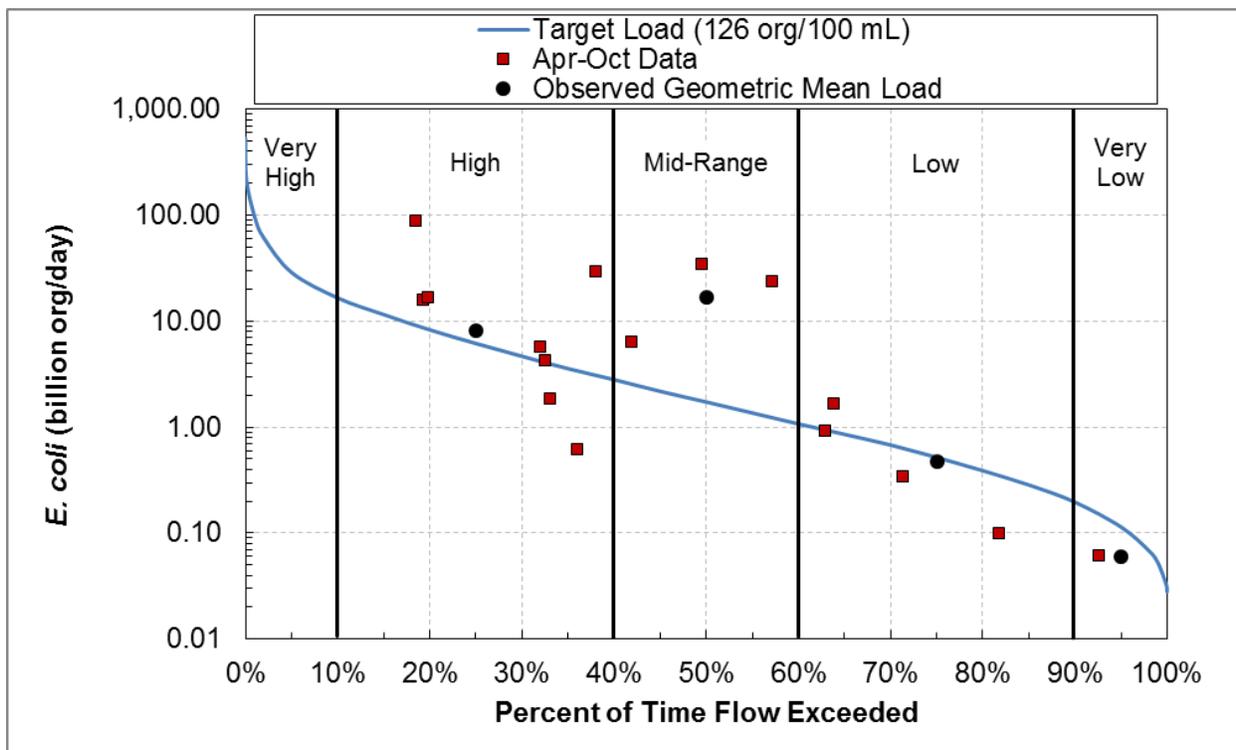
Figure 75. *E. coli* load duration curve, Sargent Creek (04010201-848).

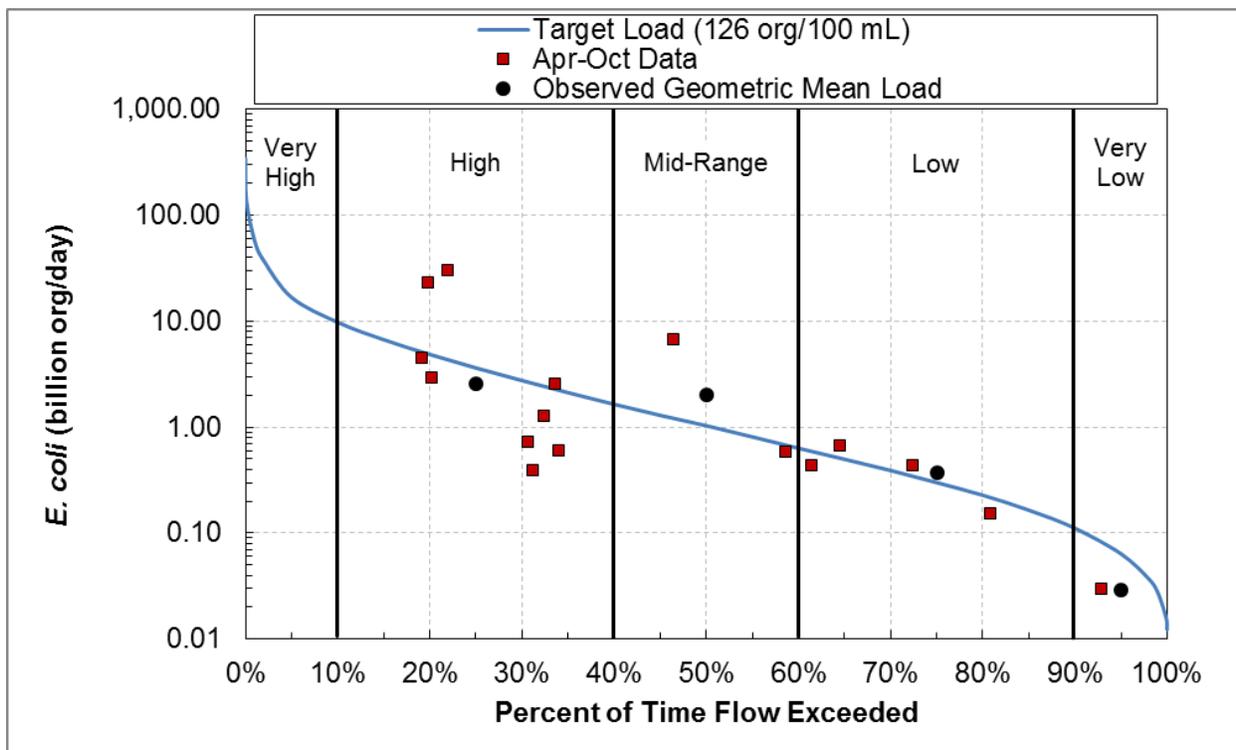
Figure 76. *E. coli* load duration curve, Stewart Creek (04010201-884).

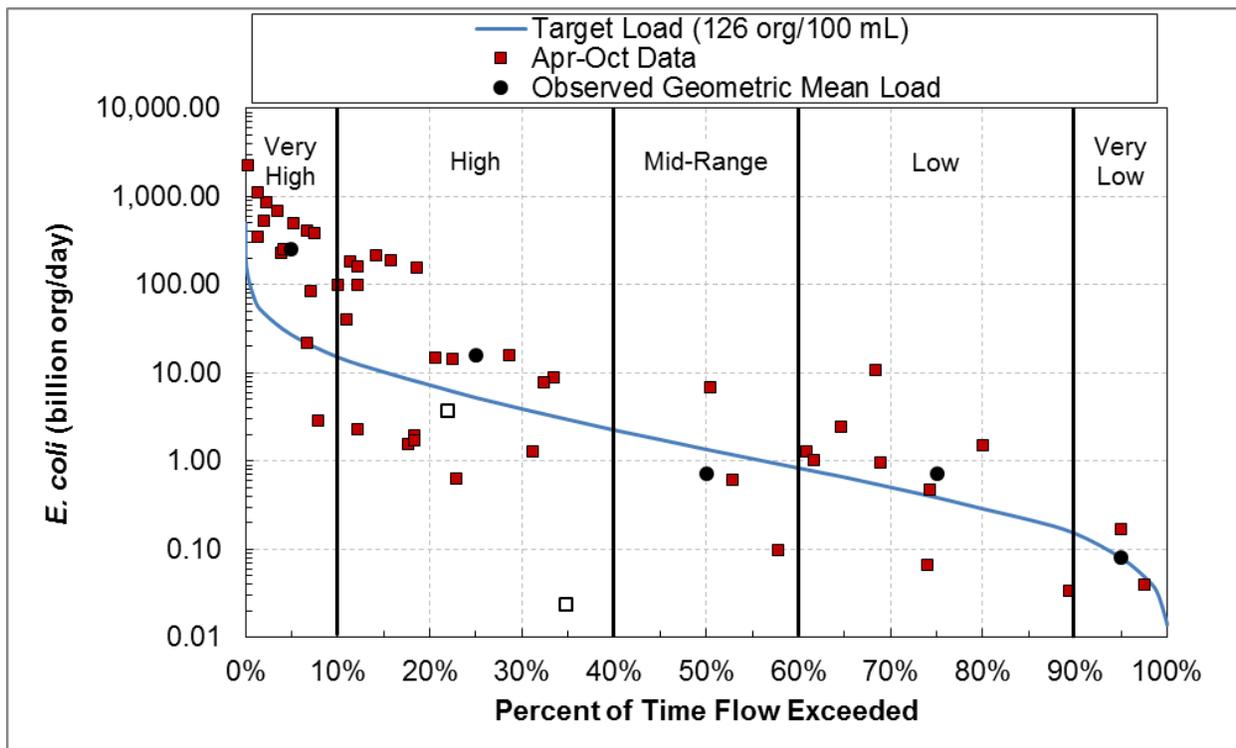
Figure 77. *E. coli* load duration curve, Unnamed Creek (Merritt Creek; 04010201-987).

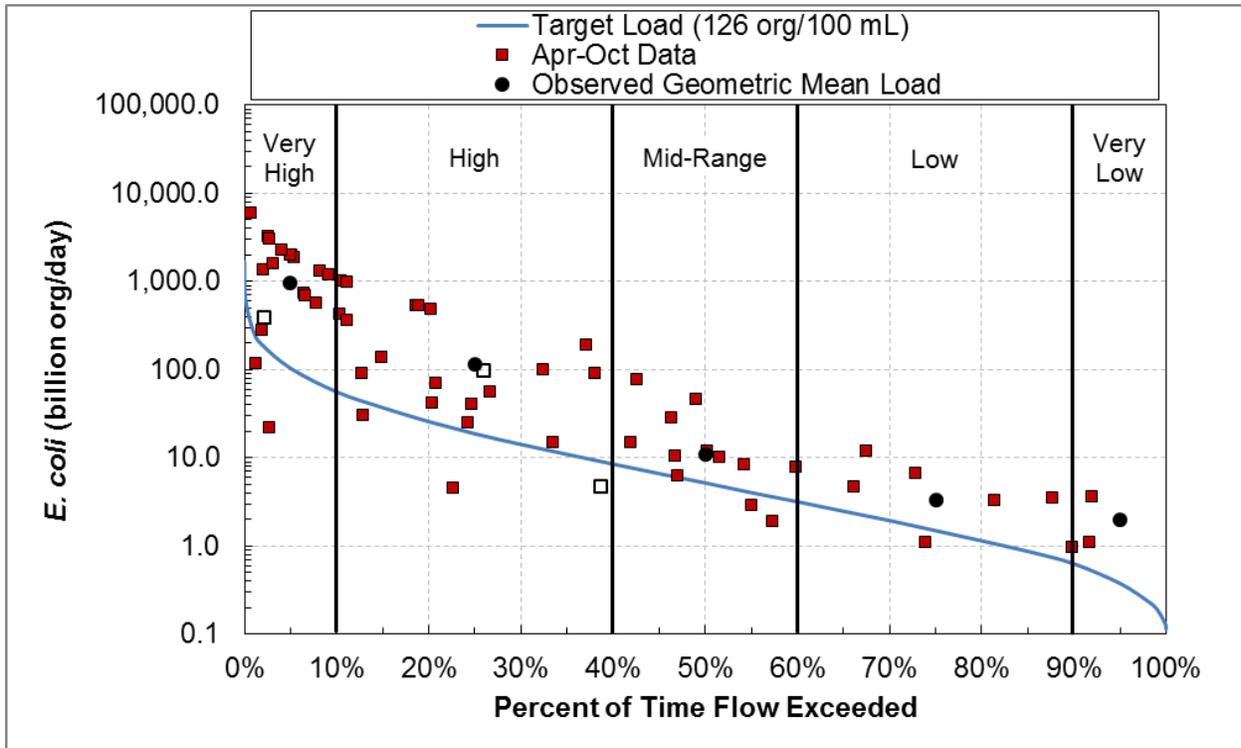
Figure 78. *E. coli* load duration curve, Tischer Creek (04010102-544).

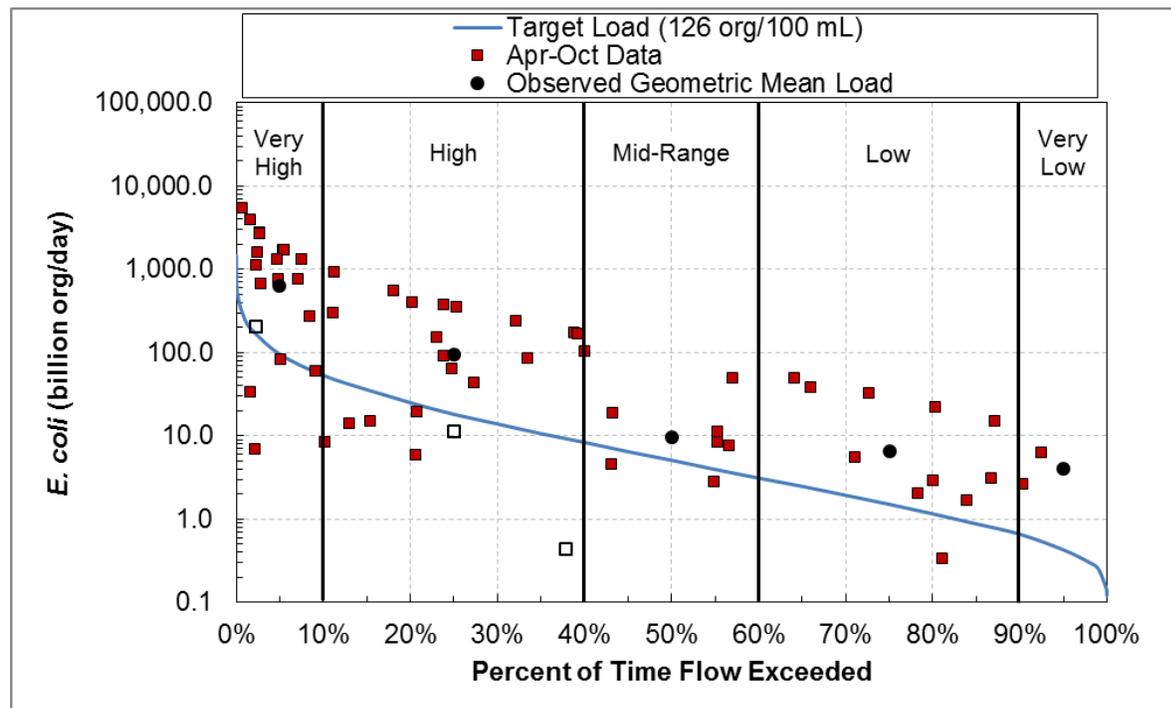
Figure 79. *E. coli* load duration curve, Chester Creek (04010102-545).

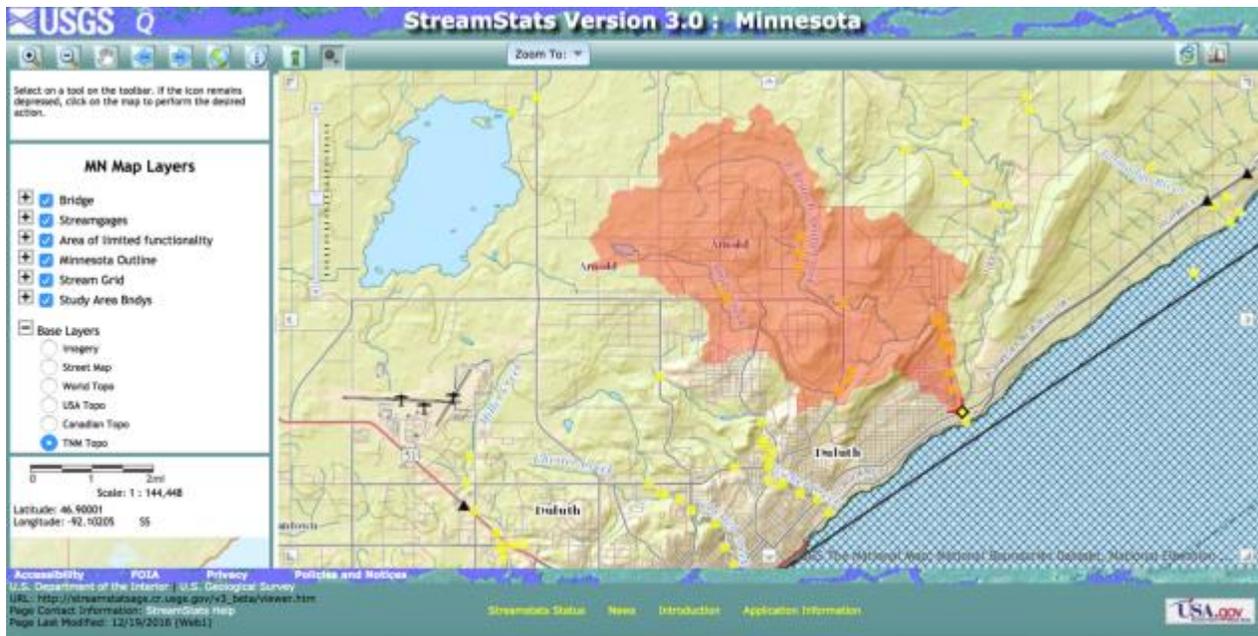
Figure 1. Amity Creek Watershed Delineated by USGS StreamStats ([streamstatsags.cr.usgs.gov](http://streamstatsags.cr.usgs.gov)).

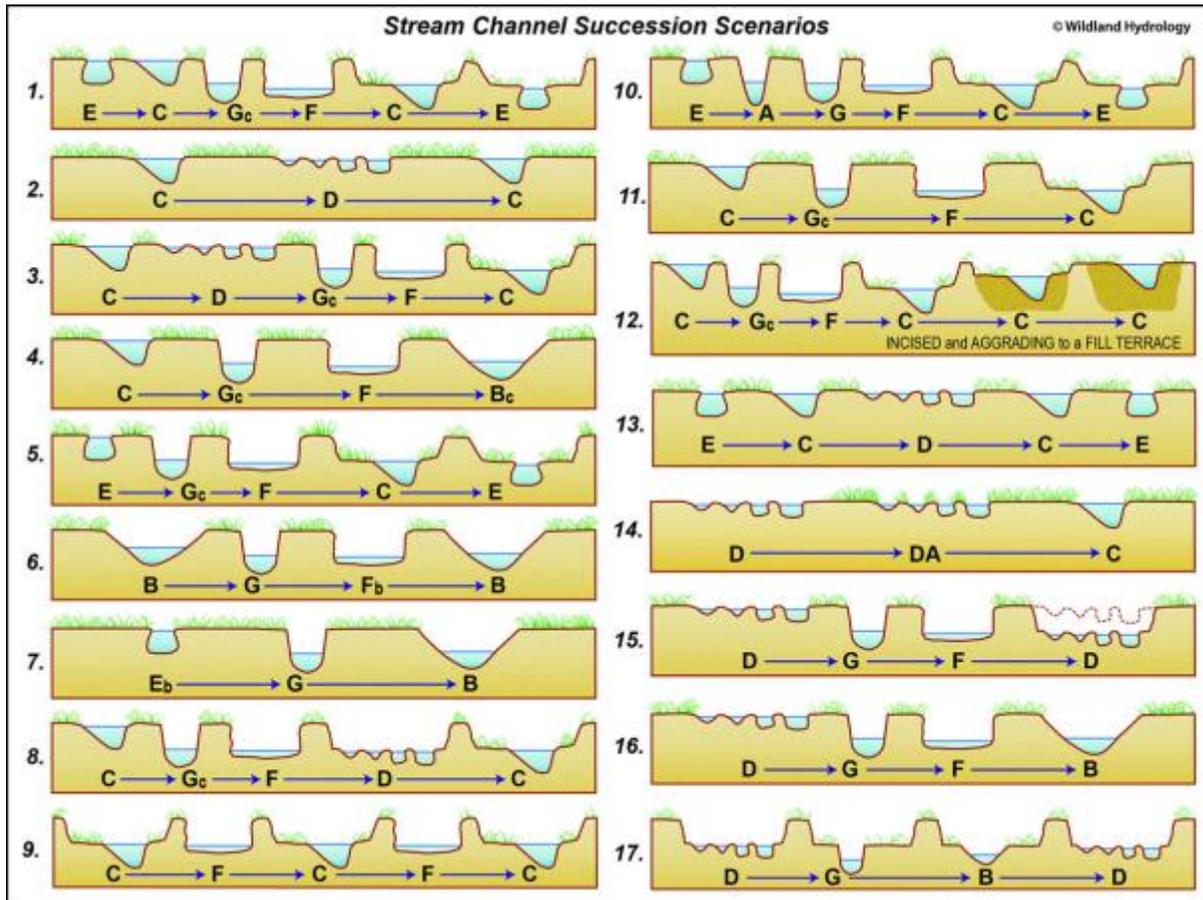
Figure 3. Stream Channel Succession Scenarios for Predicting Channel Evolution (Rosgen, 2006).

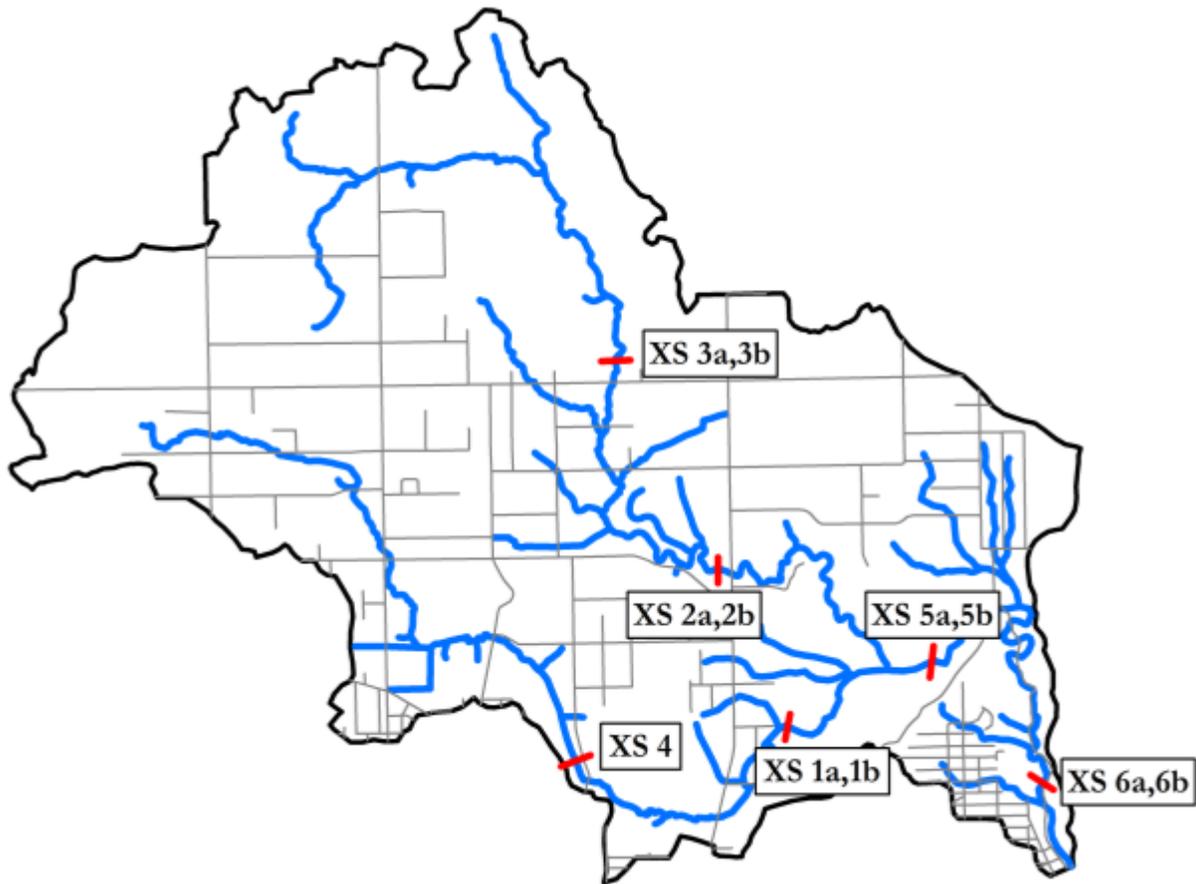
Figure 6. Locations of Cross-section and BANCS Measurement Sites.

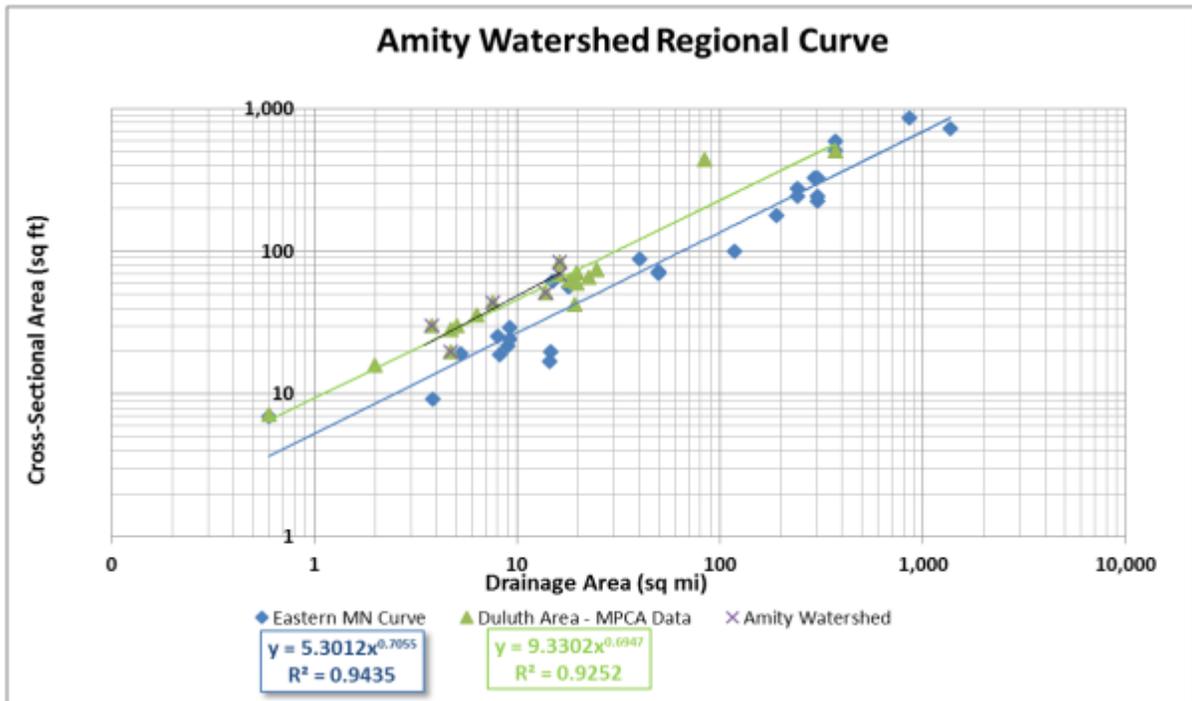
Figure 7. Bankfull Cross-Section Areas from Table 3 Plotted on Regional Curve Relationships for Eastern Minnesota and Duluth Area.

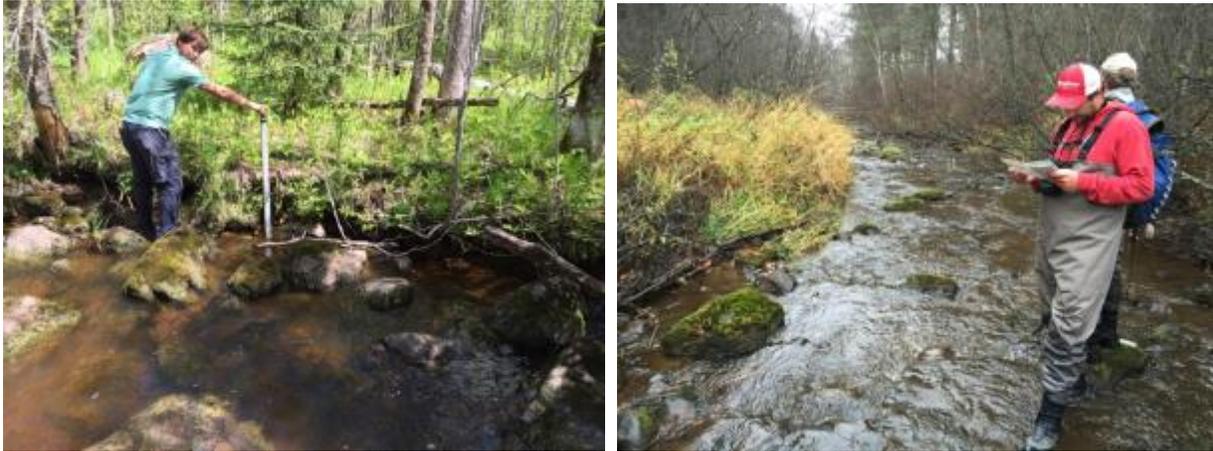
Figure 8. Category 1 Erosion Rates Observed in Reaches AM-14 and EB-3 (less than 0.1 ft/yr).

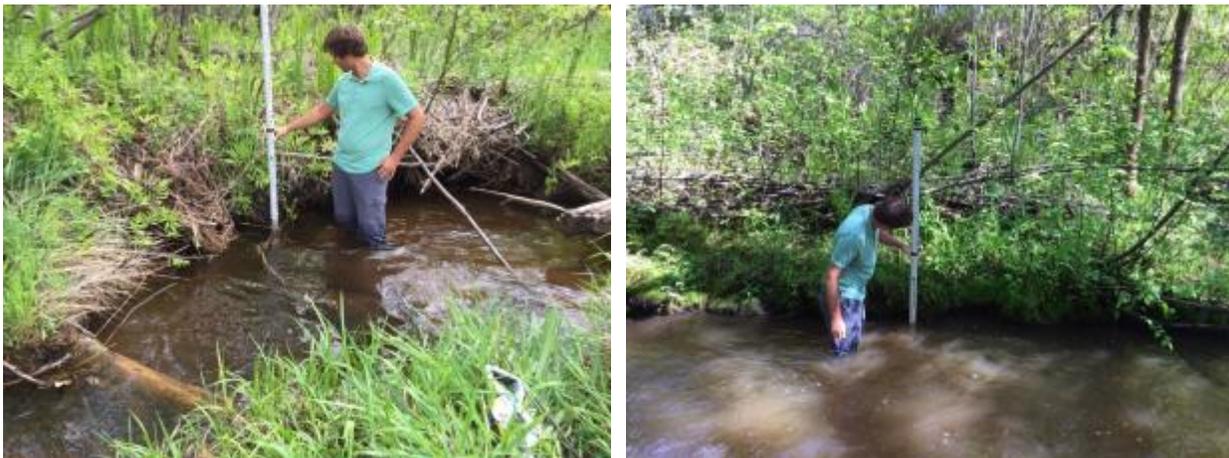
Figure 9. Category 2 Erosion Rates Observed in Reaches EB-5 and AM-10 (0.1 to 0.4 ft/yr).
