# Duluth Urban Area Streams Total Maximum Daily Load

Restoring and protecting urban streams in Duluth and surrounding areas.

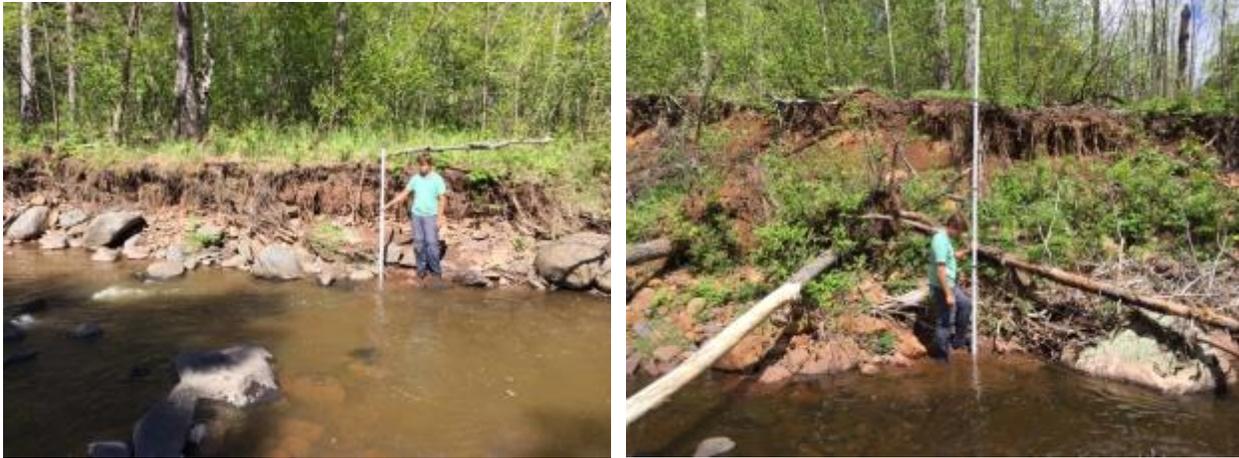
Figure 10. Category 3 Erosion Rates Observed in Reaches AM-2 and EB-2 (0.3 to 0.5 ft/yr).

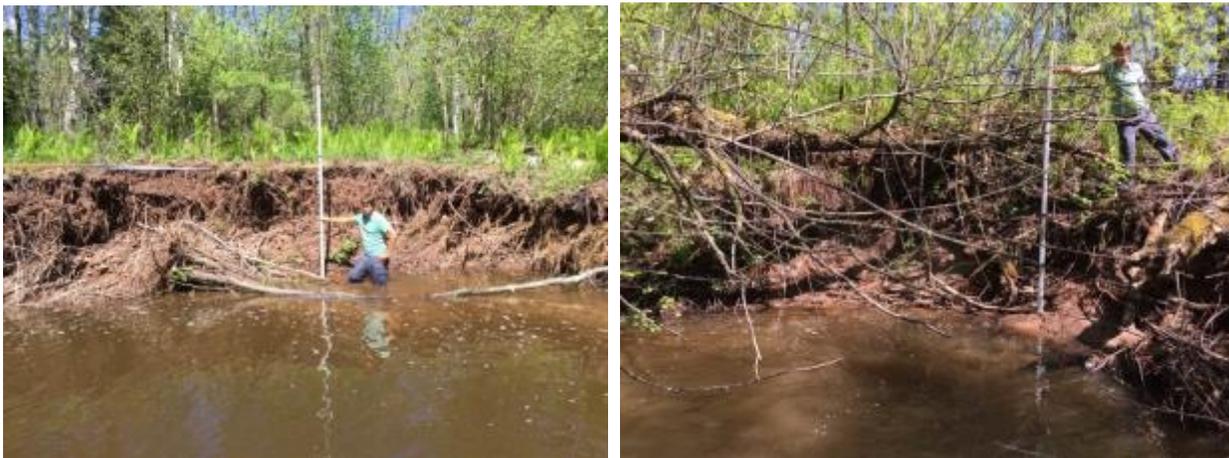
Figure 11. Category 4 Erosion Rates Observed in Reaches AM-9 and AM-10 (0.5 to 2.0 ft/yr).

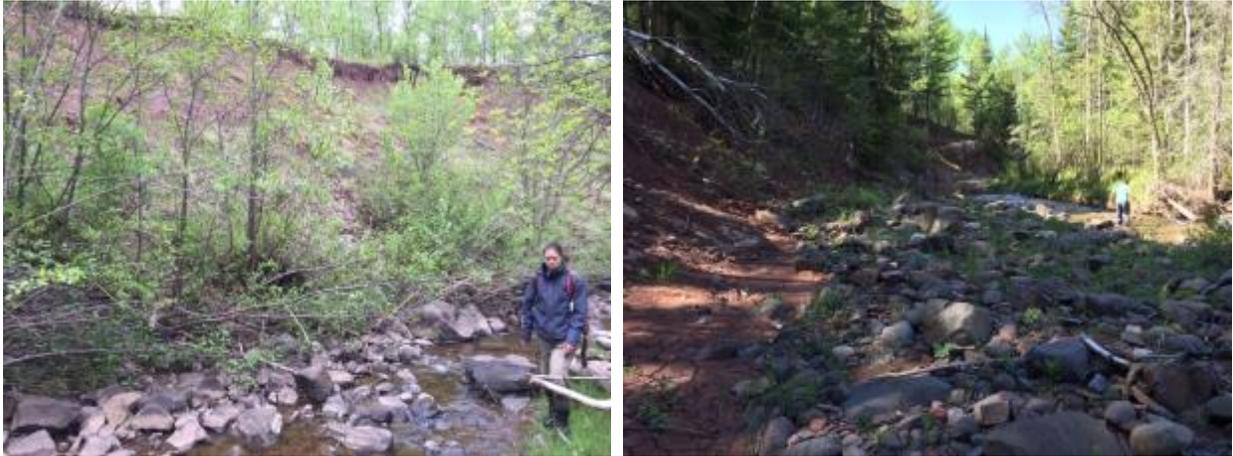
Figure 12. Category 5 Erosion Rates Observed in Reaches AM-3 and AM-2 (less than 0.1 ft/yr streambank erosion and variable hillslope erosion rates).

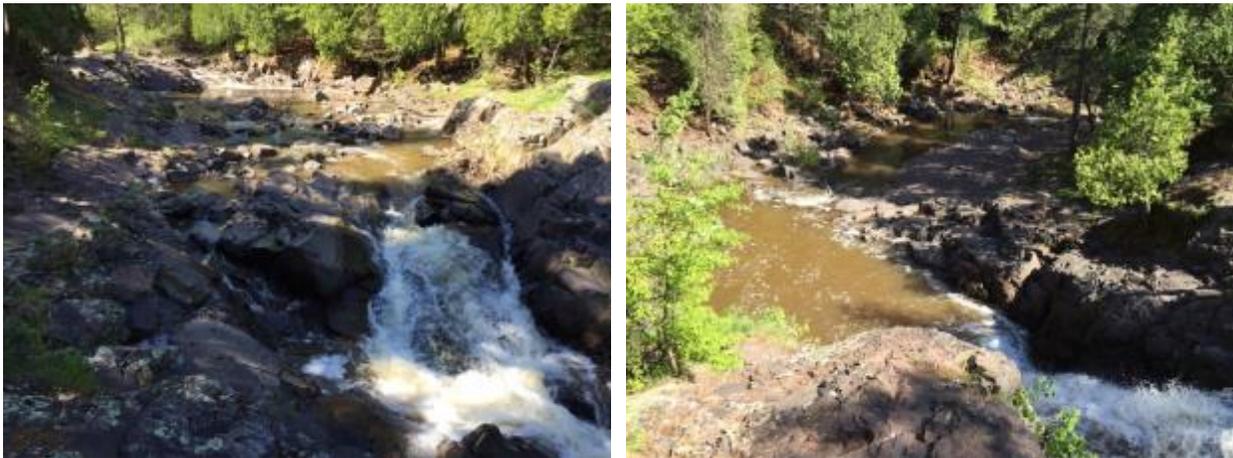
Figure 13. Category 6 Erosion Rates Observed in Reaches AM-1 and AM-8 (less than 0.1 ft/yr streambank erosion and no hillslope erosion).

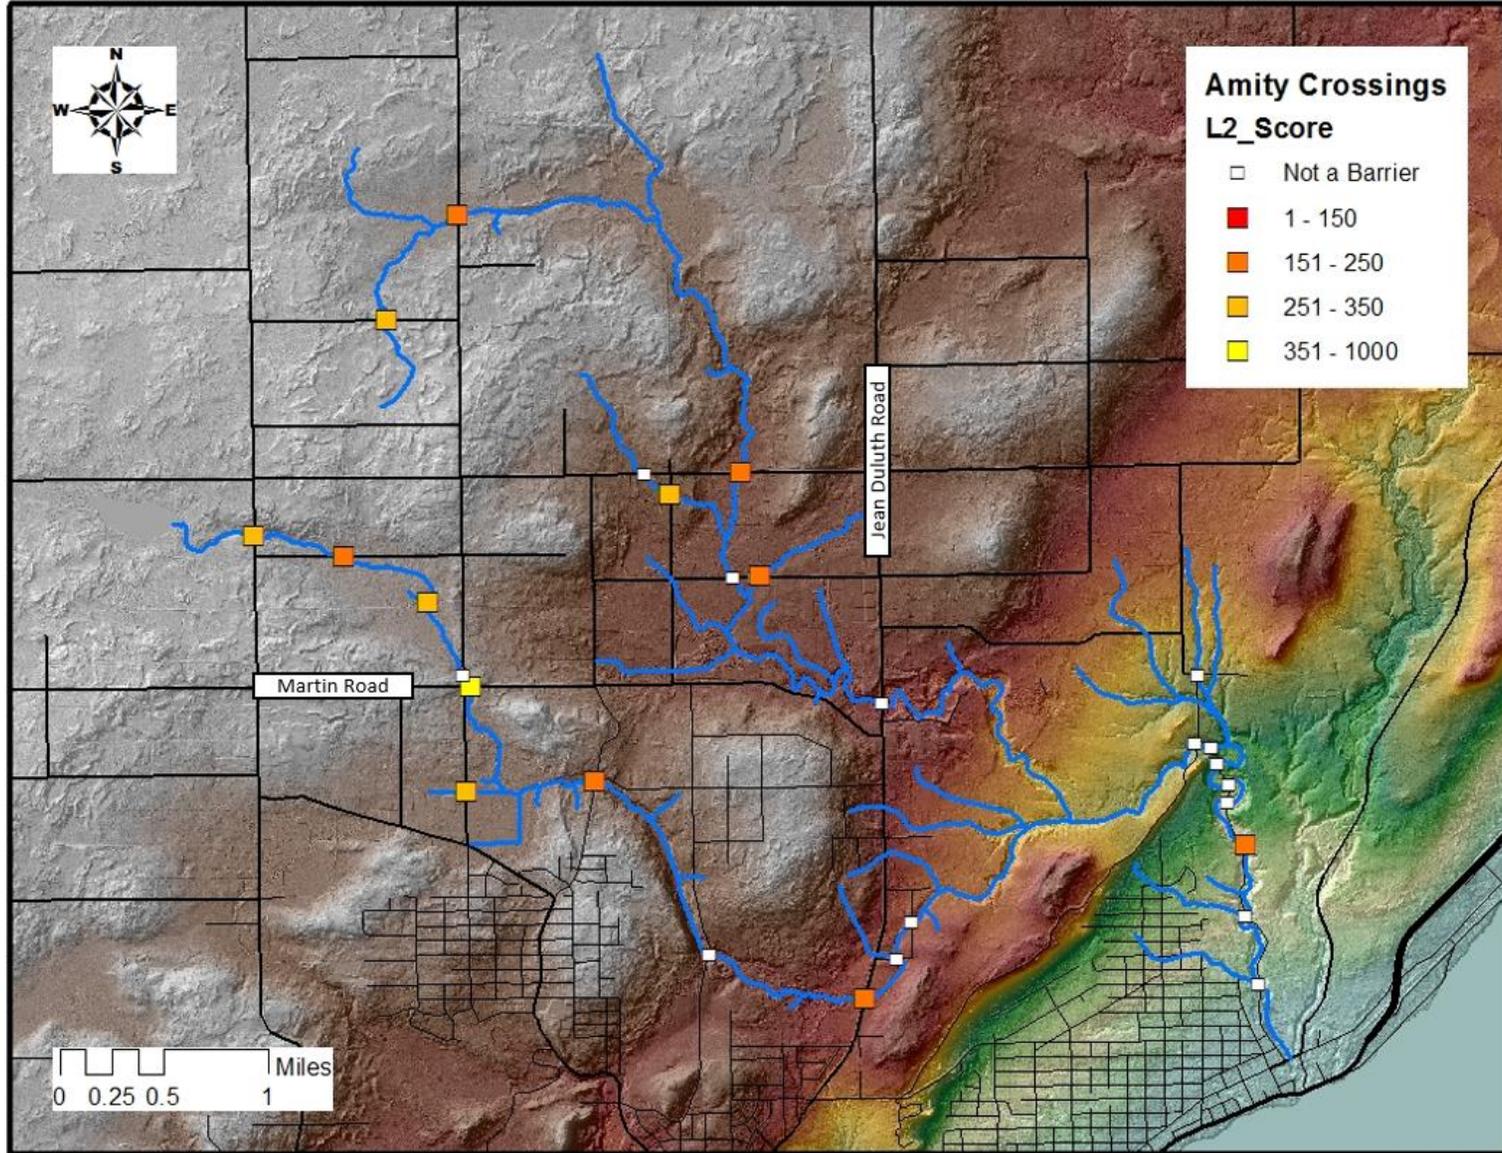
Figure 1. Road crossings within the Amity Creek watershed.

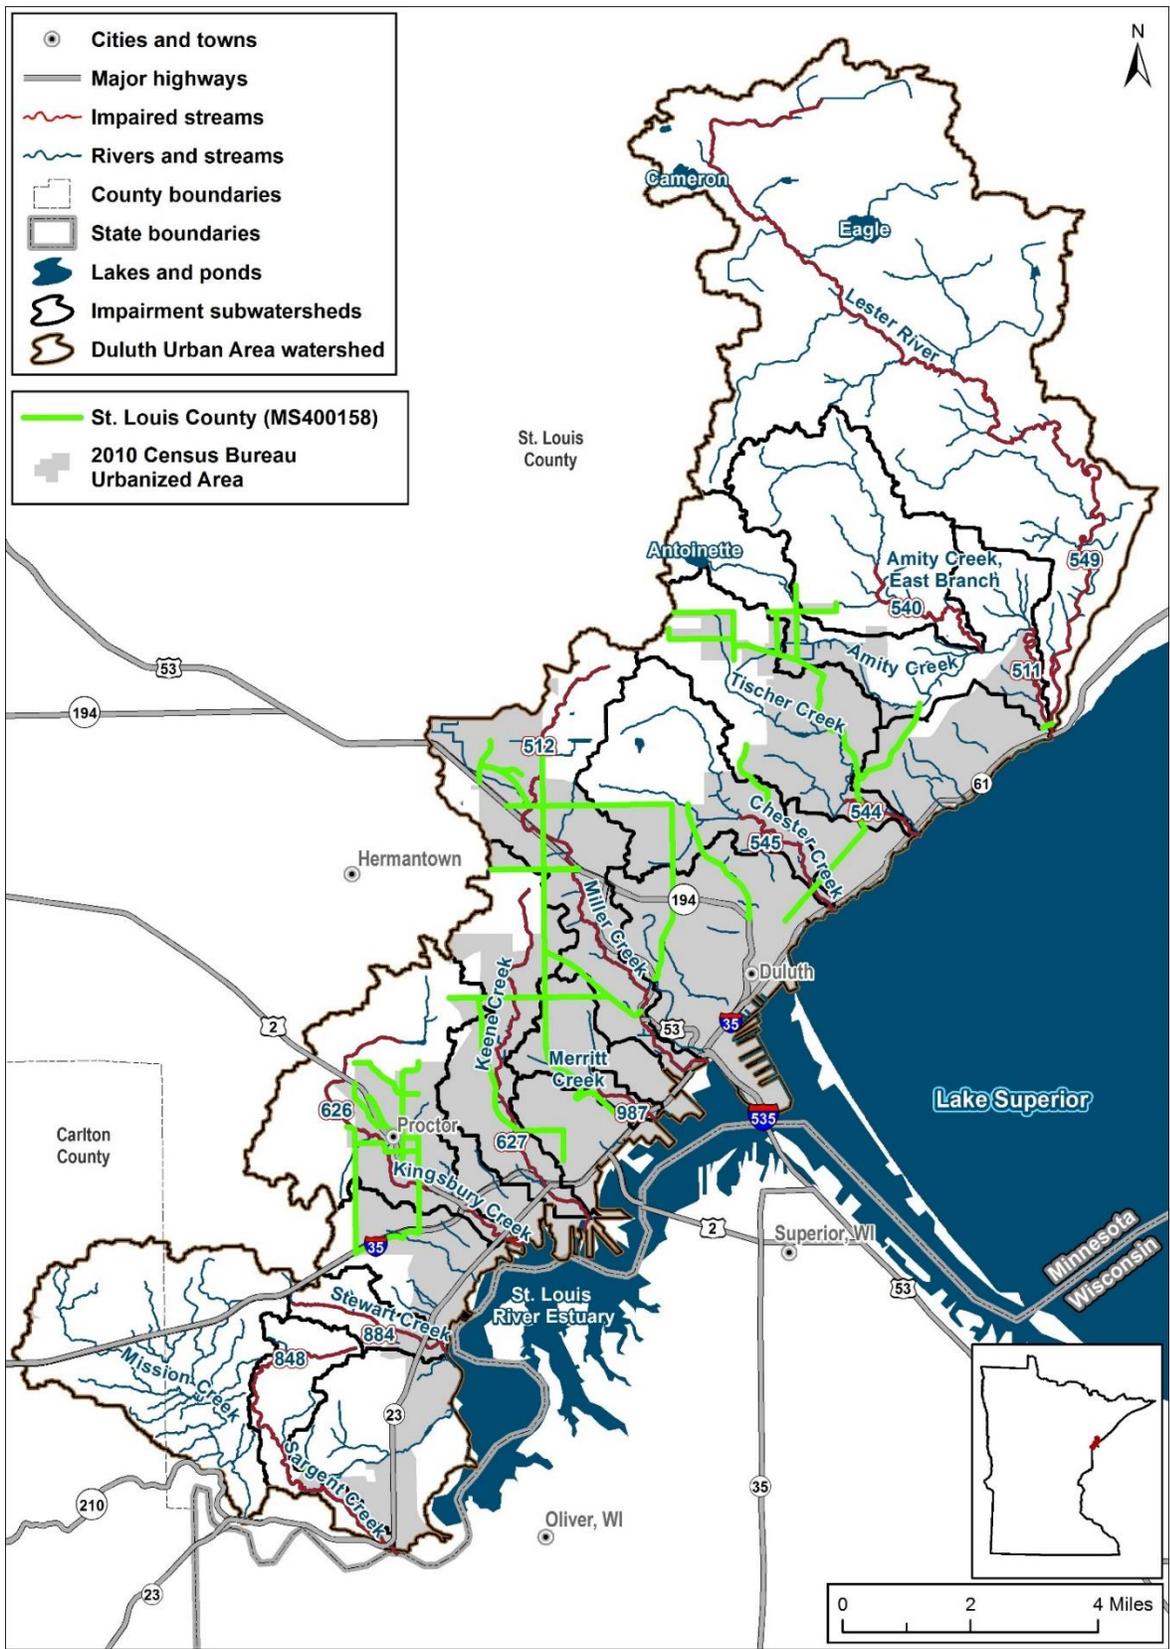
Figure 81. St. Louis County MS4.

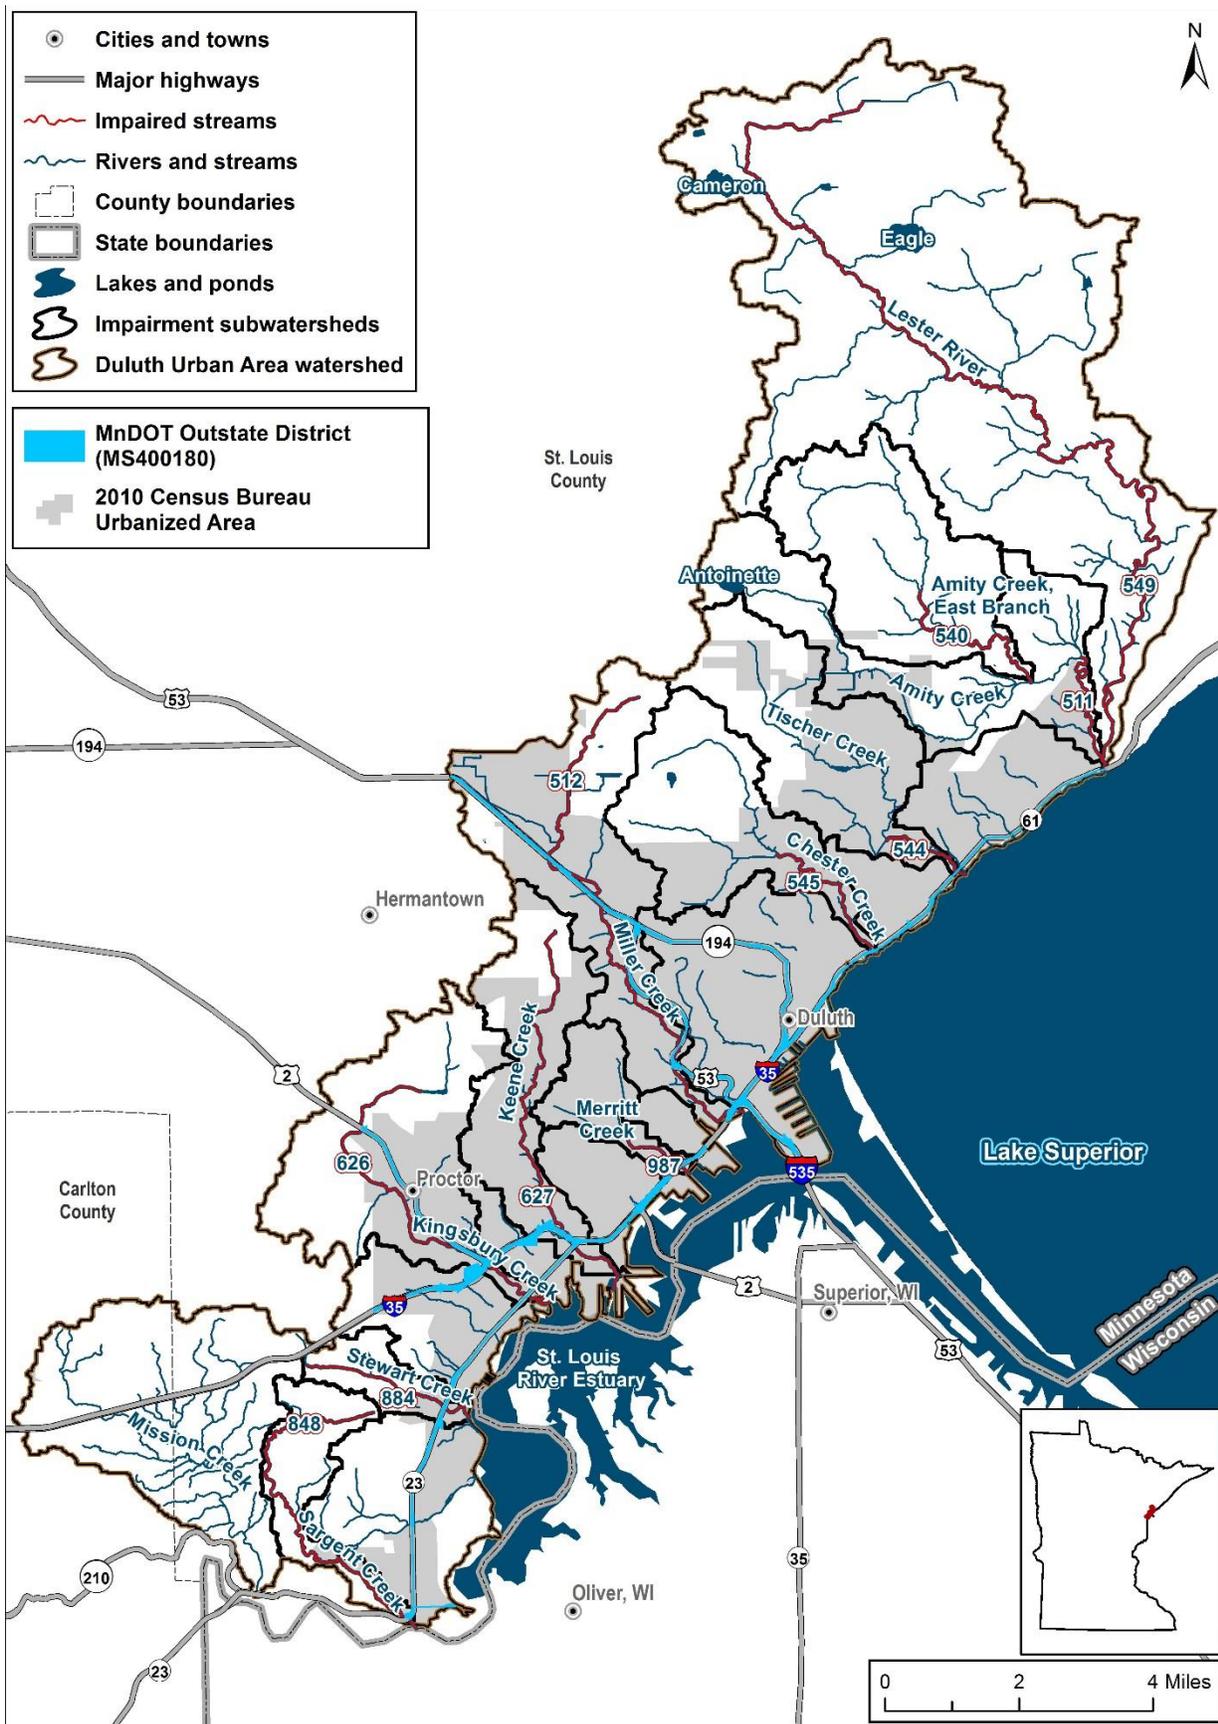
Figure 82. MnDOT Outstate District MS4.

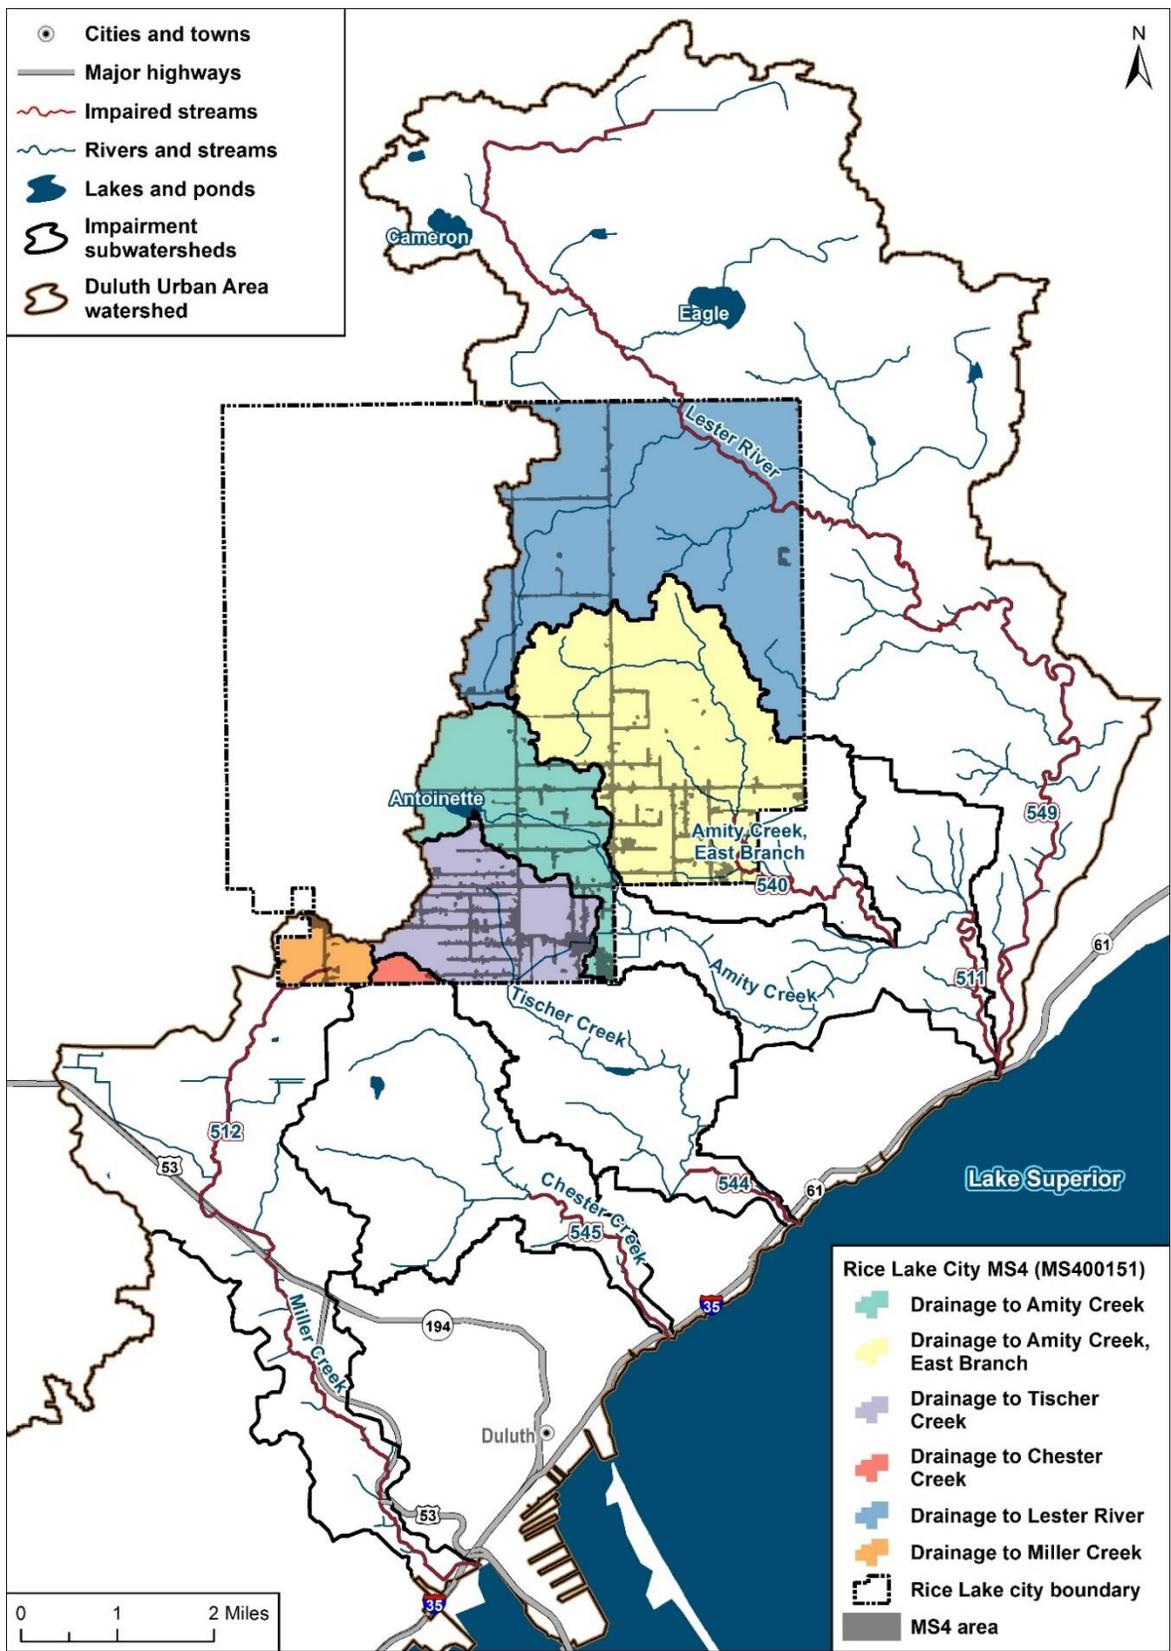
Figure 83. Rice Lake MS4.

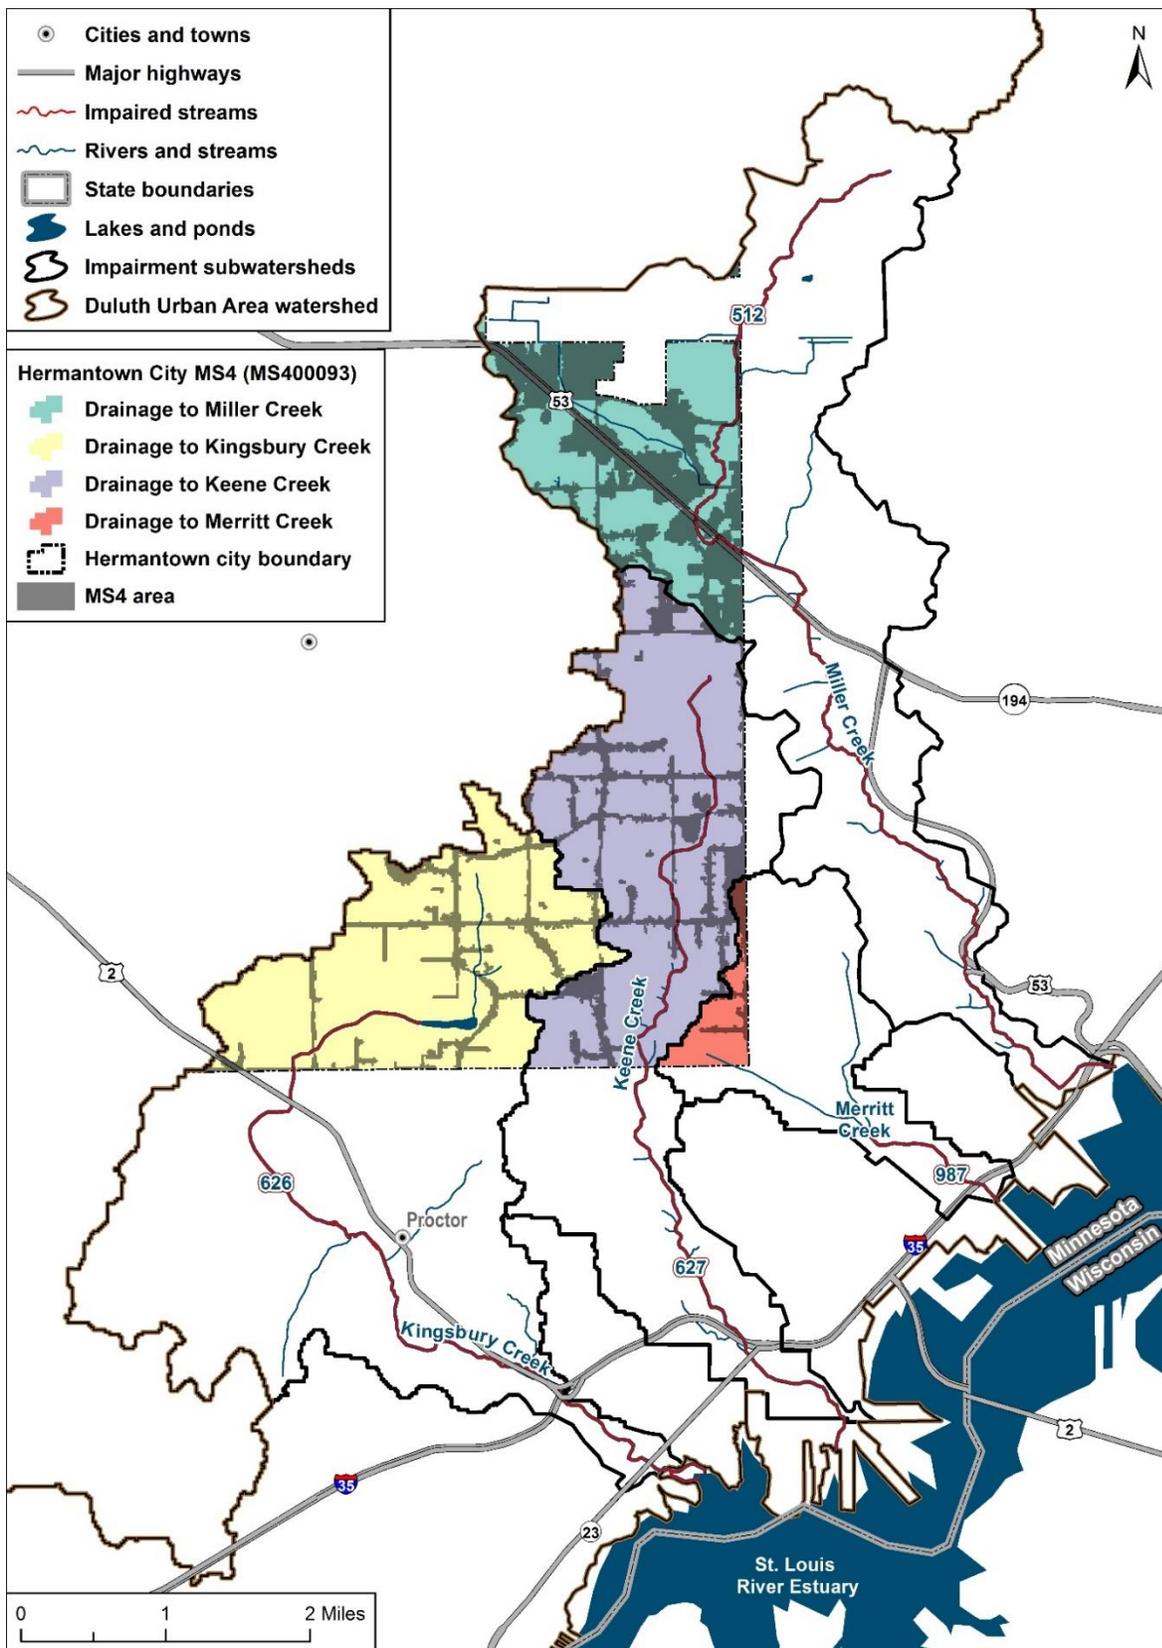
Figure 84. Hermantown MS4.

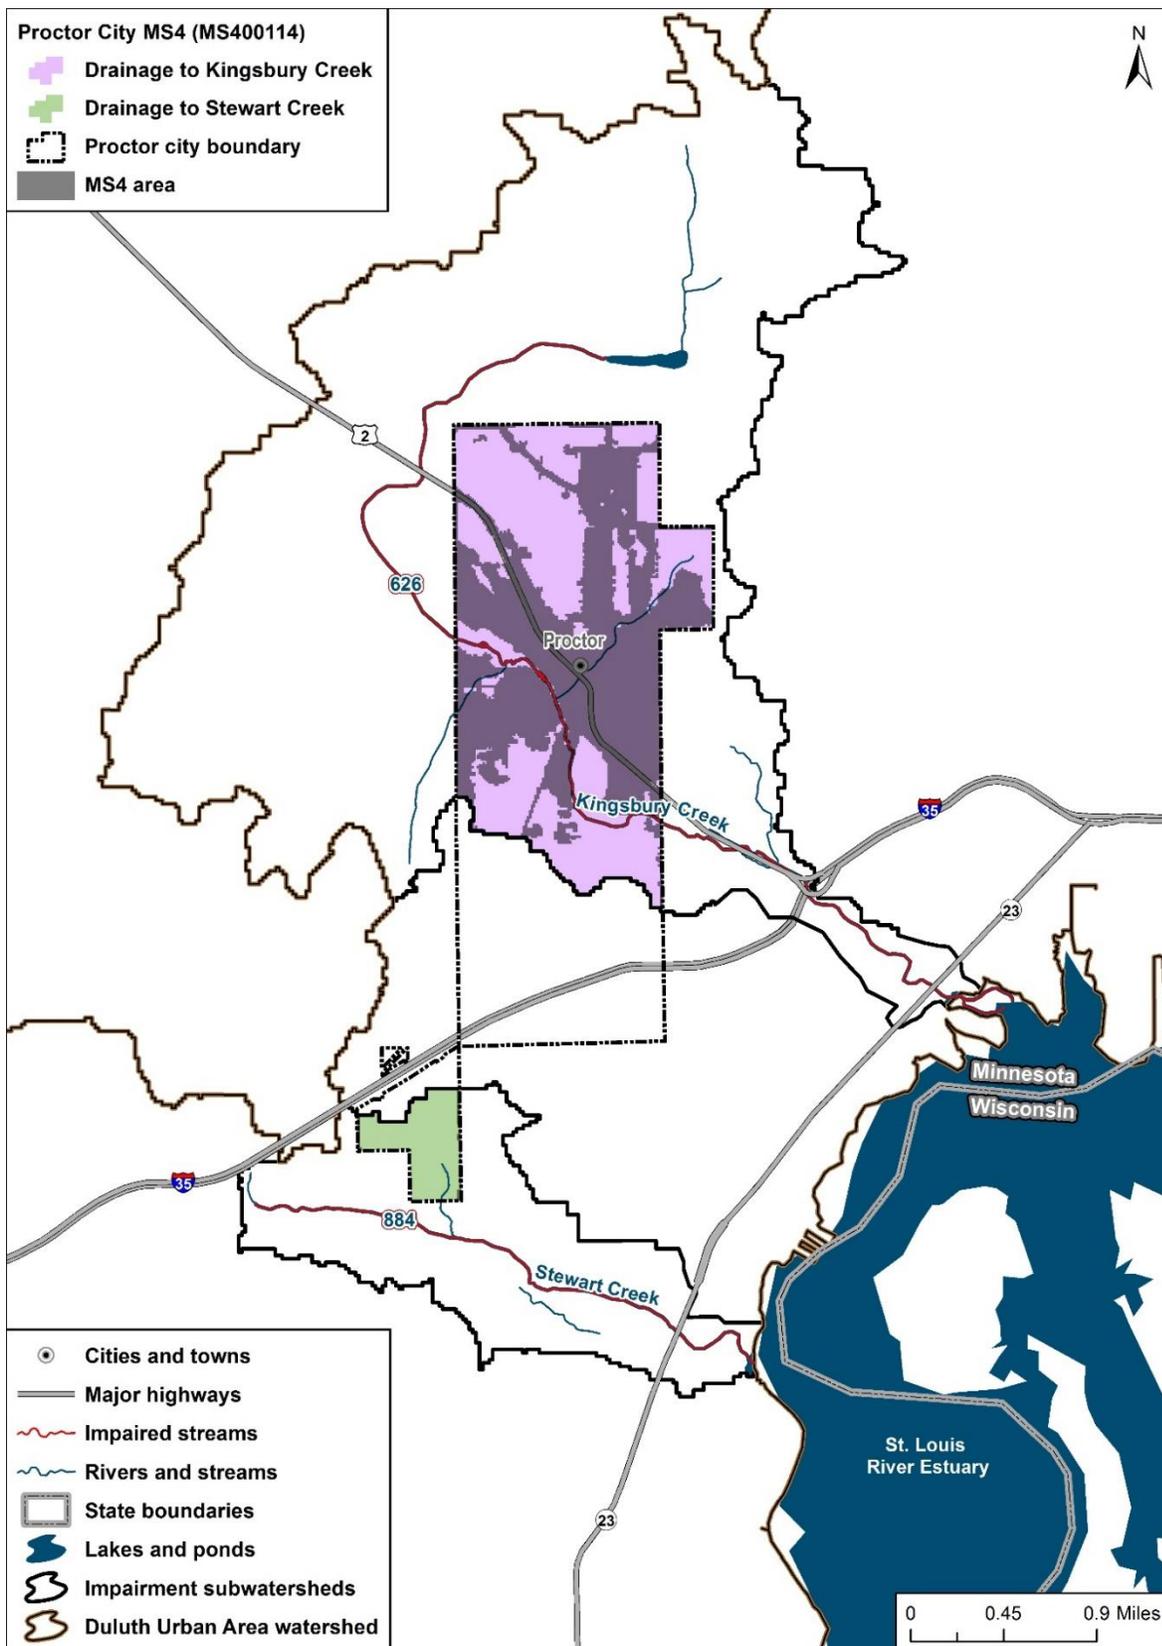
Figure 85. Proctor MS4.

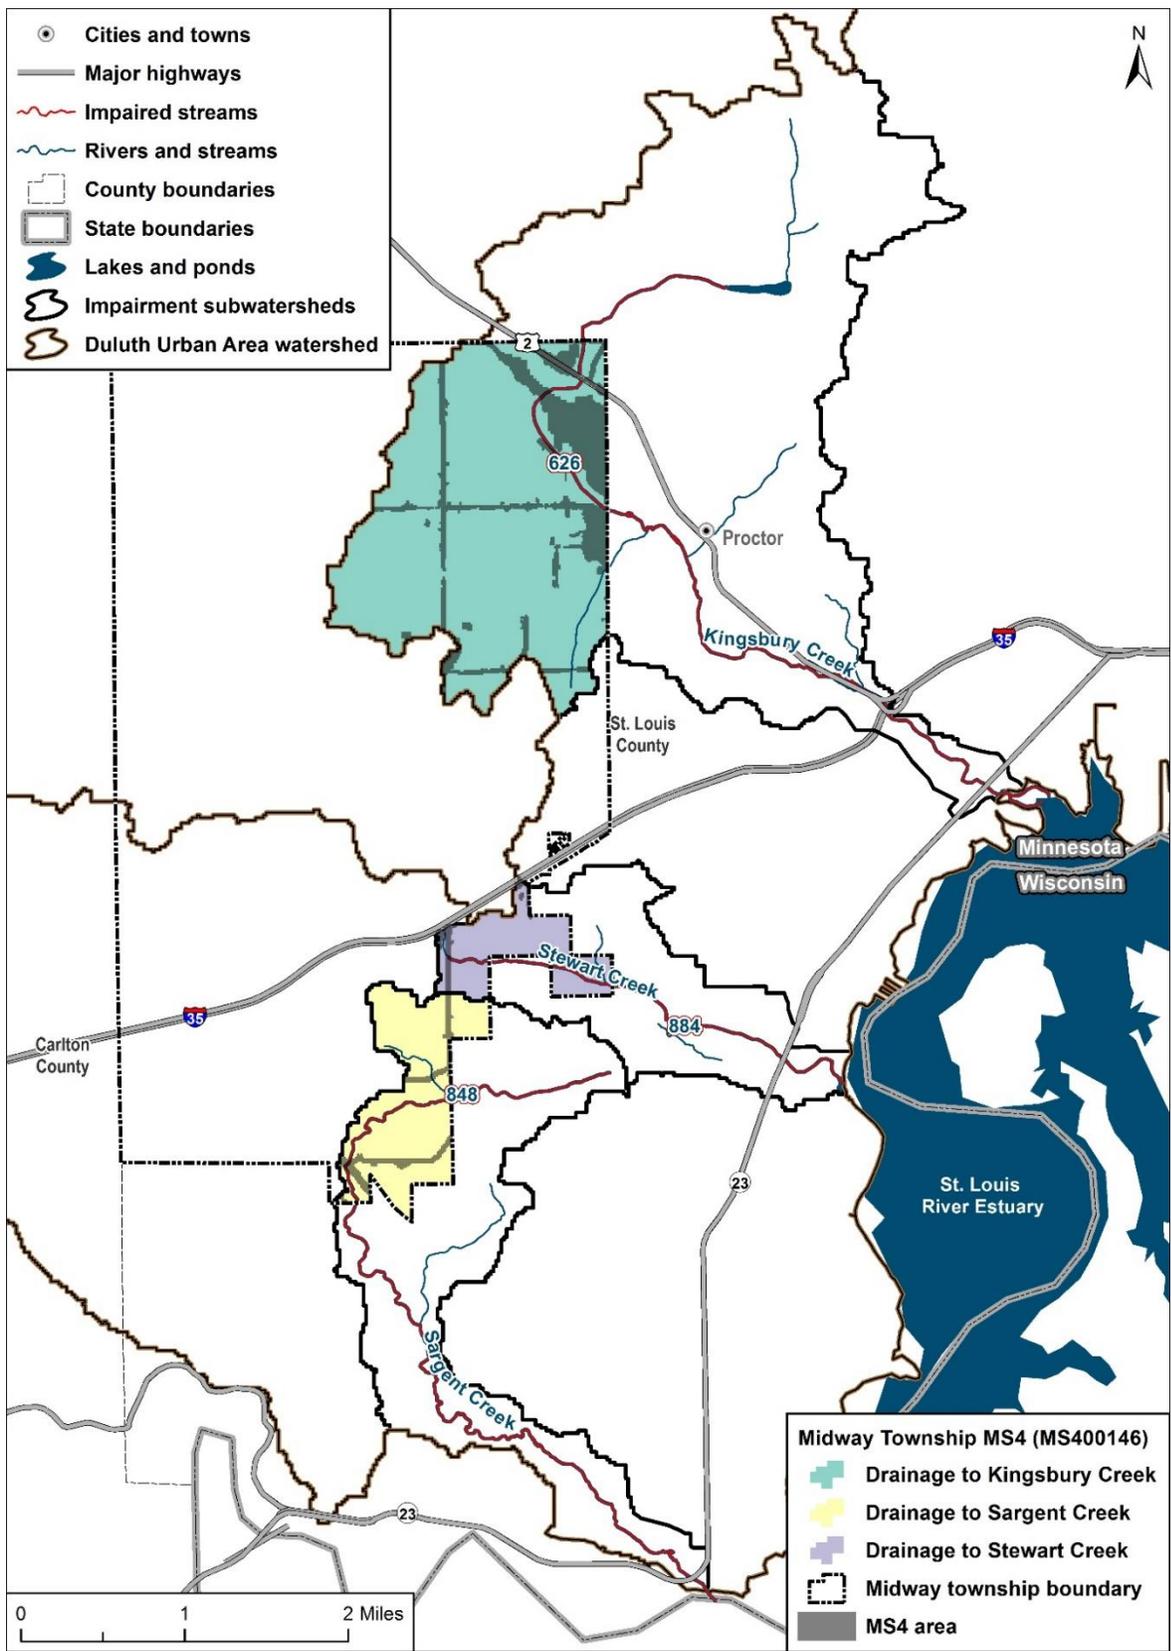
**Figure 86. Midway Township MS4.**

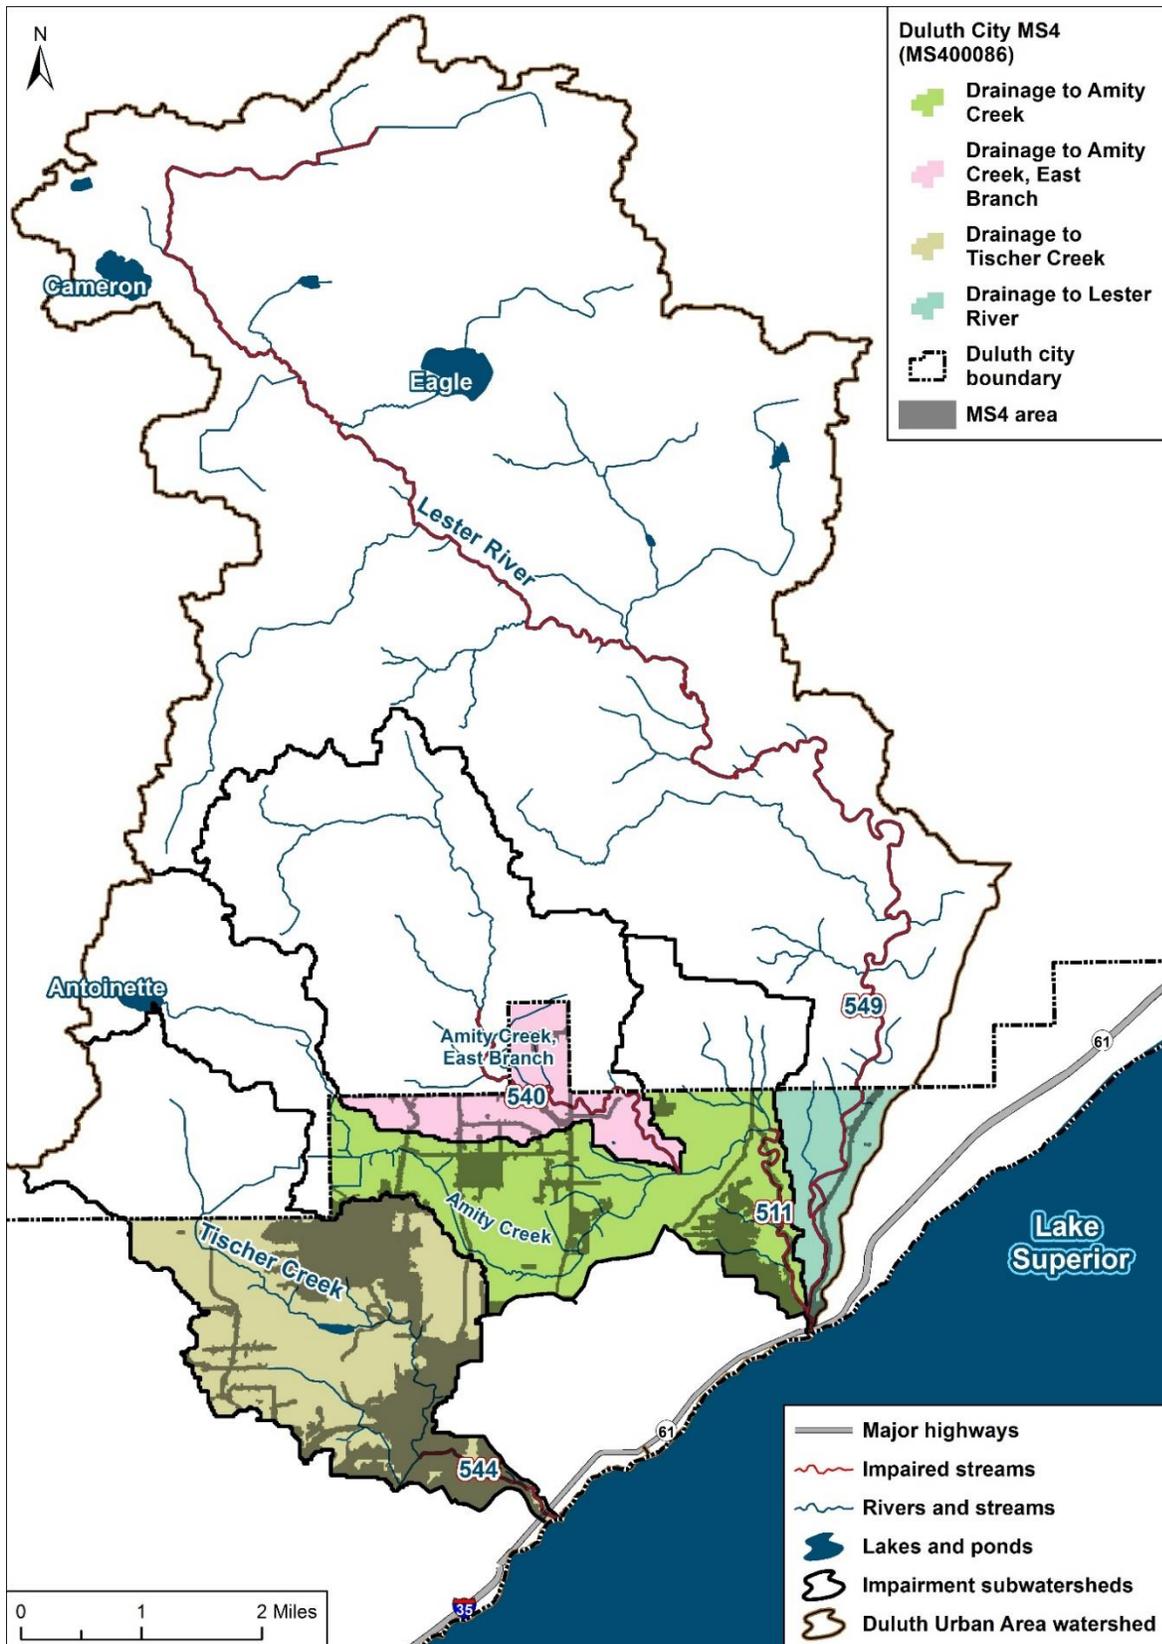
Figure 87. Duluth MS4 (northern).

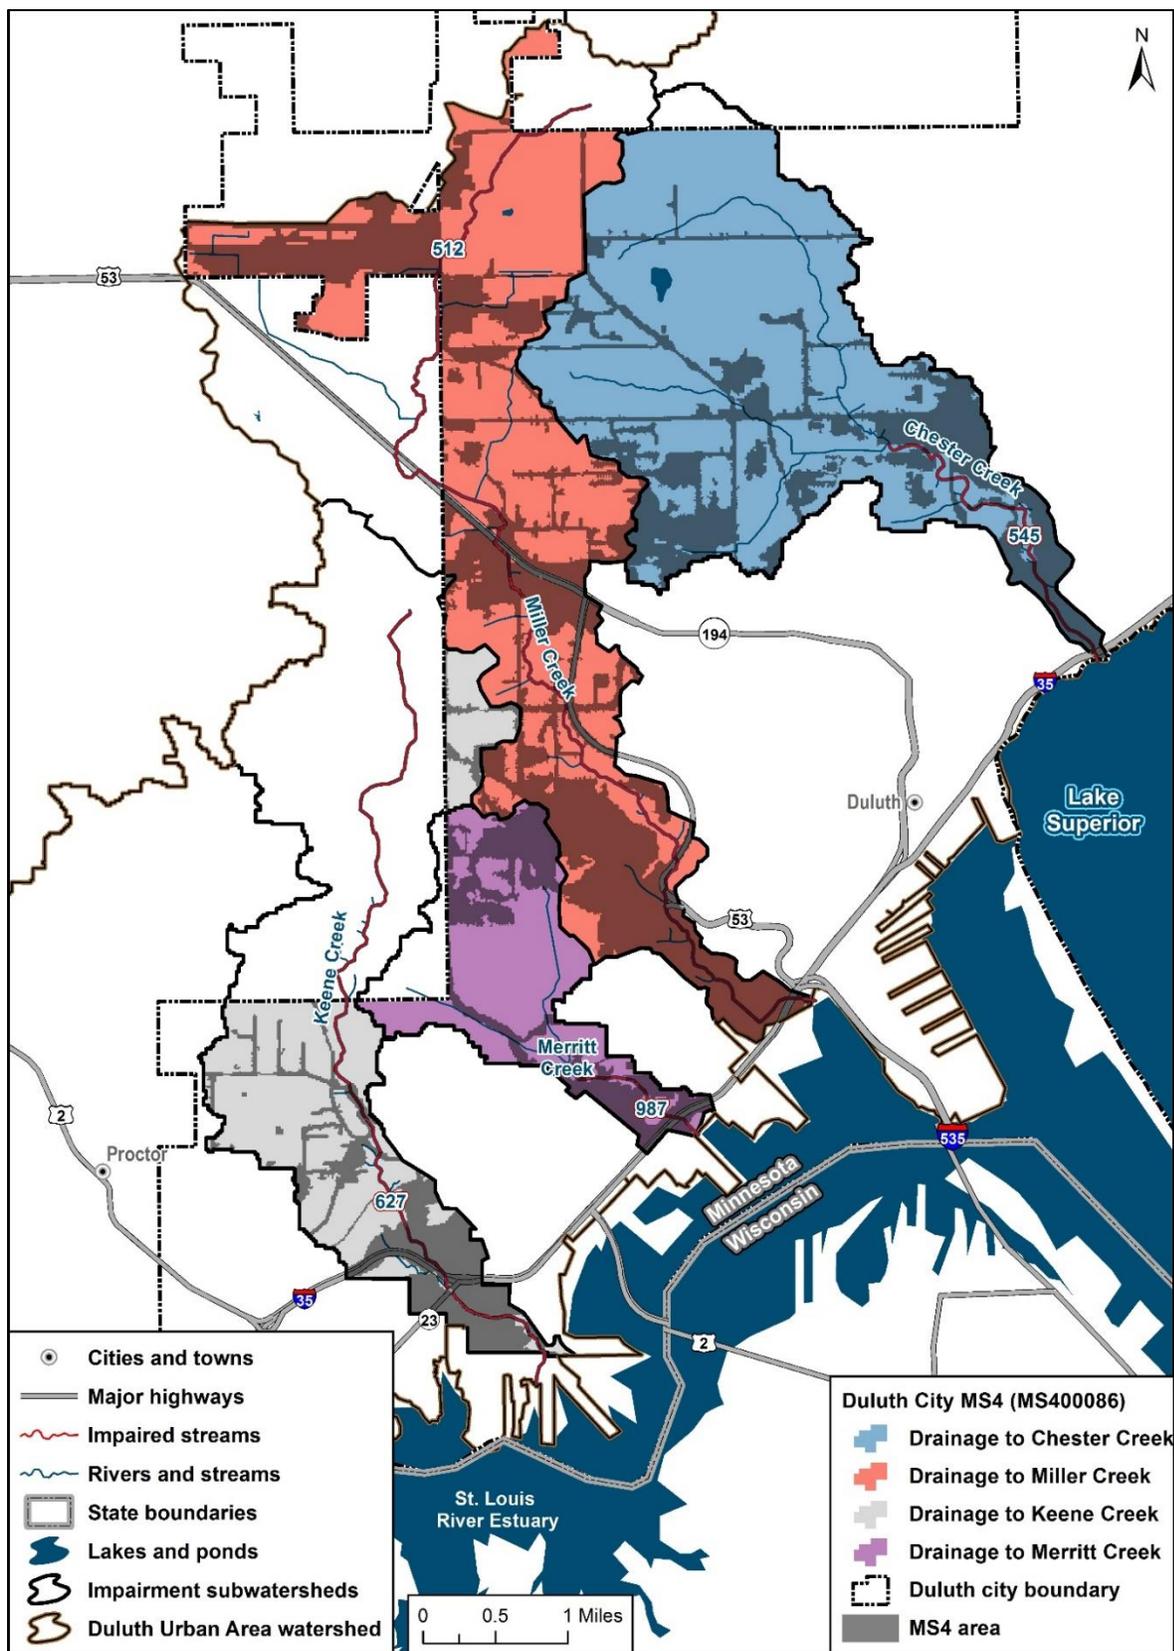
Figure 88. Duluth MS4 (middle).

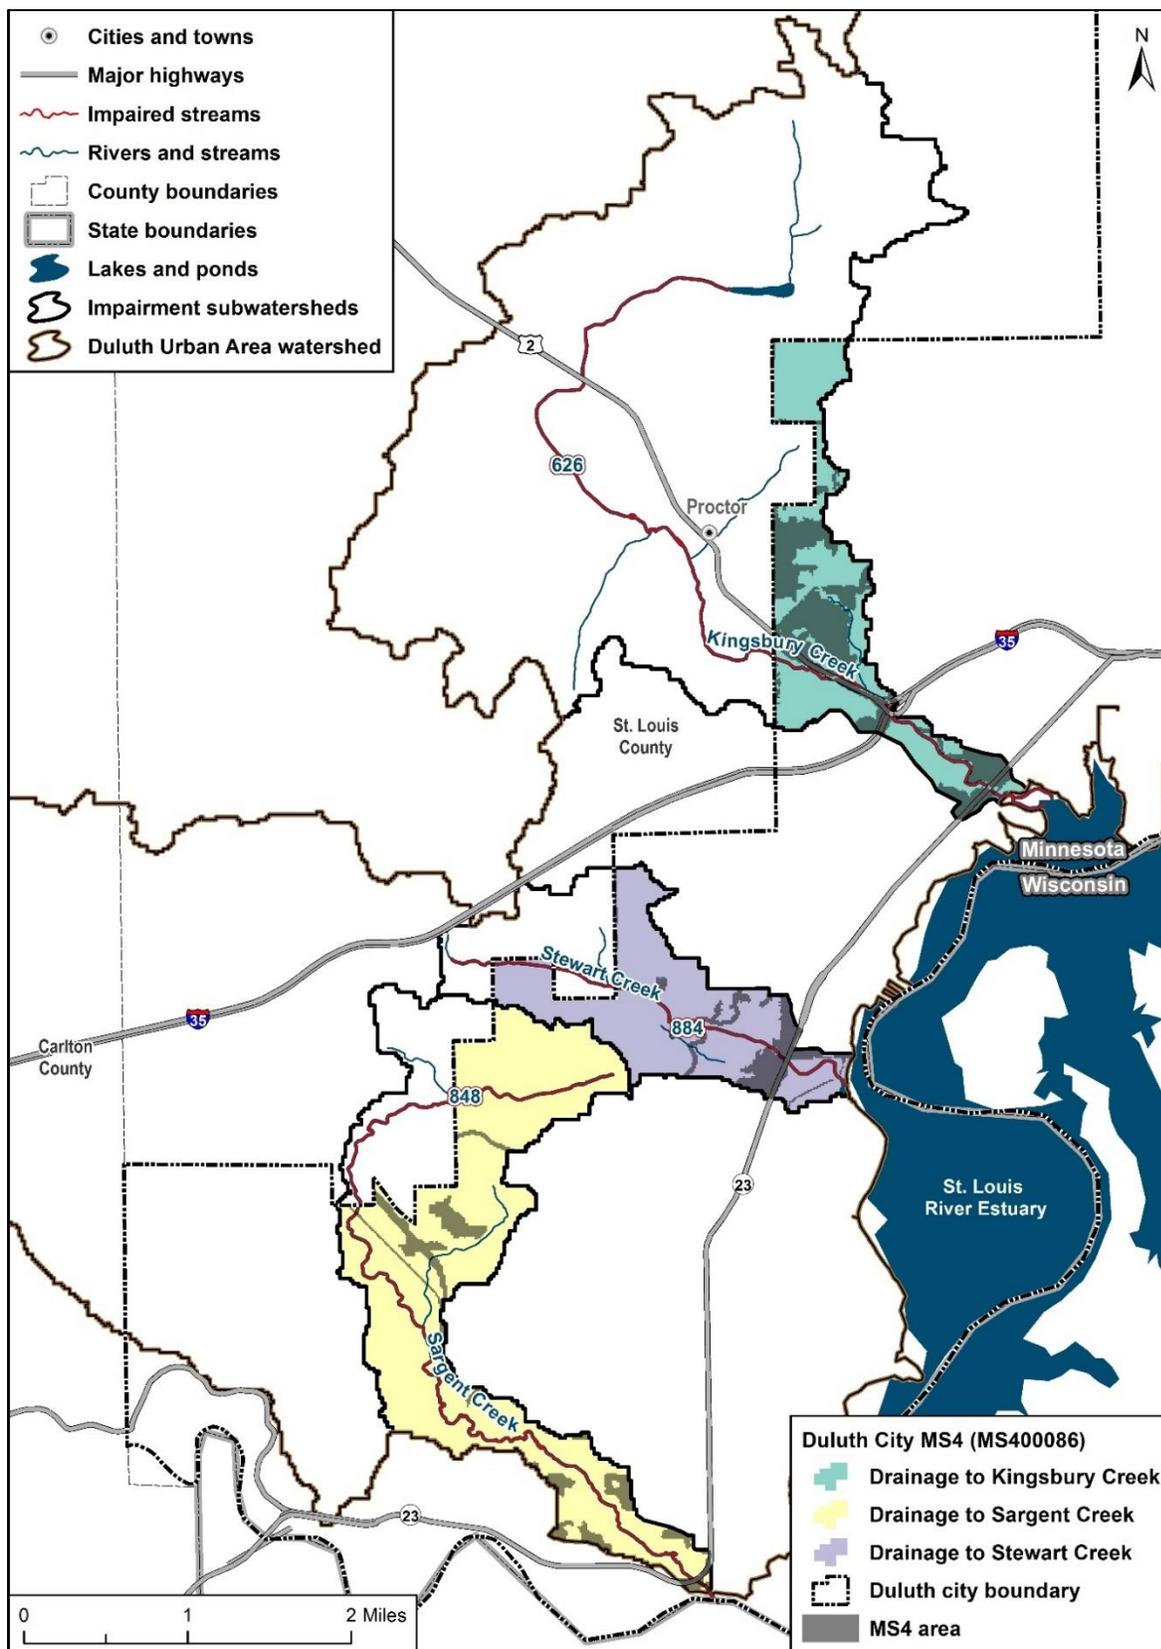
Figure 89. Duluth MS4 (southern).
