# Duluth Urban Area Streams Total Maximum Daily Load

Restoring and protecting urban streams in Duluth and surrounding areas.

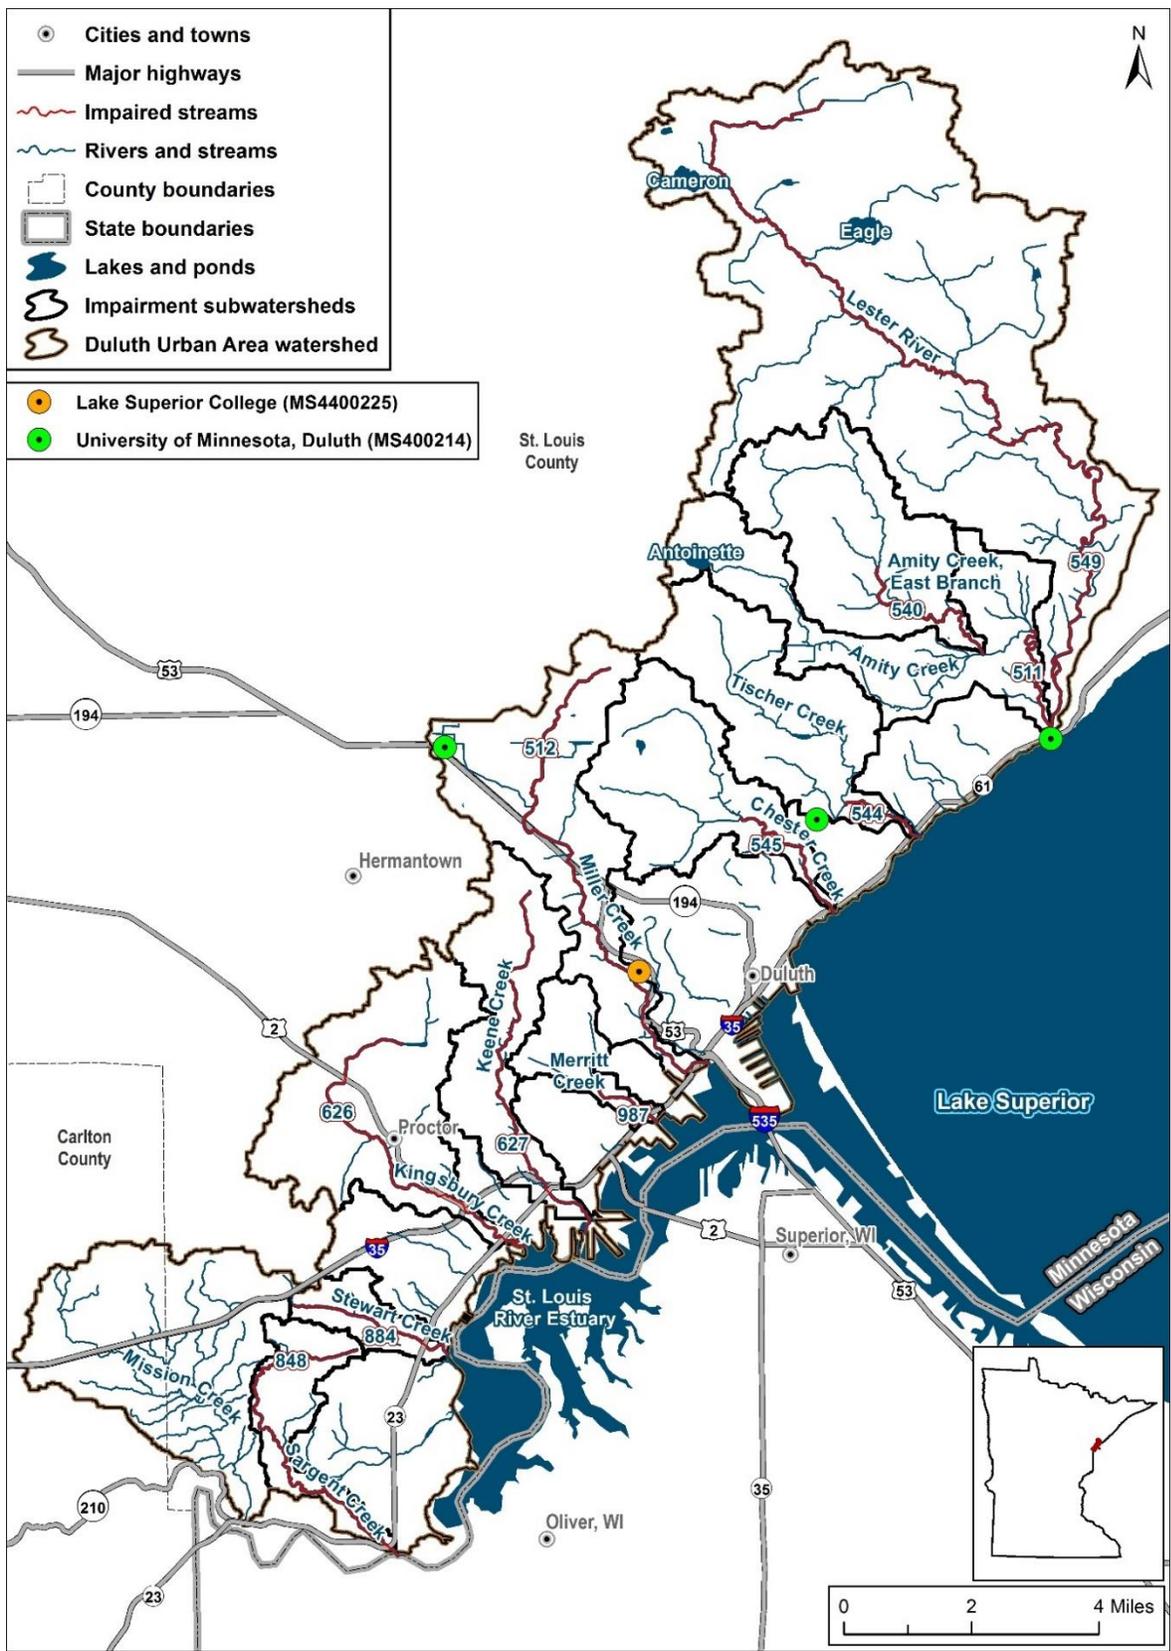
Figure 90. University of Minnesota and Lake Superior College MS4s.
