January 2021

Clearwater River Watershed Total Maximum Daily Load

This is a plan for restoring waters throughout the Clearwater River major watershed that are impaired by total suspended solids, *E. coli*, low dissolved oxygen, low index of biotic integrity scores, and eutrophication.

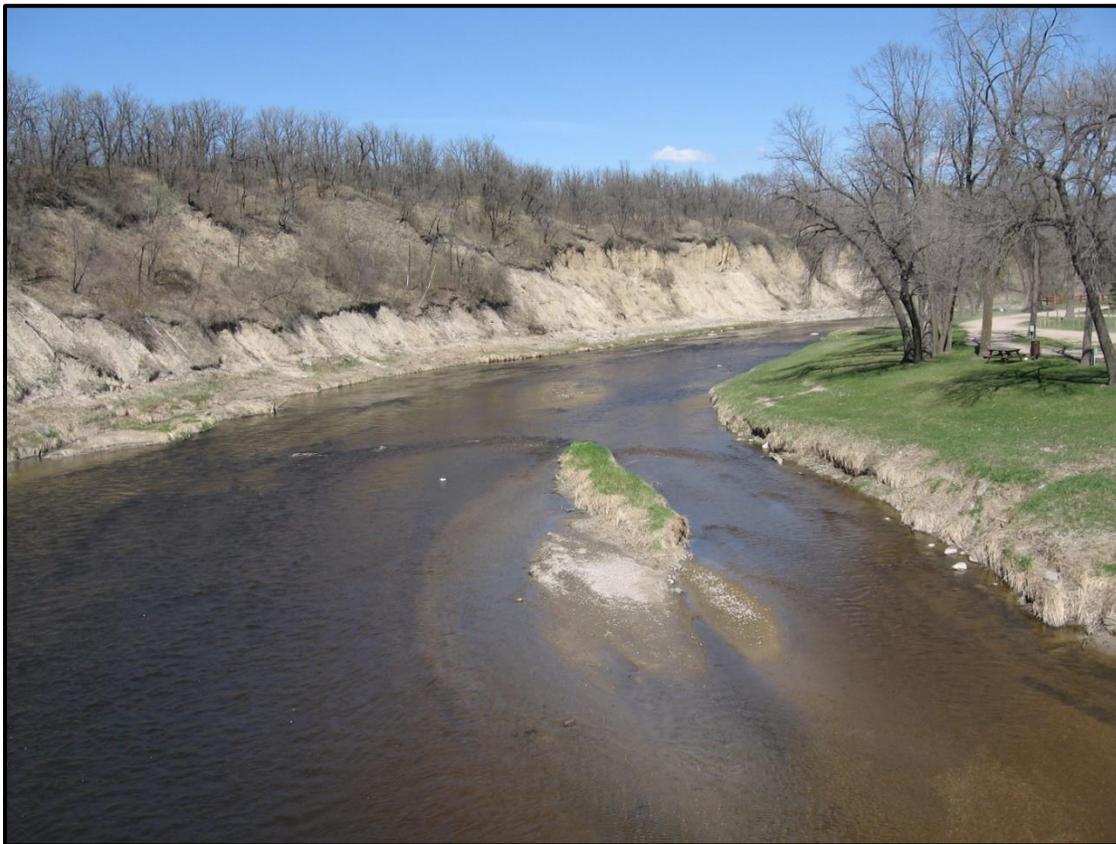
Figure 1-3. Photo of Clearwater River in Red Lake Falls (AUID 501) (Station ID S002-118)

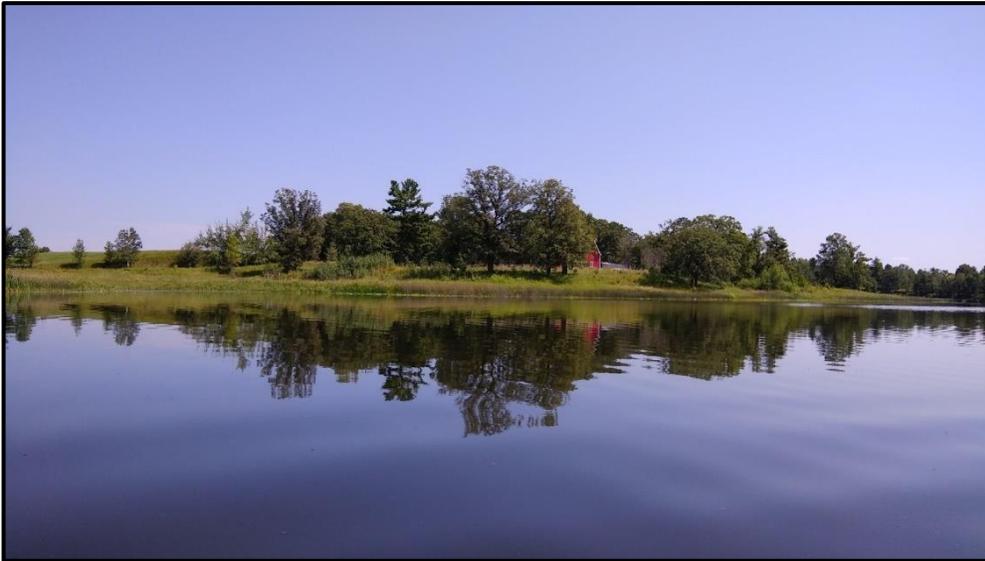
Figure 3-5. Photo of a former cattle farm on Long Lake, looking northeast from sampling station 04-0295-00-201

The depth of Long Lake has been measured at 17.8 feet near the 04-0295-00-201 sampling site. Much of northeastern end of the lake, even in the open-water portion, is very shallow and the bottom of the lake has a layer of muck or very soft flocculated organic sediment (Figure 3-7). The eastern shore of the lake has a sand/gravel bottom (Figure 3-7). There is no public access to the lake. Much of the shoreline is forested and well buffered. Aquatic vegetation lines the shoreline. Much of the lake's shoreline is bordered by wetlands. There are two beaver lodges on the lake. There are no obvious, active sources of excess nutrients near the lake, although there had been a cattle operation along a portion of the lakeshore (a Red Barn can be seen in Figure 3-5). There is no record of fish sampling in this lake.

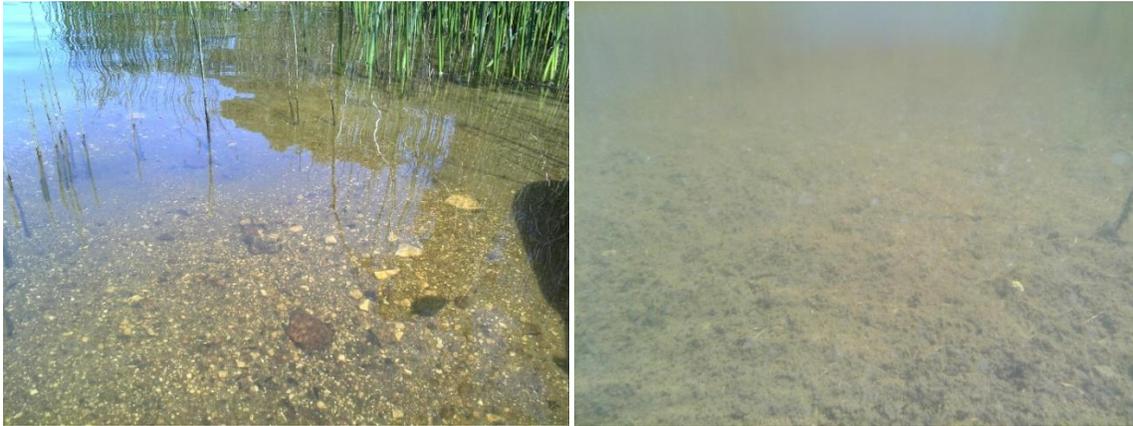
Figure 3-7. Photos of sandy (left) and soft (right) lake bottom along the shore of Long Lake

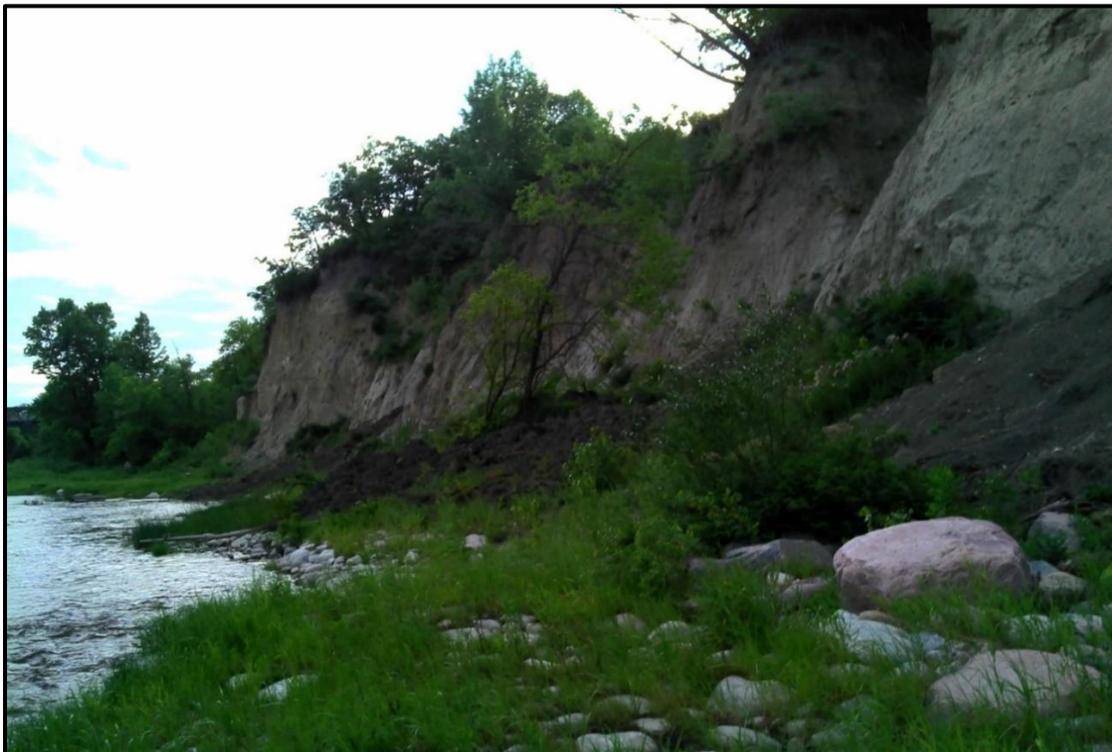
Figure 4-2. Photo of bluffs along the Clearwater River near Red Lake Falls (AUID 501)

The gradient and stream power increase as the river flows toward its confluence with the Red Lake River in Red Lake Falls. As the Clearwater River approaches Red Lake Falls and its gradient steepens, the river is lined with tall, eroding bluffs (Figure 4-2). The Clearwater River is impaired by excess TSS upstream of this reach, so it is already impaired at its furthest upstream extent by sources that contribute to AUIDs 511, 648, and 647. The frequency of high TSS readings was higher within this reach compared to the next assessed upstream AUID (AUID 511).

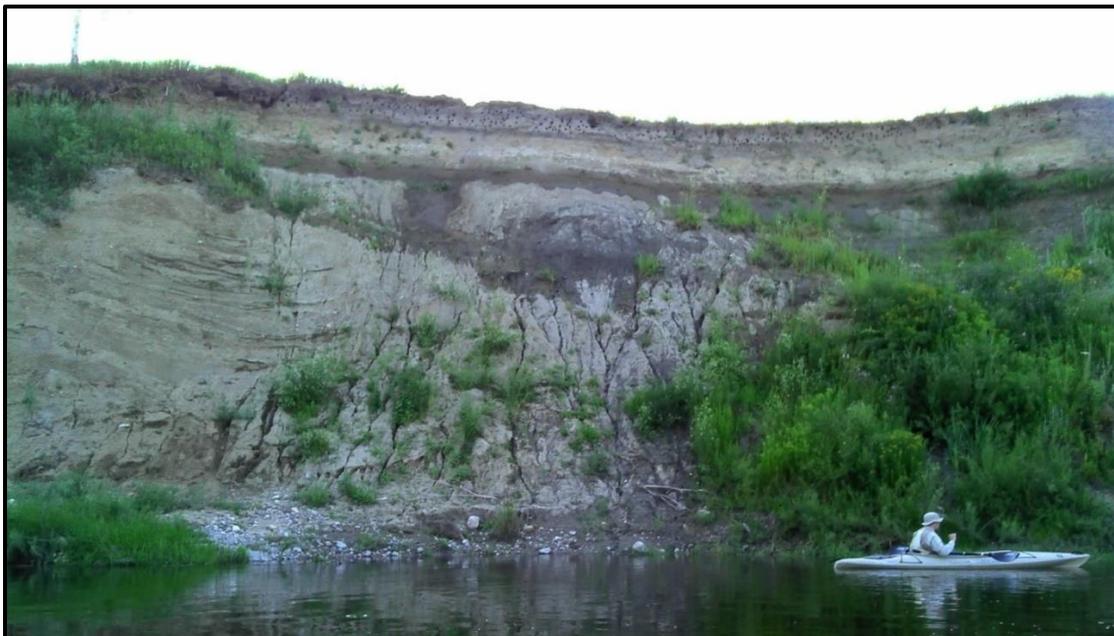
Figure 4-3. Photo of high, steep, eroding streambank along Clearwater River (AUID 511)

There are some notable sources of sediment along this reach. Eroding streambanks were documented by fluvial geomorphology reconnaissance work. One very large eroding bank, where the Clearwater River flows near CR 120, is shown in Figure 4-3. There are many eroding streambanks downstream of CSAH 12. Like AUID 501, the outlets of drainage systems that flow into this reach are also very unstable. There are cultivated fields that encroach upon the river and buffers need to be improved. A cattle operation has reduced vegetative protection along a cut-bank.

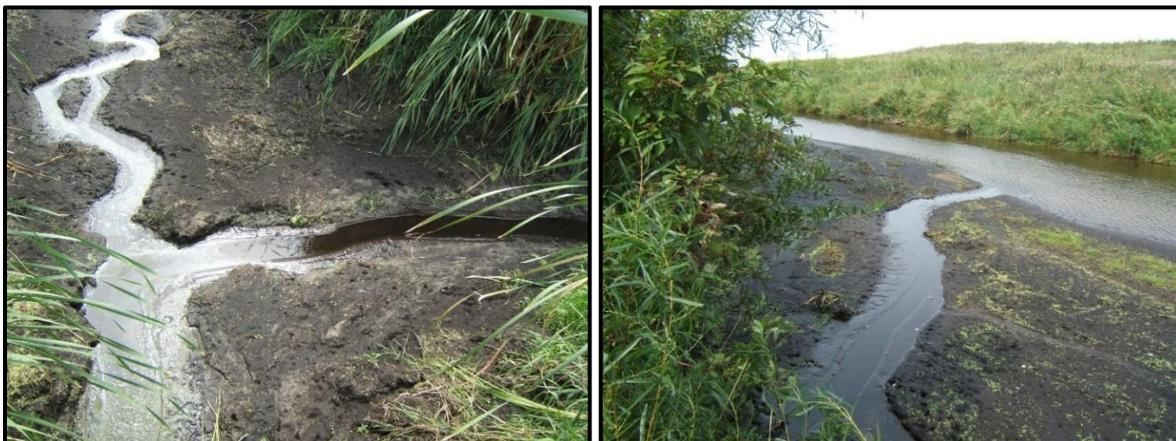
Figure 4-5. Photos of erosion within a wild rice paddy ditch (left) and sedimentation in the Clearwater River (AUID 647) from a wild rice paddy discharge (right)

Monitoring at the outlets of wild rice paddies during drawdown in late summer has shown that surface drainage within wild rice paddies has a very detrimental effect upon water quality in the Clearwater River (Figures 4-5 and 4-6). This sampling has also documented the benefits of adding controlled main-line tile drainage practices, along with elimination of surface drainage ditches within wild rice paddies, were that drainage water was clean, clear, and had low nitrate levels. Main-line tile drainage systems also provide benefits to the farmers like more even drainage, more even ripening, and less ditch maintenance. More information can be found in the *Red Lake River Farm to Stream Tile Drainage Water Quality Study Final Report*.

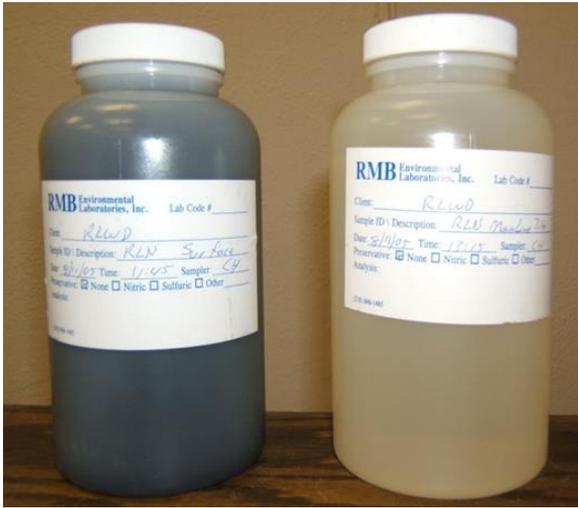
Figure 4-6. Visual comparison wild rice paddy discharges: surface drained wild rice paddy (left) and a main line tile drained wild rice paddy (right)

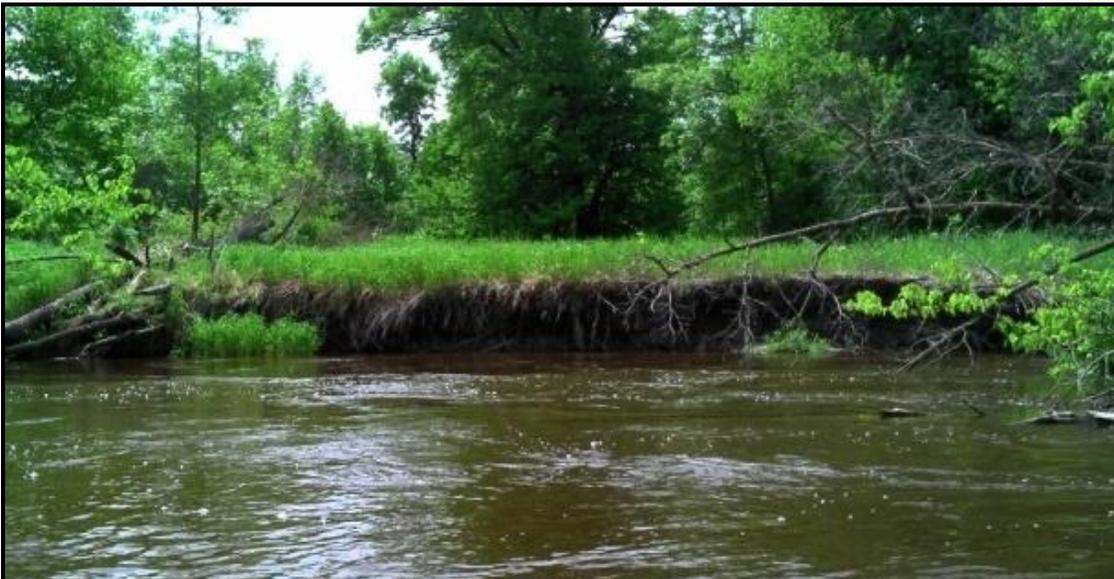
Figure 4-7. Photo of undercut, eroding streambank along the Clearwater River (AUID 648)

Streambank and overland erosion contribute to increases in TSS concentrations as the Clearwater River flows from the channelized reach to its confluence with the Lost River. Streambanks are sloughing where deep rooted and woody vegetation has been removed (Figure 4-7). Gullies have formed where runoff flows from cultivated fields. Feedlots and livestock grazing near the river have exposed soil and deposited animal waste that can be washed into the river during runoff events. There is a lack of accessible crossings in the upper portion of this reach, so there isn't detailed data that could improve the understanding of how TSS levels change between the downstream end of the channelized reach and the Plummer USGS Gauge monitoring station (S002-124). A kayak monitoring trip from CR 127 to Minnesota Street N with regular measurements of turbidity or transparency after a runoff event could help identify areas with the worst erosion problems. The development of detailed water quality models like PTMApp should also aid in identifying specific sites where implementation of BMPs could be most cost effective at reducing erosion and TSS loads. The outlets of drainage systems need to be stabilized where they enter the Clearwater River to prevent further head-cutting and gully formation.

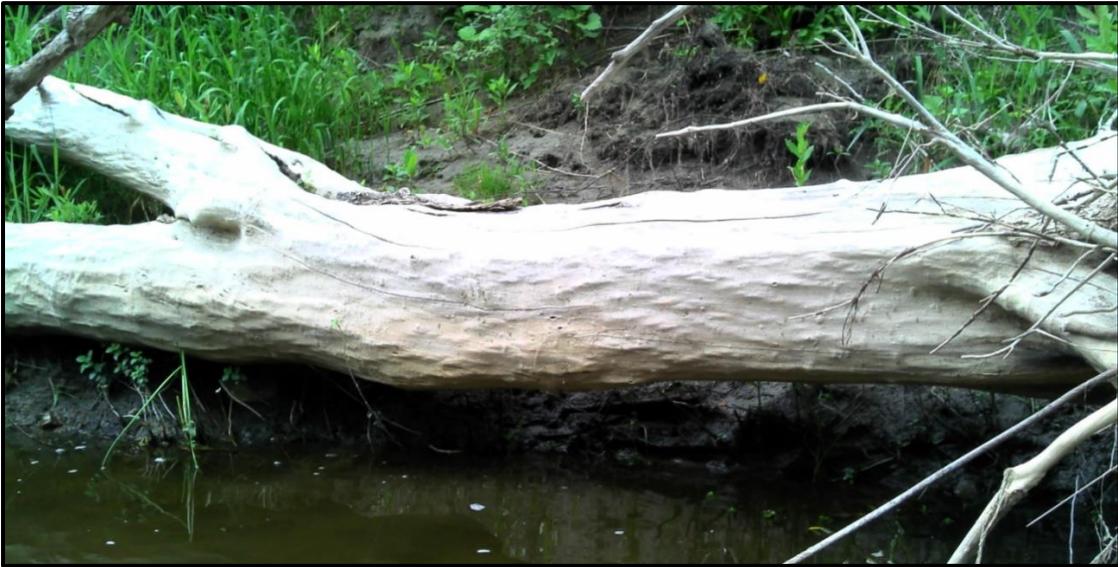
Figure 4-14. Photo of a tree trunk over the Lost River (AUID 505) that has been abraded by swift, sediment-laden water

Exploration of the Lost River between CR 118 and the confluence with the Clearwater River revealed that a large amount of sand is being transported along the lower portion of the river. Large sediment bars are visible in aerial photos. Reconnaissance via kayak discovered that, in addition to the sediment bars, trees and logs along the bank of the river appeared to have been sandblasted by powerful, sediment-laden streamflow (Figure 4-14).

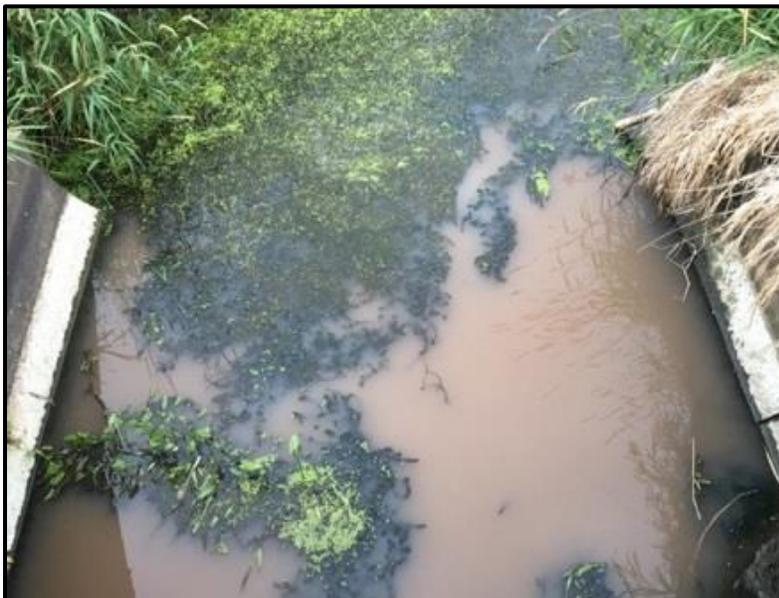
Figure 4-16. Photo of Poplar River water quality condition during Fosston WWTF discharge, July 7, 2016 at station S003-127 (AUID 518)

Historically, the Fosston WWTF has negatively impacted water quality in the Poplar River with extreme concentrations of nutrients and other pollutants documented in the river. There are records of citizen complaints to state and local agencies about discharge from the Fosston WWTF and the resulting poor water quality in the river over the years. Samples have been collected to document those conditions. The facility was upgraded in 2012 to improve the efficacy of the treatment process and additional improvements are tentatively planned for 2021 or 2022, pending funding. Two violations of the WWTF's *E. coli* limit have occurred since the 2012 improvements.

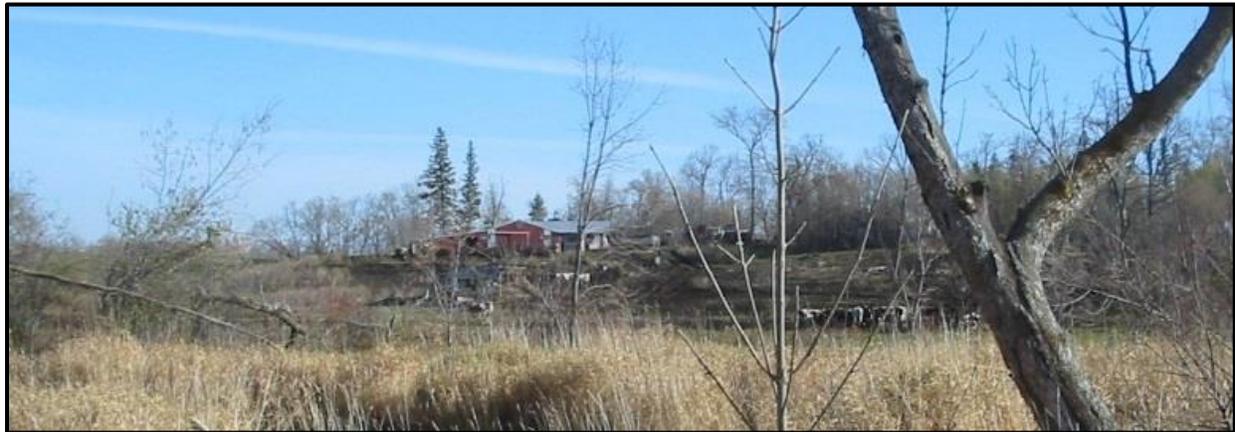
Figure 4-18. Livestock operation along the Lost River (AUID 512), northeast of Gonvick

Livestock operations along the river are a primary, suspected source of *E. coli* bacteria in the Lost River. There is one registered feedlot (according to publicly available 2016 GIS data) just downstream (northeast) of the city of Gonvick. That feedlot appears to be particularly impactful upon the Lost River. Cattle have access to the stream and have removed vegetation near the river (Figure 4-18). This area should be investigated under Minnesota’s Buffer Law.

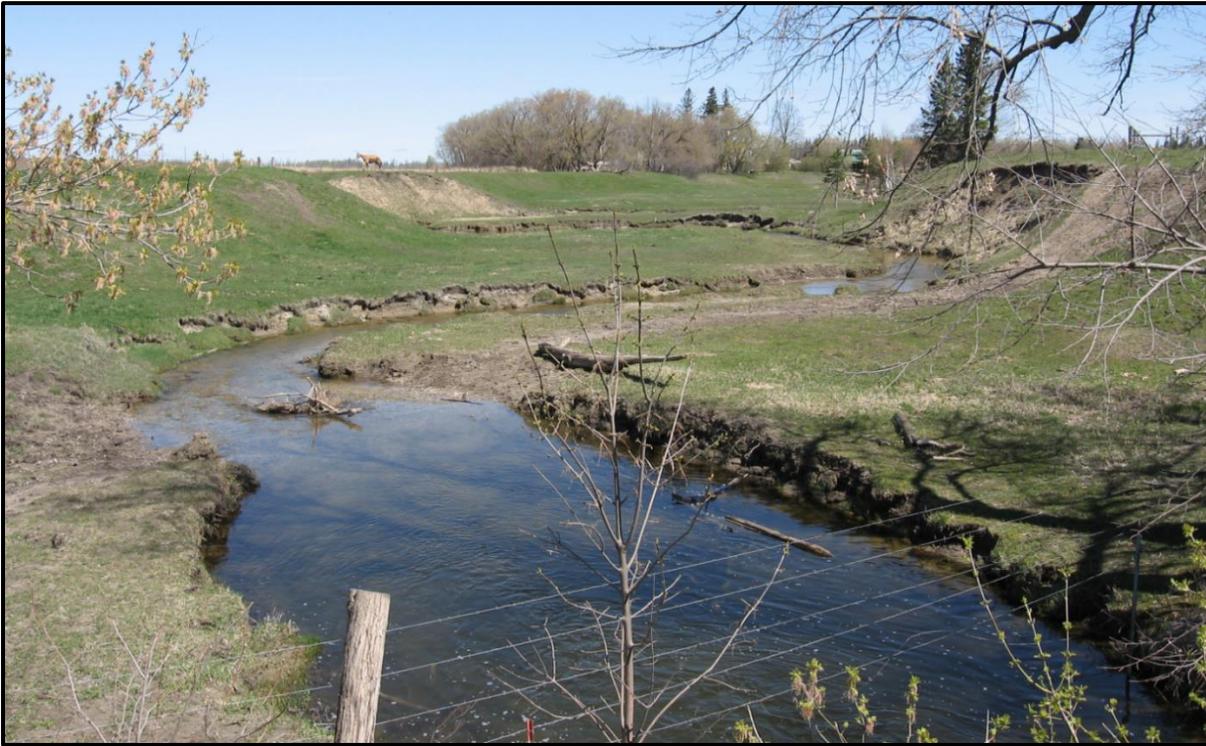
Figure 4-19. Damaged stream banks along the Lost River (AUID 512) due to intensive grazing downstream (north) of the 486th Street crossing

In addition to the registered feedlot, there were other livestock operations along the Lost River. Cattle have access to the river a short distance upstream of the 139th Avenue sampling site. Livestock (cattle and horses) have destroyed vegetation along more than 670 meters of the Lost River corridor downstream (north) of 486th Street (Figure 4-19). Due to the livestock use of that corridor, streambanks have also become unstable.

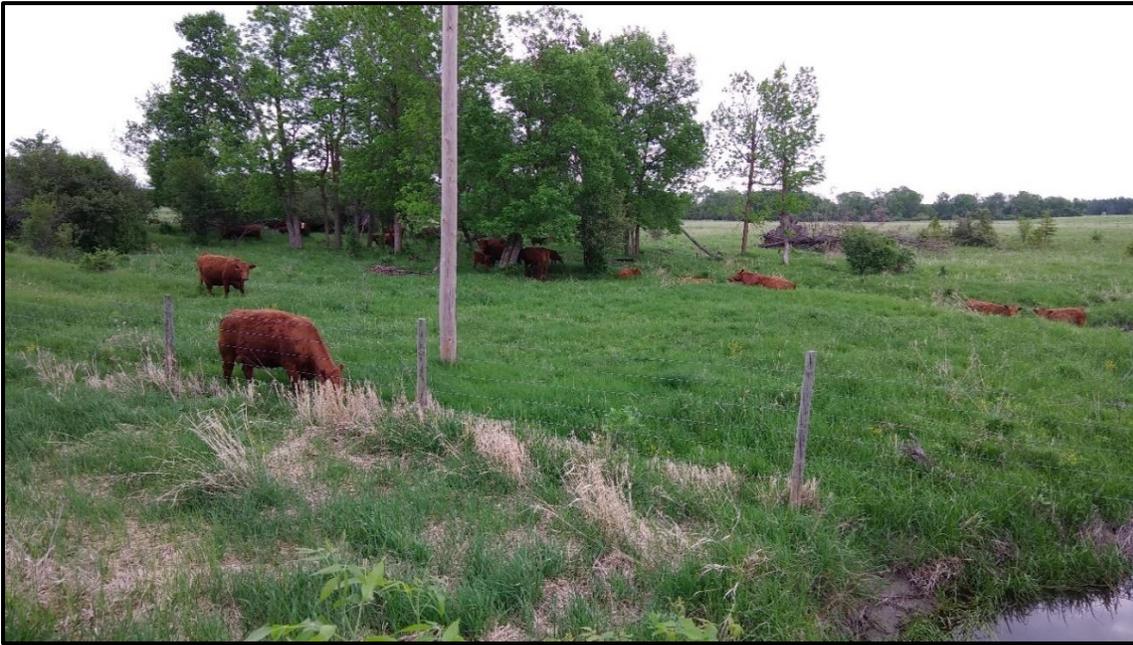
Figure 4-25. Pasture and cattle along Silver Creek, upstream of 159th Ave (station S000-712 on AUID 527)

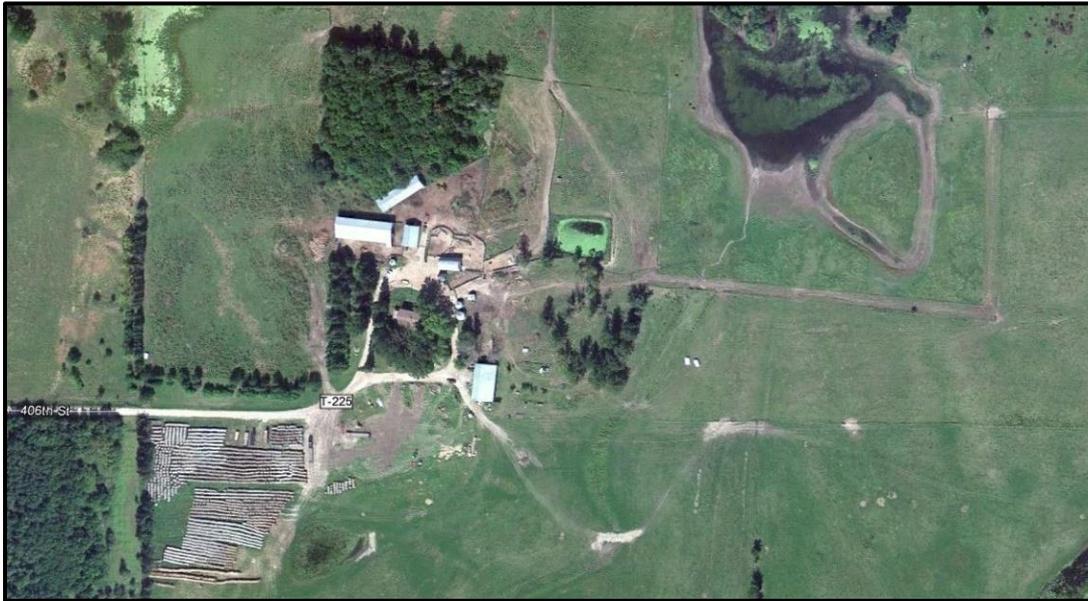
Figure 4-26. Livestock operation near the Lost River (AUID 530)

There were multiple livestock operations along the reach between S004-206 and S005-501 and one residence along the reach. A feedlot along T-1 (Nasset Creek Drive) was the most likely human-made source of excess *E. coli* bacteria (Figure 4-26). Other sources of high *E. coli* concentrations within the Lost River included the sources (pasture) that were contributing to the *E. coli* impairment in Nasset Creek, which flows into the Lost River between S004-206 and S005-501. Natural background *E. coli* from birds, wildlife, and beaver also likely contribute to *E. coli* concentrations.

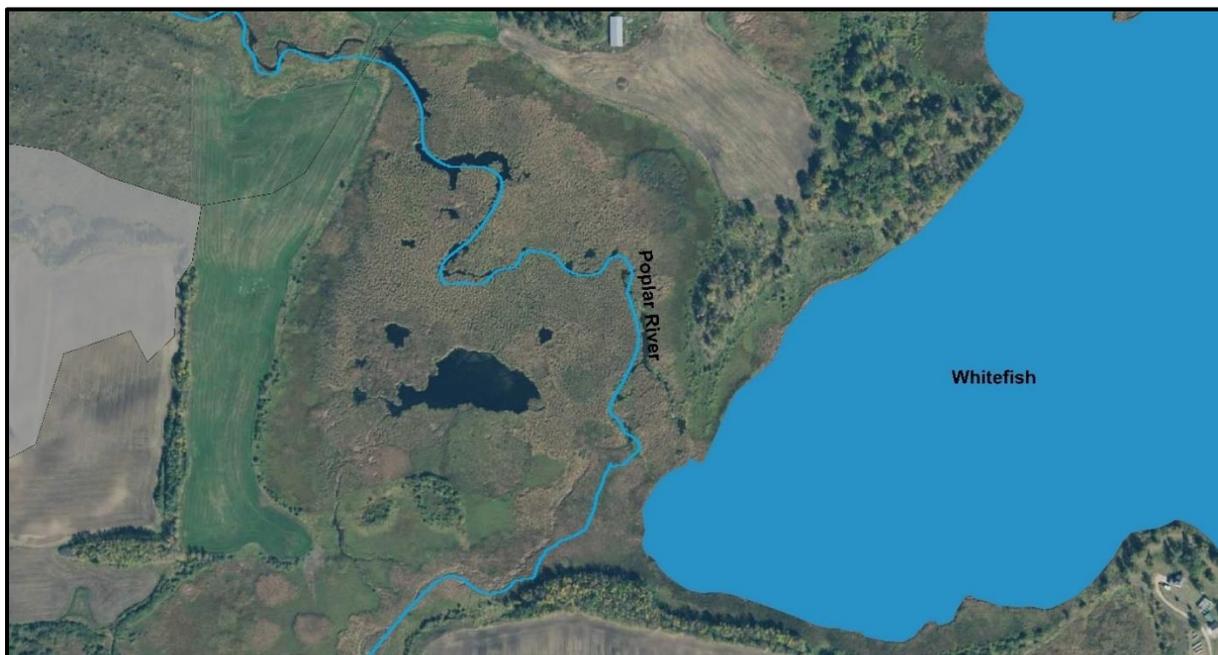
Figure 4-36. Aerial photo of the Poplar River (AUID 518) as it flows through wetlands past the west end of Whitefish Lake

This portion of Poplar River is relatively long and complex. Characteristics like gradient and DO levels vary throughout this reach. Longitudinal sampling results found that DO levels increase and decrease throughout the reach. The river flows through a series of lakes and wetlands. The DO levels are often depressed in those low-gradient areas where the stream was flowing through riparian wetlands, or shortly downstream of those wetland areas. The DO concentrations improved where the river flowed between those wetlands due to increased gradient and a more defined channel. The worst F-IBI score along the Poplar River was found upstream of the CSAH 27 (395th Street SE) crossing (14RD218). Between CSAH 1 and CSAH 27, the Poplar River flows through a large wetland on the western side of Whitefish Lake. In some aerial photos, the channel seems to disappear (Figure 4-36).

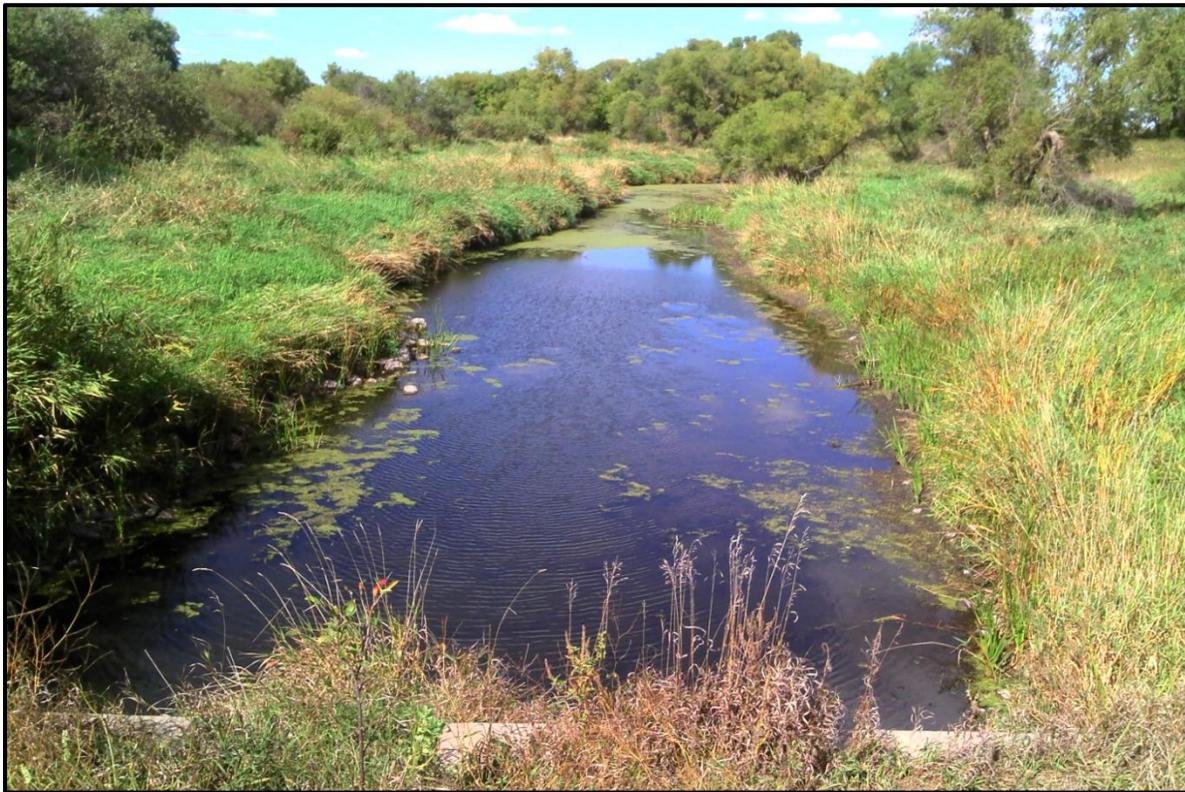
Figure 4-40. Stagnant conditions at CSAH 35 (station S003-498) on the Hill River (AUID 539)

Connectivity issues along this portion of the Hill River included the Hill River dam on the upstream end of this reach and multiple beaver dams along the upper portion of the reach. Beaver dams may also be exacerbating the stagnant conditions in the upper, northward-flowing portion of this AUID. The gradient of the river is relatively low where it flows northward, and that portion of the river is bordered by riparian wetlands. The channel is relatively wide in that portion of the river (see photo in Figure 4-40) compared to the rate of flow, so velocities can be low for much of the summer. The river was relatively stagnant and often resembles a wetland at the CSAH 35 crossing (S003-498)

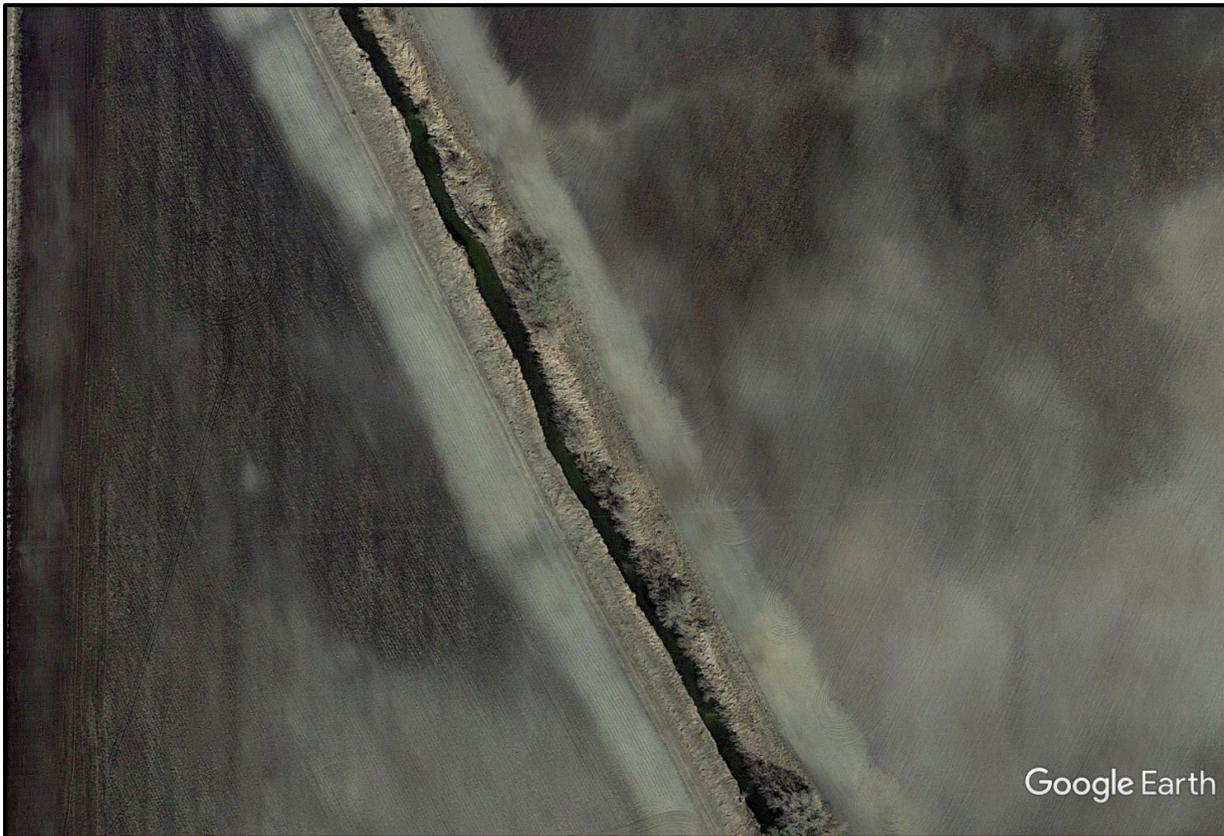
Figure 4-44. Lack of buffer width and lack of shading along the Lost River (AUID 645)

The SID report found evidence of a causal relationship between habitat availability and the F-IBI impairment in four different F-IBI metric responses, geomorphologic assessment, and observations of stream characteristics. There was a lack of shading along the channelized portion of this reach. Even without high TP concentrations, the river still had excess periphyton growth and DO flux. The lack of shading may have exacerbated the signs of eutrophication that were observed in the river. Diversity of habitat was severely limited by the channelization. A geomorphologic assessment found that the stream was moderately unstable. Riparian land use along this reach mostly consisted of row crops and pastures. Much of the riparian buffer along this reach was lacking in width and/or quality (Figure 4-44). The reach is required to have a 50-foot buffer under Minnesota's new Buffer Law. Recent aerial photos show that the buffer fell short of that mark along much of the row-cropped portions of the immediate drainage area. Reconnaissance in 2019 found portions of AUID 645 that were still lacking a buffer.

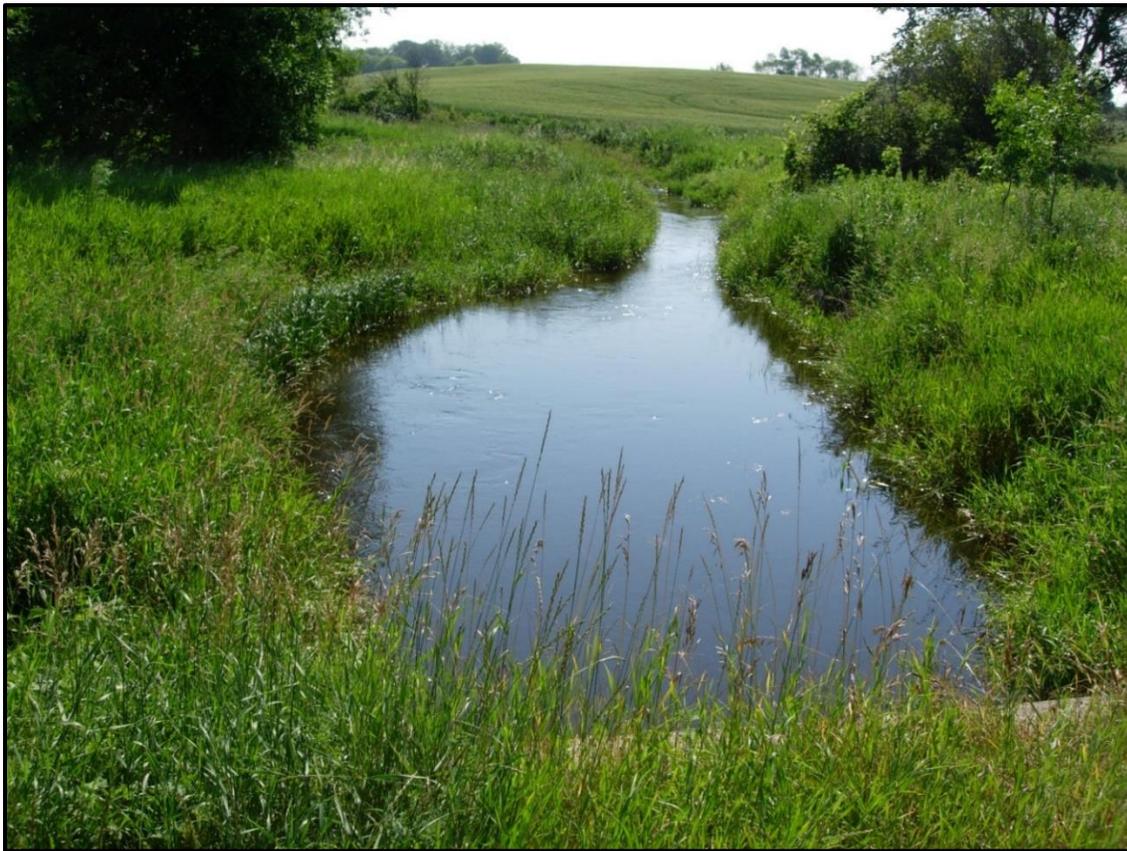
Figure 4-47. Photo of the Hill River (AUID 656) at water quality station S007-847

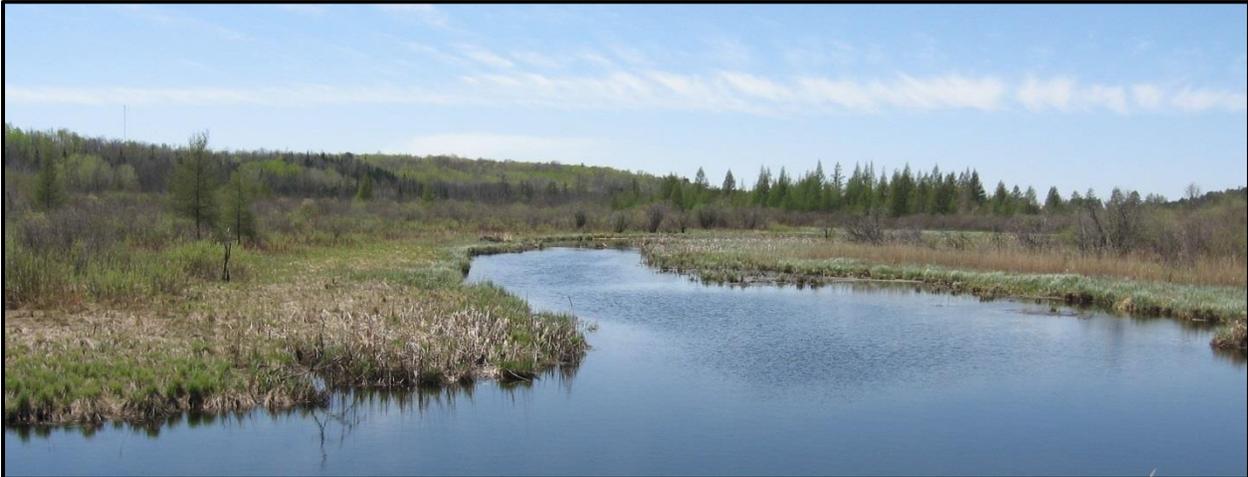
Figure 4-52. Photo of the Clearwater River (AUID 517) at S001-458 near Bagley

An intensive study of upper reaches of the Clearwater River, along with Walker Brook, discovered physical features of this portion of the watershed had a greater effect on DO concentrations than relatively low pollutant concentrations that have been found in this reach. The headwaters portion of the Clearwater River shares multiple characteristics with the Walker Brook drainage area (described in Section 4.5.1). The Clearwater River headwaters and Walker Brook are connected and located in the same area of the watershed. They share a geologic history in which they originated as part of a glacier margin meltwater stream around 15,000 years ago. The headwaters reach has a low gradient (Figures 4-52 and 4-53). It has riparian wetlands (fens) similar to those found along Walker Brook, with a similar redox potential. The headwaters of the Clearwater River receive an estimated 1.75 cfs/km of seepage from deep aquifers, but low gradient and lack of riffles provide minimal opportunity for oxygenation from turbulence. Fens along the Clearwater River are biologically active (consuming oxygen during decomposition of organic matter) and most of the runoff to the river flows through those fens.

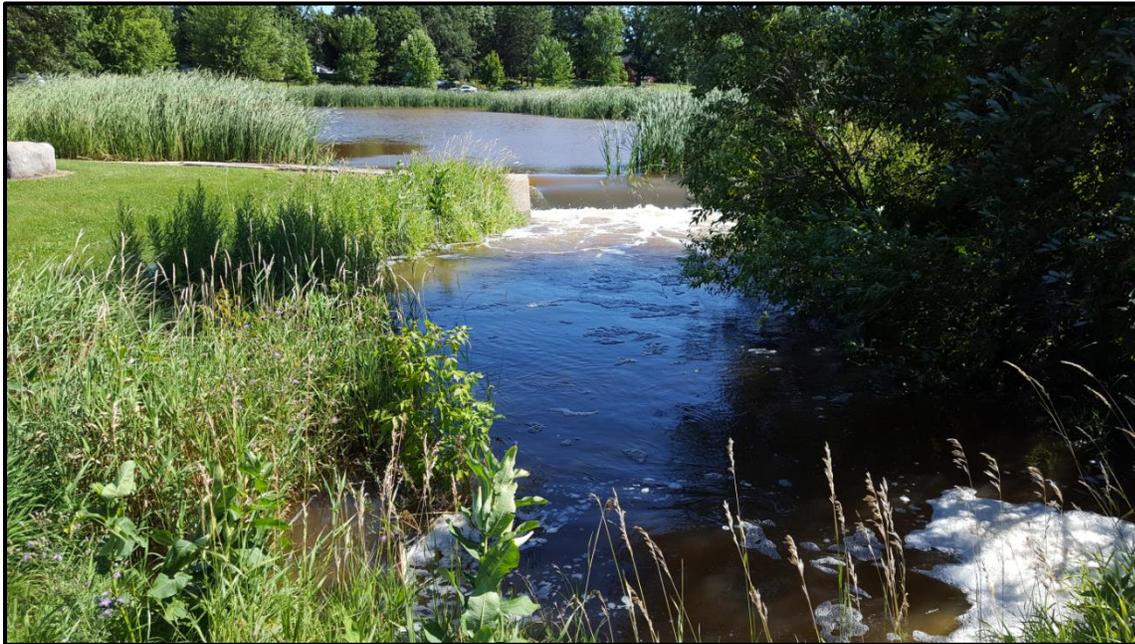
Figure 4-58. Dam on Clear Brook (AUID 536) within the town of Clearbrook

Clear Brook flows through multiple areas where water is stagnant. Those areas are relatively flat and ponded behind barriers like beaver dams and man-made dams. Drainage in the headwaters of the stream flows through wetlands between Steenerson Lake and CSAH 49. A tributary of Clear Brook (AUID 571) also crosses CSAH 49, but rarely flows. The AUID 571 tributary looked more like a wetland than a stream (lacks a defined channel in areas beyond the culvert at CSAH 49) and exhibited very low DO when longitudinal measurements were collected in 2017 (Figure 4-59). Beaver activity has created a large, ponded area upstream of the old railroad grade that crosses the stream where it enters the town. There is a man-made pond in the city of Clearbrook, upstream (east) of Main Street (Figure 4-58). Longitudinal data collection in the summer of 2017 found that the DO levels downstream of the dam at Main Street were better than the levels at any other crossing. This was likely due to mechanical aeration of the water as it flows over the dam. Though the stream has a defined channel downstream of the dam, the DO levels were lower at the two furthest downstream crossings (CSAH 5 and CSAH 92). At CSAH 92, there is an enlarged, deep, stagnant scour pool immediately downstream of the culvert. The stagnation of water within that pool could have affected DO levels. Further investigation of the extent of the problem is recommended. In 2018 during a sampling event, RLWD staff discovered an excavation of the Clear Brook channel between Main Street North and Tower Street NW (CSAH 5), that was an unpermitted (violation) extension of an upstream excavation project that the DNR had issued a Public Waters Permit for sediment to be removed from the stormwater pond upstream of Main Street North.

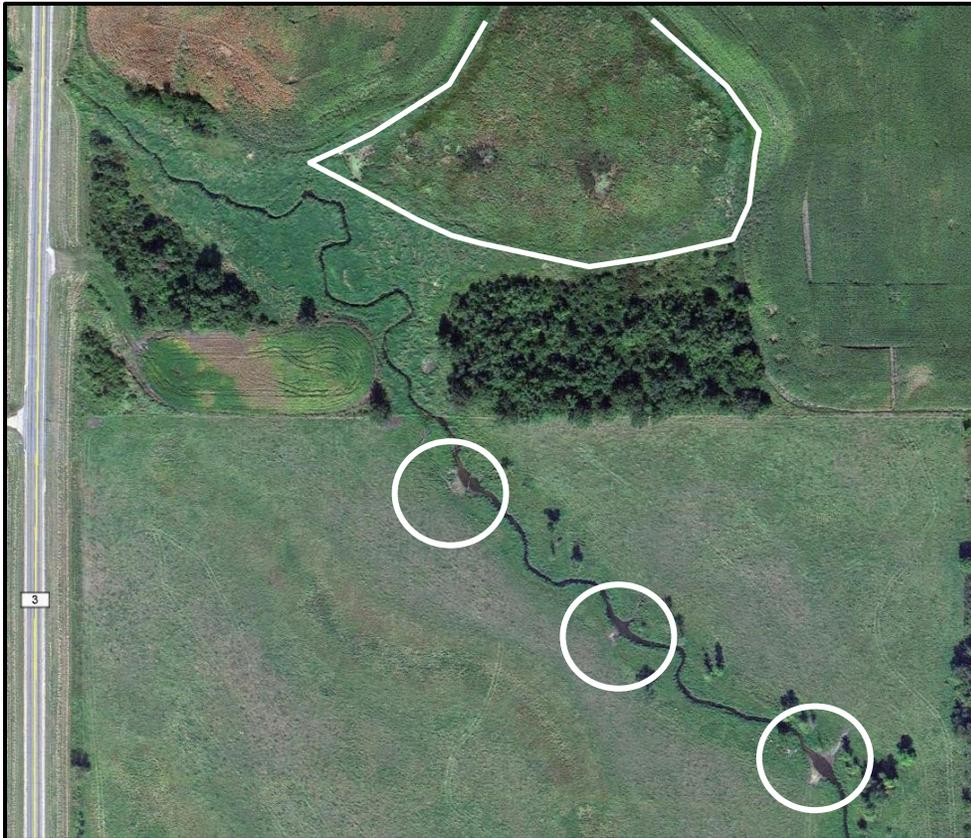
Figure 4-71. Potential wetland restoration area and cattle crossings along the Hill River (AUID 655) upstream of CSAH 3.

fish passage barriers that might result from the obstruction of flow. The effect on drainage for upstream landowners and current drainage benefits of CD 68 would need to be considered during a discussion of on-channel restoration. Based on the topography and aerial imagery (no ground-truthing), there appears to be an outline of a 3.5-acre basin that could be targeted for an off-channel restoration (Figure 4-71). The possibility of a stream restoration project with the construction of meanders could also be explored (Figure 4-72).

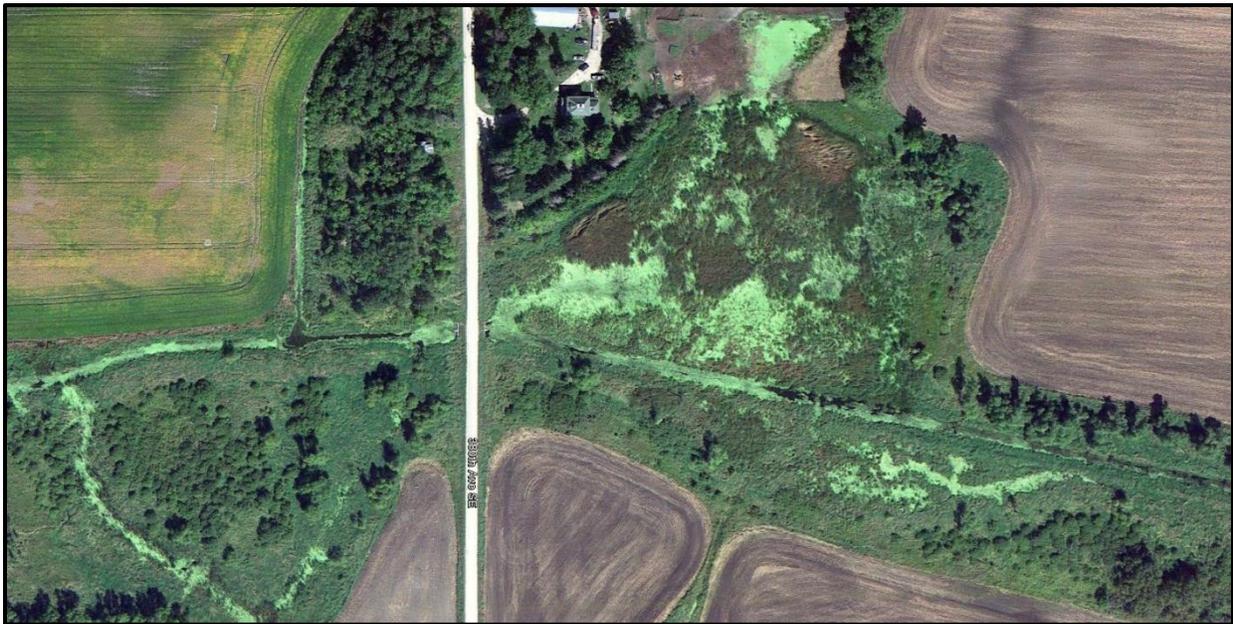
Figure 4-73. Stagnant water along the Hill River (AUIDS 655 and 656) and a drained wetland upstream of 380th Avenue SE

A portion of the Hill River was channelized between 340th Street Southeast and 380th Avenue Southeast as part of Polk County Ditch 81 (CD 81). The DO levels decreased dramatically along that reach. Aerial photos indicated that water in the channel was stagnant, particularly near the 380th Avenue crossing (Figure 4-73). The apparent stagnation ended near the downstream end of the channelized, CD 81 portion of the Hill River where there was a significant change in gradient. The stagnation and possible eutrophication reappeared downstream in the NW $\frac{1}{4}$ of Section 32 and the NE $\frac{1}{4}$ of Section 31 of Eden Township in Polk County. The stagnant conditions could be exacerbated by beaver activity downstream (west) of 380th Avenue Southeast. Runoff from a livestock operation could be causing eutrophication in the Hill River and an adjacent wetland.

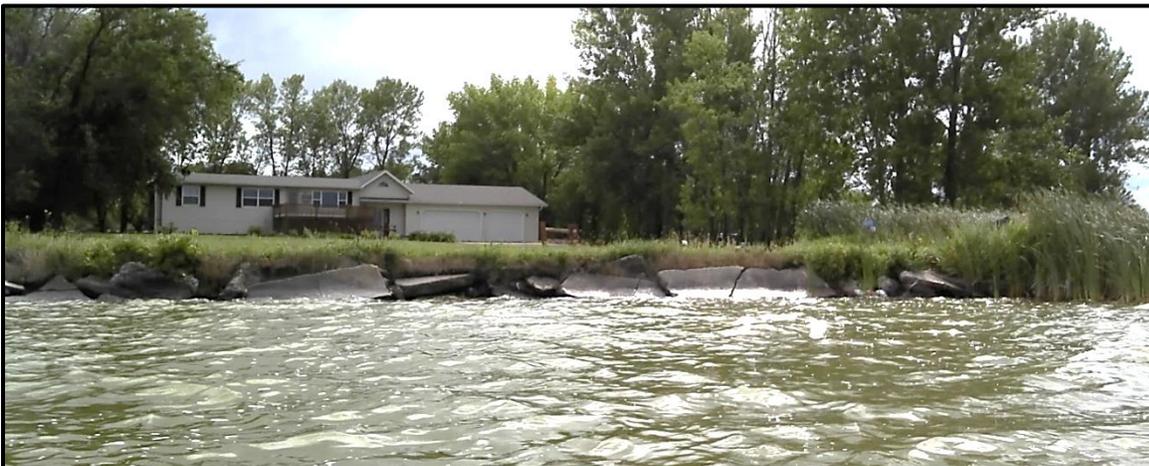
Figure 4-75. Erosion along the shore of Cameron Lake (60-0189-00)

Water quality in Cameron Lake was heavily influenced by internal nutrient loading from nutrient rich sediments. Past sources of excess nutrients in the lake sediment included historical sewage and historical creamery wastewater that was discharged into the lake. Currently, stormwater from the city of Erskine (Figure 4-74) and minor shoreland erosion (Figure 4-75) are the primary, identifiable, anthropogenic, external sources of pollution entering the lake.

minimal flushing of nutrients out of the lake. Flow into the lake is limited by the direct drainage area of the lake and flow through the outlet is minimal. Much of the developed lakeshore is lined with rock for toe-protection of the sloping shoreline. However, many residences have cleared away natural vegetation and have closely cropped lawns up to the edge of the shore. Loose rock has been used for landscaping in some locations and it will likely be washed into the lake. New construction has been completed very close to the lakeshore. Emergent vegetation has been removed along the shoreline, by spraying in some places, which could have increased the probability of shoreland erosion.

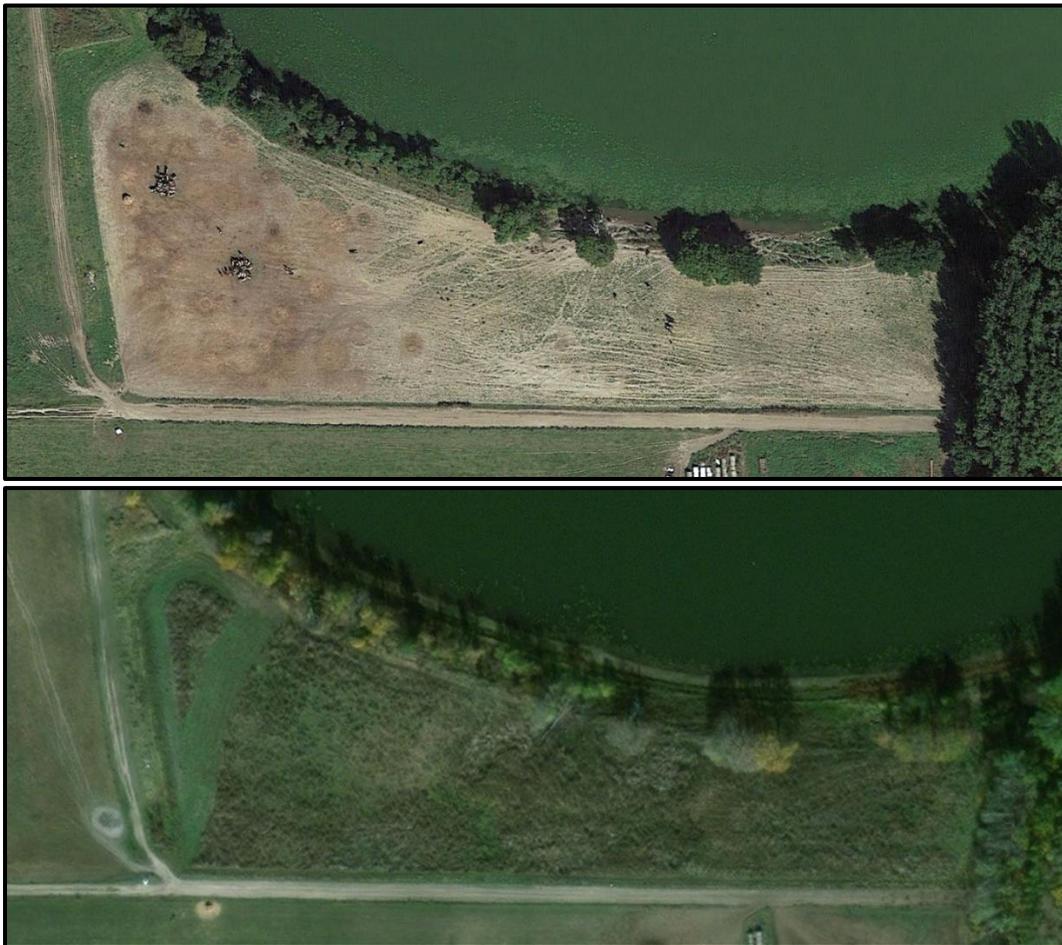
Figure 4-76. South shore of Stony Lake (15-0156-00) with cattle near the shore in 2011 (top) and well buffered in more recent years (bottom)

Historical runoff from a livestock operation and ongoing runoff from cultivated fields were the most likely sources of the excess nutrients in Stony Lake. Aerial photos as recent as 2013 showed that cattle had access to the south side of the lake and grazed the land intensely enough to remove vegetation (Figure 4-76). The landowner has created a good buffer between the livestock and the lake in more
