January 2021

Clearwater River Watershed Total Maximum Daily Load

This is a plan for restoring waters throughout the Clearwater River major watershed that are impaired by total suspended solids, *E. coli*, low dissolved oxygen, low index of biotic integrity scores, and eutrophication.

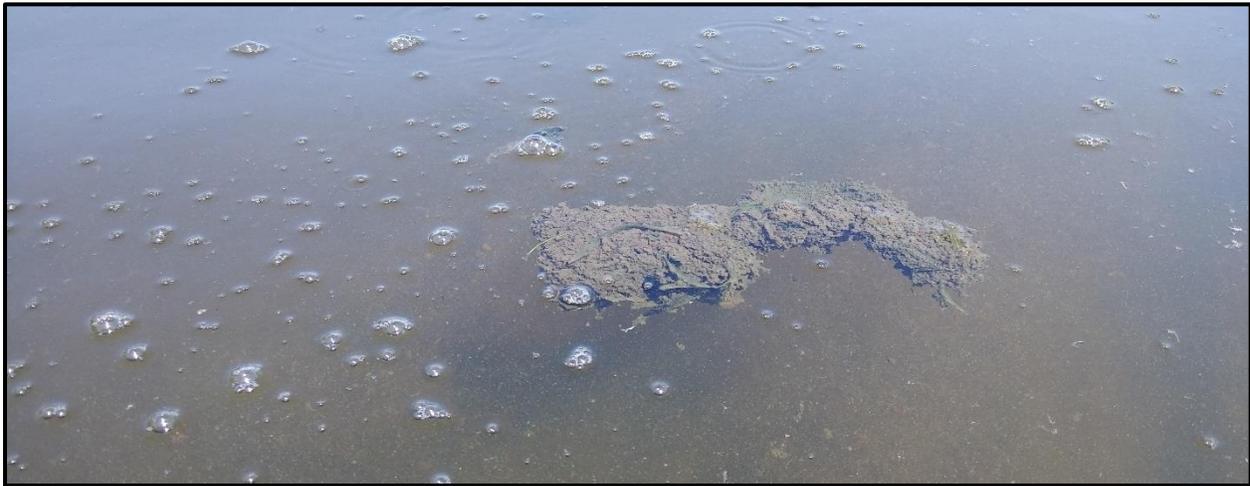
Figure 4-77. Floating clump of unidentified algae/bacteria/nostoc in Long Lake (04-0295-00)

Chunks of floating bacterial/algal clumps (Figure 4-77) were noted while sampling in the southwestern portion of the lake (near where the cattle operation was once located). There was some evidence of historical shoreline disturbance from cattle, but those areas were healing (revegetating). Additional monitoring, with landowner permission, is recommended to see if conditions in the lake improve with additional years without the presence of cattle. Samples collected during 2018 exploration of the lake met standards. Laboratory identification of the algae/bacteria in the floating clumps may also be helpful.

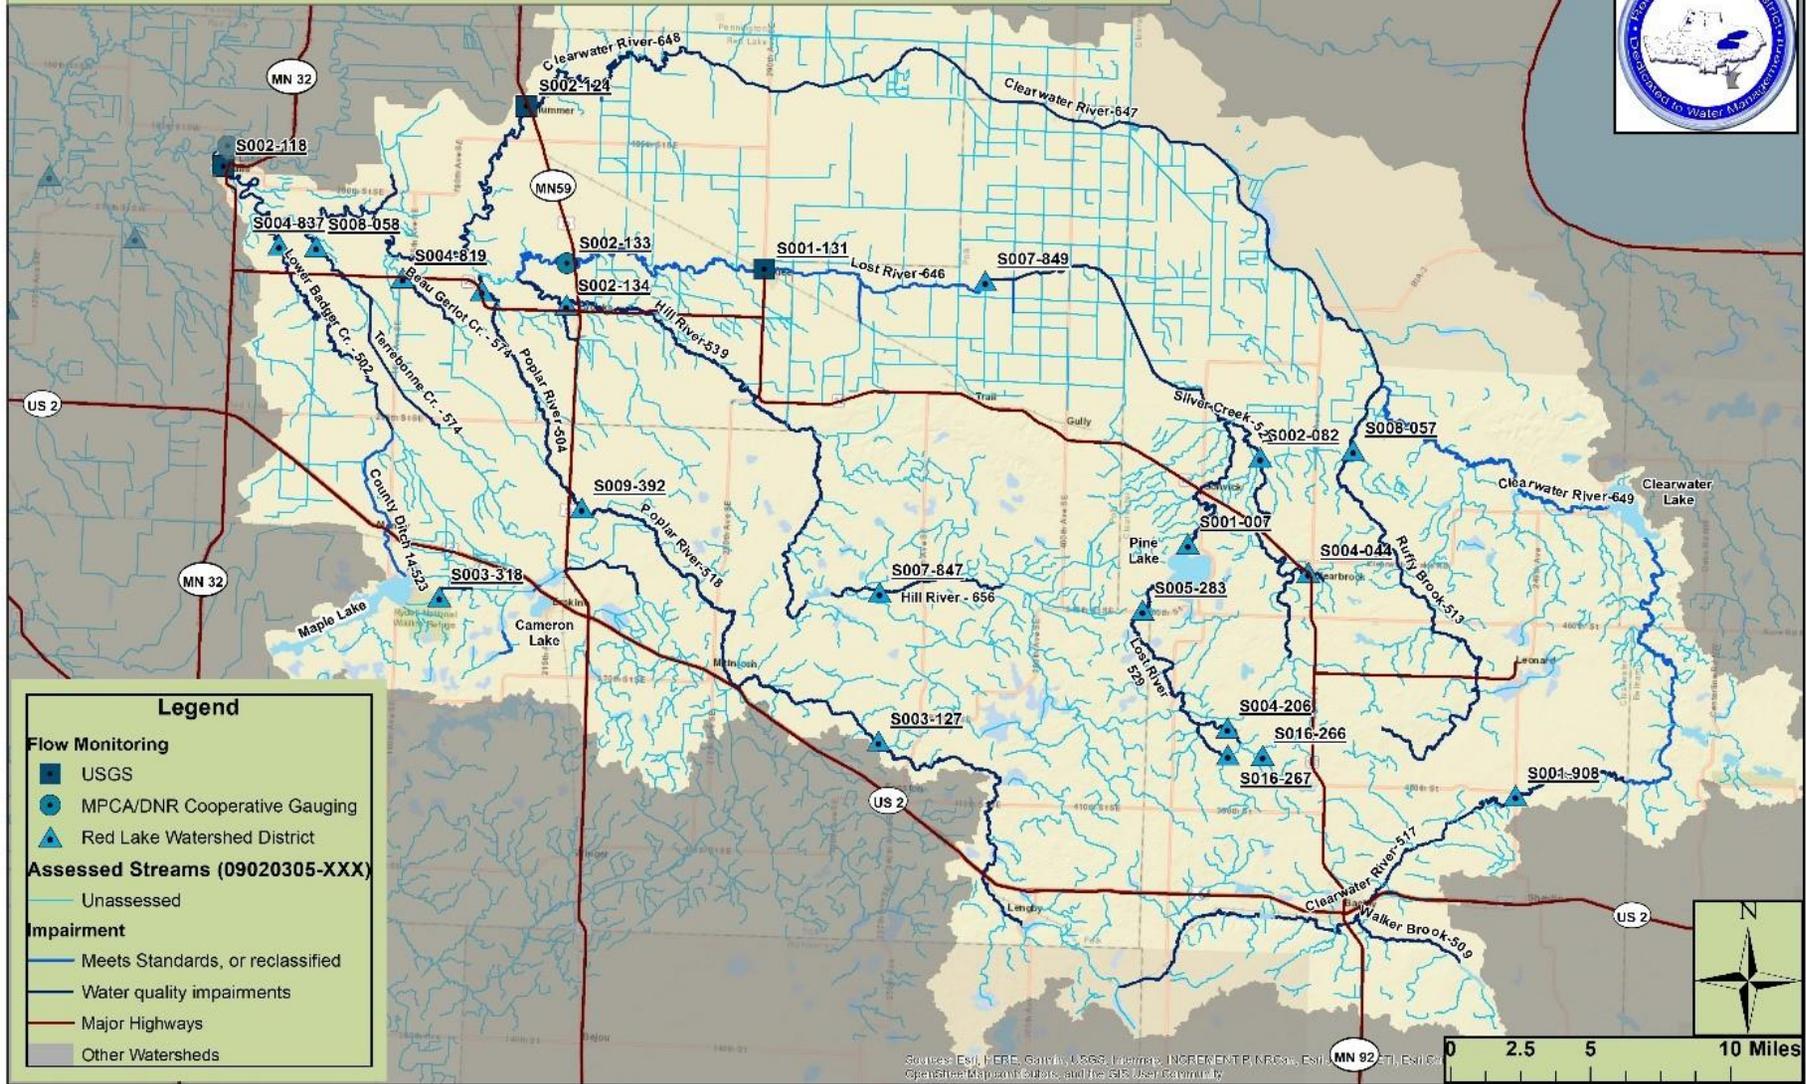
Clearwater River Watershed - 2017 Flow Monitoring Sites

Figure 8-2. Flow and stage monitoring stations in the Clearwater River Watershed, 2017 monitoring season

The map in Figure 8-2 shows that flow monitoring stations are located near the downstream end of most pollutant-impaired streams in the watershed. However, there are at least three impaired AUIDs that could use additional flow monitoring on the Clearwater River (AUID 647), Clear Brook, and the Lost River (AUID 512). Real-time stage and discharge monitoring stations have been installed in several locations along the Clearwater River and its tributaries. The DNR/MPCA Cooperative Gauging Program also monitors several sites without the use of telemetry. Other significant reaches of the watershed are monitored with HOBO water level loggers by the RLWD (without telemetry).
