# The status of Coldwater fish in Dunka River, a protection-priority stream in northern Minnesota

## Why is the stream reach being reviewed?

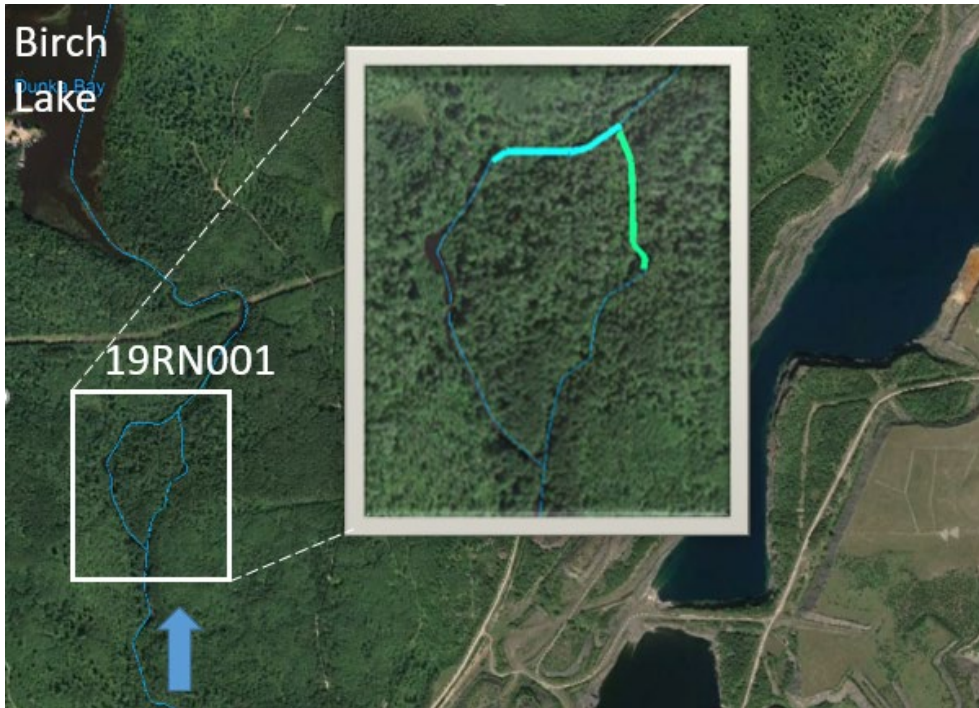
**Figure 1:** Fish were samples at station 19RN001, in a split-channel section of the Dunka River. Mine pits are located on both sides of the channel upstream of the station. The stream flow in a northern direction (blue arrow) to Birch Lake. The reach was sampled on the river-right (green line) and river-left (blue line). Latitude/Longitude: 47.71078/-91.87025

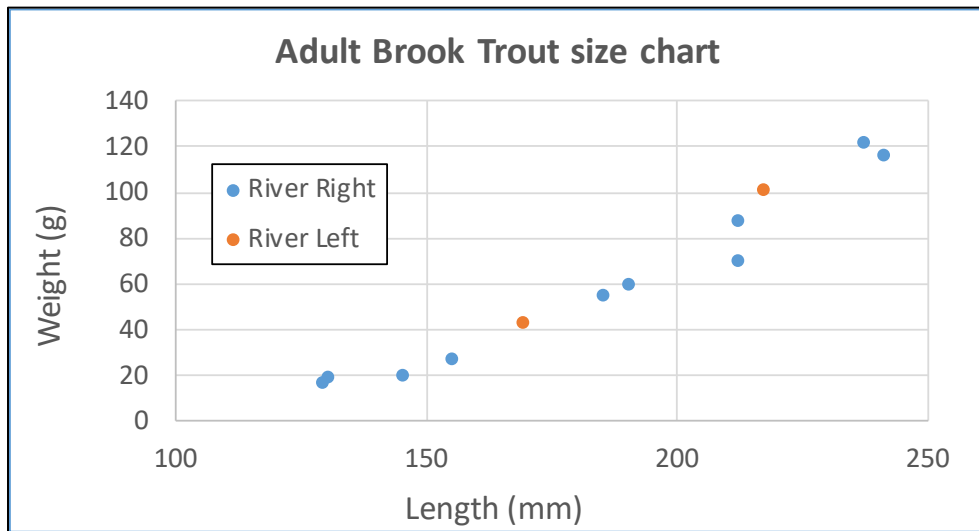
**Figure 2: Size distribution of adult Brook Trout captured at 19RN001. Colors indicate location of capture, river-right or river-left.**

Ten fish species (Table 1) were sampled at biological station 19RN001. Cold/Coolwater species accounted for over 73% of the individuals, which included Brook Trout, Sculpin, Longnose Dace, and Blacknose Dace. Both adults and young-of-year Brook Trout were captured with the majority found in the river-right channel where the stream width was narrower, pools were deeper, and cover (canopy and instream) was extensive. The presence of both young-of-year and adult Brook Trout is evidence that the species is both natural reproducing and self-sustaining in this reach. Adult Brook Trout ranged in size; distributions are shown in Figure 2. Sculpin, another sensitive Coldwater species, were sampled only on the river-right. Smallmouth Bass, a Warmwater species not typically sampled in the described community, accounted for less than 5% of the sample and were only captured on the river-left. All bass were young-of-year, likely present in the stream due to the close proximity to Birch Lake.

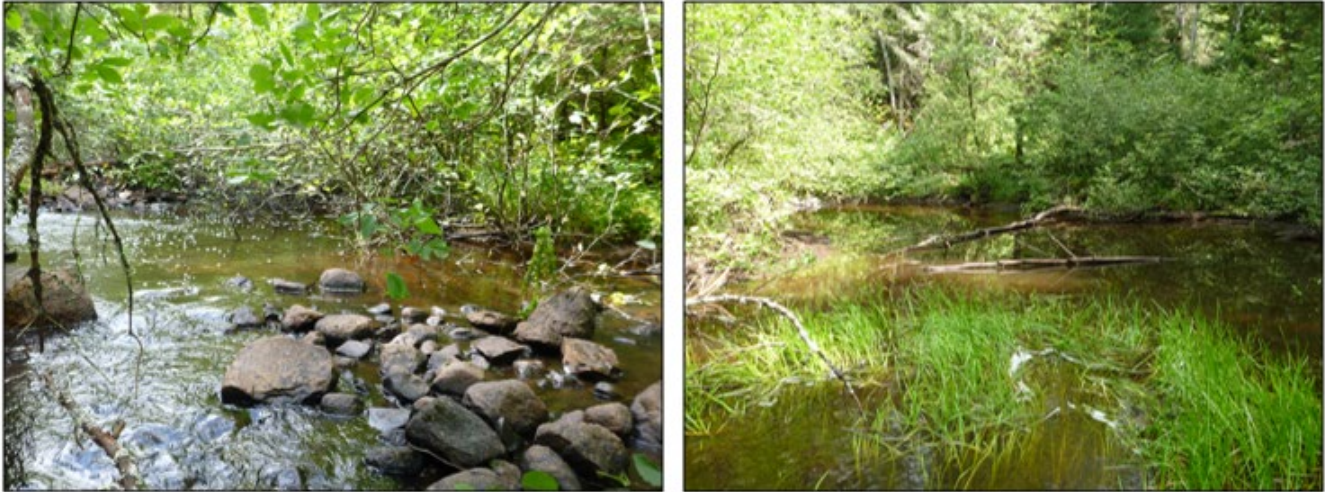
**Figure 3: Station 19RN001, River-right. Narrower braid with areas of fast (left) and slow (right) water velocities, good cover, and deep pools. Twenty-three Brook Trout were sampled and included both young-of-year and adult age classes.**

The fish habitat at this site is good, scoring 76.9 out of 100. The score was based on combined characteristics of the two braids (Figure 3 and Figure 4). Five categories contributed to the total score; they are land use, riparian, substrate, cover, and channel morphology. Land use scored fair, receiving half of the five possible points, because mining activities are adjacent to the otherwise forested/wetland environment. The stream riparian scored well (13/14) due to extensive buffer widths, intact banks, and moderate to heavy shading. The substrate scored well (22/28) due to an adequate variety of sizes including coarser sand, gravel, cobble, and boulders to finer materials such as silt and detritus. Little to no embeddedness of the coarser substrates by finer particles was observed which infers good substrate conditions for Brook Trout spawning. Instream cover was overall

moderate when considering the two branches together; although cover on the river-right was more extensive. Instream cover included overhanging vegetation, deep pools, logs, boulders, shallows, and macrophytes. Channel morphology was good (26/35) with deep pools, high channel stability, various stream velocity types (slow/eddies to fast), fair sinuosity, and good channel development contributing to the score. Beneficial aquatic vegetation included sedge, arrowhead, and wild celery.

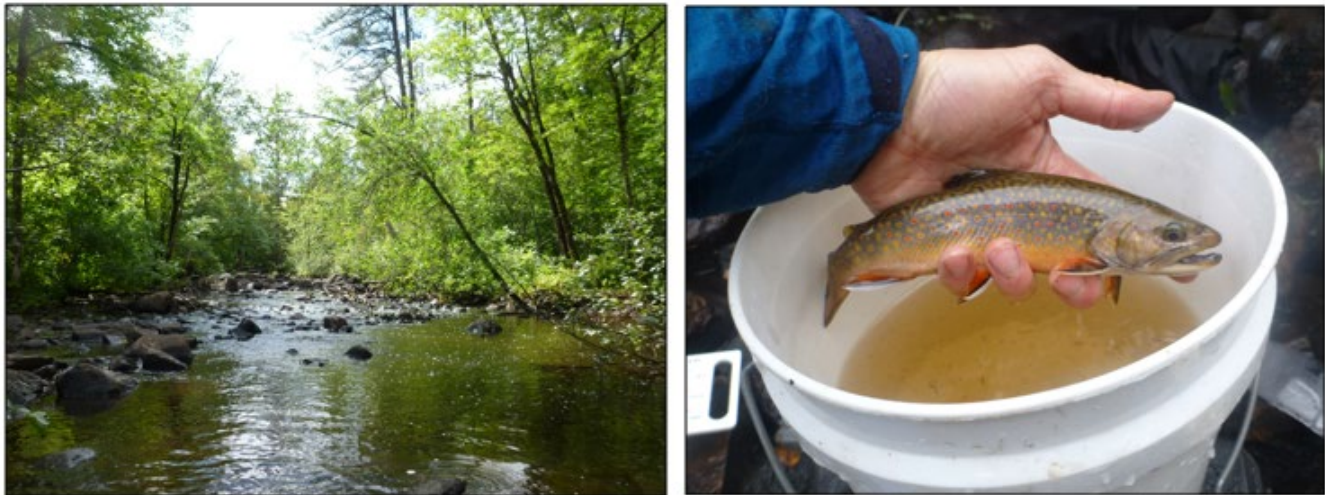
**Figure 4: Left image: Station 19RN001, River-left. Wider braid with less in-channel cover than the right braid. Two adult Brook Trout sampled. Right Image: Brook Trout sampled at 19RN001**
