Bois De Sioux River Watershed

Red River of the North Basin

Summary

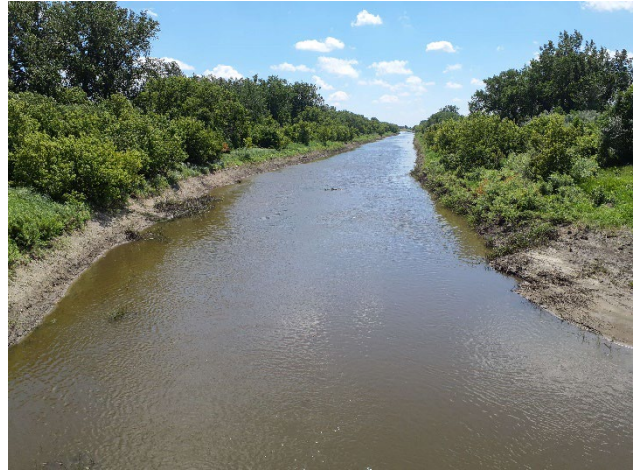
Figure 1. The Bois de Sioux River Watershed spans across Minnesota, North Dakota, and South Dakota. Flow proceeds from the elevated moraine deposits at the periphery of the watershed (red and yellow) to the flat Lake Agassiz Plain (green) where the Bois de Sioux River flows north to meet the Ottortail River in Wahpeton/Breckenridge. This report covers the Minnesota portion of the watershed, excluding the [Mustinka River](#) and its tributaries.

West of Campbell, the Bois de Sioux River meets the Rabbit River which, along with its tributaries, drains much of the Minnesota portion Bois de Sioux Watershed (Figure 1). The North Ottawa Impoundment collects flow from much of the headwaters of the Rabbit River via the Judicial Ditch 12 network and Grant County Ditch 22. Very little assessable data has been collected above the North Ottawa Project due to low flow conditions during the summer. Water from the North Ottawa Project can be released through two different outlets. On the west side of the impoundment, Judicial Ditch 12 is used in response to spring draw-downs and flood events. Judicial Ditch 2, on the north side of the impoundment, serves as the primary outlet and connects with the mainstem of the Rabbit River East of Nashua. Monitoring in 2021-22 corroborated existing aquatic life use impairments on Judicial Ditch 2 and Rabbit River, South Fork. The Rabbit River, South Fork is now impaired for aquatic life use based on low fish and macroinvertebrate IBI scores, low dissolved oxygen, and excess nutrient levels and turbidity. The Rabbit River itself is impaired for the same suite of aquatic life use parameters as well as aquatic recreation use due to excess *E. coli* levels. Both the South Fork and the mainstem of the Rabbit River are incised. Erosion along with excess nutrients from agricultural land use are major stressors for aquatic life in these systems. In 2022, the Bois de Sioux River Watershed District began construction of the Redpath Flood Impoundment & Mustinka River Rehabilitation Project in the neighboring Mustinka River Watershed. Once completed, these projects will create 23,000-acre feet of storage and reduce the frequency of overland flooding from the Mustinka River to the Rabbit River Basin. A reduction in overland flooding to the Rabbit River basin is likely to reduce peak flows within the Rabbit and Bois de Sioux Rivers, decrease sediment transport and help improve conditions for aquatic life. For more information on the Redpath Project see the [Bois de Sioux River Watershed District website](#).

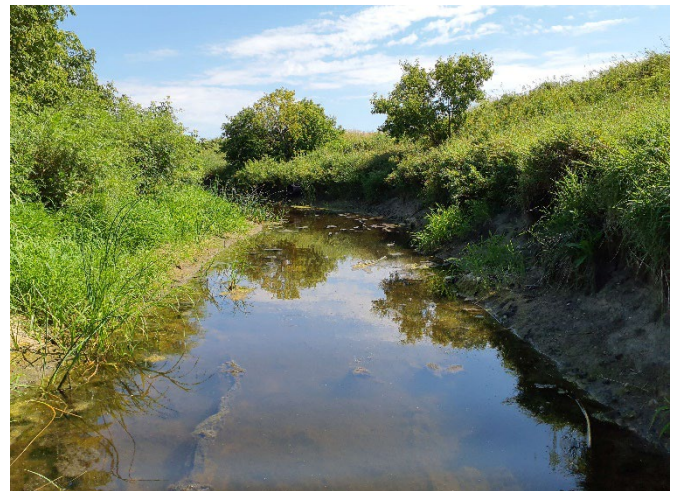
The Rabbit River directly upstream of Campbell, MN and the confluence with the Rabbit River, South Fork. Channel incision, bank sloughing, and excess nutrient load are water quality concerns at this site.

Grant County Ditch 22, east of Tintah. Levees divide the impoundment into nine pools which can be flooded, planted for agricultural production, or managed for migratory bird habitat. Profits from the agricultural land within the impoundments are used to fund its operation and maintenance. At full capacity, the impoundment offers 18,210 acre feet of flood storage which greatly reduces flooding risk locally and helps to reduce peak flows to the Bois de Sioux River. Since its construction, the impoundment has become a popular destination for birders. Over 200 species of birds have been observed at the impoundment, some of which are rarely observed elsewhere in Minnesota. For more information on the North Ottawa Project see the [Bois de Sioux River Watershed District website](#).

- The North Ottawa Project was completed in 2016. It's three-square mile series of impoundments collect water from a 74 square mile drainage including Judicial Ditch 12 and

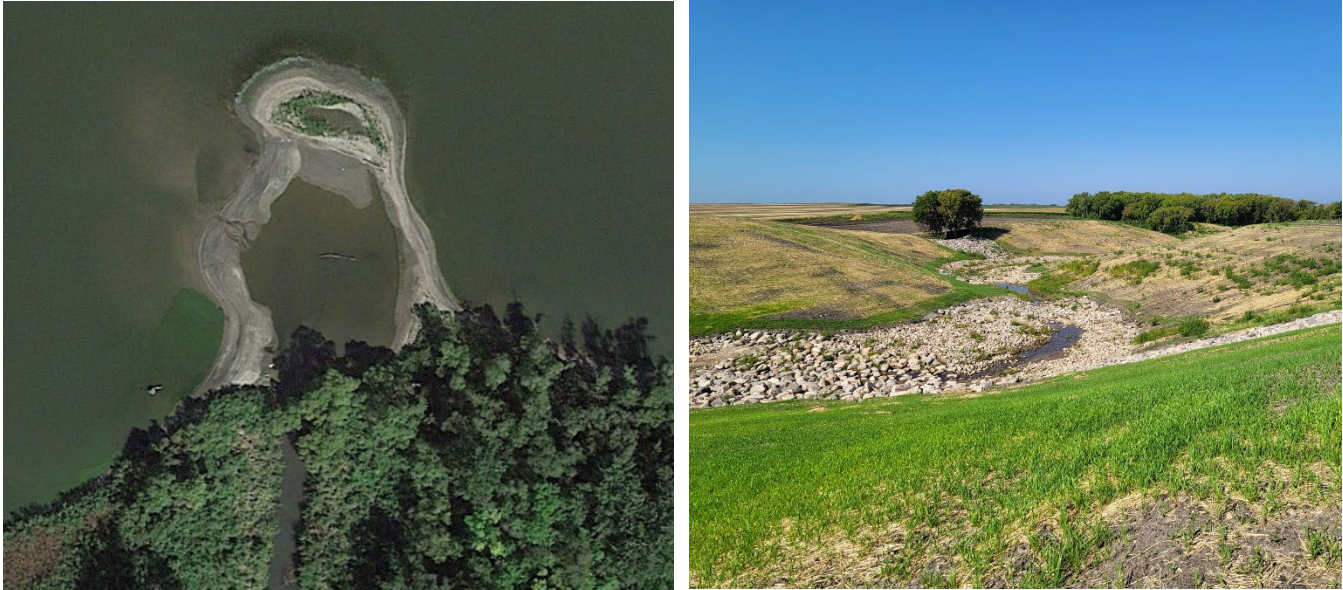
Left: Sediment plume is visible where TCD 52 meets Lake Traverse. Right: The TCD 52 above Highway 27 has been widened and armored to reduce erosion and stabilize the stream banks.

Traverse County Ditch 52 (TCD 52) was created in 1951 and connected a network of ditches and tributaries that drain 30 square miles of land on the east side of Lake Traverse. Flow from this expanded ditch network, when funneled through an undersized channel, rendered this system susceptible to severe erosion and a particularly dramatic precipitation event in the late 1950's dramatically destabilized the newly created ditch. Over time, erosion from TCD 52 has resulted in a sediment delta where it meets Lake Traverse and may contribute to the nutrient-related aquatic recreation use impairment on Mud Lake. In total, sediment loss from TCD 52 is estimated at more than four million cubic feet.

In the spring of 2020, the Bois de Sioux River Watershed District and Moore Engineering began work on the Lake Traverse Water Quality Improvement Project. This project was focused on reducing erosion on TCD 52 and sediment deposition in Lake Traverse. The first phase of this project in 2020 -2022 stabilized the failing banks and eroding channel bottom along the portion of TCD 52 below Highway 27. In 2023, streambanks upstream of the ravine and County Road 18 were stabilized. The channel has been re-graded, widened, and rock riffles were installed in both sections to provide greater habitat complexity.

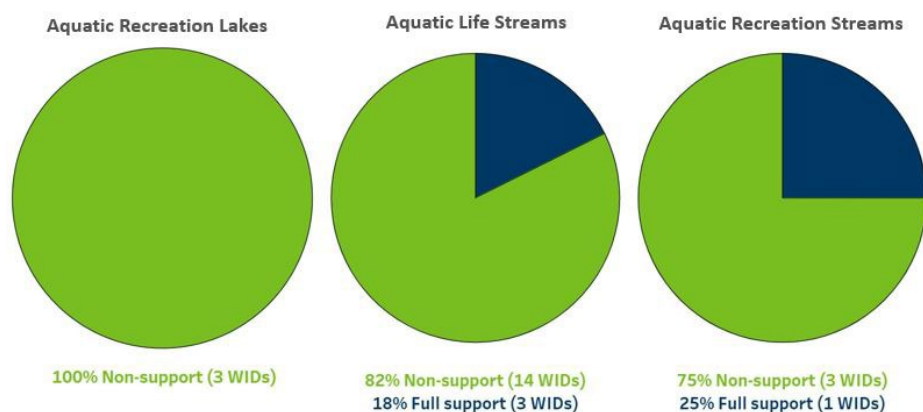
Figure 3. Bois de Sioux River Watershed assessment results for aquatic life use in streams and aquatic recreation use in streams and lakes. Aquatic life use was not assessed in any lakes within this watershed.

The MPCA determined that 82% of the stream reaches in the Bois de Sioux River Watershed that were assessed for aquatic life are impaired (Figure 3). Aquatic life use impairments caused by excess TSS, turbidity, nutrients and low dissolved oxygen levels are widespread, and fish and macroinvertebrate communities are significantly degraded, with few exceptions. Of the four stream reaches assessed for aquatic recreation use, three are impaired (Figure 3).

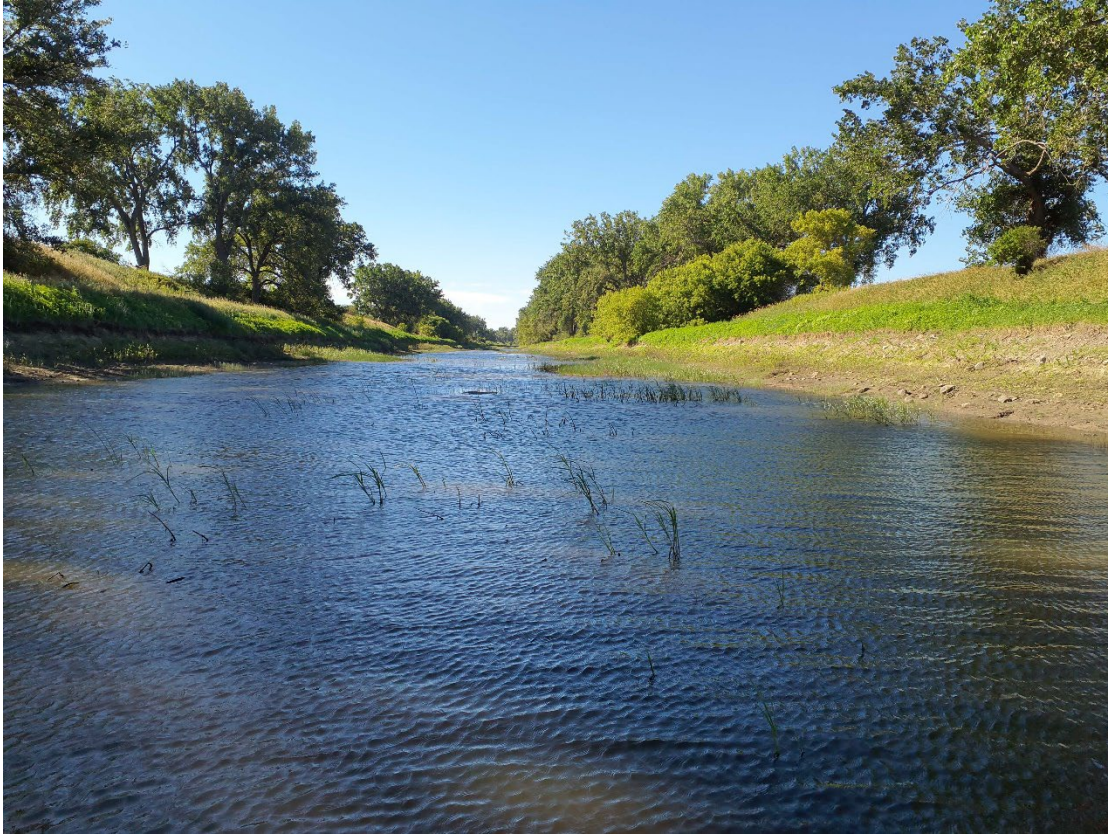
The Bois de Sioux River eight miles downstream of the White Rock Dam on August 3, 2022. Low depth variability and limited habitat complexity contribute to aquatic life use impairments on this channelized stretch of the Bois de Sioux River.

Downstream of White Rock Dam and upstream of its confluence with the Rabbit River, the Bois de Sioux River is impaired for aquatic life use due to low fish and macroinvertebrate IBI scores, low dissolved oxygen, excess turbidity, and excess nutrient levels. This stretch is also impaired for aquatic recreation use due to excess *E. coli* levels. Flows from the dam fluctuate drastically during the summer months. At times when flow from the dam is restricted, Big Slough, across the river in North Dakota, contributes most of the flow to this upstream stretch of the Bois de Sioux River. The entirety of this upstream stretch of the Bois de Sioux River is ditched, exhibits very limited depth variability, and generally limited habitat for aquatic life.
